# The results of an archaeological evaluation at the former Shepherd Neame Depot, Belvedere Road, Faversham, Kent.

**The Former Shepherd Neame Depot, Belvedere  
Road, Faversham,  
Kent**

**Archaeological Evaluation**

**Site Code: BRF07**

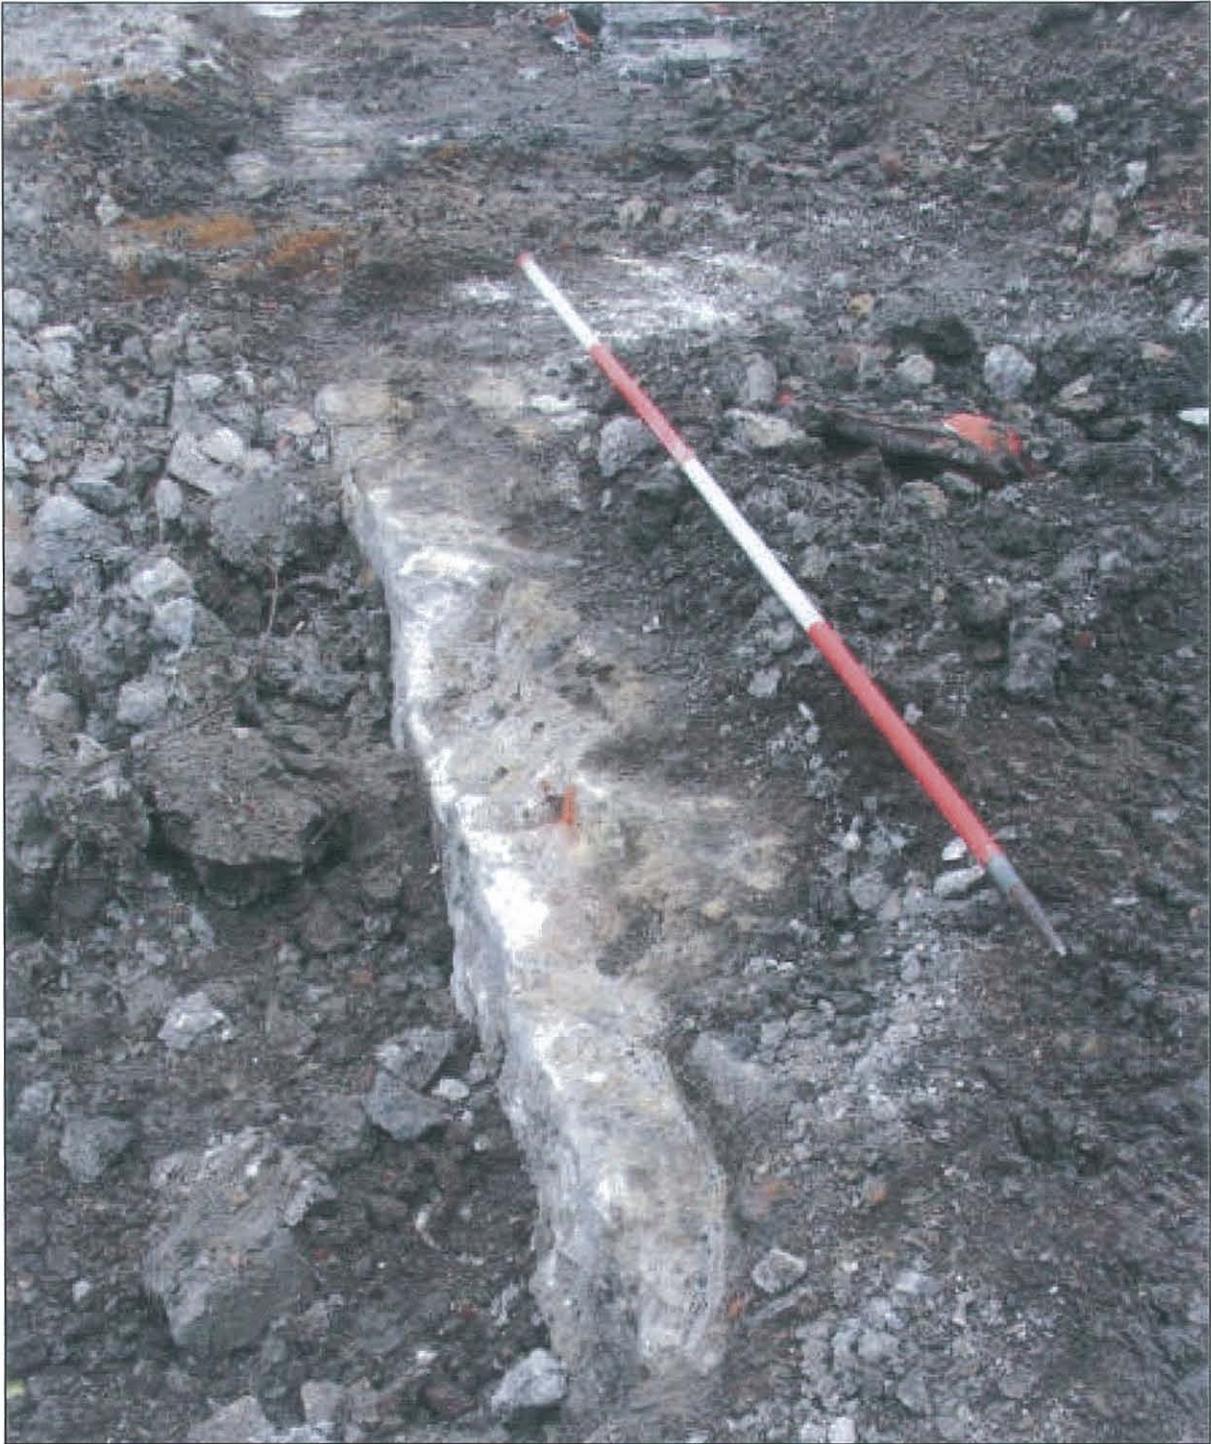
Plate 1. Medieval wall (11).

Excavations associated with the demolition and removal of hardstanding areas confirmed the common upper stratigraphy of the site, comprising burnt brick rubble formation layers and surfaces. However, excavations adjacent to Trench 4 uncovered the upper courses of what appeared to represent a medieval wall on a northwest-southeast alignment. Careful investigation and cleaning of the feature exposed a length of 8m and width of 0.41m. The wall

(11), as shown in Plate 1 and on Figure 8, comprised random coursing bonded with a pale yellow lime mortar. Unfortunately high voltage electricity cables directly adjacent to the wall prevented further excavation (on health & safety grounds) so it was decided that the most appropriate and preferable form of mitigation would be to preserve the wall in situ. The upper facing of the wall, which appeared to be later additions, were exposed at a level of c.4m AOD. This meant that construction layers associated with the proposed road (finished ground level c. 4.5m AOD) would provide a sufficient protective layer. As a result it was agreed that the wall was to be covered and protected prior to backfilling, and thus remain in situ. A Geotex liner and fine grain sand were placed over the wall, providing a cushion from overlying Type I hardcore. The location of the wall, along with associated levels, is shown on Figure 8.

With the exception of a possible medieval wall, the evaluation carried out at the former Shepherd Neame Depot, Belvedere Road, Faversham did not encounter any archaeological remains, suggesting that none survive within the immediate vicinity of the site. The exposed upper section of a ragstone wall was exposed and initial examination of the construction methods and material provisionally suggested a medieval date. The orientation of the structure, along with its proximity to Faversham Creek and the Abbey, suggest that the wall may have formed part of an establishment similar to the 'ribbon development of merchant's houses was built along the spine of the Thorne peninsula' (Wilkinson 2006:9) 'probably with cellars and warehouses built on the east bank of Faversham Creek, along the line of Abbey Street and Court Street (Kent County Council 2004:13). That said, archaeological evidence found to date suggests that such structures would have been half-timbered (Paul Wilkinson *pers comm.*). This, however, could not be confirmed as health & safety issues prevented further investigation. As a result it was decided that the most appropriate and preferable form of mitigation would be to preserve the wall in situ.
