Archaeological Evaluation at 87 London Road,  
Sittingbourne, Kent

LRS-EV-14

# Archaeological Evaluation at 87 London Road, Sittingbourne, Kent

Site Code: LRS-EV-14

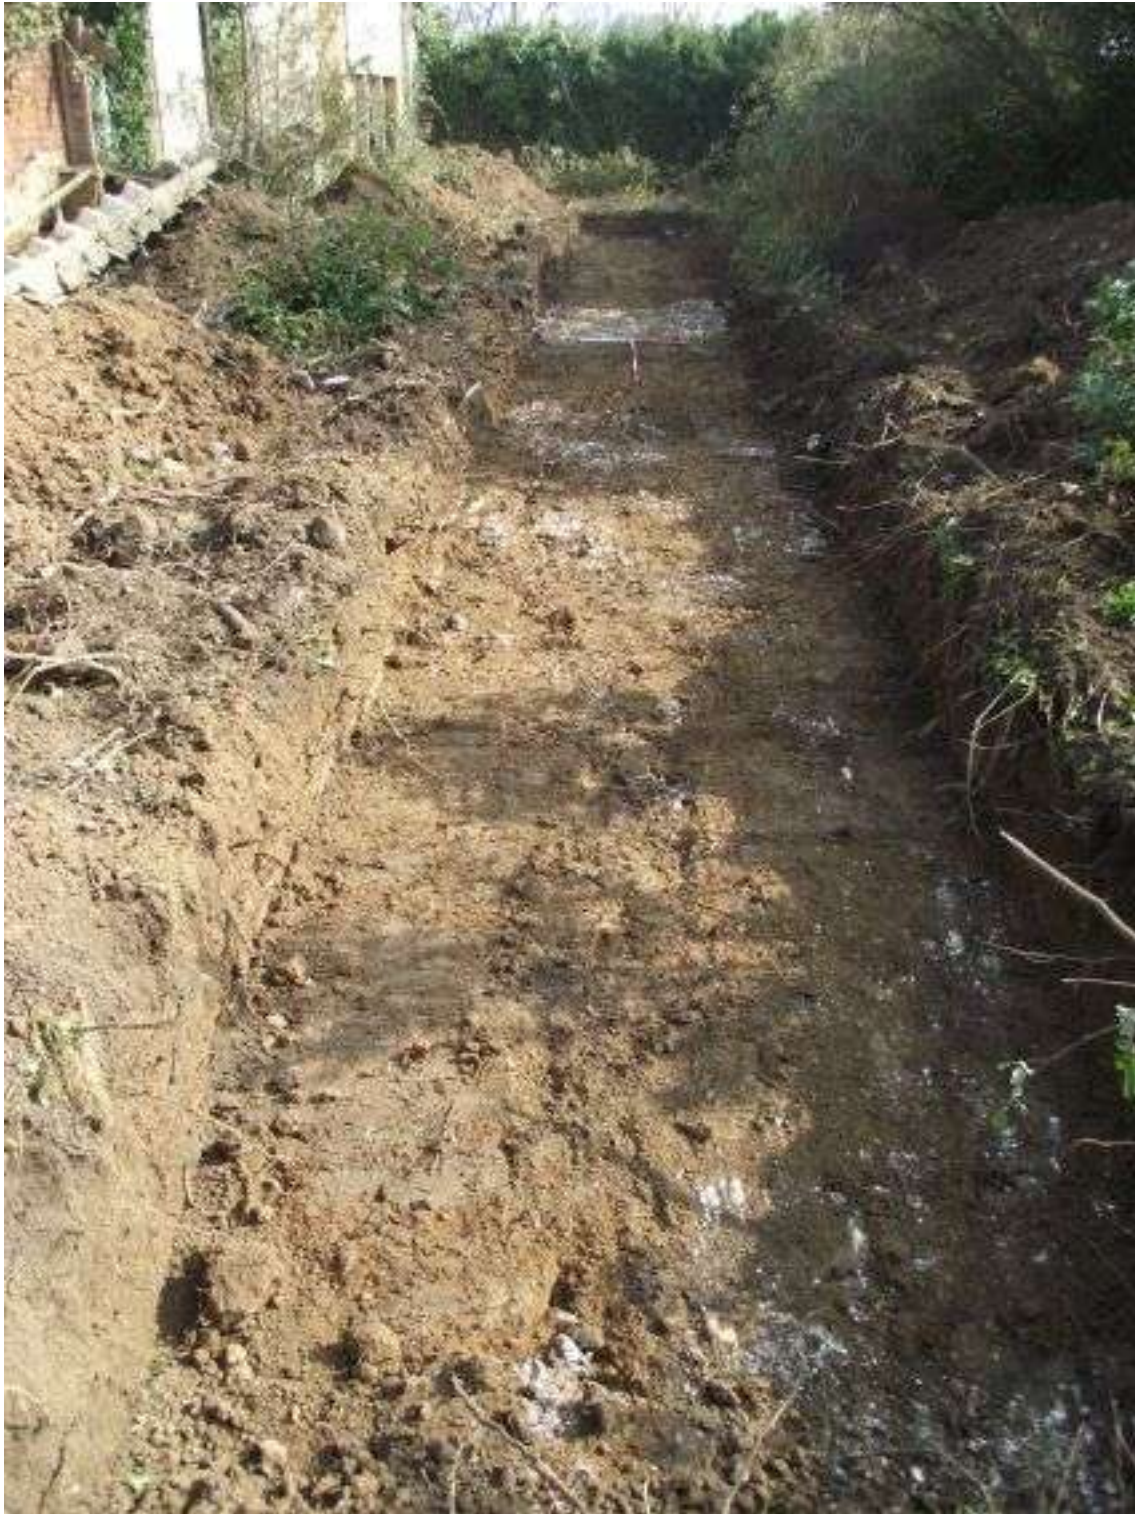
Plate 3 Trench 1 - General shot looking southeast

Trench 1 was located in close proximity to the south-western side of the fire gutted house, with only 2.4m distance between the trench and the bay window (Plate 3). This trench, aligned northwest – southeast, was located within the possible vicinity of the smock windmill, and excavation revealed what may have been the foundations for the circular footings of the mill. The feature **[005]** measured 2.20m in length and 1.70m wide. Due to the trench's close proximity to the structurally unstable shell of the burned out house, the feature was only partially excavated to a depth of 0.40m (or 0.80m below the present ground surface), but one fragment of brick was found at the base of the eastern edge of the cut. The fill **(004)** consisted entirely of what appears to have been freshly quarried chalk and associated medium to large flint nodules, and was virtually sterile of inclusions except for the one small sherd of brick. Feature **[005]** cut the natural drift geology **(003)** and was sealed by subsoil **(002)** which was up to 0.22m thick in this trench. Topsoil **(001)** sealing the subsoil measured up to 0.32m thick. This area of the site was badly overgrown with brambles and shrubs, and the trench was heavily disturbed by roots.

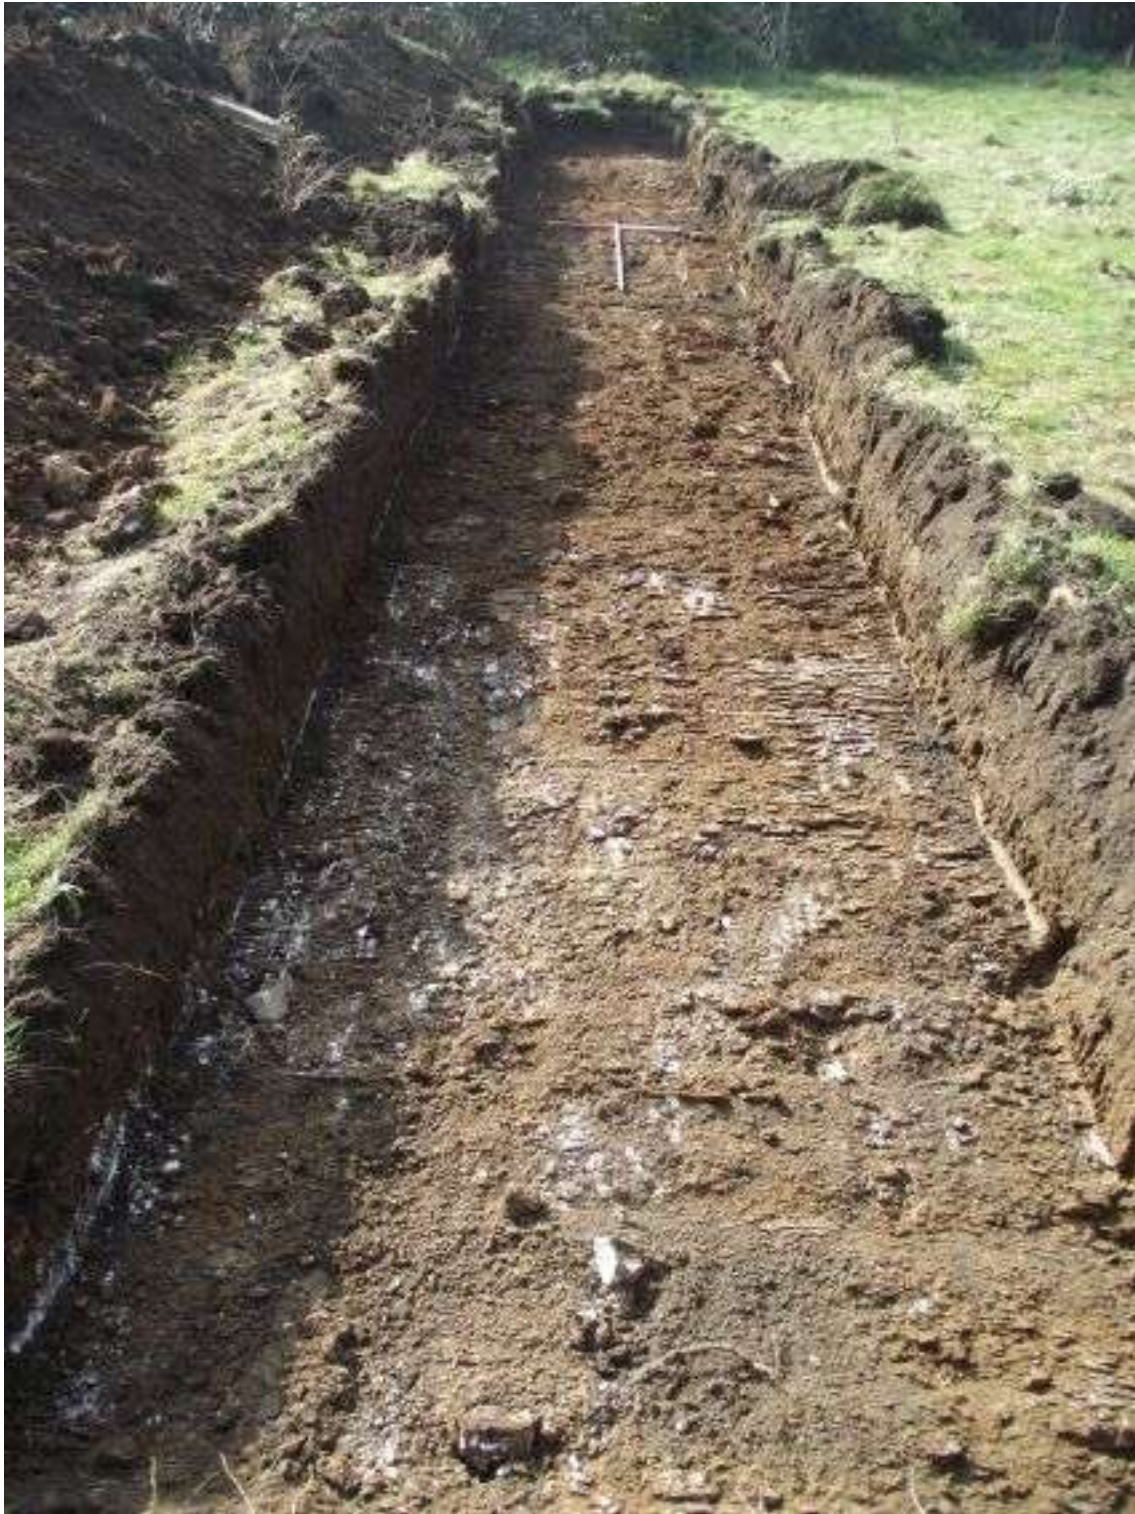
Plate 4 Trench 2 - General shot looking west-southwest

Trench 2 was located on the lawn to the rear of the property and aligned roughly east-northeast – west-southwest (Plate 4). No features were seen in this trench. The subsoil **(002)** measured up to 0.24m thick and the topsoil **(001)** measured 0.30m thick.

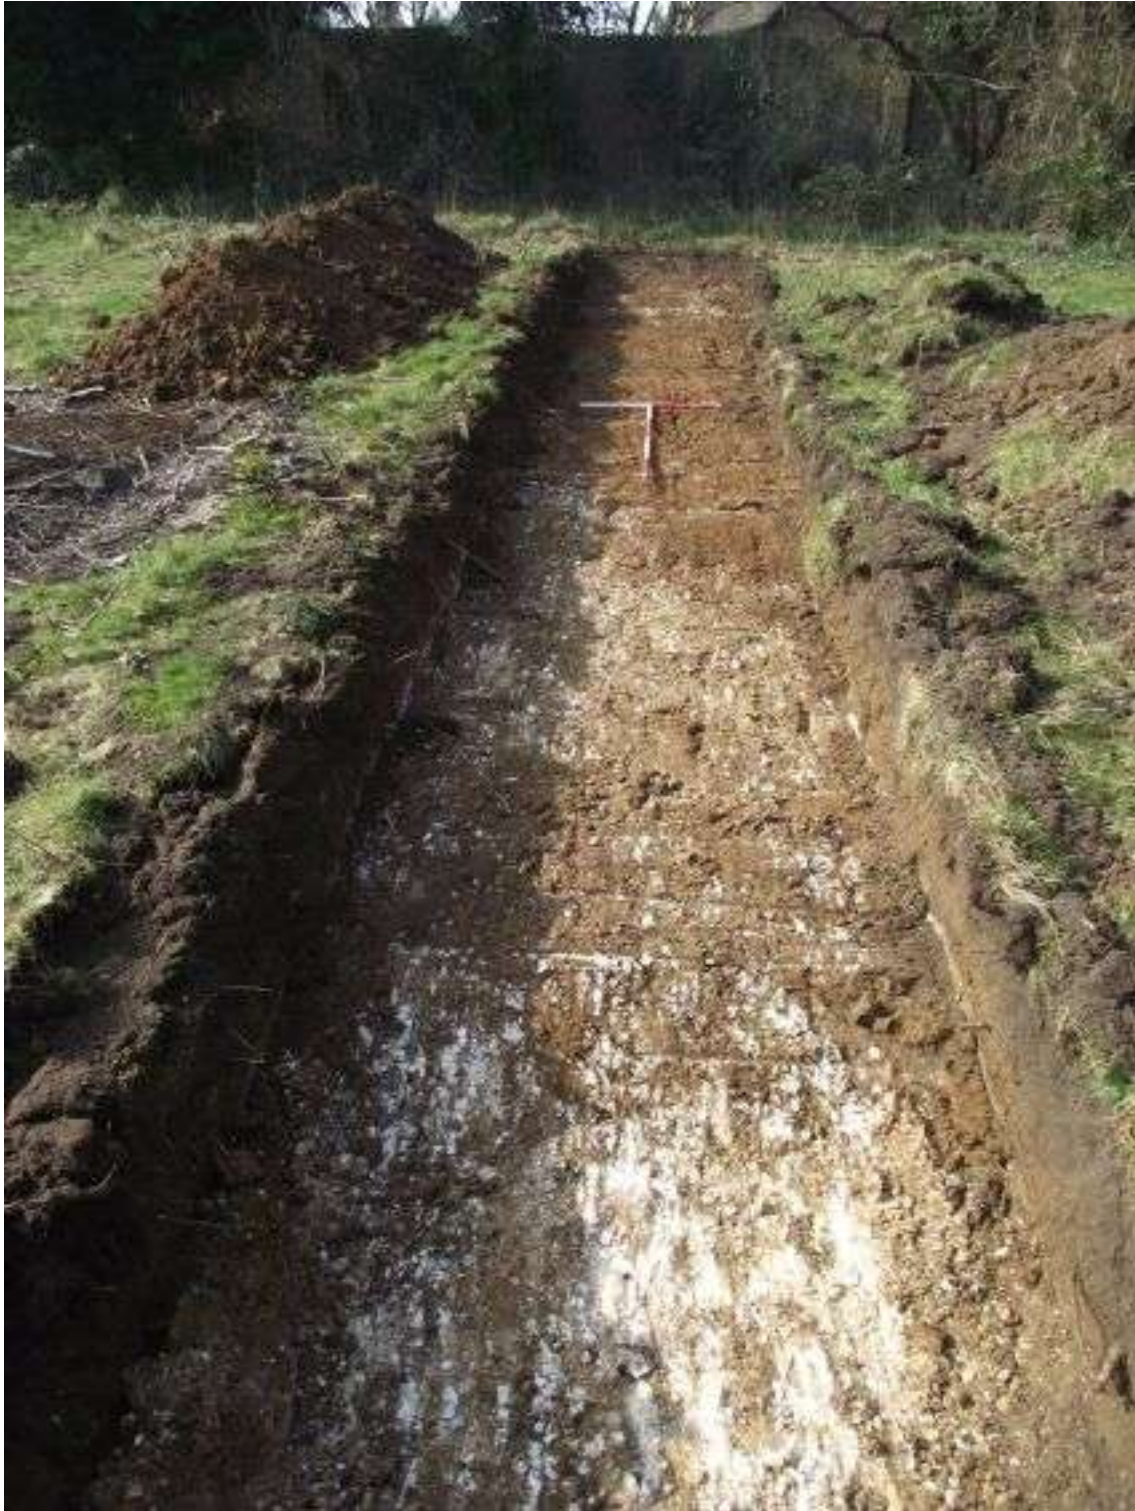
Plate 5 Trench 3 - General shot looking northwest

The natural chalk bedrock **(006)** was only exposed in a sondage in Trench 3 at a depth of 0.59 below the present ground surface (Plate 5). All the trenches contained areas where the degraded upper layer of chalk was seen to erupt through the natural drift deposit **(003)** which was composed of mid-reddish brown friable sandy silty clay with fine sands and

Trench was located at the far end of the rear garden and was aligned northwest – southeast (plate 5). One feature was exposed during the evaluation, and a sondage was cut at the southeast end of the trench to test the geology and identify the upper strata of the chalk

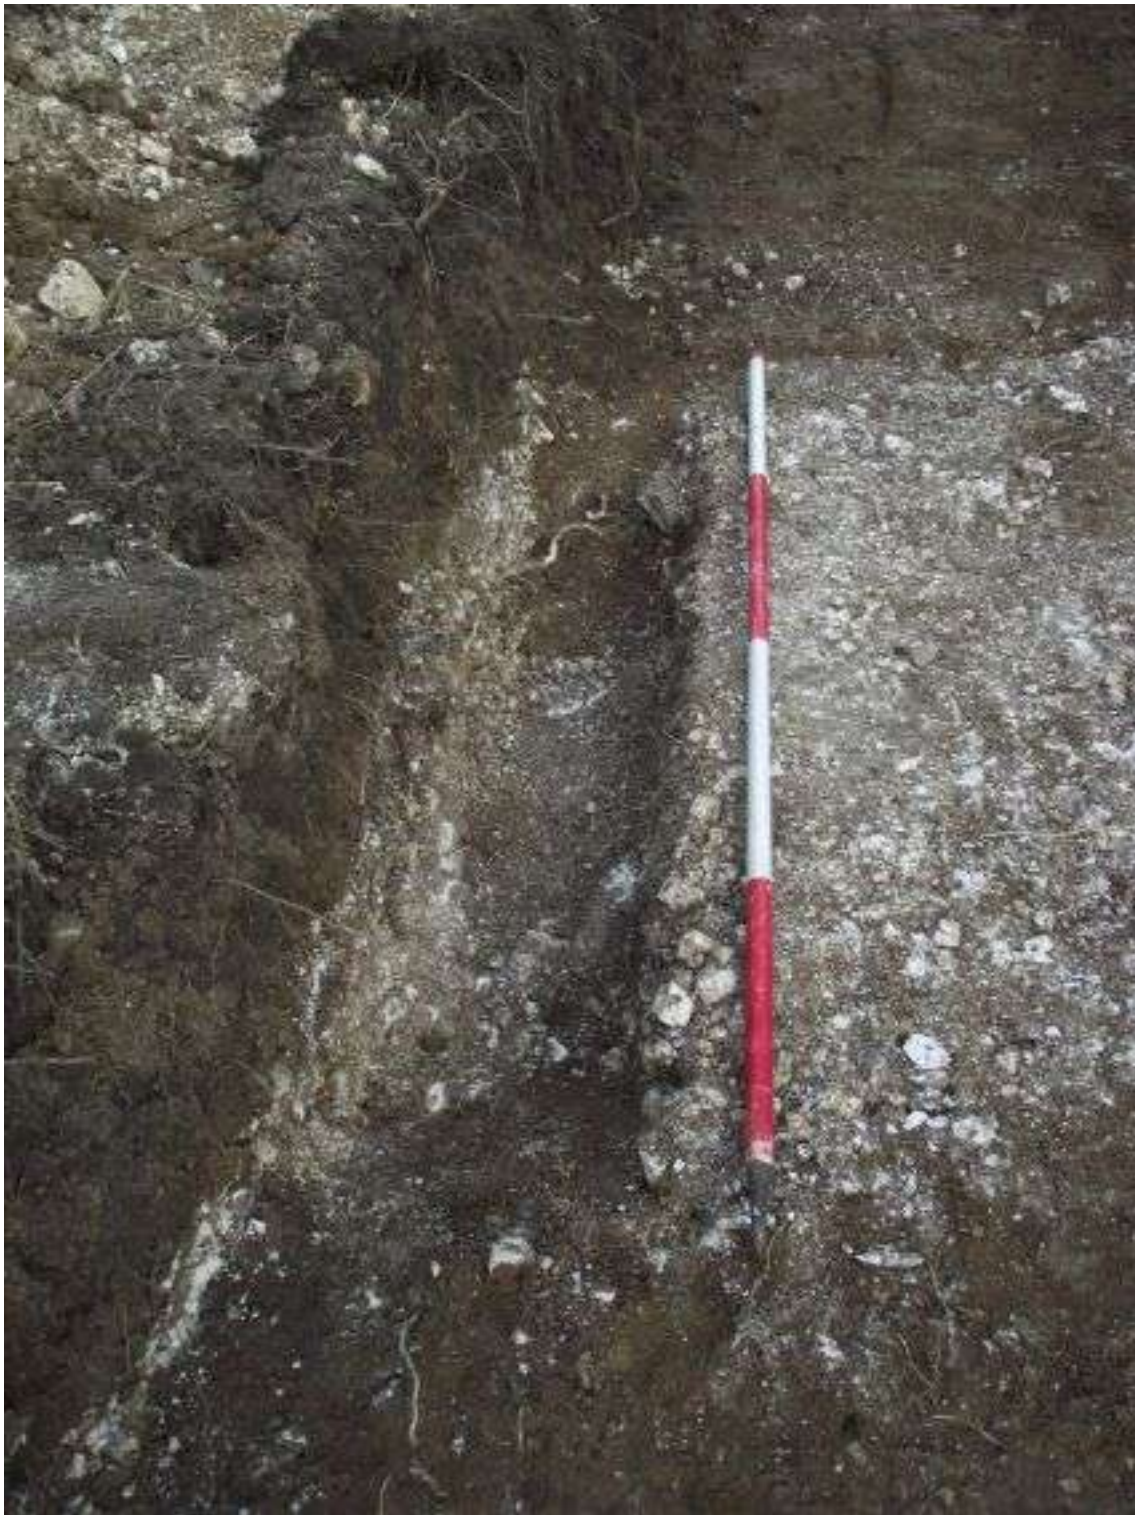
Plate 6 Trench 1 – Section of [005] looking southeast, 2m scale

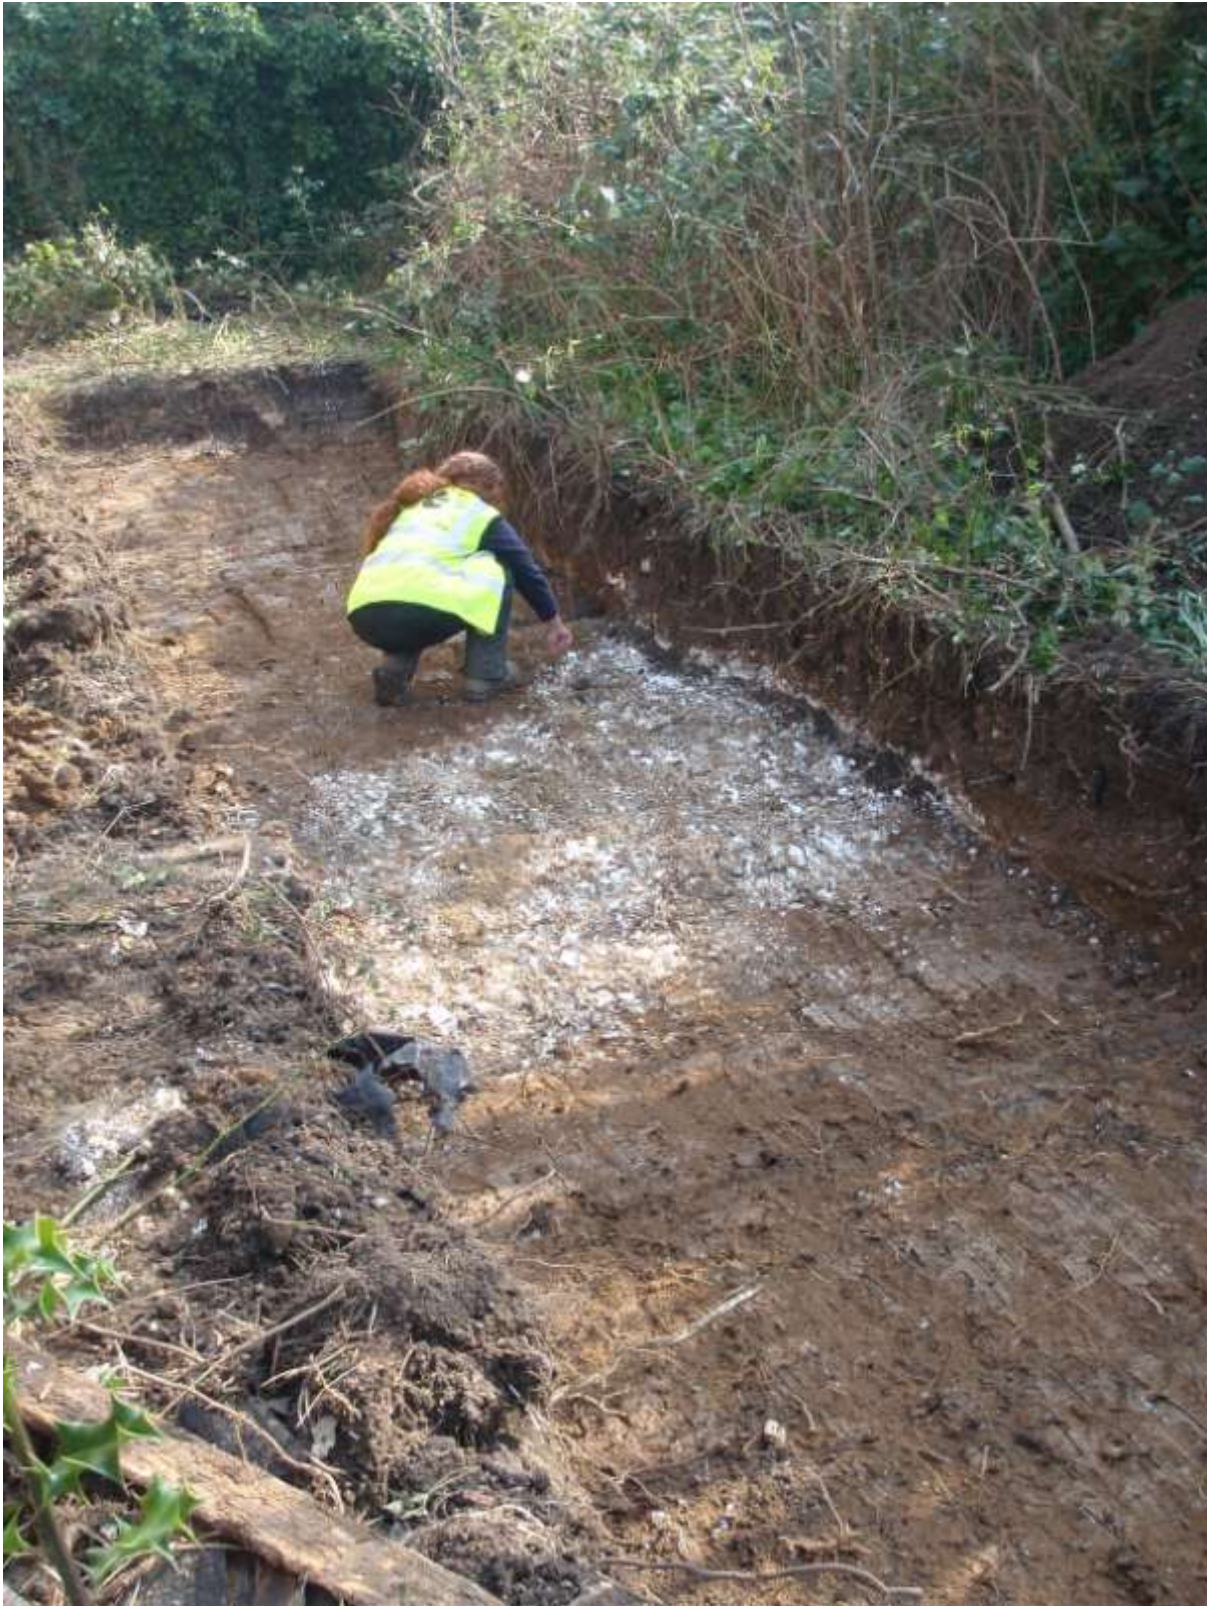
Plate 7 – Trench 1, looking south south-east

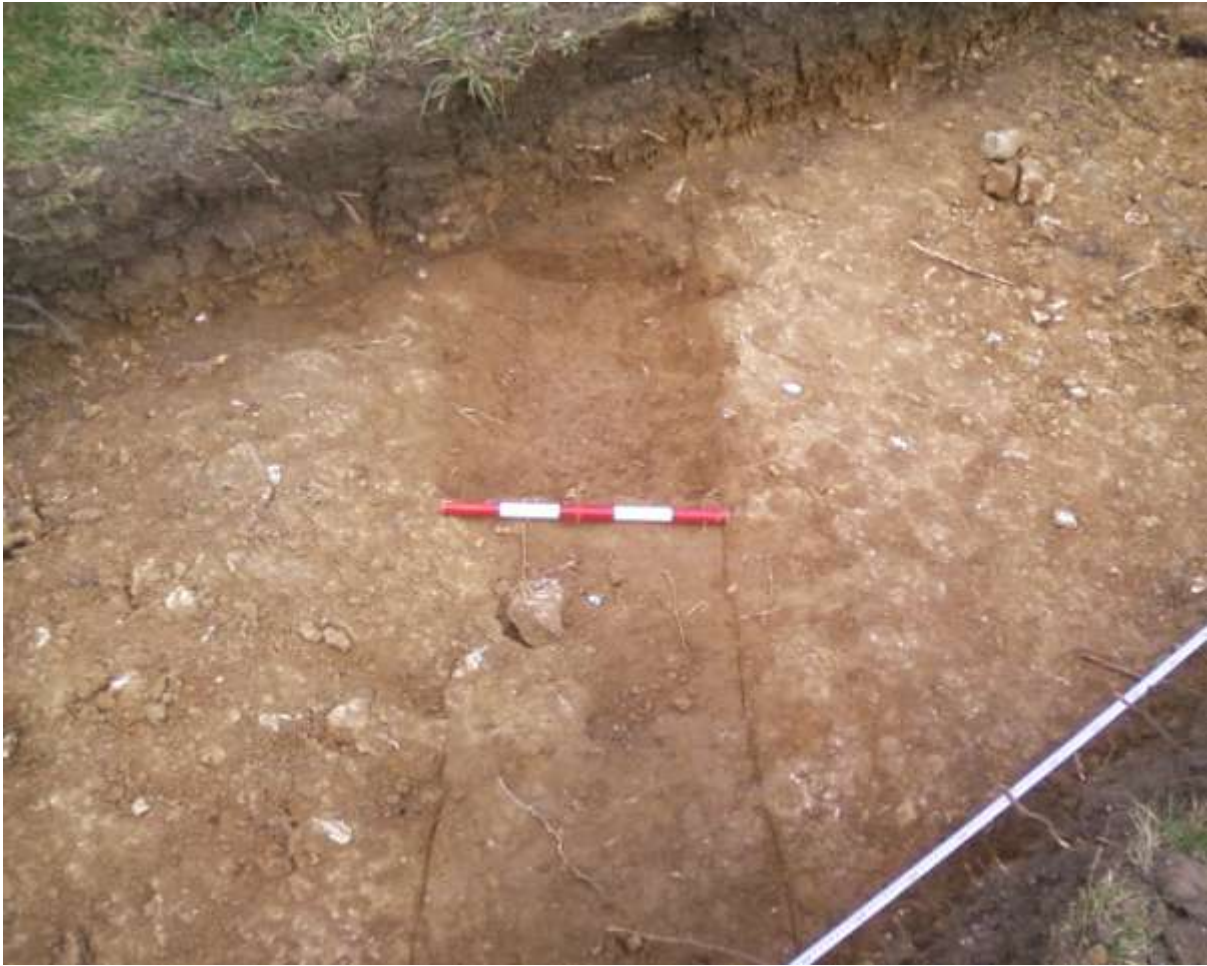
bedrock. The northeast – southwest aligned ditch **[007]** was 2.27m long, 0.50m wide and up to 0.12m deep with sharp breaks of slope, sides angled at approximately 55° and a concave base. The fill **(006)** of the ditch was composed of mid greyish brown firm clay silt with common small to medium flint nodules, rare small tabular flints and rare small flint pebbles. Finds in this context consisted of rare small struck flints and common sherds of flint tempered pottery dating from the Mid to Late Mid Bronze Age.. Also seen in Trench 3 at the extreme northwest end of the trench was a medium sized, up to 0.06m diameter, lump of daub or kiln material, although no apparent cut for a feature was visible. The depth of the drift geology **(003)** which overlay the chalk bedrock was up to 0.13m thick in the sondage and was covered by the subsoil **(002)** which was up to 0.23m thick. The topsoil **(001)** was approximately 0.23m thick.

Plate 8 – Trench 3, Linear [007] looking northeast, 0.50m scale

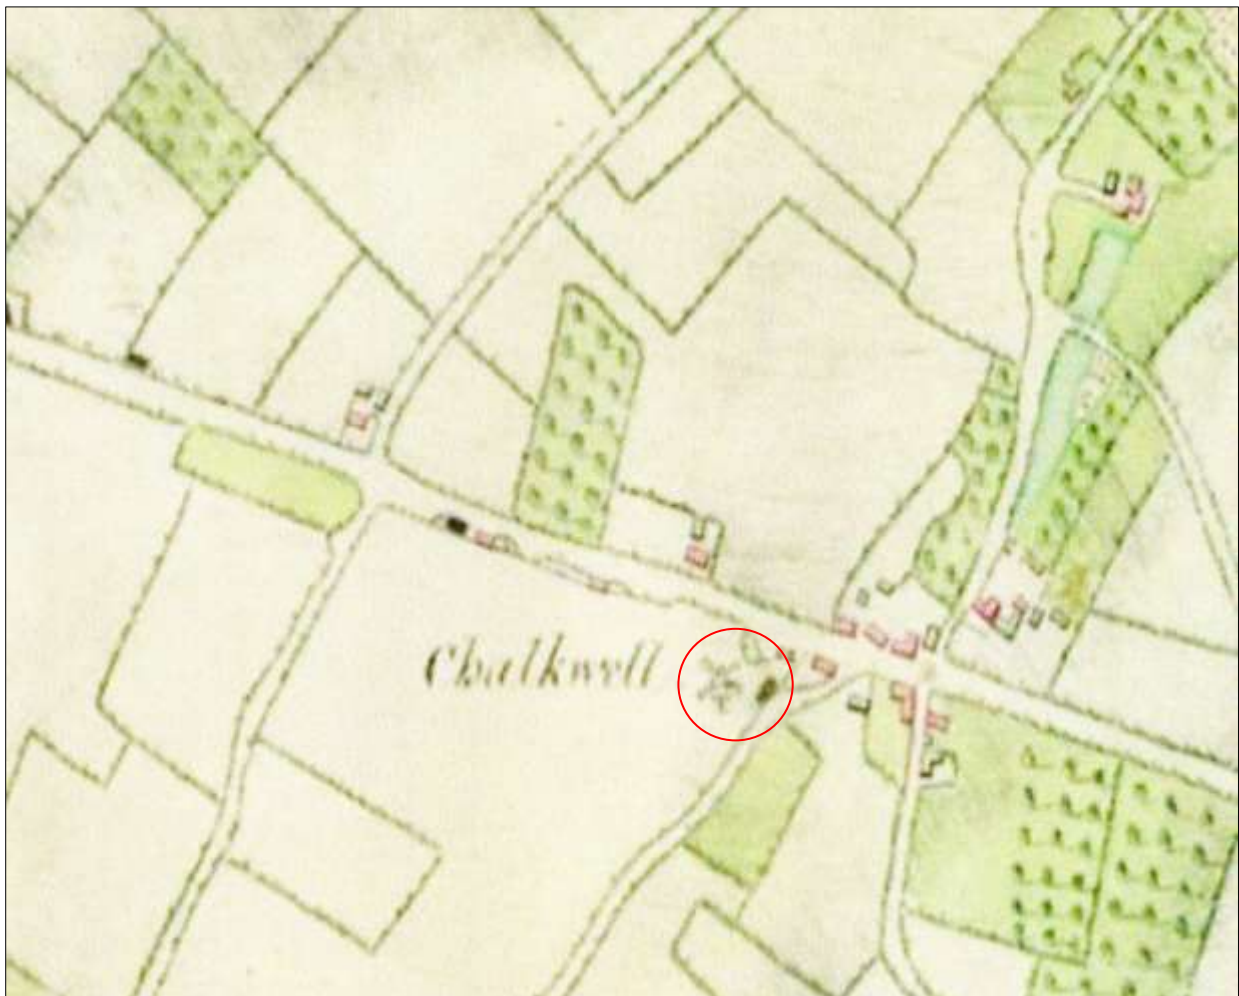
5.3 It is noteworthy that the seven available historical Ordnance Survey maps 1799-1975 show that urban development starts late in the area of London Road. The only feature shown on the proposed development site in 1799 is a windmill and ancillary building (Figure 1).

Figure 1. Development site as shown on the OS Surveyors Drawings of 1799

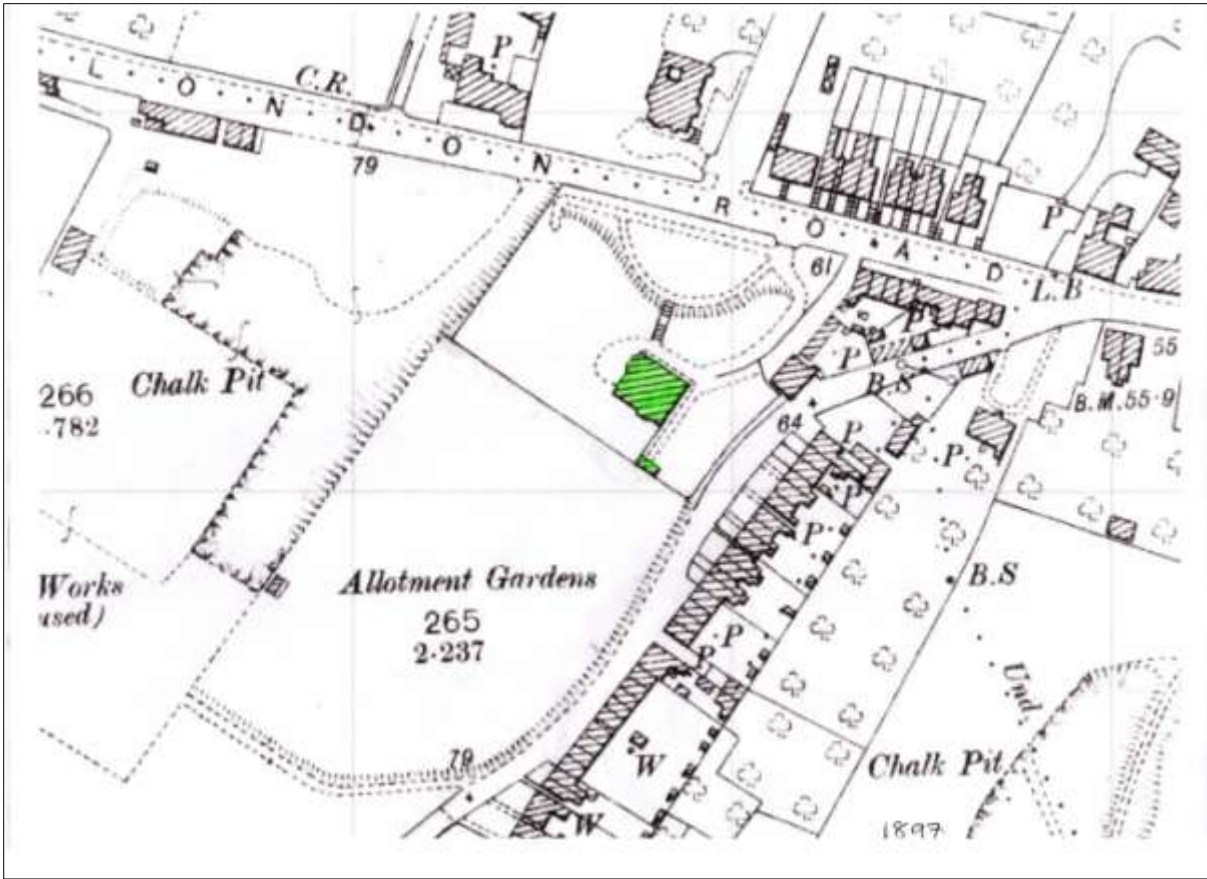
5.5 By 1897 the windmill has been demolished and replaced by a substantial brick built detached residential dwelling with landscaping features including steps down to London Road, the Roman road from Dover, Richborough, Canterbury to London and beyond. A gravel drive sweeps round the house to the main entrance which is located on the west side of the building. A small coal store or stabling is situated in the south-west corner of the yard abutting to the earlier boundary wall shown on the 1867 OS map (Figure 3).

Figure 3. Proposed development site in 1897 with buildings to be demolished shaded green

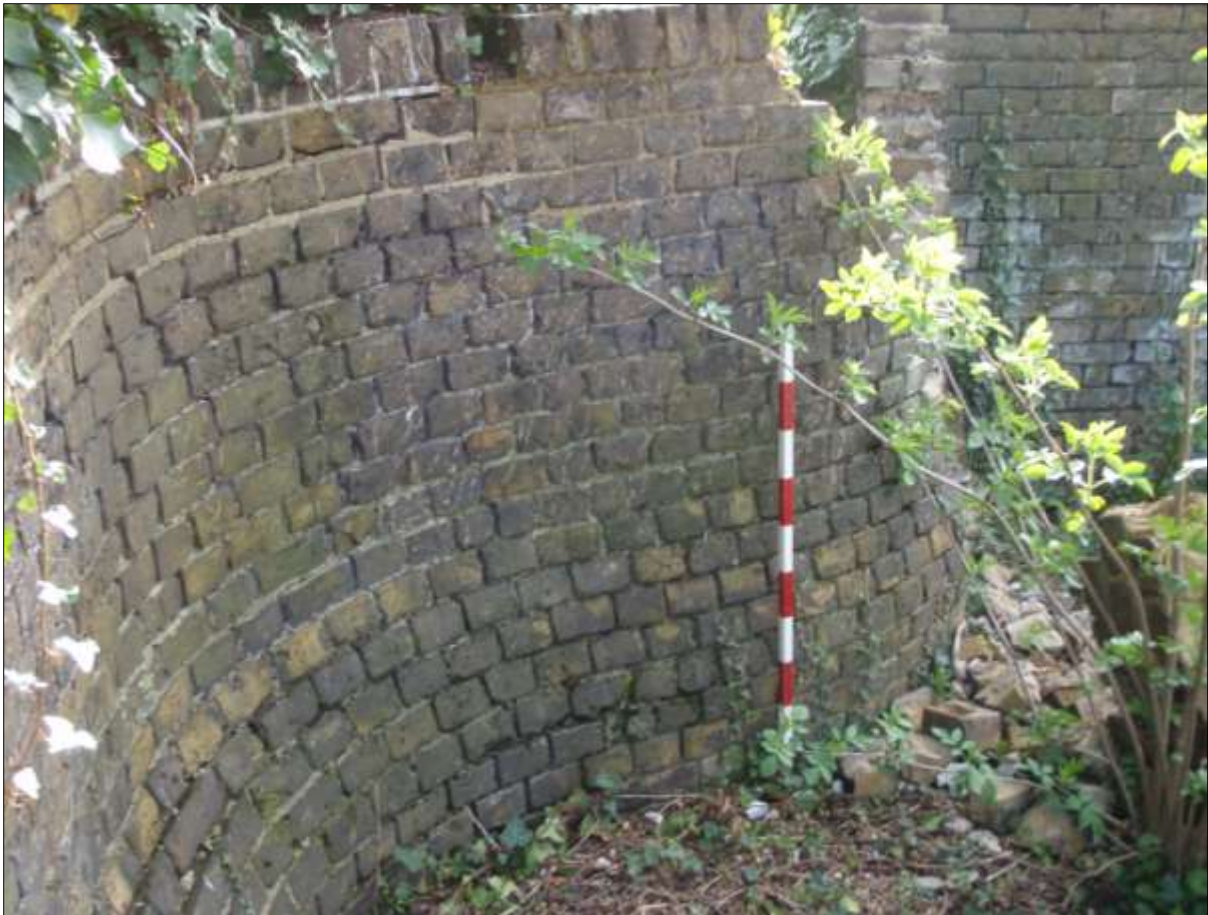
Figure 5. Circular feature of unknown function shown on the 1908 OS map

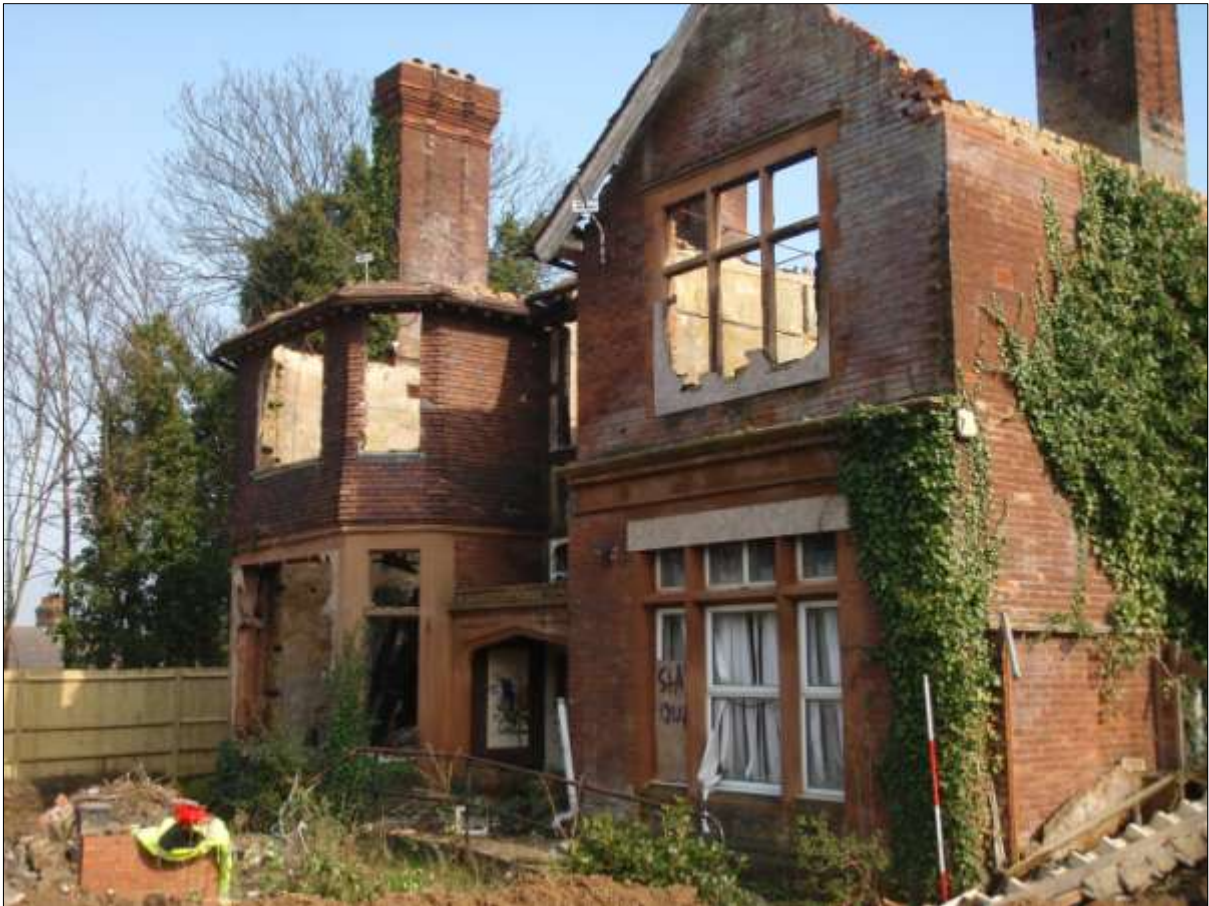
Figure 4. View of the west front (looking north-east)

Behind these facades the structure of a building like 87 London Road (above Figure 4) had changed from those produced fifty years earlier.

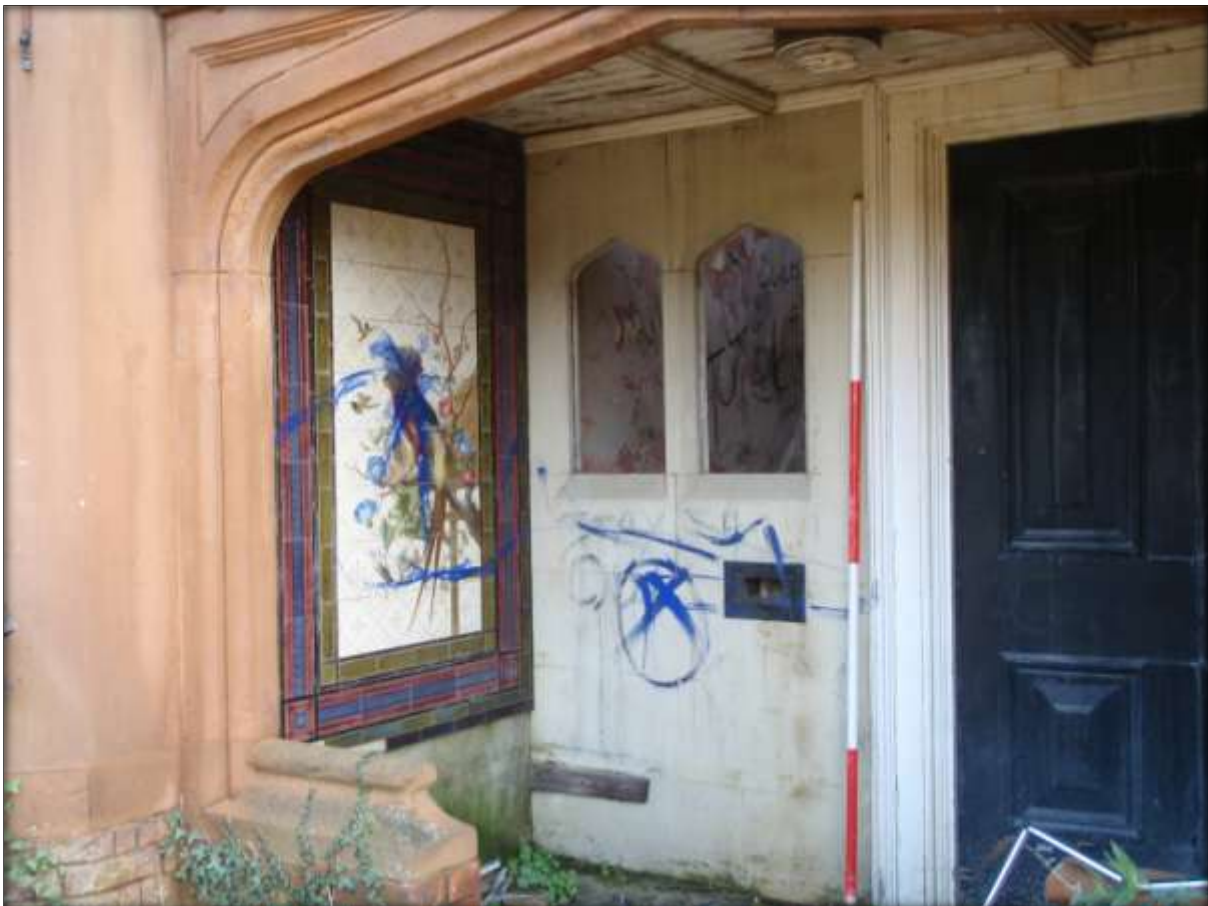
Figure 5. Front porch built of fine red sandstone in the Tudor style and located on the west front with two inset tile panels (2m scale).

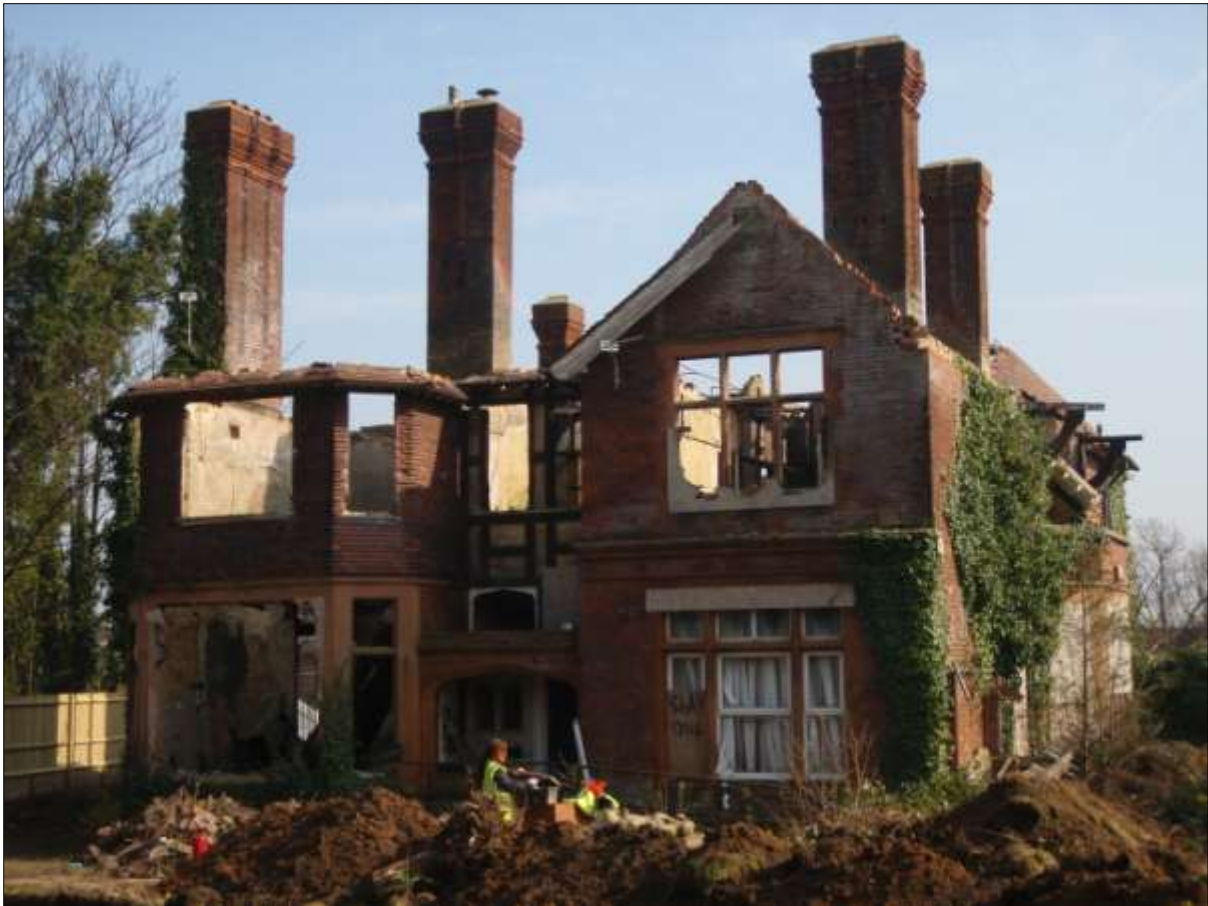
Figure 6. West front (looking east) of the cross-wing house with porch which shows the Tudor influence on the chimney stack design and the main porch entrance. The roof structure which survives on the south wing shows a gabled roof with decorative barge board with common rafters steadied by collars. The two large three-light mullioned windows are constructed of red sandstone with modern replacement uPVC windows. Between the two mullioned windows a stone stringer course can be seen. The ground floor mullioned window has leaded fanlight windows with leaded glass scenes of rural industry. It seems most of these decorative leaded glass panel were removed when the uPVC windows were inserted and placed for safekeeping in the local museum (see Note 1).

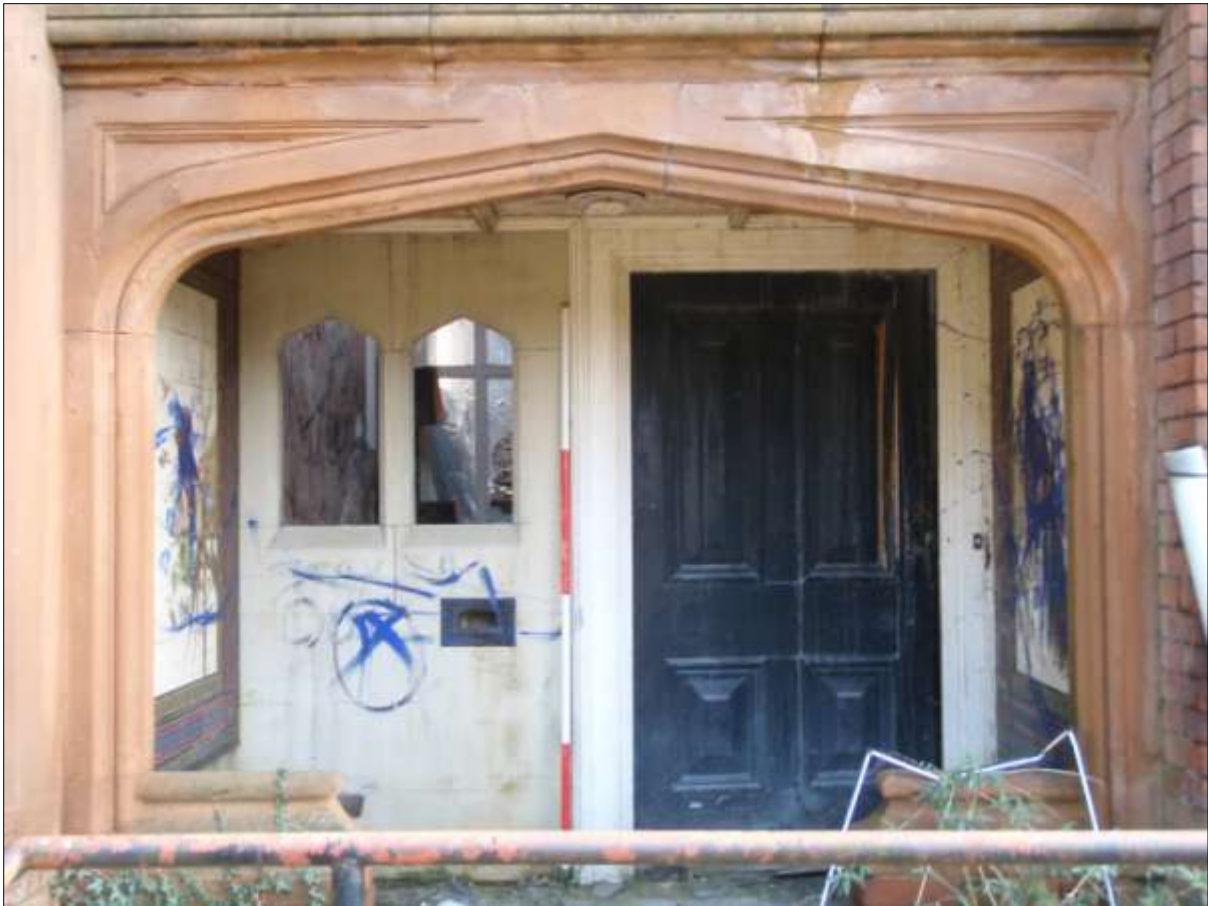
Figure 7. The main entrance is framed by a four-centred Tudor arch with carved spandrels in red sandstone leading to a framed fielded panelled door finished in black paint. To the left of the door an off-white stone fielded panel with two Tudor arched windows with later letter box. Two framed pictorial tiled inserts are to be seen on the porch walls left and right of the main door. Both have been vandalised by sprayed paint (2m scale).

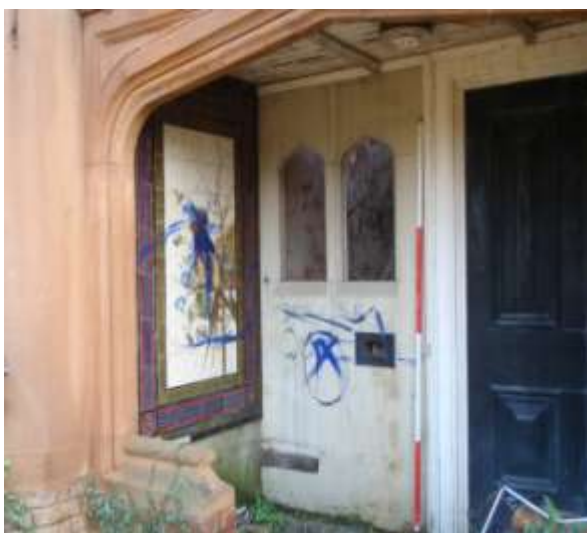
Figure 8. Framed ceramic tiled pictorial insert.

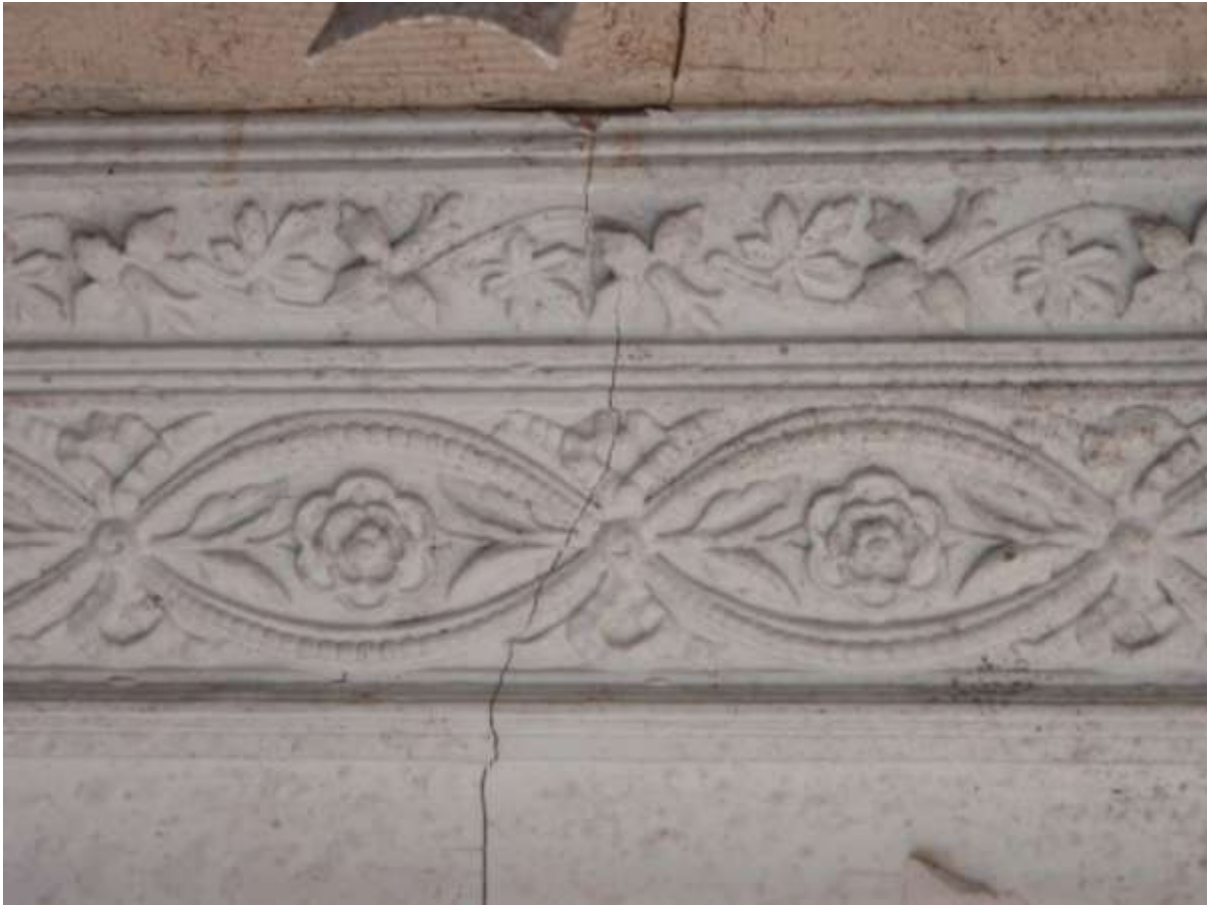
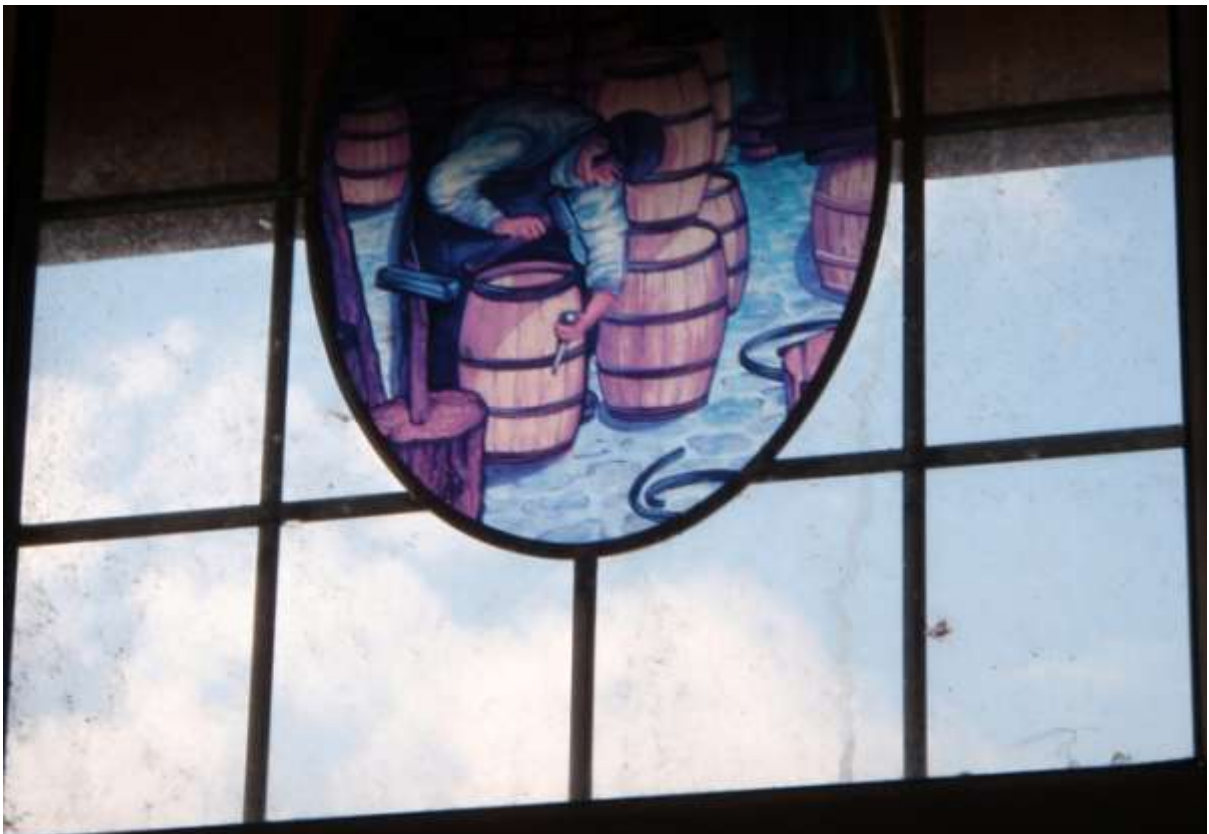
*Figure 10, 11 Detail of decorative coving on ceiling of hallway, and below leaded fanlight*
