Archaeological Evaluation at 87 London Road,  
Sittingbourne, Kent

LRS-EV-14

# Archaeological Evaluation at 87 London Road, Sittingbourne, Kent

Site Code: LRS-EV-14

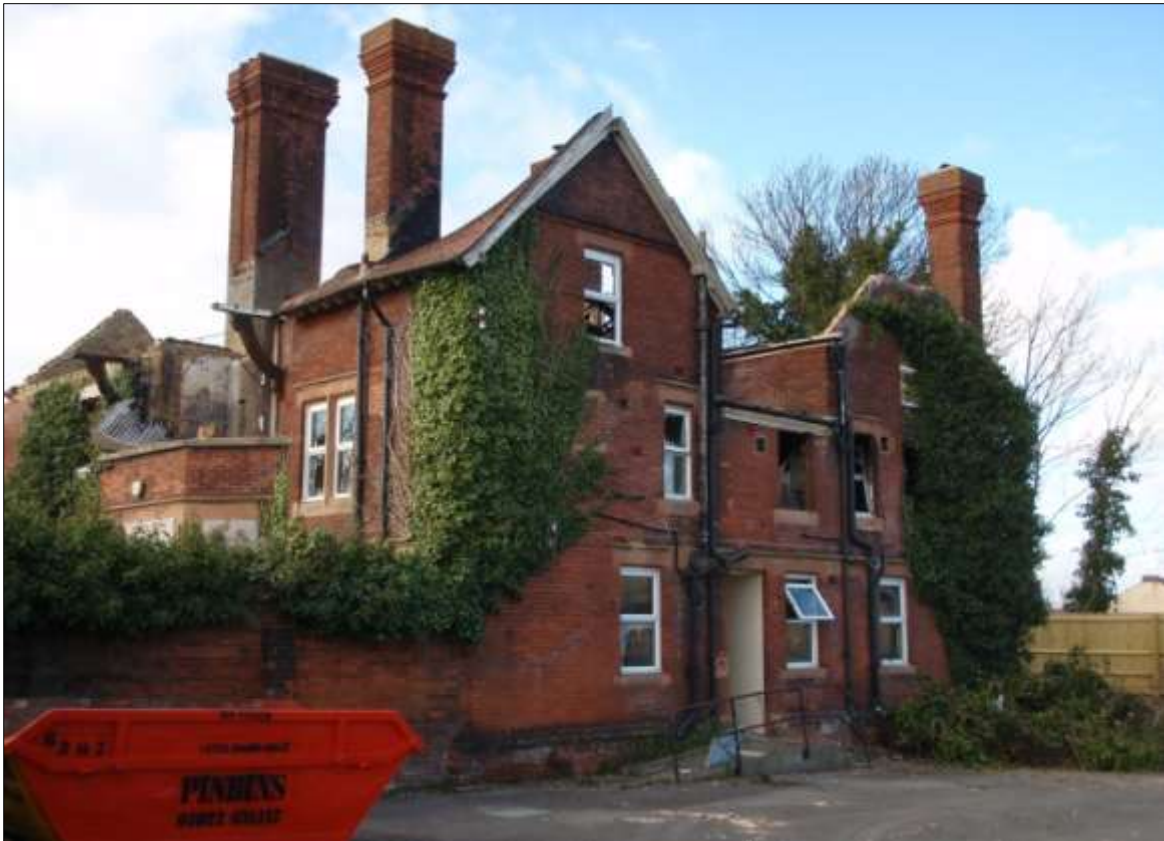
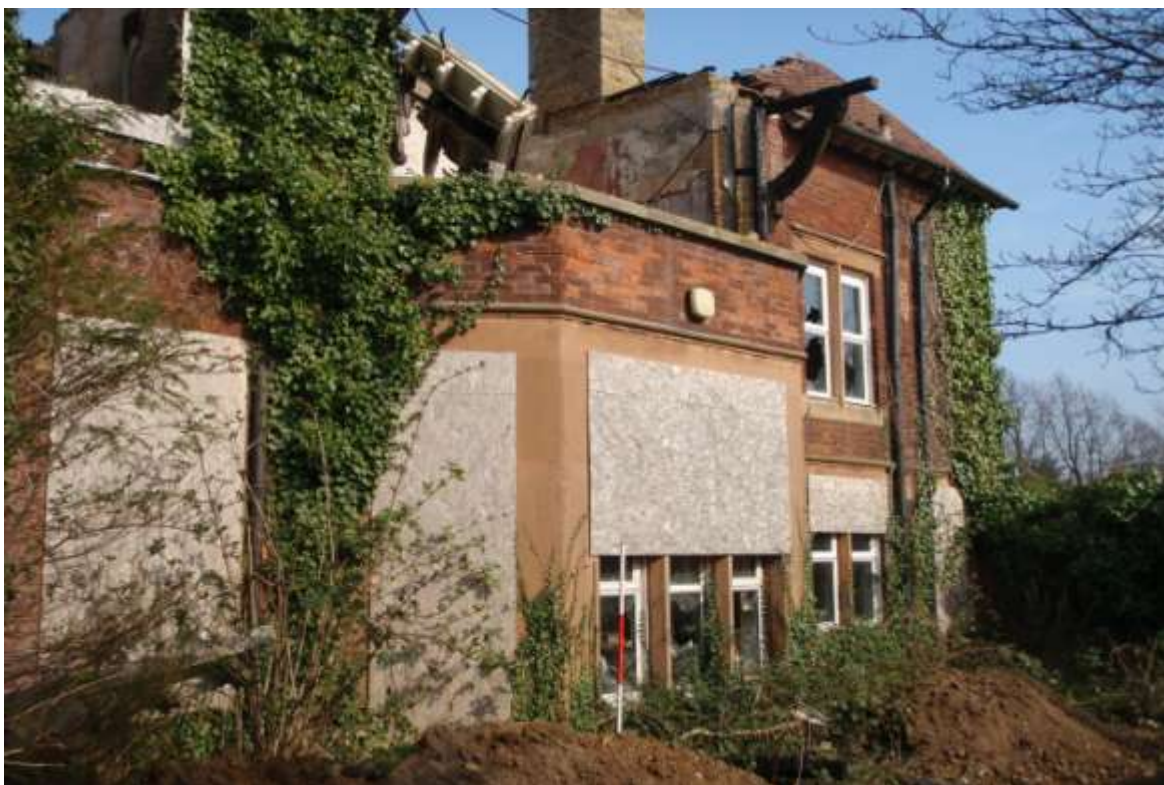
Figures 12, 13 Rear of property (facing west) show both gables, windows with red sandstone sills and lintels. South side of the house, (below) showing mullioned bay construction. Scale in 50cm sections.

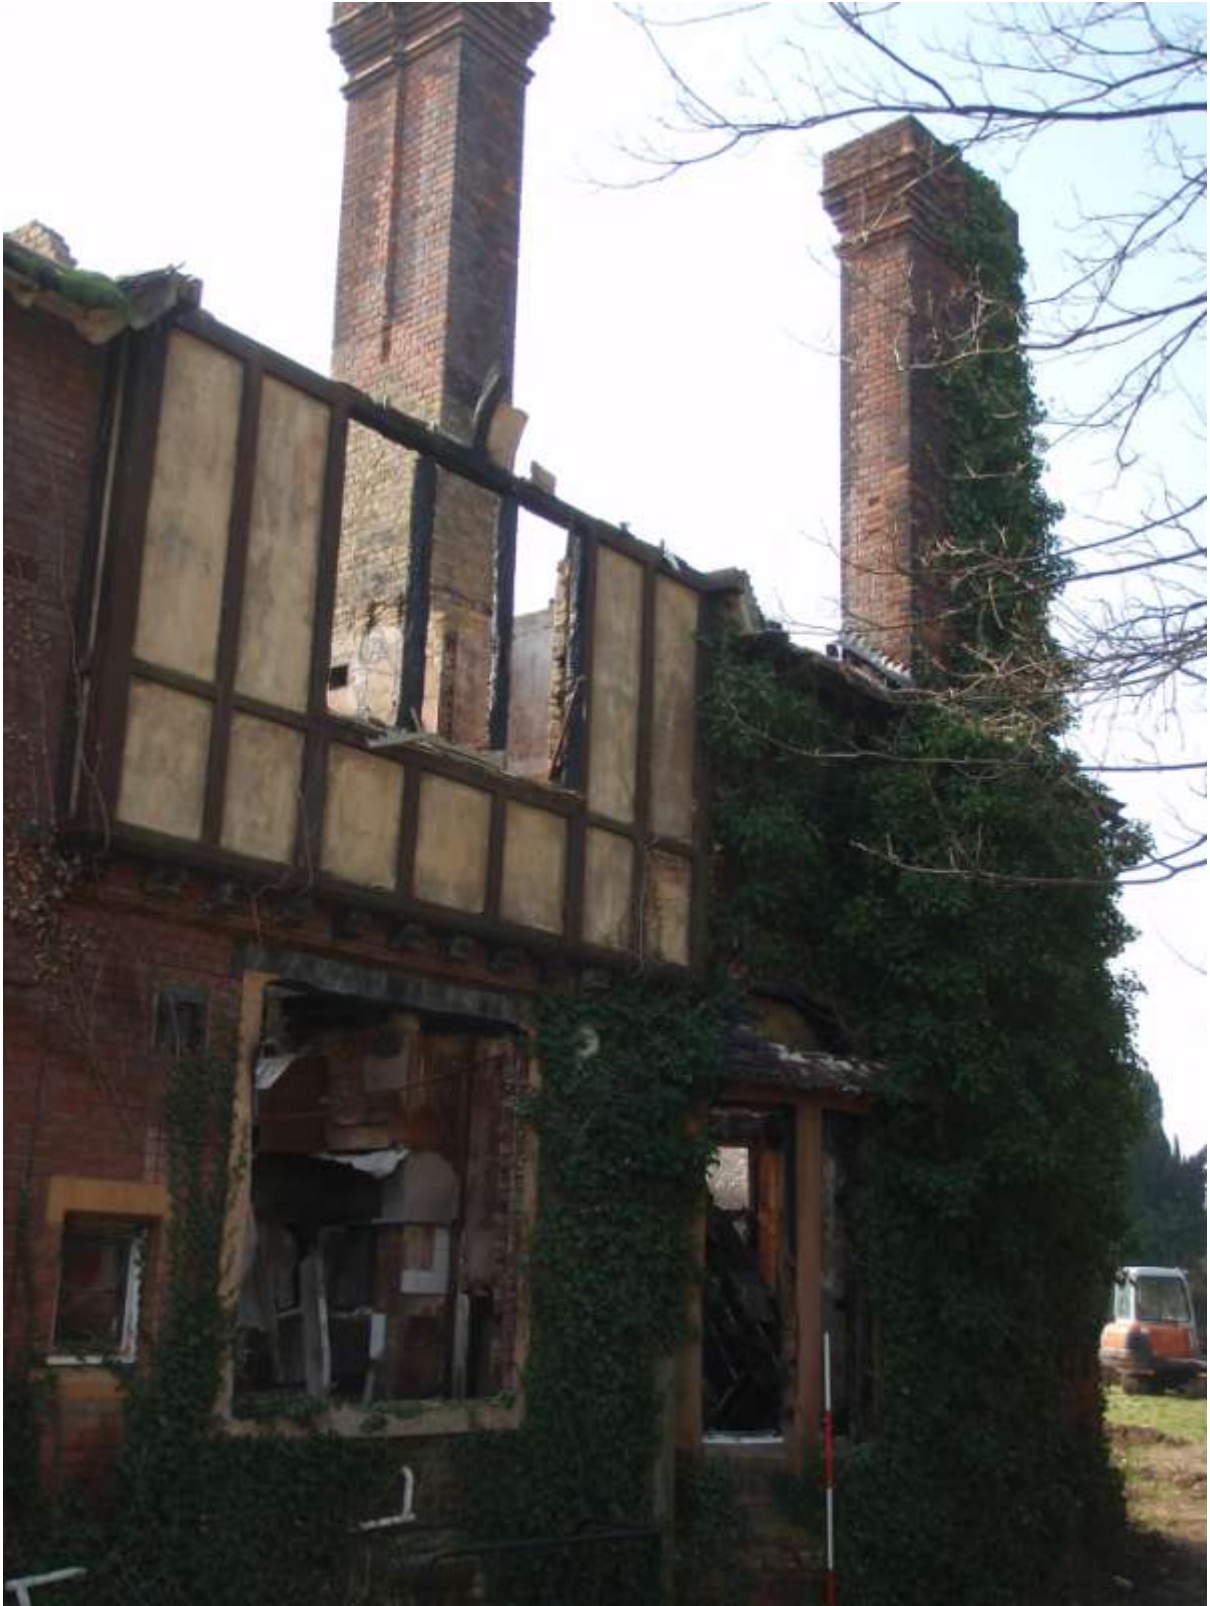
Figure 14. Showing north side of the house with timber-framed jettied upper storey in Elizabethan- style with three-light mullioned window. Infill panels are finished in off-white lime mortar. Below on the ground floor the windows are framed in red sandstone.

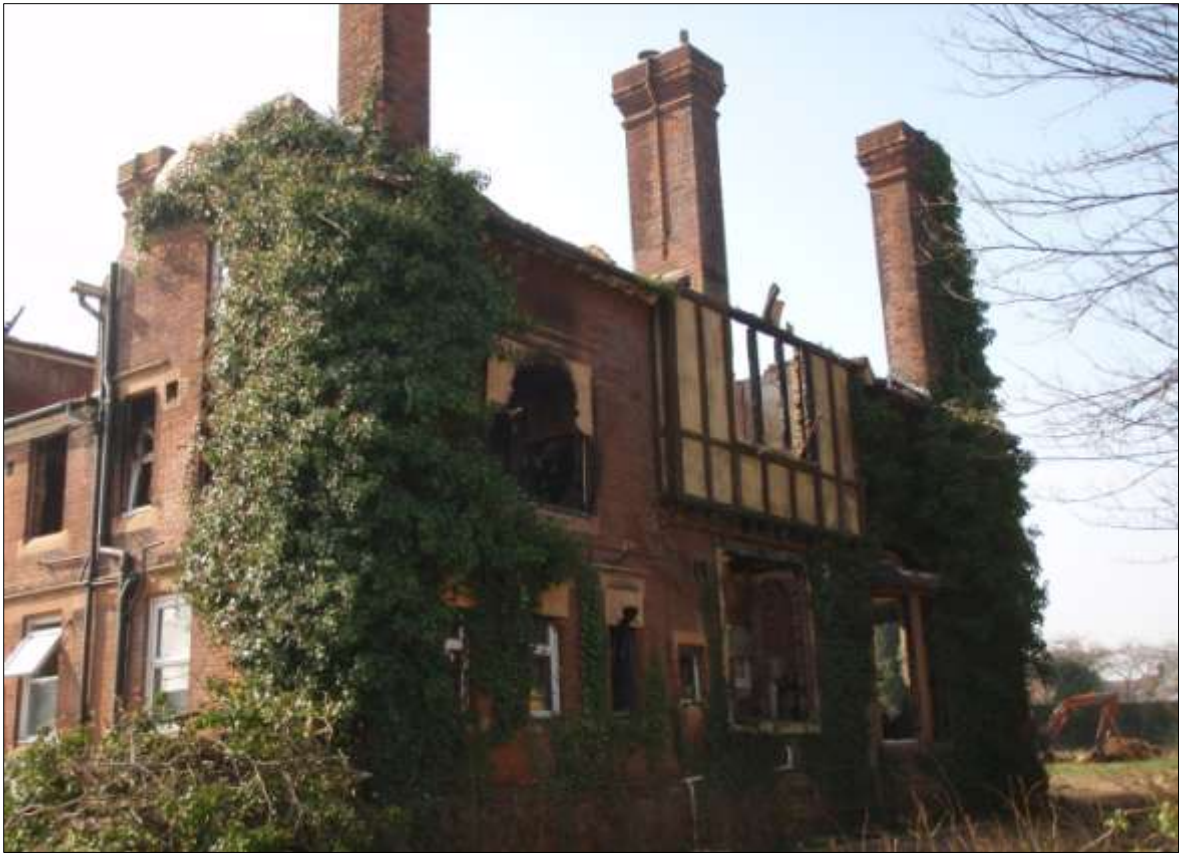
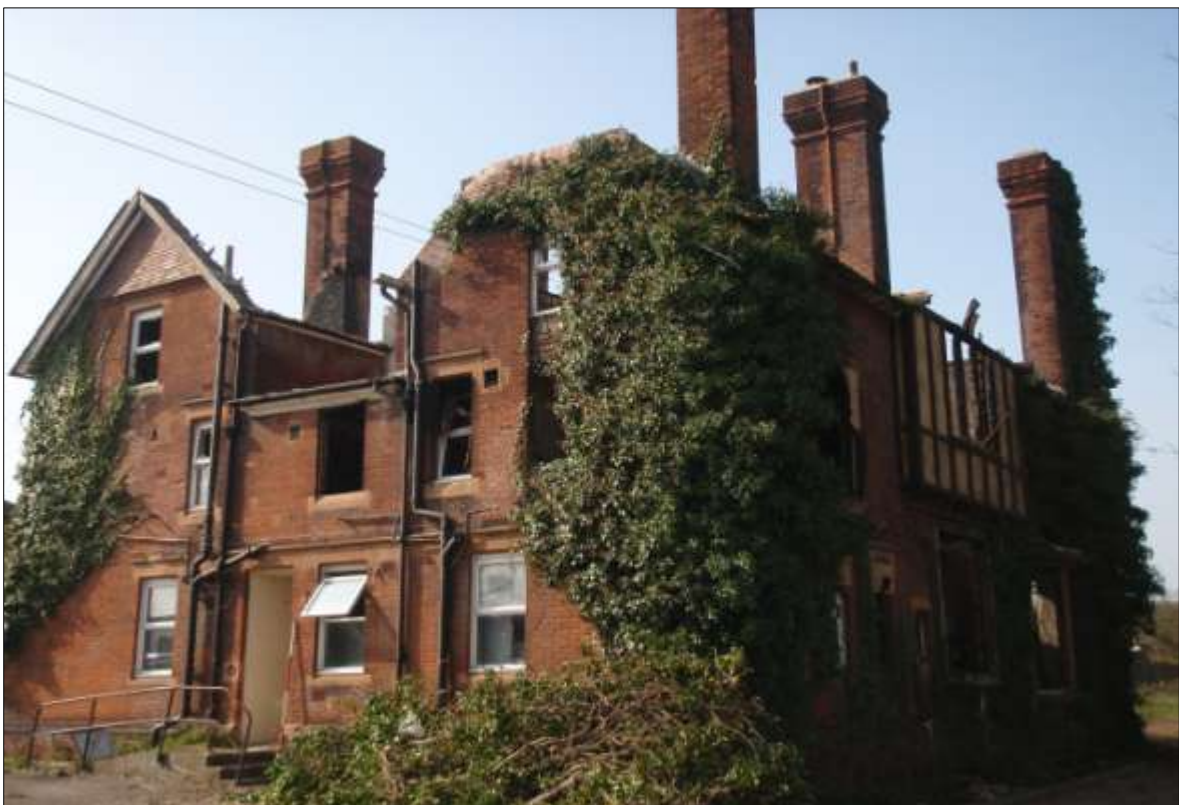
*Figure 15, 16. View of north and east sides (facing south-west)*

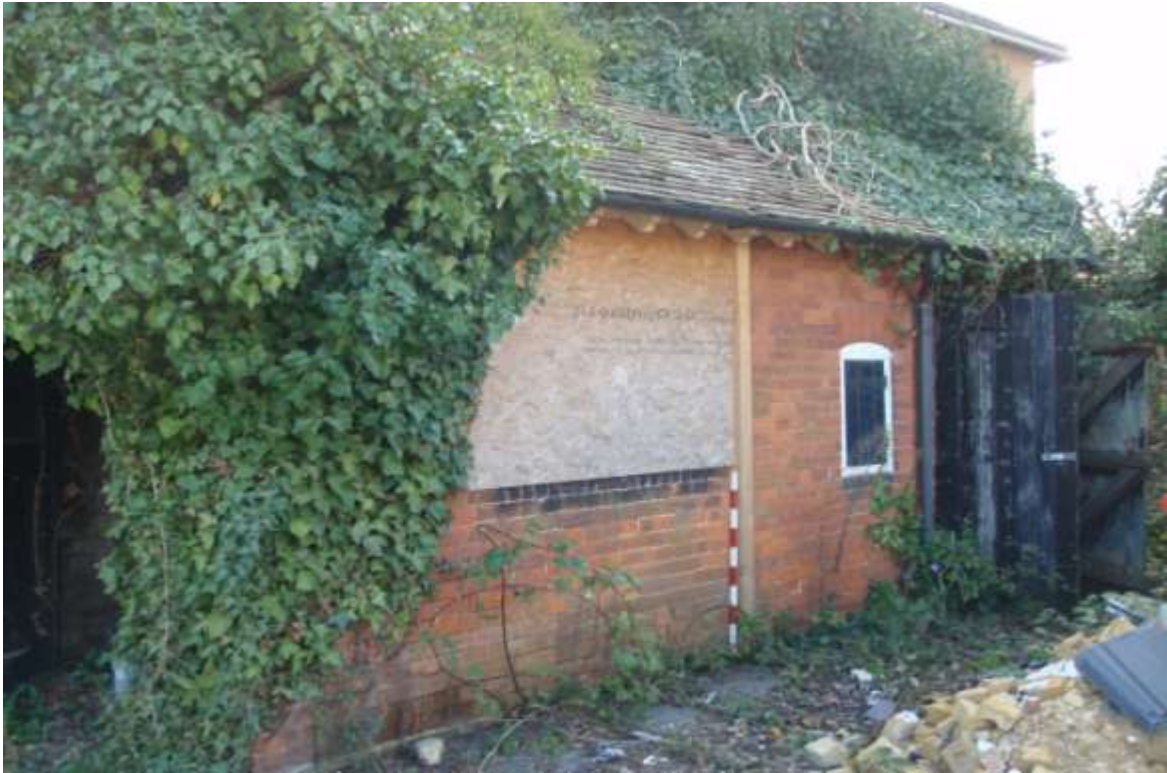
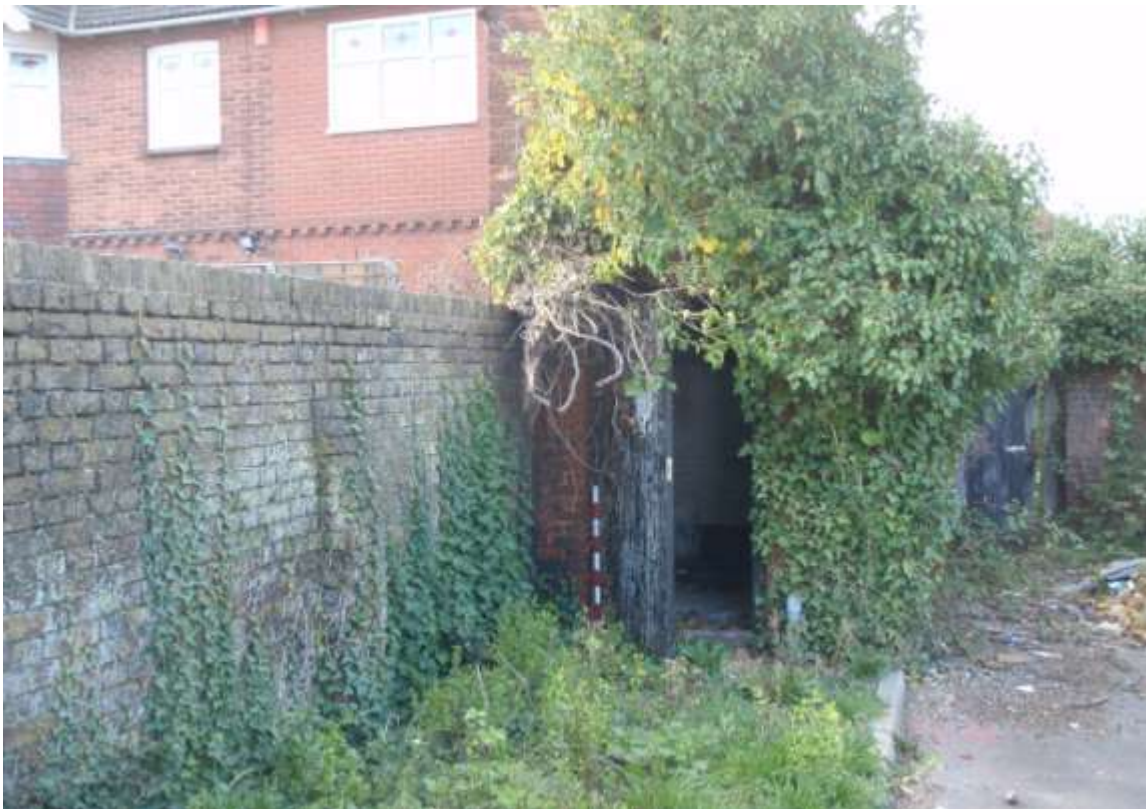
*Figure 17, 18. View of coal shed or stables, and (below) view of building butting up to earlier boundary wall of windmill (Scale 1m).*
