Archaeological Monitoring of Land at Fairmeadow, Maidstone, Kent

Site Code MA/WB/15

Report for Chartway Group Ltd
Date of report 22/10/2015

Planning No. MA/14/0096

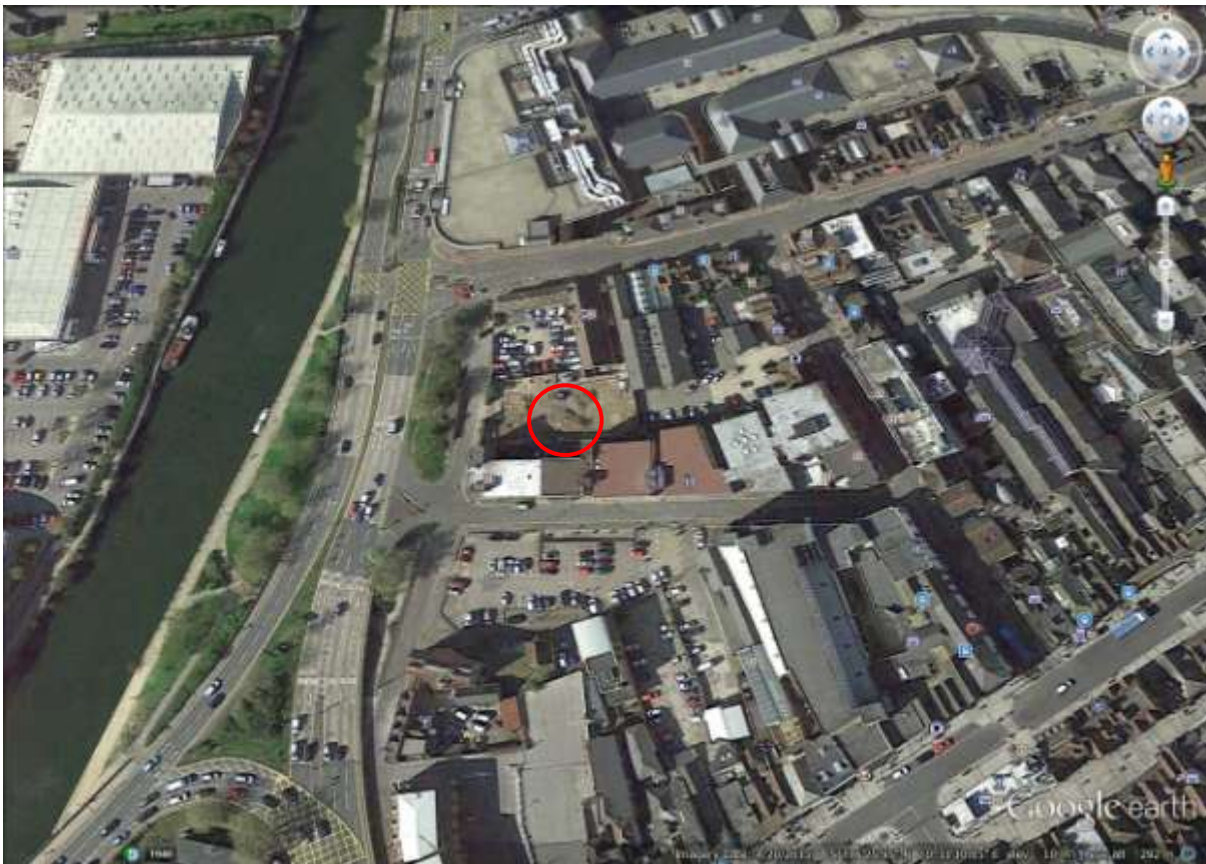
Plate 1. Aerial view of site (red circle) showing the site prior to development.

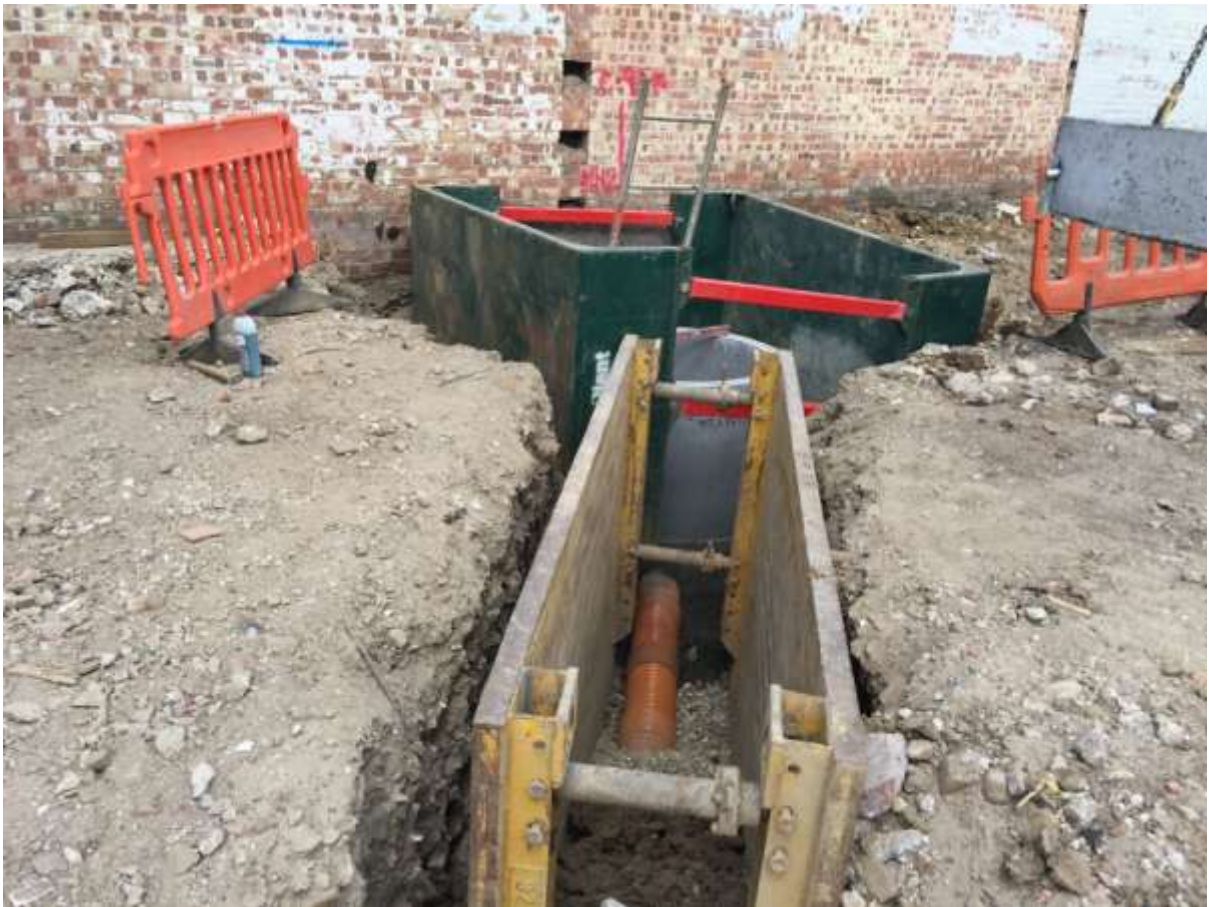
Plate 2. Drainage being installed (in made up ground)

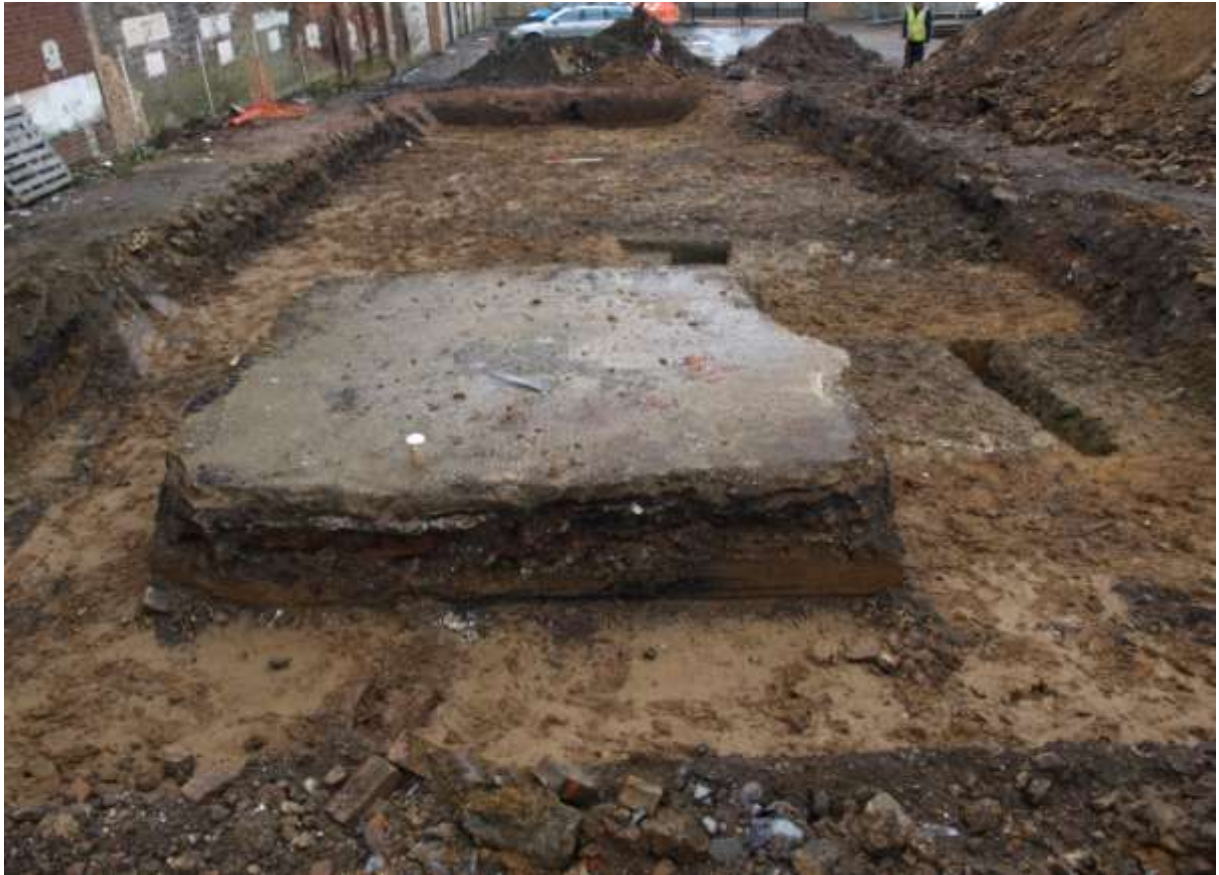
Plate 1. Showing exposed part of the site, the well feature visible in foreground. One metre scale in background, looking west.

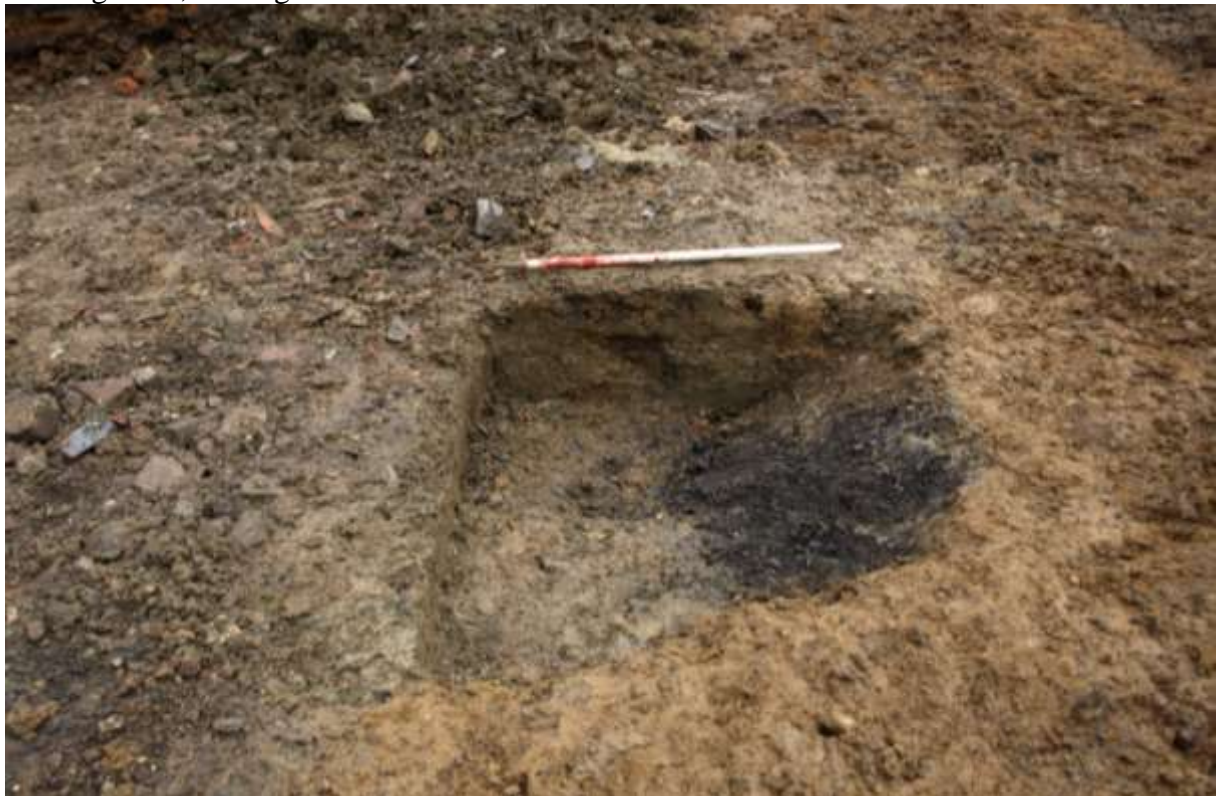
Plate 2. Showing large rubbish pit 04. Looking north, one metre scale.

A large north-west; south-east aligned sub-oval cut (**CN 04**) (**Plate 2 Section Fig.4 s.1.1**) had steep eastern side, vertical southern side and appears to be machine-dug. Its back-fill sequence comprised thin band of loosely compacted blue-grey deposit (CN 05) comprising burnt coke with slate aggregate and was capped by extensive top deposit of green friable silt-clay (CN 06). That was truncated from the top by small yellow-orange fine sand-clay (CN07) and mixture of coarse sand, gravel and green silt-clay recorded as (CN 08). This modern feature measured over 7 metres-long by 5.1 metres-wide with estimated depth of 1.2metres.

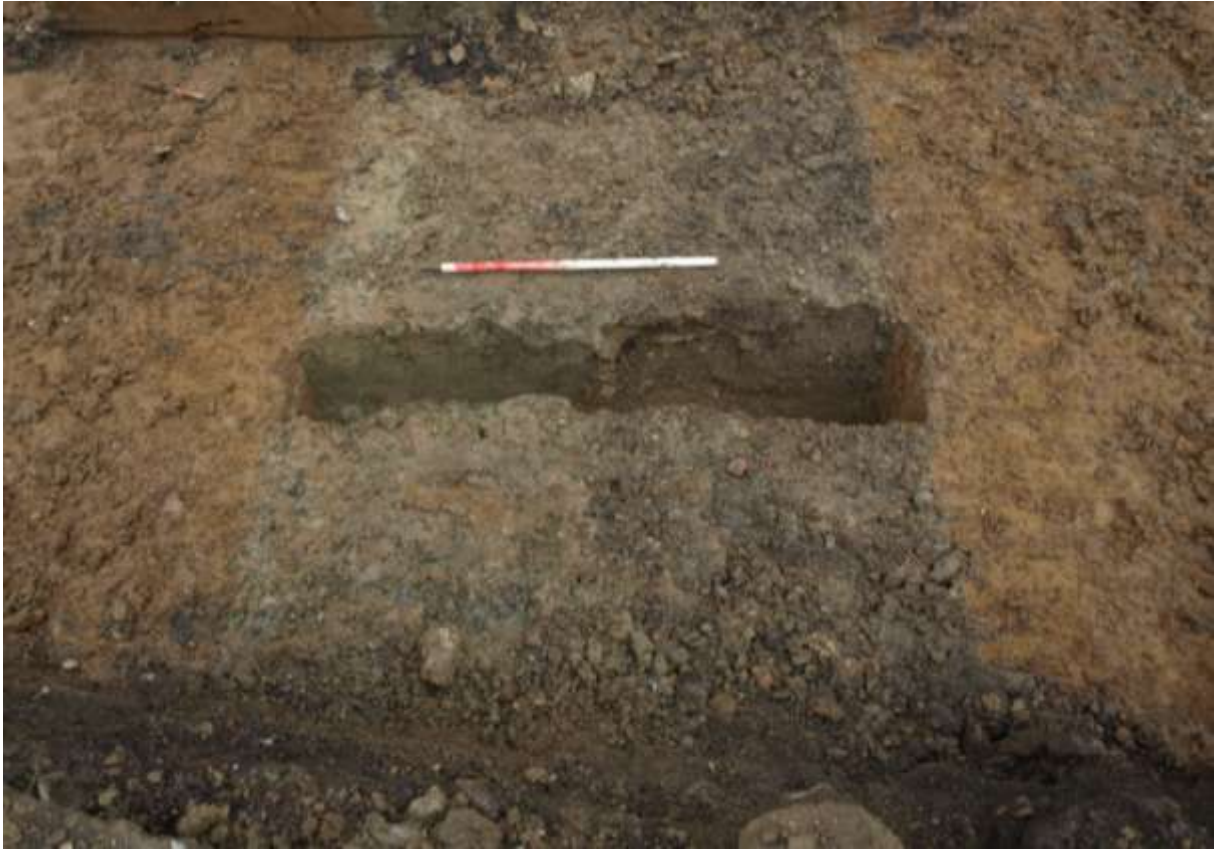
Plate 3. Showing linear trenches 9 and 11. Looking south, one metre scale

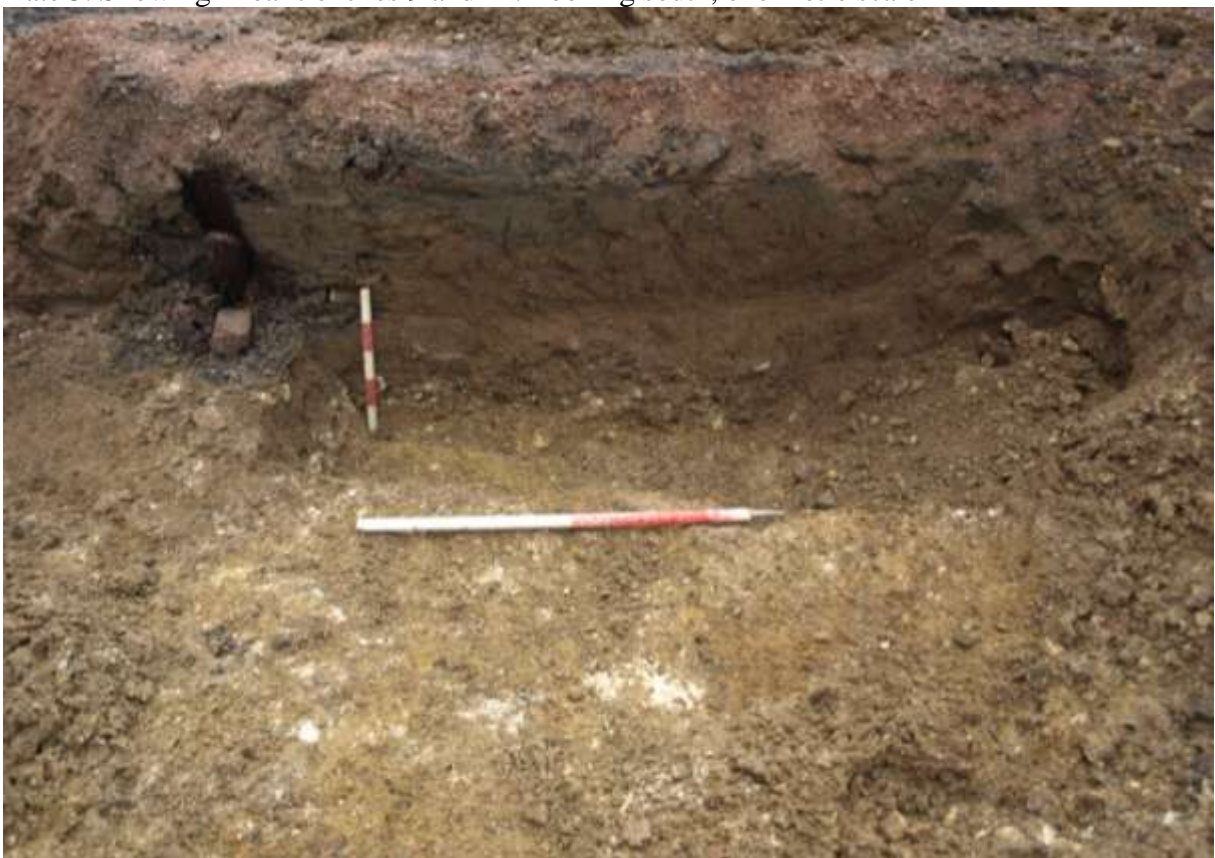
Plate 4. Showing section through rectilinear cut 13, modern post-hole 17 visible to the left. One and half metre scales.

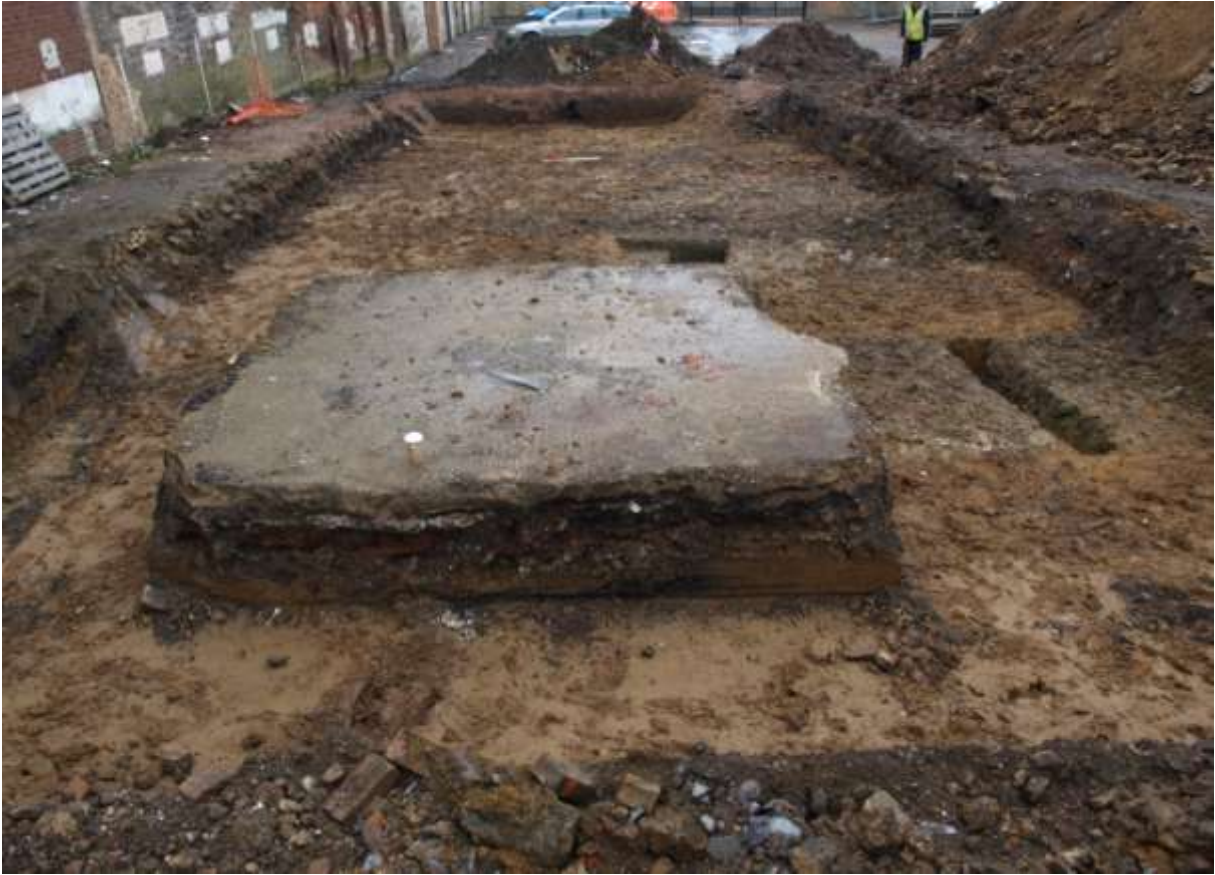
Plate 1. Showing exposed part of the site, the well feature visible in foreground. One metre scale in background, looking west.

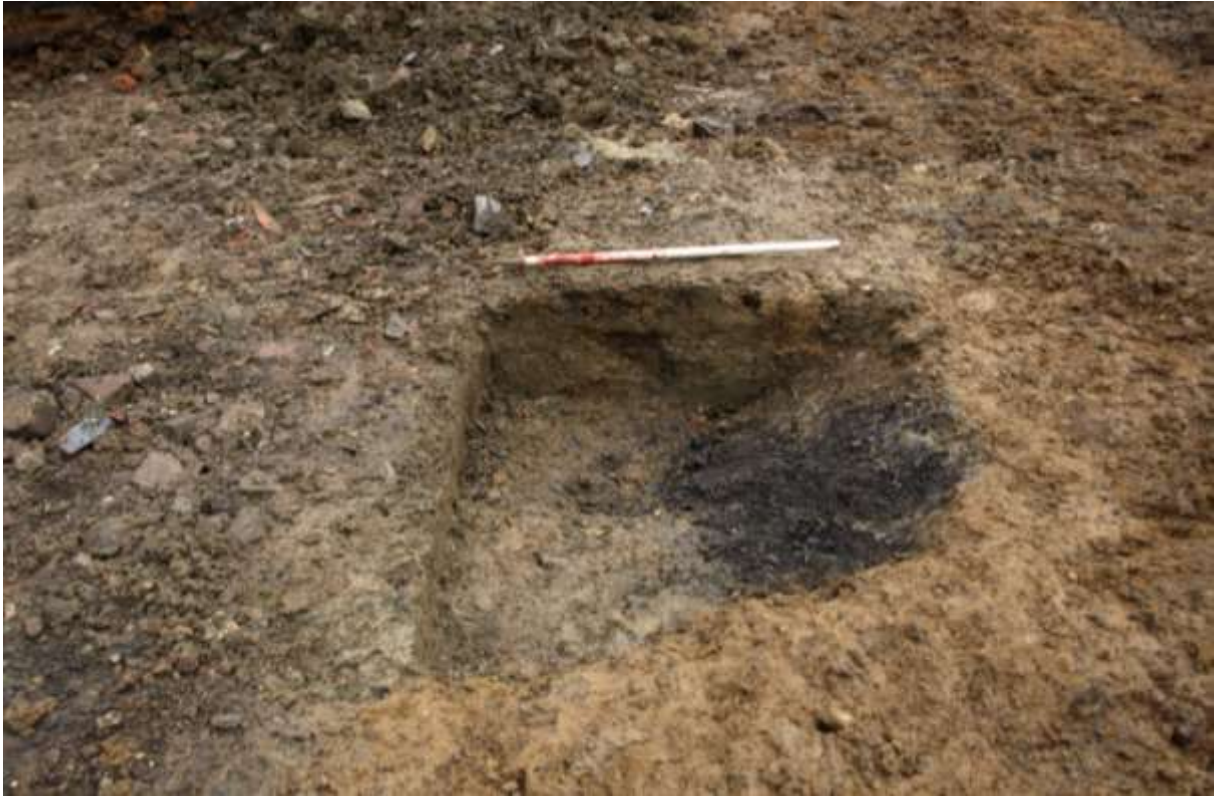
Plate 2. Showing large rubbish pit 04. Looking north, one metre scale.

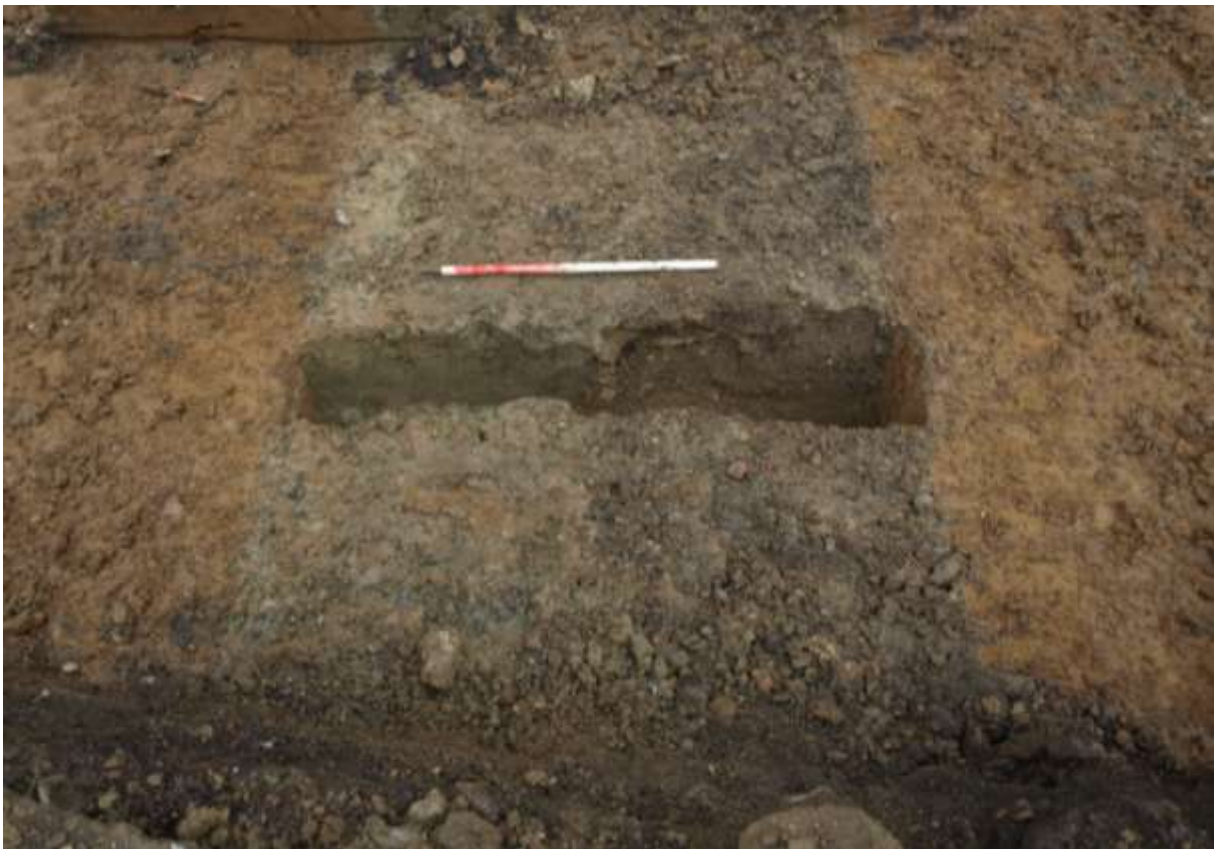
Plate 3. Showing linear trenches 9 and 11. Looking south, one metre scale

Two contiguous north-south aligned linear cuts (**CNs 09 and 11**) (**Plate 3 Section Fig.4 s.1.2**) were investigated in 0.45m-wide slot. Cut (CN 09) measured 1.05m-wide and was back-filled with context (CN 10) comprising green friable silt-clay with infrequent modern inclusions. Abutted from the west cut (CN 11) measured 0.95m-wide and was back-filled by deposit (CN 12) comprising coarse sand with gravel and green silt-clay.

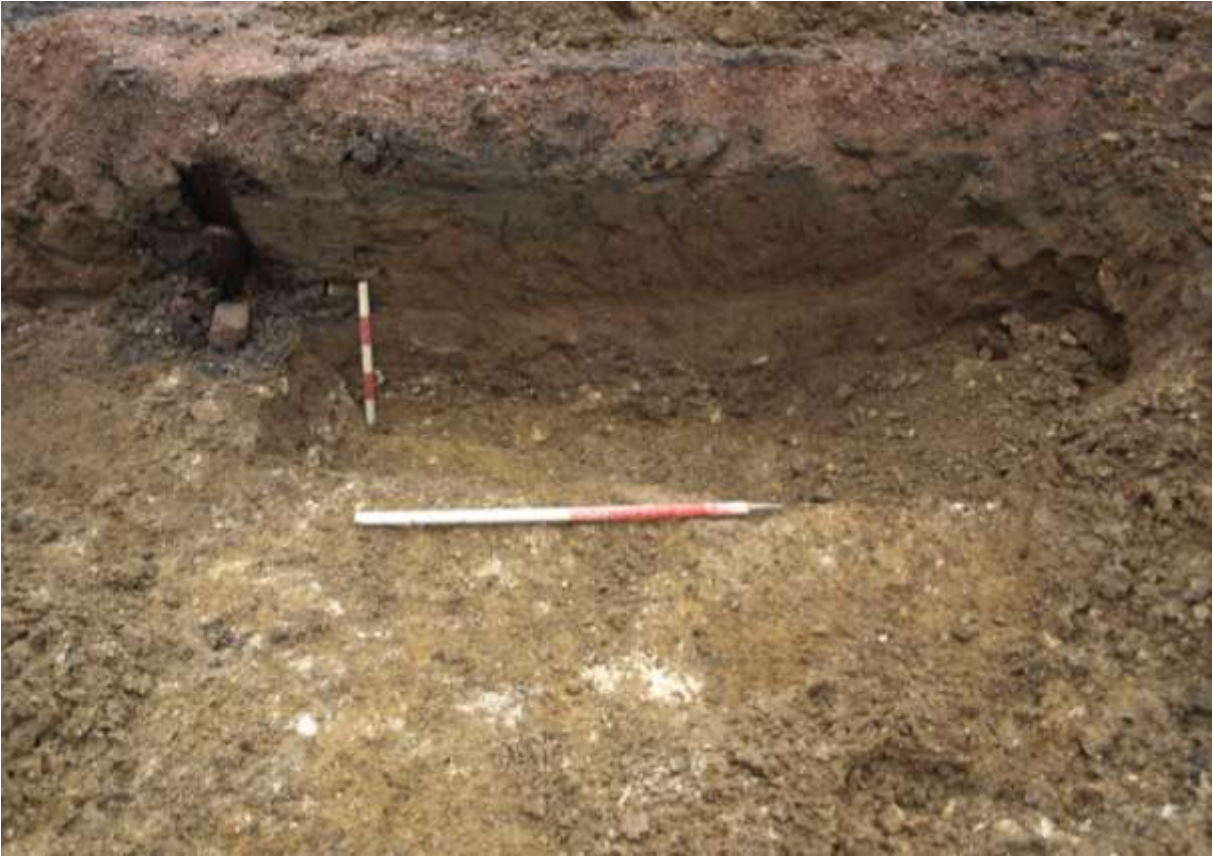
Plate 4. Showing section through rectilinear cut 13, modern post-hole 17 visible to the left. One and half metre scales.

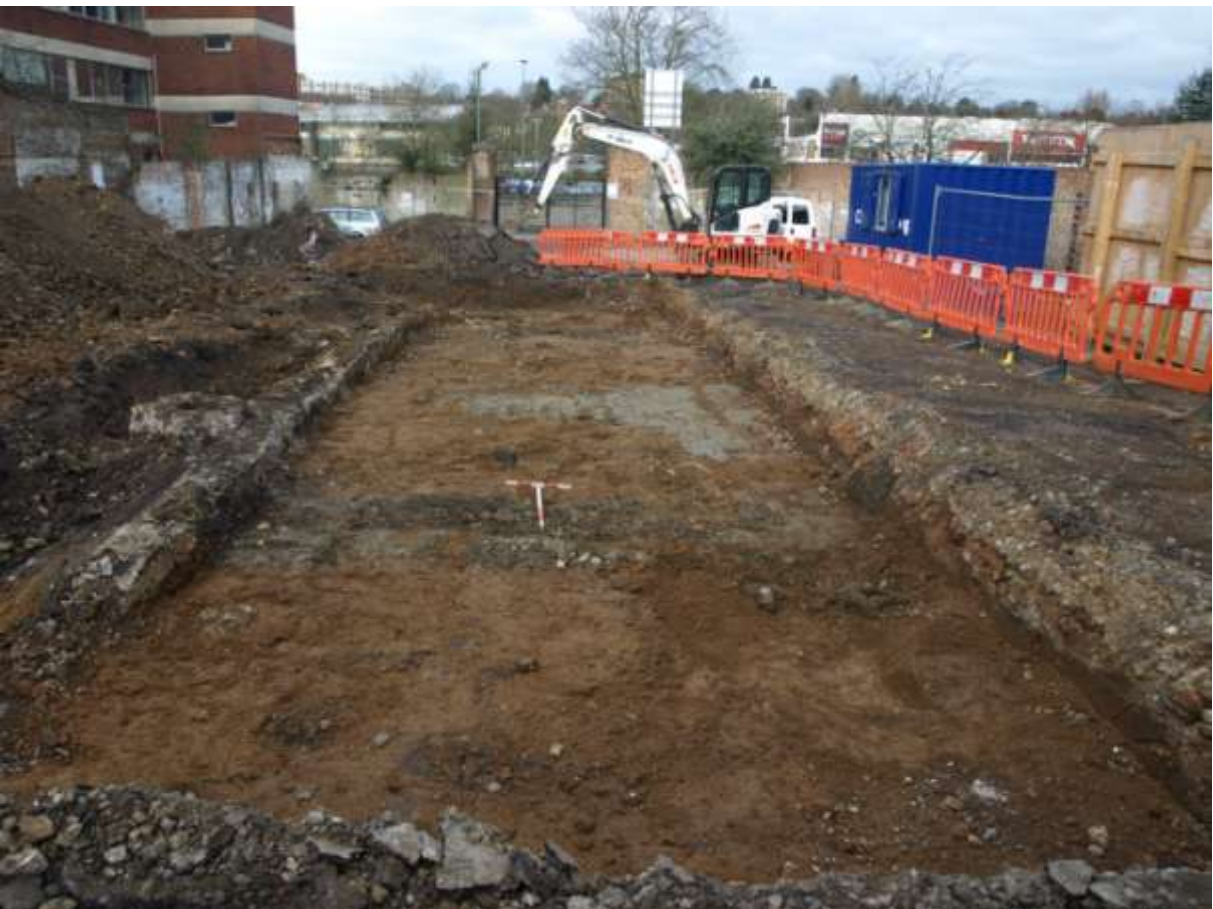
Plate 5. Showing exposed Area 2 comprising the northern part of the site, the linear formation 24 visible to the left. Looking west one and half-metre scales.

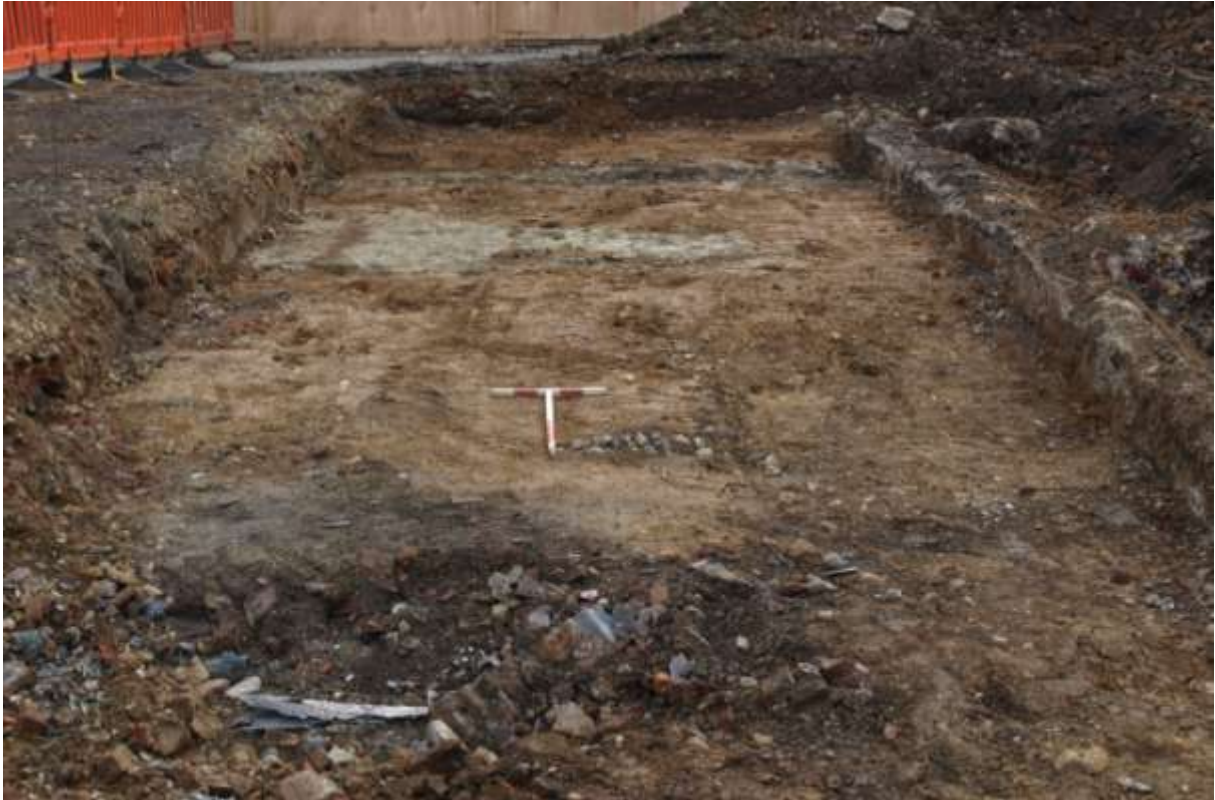
Plate 6. Showing northern part of the site, looking east. The large rubbish Pit 22 visible in foreground. One and half metre scales.

Large rubbish Pit 22 (Plate 5) was exposed in northern part of the site. Shallow machine scoop revealed that its back-fill (CN 23) consisted of broken glass, 19th-20th century beer bottles, crushed hardcore, tiles, well corroded fragments of corrugated sheet and small fragments of asbestos.

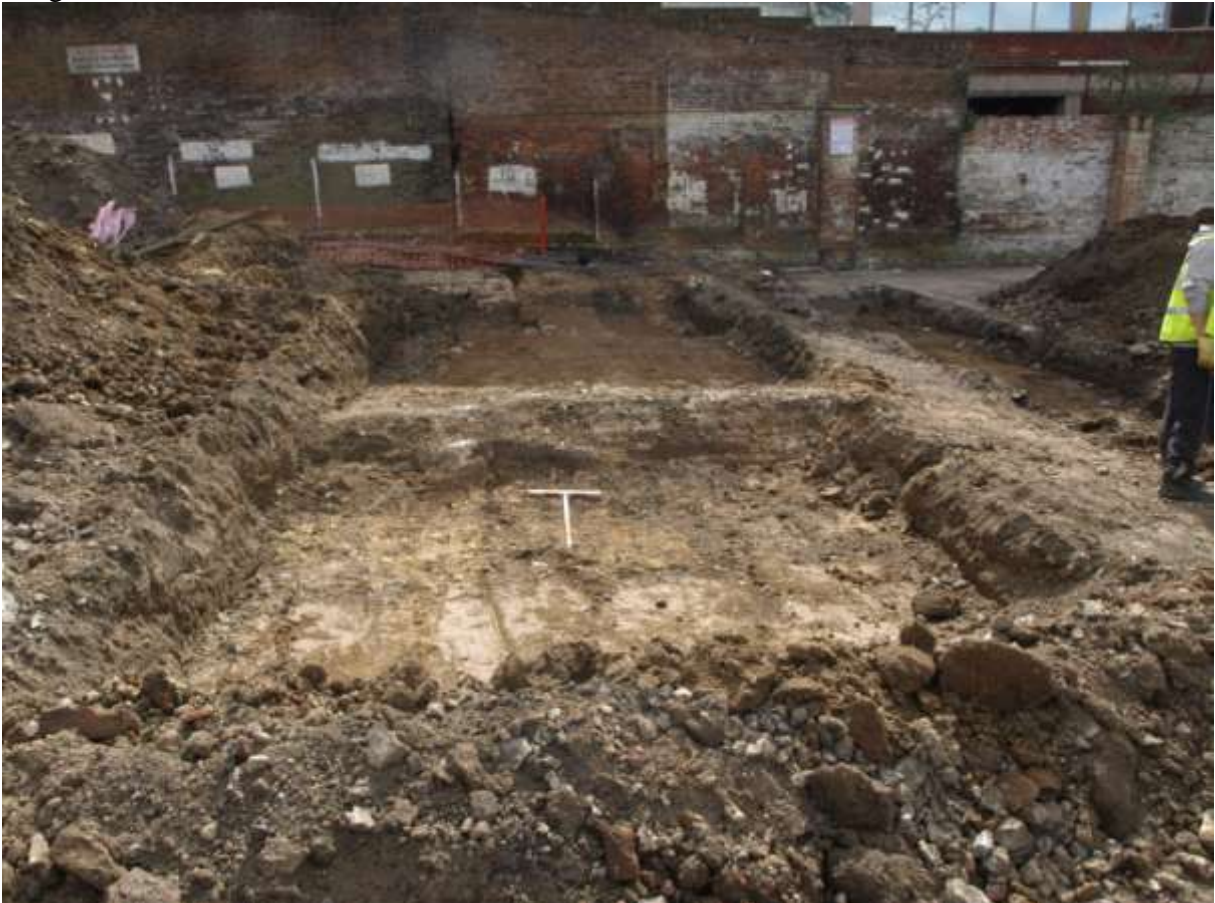
Plate 7. Showing the exposed Area 3 overlapping Area 1. The cut 13 denoted by wall and drain visible in background against existing wall (looking south, one and half metre scales)

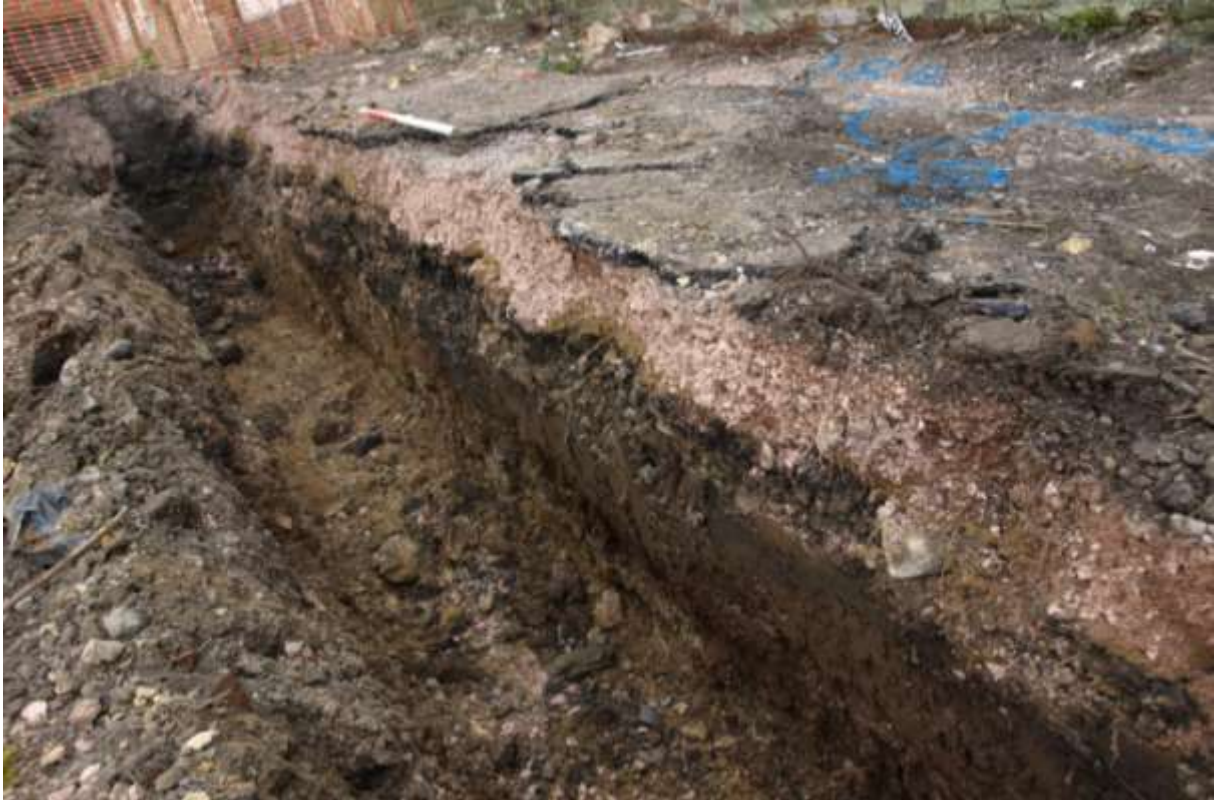
Plate 8. Overlook view on 6m-long section 1.4. Looking south-east, one metre scale.

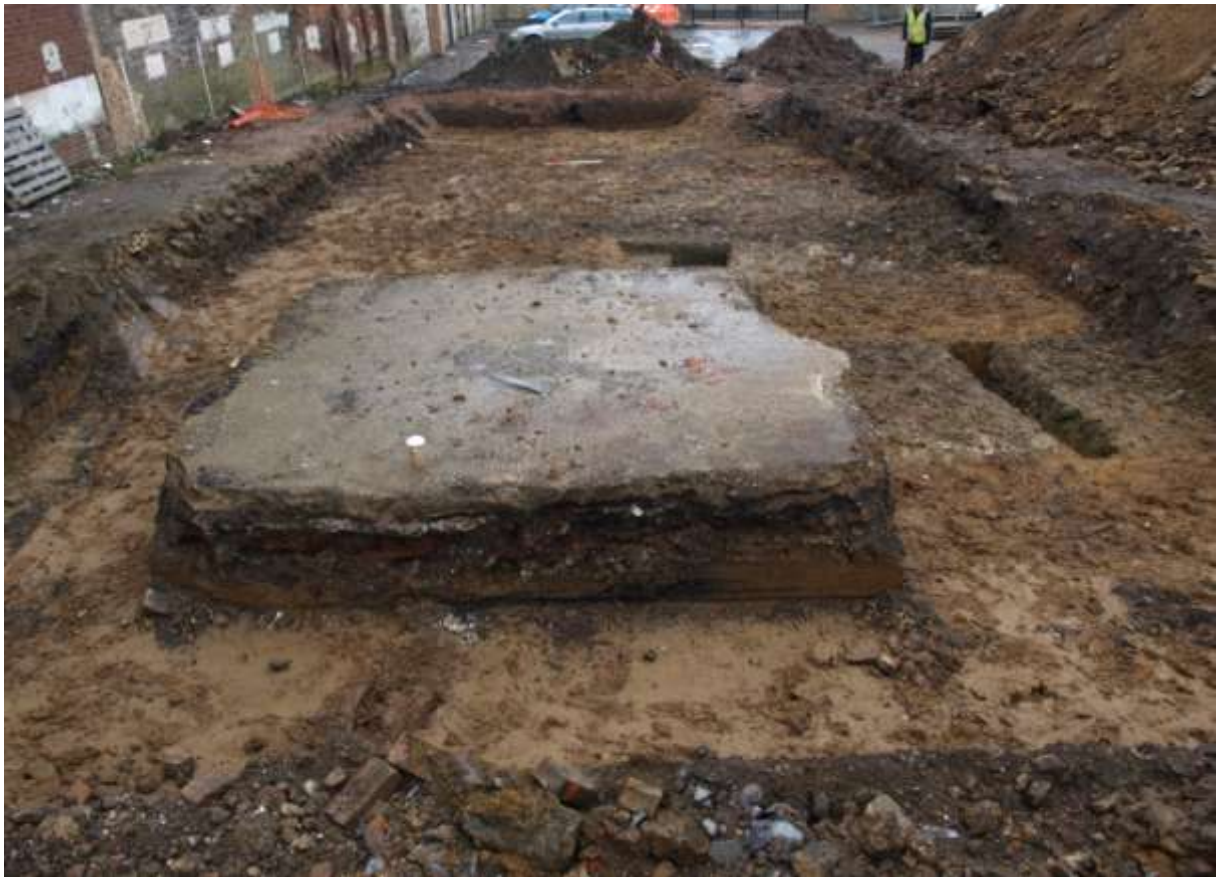
Plate 1. Showing exposed part of the site, the well feature visible in foreground. One metre scale in background, looking west.

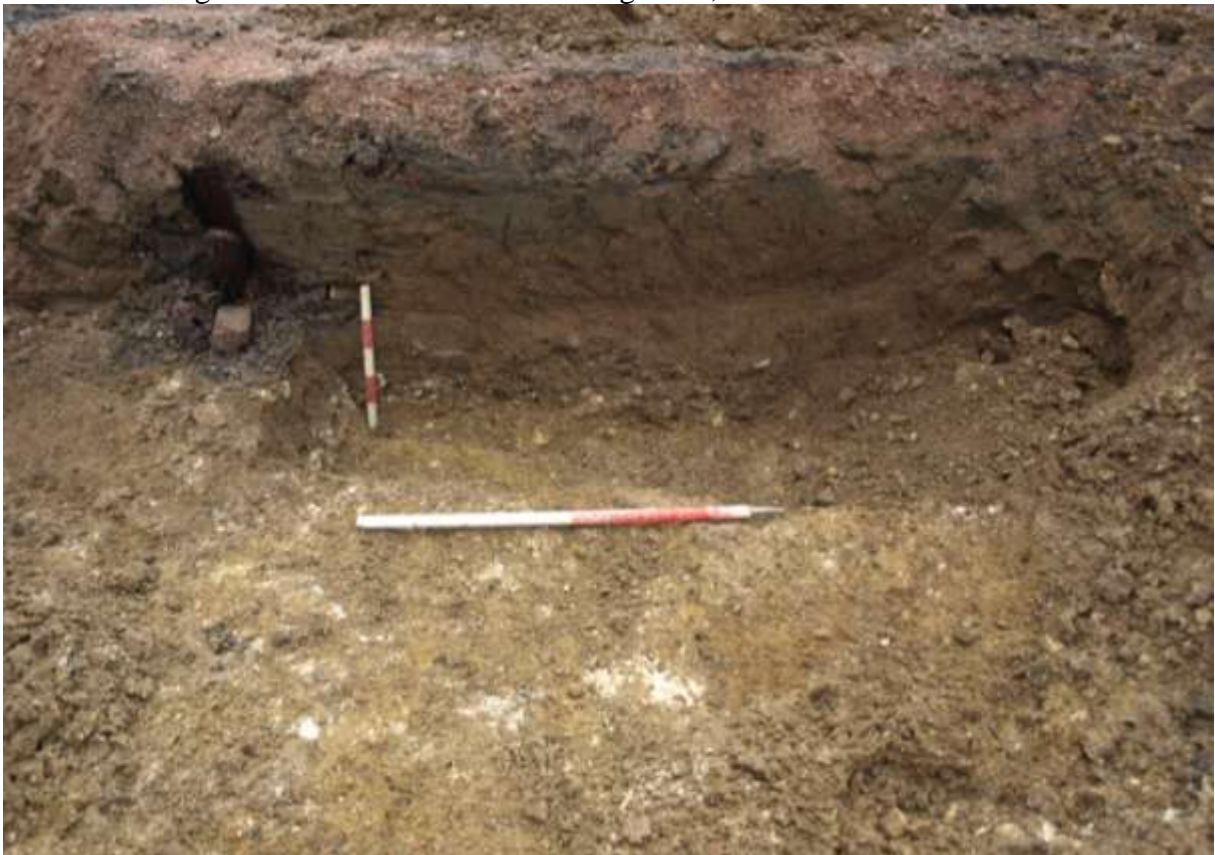
Plate 4. Showing section through rectilinear cut 13, modern post-hole 17 visible to the left. One and half metre scales.

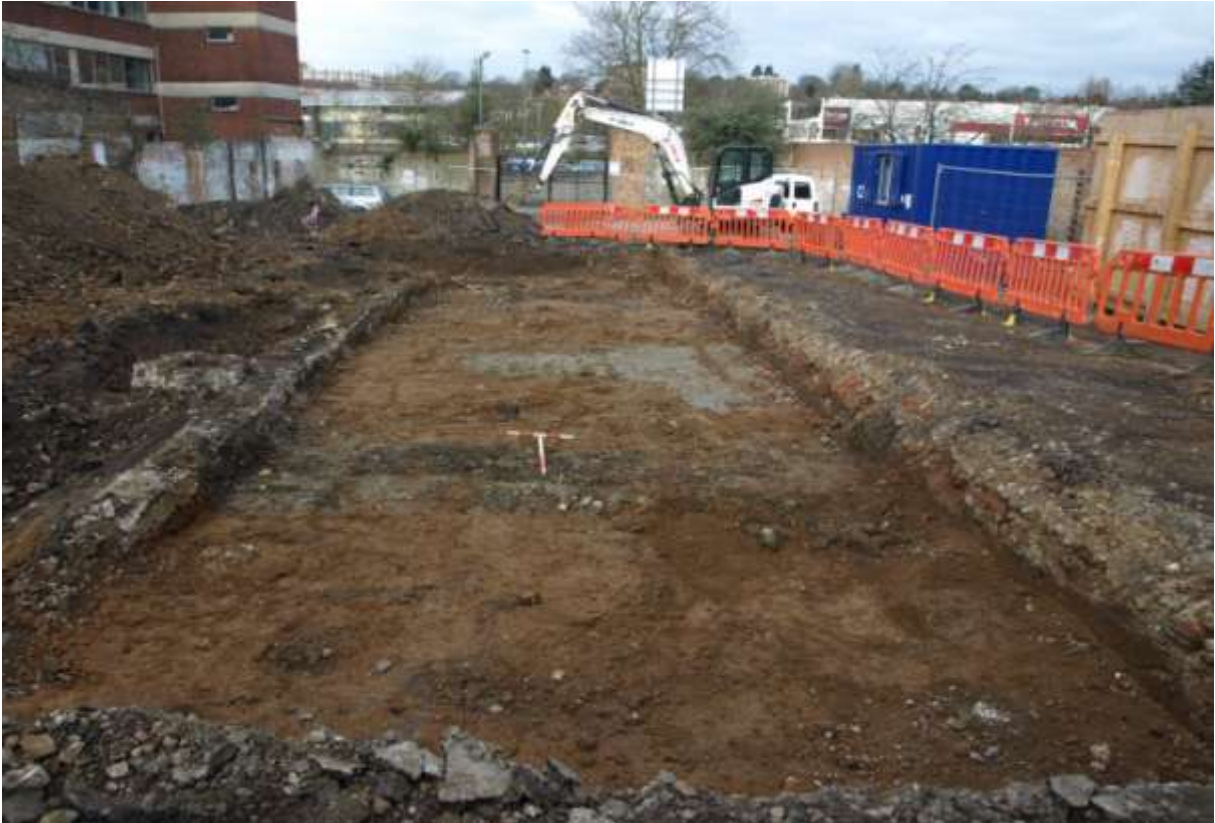
Plate 5. Showing exposed Area 2 comprising the northern part of the site, the linear formation 24 visible to the left. Looking west one and half-metre scales.

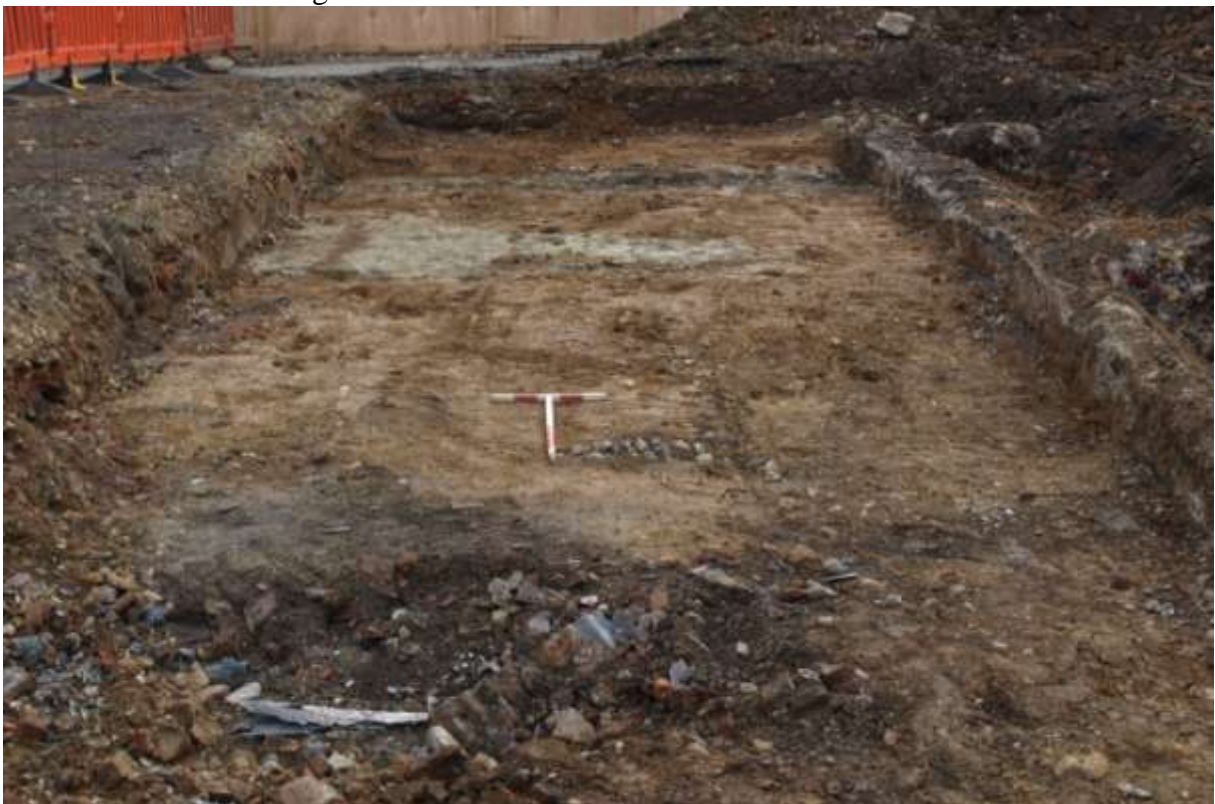
Plate 6. Showing northern part of the site, looking east. The large rubbish Pit 22 visible in foreground. One and half metre scales.

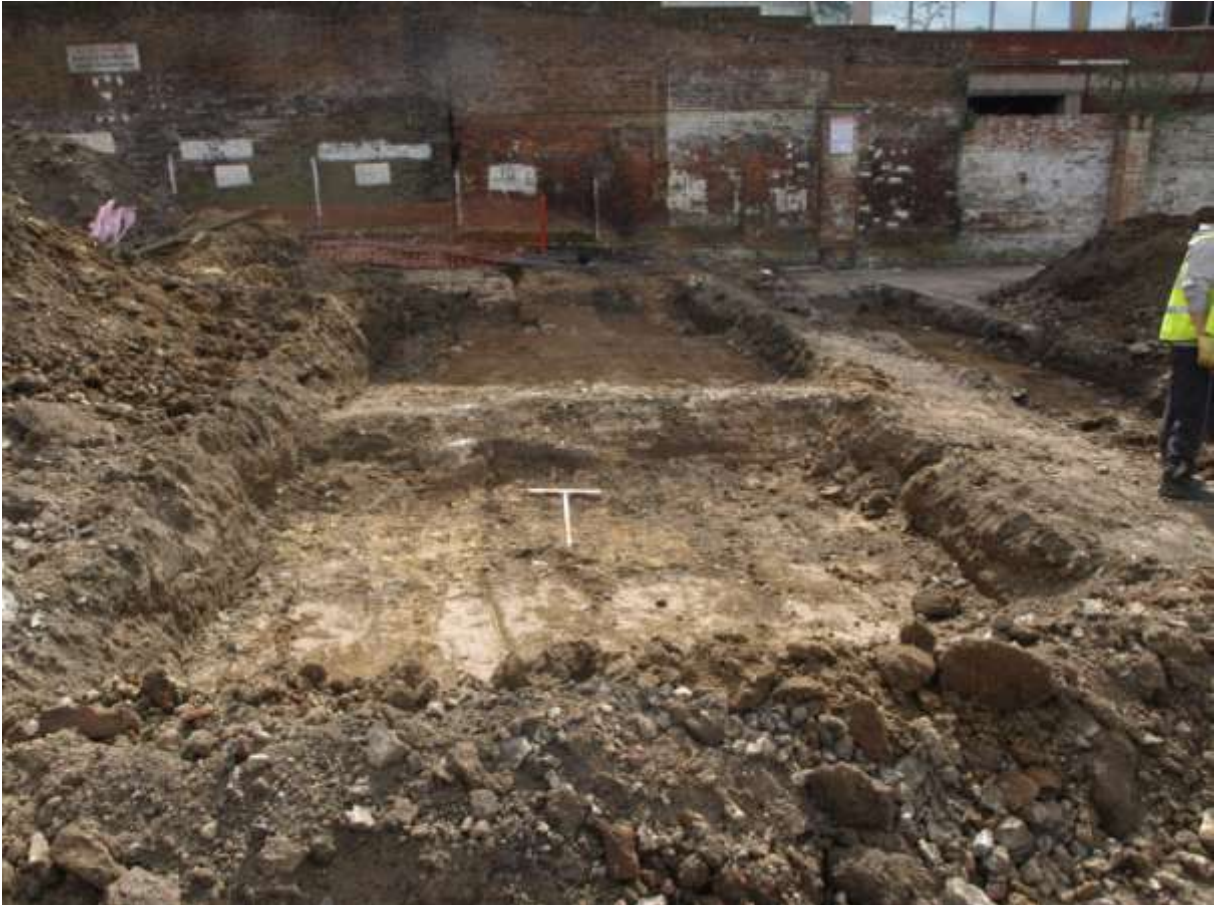
Plate 7. Showing the exposed Area 3 overlapping Area 1. The cut 13 denoted by wall and drain visible in background against existing wall (looking south, one and half metre scales)

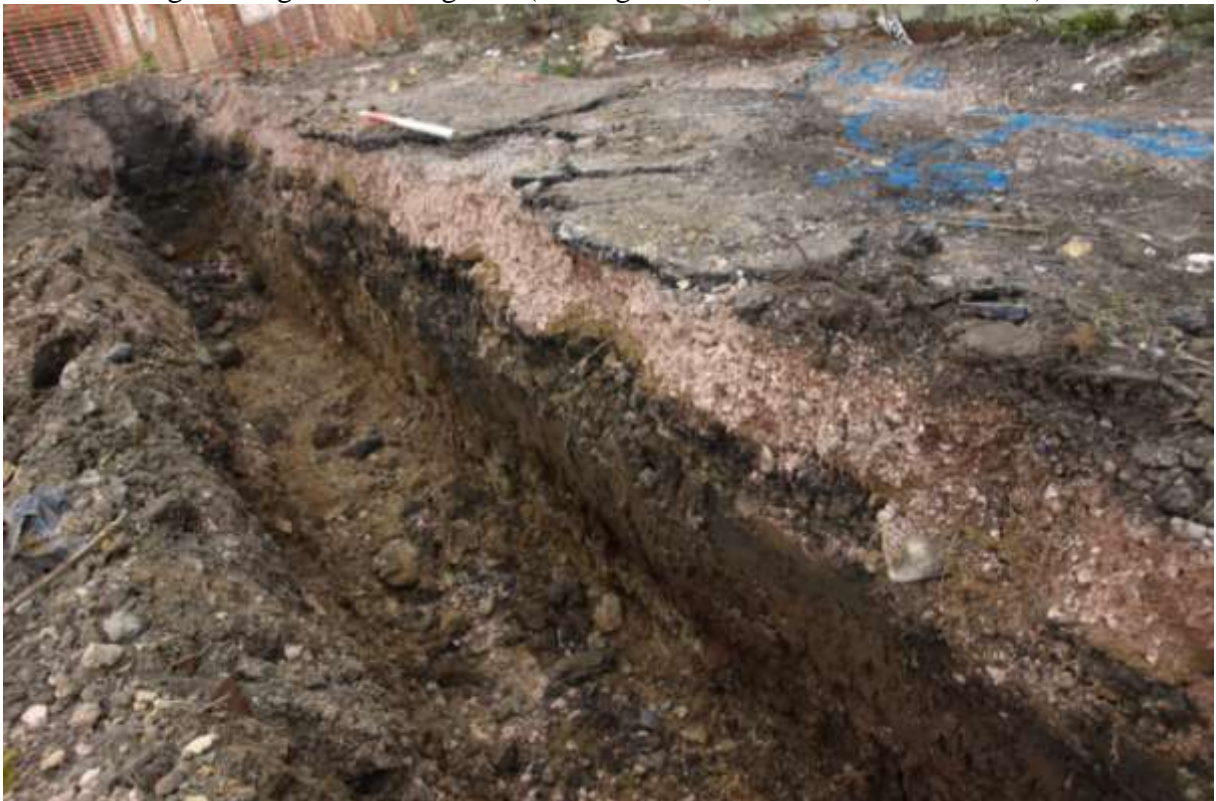
Plate 8. Overlook view on 6m-long section 1.4. Looking south-east, one metre scale.

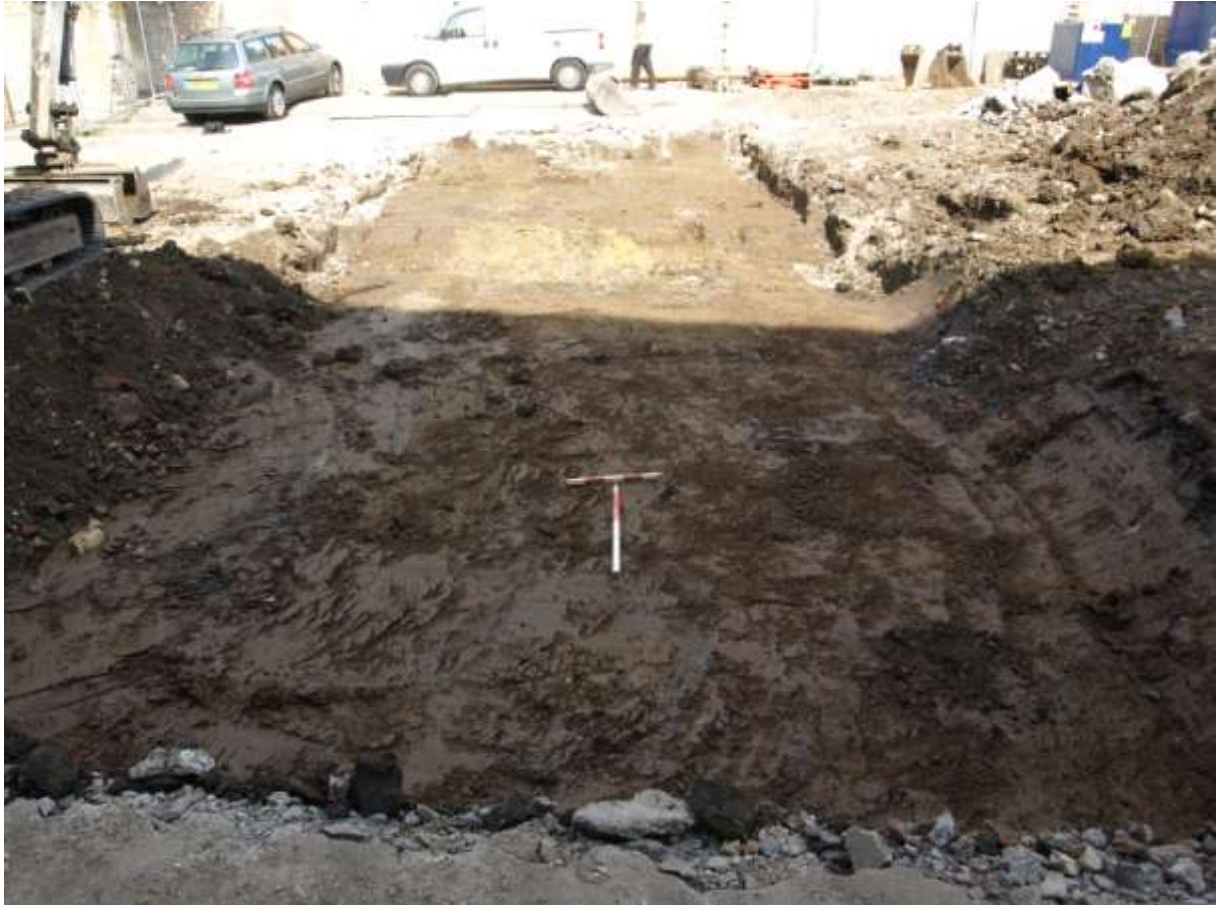
Plate 9. Overlook onto freshly exposed Area 4. Looking north, one and half metre scales.

Another consequently stripped area to the west (Plan.Fig.6) (Plates 9 and 10) exposed orange-brown alluvial natural with rectilinear modern intrusions and a large concrete footing cut into it (Plates 11 and 12). The block measured in plan 1.06m by 1.07m and the depth of a hollow where was accommodated measured 0.6m in depth.
