Archaeological Monitoring of Land at Fairmeadow, Maidstone, Kent

Site Code MA/WB/15

Report for Chartway Group Ltd
Date of report 22/10/2015

Planning No. MA/14/0096

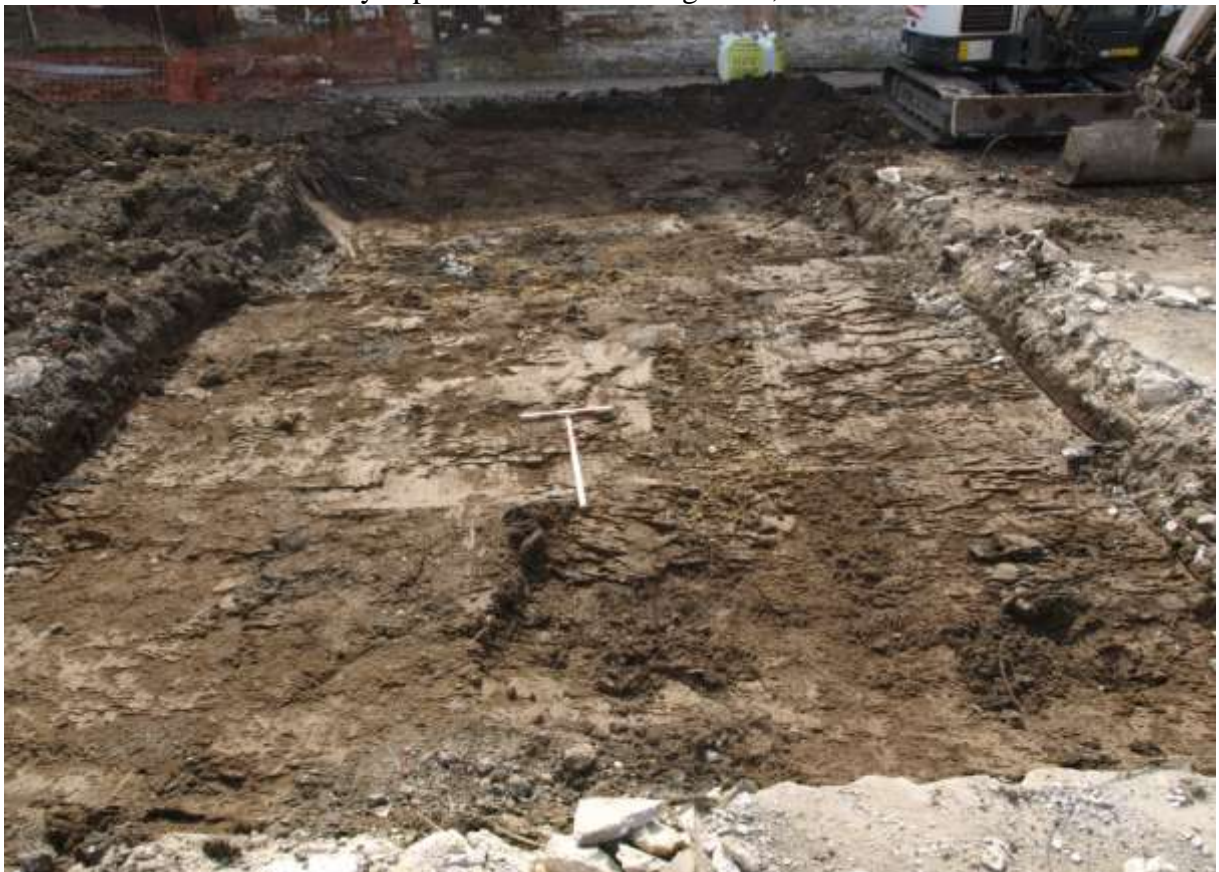
Plate 10. Overlook onto freshly exposed Area 4. Looking south, one and half metre scales.

Another consequently stripped area to the west (Plan.Fig.6) (Plates 9 and 10) exposed orange-brown alluvial natural with rectilinear modern intrusions and a large concrete footing cut into it (Plates 11 and 12). The block measured in plan 1.06m by 1.07m and the depth of a hollow where was accommodated measured 0.6m in depth.

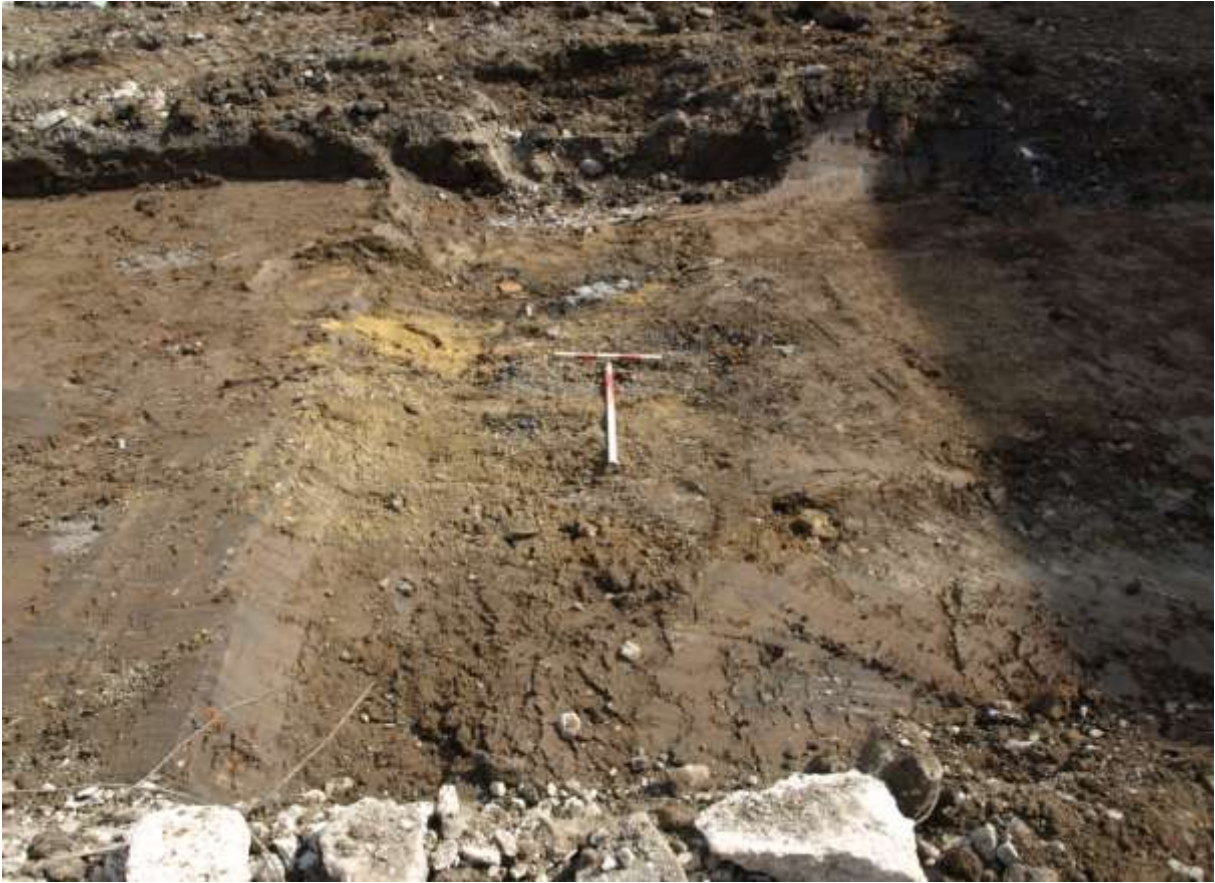
Plate 11. Showing the ground beneath the concrete footings (after they've been removed). Looking east, one and half metre scales.

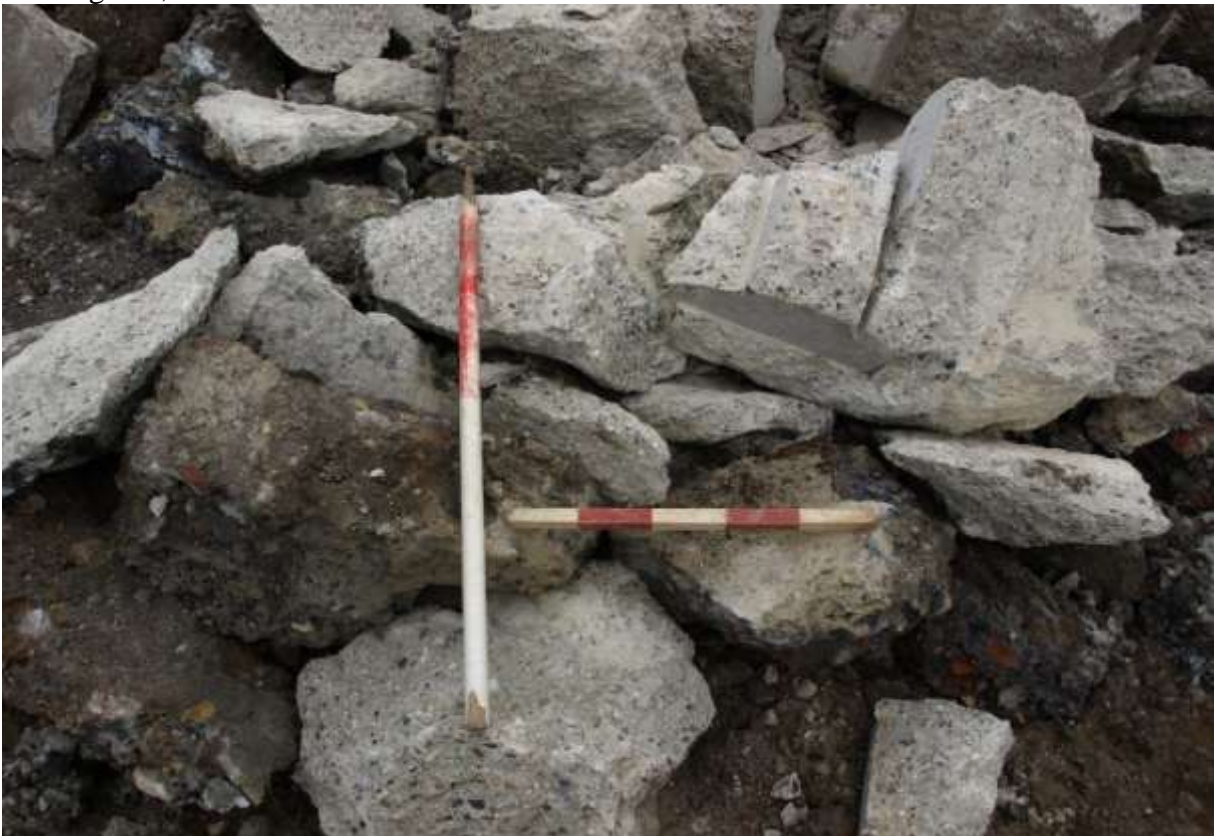
Plate 12. Showing the details of removed concrete footings. One and half metre scales.

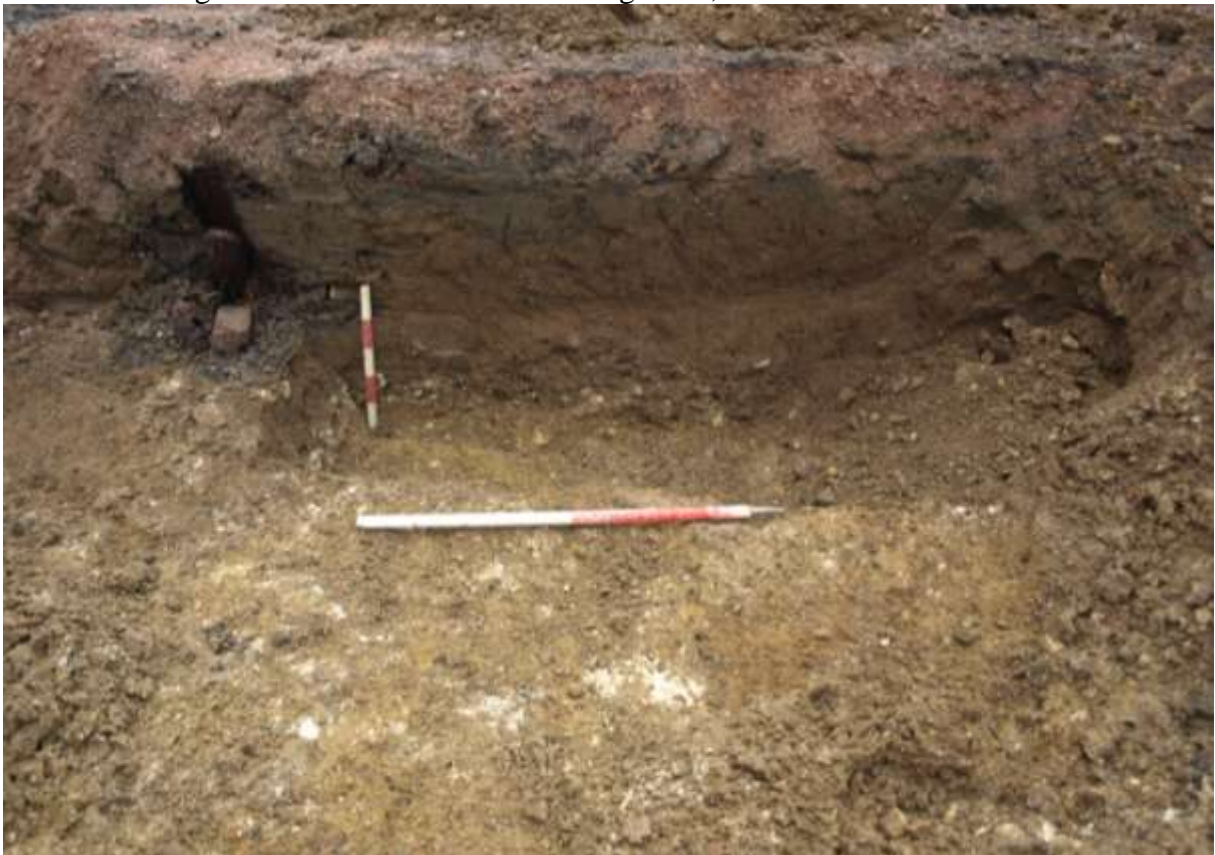
Plate 4. Showing section through rectilinear cut 13, modern post-hole 17 visible to the left. One and half metre scales.

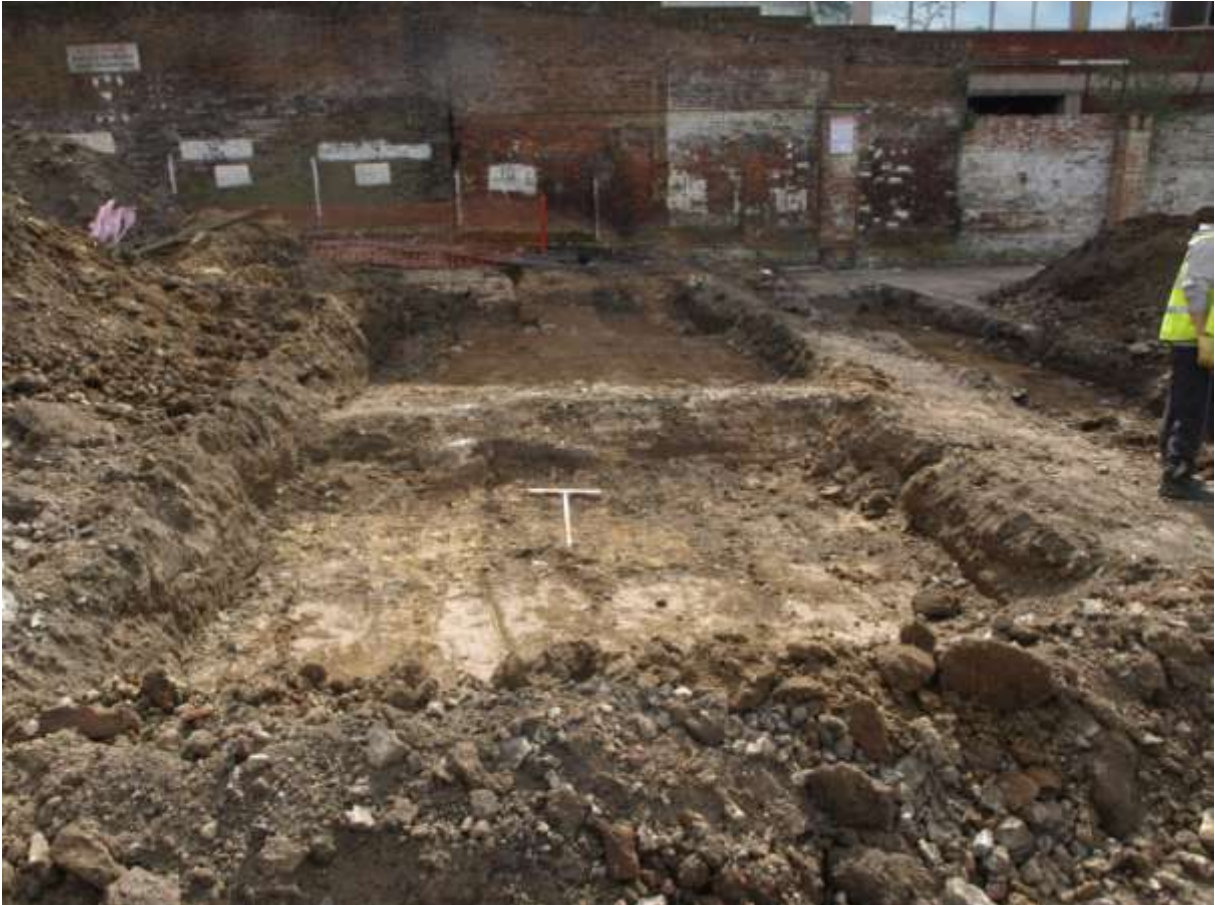
Plate 7. Showing the exposed Area 3 overlapping Area 1. The cut 13 denoted by wall and drain visible in background against existing wall (looking south, one and half metre scales)

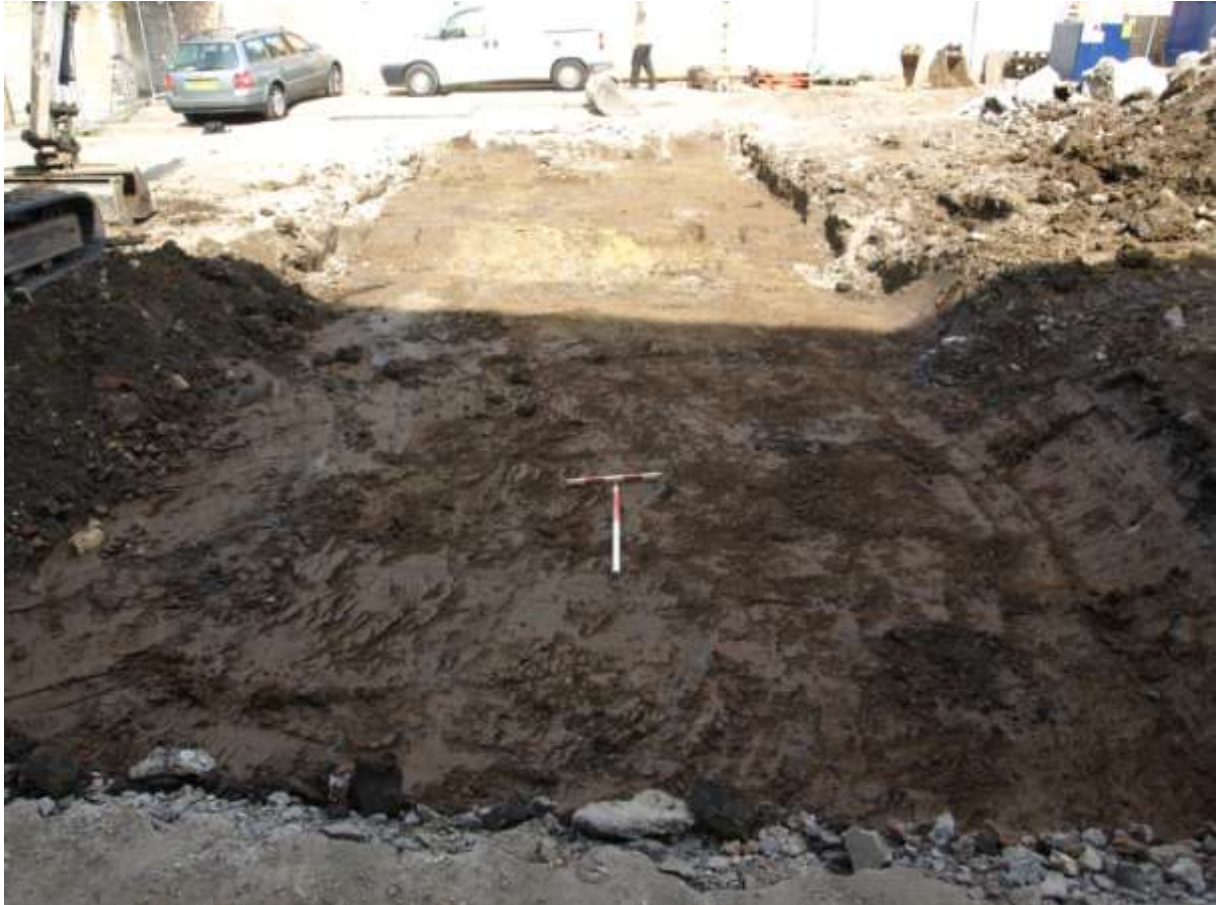
Plate 9. Overlook onto freshly exposed Area 4. Looking north, one and half metre scales.

Another consequently stripped area to the west (Plan.Fig.6) (Plates 9 and 10) exposed orange-brown alluvial natural with rectilinear modern intrusions and a large concrete footing cut into it (Plates 11 and 12). The block measured in plan 1.06m by 1.07m and the depth of a hollow where was accommodated measured 0.6m in depth.

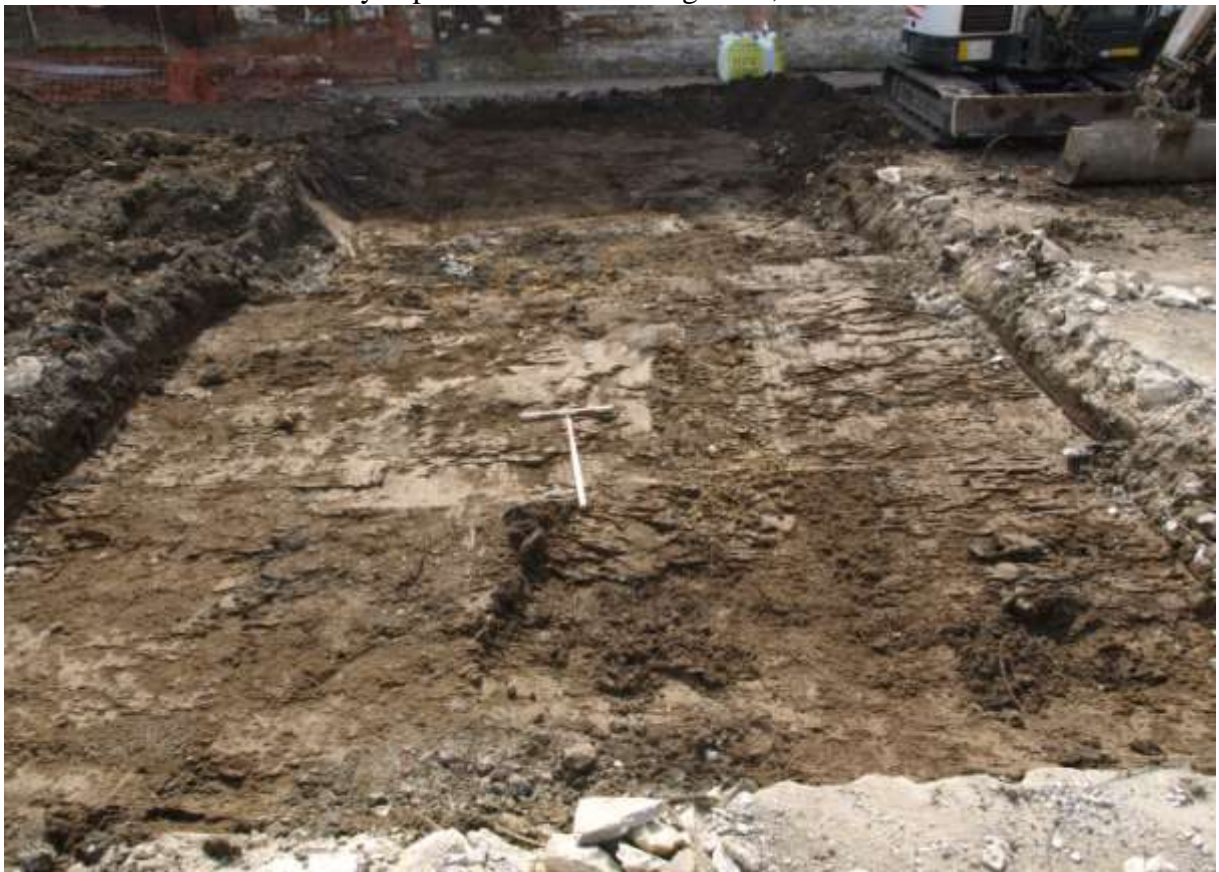
Plate 10. Overlook onto freshly exposed Area 4. Looking south, one and half metre scales.

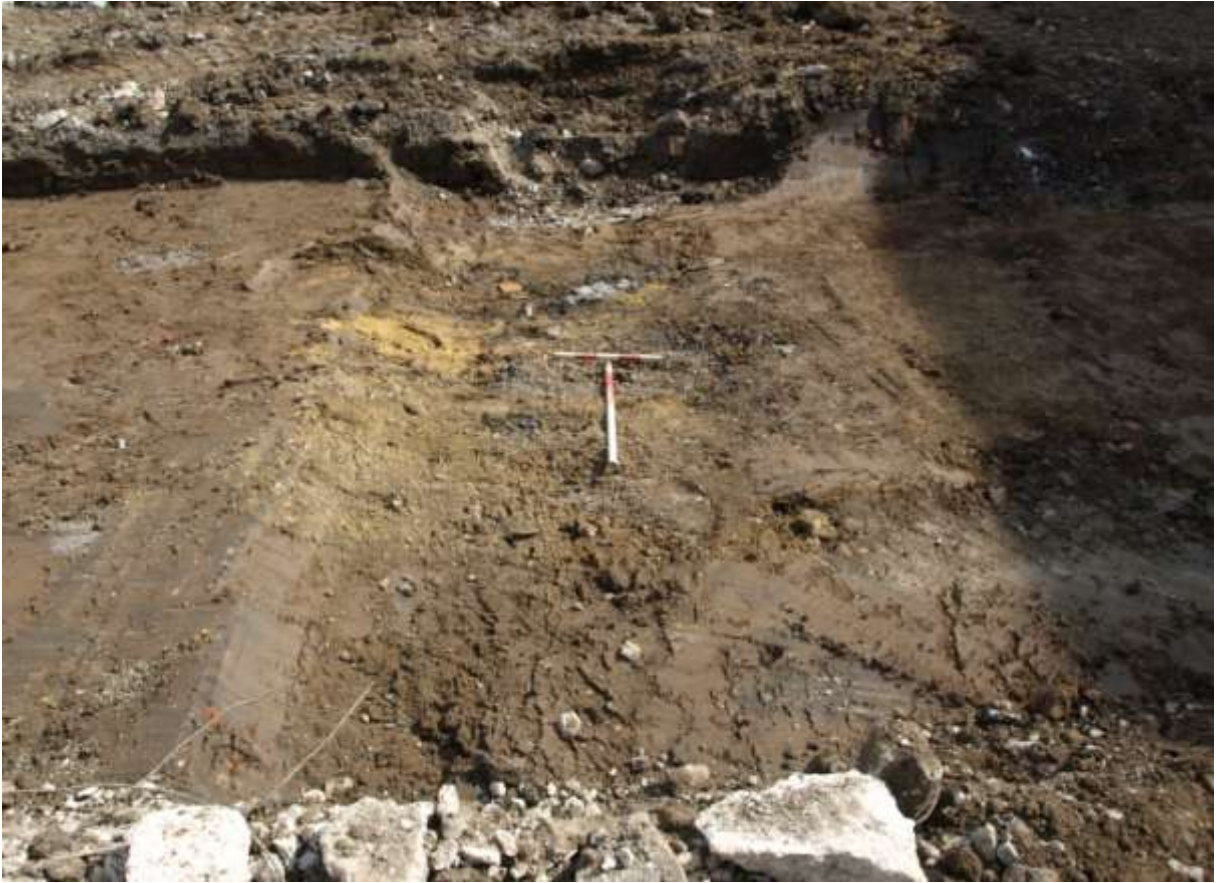
Plate 11. Showing the ground beneath the concrete footings (after they've been removed). Looking east, one and half metre scales.

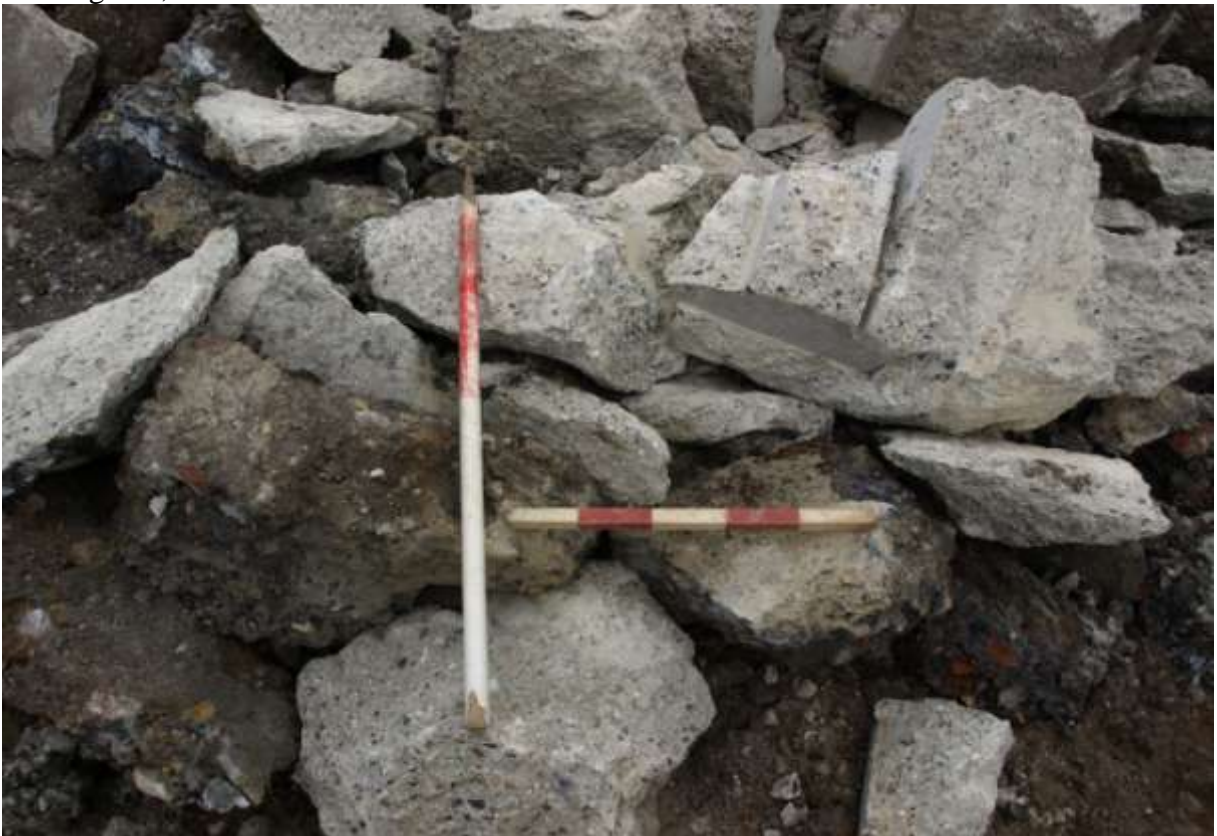
Plate 12. Showing the details of removed concrete footings. One and half metre scales.

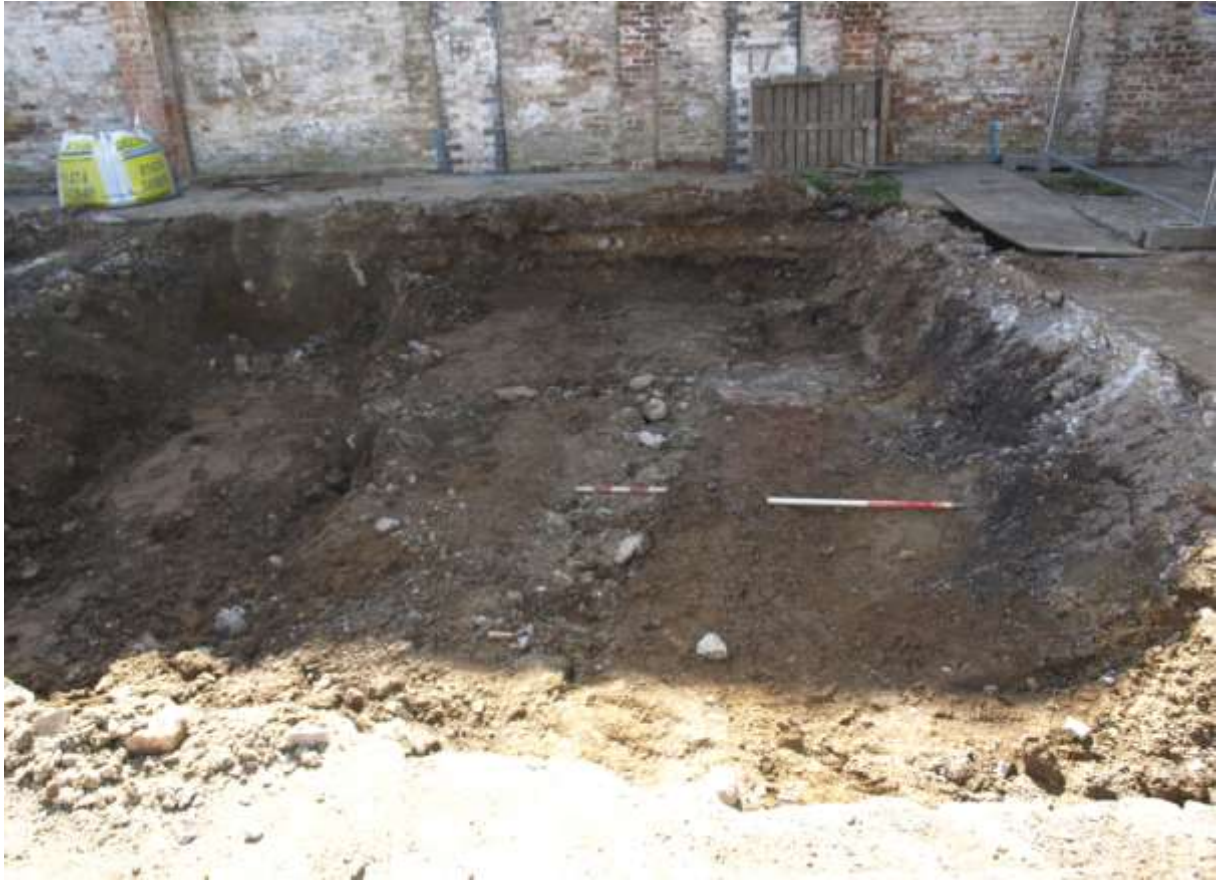
Plate 13. Showing southern part of exposed Area 5. Looking south, one and half metre scales.

The last portion of the site subjected to archaeological evaluation was Area 5 (**Plan. Fig.8, Plates 13 and 14**) located to the west. An exposed orange-brown natural surface was truncated by several modern cuts comprising concrete footings, service trench and possible drain-containing trench (CRN 28) was back-filled with ragstone cobbles, sand and infrequent brick fragments and tiles (**Plate 16**).

A two perpendicular brick walls (CRNs 26 and 27) were exposed and comprised an 'L' shape corner which enclosed a 1.2m-deep modern service trench to the west of Wall 26 and concrete footing (**Plan.Fig.8, Plate 13 to the left**)

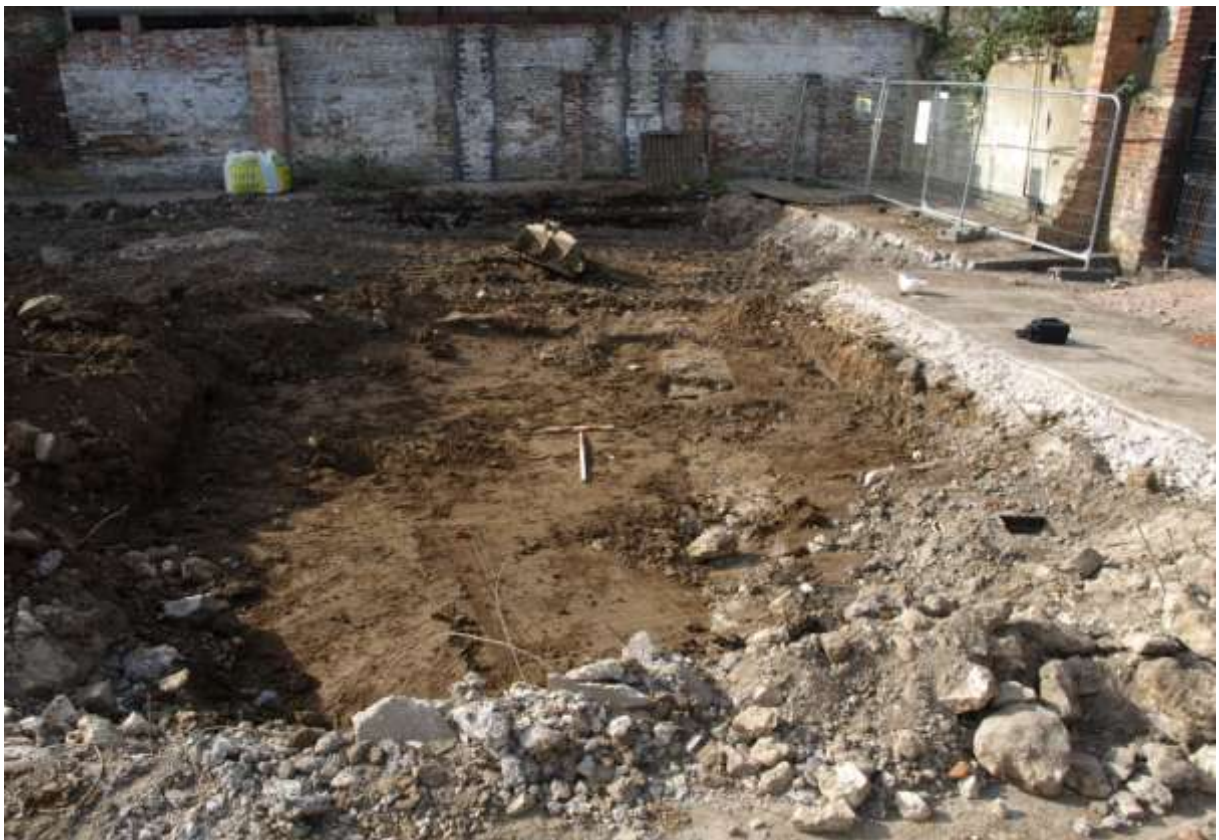
Plate 14. Showing exposed Area 5. Looking south, one and half metre scales. Trench 29 visible in foreground to the right and Trench 28 in background also to the right.

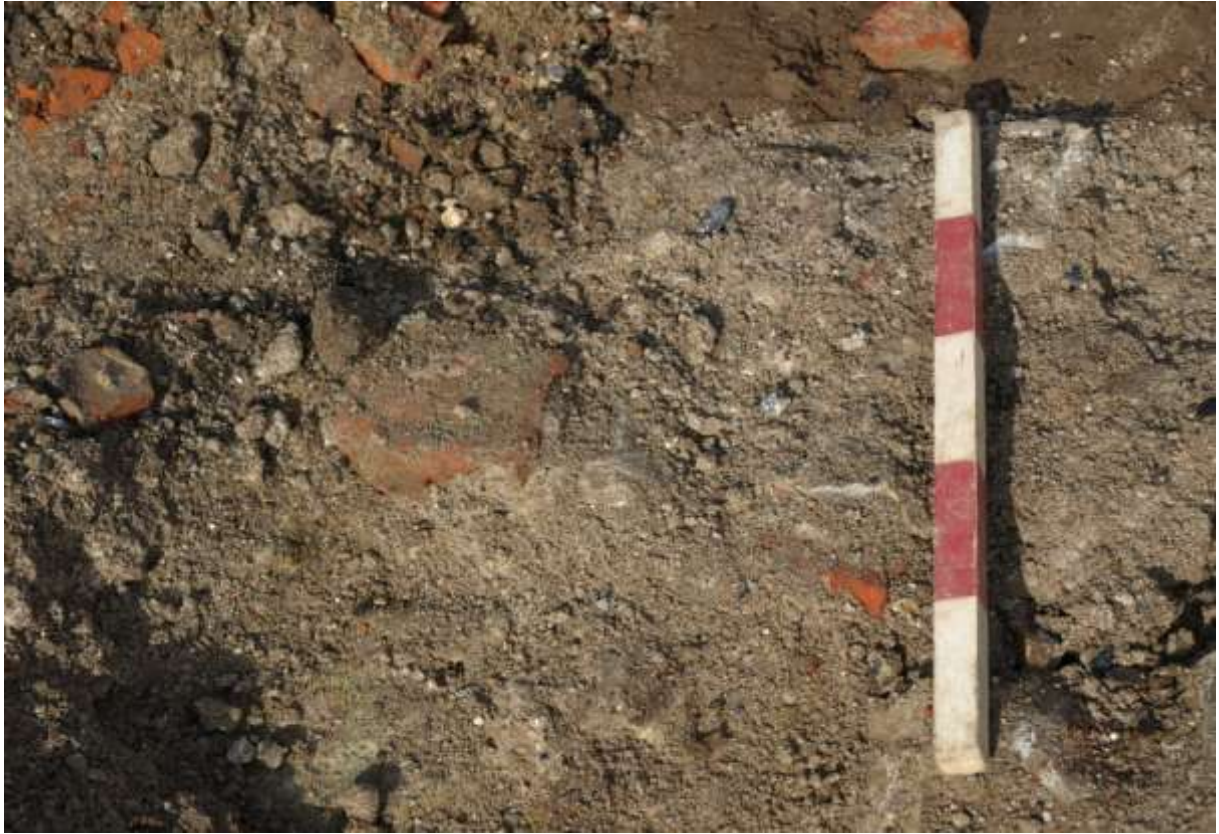
Plate 15. Showing details of Trench 29 back-fill. Half metre scale

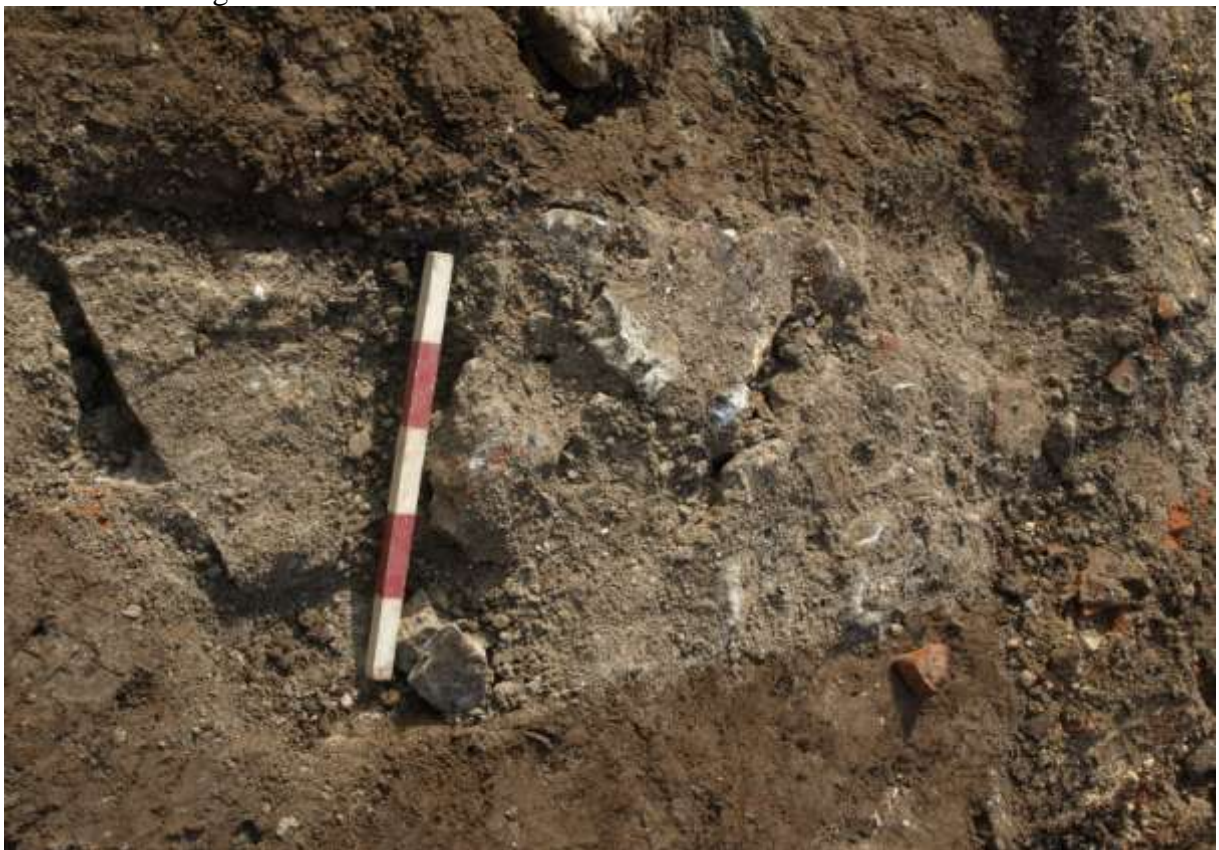
Plate 16. Showing details of Trench 28 back-fill. Half metre scale.

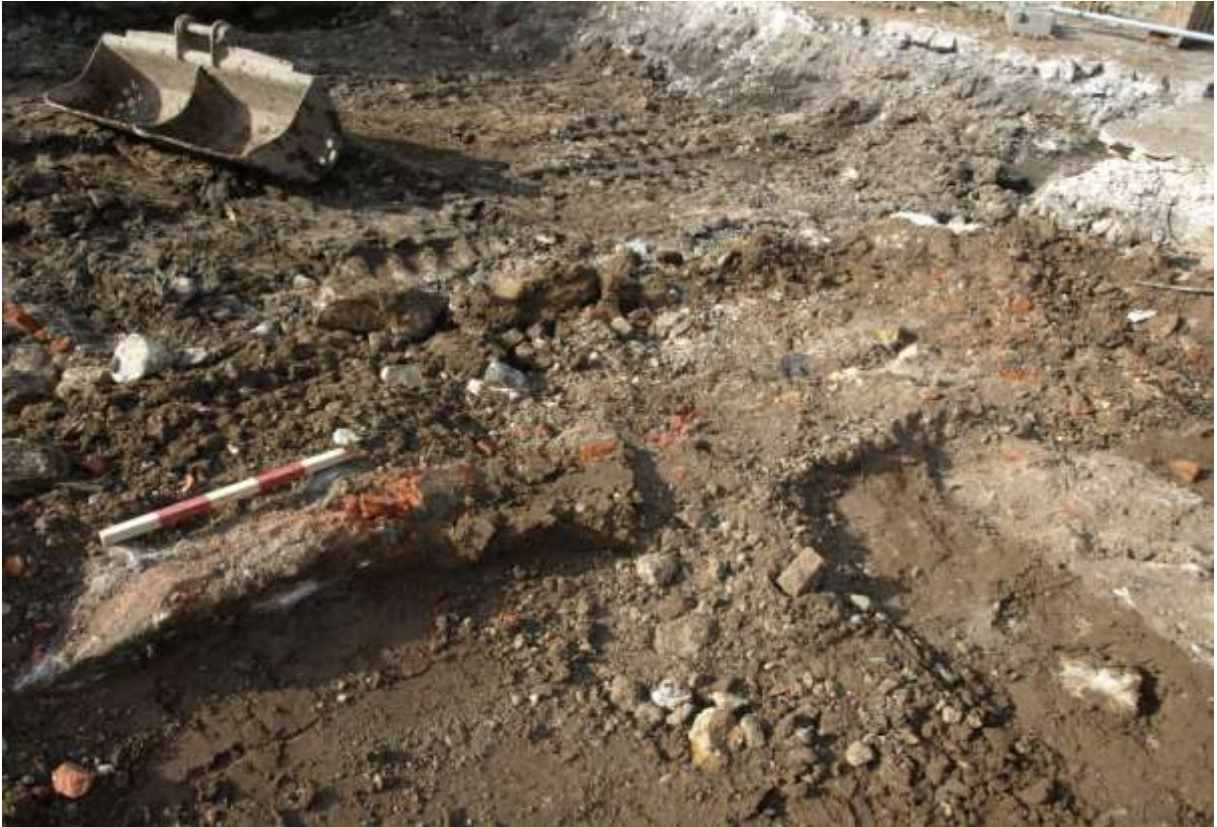
Plate 17. Showing wall 27 which appears to be truncated by Trench 28. Looking south-west, half metre scale.

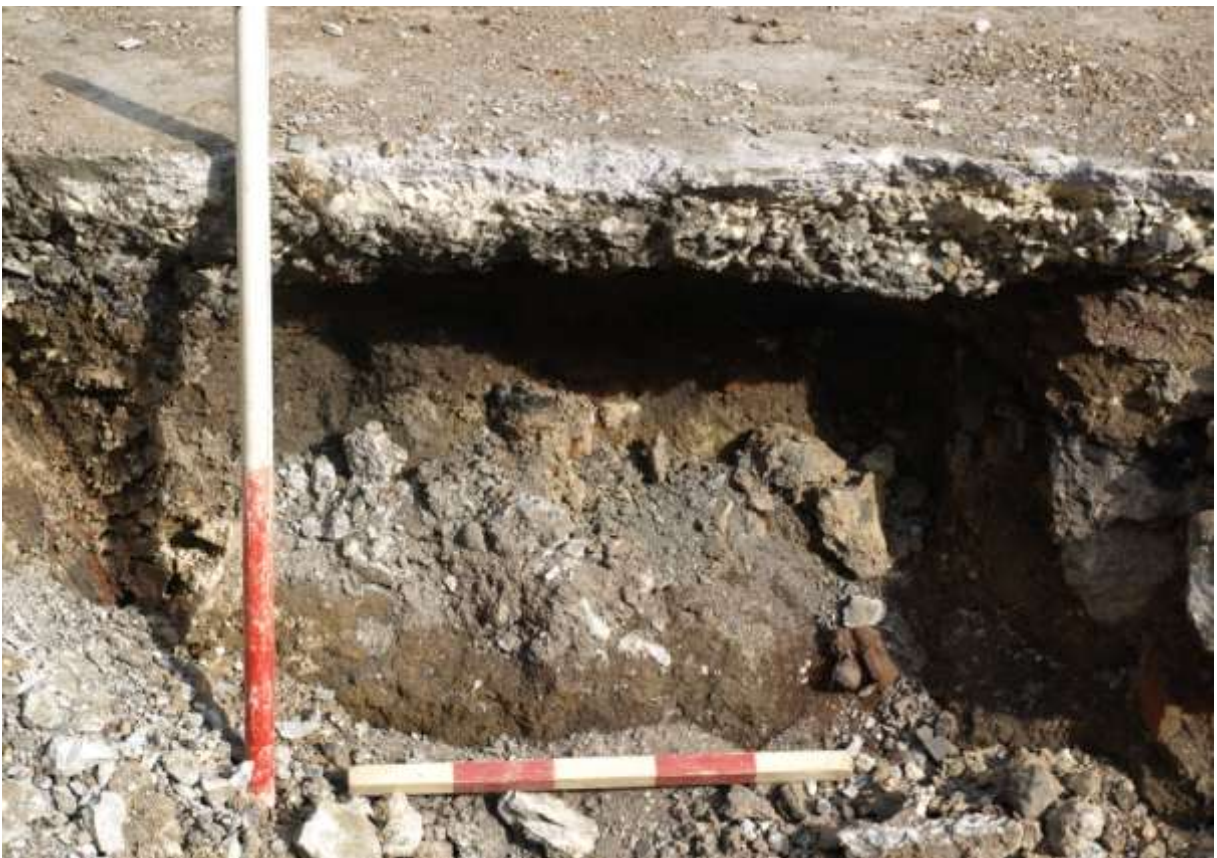
Plate 18. Showing modern deposit sequence underlying small not exposed area between western limit of Area 5 and site entrance from Fairmeadow Rd. One and half metre scales.

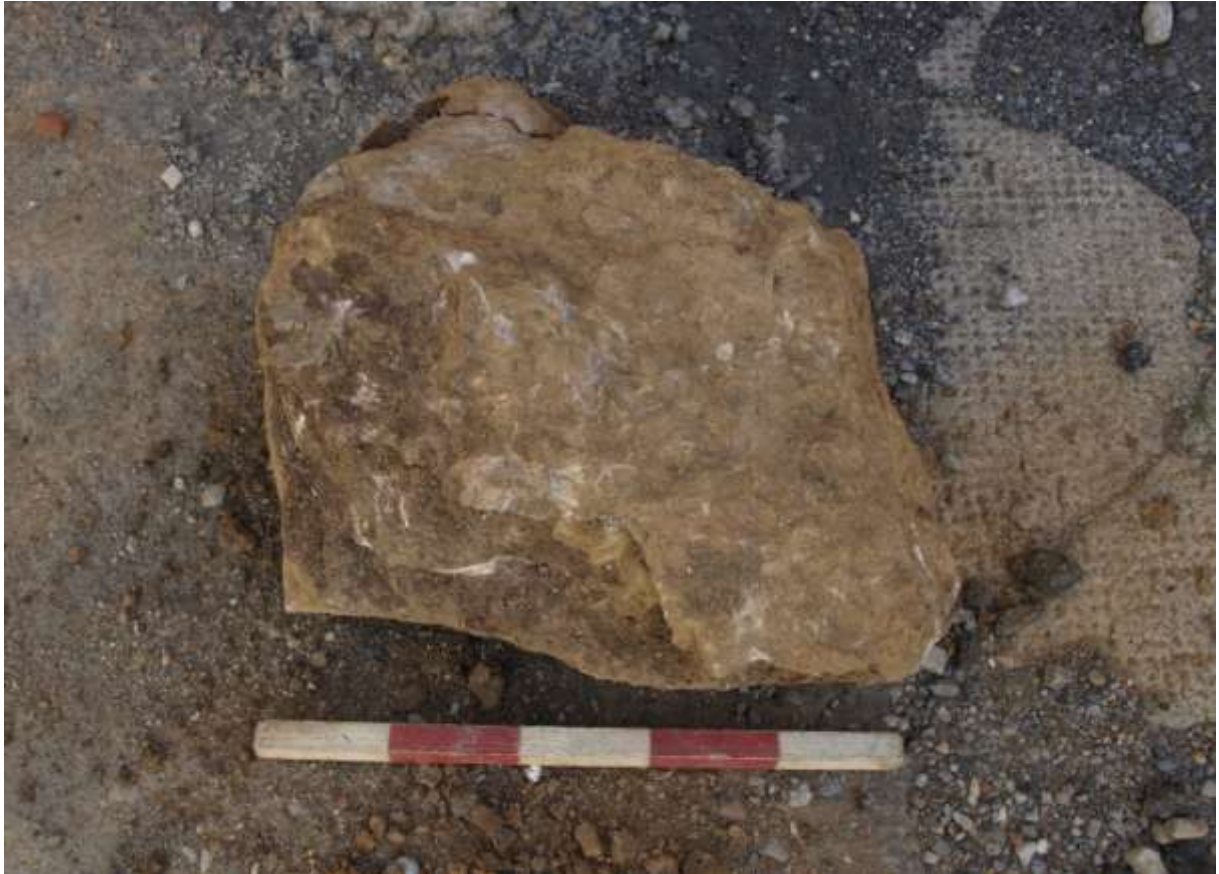
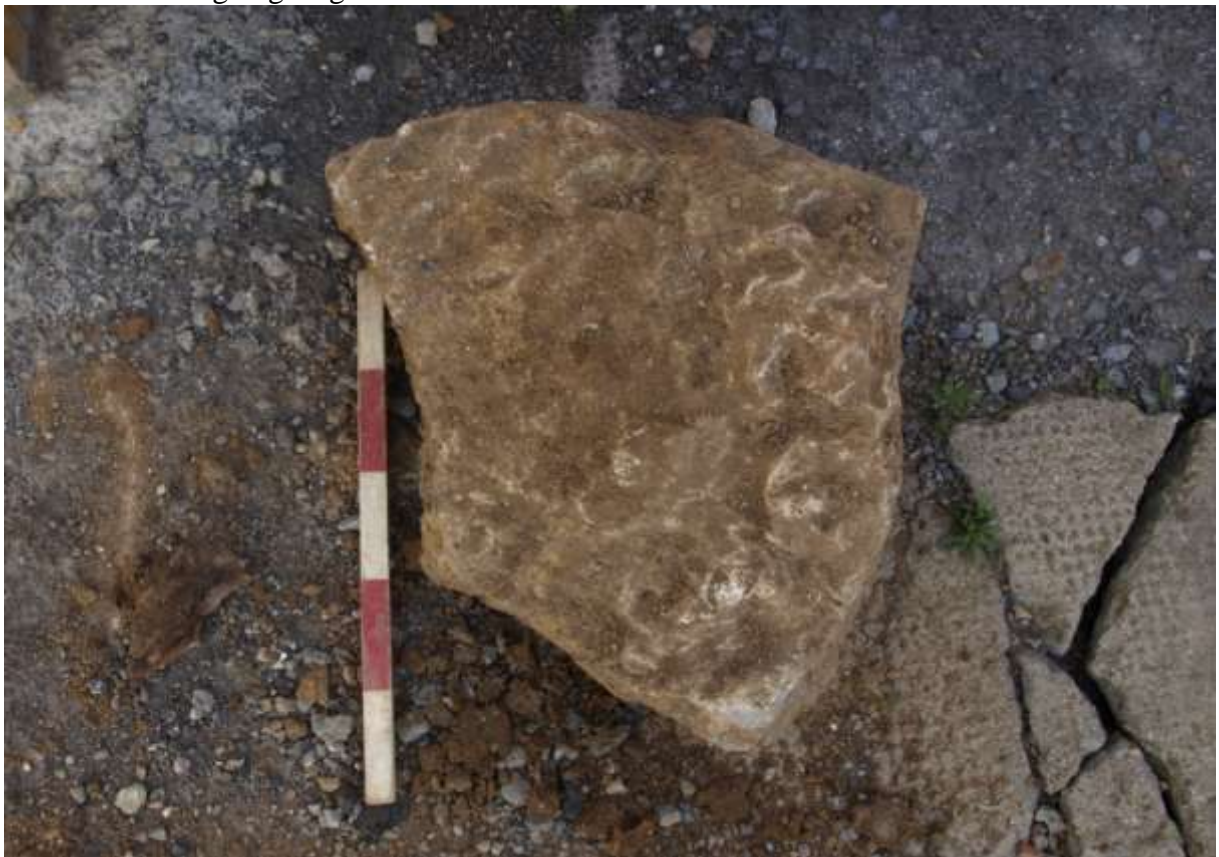
Plate 19. Showing large ragstone block retrieved from natural surface in Area 2. Half metre scale

Plate 20. Showing large ragstone block retrieved from natural surface in Area 2. Reverse
