Archaeological Evaluation of Land at Goffs Park, Crawley, West Sussex

Site Code: GOF/EV/16

SWAT Archaeology

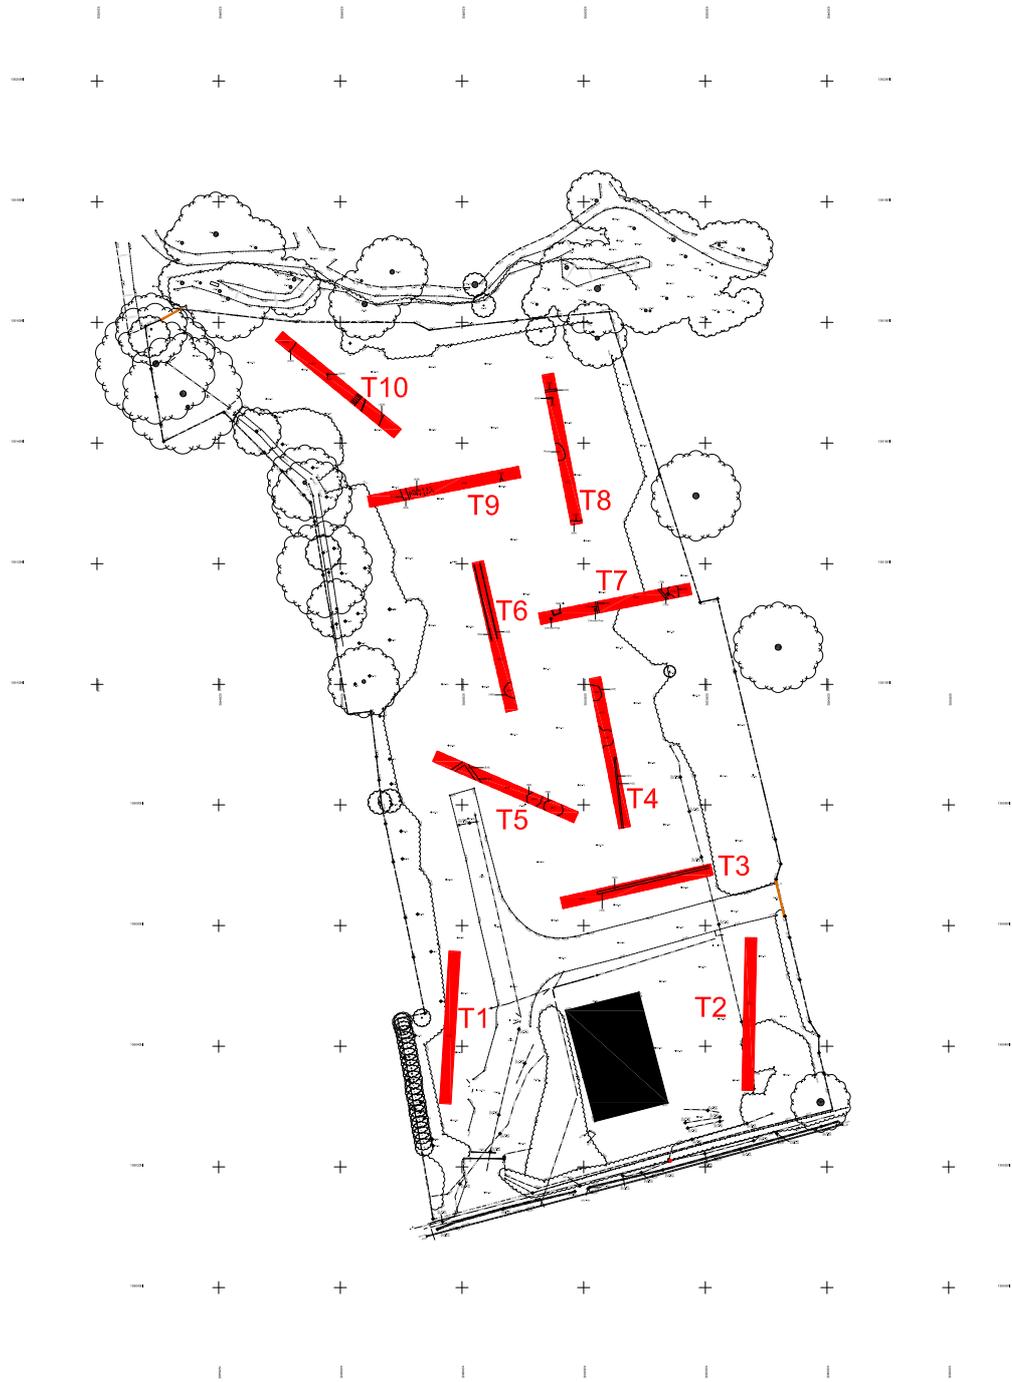
Figure 1: Location of Evaluation Trenches

The evaluation has identified no archaeological features within the 10 trenches (Figure 1).

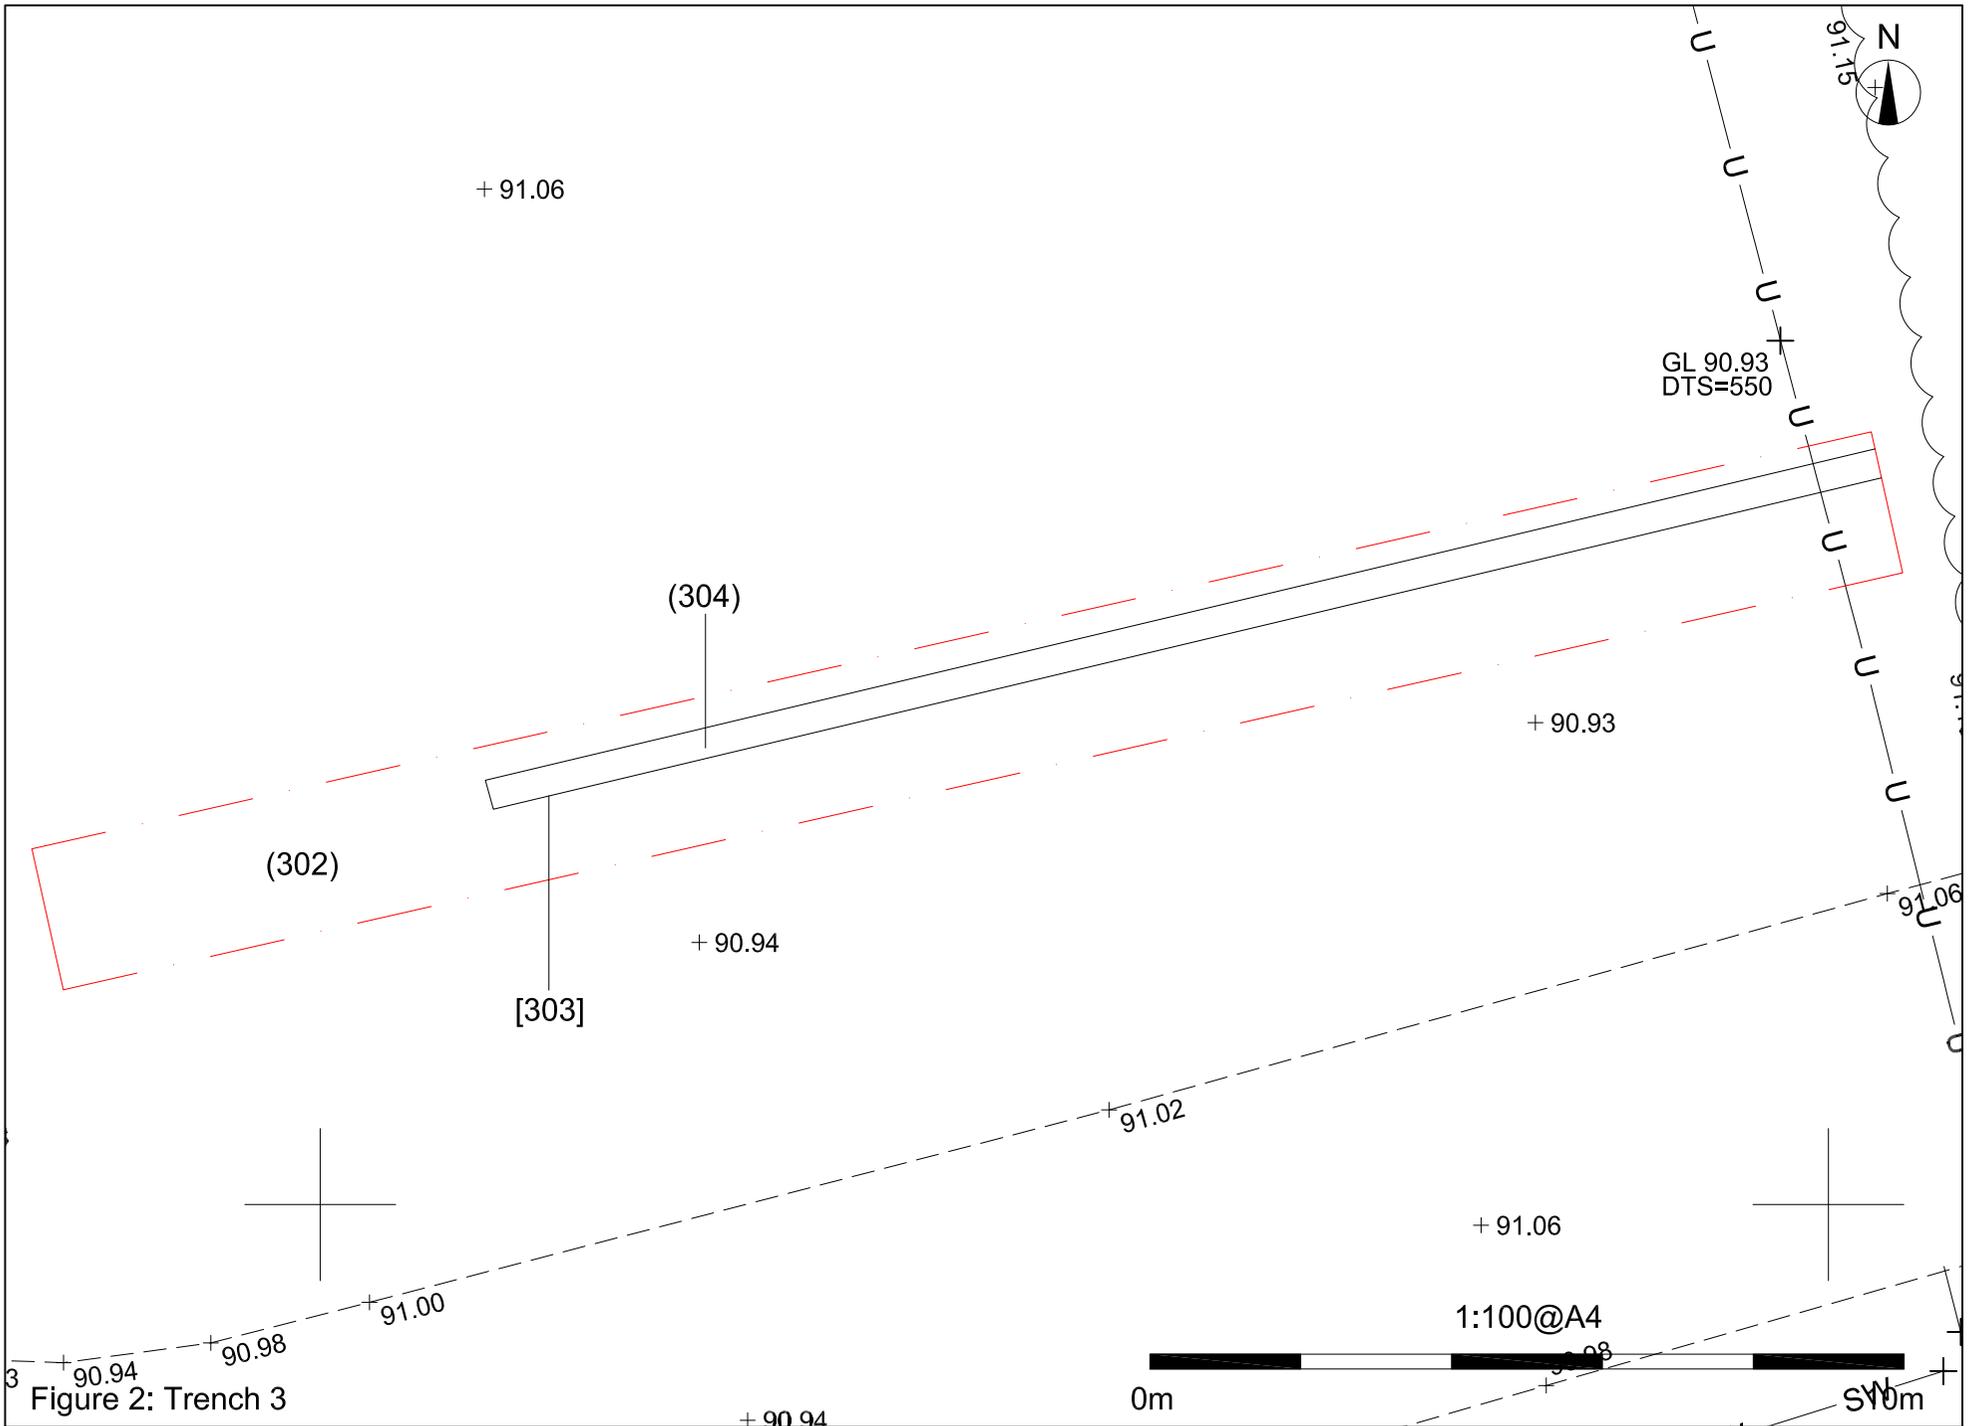
Figure 2: Trench 3

9.3 The plan is recorded in Figures 1 and 2 (see also Plates 6, 7, 8, 9). The trench lay on a W to E alignment and measured approximately 25m by 1.90m.

Undisturbed natural geology **(303)** was identified across the trench as Wealden Clay, at a depth of approximately 0.30m (90.70m OD) below the present ground surface at 91.00m OD at mid-trench. Cut into the natural was a modern foundation trench **[303]** infilled with gravel and concrete pieces and about 36cm wide. Above this was a layer of concrete crush **(301)** 0.18m thick topped by a thin layer of sand and earth.

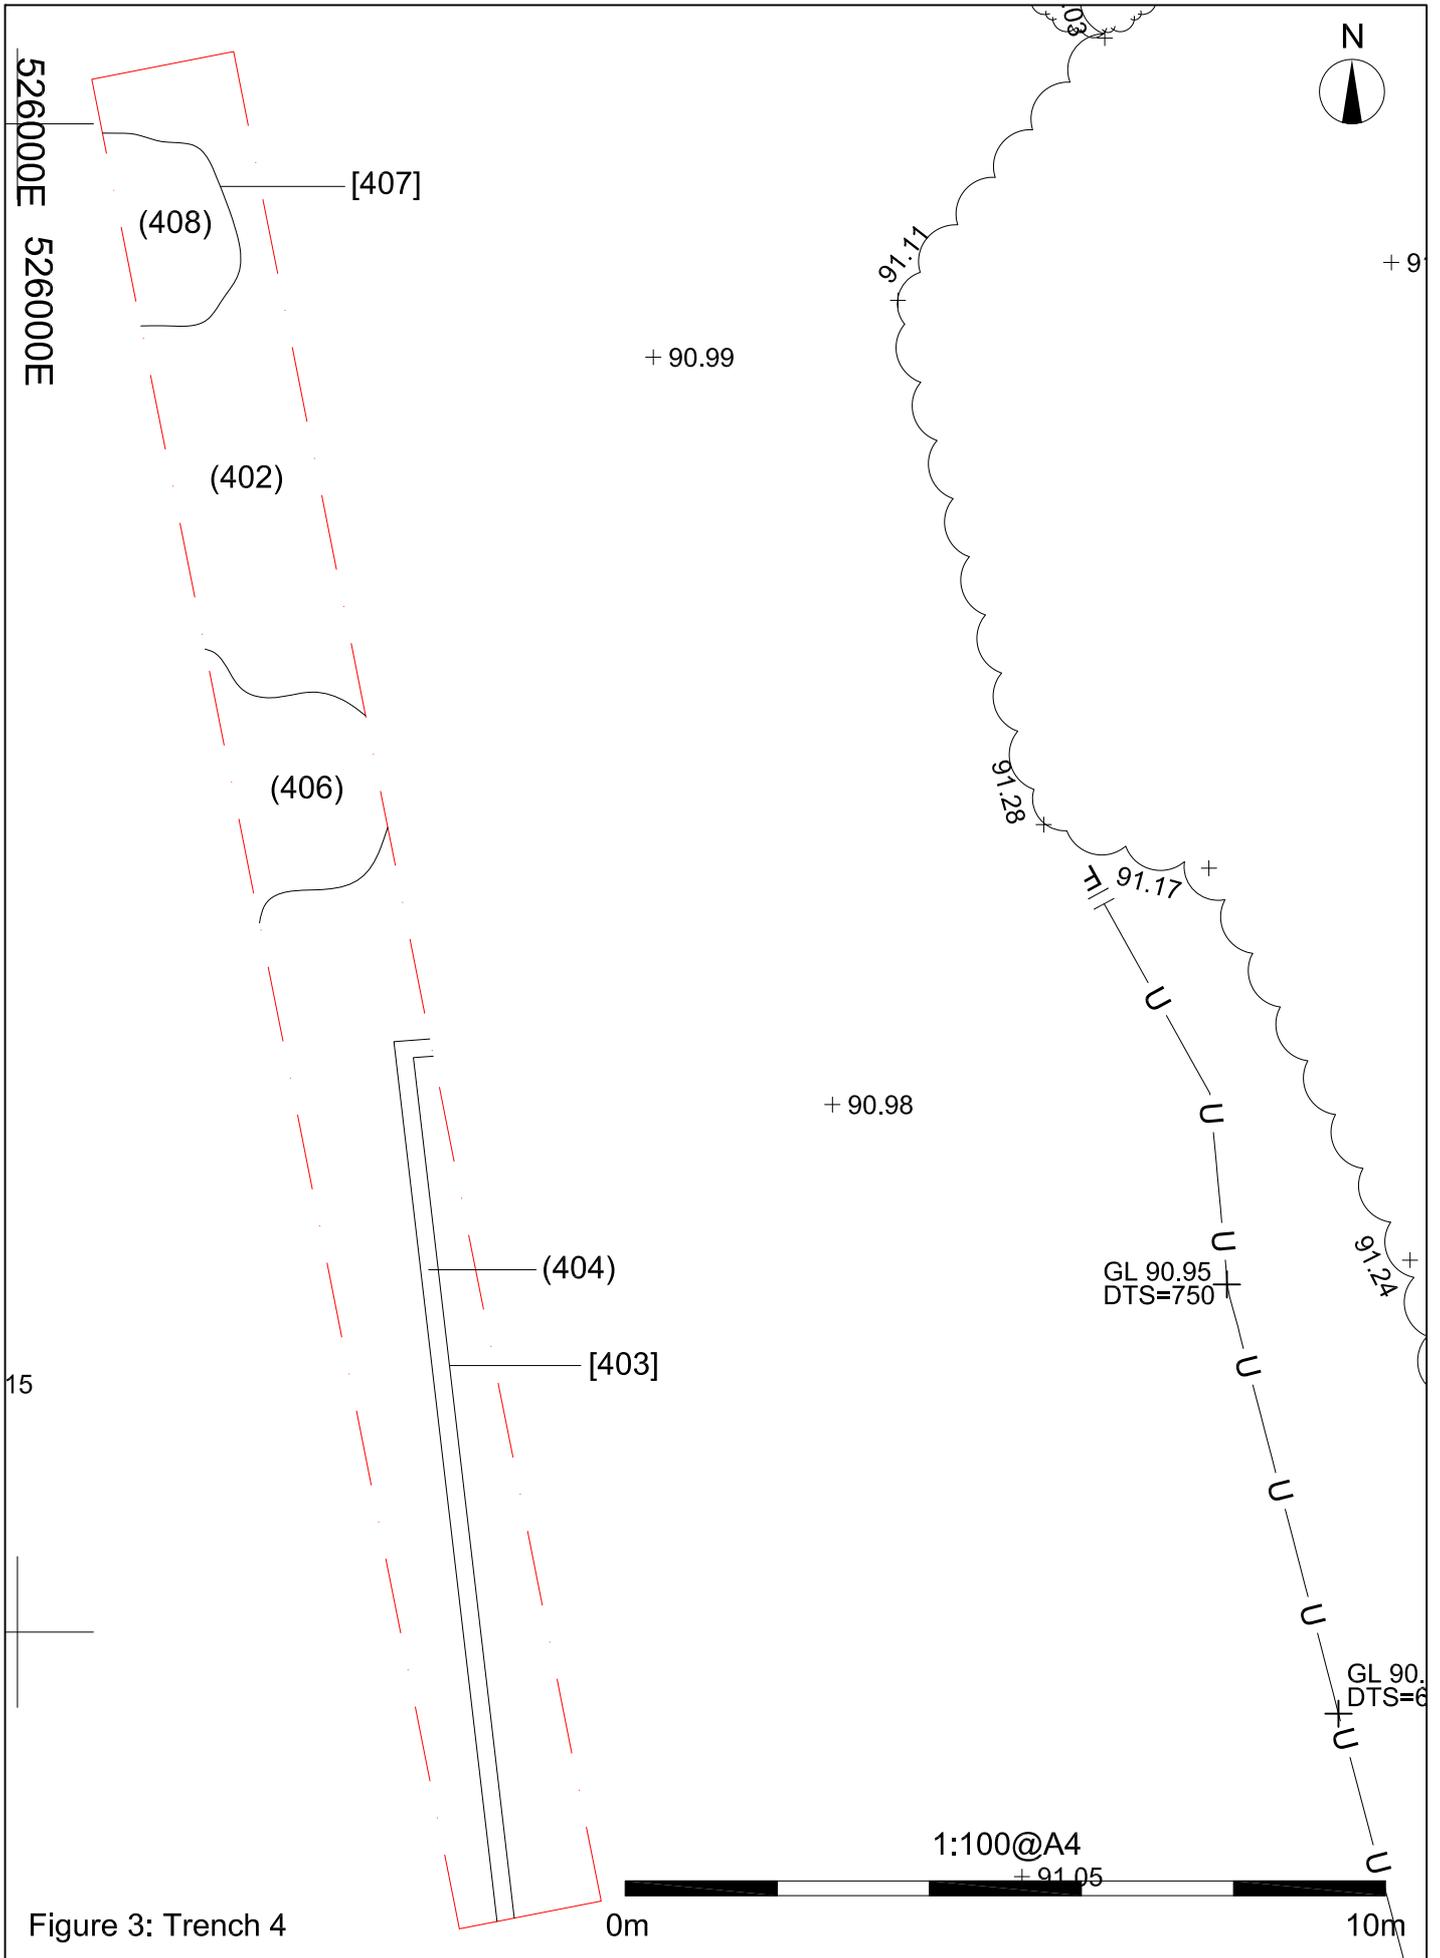
Figure 3: Trench 4

9.4 The plan is recorded in Figures 1 and 3. (see also Plate 11) The trench lay on an SSE to NNW alignment and measured approximately 25m by 1.90m.

Undisturbed natural geology **(402)** was identified across the trench as Wealden Clay, at a depth of approximately 0.20m (90.80m OD) below the present ground surface at 91.00m OD at mid-trench. Cut into the natural were three modern features, two modern rubbish dumps **[407], (406), (408)** and a modern foundation trench **[403]** 23cm wide and filled with gravel and crushed concrete **(404)**. The natural geology **(405)** was sealed by a layer of gravel and cement crush mix 0.20m thick.

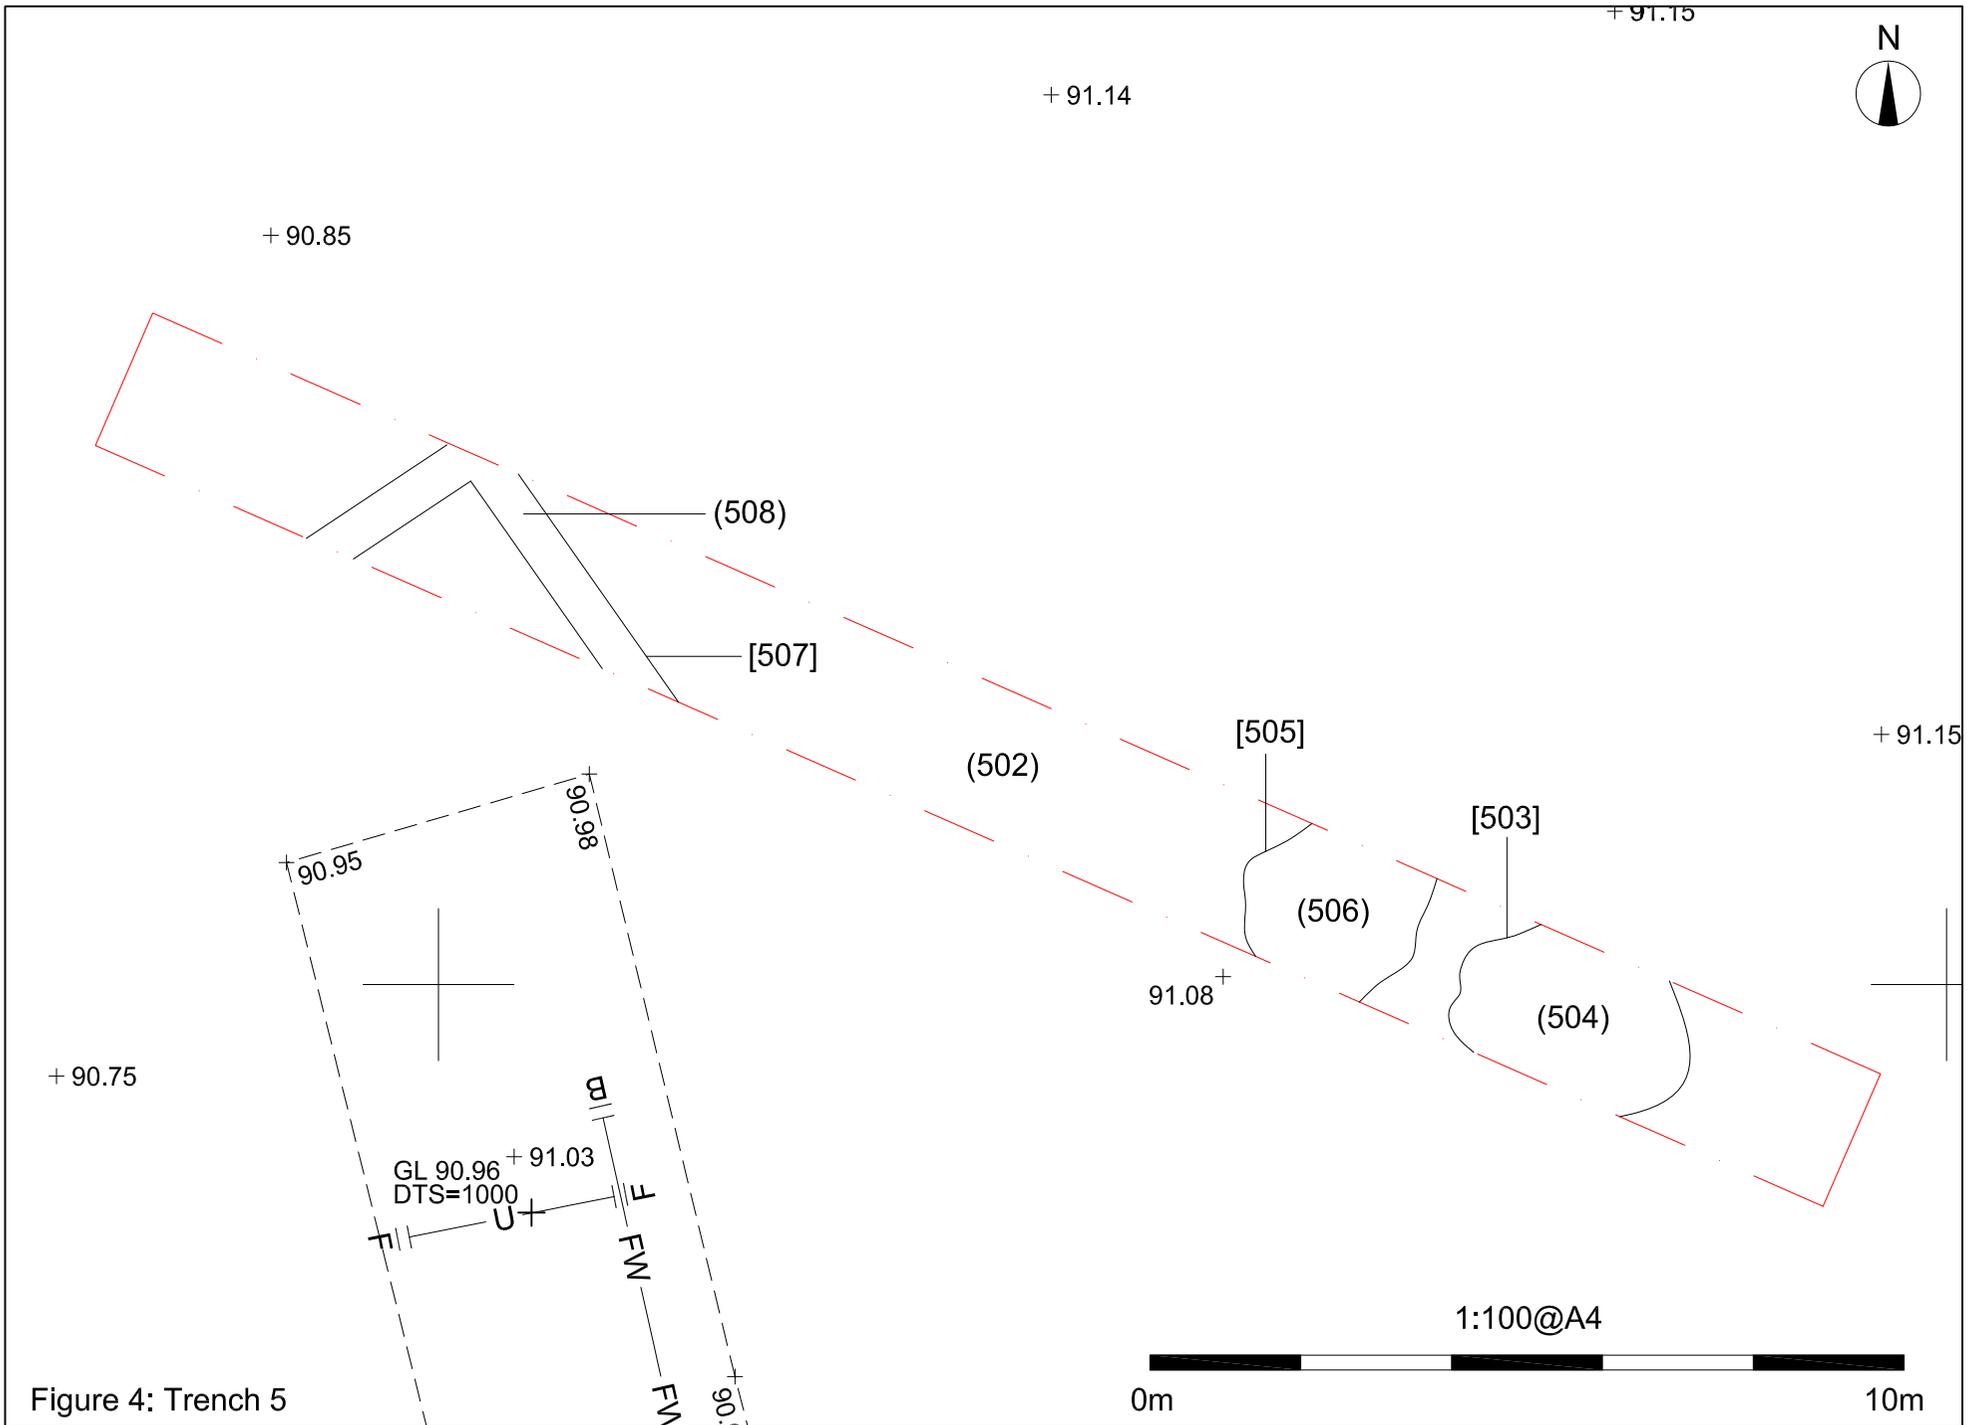
Figure 4: Trench 5

9.5 The plan is recorded in Figures 1 and 4 (see also Plates 12-15). The trench lay on an ESE to WNW alignment and measured approximately 25m by 1.90m.

Undisturbed natural geology **(502)** was identified across the trench as Wealden Clay, at a depth of approximately 0.30m (90.70m OD) below the present ground surface at 91.00m OD at mid-trench. Cut into the natural were three modern features, two dumps **[503], [505]** of broken concrete paving slabs, bricks and concrete lumps **(504), (505)** and to the west a modern foundation **[507]** trench 57cm wide infilled with Type 2 mixed with clay and modern clay tile fragments (508). The natural geology was sealed by a layer of concrete crush.

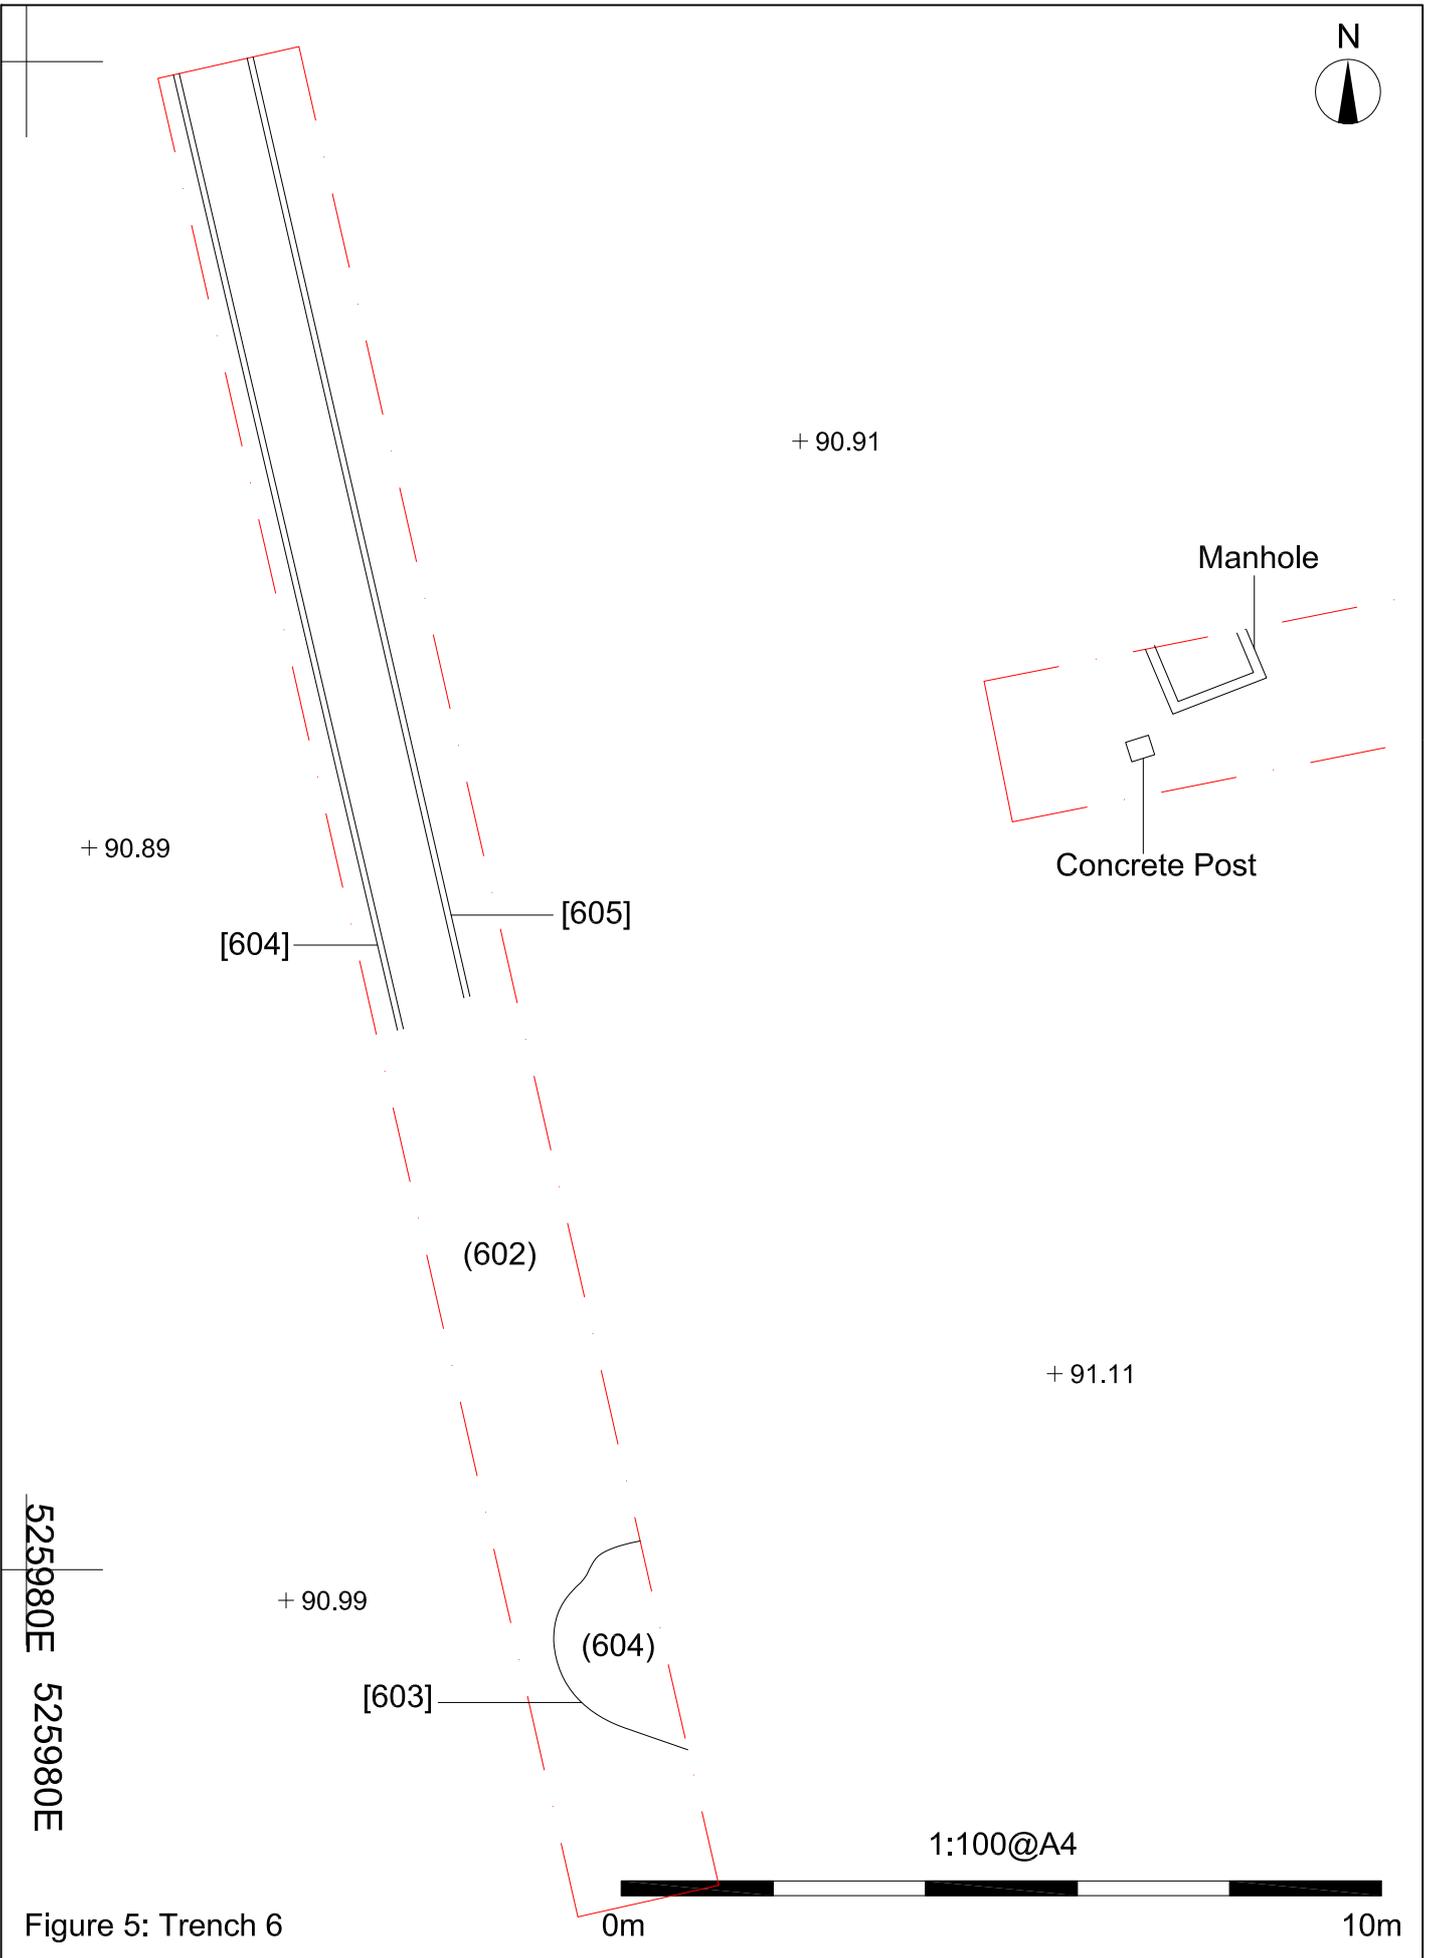
Figure 5: Trench 6

9.6 The plan is recorded in Figures 1, 5 (see also Plates 16, 17, 18). The trench lay on a NNW to SSE alignment and measured approximately 25m by 1.90m.

Undisturbed natural geology **(602)** was identified across the trench as Wealden Clay, at a depth of approximately 0.30m (90.70m OD) below the present ground surface at 91.00m OD at mid-trench. Cut into the natural were two features, to the south a modern rubbish dump **[603]** infilled with cement block fragments and broken roofing tiles **(604)** and to the north to parallel runs of planking on edge **[604]**, **[605]** presumably a modern pathway. The natural geology was sealed by a 11cm thick layer of concrete crush overlaid by a 9cm layer of bright orange crushed brick.

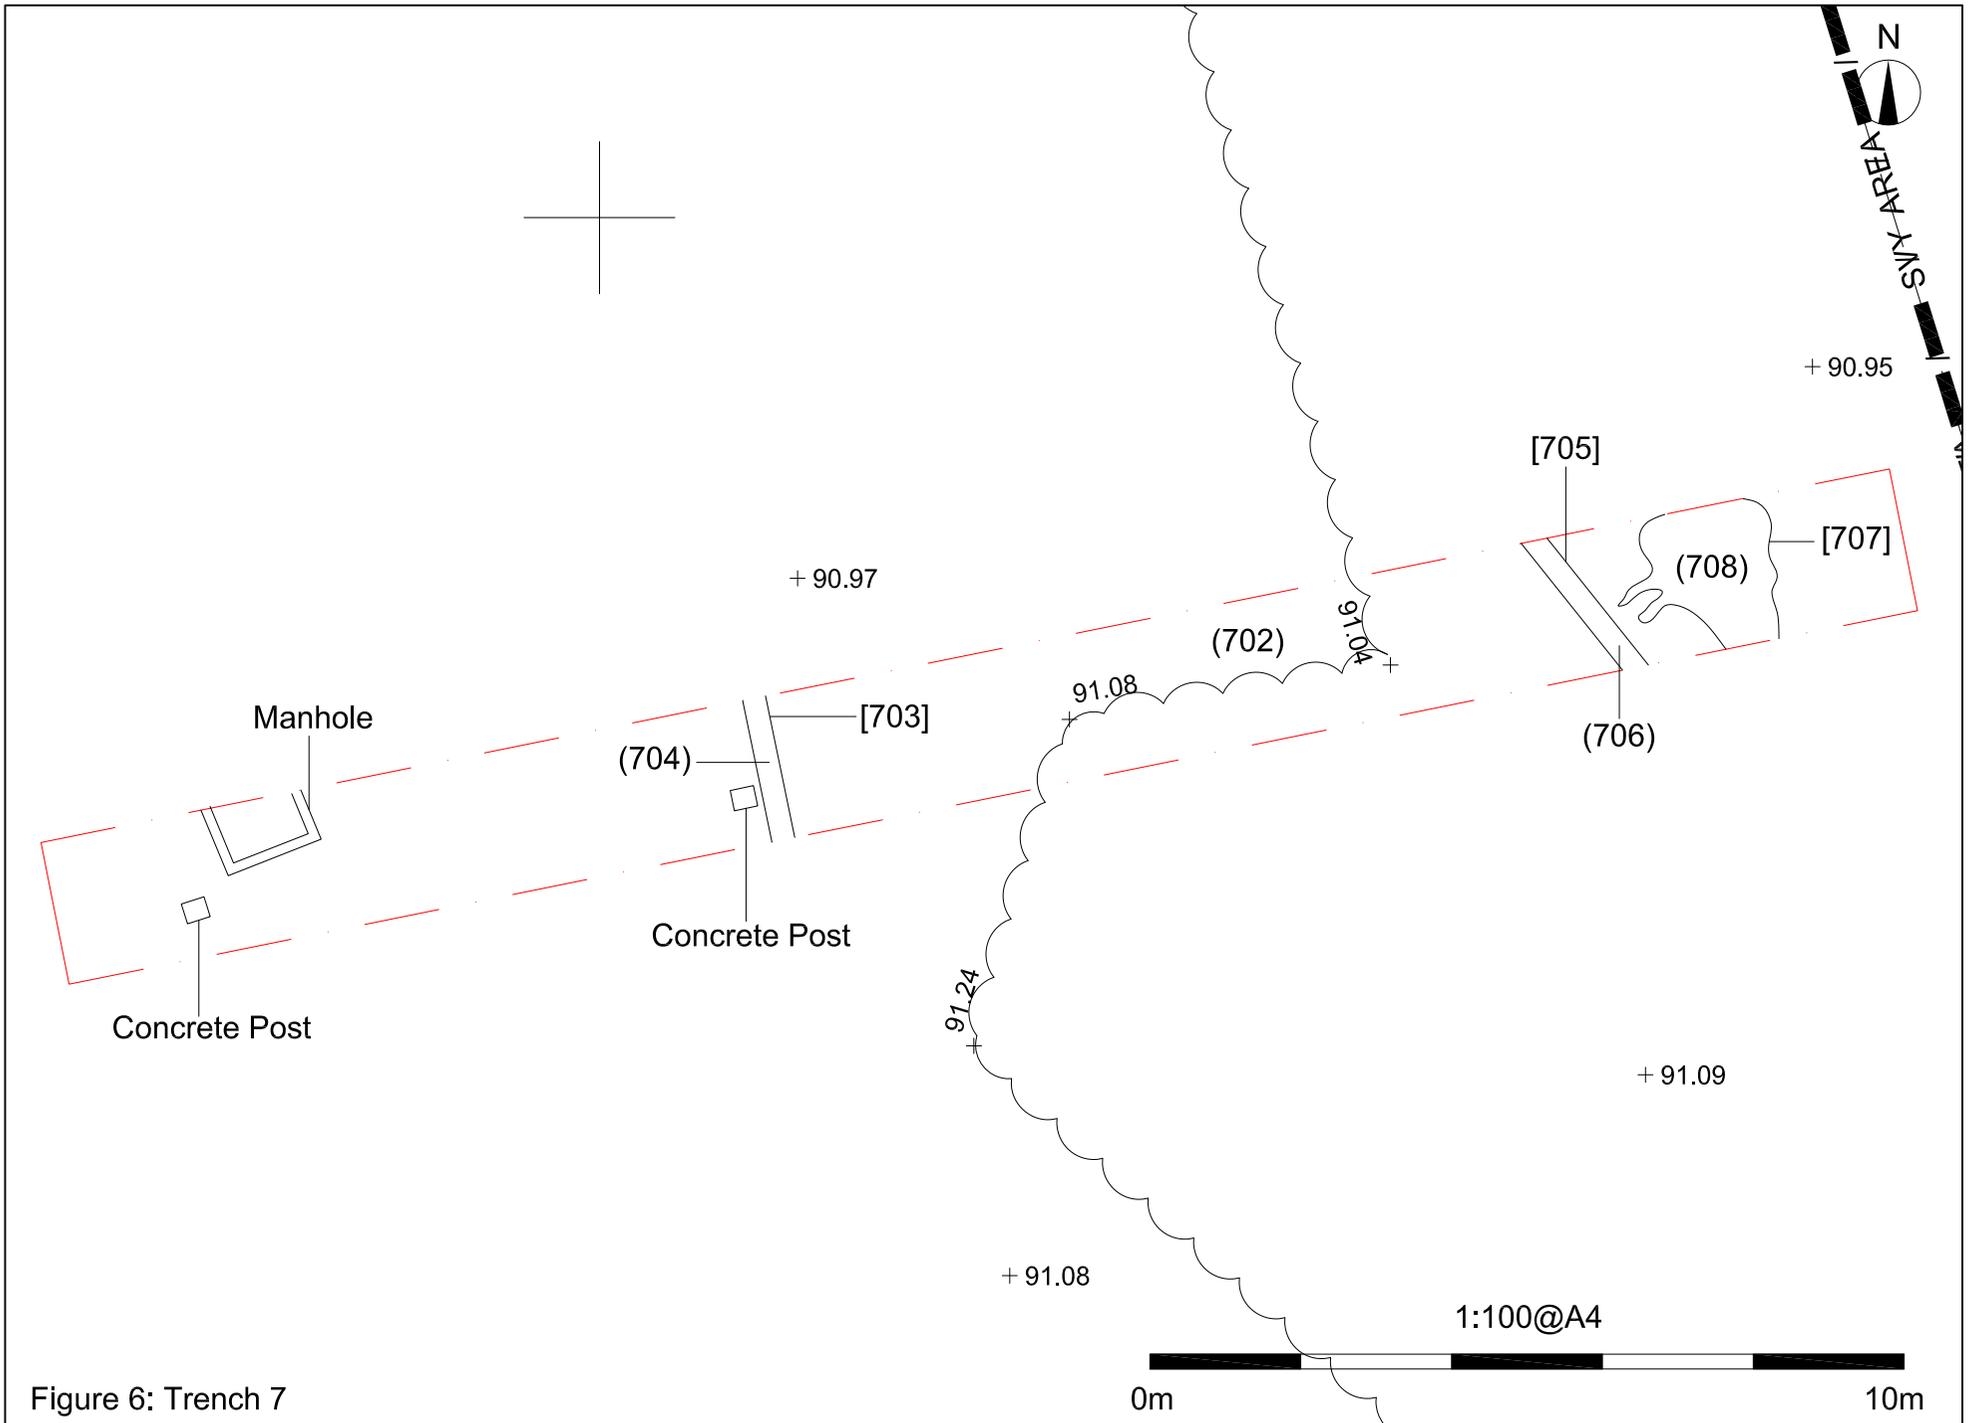
Figure 6: Trench 7

9.7 The plan is recorded in Figures 1, 6 (see also Plates 19-23). The trench lay on a WSW to ENE alignment and measured approximately 25m by 1.90m.

Undisturbed natural geology **(702)** was identified across the trench as Wealden Clay, at a depth of approximately 0.30m (90.70m OD) below the present ground surface at 91.00m OD at mid-trench. Cutting into the natural geology were six features, to the west a modern manhole and cover and adjacent concrete post. Mid trench a drainage channel **[703]** filled with clinker **(704)** and about 31cm wide. To the east another drainage channel **[705]** infilled with clinker **(706)** and 31cm wide and exposed at the south end an in situ an earthenware pipe. Adjacent another modern rubbish dump **[707]** filled with concrete crush and broken paving stones **(708)**. The natural geology was sealed by gravel mixed with lumps of concrete.

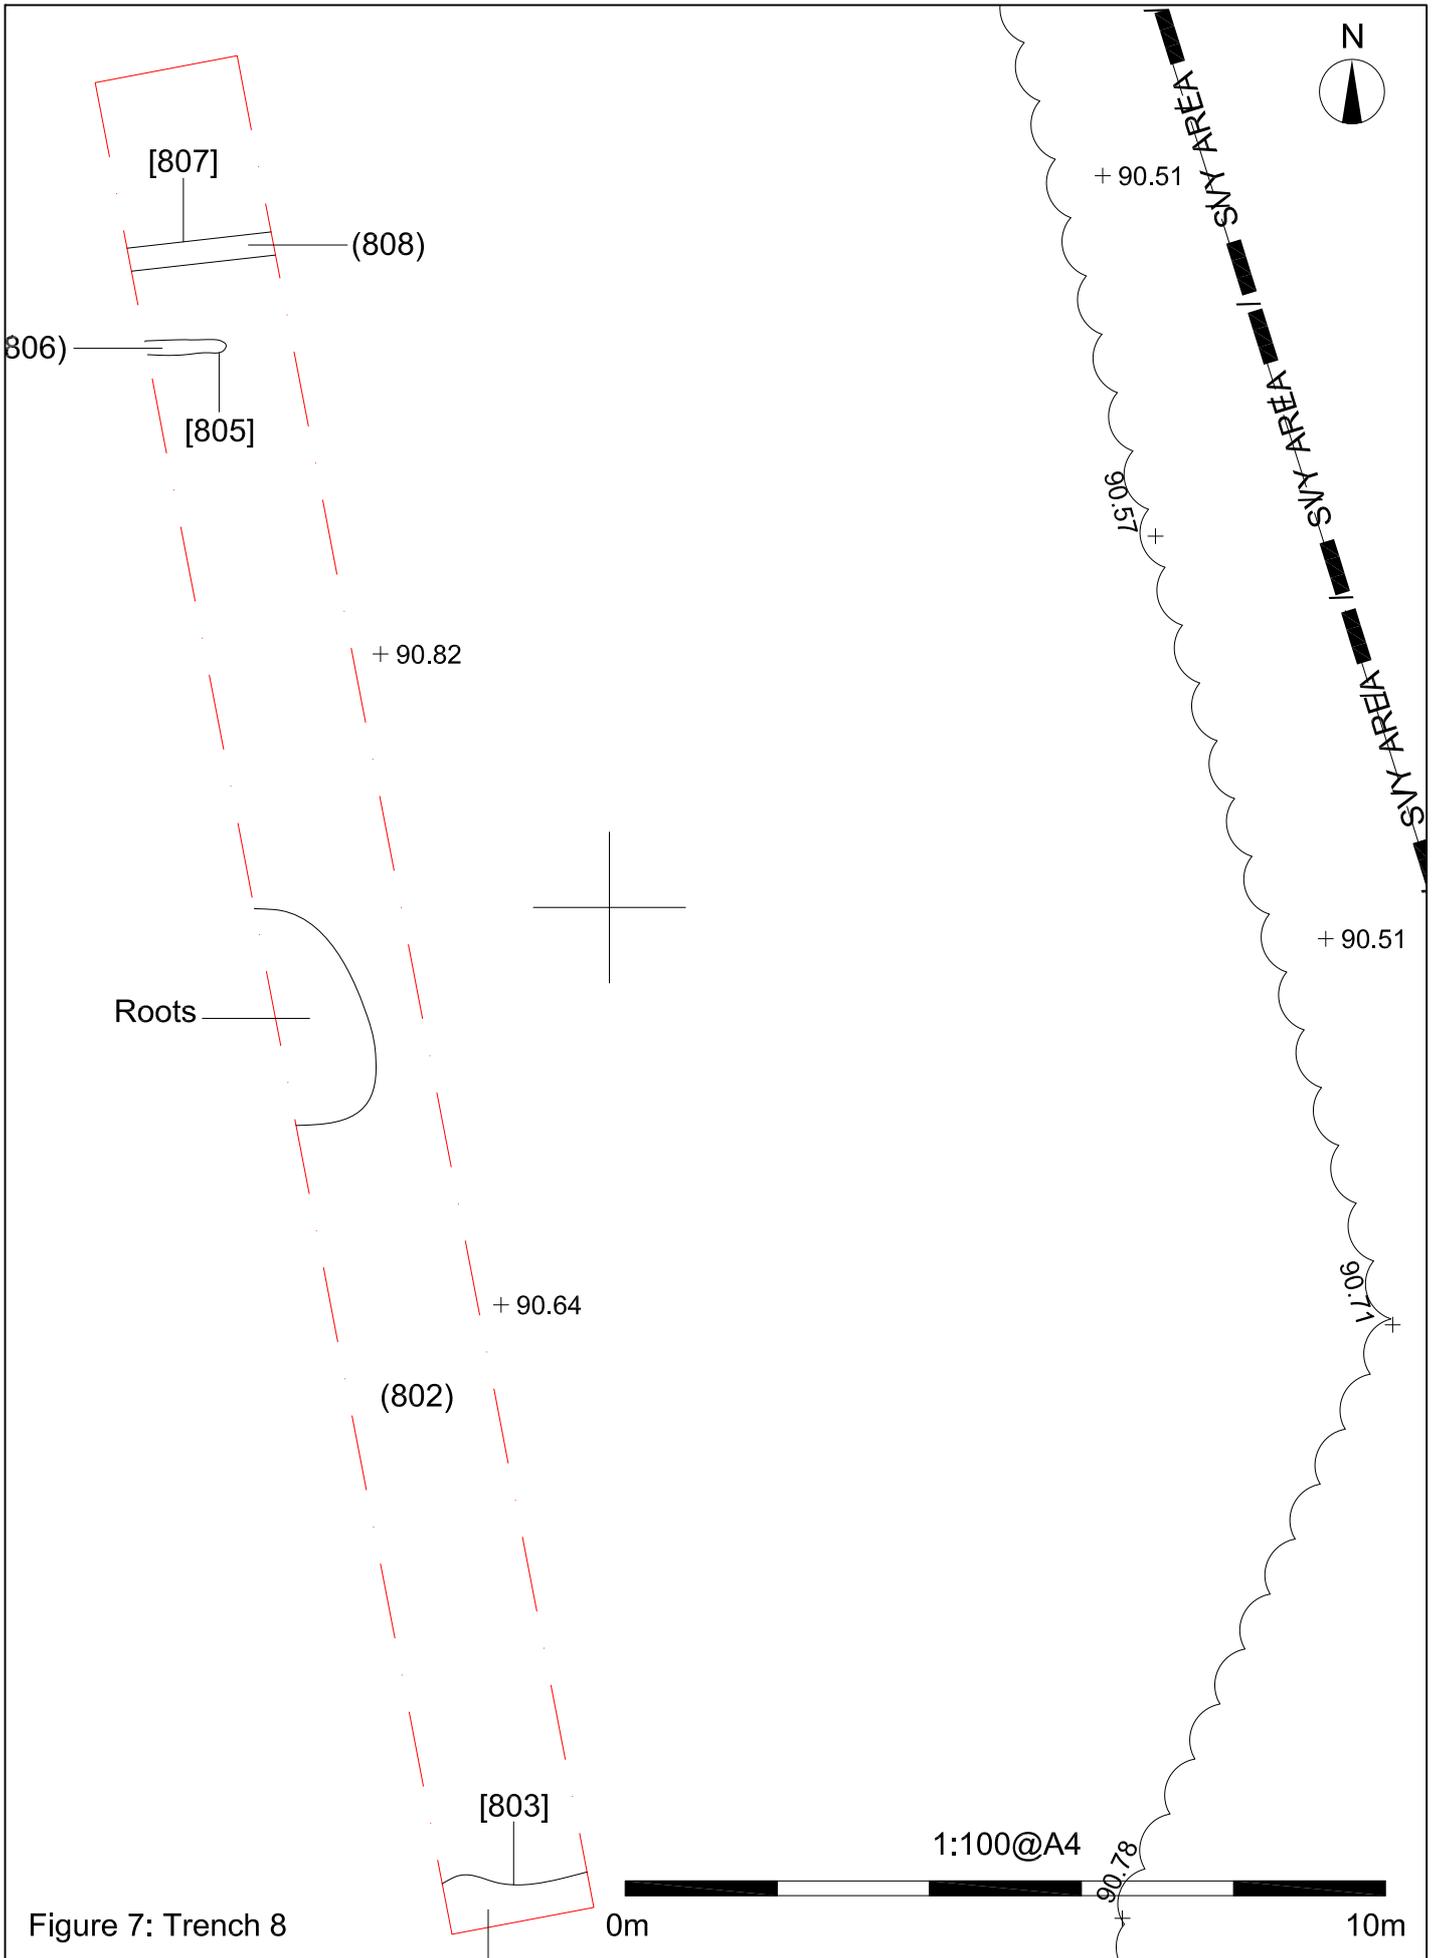
Figure 7: Trench 8

9.8 The plan is recorded in Figure 2 and 7 (see also Plates 24-28). The trench lay on an NNW to SSE alignment and measured approximately 25m by 1.90m.

Undisturbed natural geology **(802)** was identified across the trench as Wealden Clay, at a depth of approximately 0.32m (90.38m OD) below the present ground surface at 90.70m OD at mid-trench. Cut into the natural geology were four modern features. To the south a modern dump **[803]** of broken frogged bricks. Mid trench a disturbed area of a tree bole and to the north two modern pits **[805]** and **[807]** both infilled with broken paving slabs and broken bricks **(806)** and pea gravel containing a blue plastic pipe **(808)**. The natural geology was sealed by a layer of mixed soil, gravel and concrete pieces.

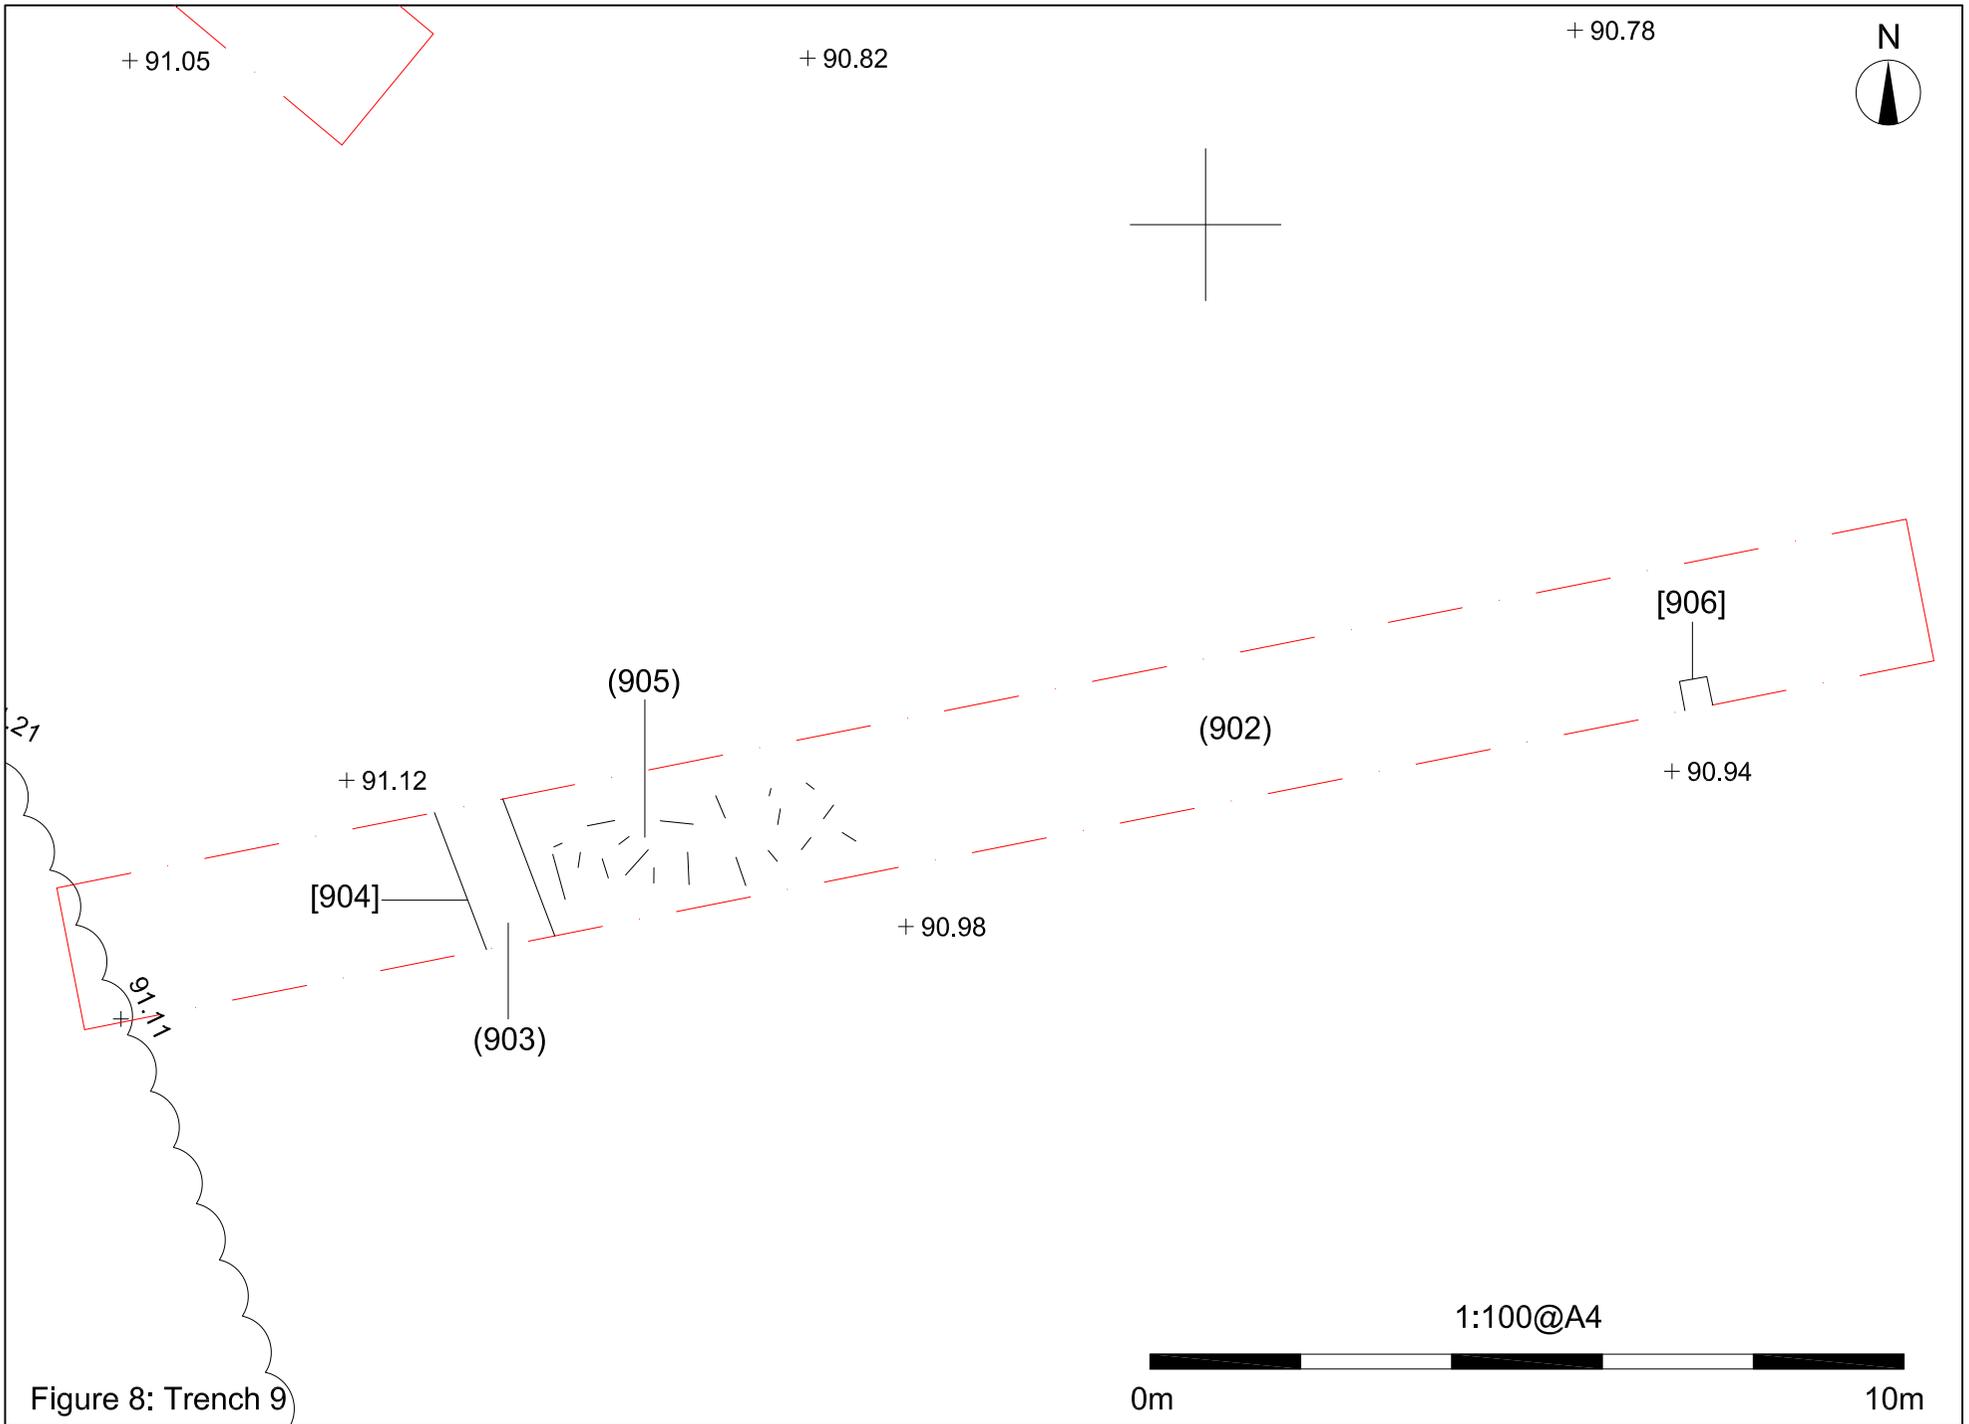
Figure 8: Trench 9

9.9 The plan is recorded in Figures 1, 8 (see also Plates 29-33). The trench lay on a WSW to ENE alignment and measured approximately 25m by 1.90m.

Undisturbed natural geology **(902)** was identified across the trench as Wealden Clay at a depth of approximately 0.30m (90.60m OD) below the present ground surface at 90.90m OD

at mid-trench. Cutting into the natural geology were four features. To the west an area of extremely bright orange crushed brick butting up to a concrete foundation [904], To the east an area of extremely wet clay with modern tree branches (905) laid into the mud and further to the east a concrete post pad [906]. The natural geology was sealed by a layer of broken concrete and gravel mix.
