Archaeological Evaluation of Land at Goffs Park, Crawley, West Sussex

Site Code: GOF/EV/16

SWAT Archaeology

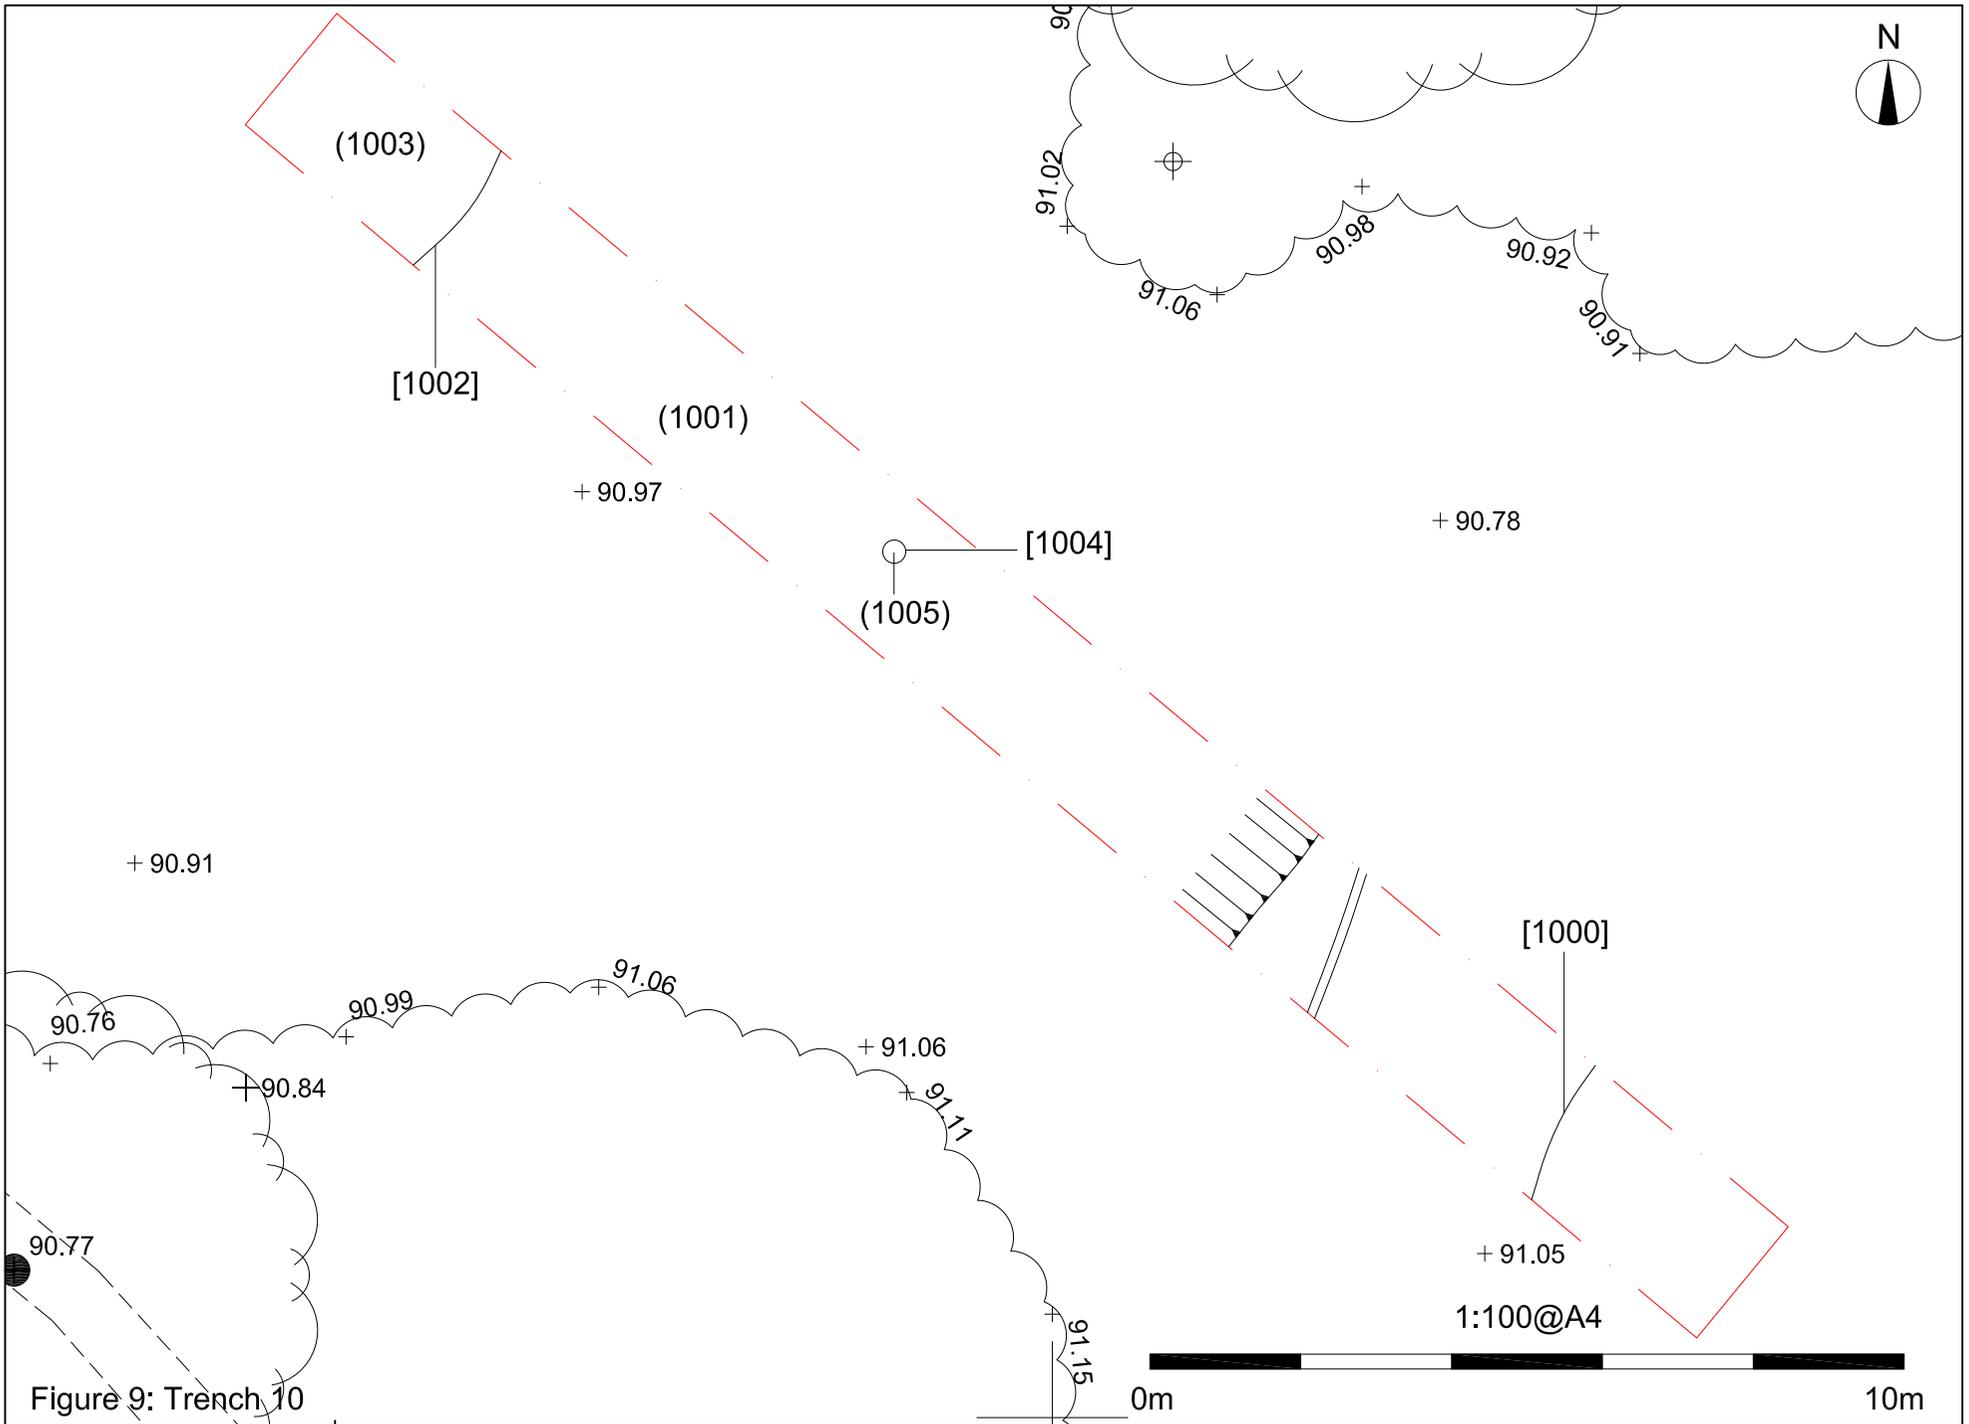
Figure 9: Trench 10

9.10 The plan is recorded in Figures 1 and 9. (see also Plates 34-38) The trench lay on an NW to SE alignment and measured approximately 24m by 1.90m.

Undisturbed natural geology (1001) was identified across the trench as Wealden Clay, at a depth of approximately 0.30m (90.60m OD) below the present ground surface at 90.90m OD at mid-trench. Cutting into the natural geology were three features. To the west a large modern rubbish pit [1002] infilled with dumped building debris (1003). Mid trench a 30cm diameter possible post hole [1004] infilled with modern bright yellow sand (1005). To the east the remains of a roadway [1000] comprising timber edging, and layers of geotex fabric, sand, concrete and brick crush topped by cinders. Above this a mix of very wet topsoil and peat.

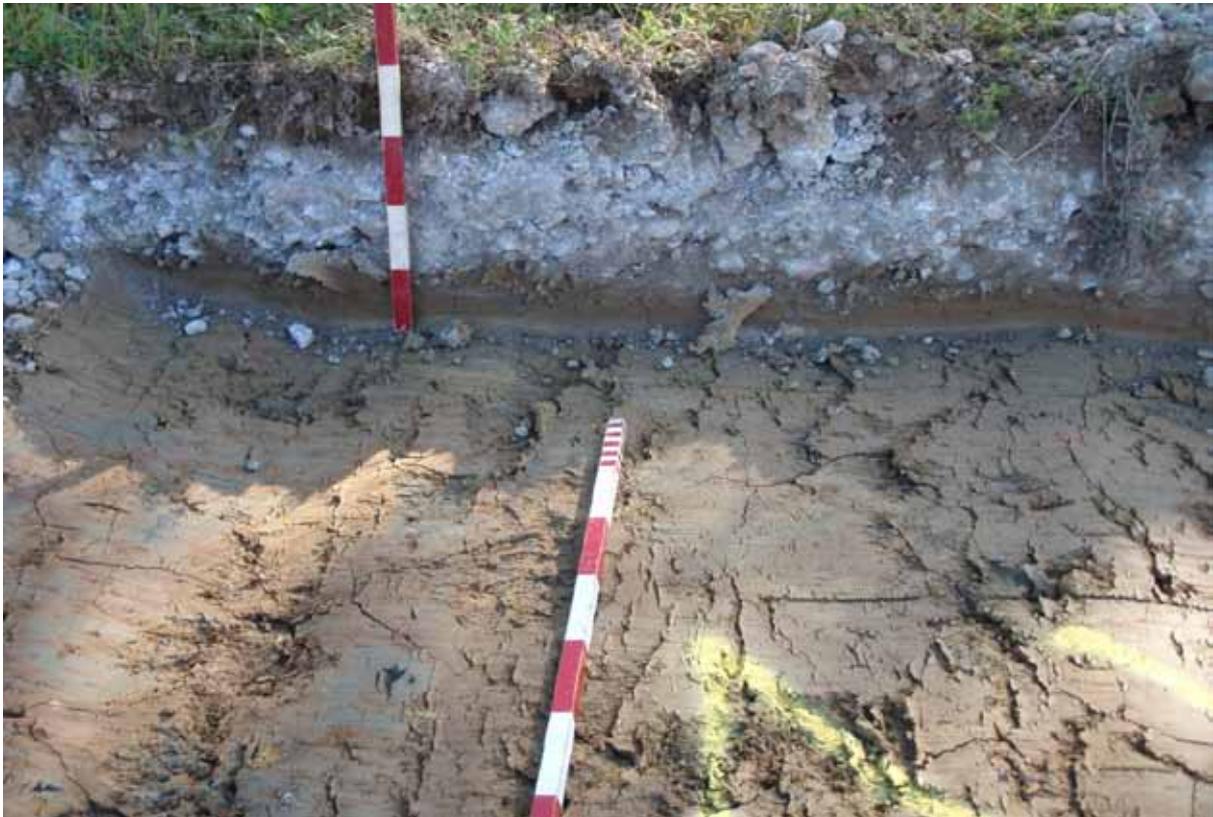
Undisturbed natural geology **(203)** was identified across the trench as Wealden Clay, at a depth of approximately 0.30m (90.20m OD) below the present ground surface at 90.50m OD at mid-trench. The natural geology was sealed by a layer of concrete crush **(202)** 0.20m thick. Above this was a dark layer of topsoil **(201)** 0.07m thick, mid to dark brown in colour and containing small stones and humic material, but otherwise relatively clean.

Plate 5. Trench 2 section

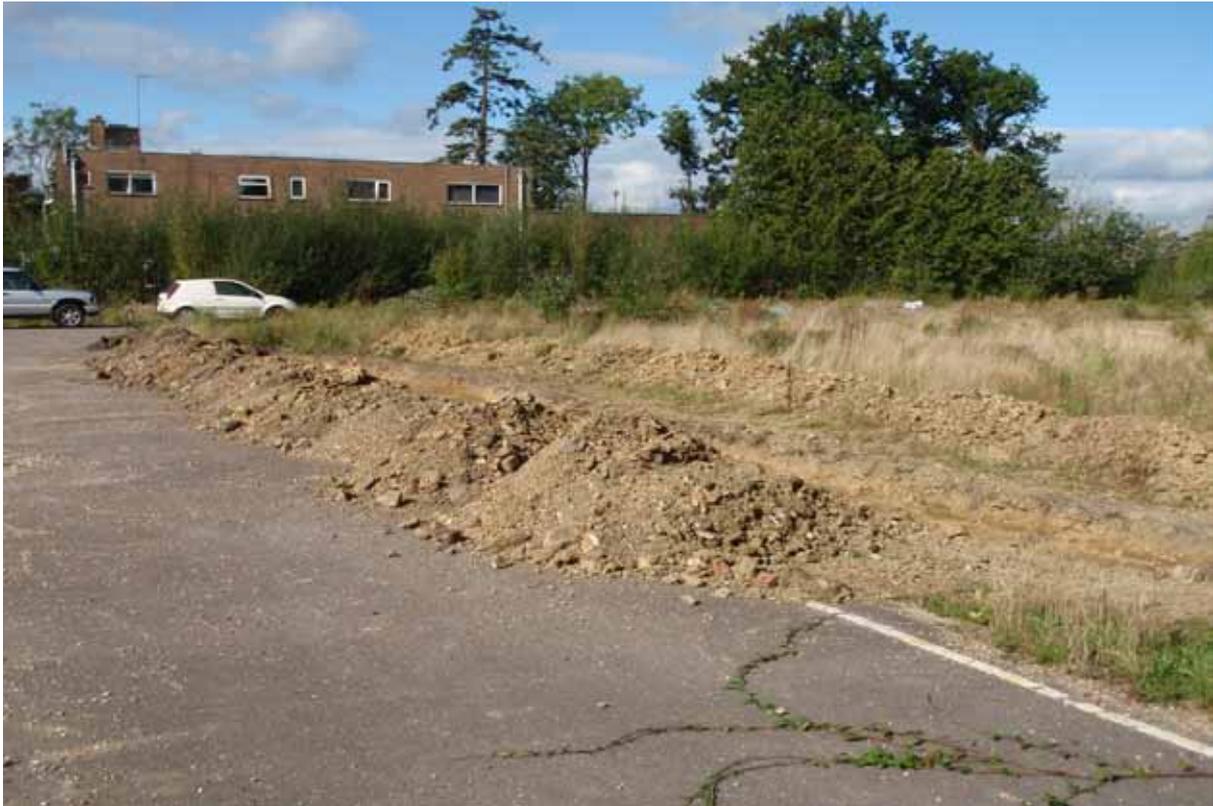
Plate 6. Trench 3 location

9.3 The plan is recorded in Figures 1 and 2 (see also Plates 6, 7, 8, 9). The trench lay on a W to E alignment and measured approximately 25m by 1.90m.

Undisturbed natural geology **(303)** was identified across the trench as Wealden Clay, at a depth of approximately 0.30m (90.70m OD) below the present ground surface at 91.00m OD at mid-trench. Cut into the natural was a modern foundation trench **[303]** infilled with gravel and concrete pieces and about 36cm wide. Above this was a layer of concrete crush **(301)** 0.18m thick topped by a thin layer of sand and earth.

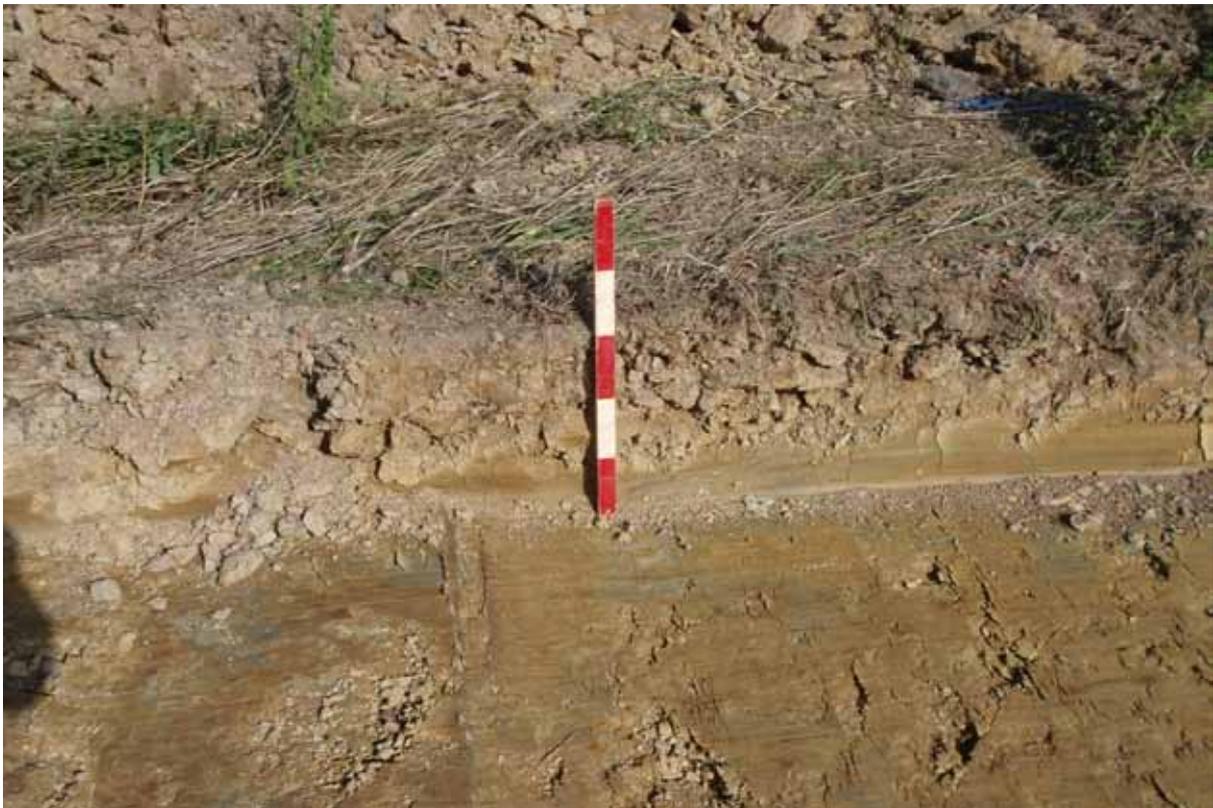
Plate 7. Trench 3 section

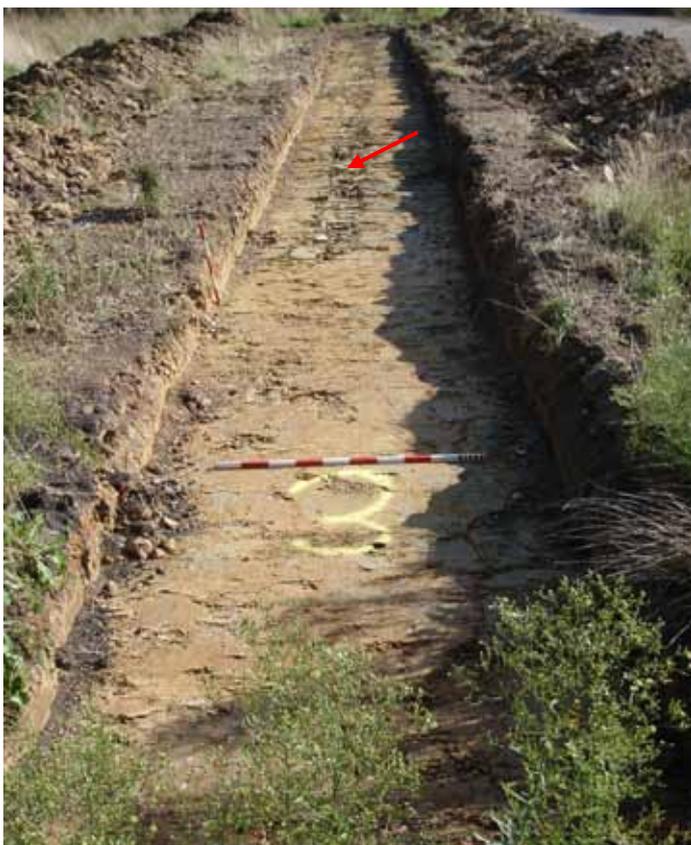
Plate 8. Trench 3 modern foundations (red arrow)

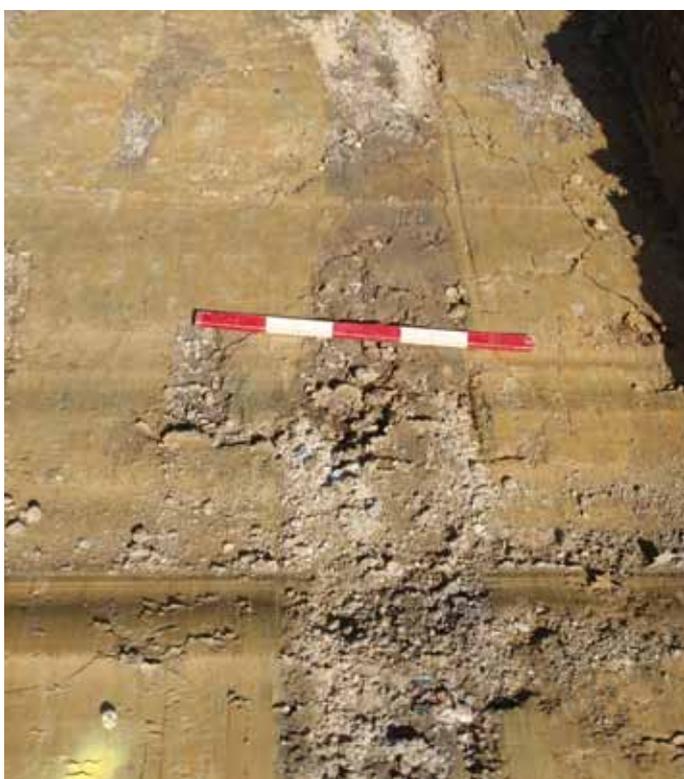
Plate 9. Trench 3 modern foundations detail

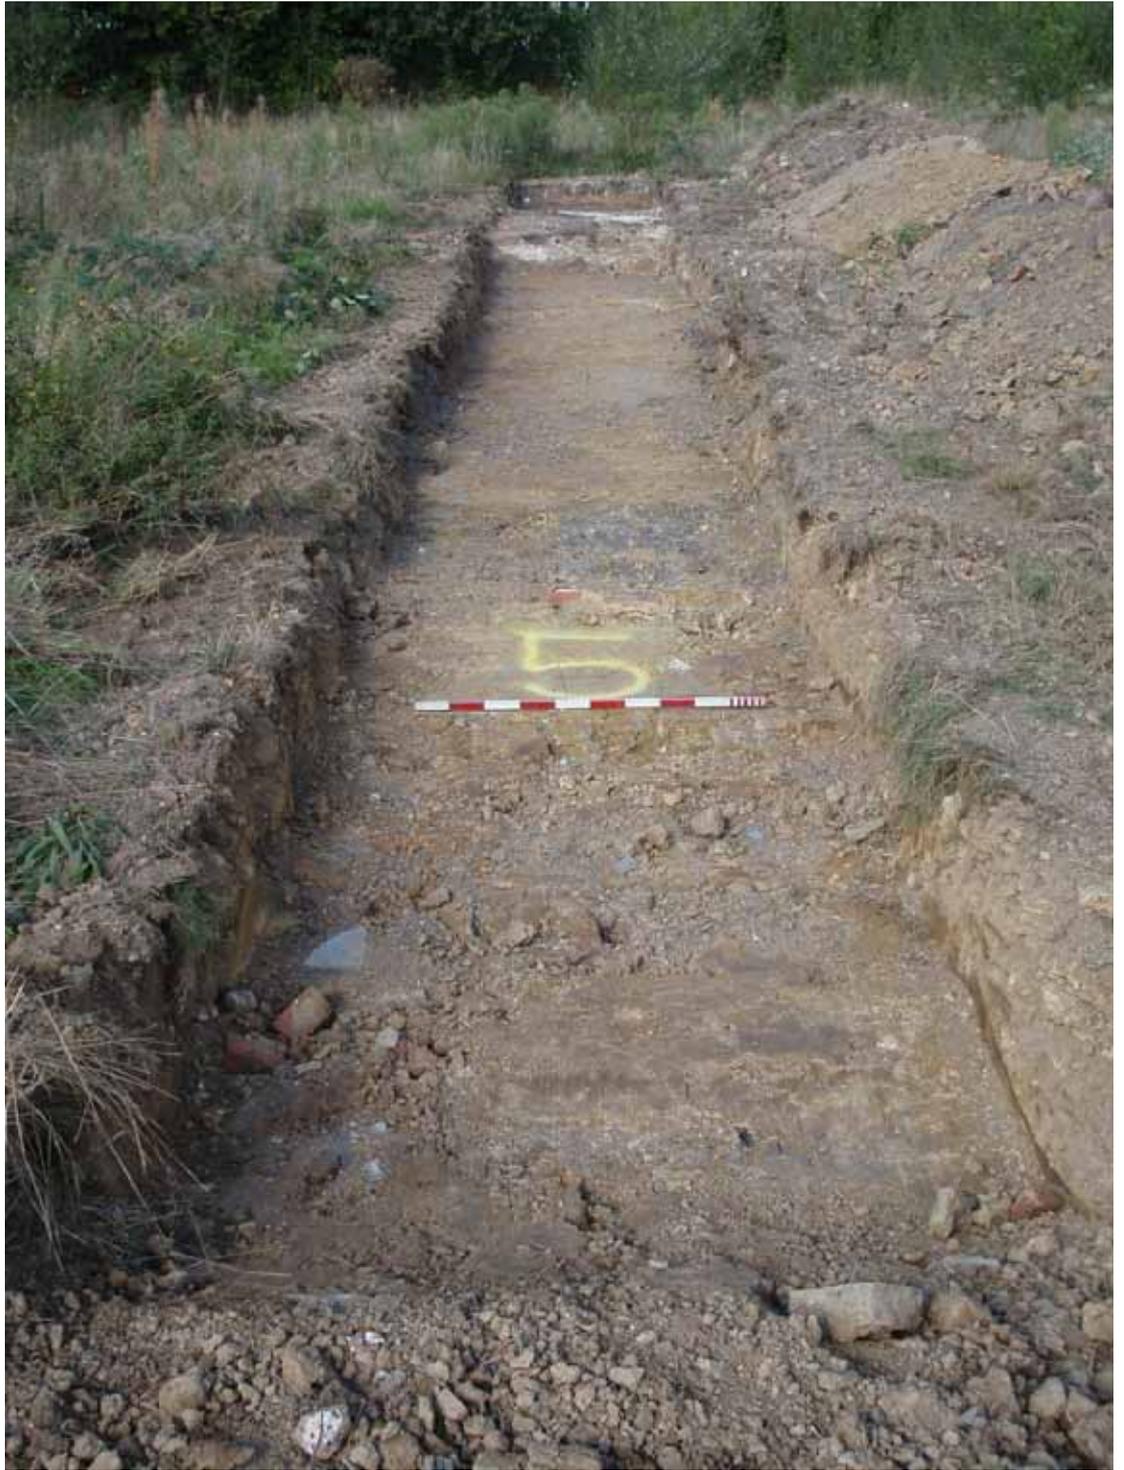
Plate 11. View of Trench 5

9.4 The plan is recorded in Figures 1 and 3. (see also Plate 11) The trench lay on an SSE to NNW alignment and measured approximately 25m by 1.90m.

Undisturbed natural geology **(402)** was identified across the trench as Wealden Clay, at a depth of approximately 0.20m (90.80m OD) below the present ground surface at 91.00m OD at mid-trench. Cut into the natural were three modern features, two modern rubbish dumps **[407], (406), (408)** and a modern foundation trench **[403]** 23cm wide and filled with gravel and crushed concrete **(404)**. The natural geology **(405)** was sealed by a layer of gravel and cement crush mix 0.20m thick.

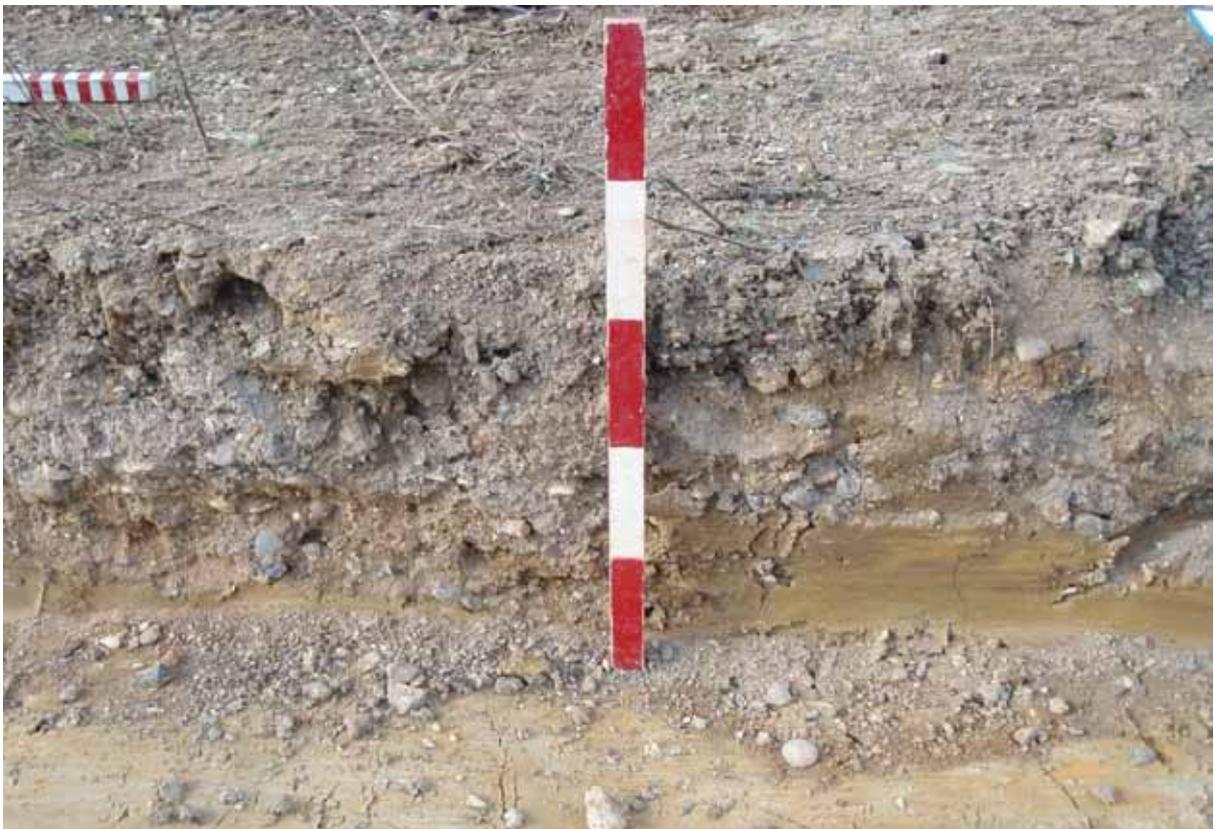
Undisturbed natural geology **(502)** was identified across the trench as Wealden Clay, at a depth of approximately 0.30m (90.70m OD) below the present ground surface at 91.00m OD at mid-trench. Cut into the natural were three modern features, two dumps **[503], [505]** of broken concrete paving slabs, bricks and concrete lumps **(504), (505)** and to the west a modern foundation **[507]** trench 57cm wide infilled with Type 2 mixed with clay and modern clay tile fragments (508). The natural geology was sealed by a layer of concrete crush.

Plate 13. Trench 5 section

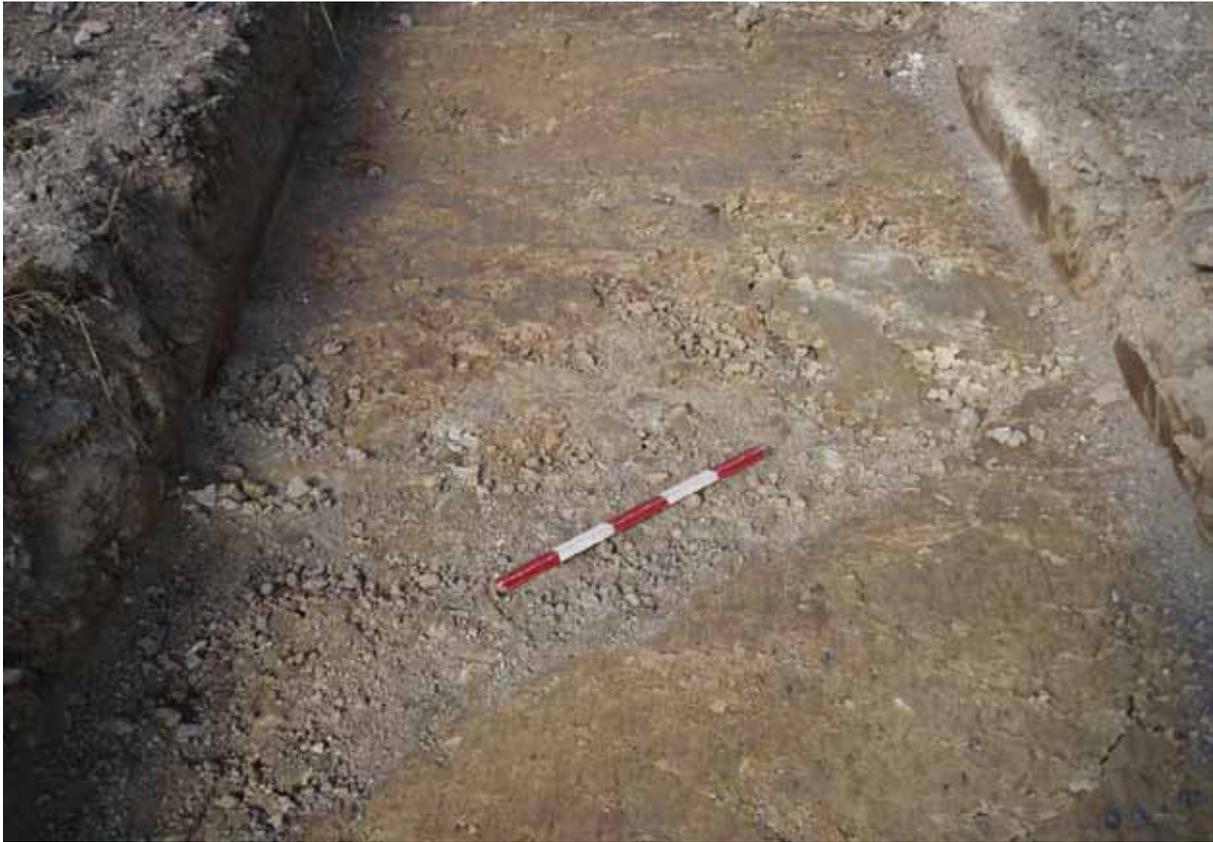
Plate 14. Trench 5 feature [507]

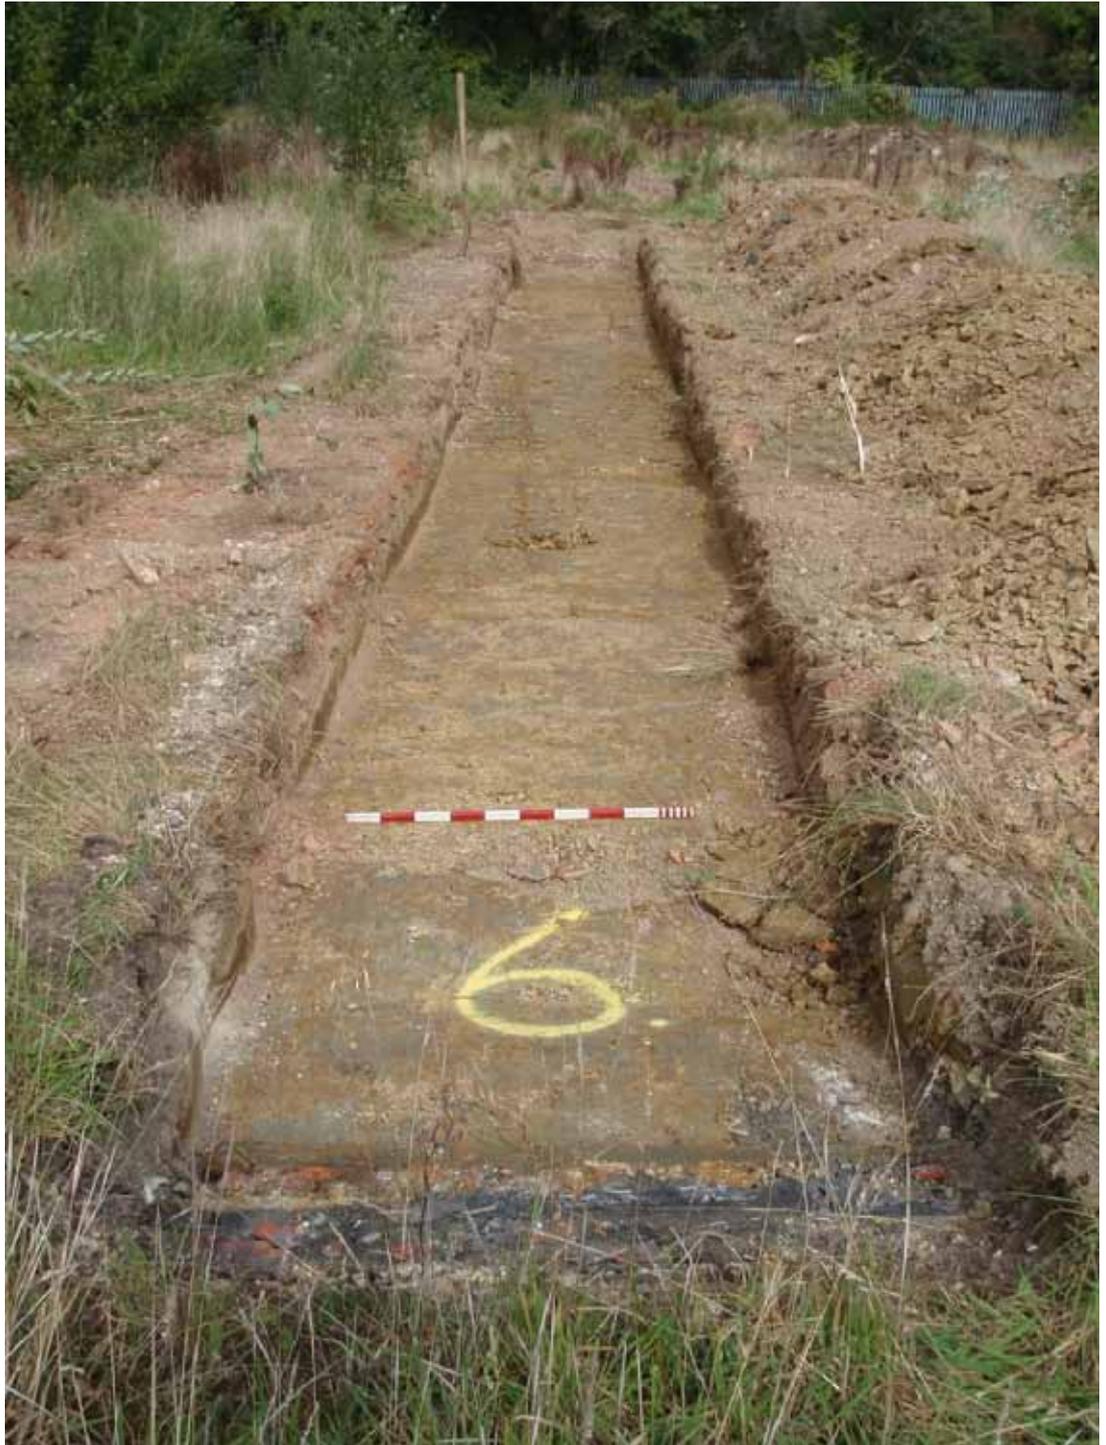
Plate 16. View of Trench 6

9.6 The plan is recorded in Figures 1, 5 (see also Plates 16, 17, 18). The trench lay on a NNW to SSE alignment and measured approximately 25m by 1.90m.

Undisturbed natural geology **(602)** was identified across the trench as Wealden Clay, at a depth of approximately 0.30m (90.70m OD) below the present ground surface at 91.00m OD at mid-trench. Cut into the natural were two features, to the south a modern rubbish dump **[603]** infilled with cement block fragments and broken roofing tiles **(604)** and to the north to parallel runs of planking on edge **[604]**, **[605]** presumably a modern pathway. The natural geology was sealed by a 11cm thick layer of concrete crush overlaid by a 9cm layer of bright orange crushed brick.

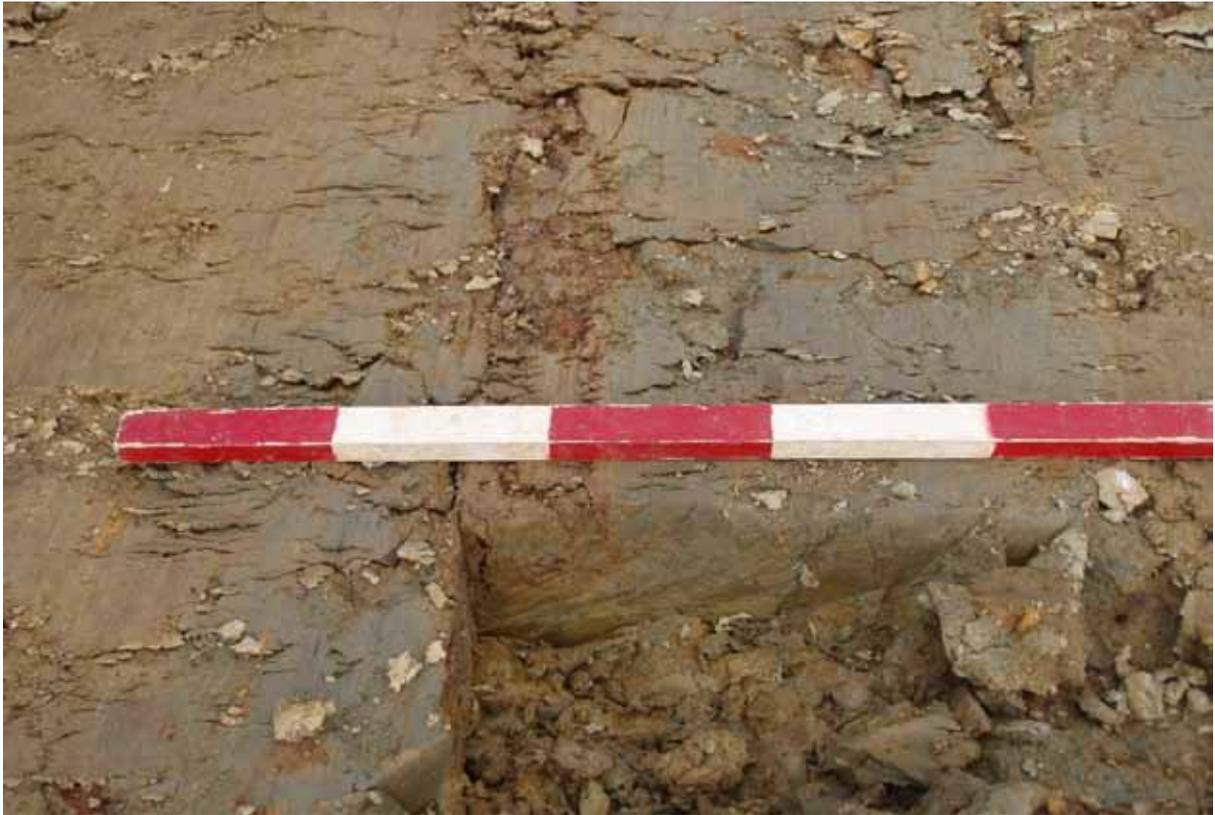
Plate 17. Trench 6 detail of path edging [604]

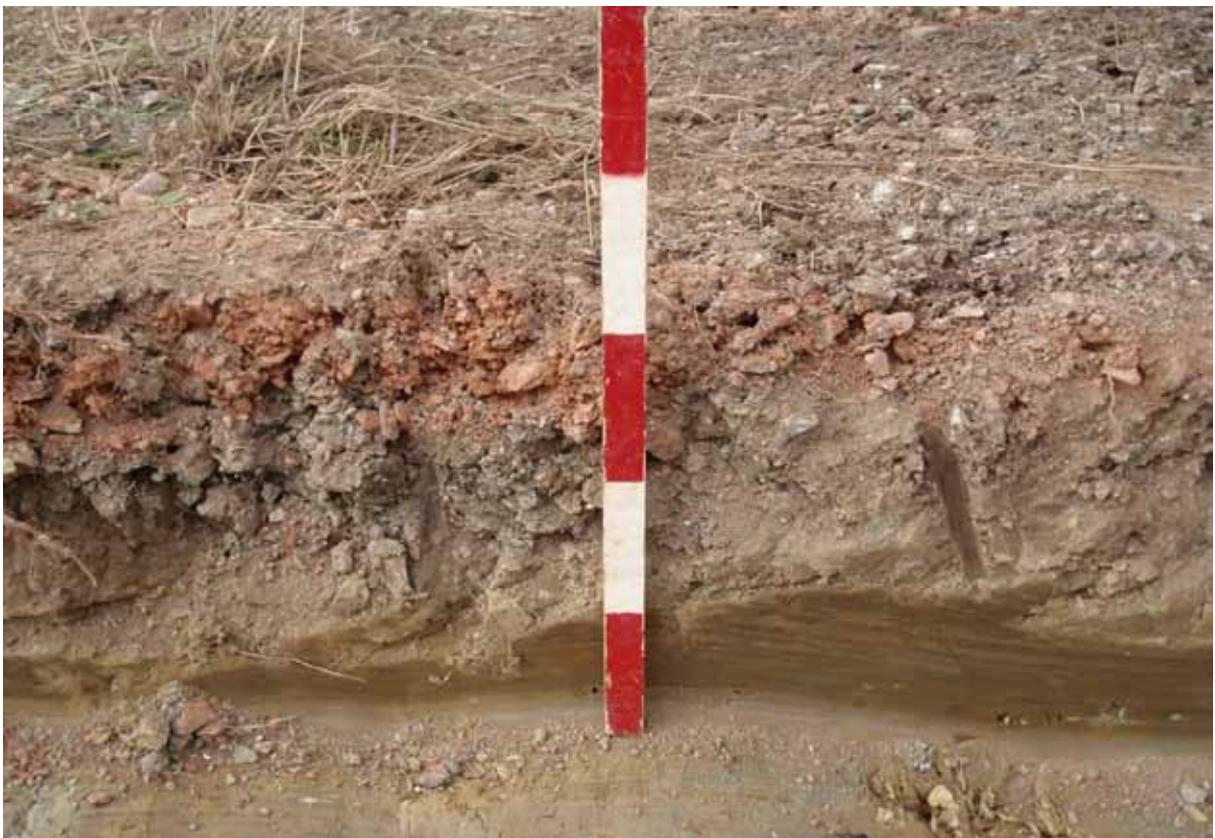
Plate 18. Trench 6 section

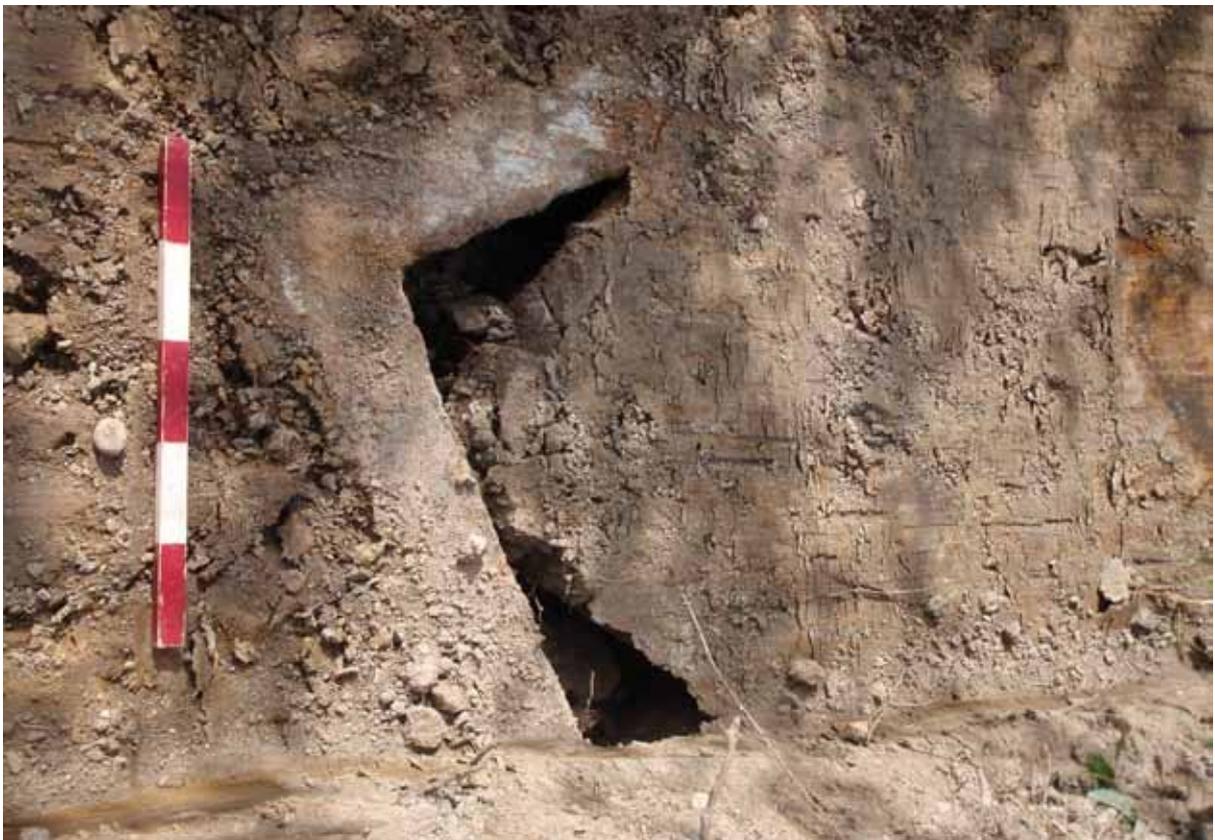
Undisturbed natural geology **(702)** was identified across the trench as Wealden Clay, at a depth of approximately 0.30m (90.70m OD) below the present ground surface at 91.00m OD at mid-trench. Cutting into the natural geology were six features, to the west a modern manhole and cover and adjacent concrete post. Mid trench a drainage channel **[703]** filled with clinker **(704)** and about 31cm wide. To the east another drainage channel **[705]** infilled with clinker **(706)** and 31cm wide and exposed at the south end an in situ an earthenware pipe. Adjacent another modern rubbish dump **[707]** filled with concrete crush and broken paving stones **(708)**. The natural geology was sealed by gravel mixed with lumps of concrete.

Plate 21. Trench 7 view of manhole

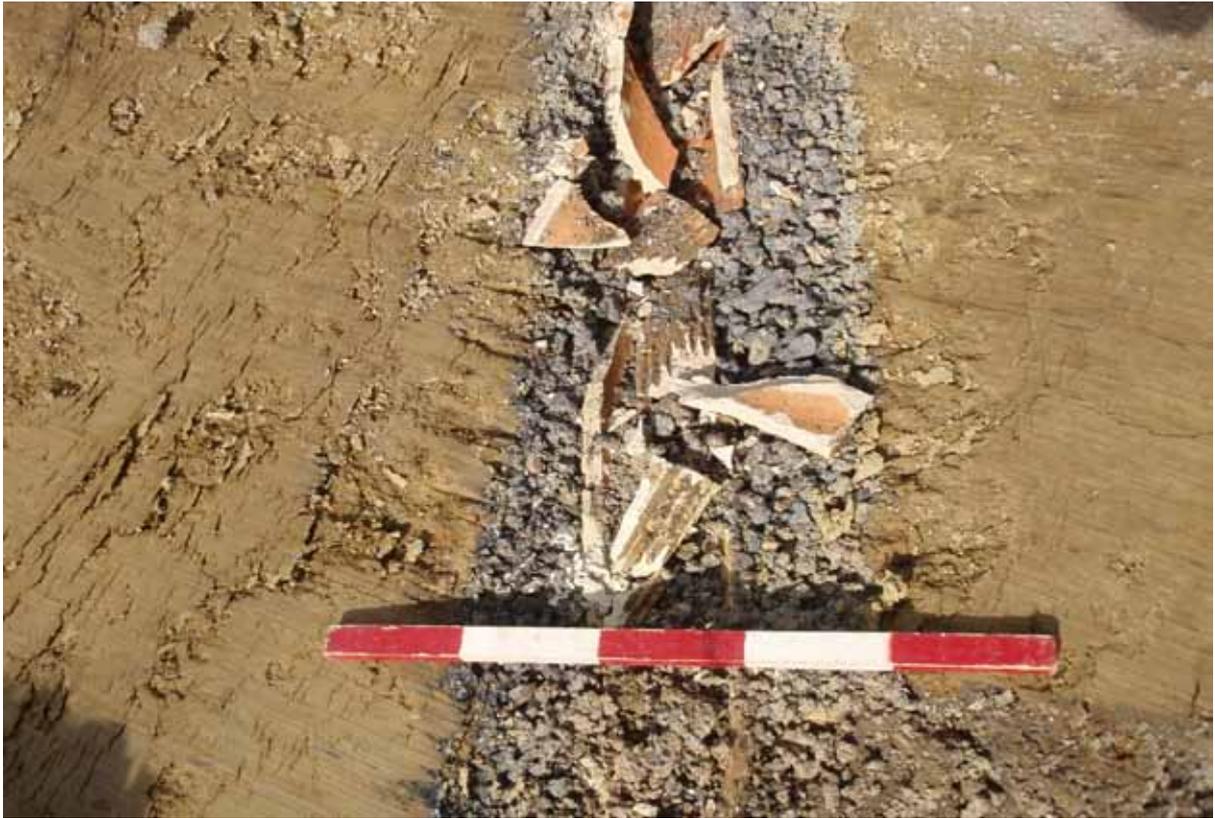
Plate 22. Trench 7 drainage channel [705]

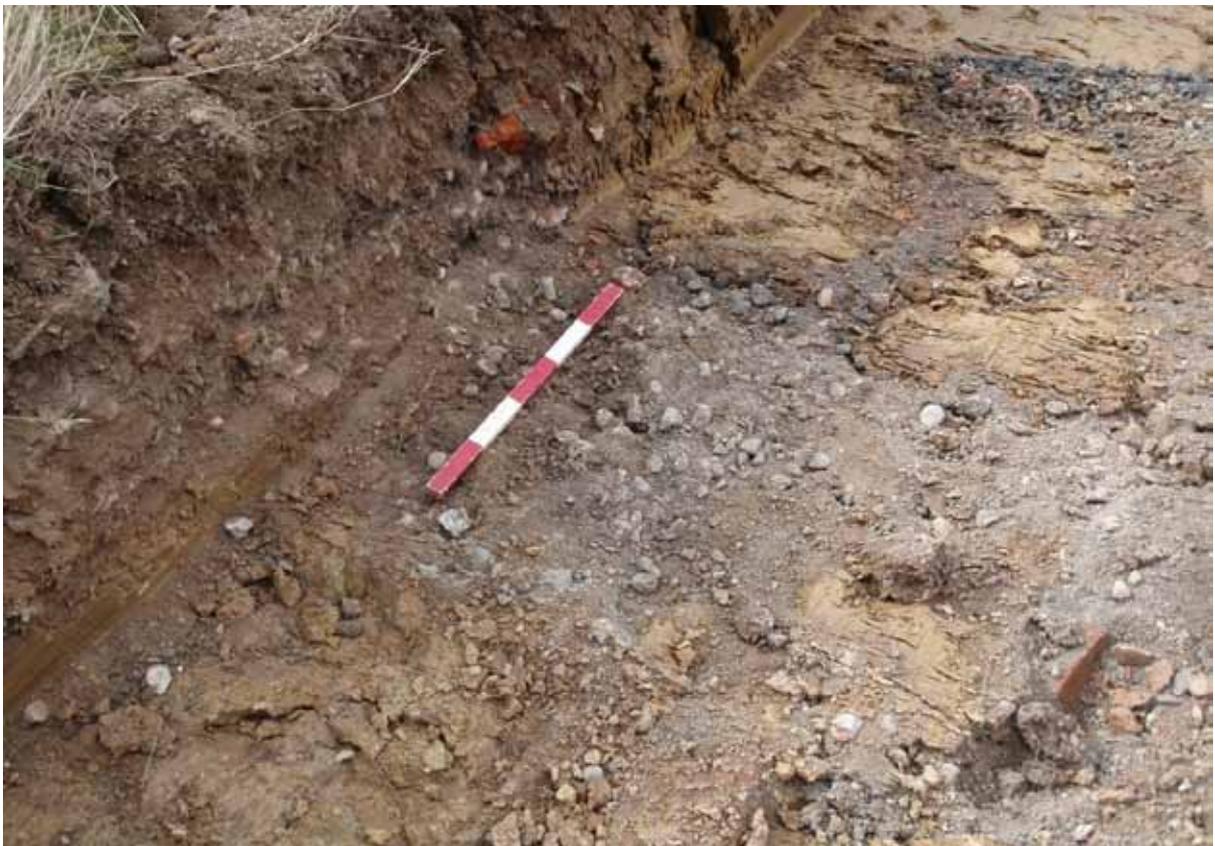
Plate 23. Trench 7 modern dump [707]

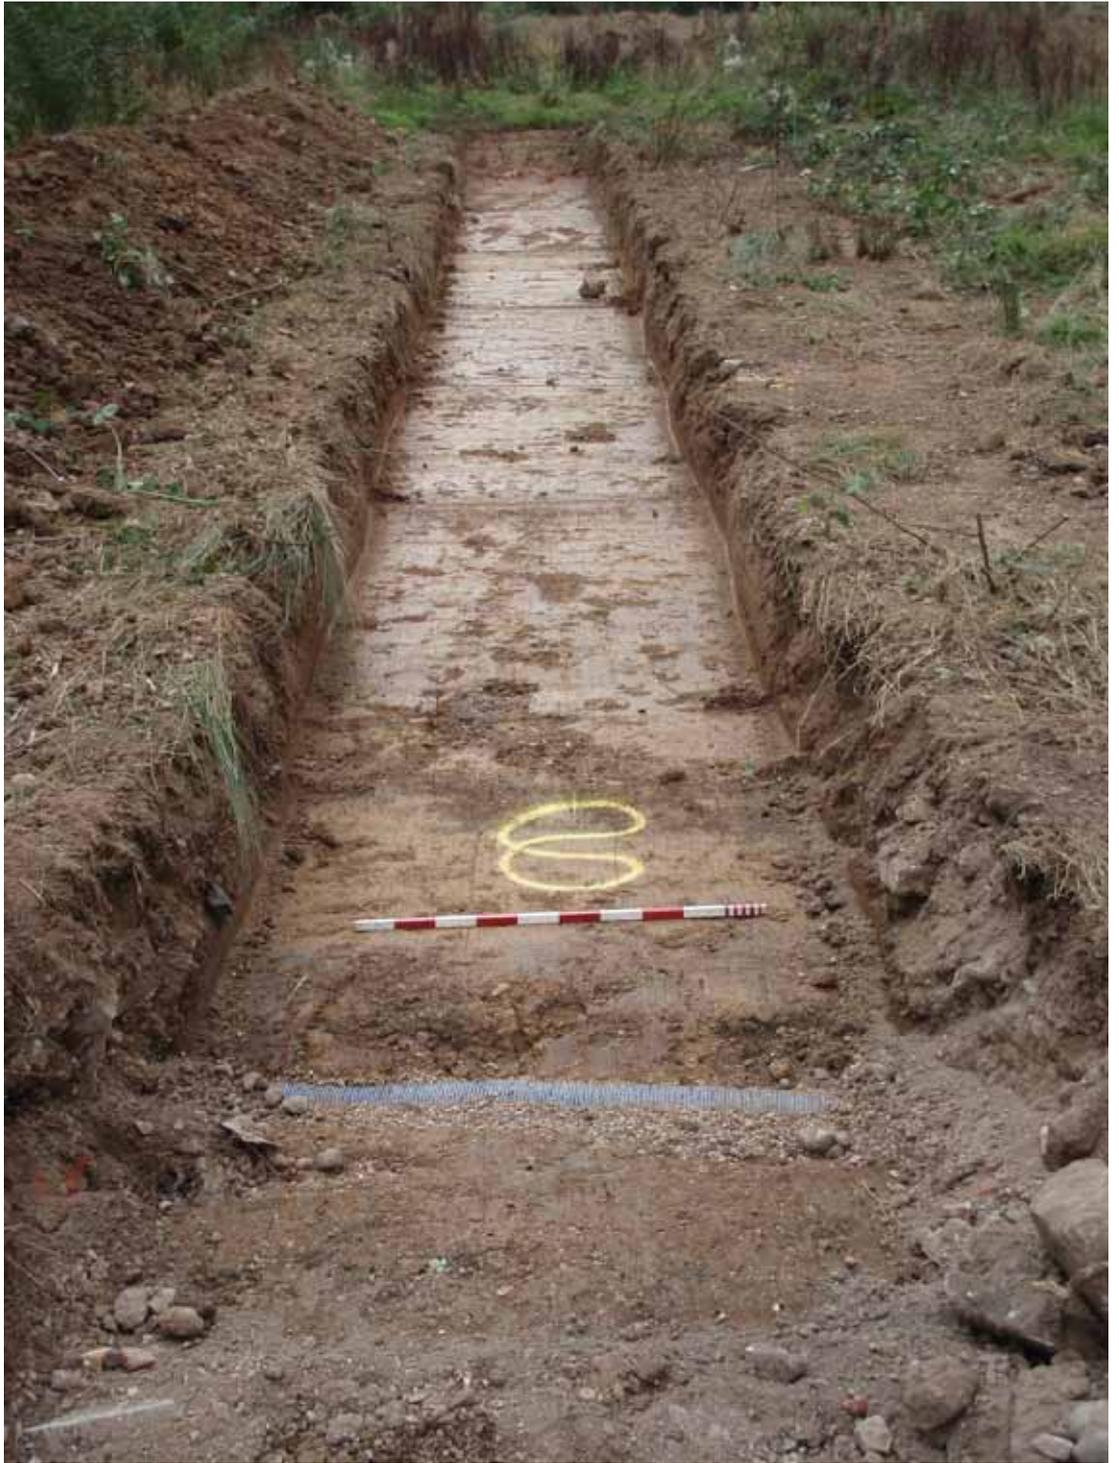
Plate 24. View of Trench 8

9.8 The plan is recorded in Figure 2 and 7 (see also Plates 24-28). The trench lay on an NNW to SSE alignment and measured approximately 25m by 1.90m.

Undisturbed natural geology **(802)** was identified across the trench as Wealden Clay, at a depth of approximately 0.32m (90.38m OD) below the present ground surface at 90.70m OD at mid-trench. Cut into the natural geology were four modern features. To the south a modern dump **[803]** of broken frogged bricks. Mid trench a disturbed area of a tree bole and to the north two modern pits **[805]** and **[807]** both infilled with broken paving slabs and broken bricks **(806)** and pea gravel containing a blue plastic pipe **(808)**. The natural geology was sealed by a layer of mixed soil, gravel and concrete pieces.

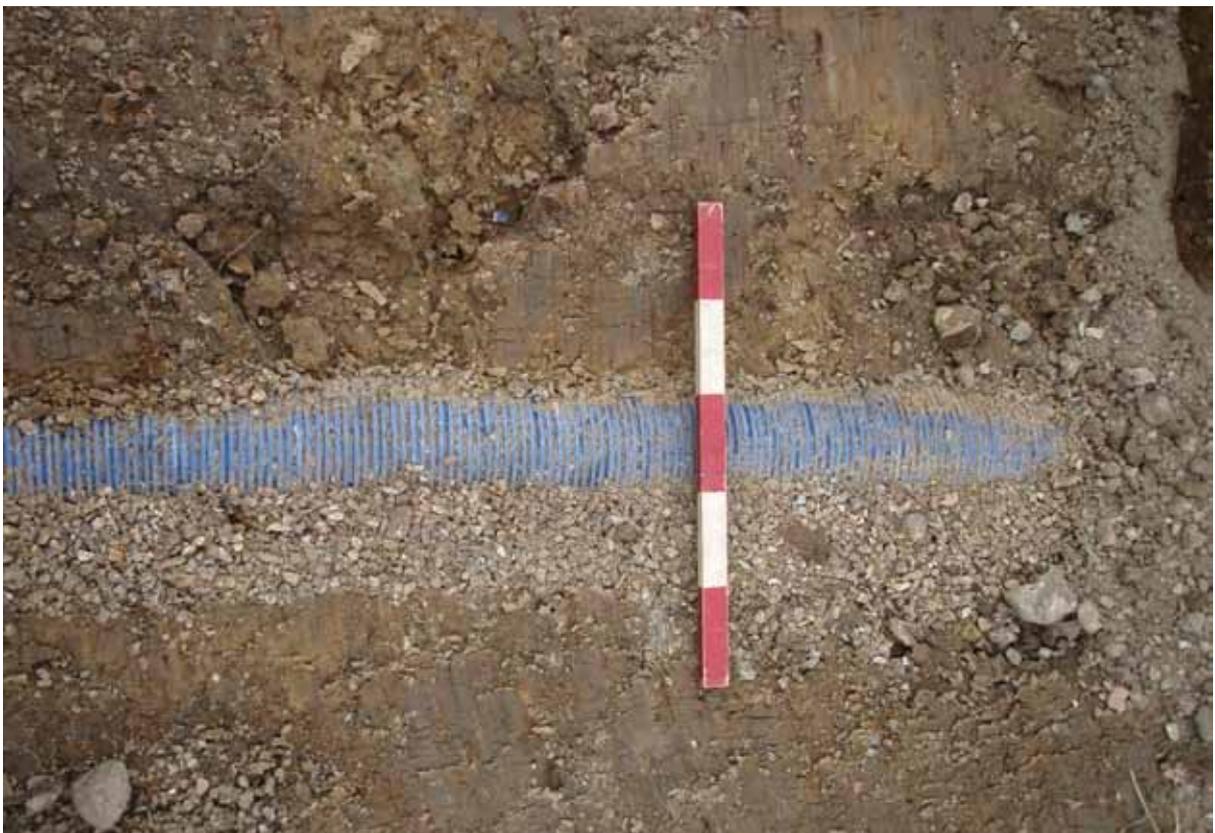
Plate 26. Trench 8 detail of drainage pipe (808)

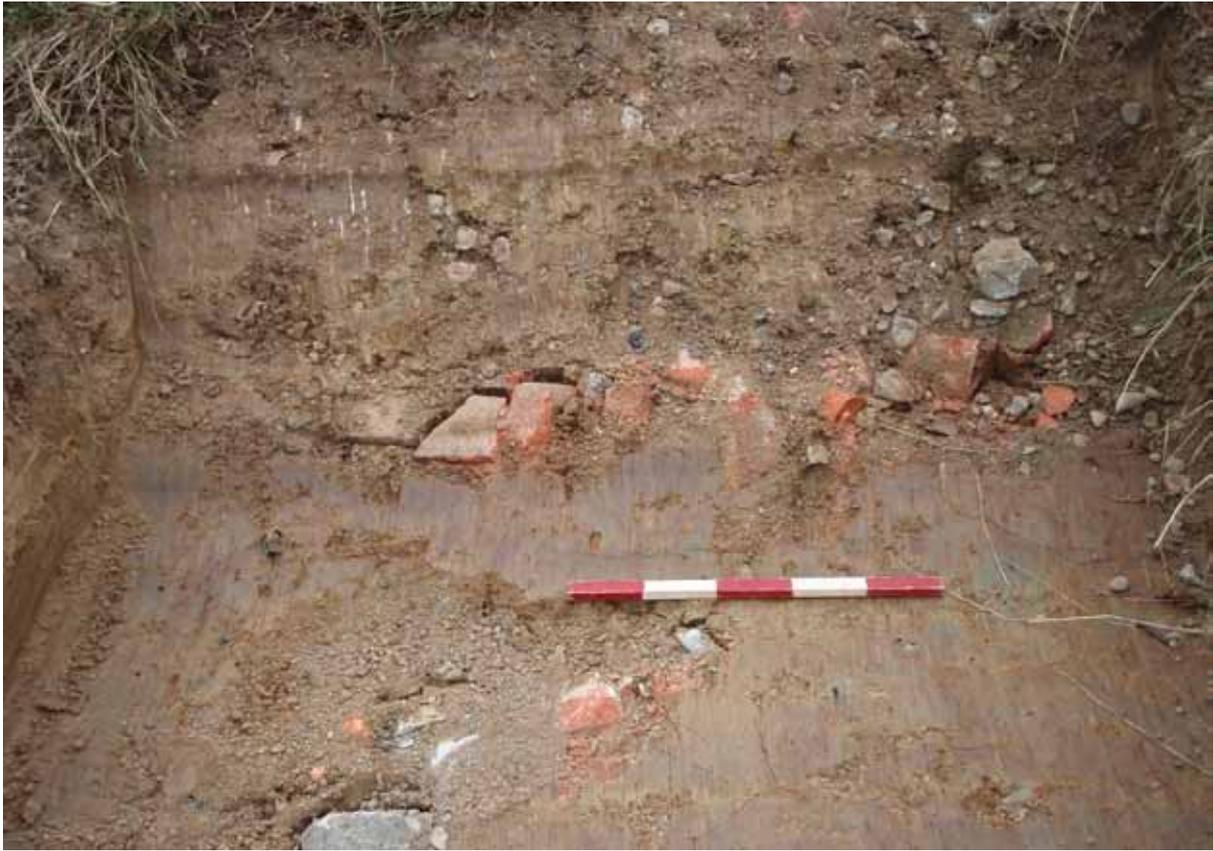
Plate 27. Trench 8 modern dump [803]
