Archaeological Evaluation of Land at Goffs Park, Crawley, West Sussex

Site Code: GOF/EV/16

SWAT Archaeology

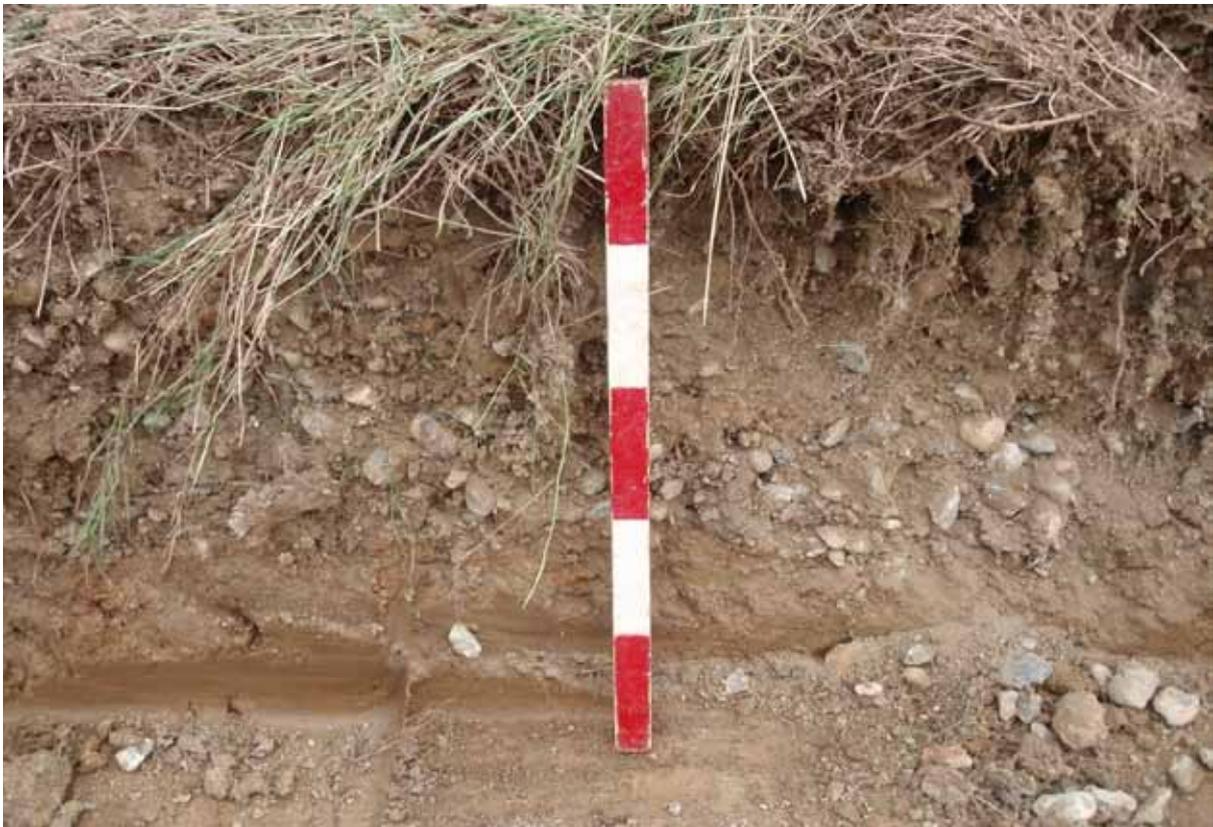
Undisturbed natural geology **(802)** was identified across the trench as Wealden Clay, at a depth of approximately 0.32m (90.38m OD) below the present ground surface at 90.70m OD at mid-trench. Cut into the natural geology were four modern features. To the south a modern dump **[803]** of broken frogged bricks. Mid trench a disturbed area of a tree bole and to the north two modern pits **[805]** and **[807]** both infilled with broken paving slabs and broken bricks **(806)** and pea gravel containing a blue plastic pipe **(808)**. The natural geology was sealed by a layer of mixed soil, gravel and concrete pieces.

Plate 28. Trench 8 section

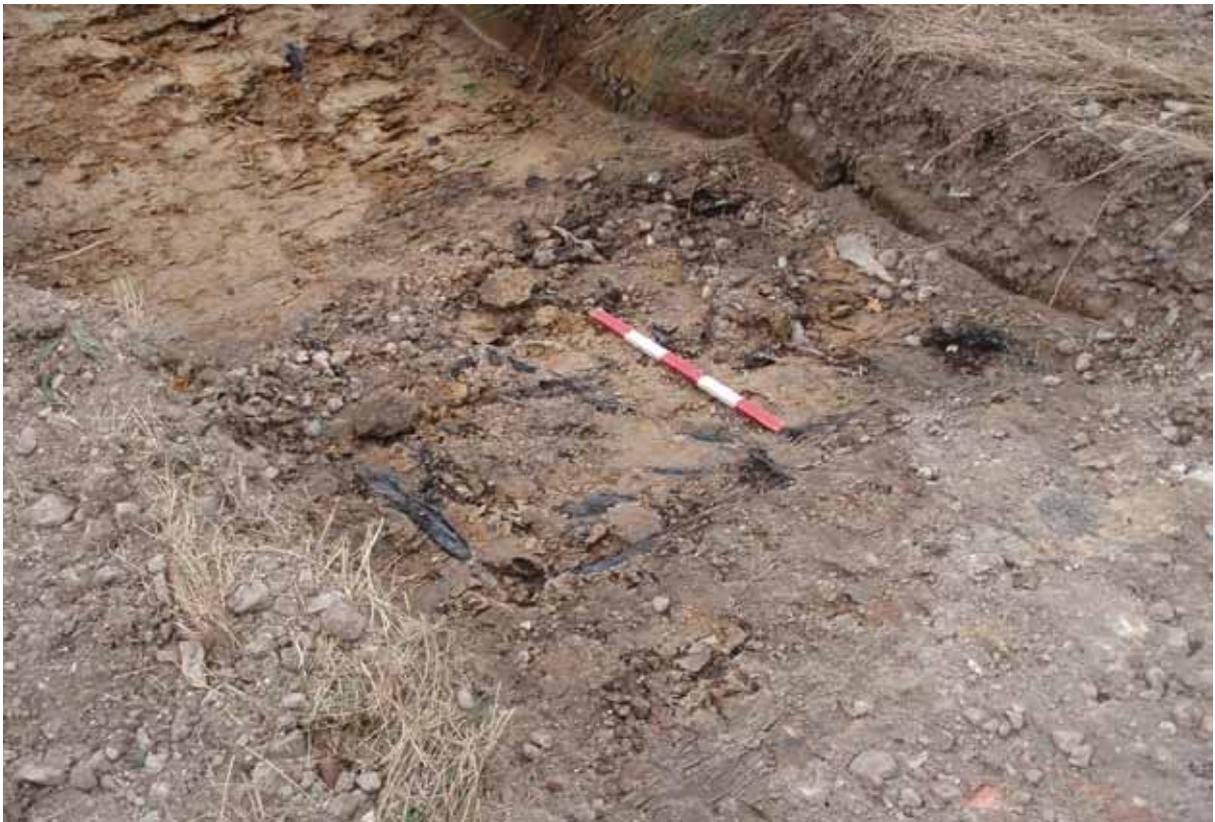
at mid-trench. Cutting into the natural geology were four features. To the west an area of extremely bright orange crushed brick butting up to a concrete foundation [904], To the east an area of extremely wet clay with modern tree branches (905) laid into the mud and further to the east a concrete post pad [906]. The natural geology was sealed by a layer of broken concrete and gravel mix.

Plate 31. Trench 9 view of feature (905)

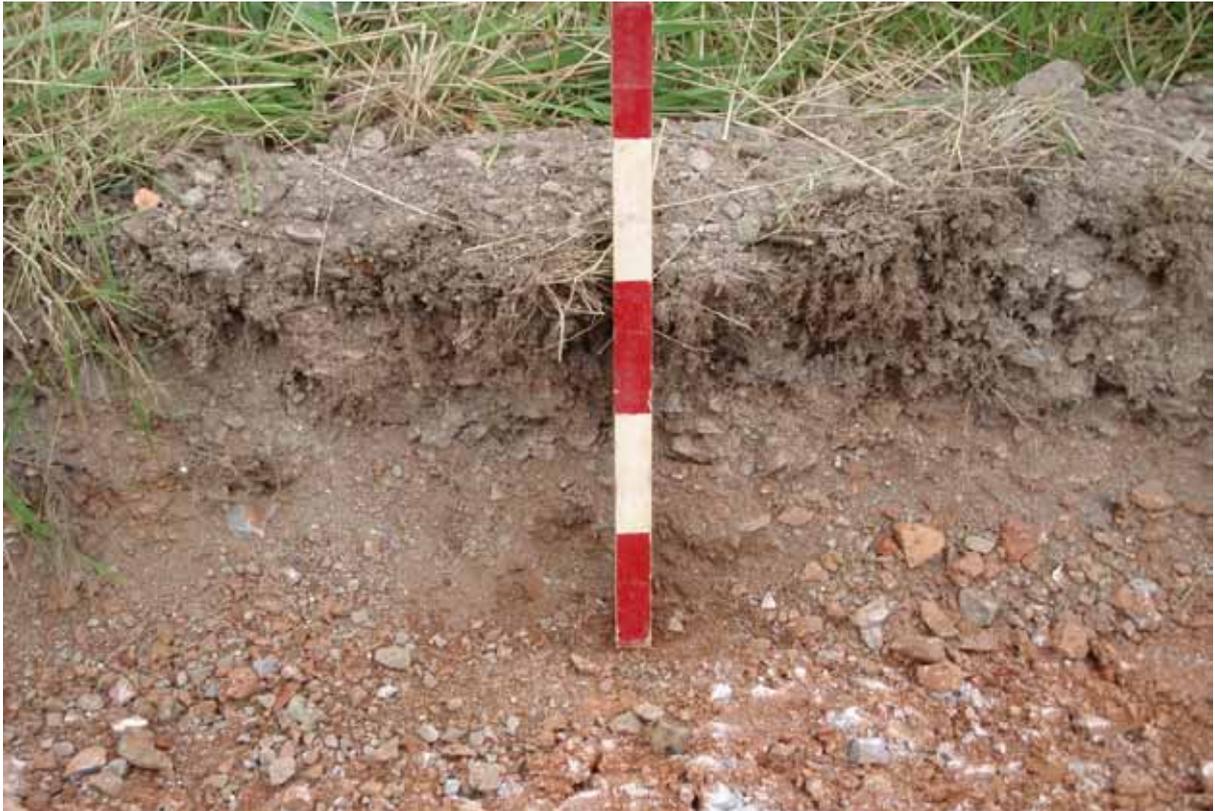
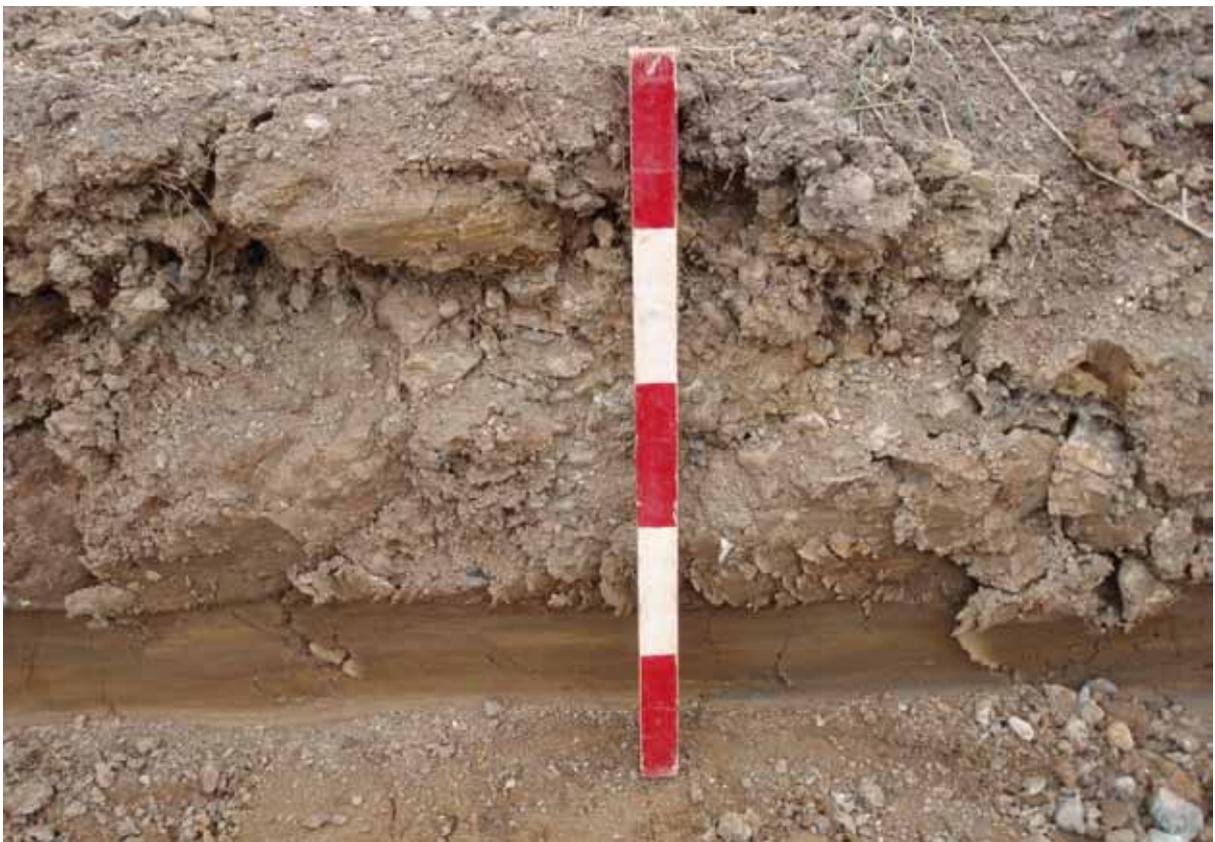
Undisturbed natural geology **(902)** was identified across the trench as Wealden Clay at a depth of approximately 0.30m (90.60m OD) below the present ground surface at 90.90m OD

Plate 32. Trench 9 section

Plate 33. Trench 9 section

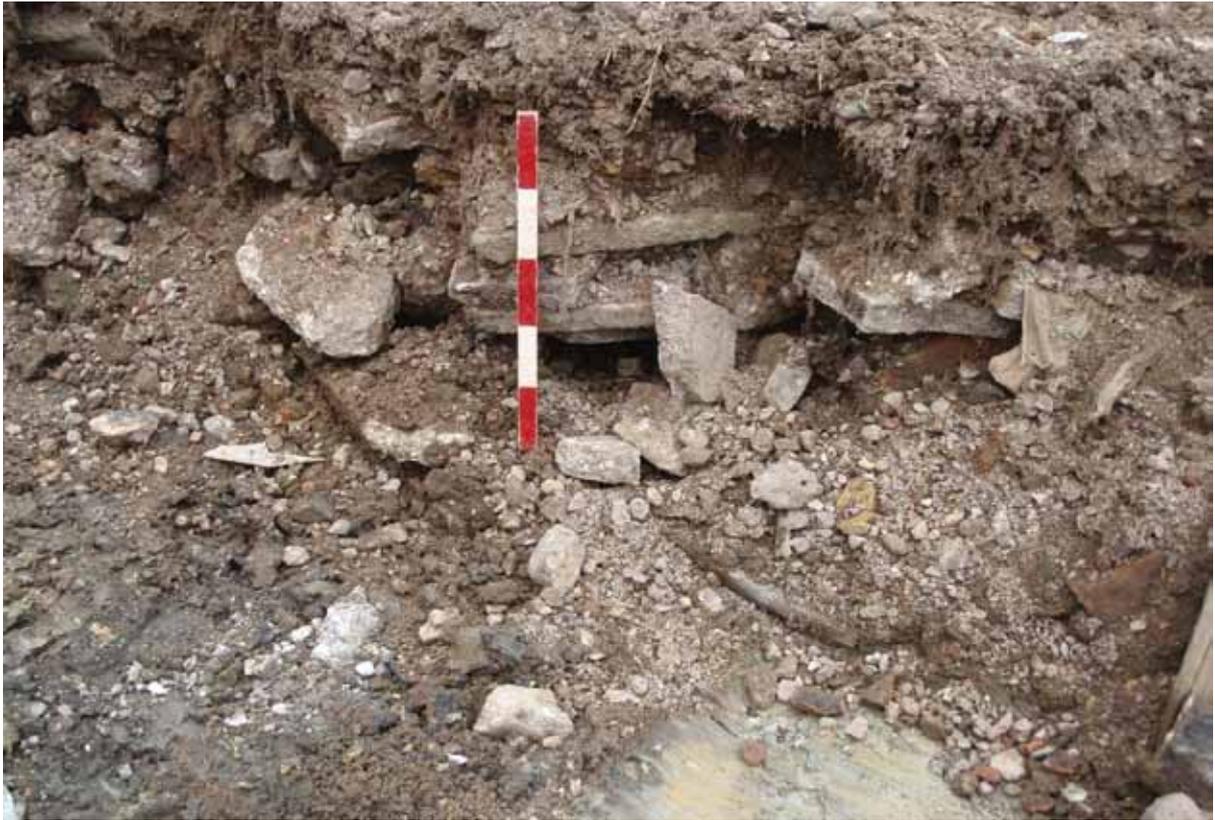
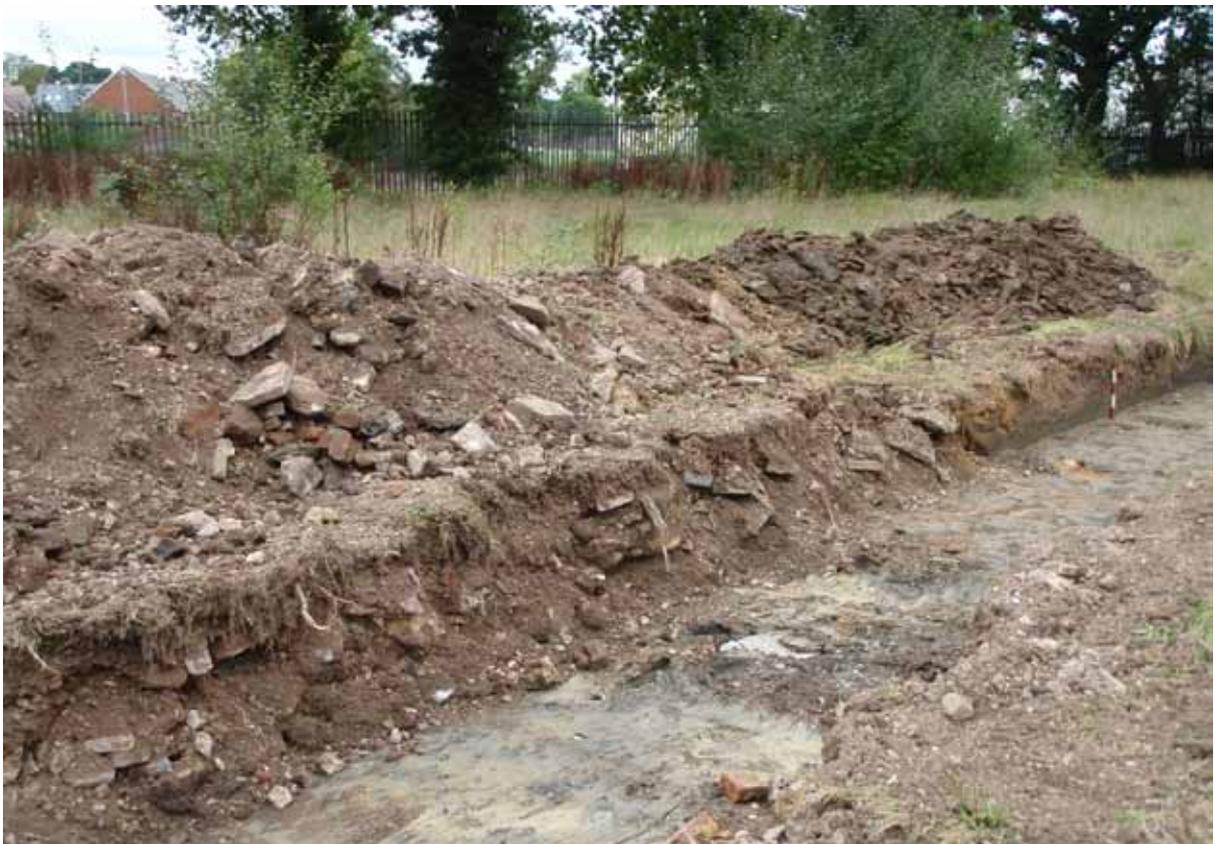
Undisturbed natural geology (1001) was identified across the trench as Wealden Clay, at a depth of approximately 0.30m (90.60m OD) below the present ground surface at 90.90m OD at mid-trench. Cutting into the natural geology were three features. To the west a large modern rubbish pit [1002] infilled with dumped building debris (1003). Mid trench a 30cm diameter possible post hole [1004] infilled with modern bright yellow sand (1005). To the east the remains of a roadway [1000] comprising timber edging, and layers of geotex fabric, sand, concrete and brick crush topped by cinders. Above this a mix of very wet topsoil and peat.

Plate 34. Trench 10 section SW side

Plate 35. Trench 10 view of section

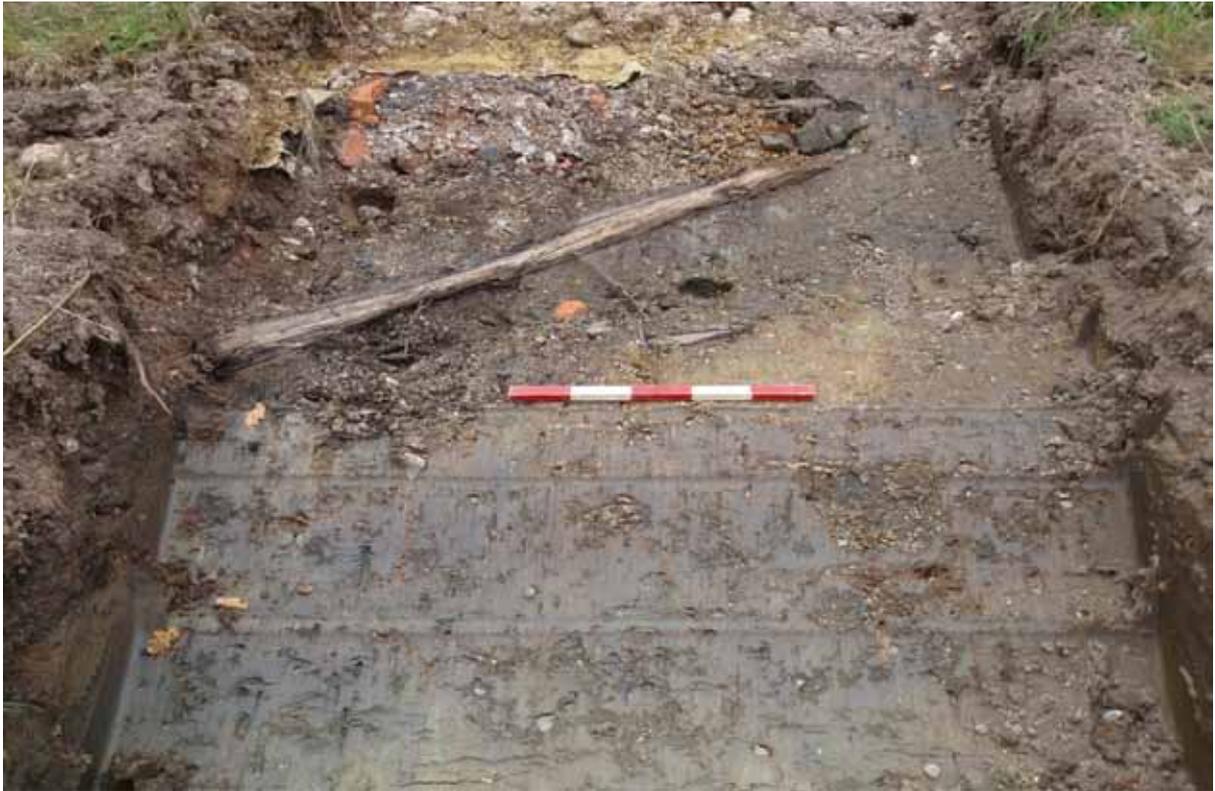
Plate 36. Trench 10 view of roadway [1000]

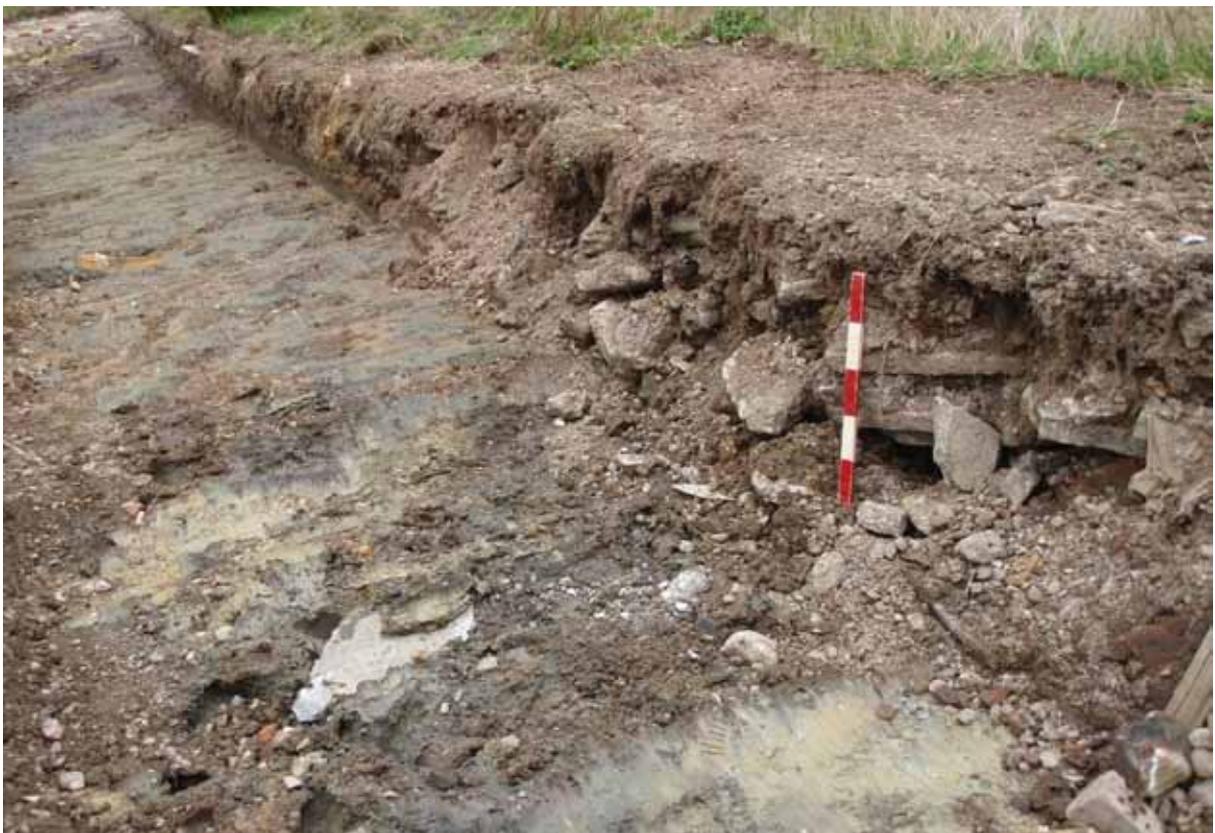
Plate 37. Trench 10 view of rubbish pit [1002]

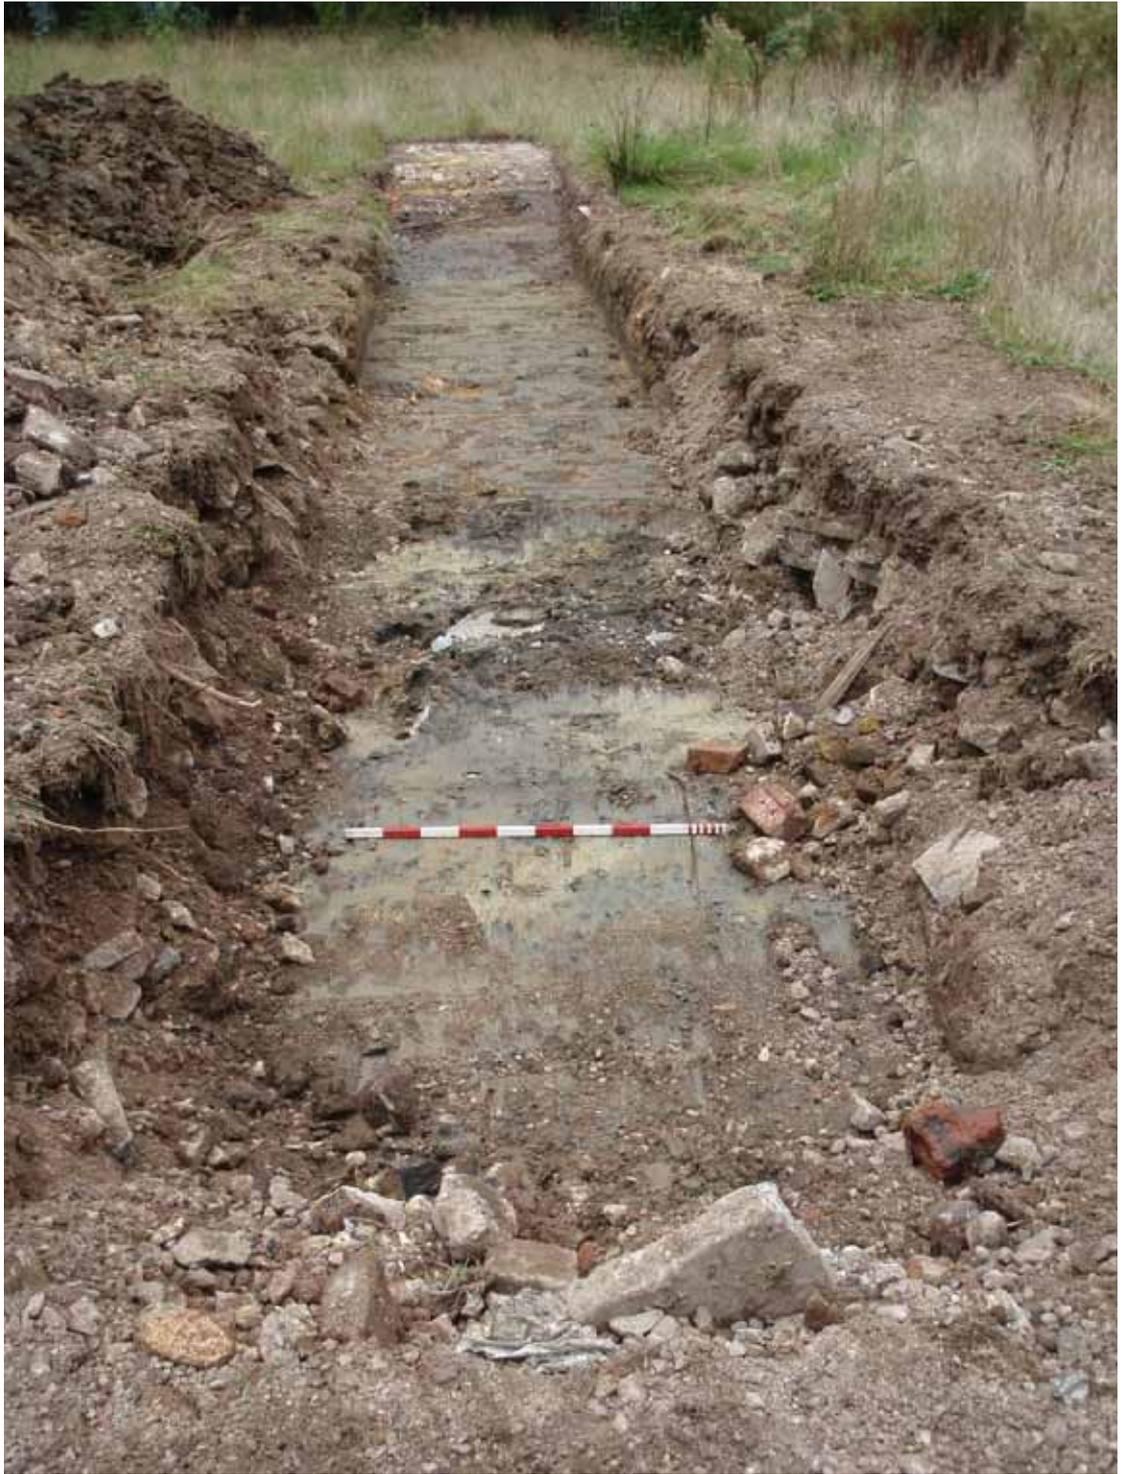
Plate 38. Trench 10 view of disturbed ground
