Archaeological Monitoring and Recording of Land at Bolebroke Castle, Hartfield, East Sussex

Site Code BOLE/WB/16

Report for BHD Architects
Date of report 22/04/2016

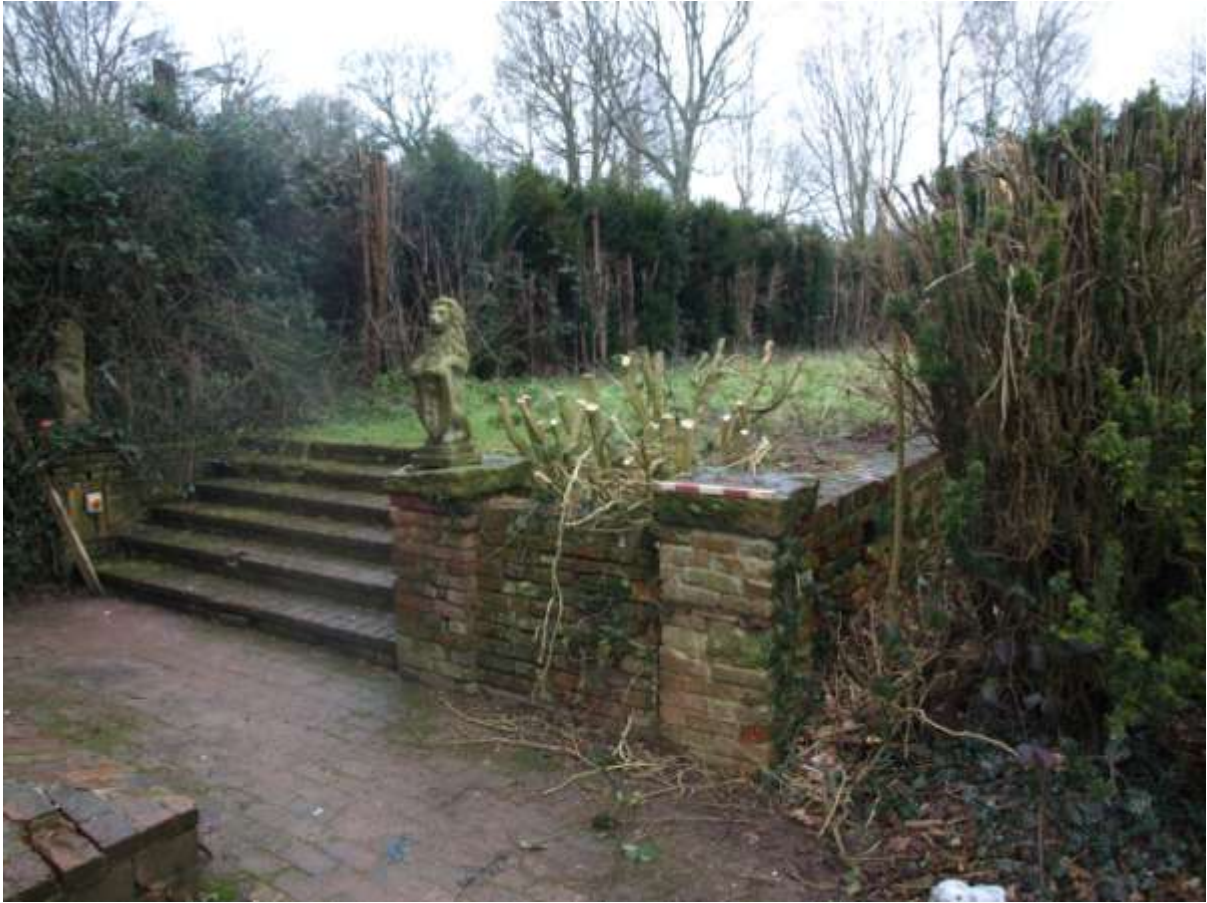
Plate 4: Looking North West at retaining wall [108].

7.1 The first phase of work was to clean and record walls [107, 108] located just to the south-west of the development (Figure 2 & Plates 4, 5, 6). This wall was built as a retaining wall to the east of the flight of stone steps leading into the garden (101) and is likely to be of 19th century build (Plate 5). The nine courses of English Bond are set in a white/cream lime mortar and capped with a single course of bricks laid on edge [107]. The wall has been badly rebuilt at some stage with courses losing their integrity and sub-rectangular blocks of sandstone added to the build (Figure 4 & Plate 5). The wall continues to the north but has been truncated down to one of the English Bond courses (Plan 1.1).

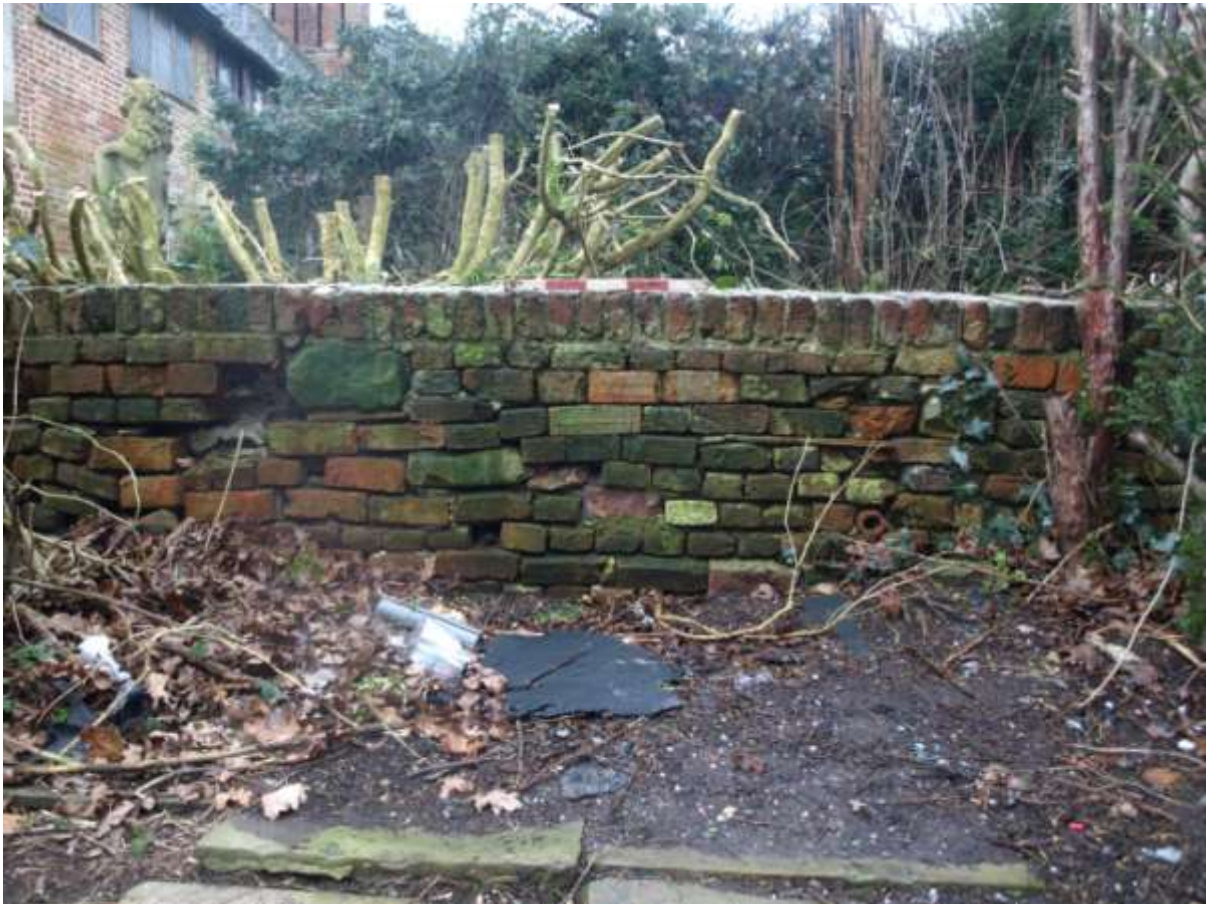
Plate 5: Looking west at wall [108]

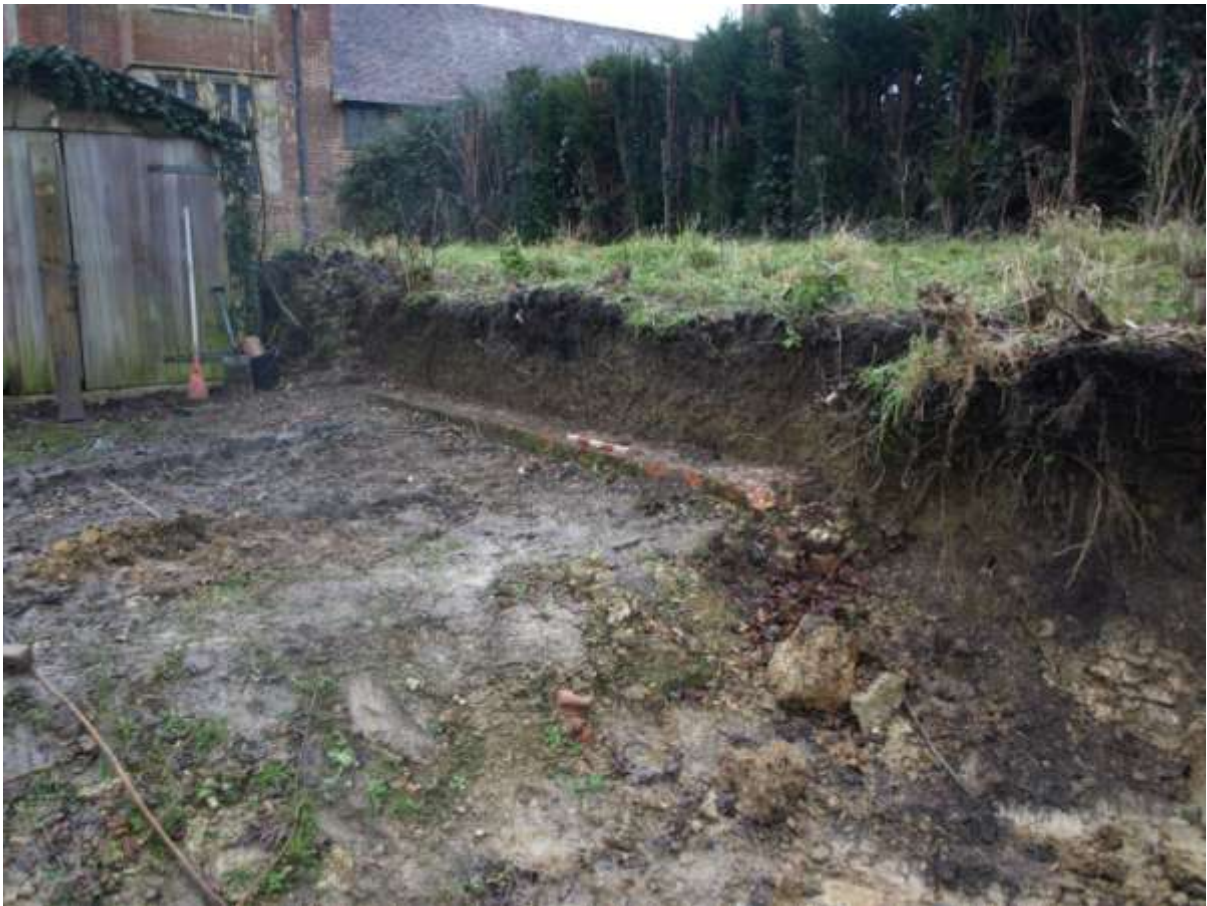
Plate 6: Looking South West at wall [107] and overlaying wall [108], visible in section next to shed.

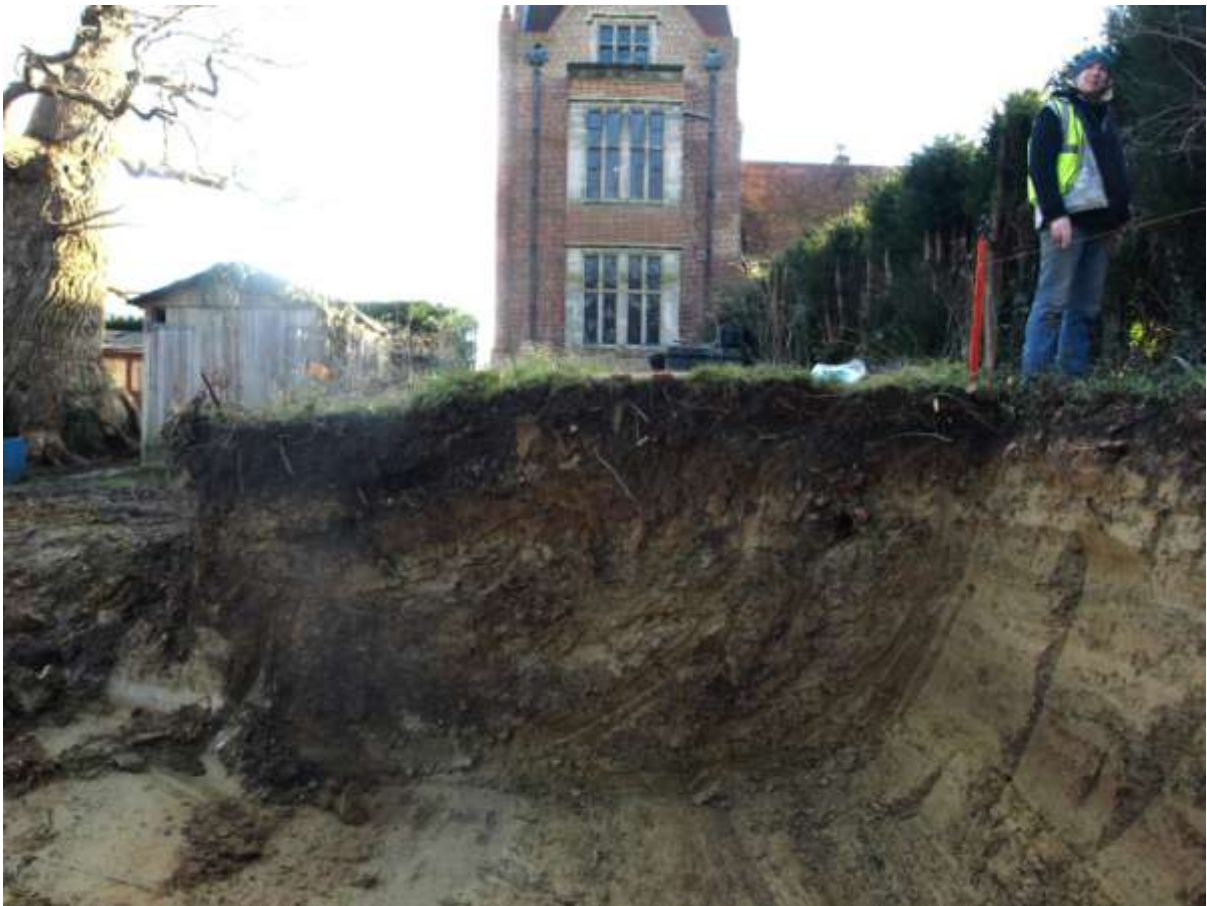
Plate 7: Looking South at Section 1 of Trench 1.

A vertical section was cleaned off at right angles to the wall [107] and shows quite clearly the dump layers of soil deposited after the retaining wall [108] had been built (Figure 5. Section 1). No cultural material was retrieved from any of the deposits (102, 106, 103, 101). Of some interest is the land drain cut [105] through (106 and 107) and infilled with flint shingle (104) but again without any dating material (Plate 7, Figure 4-Section 1).

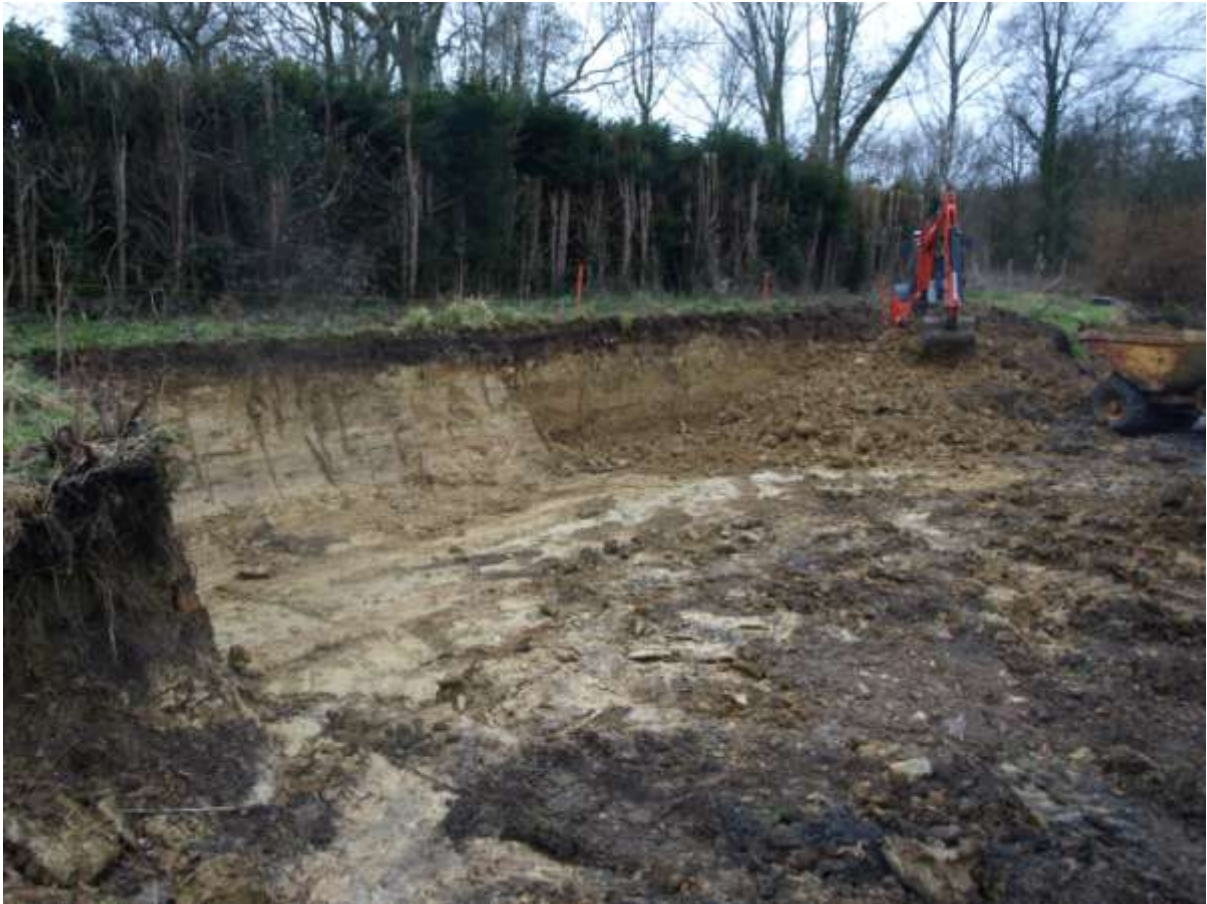
Plate 8: Looking North West at Trench 1.

7.2 The next stage of works was to continue the reduction of the slope under strict archaeological control with a 360' tracked machine equipped with a bladed ditching bucket (Plate 8 and Trench 1 Figure 2). No archaeological features, artifacts or garden wall were exposed in this phase of work. Work continued to the north and a wall was revealed close to the fence line (Figure 2, Trench 2 & Section 2. Plates 9-11).

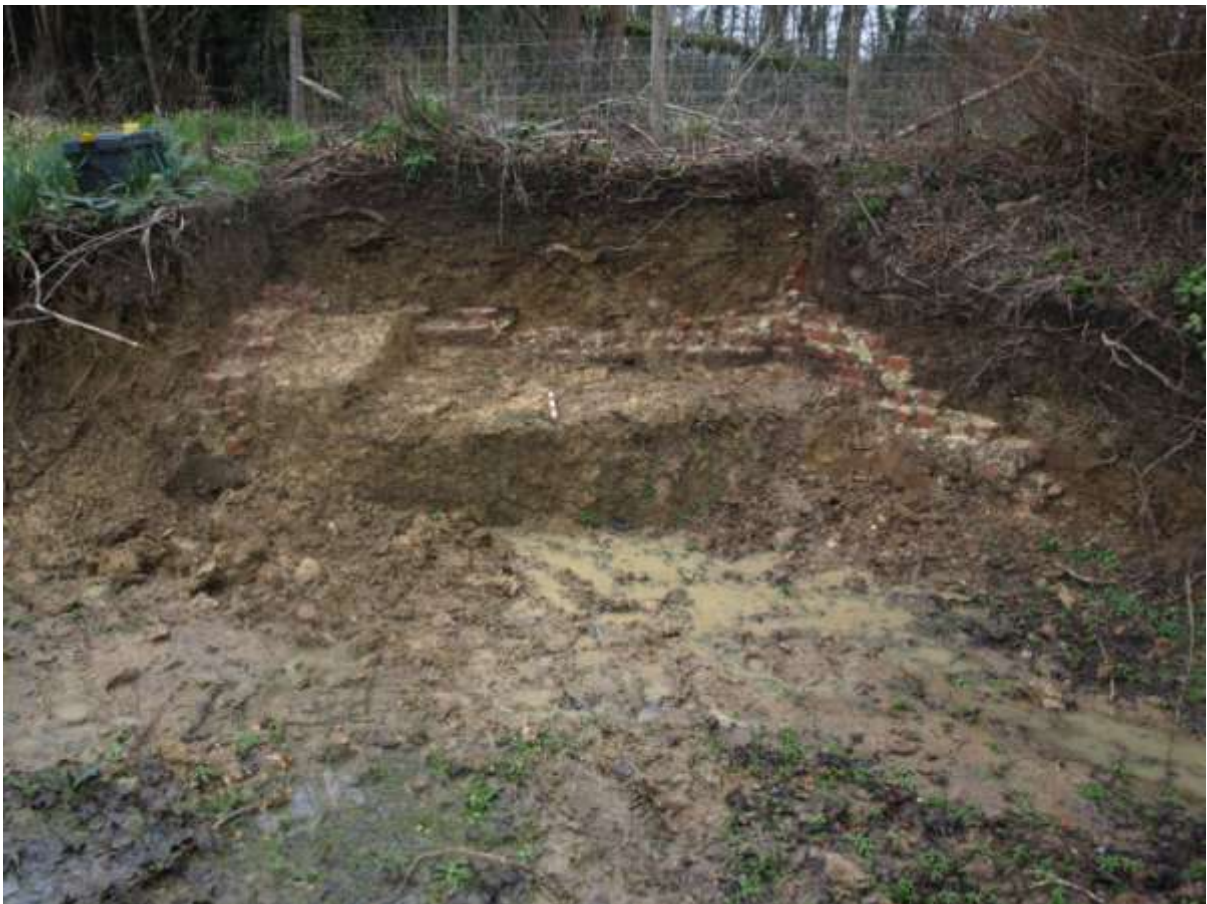
Plate 9: Looking west at brickwork exposed in Trench 2

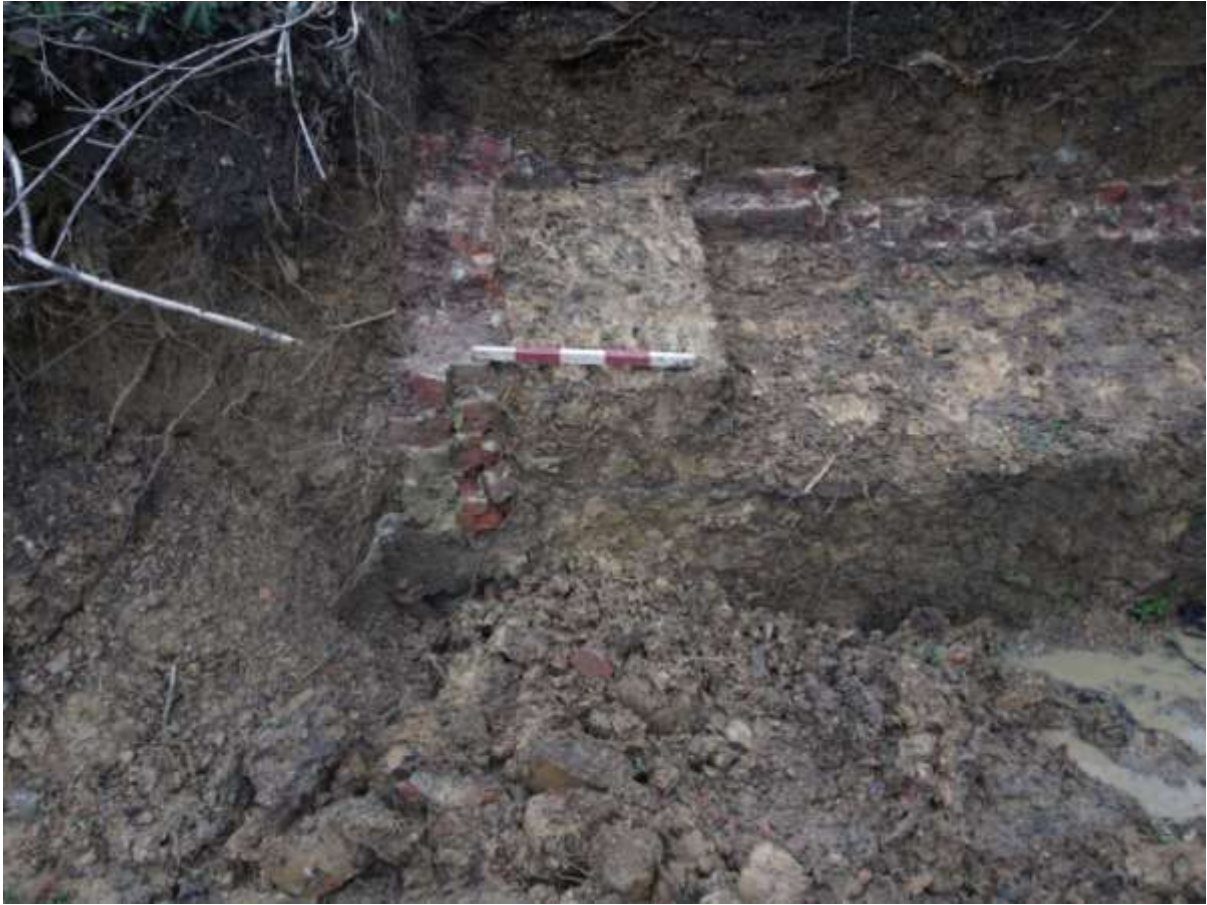
Plate 10: Looking West at cross section of the wall [203]

This wall is built of red brick in a English Bond and set in a lime mortar [203] and is a corner of a building- probably the building shown on the William Figgs plan of 1799- but is much truncated (Plate 10) with no surviving floors (Plate 11 & Figure 5 Section 2 & Plan 1.2). This structure is outside the development area and the recommendation is re-burial and preservation in situ.

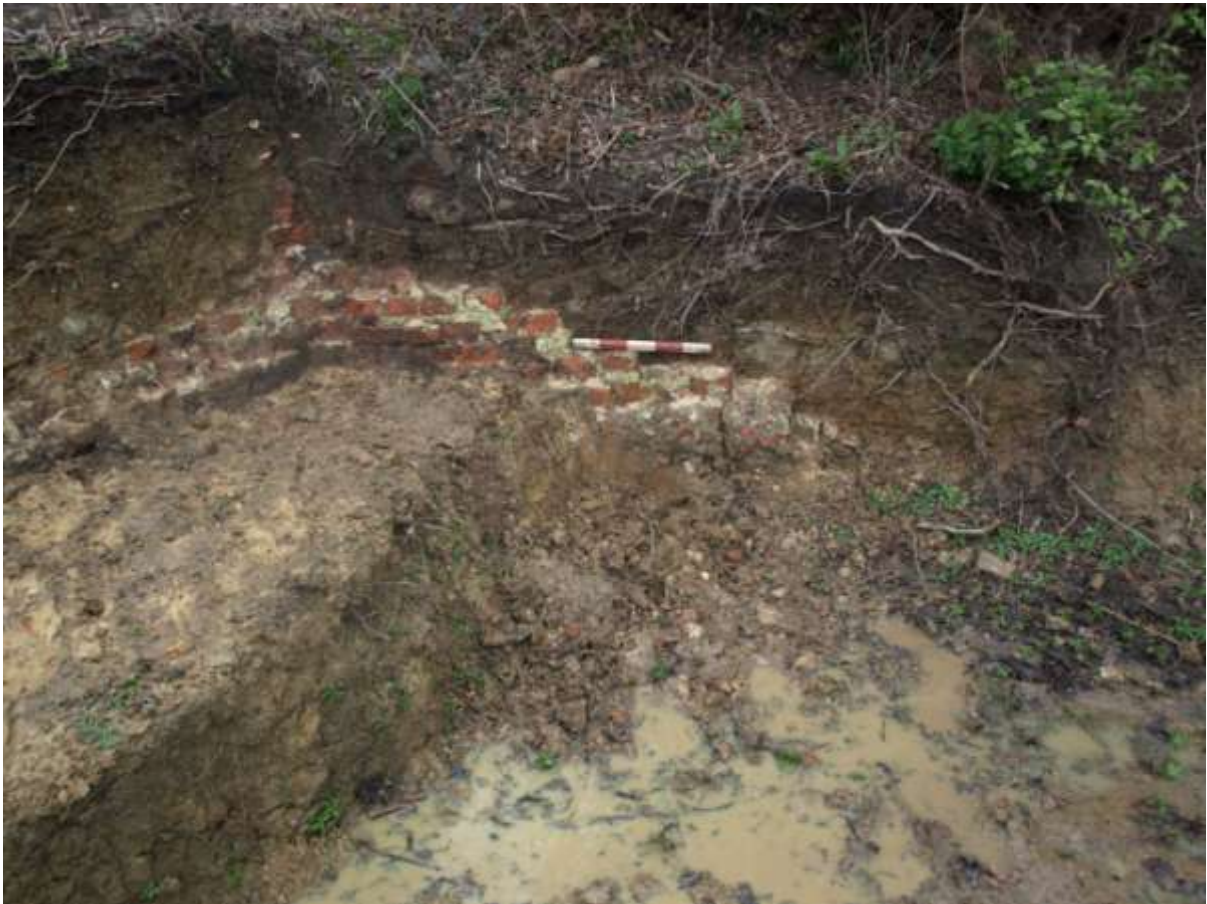
Plate 11: Looking North West at wall [203] exposed in Trench 2.
