1.1 In November 2014 Dr Paul Wilkinson of SWAT Archaeology carried out a historic building recording of Goodlands Cottage, Hawkwood Estate, Chislehurst, Kent (Figure 1). The building is presently unoccupied and is undergoing restoration and repair.

PROJECT: GOODLANDS COTTAGE		SWAT ARCHAEOLOGY	
DRAWING TITLE: Plans (ground floor, first floor, cellar) and Front Elevation			
SIZE AND SCALE: 1:100@A3	DATE: 11/11/2016	DRAWN BY: BARTOSZ CICHY	
DRAWING NUMBER: 1-4	SITE CODE: GC-BR16	REF. FILE: Drawing1.DWG

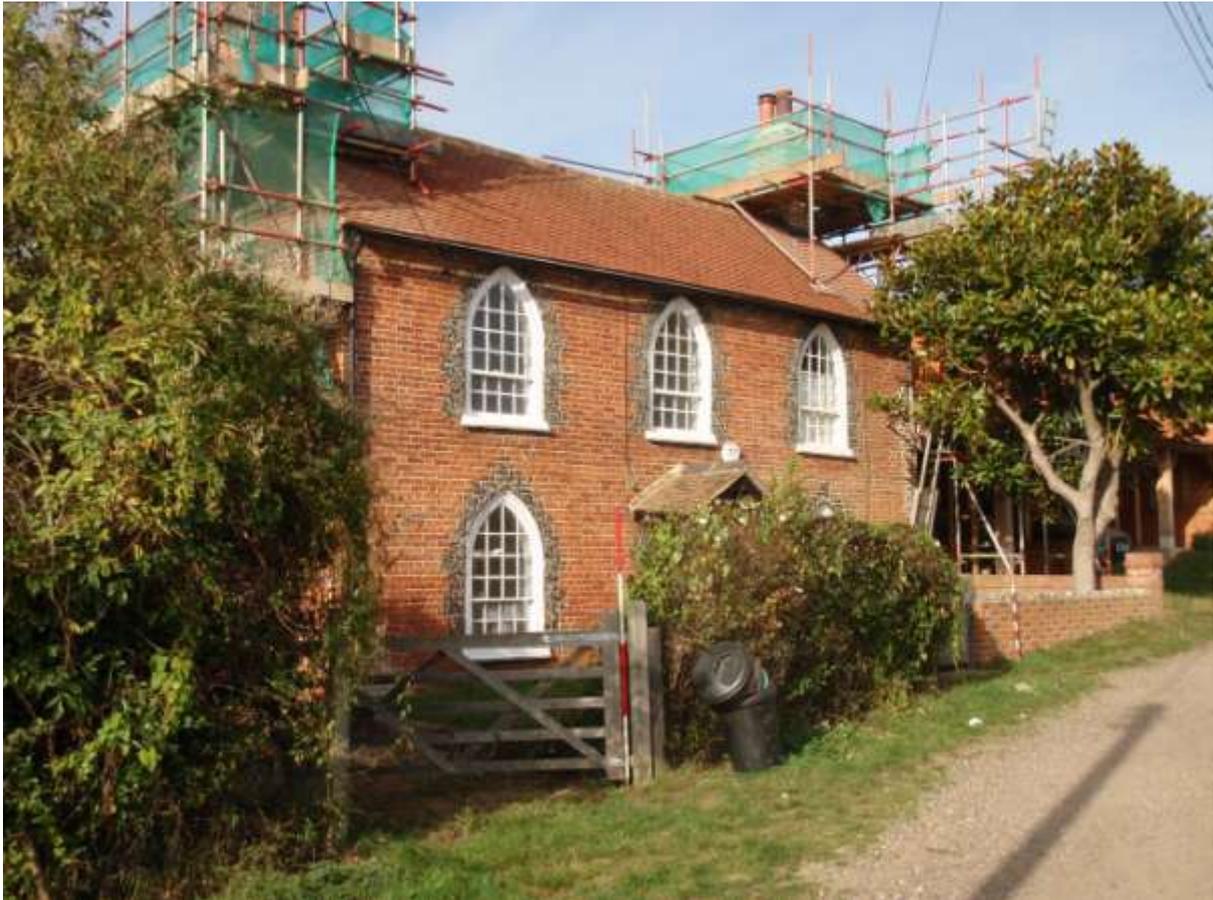
Plate 1. Front elevation of Goodland Cottage (looking north)

3.3 The eastern pile representing Phase 1 is red brick fronted with a tile roof. The brickwork is very fine quality red brickwork with quoins of regular knapped flintwork surrounding four gothic windows. The windows have conventional orthogonal glazing bars and sliding sashes. No attempt at 'tracery' was made in the glazing bar treatment. The front door is similarly gothic with a porch formed of knobbly tree-trunks, possibly original. The roof is plain clay tiled and gabled. The chimneys are integral to the two gable ends and project into the two front rooms (Plates 1, 2, 3, 4).

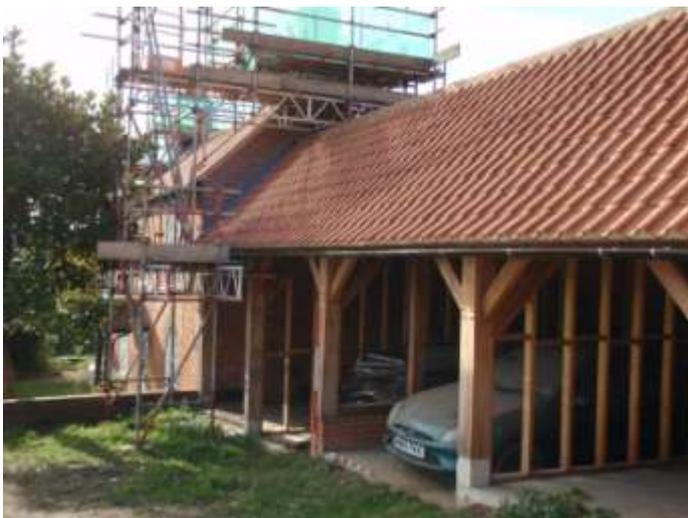
Plate 2. Front elevation of the new four bay barn (looking west)

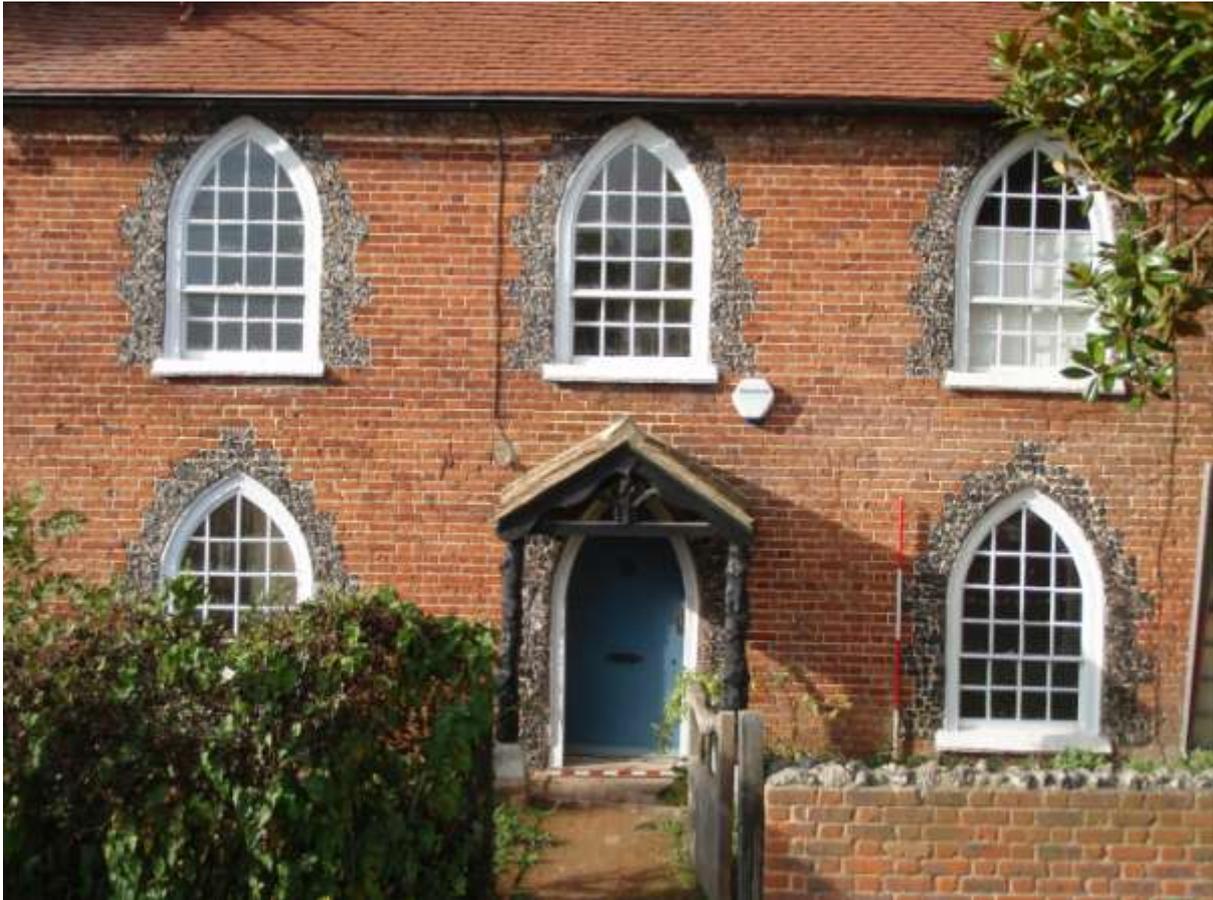
Plate 3. Front elevation of Goodlands Cottage (looking north-west)

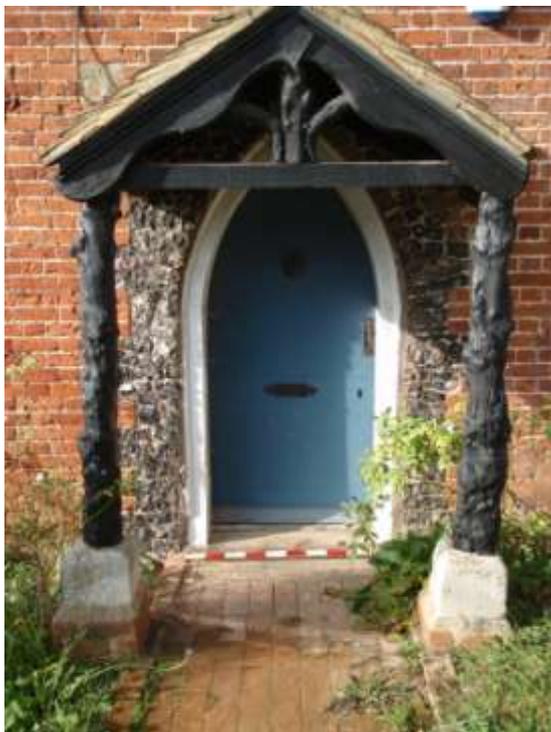
Plate 4. Close-up of front door

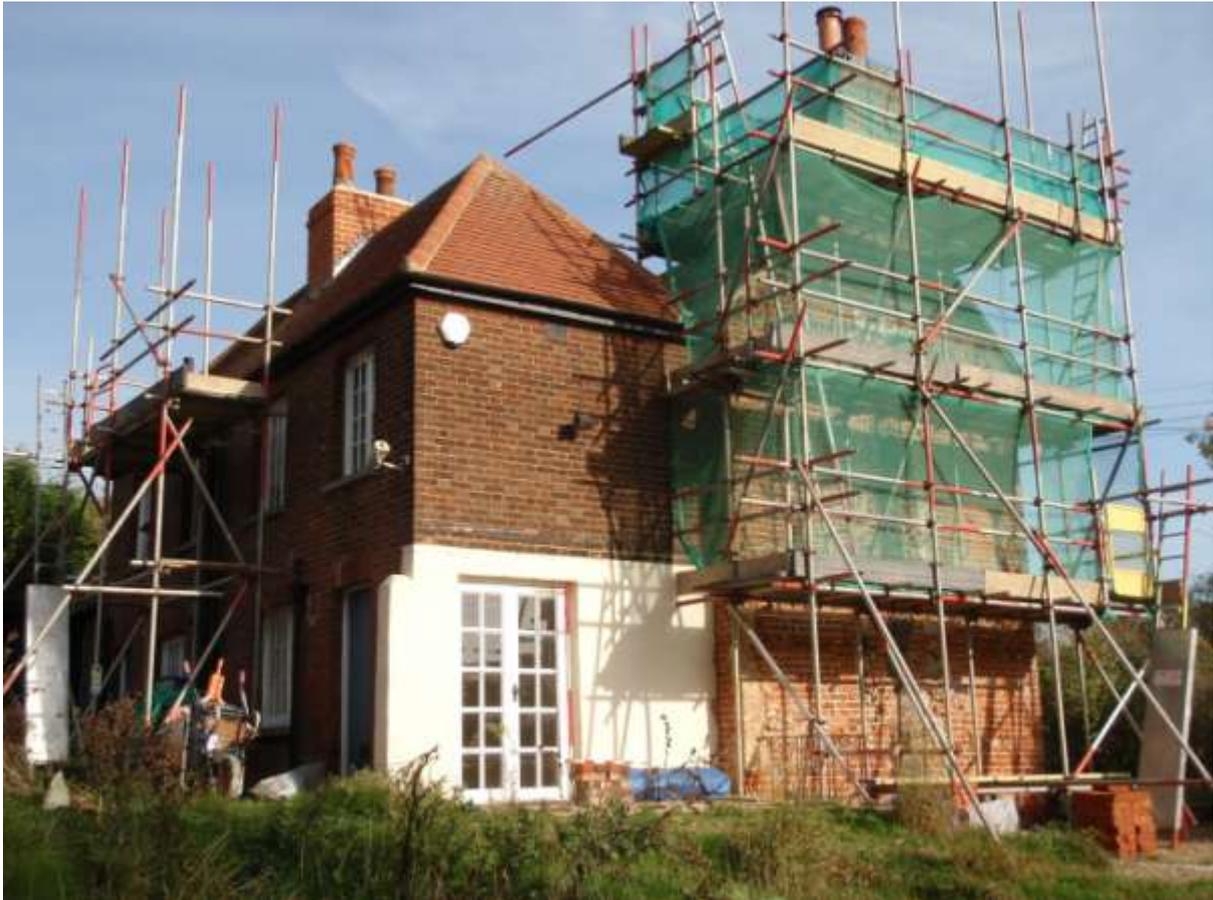
Plate 5. West (rear) and south elevation showing new roof (looking north-east)

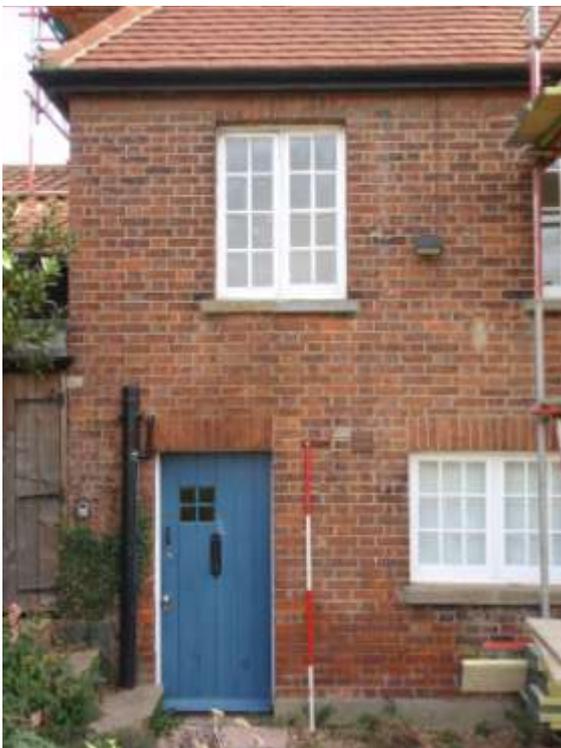
Plate 6. Detail of west (rear) elevation (looking east)

3.5 The western pile representing Phase 2 is of brown stock brick construction. The windows are simple side hung timber casement windows. The roof construction is plain clay tiled and hipped on all corners. The two piles are separated by a central valley draining onto the barn to the north. There is a central chimney stack serving internal chimney breast facing north and south. There is evidence that the northern ground floor chimney breast has been removed (Plates 6, 7, 8, 9).

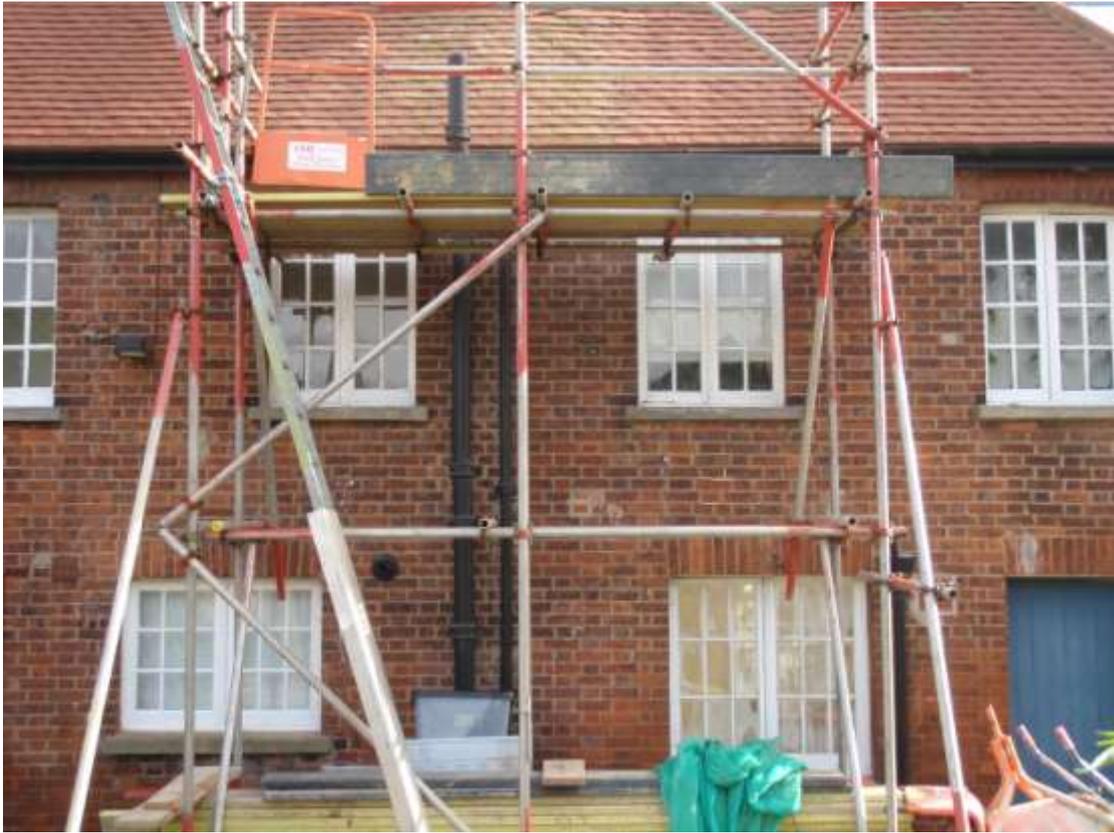
Plate 7. Detail of west (rear) elevation phase 2 (looking east)

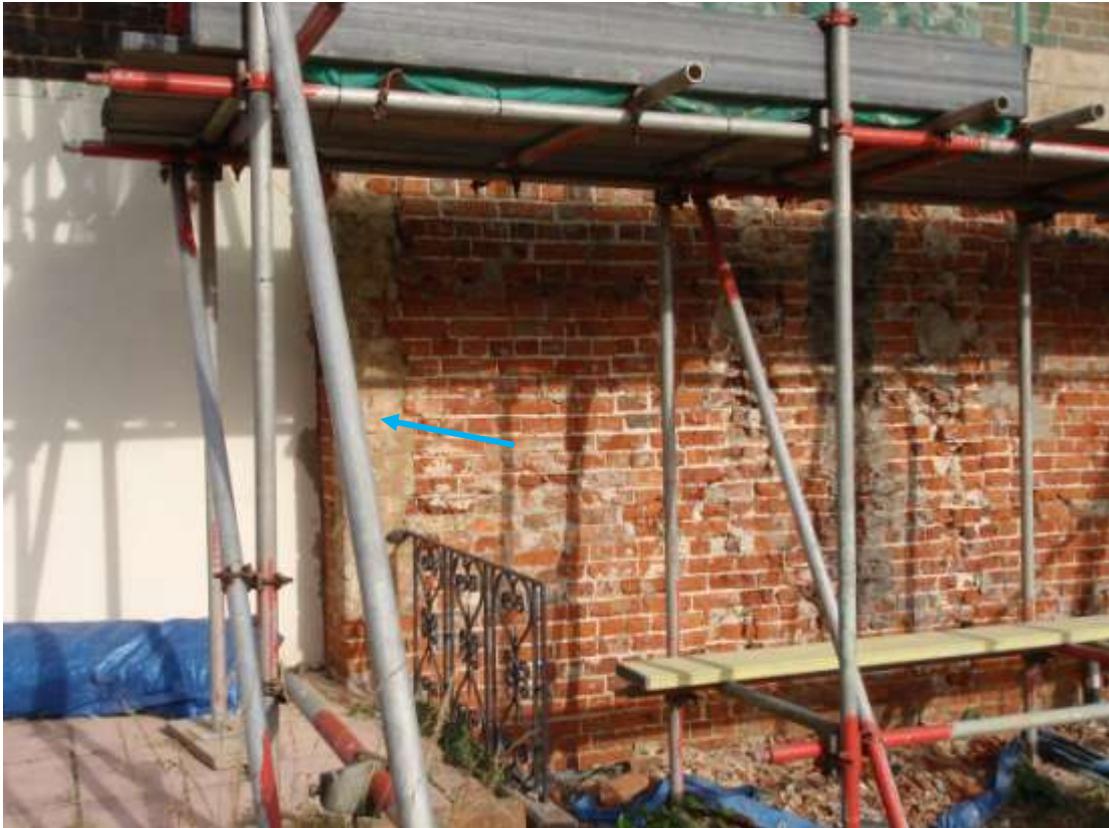
Plate 8. Detail of south elevation phase 1 showing damaged brickwork of demolished 'bake-house')

3.6 With the removal of the concrete render, it is clear that the southern end of the building has been truncated. Timber plates joined into the wall plates at eaves level would originally have been internal features and the southeast corner of brickwork can be seen to have been carefully cut. Furthermore with the removal of the render, it can be seen that the front and rear wall of the eastern pile are not completely bonded and there are remains of flue structures and a central brick oven within the walling. A small blocked opening to the west of the oven can be observed. This would have been accessible from the southern room.

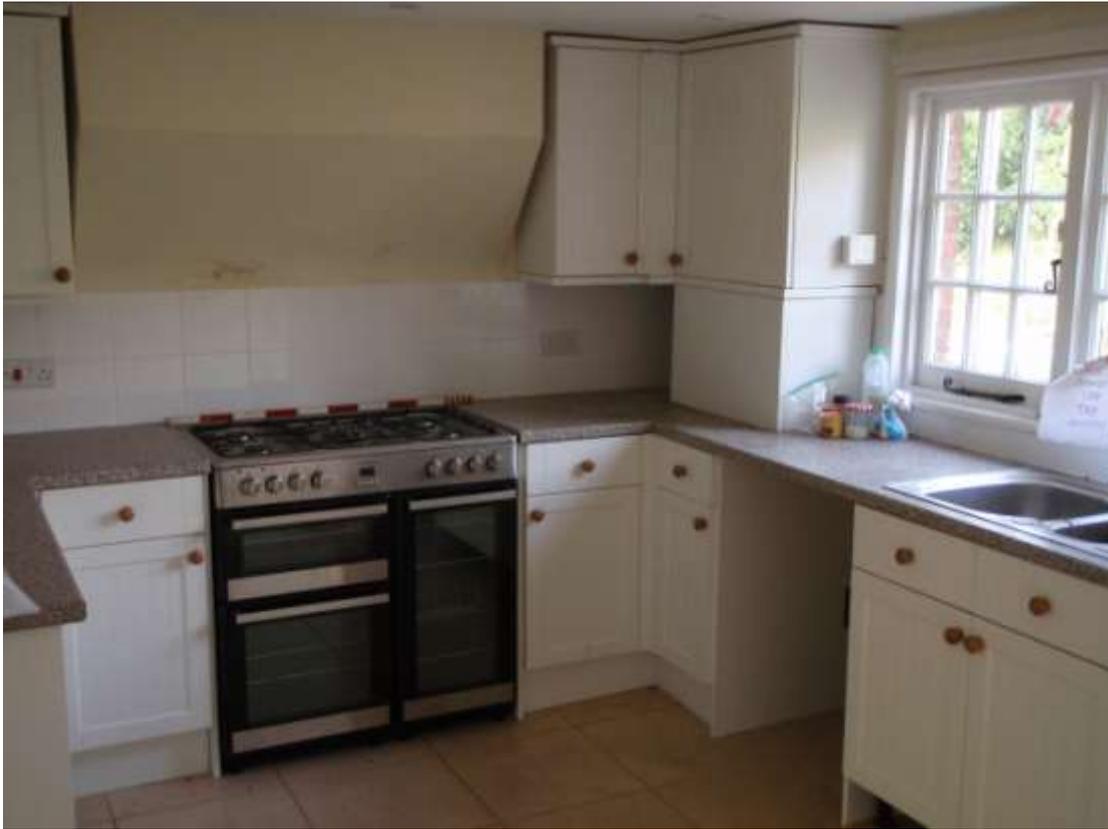
Plate 9. Kitchen (1) interior (looking west)

4.3 The 'Kitchen' (1) is located in Phase 2 and measures internally 3.04 x 4.22m (Plate 9). The kitchen is fitted out with modern kitchen units, a stainless steel sink and electric/gas hob and oven cooker. The kitchen units are topped with formica type plastic worktops and the floor is tiled with modern ceramic tiles. In the centre of the east wall a simple panelled wooden door painted white which leads to the 'Living Room'.

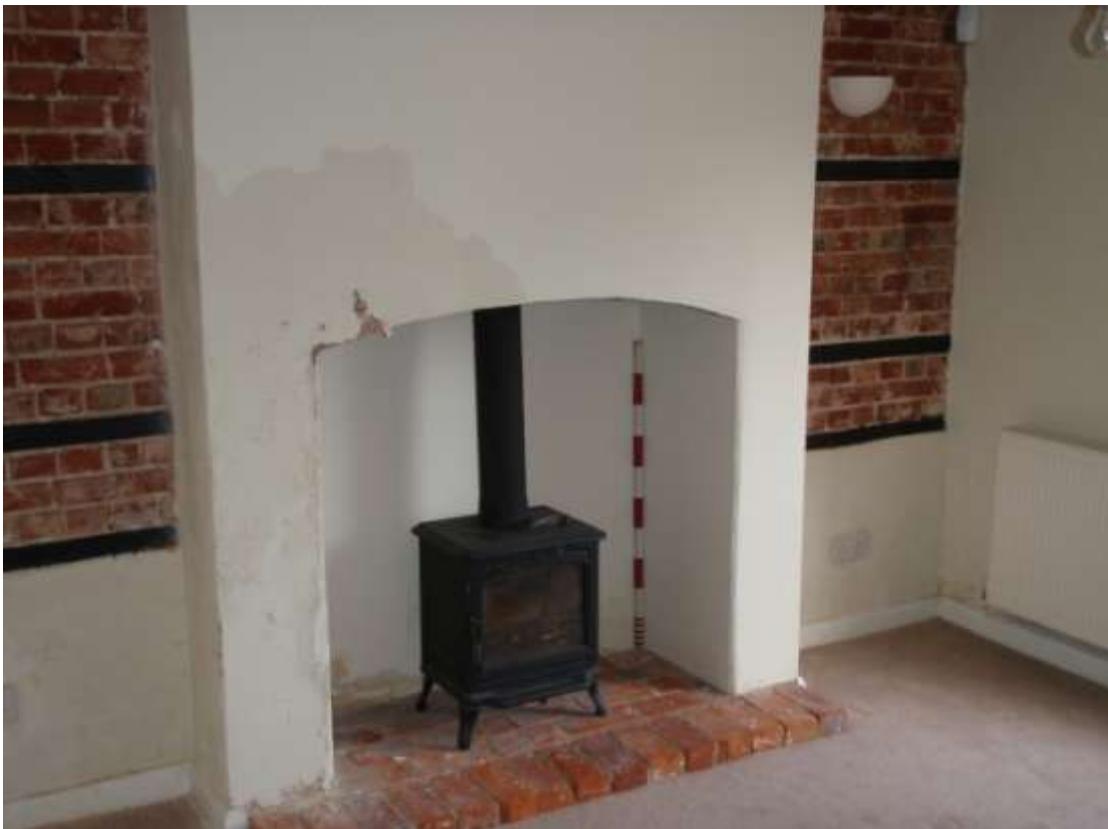
Plate 10. Living Room (2) interior (looking north-east)

4.4 The Living Room (2) is located in Phase 1 and measures internally 3.56 x 3.65m (Plates 10, 11). The room is lighted by one of the gothic windows and heated in an original fireplace recess by a modern woodstove sitting on a brick hearth which again is modern. Each side of the plastered chimney breast the

wall plaster has been removed to expose the original brickwork laid in English Bond and set in lime mortar between horizontal sawn timber framing. The walls are plastered and painted, the ceiling lathe and plaster and the floors covered in carpet. Apart from the kitchen entrance there are two other simple panelled white painted wooden doors, one leads to an under stairs cupboard, the other to the front hall.

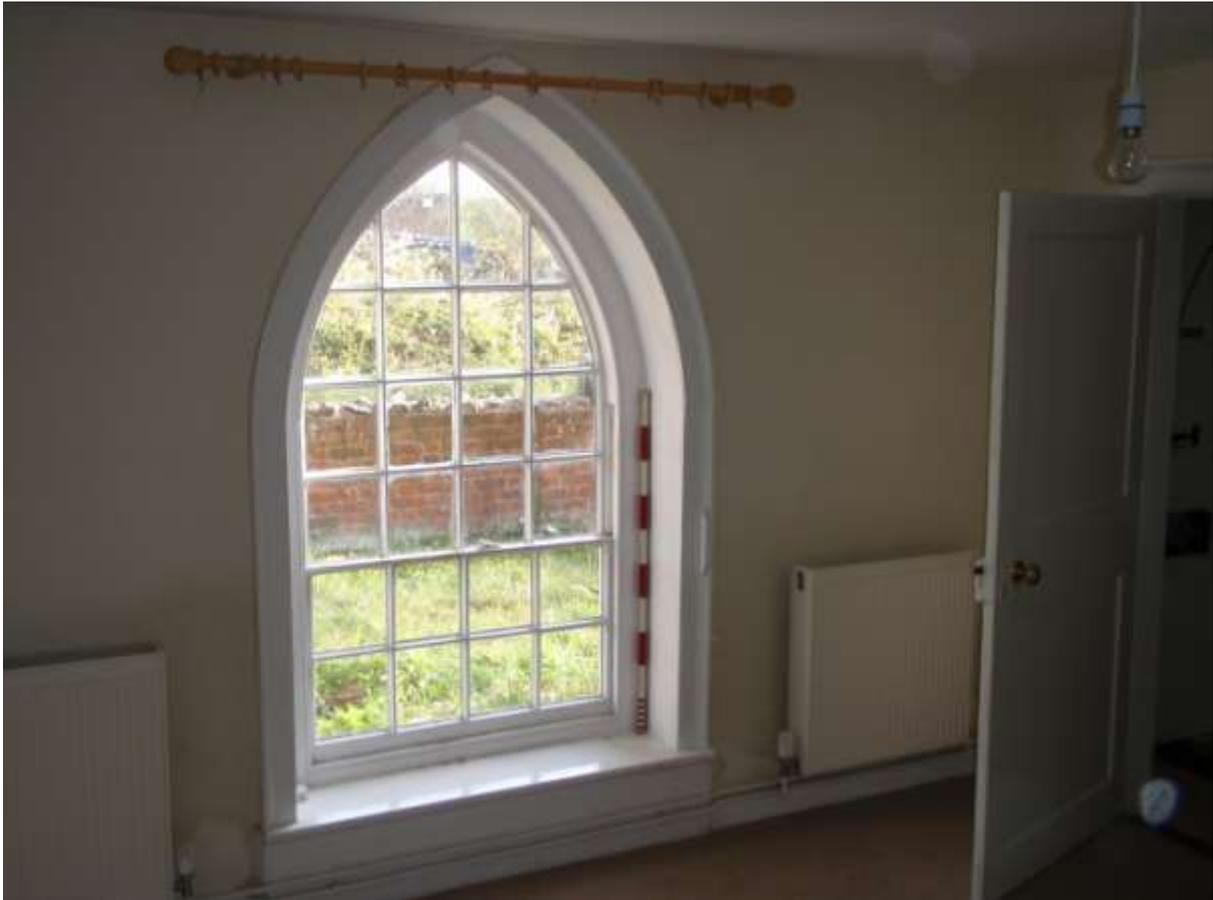
Plate 11. Living Room (2) interior (looking south-east)

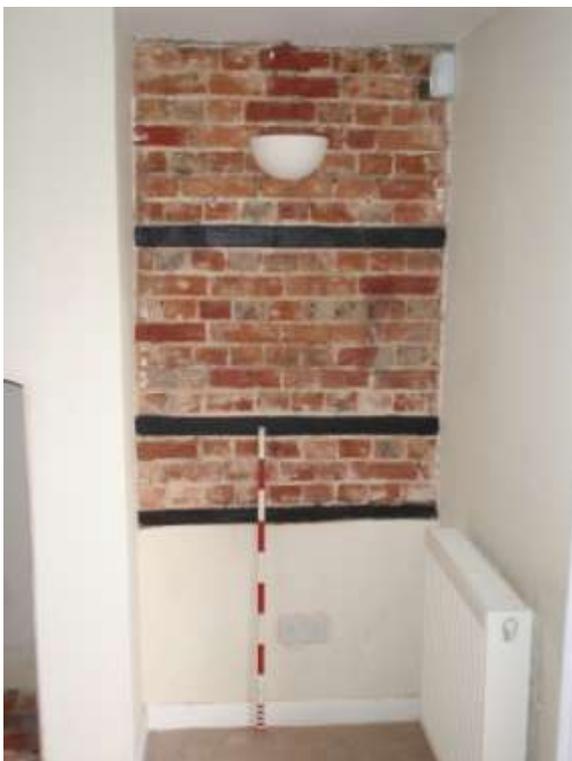
Plate 12. Detail of north wall Living Room (2)

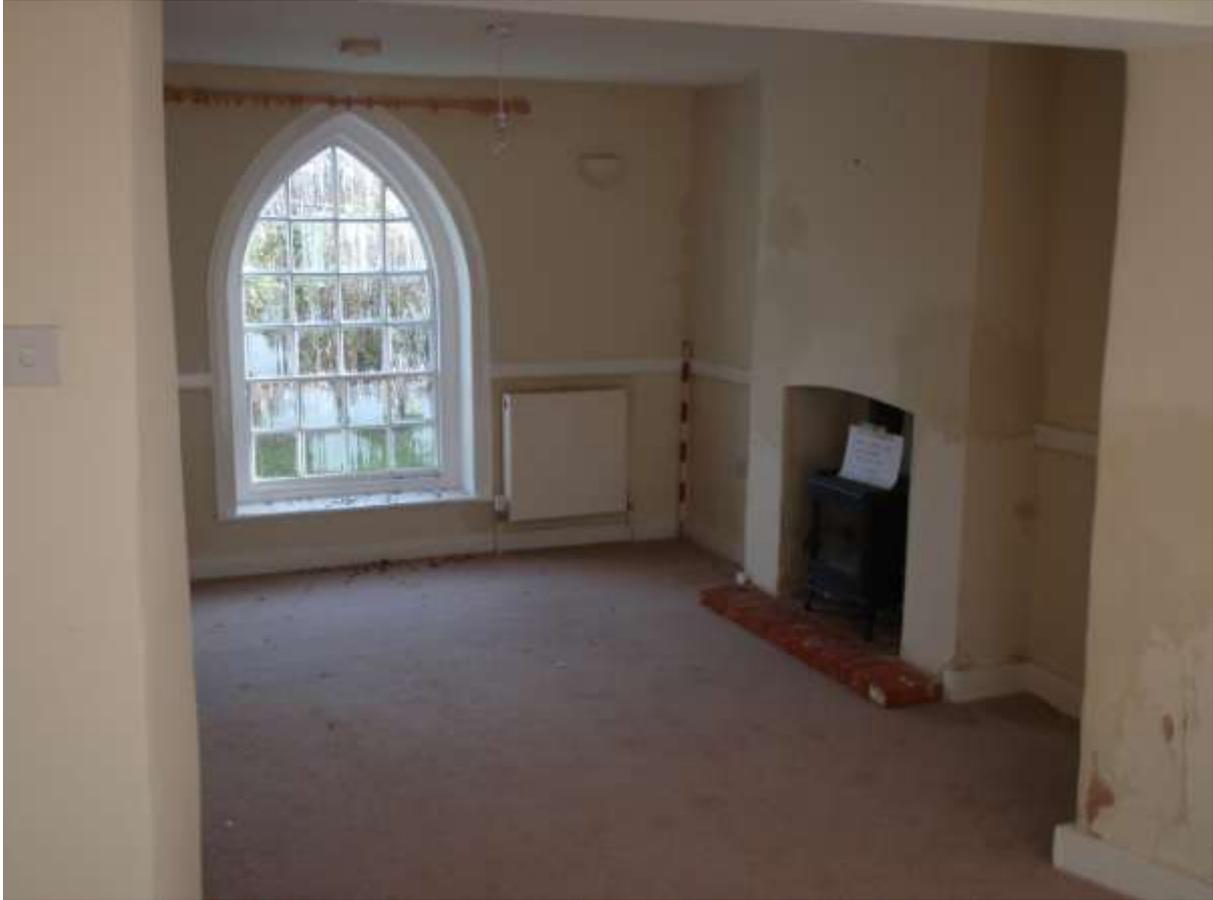
Plate 13. View of interior Dining Room (4) from Utility Room (5) and looking south-east

4.6 The Dining Room (4) measures 3.52 x 3.65m and is lit by a single Gothic window (Plate 13) and heated by a modern wood burning stove situated in the original projecting chimney breast on the south wall. The walls are plastered and painted and the ceiling lathe and plaster. The floor carpeted. In the last decade the room has been 'knocked through' to the 'Utility Room' to make a room which is 6.43 x 3.52m. The 'Utility Room' (5) is located in Phase 2 and is plastered with a lathe and plaster ceiling and has a low entrance to the cellar (Plate 0). On the south wall a pair of modern fully glazed timber double doors lead out to the garden (Plate 13).

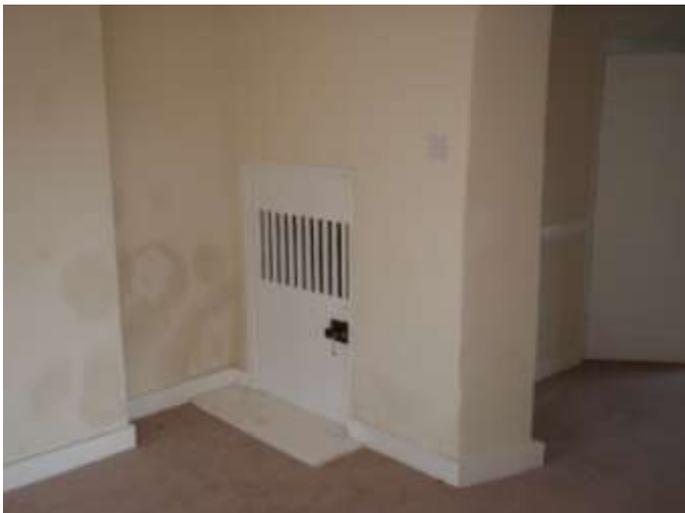
Plate 14. Detail of Utility Room (5) showing doorway to cellar

4.2 The cellar does not cover the total footprint of the building and is accessed from the 'Utility Room' and measures internally 5.21 x 3.51m. Presumably in Phase 1 the cellar would be accessed from outside the building. The cellar is drained by a continuous running electric pump as it seems there is a fresh water spring erupting in the area of the drain which is set just below the level of the modern concrete floor.

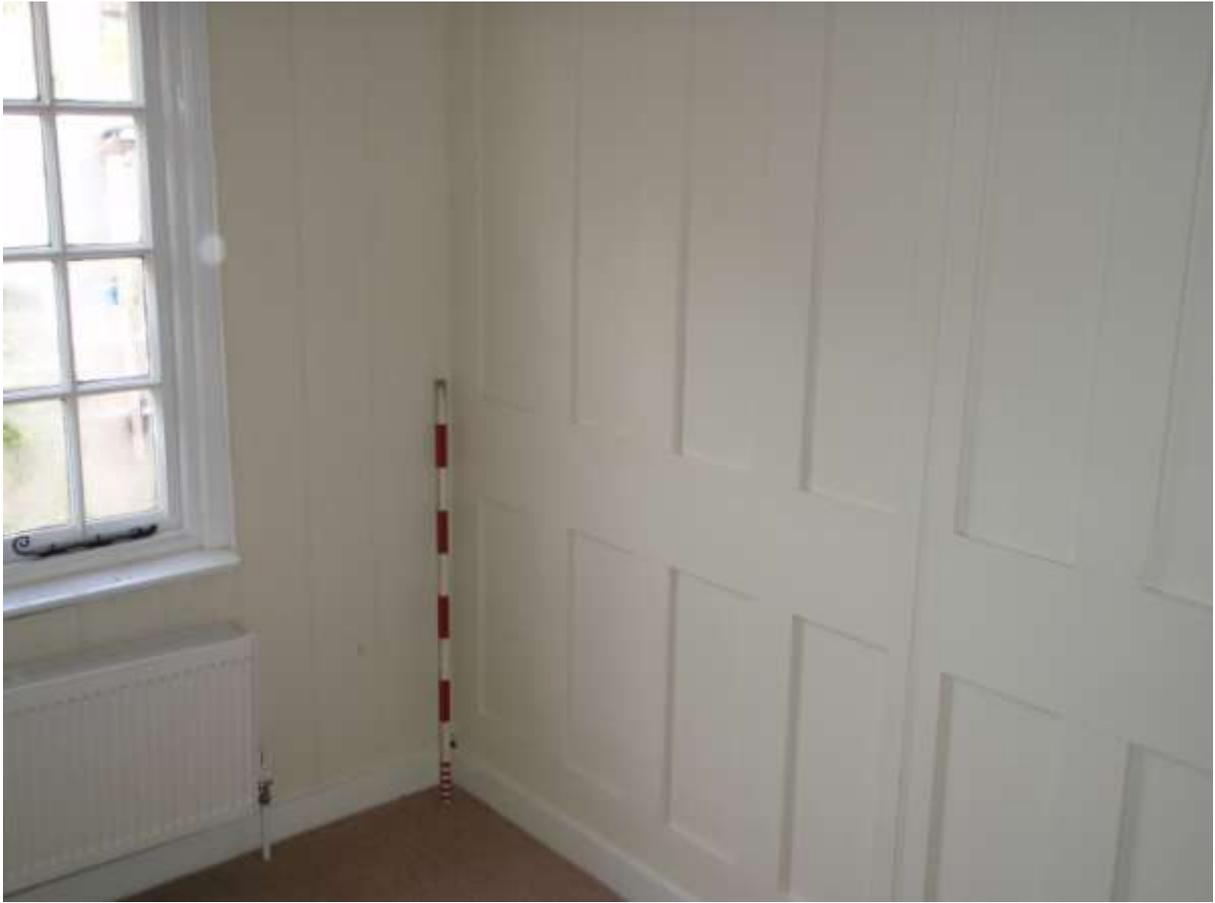
Plate 15. View of modern partition in Bedroom (8)

4.7 Upstairs the 'Landing' (6) leads into 'Bedrooms' (7) & (12), and in the Phase 2 building 'Bedrooms' (8) & (11) and modern 'Bathroom' (9) and 'WC' (10) and Plates 15, 16, 17, 18).The attic was not accessible and no details of roof construction were available.

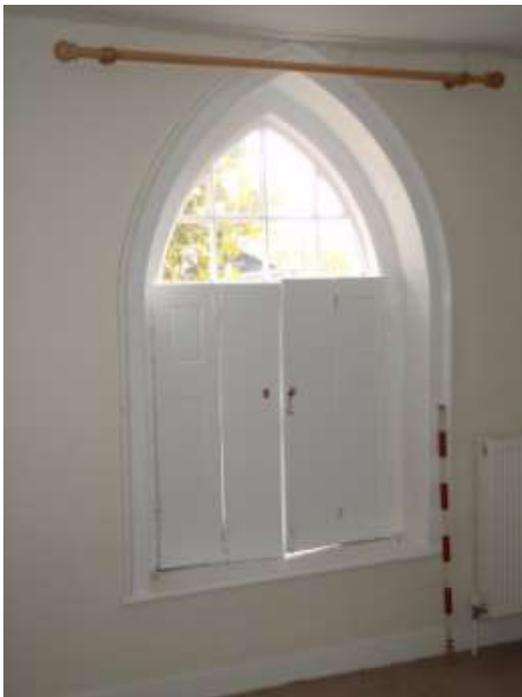
Plate 16. View of window and shutters in Bedroom (7)

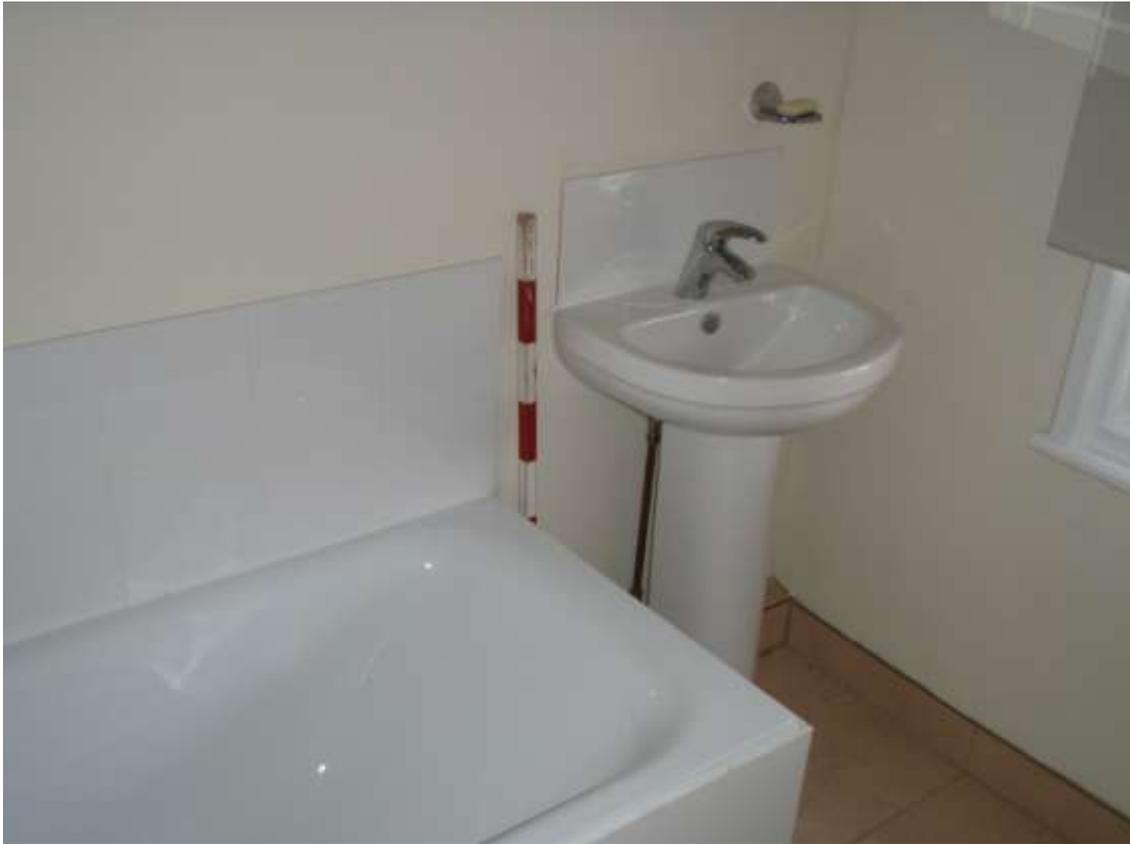
Plate 17. View of Bathroom (9)

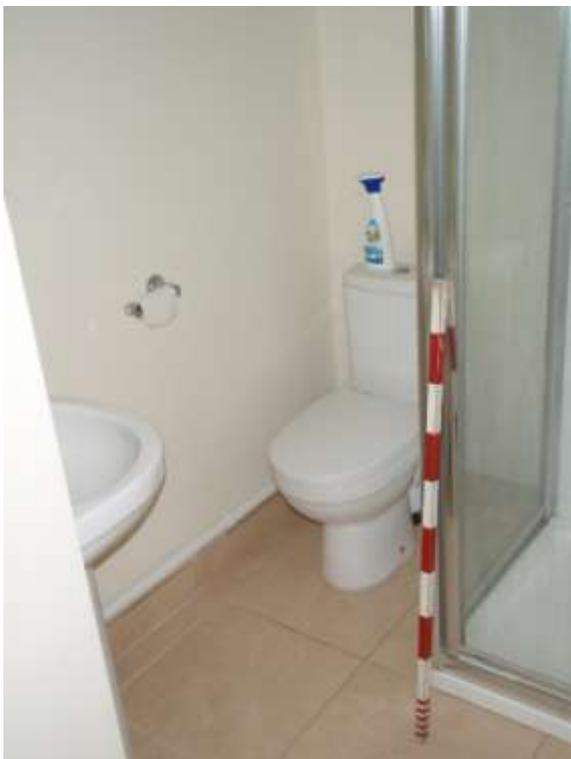
Plate 18. View of WC (10)

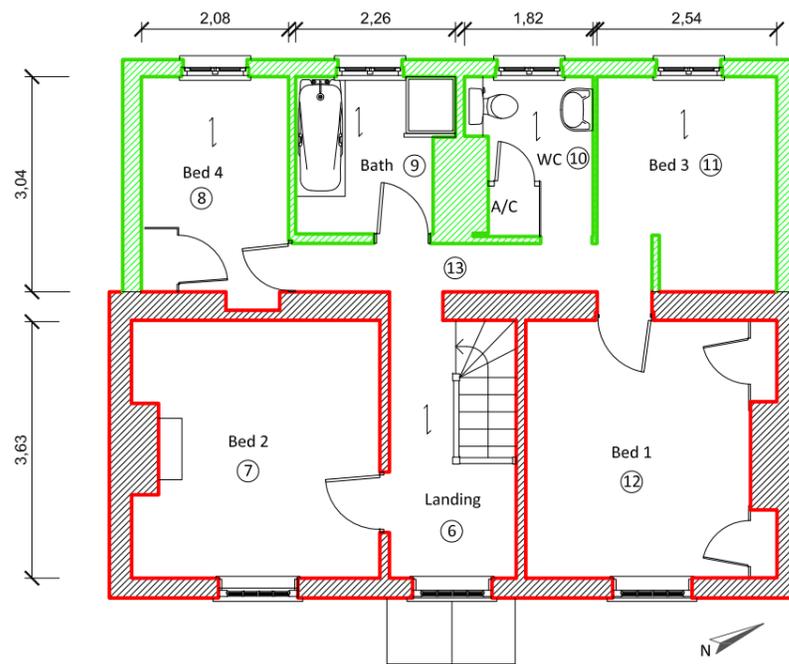
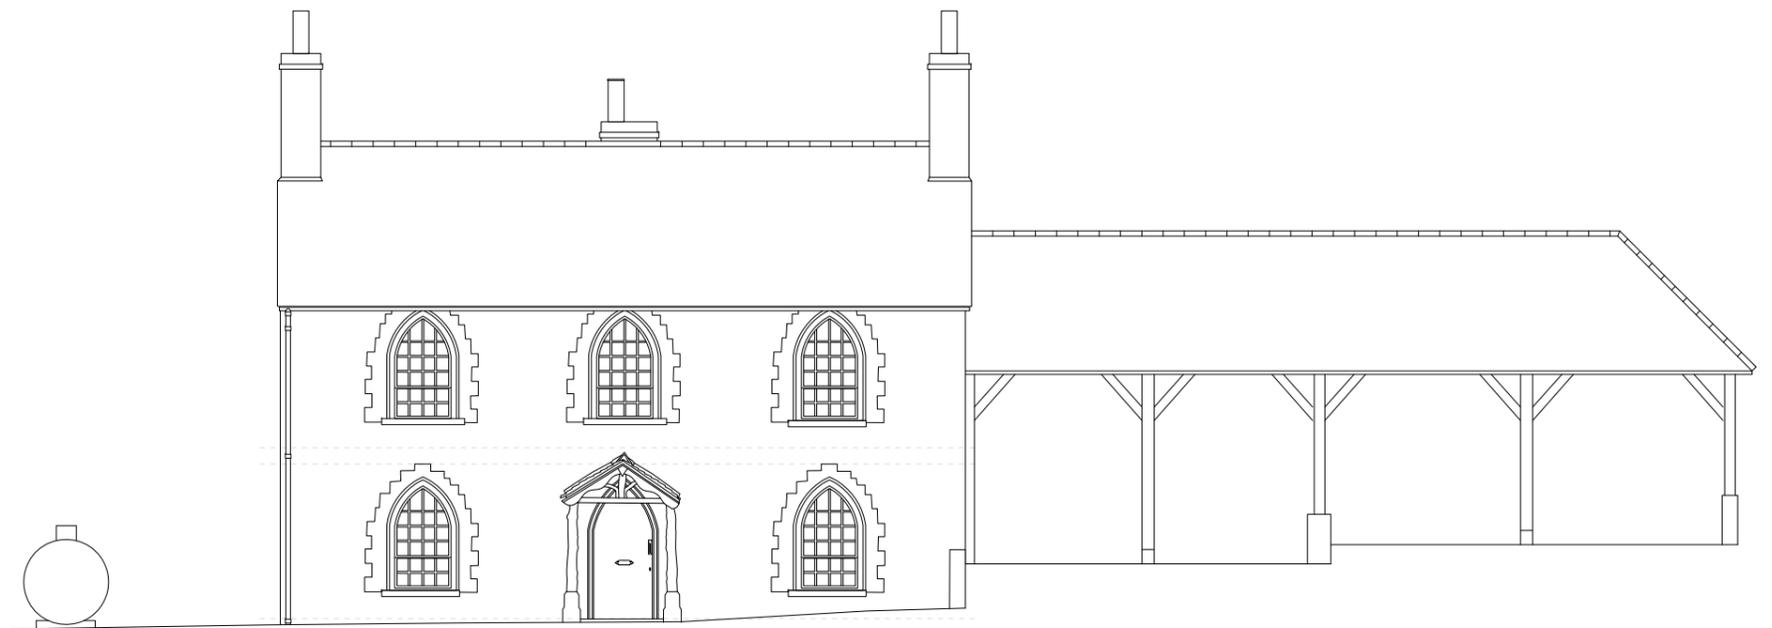
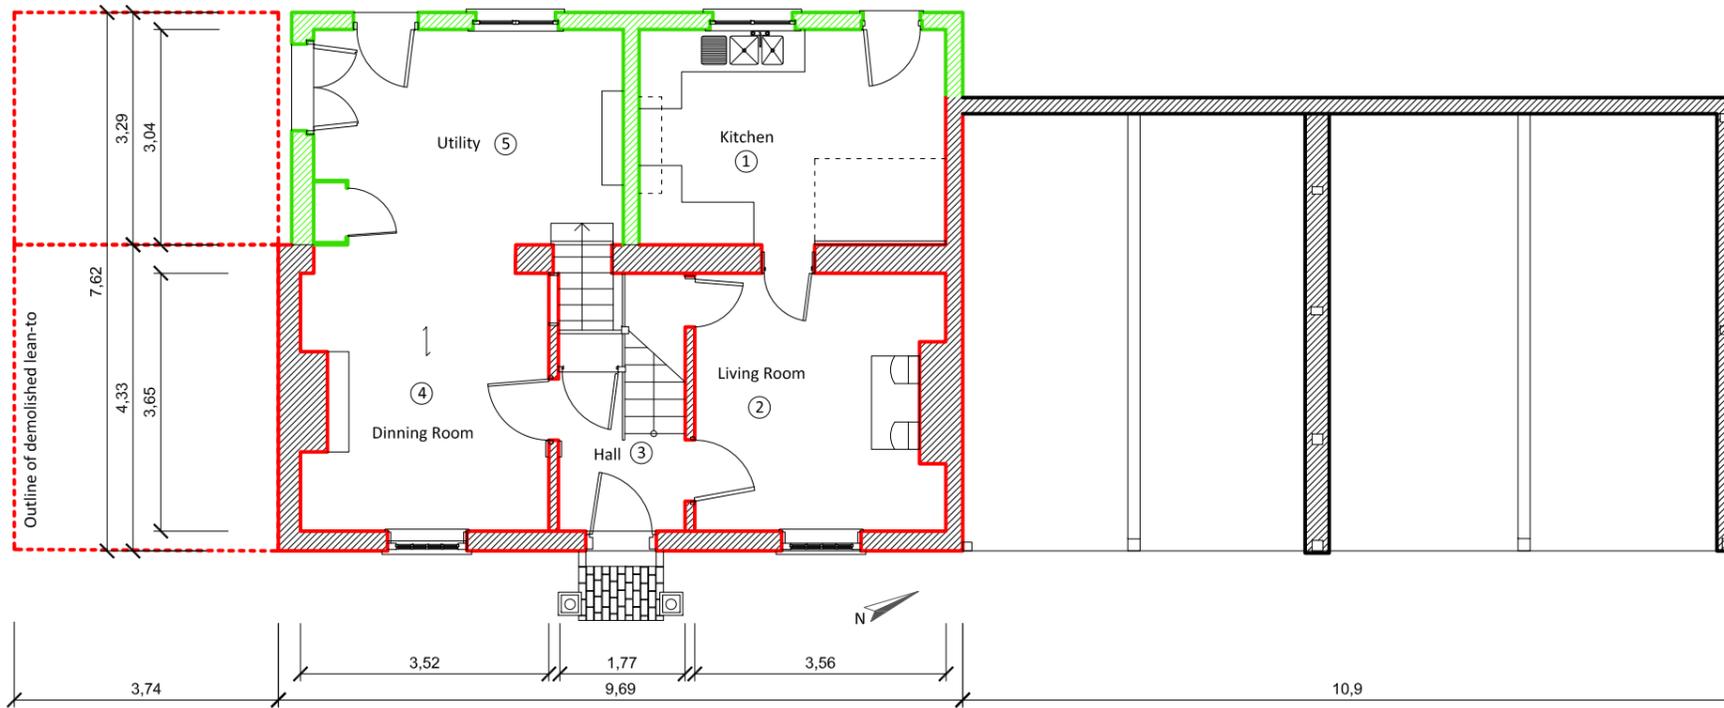
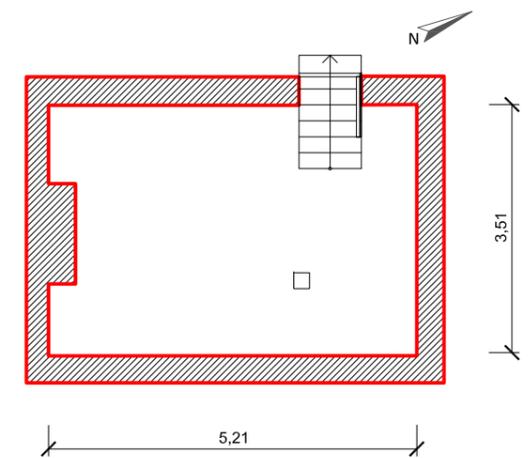
Figure 1: Existing floor plans of the Goodlands Cottage with two phases outlined in red (circa 1754) and green (circa 1850).

The building is a four room double pile small farmhouse entered in the centre from the east, where rises a central staircase giving access to the upper rooms

3.2 The building represents two principal phases of construction. Phase 1 of 18th century date is represented by the eastern half of the house. Until recently the barn to the north formed part of Phase 1. However this is entirely

re-built after a fire in 2012. Phase 2 of circa 1900 represents the western half of the house and possible subdivision into two cottages.

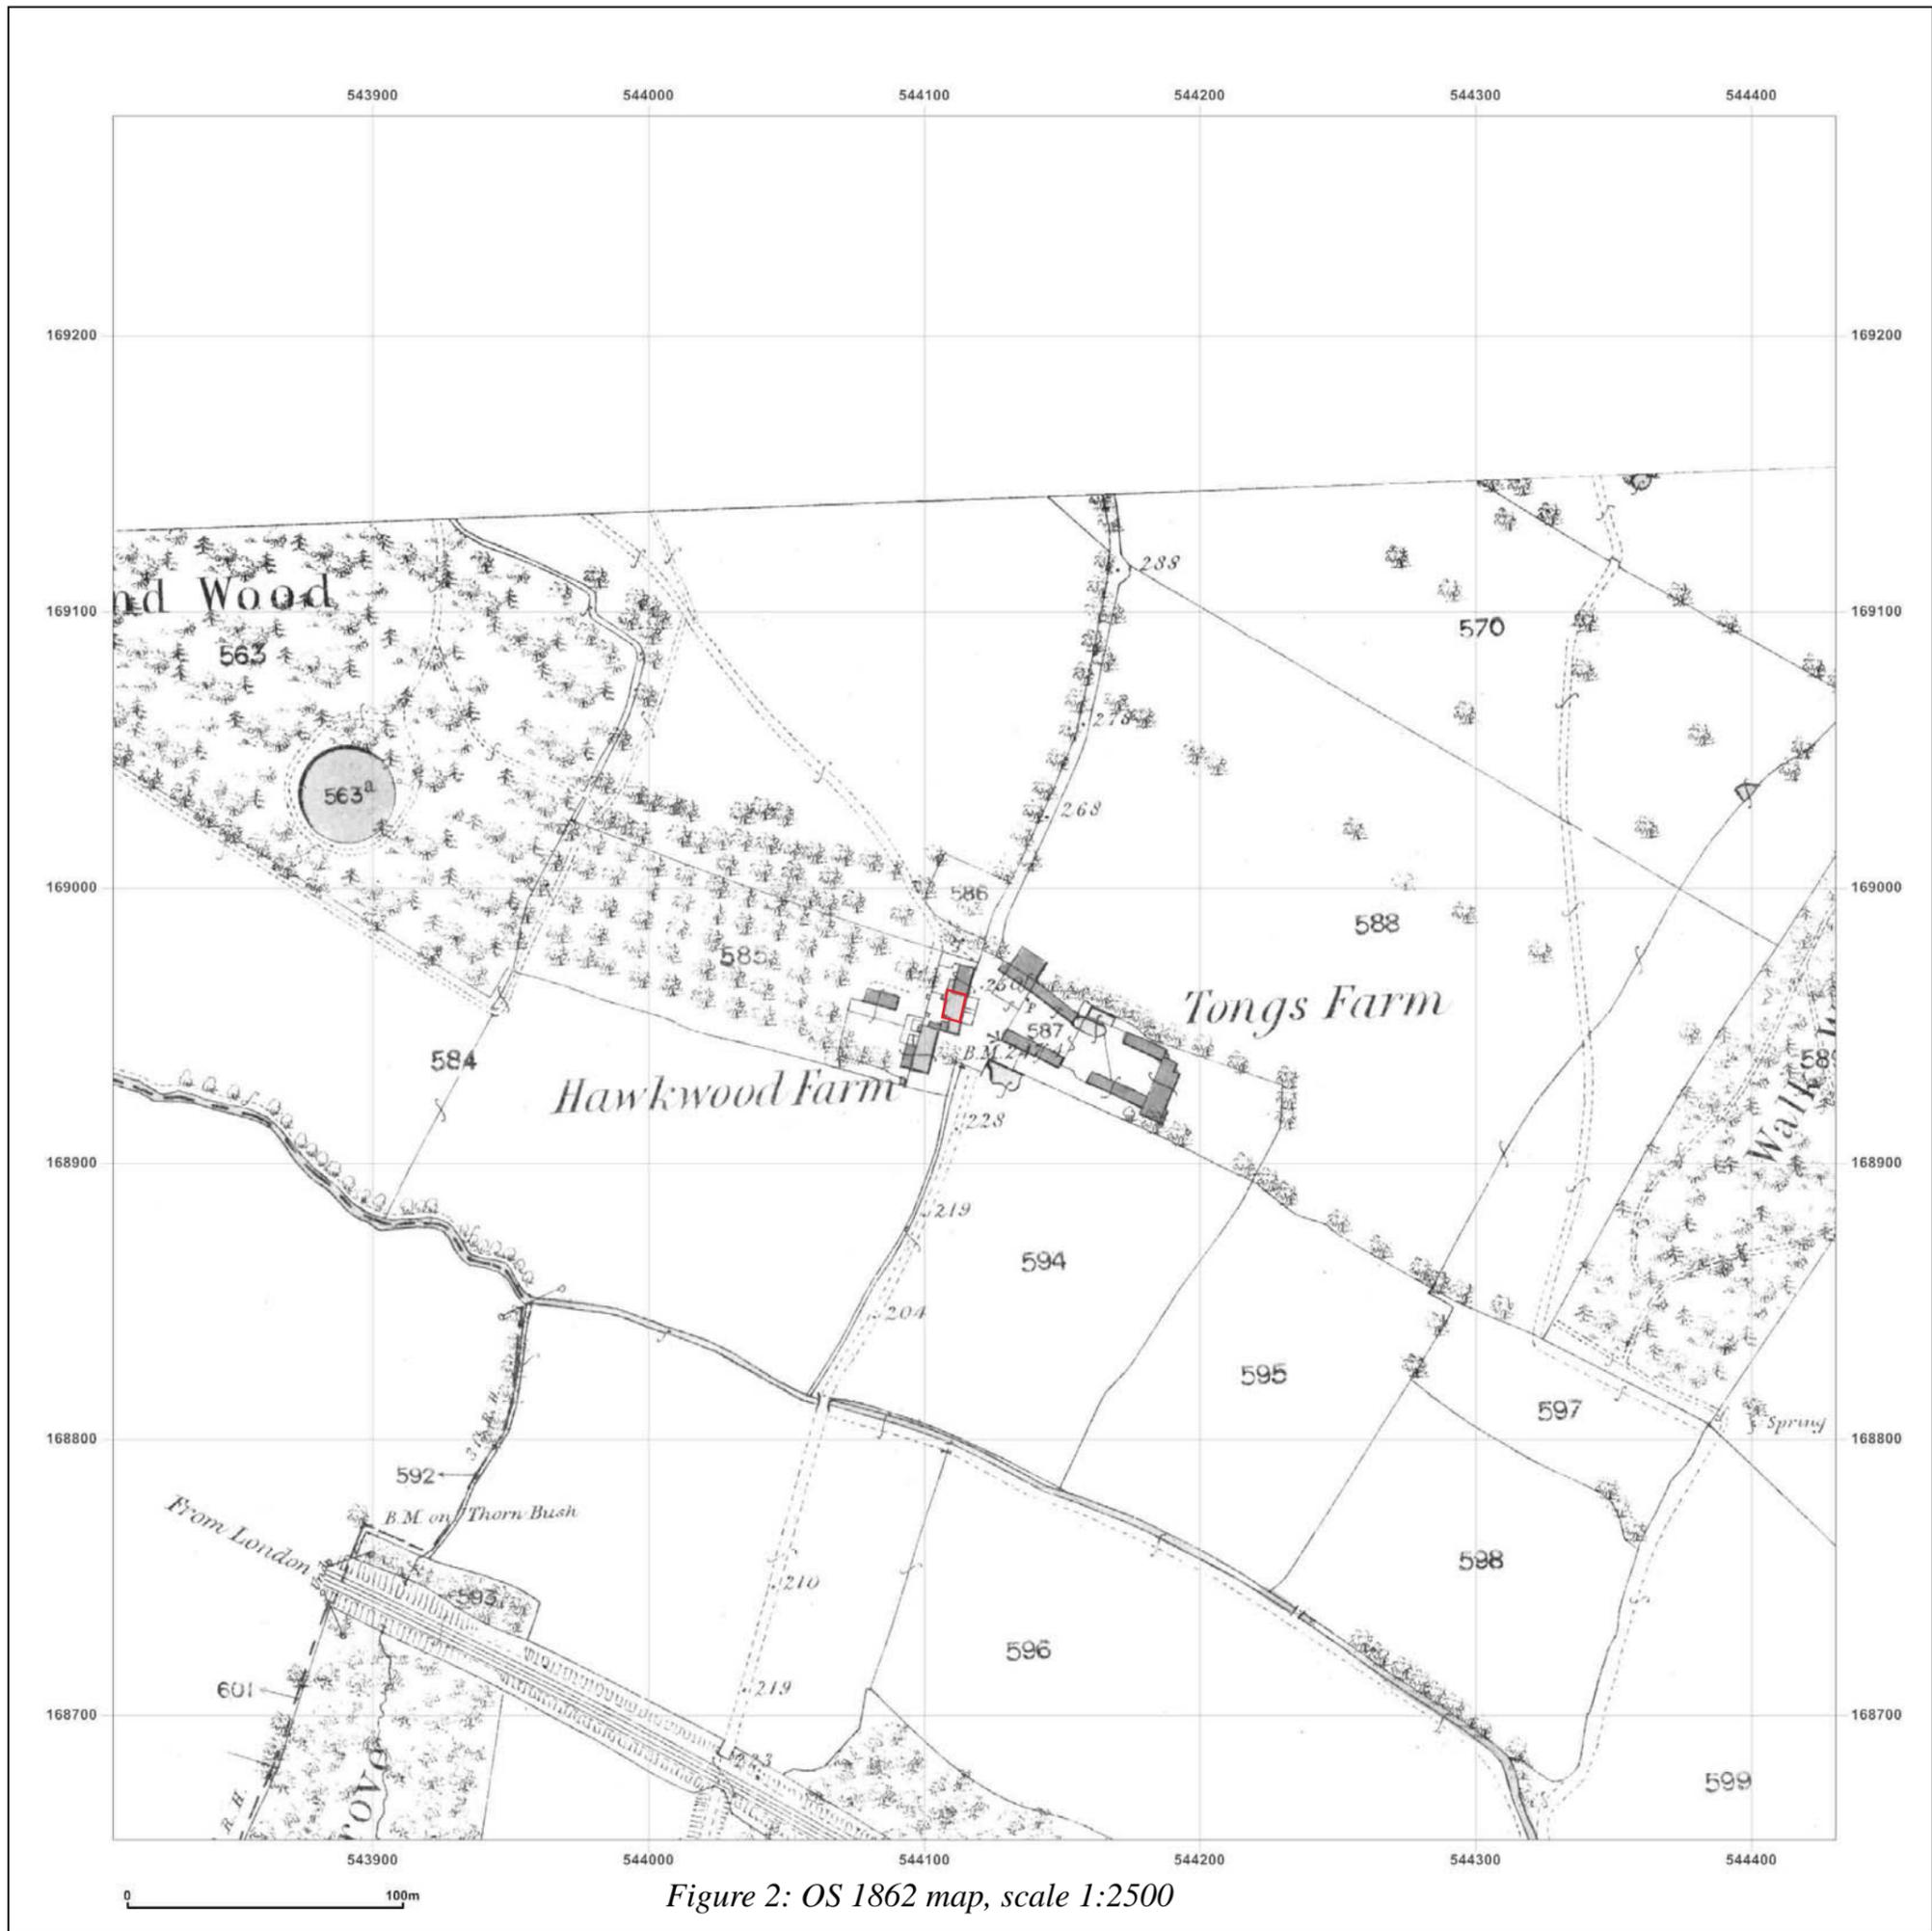
Figure 2: OS 1862 map, scale 1:2500

A rapid map assessment of OS Historic Mapping and Aerial Photographs (Figures 0-00 Plates 1a-5a) show that in 1862 the cottages location was in a farm complex known as 'Hawkwood Farm' with buildings to the south, east and west (front cover and Figure 2).
