1.1 In November 2014 Dr Paul Wilkinson of SWAT Archaeology carried out a historic building recording of Goodlands Cottage, Hawkwood Estate, Chislehurst, Kent (Figure 1). The building is presently unoccupied and is undergoing restoration and repair.

PROJECT: GOODLANDS COTTAGE		SWAT ARCHAEOLOGY	
DRAWING TITLE: Plans (ground floor, first floor, cellar) and Front Elevation			
SIZE AND SCALE: 1:100@A3	DATE: 11/11/2016	DRAWN BY: BARTOSZ CICHY	
DRAWING NUMBER: 1-4	SITE CODE: GC-BR16	REF. FILE: Drawing1.DWG

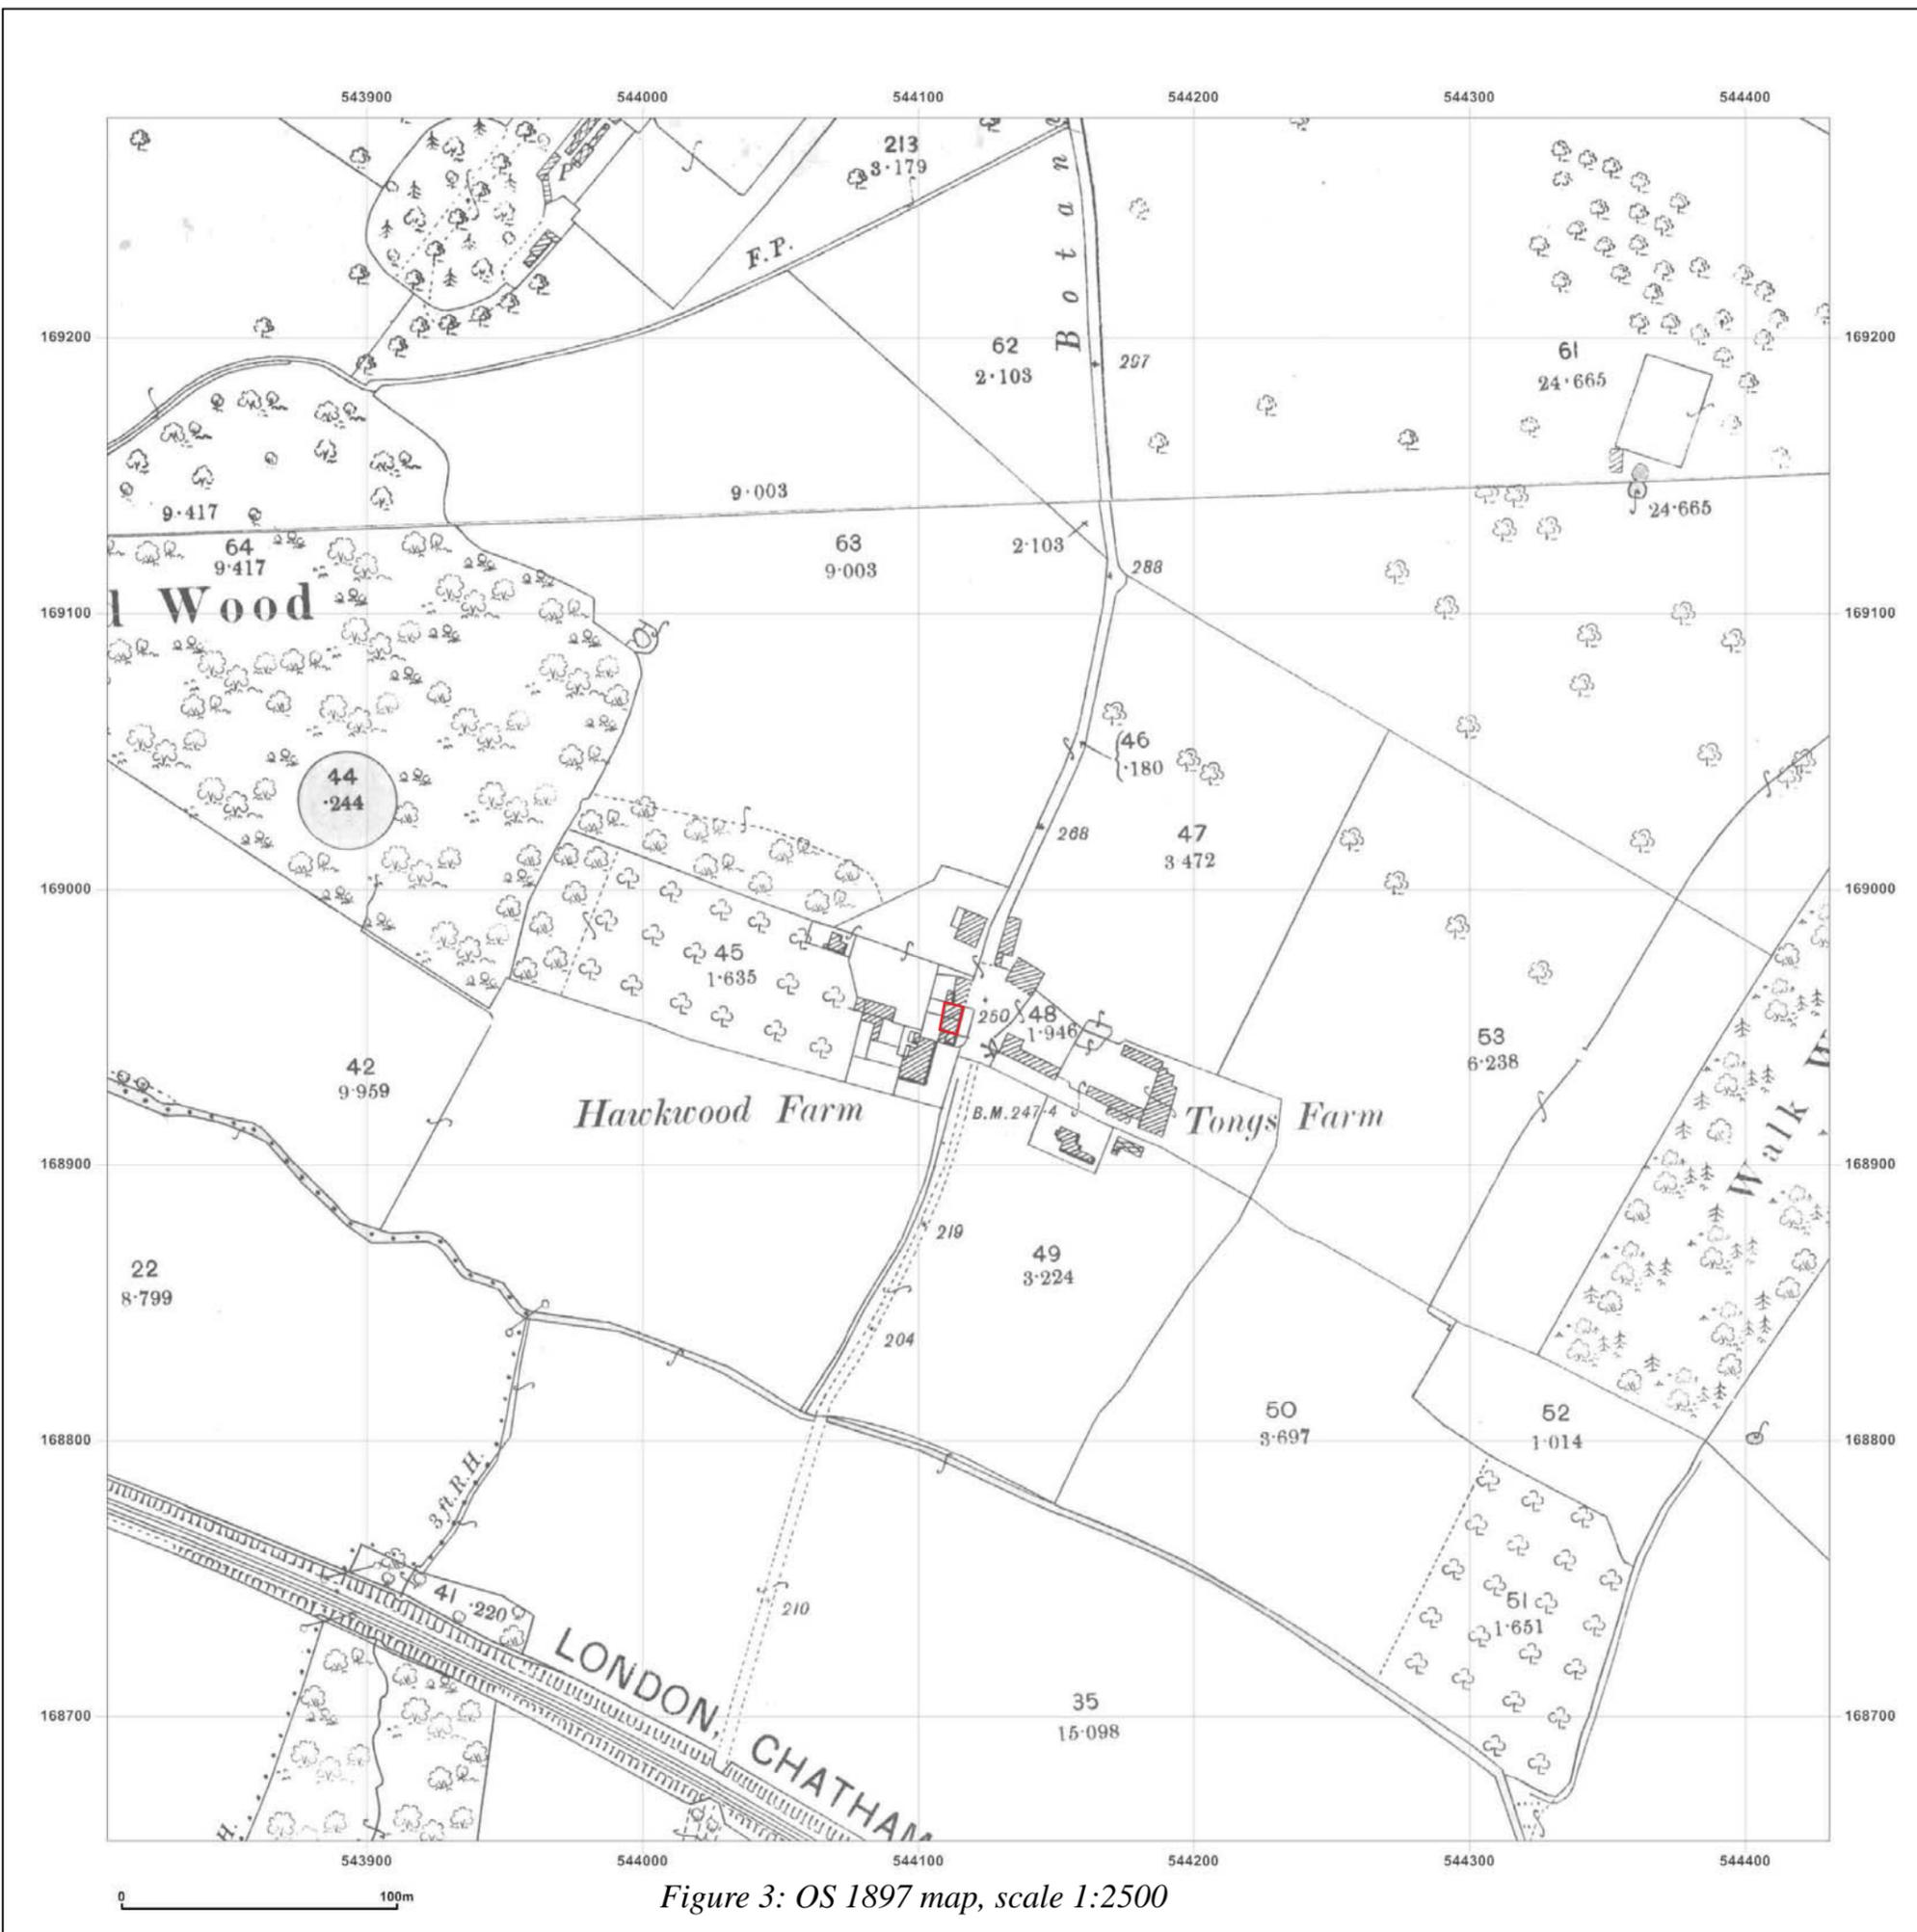
Figure 3: OS 1897 map, scale 1:2500

By 1897 additional buildings had been added to the group and the buildings to the east hived off into 'Tongs Farm'. The cottage itself had an open bay barn attached upslope and to the north-east facing wall whilst to the south-west facing wall a sloped roof lean-to building which is not apparent now.

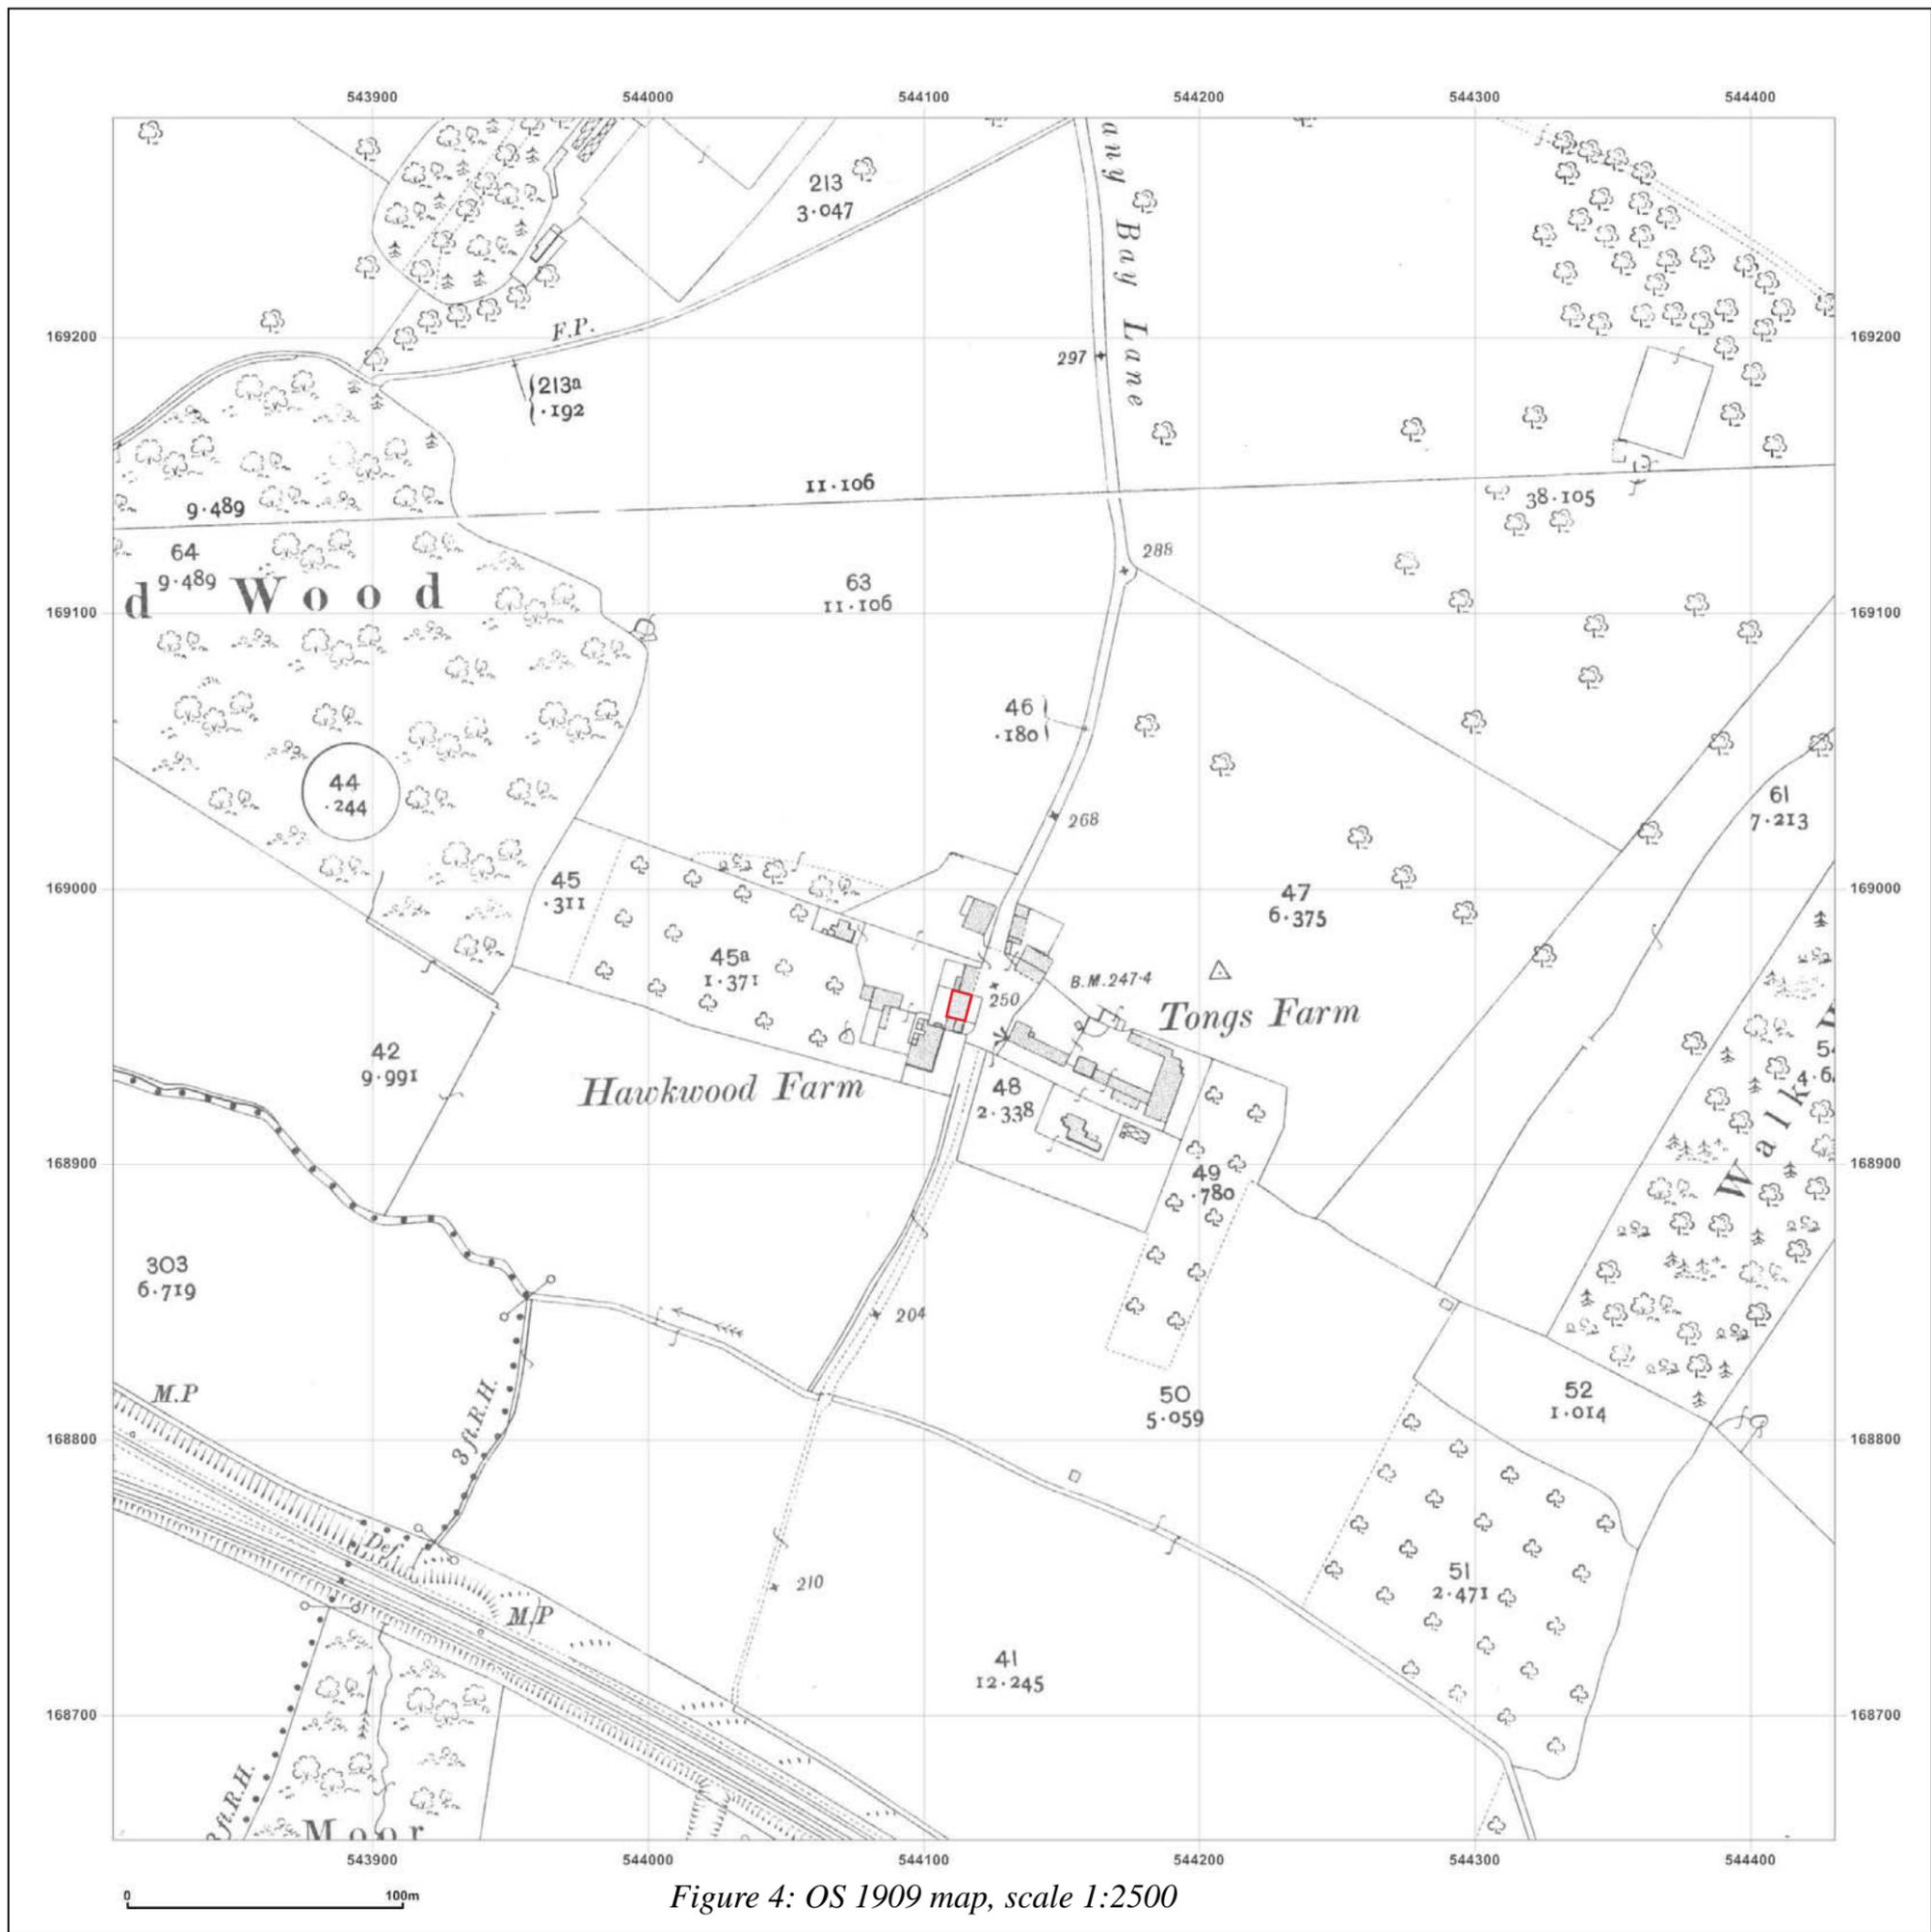
Figure 4: OS 1909 map, scale 1:2500

The OS map of 1909 (Figure 4) shows more or less the same plan but by 1931-33 the lean-to structure attached to the south facing wall of the cottage has been demolished (Figure 5).

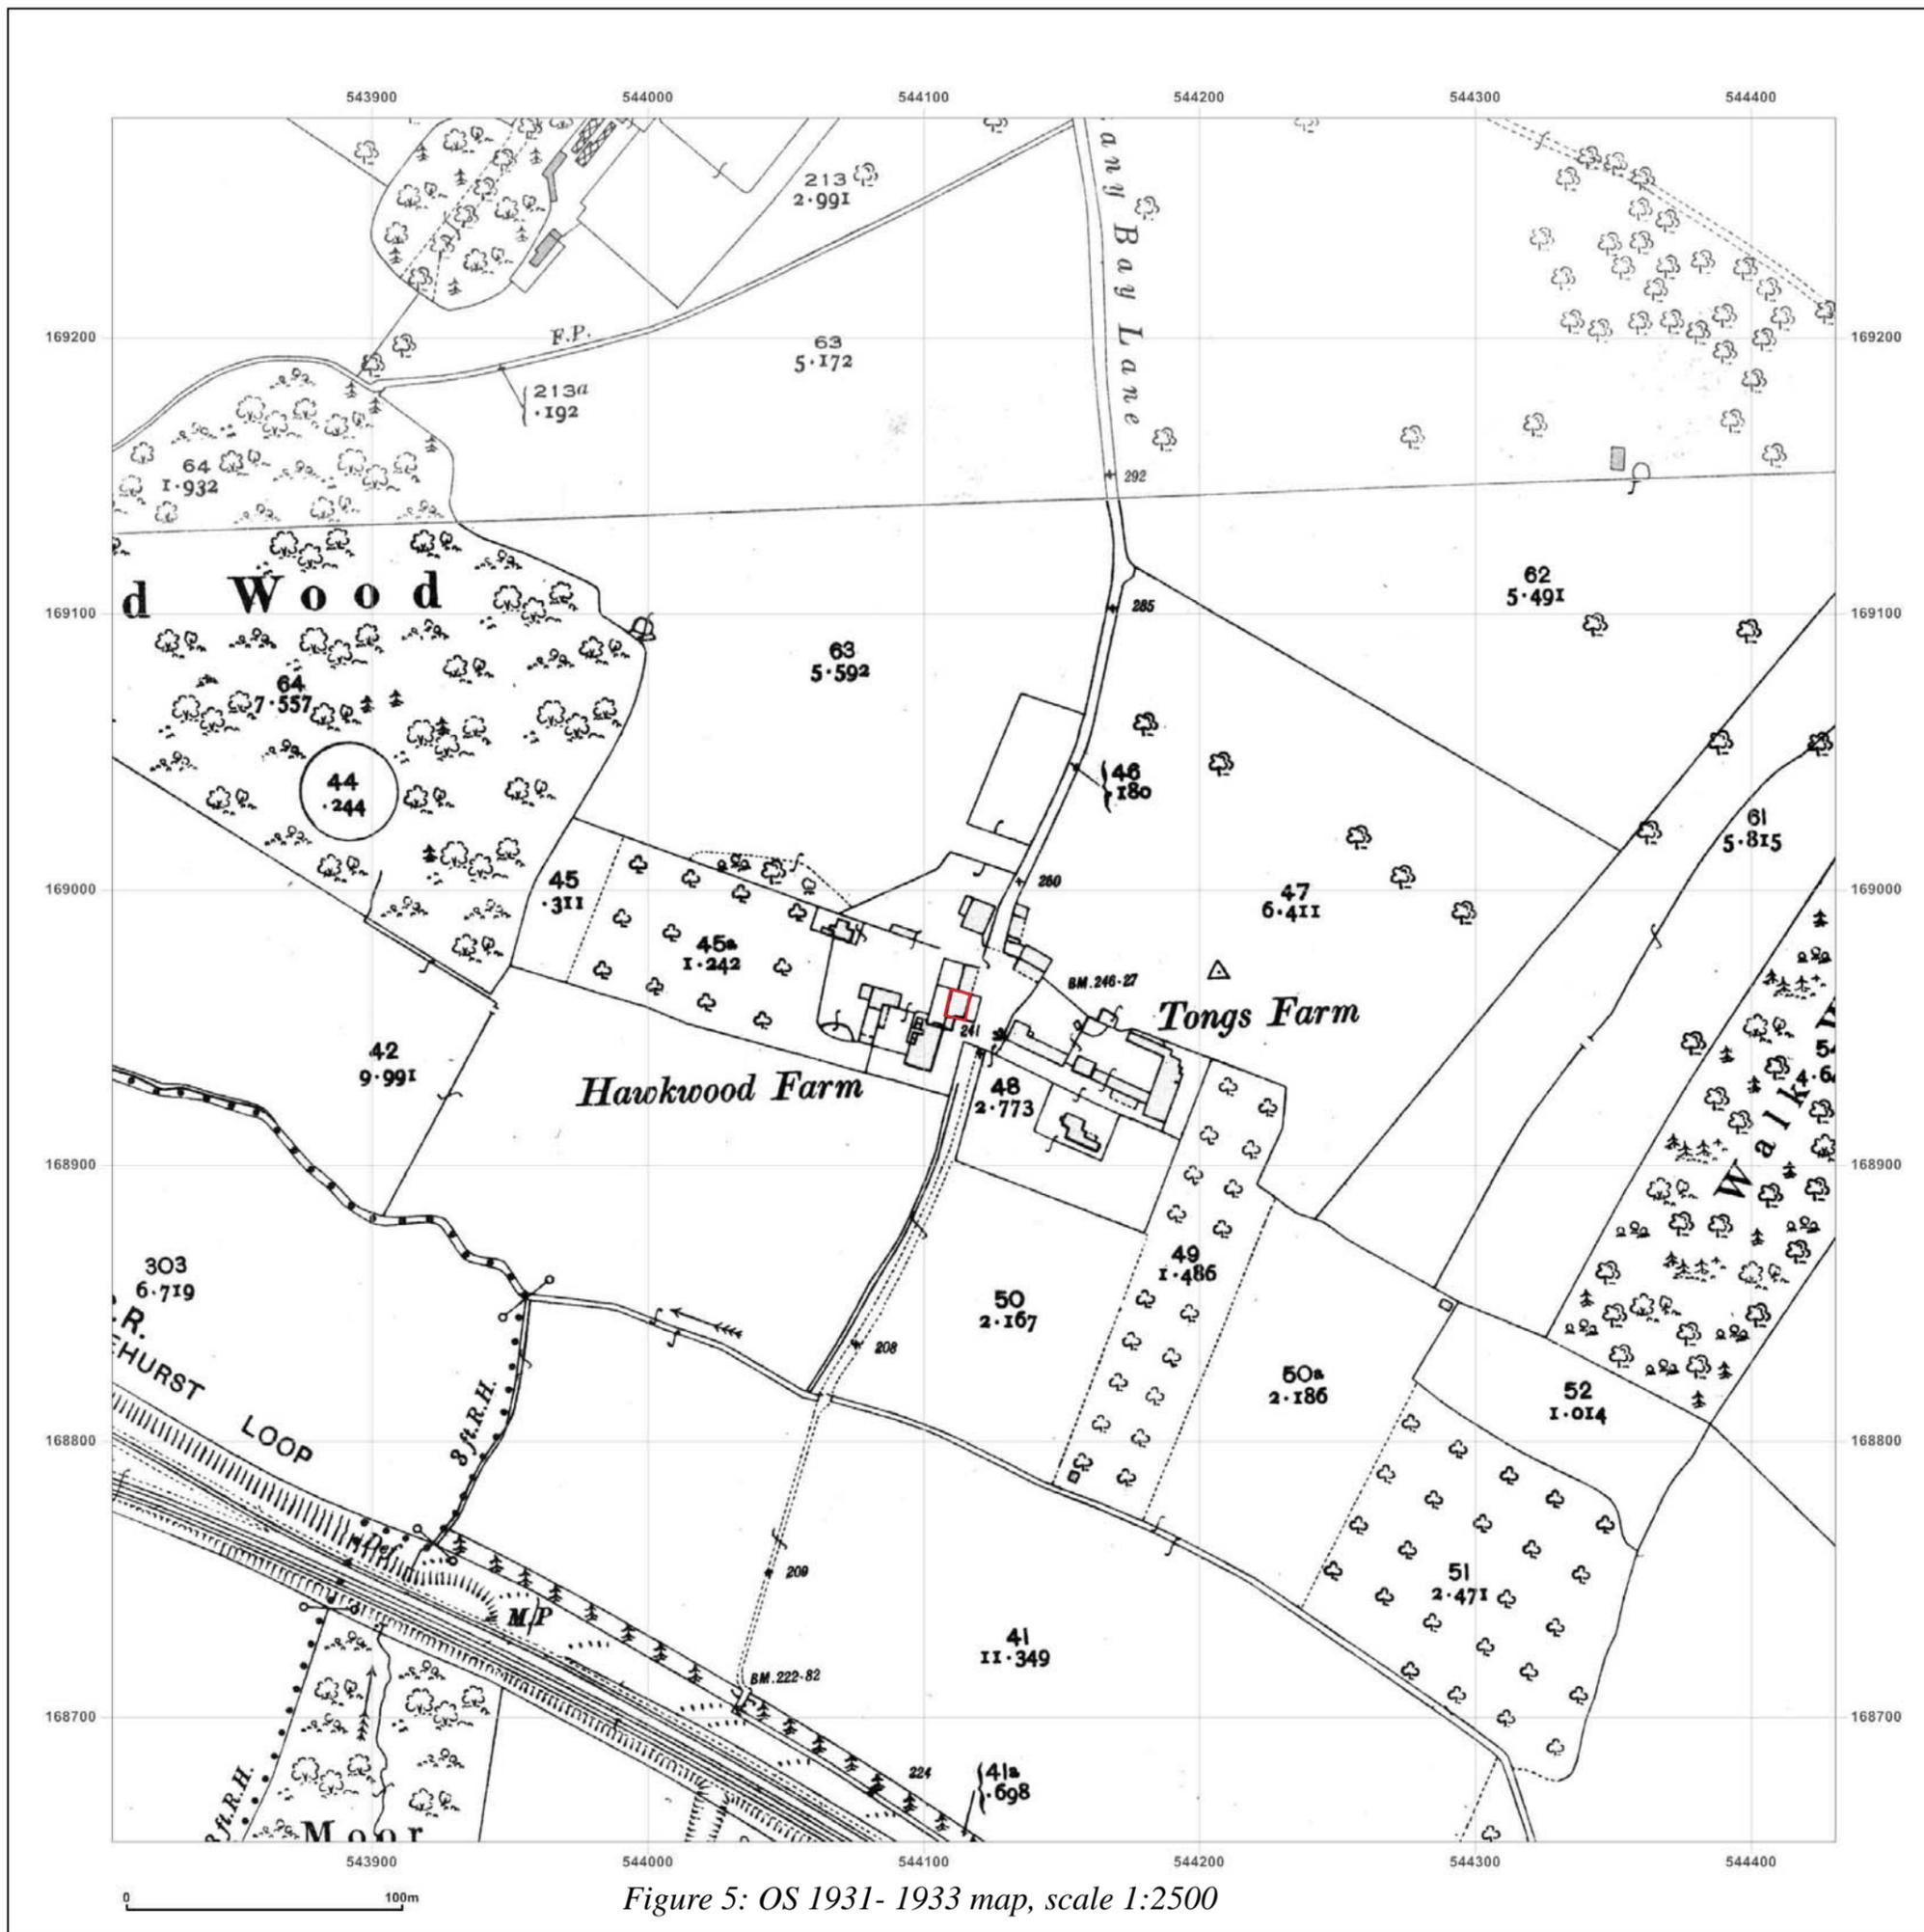
Figure 5: OS 1931-1933 map, scale 1:2500
