# Cultural Heritage Impact Assessment for 2 Leslie Drive, Faversham, Kent

Report for  
Edgington Architectural Services

15<sup>th</sup> November 2016

## **Cultural Heritage Impact Assessment for 2 Leslie Smith Drive, Faversham, Kent**

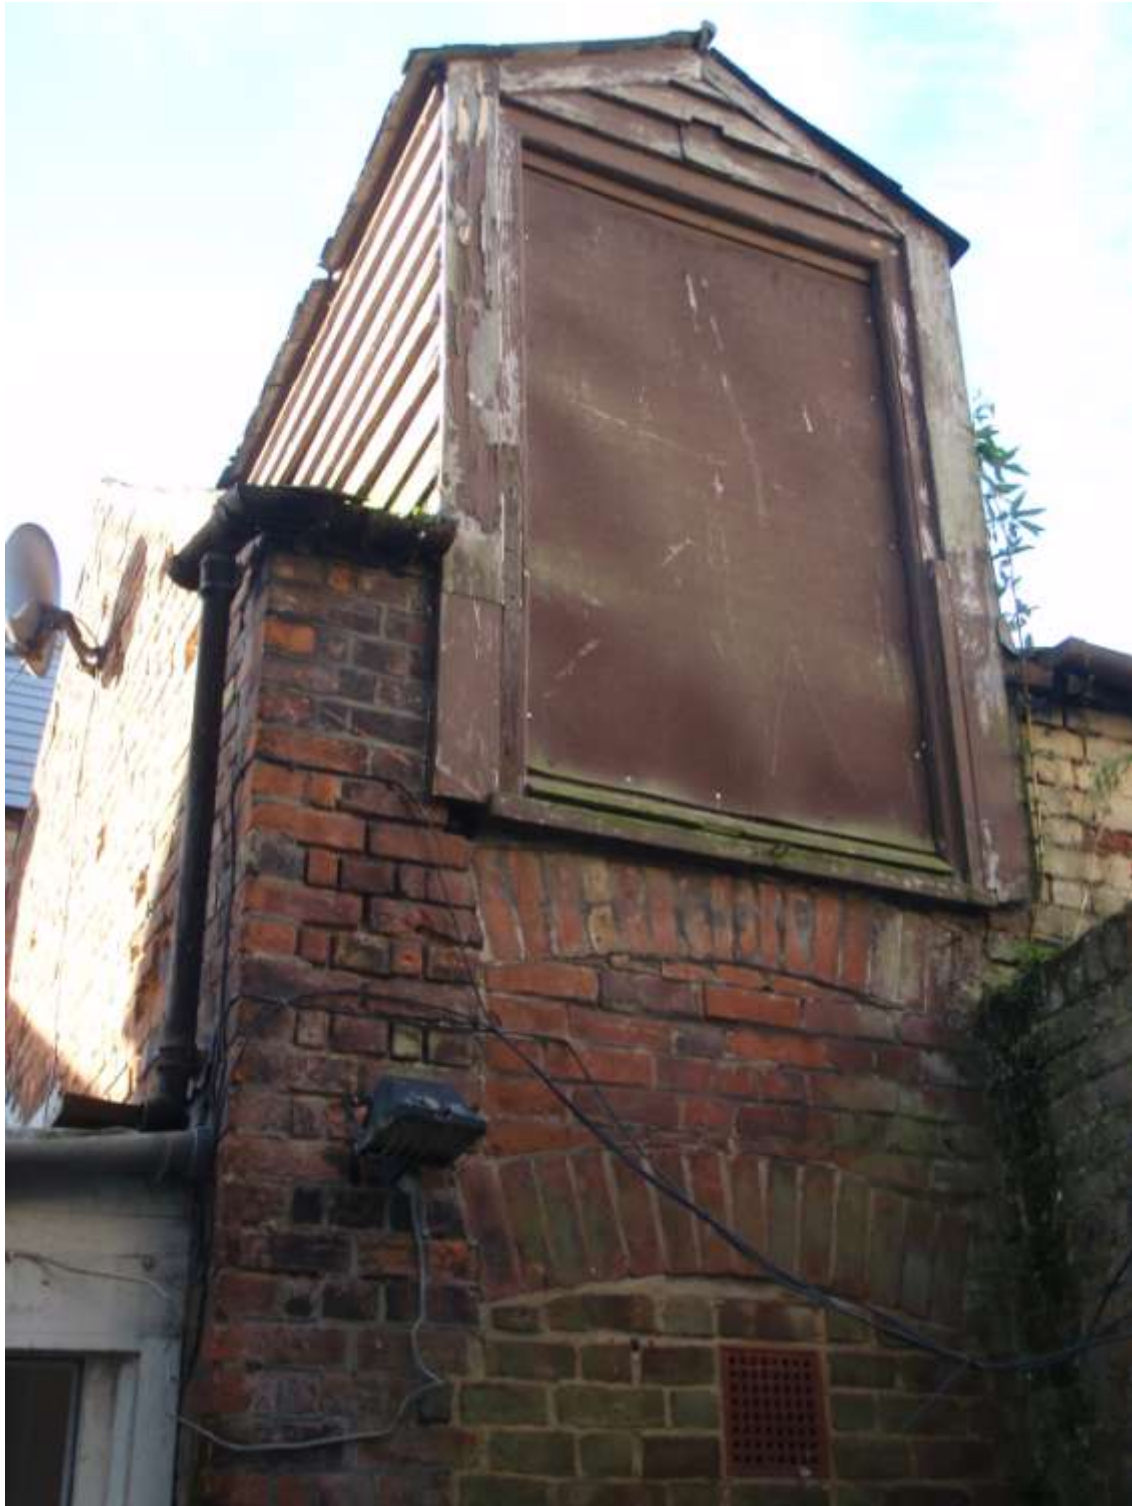
**Plate 1.** View of north east corner and showing part of the original fabric of mixed orange to dark red brick laid in a type of English bond with buff penny-struck lime mortar. Two segmental arched windows both blocked with later brickwork and above a gabled dormer loading bay of timber construction with feathered edged boarding on the timber stud wall cheeks. To the right can be seen the yellow stock bricks of a later reconstruction.

Phase 1. C.1868: Two conjoining buildings of two floors built of brick with a sloped roof and 1<sup>st</sup> floor dormer loading bay (Plate 1).

8.1 Very little of the original building has survived. In essence it is the red brick north east corner with its dilapidated first floor timber dormer loading bay (Plate 1) and the east gable wall.

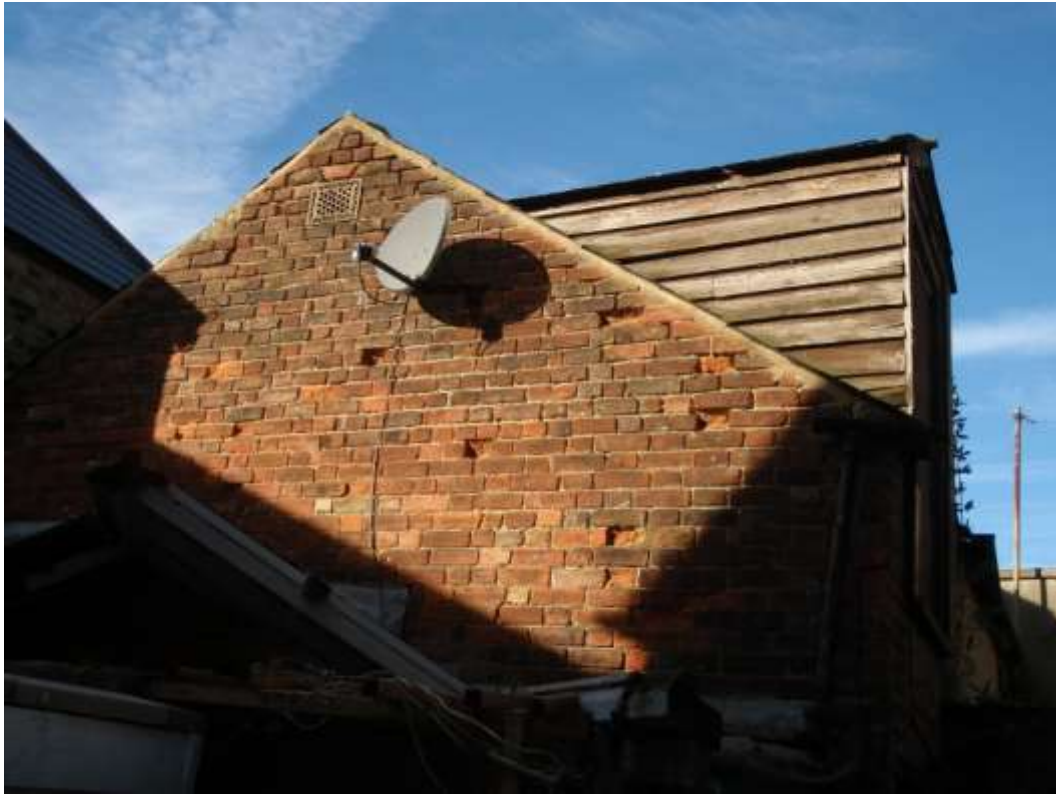
**Plate 2.** View of east gable showing part of the original fabric of mixed orange to dark red brick laid in a type of English bond with buff penny-struck lime mortar and the cheek face of the timber dormer.

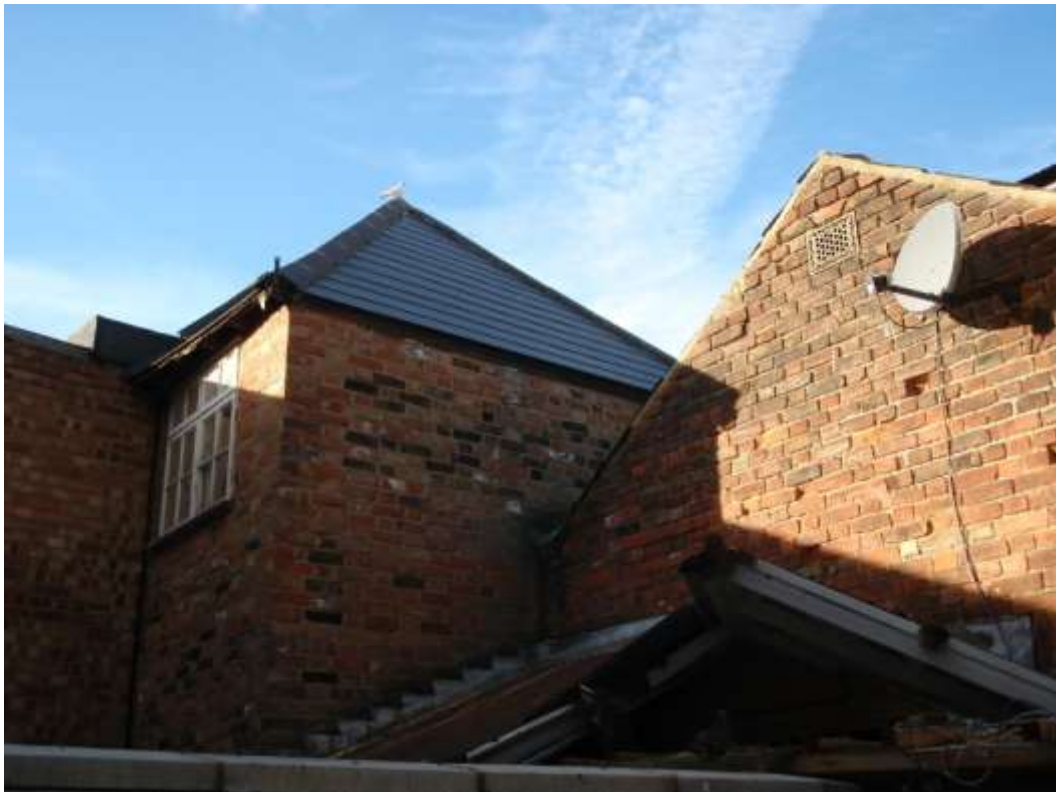
**Plate 3.** View of east gable showing the new build adjoining building.

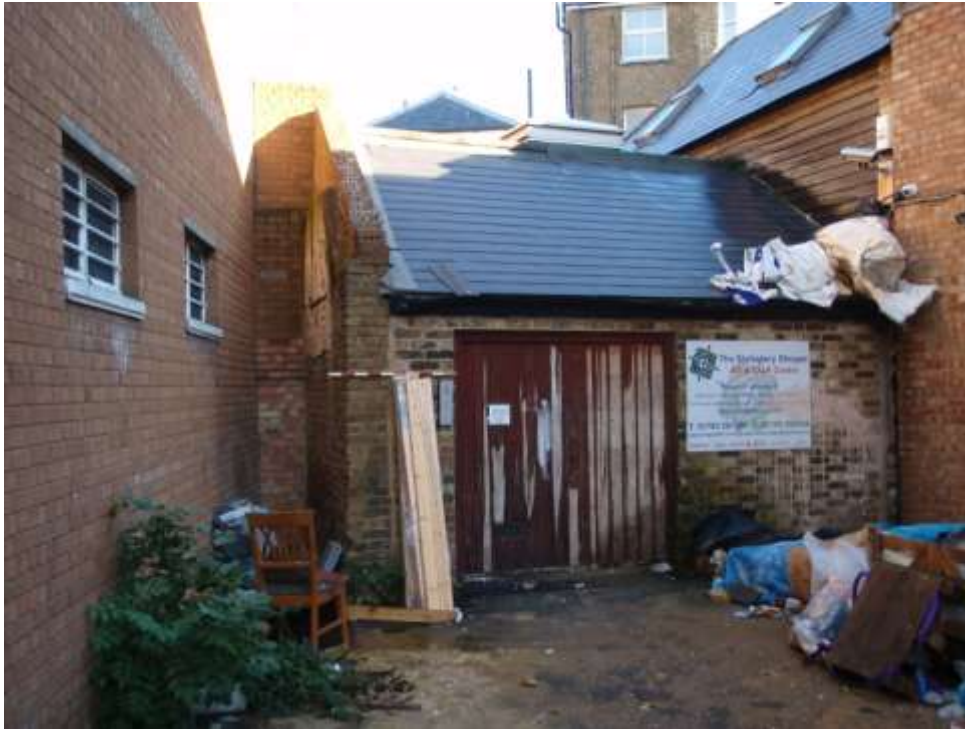
**Plate 4.** View of south entrance to the building from Leslie Smith Drive showing on the left an earlier phase of construction in yellow stock bricks with a modern rebuilt south wall in reused bricks butting to the yellow stocks. Sloping roof laid with modern slate tiles to a modern flat roof pierced by modern plastic square fanlights.

Phase 2. C. 1960: rebuild of the west wall and part of the north wall in yellow stock bricks (Plate 4).

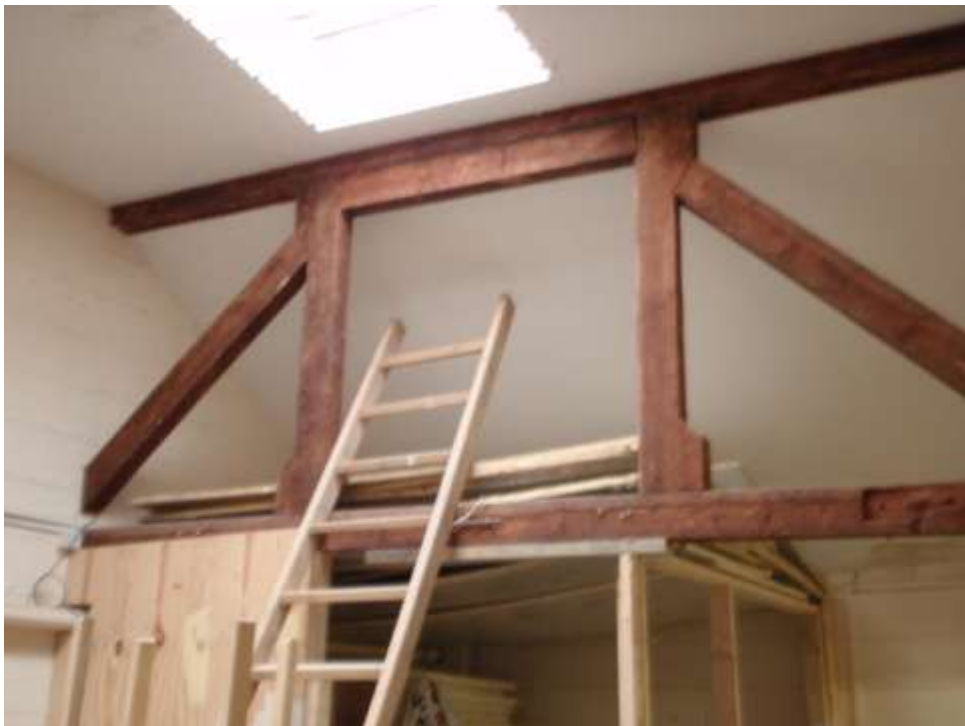
**Plate 5.** View of interior of south building showing reused radial machine cut Queen Post roof truss and purlins topped by a reused radial machine cut timber joist to facilitate construction of the modern flat roof. The west wall (left) is of modern concrete block construction as is the wall to the north.

8.2 In addition the reused Queen posts (Plate 5) have no heritage significance and are reused timbers which may or may not be from the original build of 1868.

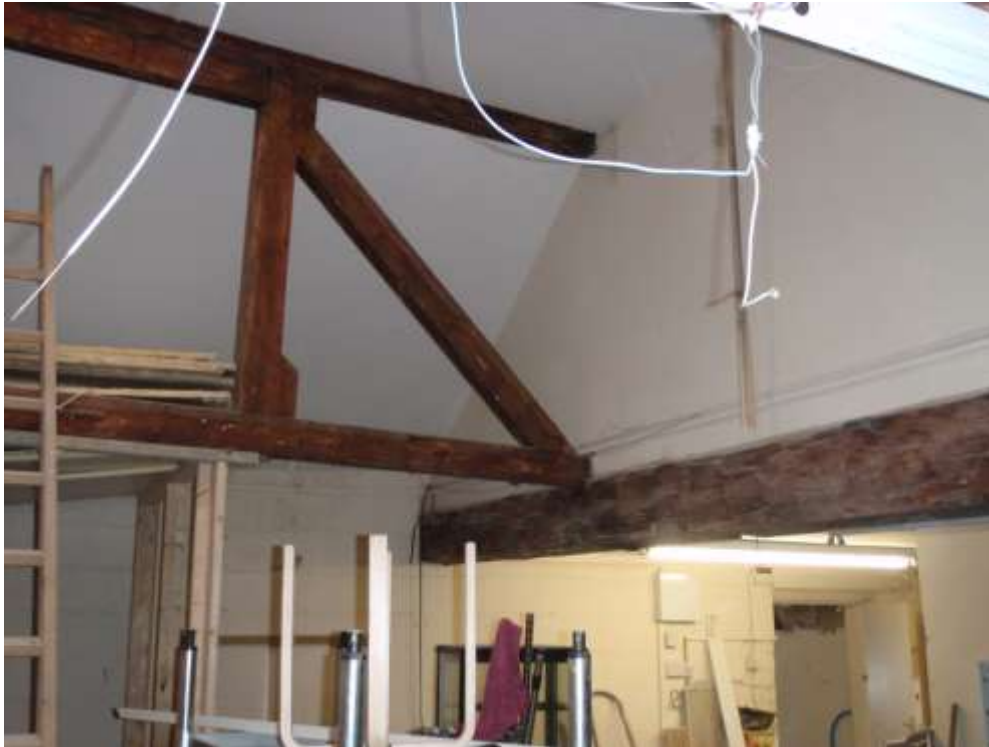
**Plate 6.** View of interior of south building looking to the east and showing the reused Queen post truss sitting on an reused earlier adzed timber floor beam with modern construction above it.

Phase 3. C.2000: rebuild of the south, east walls with new flat roof (Plate 6).

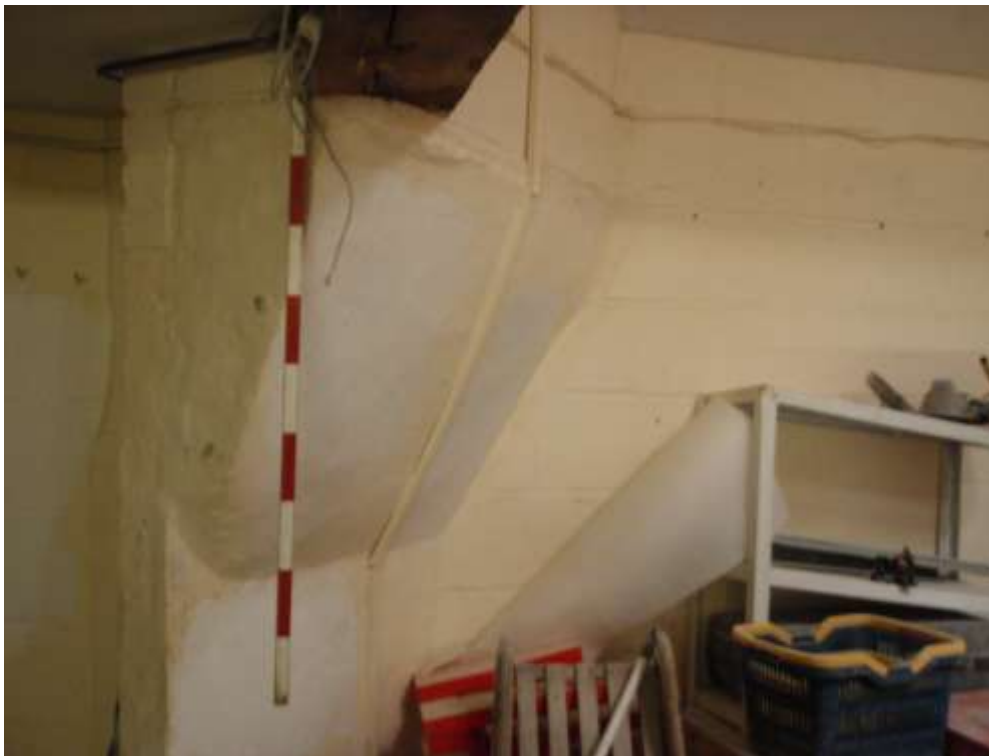
**Plate 7.** View of odd arrangement of cantilevered blockwork to hold up the reused floor beam presumably because the beam was too short.

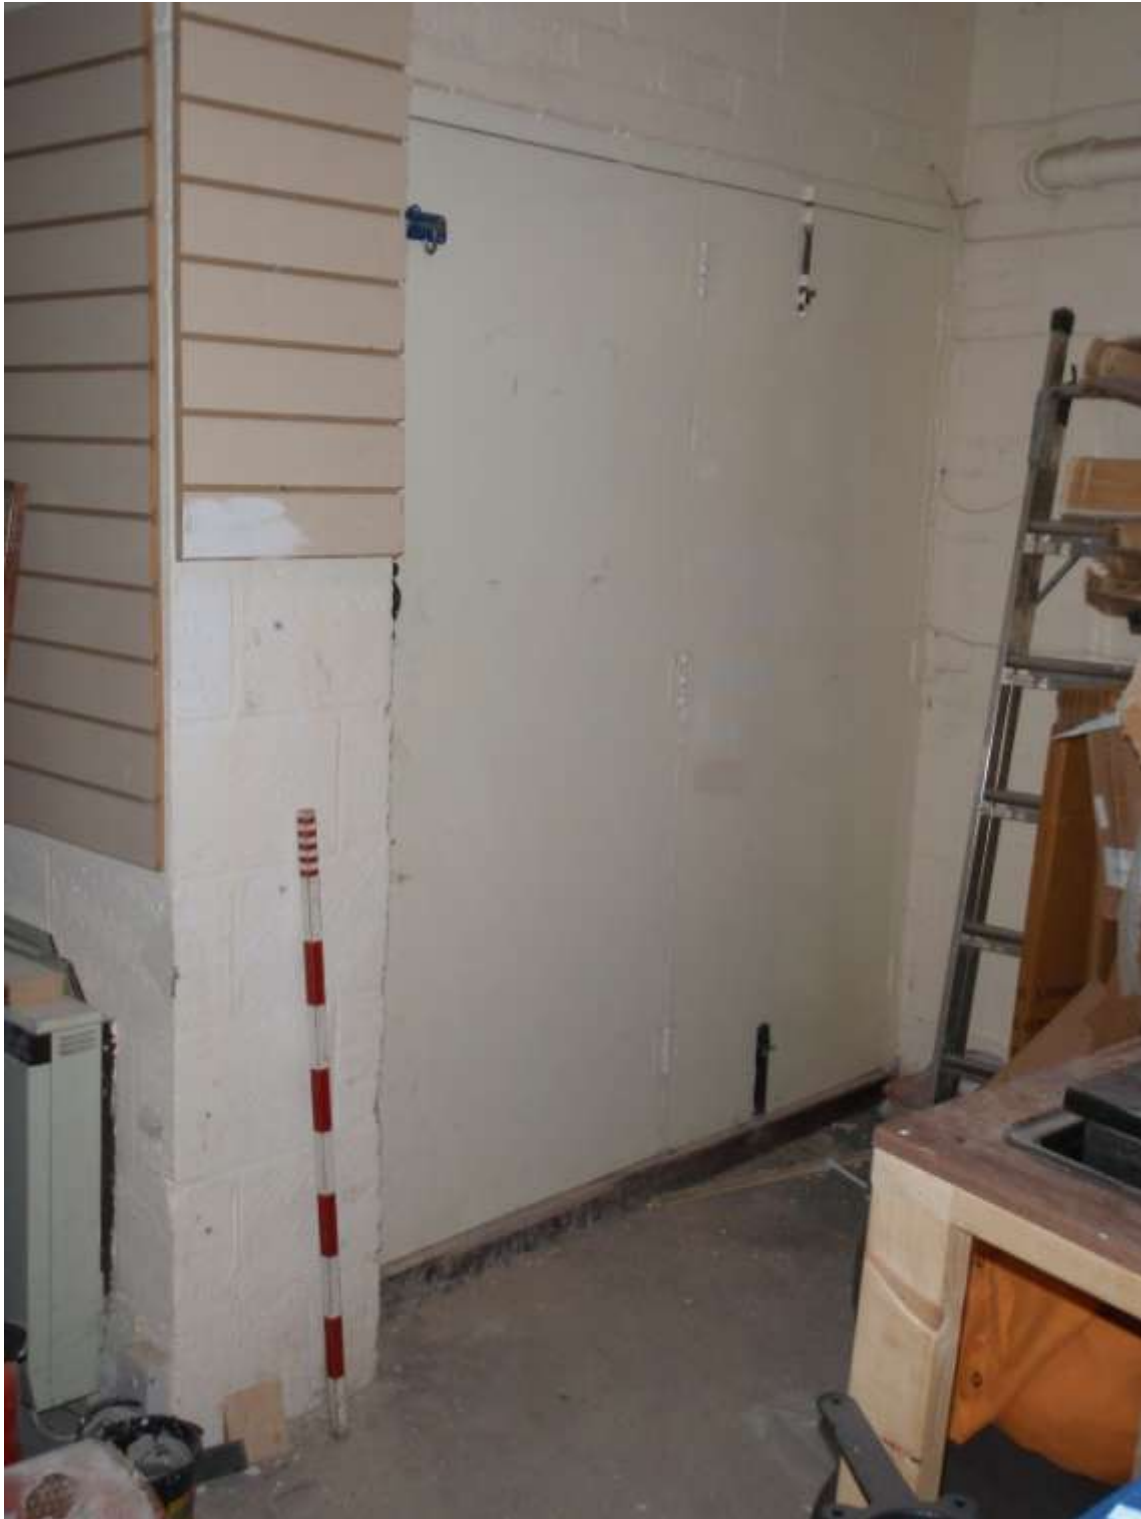
**Plate 8.** View of interior of north building showing modern concrete floor, modern blockwork and part of the original brick wall on the right.

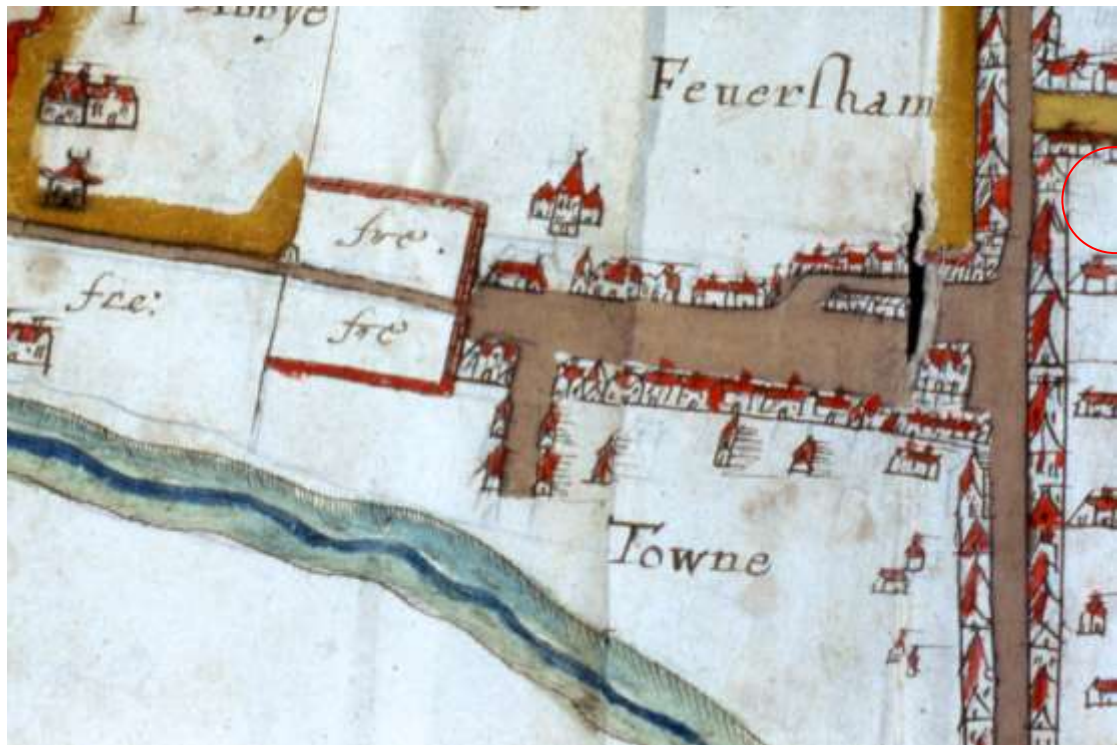
Figure 1. Elias Allen map from the early 16<sup>th</sup> century

2.6 Prior to 1868 the buildings are not shown on the early 16<sup>th</sup> century map of Elias Allen which shows the late medieval frontage of Preston Street (Figure 1) or the 1745 map by Edward Jacob (Figure 3) or indeed the Ordnance Survey Surveyors Drawing of 1798 (Figure 2).
