Archaeological Trial Trenching and Evaluation at the Barkaway Site, Ospringe, Kent

Site Code: BARK/EV/16

SWAT Archaeology

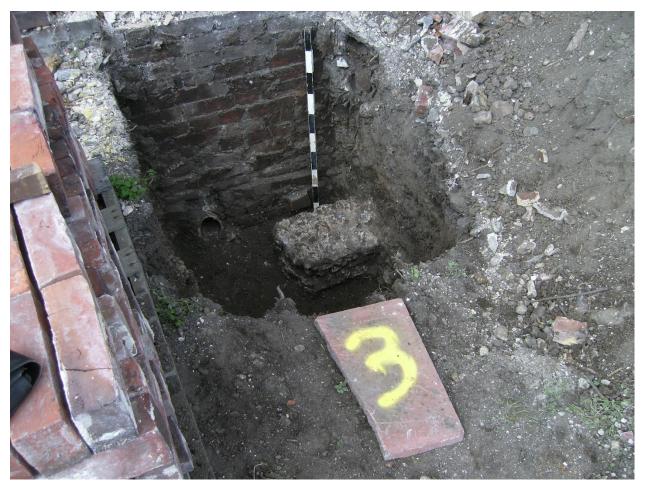
Plate 4. Test pit 3 from the south showing the wall foundation (CRN 9) cut away by a modern drain, one-metre scale

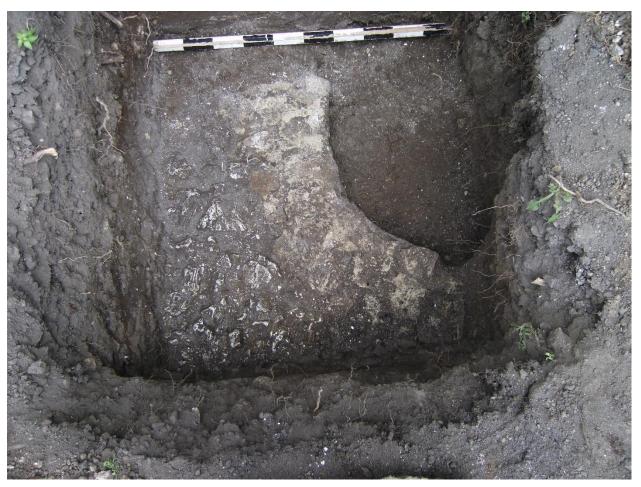
Plate 5. Test pit 3 showing the curved wall foundation (CRN 9) and the abutting chalk layer, one-metre scale

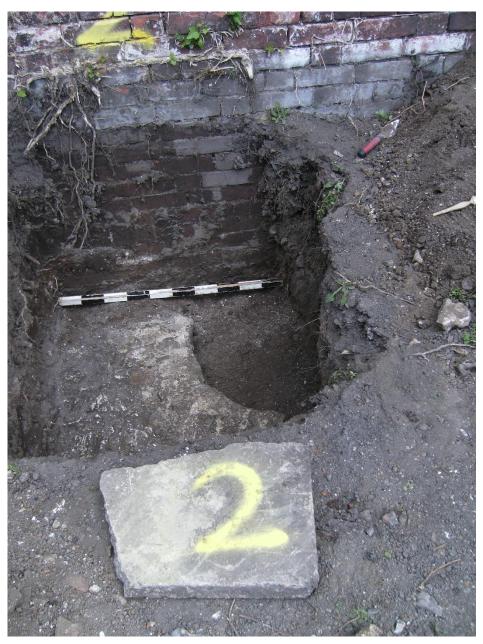
Plate 6. Test pit 2 from the south showing the curved section of the wall foundation (CRN 9), one-metre scale

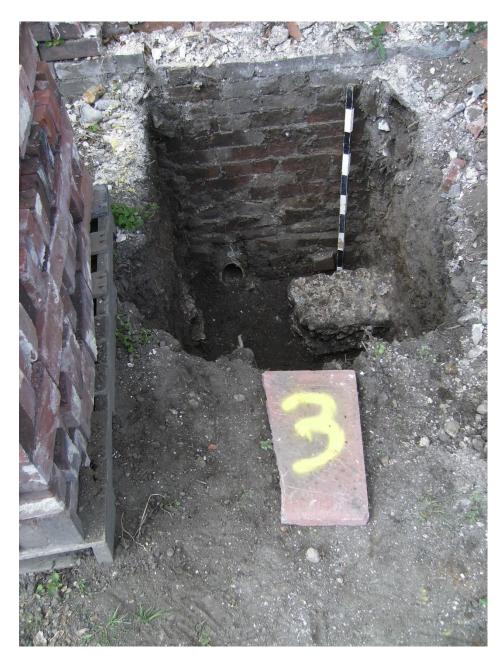
Plate 13. Test pit 3 from the south showing the wall foundation (CRN 9) cut away by a modern drain, one-metre scale

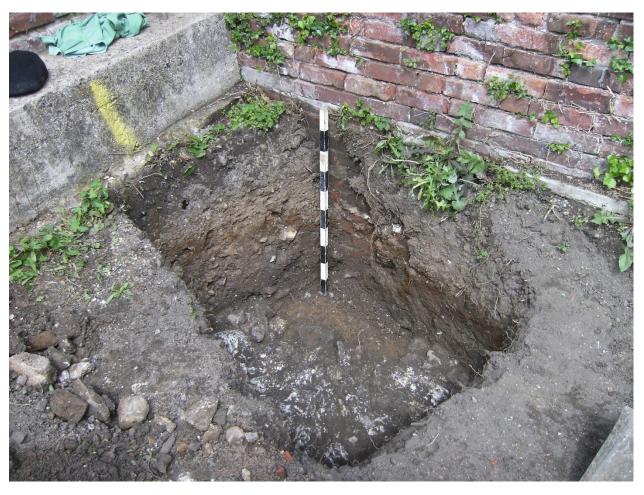
Plate 14. Test pit 1 from the southeast showing a remnant of the wall foundation (CRN 9) with the abutting chalk to the south

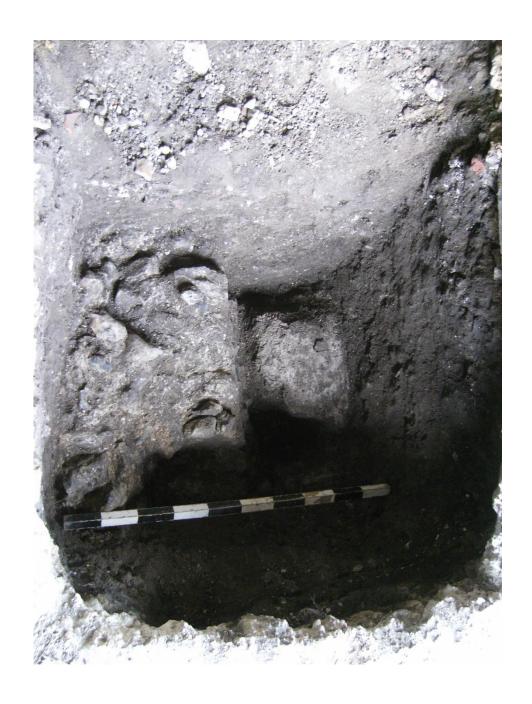
Plate 16. Test pit 23 from above showing the Common Hall western wall foundation (CRN 20), one-metre scale

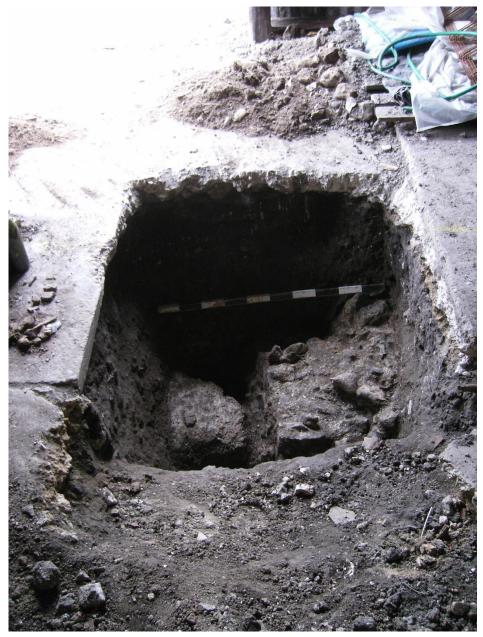
Plate 17. Test pit 23 from the south showing the Common Hall western wall foundation (CRN 20), with an expose 'island' of the abutting exterior layers, one-metre scale

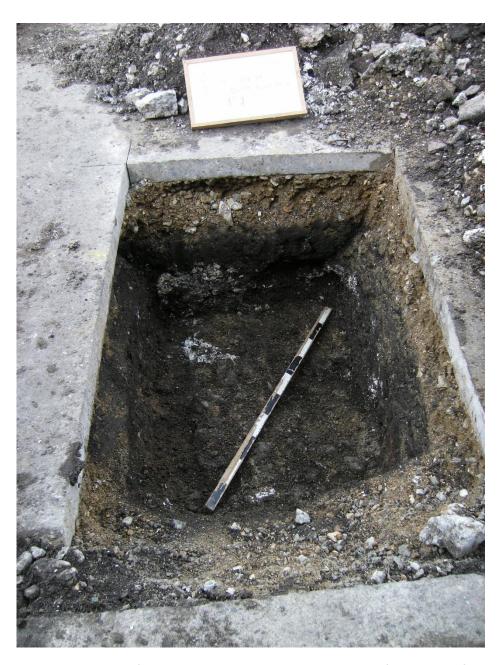
Plate 18. Test pit 22 from the south showing the western wall foundation of the Common Hall exposed at its base, one-metre scale

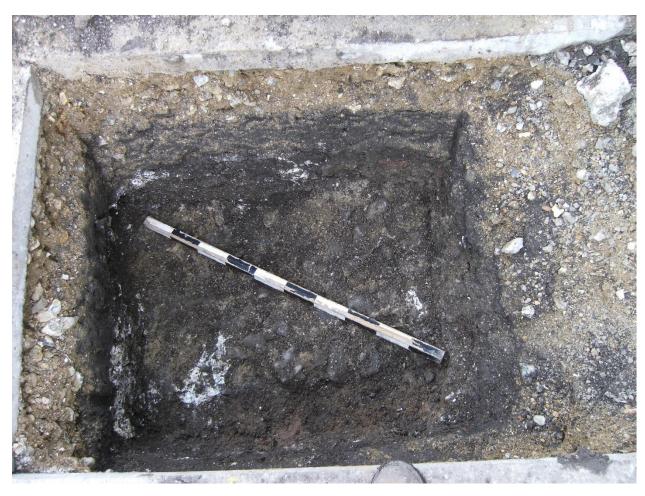
Plate 19. Test pit 22 from above showing the western wall foundation of the Common Hall exposed at its base, one-metre scale

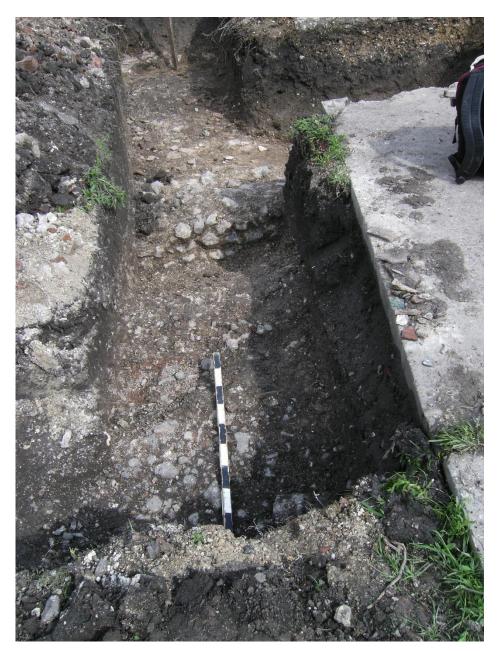
Plate 20. Test pit 21 from the west with showing flint cobbles (CRN 80) abutting the Common Hall wall foundation (CRN 20), with clay floor bedding (CRN 90) abutting the foundation in the foreground (one-metre scale)

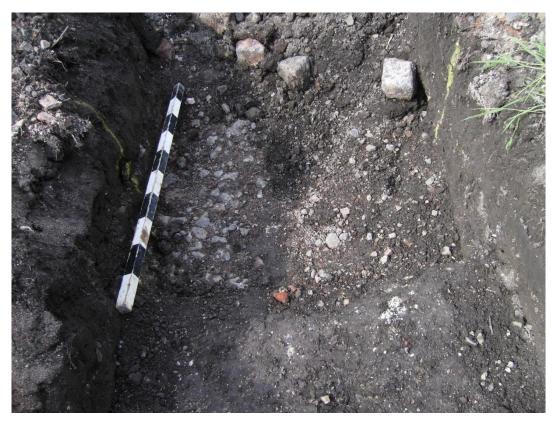
Plate 21. Test pit 18 showing the exposed cobbles of the exterior courtyard lying west of the western wall foundation of the Common Hall, one-metre scale

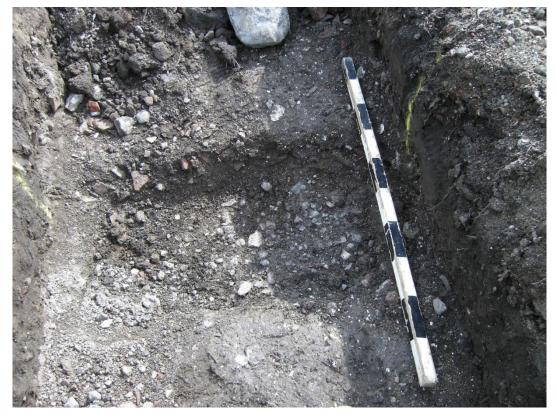
Plate 22. Test pit 19 showing the exposed cobbles of the exterior courtyard lying west of the western wall foundation of the Common Hall, one-metre scale

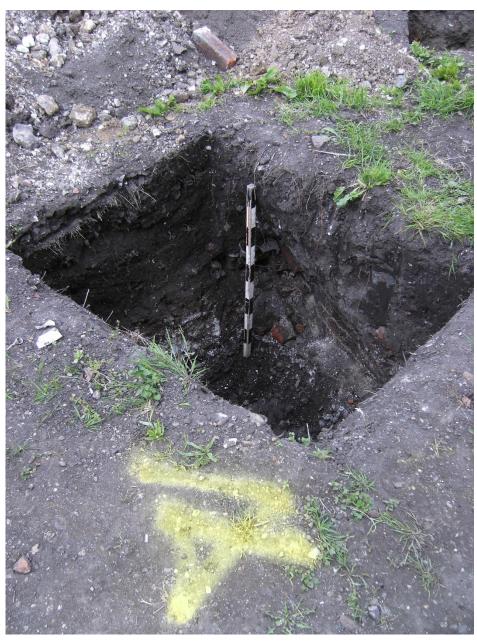
Plate 26. Test pit 7 showing the modern drain cutting through its western side, onemetre scale

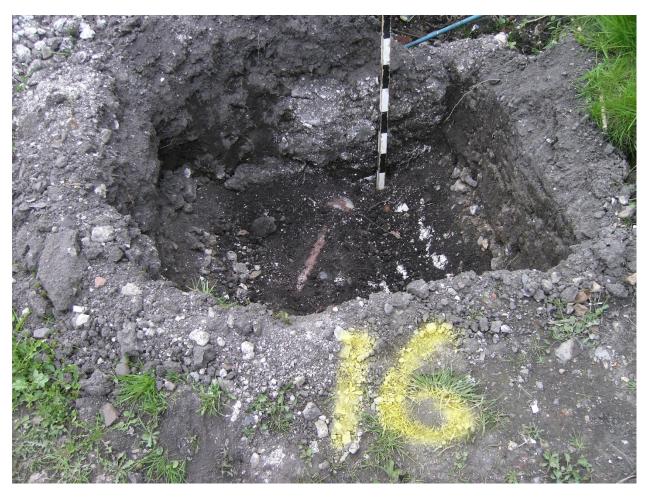
Plate 30. Test pit 16 from the east showing the modern drain pipe cutting through it, one-metre scale

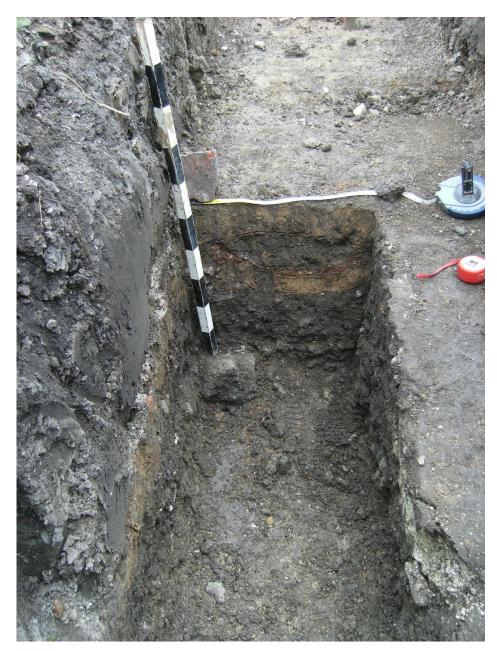
Plate 31. Test pit 27 from the south showing the internal clay floor bedding of the Common Hall and the bowl-shaped hearth or oven structure, one-metre scale

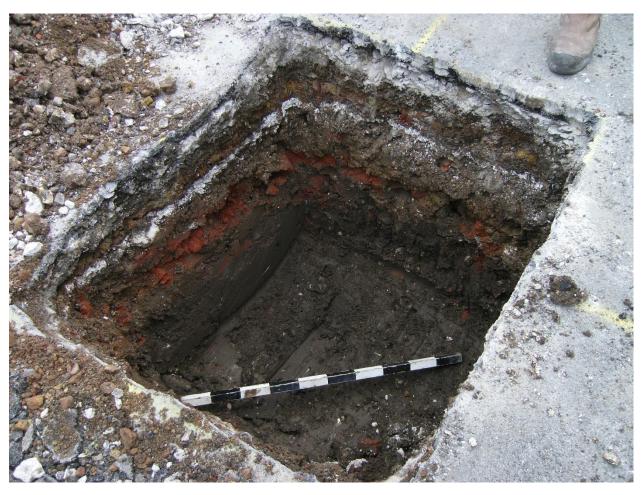
Plate 32. Test pit 25 showing modern yard or entrance-way layers over a humic, brickearth-like soil deposit, one-metre scale

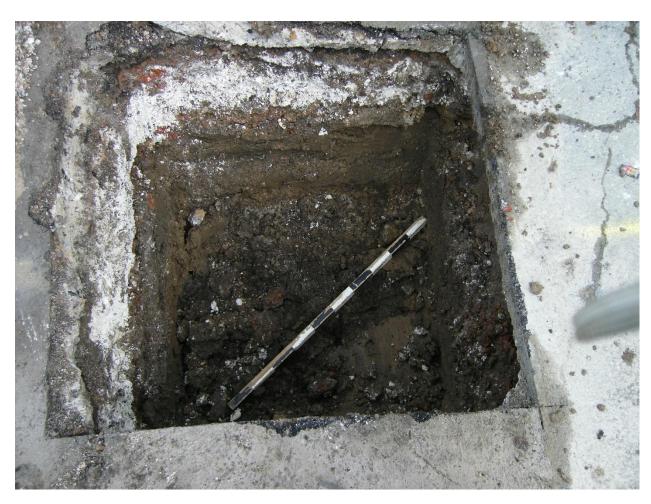
Plate 33. Test pit 26 showing modern yard or entrance-way layers over a humic soil deposit, one-metre scale

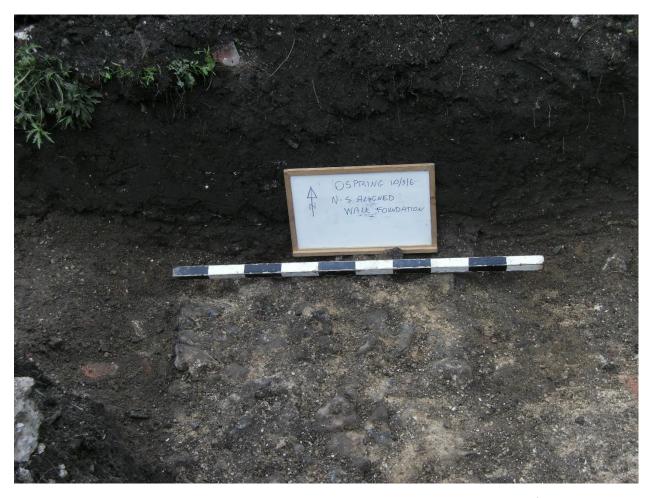
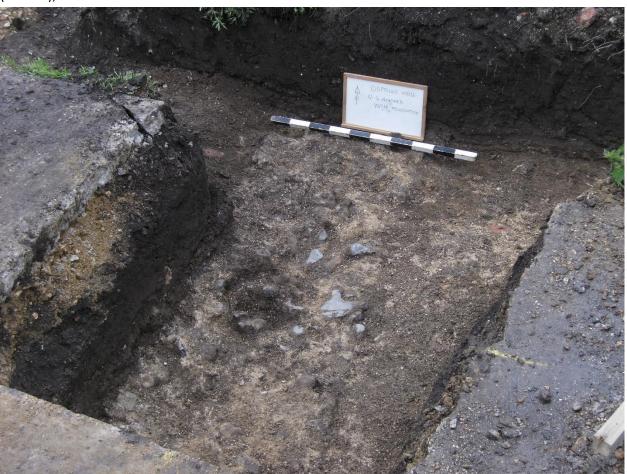
Plate 35 above and **Plate 36** below. Test pit 21 showing the Common Hall western wall foundation (CRN 20), one-metre scale
