# Archaeological Evaluation of Land north of Royal Fountain Mews/Hotel, West St, Bluetown, Sheerness, Kent

Site Code: FOUNT/EV/16

(Planning Application: SW/14/0092)

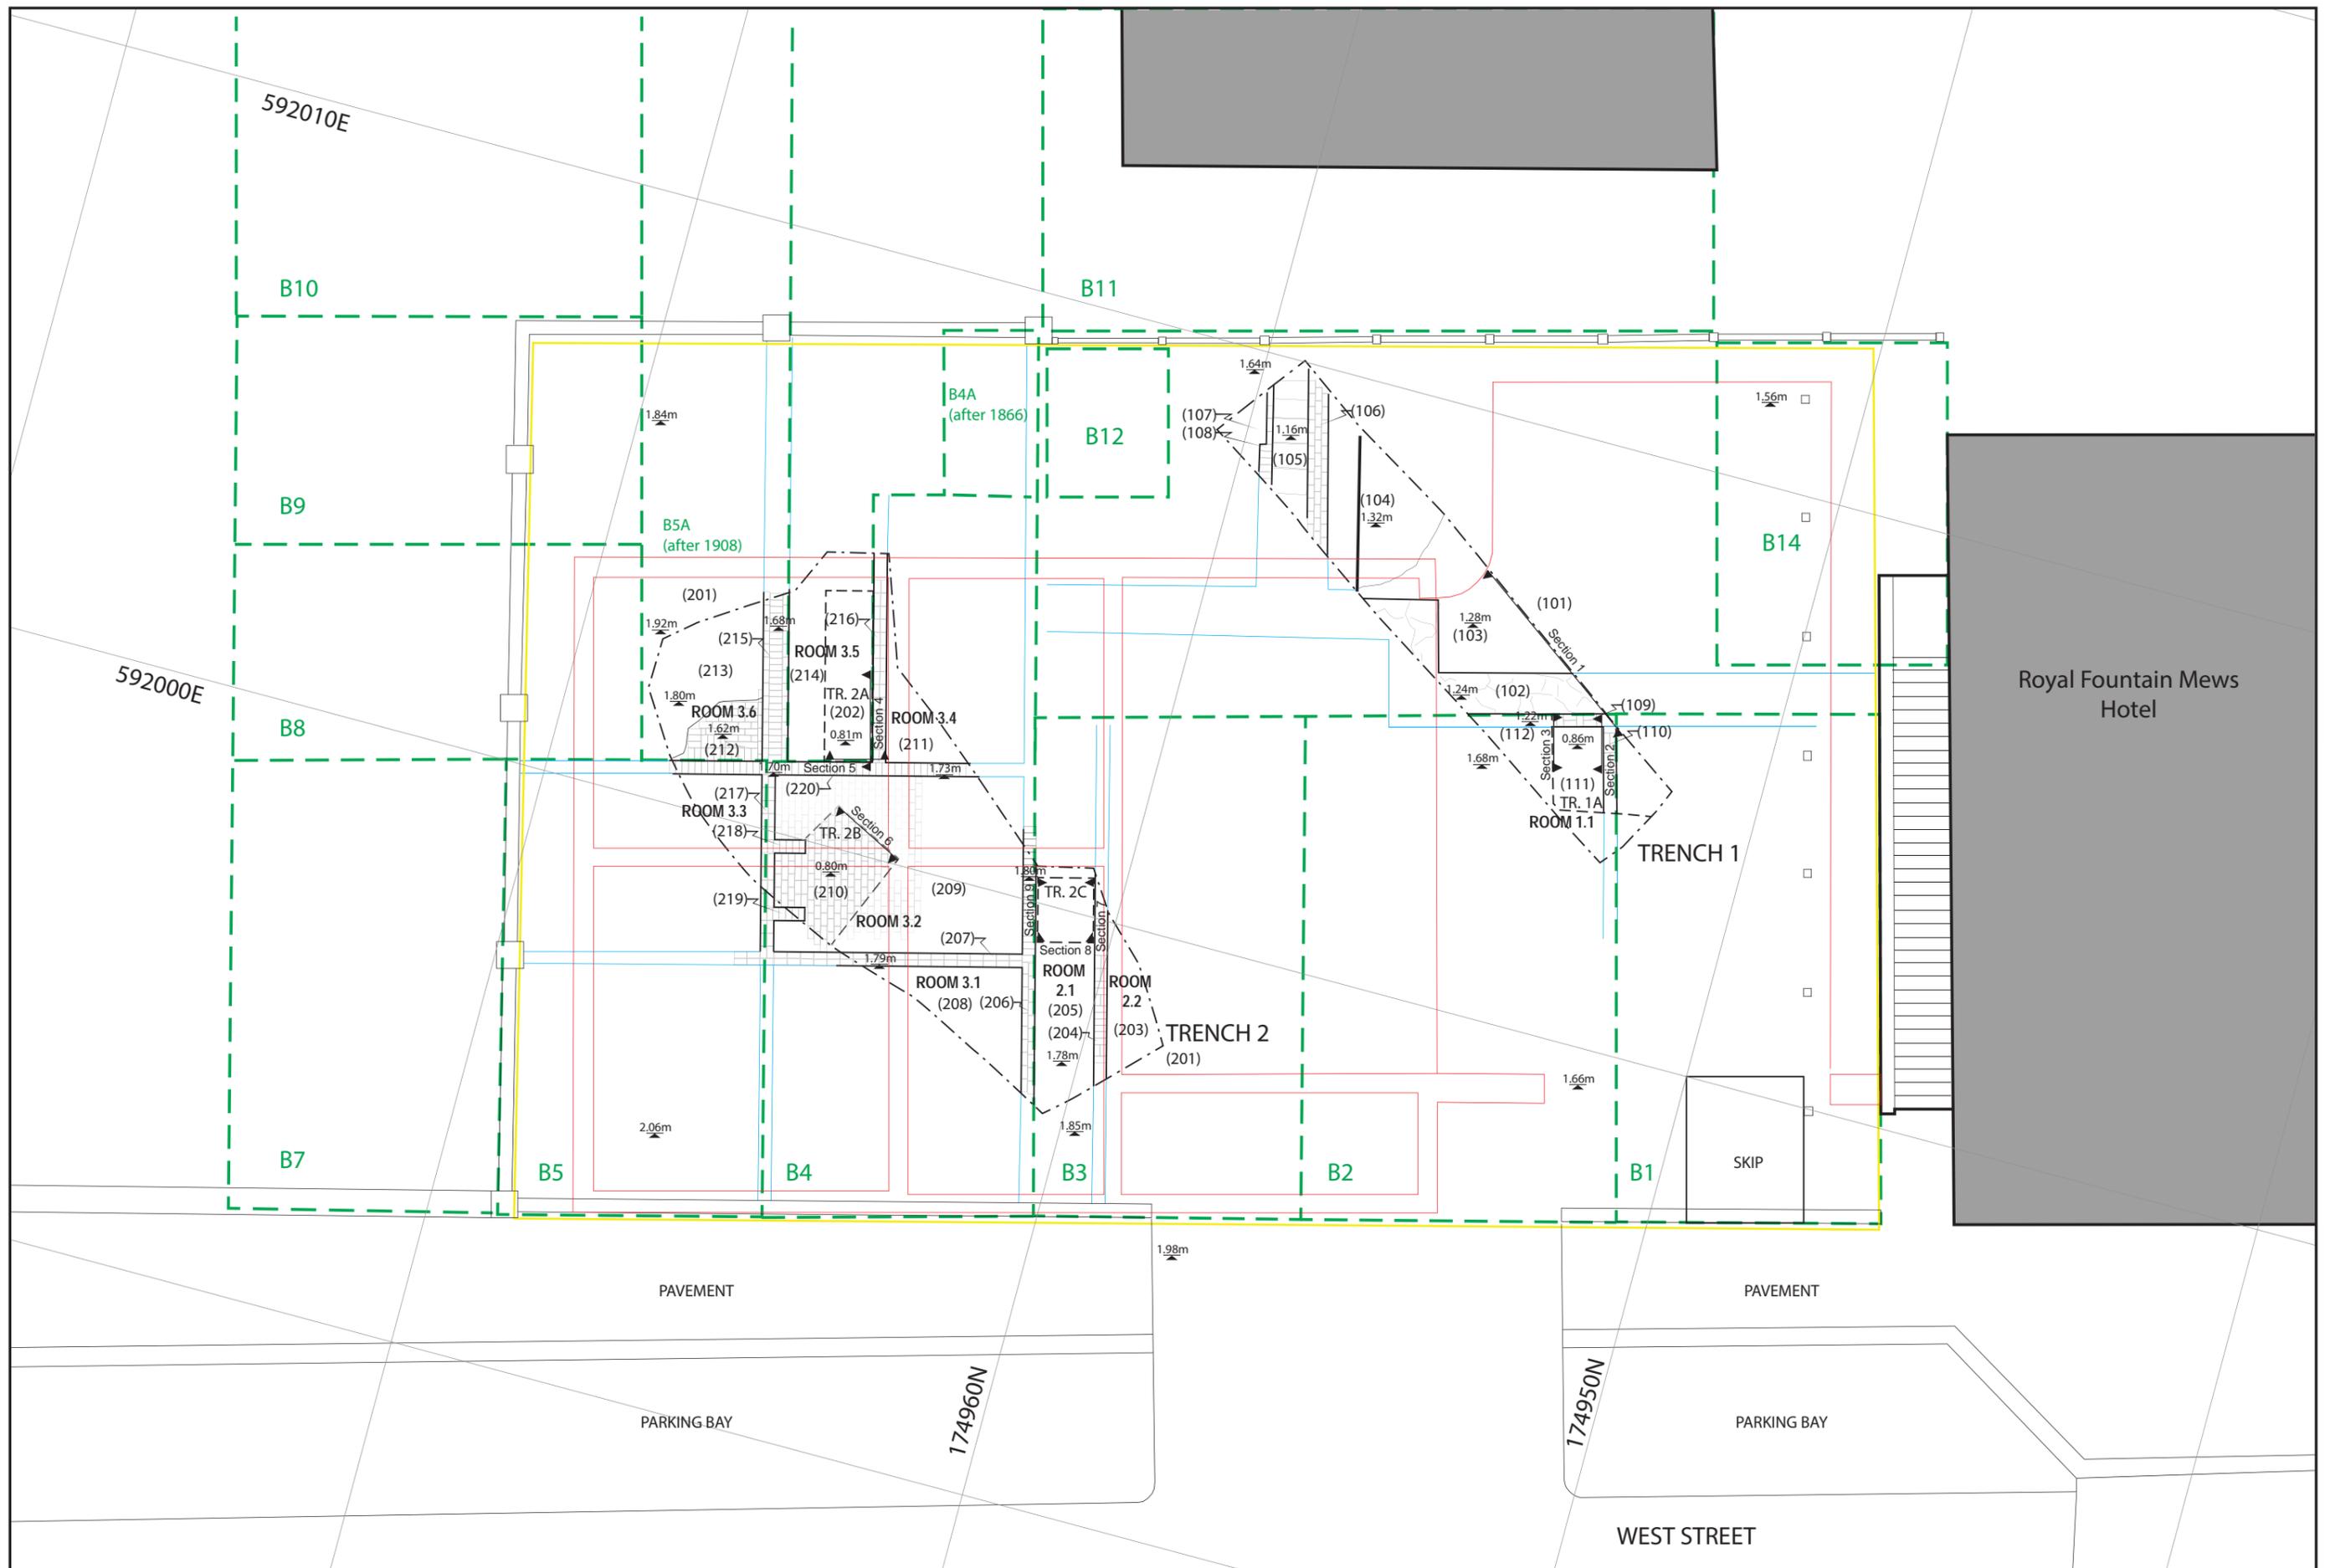
Figure 4: Site plan with evaluation trenches, extrapolated features and proposed development.

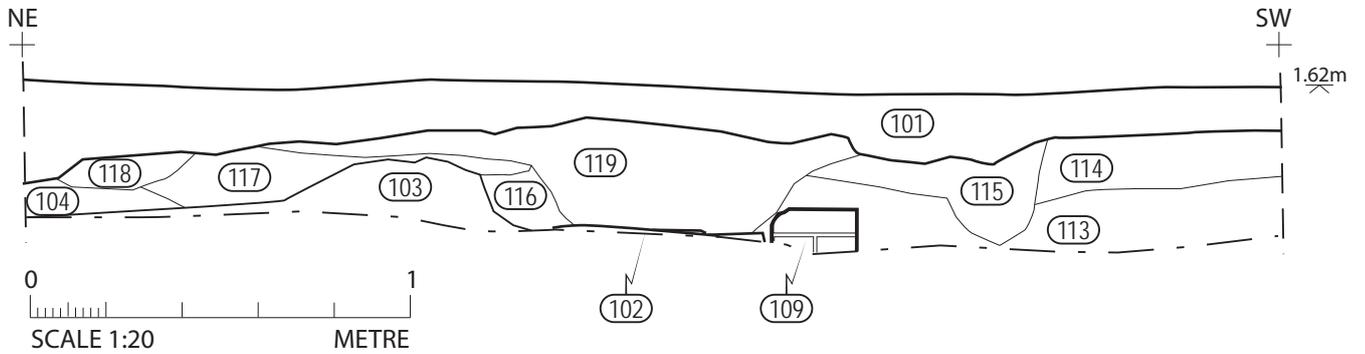
### Section 1

- (101) - Topsoil - moderately compacted black loam with abundant rubbish (electric cables, wires, scrap metal, cans, glass, plastic, bricks) and bush roots.

- (102) - Pavement - heavily cracked tarmac
- (103) - Layer / demolition - well compacted hardcore with black loam
- (104) - Layer / dump (after 1950) - moderately compacted hardcore with abundant black loam

- (109) - Wall - Flemish bond - 3 courses exposed to the floor level
- (110) - Wall - Flemish bond - 3 courses exposed to the floor level
- (111) - Floor - concrete

- (112) - Layer/ Fill of Room 1.1 - moderately compacted hardcore mixed with black loam and occ. glass, pottery, wood fragments, roof tiles, iron bars, wires and nails contained concentrations of pottery, concentration of glass bottles and the smell of vine

- (113) - Layer / dump (after 1950) - firmly compacted black loam with moderate brick fragments, mortar, occ. timber fragments, cans, wires, nails, plastic

- (114) - Layer / car park surface - compacted hardcore
- (115) - Layer / dump - moderately compacted, yellow sand
- (116) - Layer / erosion of (103) - moderately compacted black loam with abundant brick fragments and mortar

- (117) - Layer / dump - moderately compacted, yellow sand
- (118) - Layer / dump - well compacted brick fragments
- (119) - Layer / dump - loose masonry stones, some bricks sealed by soft black loam

Section 1 was the trench section (Figure 7) which records the crazy paving path **[102]** set against a wall **[109]** of three courses set in a Flemish bond. To the SW dump materials **(113)** of firmly compacted black loam with moderate brick fragments, mortar, timber fragments, can, wire, nails and plastic and dated by the excavator to after 1950. Above this, a layer a compacted hardcore **(114)** interpreted by the excavator as the surface of a car park. Cut into this context was a dump of moderately compacted yellow sand **(115)**.

To the NE of the wall and above the 'crazy' paving path **[102]** was covered by numerous dumps of material all 20<sup>th</sup> century according to the excavator. Sealing this dumped material was a layer of compacted black loam **(101)** with inclusions of electric cables, wire, scrap metal, glass, plastic, bricks.

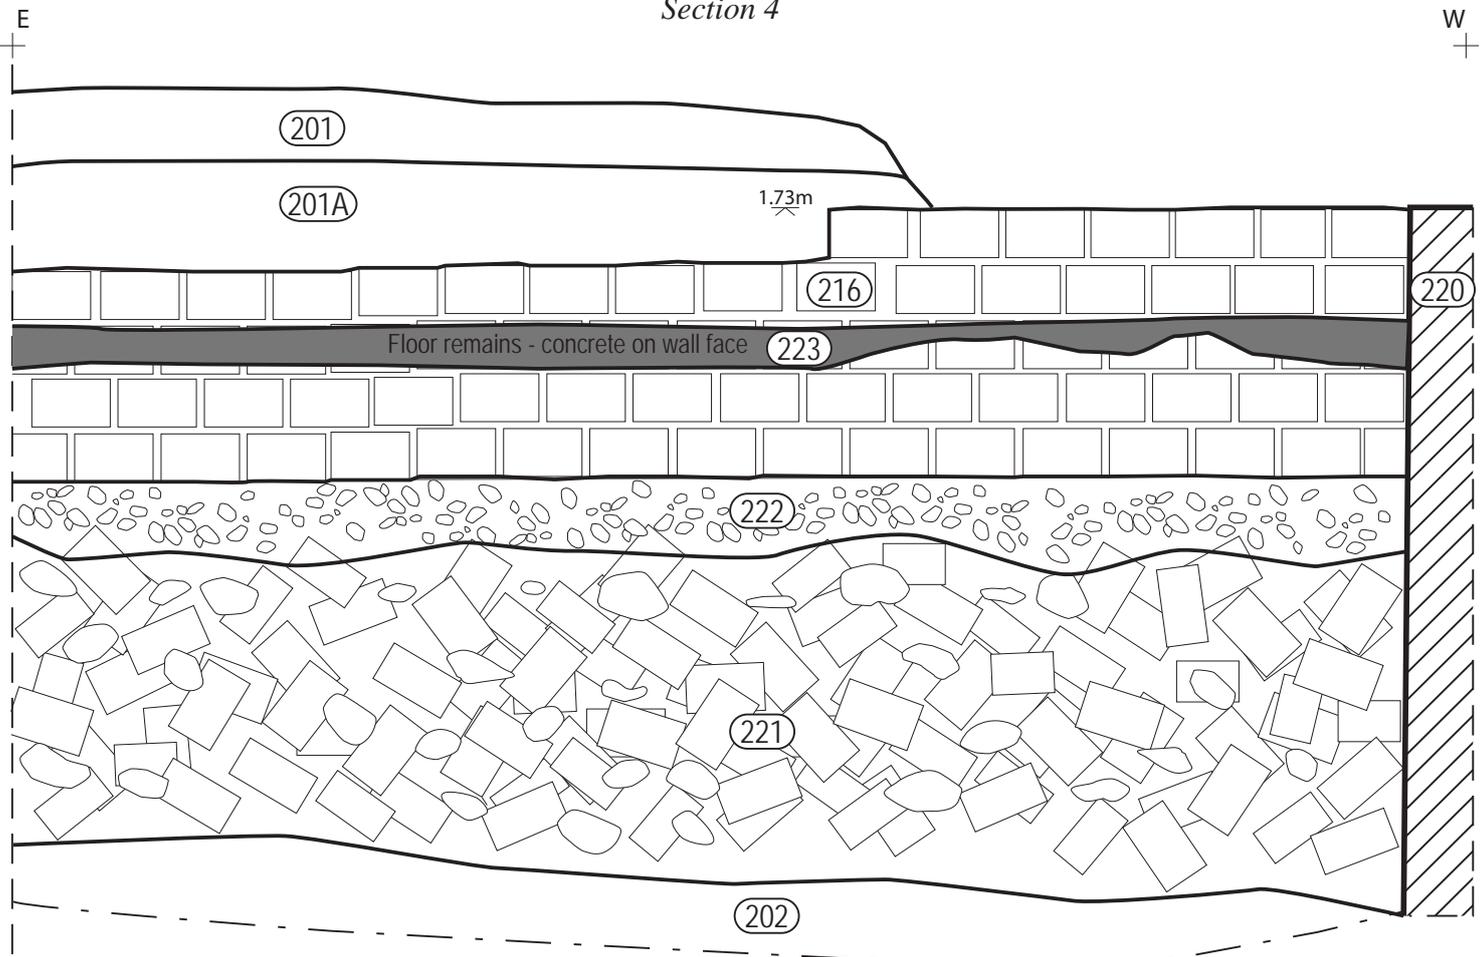
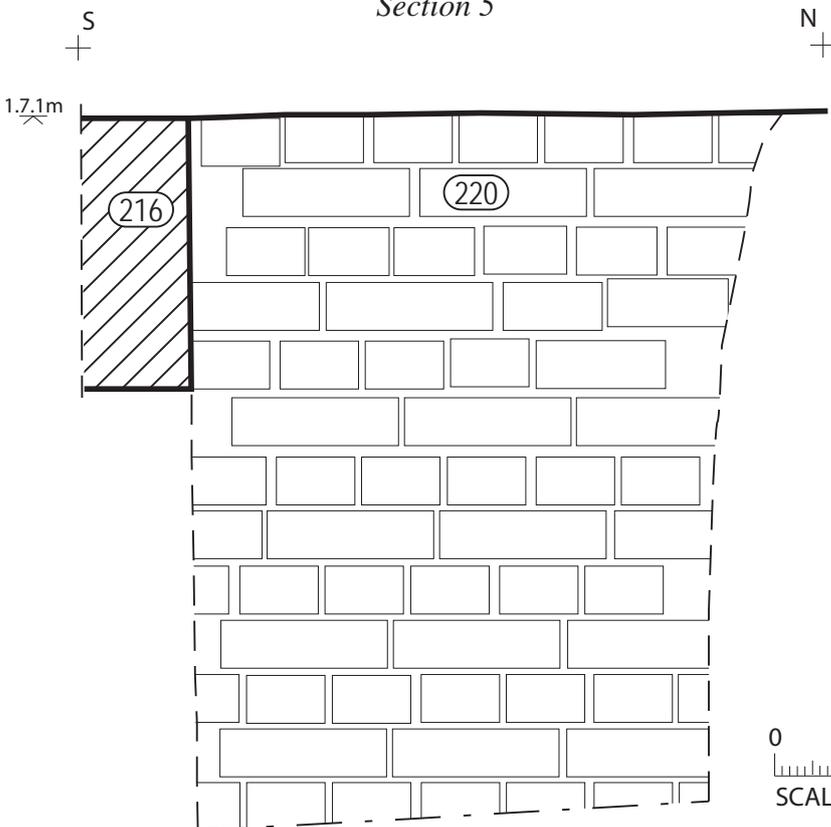
Figure 8: Sections exposed in Trench 2A

- (201) - Top soil - mid compaction, loam with abundant roots and rubbish
- (201A) - Tarmac - car park
- (202) - Natural - marsh clay in mid bluish grey colour
- (216) - Wall - 6 courses in header bond
- (220) - Wall - 13 courses in English bond
- (221) - Layer / building construction - foundations bedding - bricks and large brick fragments
- (222) - Layer / building construction - wall bedding - coarse gravel with mortar

Section 4 was located in a test pit (TR 2A) on the south side of Room 3.5 (Figure 6 and Plate 12) and was excavated by hand to a depth of 0.92m at 0.81m OD. Revealed was the natural (**202**) marsh clay in mid blue grey colour at 0.81m OD. Above this was a layer of broken bricks about 0.38m thick (**221**) overlaid by a band of mortared course gravel levelled off as a bedding foundation [**222**] for five courses of red brick set in a header course and bonded with grey white gritty mortar [**216**] and overlaid by a layer of tarmac (**201A**) again overlaid by a topsoil (**201**). Of interest is a band of concrete (**223**) adhering to the bonded brick courses and interpreted by the excavator as the remains of a concrete floor.

Section 5 was located in the same test pit but is the west face and revealed 13 courses of red brick 0.21m x 0.11m x 0.07m in size and laid in a tight English bond set in a off-white sandy lime mortar.

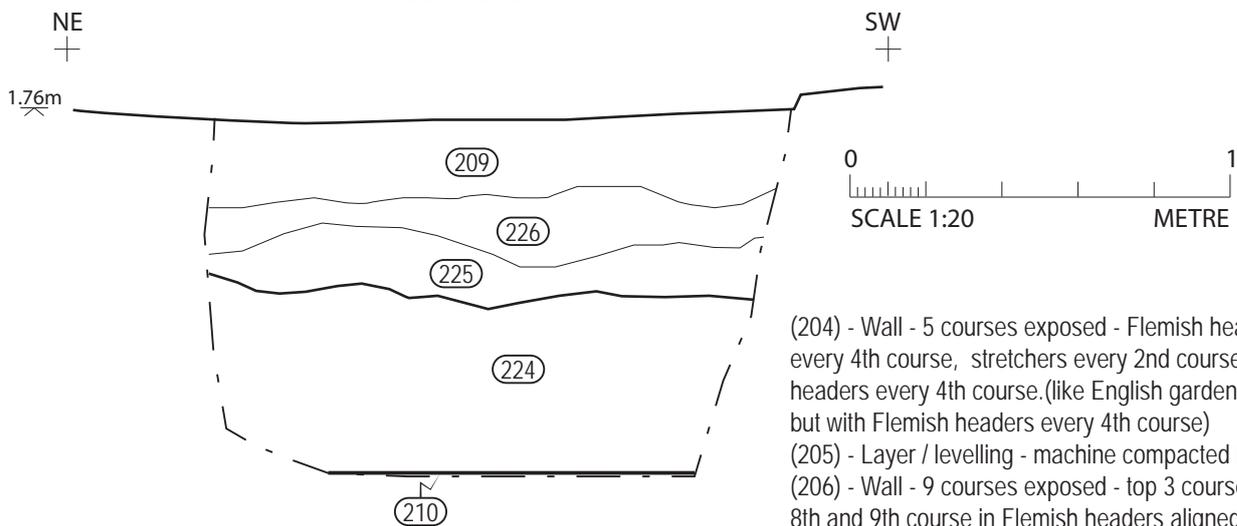
- (204) - Wall - 5 courses exposed - Flemish headers every 4th course, stretchers every 2nd course headers every 4th course. (like English garden bond but with Flemish headers every 4th course)
- (205) - Layer / levelling - machine compacted hardcore
- (206) - Wall - 9 courses exposed - top 3 courses and 8th and 9th course in Flemish headers aligned every second course, headers alternate 1/3 brick length left on successive course. Courses 4-6 in Flemish bond with 3/4 brick, 7th course have stretchers only.
- (209) - Layer / levelling - compacted hardcore
- (210) - Floor - brick in stretcher pattern
- (224) - Layer / demolition - moderately compacted hardcore (roof tiles, bricks, concrete) with black loam

Section 6 was located in the centre of Room 3.2 (Figure 9. Plates 8, 9) and was the SE face of test pit TR. 2B. The excavation revealed a brick floor [**210**], stretcher laid at 0.80m OD. Above the brick floor was a fill of demolition (**224**) comprising moderately

compacted bricks, tiles, concrete about 0.17m thick. Overlaying this demolition layer was three layers of additional demolition material **(225, 226, 209)**.

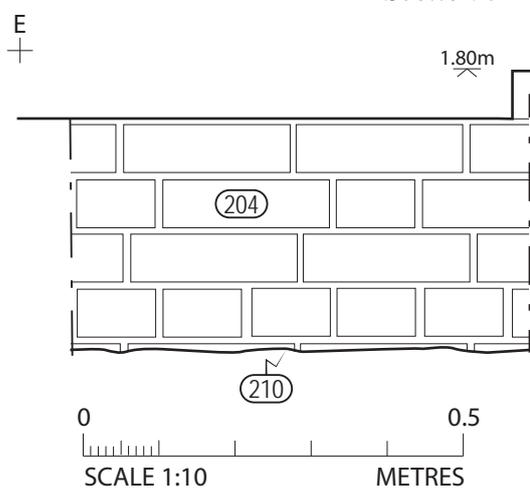
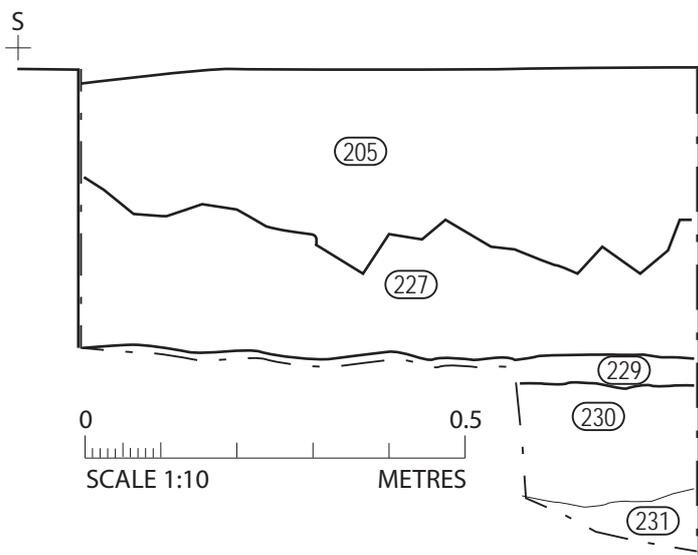
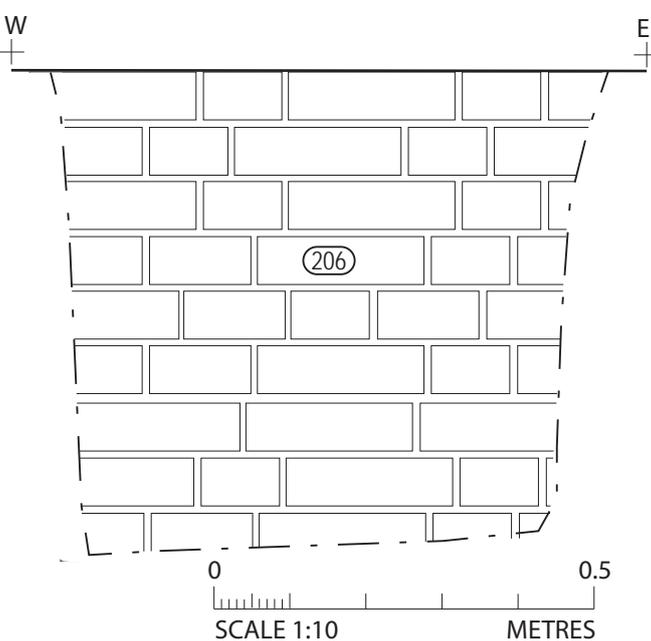
Figure 9: Sections exposed in Trench 2B and Trench 2C

- (225) - Layer / levelling - compacted hardcore with mid brown sand
- (226) - Layer / levelling - compacted bricks with black loam
- (227) - Layer / levelling - firmly compacted black loam with abundant brick fragments, small concrete, small fragments of carbon (burnt and un-burnt coal, coke and anthracite) occ. metal (nails, bars plates, joints), rotten timber planks, wires.
- (229) - Layer / pavement - dry pebble surface - about fist size sub round stones sits in firmly compacted black clay. Laid after 2nd World War.
- (230) - Layer / dump - moderately compacted mixture of demolition rubble with black clay and burnt and un-burnt coal, coke and anthracite - these were noted as flecks and dust very small particles.
- (231) - Layer / dump - same as (230) with grit and black clay

Sections 7, 8, 9 are located in test pit TR 2C in Room 2.1 (Figures 6, 9 and Plates 14-17).

The area of Section 7 was excavated by hand to a depth of about 0.65m at about 1.05m OD. Part of the surviving cobbled floor (Plate 16 and Figure 9). Above the cobbled floor **[229]** five courses of a brick wall **(204)** with Flemish headers every fourth course, stretchers every second course typical of a English garden bond but with headers every fourth course.

The area of Section 8 (Plate 15 and Figure 8) was excavated by hand to a depth of about 0.70m at about 1.10m OD. Revealed was a cobbled floor in a matrix of firmly compacted black clay **[229]**. A small sondage through the cobbled floor exposed two layers, the lowest **(231)** was similar to the layer immediately above **(230)** which was a compacted layer of clay stained black with coal dust, small specks of coal and coke. Above the cobbled floor **[229]** a deposit of black loam with abundant brick fragments **(227)** and deposit **(205)** above was a compacted mass of brick demolition material- broken bricks, concrete fragments.

The area of Section 9 was also excavated by hand to a depth of about 0.64m at about 1.16m OD and revealed nine courses of laid bricks **[208]** in a header and stretcher pattern (Figure 9 and Plate 17).

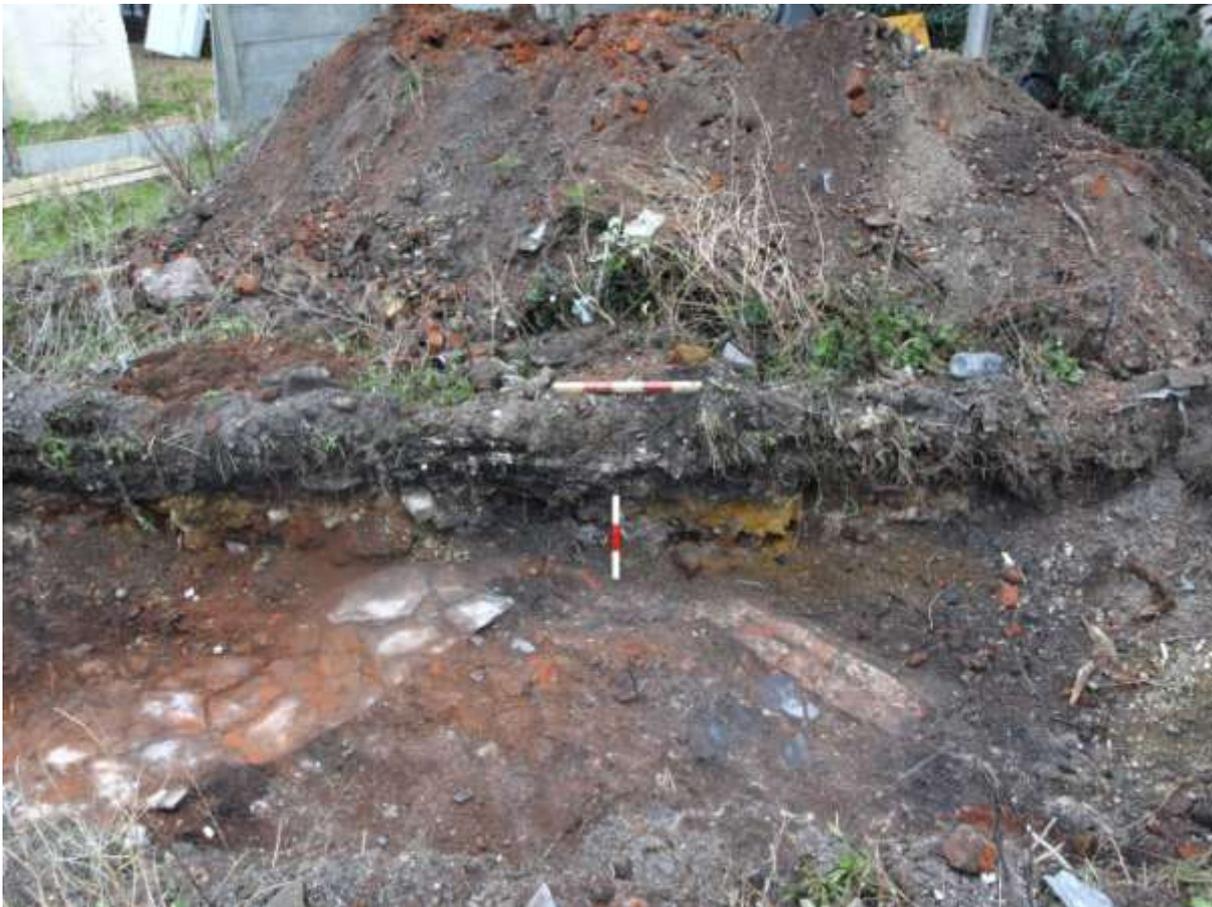
**Plate 5: Looking south east at Section 1 exposed in Trench 1.**

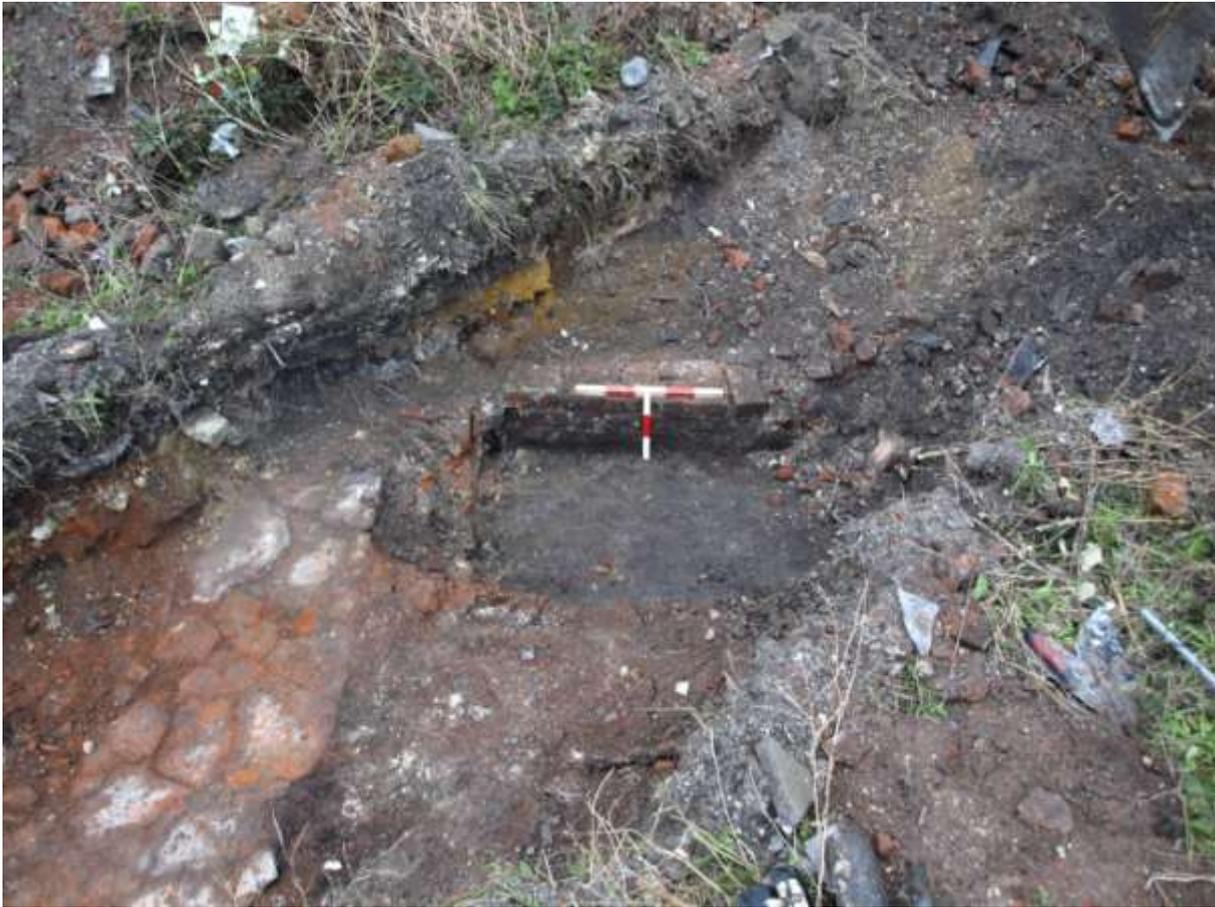
Plate 6: Looking south east at the corner of the Room 1.1 exposed in Trench 1A

Section 2 (trench 1A) was located in the return of walls **[109, 110]**. The fill of Room 1.1 **(112)** was moderately compacted hardcore mixed with black loam and occasional fragments of modern glass, pottery, wood, wire, and nails (Figure 7 and Plate 6). With the removal of context **(112)** a smooth concrete floor was revealed **(111)** at 0.86m OD.

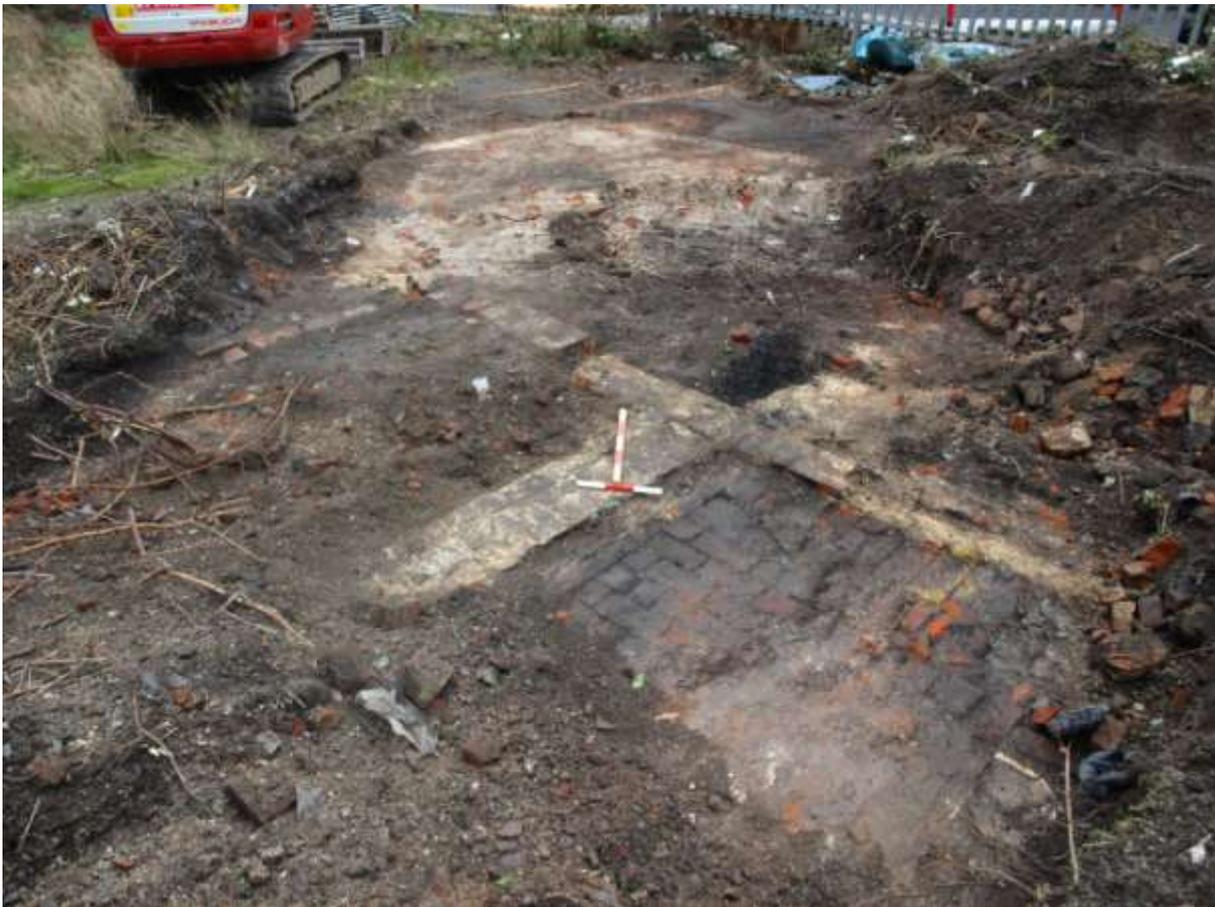
Plate 7: Looking south west at building remains exposed in Trench 2

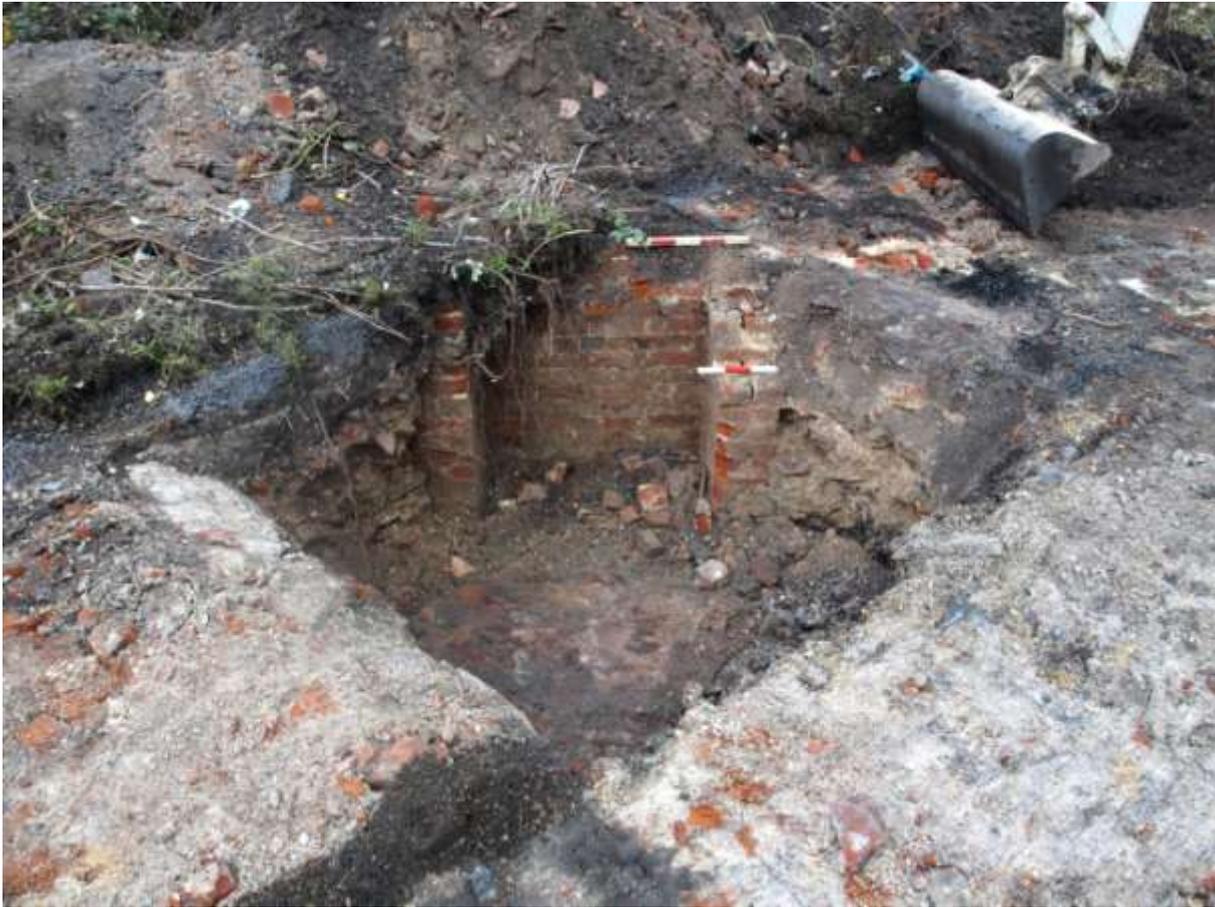
**Plate 8: Looking north at fireplace and brick floor in Room 3.2 exposed in trench 2B**

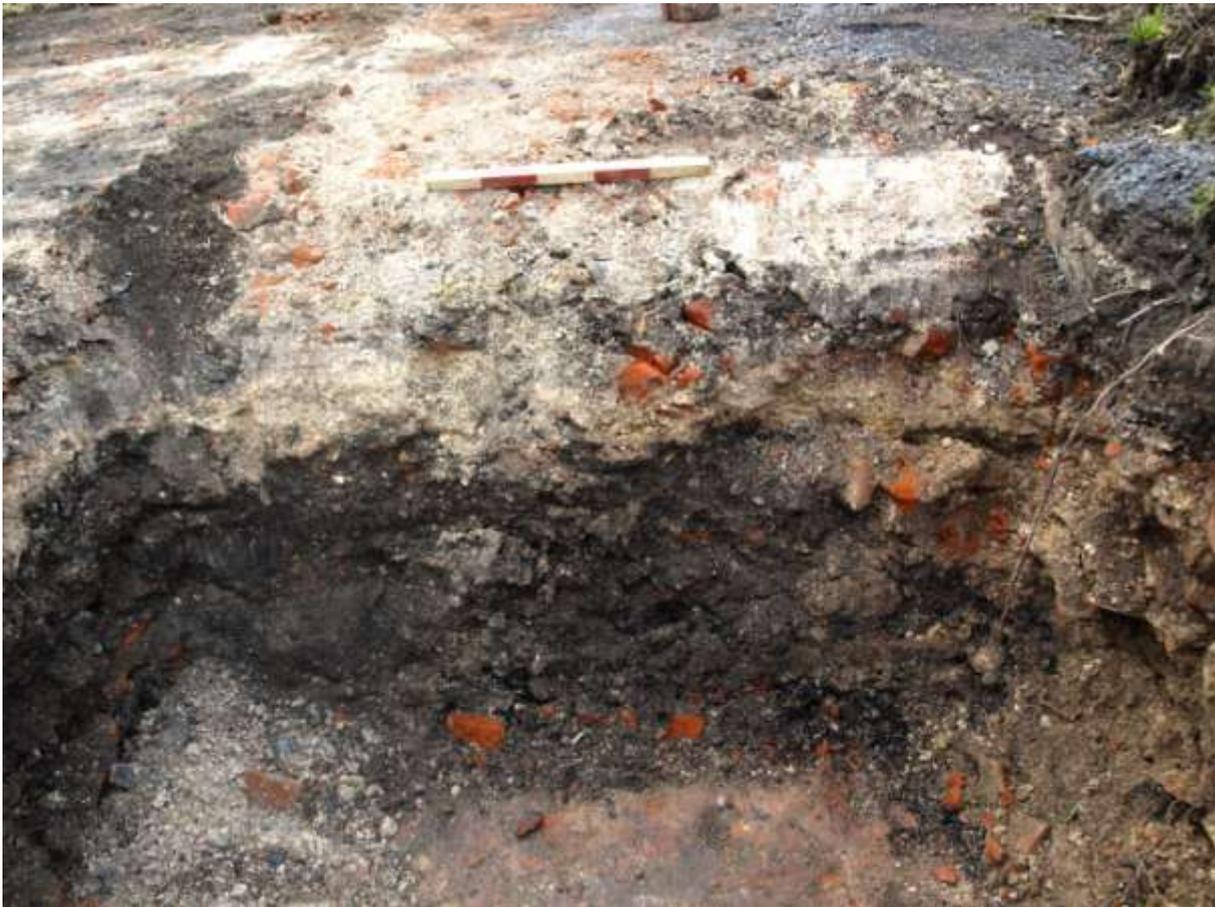
**Plate 9: Looking west at Section 6 through backfill of Room 3.2**

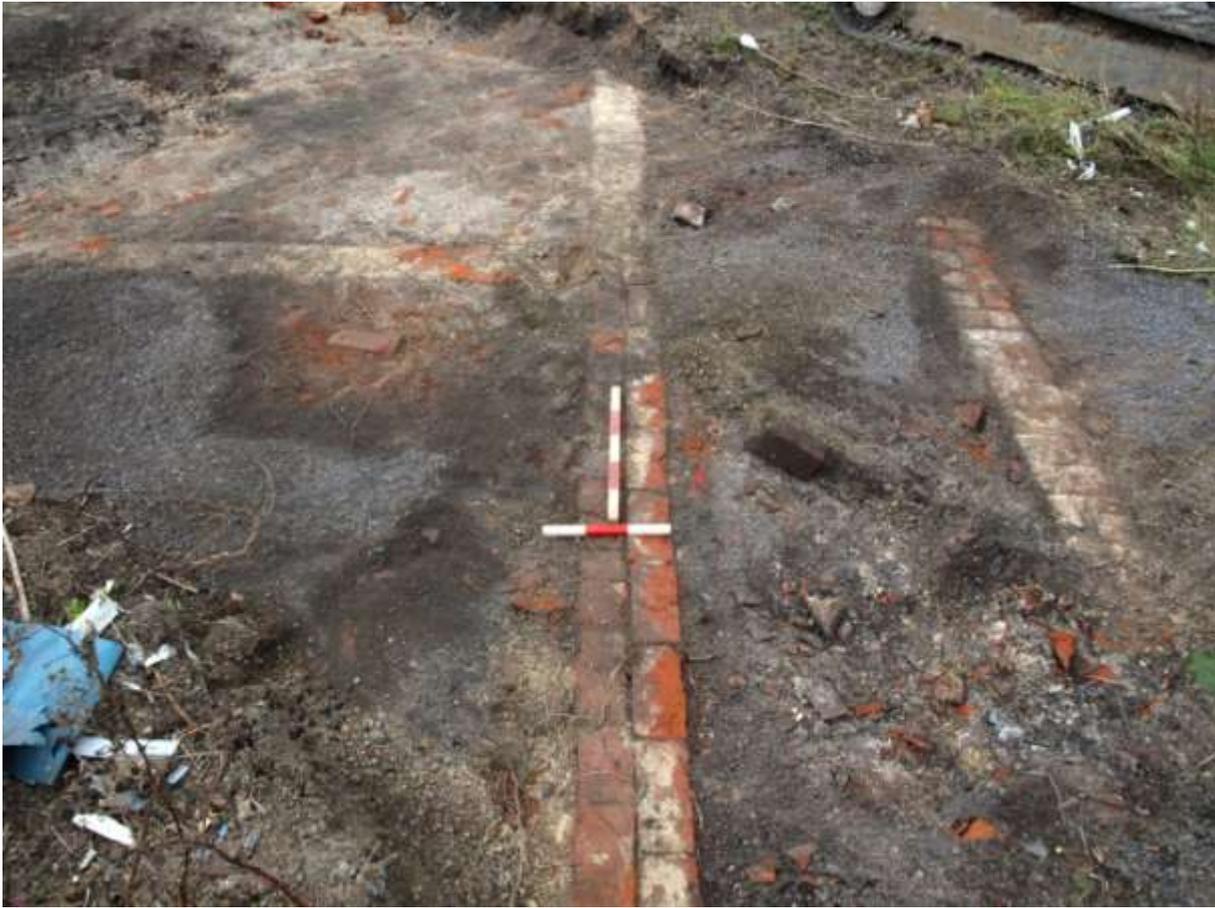
Plate 10: Looking east at walls exposed in Trench 2. Wall (206) underneath the scales, wall (204) on the right and wall (207) on the left.

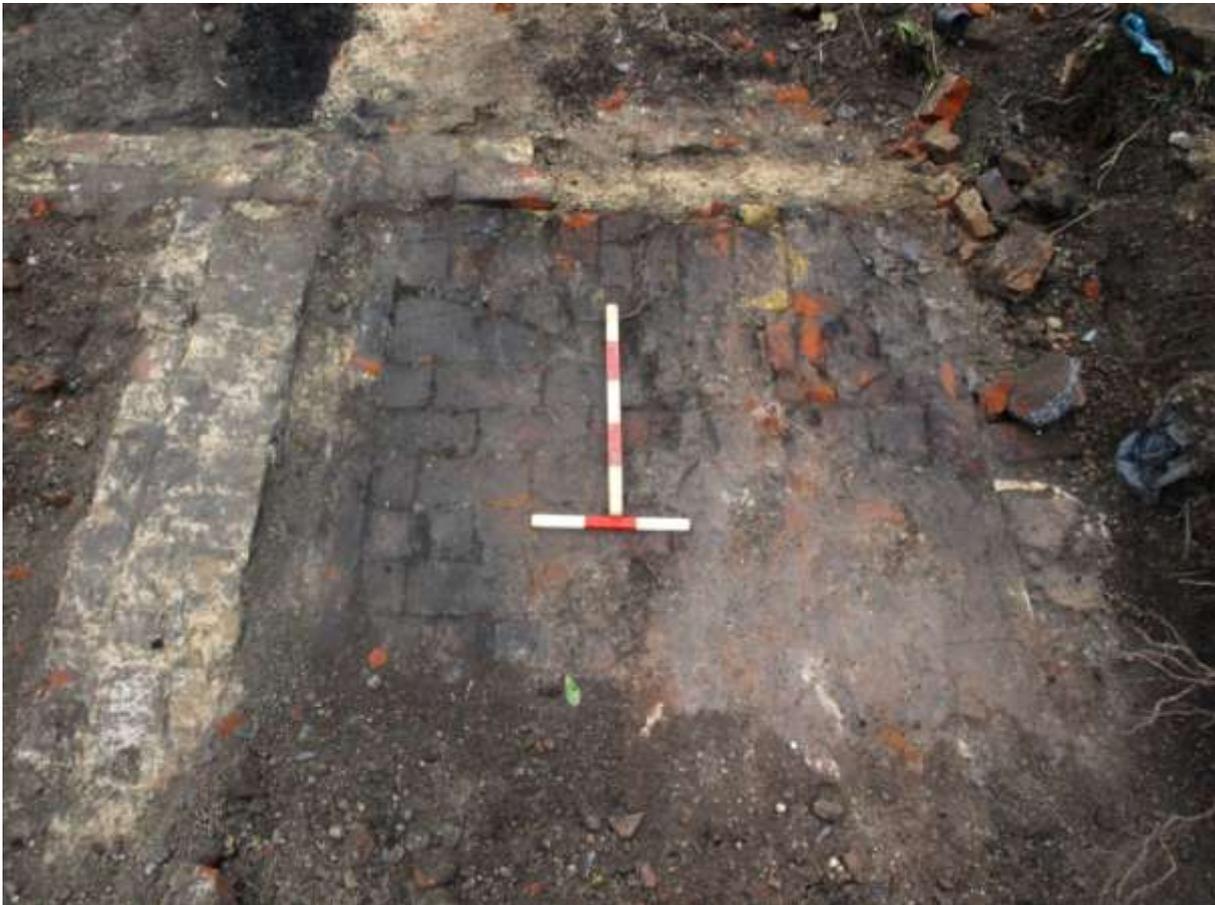
Plate 11: Looking west at brick floor (212) – Room 3.6 exposed in Trench 2

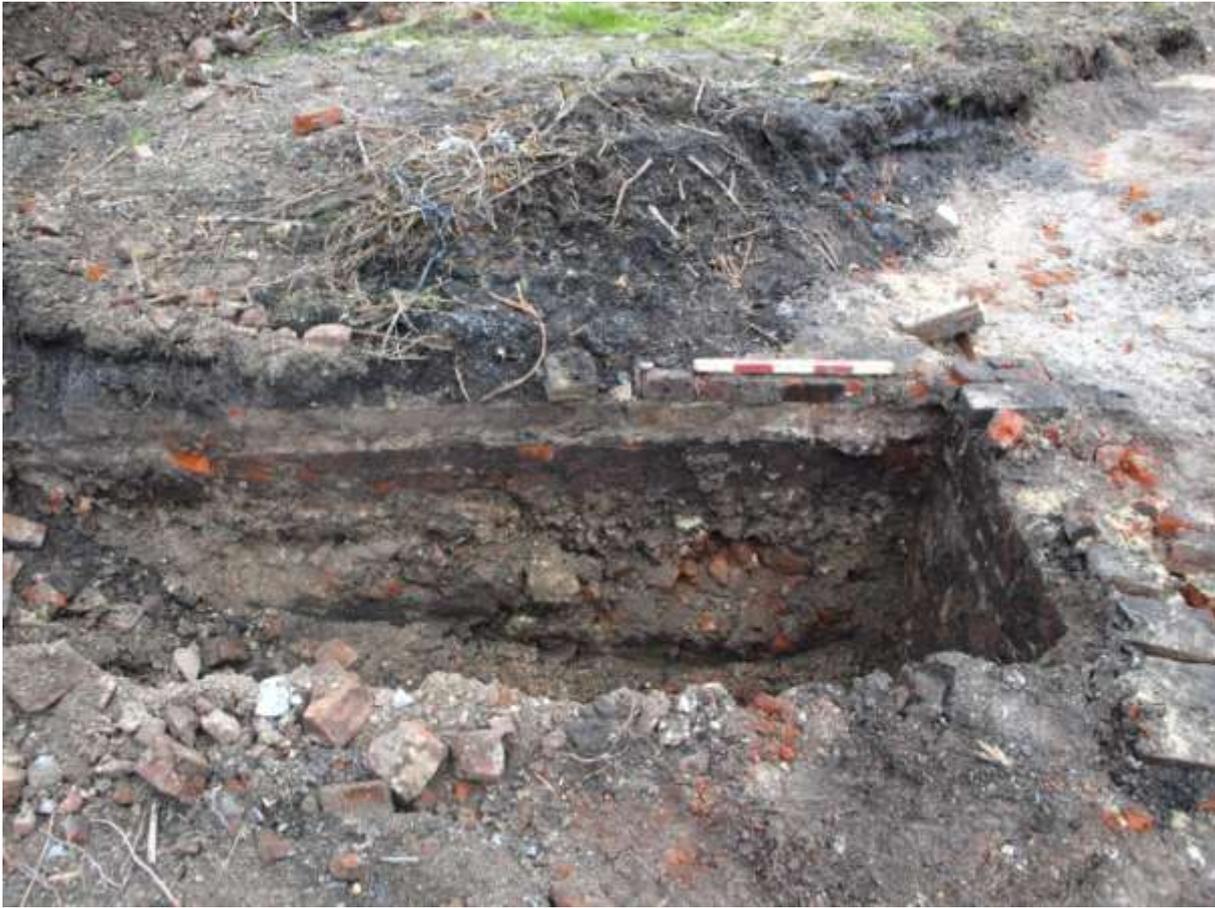
Plate 12: Looking south at Section 4 exposed in Trench 2A

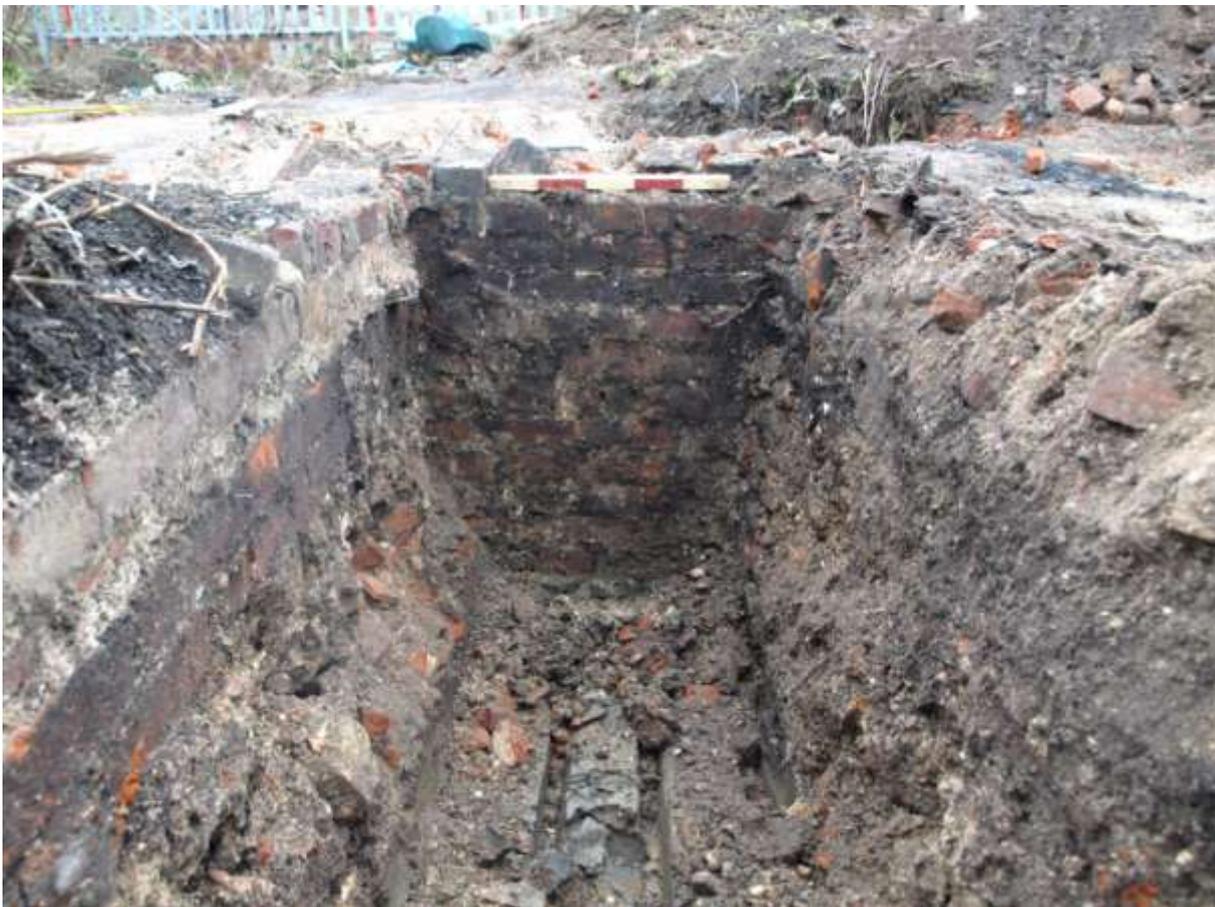
Plate 13: Looking west at elevation of the wall (220) exposed in Trench 2A – Section 5

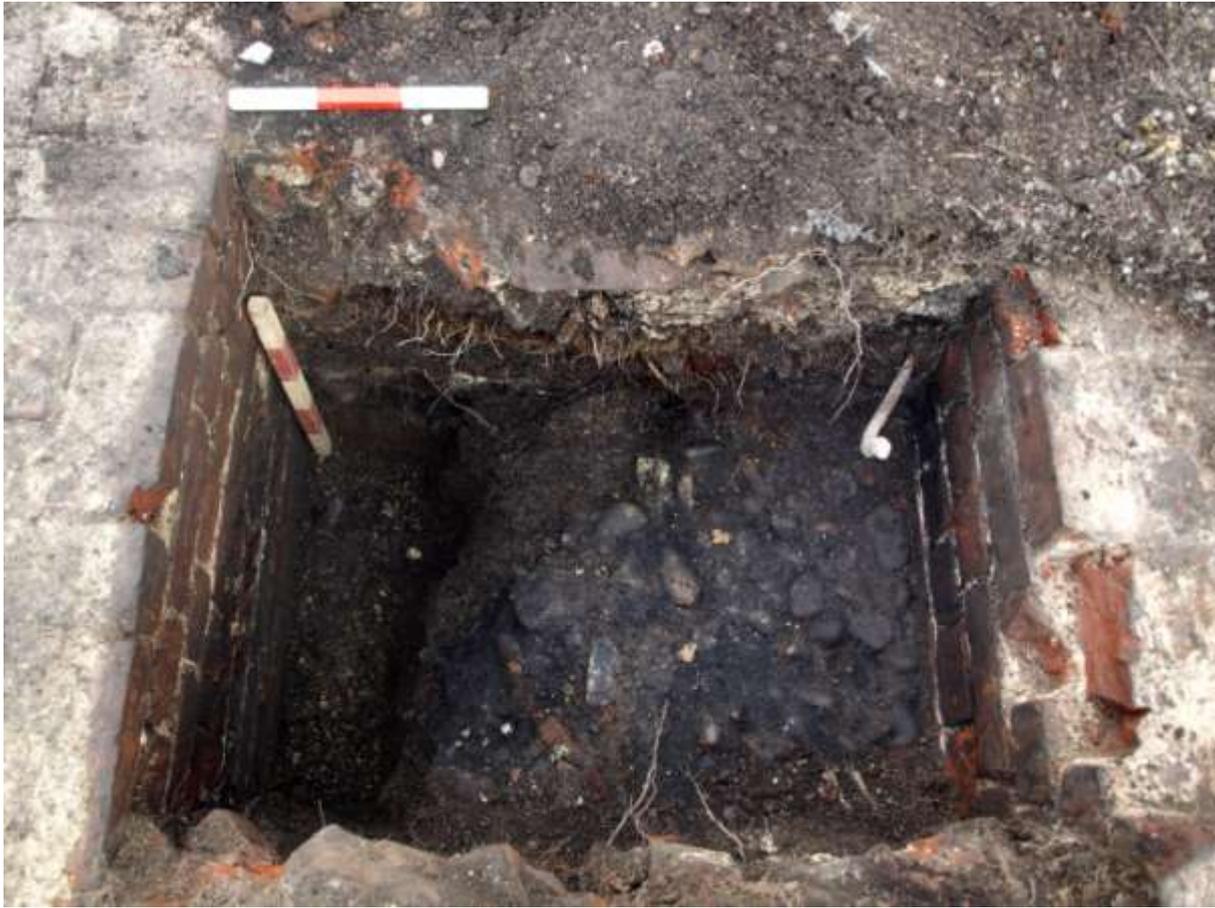
Plate 14: Looking east at pavement (229) exposed in Trench 2C and underlying backfill (230) of the demolished Room 2.1.

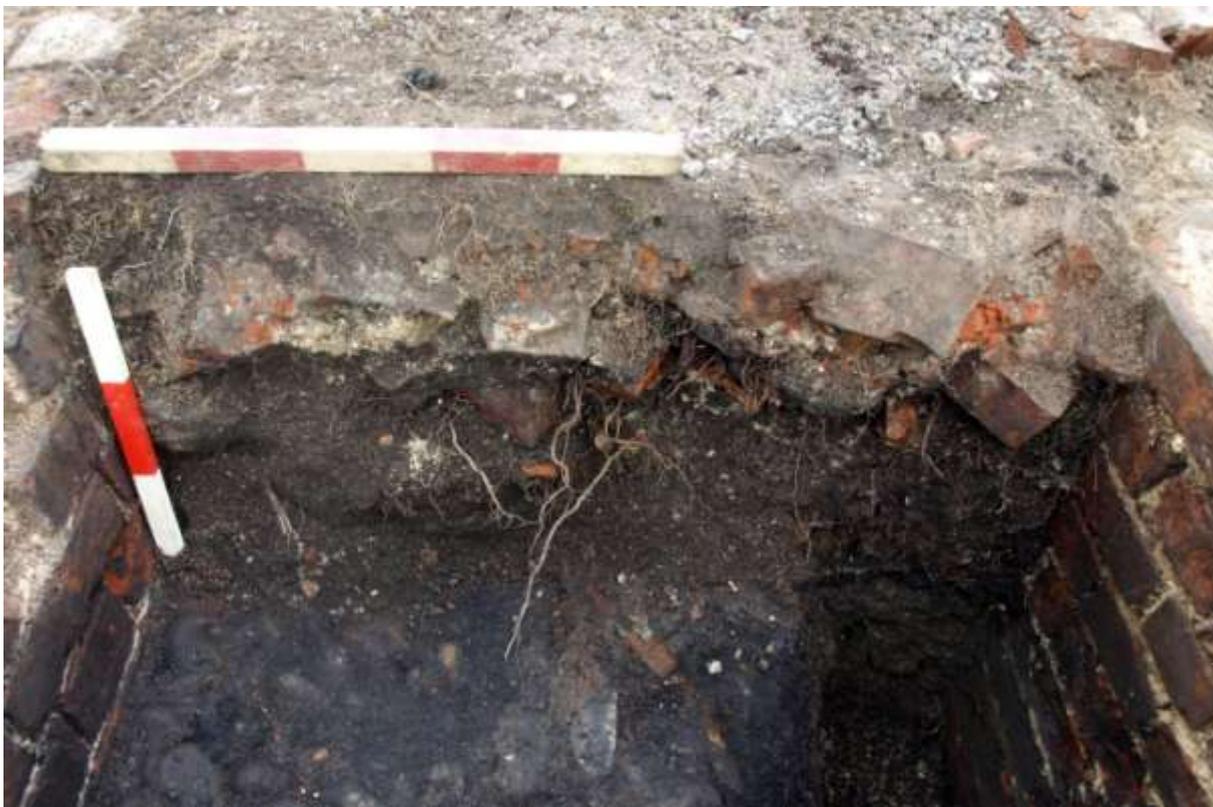
Plate 15: Looking west at Section 8 exposed in Trench 2C
