# Archaeological Evaluation of Land north of Royal Fountain Mews/Hotel, West St, Bluetown, Sheerness, Kent

Site Code: FOUNT/EV/16

(Planning Application: SW/14/0092)

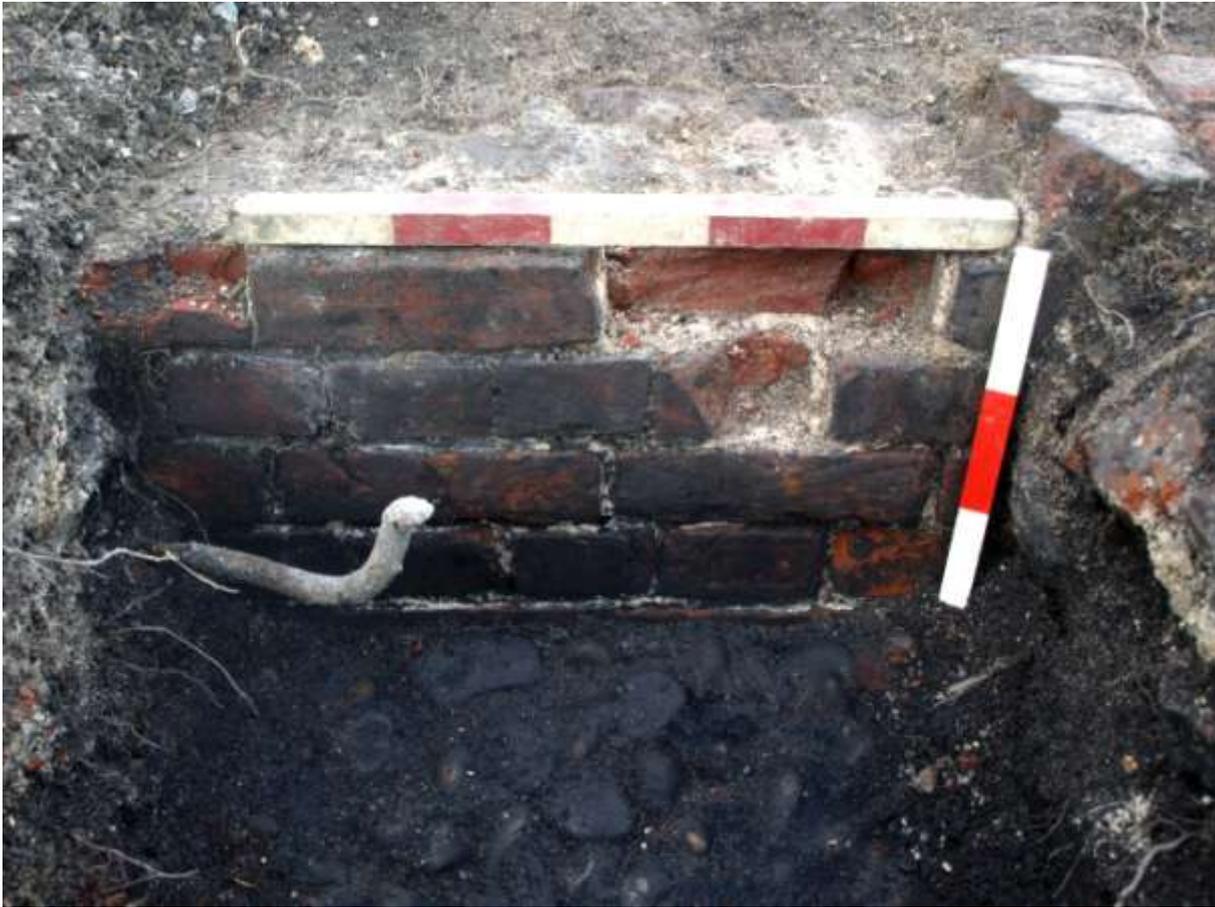
Plate 16: Looking south at elevation of the wall, section 7 (204) exposed in Trench 2C

The area of Section 7 was excavated by hand to a depth of about 0.65m at about 1.05m OD. Part of the surviving cobbled floor (Plate 16 and Figure 9). Above the cobbled floor **[229]** five courses of a brick wall **(204)** with Flemish headers every fourth course, stretchers every second course typical of a English garden bond but with headers every fourth course.

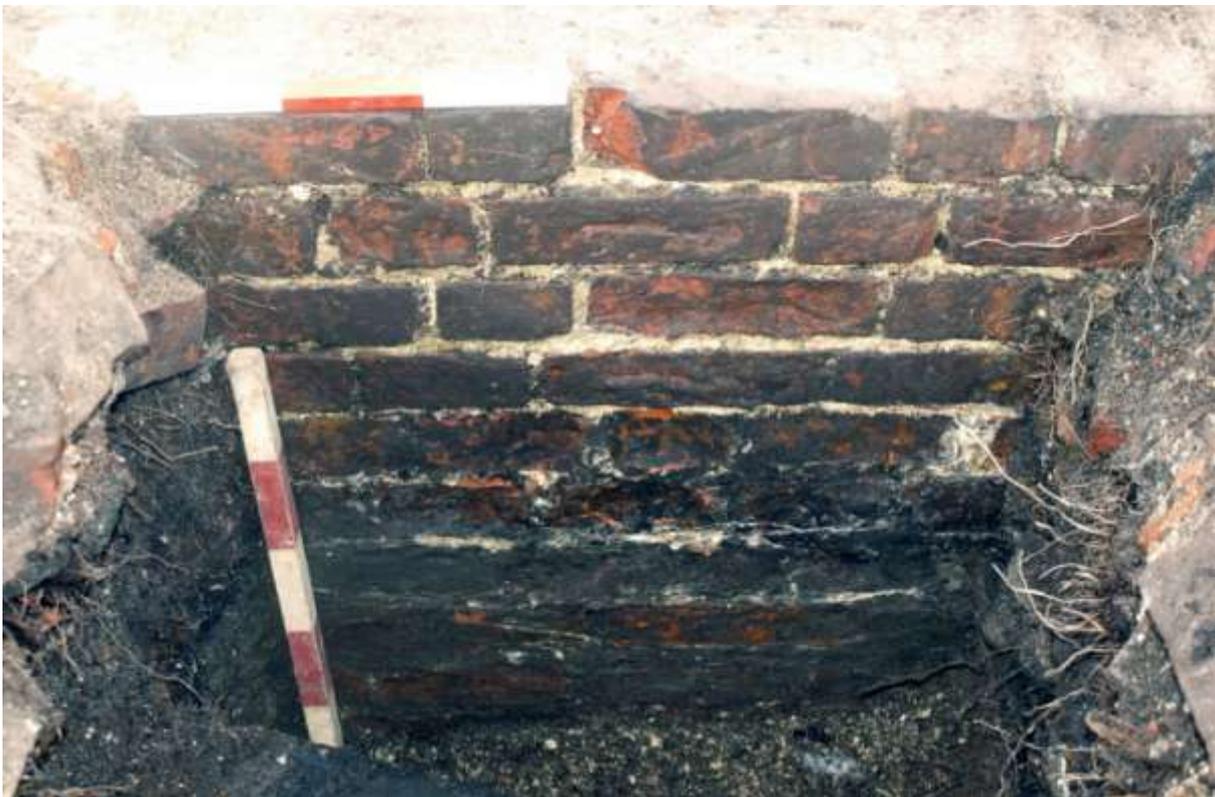
Plate 17: Looking north (Section 9) at elevation of the wall (206) exposed in Trench 2C

The area of Section 9 was also excavated by hand to a depth of about 0.64m at about 1.16m OD and revealed nine courses of laid bricks **[208]** in a header and stretcher pattern (Figure 9 and Plate 17).
