Archaeological Evaluation of Land at St Philip Howard School, 41 Avenue Road, Herne Bay, Kent

Site Code: STP /EV/17

(Planning Application: CA/15/02786)

**Archaeological Evaluation of Land at St Philip Howard School, 41 Avenue
Road, Herne Bay, Kent**

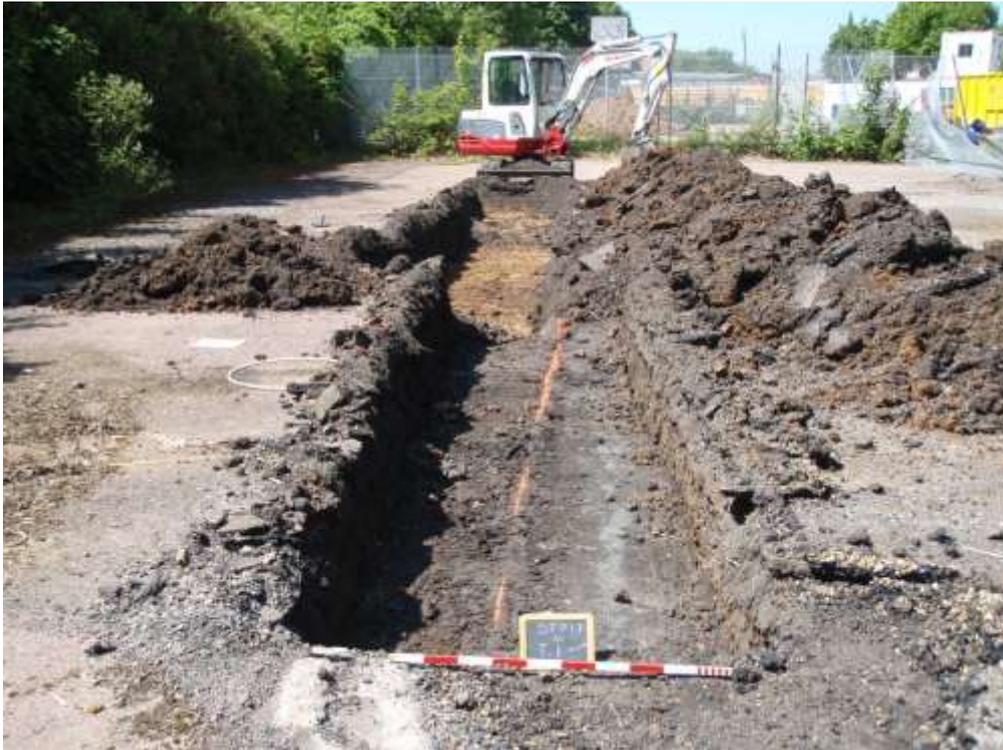
Plate 1. Trench 1 (looking W)

Undisturbed natural geology **(103)** was identified across the trench as light orange brown sandy silt, at a depth of approximately 0.40m (10.20mOD) below the present ground surface at 10.60m OD at the E end of the trench.

The natural geology **(103)** was sealed by a layer of mid brown to orange silty sandy clay with occasional flint subsoil about 0.15m thick **(102)** topped by tarmac overlaying topsoil **(103)** 0.25m thick.

The east end of the trench exposed a modern tarmac surface outlined by red bricks on edge (Plate 0).

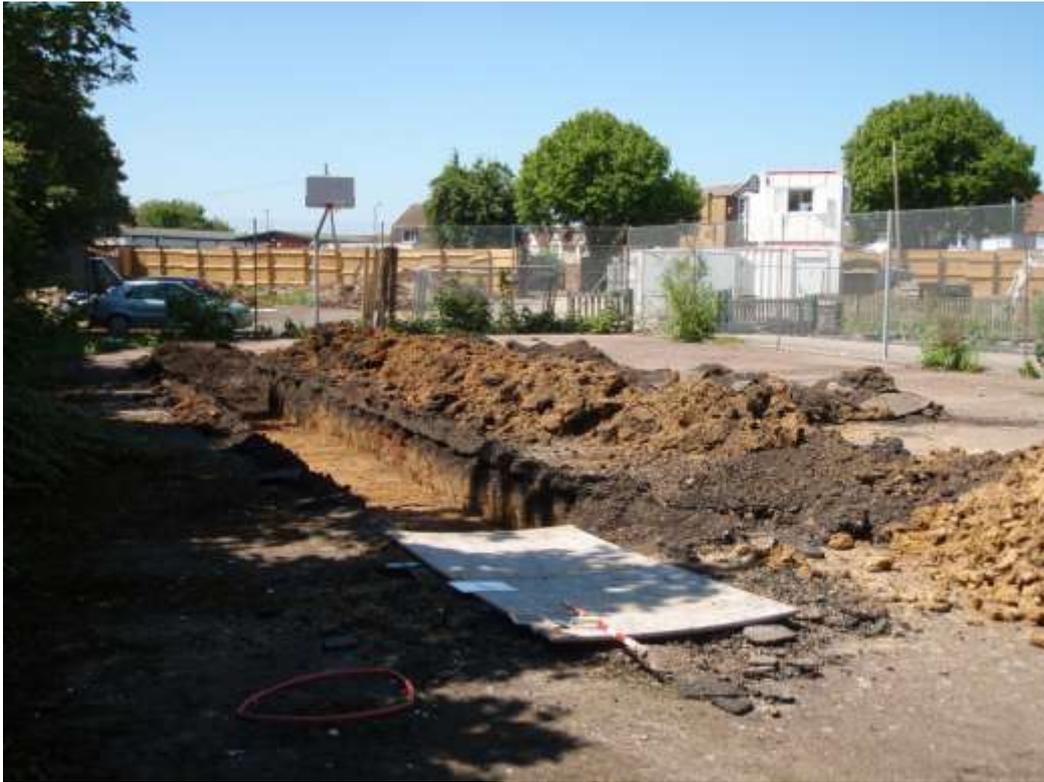
Plate 3. Trench 2 (looking NW)

Undisturbed natural geology **(203)** was identified across the trench as light orange brown sandy silt, at a depth of approximately 0.38m (10.64mOD) below the present ground surface at 11.02m OD at the W end of the trench.

Mid-trench there were some areas of modern burning and dumping (Plate 0).

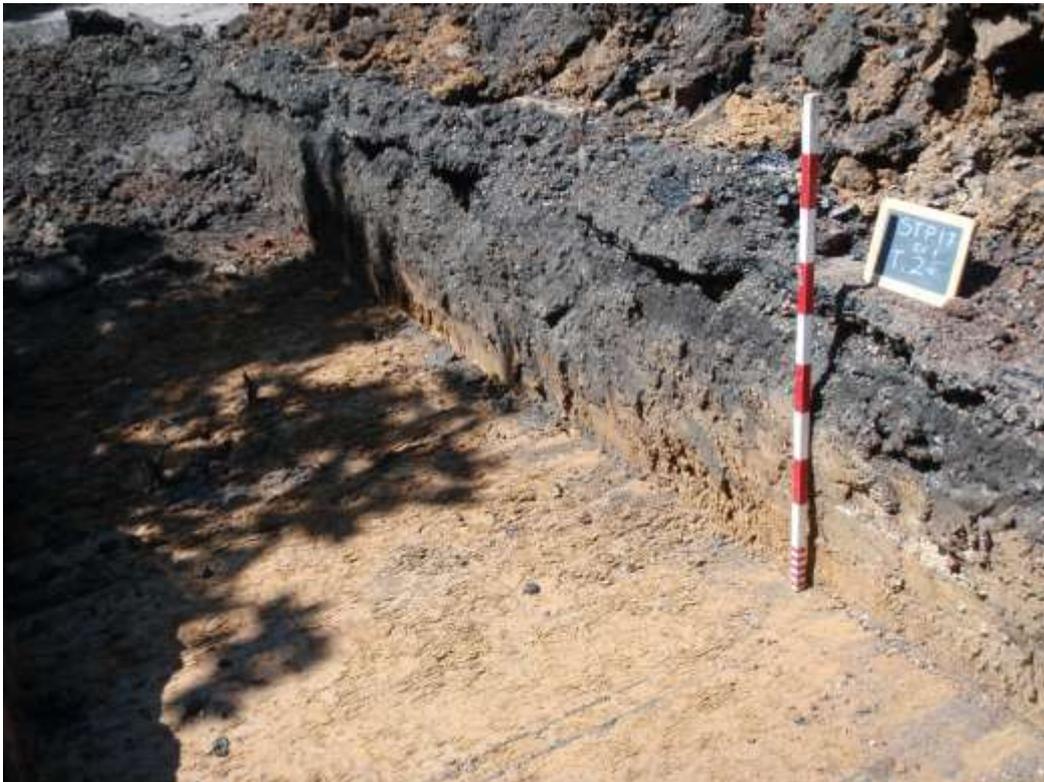
Plate 4. Trench 2 section

The natural geology **(203)** was sealed by a layer of mid brown to orange silty sandy clay with occasional flint subsoil about 0.24m thick **(202)** topped by topsoil overlaid by tarmac **(203)** 0.16m thick.

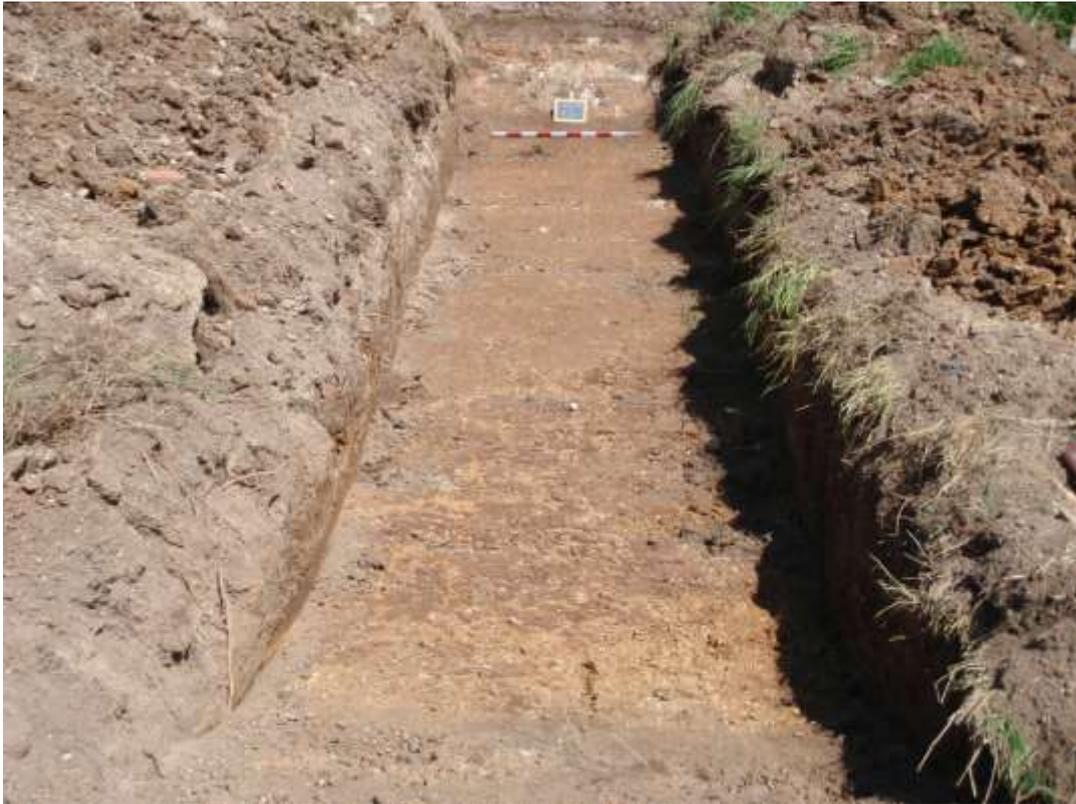
Plate 5. Trench 3 (looking W)

Undisturbed natural geology **(303)** was identified across the trench as light orange brown sandy silt, at a depth of approximately 0.40m (10.38mOD) below the present ground surface at 10.78m OD at the SSW end of the trench.

At the NNE end of the trench there was an area of modern dumping that had impacted on the subsoil (Plate 0).

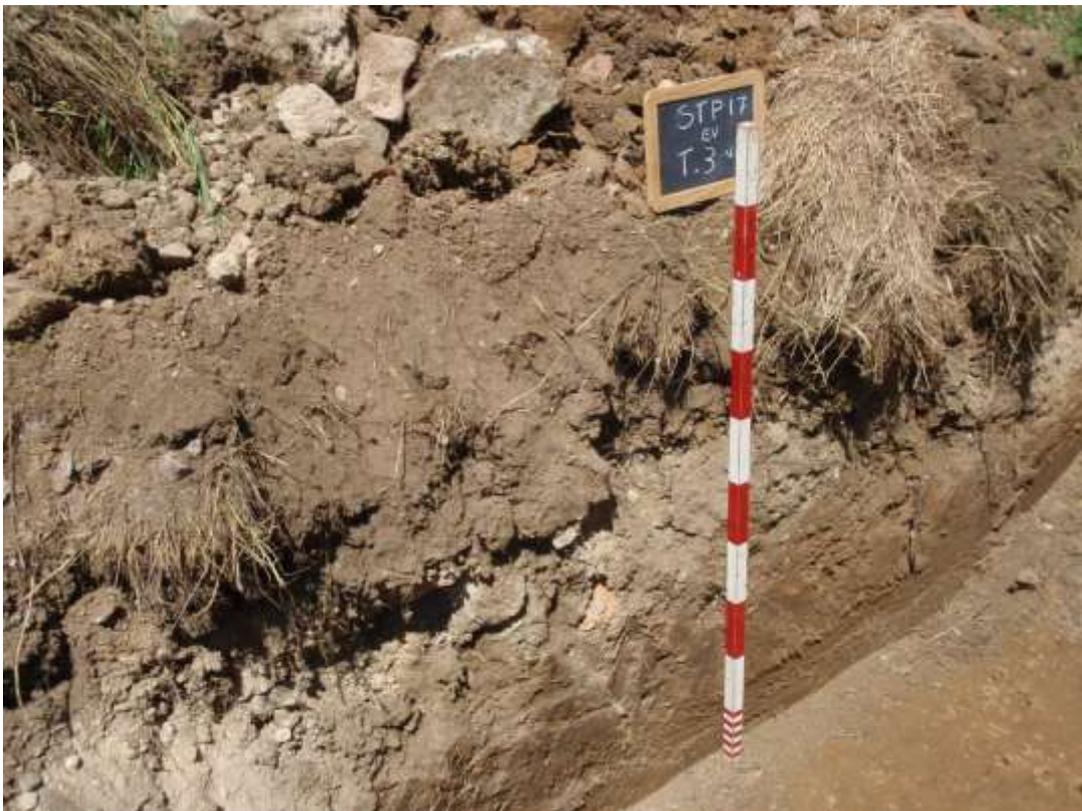
Plate 6. Trench 3 section

The natural geology **(303)** was sealed by a layer of mid brown to orange silty sandy clay with occasional flint subsoil about 0.25m thick **(302)** topped by topsoil **(303)** 0.15m thick.

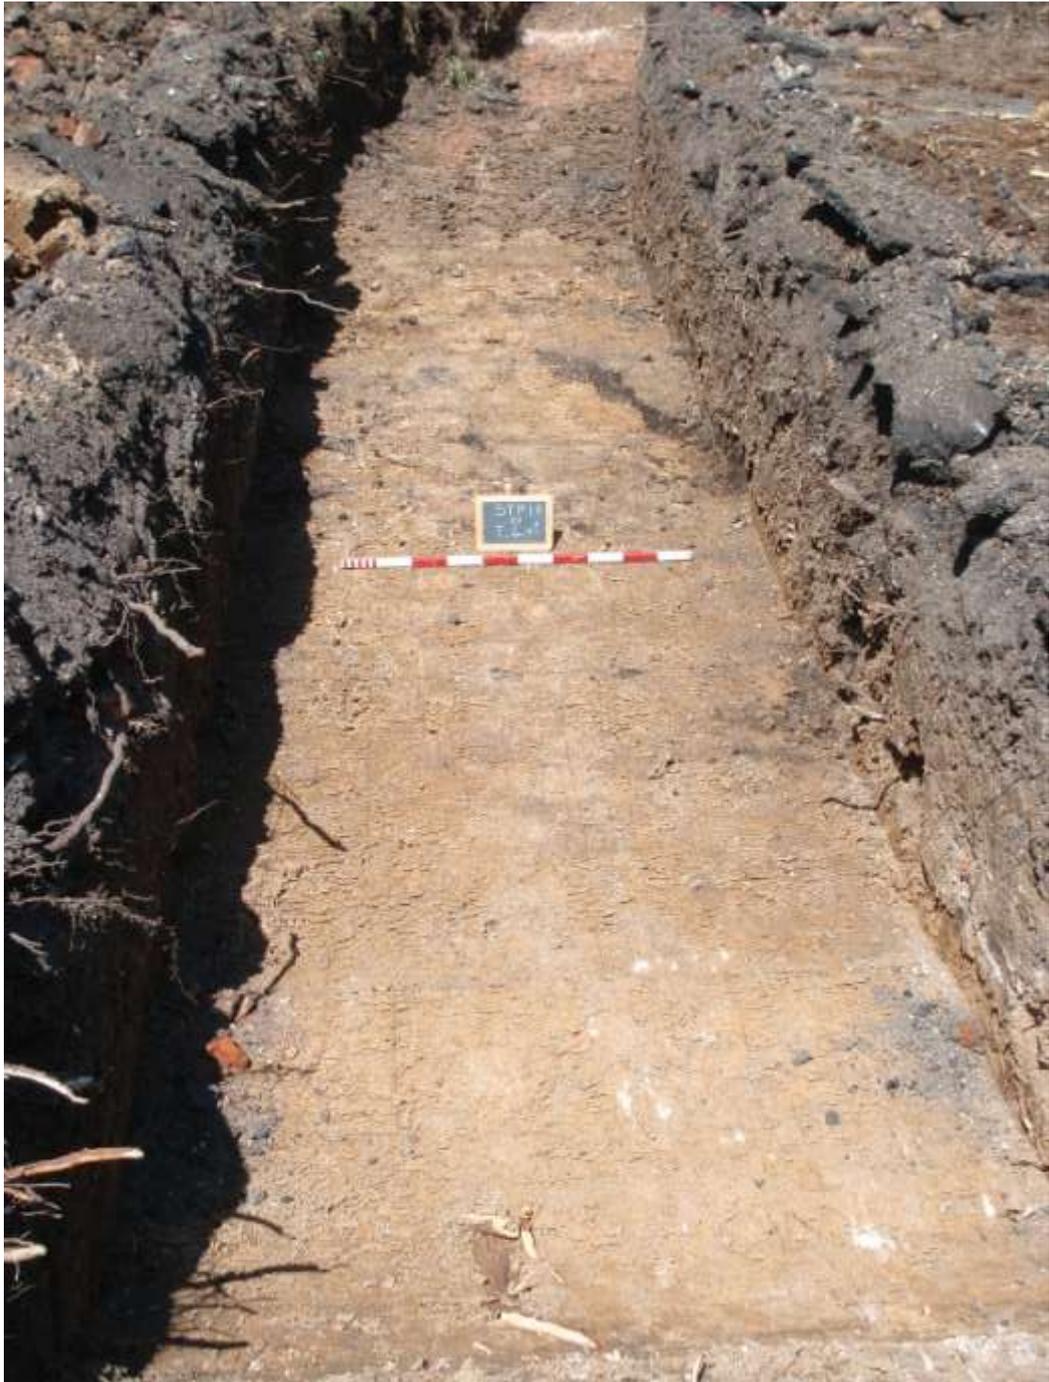
Plate 7. Trench 4 (looking NW)

Undisturbed natural geology **(103)** was identified across the trench as light orange brown sandy silt, at a depth of approximately 0.40m (10.52mOD) below the present ground surface at 10.92m OD at the NW end of the trench.

The natural geology **(103)** was sealed by a layer of mid brown to orange silty sandy clay with occasional flint subsoil about 0.23m thick **(102)** topped by topsoil **(103)** 0.15m thick. The NW end of the trench exposed modern dumping of building materials (Plate 0).

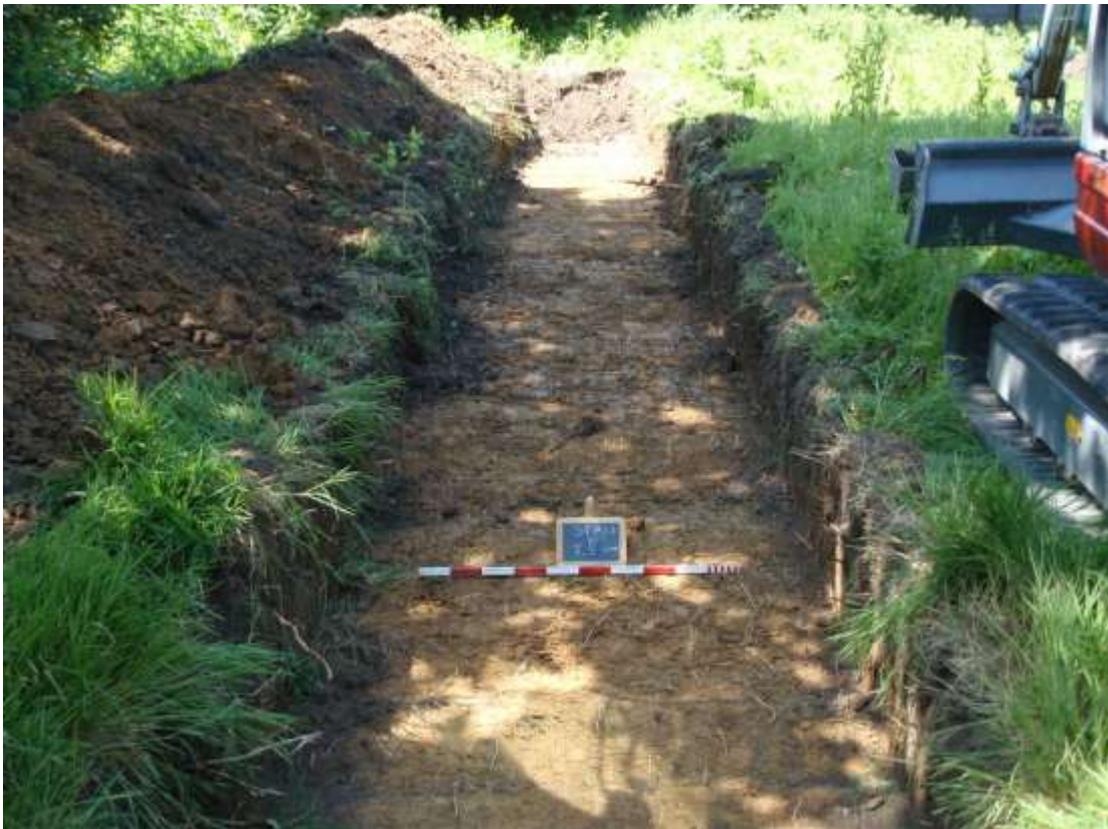
Plate 9. Trench 5 (looking W)

Undisturbed natural geology **(403)** was identified across the trench as light orange brown sandy silt, at a depth of approximately 0.42m (10.61mOD) below the present ground surface at 10.99m OD at the W end of the trench.

The natural geology **(403)** was sealed by a layer of mid brown to orange silty sandy clay with occasional flint subsoil about 0.28m thick **(402)** topped by topsoil **(403)** 0.14m thick. A large dump of concrete pieces had been cut into the subsoil.

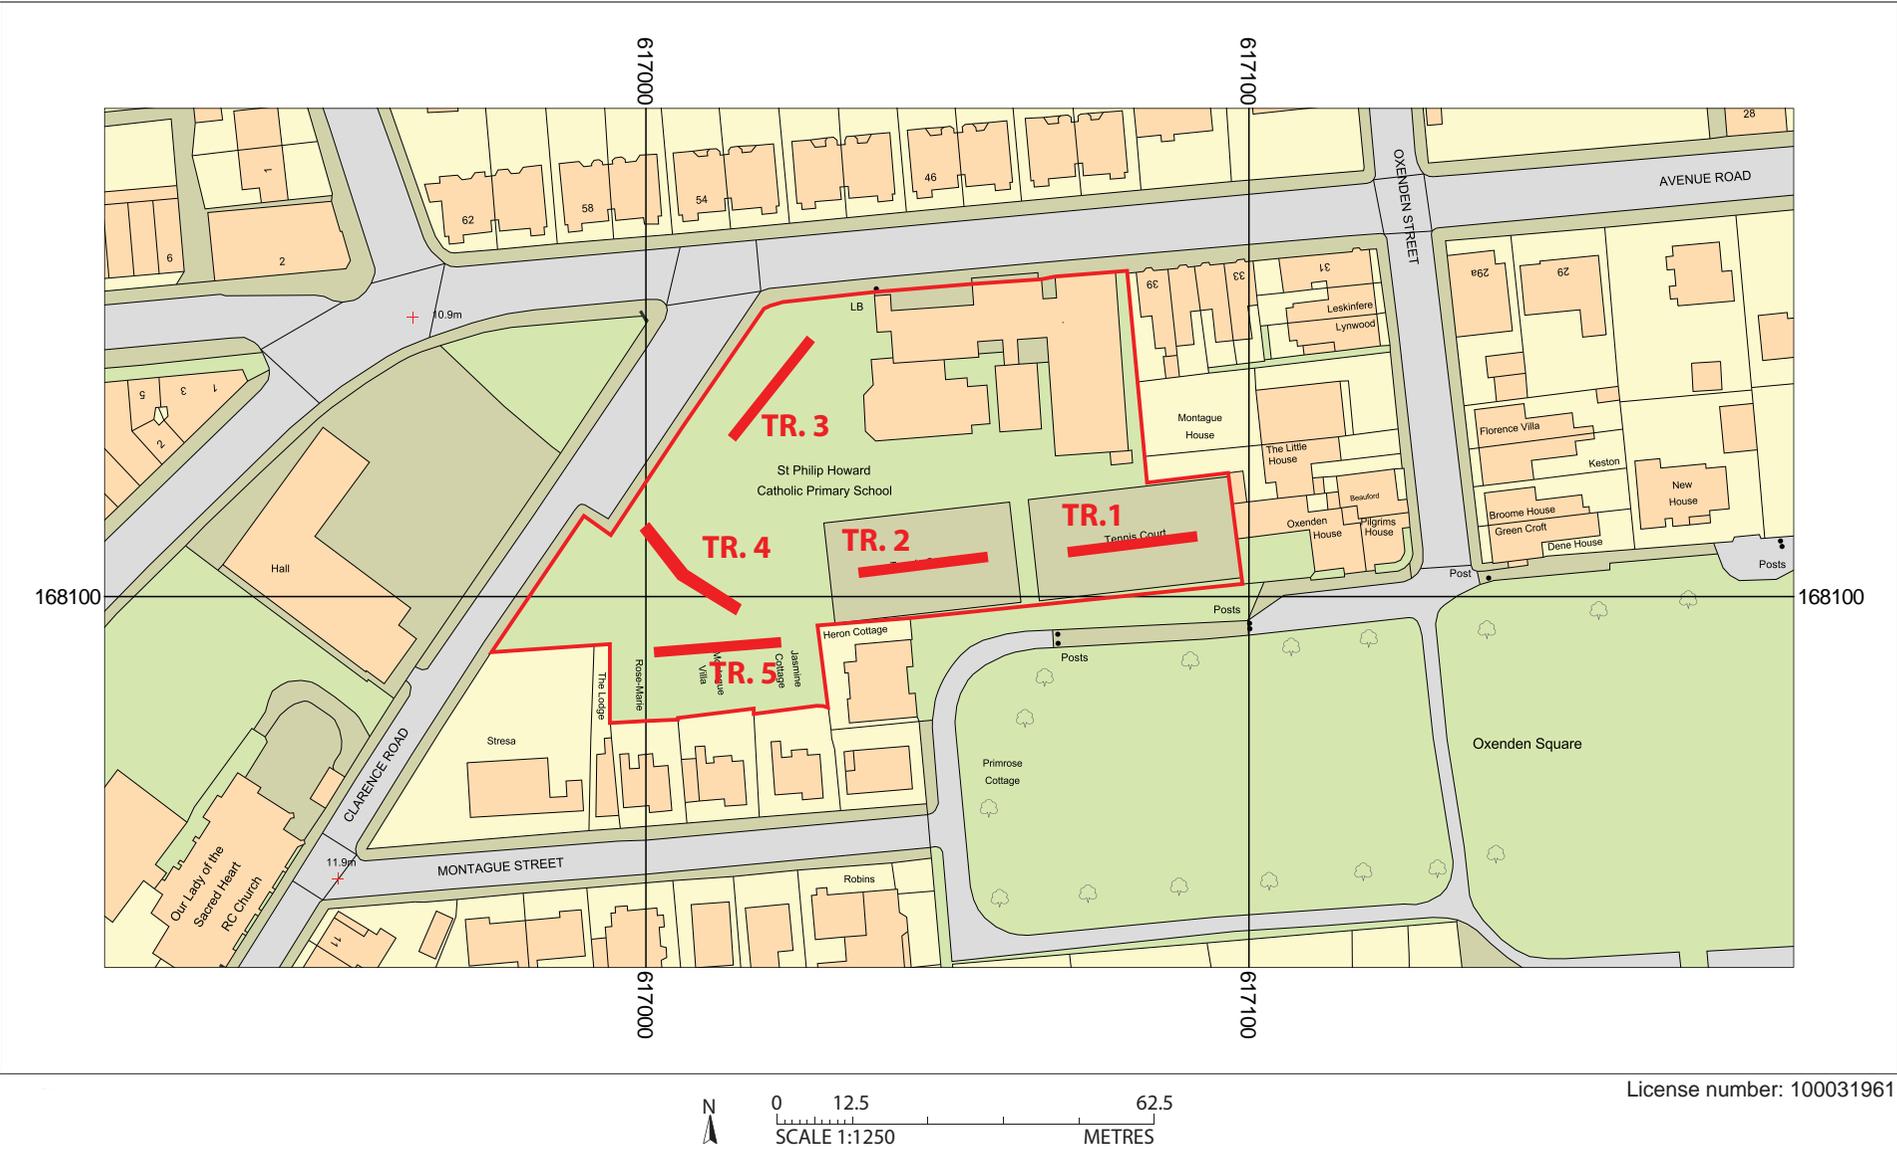
Figure 2: Trench location plan, scale 1:1250

The evaluation comprised 5 machine excavated trenches (19-26m x 1.8m) in a layout agreed with the City Archaeologist. The sixth evaluation trench could not be done as the contractor's site offices were located in this area. However, the other five trenches were

The plan is recorded in Figure 2 (see also Plate 4). The trench lay on an EW alignment and measured approximately 25m by 1.40m.

The plan is recorded in Figure 2 (see also Plate 5). The trench lay on an EW alignment and measured approximately 25m by 1.40m.

The plan is recorded in Figure 2 (see also Plate 6). The trench lay on an NNE alignment and measured approximately 26m by 1.40m.

The plan is recorded in Figure 2 (see also Plates 8, 9). The trench lay on an NW alignment and measured approximately 28m by 1.40m.

The plan is recorded in Figure 2 (see also Plate 7). The trench lay on an EW alignment and measured approximately 26m by 1.40m.
