**HISTORIC BUILDING RECORDING OF THE OLD
POLEGATE STATION, STATION ROAD, POLEGATE,
EAST SUSSEX**

Date of report 30.05.2017

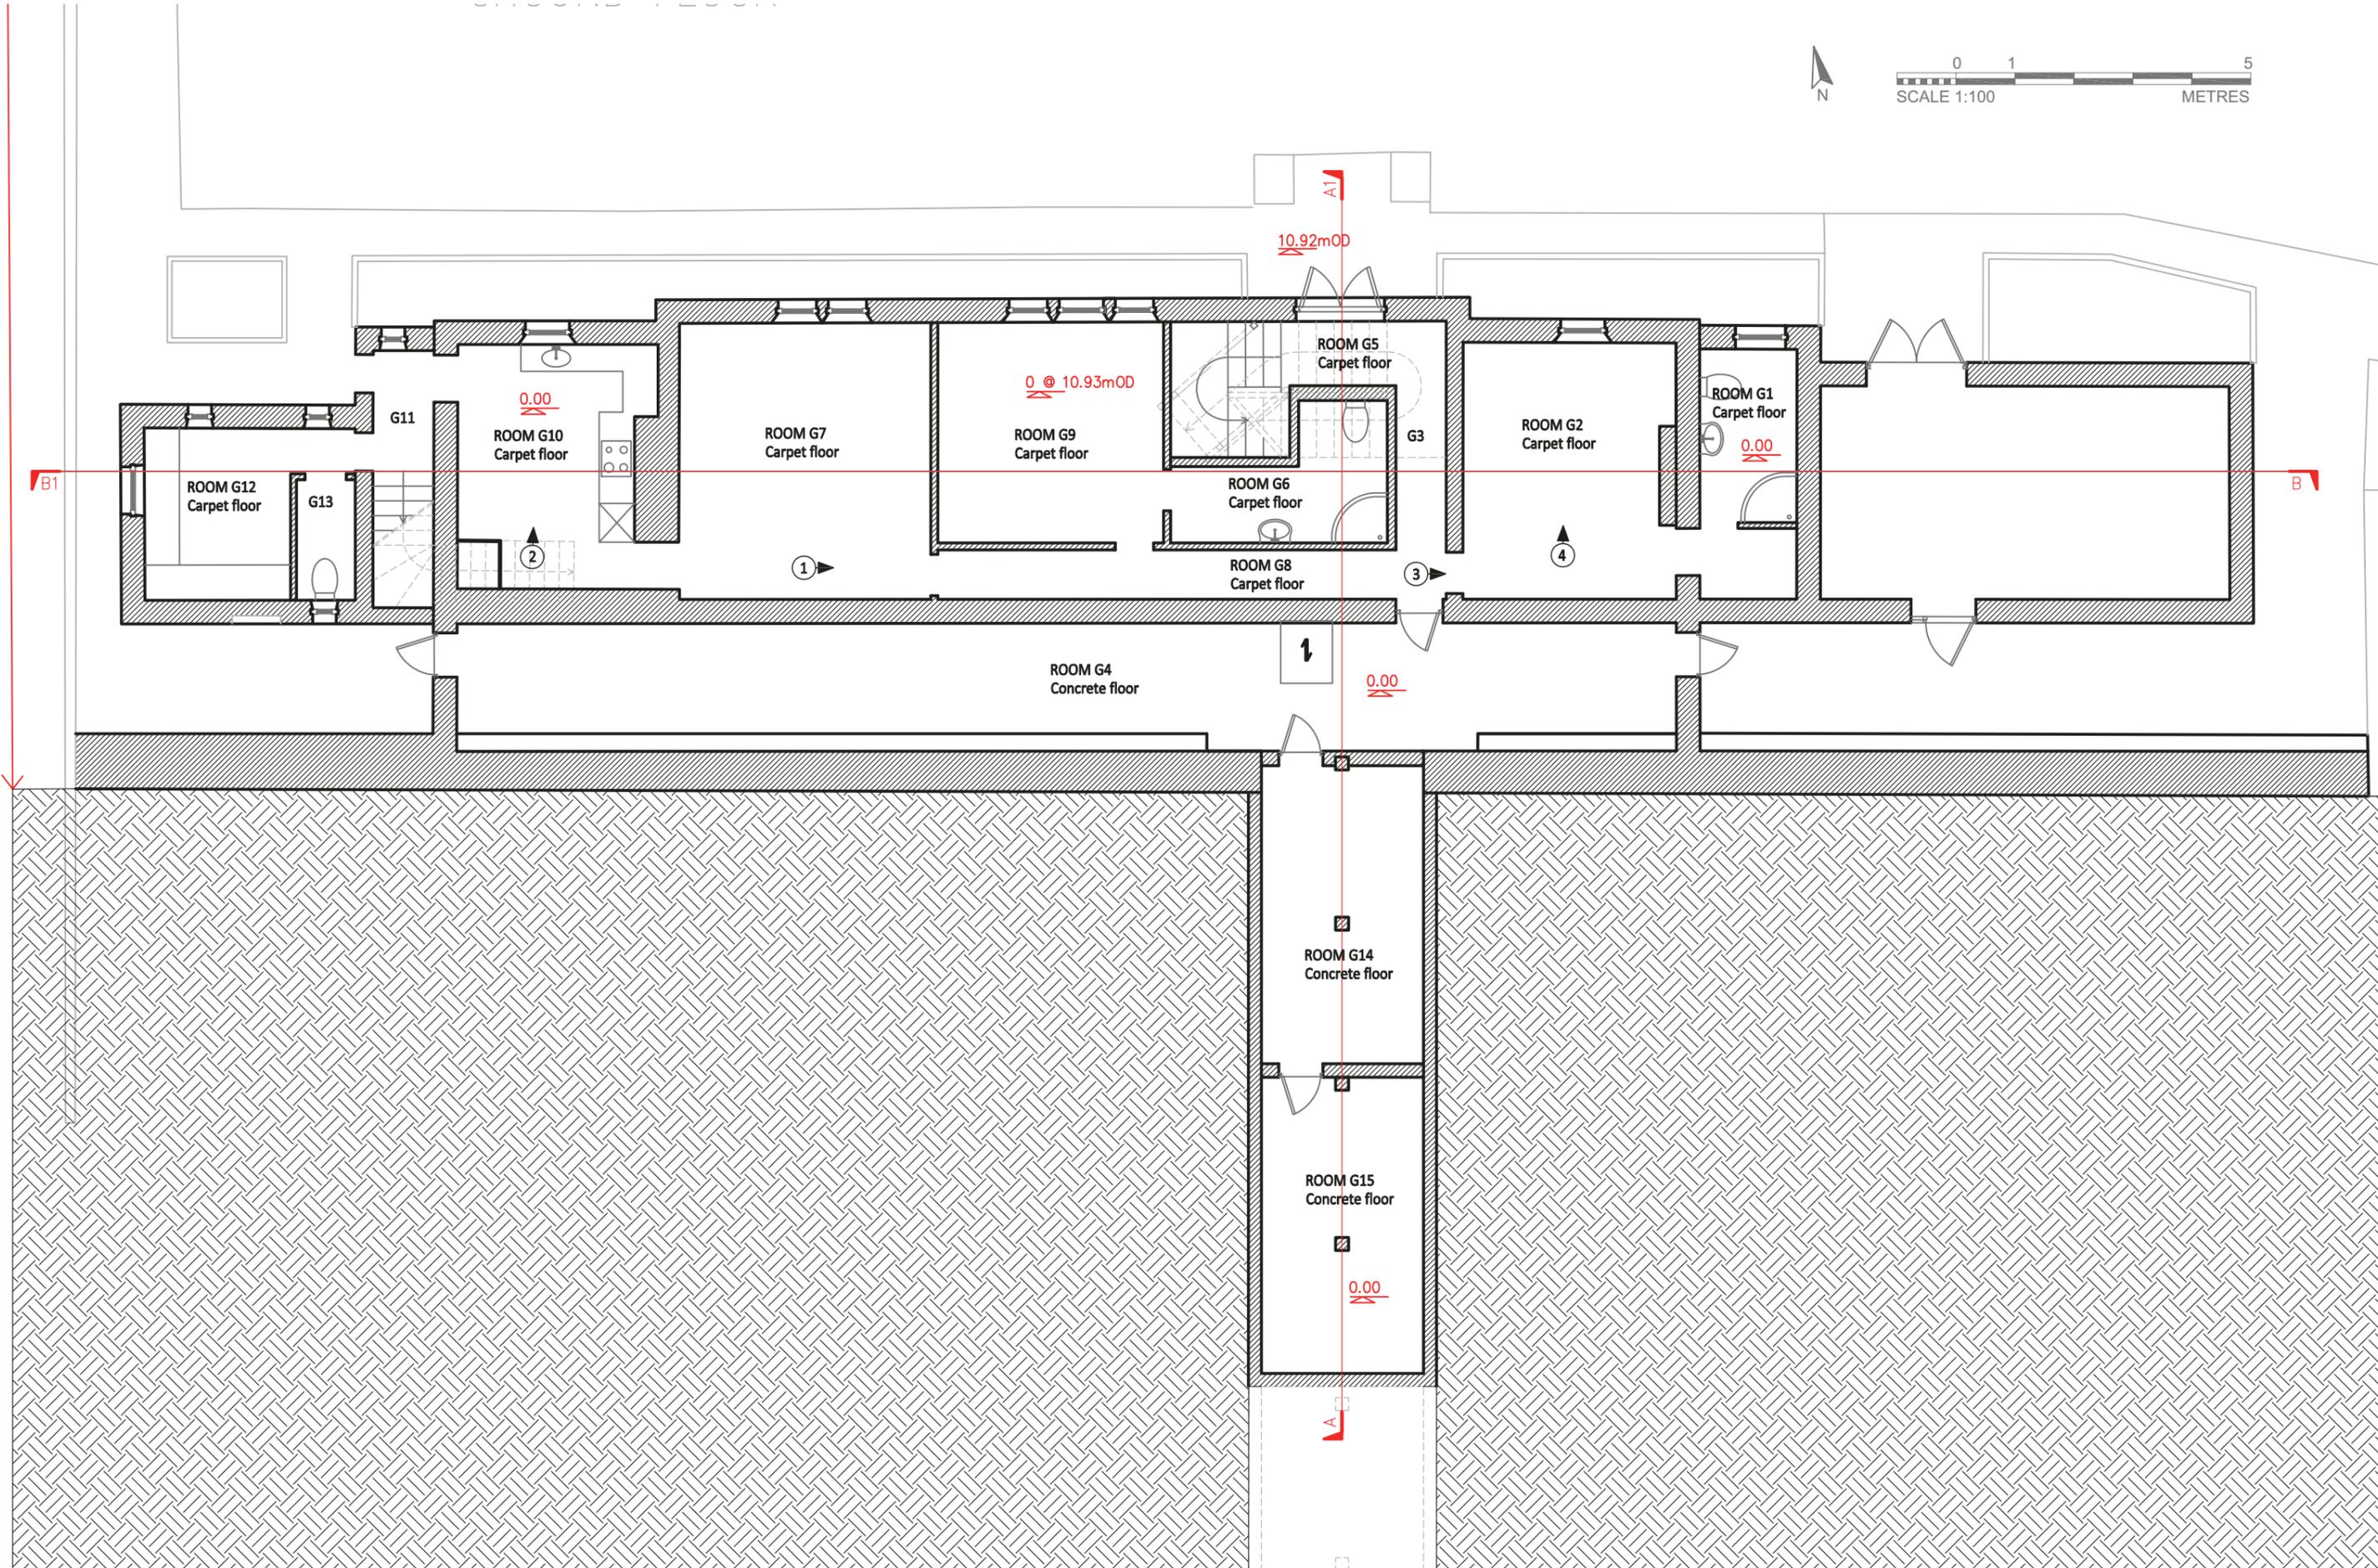
Figure 3: Ground floor plan

4.1 The Old Railway Station is on two floors. The ground floor has been divided into nine rooms, with two corridors and a small entrance lobby that appears to have been used as living accommodation. In addition to these rooms there is a long narrow room at the southern side of the property, which houses a lift which appears to supply the restaurant on the first floor with tableware.

In the centre of the southern wall of this room there is the partially sealed entrance to the subway/tunnel which leads to the platform on the southern side of the railway track. A short length of the subway/tunnel is still accessible, this having been divided in to two rooms. The first floor consists of restaurant, with the kitchen located in the south-western corner of this floor. The only other two rooms on this floor are the ladies and gentlemen's W.C.

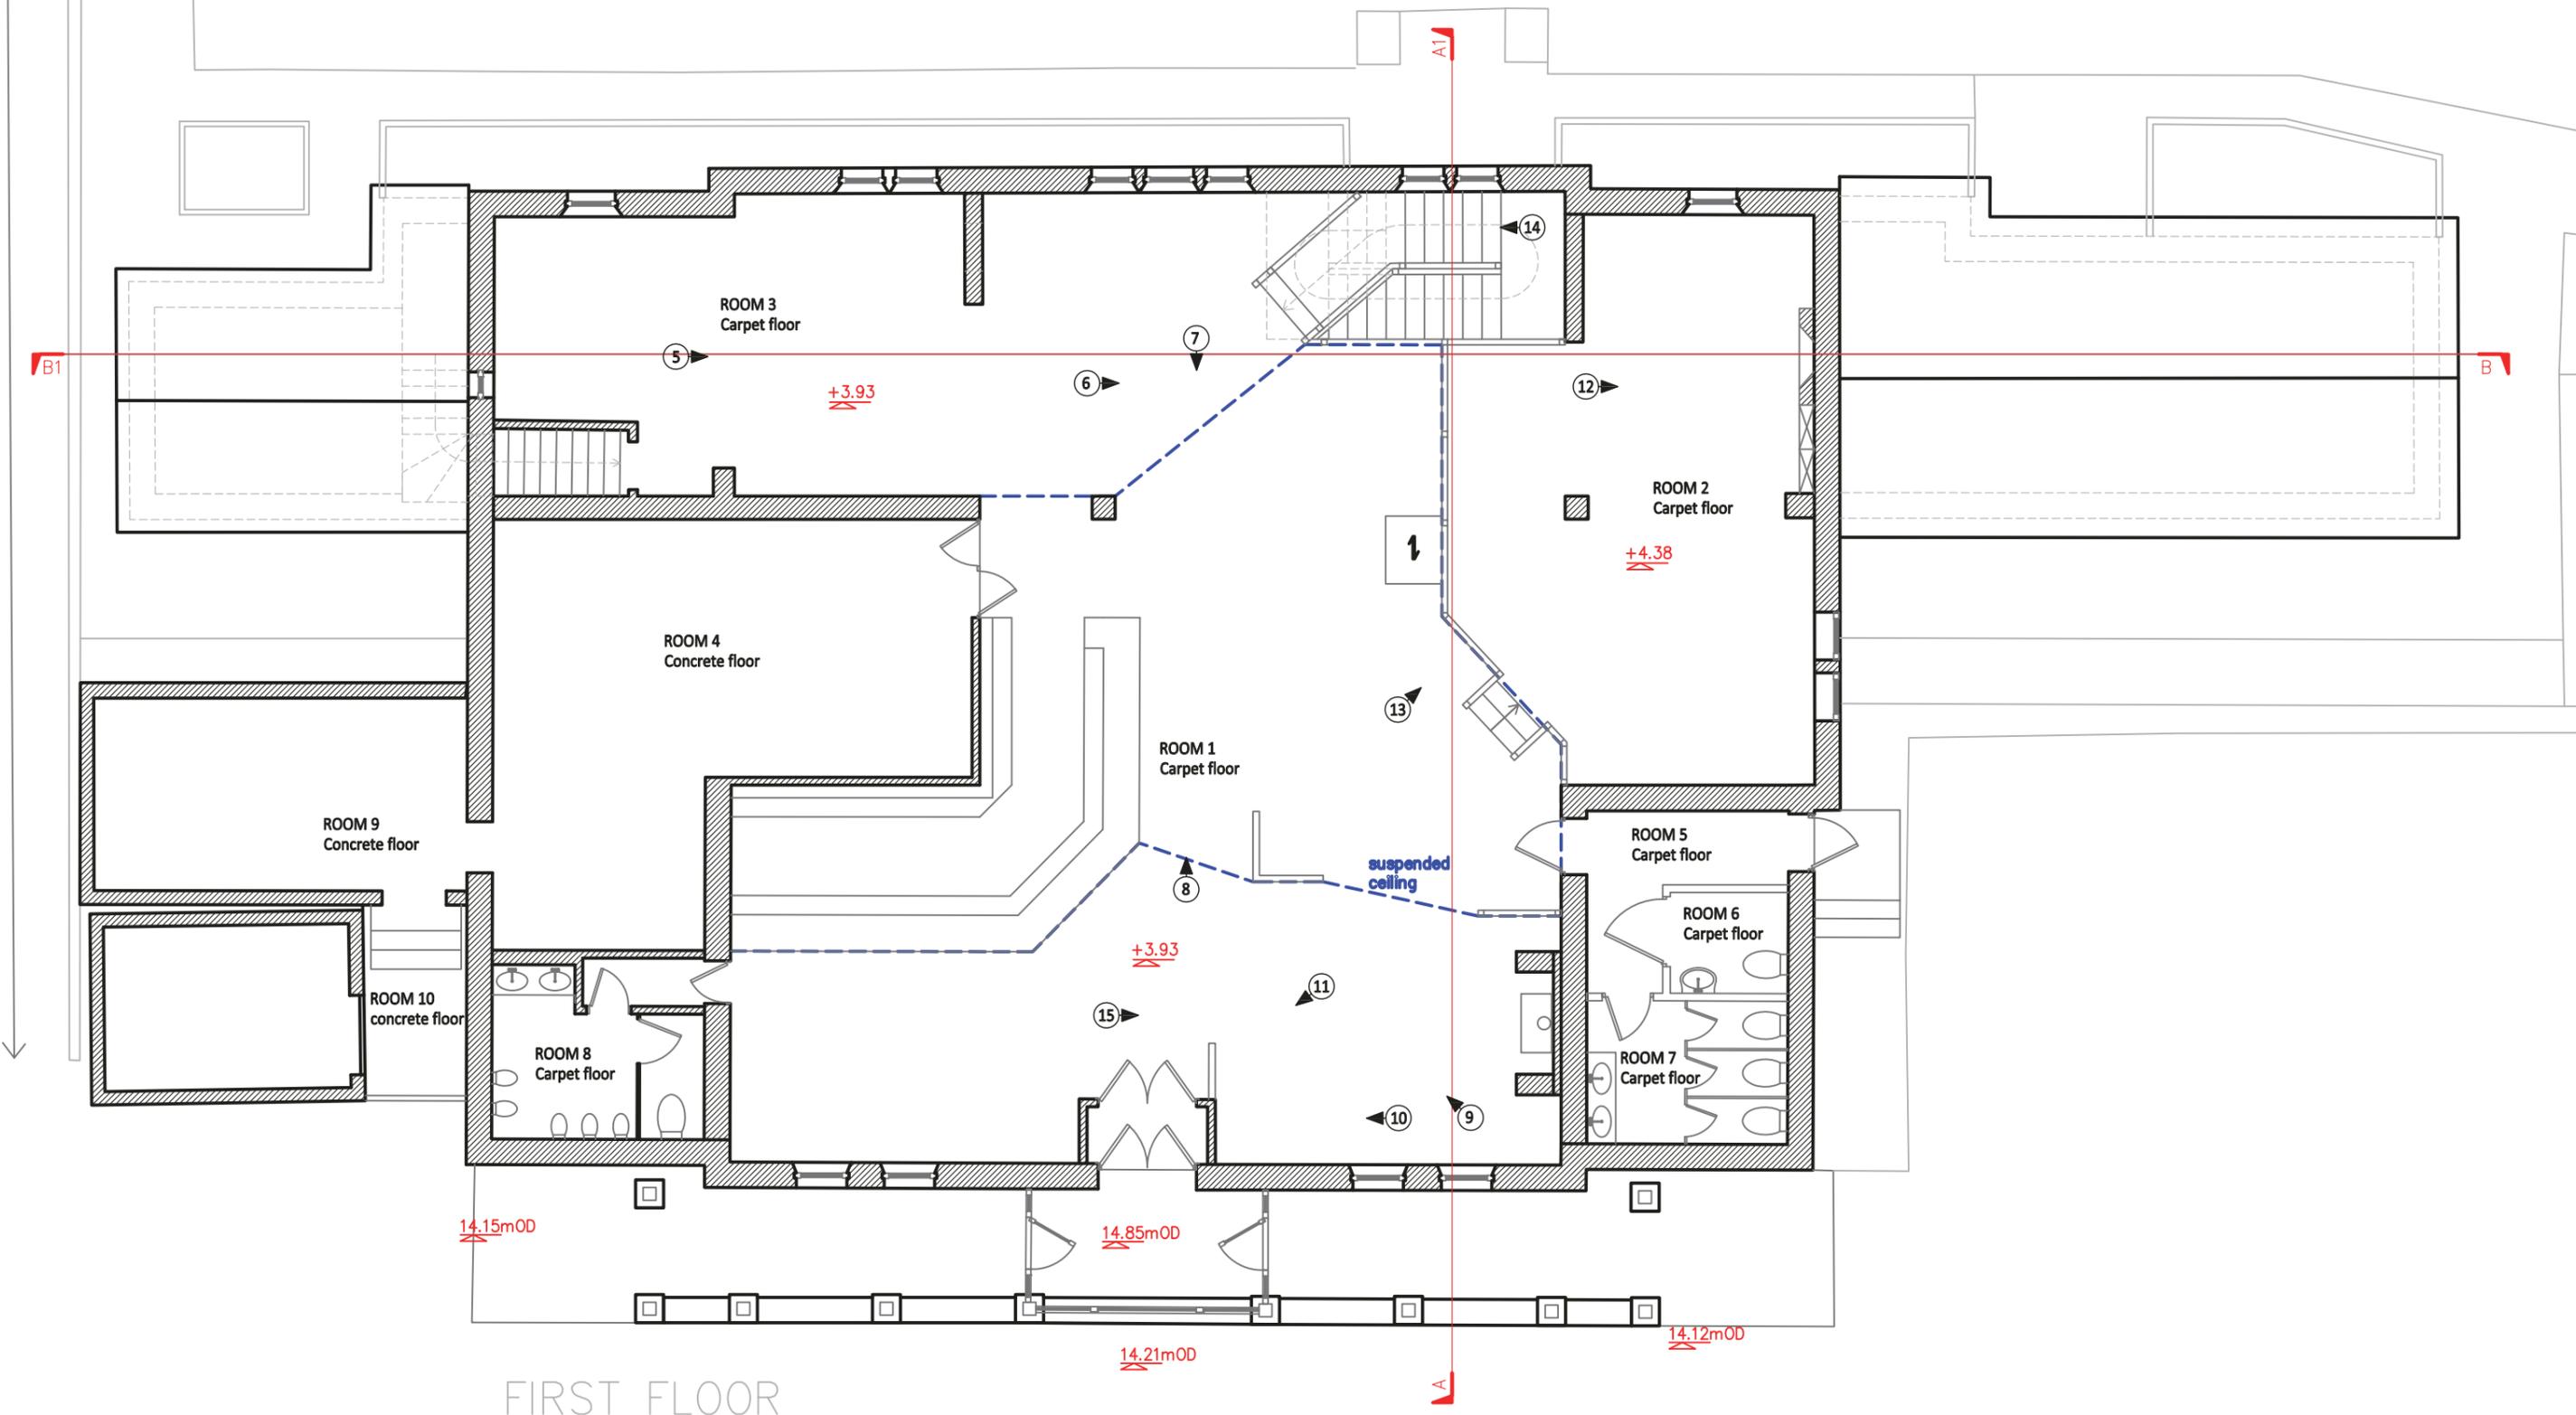
FIRST FLOOR

The main room on this floor is the restaurant. This is 'L' shaped with the eastern end being raised on a platform 450mm above the floor level of the main body of the room. The raised area is reached by three low steps located in the south-western corner of it. The raised area is surrounded by a barrier constructed of wooden hand rail which is supported by turned wooden balustrades, and square section newel posts with a ball finial. The balustrades, handrail and newel posts are of the same type as used on the north-eastern staircase (Plates 5, 6, 7, 8, 9).

The main body of the room is 'L' shaped with the kitchen being located in the south-western corn of this floor. The exterior eastern and southern walls of the kitchen have the restaurant bar adjacent to them. This is of brick construction with a wooden top, and has wooden cupboards and shelving units with mirrors behind them (Plate 9).

The wall of both the raised area and the main body of the room are plaster with wall paper. This is a mixture of smooth and embossed paper and all being painted. The walls all have wooden moulded picture frames and dado rails attached, and also skirting boards with a moulded upper part. The ceiling has a modern plastered finish and is fitted with sunken halogen lights. Parts of the south-eastern corner of the main part room have been partitioned off with low wooden partitions, which have their upper parts with stain glass panels (at the time of this survey these had been smashed but appear to of had a floral design. The floor is carpeted (Plates 9, 10).

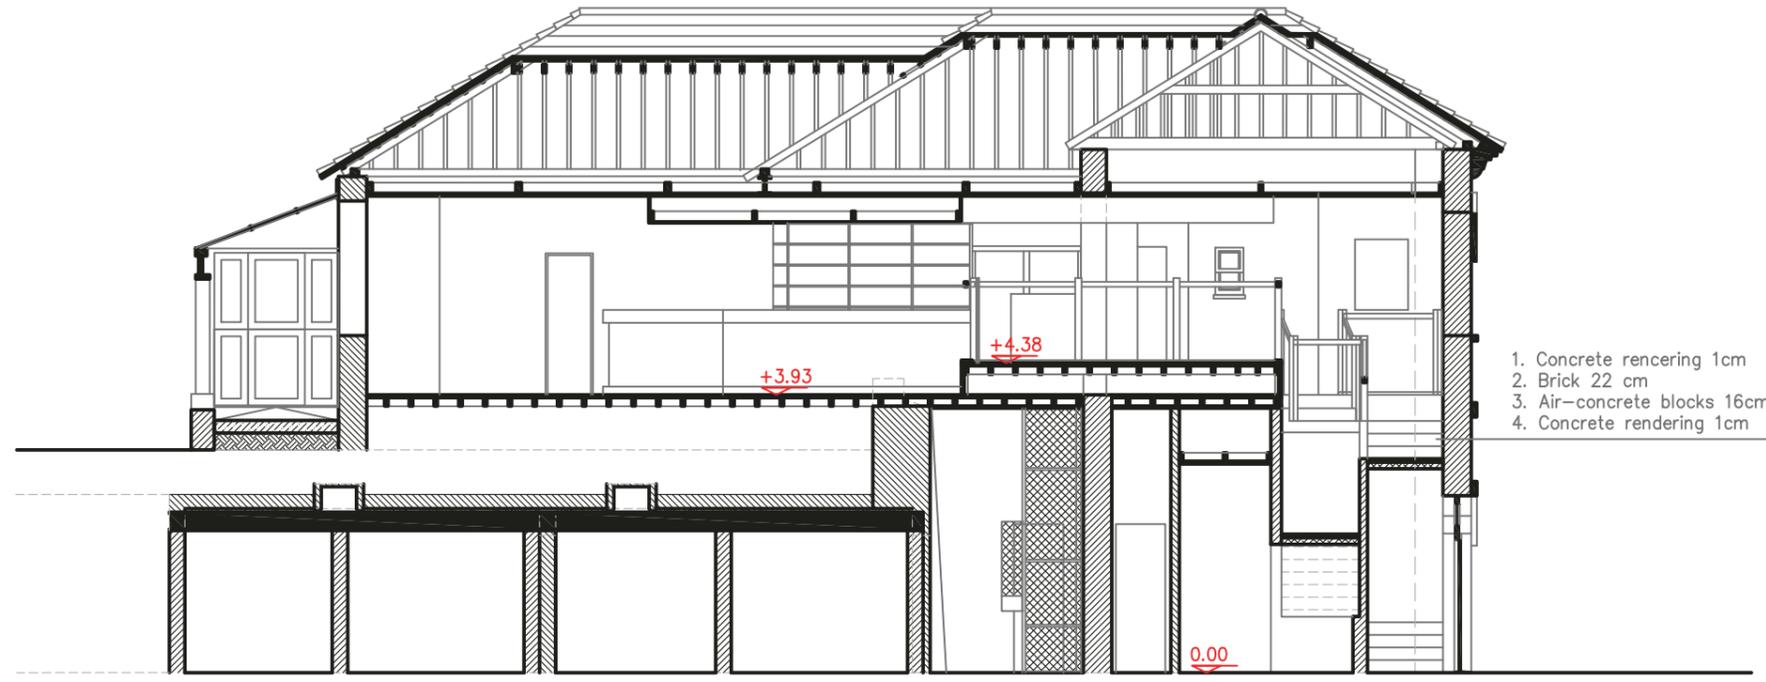
SECTION A-A1

CROSS-SECTION OF
SUBWAY TUNNEL

1. Concrete rendering 1cm
2. Brick 22 cm
3. Air-concrete blocks 16cm
4. Concrete rendering 1cm

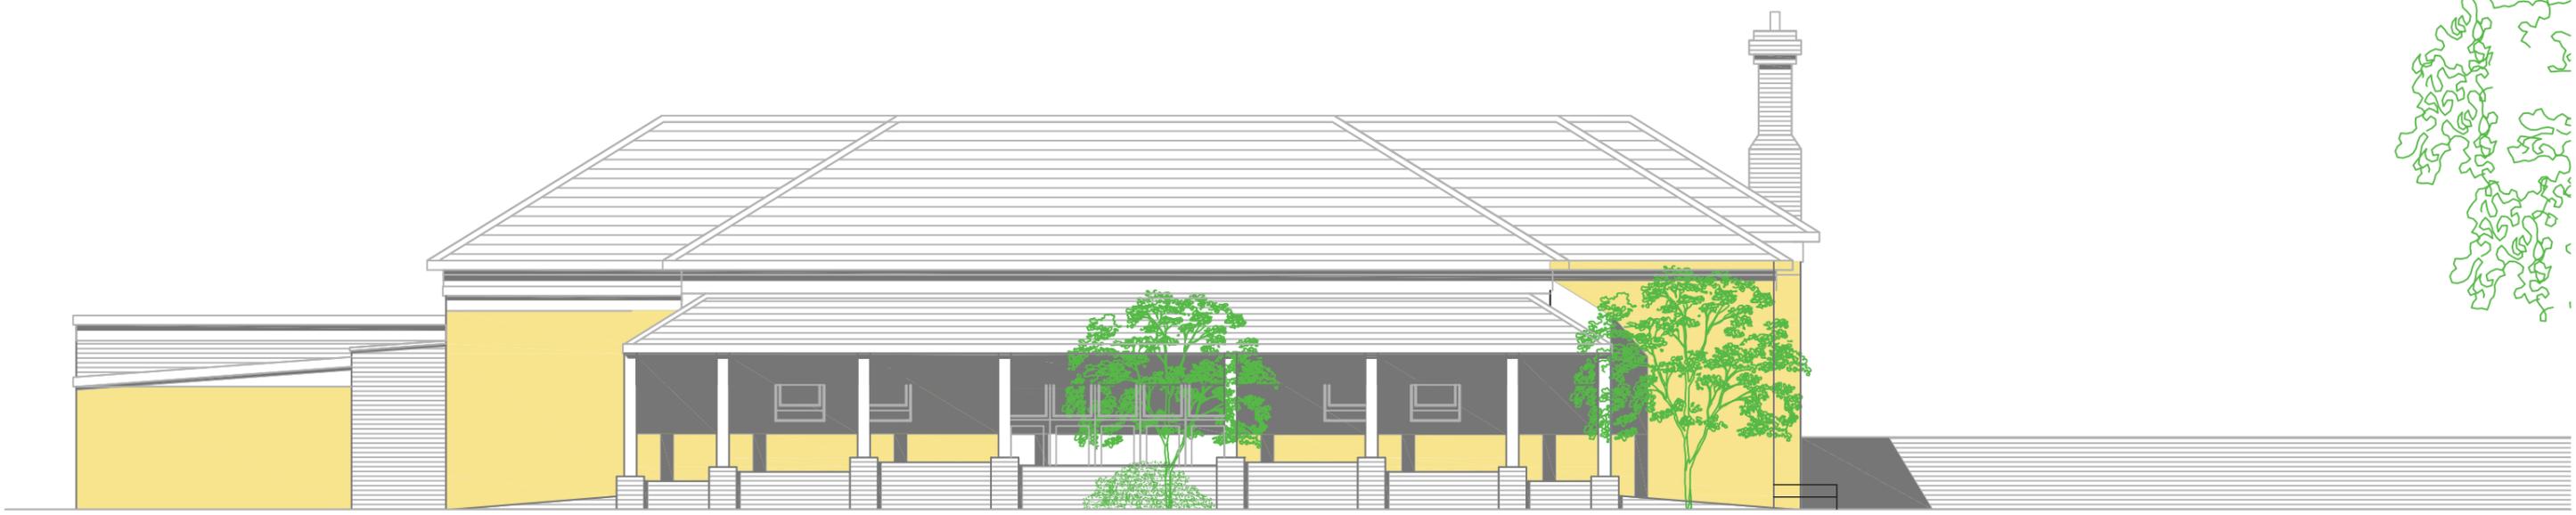
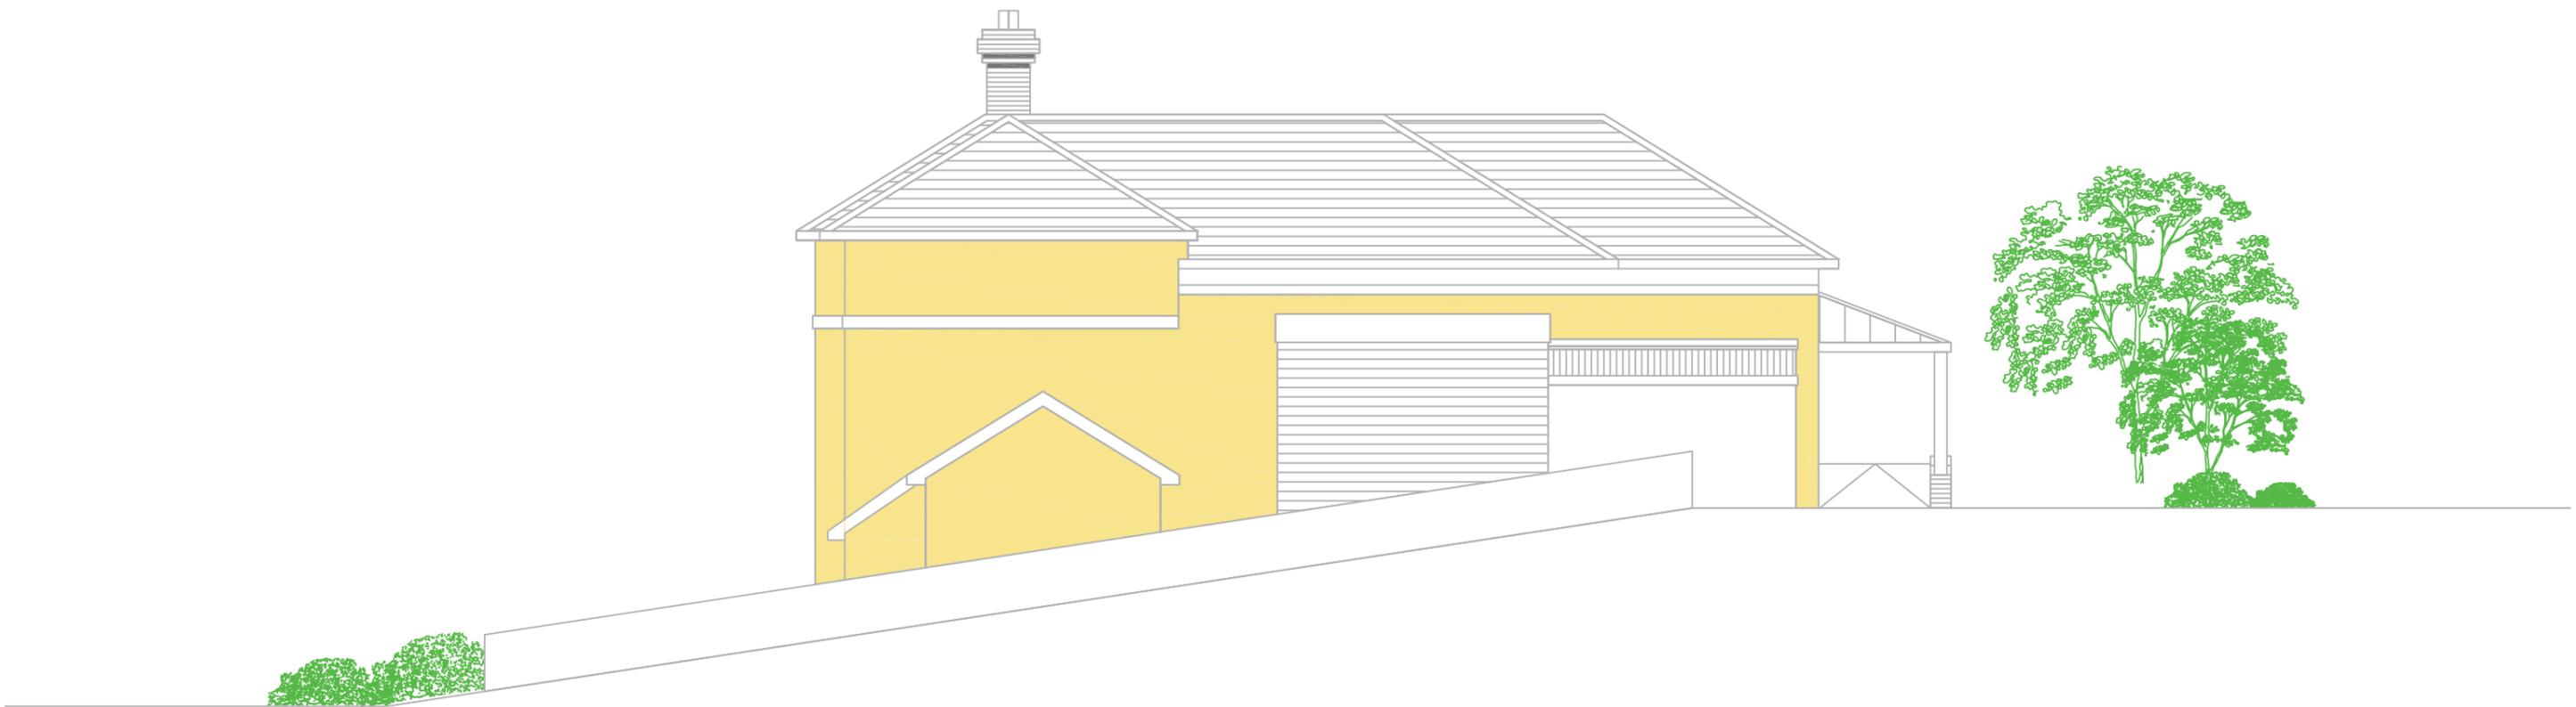
Figure 8: North and West Elevation

The northern elevation and has a painted cement rendered finish. This elevation is of five bays with the centre three bays slightly projecting to the north (Plate 41). The main entrance to the ground floor is located at the eastern end of the projecting centre part of the building, and has been fitted with modern double UVPC doors with glazed upper parts. Above the doors there is a semi-circular fanlight (Plate 21).

The western elevation of the building has a painted cement rendered finish. The northern end of this elevation has the same decorative cornice as seen on the northern elevation of the building, but the southern end of this elevation has the simple black painted barge board as on the southern elevation. There is also a notable change in the lower level of the roof at the southern end which corresponds to the change from the cornice to bargeboard. There are two windows in this elevation both located on the first floor; the window on the north end is a sash window. The string course respects the window and is arched above it. There is no lower string course apparent on the southern end of this elevation. The second is a modern wooden sash window located to the north of the weather boarded extension on the south-western corner of the building. On the southern side of this elevation is the metal extractor for the kitchen.

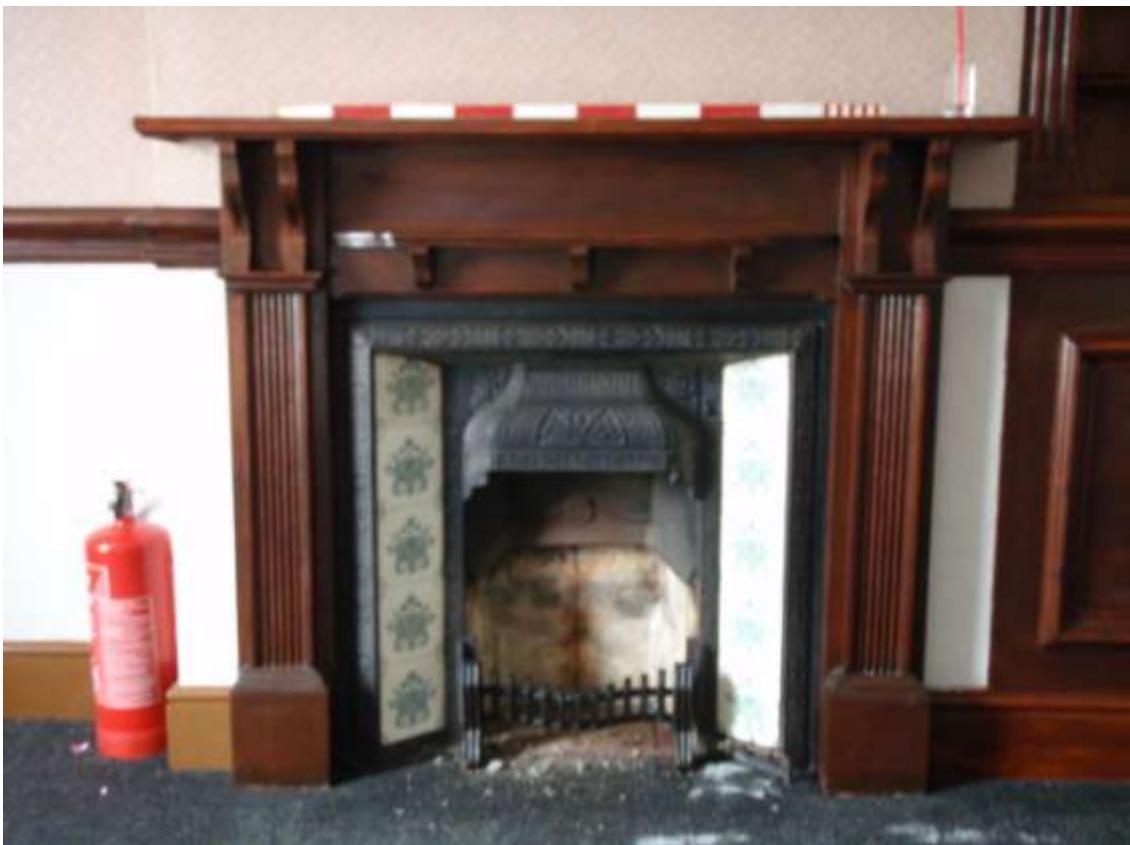
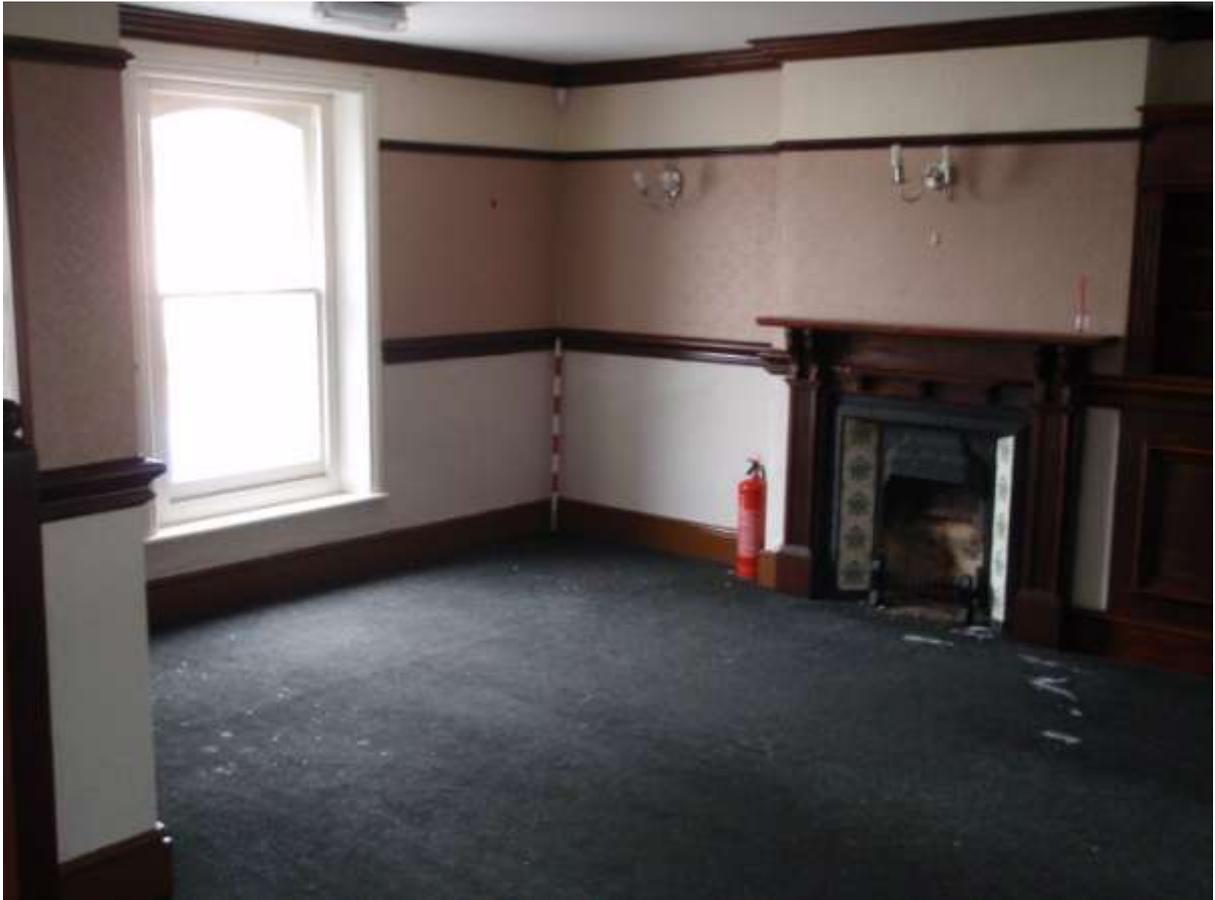
Plate 12. In Room 2 looking east

The original chimney breast to building is located north of centre on the eastern wall, with a Victorian cast iron fireplace which may be *in-situ* but has a modern outer wood surround. The cast iron fire place has a column of five ceramic tiles on both sides of the opening to the fireplace. The tiles are white with a blue floral design on them. To the south of the fireplace is a modern shelving unit which appears to be contemporary with the outer fireplace surround (Plates 12, 13).

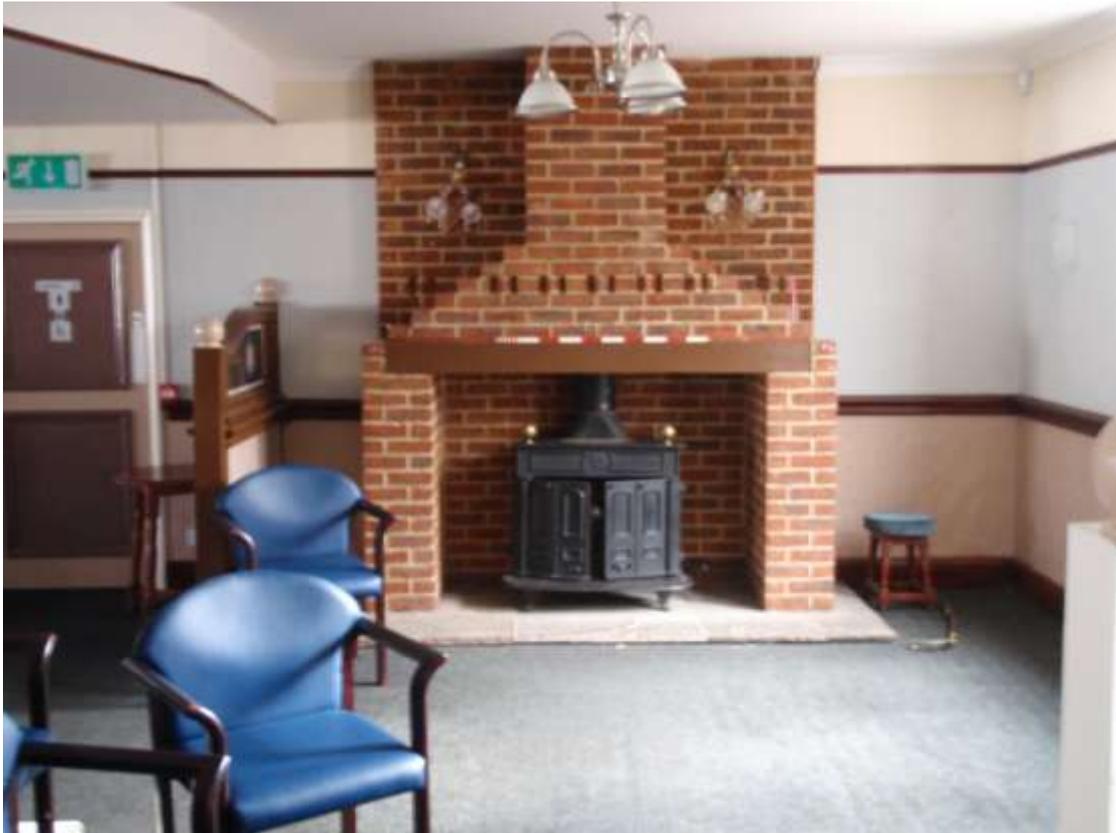
Plate 15. In Room 1 looking east

There is a second chimney breast located at the southern end on the eastern wall of the main body of the room. The chimney breast has exposed brickwork with a modern wooden lintel above the opening of the fire place, which is fitted with a modern wood burning stove (Plate 15).

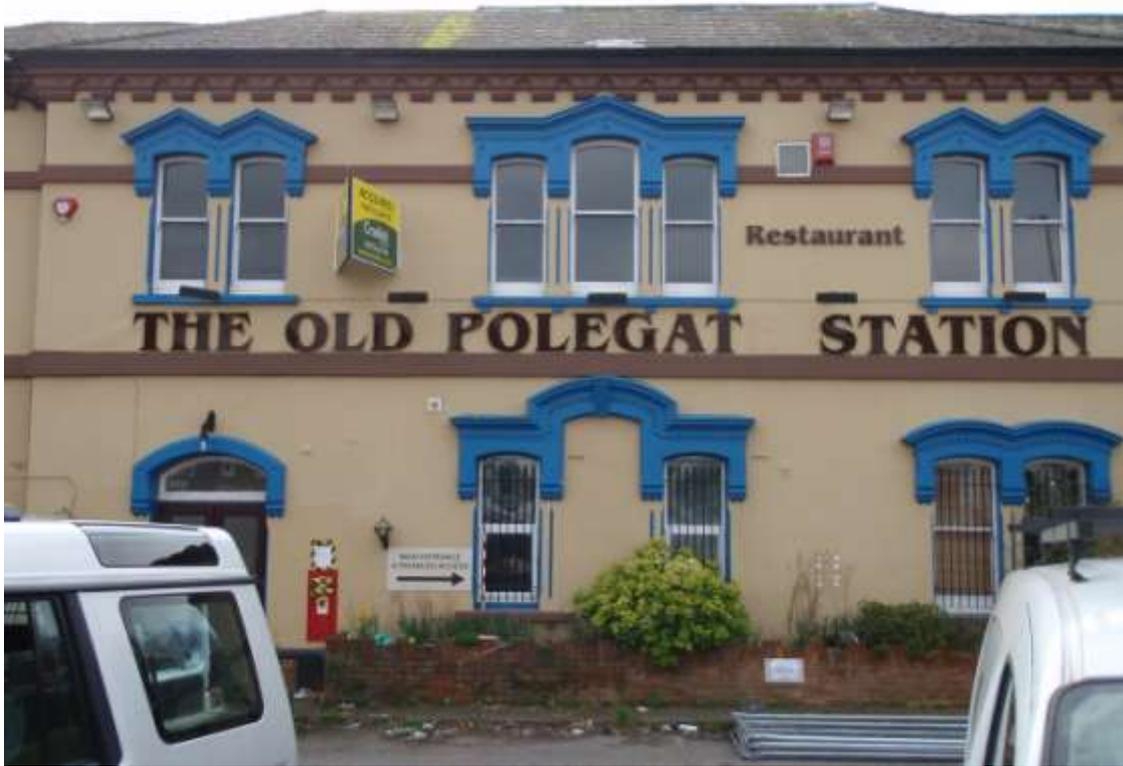
Plate 17. Front facade (looking south)

However, the two double and the triple windows in the centre of the building having pointed heads. Running horizontally there are two slightly raised undecorated string courses, located at the first floor level and at the level of the top of the first floor windows. There is a decorative cornice running round the building at the top of the elevation (Plate 17).

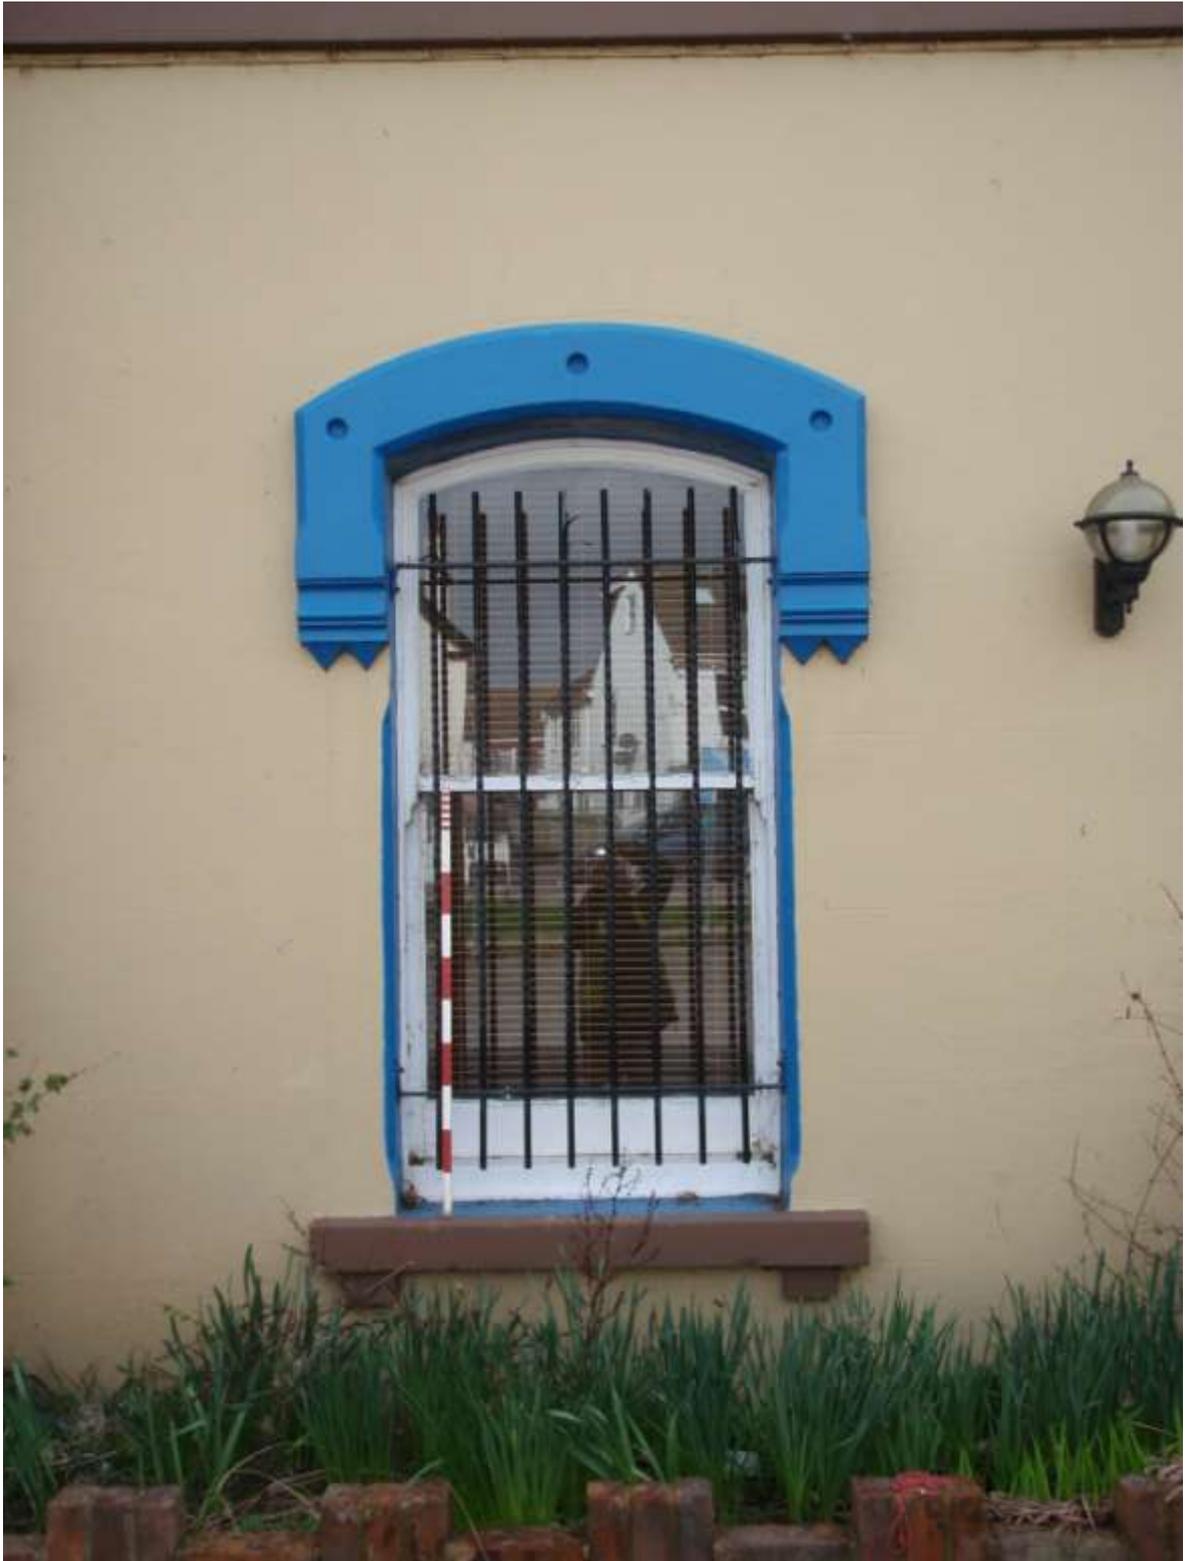
Plate 23. Detail of window front facade

It is possible that these were originally a triple window as on the first floor, but the centre unit being later blocked in. To the west of this there is double window and at the western end of the building a single window. These are all sash windows and could possibly be original, evidenced by the paint build up noted in the survey of the interior of the building. The top element of the sash windows are rounded, with exterior horns on the exterior of the base of the upper element of the window. All the windows on the ground floor have rounded moulded brick embellishments above (plate 23).

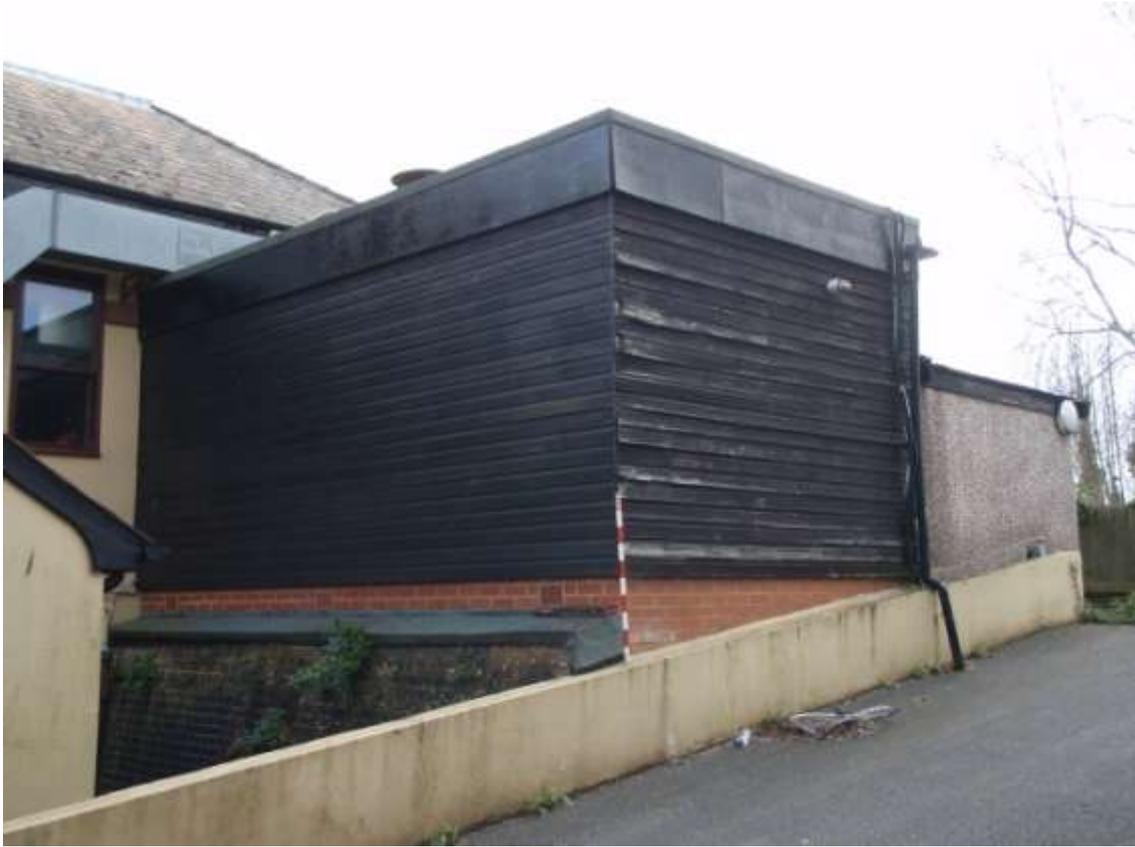
Plate 28. Detail of modern extension behind west wing (looking SE)

Attached to the western end of this elevation is a second modern extension, which appears to be of two phases. The northern part of this extension is of brick construction which has largely been covered with black painted horizontal weatherboarding. This part of the extension has no openings and has a flat ashfelt sheeting cover roof (Plate 28).

Attached to the southern side of this is the second part of this extension which has a pebble dashed finish. The roof is of corrugated iron. This extension appears to have been separated from the main body of the building, but at a later date has had a small fill in building built. This is evidenced by the slightly higher roof line and different building material which is black painted horizontal weatherboarding. This part of the building has the only exterior entrance to the western extensions which is fitted with a door which is also constructed of horizontal weather boarding (Plate 28).

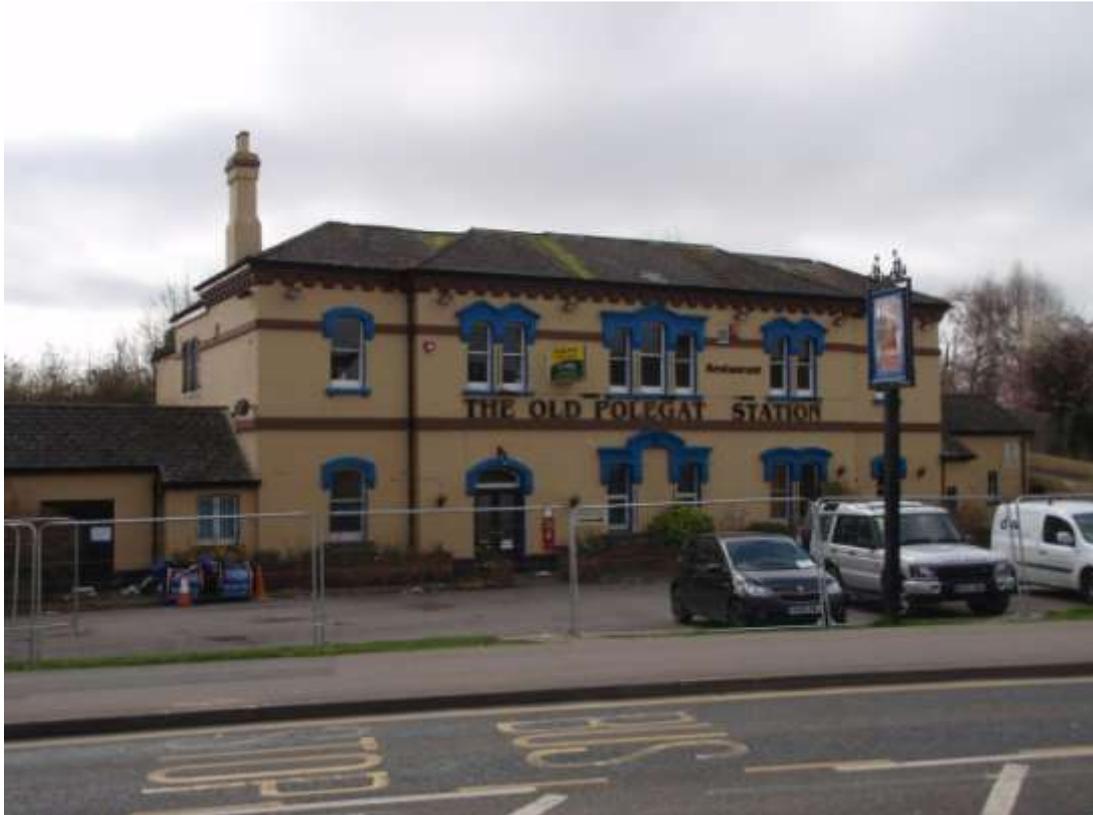
Plate 38. Front of property (looking SW)

The eastern elevation is the same painted cement rendered elevation as seen on the other elevations, with the two raised string courses on the northern end. There is no lower string course on the southern end of this elevation. There are two windows on the first floor of this elevation these are located at the southern end of this elevation, both are modern UVPC units. As on the western elevation the decorative cornice is on apparent on the northern end of this elevation. On the southern end the cornice is replaced by the black painted barge board. Also the lower part of the roof is at a different height (Plate 38).

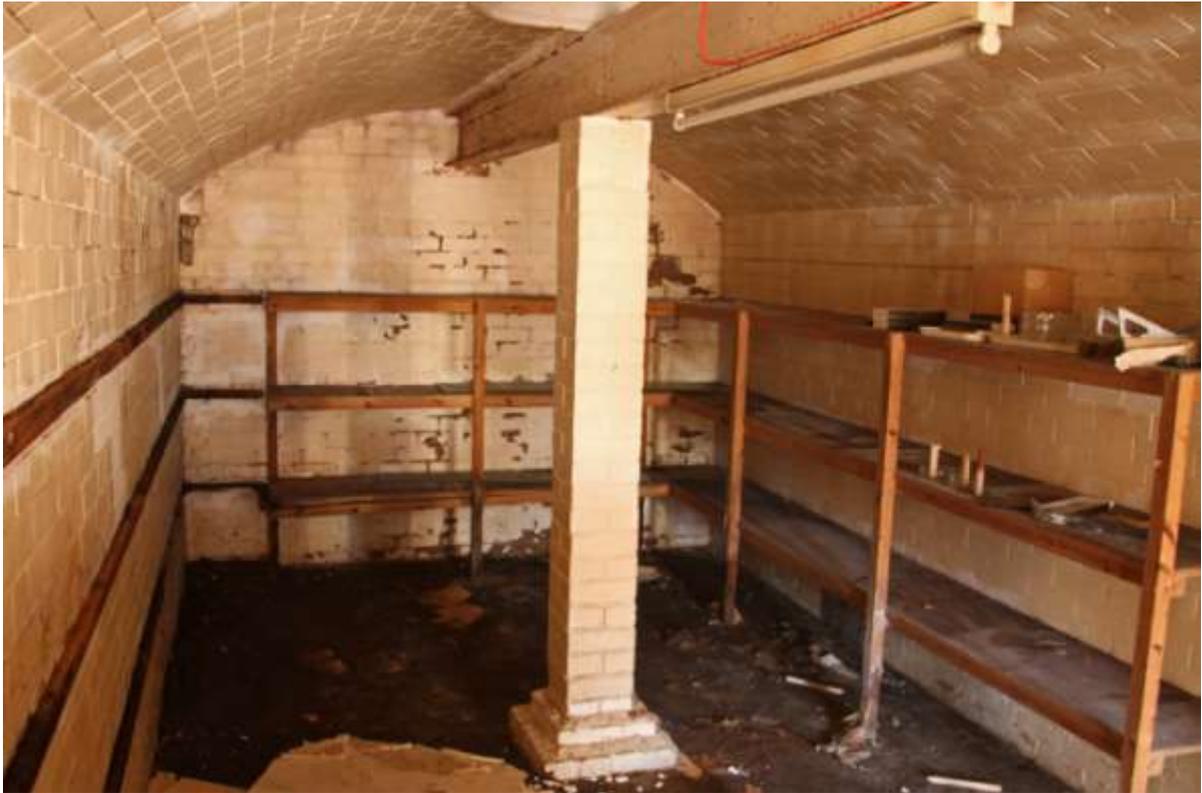
Plate 48. Internal view of tunnel set into the railway embankment wall (looking south)

Phase 3: Additional recording of railway associated structures revealed by the demolition of the building and to include the pedestrian tunnel shown to exist on OS Historic Mapping and the retaining embankment wall identified in the initial walk over survey (Plates 44-49).
