HERITAGE STATEMENT AND  
ASSESSMENT OF 69 HIGH STREET,  
HYTHE, KENT

1.1 In May 2017 Dr Paul Wilkinson of SWAT Archaeology carried out a historic building assessment of 69 High Street, Hythe, Kent (Plate 1). The building is presently unoccupied and is undergoing development and repair.

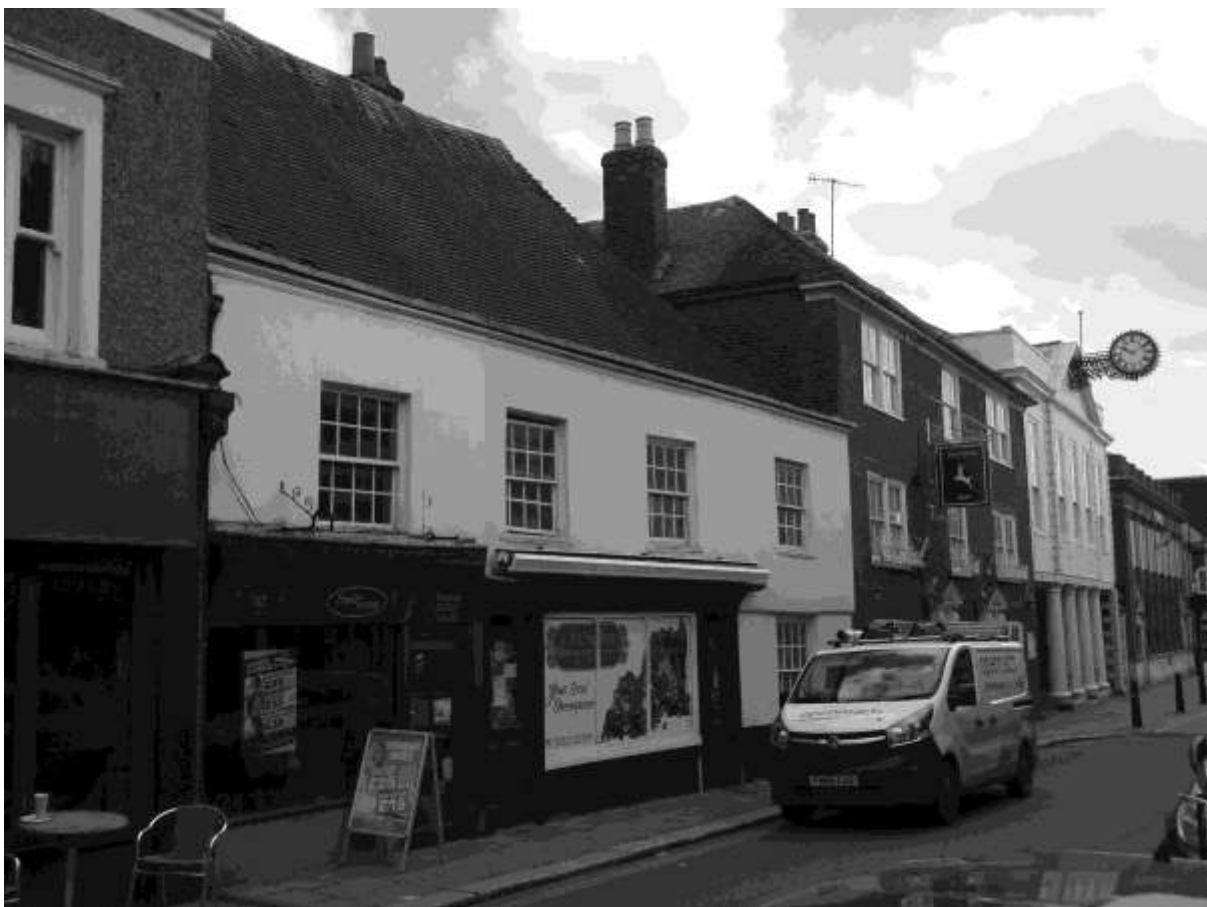
Front cover: 21st century photograph of the site (looking north-east)

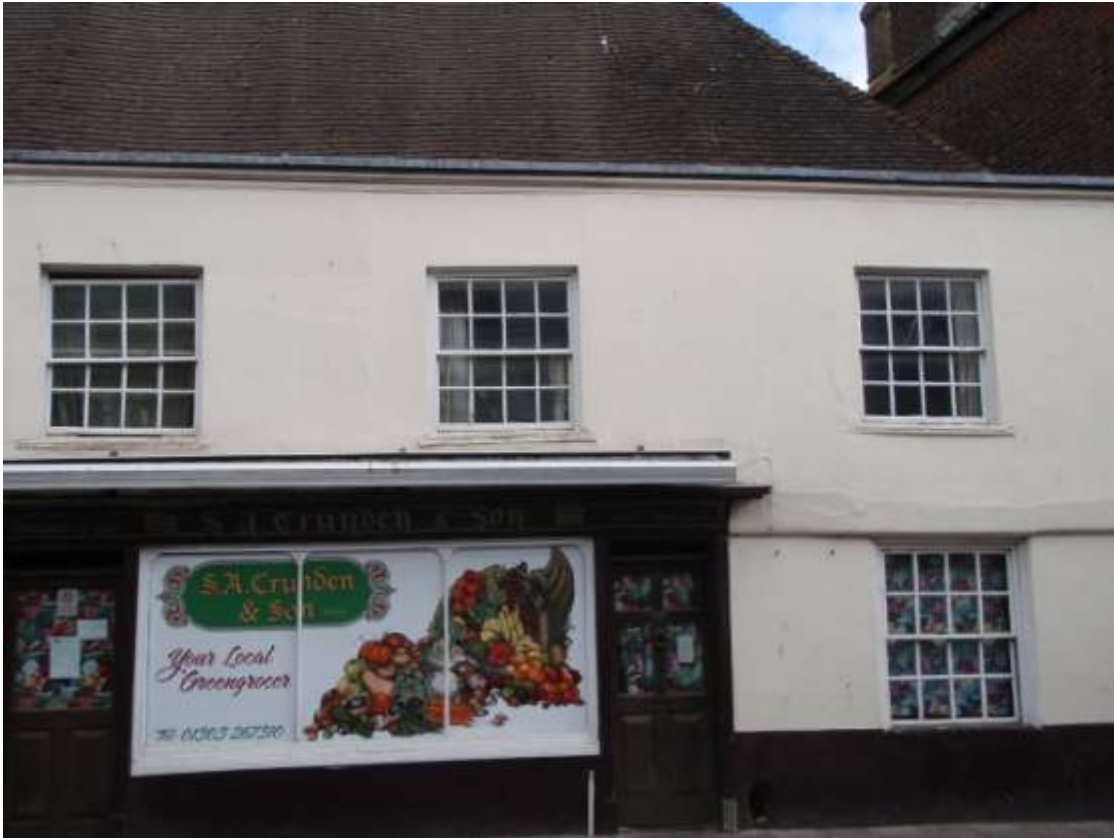
Plate 1. Frontage of building (looking north)

2.3 The frontage to the High Street is of importance with the building being re-fronted in the c.18<sup>th</sup> century with a rendered brick facade and in the early 19<sup>th</sup> century additional work undertaken of under-building of the jettied building. The shop front is an early to mid 19<sup>th</sup> century build (Plate 1).

**No structural alterations are planned for the front facade of the building.**

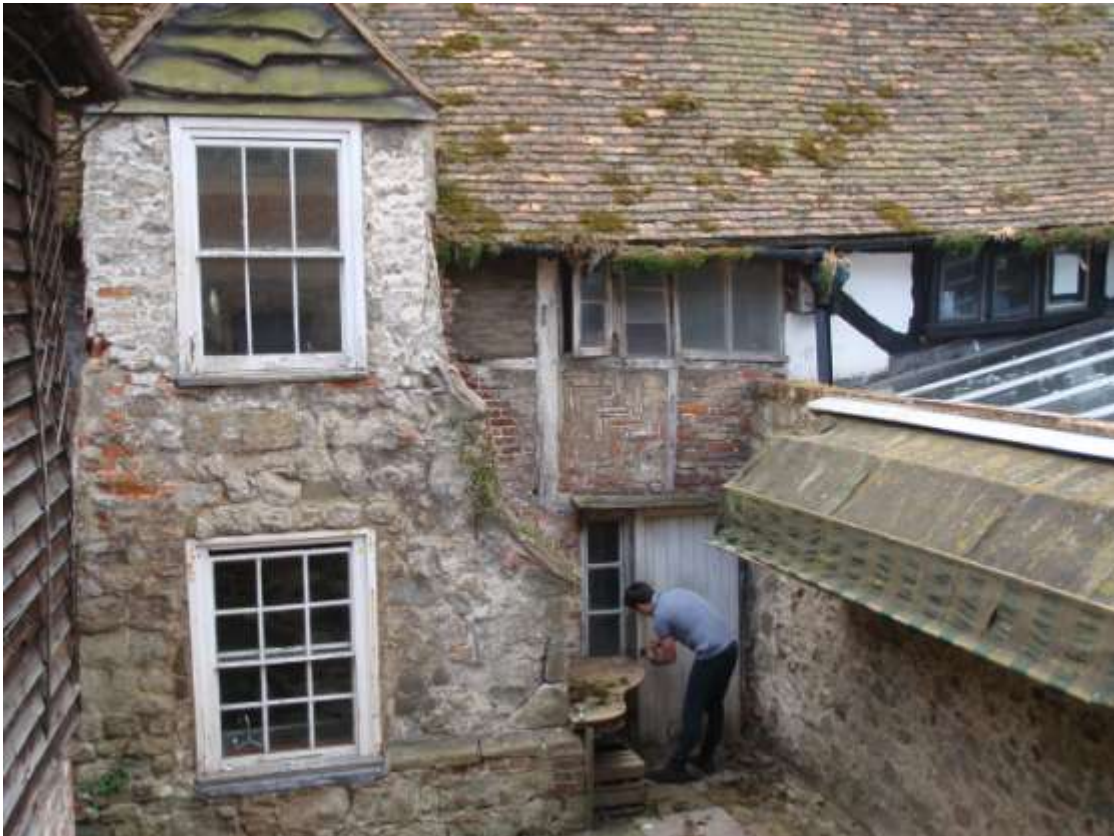
Plate 2. Rear frontage of building (looking south)

2.4 The rear of the building is of some importance with most of the framing visible infilled with wattle and daub panels and some nogged brick infills (Plates 2, 8).

**No structural alterations are planned for the rear facade of the building.**

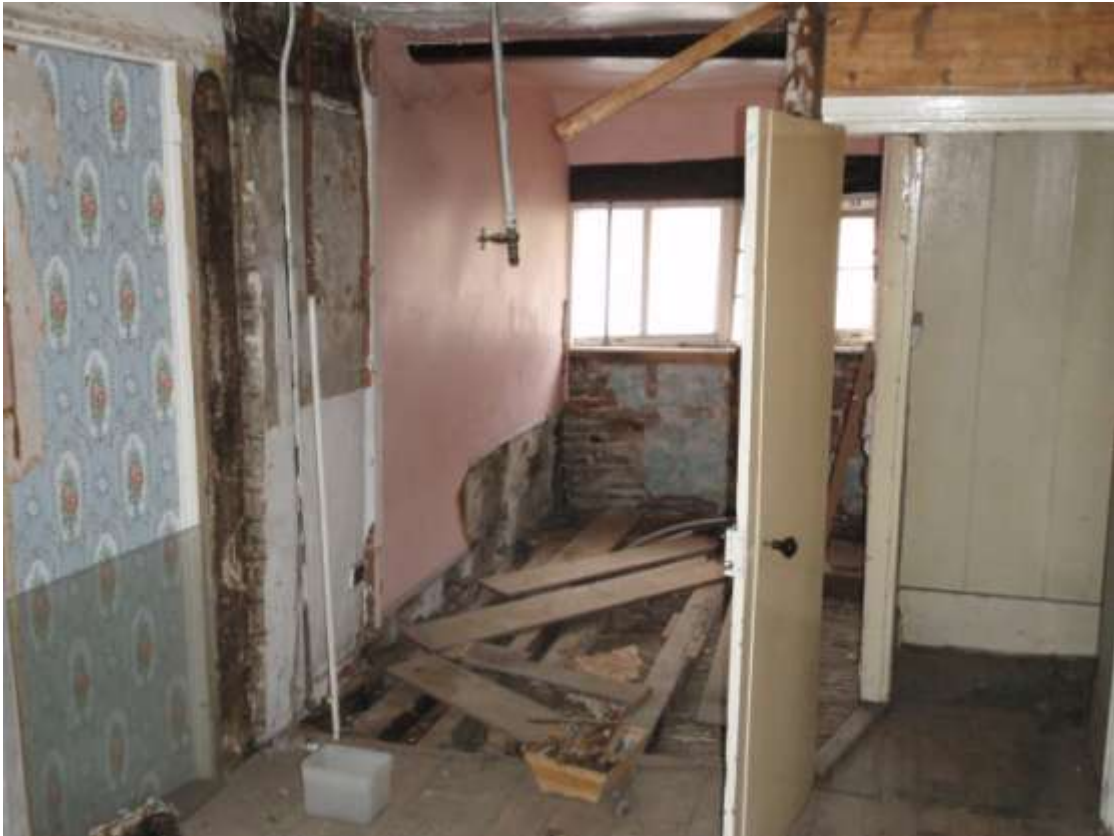
Plate 3. First floor (looking north)

2.7 The historic layout is much clearer at first floor. Here the original hall partition remains complete with only one penetration for a doorway. Apart from this, the interiors and subdivisions, doors, etc are early c19th and not of any exceptional interest. The staircase is however of note – a wide stair with elegant Regency handrail and slender stick balusters. There appears to have been extensive repairs carried out to the eaves plate along the frontage and renewal of the main tie beam at the East end adjacent to the party wall. This work was all clumsy carried out in modern times. A mass of brickwork over against the party wall, which is holding up the joint in the tie beam at the East end, is particularly clumsy and obnoxious over engineering. The c14th hall partition continues into the attic space and here it is mostly complete and the original smoke blackening from the original open hall can clearly be seen. (Plates 3, 4).

**The structural alterations planned for the first floor are to restore the 4 casement window, replace the existing back door with a traditional four panel door and remove the brick pier and replace with an oak post.**

- Open up the upper part of the stairs to allow the balustrade to remain and be repaired
- No cutting through the c14th hall partition
- Remove modern brickwork pier on the east side and replace with oak post

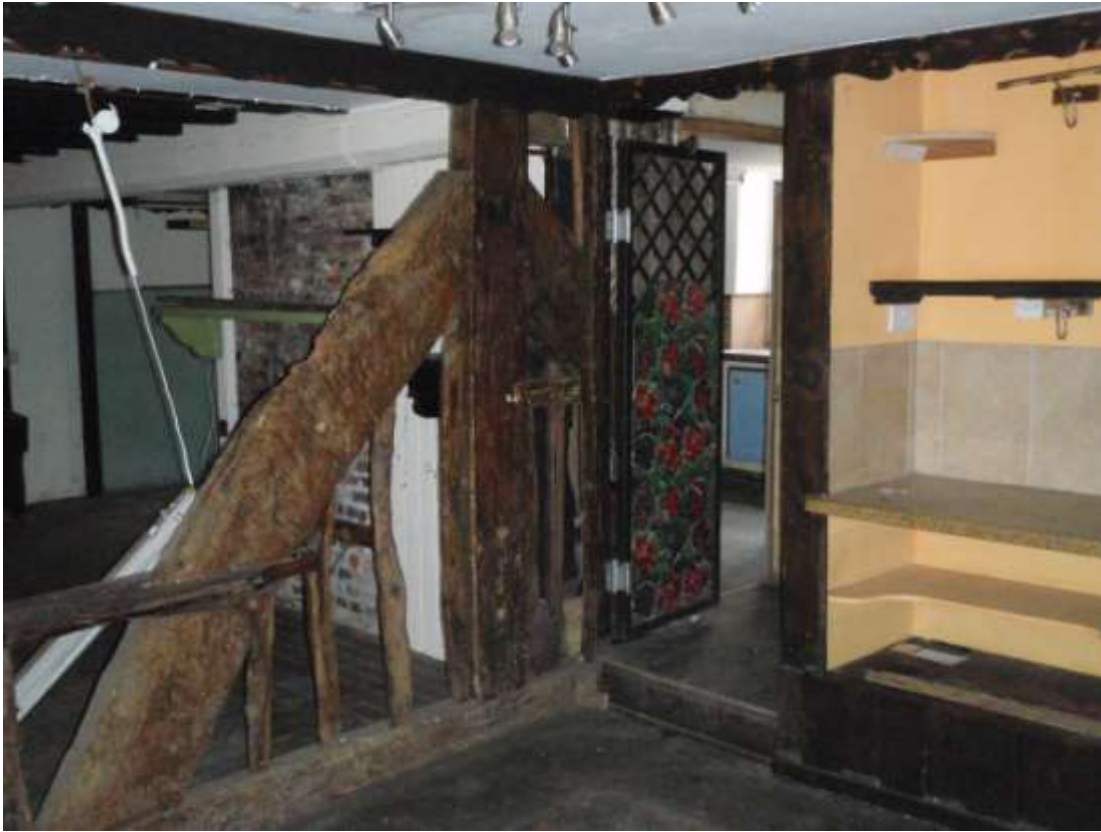
Plate 5. Ground floor-original 14<sup>th</sup> century frames and studding

2.6 Within, at ground floor level, the shop floor has all been stripped out with only remnants of the oak framing of the hall partition left exposed within the space. The party wall to the eastern side is stone but it is not clear whether this is the structure of this building or that of the adjacent property. There is a stack in the centre of the space but this is merely a block of brickwork of no intrinsic interest which appears to have been completely rebuilt in the c19th century. Of particular interest are the exposed c.14<sup>th</sup> century framing and studding. These need to be retained (Plates 5, 6 & Figure 1).

**No structural alterations are planned for the ground floor.**

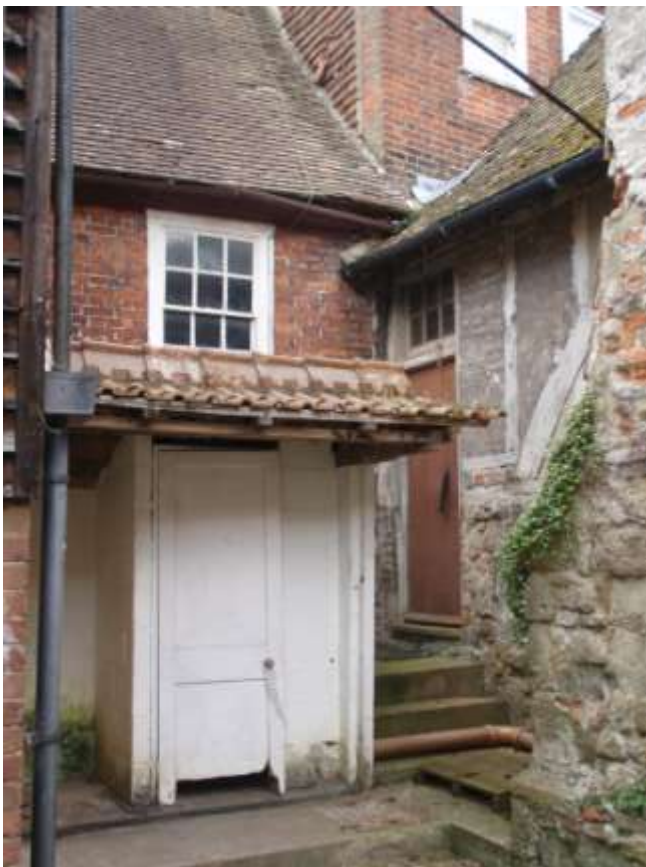
Plate 8. Rear area (looking south-west)

2.5 The yard paving is of very special interest, made up of irregular Ragstone cobbles that rises up from the back of the building with a sloping terraced area incorporating massive Ragstone blocks and architectural arch segments at a change of level between the lower and upper yard areas. This continues to rise towards the rear outbuilding before leading toward the passage at the western end of the site which continues to rise up to Dental Street. These yard surfaces,

ancient architectural stone fragments and steps are of much importance and will need to be handled very carefully, resisting the urge to make everything smooth and even so as to comply with the building regulations.

- Restoration of 4-casement window
- Replace back door with an improved traditional pattern
- The yard to have an accurate survey showing the layout of the stones with some repair

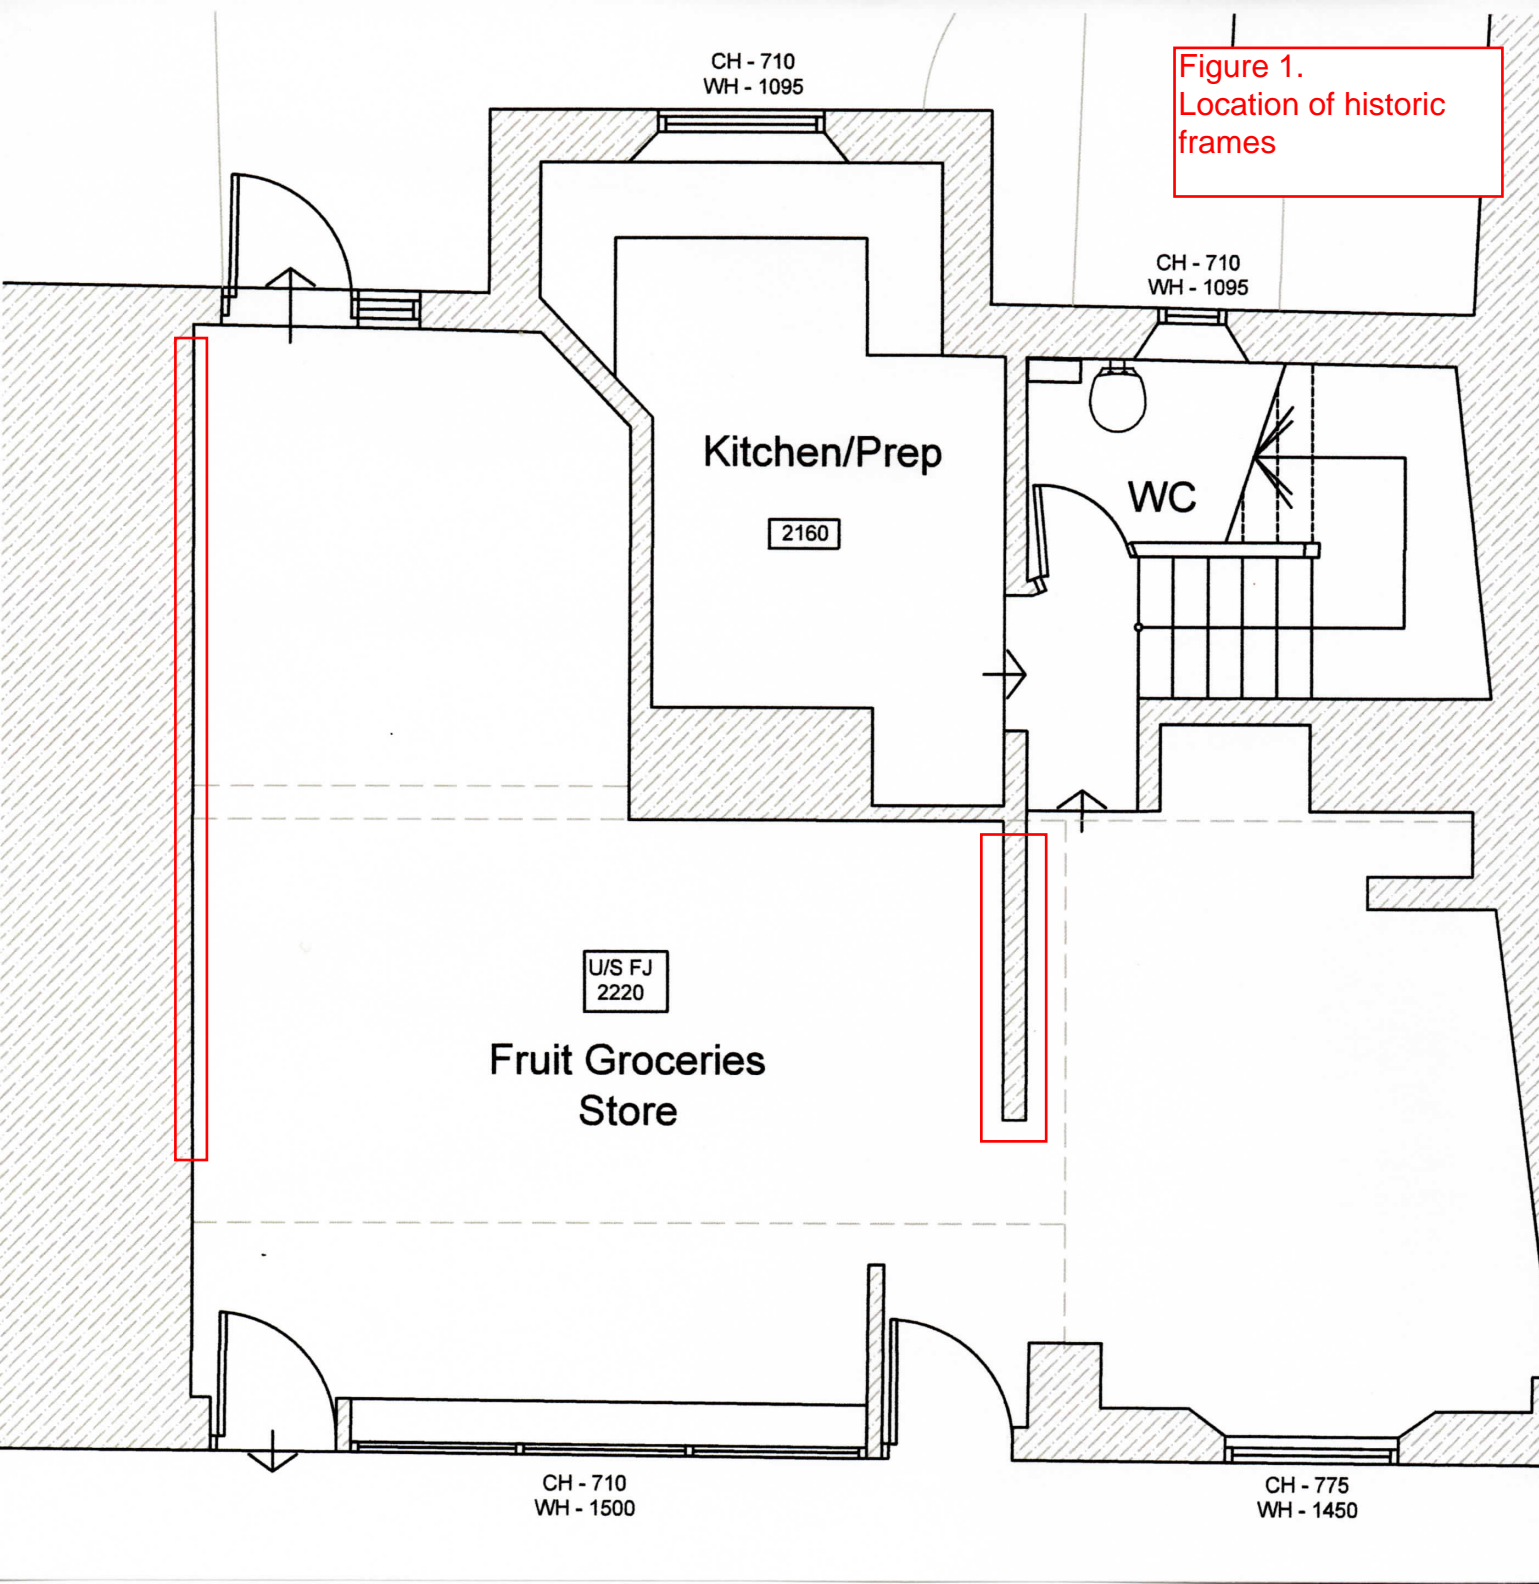
Figure 1.  
Location of historic  
frames

Figure 1. Ground floor plan showing location of c.14<sup>th</sup> century framing
