# Archaeological Evaluation of Land behind 20 Beach Road, Westgate on Sea, Kent

Site Code: BEACH/EV/17

Planning Application: F/TH/16/0423

**SWAT Archaeology**

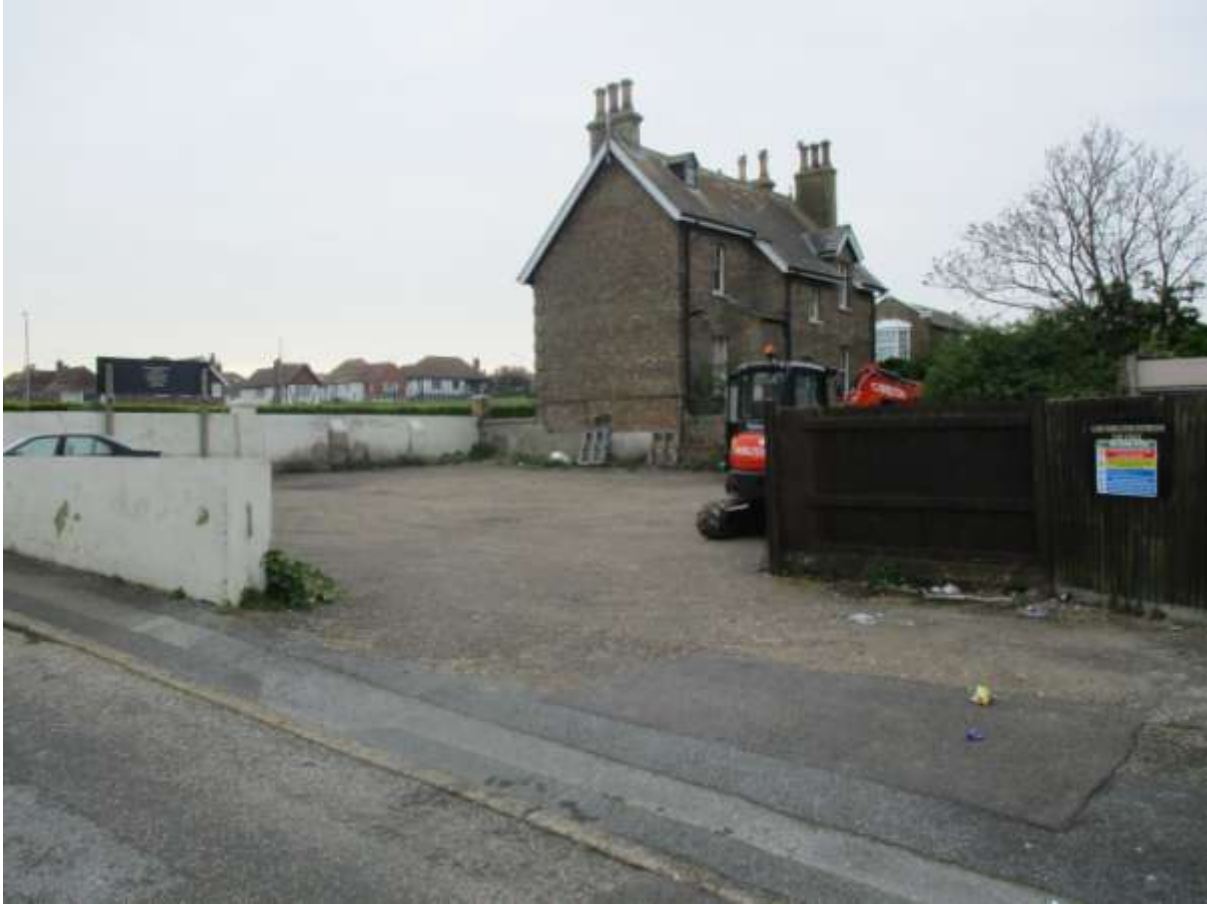
Plate 1. The site (looking SE)

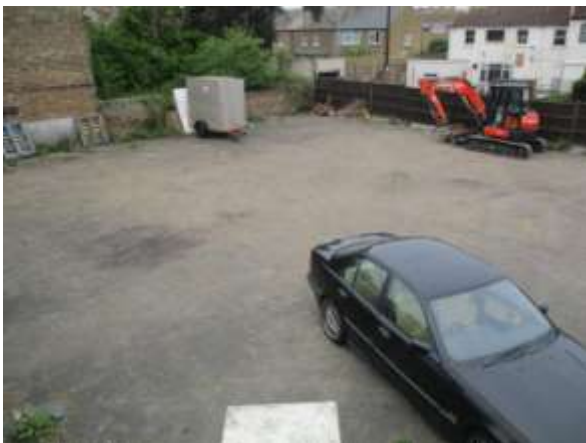
Plate 2. The site (looking SW)

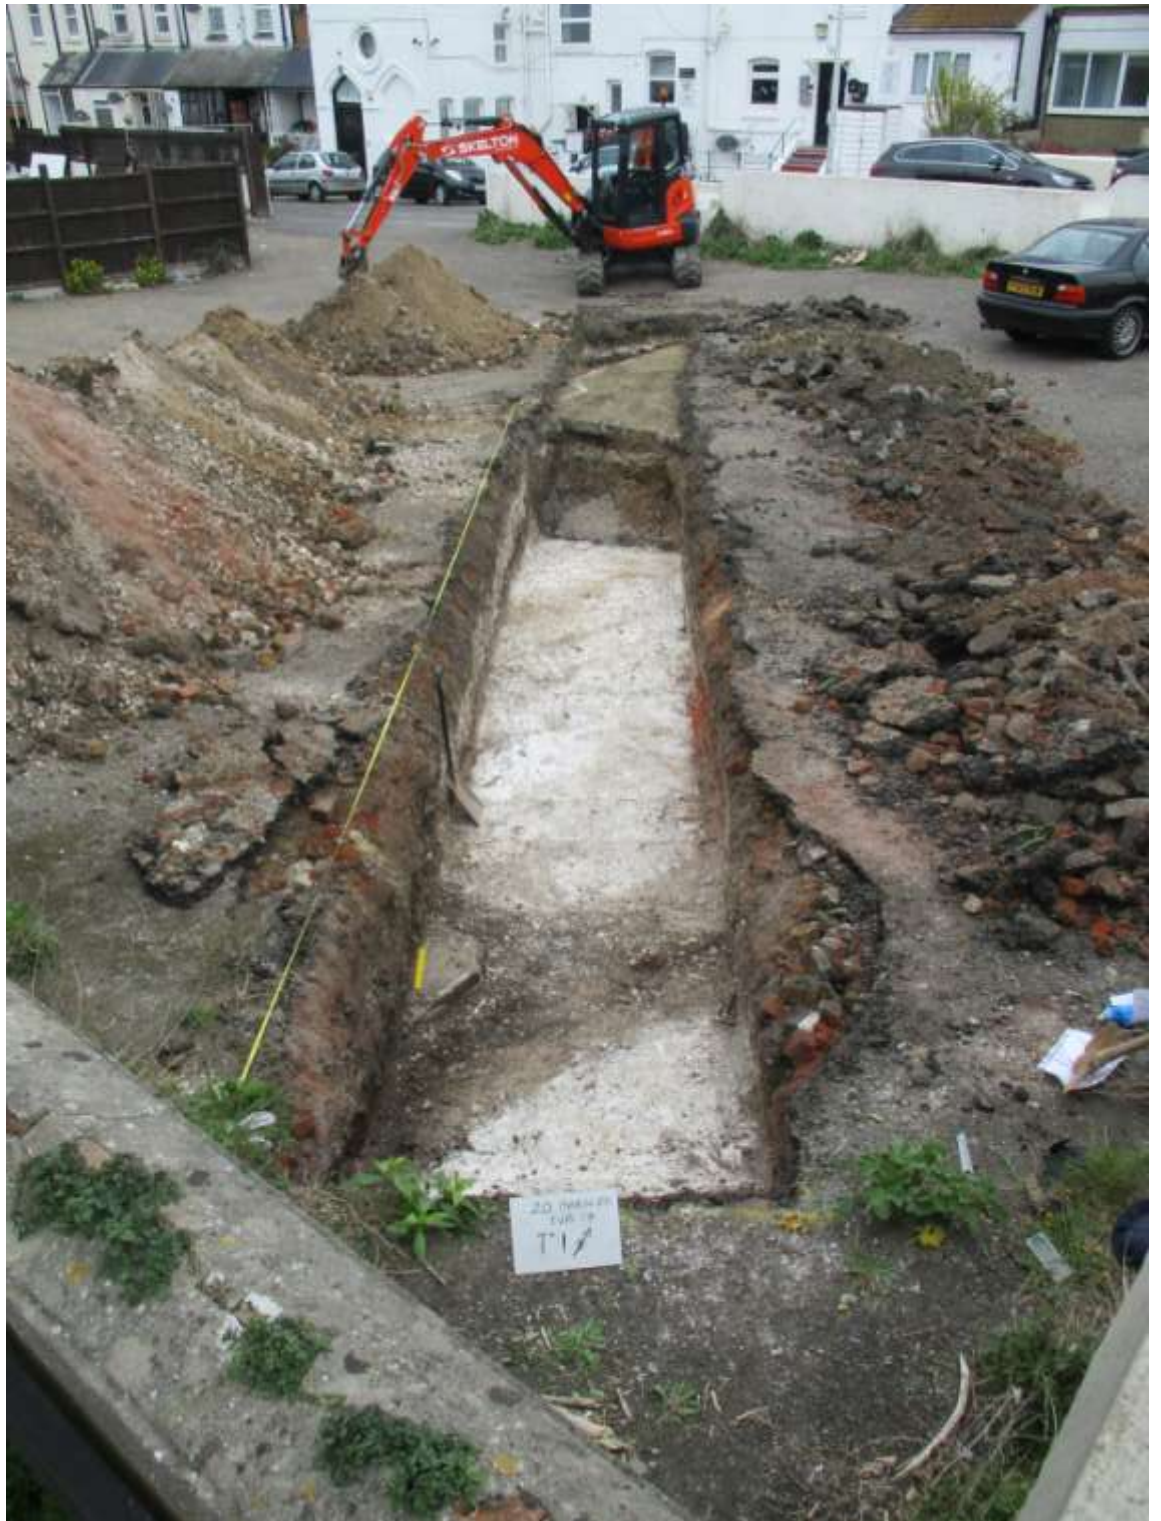
Here, the original surface of bedrock Upper Chalk (Context Recording Number 12) was exposed in part at an average depth of one metre below the present ground surface of 8.00m aOD. In the places where it survived intact (in the central and south-eastern part of the trench) it was covered by a 0.18m-thick layer of mid-light brown colluvial brickearth-like soil (CRN 19) with frequent granular chalk inclusions. This was interpreted as an example of the original subsoil, a view supported by the overlying presence of a band of dark brown humic soil of variable thickness (average 0.12m-thick), also containing granular chalk and which almost certainly represented a remnant of the original topsoil. This in turn was sealed by a 0.3m-thick band of crushed chalk (CRN 17) that was devoid of any other inclusions and was interpreted as a levelling or bedding layer, presumably related to an earlier phase of construction, possibly contemporary with buildings surrounding the development site, which are predominantly of nineteenth-century construction. This layer was overlain by a 0.3m-thick band (CRN 16) of mixed clay, chalk, brick and stone fragments, brick fragments

The above-described sequence of horizontal deposits was the only undisturbed archaeological sequence in the trench but was not deemed to be of any great archaeological significance. It had been cut away to the southeast during the construction of a large sewer pipe (CRN 20), the mid grey-brown chalk-rich humic fill of which (CRN 21) was in turn cut during the excavation of trench (CRN 8), cut to accommodate a concrete-capped manhole (CRN 5).

To the northwest the intact stratigraphic sequence was cut away by a massive pit (CRN 10), which was more than 1.5m deep and greater than 7.3m in extent, as it extended beyond the northwest limit of excavation. The many and varied fills of this pit were modern (several unbroken champagne bottles and much modern domestic detritus were recovered from them) and they were recorded generically as CRN 9. Part of the corner of a large, 0.2m-thick rectangular concrete slab (CRN 11), clearly of relatively modern construction, capped this pit, which underlay the 0.15m-thick brick and rubble bedding (CRN 2), over which the present tarmac surface of the car park was laid.

Plate 3. Trench 1 (looking NW)

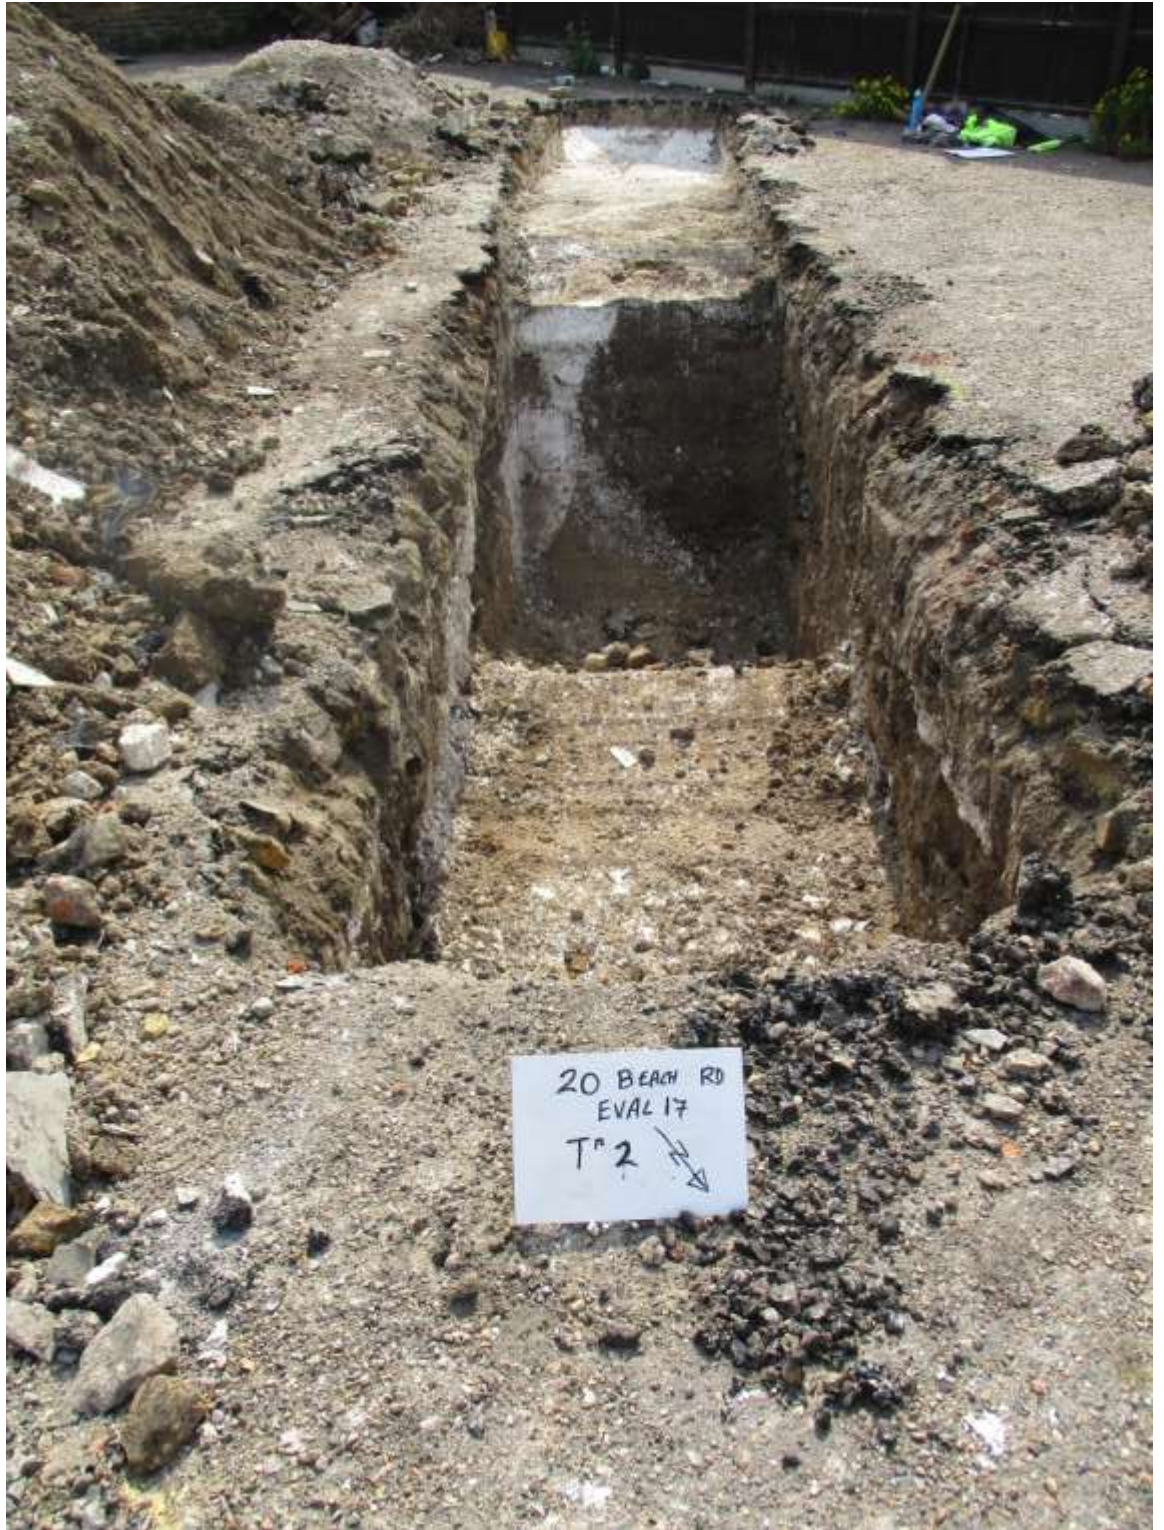
Upper Chalk bedrock (CRN 12) was also exposed in the southwest part of this trench but in this case was truncated, clearly having been higher lying in the southwest rather than the northeast part of the development site. It was cut by a modern pit (CRN 14), the fill of which (CRN 13) was sealed by compacted crushed chalk overlying mixed crushed chalk and dark brown humic silt fill, the latter containing modern glass bottles, small fragments of modern brick and scraps of metal. This pit, which was more than 2m deep, was cut away to the northeast by another large, modern pit (CRN 18), also greater than 2m in depth and extending beyond the northeast limit of excavation. This pit's fill (CRN 17), consisting of laminated layers of mid-to-light brown brickearth-like material with small-to-medium fragments of very hard sandstone. Its modernity was indicated by the presence of complete glass bottles and scrap metal artefacts, in including a crushed zinc watering can. It was cut in turn by another modern pit (CRN 16), the one-metre-thick, dark brown humic, slightly sandy

fill of which (CRN 15) contained a downward slanting lens of mixed crushed chalk and brickearth and large fragments of thick ceramic tile. It was overlain by a 0.78m-thick deposit of crushed chalk (CRN 19), almost certainly a levelling/bedding layer laid down in preparation for the overlying car park surface.

Part of a 0.5m-wide concrete foundation (CRN 20) lying on an approximate north-south alignment overlay natural chalk (CRN 12) and the fill of Pit 14 in the southwest half of this trench. Its position over large and relatively modern pits, as was the case with the concrete platform (CRN 11) exposed in Trench 1, along with the exact alignment of both the foundation's and the platform's eastern edges, indicates that these formed part of a substantial modern structure, which had been built on a site that had suffered massive disturbance, probably during the middle of the twentieth century.

Plate 4. Trench 2 (looking SSW)

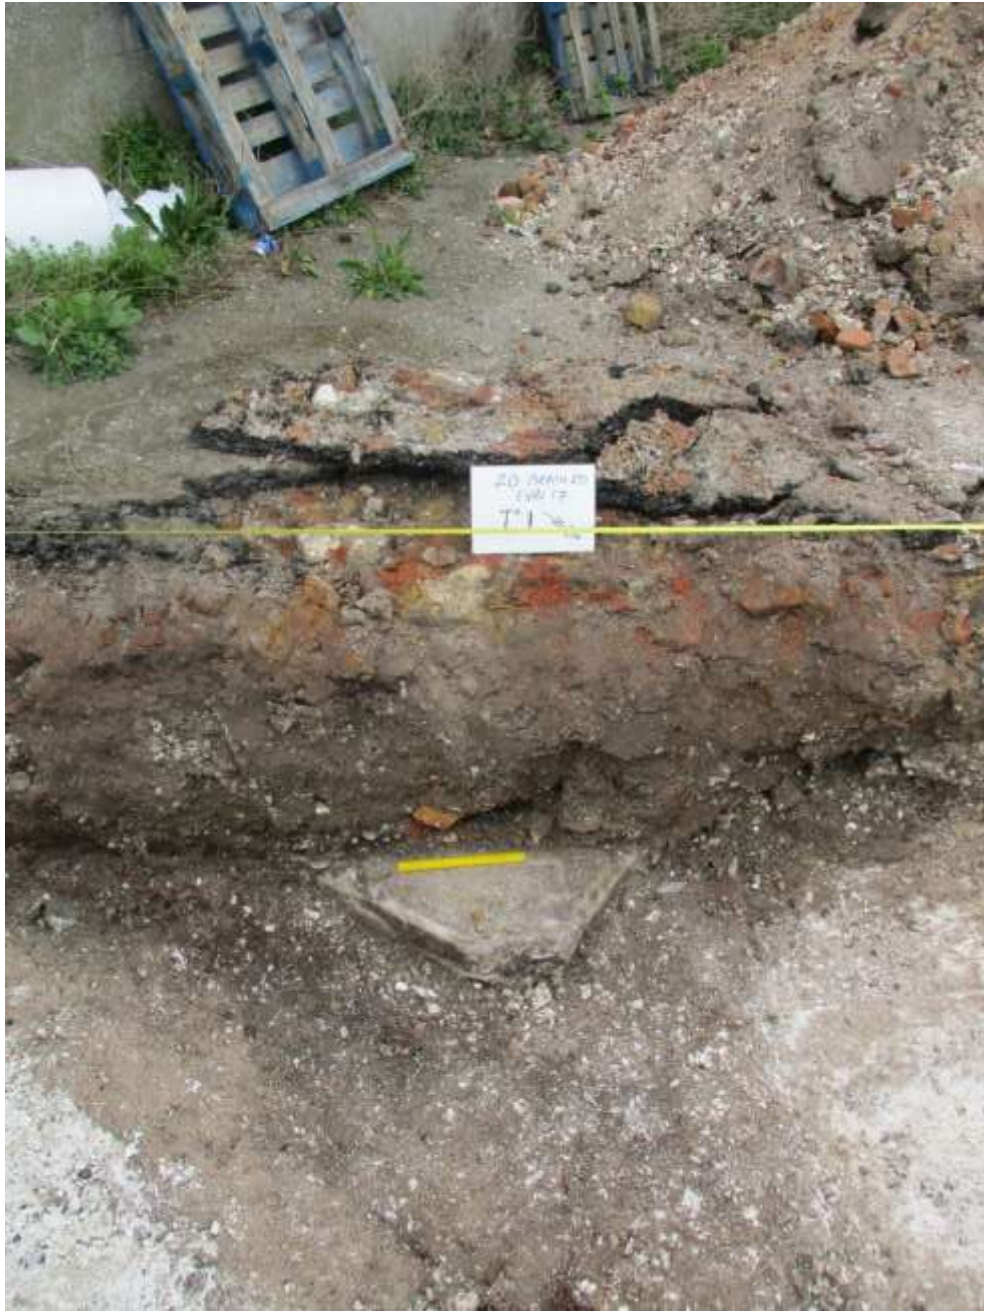
and humic soil, almost certainly the result of the a phase of demolition and disturbance created during the cutting and filling of the mass of large, modern, intercutting pits exposed in the north-west end of Trench 1 and the north-east end of Trench 2 (see below).

Plate 5. Section Trench 1

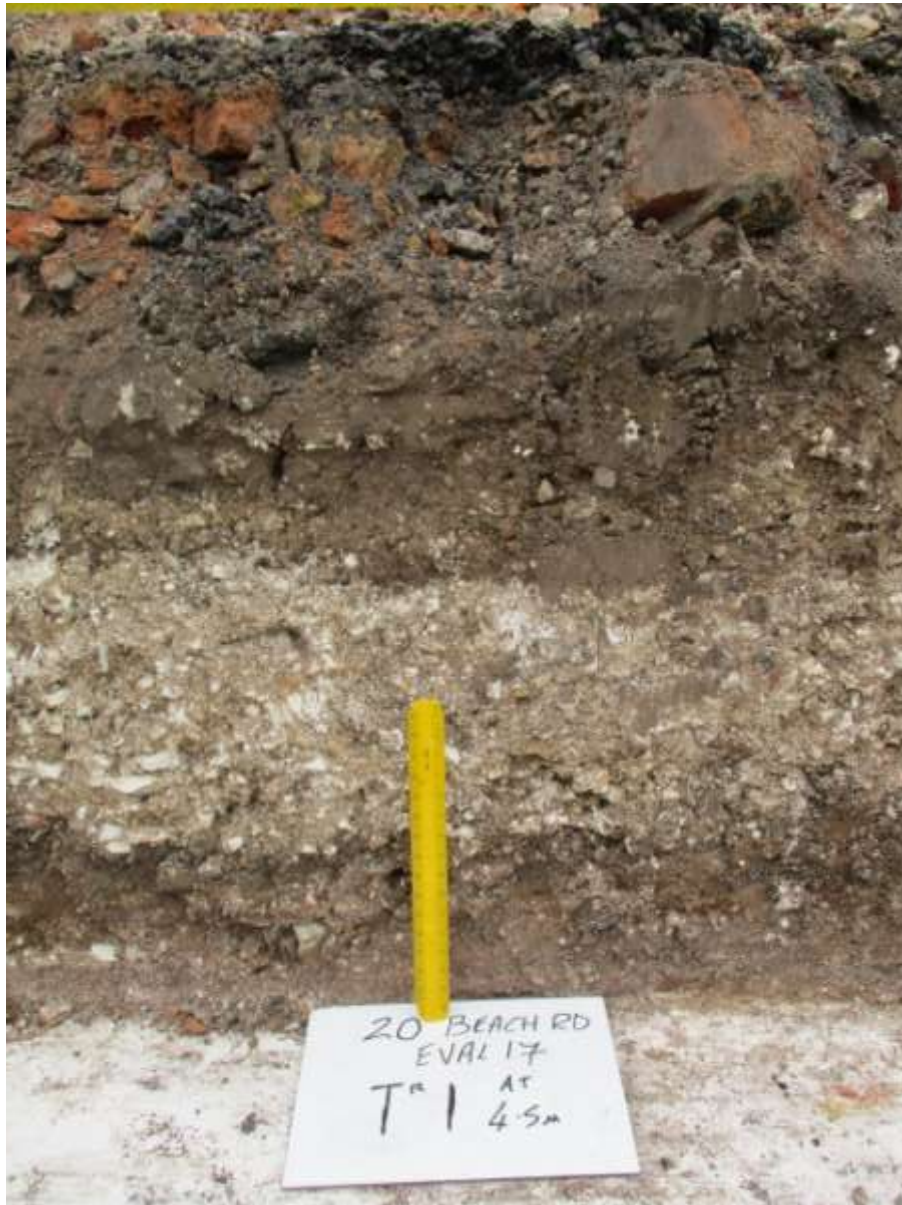
Plate 6. Trench 1 section

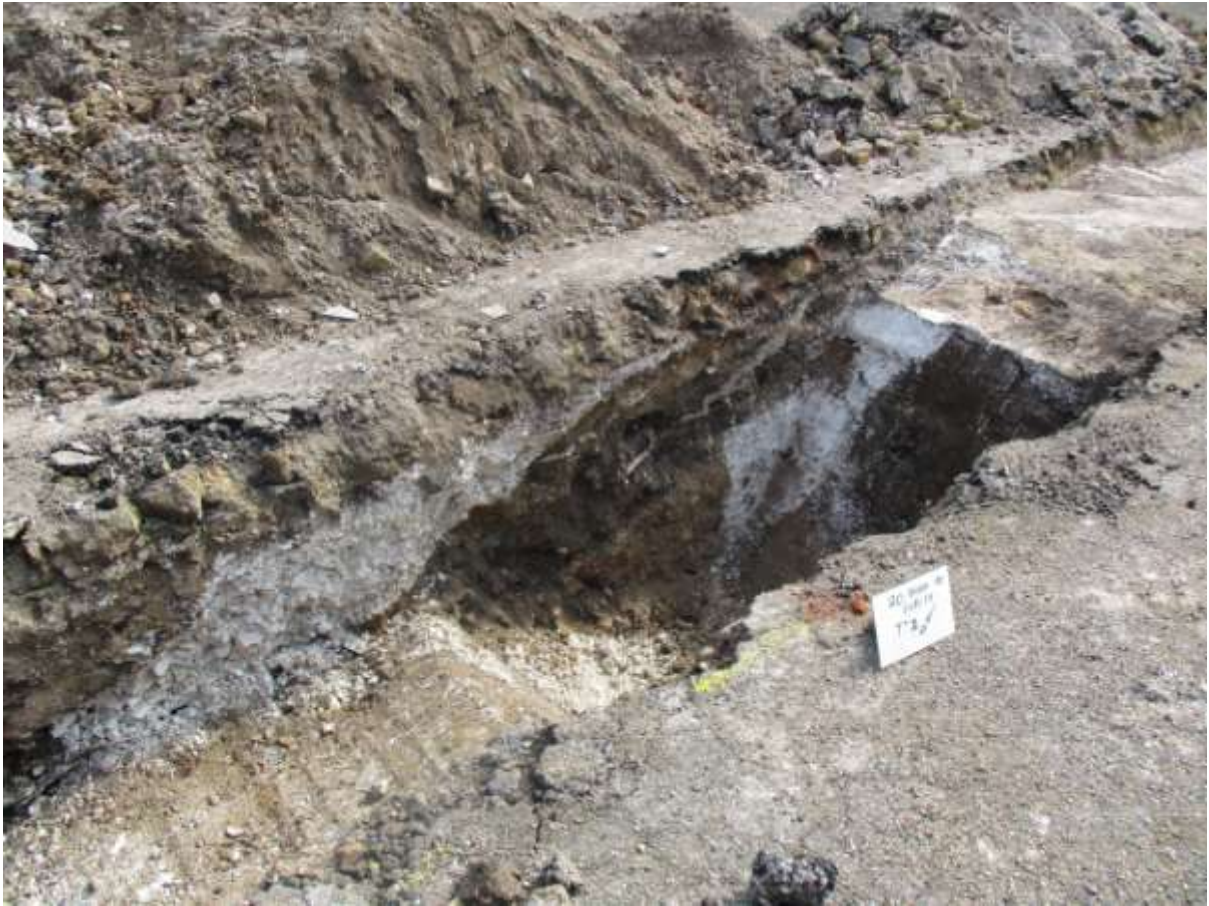
Plate 7. Trench 2 (looking NW)

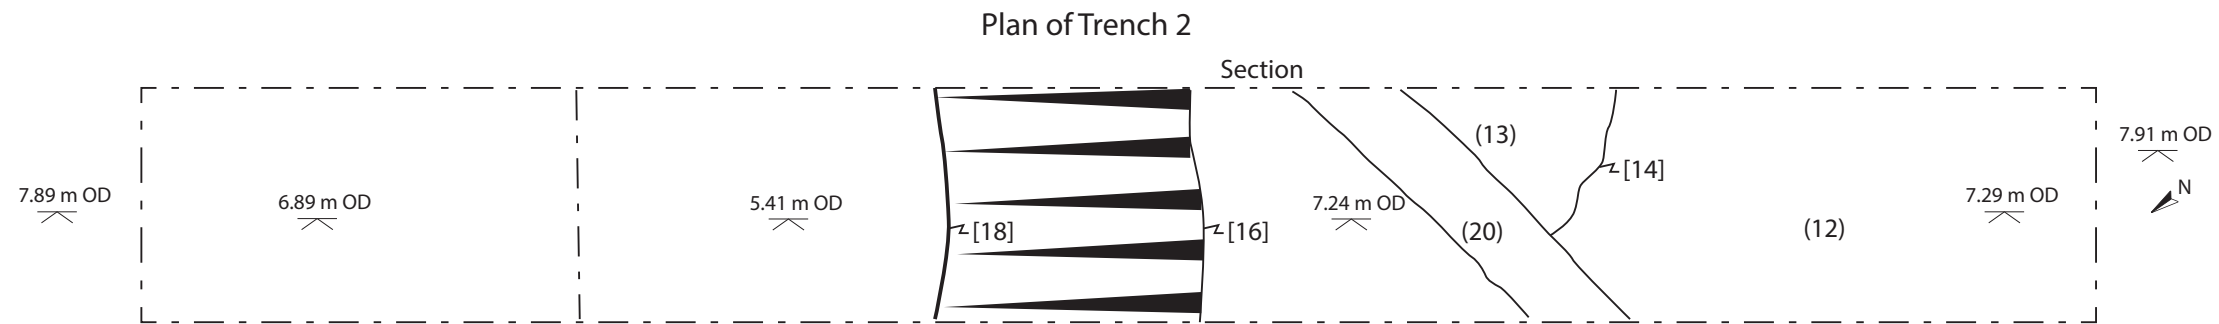
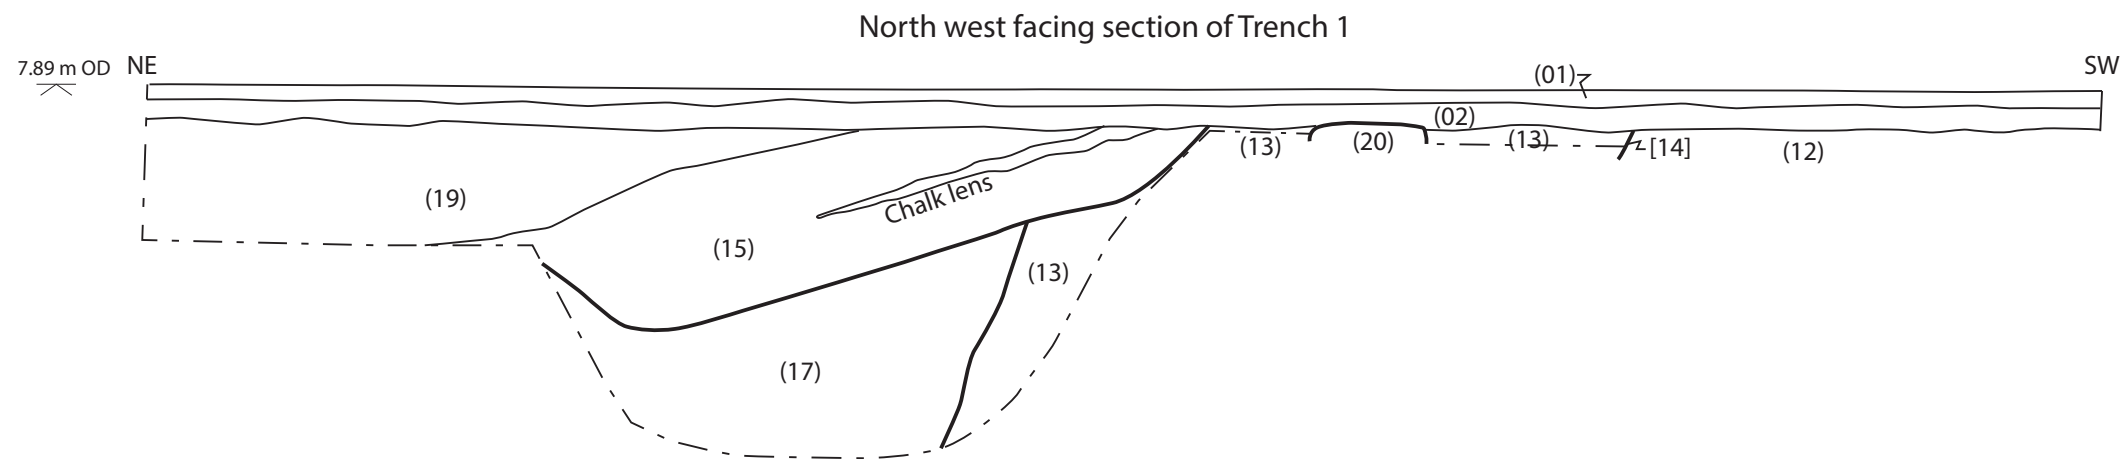
Two evaluation trenches (Figure 2) were mechanically excavated on the present site (Figure 1), which was used until very recently as a car park for The Knot public house and hotel and which has an OD height of 8.00m on the tarmac and an area of 780 m<sup>2</sup>. Trench 1, which measured 16m by 1.5m, was cut on a south-west/north-east alignment and was located in the northeast part of the site. Trench 2 measured 13m by 1.5m and was cut in the southwest part on a south-east/north-west alignment. The evaluated area was therefore 43.5m<sup>2</sup> (5.6 percent of the total site area).

The only intact and *in-situ* deposits exposed during the evaluation occurred in Trench 1 in the form of an approximately 6m-wide (on a south-east/north-west alignment) sequence of horizontally deposited layers (CRNs 12, 19, 18, 17 & 16), where CRN represented the intact surface of the Upper Chalk, CRN 19, represented the alluvial subsoil, CRN 18, the original topsoil (and probably the original ground surface), CRN 17, a levelling and/or bedding layer probably associated with the first development of the site in the nineteenth century, and the demolition and disturbance associated with the cutting of the large number of modern, intercutting pits, parts of which were exposed between five and ten metres to the north in both trenches.

Figure 2: Drawings of Trench 1 and 2
