# Archaeological Evaluation on Land at the former Springfield Paper Mill, Sandling Road, Maidstone, Kent

Site Code: Mill -EV-18

Planning Application Number: 17/5021432/FULL

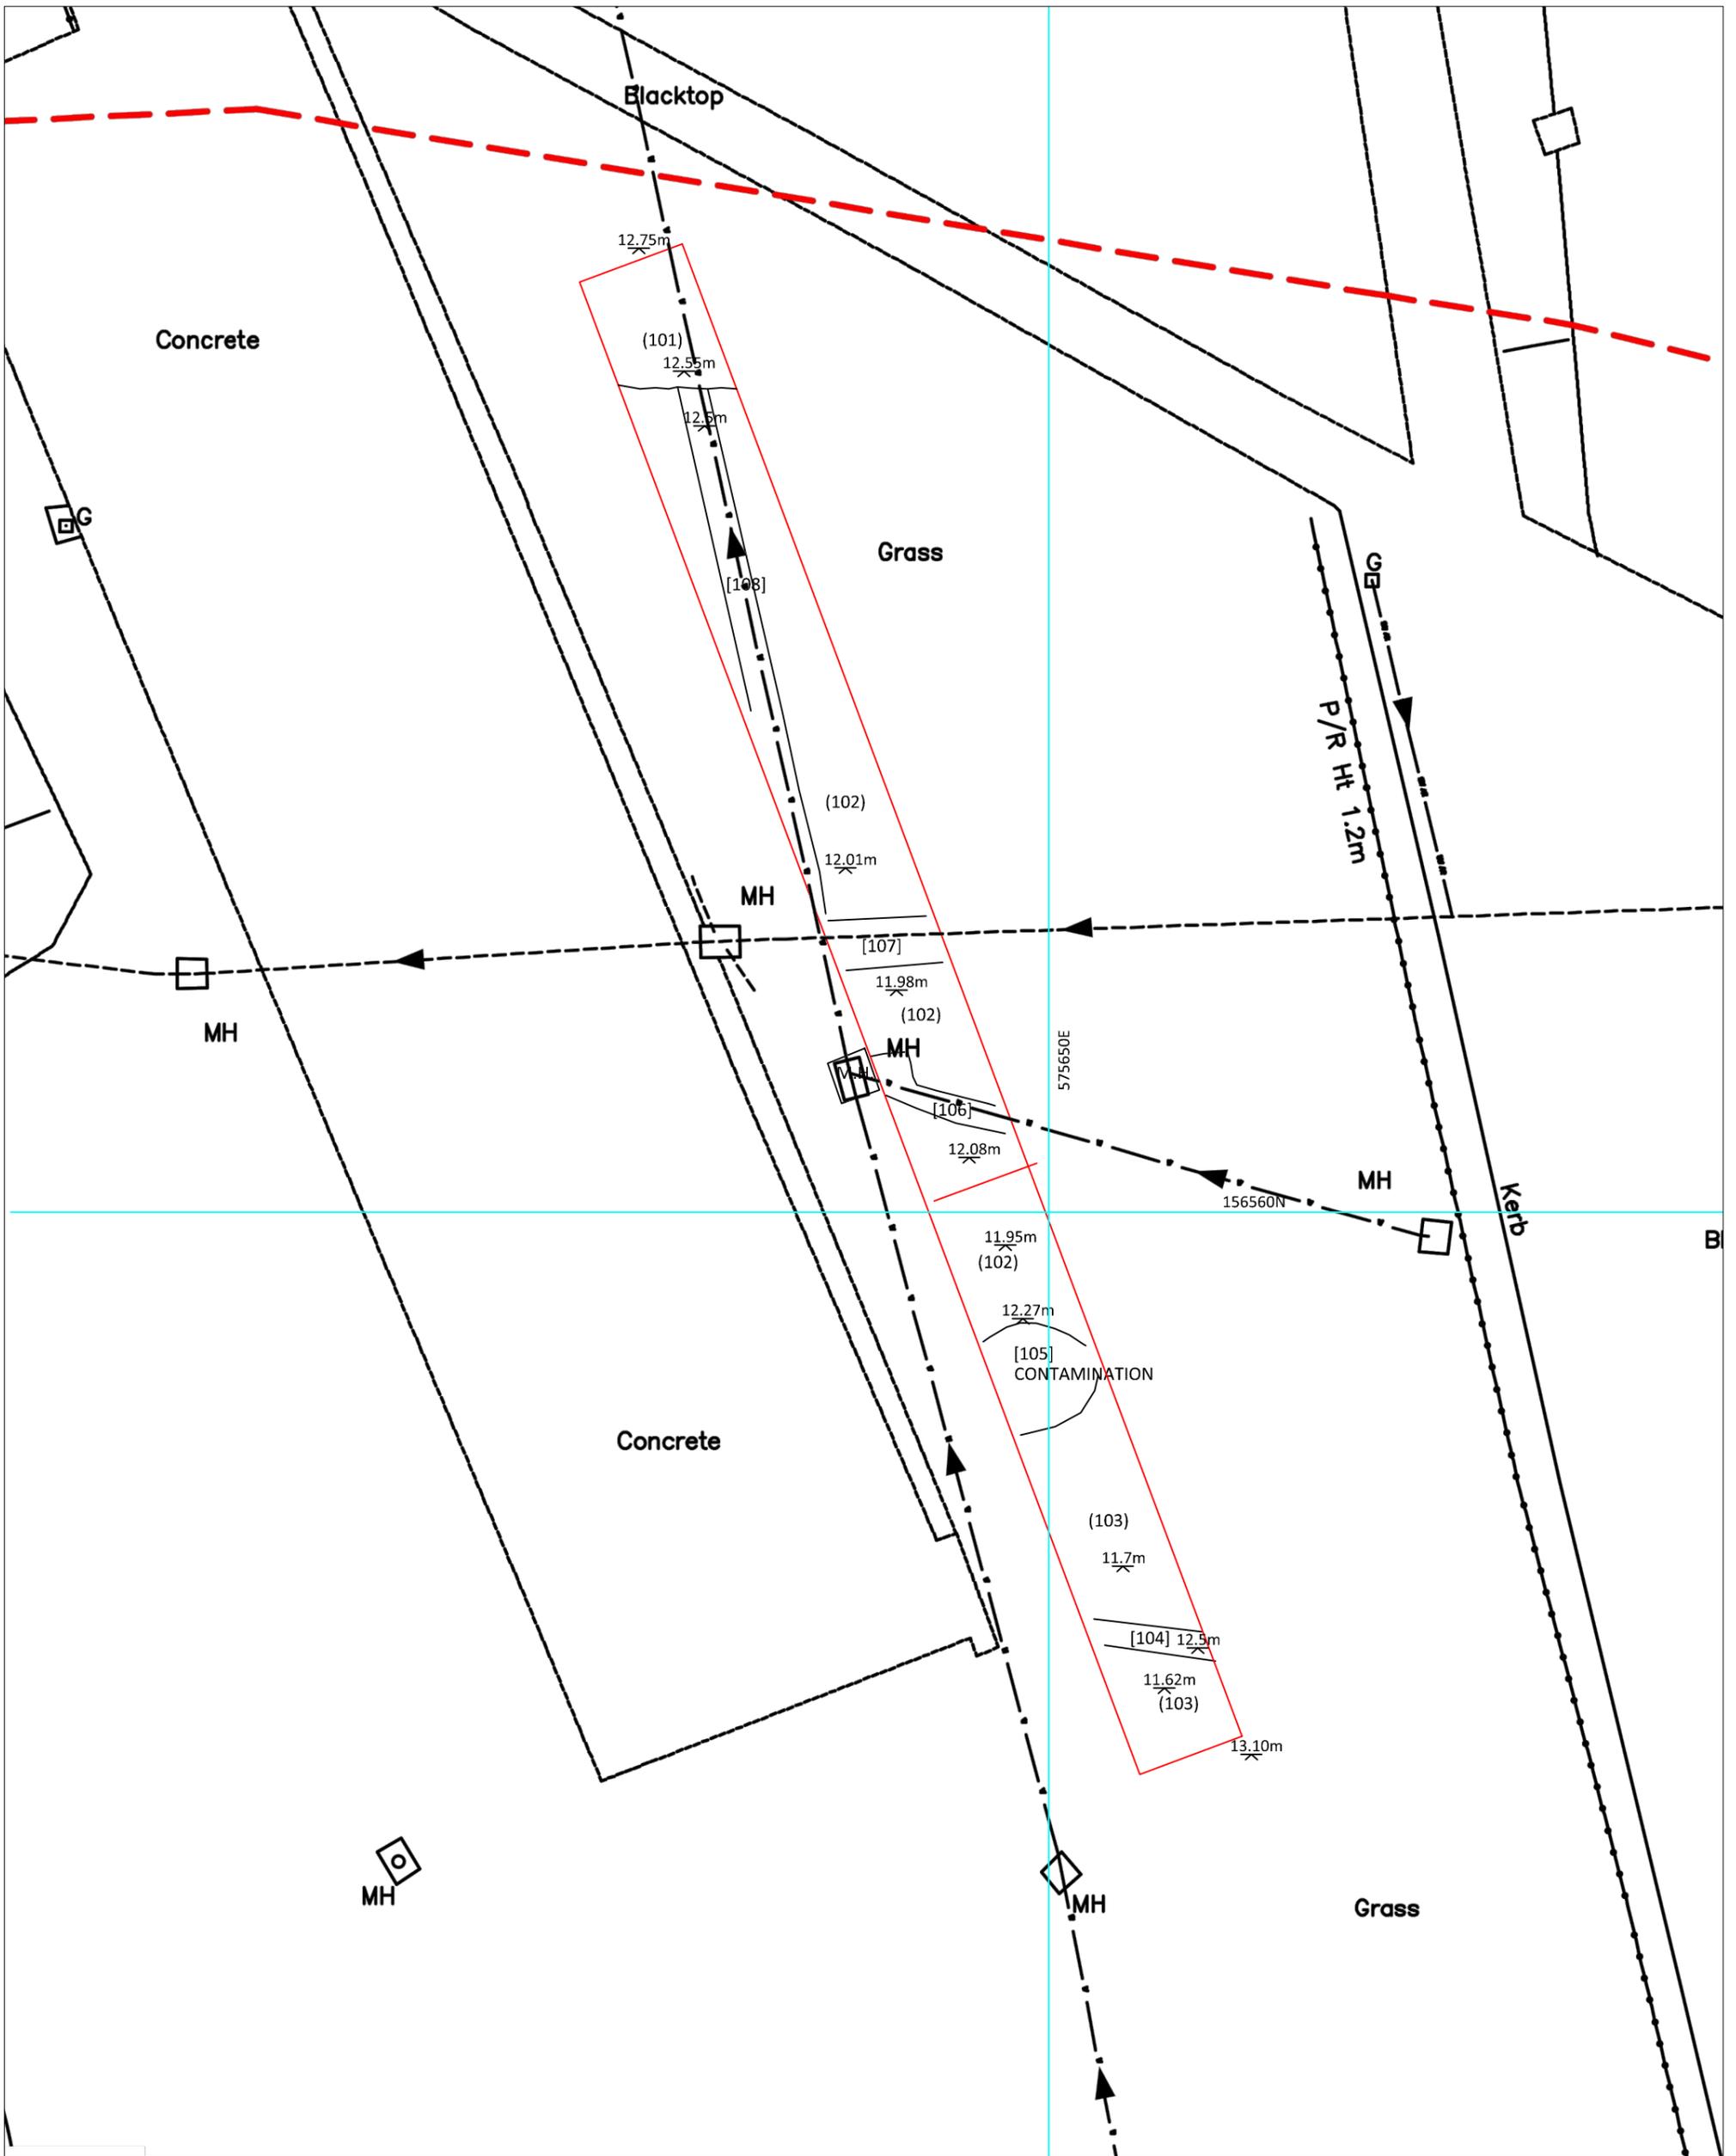
Figure 3: Plan of Trench 1

- 5.3.1 The 13 trenches were located across the site to ensure full coverage of potential archaeological remains.
- 5.3.2 **Trench 1** was located in the south area of the site and aligned NNW-SSE (Figures 1, 2 2a, 3) and exposed known services runs (Figure 3) and some contamination [105]. Plates 2, 4.

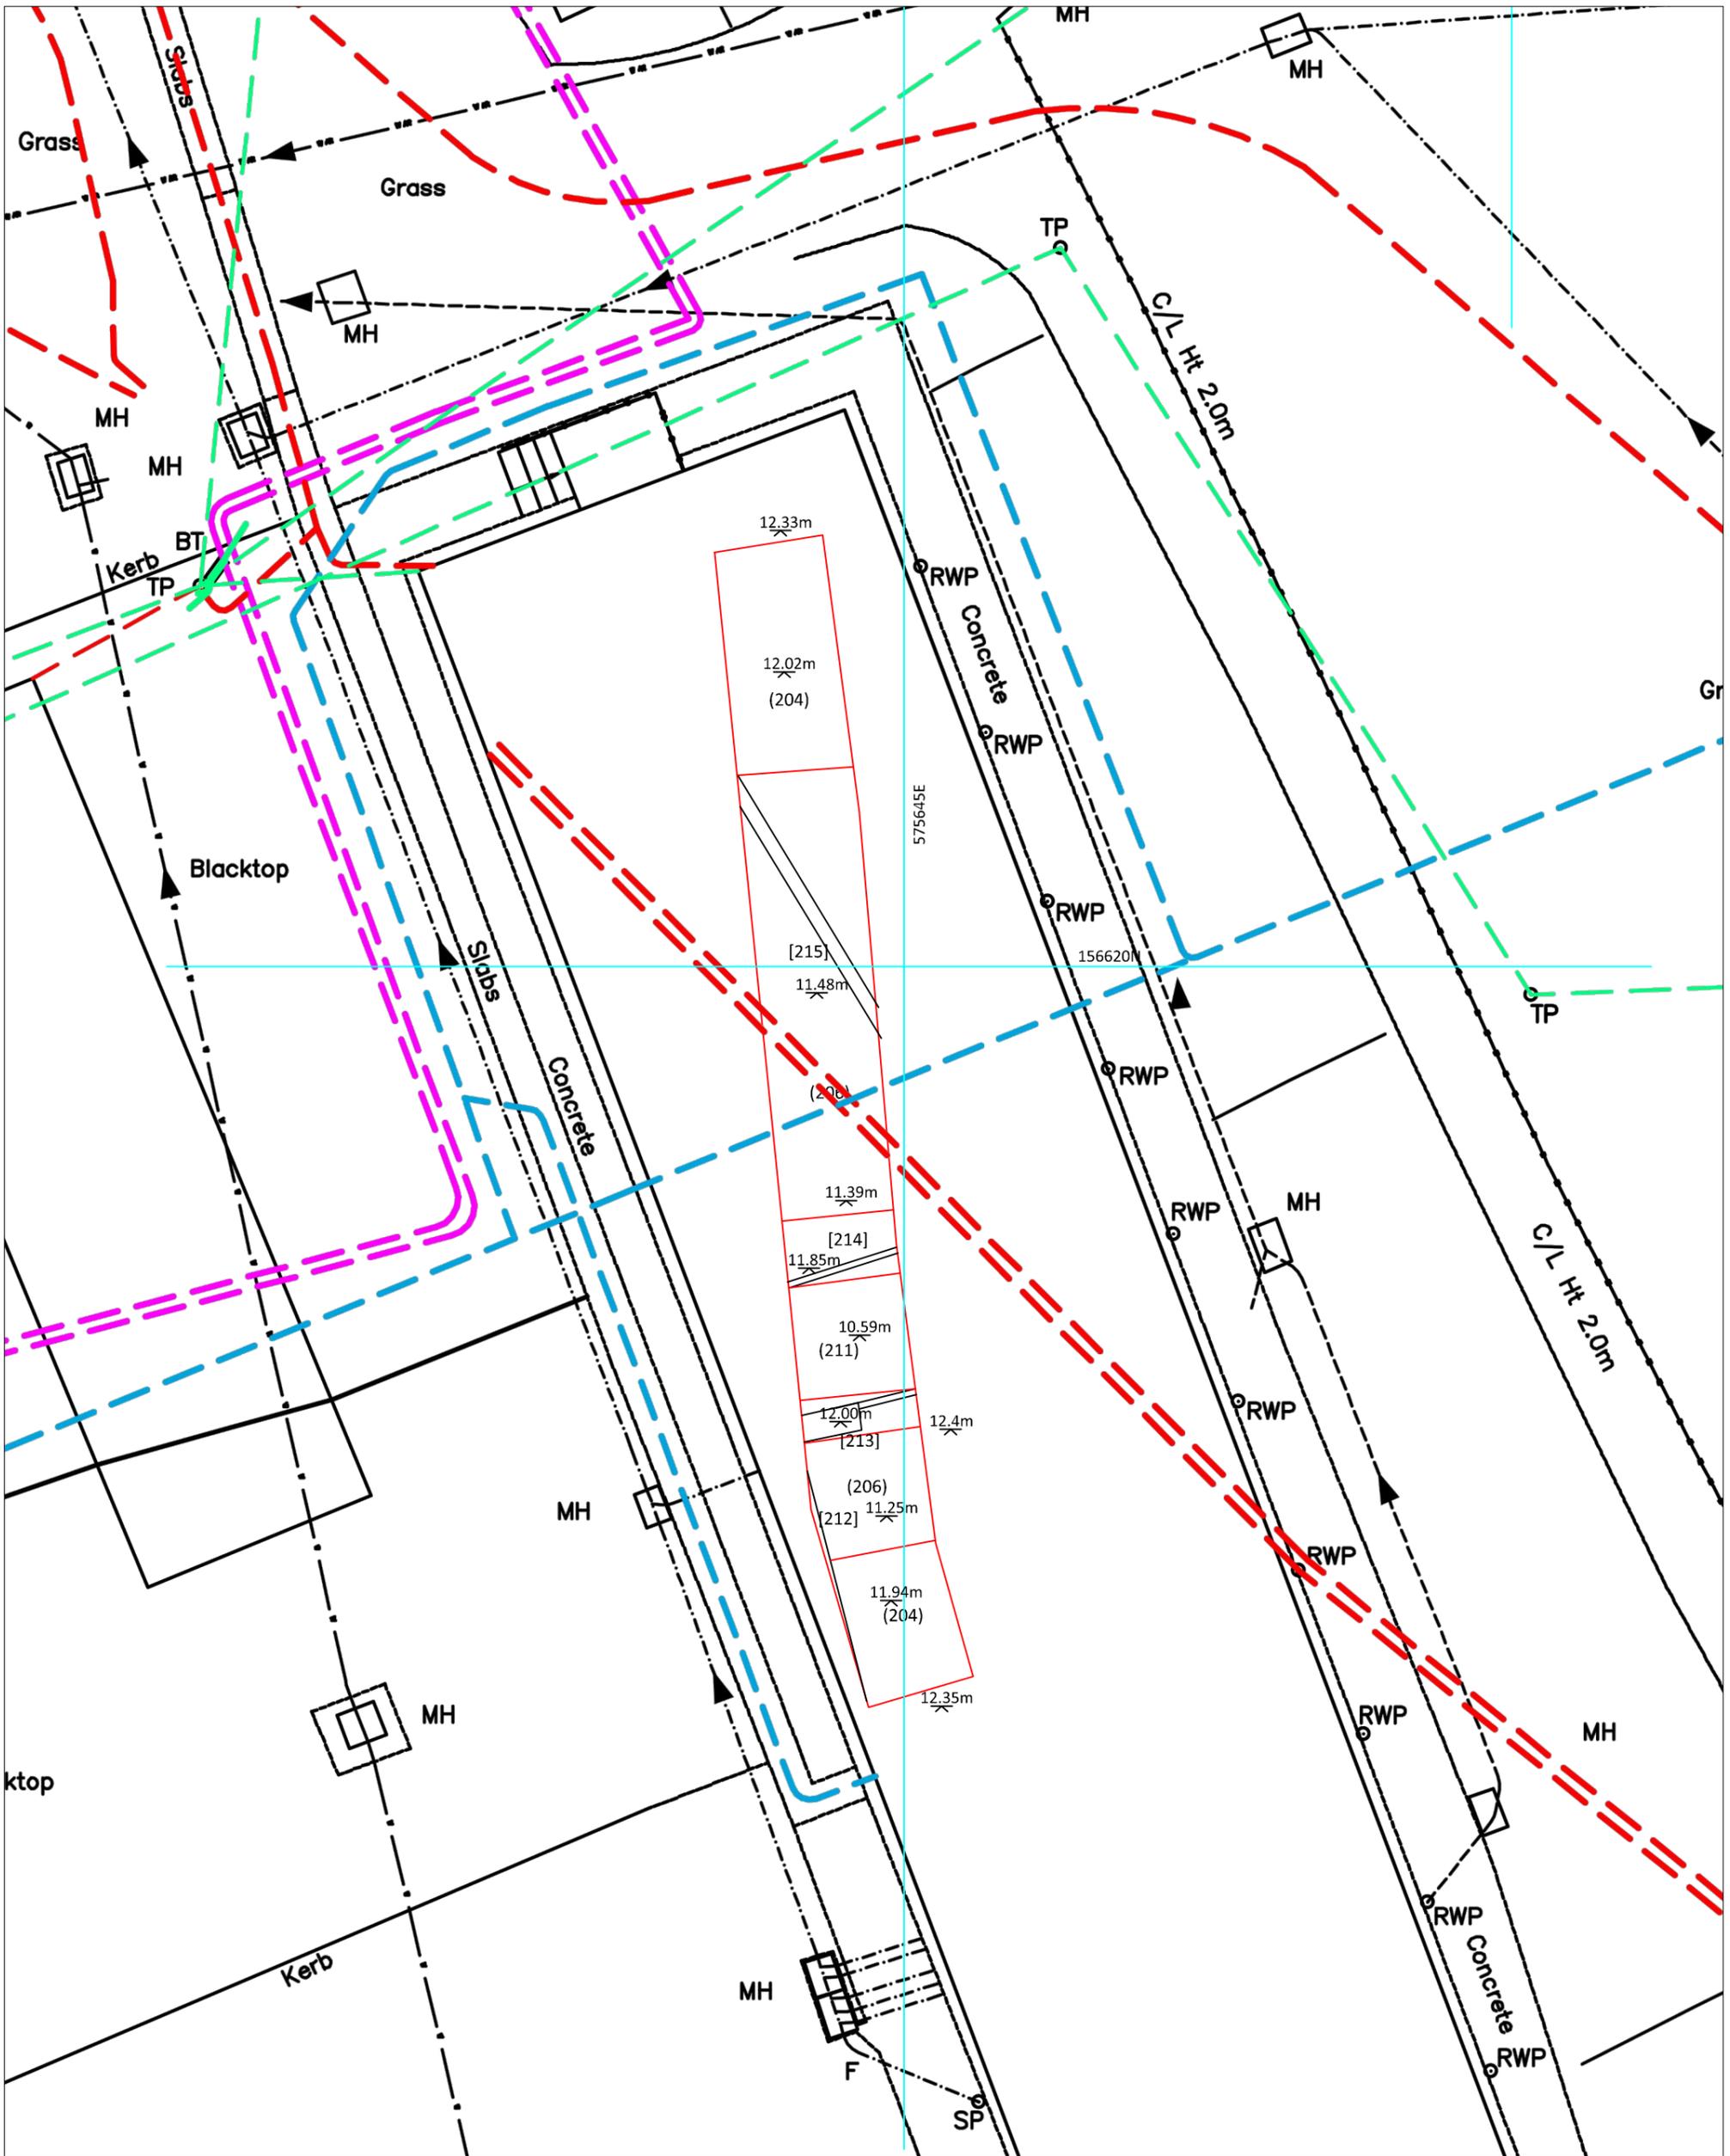
Figure 4: Plan of Trench 2

- 5.3.3 **Trench 2** was located in the south area of the site and aligned N-S (Figures 1, 2 2a, 4) and exposed known services runs with pipes and some river terracing (Figure 4). Plates 5, 6, 7.

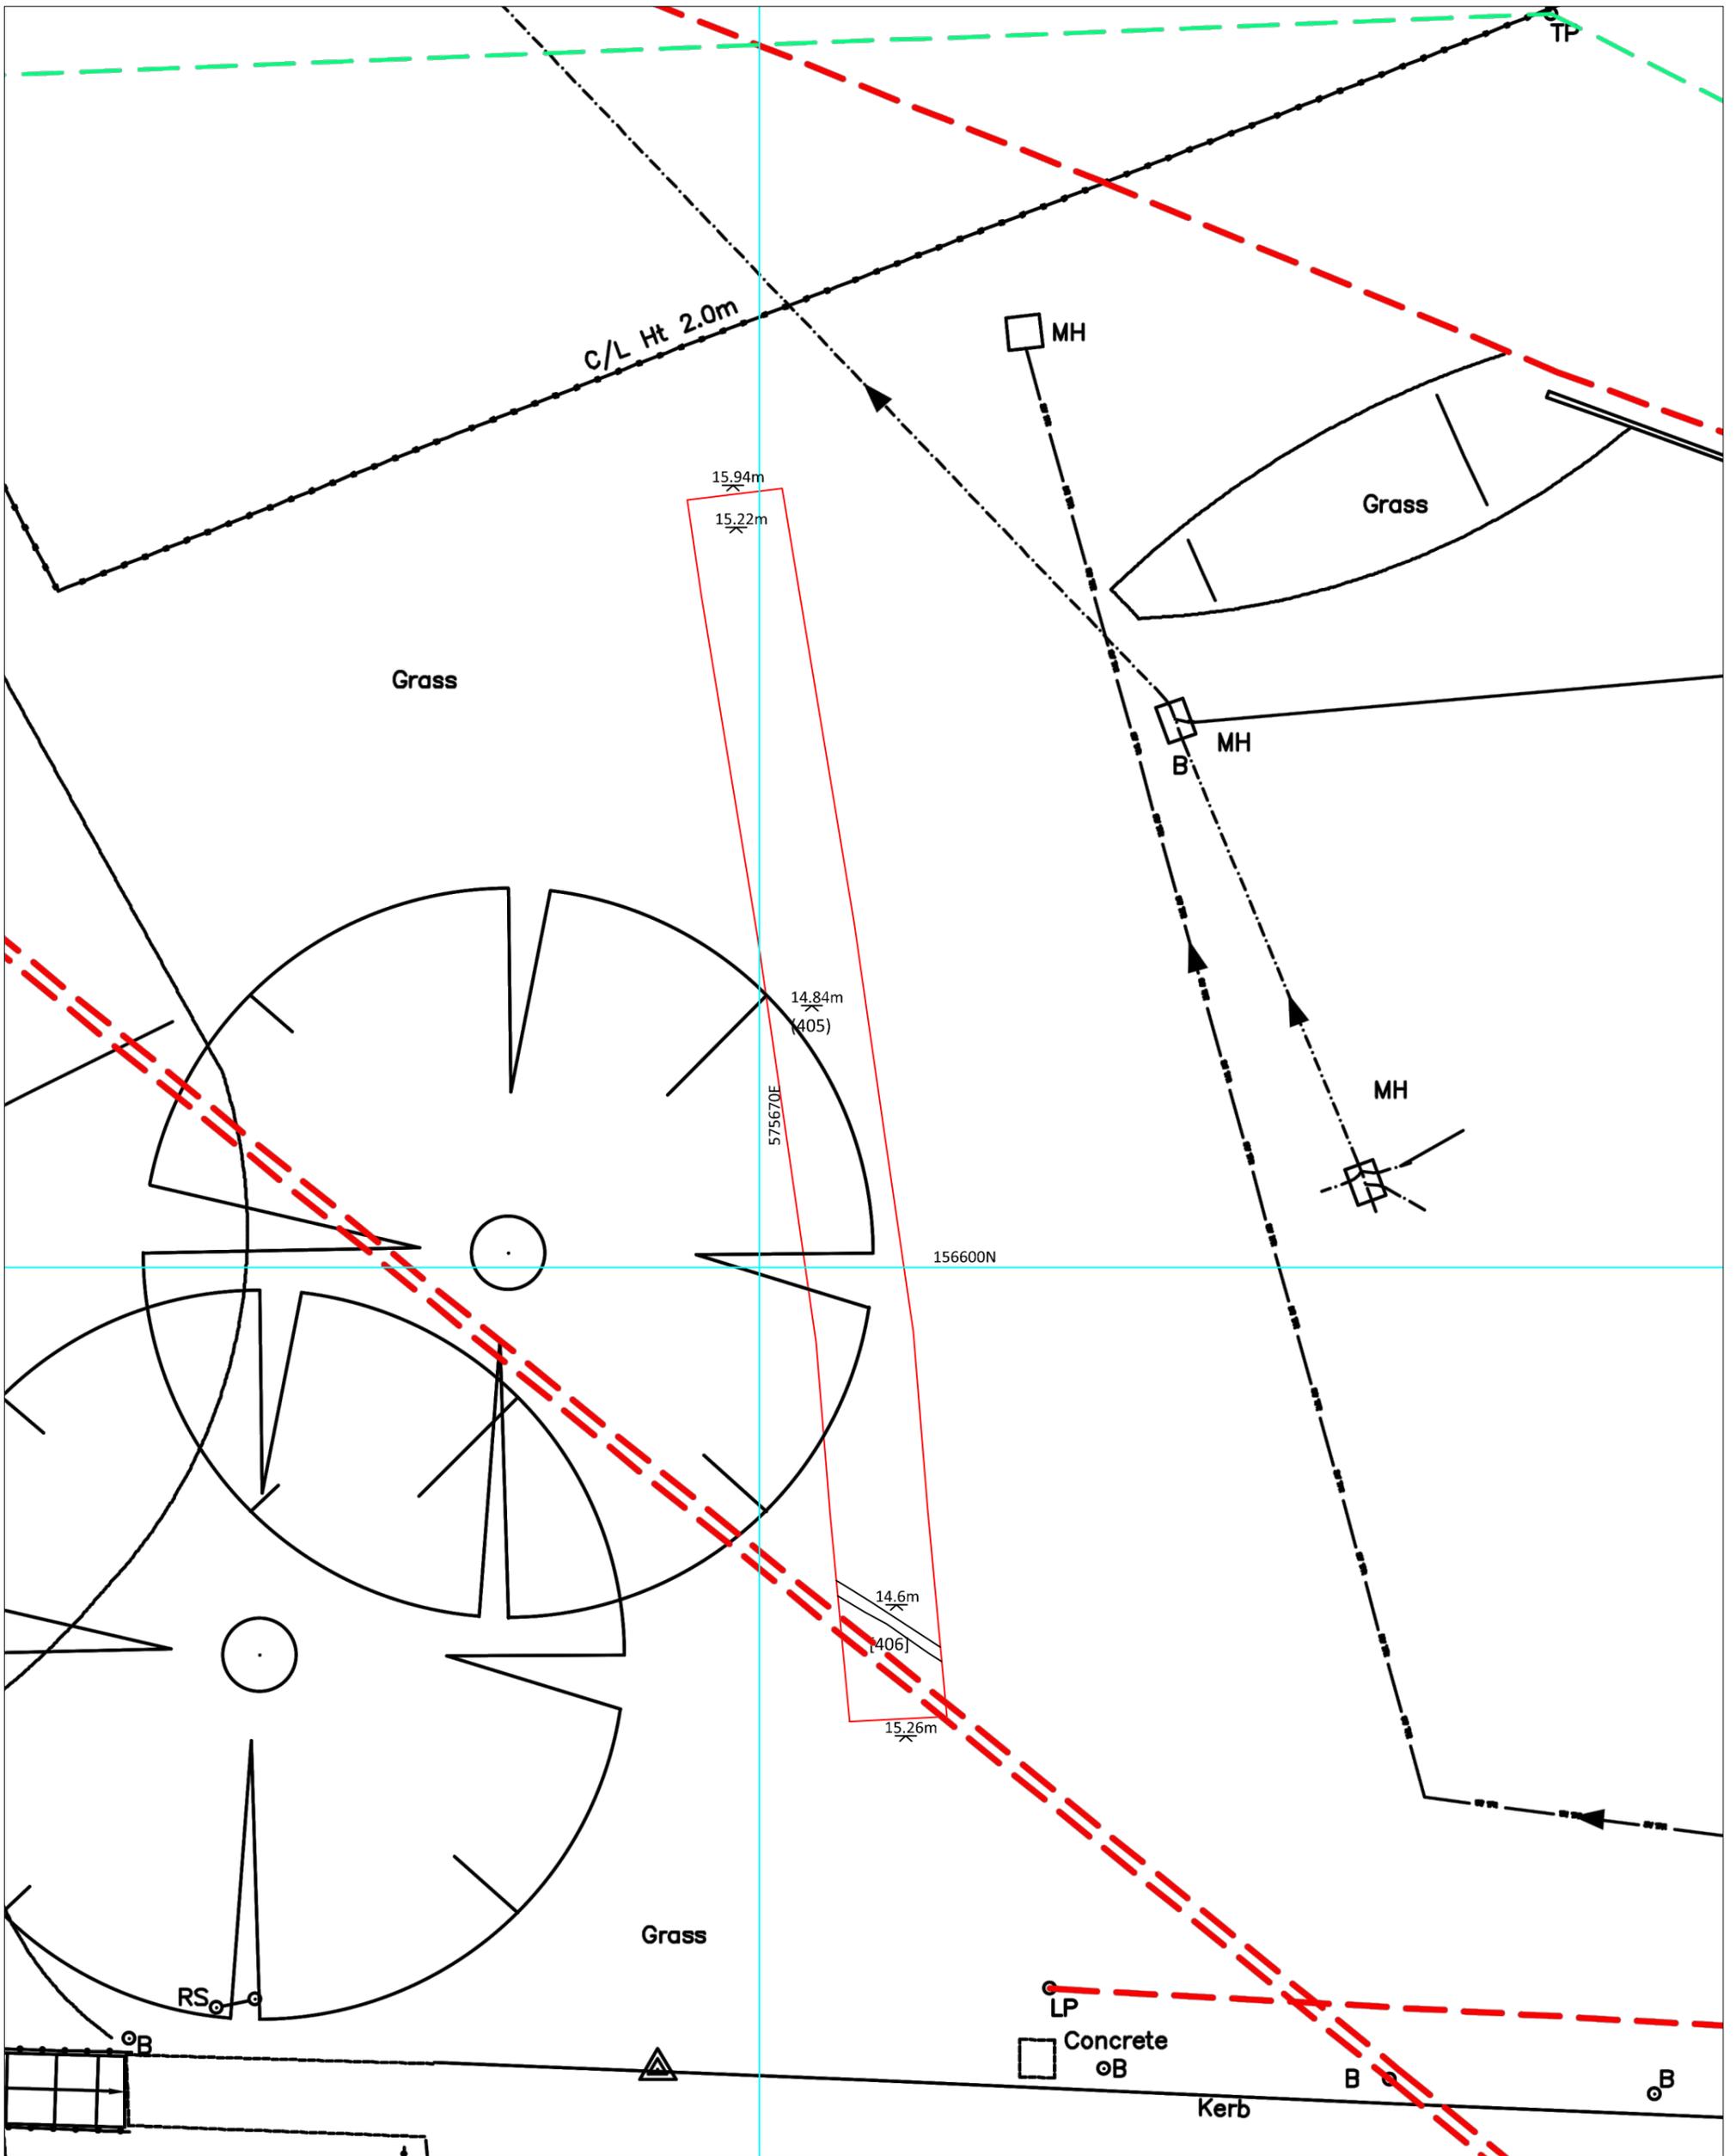
Figure 6: Plan of Trench 4

- 5.3.5 **Trench 4** was located in the south area of the site and aligned N-S (Figures 1, 2 2a, 6) and exposed known services runs (Figure 6) levelling layers and natural bedrock. Plates 9, 10.

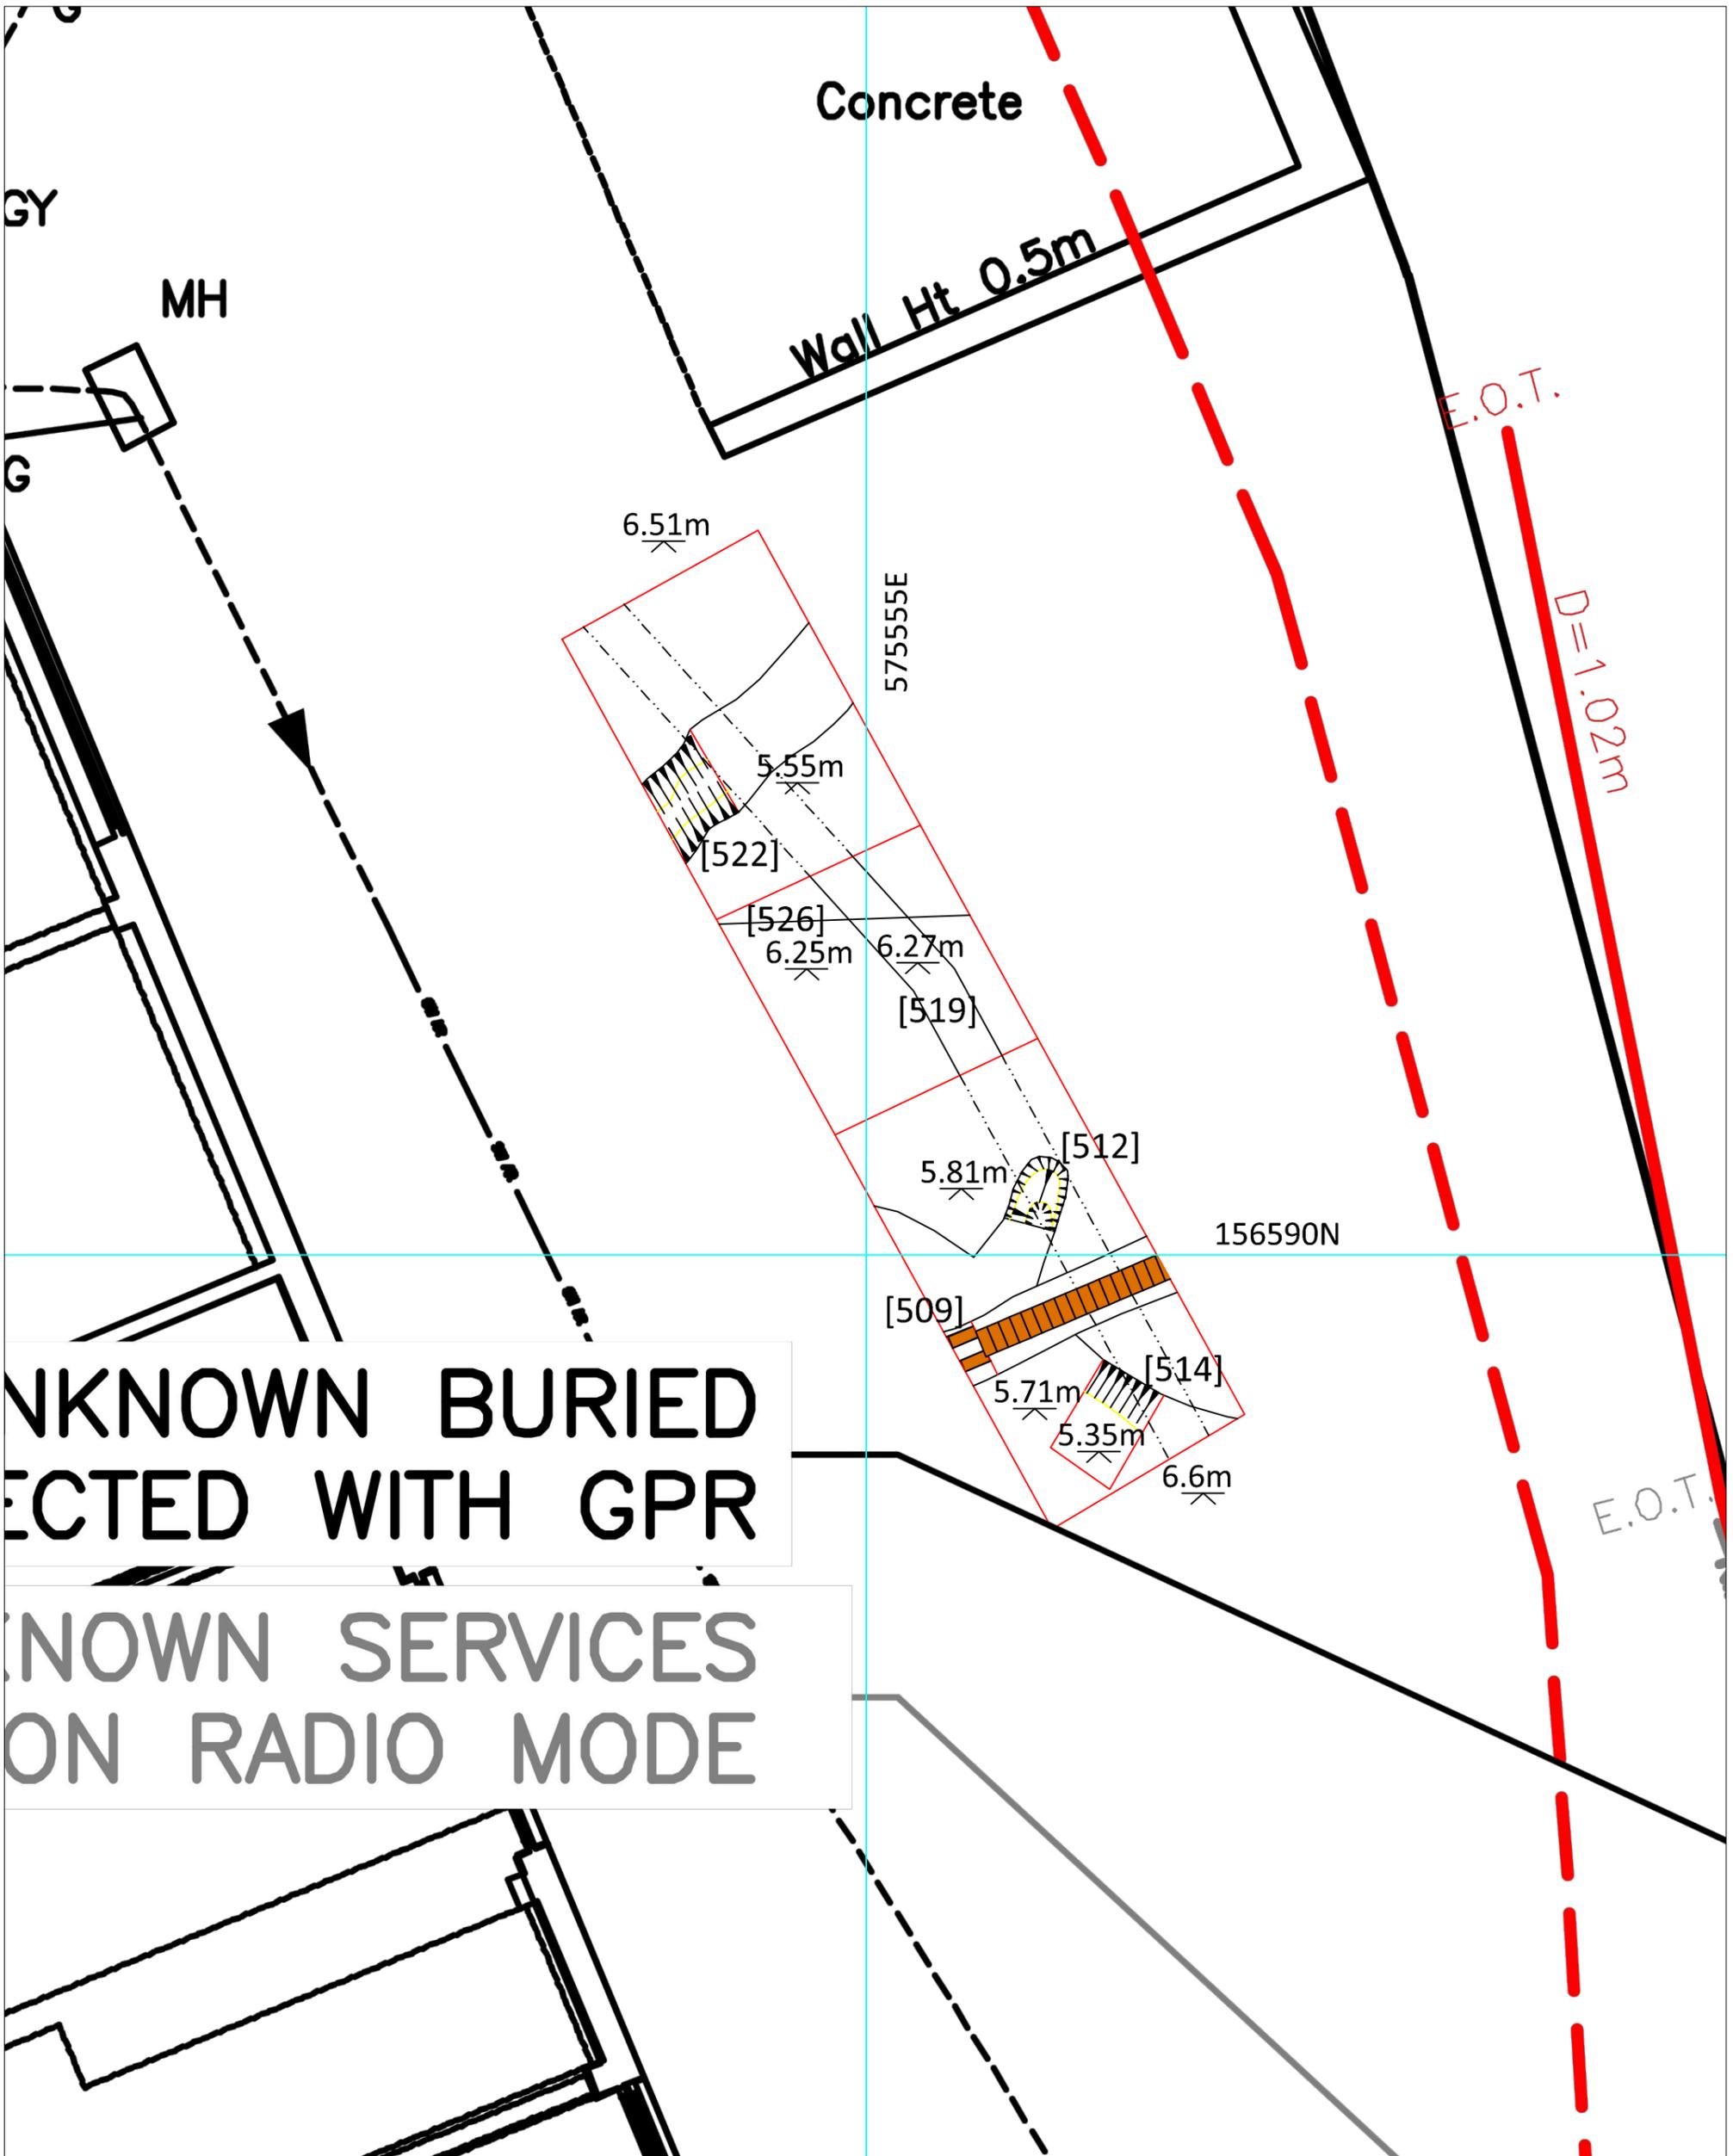
Figure 7: Plan of Trench 5

- 5.3.6 **Trench 5** was located in the mid west area of the site and aligned NNW-SSE (Figures 1, 2 2a, 7) and exposed known services run trenches (Figure 7) and some levelling layers(505). Plates 11-17.

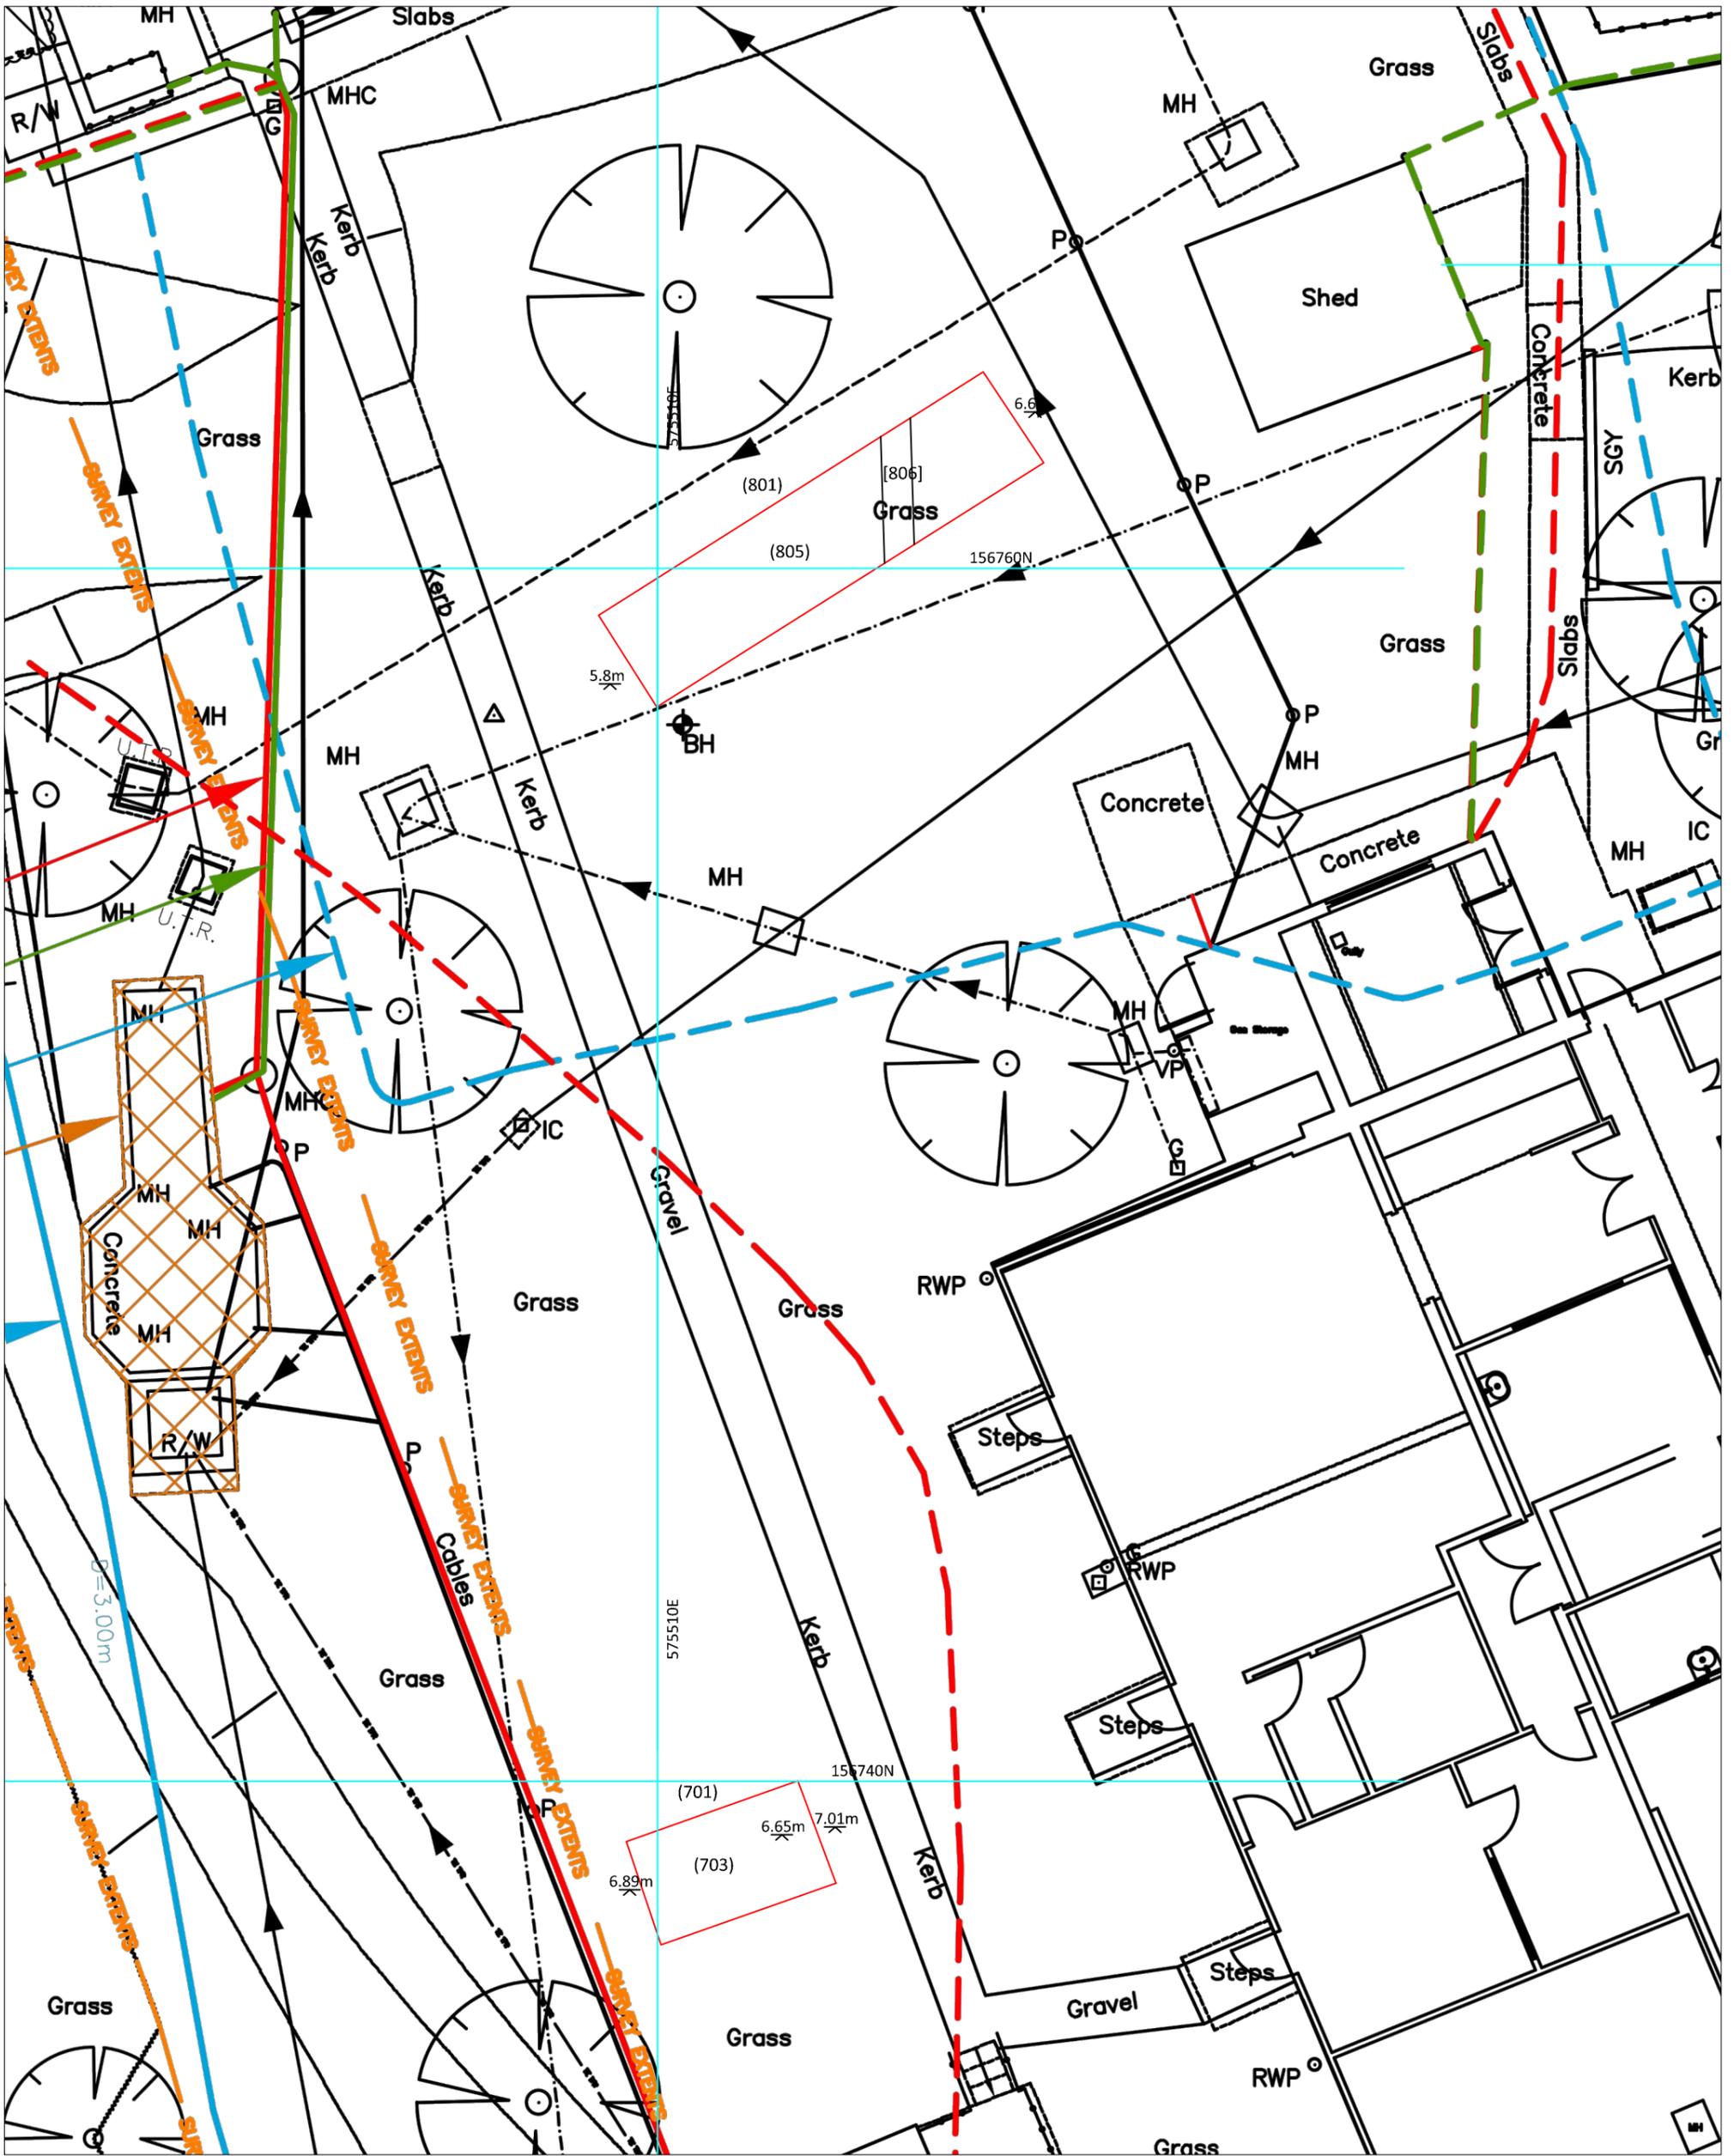
Figure 8: Plan of Trench 7 and 8

- 5.3.8 **Trench 7** was located in the mid area of the site and aligned ENE-WSW (Figures 1, 2 2a, 8) and exposed levelling layers and natural bedrock (703). Plate 19.

- 5.3.9 **Trench 8** was located in the mid area of the site and aligned WSW-ENE (Figures 1, 2 2a, 8) and exposed levelling layers and modern service trenches (Figure 8). Plates 20, 21.

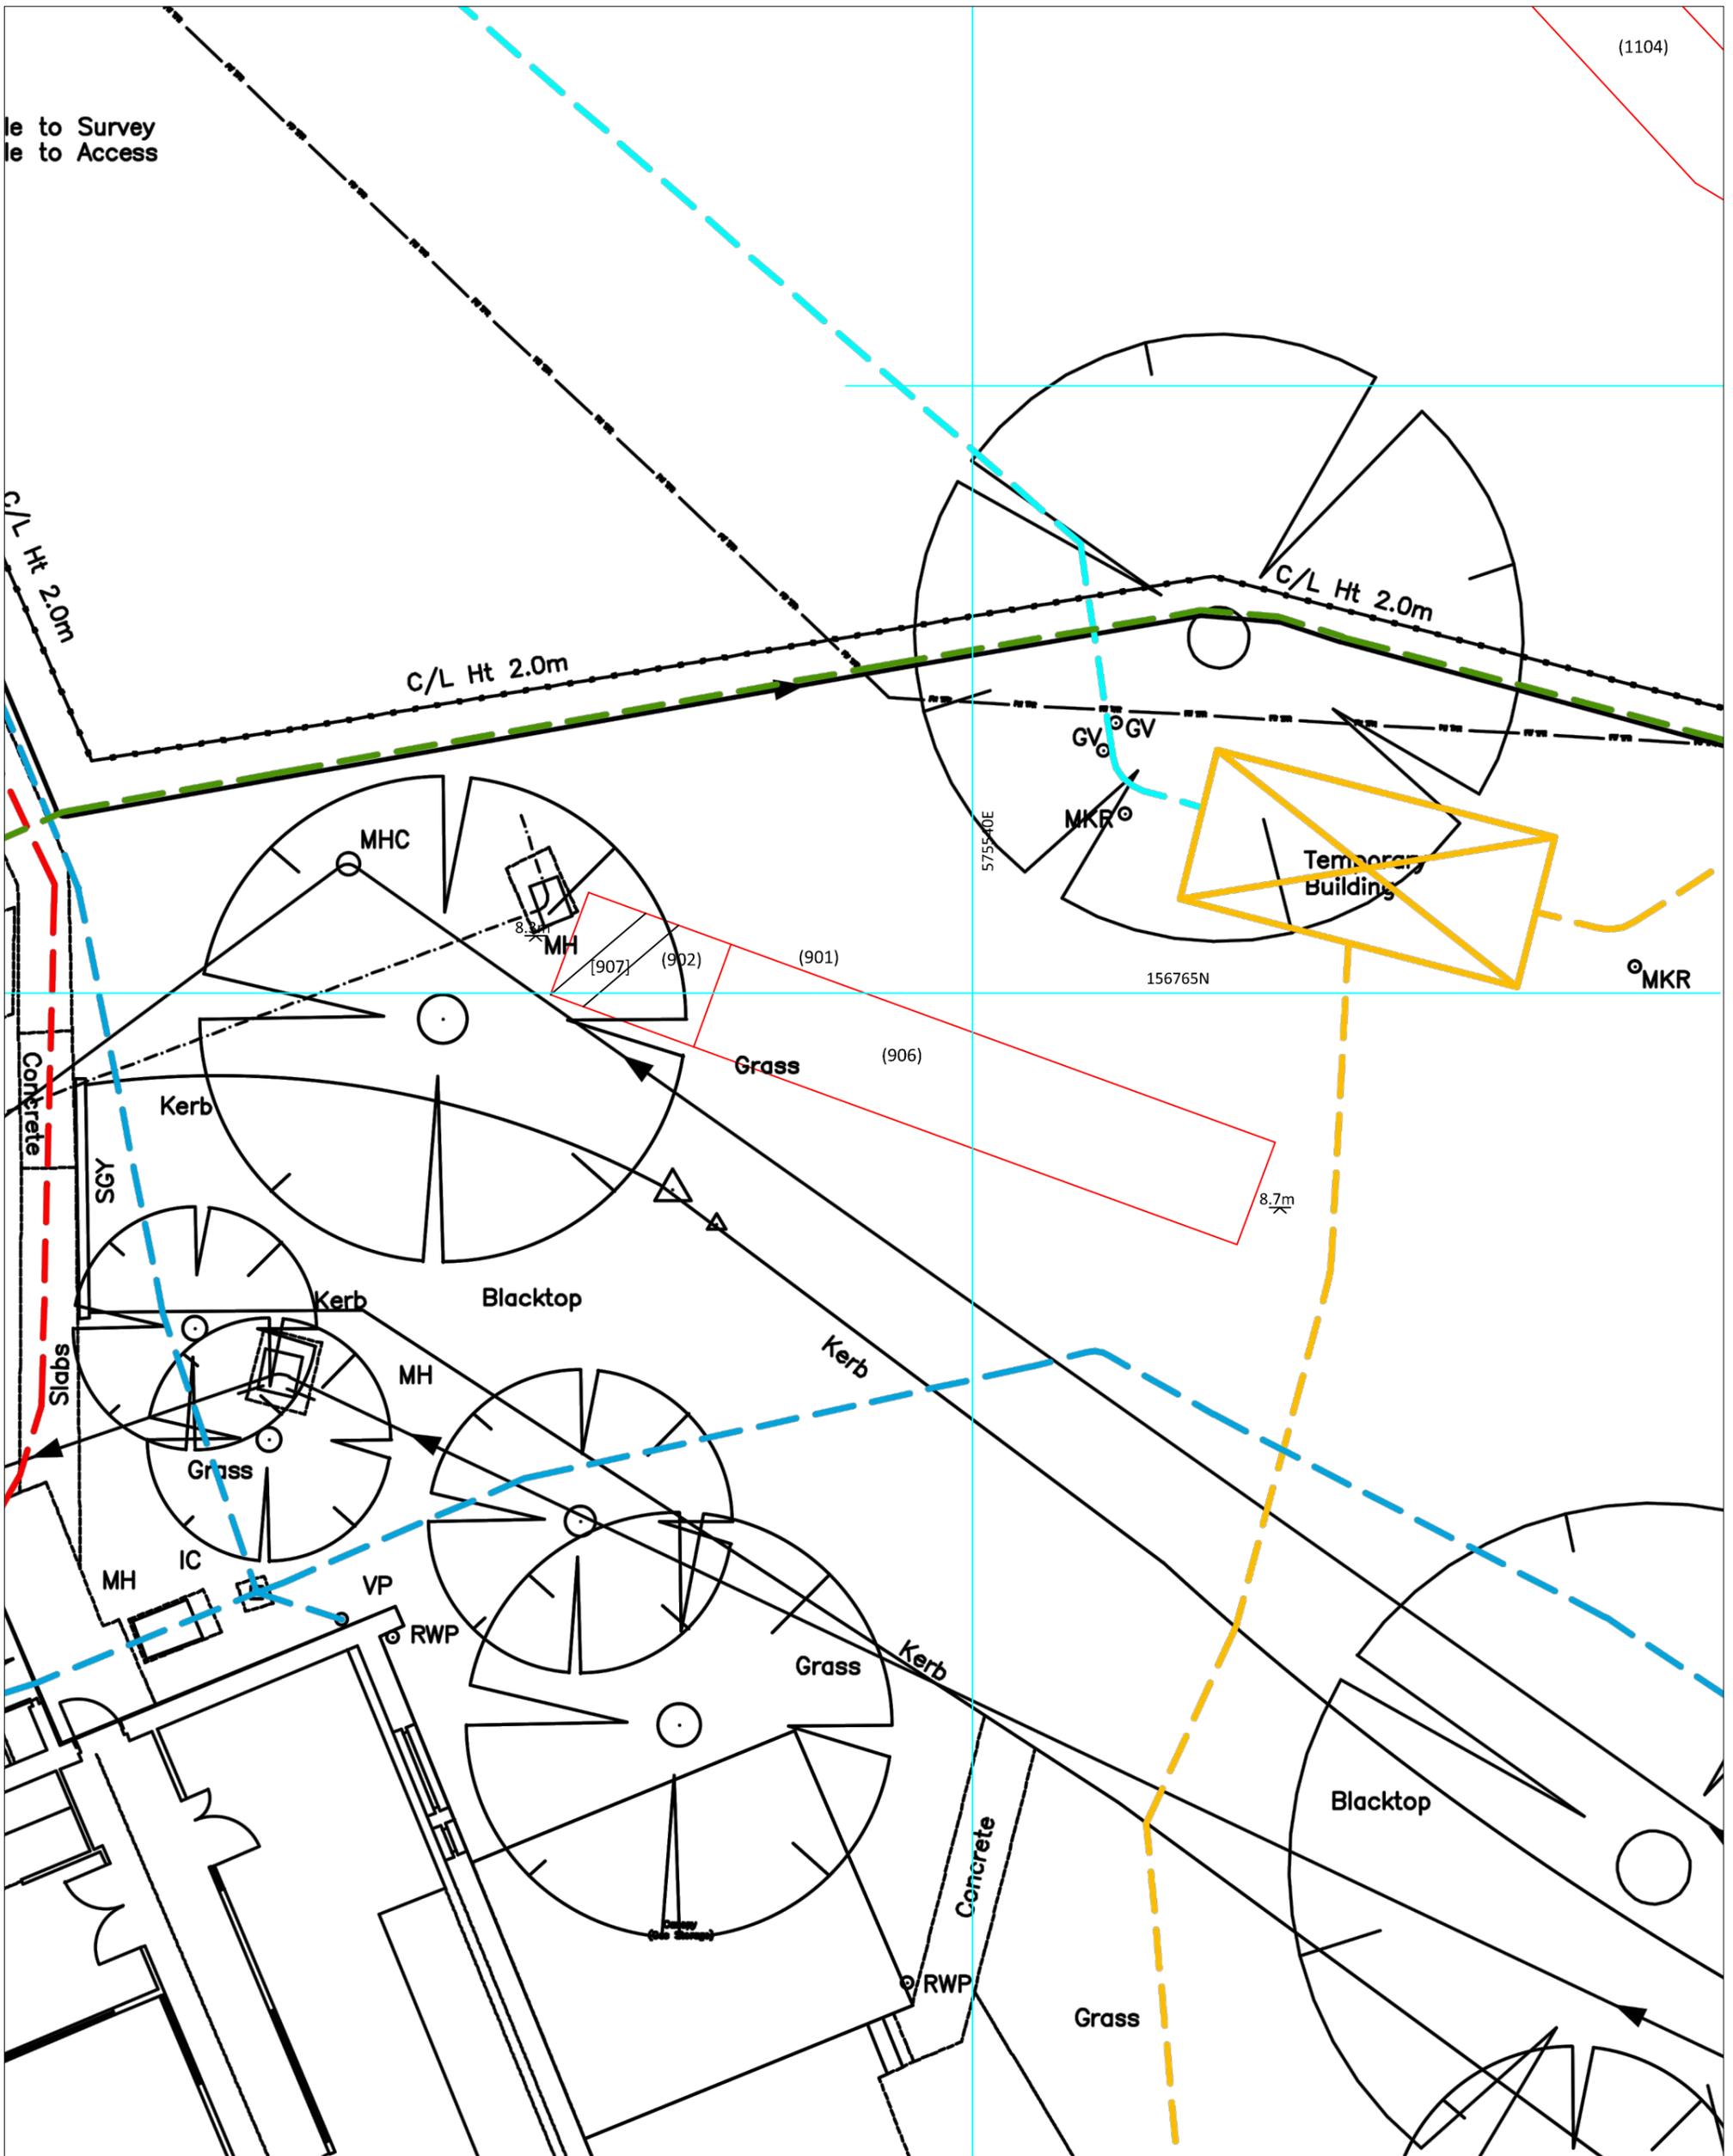
Figure 9: Plan of Trench 9

- 5.3.10 **Trench 9** was located in the south area of the site and aligned WNW-ESE (Figures 1, 2 2a, 9) and exposed levelling layers, modern trench and natural bedrock (Figure 9)]. Plate 22.
