# Archaeological Evaluation on Land at the former Springfield Paper Mill, Sandling Road, Maidstone, Kent

Site Code: Mill -EV-18

Planning Application Number: 17/5021432/FULL

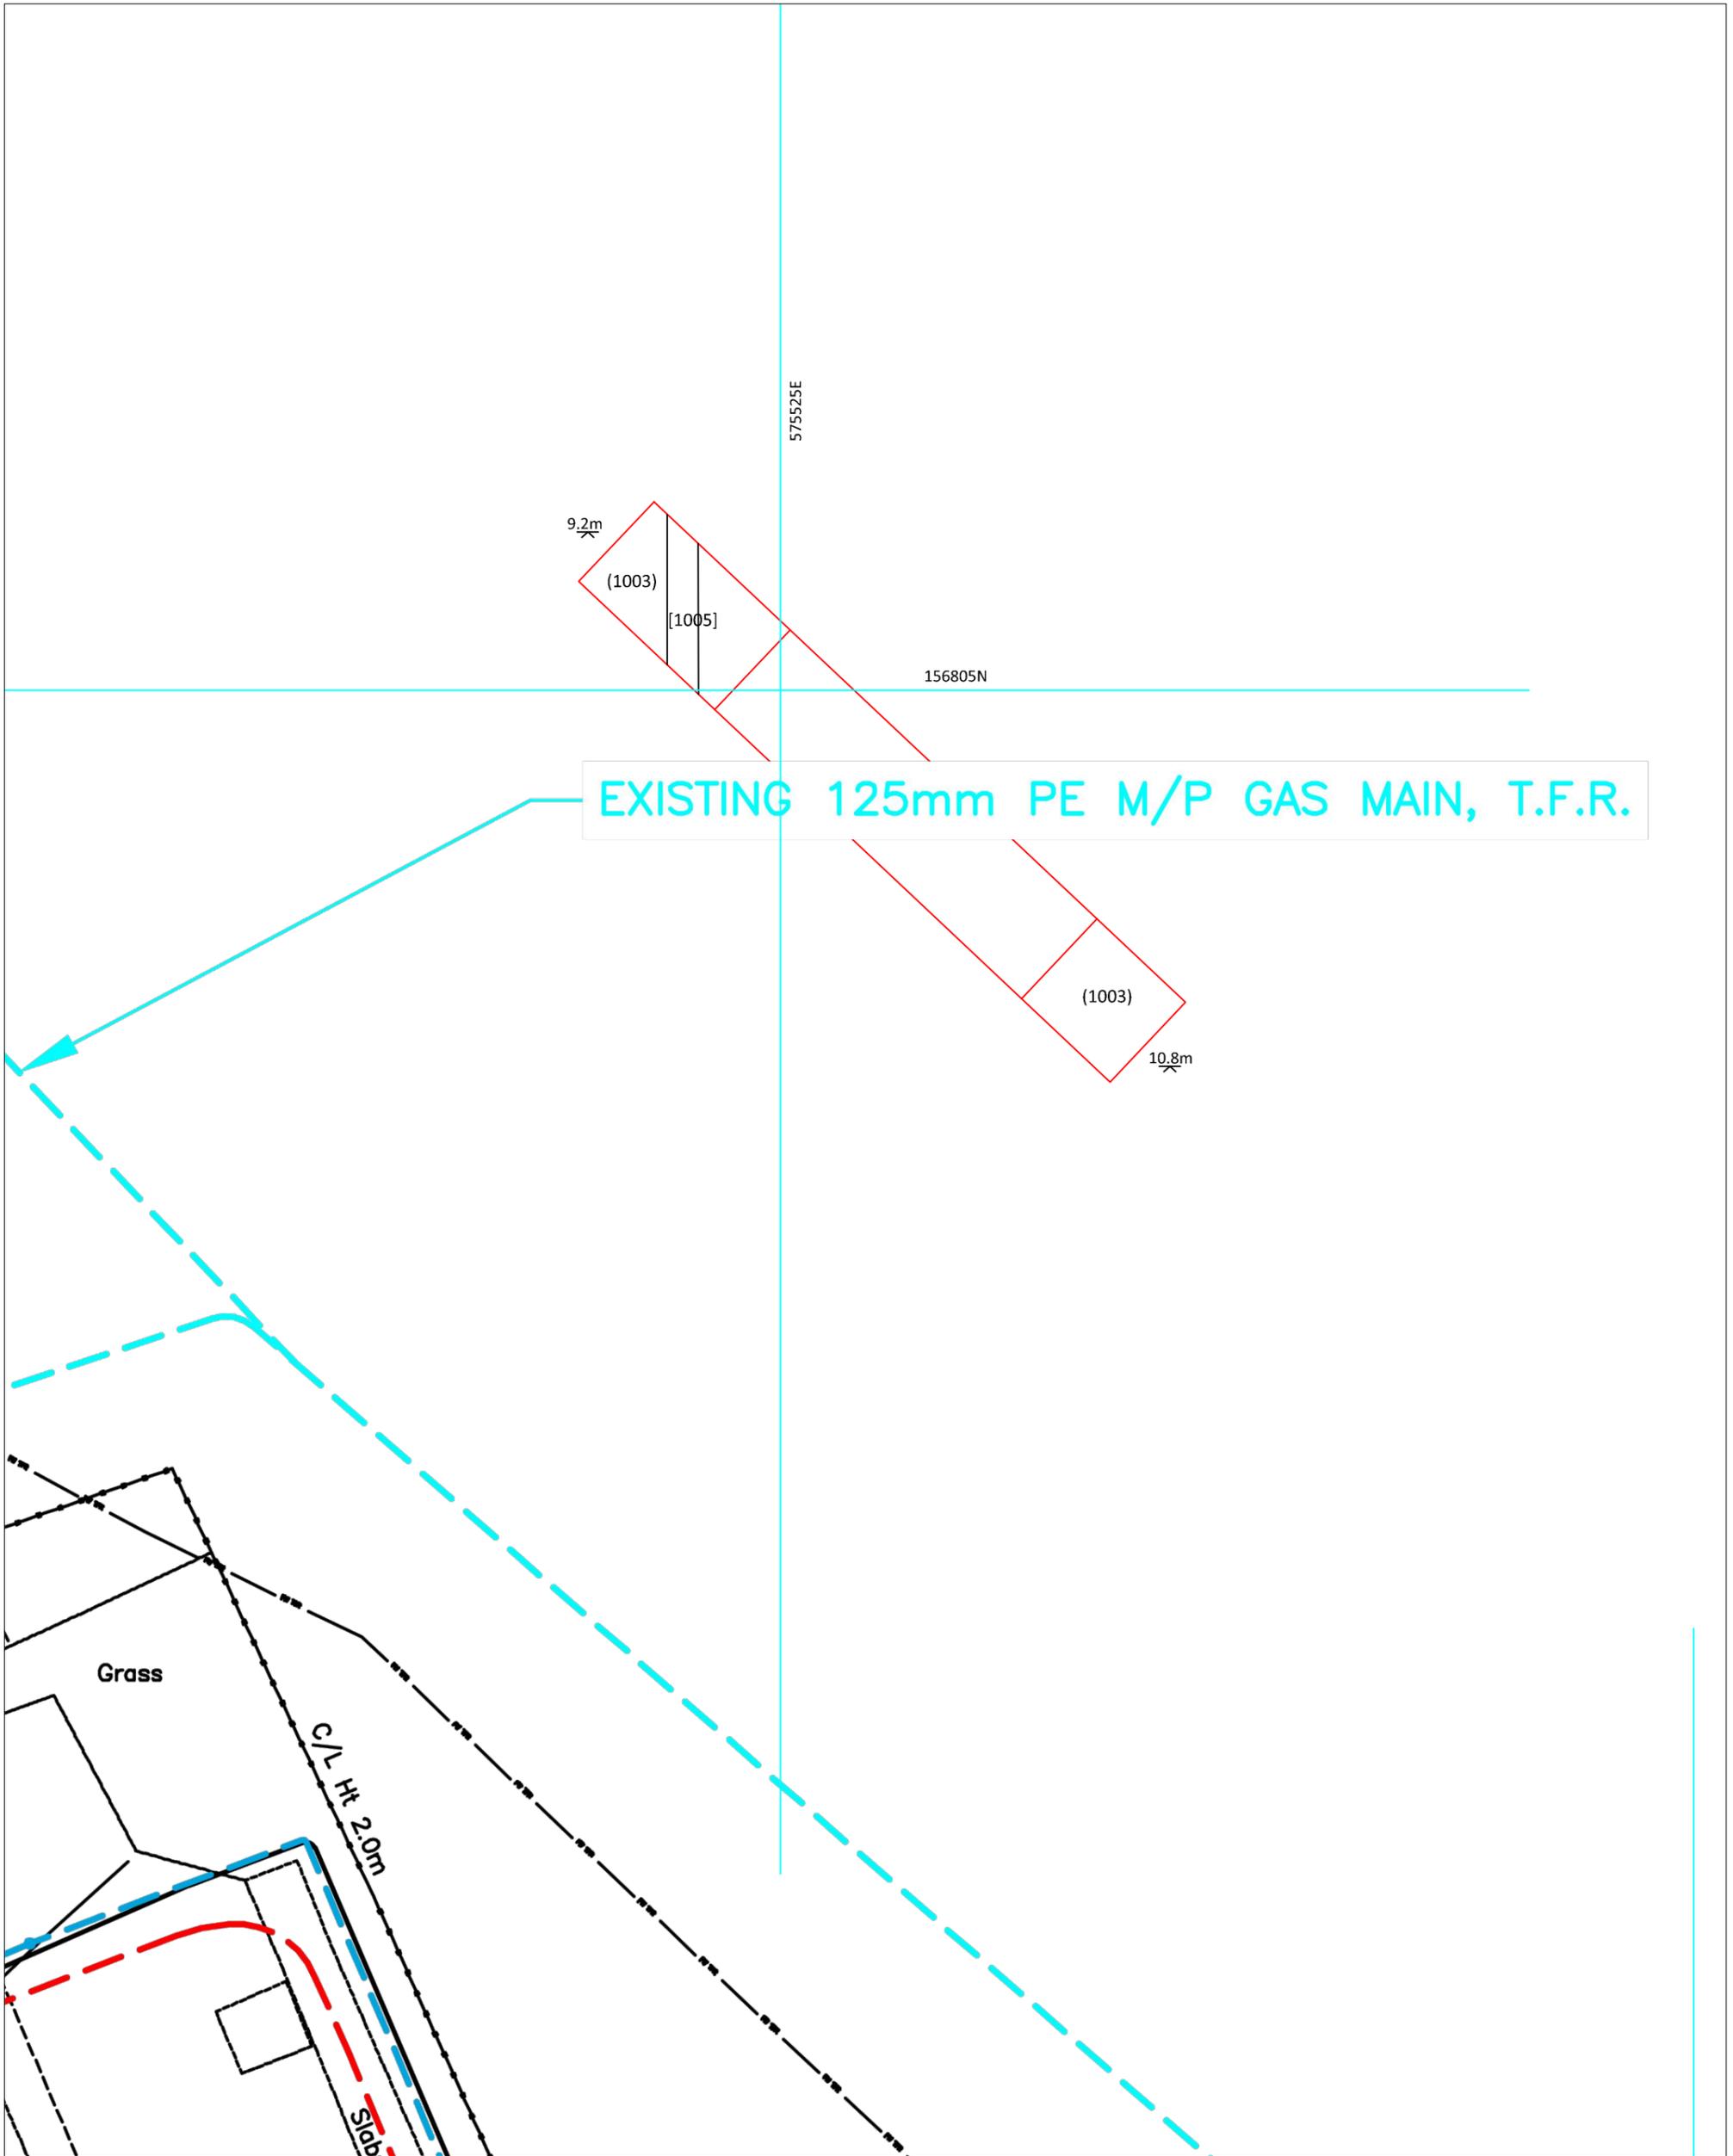
Figure 10: Plan of Trench 10

- 5.3.11 **Trench 10** was located in the north area of the site and aligned NW-SE (Figures 1, 2 2a, 10) and exposed topsoil, levelling layers (Figure 10) and natural geology (1004). Plate 23.

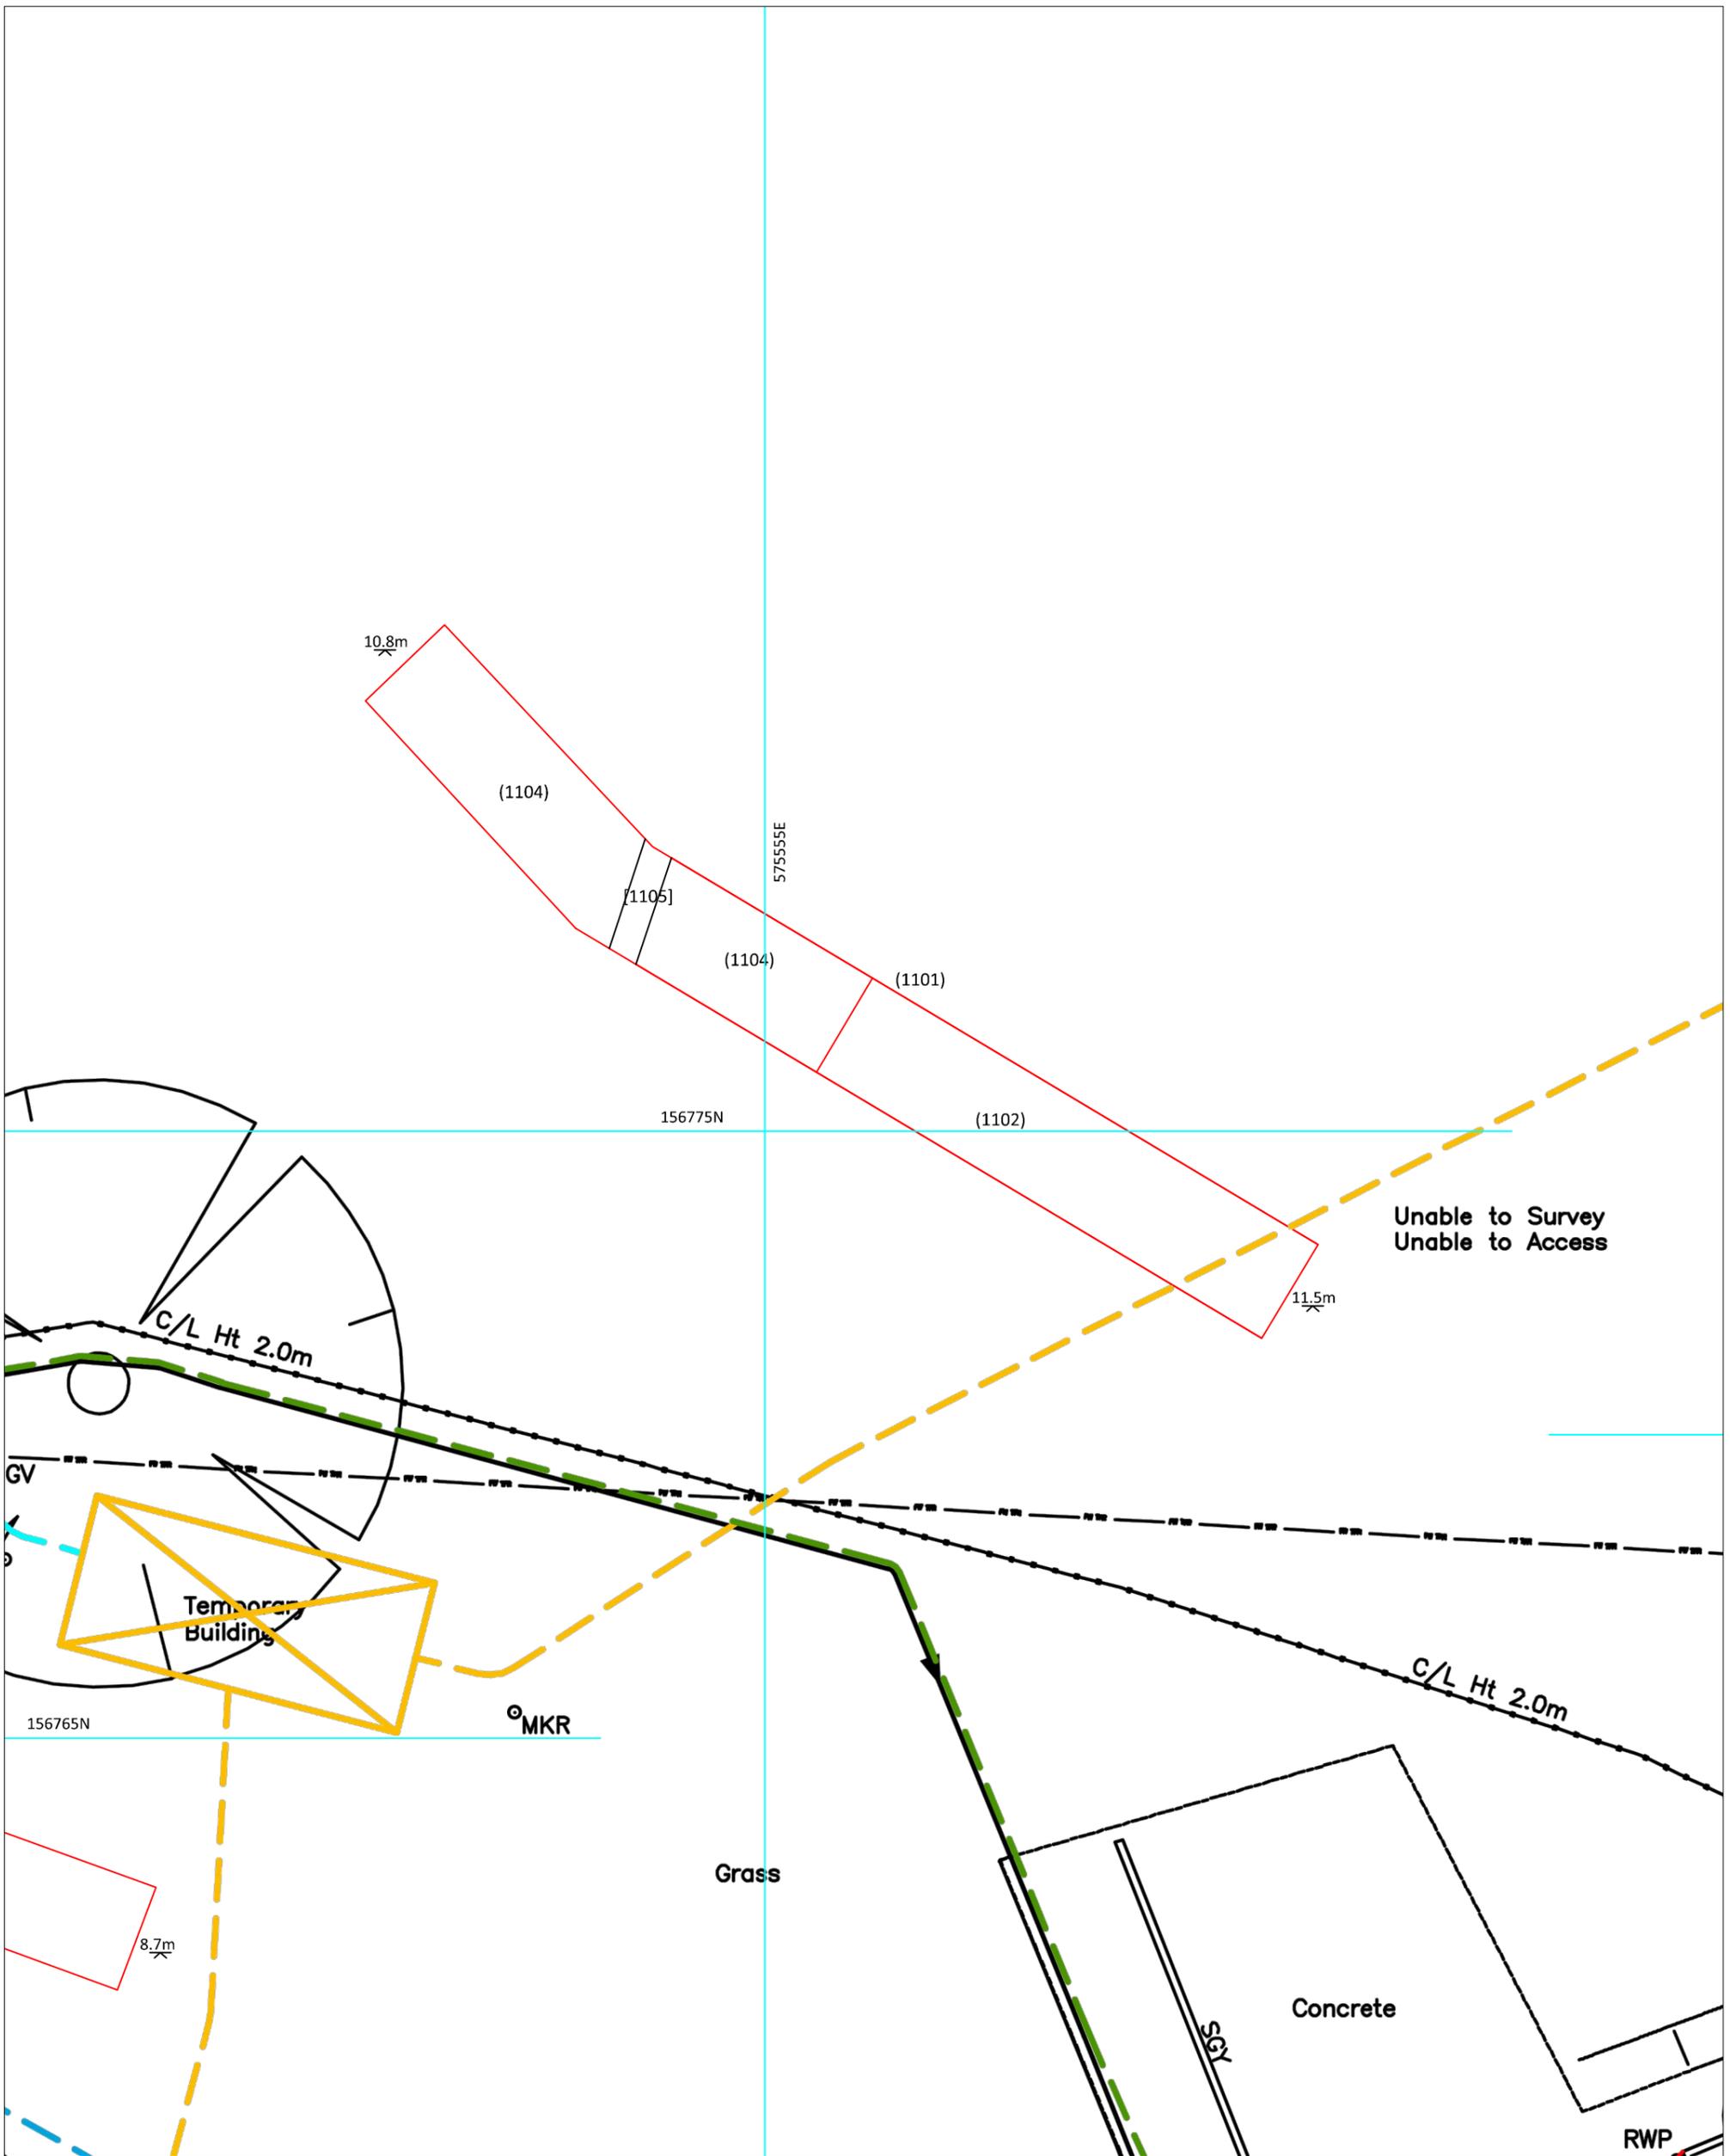
Figure 11: Plan of Trench 11

- 5.3.12 **Trench 11** was located in the north area of the site and aligned NW-SE (Figures 1, 2 2a, 11) and exposed demolition layers and modern trenches (Figure 3) and natural silty clay [1104]. Plate 24.

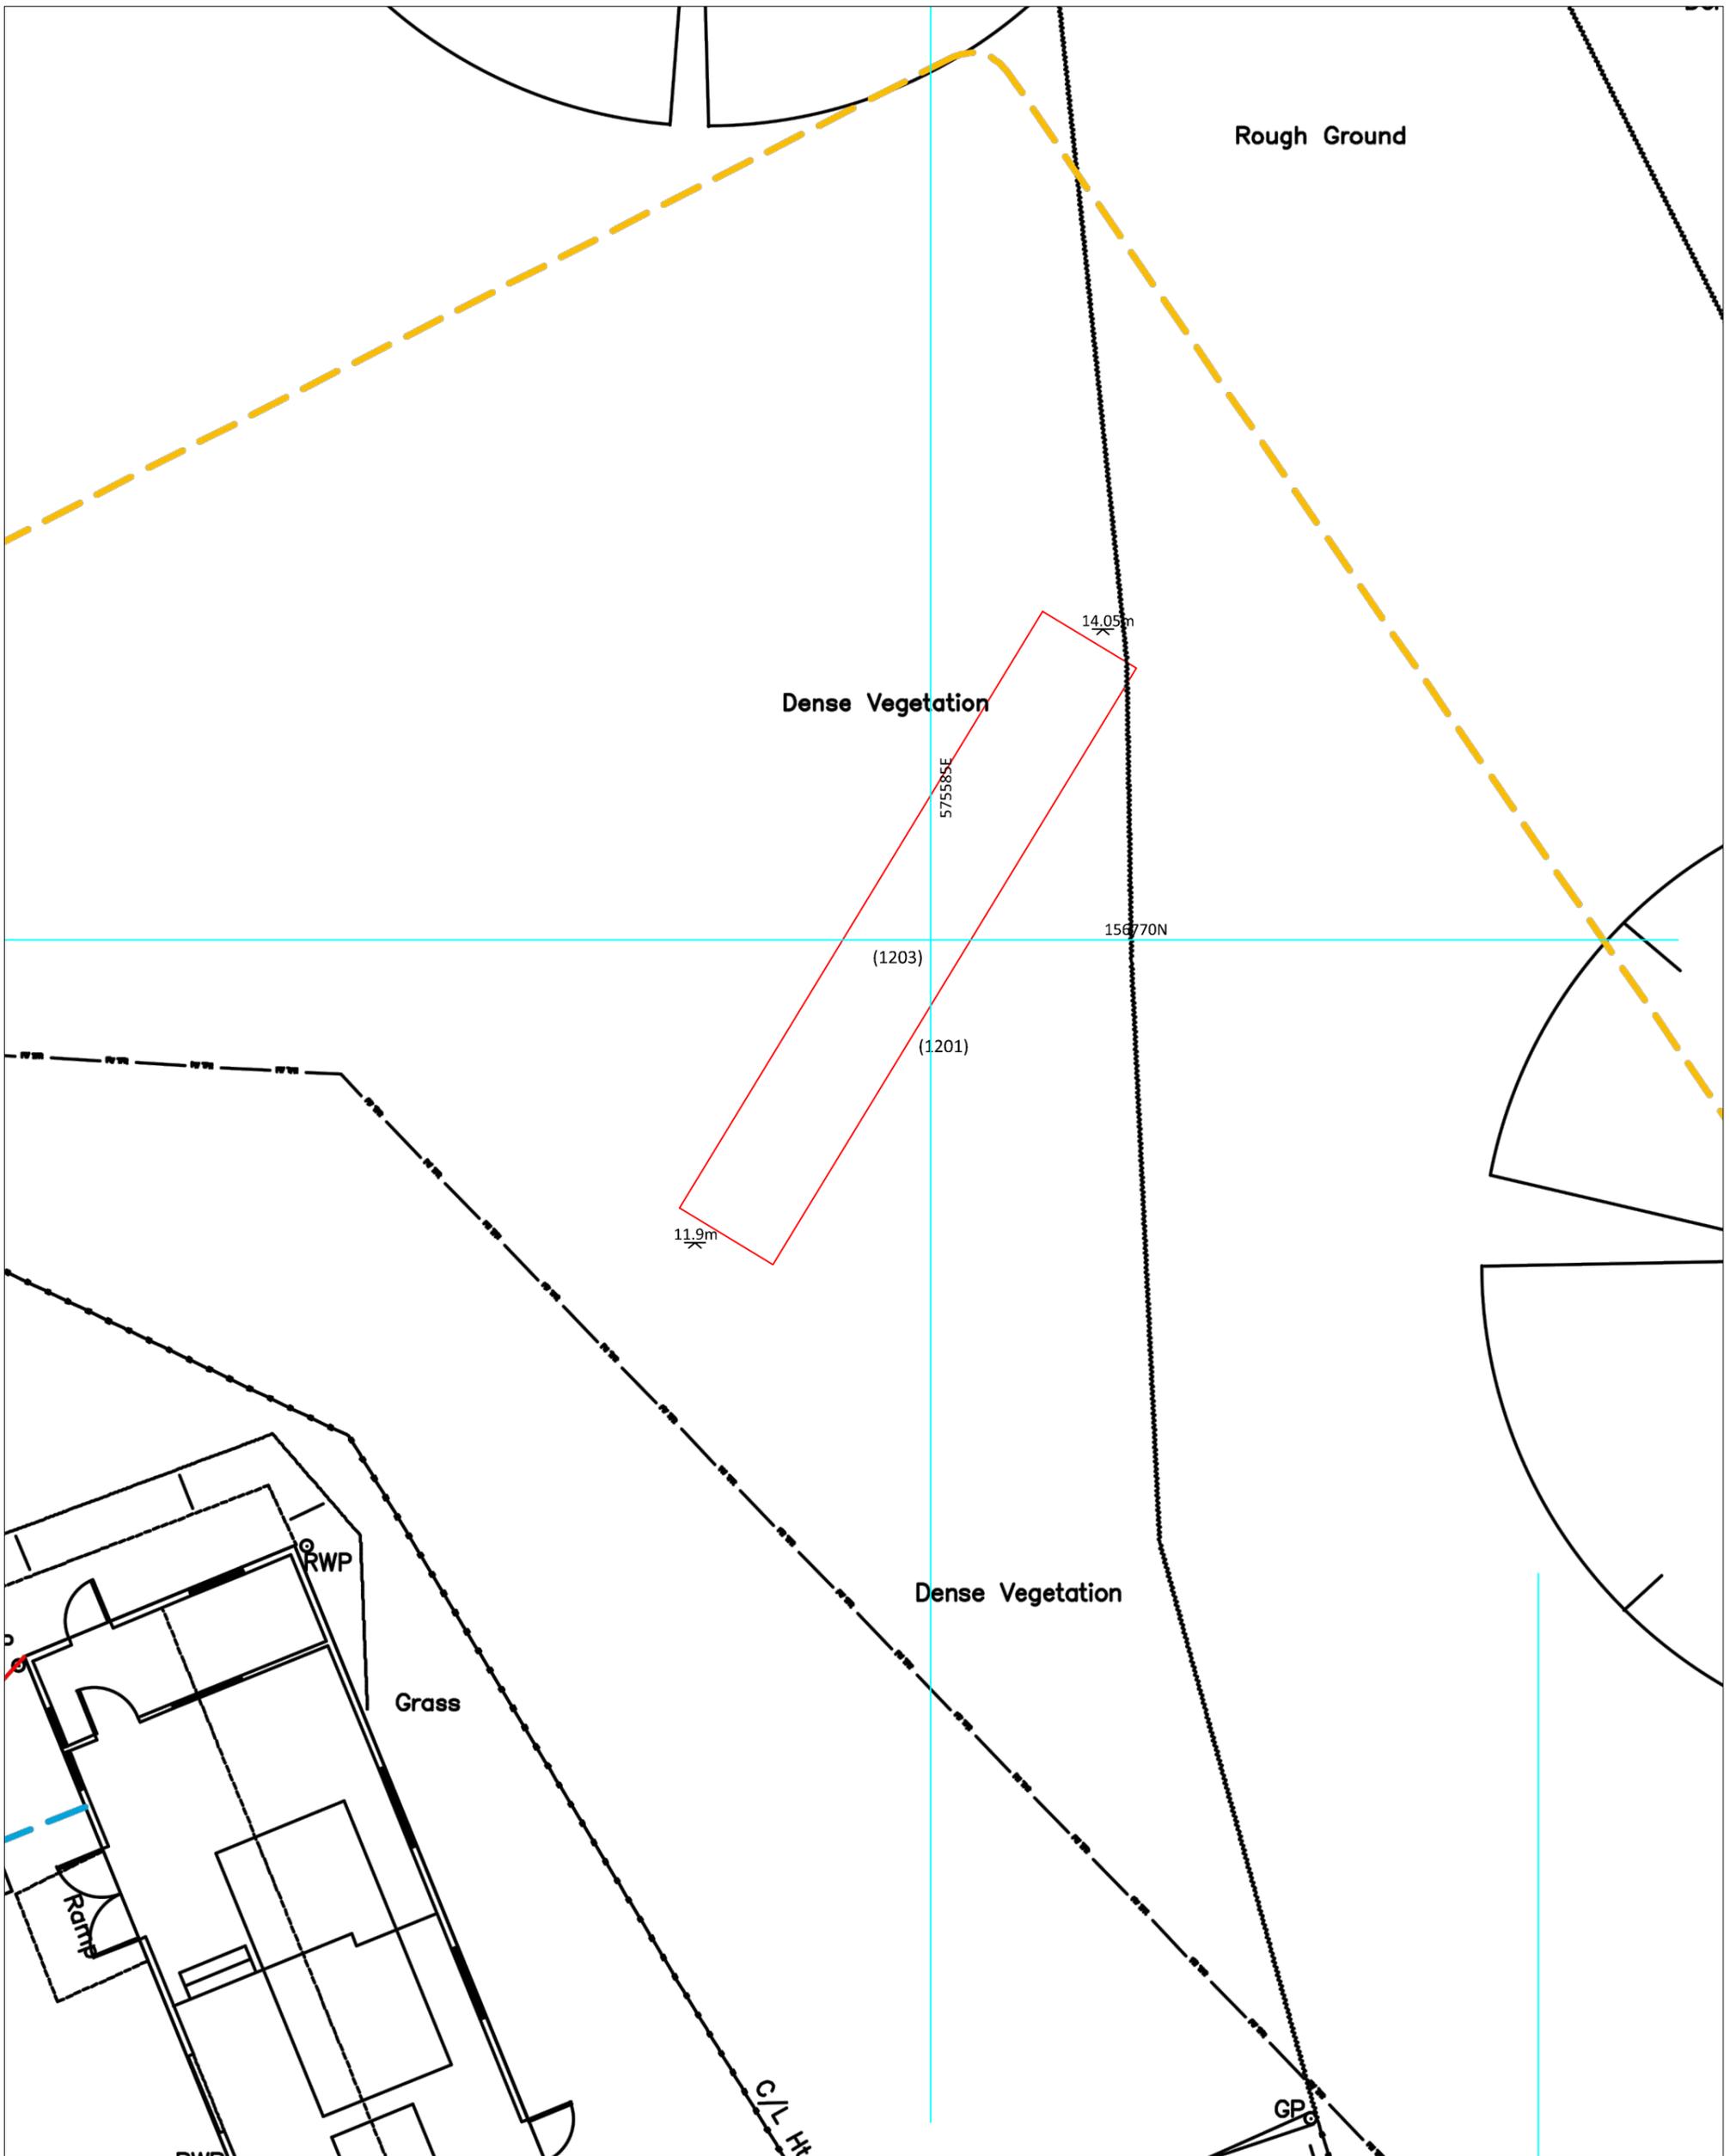
Figure 12: Plan of Trench 12

- 5.3.13 **Trench 12** was located in the north area of the site and aligned NE-SW (Figures 1, 2 2a, 12) and exposed subsoil and natural bedrock (Figure 12) and natural. Plate 25.

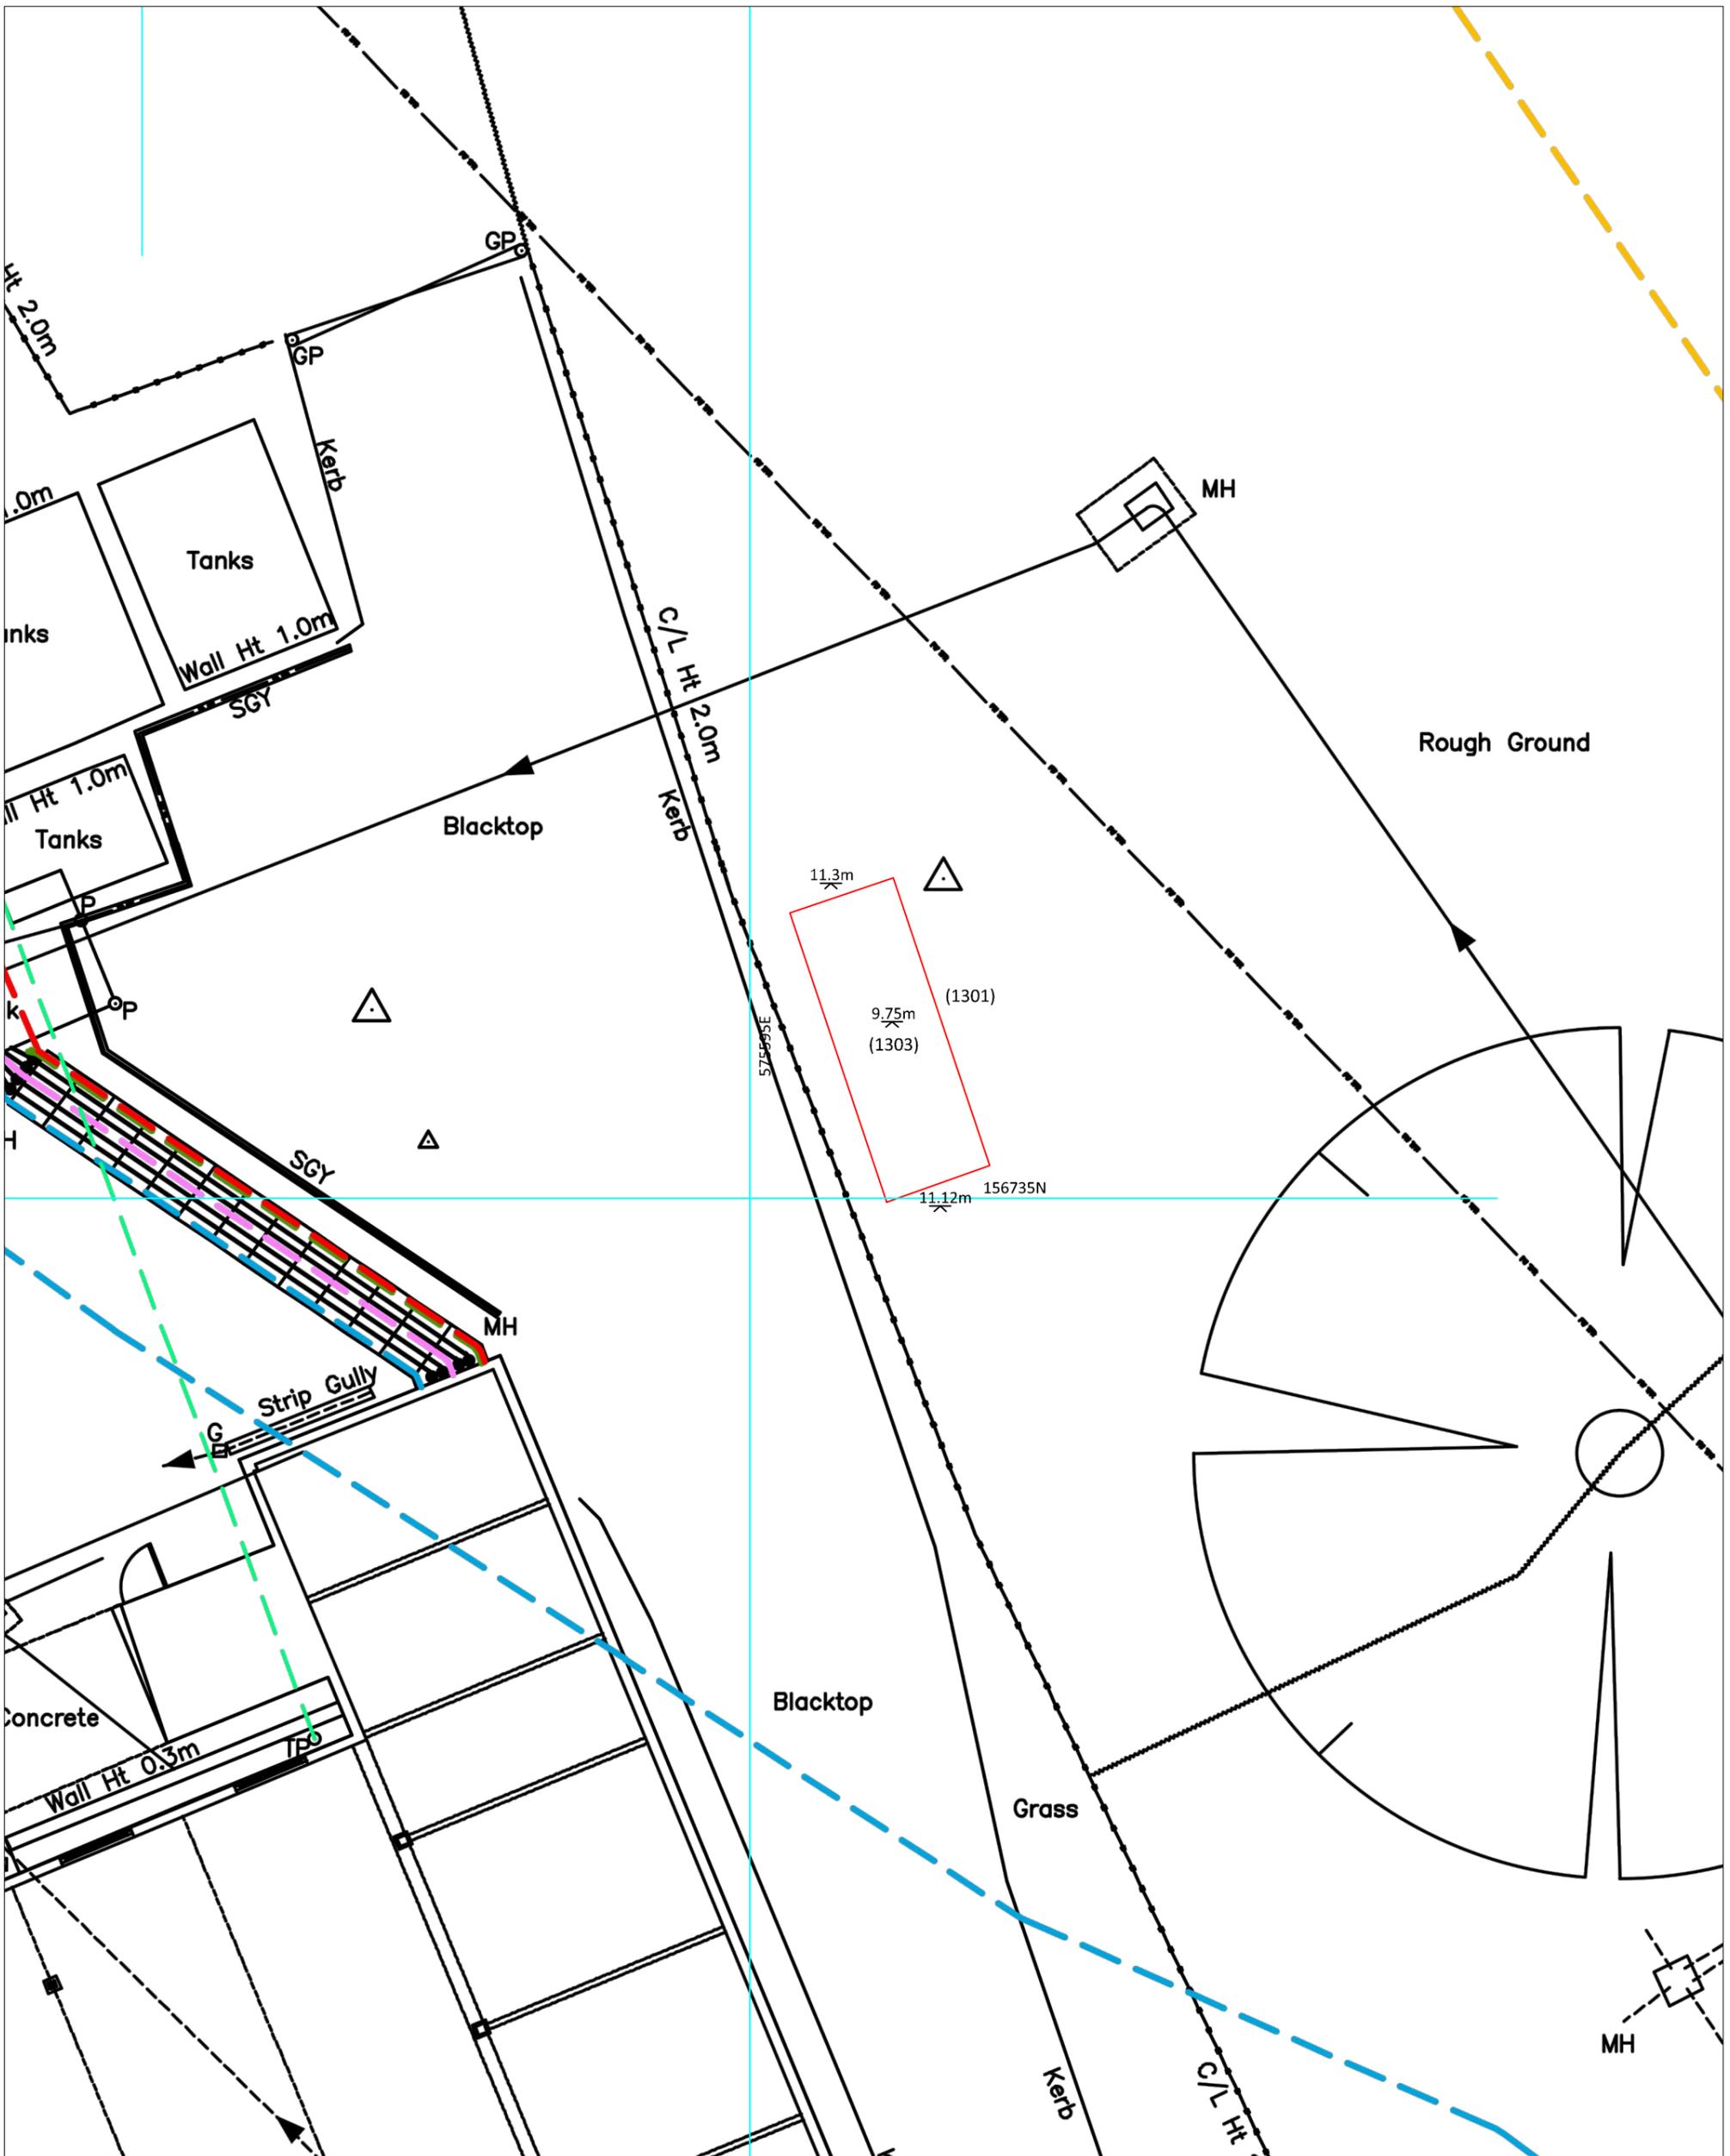
Figure 13: Plan of Trench 13

- 5.3.14 **Trench 13** was located in the north area of the site and aligned NNW-SSE (Figures 1, 2 2a, 13) and exposed built up ground (1302, Figure 13) and natural soils (1304). Plate 26.

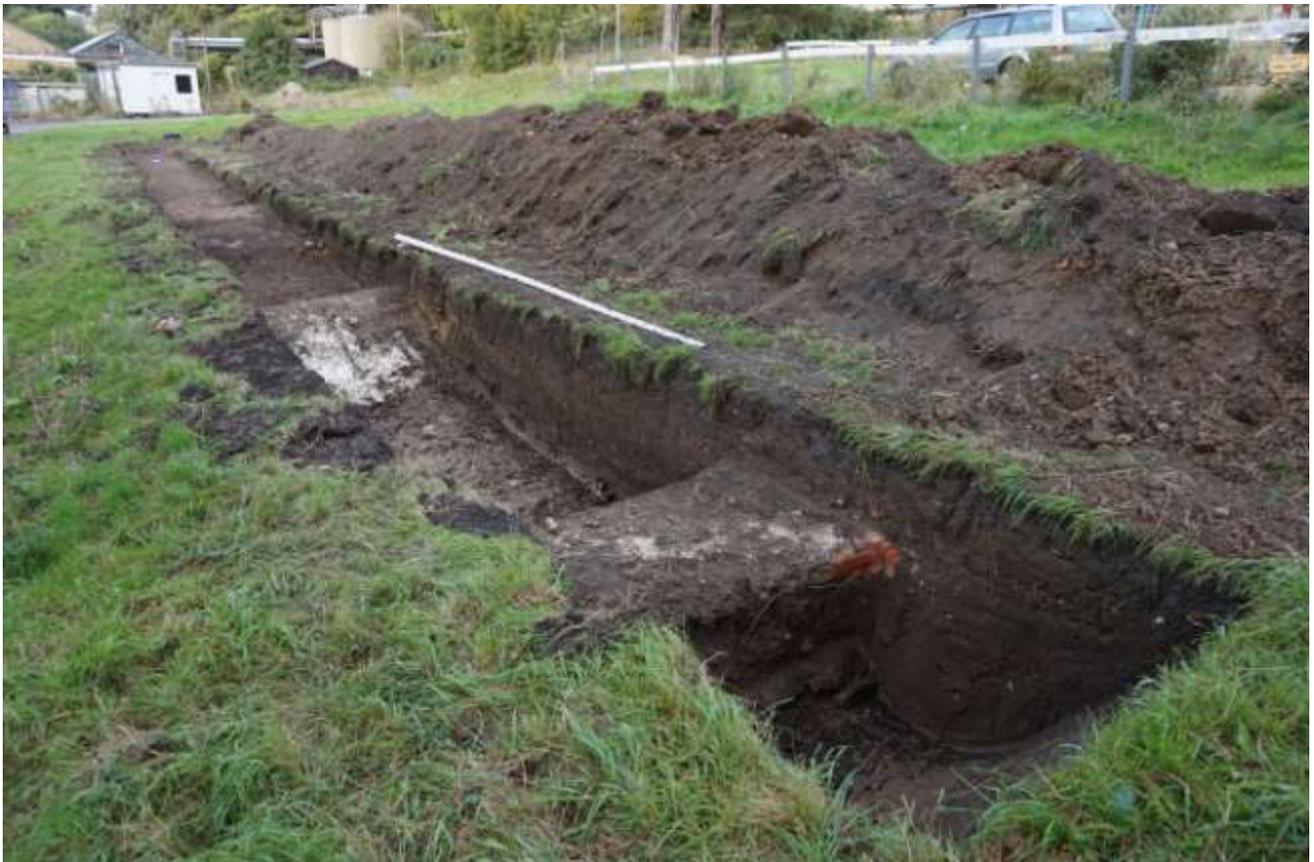
Plate 4: Looking north at Trench 1; 5 metre scale.

- 5.3.1 The 13 trenches were located across the site to ensure full coverage of potential archaeological remains.
- 5.3.2 **Trench 1** was located in the south area of the site and aligned NNW-SSE (Figures 1, 2 2a, 3) and exposed known services runs (Figure 3) and some contamination [105]. Plates 2, 4.

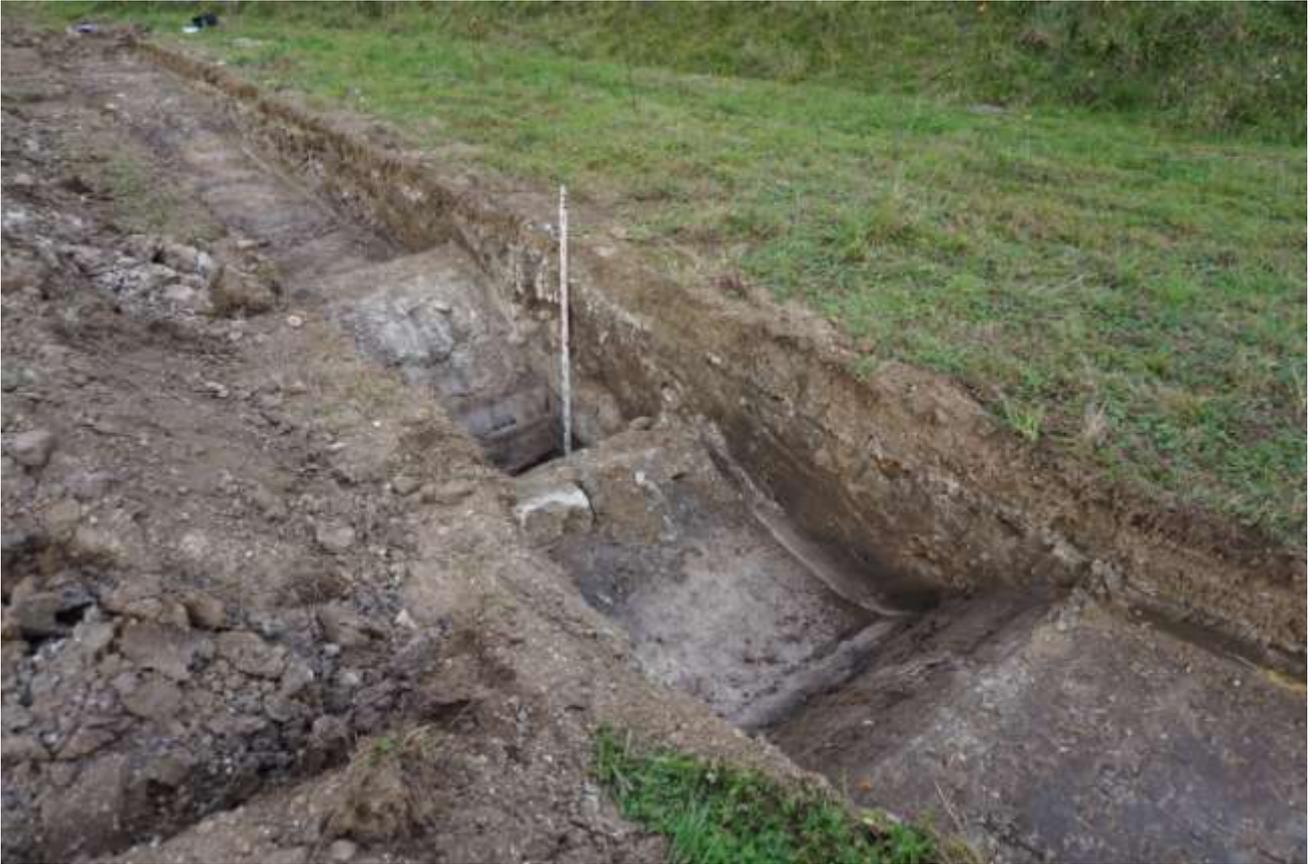
Plate 5: Looking north east at Trench 2; two metre scale.

- 5.3.3 **Trench 2** was located in the south area of the site and aligned N-S (Figures 1, 2 2a, 4) and exposed known services runs with pipes and some river terracing (Figure 4). Plates 5, 6, 7.

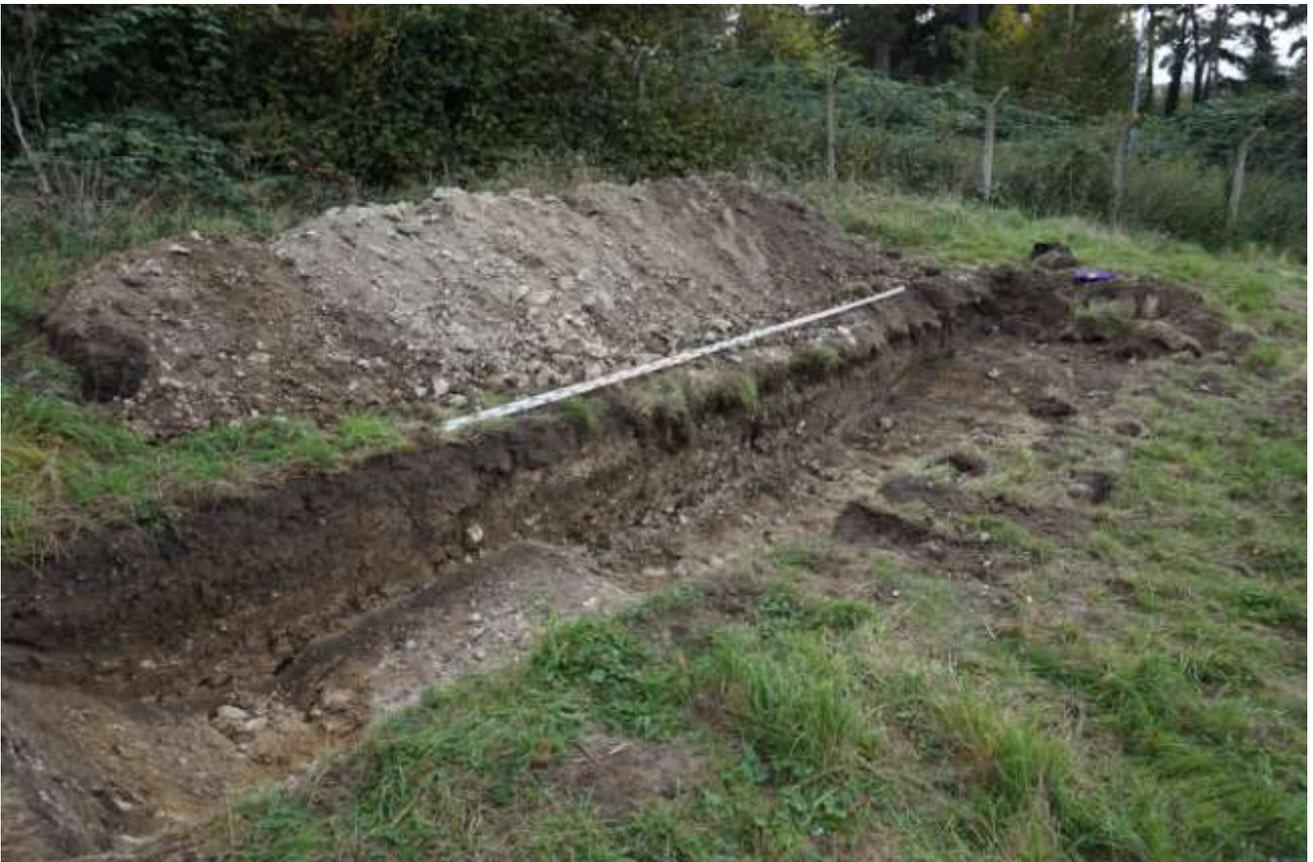
Plate 8: Looking south east at Trench 3; five metres scale.

- 5.3.4 **Trench 3** was located in the south area of the site and aligned NNE-SSW (Figures 1, 2 2a, 5) and exposed levelling layers (Figure 5) and natural bedrock (305). Plate 8.

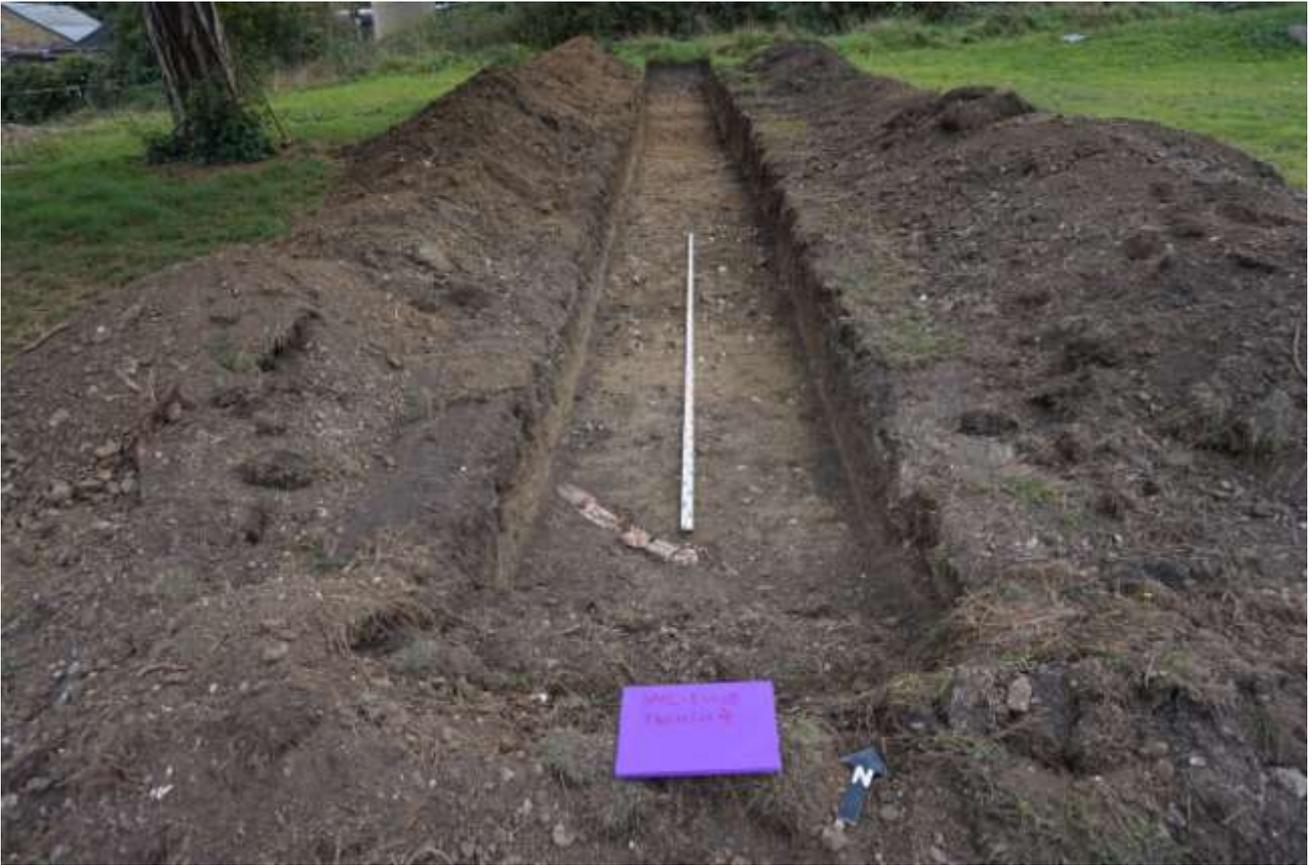
Plate 9: Looking north at Trench 4, five metre scale.

- 5.3.5 **Trench 4** was located in the south area of the site and aligned N-S (Figures 1, 2 2a, 6) and exposed known services runs (Figure 6) levelling layers and natural bedrock. Plates 9, 10.

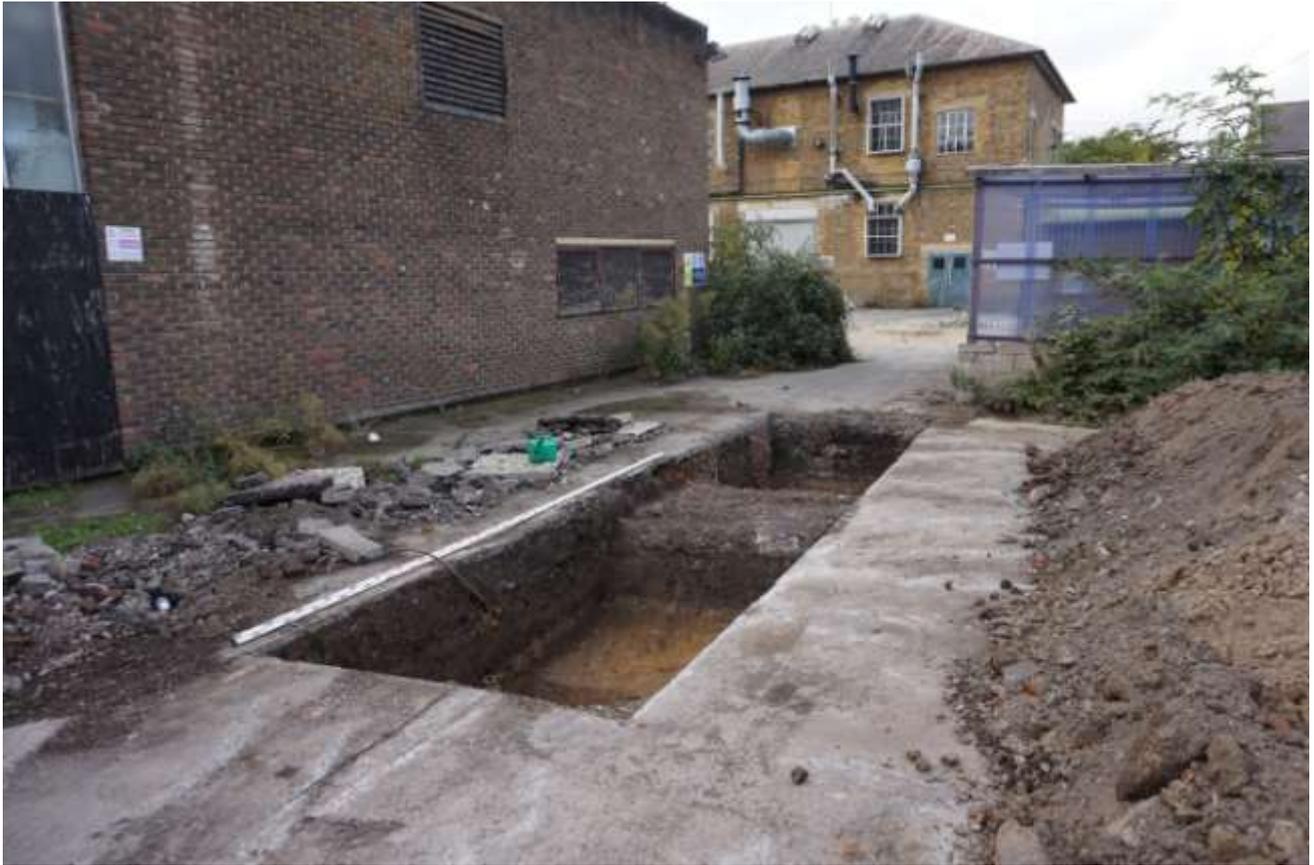
Plate 11: Looking north west at Trench 5; five metre scale.

- 5.3.6 **Trench 5** was located in the mid west area of the site and aligned NNW-SSE (Figures 1, 2 2a, 7) and exposed known services run trenches (Figure 7) and some levelling layers(505). Plates 11-17.

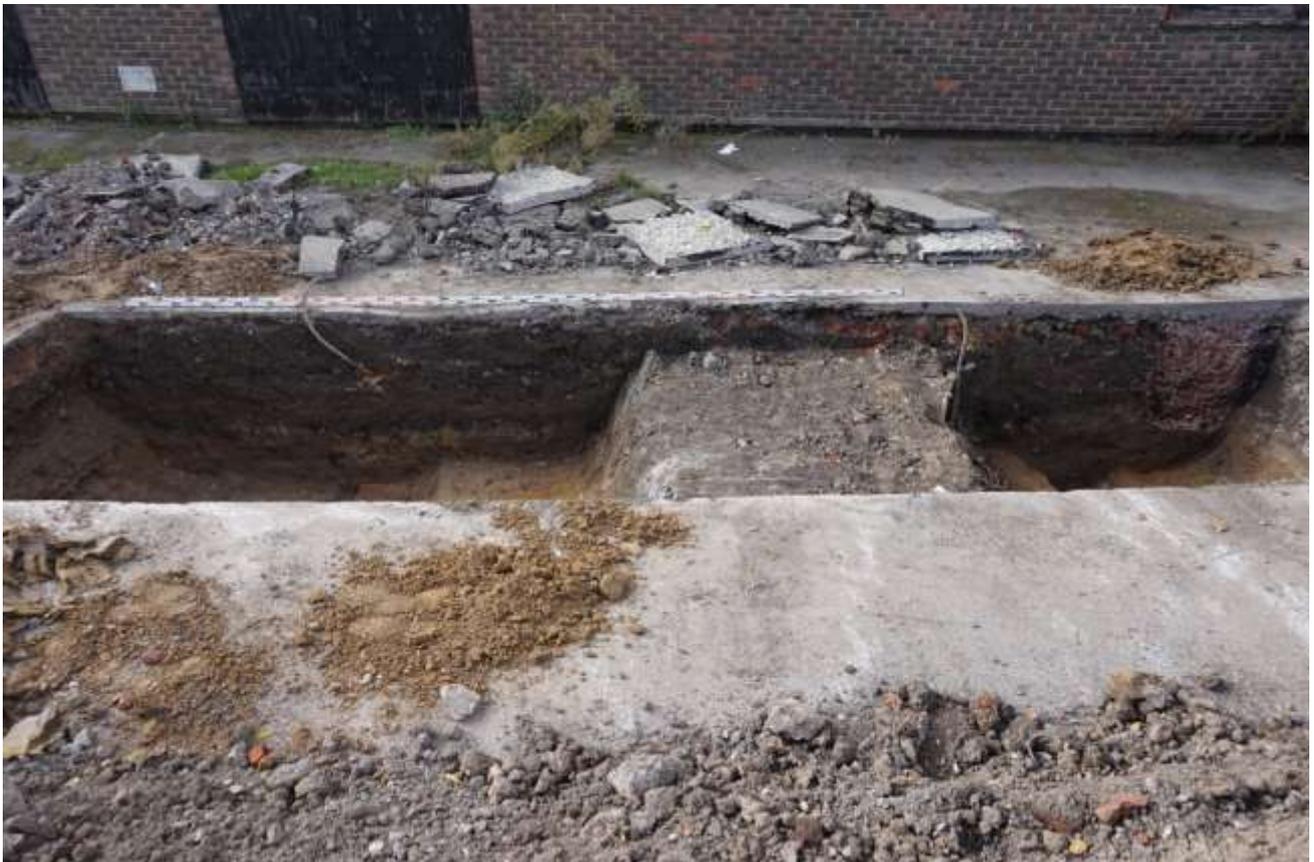
Plate 12: Looking south west at section of Trench through modern deposits overlaying modern ditches
