# Archaeological Evaluation on Land at the former Springfield Paper Mill, Sandling Road, Maidstone, Kent

Site Code: Mill -EV-18

Planning Application Number: 17/5021432/FULL

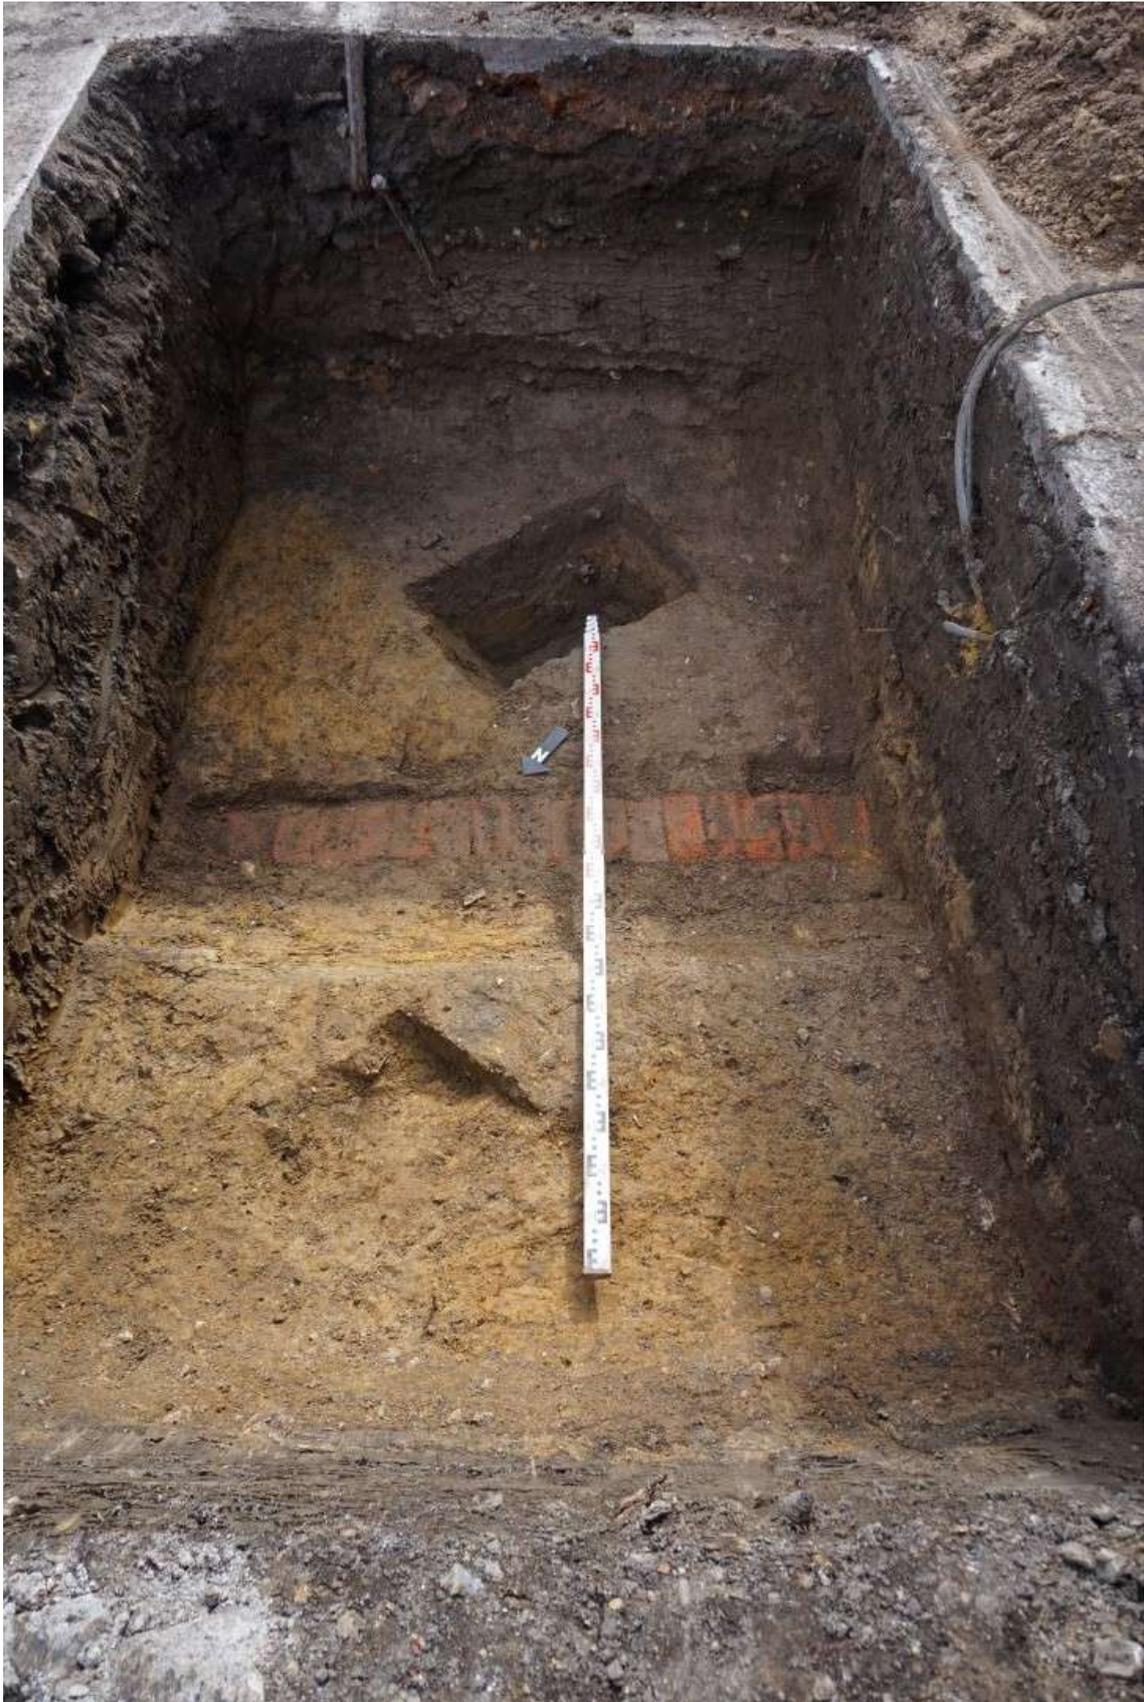
Plate 13: Looking south east at modern ditch with brick drain

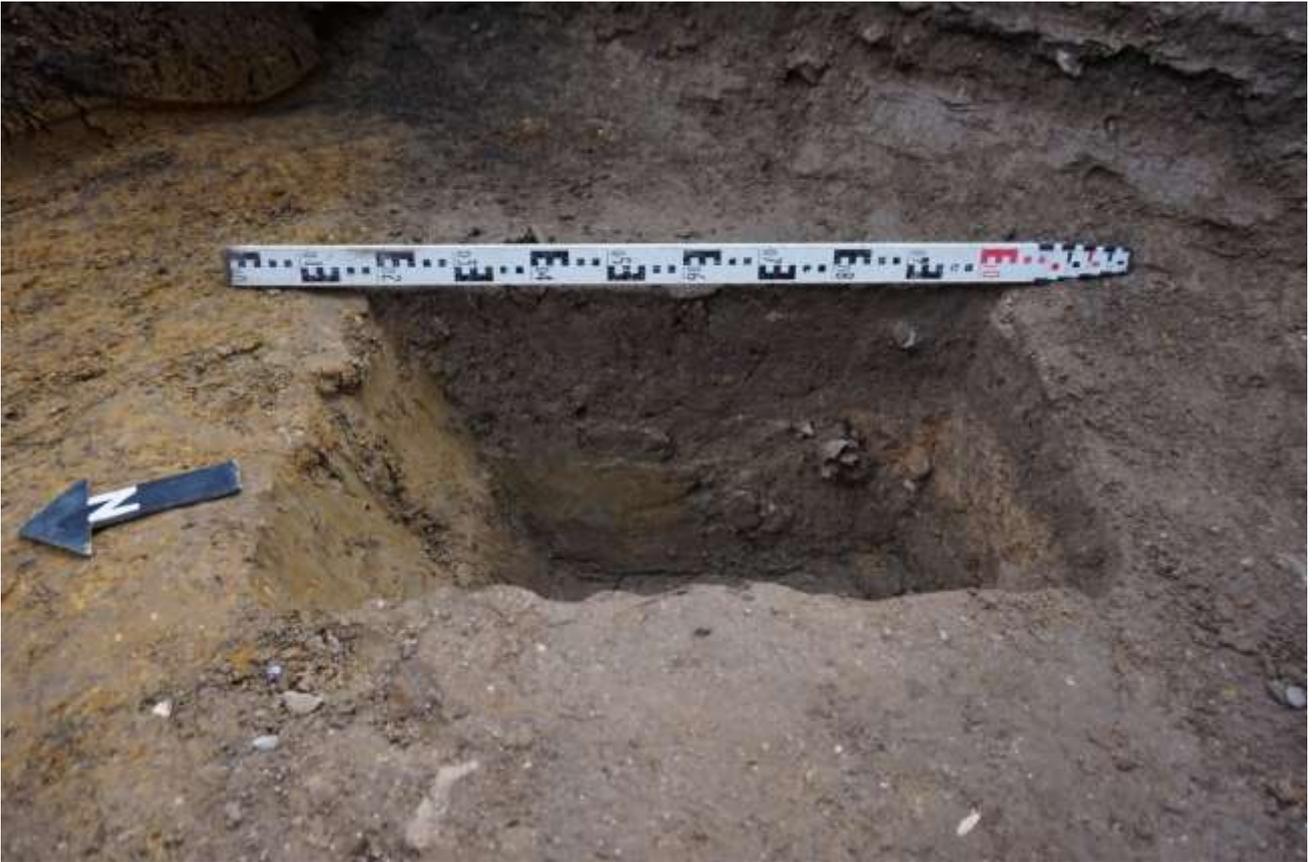
Plate 14: Looking south east at section of ditch [514]

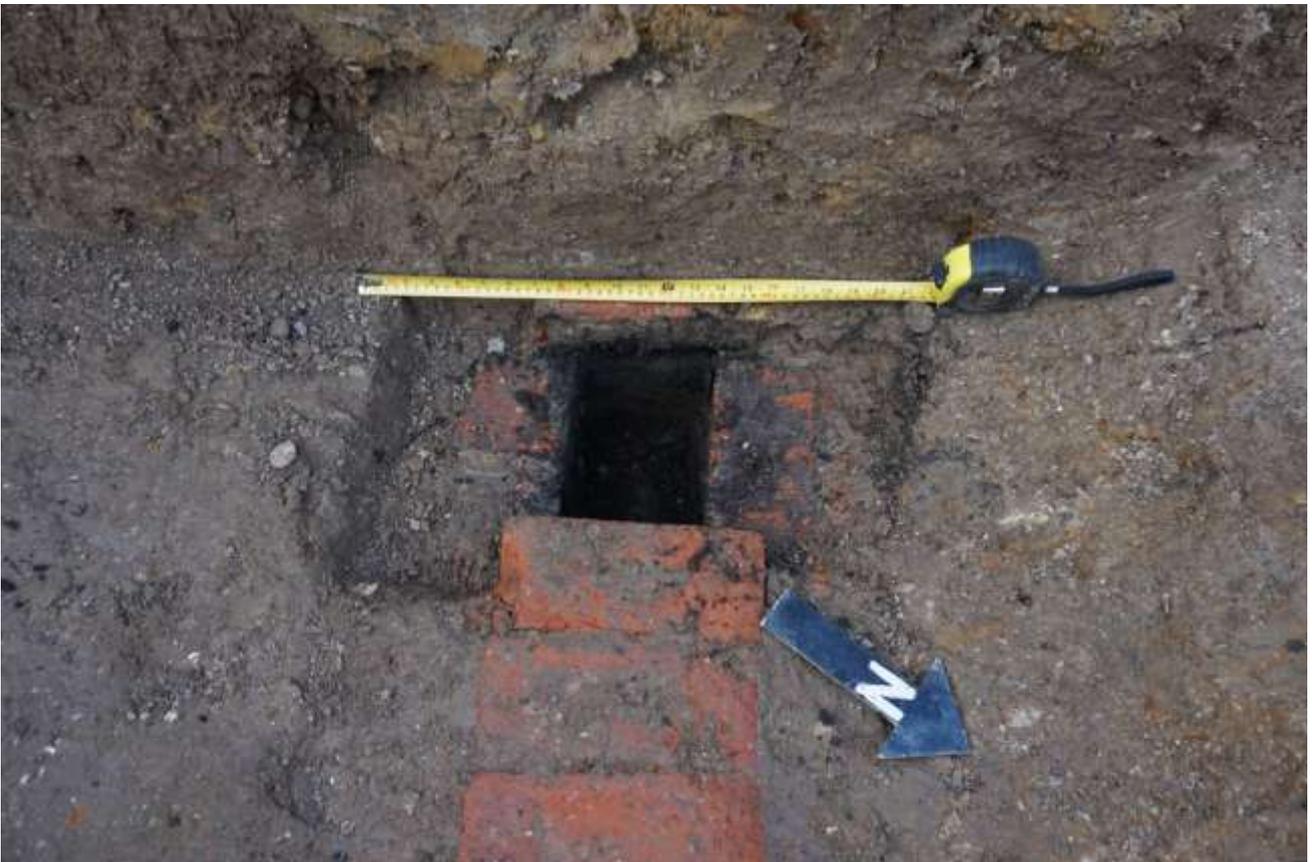
Plate 15: Looking south west at section of drain [509]

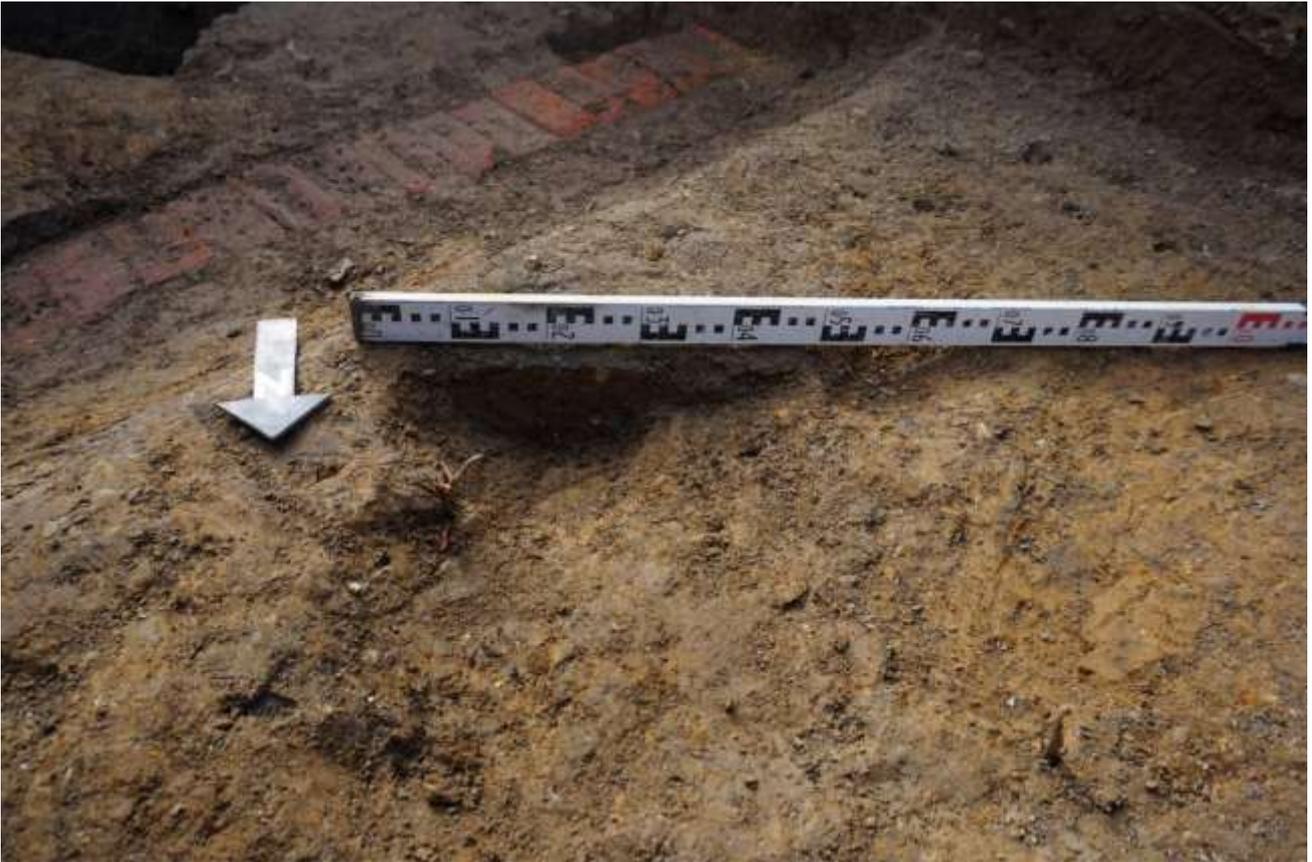
Plate 16: Looking south at section through gully terminus [512]

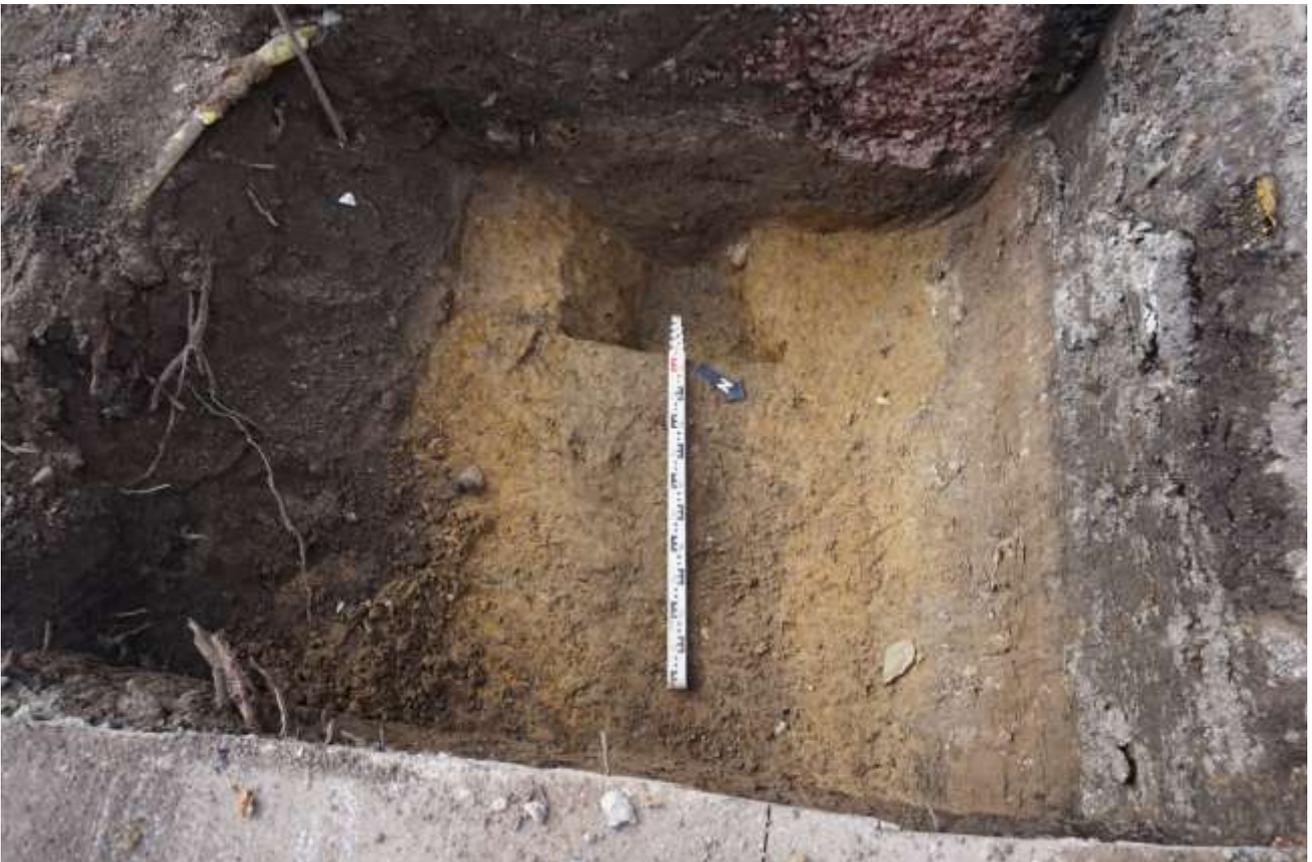
Plate 17: Looking south west at modern ditch with drain [522]

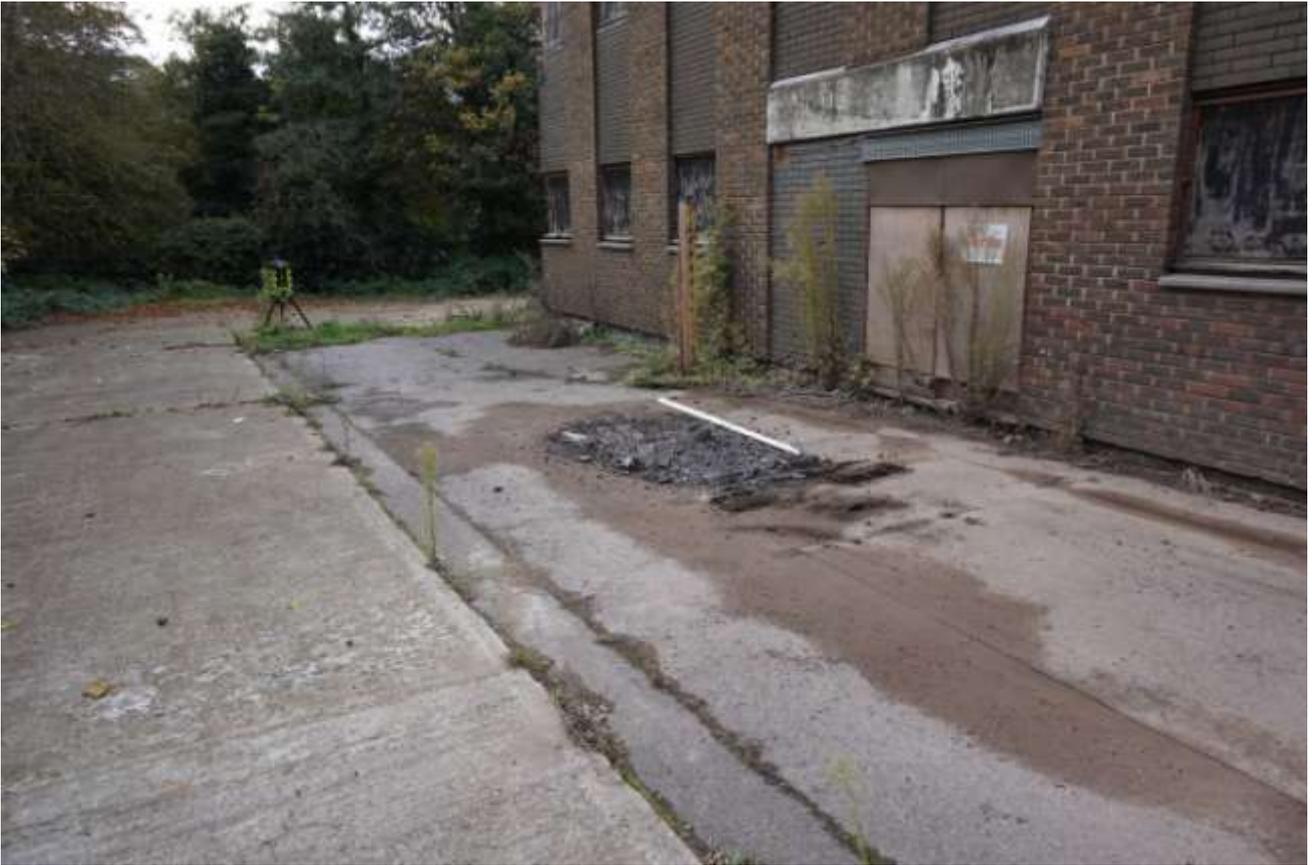
- 5.3.7 **Trench 6** was located in the mid area of the site and aligned ENE-WSW (Figures 1, 2 2a) and was abandoned because of the depth of concrete overburden. Plate 18.

Plate 18: Looking west at attempt of excavation of Trench 6. Underneath tarmac layer concrete has been exposed.

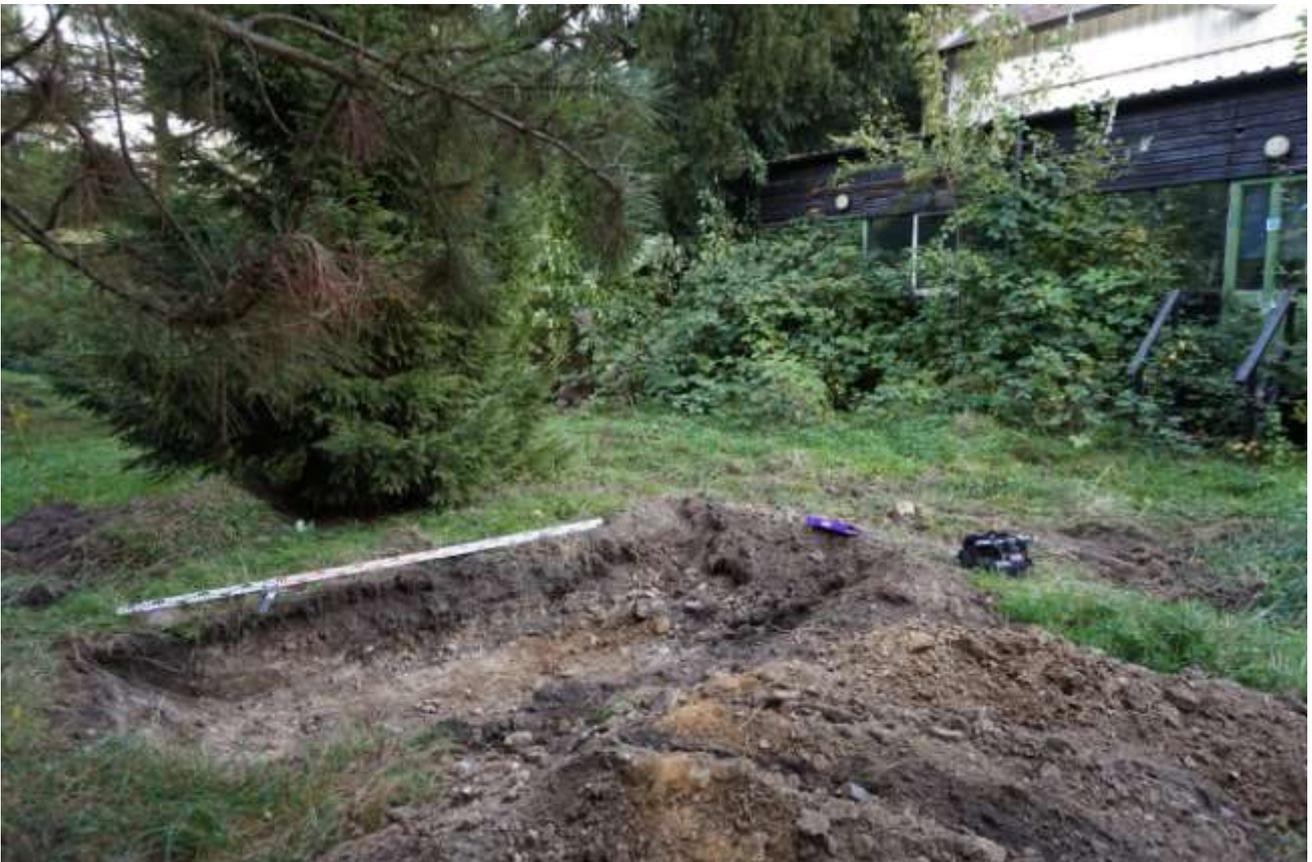
Plate 19: Looking north at Trench 7

- 5.3.8 **Trench 7** was located in the mid area of the site and aligned ENE-WSW (Figures 1, 2 2a, 8) and exposed levelling layers and natural bedrock (703). Plate 19.

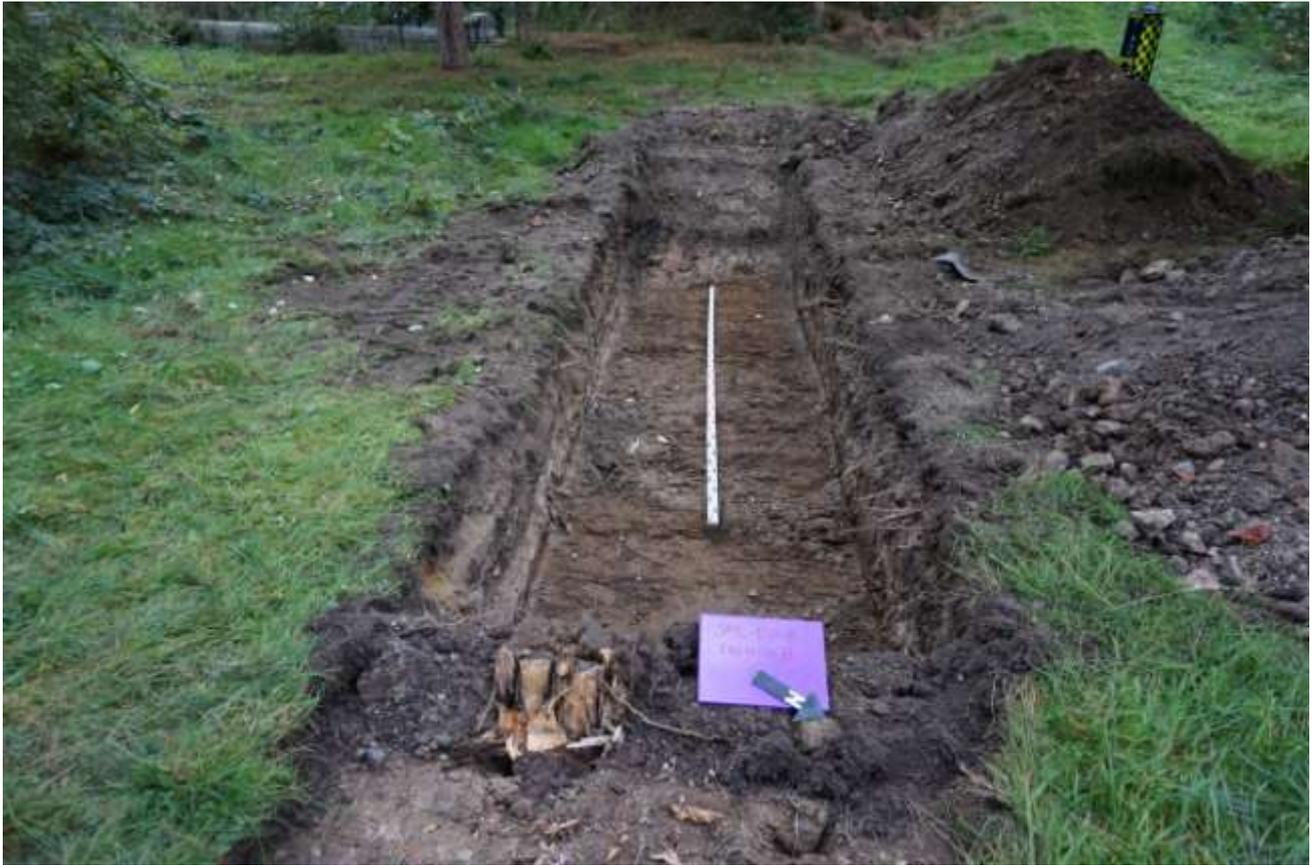
Plate 20: Looking south west at Trench 8

- 5.3.9 **Trench 8** was located in the mid area of the site and aligned WSW-ENE (Figures 1, 2 2a, 8) and exposed levelling layers and modern service trenches (Figure 8). Plates 20, 21.

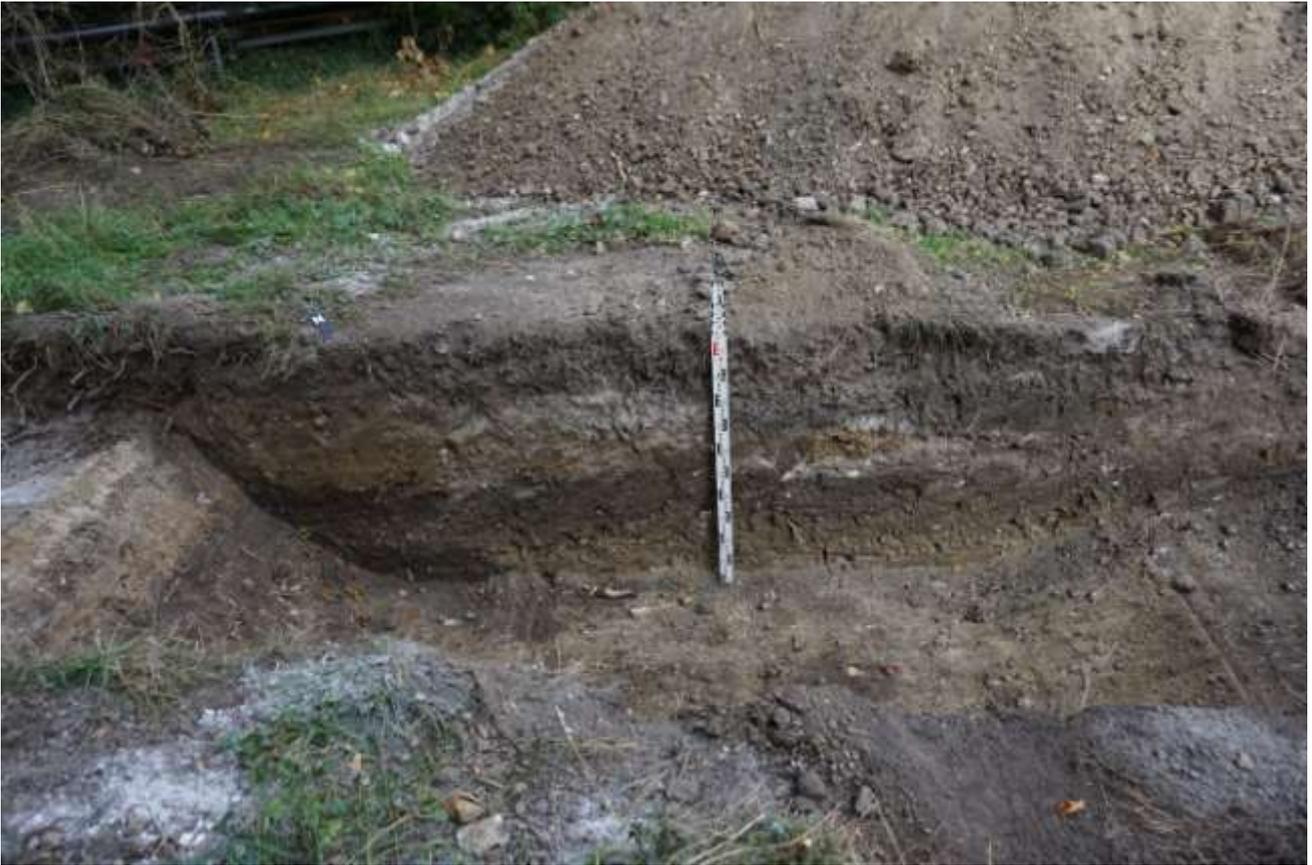
Plate 22: Looking north east at section of Trench 9

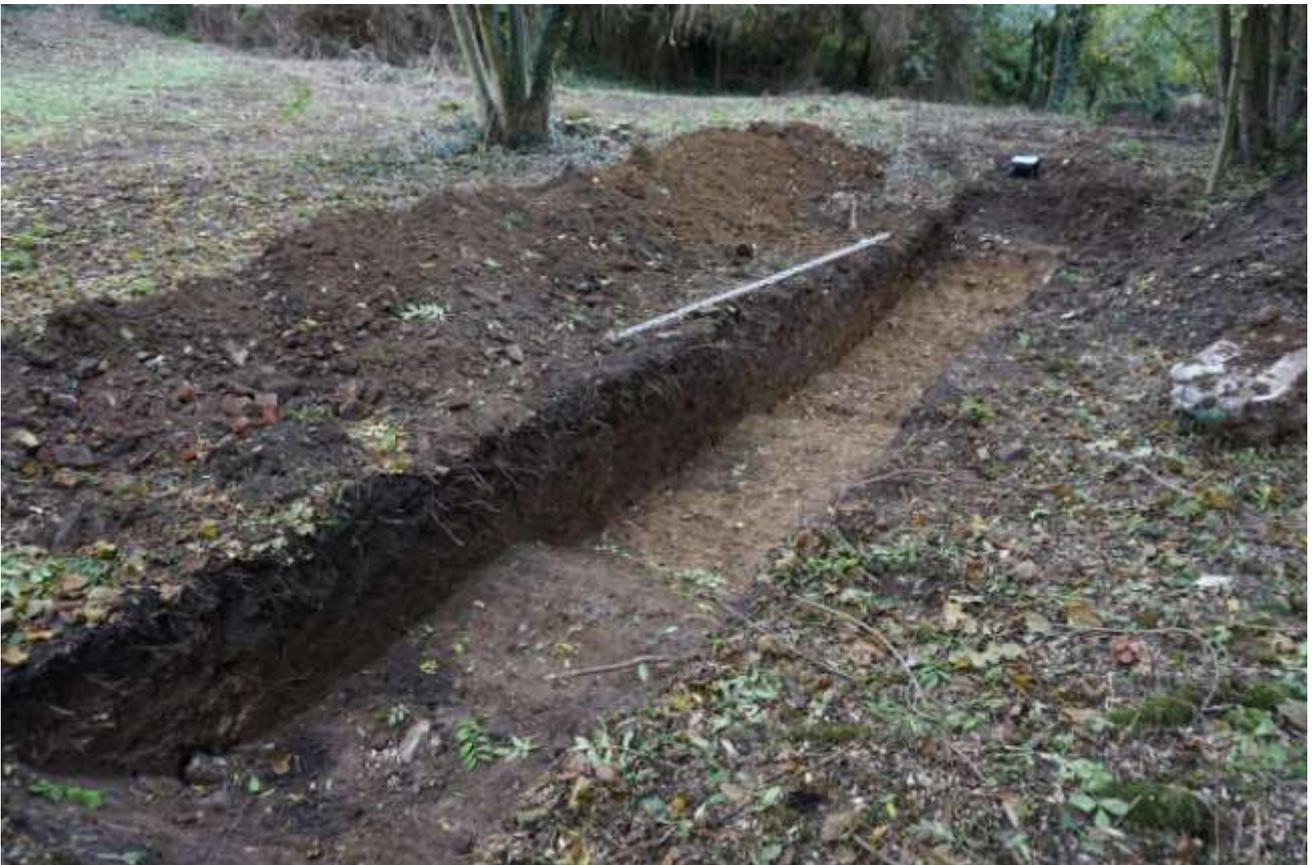
Plate 23: Looking south east at Trench 10

- 5.3.11 **Trench 10** was located in the north area of the site and aligned NW-SE (Figures 1, 2 2a, 10) and exposed topsoil, levelling layers (Figure 10) and natural geology (1004). Plate 23.

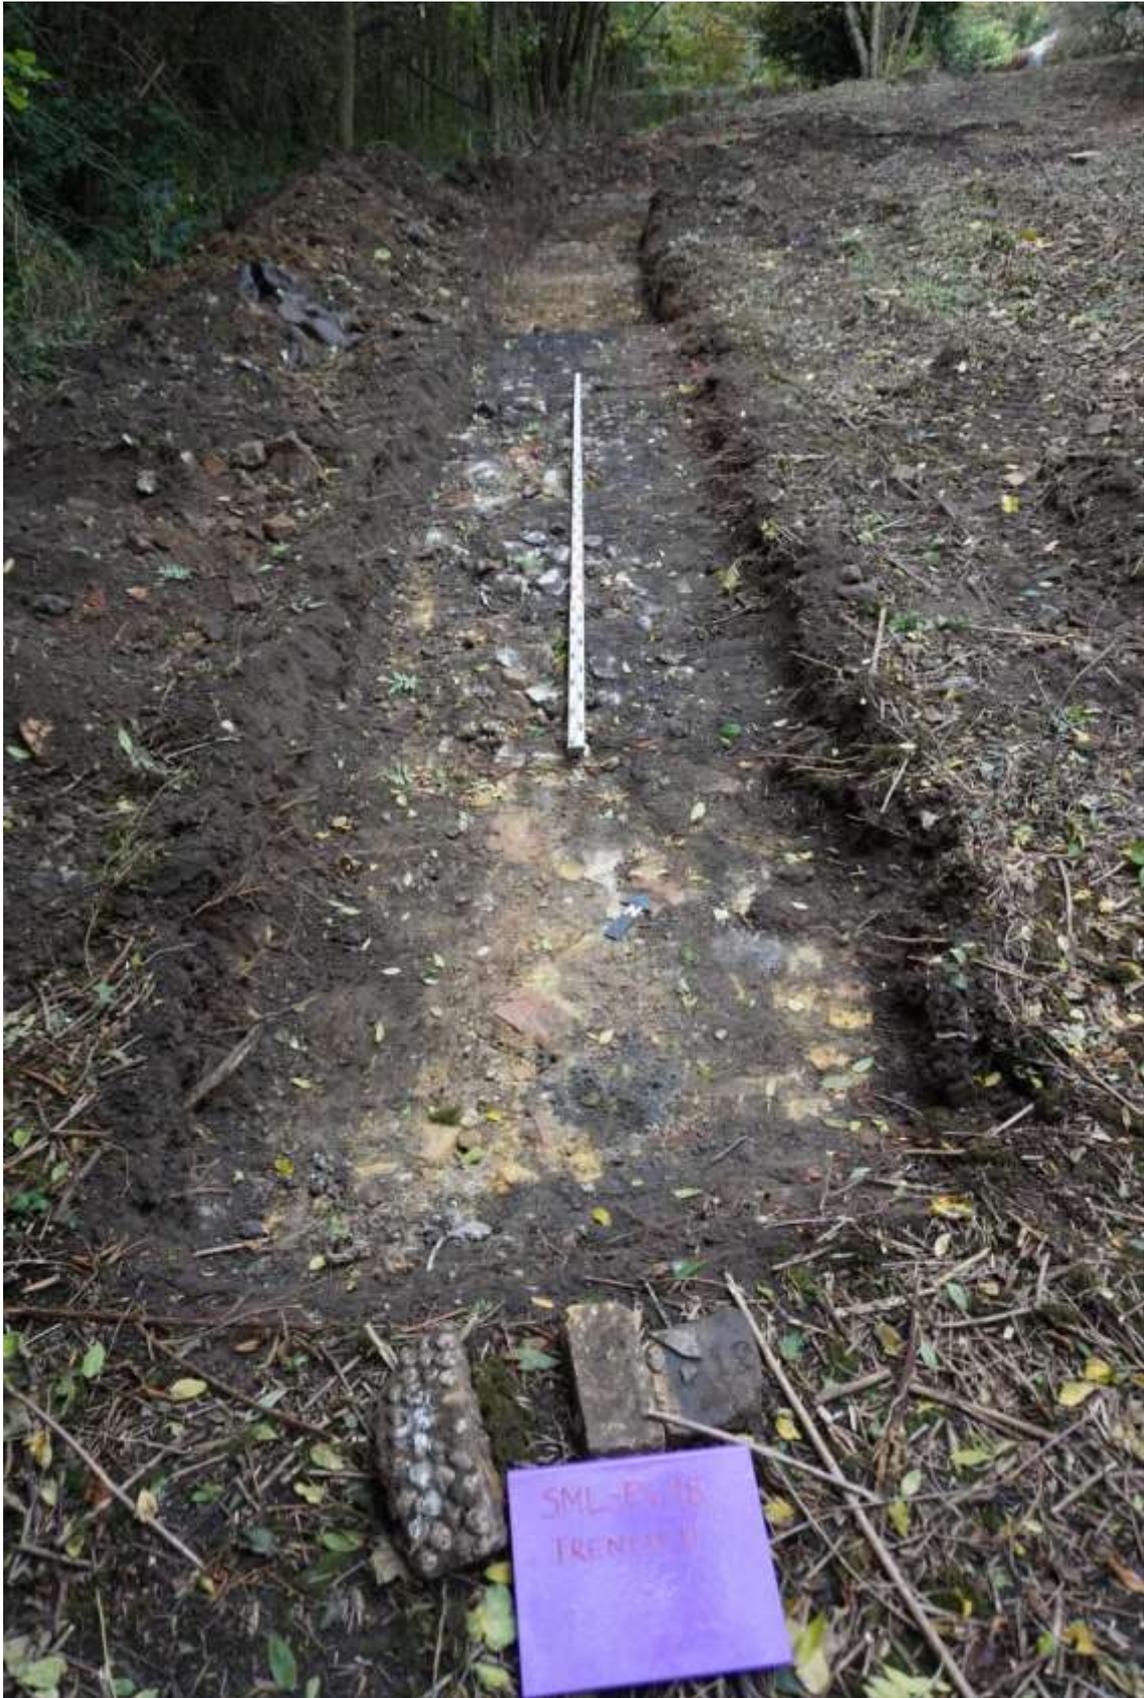
Plate 24: Looking north west at Trench 11

- 5.3.12 **Trench 11** was located in the north area of the site and aligned NW-SE (Figures 1, 2 2a, 11) and exposed demolition layers and modern trenches (Figure 3) and natural silty clay [1104]. Plate 24.

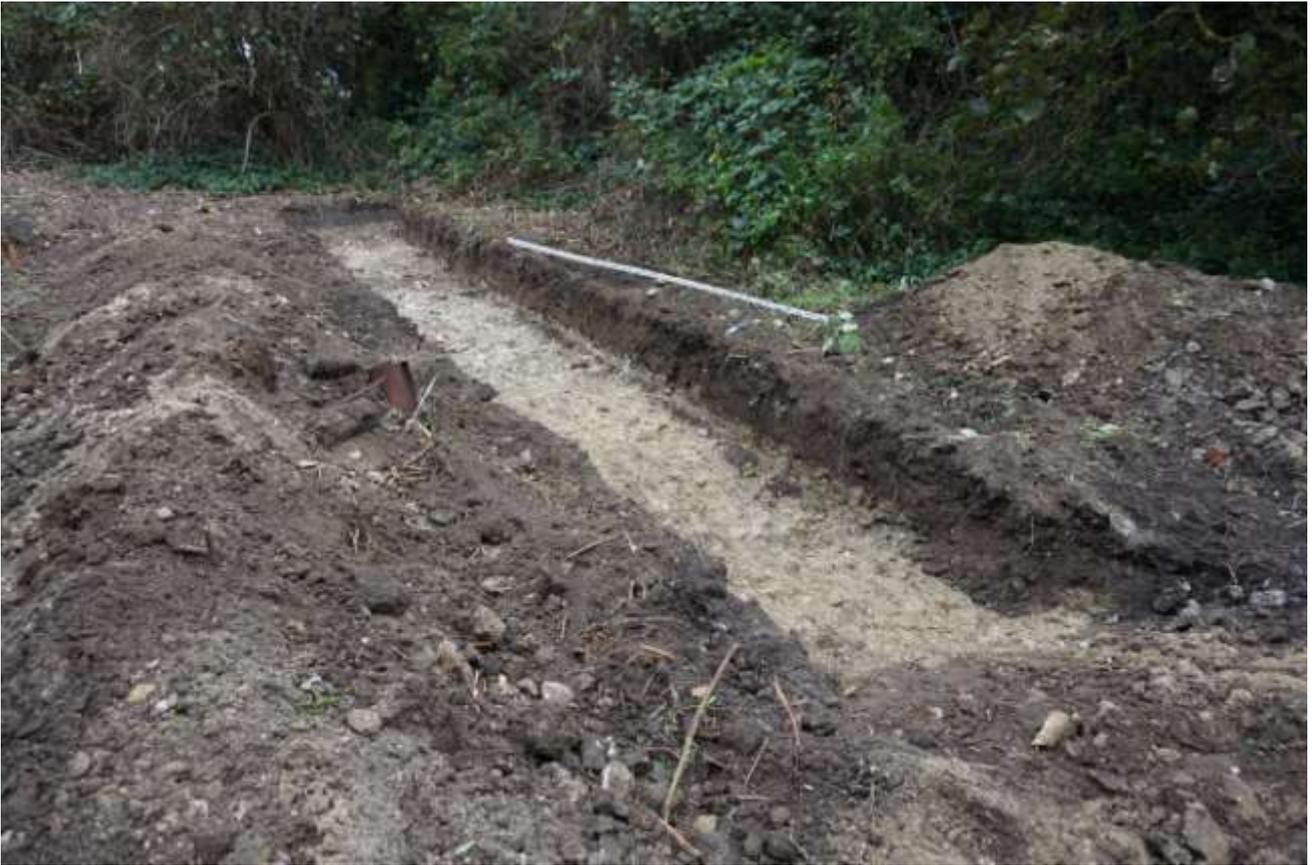
Plate 25: Looking east at Trench 12

- 5.3.13 **Trench 12** was located in the north area of the site and aligned NE-SW (Figures 1, 2 2a, 12) and exposed subsoil and natural bedrock (Figure 12) and natural. Plate 25.

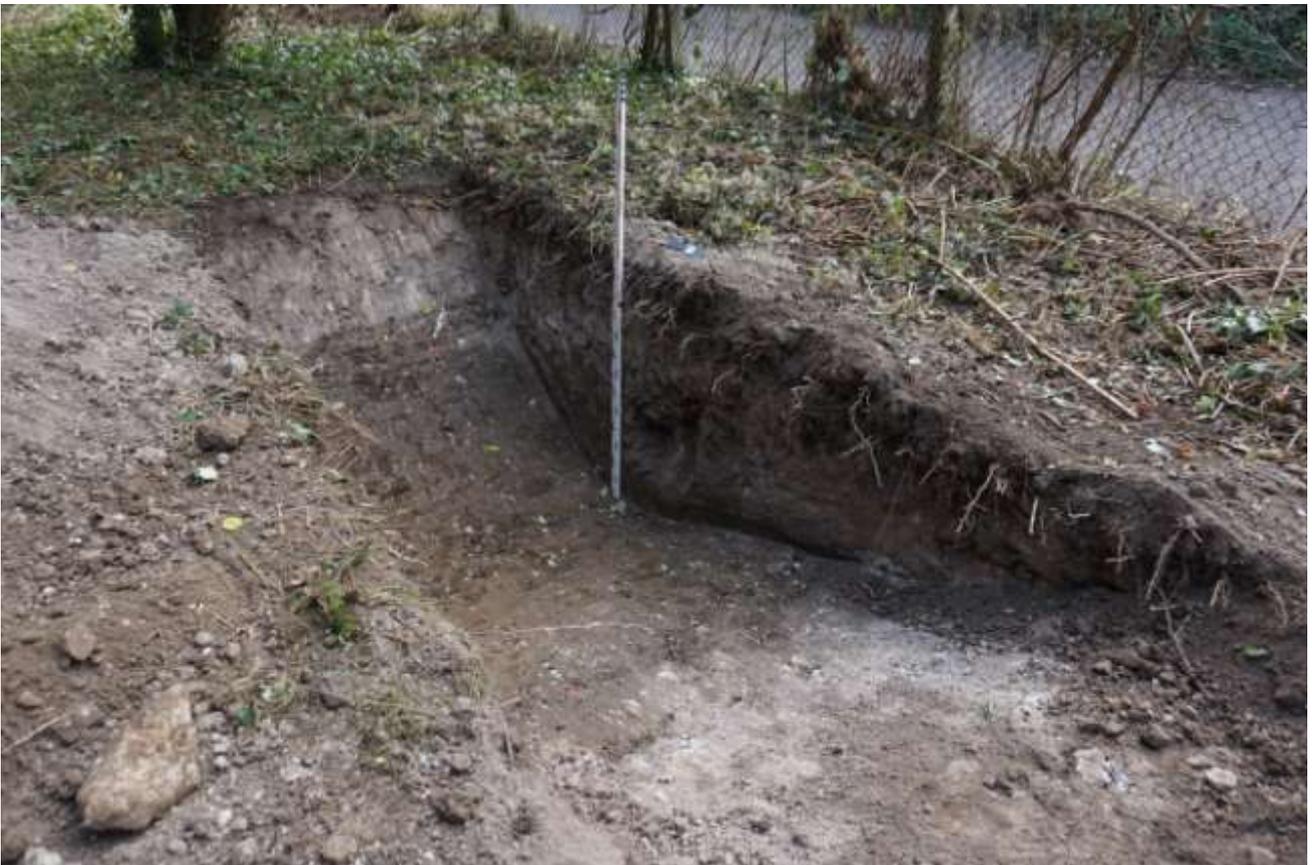
Plate 26: Looking south at Trench 13

- 5.3.14 **Trench 13** was located in the north area of the site and aligned NNW-SSE (Figures 1, 2 2a, 13) and exposed built up ground (1302, Figure 13) and natural soils (1304). Plate 26.

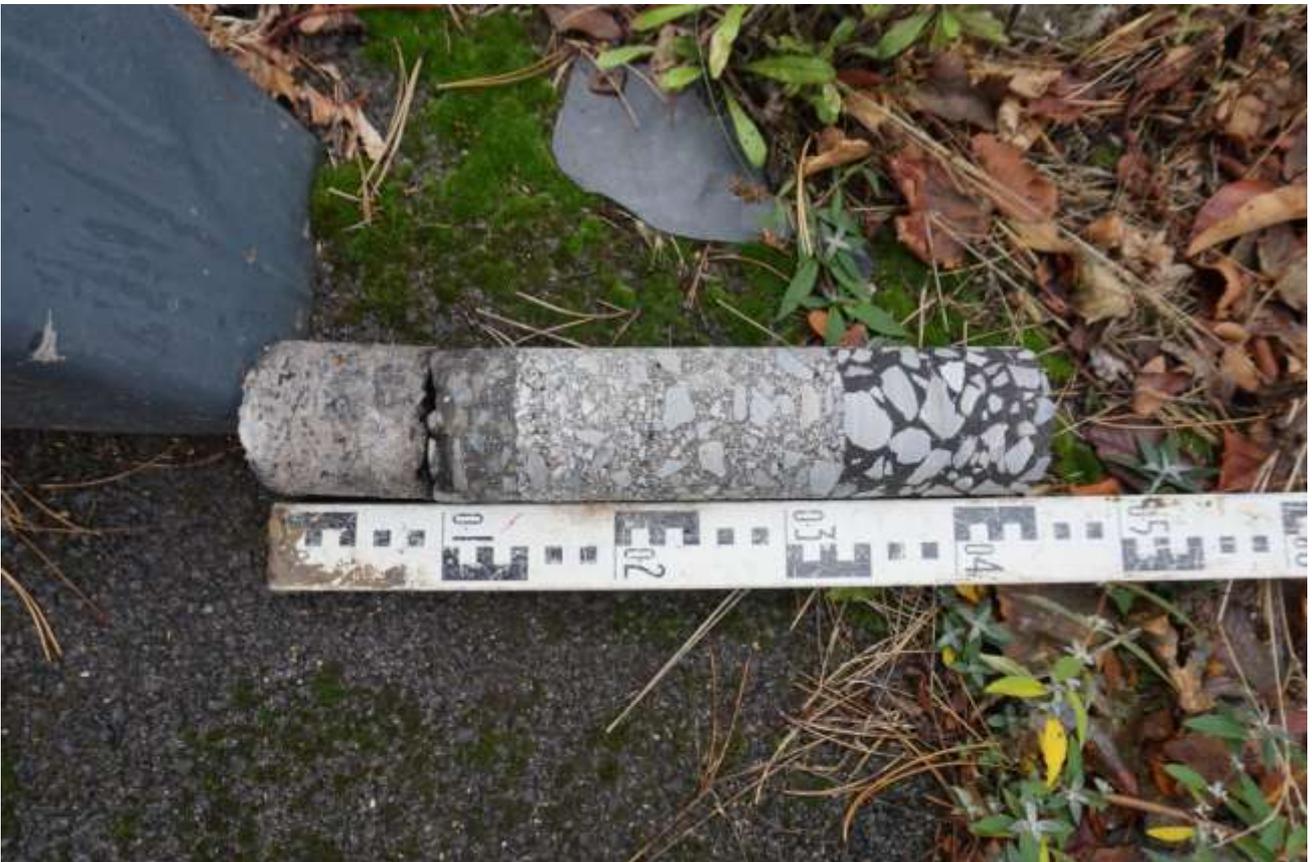
Plate 28: 0.45m high core sample extracted next to the main gate showing great depth of road layers
