# Archaeological Evaluation of Land at The Tile Warehouse and Former Boat Storage Yard (The Oval Chalet) and adjoining Land, Sea Street/Sea Wall, Whitstable, Kent

Site Code: TILE/EV/18

**SWAT Archaeology**

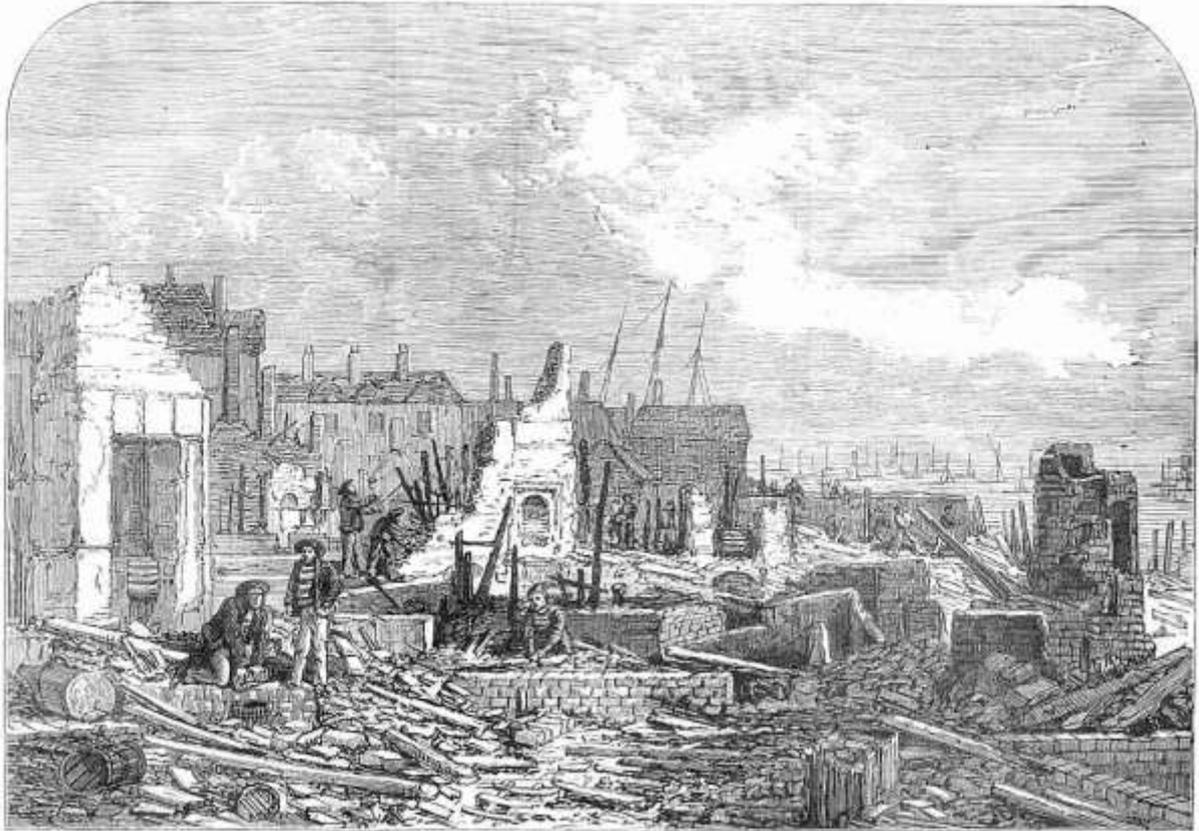
SCENE OF THE DESTRUCTIVE FIRE AT WHITSTABLE.

The scene in the Sea Wall and Sea Street area following the great fire of 1869

The above-mentioned buildings were amongst those described as being destroyed during the great fire of 1869 (an illustration from the Kentish Gazette reproduced below shows the type and degree of the damage caused by the fire in and around the Sea Wall and Sea Street area). The destruction caused by the fire appears to have acted as the initiating stimulus for a protracted period of rebuilding and renovation, as attested to by the laying of at least three new workshop floors, all associated with evidence strongly suggestive of iron working. The last of these floors appears not to be of any great antiquity, and a blacksmith's forge or similar probably occupied the site well into the twentieth century.

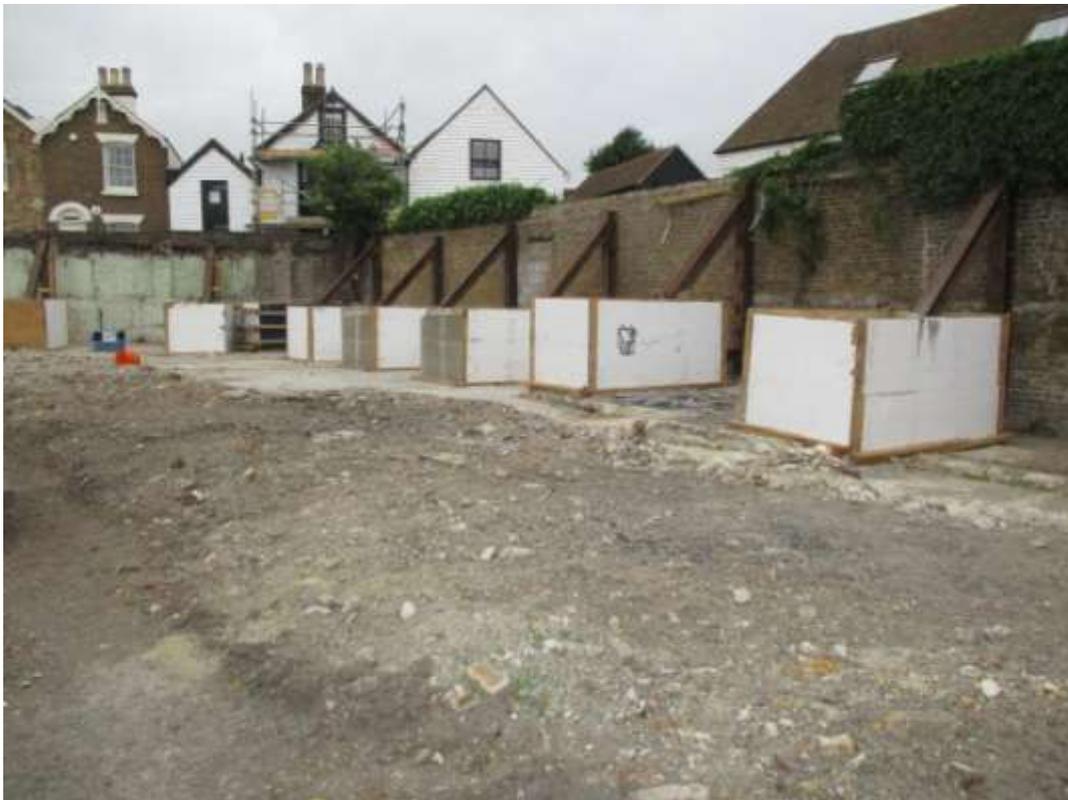
Plate 2. The substantial modern boxed-concrete wall supports supporting the eastern wall support

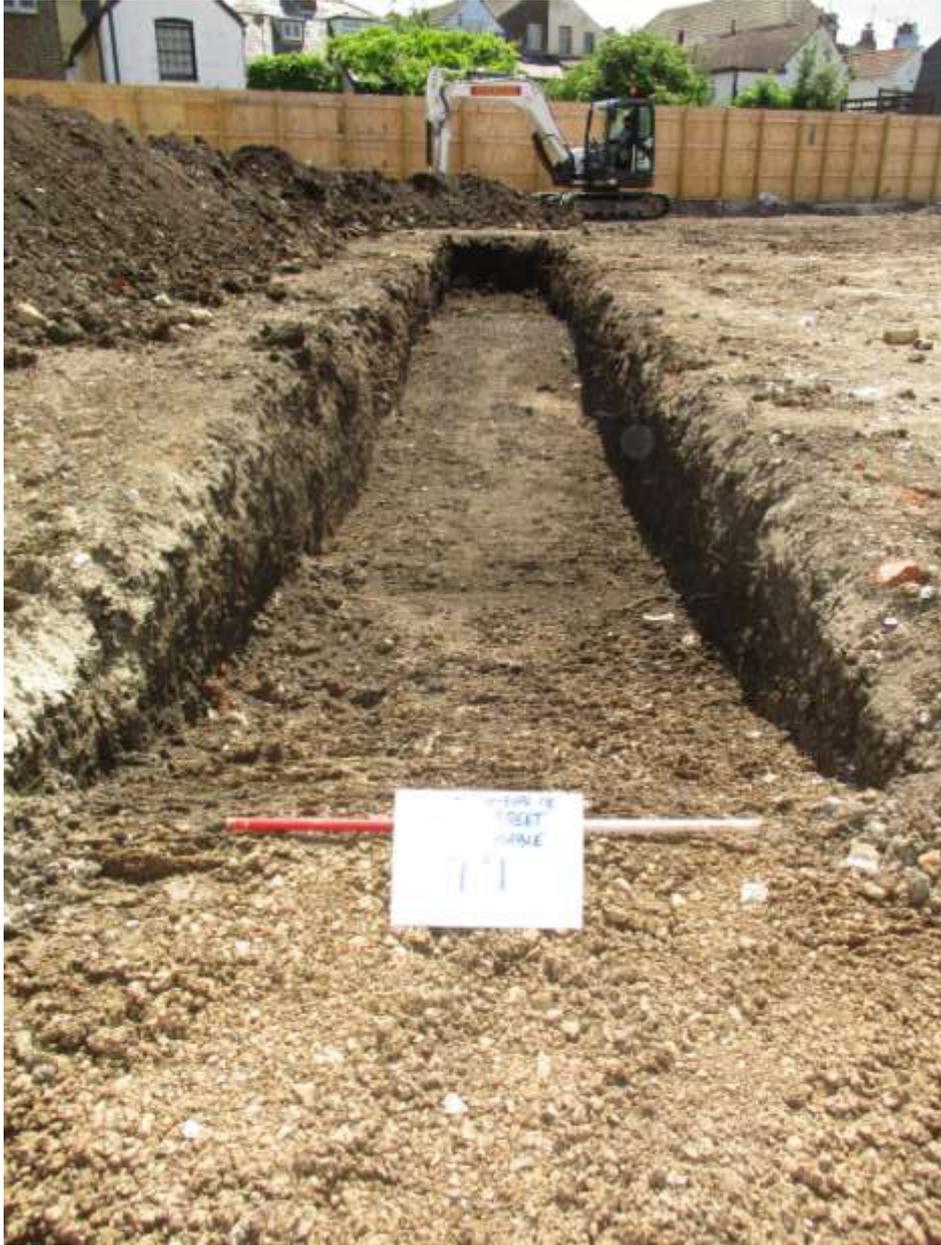
Plate 3. Trench 1 looking south from the top of the Sea Wall shingle bank north (one-metre scale)

**9.1** Trench orientation: NNW/SSE. Depth: 0.72m. Width: 2.0m. Length: 18.70m. (Figure 1 & Plate 3).

Trench 1 exposed part of the eastern side of Sea Wall, which was made (in 1583) of piled-up shingle and clay extracted from the area immediately to the east, the extraction thus creating a large ditch then used to drain excess water and effluent to the sea via the 'Outlets', as shown on a town map dated 1725. The ditch (See CRNs 1/15 and 1/13) was first discovered by the present writer during a previous excavation (Bennett 1996, 19), which showed it to have been repeatedly re-cut and scoured, as in the present case. To the east and of interpretive significance, was a relatively small horizontal deposit of charcoal (CRN 1/9) immediately overlying a similarly small and thin clay layer (CRN 1/10), the latter probably a surviving fragment of an internal clay floor, the former interpreted with confidence (given the presence at similar levels of other layers of charcoal exposed in other trenches) as evidence of the great fire that ravaged a large part of this area of Whitstable in 1869: 'Along the "Sea Wall" and in Marine-street the fire destroyed 36 stores, 16 cottages, three sail-lofts, two inns (the "Victoria" and the "Spread Eagle"), one blacksmith's forge, one ship chandler's shop and timber yard, one auction mart, one shipping office, and three shoemakers' shops; and in Harbour-street there were consumed four dwelling houses and shops, and three private dwelling houses' (<http://www.oystertown.net/1850-1874/1869-the-great-fire-of-whitstable>).

Trench 1 exposed part of the eastern side of Sea Wall, which was made (in 1583) of piled-up shingle and clay extracted from the area immediately to the east, the extraction thus creating a large ditch then used to drain excess water and effluent to the sea via the 'Outlets', as shown on a town map dated 1725. The ditch (See CRNs 1/15 and 1/13) was first discovered by the present writer during a previous excavation (Bennet 1996, 19), which showed it to have been repeatedly re-cut and scoured, as in the present case. To the east and of interpretive significance, was a relatively small horizontal deposit of charcoal (CRN 1/9) immediately overlying a similarly small and thin clay layer (CRN 1/10), the latter probably a surviving fragment of an internal clay floor, the former interpreted with confidence (given the presence at similar levels of other layers of charcoal exposed in other trenches) as evidence of the great fire that ravaged a large part of this area of Whitstable in 1869: 'Along the "Sea Wall" and in Marine-street the fire destroyed 36 stores, 16 cottages, three sail-lofts, two inns (the "Victoria" and the "Spread Eagle"), one blacksmith's forge, one ship chandler's shop and timber yard, one auction mart, one shipping office, and three shoemakers' shops; and in Harbour-street there were consumed four dwelling houses and shops, and three private dwelling houses' (<http://www.oystertown.net/1850-1874/1869-the-great-fire-of-whitstable>).

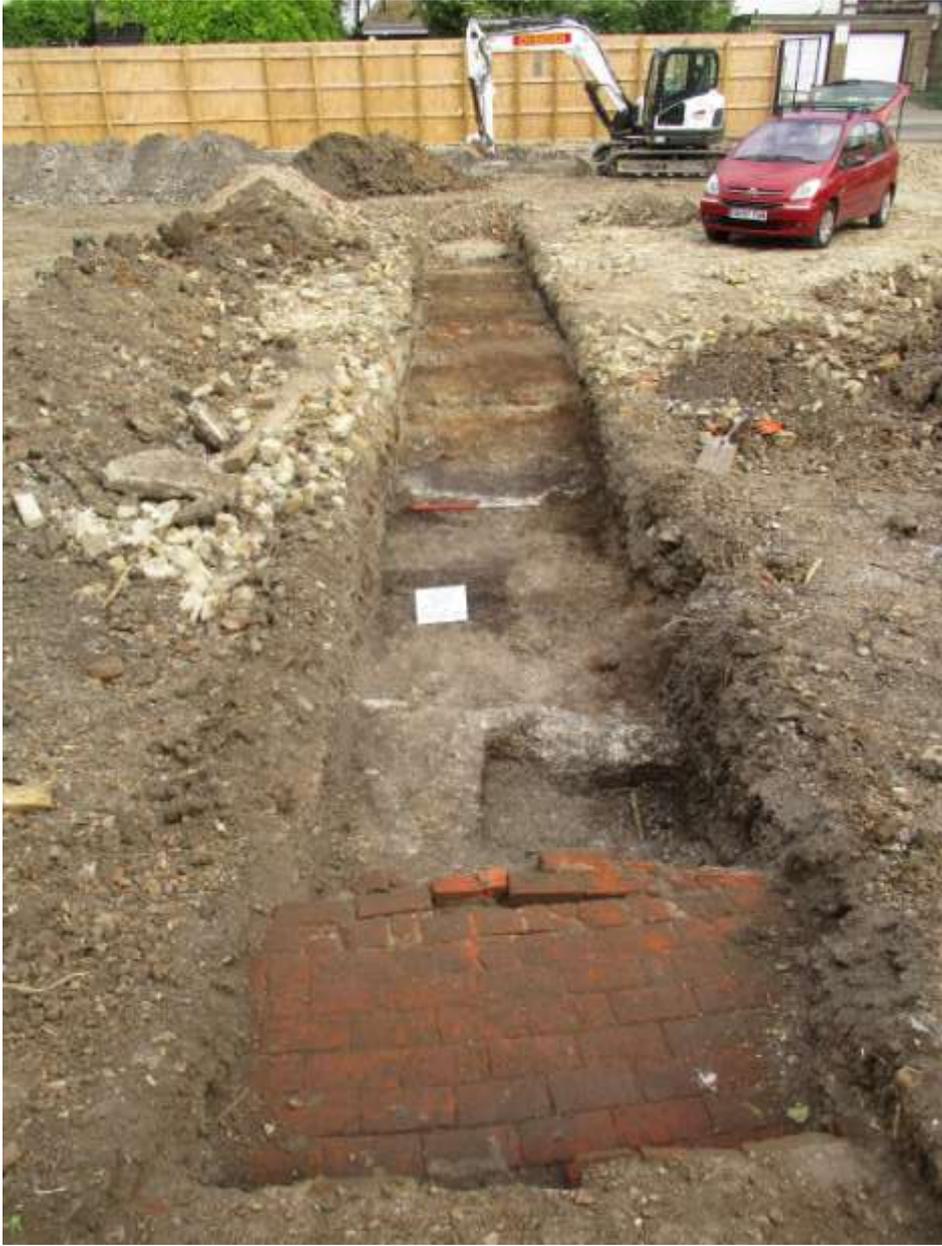
Plate 4. Trench 2 looking south from brick-paved walkway (CRN 2/3) and the feature and deposit complex in the mid and foreground (one-metre scale). The horizontal dark deposit (CRN 22) overlying chalk (CRN 21) and just above the scale almost certainly represents intense scorching dating to the great fire of 1889

**9.2** Trench orientation: about NW/SE. Depth: 0.28m. Width: 2.0m. Length: 19m. (Figure 1 & Plates 4 & 6).

The complex stratigraphic sequence exposed in this trench told a relatively simple story. As in the case of Trench 1, the bank of shingle (CRNs 2/10 and CRN 1/11 almost certainly represents the surviving and probably much modified remains of the original sea wall, after which Sea Wall, the overtopping street, took its name. The sea wall was raised in 1583 (Bowler 1983, 32) as part of an eastern extension of the town's coastal defences, with the clay, silt and shingle from which it was made being extracted from the area immediately to the east. As previously discussed, this process created a massive ditch or dyke, used as a drain and common sewer that flowed into the sea at the 'Outletts', which a map of 1725 shows was still in use in the early eighteenth century. Previous work in the Horsebridge area showed the ditch to be in excess of five metres wide and more than 1.3m in depth (Bennet 1996, 19).

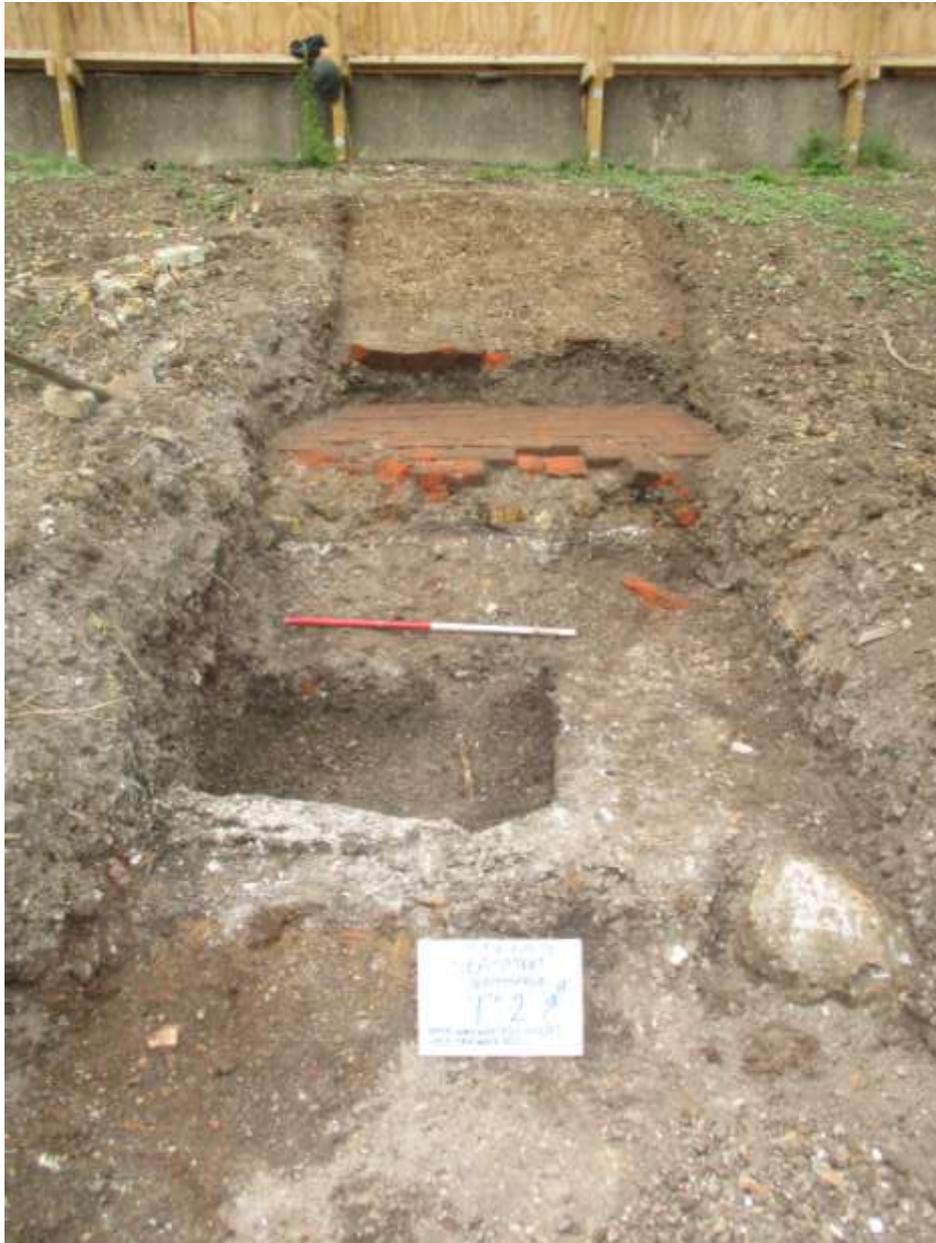
Plate 5. Trench 2, northern end, showing the shingle bank of Sea Wall (CRN 2/10), brick-paved walkway (CRN 2/3) and the slot cut through the adjacent ditch (CRN 2/8)

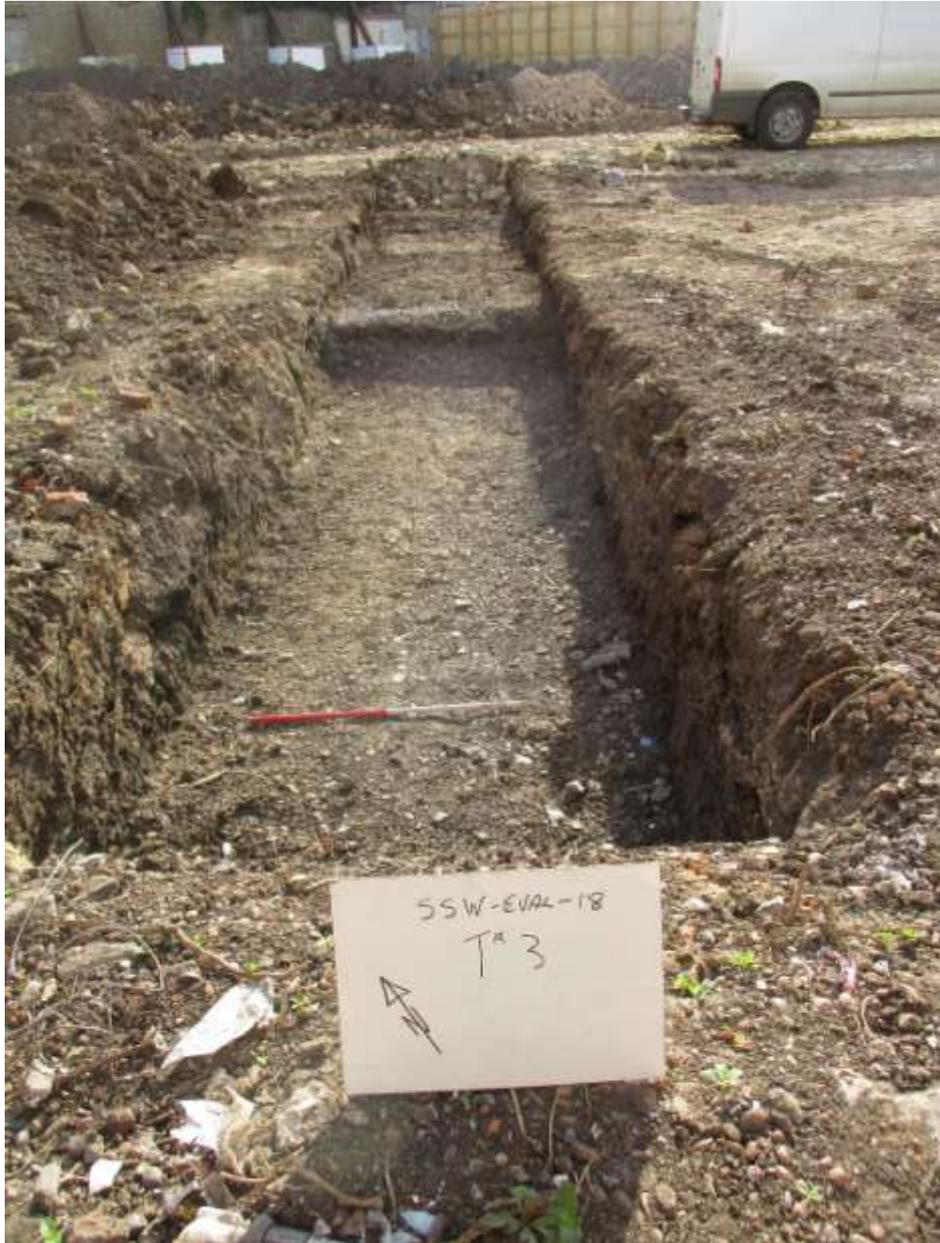
Plate 7. Trench 3 from the north-west showing beach shingle layer (CRN 3/4) with made-floor layer (CRN 3/5) in the background (one-metre scale)

The deposit sequence here was markedly simpler than that exposed in Trench 2, a short distance to the north. Only one example of the made-floor deposits evident in Trench 2 occurred here, in the form of CRN 3/5, located in the trench's eastern margin, indicating that the south-western part of the site was not a major focus of the industrial use of the site as described above. The remainder of the trench exposed a natural beach deposit sealed by a single probable dump layer sealed by modern mixed rubble and soil levelling spreads.

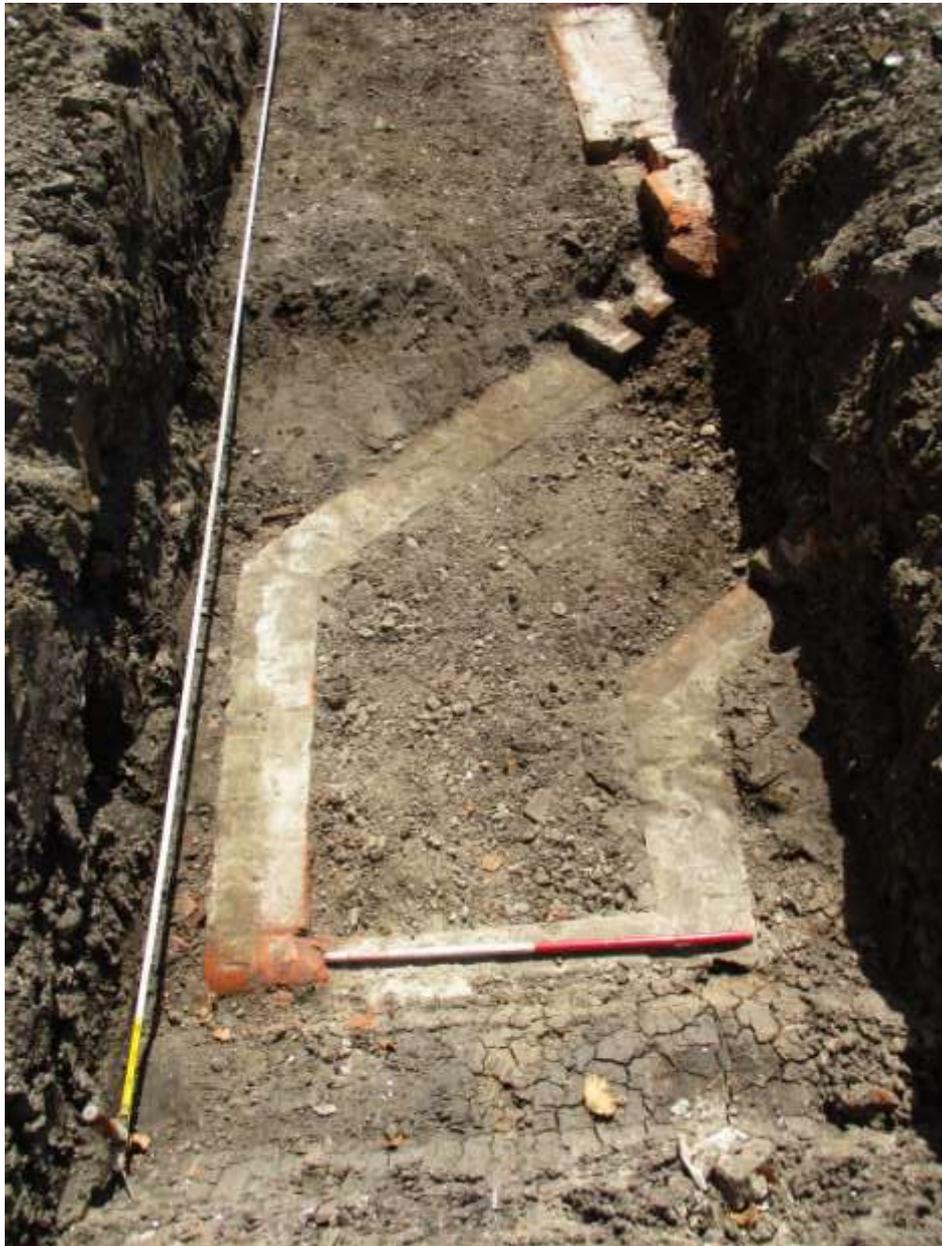
Plate 8. Trench 4, east end, showing brick foundation/cellar remains (CRN 3/4, two-metre scale)

In addition, it may be proposed that the truncated brick foundations (CRNs 4/3[4] and 4/9[10] exposed at significantly higher levels in this trench were contemporary with the third- or, more likely, fourth-phase made floor of the workshop/blacksmith's forge to the west of the brick built structure. A further proposal may be made with some confidence that the remains as a whole comprised a brick-built, cellared house fronting onto Sea Street with a workshop, almost certainly the blacksmith's, situated to the rear.

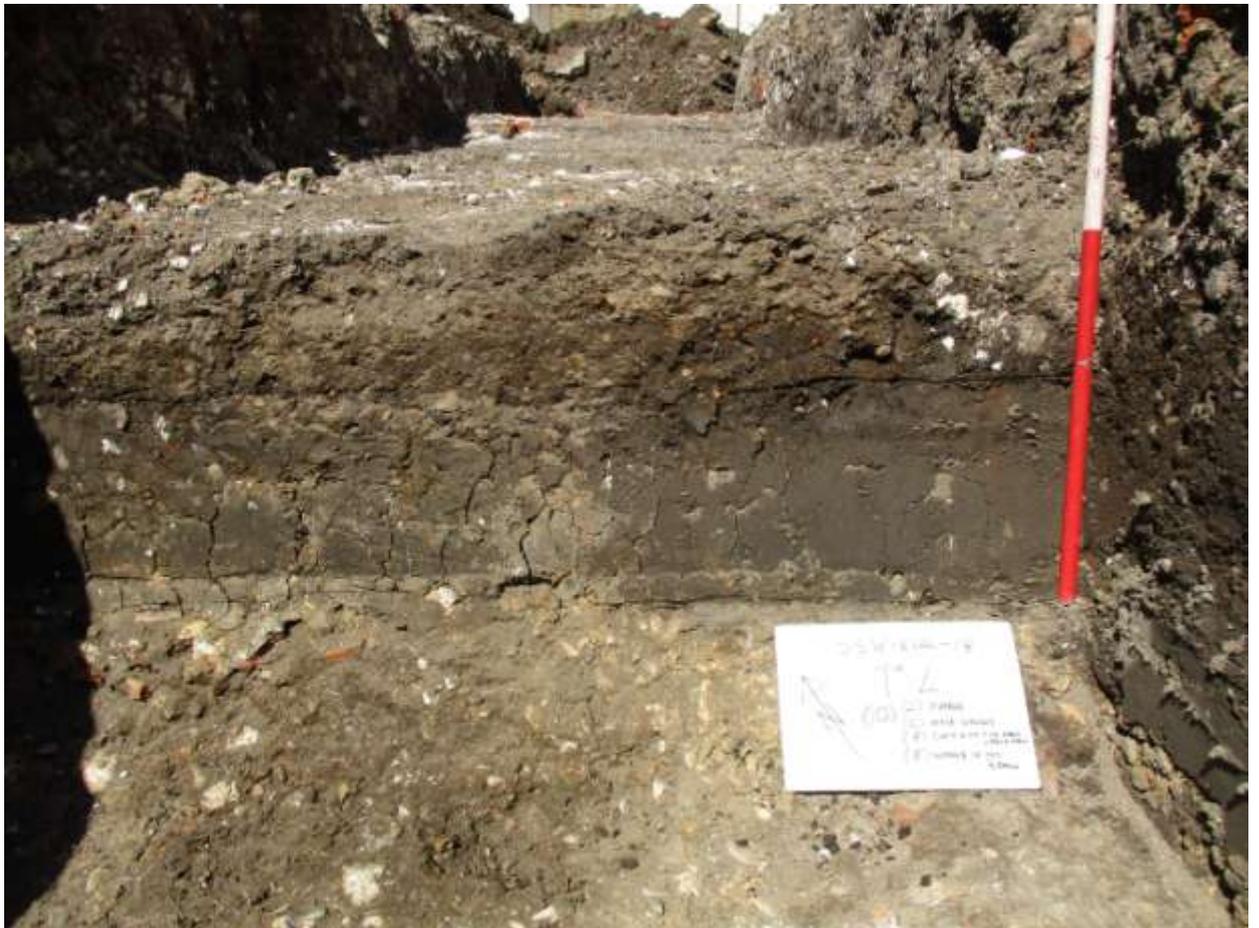
Plate 9. The test trench in the eastern end of Trench 4 showing basal beach deposit (CRN 4/8 under clay layer (CRN 4/7) under made ground (CRN 4/6) under rubble layer (CRN 4/2, one-metre scale)

The most significant evidence exposed in this trench was the exposure at a depth of 1.74m below the present ground surface of an oyster-shell littered beach deposit (CRN 4/8) that almost certainly marked the margin of the intertidal zone adjacent to Sea Street before the construction of the 1583 sea wall. The overlying 0.3m-thick clay layer (CRN 4/7) indicated a major change in the depositional regime in this area, and this can be postulated, albeit with

confidence, to have been the result of the construction of the 1583 sea wall, such a postulation being supported by the presence of three sixteenth-century potsherds recovered from the clay (such a substantial accumulation of clay at this depth is unlikely to have been caused by the flood of 1779).

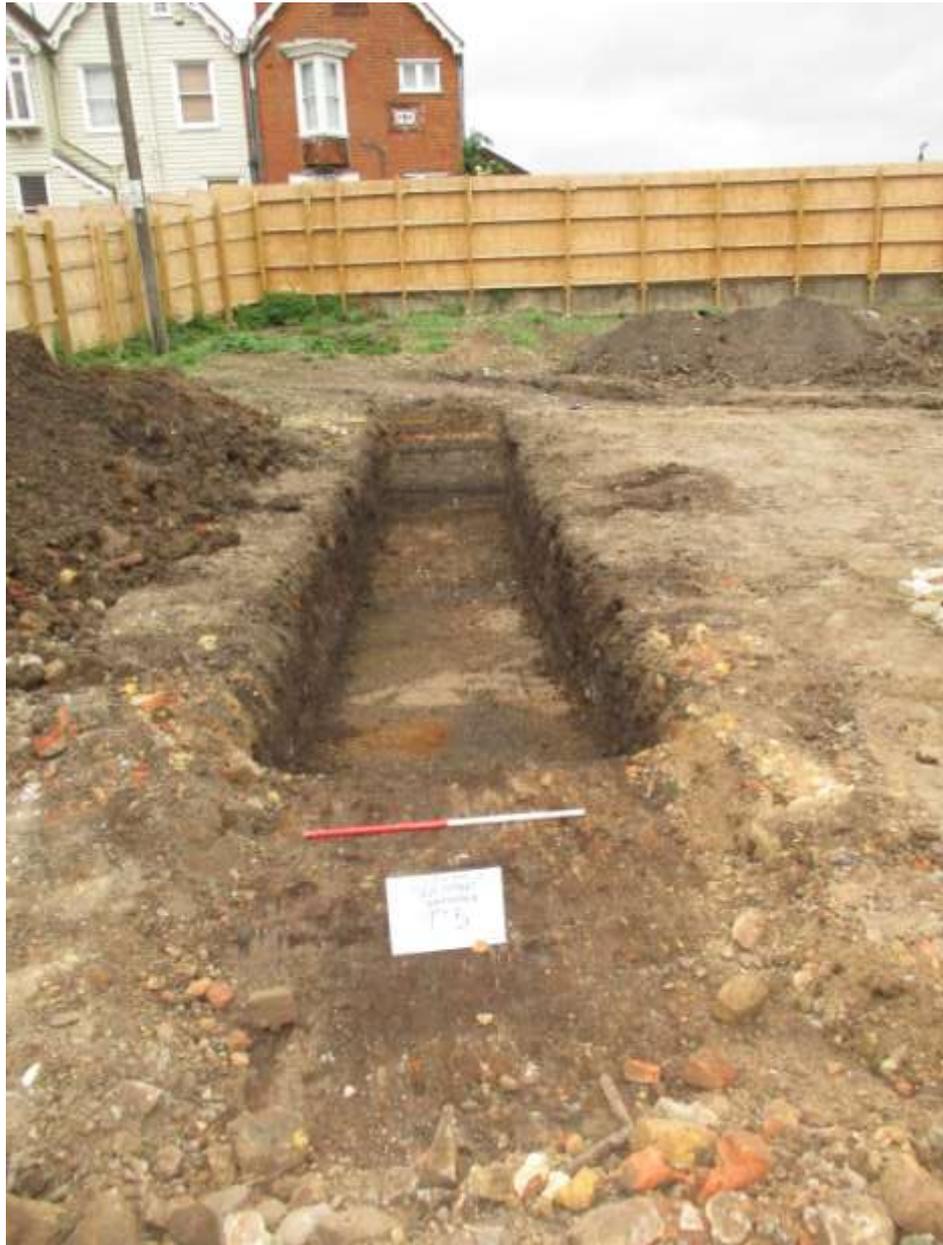
Plate 10. Trench 5 from the south showing, in the far section, levelling layers and an overlying made-floor layer (CRN's 5/9 to 5/3) overlying beach shingle/gravel deposits (CRN 5/10 to 5/13)

As in the case of Trench 4, the apparently complex deposit accumulation exposed in this trench told a relatively simple story. Given that the basal grey-brown clay layer (CRN 5/13) is an example of the similar clay deposit exposed in Trench 4, the date-range represented covers the period immediately following the construction of the 1583 sea wall up to the early twentieth century, the latter represented by the compact made floor layer (CRN 5/2) over a bedding layer (CRN 5/3), which is undoubtedly an extension of the made floor (CRN 3/5, bedding CRN 5/6) exposed in the eastern end of Trench 3. The same floor layer appeared as the fourth and latest made floor exposed in Trench 2 (CRN 2/26), in an area where industrial activity in the shape of a blacksmith's forge/workshop was of much greater longevity.

The intervening layers almost certainly represent varied dumped waste materials and/or levelling layers deposited that eventually lead to a land aggradation of over 1.7m in the area reclaimed east of the 1583 sea wall.
