**Archaeological Investigations on Land at The Cedars, 21 Bond Gardens,
Wallington, SM6 7LW**

Site Code: BOND/EV/17

Planning Application Number: 2016/74658/FUL

Version: v03

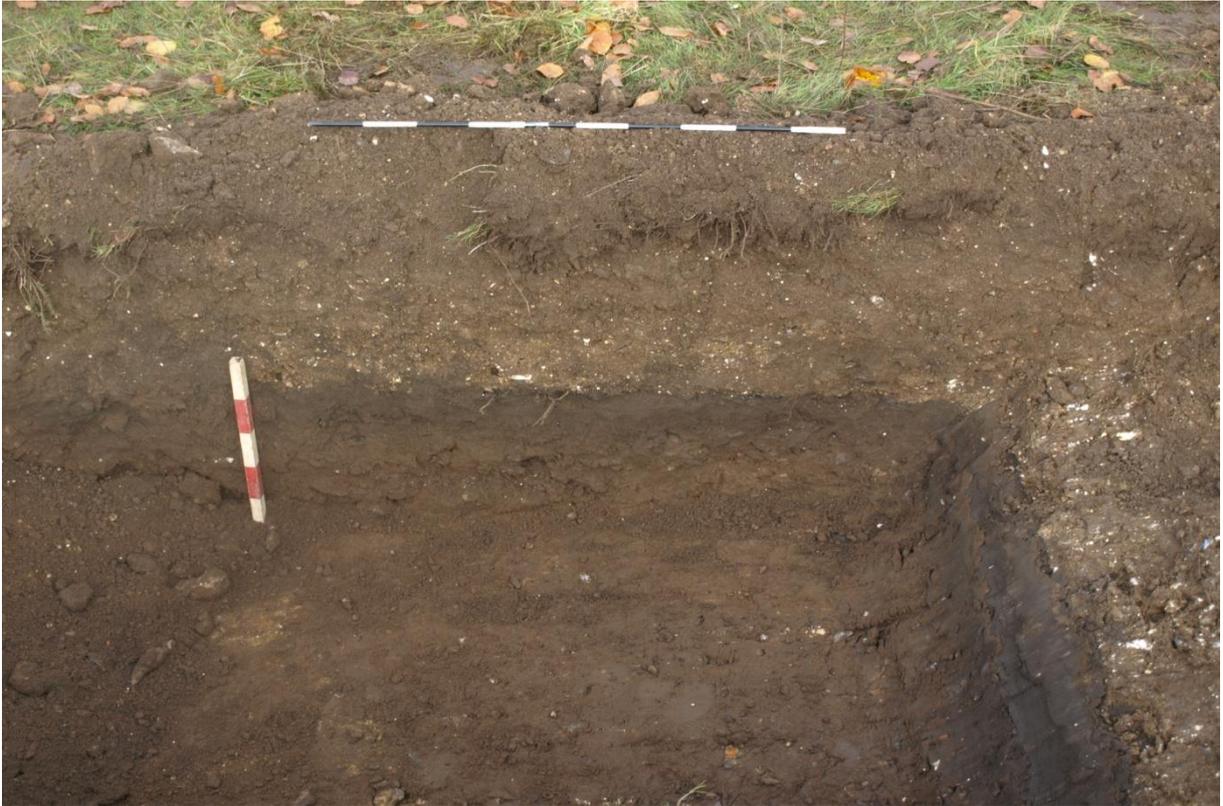
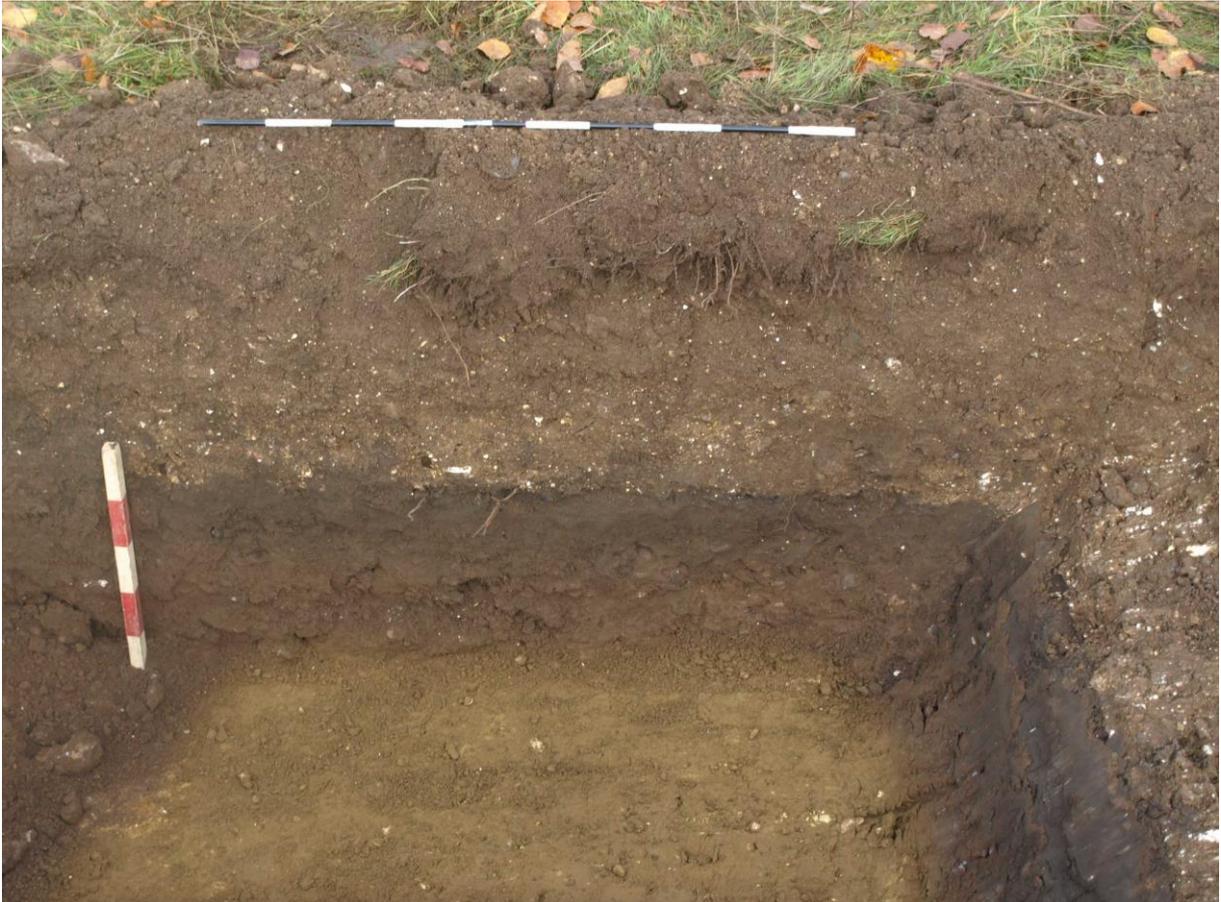
Plate 5: Showing representative section 1.1 in Trench 1 (trial test-pit in Trench 1). Viewed from the south

5.3.2 The stratigraphic sequence comprised topsoil (101) overlying a layer of redeposited brown/grey clay silt with moderate crushed demolition debris (102). Below this, a dark grey brown organic silt clay represented the former topsoil on the site (104), which sealed a red brown subsoil (105) at a depth of approximately 1.19m (36.6m aOD) (Figure 9, Section 1). In order to comply with Health & Safety protocols the test pit ceased at a depth of 1.2m. At this depth small patches of yellow orange sand started to emerge (Plate 4 and Plate 5) suggesting that natural levels were present just beyond the level of excavation.

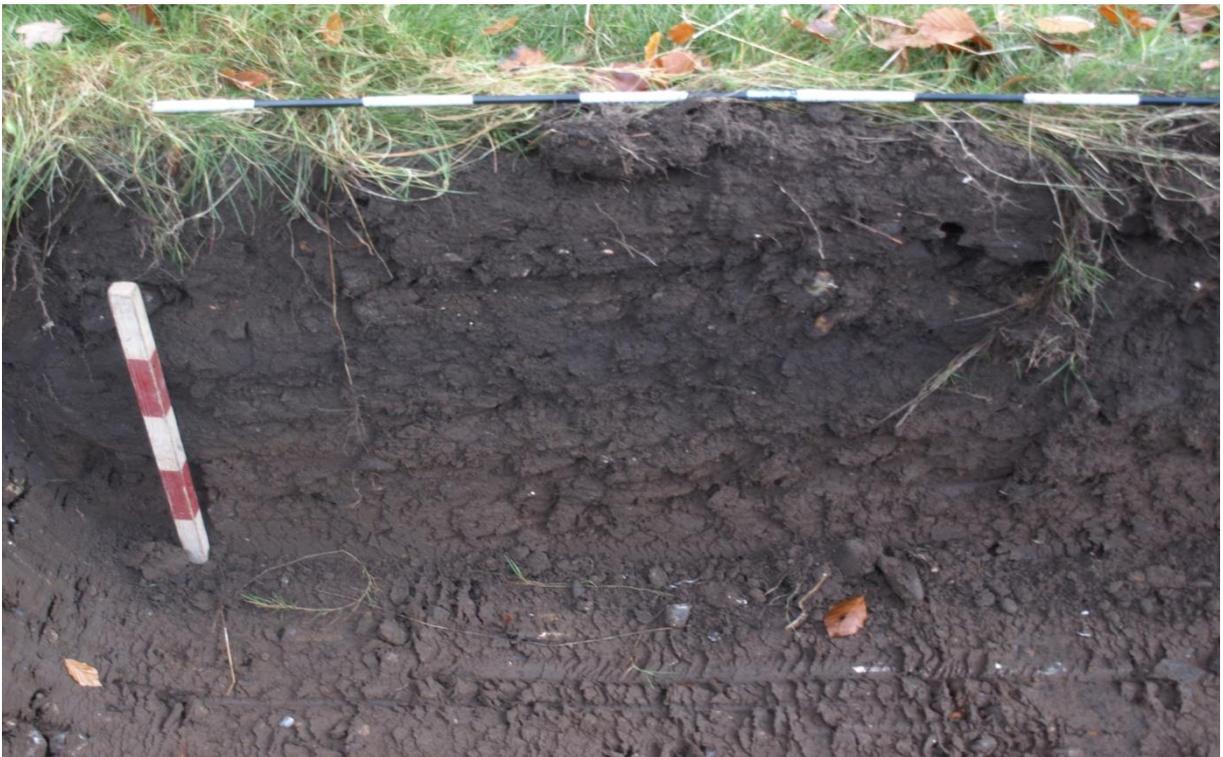
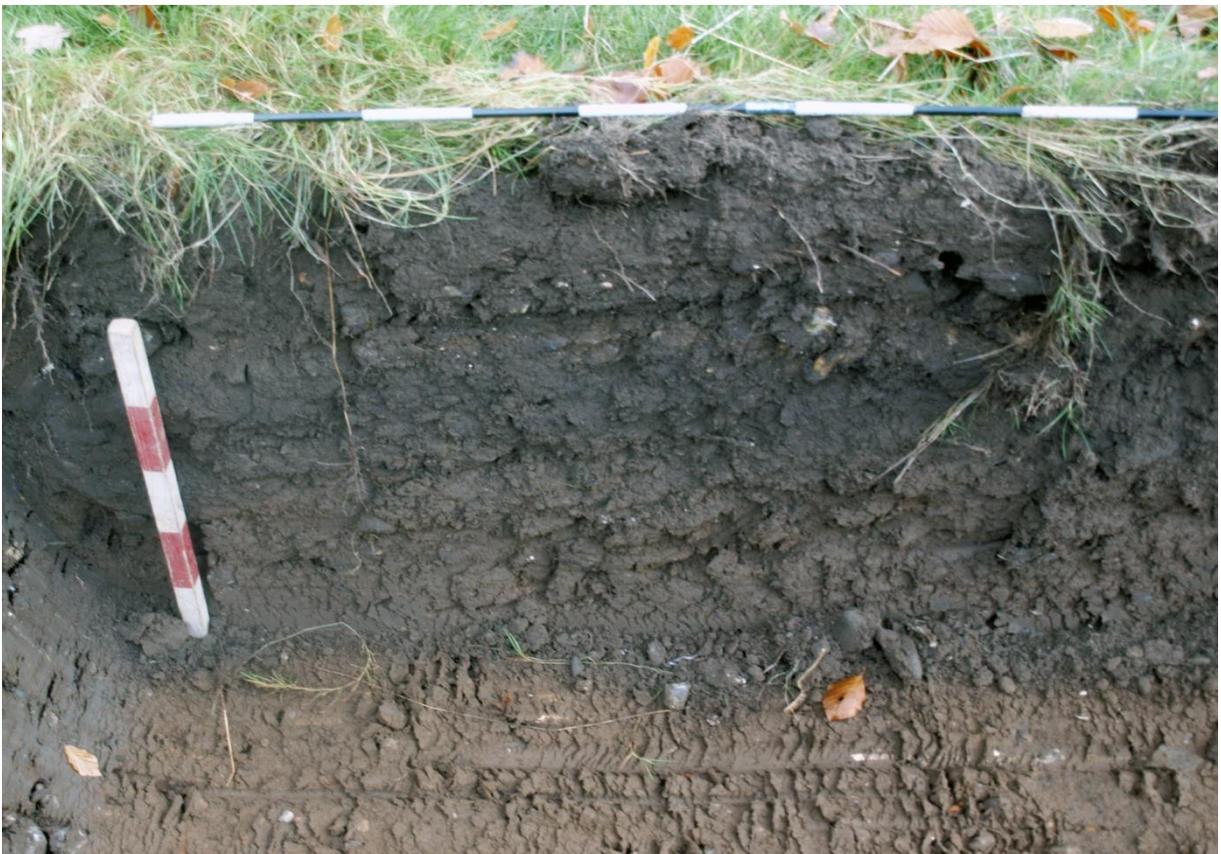
Plate 6: Showing representative section 2.1 in Trench 2 (trial test-pit in Trench 2). Viewed from the west

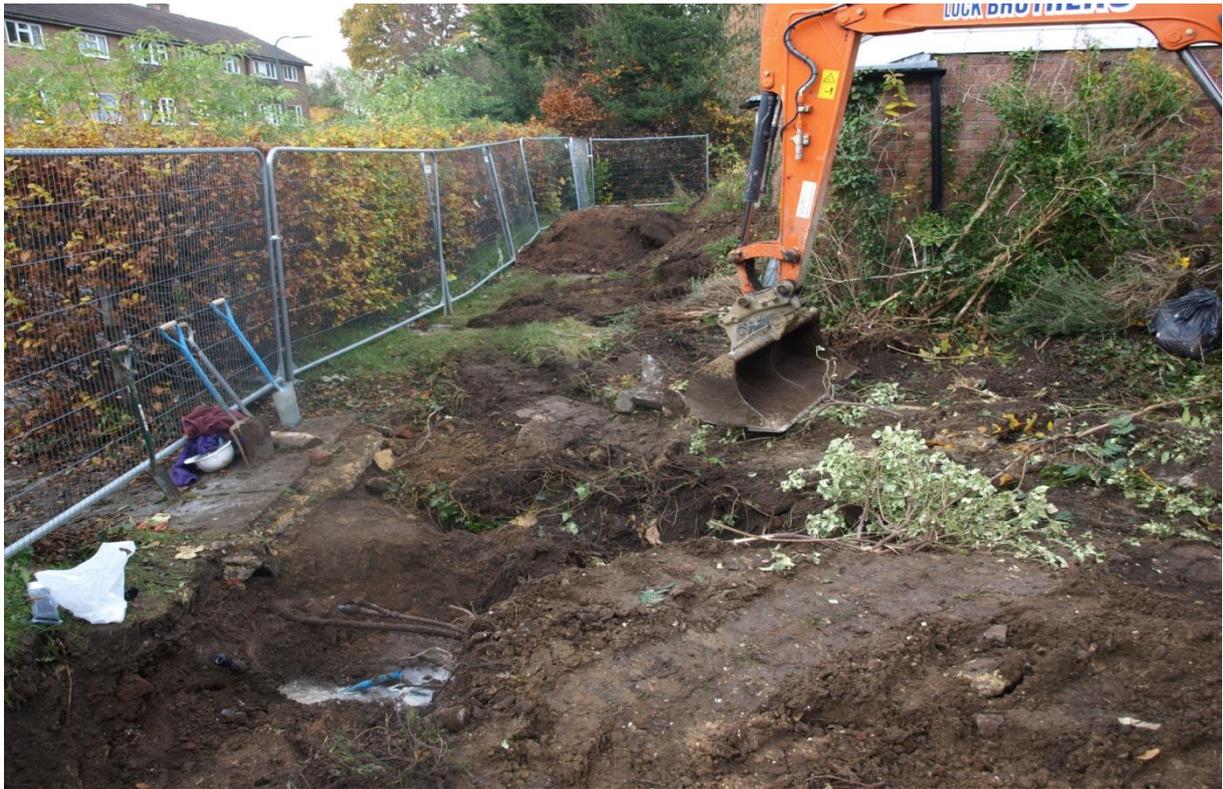
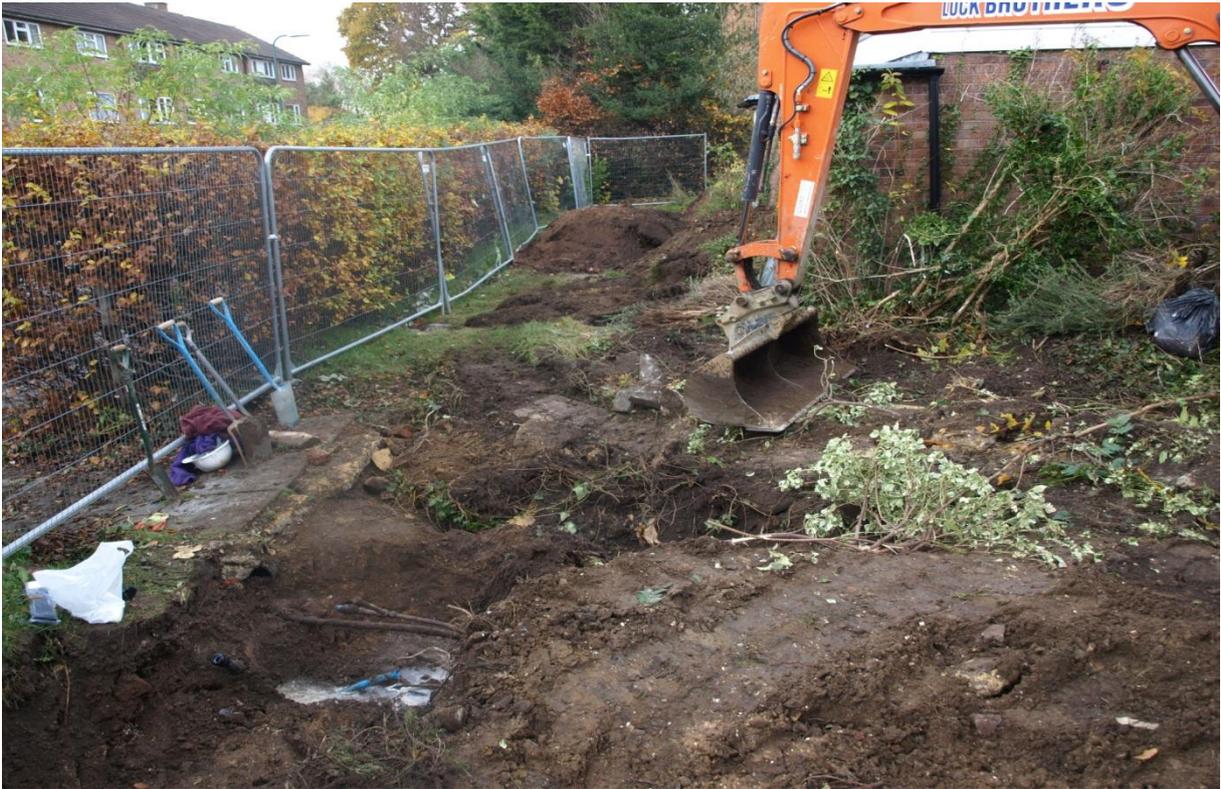
Plate 9: Showing eastern end of evaluation Trench 3, live water-main visible in foreground, viewed from the east

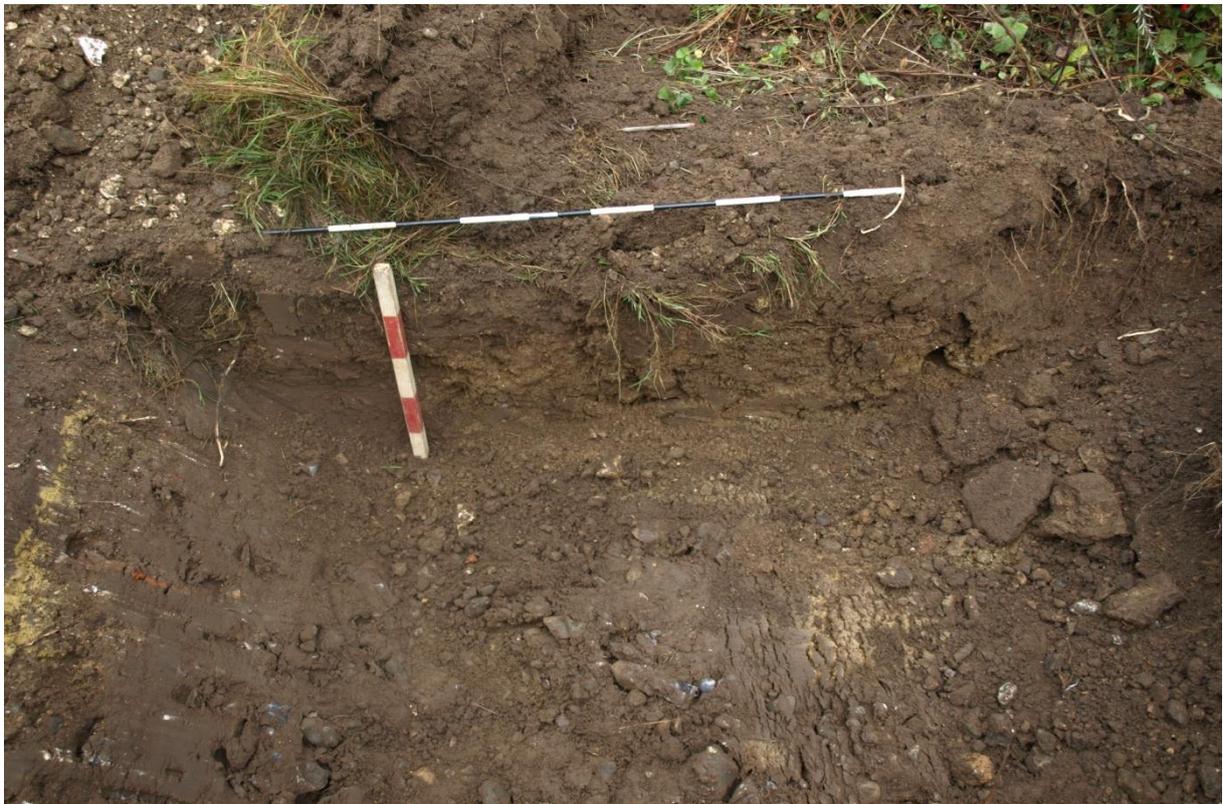
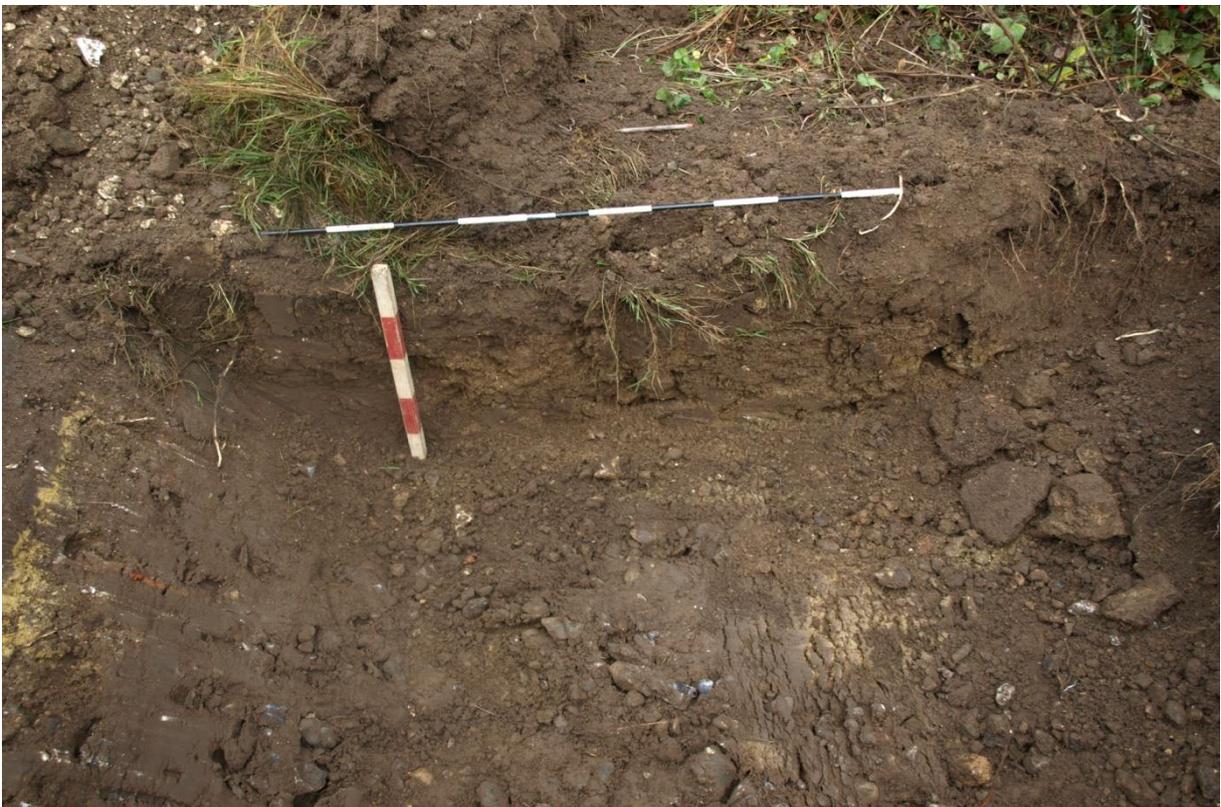
Plate 10: Showing representative section 3.1 in Trench 3, viewed from the south

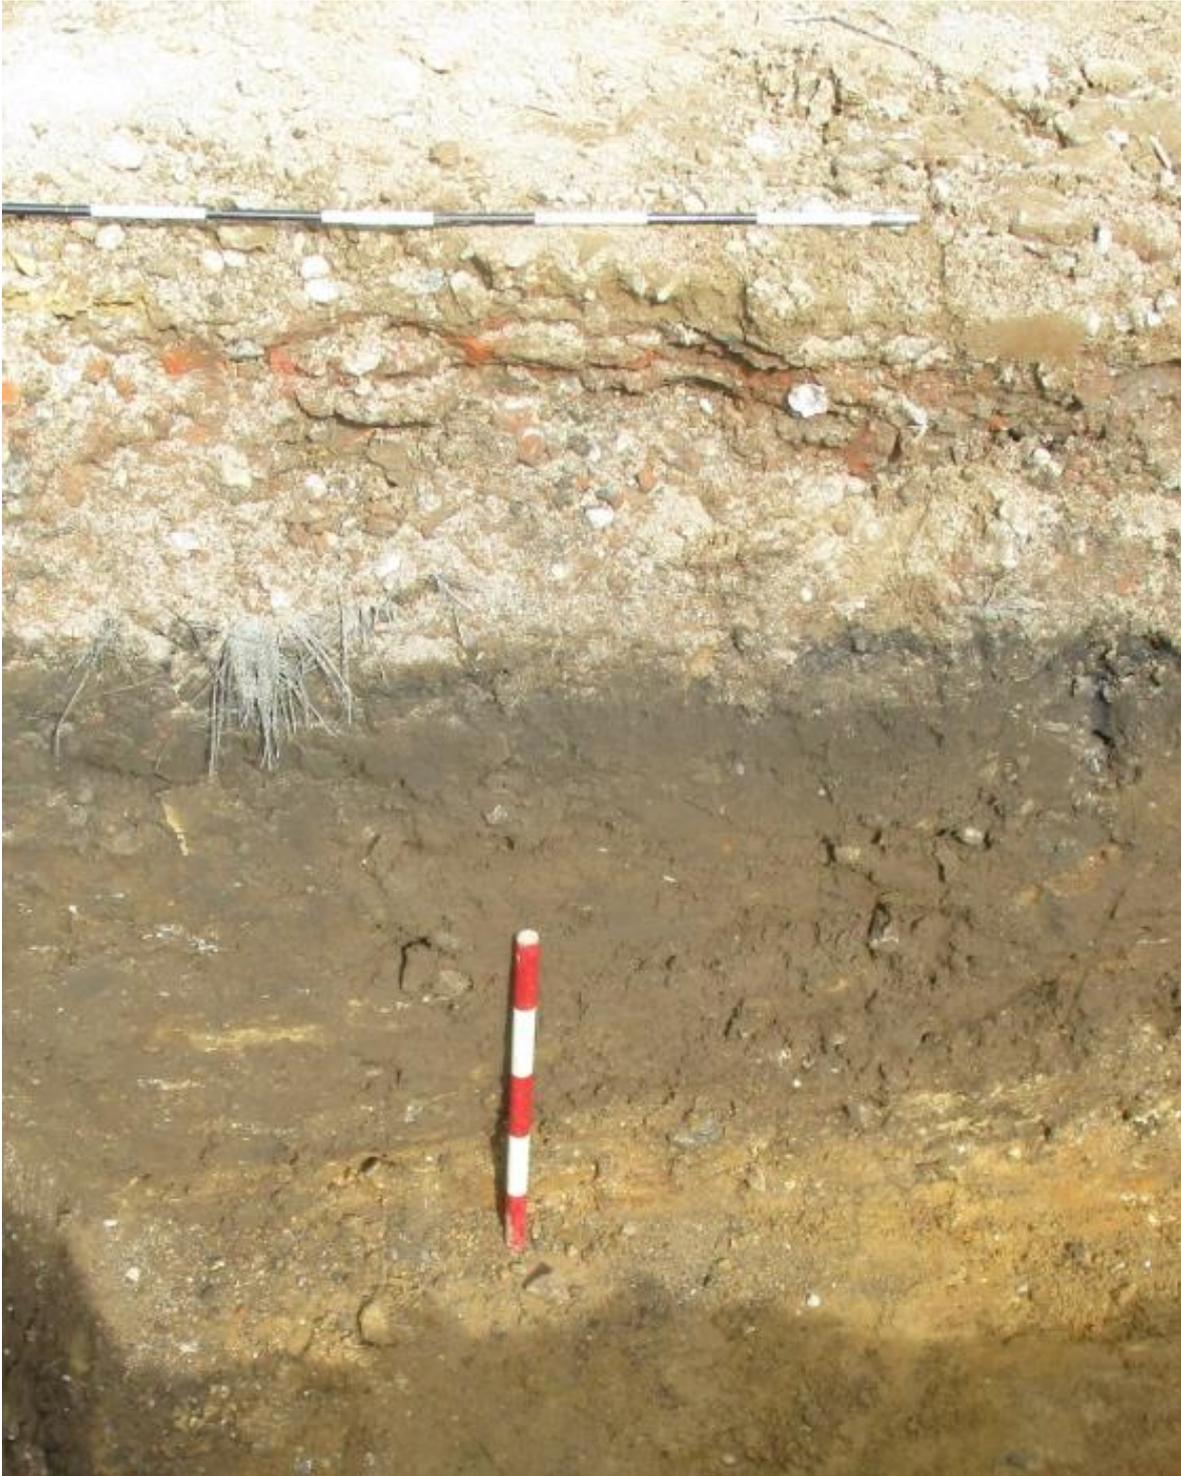
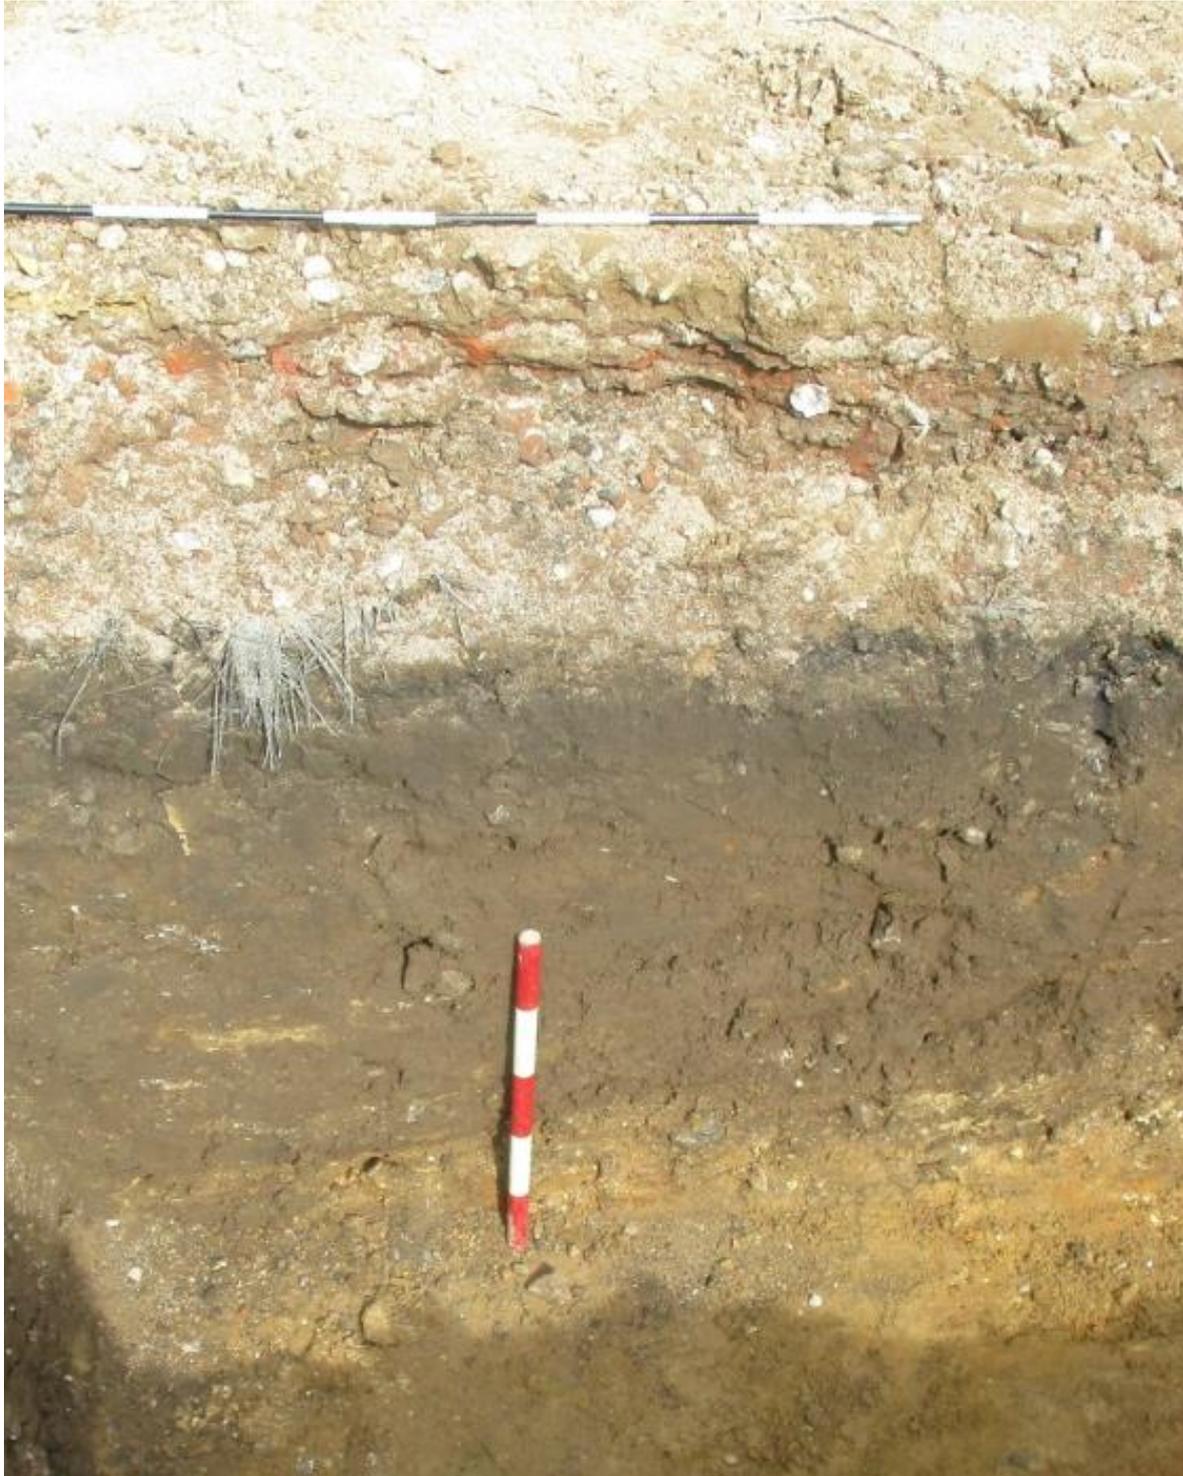
Plate 12: Showing representative section 9 in Trench 5, viewed from the southeast

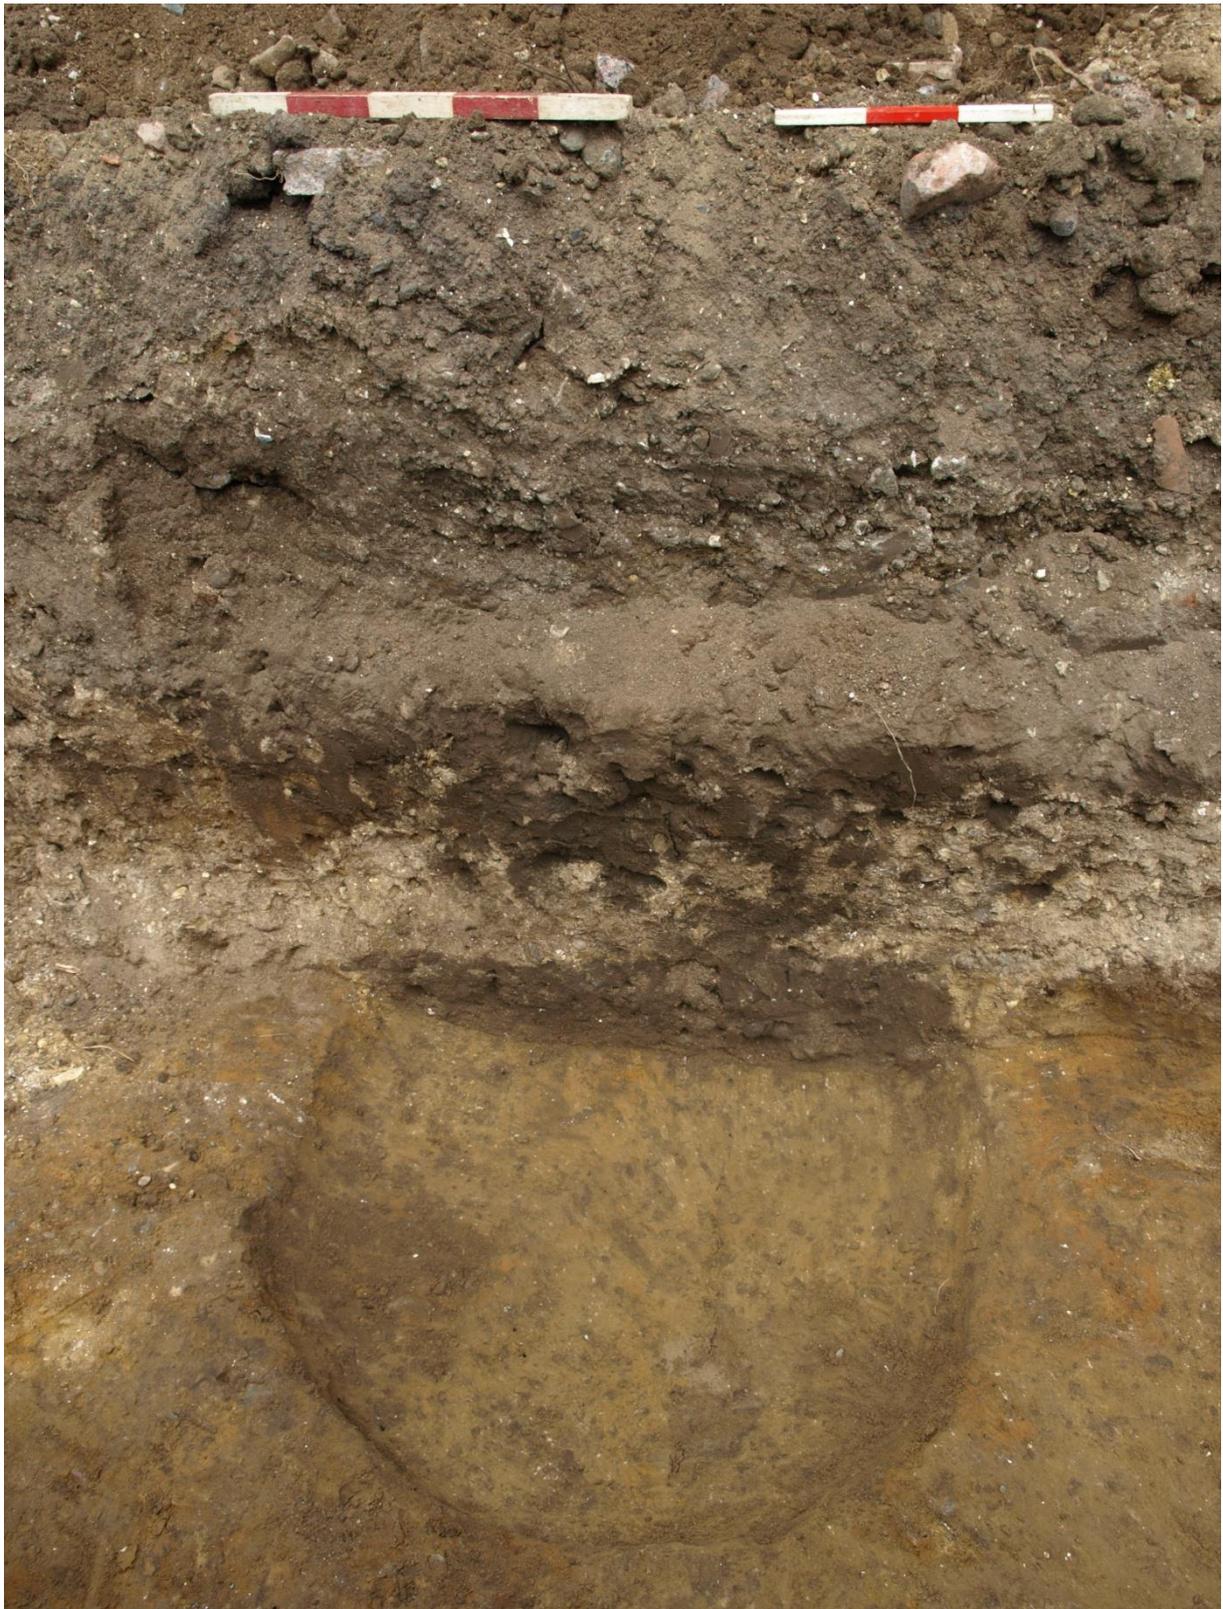
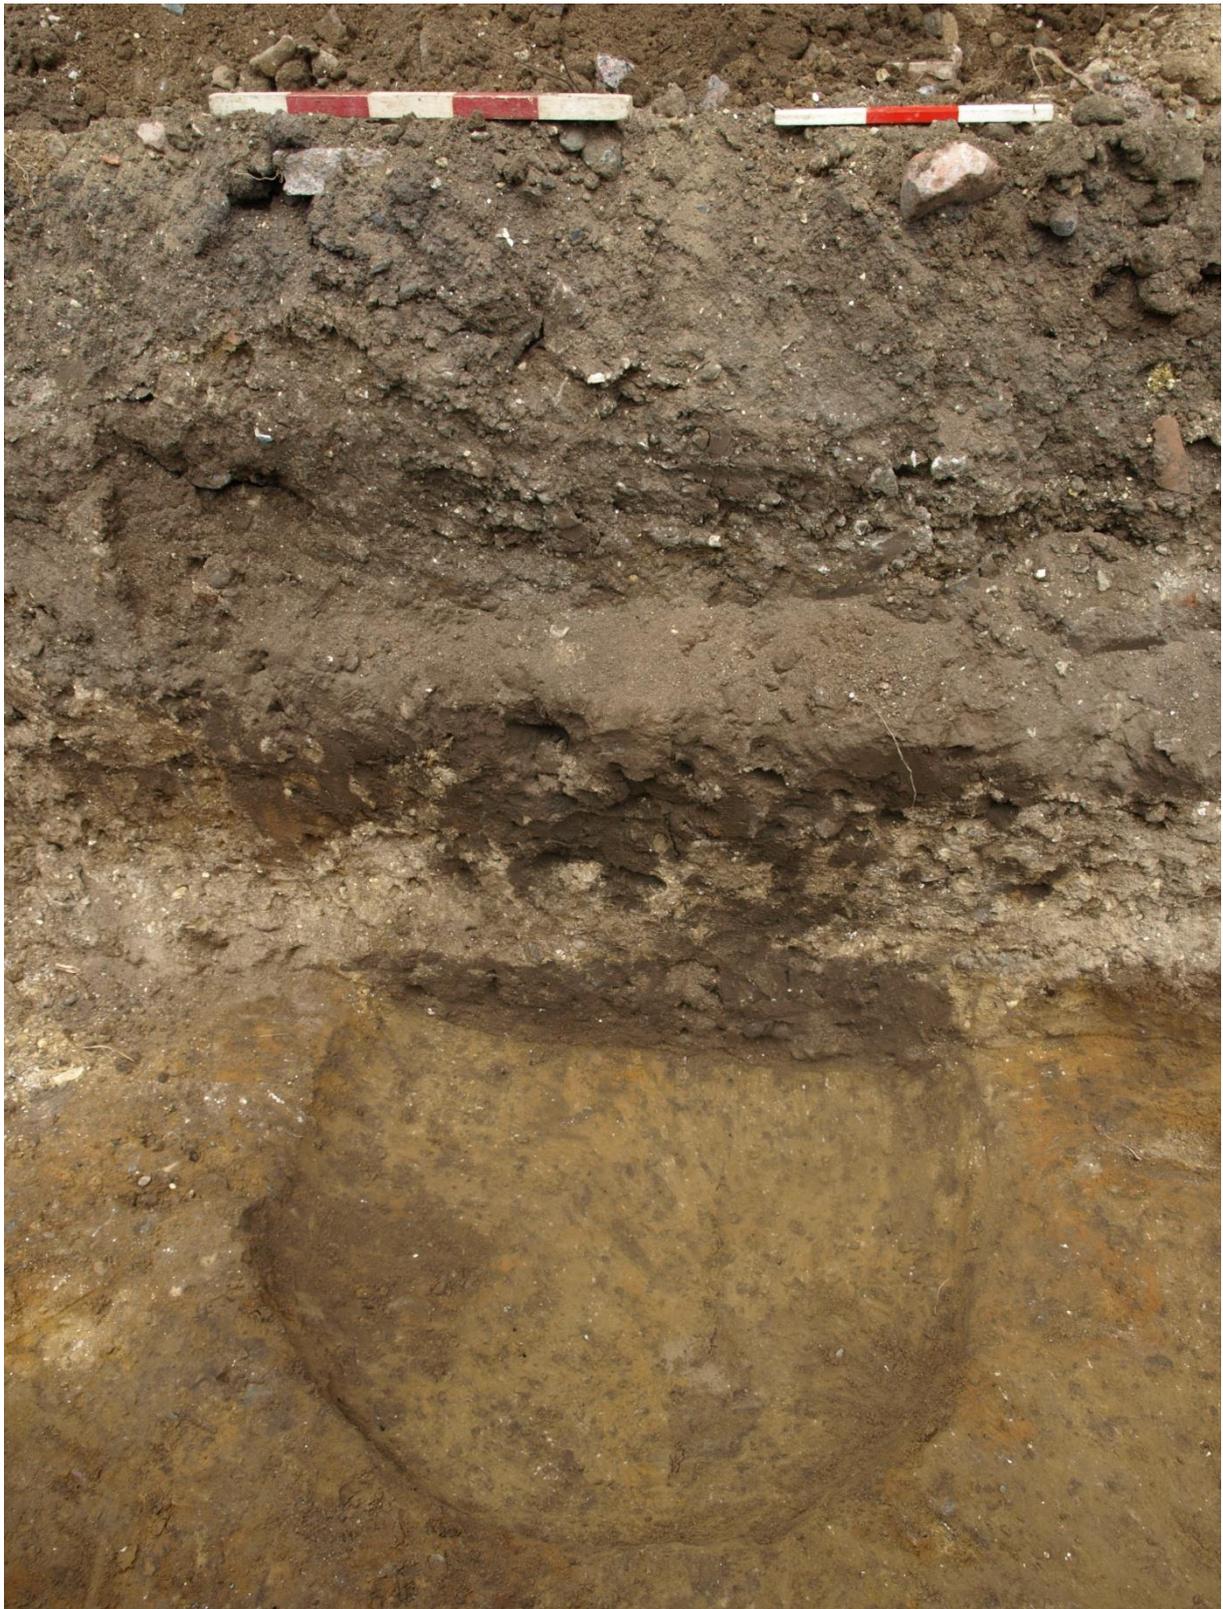
Plate 14: Showing representative section 7 and half-sectioned Pit 606 in Trench 6

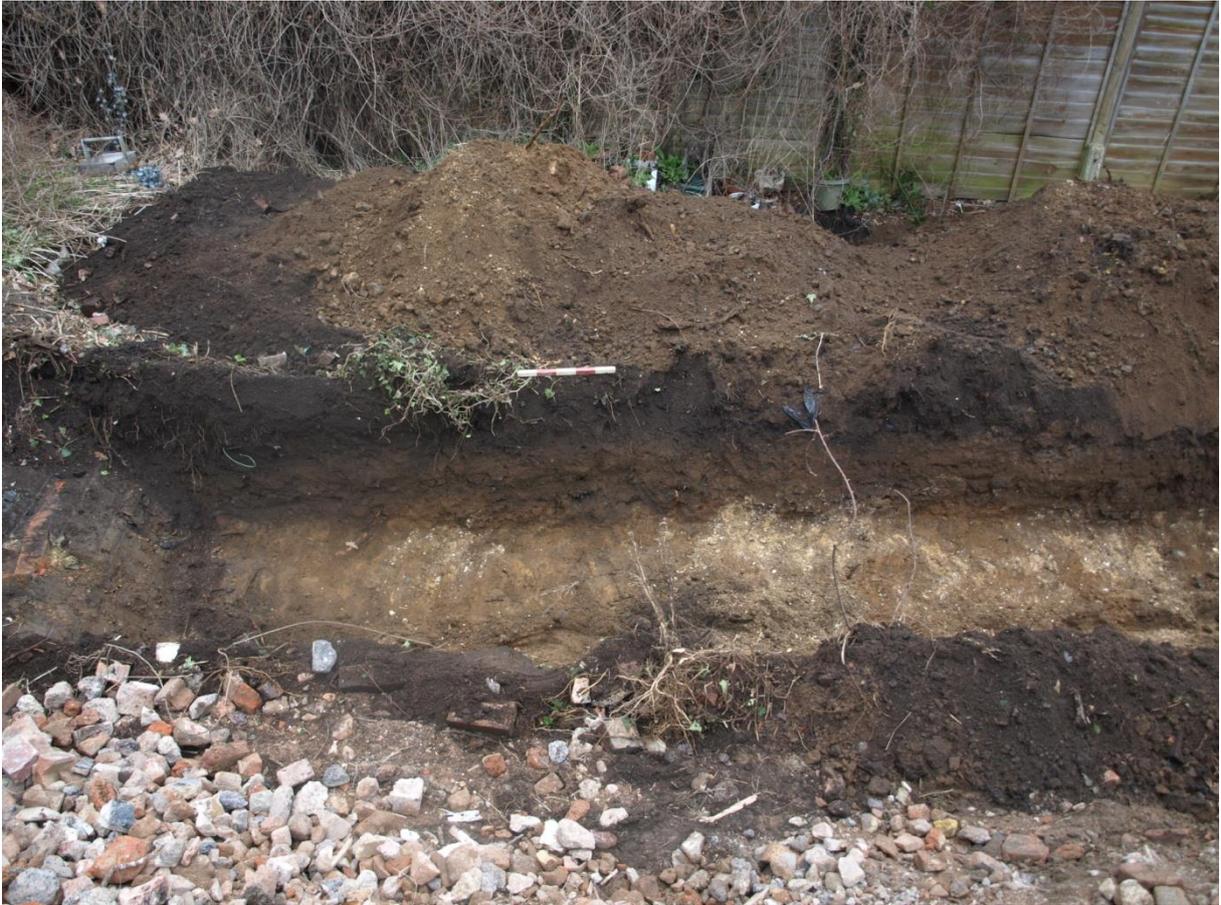
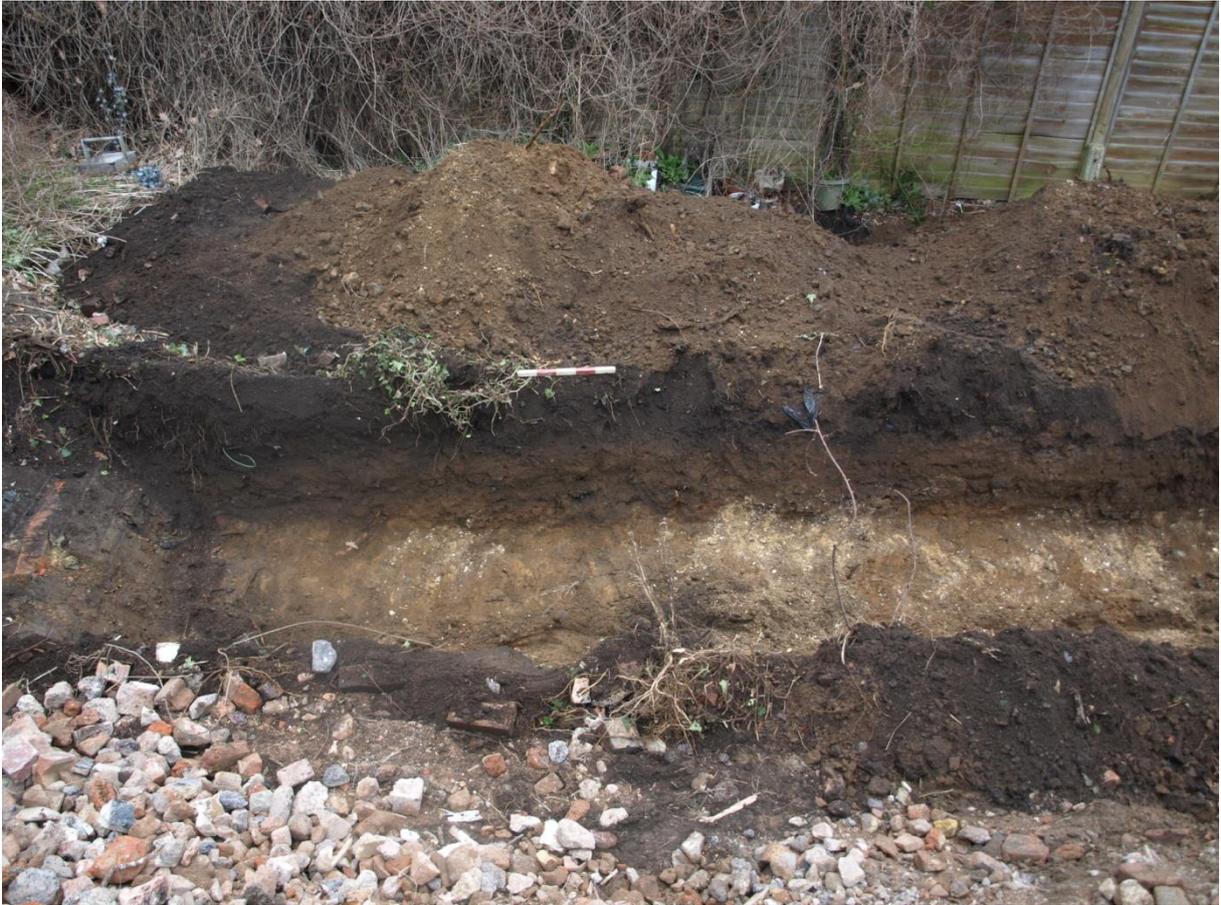
Plate 16: Showing representative section 4 in Trench 4, viewed from the west

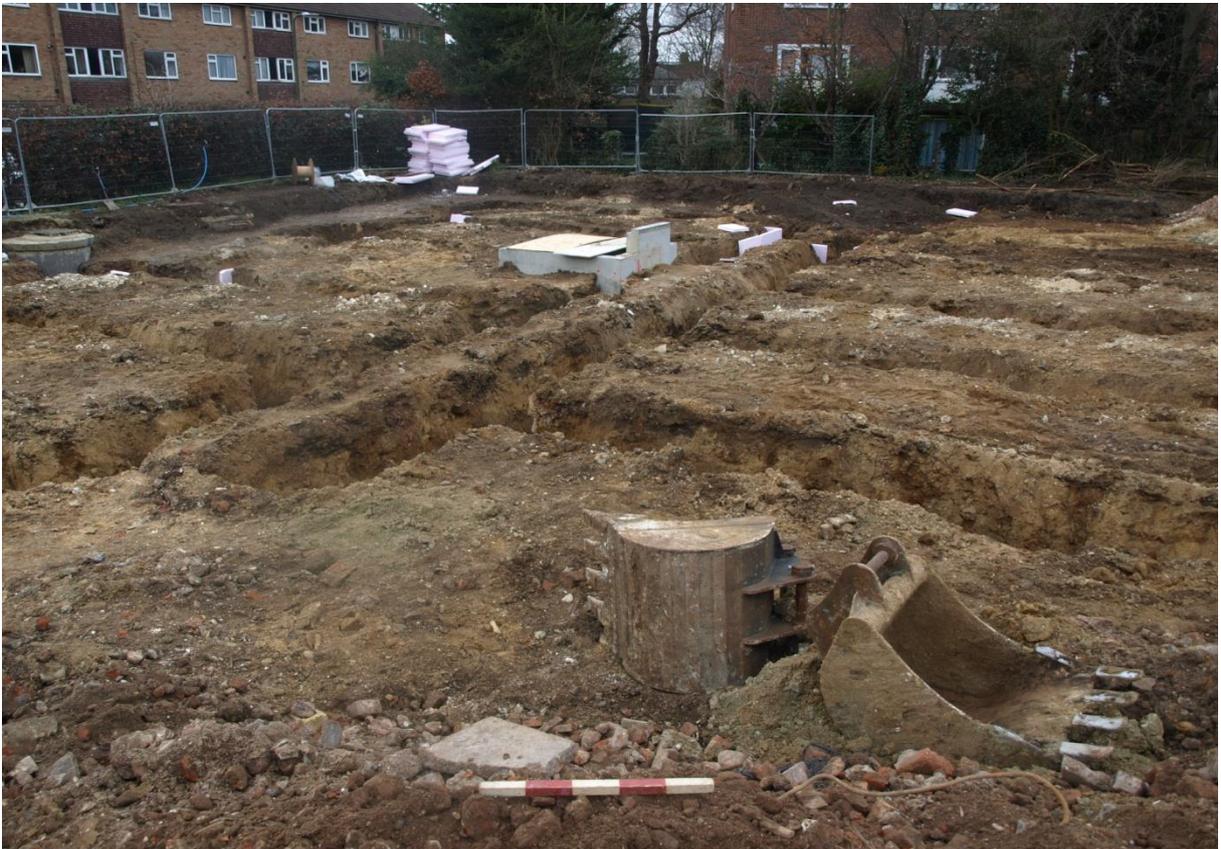
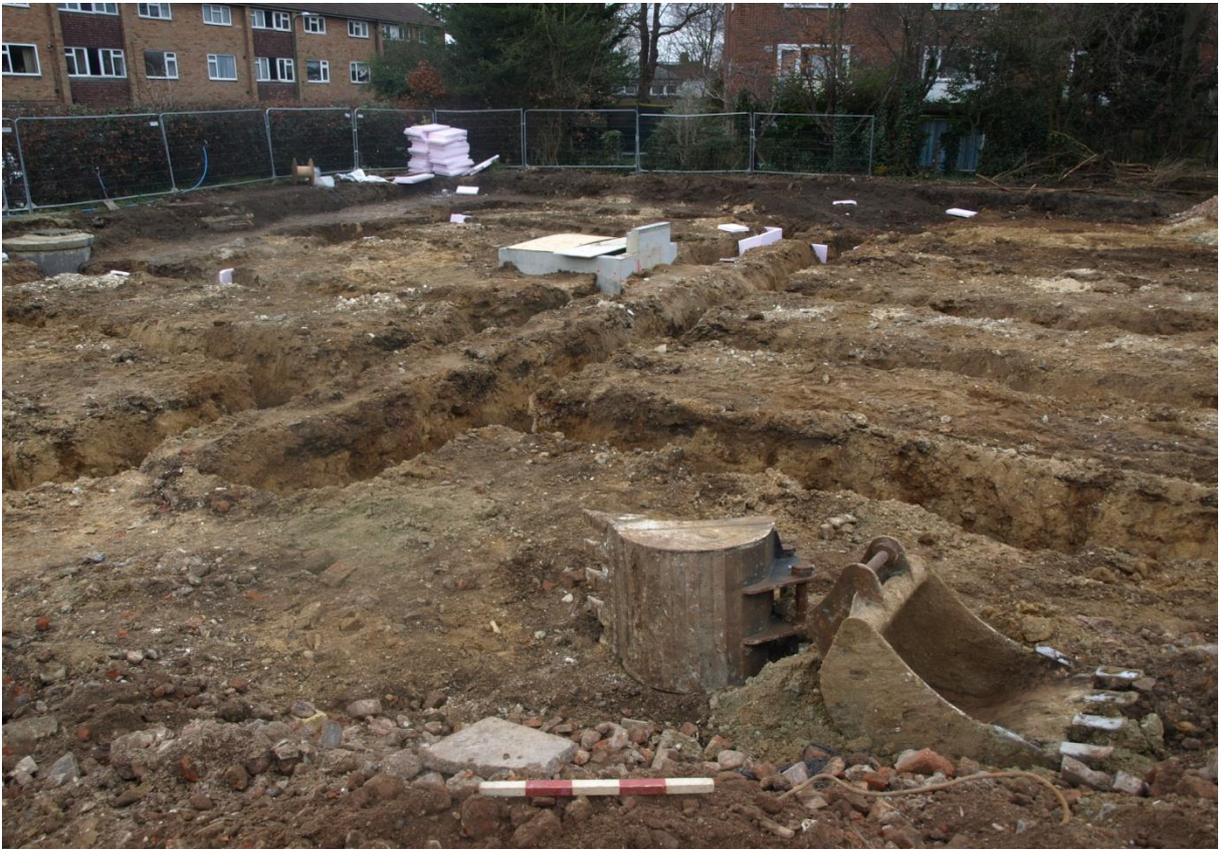
Plate 17: Showing foundation trenches, viewed from the northeast

5.3.13 A watching brief was carried out during the excavation of foundation trenches (Plate 17), during which time a series of surviving natural geological deposits were recorded. Section 5 and Section 6 (Figure 9) were located within the central area of the new building (Figure 7) and both illustrate that modern redeposited hardcore (701), 0.20m in depth, directly overlay surviving geological

sand, gravel and chalk (702-705), present at a level between 35.5m aOD and 36.01m aOD. No archaeological finds or features were present within the footprint of the new foundation.

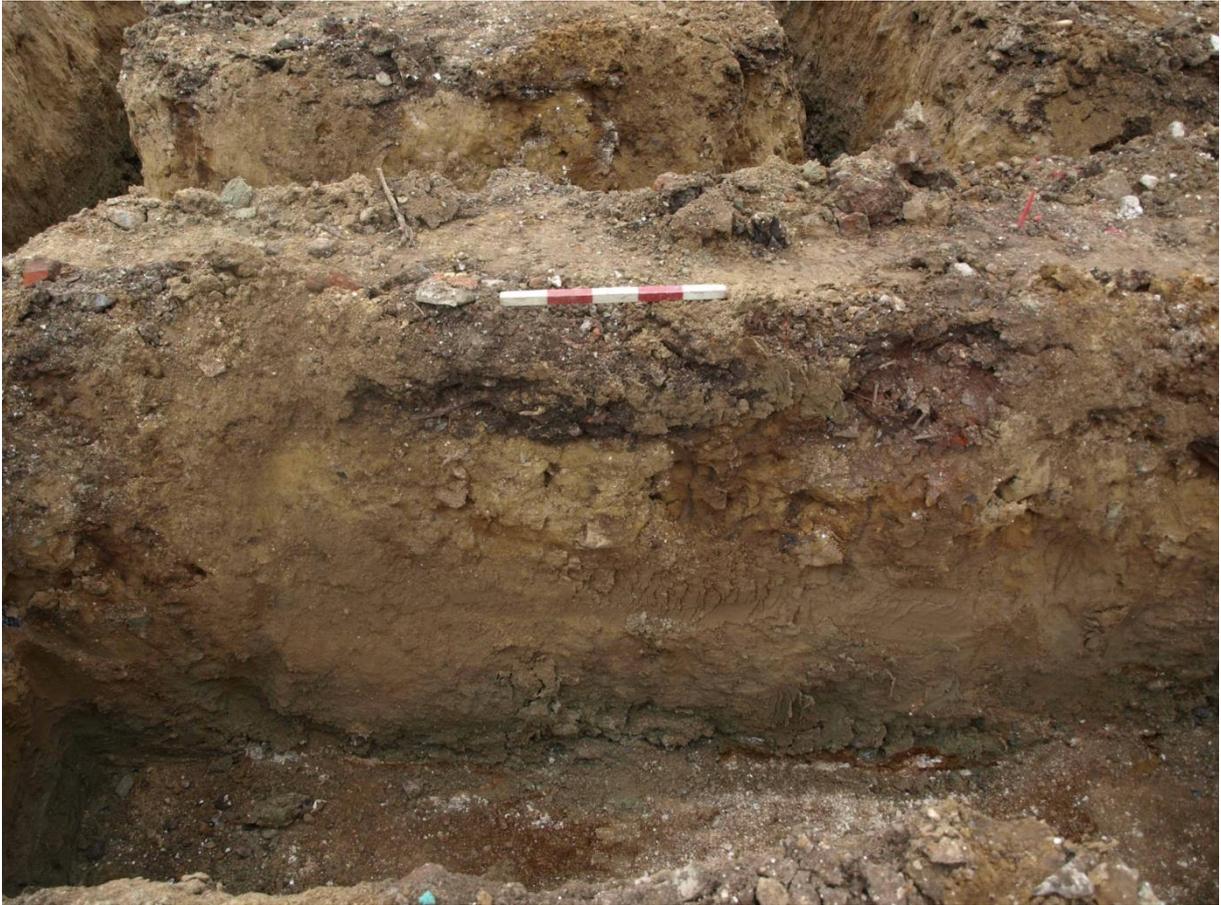
Plate 18: Showing representative section 5 of foundation trench, viewed from the north
