Archaeological Evaluation on Land adjacent to Clifftop and Redriff, North Foreland Avenue, Broadstairs, Kent

Site Code: CLIFF -EV-18

Report for Castle Homes

25/07/2018

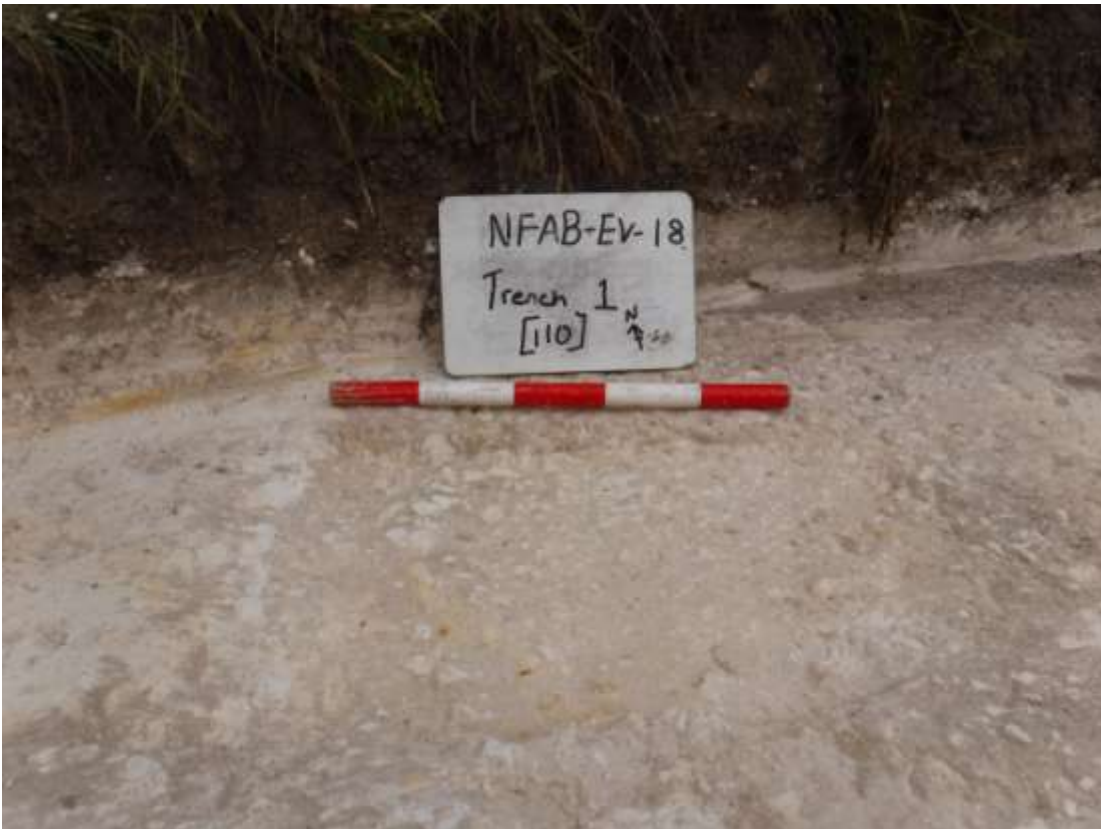
Plate 10 Investigation of re-deposited chalk patches in Trench 1

Trench 1 lay on a south-west north-east alignment and measured approximately 25m by 1.8m. The Trench was sealed by a 0.28m thick layer of Topsoil (100), consisting of a mid grey brown friable silt with modern CBM inclusions. Below this was a 0.12m thick layer of mid brown silt subsoil with small chalk piece and modern CBM inclusions (101). Below (101) was a chalk interface layer consisting of loose chalk and subsoil (102) with a thickness of 0.05m. This sealed the natural geology (111), which consisted of Margate Chalk Member. Cut into the natural geology was a number of areas of re-deposited chalk that did not produce any archaeological material. [104] was a sub-circular cut with moderate sloping sides and a concave base measuring 0.8m by 0.62m, which was located 0.5m from the south-west end of the trench and contained 0.1m thick deposit of re-deposited chalk and grey silt (103). 5m from the south-west end of the trench was [106] a sub-circular cut measuring 0.64m by 0.5m+, which was filled with 0.06m of re-deposited chalk (105). 7.5m from the south-west end of the trench was a 'L' shaped linear deposit of re-deposited chalk measuring 1.6m by 1.36m+, which had two interventions cut into it [108] and [110] which contained re-deposited chalk at a thickness of 0.08m (107) and 0.05m (109). Further investigation of re-deposited chalk patches in this trench was undertaken after a request from Simon Mason KCC and no additional features or finds were revealed (Plates 10, 11, 12, 13)

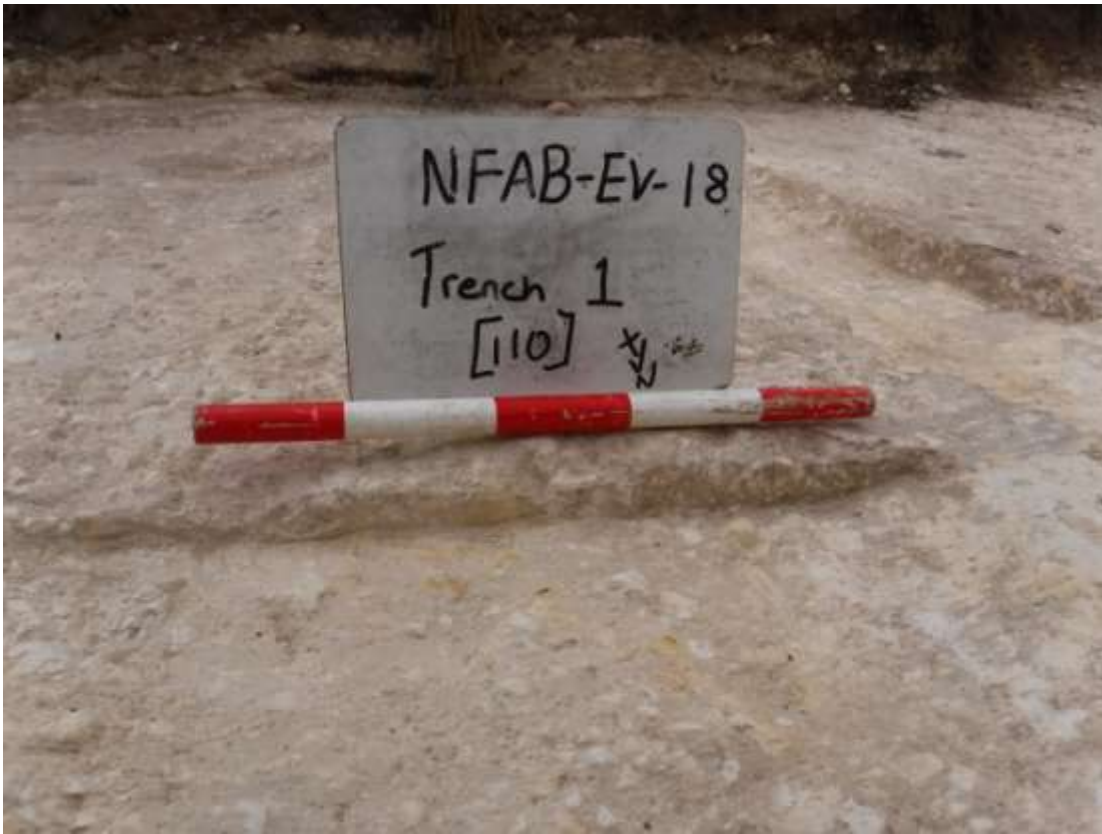
Plate 11 Investigation of re-deposited chalk patches in Trench 1

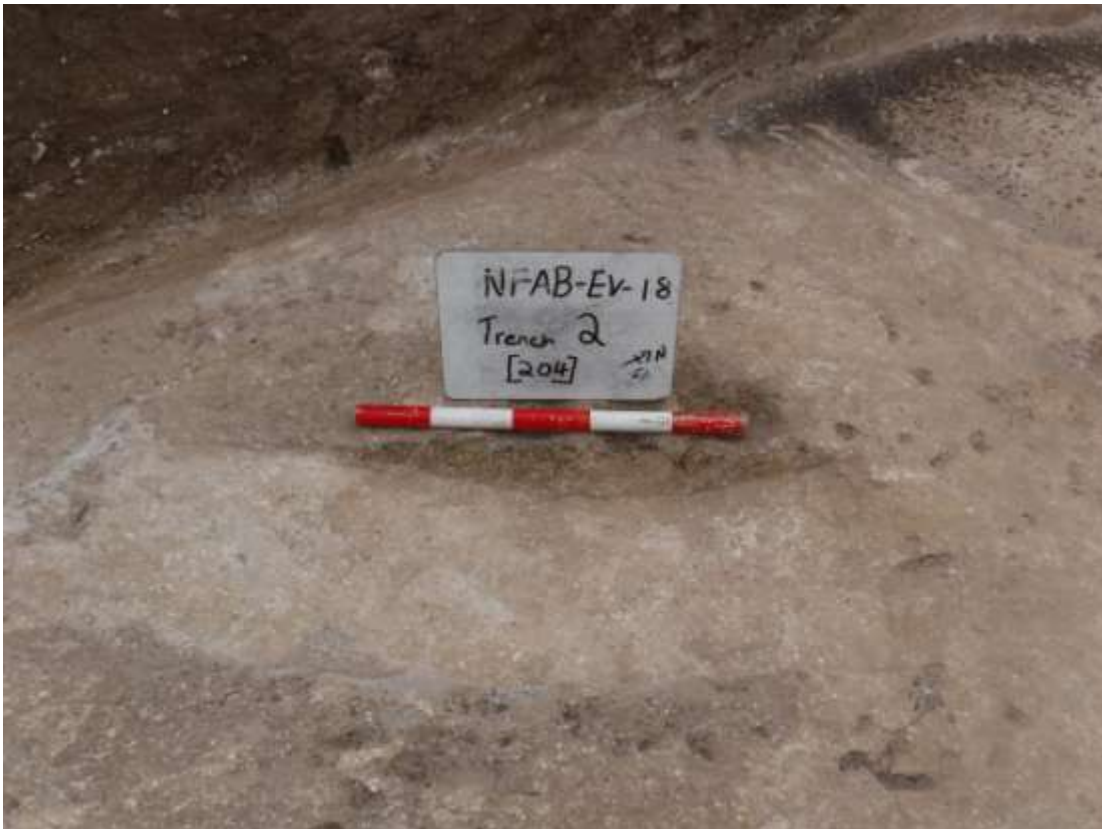
Plate 12 Investigation of re-deposited chalk patches in Trench 2

Trench 2 lay on a north-east south-west alignment and measured approximately 25m by 1.8m. The Trench was sealed by a 0.36m thick layer of Topsoil (200), consisting of a mid grey brown friable silt with modern CBM inclusions. Below this was a 0.13m thick layer of mid brown silt subsoil with small chalk piece and modern CBM inclusions (201). Below (201) was a chalk interface layer (202), which consisted of loose chalk and subsoil with a thickness of 0.04m. This sealed the natural geology (205), which consisted of Margate Chalk Member. Cut into the natural geology was [204], which measured 1.1m+ by 0.8m and was sub-circular area of re-deposited chalk (203) that did not produce any archaeological material and had a thickness of 0.08m. [204] was located 0.8m from the north end of the trench.

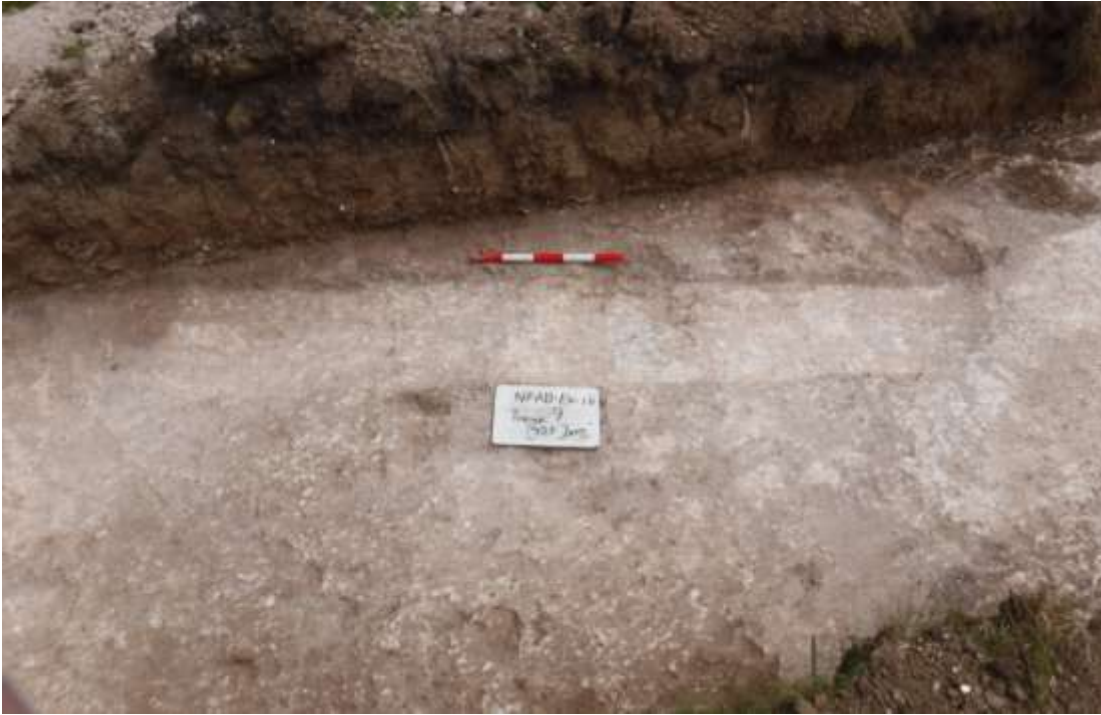
Plate 13 Investigation of re-deposited chalk areas in Trench 9

Trench 9 lay on a north-east south-west alignment and measured approximately 23.5m by 1.8m. The Trench was sealed by a 0.25m thick layer of Topsoil (900), consisting of a mid grey brown friable silt with modern CBM inclusions. This sealed a modern service (901), most likely a water pipe. Below this was a 0.3m thick layer of mid brown silt subsoil with small chalk piece and modern CBM inclusions (902). Below (902) was a chalk interface layer (903), which consisted of loose chalk and subsoil with a thickness of 0.06m. This sealed the natural geology (908), which consisted of Margate Chalk Member. Cut into the natural geology were two conjoining 'linear' shaped shallow deposits of re-deposited chalk. [905] measured 1.8m+ by 3m and was 8m from the south-west end of the trench and was filled by (904) a 0.1m thick very firm layer of re-deposited chalk that contained no archaeological material. [907] measured 1.8m+ by 1m and was 6.5m
