Archaeological Trial Trenching and Evaluation at the Barkaway Site, Ospringe, Kent

Site Code: BARK/EV/16

SWAT Archaeology

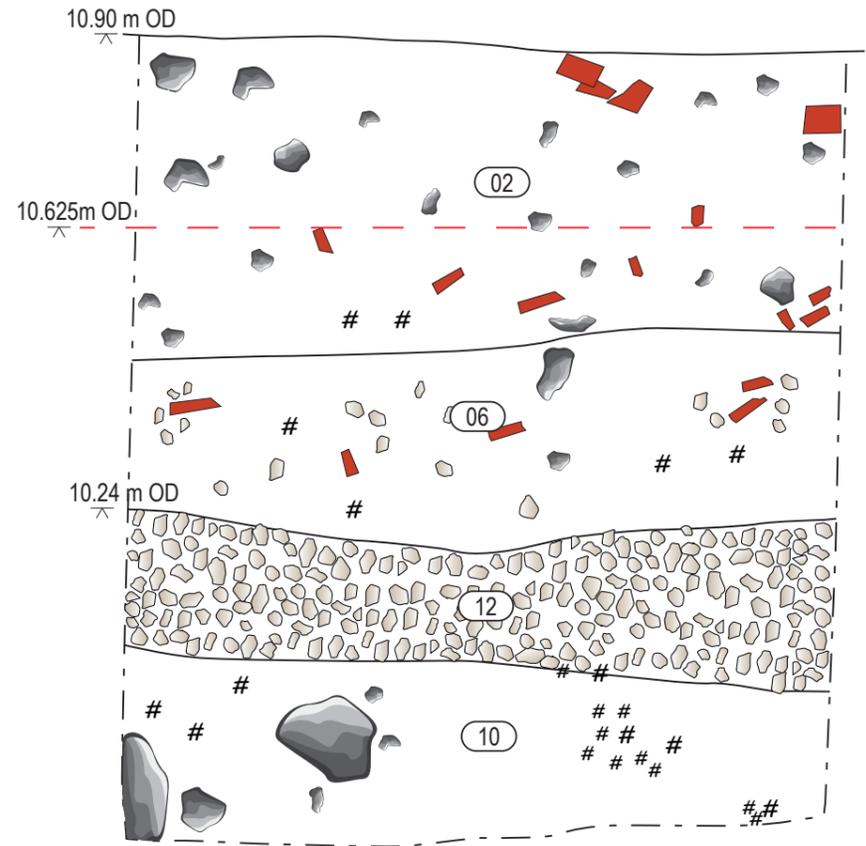
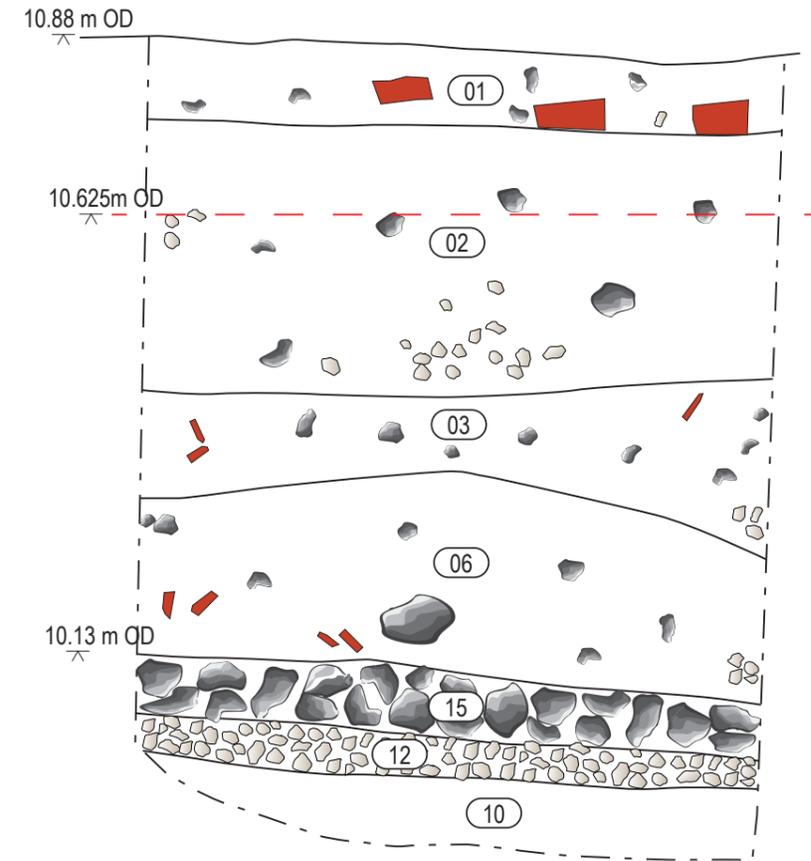
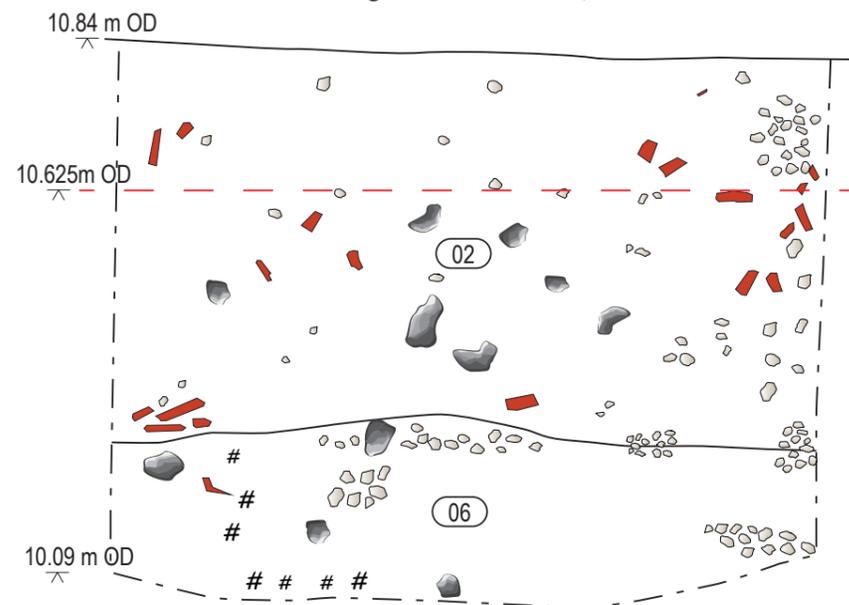
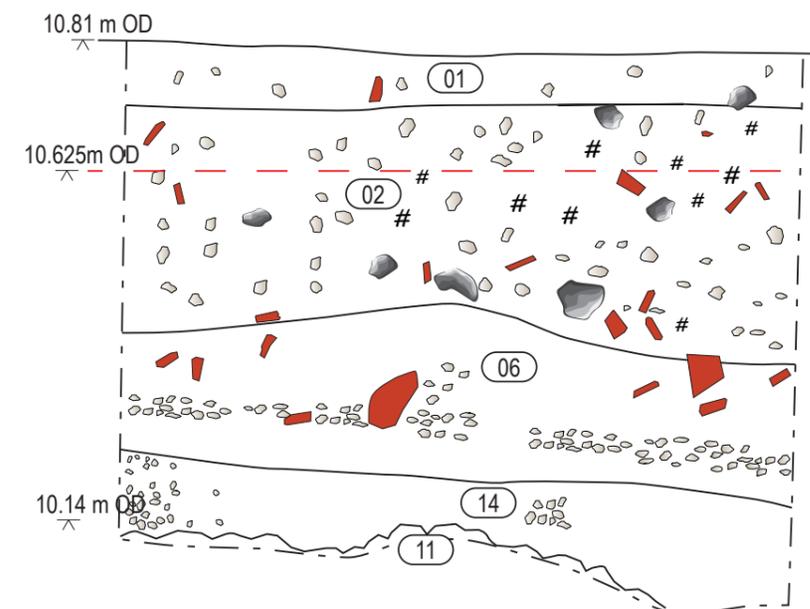
Figure 11: Sections of Trench 6, 8, 9 and 10.

Section 2.2
South facing Section of Trench 6, scale 1:10

Section 2.3
South facing Section of Trench 8, scale 1:10

Section 2.5
East facing Section of Trench 9, scale 1:10

Section 2.1
South facing Section of Trench 10, scale 1:10

- 6.1.3 The light-to-mid brown soil underlay what appeared to be a substantial layer of large and medium-sized flint nodule and fragments (CRN 11), which was exposed in TPs 8, 10, 11, 12, 13 and 14 at depths of between 0.75m and 0.95m and varying between 0.18m and 0.32m in thickness (Figs. Sections 1.10, 2.1, 2.4 2.6. Plates 2, 3, 7, 8, 9, 10, 11 15, 24-30). The flint layer was perhaps too irregular to represent the remains of a cobbled surface and was interpreted as a localised levelling spread laid down to raise the ground level.

- 6.1.4 The flint layer was sealed in TPs 12, 13 and 14 (the south-westernmost pile locations) by a compact crushed chalk layer (CRN 12) of approximately 0.13m thickness and at a depth of 0.62m and 0.75m respectively, and a similar (if not the same) compact crushed chalk layer (CRN 12) was also present in TPs 5 and 6, where it directly overlay the basal light-to-mid brown silty soil (CRN 10) rather than a flint-dominated deposit. A similar chalk layer (CRN 13), also overlying basal light-to-mid brown silty soil, was exposed in TP 8, but in this case the chalk layer underlay a layer of mid-to-large flints (CRN 15), as it did in TP 12. The chalk

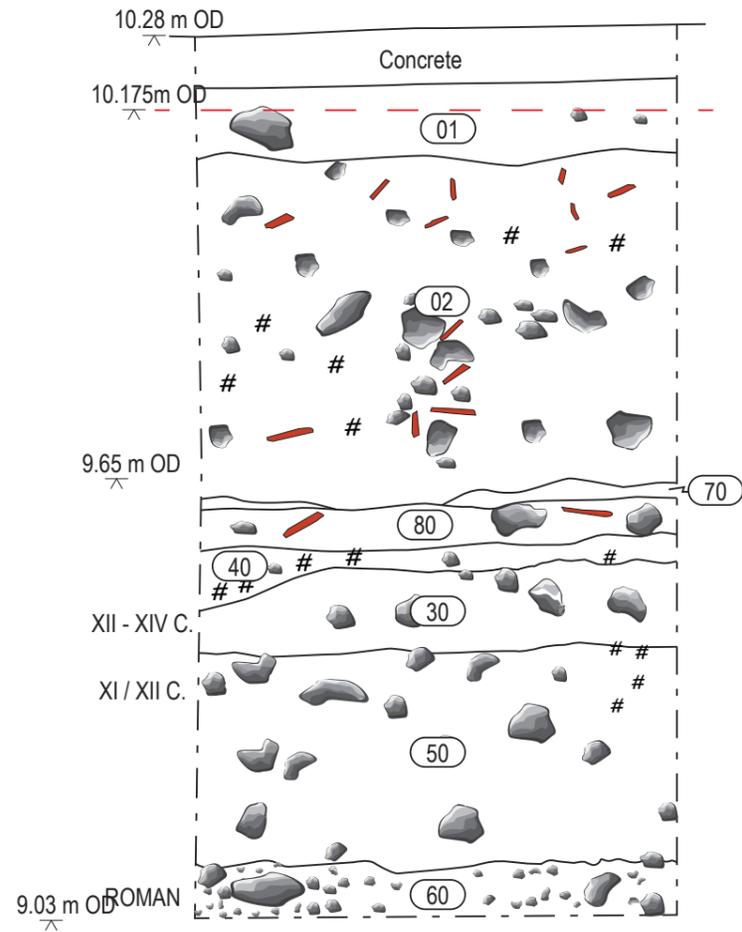
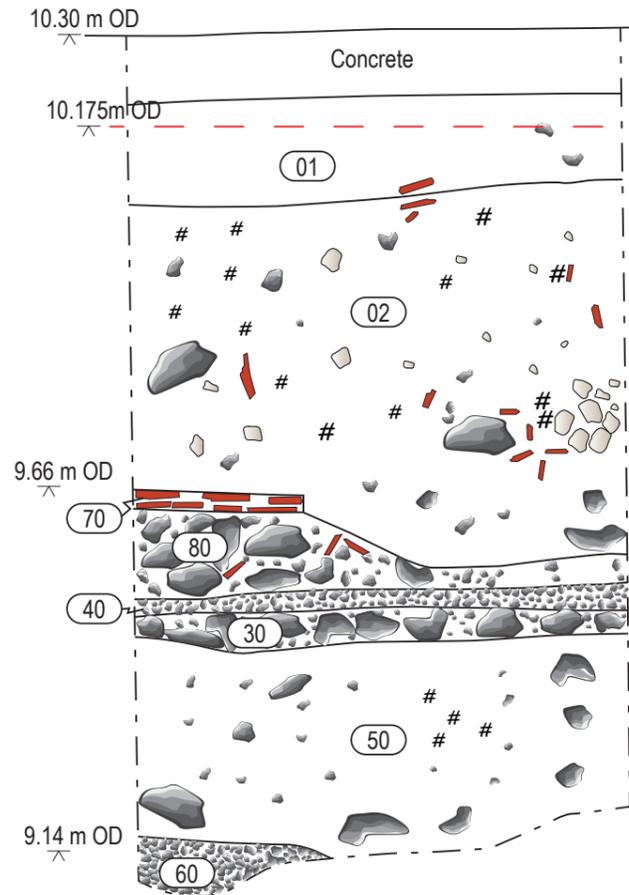
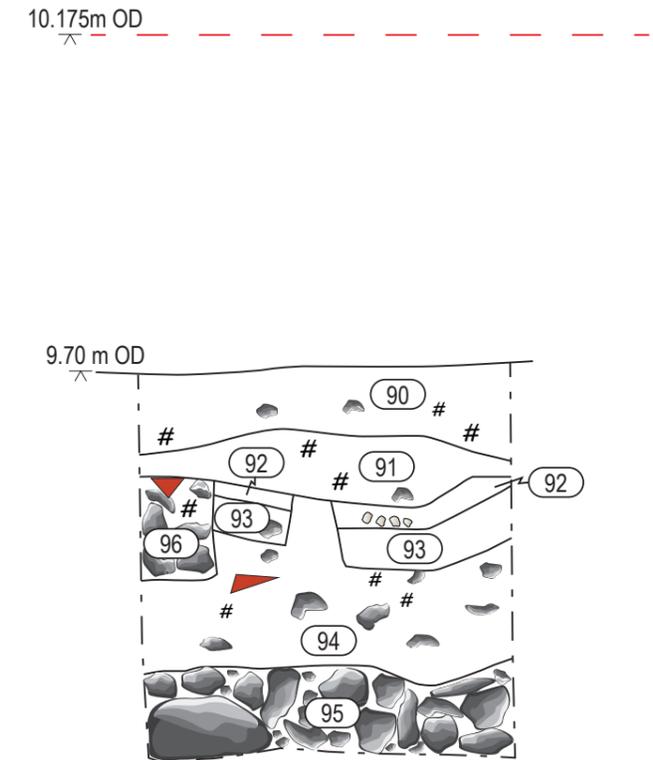
Figure 13: Sections of Trench 17, 20 and 27.

Section 3.2
West facing Section of Trench 17, scale 1:10

Section 3.3
West facing Section of Trench 20, scale 1:10

Section 3.4
South facing Section of Trench 27, scale 1:10

- 6.2.2 The earliest deposits examined here were exposed in TP 17 and 20 in the form of dark brown silty loam (CRN 60) with infrequent flint inclusions (Fig. Sections 3.2, 3.3. Plates 12, 17, 23, 23). This material, which was more than 0.14m thick, produced (from its surface) six potsherds from two relatively small interventions, five of which sherds were of first-, second- or early third-century Roman-period type, one of which was of twelfth or thirteenth-century date, providing evidence of on-site or near-site Roman-period settlement. The dark brown silty loam underlay a 0.35m-thick, mid-brown slightly silty humic soil (CRN 50), which was similar to, if not the same as the lowest layer (CRN 10) exposed in TPs 3, 5, 6, 8 and 12 to the west. The interventions in TPs 17 and 20 produced two potsherd from this layer, both of late eleventh- or twelfth-century date, suggesting that the layer predated the construction of the hospital, thought to have been built in 1234 by order of King Henry III. This inference was supported by the presence of an immediately overlying laminated flint-cobbled layer (CRNs 30, 40 and 80), which was shown in Test Pits 20 and 21 to abut the western wall foundation of the building previously identified as the hospital's Common Hall (Fig. Section 3.3. Plates 20, 23, 35, 36). Only the primary cobbling layer (CRN 30) produced pottery, in this case in the form of nine sherds, four of first-, second- or third-century date, again providing evidence of Roman-period activity on or near the site, and five of the twelfth, thirteen and fourteenth centuries, these undoubtedly domestic detritus from the use of the hospital. The compacted upper surface of the uppermost laminated flint cobbling (CRN 80) was also exposed in TPs 18 and 19, proving it to be extensive and continuous, and therefore almost certainly part of a courtyard or roadway adjoining the western wall of the Common Hall.

- 6.2.4 The identification of the clay floor as an internal floor or floor bedding was re-enforced by its exposure in an exploratory test pit (TP 27), some five metres to the south (Fig. Section 3.4. Plate 31). Here, the orange-brown clay floor bedding overlay a darker layer of compact clayey brown soil (CRN 91), with both layers containing moderate amounts of flecked charcoal and both overlying a shallow oven or, more likely a hearth, which consisted of a red-scorched clay lens (CRNs 92) sealing a 90mm-thick band of orange-brown clay (CRN 93), both abutting what appeared to be a crude supporting structure of packed flints (CRN 96). The hearth-like structure had been pieced by what appeared to be a stake-hole (no context number attributed) cutting down from the surface of the scorched clay lens. The underlying deposits (CRNs 94 and 95) consisted of, respectively, mid-brown silty soil and a flint-dominated silty clay layer of unknown origin.
