# Archaeological Evaluation on Land at Street Farm, Stoke Road, Hoo St Werburgh, Kent

Site Code: STO -EV-18

Planning Application Number: MC/15/0098

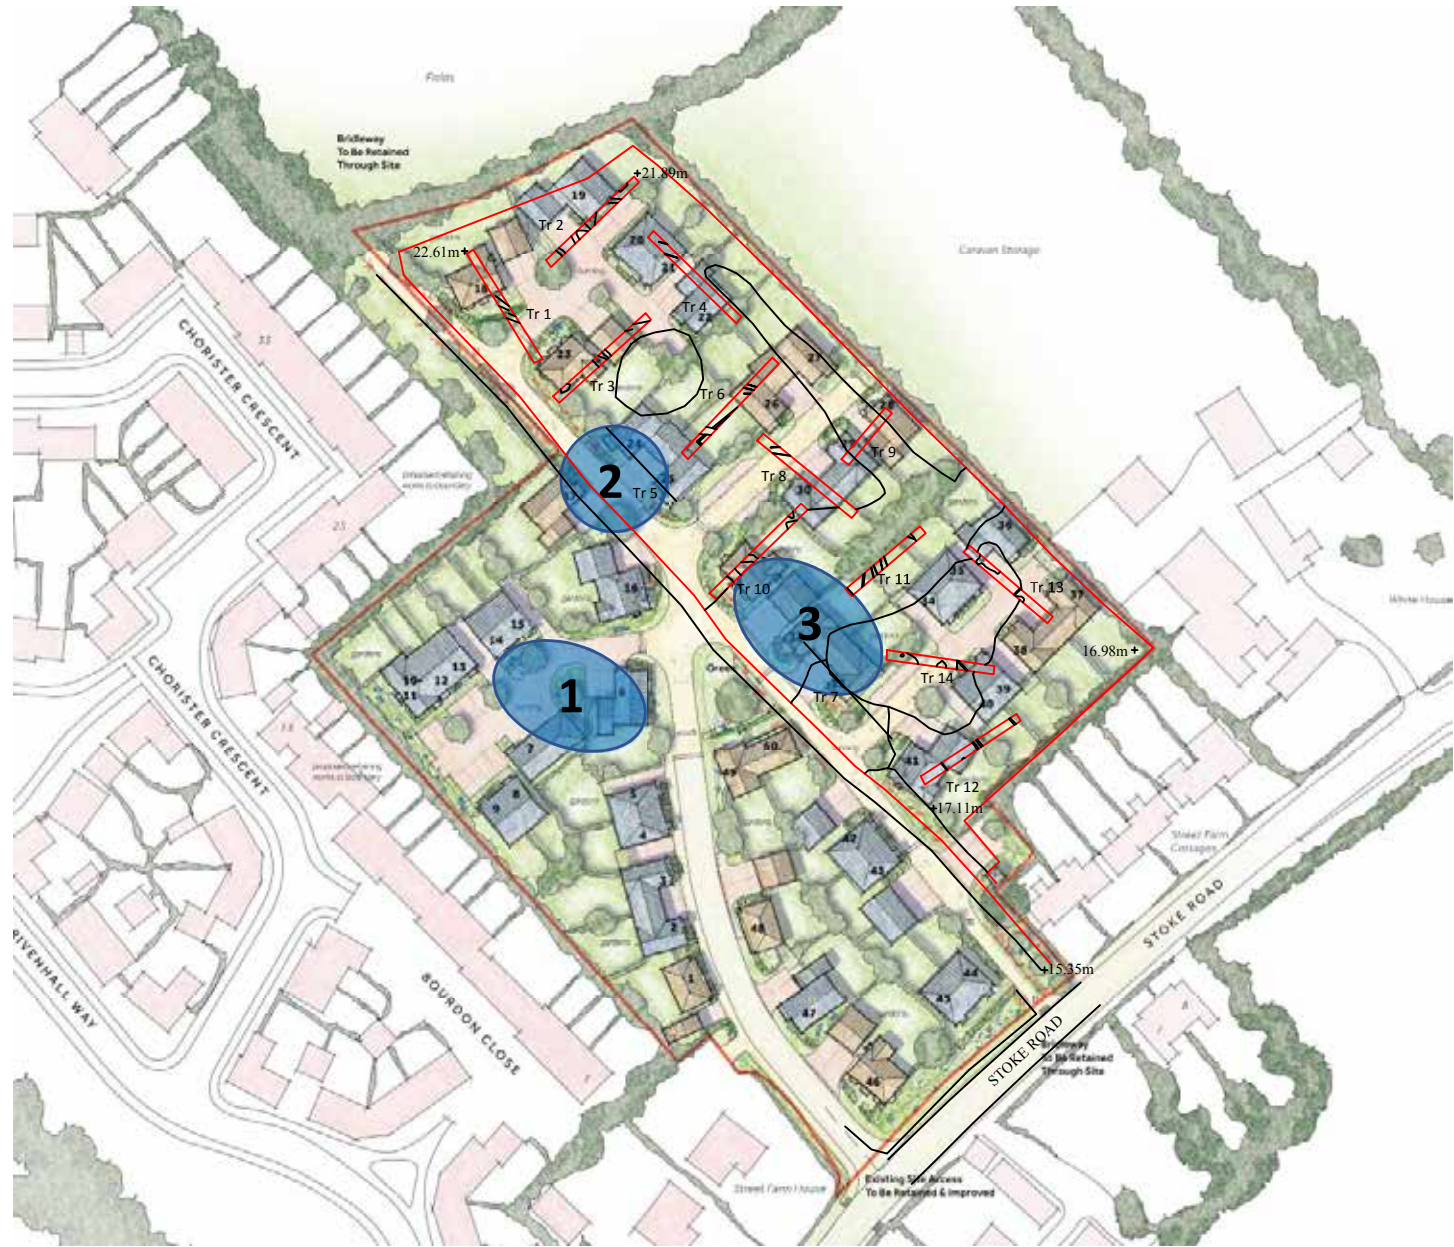
Figure 4: Evaluation trenches superimposed on contamination plan

Petroleum Hydrocarbon Hotspots

**Estimated Excavation Volumes**

1 = 30m x 15m x 1m  
= 450m<sup>3</sup>

2 = 20m x 20m x 1m  
= 400m<sup>3</sup>

3 = 30m x 15m x 1.5m  
= 625m<sup>3</sup>

Total = ~1525m<sup>3</sup>

Client:	Esquire Developments	Date:	31/05/2018	Project ID:	LP1607
Site:	Street Farm, Hoo, Rochester	Title:	Hydrocarbon Hotspot Excavations with Volume Estimates	Figure No.:

Trench 5	Trench unexcavated due to ground contamination Trench alignment: NW-SE NW-end Ground Level: 20.99m      SE-end Ground Level: 20.30m
----------	---

Trench 7	Trench unexcavated due to ground contamination Trench alignment: NE-SW NW-end Ground Level: 19.51m      SE-end Ground Level: 19.67m
----------	---

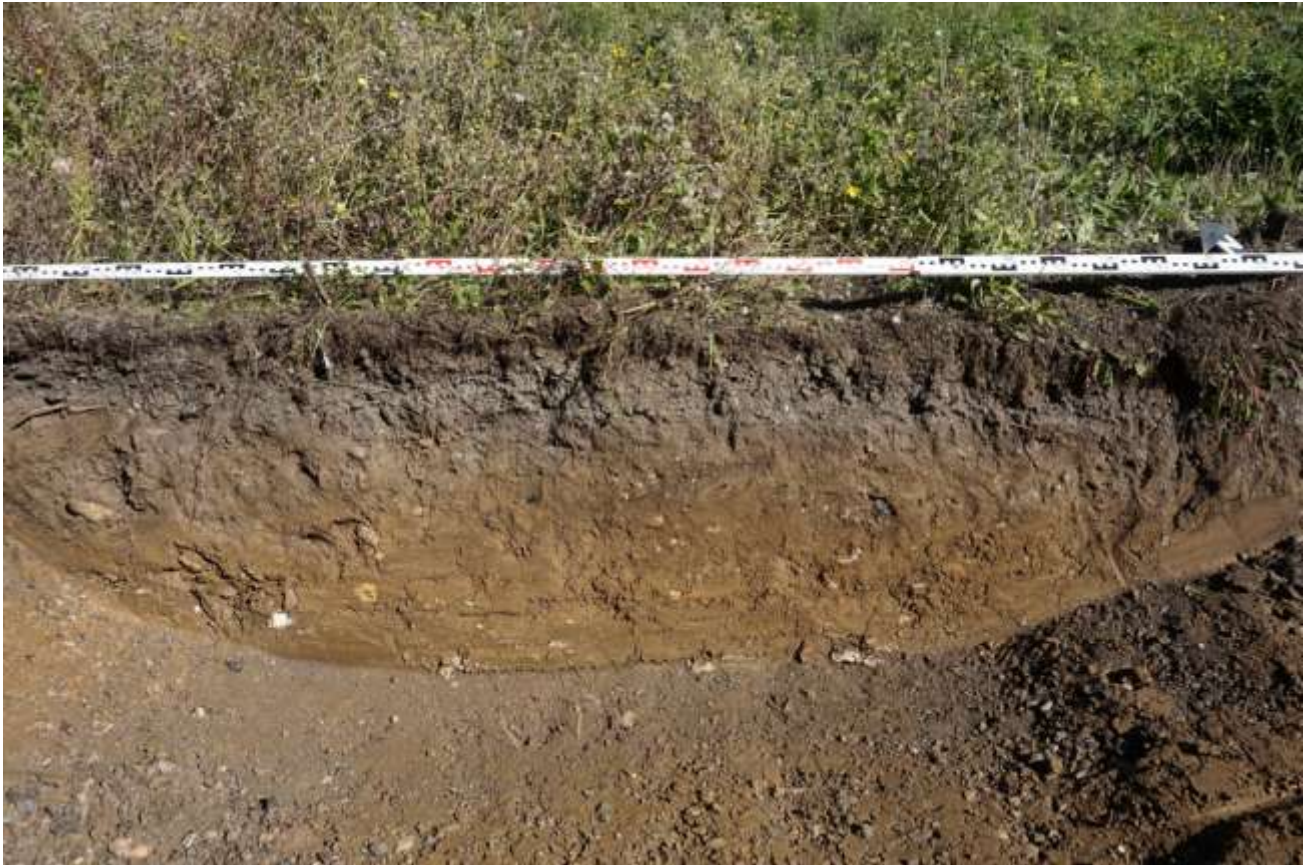
**Plate 4: Looking north east at representative section of Trench 1**

Trench 1			
Dimensions: 25m x 1.8m Depth: 0.45m-0.74m Trench alignment: NW-SE NW-end Ground Level: 22.61m SE-end Ground Level: 21.55m			
Context	Interpretation	Description	Depth (m)
101	Topsoil	Thin layer overlaying driveway surface. Mid compaction, black clayey silt with occ. modern rubbish and modern building material fragments.	0.00-0.05
102	Layer – Driveway	Compacted tarmac beads. Driveway surface associated with trailer park.	0.05-0.18
103	Layer – modern leveling	Very firm compaction, dark brown, silty clay with occ. flints, coal, plastic, glass and building material fragments	0.18-0.44
104	Natural – London clay	Firm compaction, mid orangish brown clay with occ. flints, concentration of chalk flecks and lenses of flint gravel in sandy clay.	0.4-0.8
105	Layer – Modern leveling or trailer park machined trample layer	Firm compaction, mid brown clay with occ. flints and freq patches of mid grey silty clay. Re deposited London clay or natural disturbed by heavy machinery ruts.	0.4-0.8

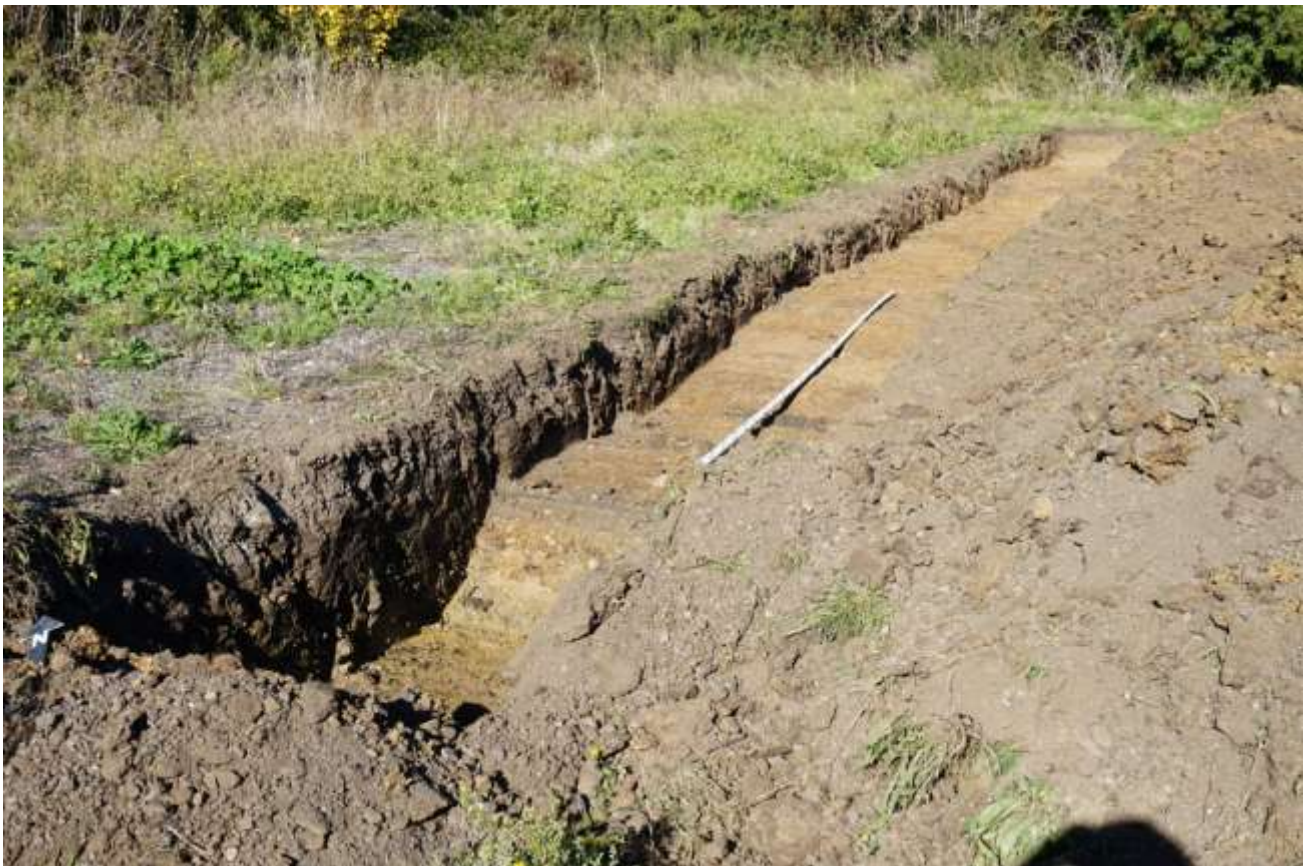
**Plate 5: Looking north at Trench 2. Excavated modern pit is visible in front of 5m scale**

[207]	Modern Pit	Rectangular in plan, not fully exposed, un-excavated pit filled with firm compaction, dark brown, silty clay with occ. modern inclusions.	0.15-0.5+
[208]	Modern Pit	Larger oval in plan, not fully exposed, un-excavated pit filled with firm compaction, dark brown, silty clay with occ. modern inclusions.	0.15-0.9

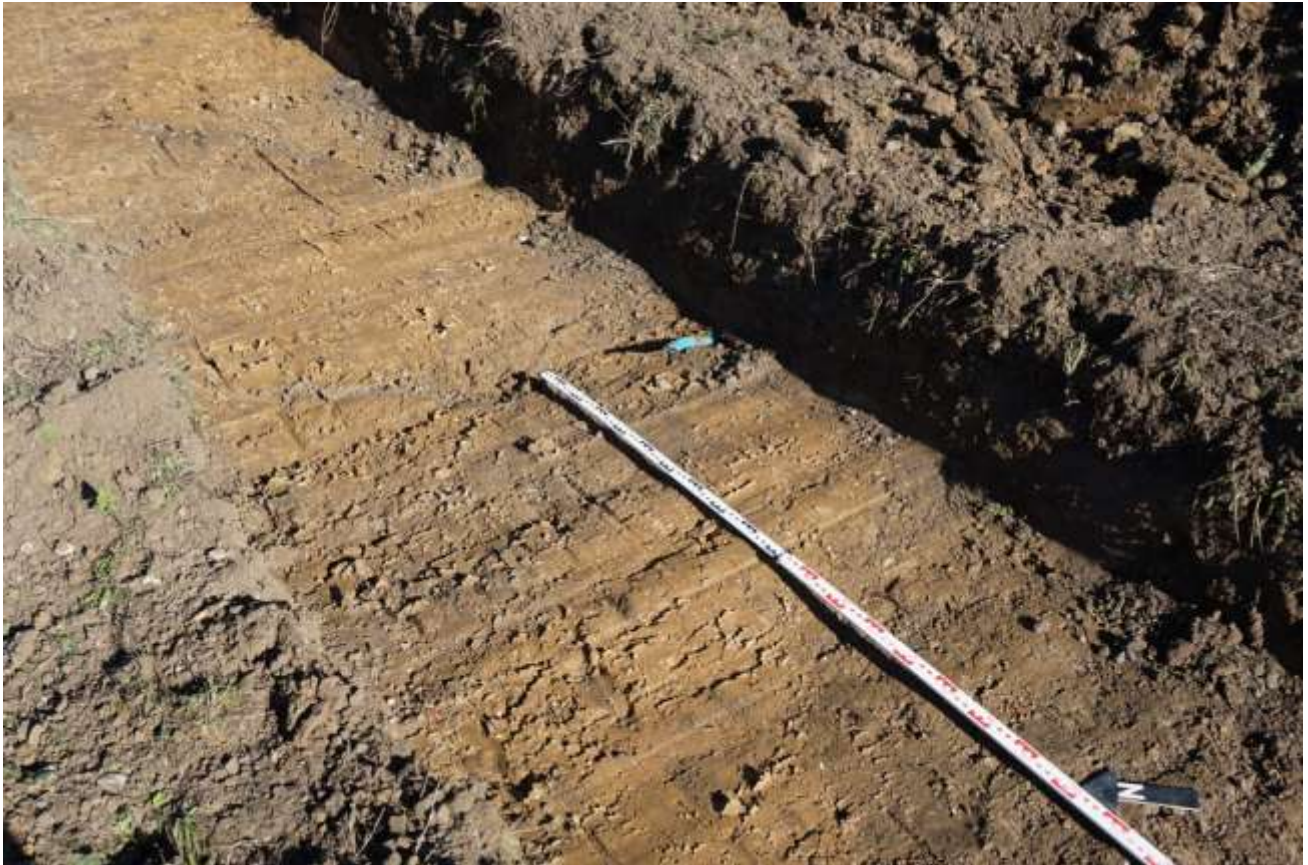
Plate 6: Looking east at plastic water pipe exposed in Trench 2

Trench 2			
Dimensions: 23.5m x 1.8m Depth: 0.5m Trench alignment: NE-SW NE-end Ground Level: 21.82m SW-end Ground Level: 22.13m			
Context	Interpretation	Description	Depth (m)
201	Topsoil	Thin layer overlaying driveway surface. Mid compaction, black clayey silt with occ. modern rubbish and modern building material fragments.	0.00-0.05
202	Layer – Driveway	Compacted tarmac beads. Driveway surface associated with trailer park.	0.05-0.15
203	Layer – modern leveling	Very firm compaction, dark brown, silty clay with occ. flints, coal, plastic, glass and building material fragments	0.15-0.5
204	Natural – London clay	Firm compaction, mid orangish brown clay with occ. flints, concentration of chalk flecks and lenses of flint gravel in sandy clay.	0.5+
[205]	Pit – Modern	Rectangular in plan, not fully exposed, un-excavated pit filled with firm compaction, mid brown, re-deposited natural clay.	0.15-0.5+
[206]	Modern Service trench - water	Narrow NW-SE aligned trench with blue plastic pipe (diameter: 4cm). backfilled with mixed deposit	0.15-0.5

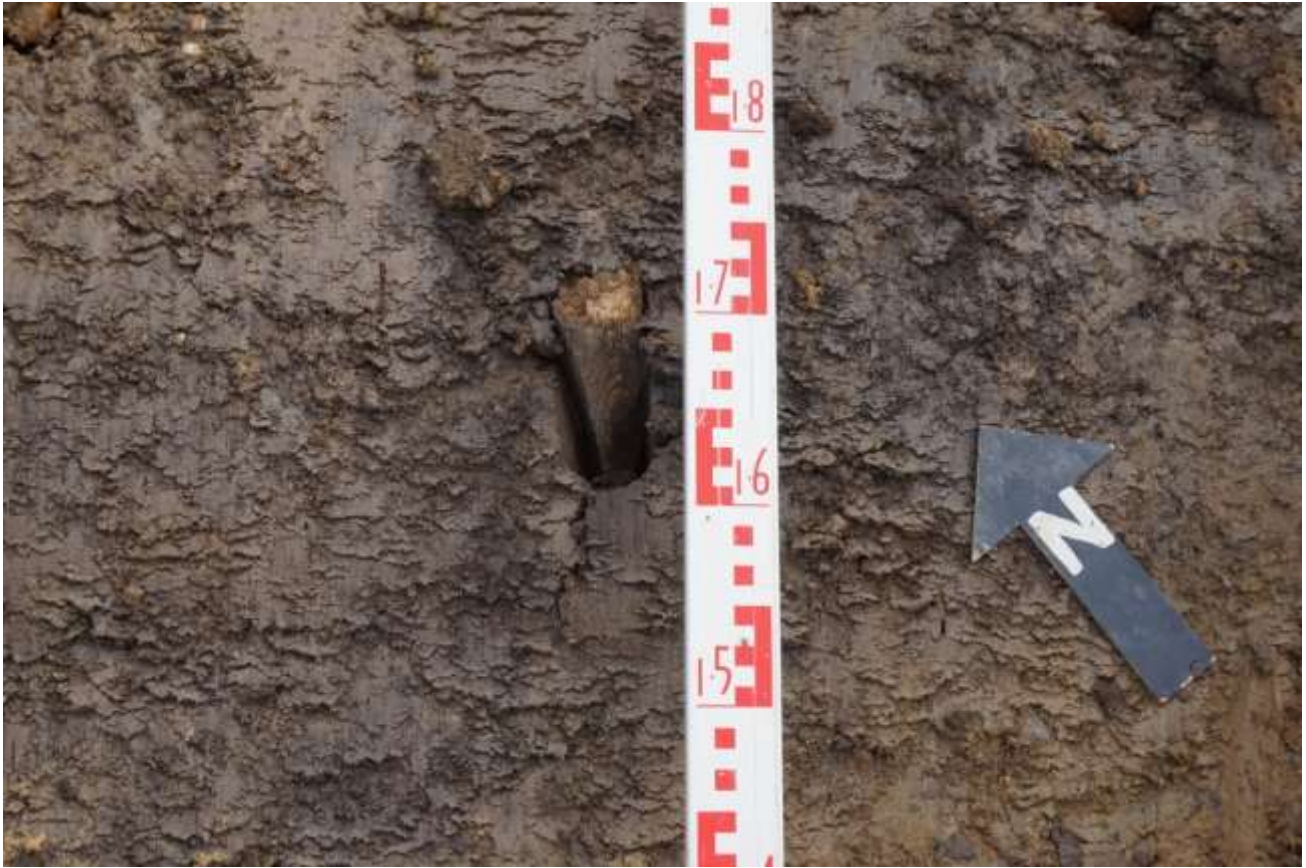
Plate 8: Looking north-west at fragment of modern wood exposed at the bottom of feature [305] located in Trench 3

Trench 3			
Dimensions: 25m x 1.8m Depth: 0.34m-0.75m Trench alignment: NE-SW NE-end Ground Level: 21.21m SW-end Ground Level: 21.16m			
Context	Interpretation	Description	Depth (m)
301	Topsoil	Thin layer overlaying driveway surface. Mid compaction, black clayey silt with occ. modern rubbish and modern building material fragments. Weeds vegetation	0.00-0.05
302	Layer – Driveway	Compacted tarmac beads. Driveway surface associated with trailer park.	0.05-0.15
303	Layer – modern leveling	Very firm compaction, dark brown, silty clay with occ. flints, metal, plastic, glass and building material fragments	0.15-0.45
304	Natural – London clay	Firm compaction, mid orangish brown clay with occ. flint pebble, concentration of chalk flecks.	0.45+
[305]	Pit – Modern	Linear in plan, not fully exposed, pit with steep sides and flat base	0.15-0.8
306	Fill of [305]	Firm compaction, mid grey, clayey silt with occ. modern wood	0.15-0.8

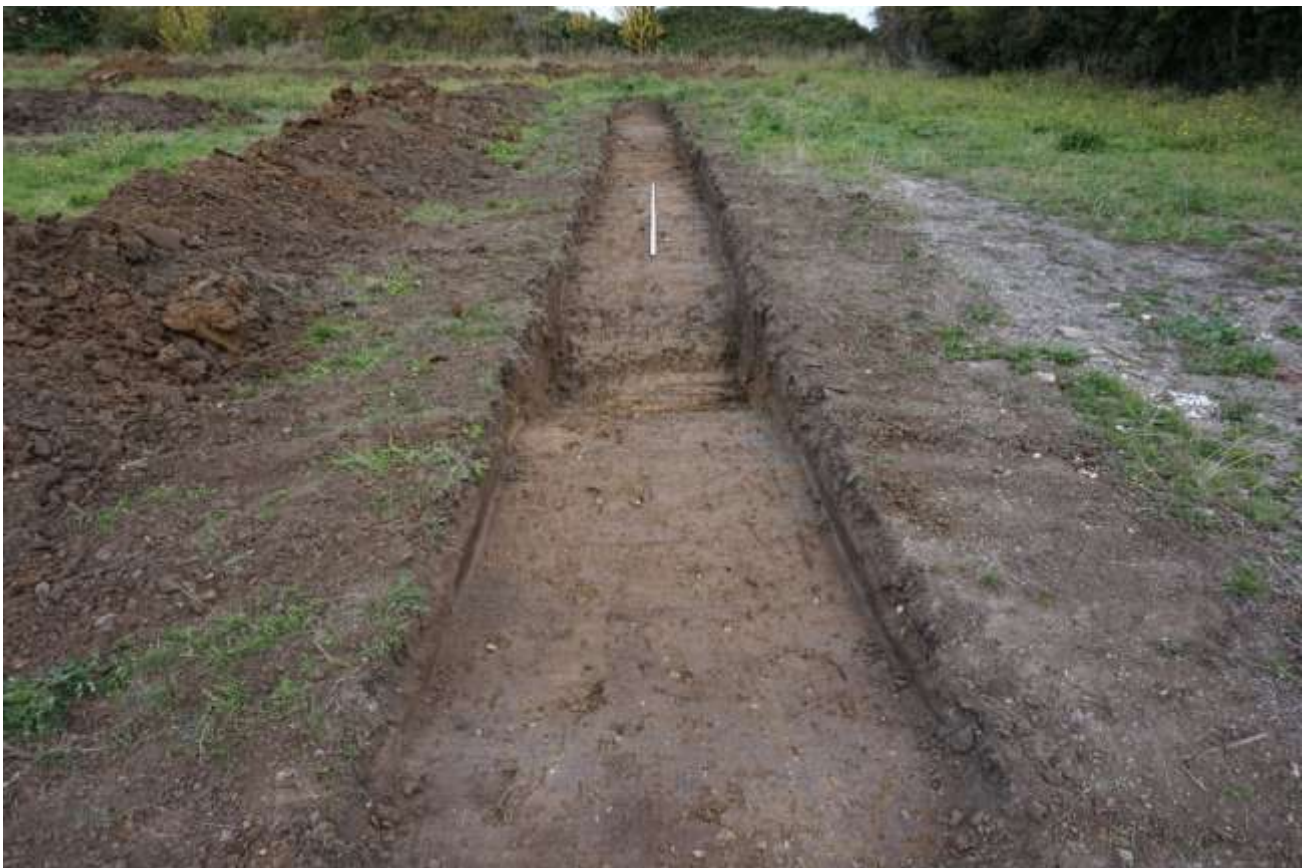
Plate 9: Looking north-west at Trench 4 with excavated test pit visible below 5m scale.

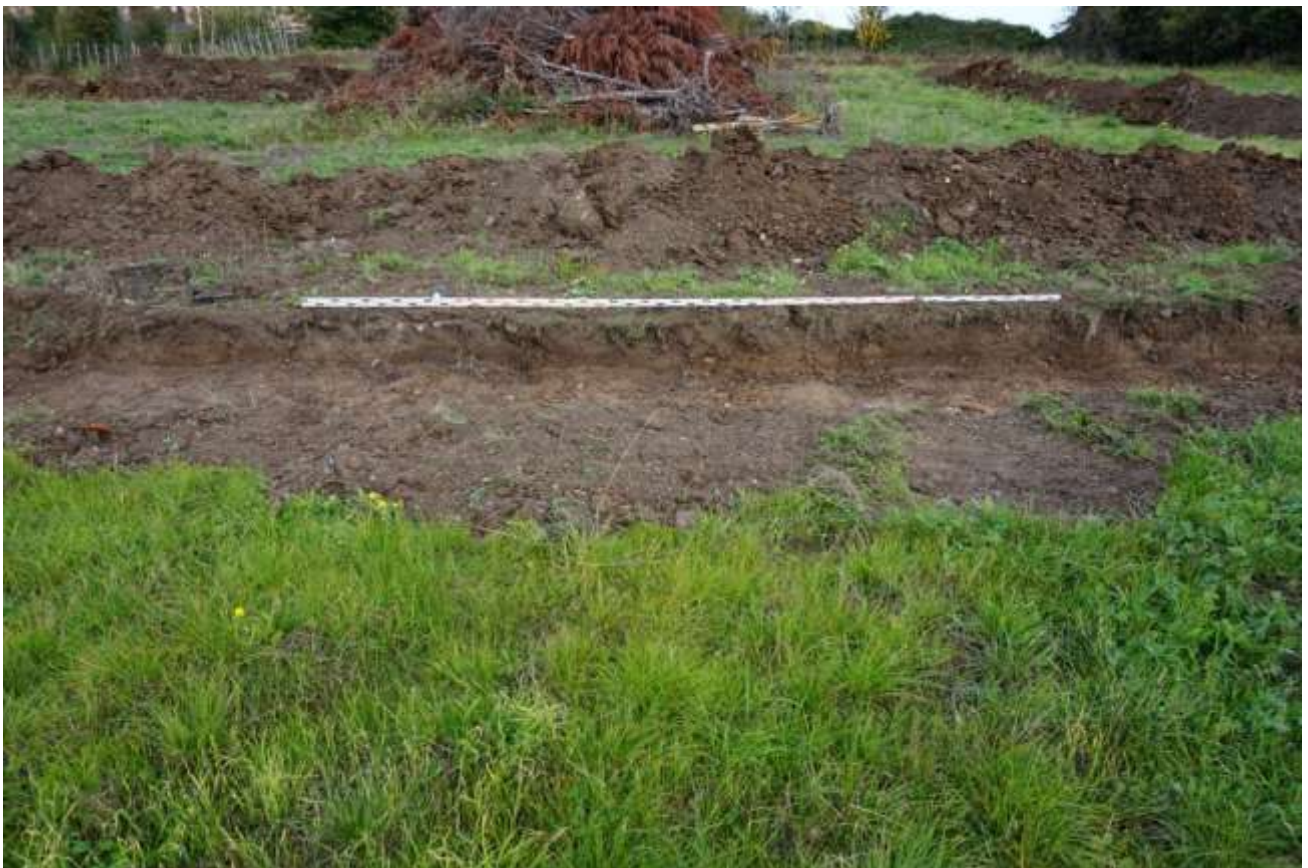
Plate 11: Looking north-west at section of trench 6.

Trench 6	Dimensions: 25m x 1.8m    Depth: 0.5m    Trench alignment: NE-SW NE-end Ground Level: 20.39m      SW-end Ground Level: 20.38m		
Context	Interpretation	Description	Depth (m)
601	Topsoil	Thin layer overlaying driveway surface. Mid compaction, black clayey silt with occ. modern rubbish and modern building material fragments. Weeds vegetation	0.00-0.05
602	Layer – Driveway	Compacted tarmac beads. Driveway surface associated with trailer park.	0.05-0.1
603	Layer – modern leveling	Very firm compaction, dark brown, silty clay with occ. modern inclusions	0.1-0.5
604	Natural – London clay	Firm compaction, mid orangish brown clay with occ. flint pebble, concentration of chalk flecks.	0.5+
[605]	Modern drain	NW-SE aligned, 0.25m wide trench with black plastic pipe (8cm in diameter) backfilled with loose pebbles and sealed with mixed deposit	0.1-0.5
[606]	Modern drain	NE-SW aligned, 0.25m wide trench backfilled with loose pebbles and sealed with mixed deposit	0.1-0.5

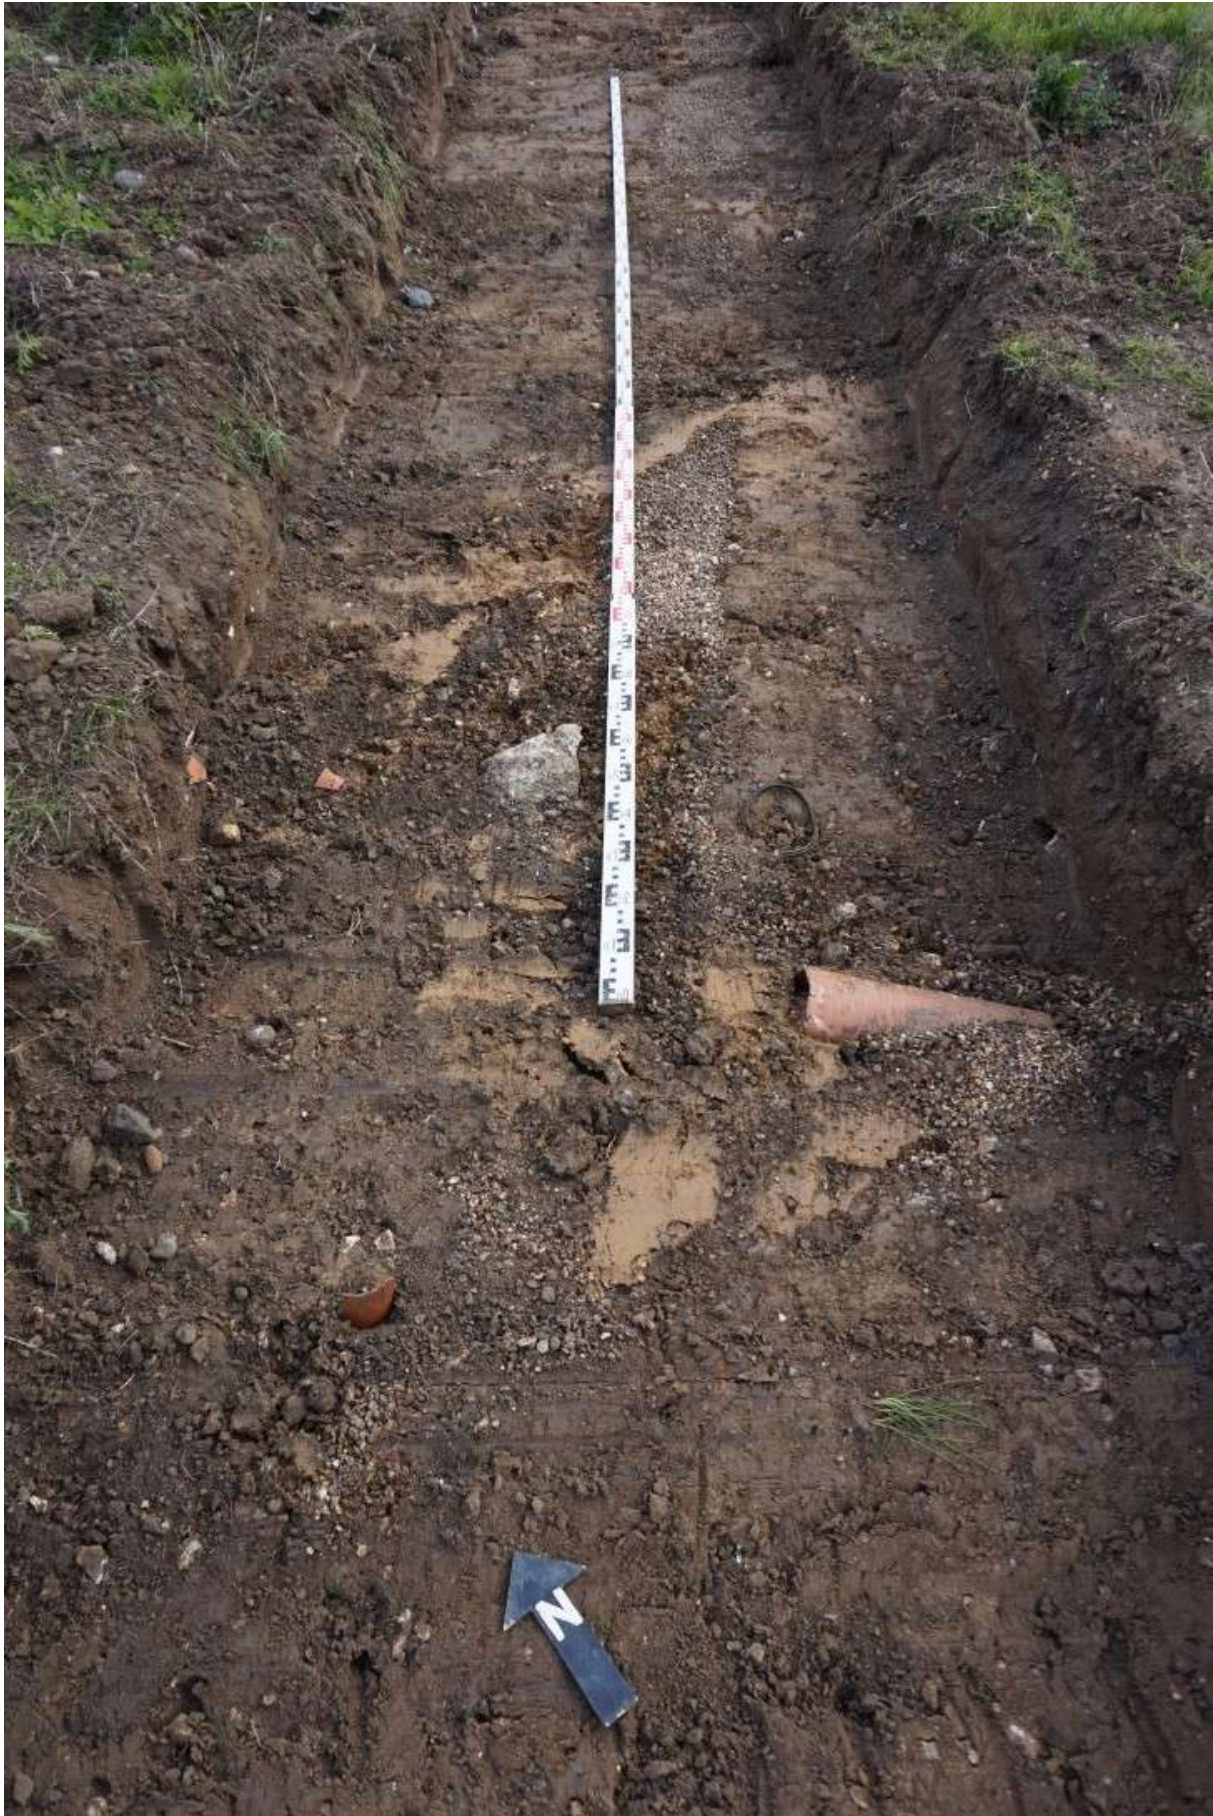
Plate 12: Looking north east at modern service and drain trench truncated by later trench exposed in Trench 6

[607]	Modern drain	E-W aligned 0.1m wide trench backfilled with loose pebbles sealed with mixed deposit.	0.1-0.5
[608]	Modern drain	E-W aligned 0.1m wide trench backfilled with loose pebbles sealed with mixed deposit.	0.1-0.5
[609]	Modern trench	NW-SE Linear cuts through modern services [606]

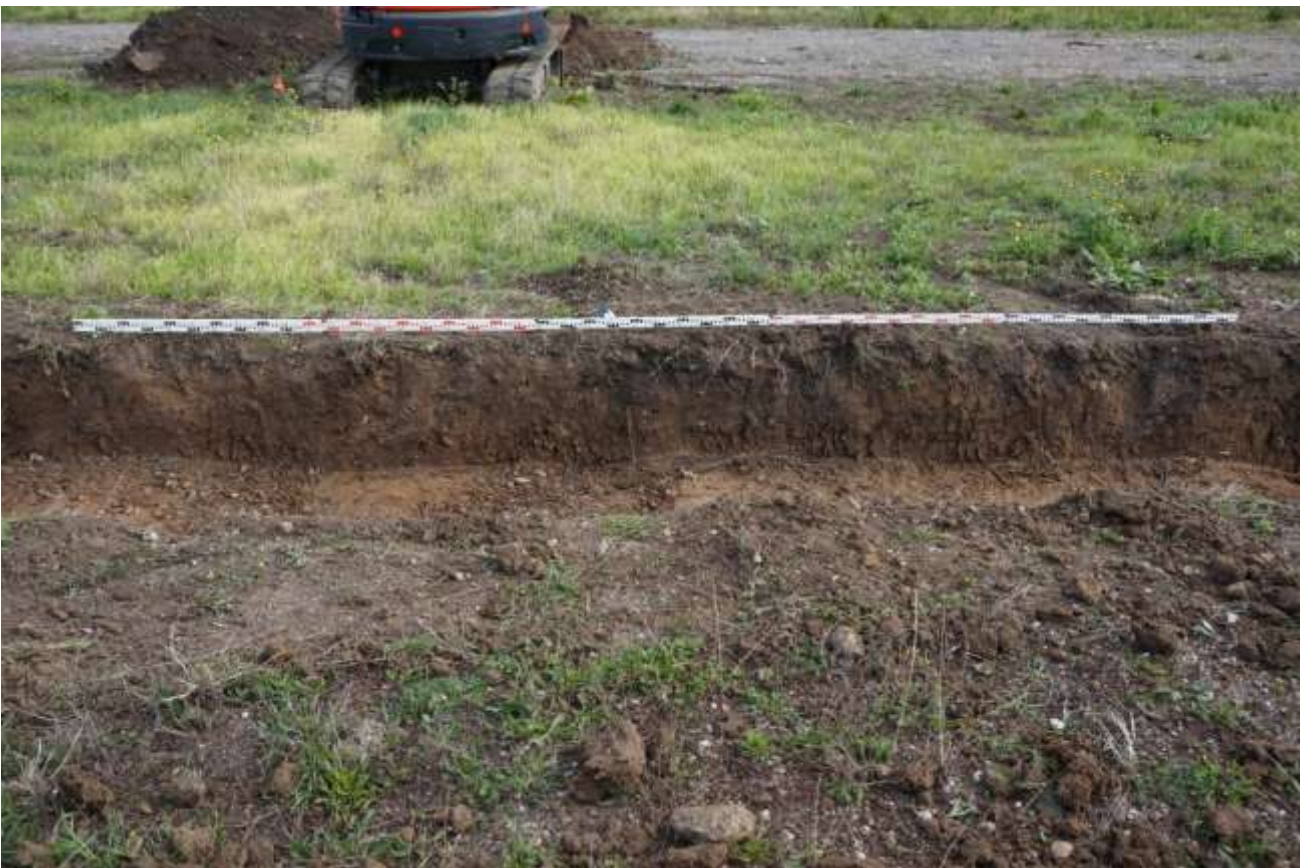
Plate 14: Looking north east at section of trench 8.

Trench 8	Dimensions: 25m x 1.8m    Depth: 0.55m    Trench alignment: NW-SE NW-end Ground Level: 19.99m      SE-end Ground Level: 19.26m		
Context	Interpretation	Description	Depth (m)
801	Topsoil	Thin layer overlaying driveway surface. Mid compaction, black clayey silt with occ. modern rubbish and modern building material fragments. Weeds vegetation	0.00-0.05
802	Layer – Driveway	Compacted tarmac beads. Driveway surface associated with trailer park.	0.05-0.15
803	Layer – modern leveling	Very firm compaction, dark brown, silty clay with occ. modern inclusions and freq. bioturbations	0.15-0.55
804	Natural – Bioturbated London clay	Firm compaction, mid brown silty clay with occ. flint and freq. tree roots	0.4-0.55
805	Natural – London clay	Firm compaction, mid orangish brown with occ. flint	0.55+

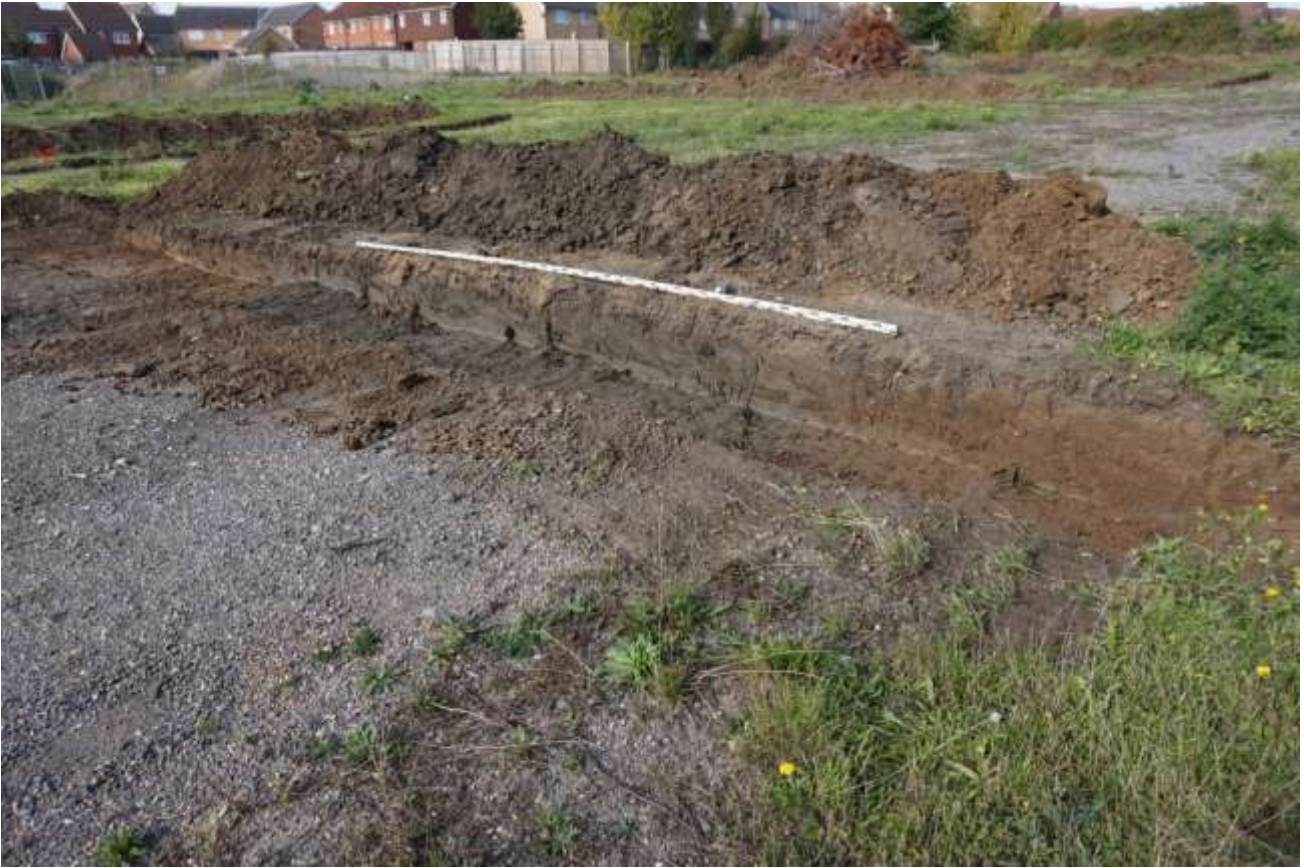
Plate 15: Looking north west at Trench 9. Large modern pit is visible underneath 5 metres scale.

Trench 9	Dimensions: 13m x 1.8m Depth: 0.6m Trench alignment: NE-SW NE-end Ground Level: 19.54m SW-end Ground Level: 19.48m		
Context	Interpretation	Description	Depth (m)
901	Topsoil	Thin layer overlaying driveway surface. Mid compaction, black clayey silt with occ. modern inclusions. Weeds vegetation	0.00-0.05
902	Layer – Driveway	Compacted tarmac beads. Driveway surface associated with trailer park.	0.05-0.1
903	Layer – modern leveling	Very firm compaction, dark brown, silty clay with occ. modern inclusions (glass, plastic wire, etc.).	0.1-0.5
904	Natural	Firm compaction, mid brown silty clay with occ. flint and freq. tree roots	0.5+
905	Natural – London clay	Firm compaction, mid orangish brown with occ. flint	0.1-0.5

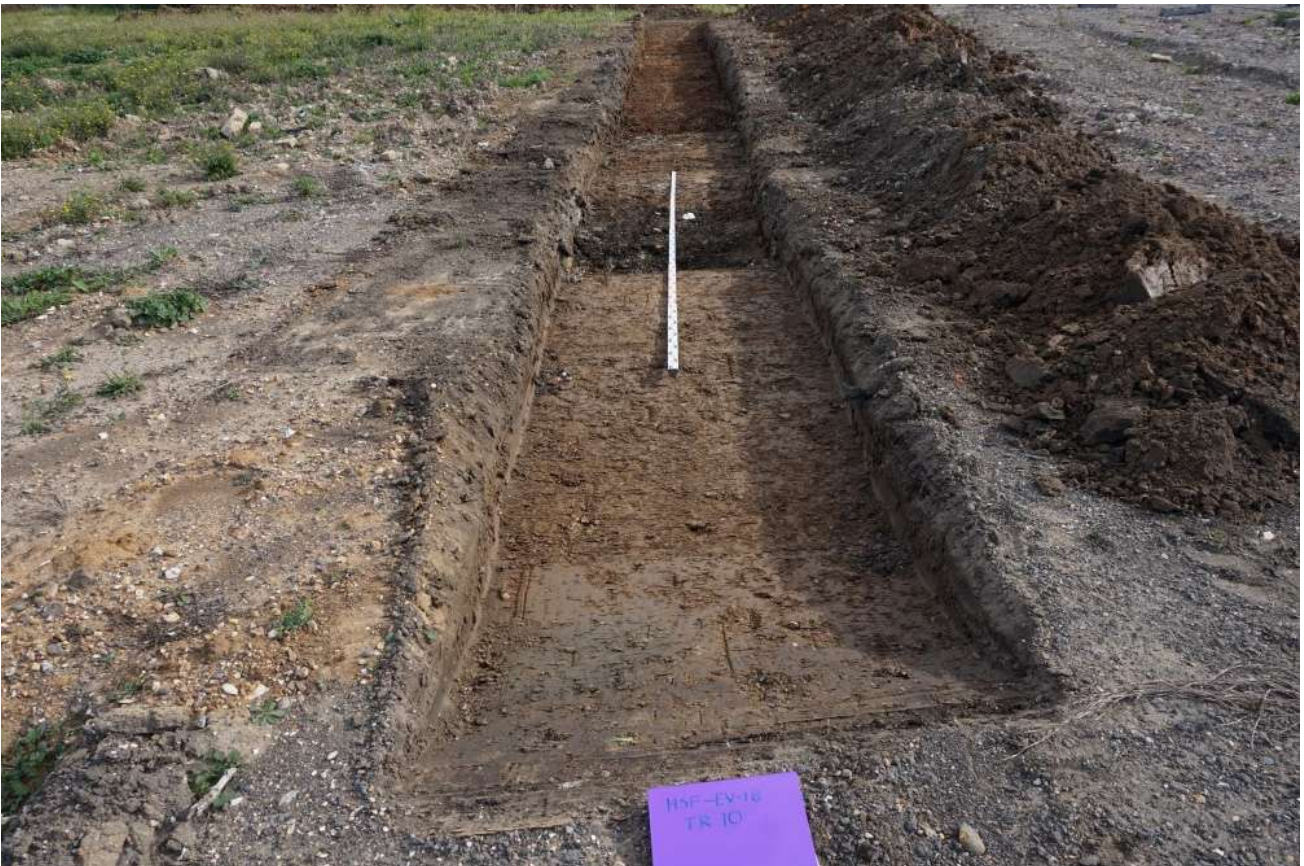
Plate 16: Looking north east at Trench 10 with machine excavated modern features.

Trench 10	Dimensions: 25m x 1.8m Depth: 0.25m-0.55m Trench alignment: NW-SE NW-end Ground Level: 18.71m SE-end Ground Level: 17.86m		
Context	Interpretation	Description	Depth (m)
1001	Topsoil	Thin layer overlaying driveway surface. Mid compaction, black clayey silt with occ. modern inclusions. Weeds vegetation	0.00-0.05
1002	Layer – Driveway	Compacted tarmac beads. Driveway surface associated with trailer park.	0.05-0.1
1003	Layer – modern leveling	Very firm compaction, dark brown, silty clay with occ. modern inclusions (glass, plastic wire, etc.).	0.1-0.3
1004	Natural	Firm compaction, mid brown silty clay with occ. flint and freq. lens of flint gravel	0.3+
[1005]	Modern pit	Rectangular large modern pit backfilled with hardcore	0-0.55+
[1006]	Modern trench	NE-SW aligned modern trench backfilled with dark brown silty clay and hardcore	0-0.55+

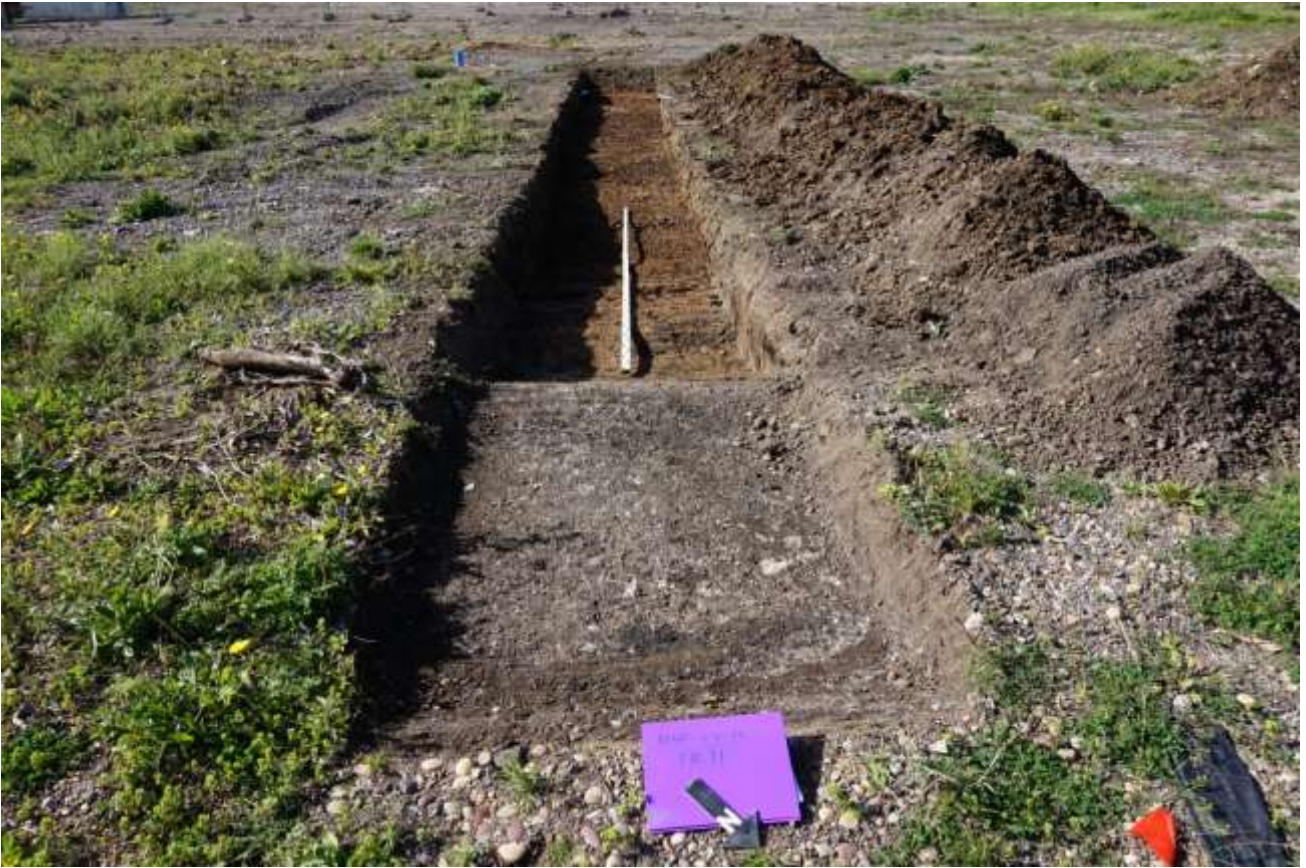
Plate 17: Looking south west at Trench 11. Tarmac surface is visible in the foreground.

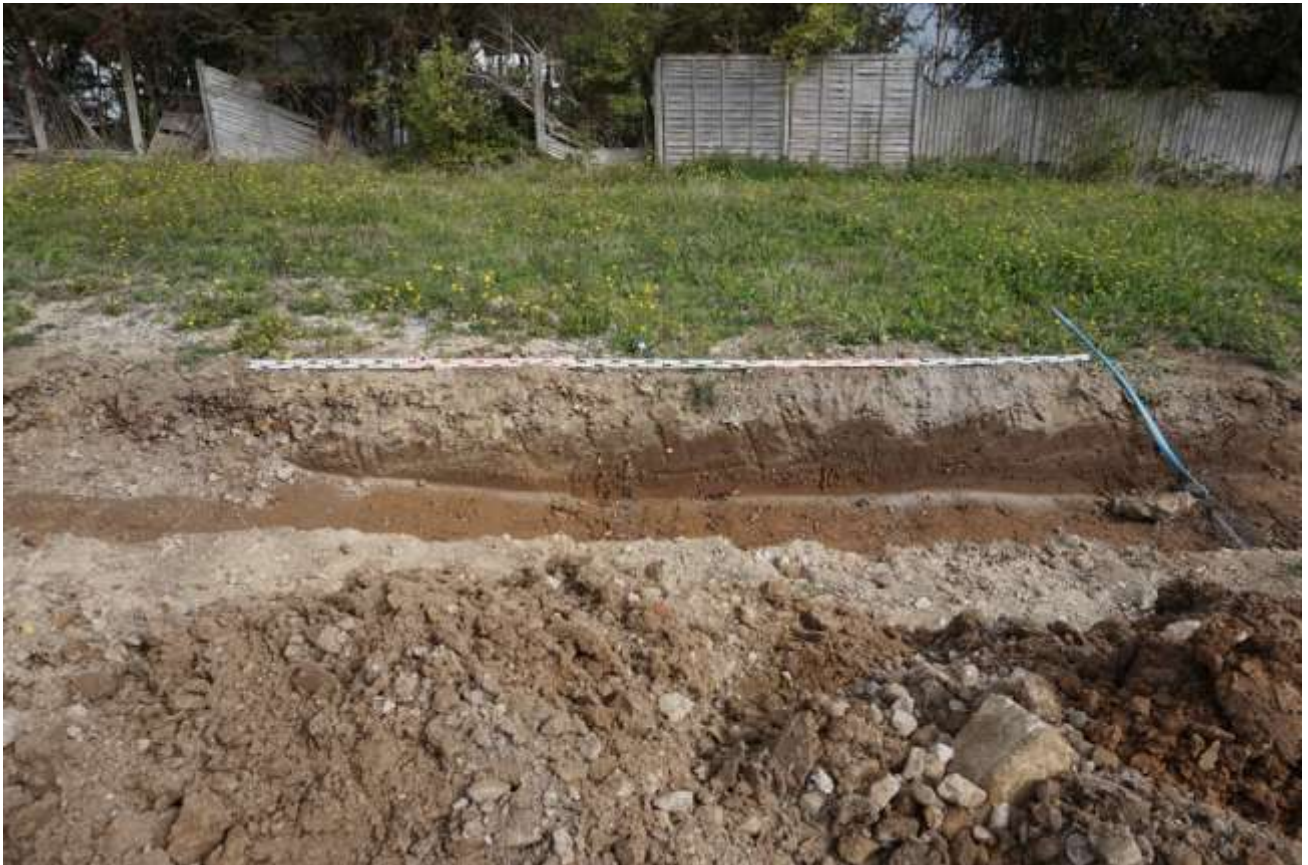
Plate 20: Looking south east at section of Trench 13

Trench 13	Dimensions: 21m x 1.8m Depth: 0.65m-0.8m Trench alignment: NW-SE NW-end Ground Level: 18.36m SE-end Ground Level: 17.46m		
Context	Interpretation	Description	Depth (m)
1301	Topsoil	Thin layer overlaying driveway surface. Mid compaction, black clayey silt with occ. modern inclusions. Weeds vegetation	0.00-0.05
1302	Layer – Driveway	Compacted tarmac beads. Driveway surface associated with trailer park.	0.05-0.15
1303	Layer – modern leveling	Very firm compaction, dark brown, silty clay with occ. modern inclusions (glass, plastic wire, etc.).	0.15-0.4
1304	Natural	Firm compaction, mid brown clay with occ. flint	0.4+
[1305]	Modern pit	large modern pit backfilled with hardcore	0-0.65+
[1306]	Modern services	NE-SW aligned modern trench backfilled with plastic drain pipe, blue narrow plastic water pipe surrounded by loose pebbles and sealed by mixed deposit of clay	0.15-0.55
[1307]	Modern pit	large modern pit backfilled with hardcore	0-0.8
