Archaeological Evaluation of Land at Aylesham Village Expansion, Aylesham, Dover, Kent. Phase 1B Compound Area

Site Code: AYLE/EV/18

(Planning Application: DOV/07/01081)

SWAT Archaeology

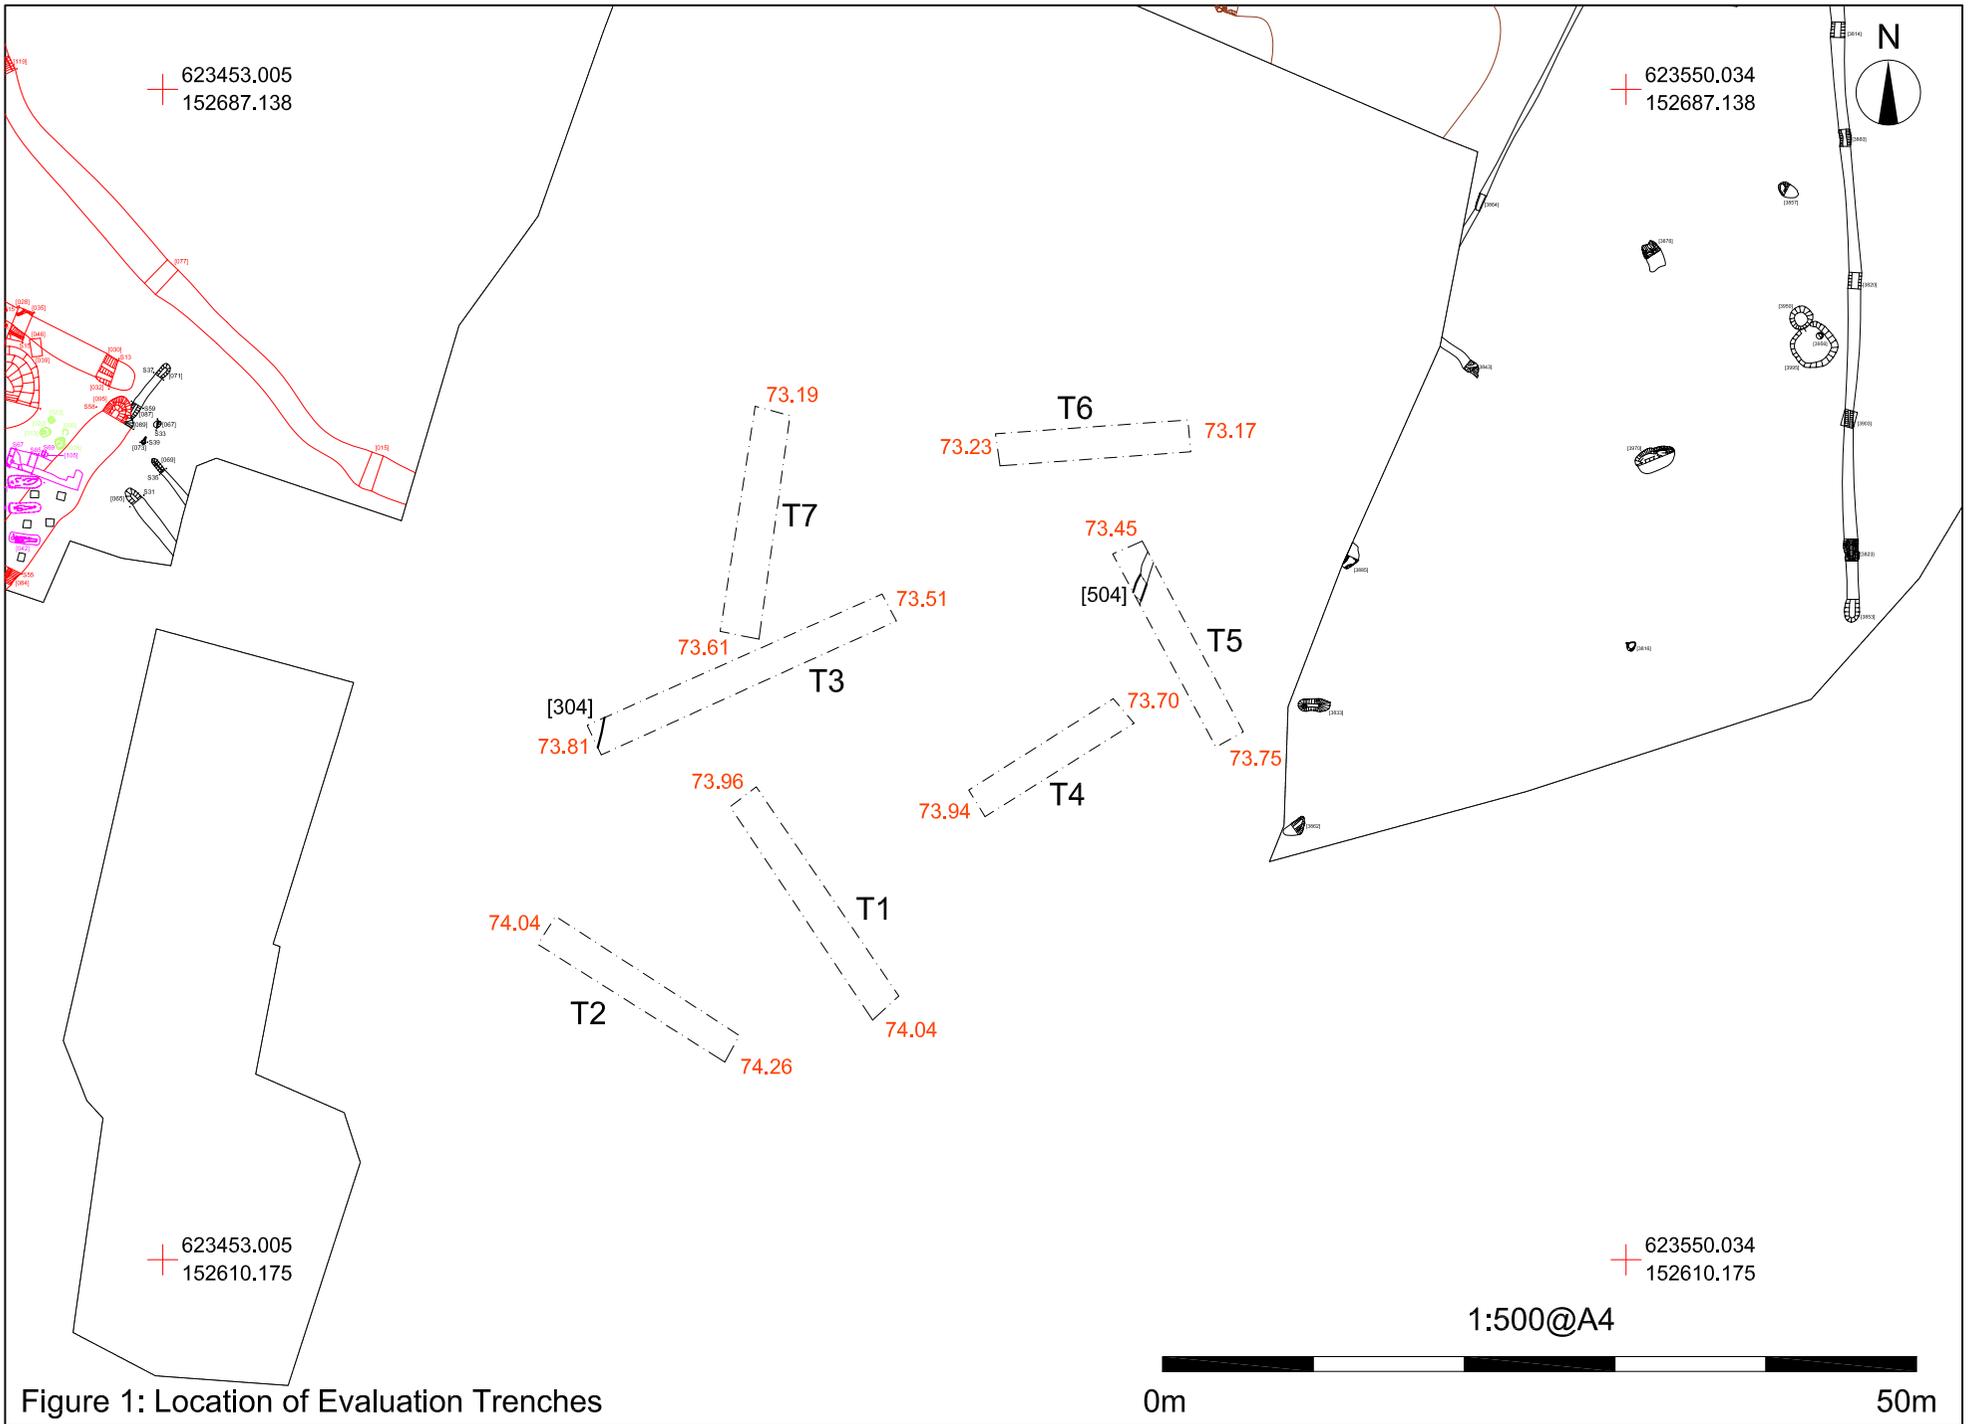
Figure 1: Location of Evaluation Trenches

The evaluation has identified no archaeological features within the trenches (Figure 1).

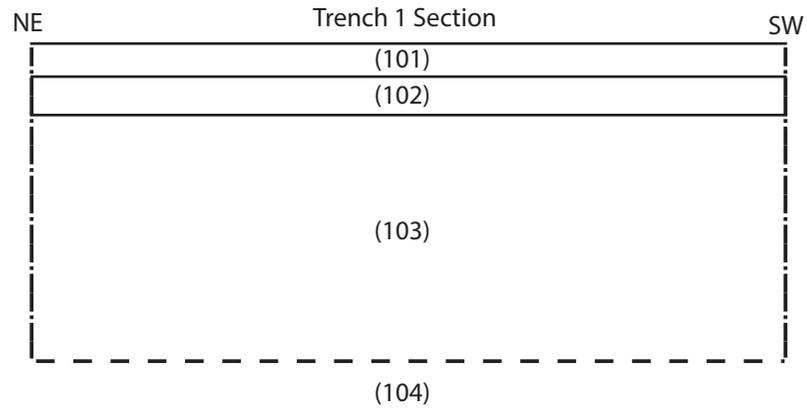
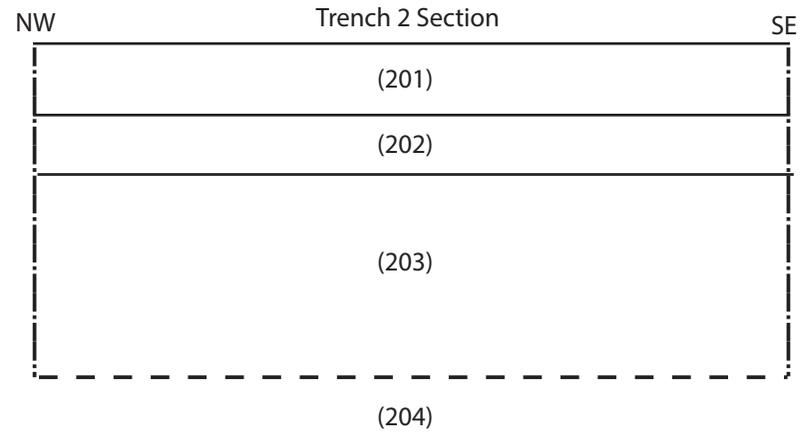
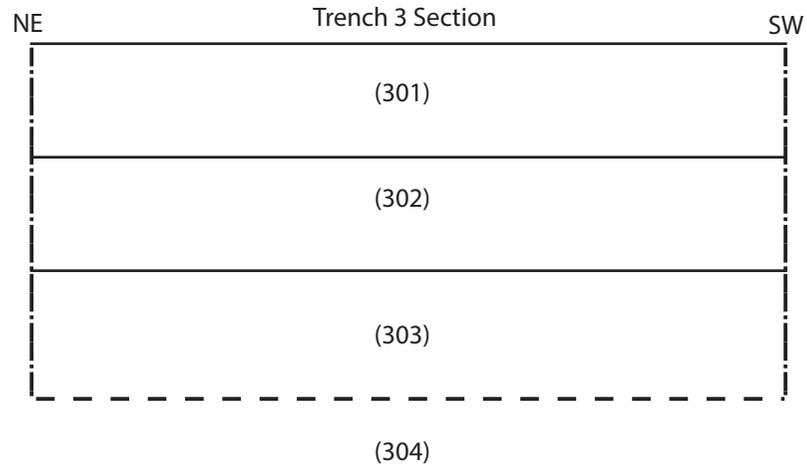
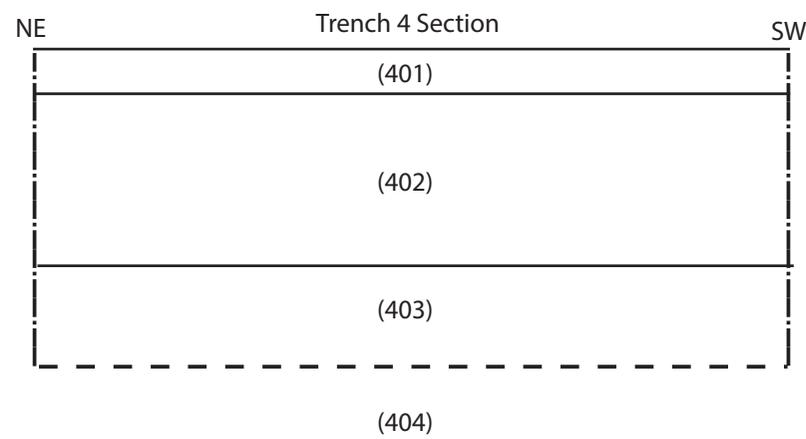
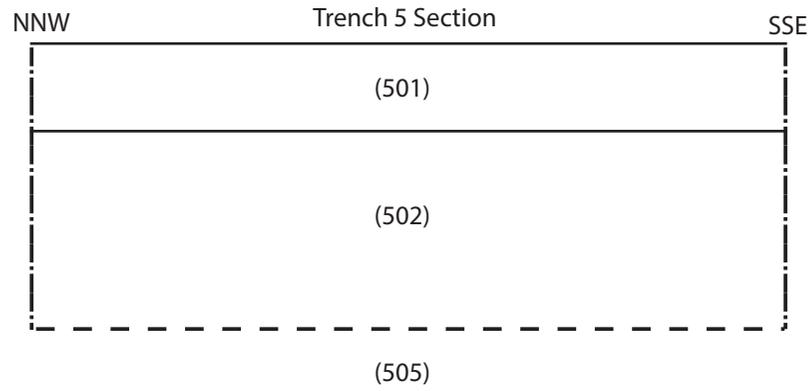
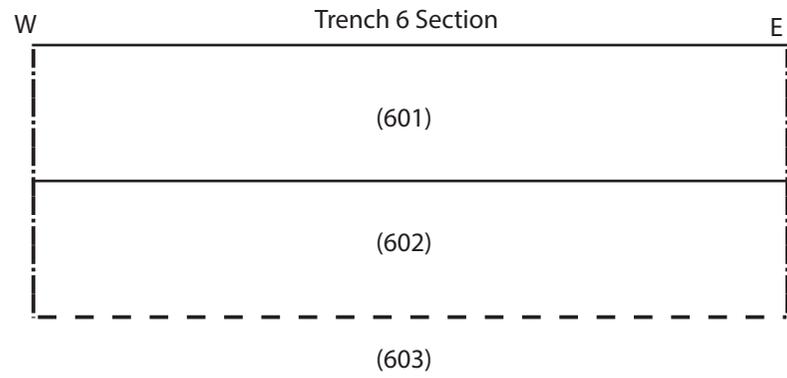
Trench 1 lay on a north-west south-east alignment and measured approximately 15m by 2m. The trench was sealed by a 0.04m layer of tarmac (101). Below this was a 0.05m layer of crushed hardcore (102) consisting of a friable coarse grey sand with very frequent modern fragmented building material inclusions which was sat on a layer of geotextile membrane. This sealed a layer of contaminated natural ground (103) made up of crushed hardcore depressed into the natural ground, which, had a thickness of 0.33m. Under this was the natural ground consisting of Reddish brown clay with outcrops of chalk (104) (Figure 2 & Plate 1).

fragmented building material inclusions which was sat on a layer of geotextile membrane. This sealed a layer of contaminated natural ground (203) made up of crushed hardcore depressed into the natural ground, which, had a thickness of 0.26m. Under this was the natural ground consisting of reddish brown clay with moderate angular flint inclusions (204) (Figure 2 & Plates 2, 8, section).

Trench 3 lay on a north-east south-west alignment and measured approximately 20m by 2m. The trench was sealed by a 0.15m layer of tarmac (301). Below this was a 0.15m layer of crushed hardcore (302) consisting of a friable coarse grey sand with very frequent modern fragmented building material inclusions which was sat on a layer of geotextile membrane. This sealed a layer of contaminated natural ground (303) made up of crushed hardcore depressed into the natural ground, which, had a thickness of 0.17m. Below this was a modern service (BT cable) cut into the natural ground (304). The natural ground below (305) consisted of a reddish brown clay with angular flint inclusions and outcrops of chalk (Figure 2 & Plates 3, 9, section).

Trench 4 lay on a south-west north-east alignment and measured approximately 11m by 2m. The trench was sealed by a 0.06m layer of tarmac (401). Below this was a layer of yellow sand with very frequent modern fragmented building material inclusions which, was sat on a layer of geotextile membrane and had a thickness of 0.23m. This sealed a layer of contaminated natural ground (403) made up of crushed hardcore depressed into the natural ground, which, had a thickness of 0.13m. Below this was the natural ground consisting of reddish brown clay with moderate angular flint inclusions (Figure 2 & Plate 4).

hardcore depressed into the natural ground, which, had a thickness of 0.26m. Below this was a linear feature [504] that ran north south across the trench at the northern end. Cut [504] had moderately inwards sloping sides and a concave base and was in filled with 0.12m of moderately compact chalk rubble. [504] Cut into the natural ground (505) that (502) sealed which, consisted of Reddish brown clay with outcrops of yellow sandy silt and chalk, with moderate angular flint inclusions (Figure 2 & Plates 5, 10, section and Plates 11, 12 linear).

Trench 7 lay on a south north alignment and measured approximately 15m by 2m. The trench was sealed by a 0.13m layer of tarmac (701). Below this was a 0.17m layer of crushed hardcore (702) consisting of a friable coarse grey sand with very frequent modern fragmented building material inclusions which was sat on a layer of geotextile membrane. This sealed a layer of contaminated natural ground (703) made up of crushed hardcore depressed into the natural ground, which, had a thickness of 0.18m. Under this was the natural ground consisting of Reddish brown clay with outcrops of yellow sandy silt and chalk, with moderate angular flint inclusions (704). (Figure 2 & Plate 7).

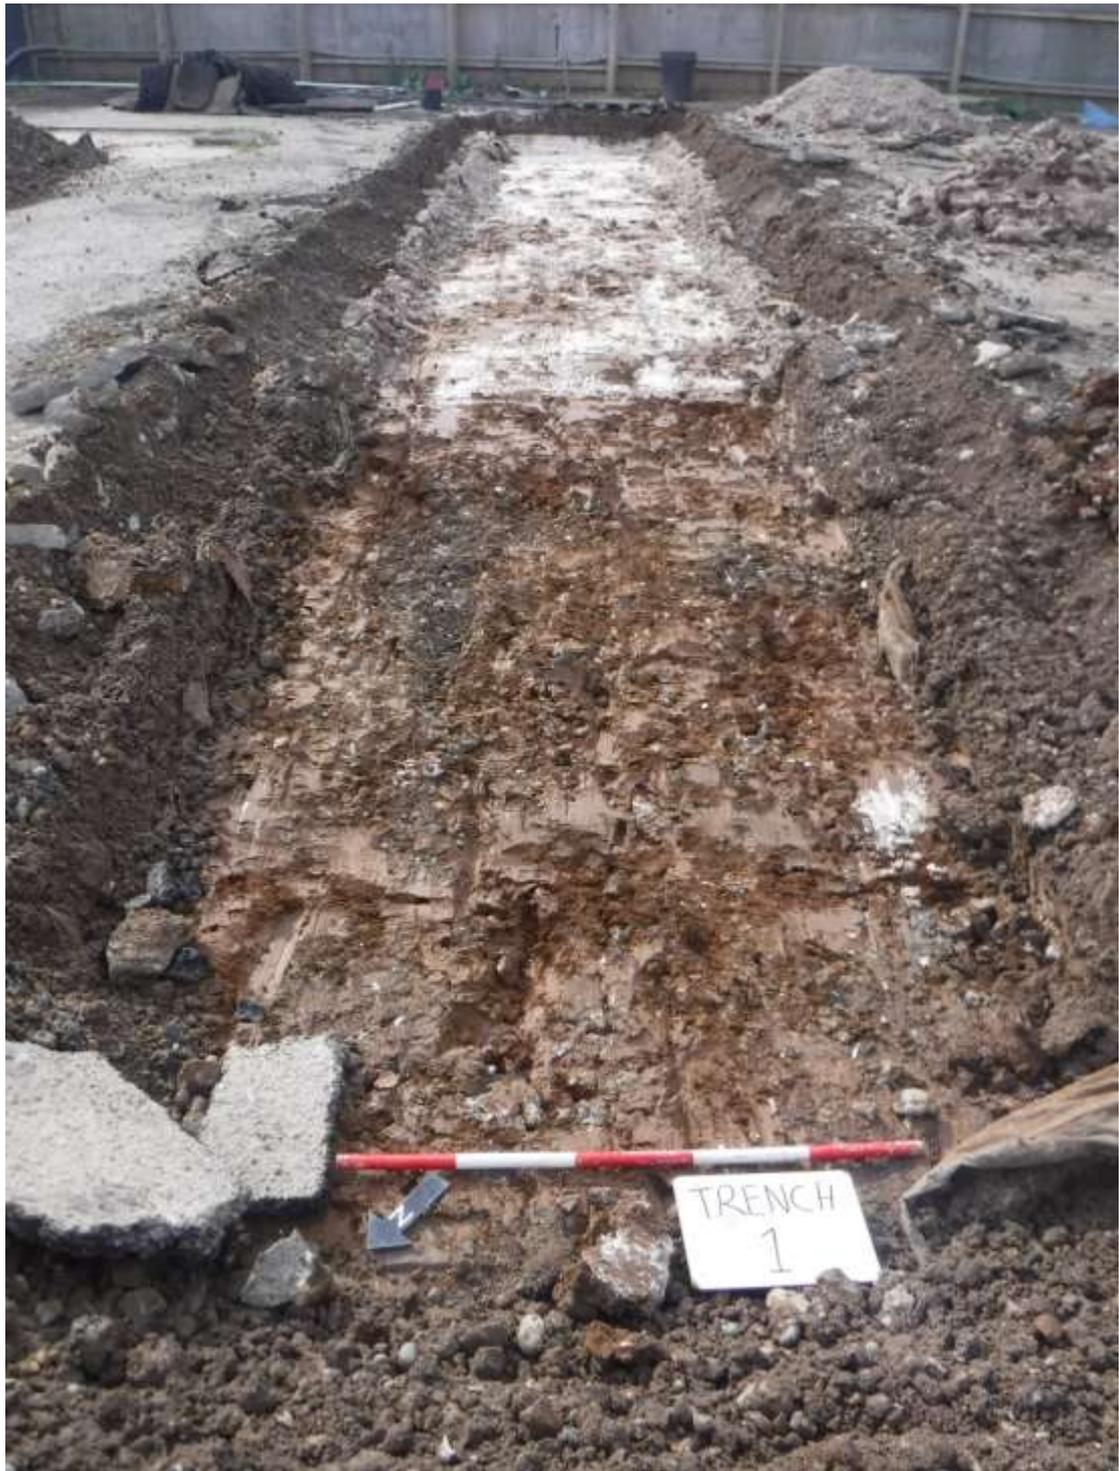
Plate 1 South-East facing view of Trench 1

Trench 1	Dimensions: 15m x 2m Ground Level:		
Context	Description	Interpretation	Depth (m)
101	Tarmac	Tarmac	0.00-0.04
102	Friable coarse grey sand with very frequent modern fragmented building material inclusions.	Crushed Hardcore	0.04-0.09
103	Mix of reddish brown clay and crushed hardcore.	Contaminated Natural	0.09-0.42
104	Reddish brown clay with outcrops of chalk.	Natural	0.42+

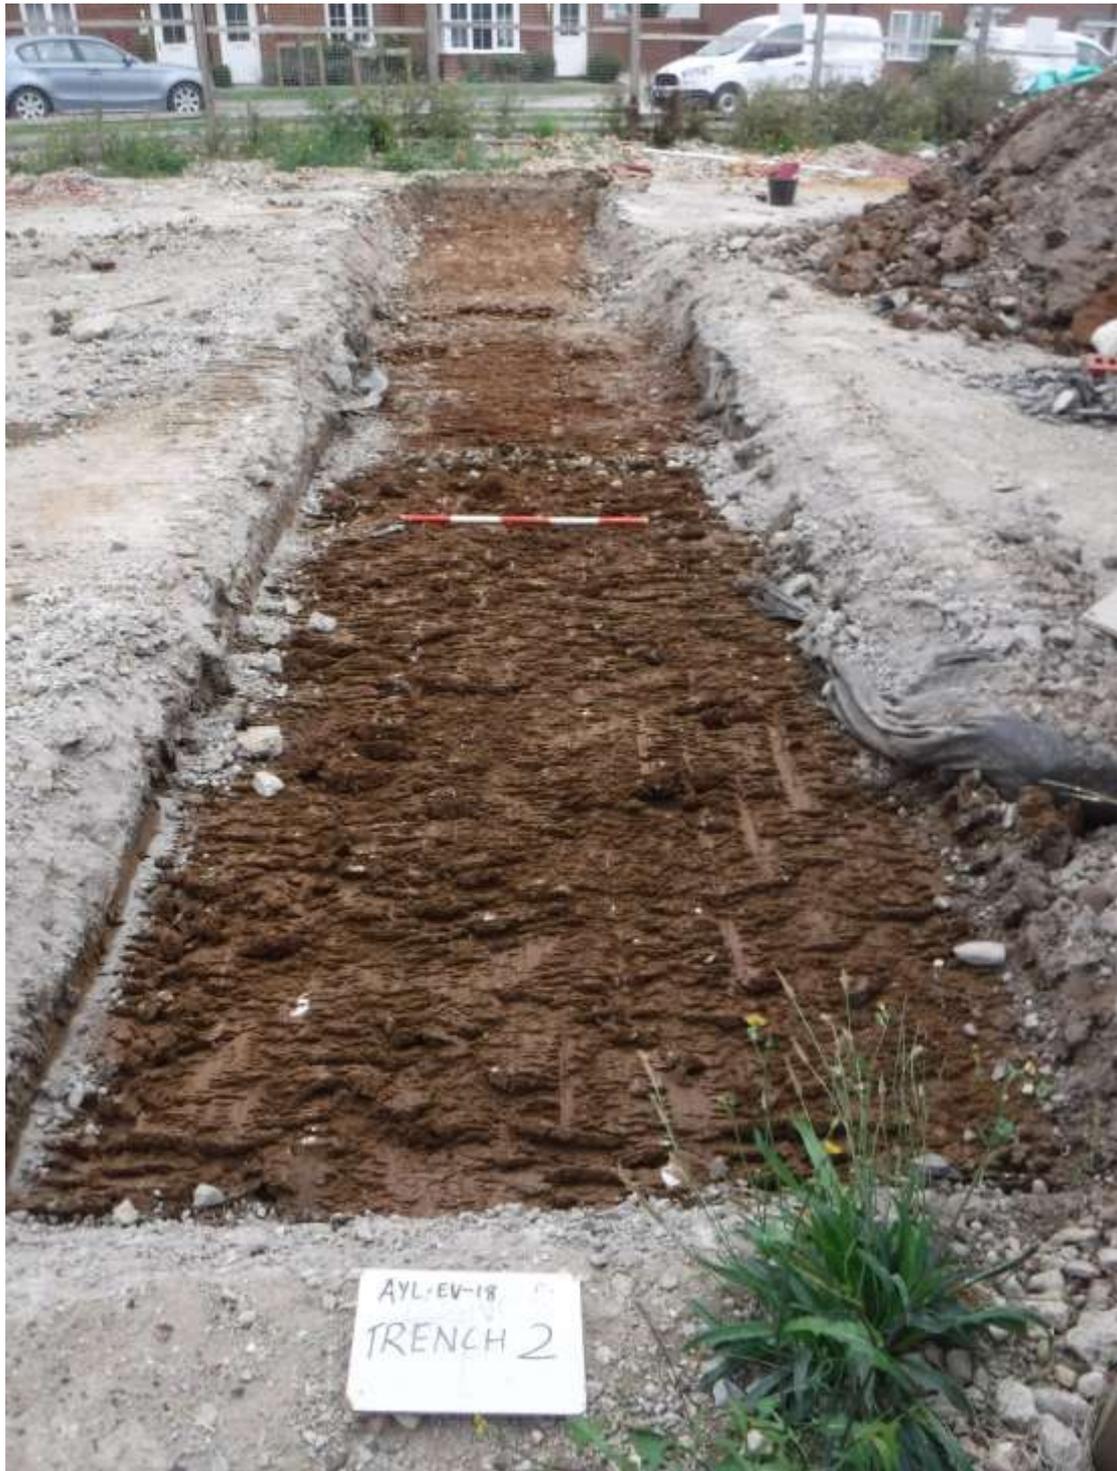
Plate 2 North-West facing view of Trench 2

Trench 2	Dimensions: 15m x 2m Ground Level:		
Context	Description	Interpretation	Depth (m)
201	Tarmac	Tarmac	0.00-0.1
202	Friable coarse grey sand with very frequent modern fragmented building material inclusions.	Crushed Hardcore	0.1-0.18
203	Mix of reddish brown clay and crushed hardcore.	Contaminated Natural	0.18-0.44
204	Reddish brown clay with angular flint inclusions.	Natural	0.44+

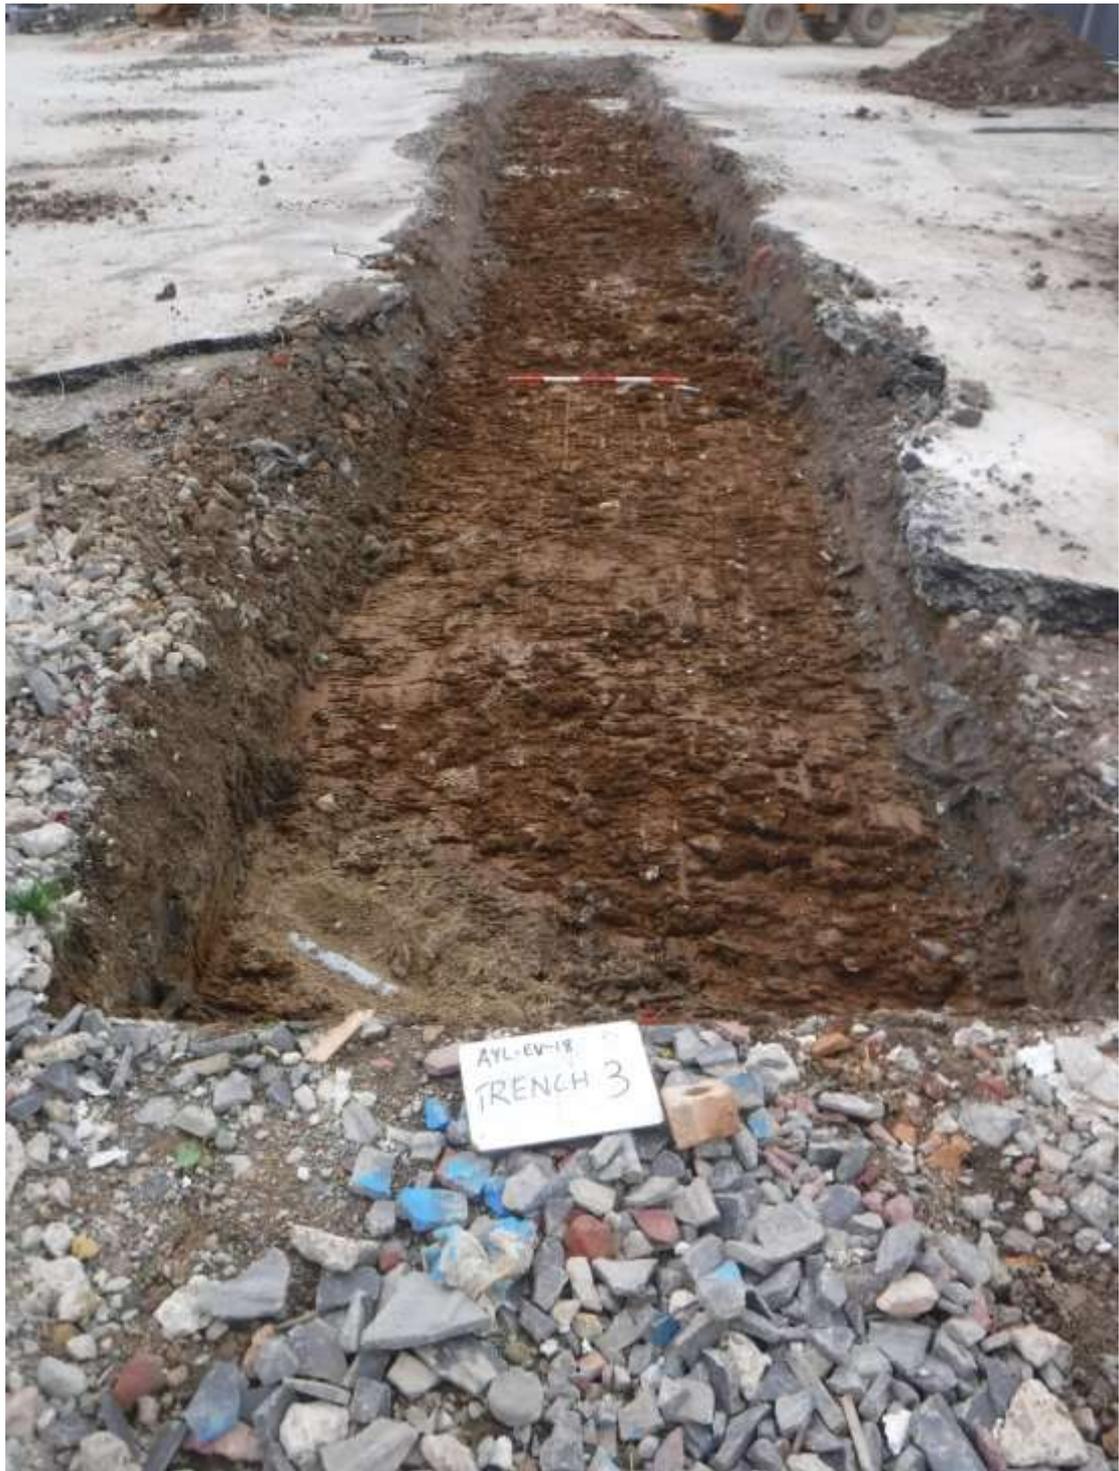
Trench 3	Dimensions: 20m x 2m Ground Level:		
Context	Description	Interpretation	Depth (m)
301	Tarmac	Tarmac	0.00-0.15
302	Friable coarse grey sand with very frequent modern fragmented building material inclusions.	Crushed Hardcore	0.15-0.3
303	Mix of reddish brown clay and crushed hardcore.	Contaminated Natural	0.30-0.47
304	Modern Service	Modern Service	-

Plate 3 North-East facing view of Trench 3 showing modern service (304)

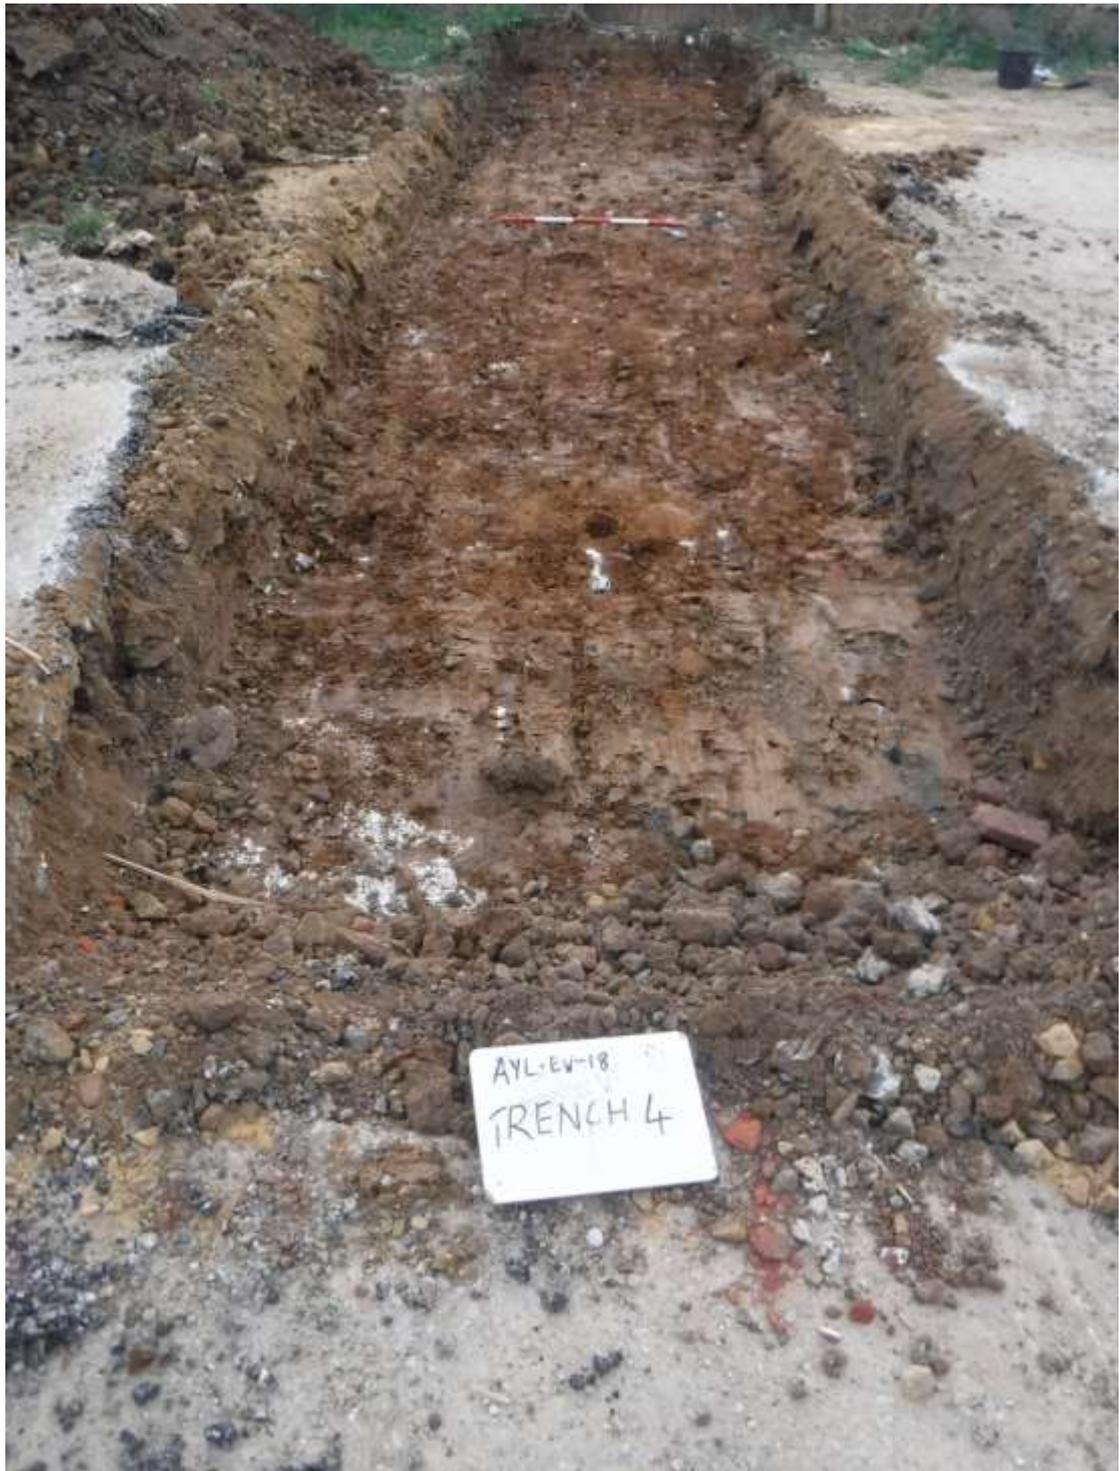
Plate 4 South-West facing view of Trench 4

Trench 4	Dimensions: 11m x 2m Ground Level:		
Context	Description	Interpretation	Depth (m)
401	Tarmac	Tarmac	0.00-0.06
402	Yellow sand with crushed hardcore inclusions.	Crushed Hardcore	0.06-0.29
403	Mix of reddish brown clay and crushed hardcore.	Contaminated Natural	0.29-0.42
404	Reddish brown clay with angular flint inclusions.	Natural	0.42+

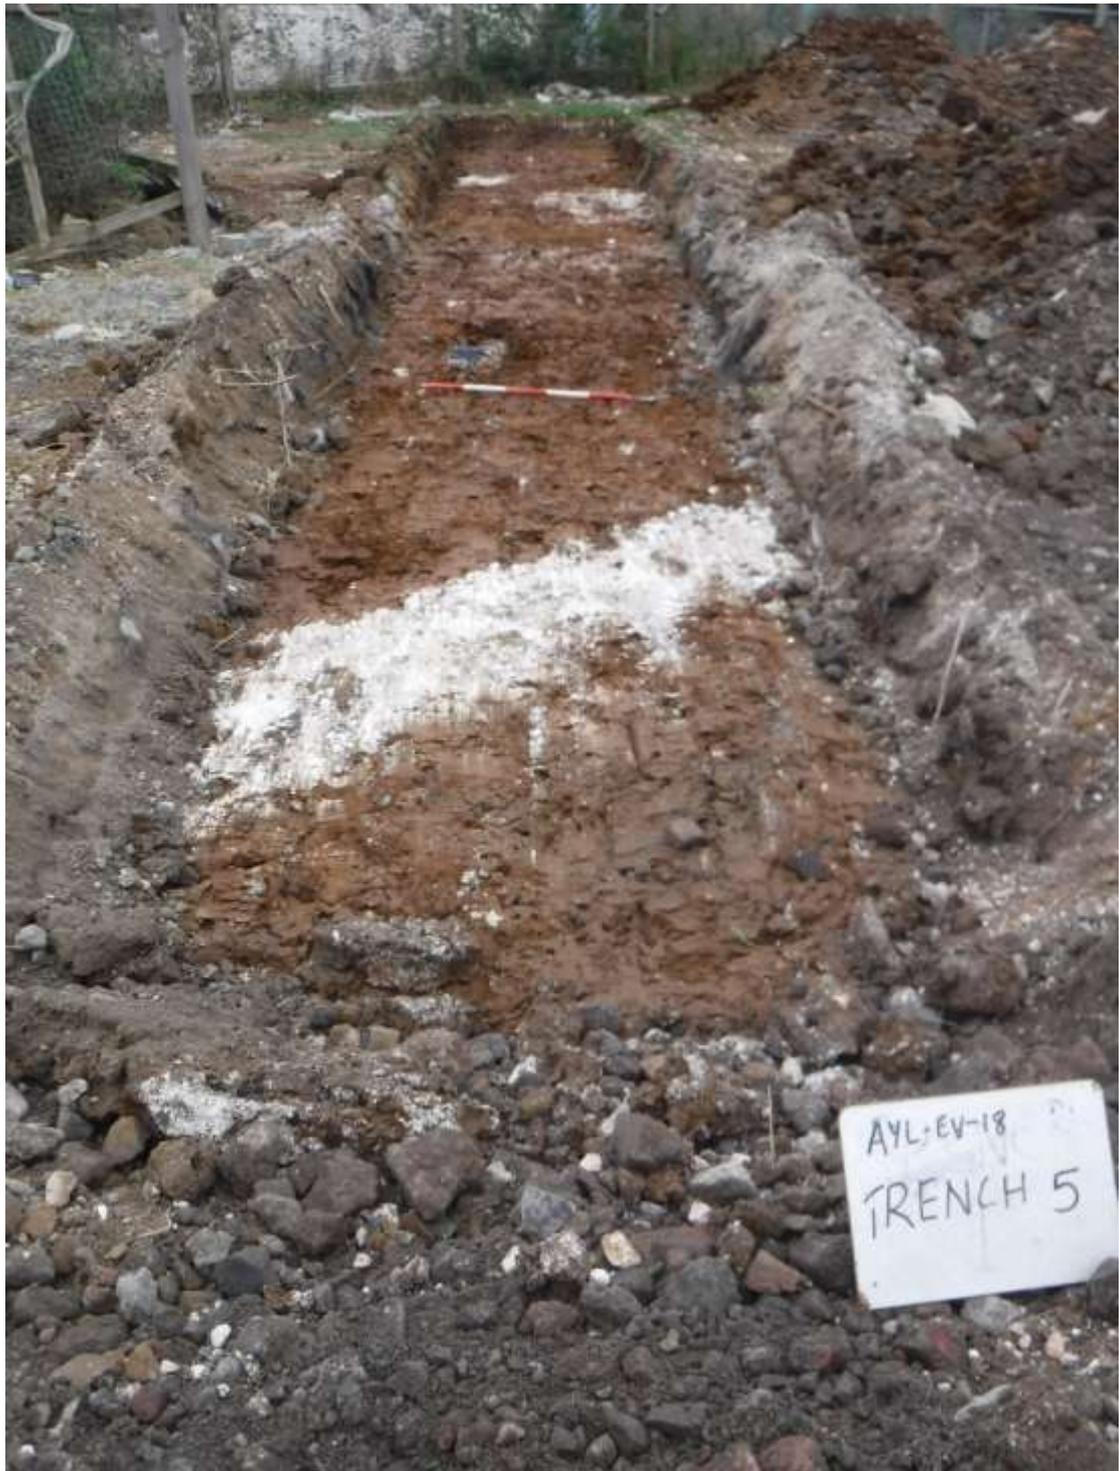
Trench 5	Dimensions: 15m x 2m Ground Level:		
Context	Description	Interpretation	Depth (m)
501	Friable coarse grey sand with very frequent modern fragmented building material inclusions.	Crushed Hardcore	0.00-0.12
502	Mix of reddish brown clay and crushed hardcore.	Contaminated Natural	0.12-0.38
503	Moderately compact chalk fill	Fill of linear [504]	0.38-0.5
504	Cut of linear feature	Cut of linear	-
505	Reddish brown clay with outcrops of yellow sandy silt and chalk, with moderate angular flint inclusions.	Natural	0.38+

Plate 5 South-East facing view of Trench 5 showing linear [504]

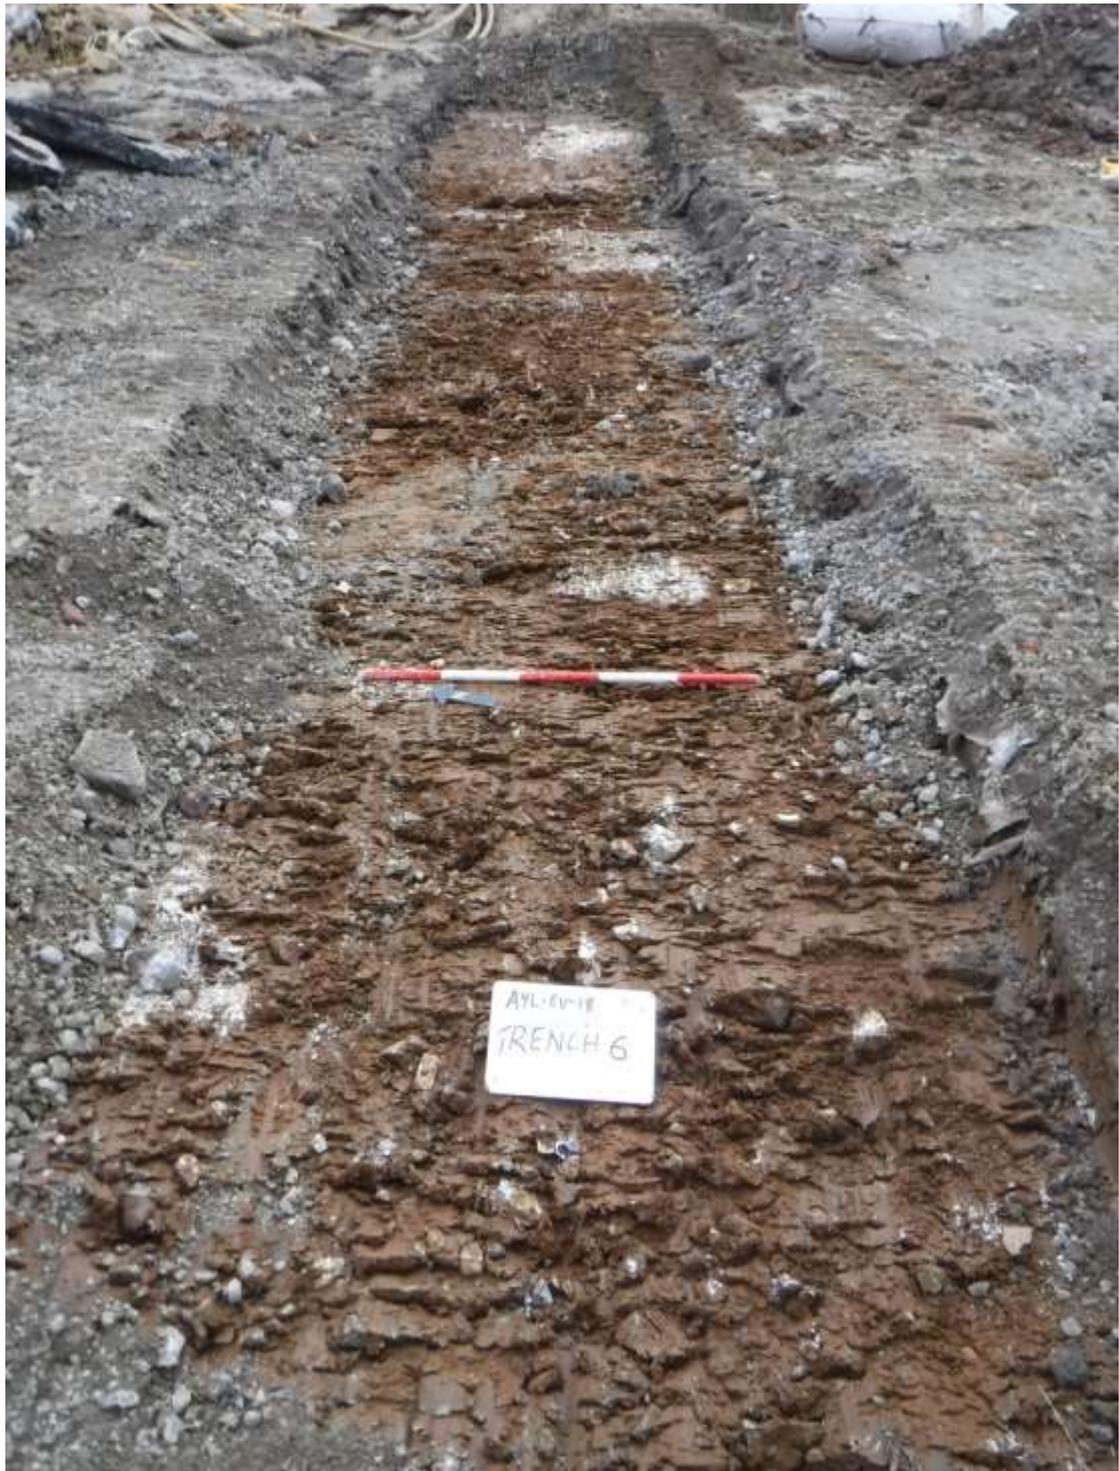
Plate 6 North-East facing view of Trench 6

Trench 6 lay on a west-east alignment and measured approximately 15m by 2m. The trench was sealed with a layer of crushed hardcore (601) consisting of a friable coarse grey sand with very frequent modern fragmented building material inclusions which was sat on a layer of geotextile membrane that had a thickness of 0.18m. This sealed a layer of contaminated natural ground (602) made up of crushed hardcore depressed into the natural ground, which, had a thickness of 0.18m. Below this was the natural ground (603) consisting of reddish brown clay with outcrops of chalk and angular flint inclusions (Figure 2 & Plate 6).

Trench 6	Dimensions: 25m x 2m Ground Level:		
Context	Description	Interpretation	Depth (m)
601	Friable coarse grey sand with very frequent modern fragmented building material inclusions.	Crushed Hardcore	0.00-0.18
602	Mix of reddish brown clay and crushed hardcore.	Contaminated Natural	0.18-0.36

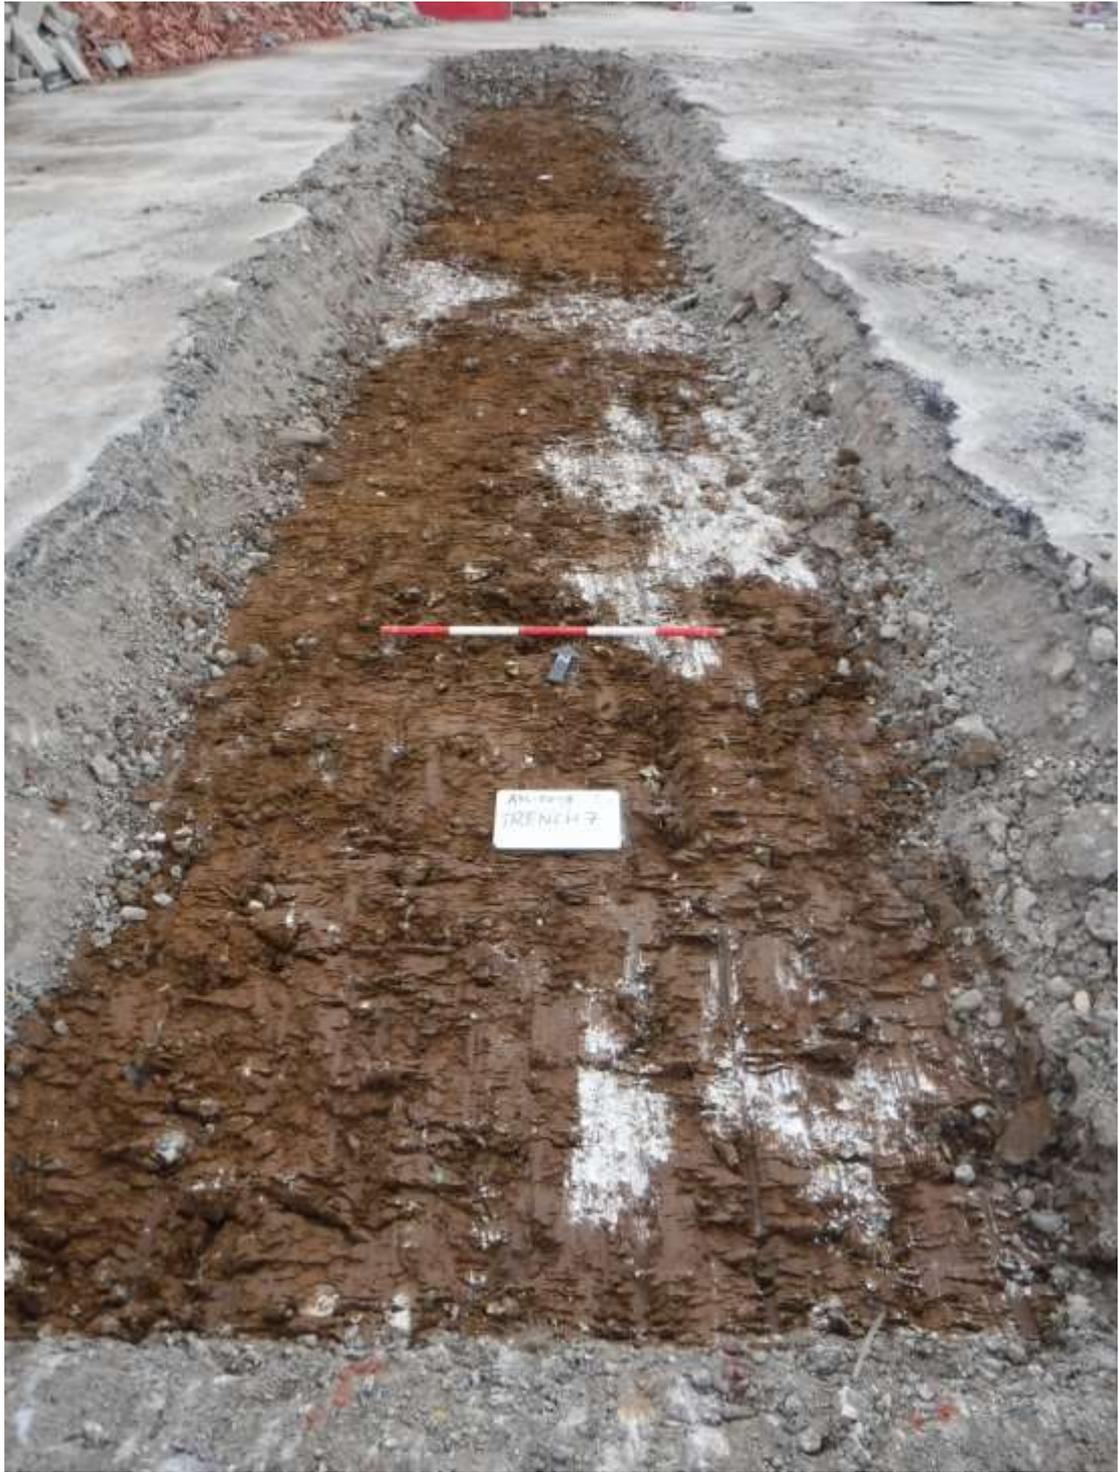
Plate 7 North North-West facing view of Trench 7

Trench 7	Dimensions: 15m x 2m Ground Level:		
Context	Description	Interpretation	Depth (m)
701	Tarmac	Tarmac	0.00-0.13
702	Friable coarse grey sand with very frequent modern fragmented building material inclusions.	Crushed Hardcore	0.13-0.3
703	Mix of reddish brown clay and crushed hardcore.	Contaminated Natural	0.3-0.48
704	Reddish brown clay with outcrops of yellow sandy silt and chalk, with moderate angular flint inclusions.	Natural	0.48+

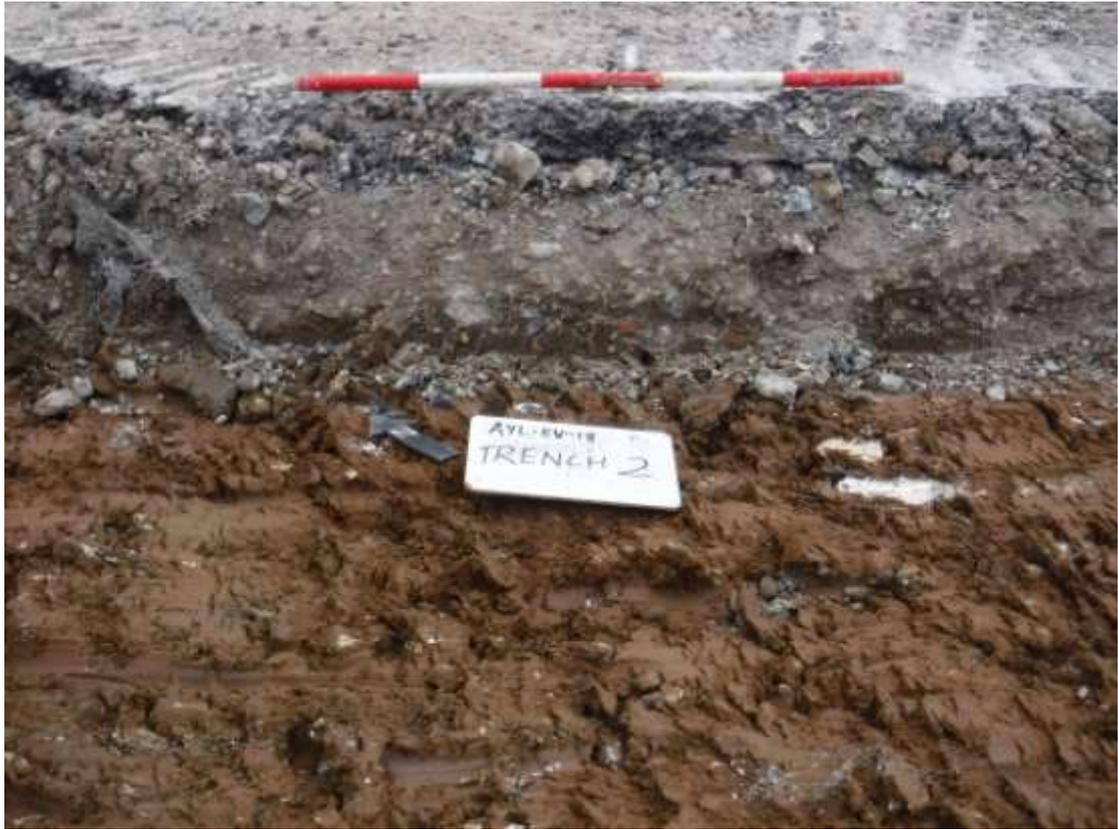
Plate 8 North-East facing Trench 2 section

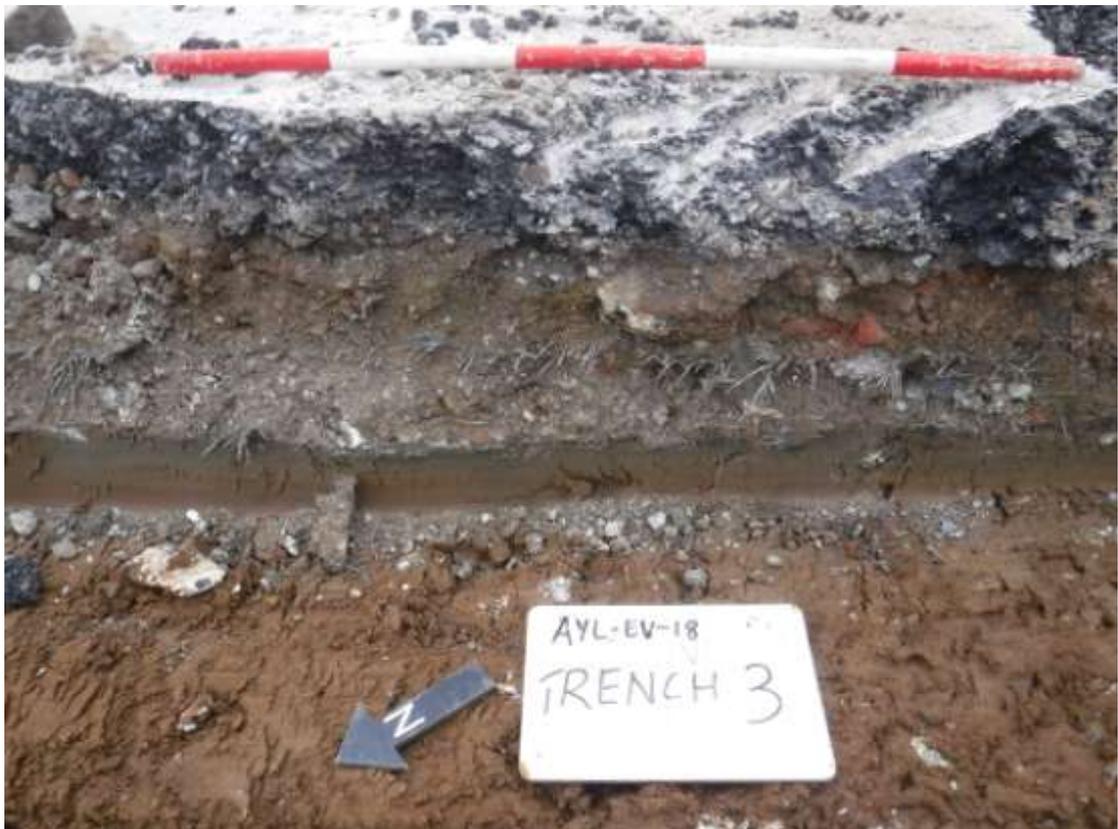
Plate 9 South-East facing Trench 3 section

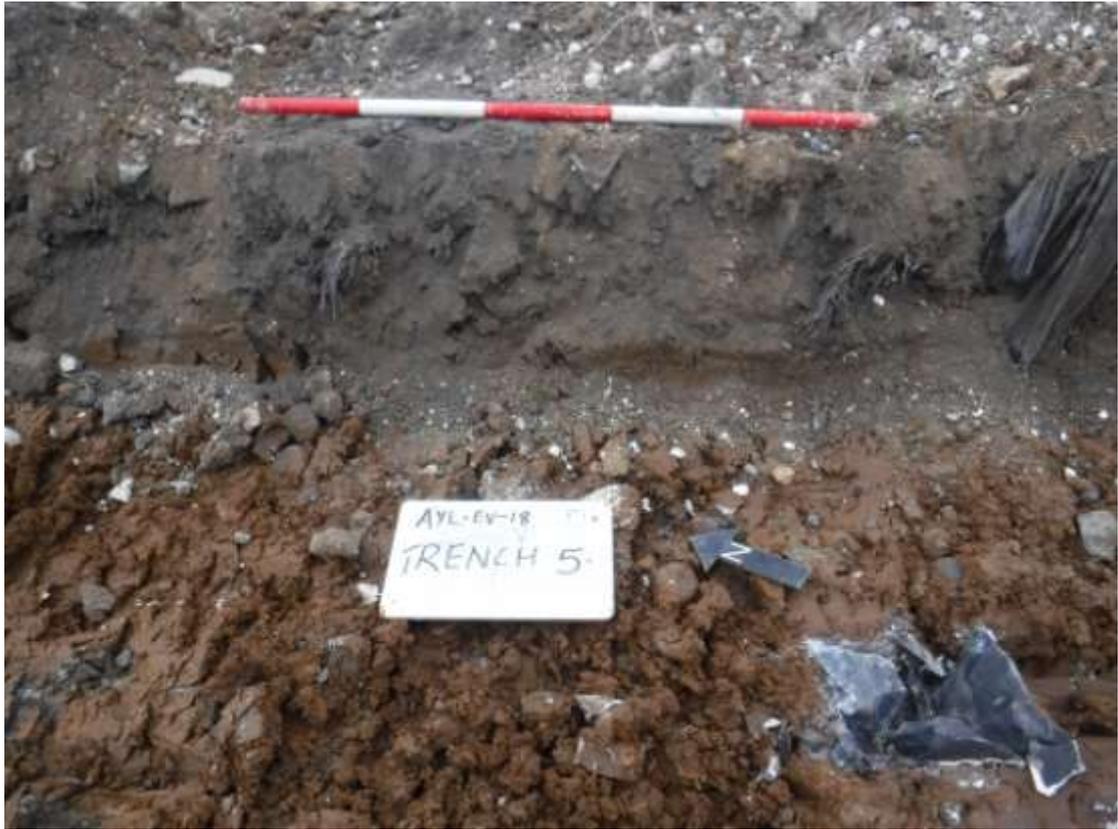
Plate 10 North-East facing Trench 5 section

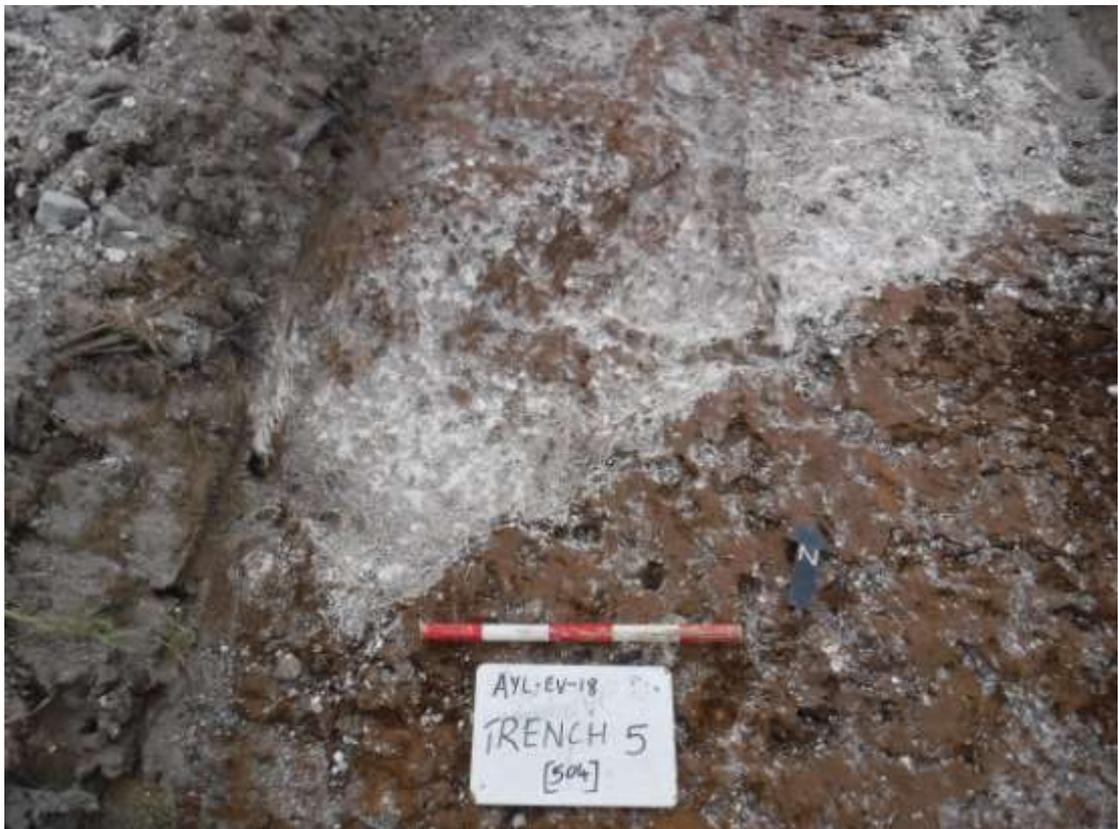
Plate 11 Linear [504]
