Archaeological Evaluation of Land at Aylesham Village Expansion, Aylesham, Dover, Kent. Phase 1B Compound Area

Site Code: AYLE/EV/18

(Planning Application: DOV/07/01081)

SWAT Archaeology

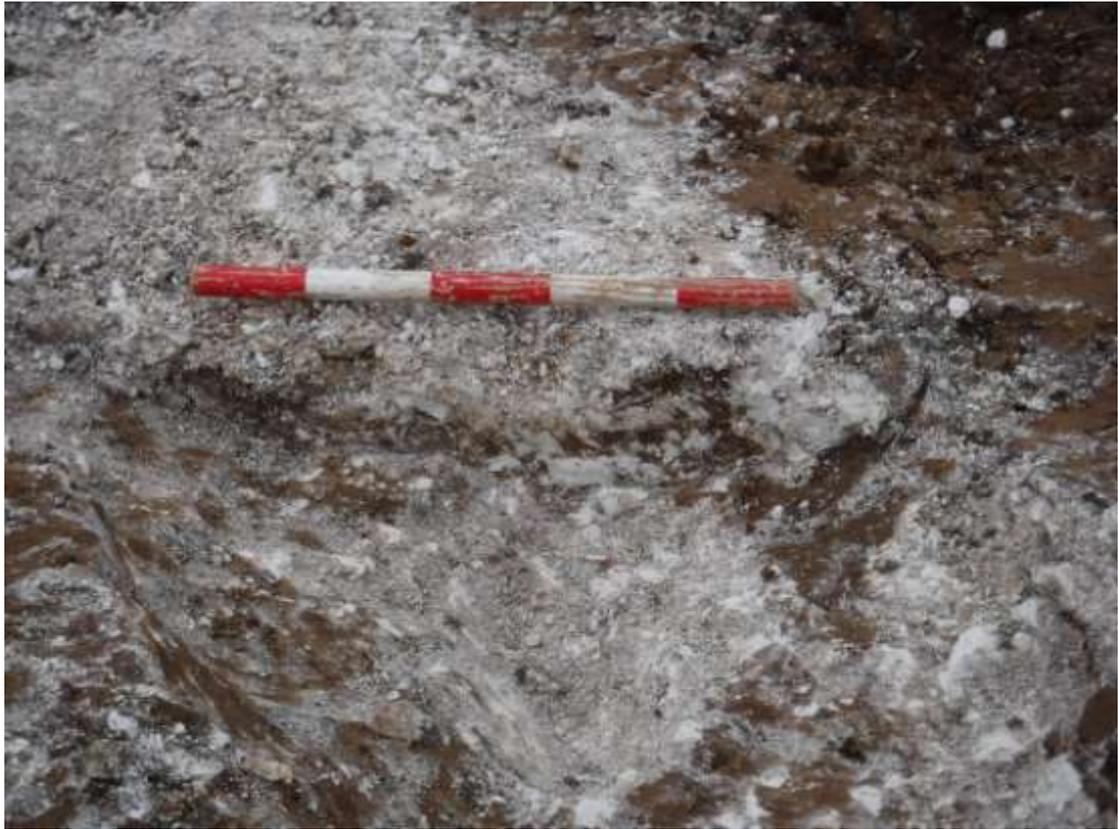
hardcore depressed into the natural ground, which, had a thickness of 0.26m. Below this was a linear feature [504] that ran north south across the trench at the northern end. Cut [504] had moderately inwards sloping sides and a concave base and was in filled with 0.12m of moderately compact chalk rubble. [504] Cut into the natural ground (505) that (502) sealed which, consisted of Reddish brown clay with outcrops of yellow sandy silt and chalk, with moderate angular flint inclusions (Figure 2 & Plates 5, 10, section and Plates 11, 12 linear).

Plate 12 East facing section of linear [504] filled with (503)

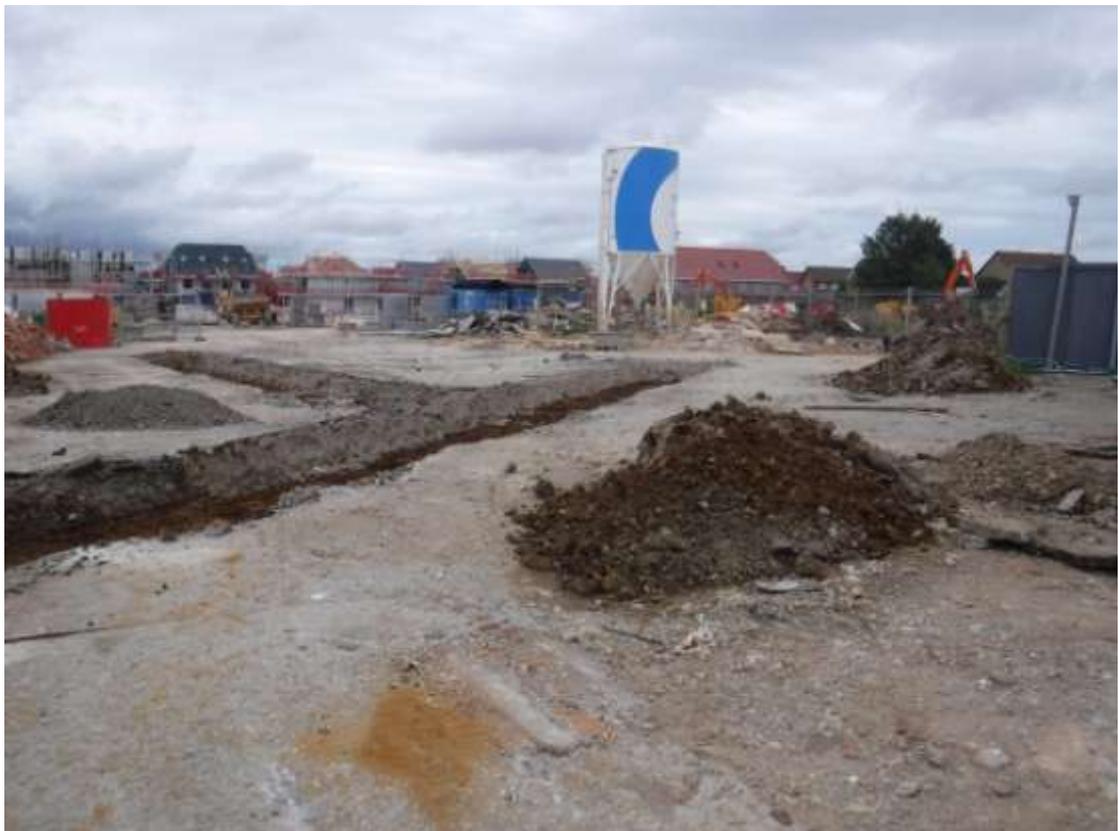
With some archaeological sites known in the vicinity of the PDA it was expected that the evaluation may produce evidence of archaeological activity. But there was none. Most of the site has been used as a car park and building compound. Two trenches could not be dug because of site obstacles (Plates 13, 14, 15). The excavated trenches showed a typical sequence of tarmac scrapings, subsoil and natural geology.

Plate 13 Overall view of site showing concrete silo at the center of the site.

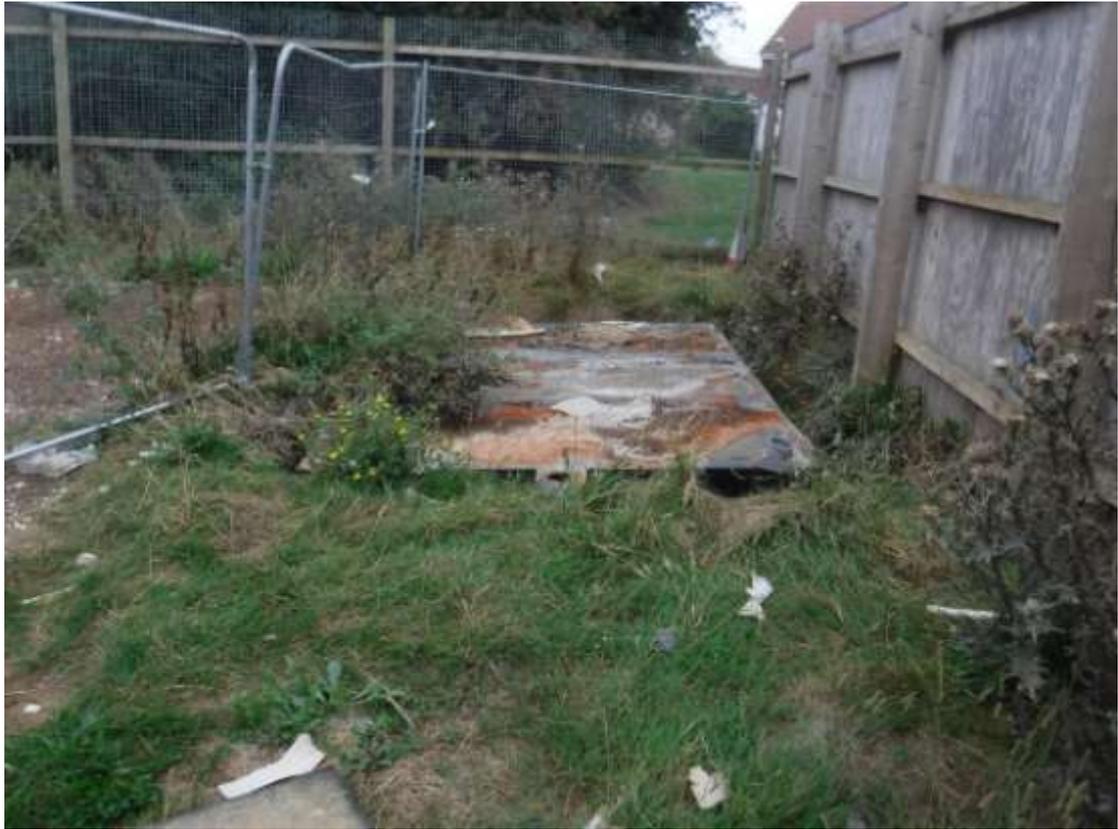
Plate 14 Trench 4 had to be moved due to on site obstacles

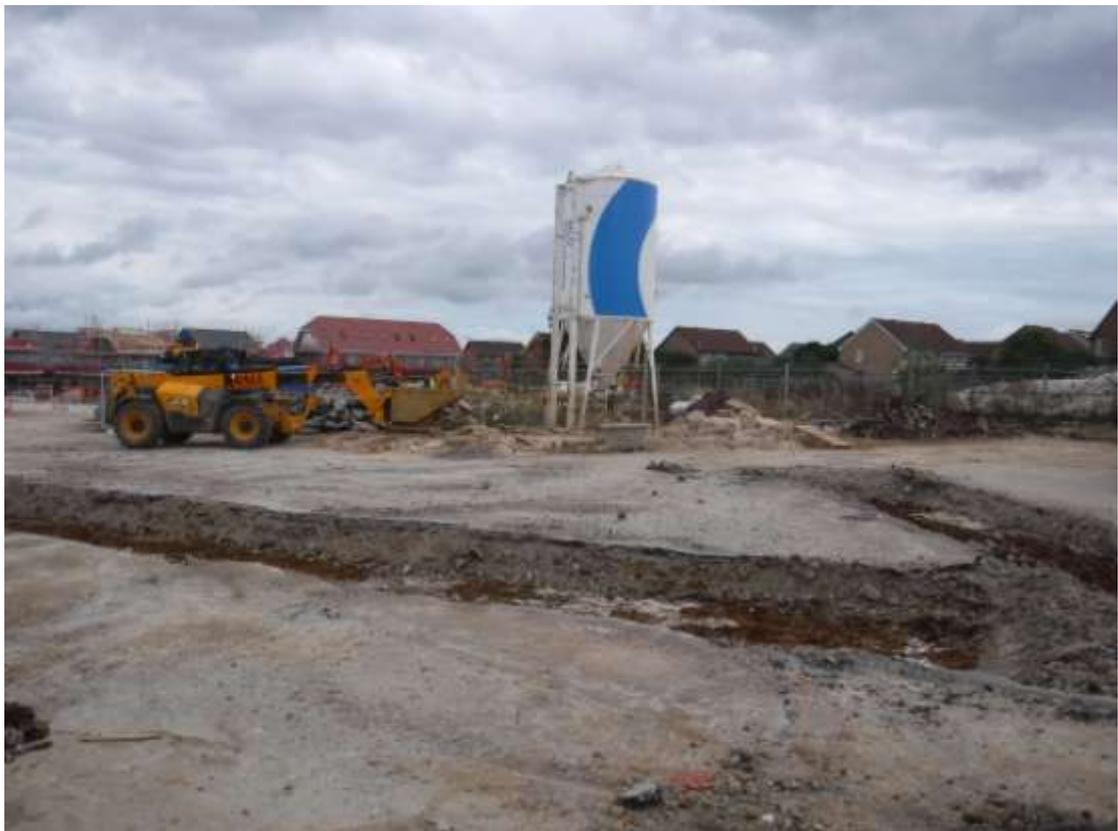
Plate 15 Concrete silo in use during evaluation.
