HISTORIC BUILDING RECORDING OF BAILIFF'S COTTAGE OFF LOWER HIGHAM ROAD, GRAVESEND, KENT

Date of report July 2019

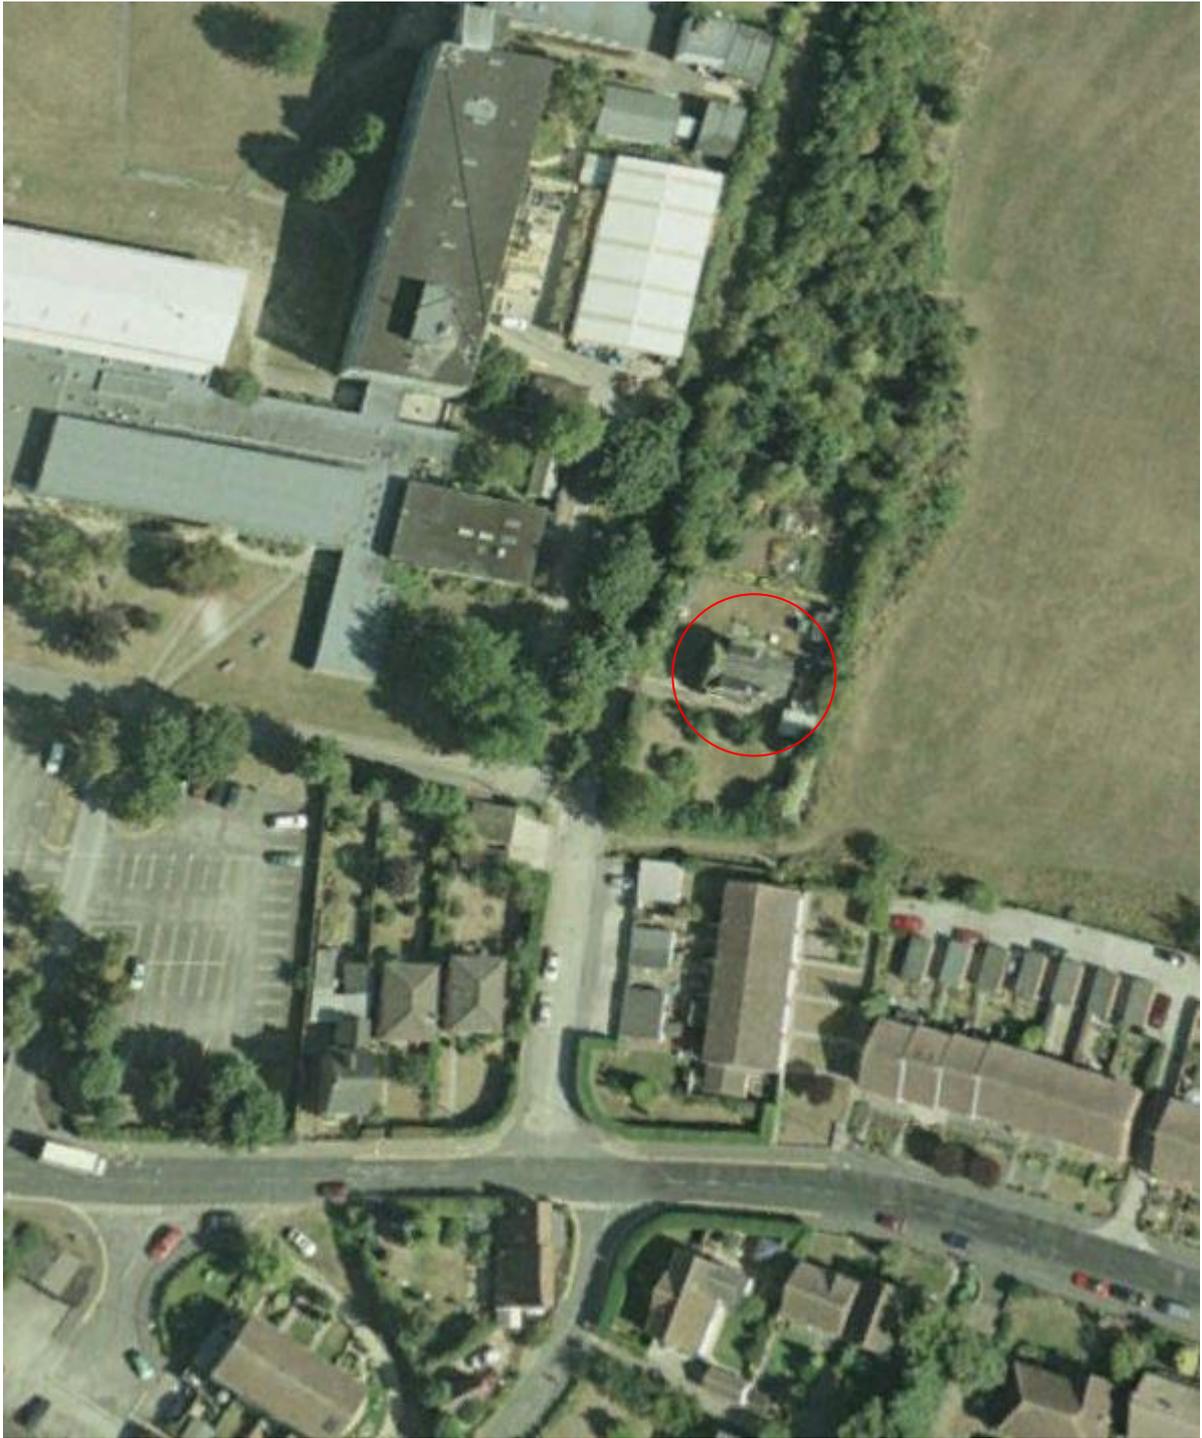
AP Plate 2. Aerial photograph of 2003

The aerial photograph of 1960 shows the farm still in existence but with additional urban development to the south (AP Plate 1) and the aerial photograph of 2003 shows Malthouse Farm to have disappeared and replaced by urban housing (AP Plate 2).

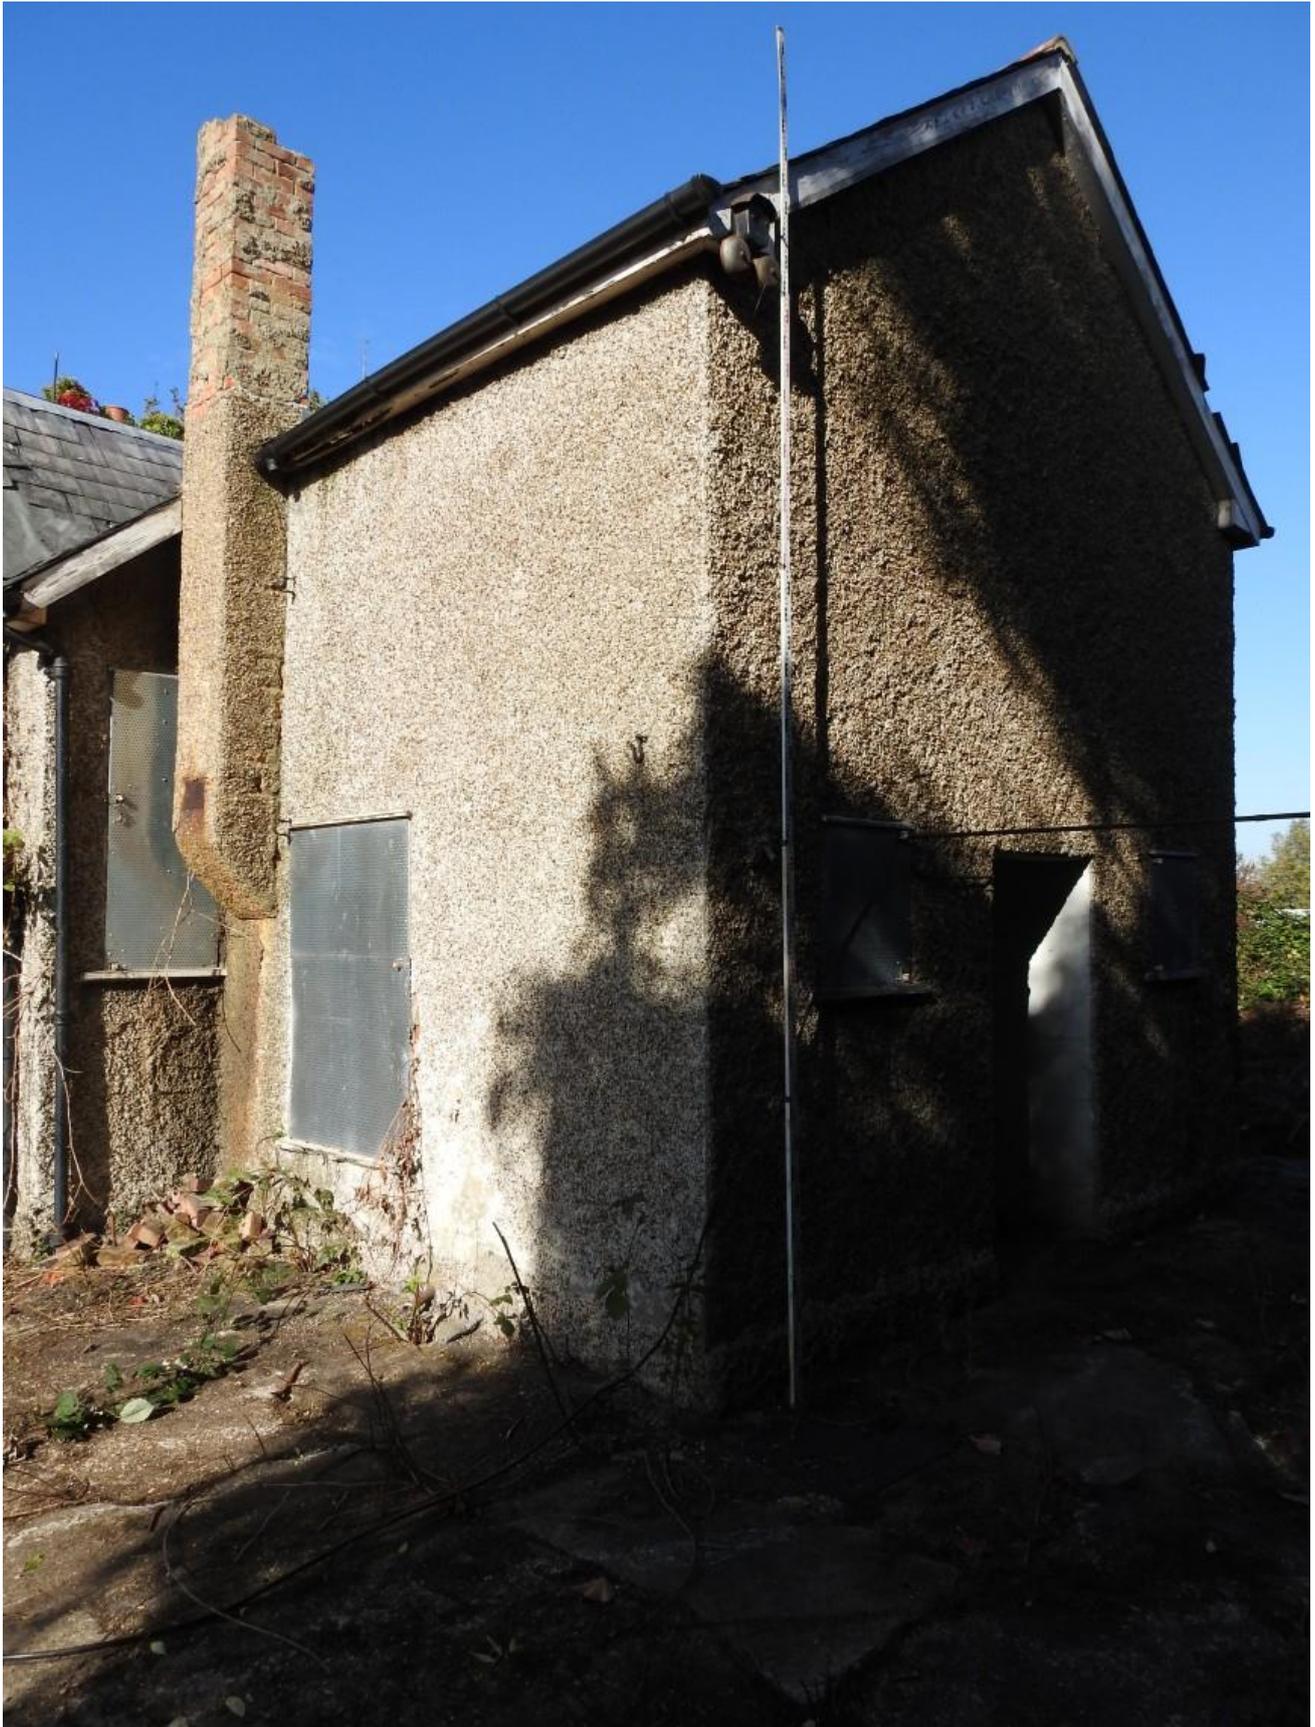
Plate 3: Looking north west at eastern elevation; five metre scale

- Gable end with two small windows on the lower storey, set either side of a simple rectangular doorway.
- Tall narrow window to the south, set back from the main elevation (Plates 3, 4)

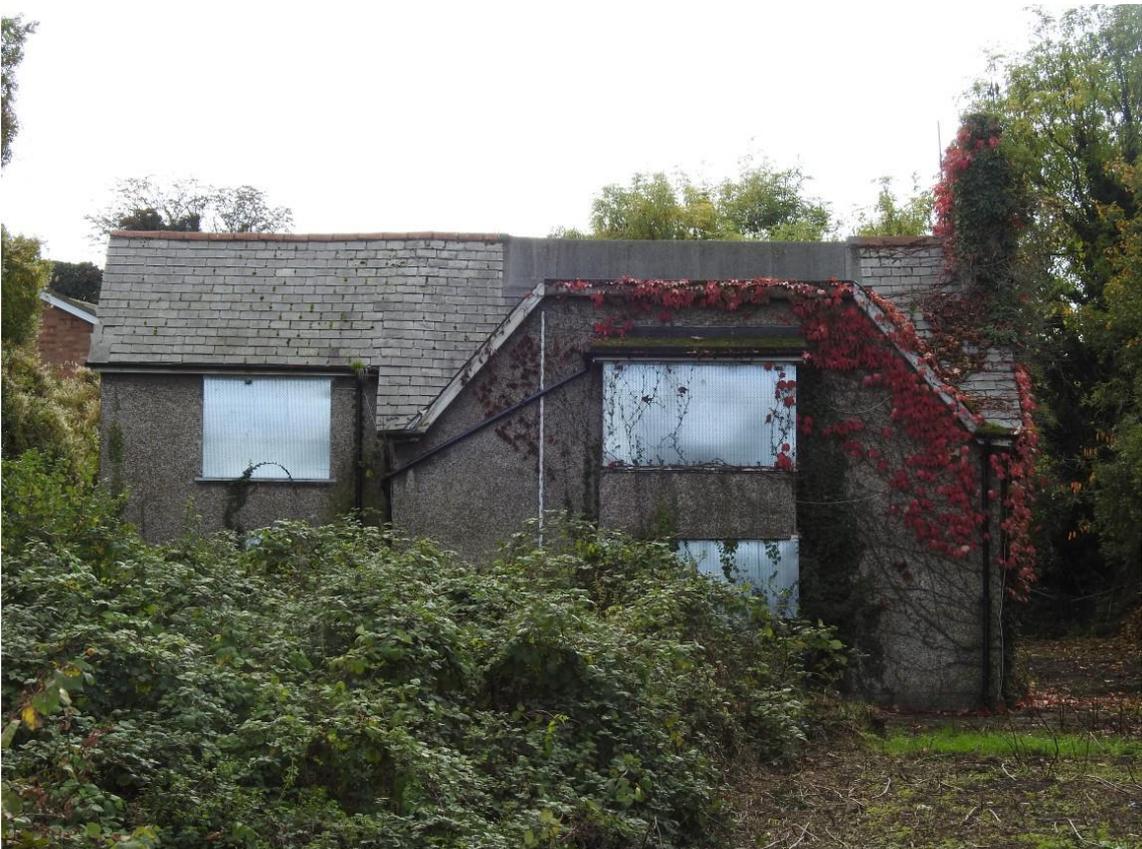
Plate 5: Northern elevation, five metres scale.

- To the east of the elevation, one window on the lower storey with a larger window on the upper storey set above it, directly under the eaves.
- Two storey bay set with one window on each storey (Plates 5, 6).

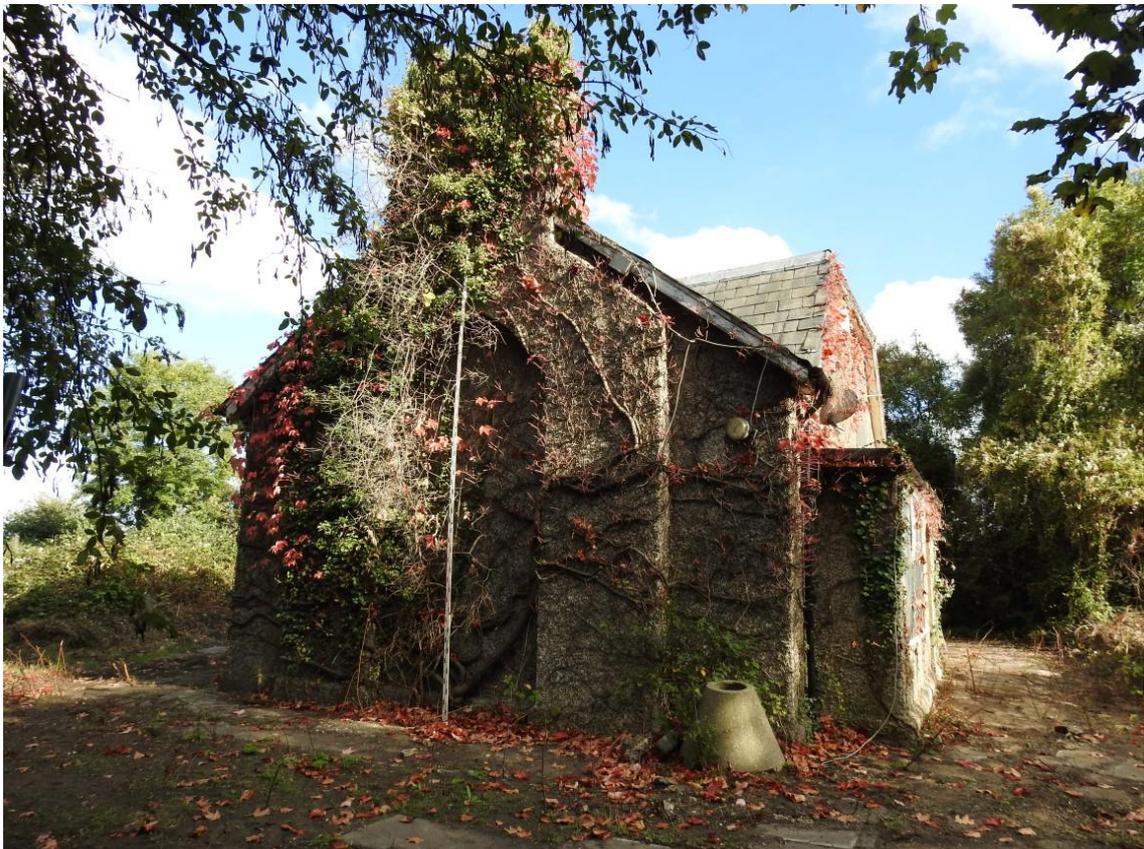
Plate 7: Western elevation

- The western elevation is dominated by a large split chimney stack extending from the gable ridge forming a roughly inverted Y-shape (Plate 7).

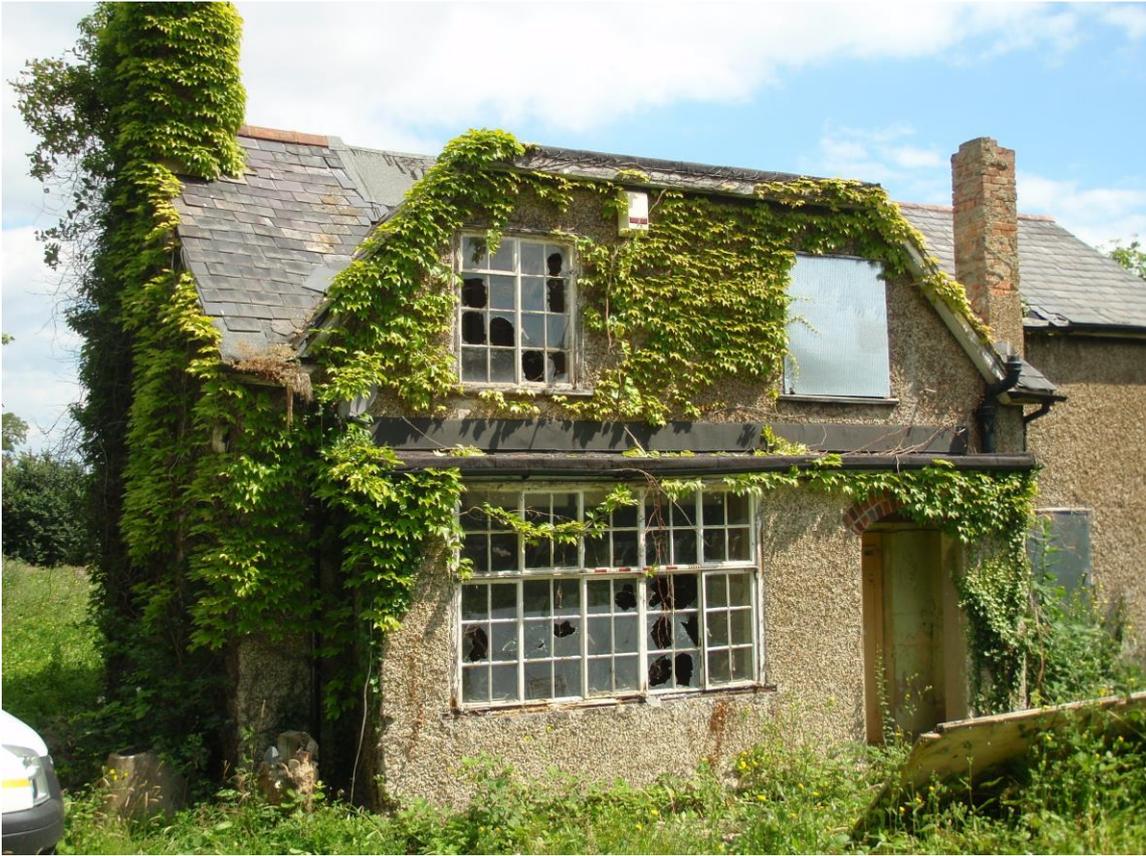
- Large wall dormer to the west of the elevation, set with two windows.
- Beneath the dormer is a narrow flat felt-roofed extension containing a porch to the east and a long window to the west.
- The porch opening is surmounted by a two-ring brick arch.
- The eastern third of the southern elevation has a larger eave height, and has a single narrow elevated chimney stack emerging from the side of the building at two metres up. To the east of this is a single window set low to the ground (Plates 8, 9).

Plate 8: South elevation shutters removed

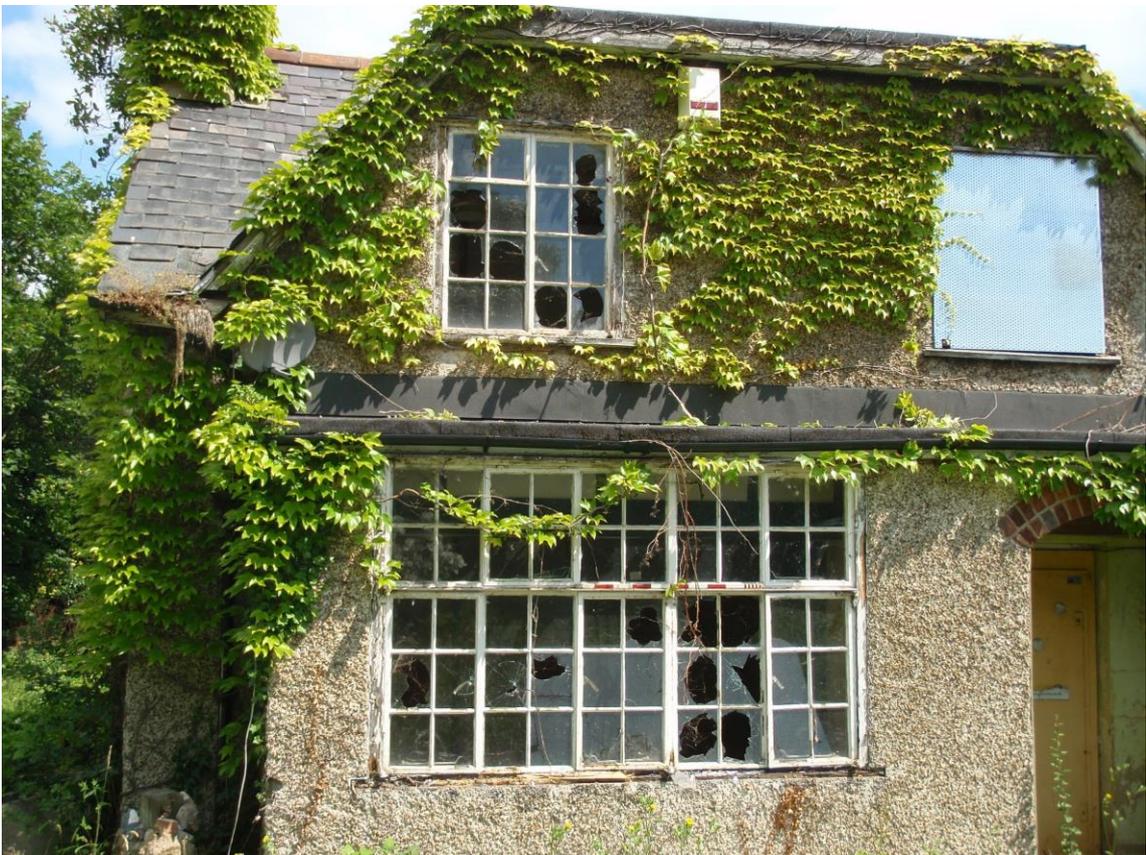
Plate 9: South elevation detail of windows

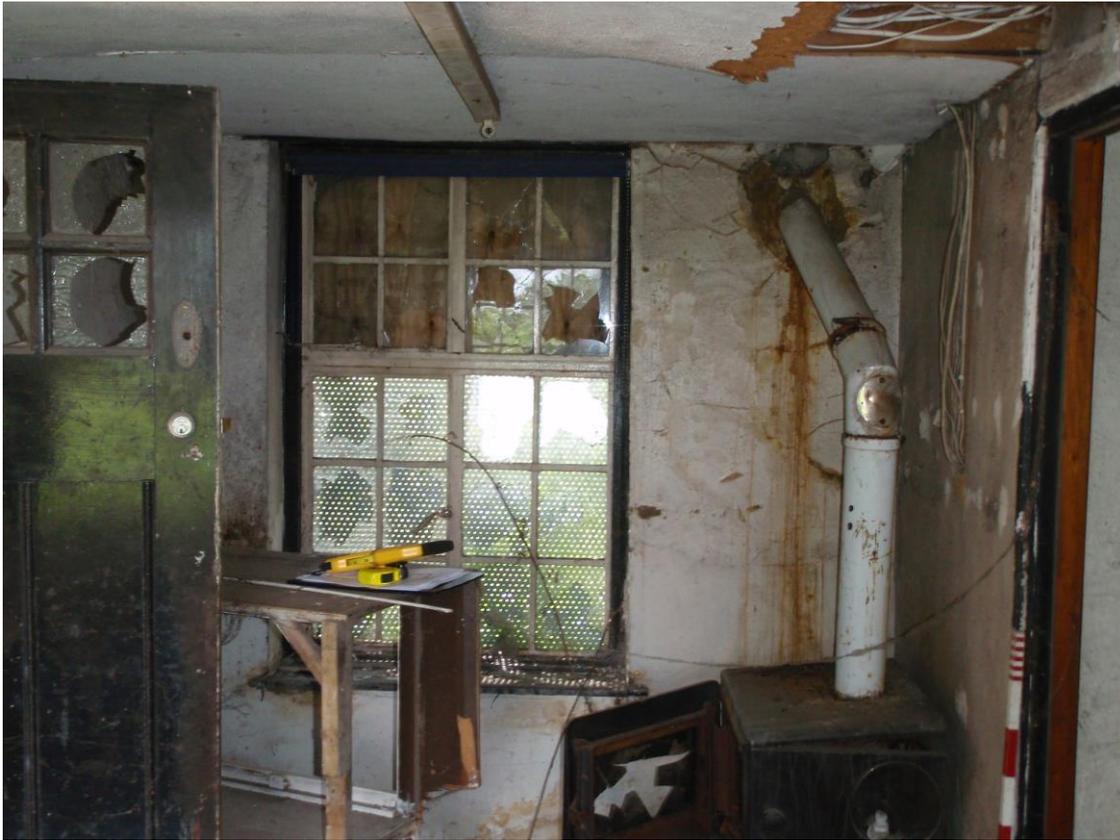
Room 1 is located on the east side of the building and is accessed by a side door (Plate 11) with a lobby to the left and a small passage which leads into the kitchen (Plate 10). The kitchen measures 2.25m X 4.5m is lighted by two windows, one in the north wall and the other in the south wall. Both windows are Crittall framed with clear glass. In the corner is the remains of a 20th century boiler (Plate 10). The ceiling is plasterboard, walls plastered and the floor concrete (Figure 4).

Plate 10: Room One with outside access door on left (looking SW)

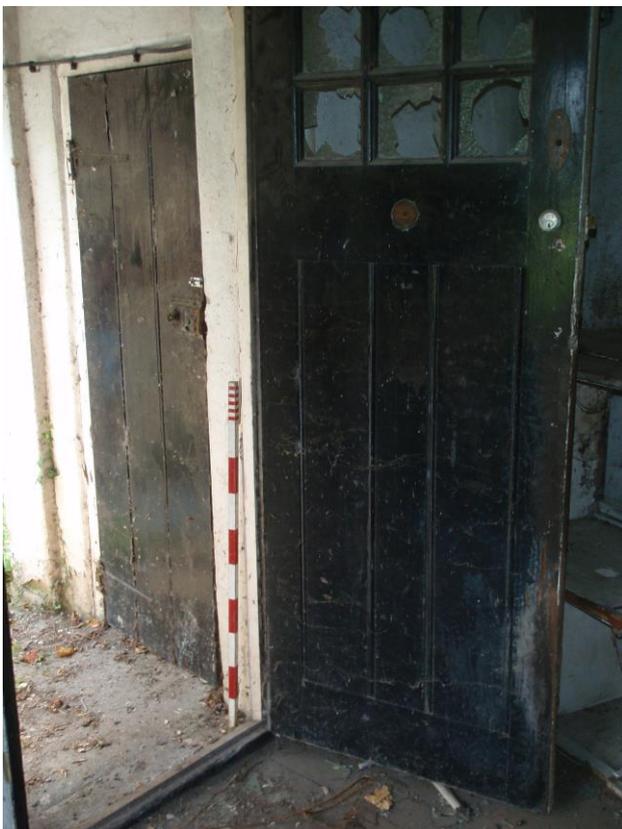
Plate 11: Side access door Room One (looking south)

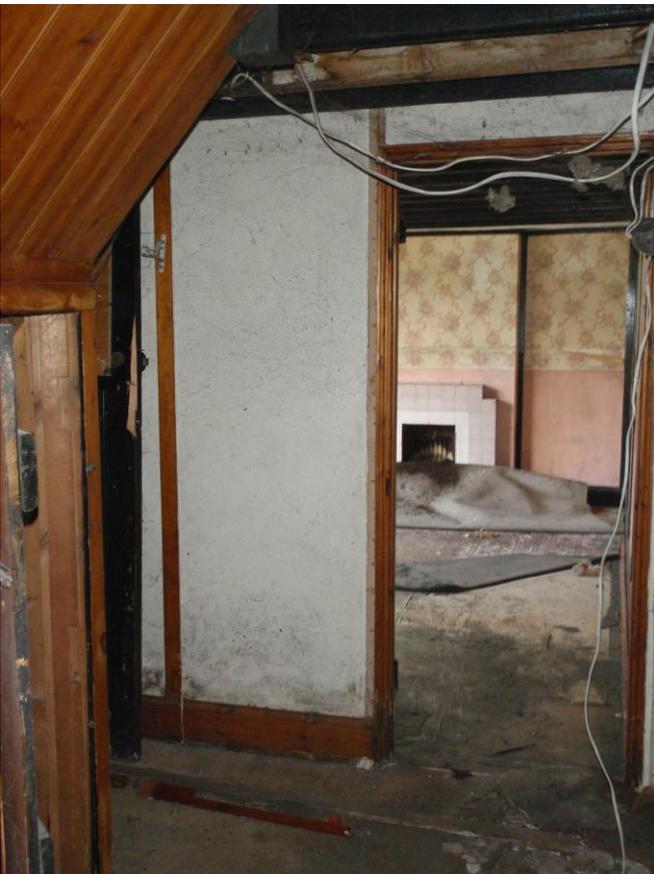
Room 2 is located in front of house and measures 3.6m X 4.05m and faces south. It is accessed from the front door located to the east of Room 2 and leads into a lobby with stairs to the right (Plate 13). The main features of the room are a fireplace located on the west wall and a feature bay window located centrally on the south wall (Plate 9). Neither features have any architectural merit (Plates 9, 12, 14, 24). Wall decoration is plasterboard panels framed with dark stained timber frames and infill panels decorated with 20th century wallpaper with pictorial patterns. The ceiling is plasterboard with dark stained exposed false joists (Plate 14).

Plate 13: Corridor from front door leading to Room Two

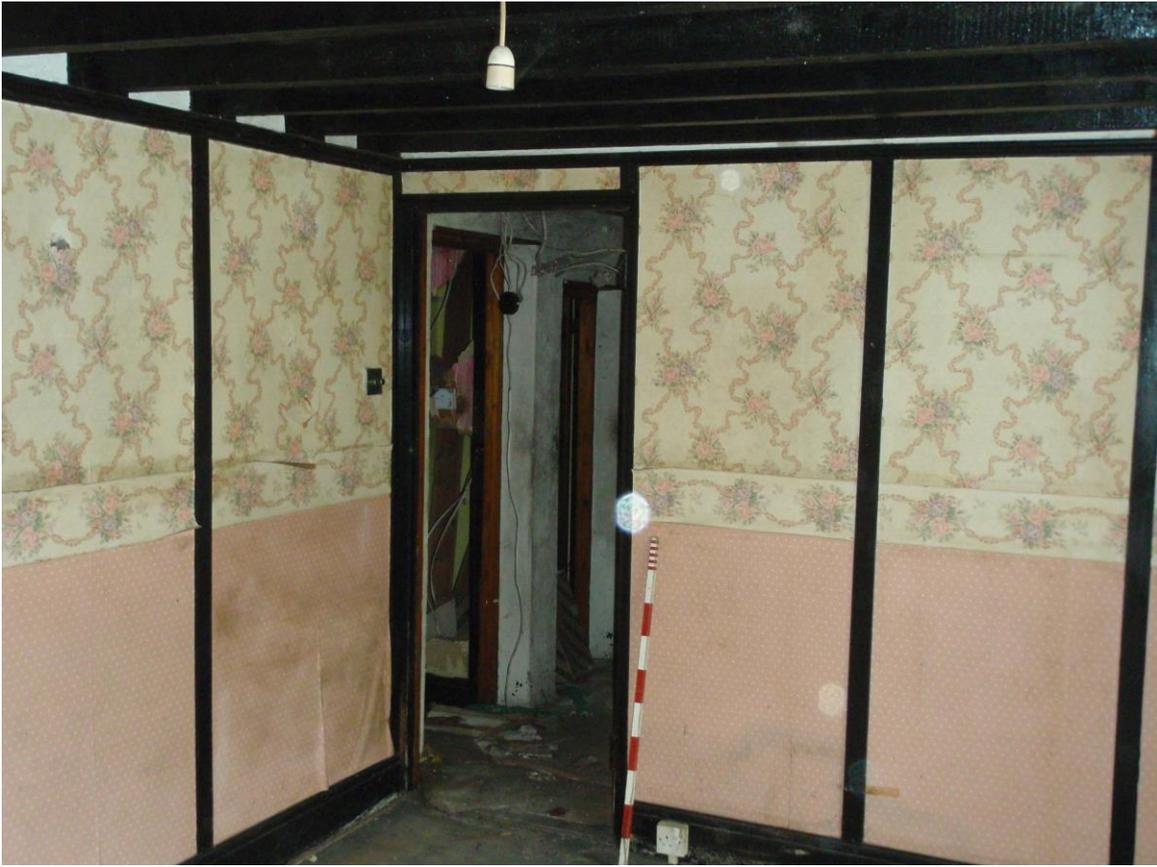
Plate 14: Room Two looking east towards front door passage and stairs. Room Three on left

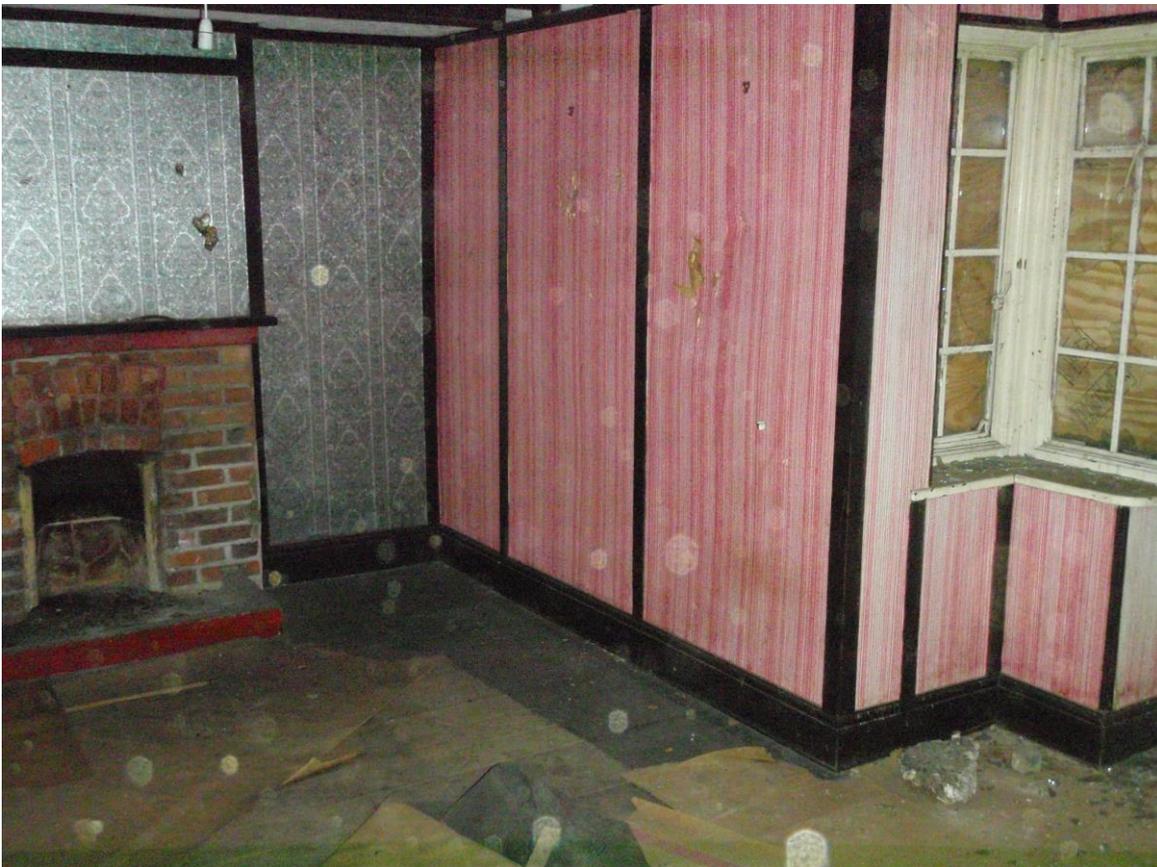
Room 3 is located to the rear of the house and measures 2.9m X 7.2m and faces north. It is accessed from the lobby located to the south (Plates 17, 18). The main features are the bay window which faces north and a brick fireplace on the west wall (Plate 15). Neither features have any architectural merit (Plates 15, 16, 18). Wall decoration is plasterboard panels framed with dark stained timber frames and infill panels decorated with 20th century wallpaper with pink and grey pictorial patterns. The ceiling is plasterboard with dark stained exposed false joists (Plate 16).

Plate 15: Room Three looking west

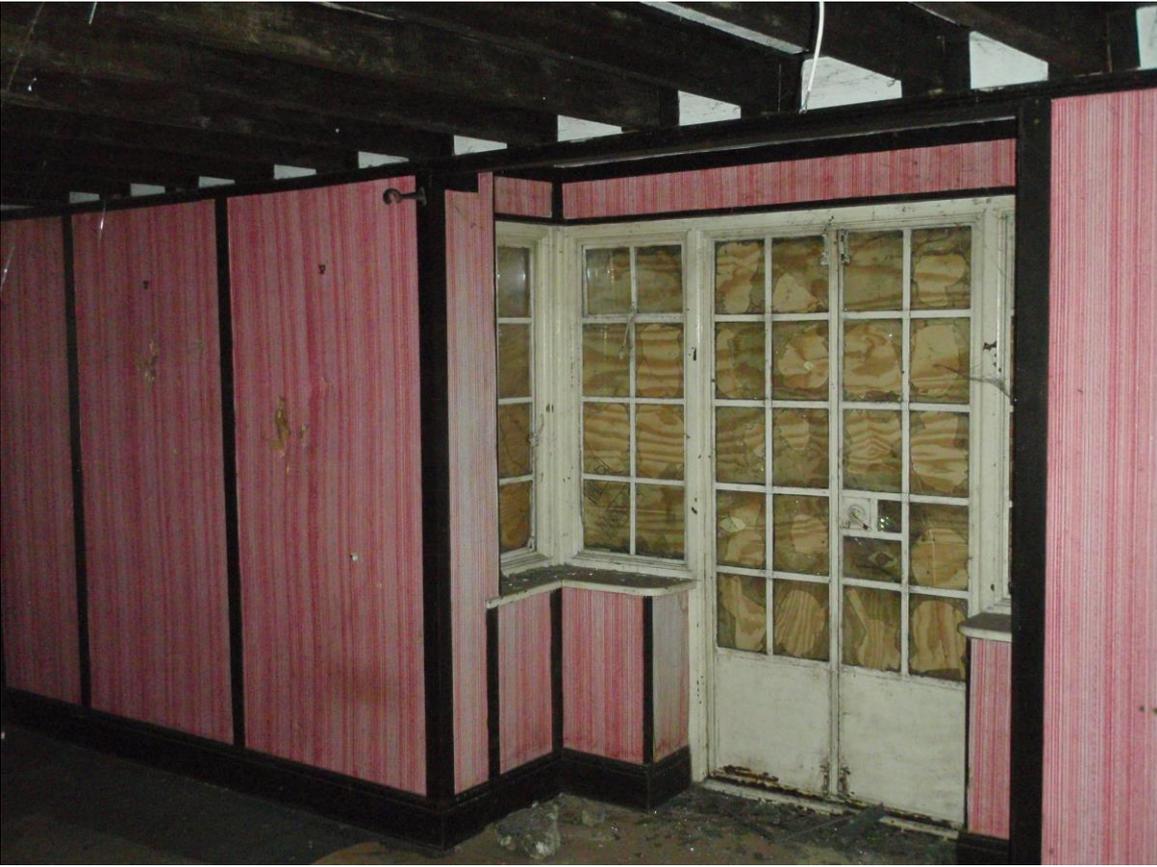
Plate 16: Room Three French doors to rear garden (looking north)

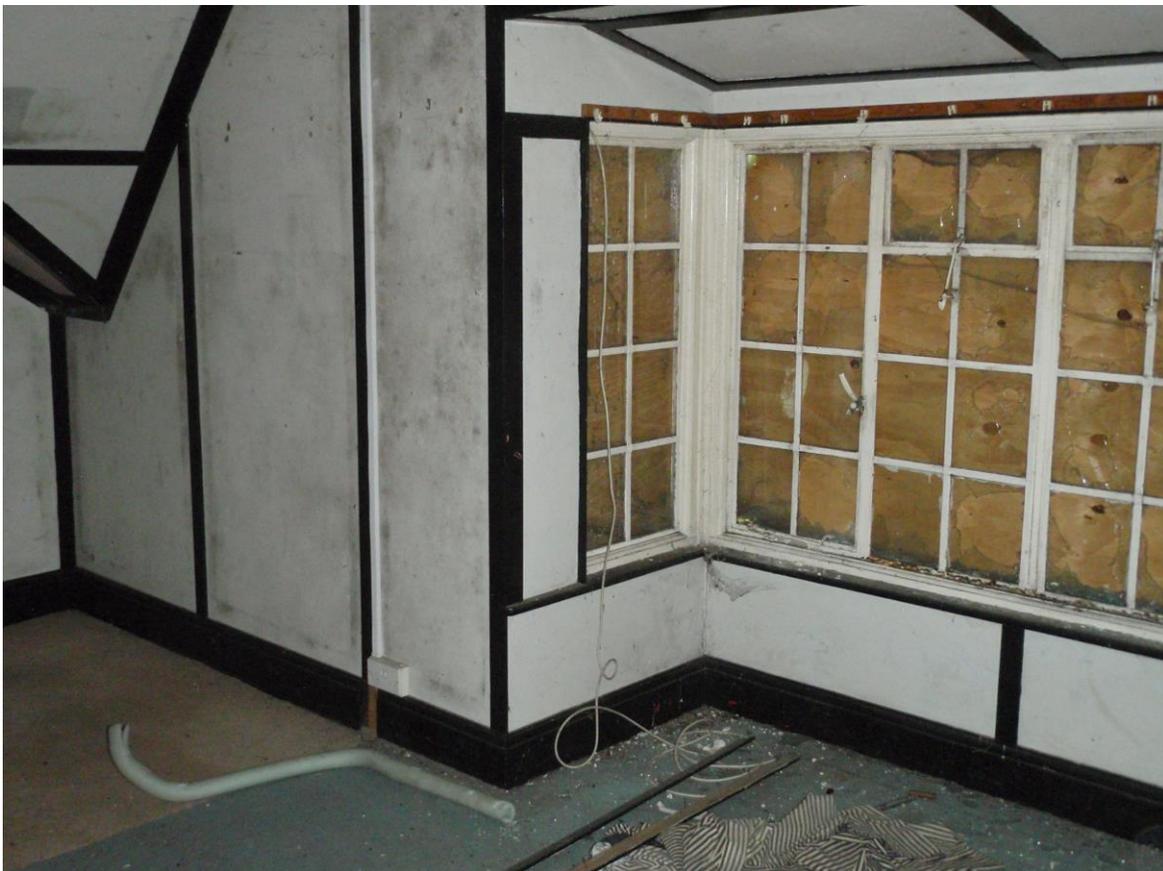
Room 6 is an upstairs bedroom and measures 4.5m X 3m and faces north with a sloping roof and boarded up fireplace with wall and ceiling finished with plasterboard panels painted white (Plate 19 and Figure 5).

Plate 19: Room Six upstairs bedroom (looking north)

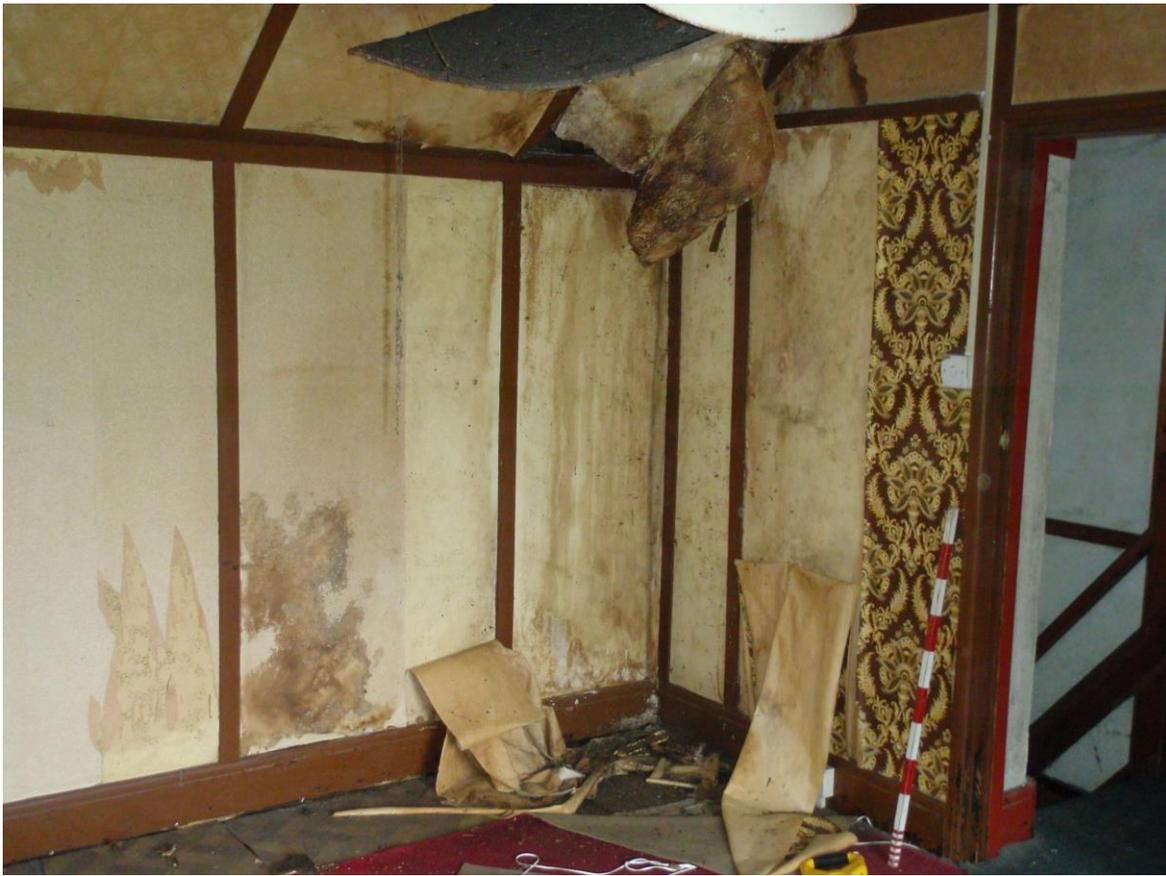
Room 5 is an upstairs bedroom and measures 4.5m X 3m and faces south with a sloping roof with wall and ceiling finished with plasterboard panels decorated with pictorial wallpaper now in poor condition (Plates 20, 21).

Plate 20: Upstairs Room Five looking west towards staircase and landing

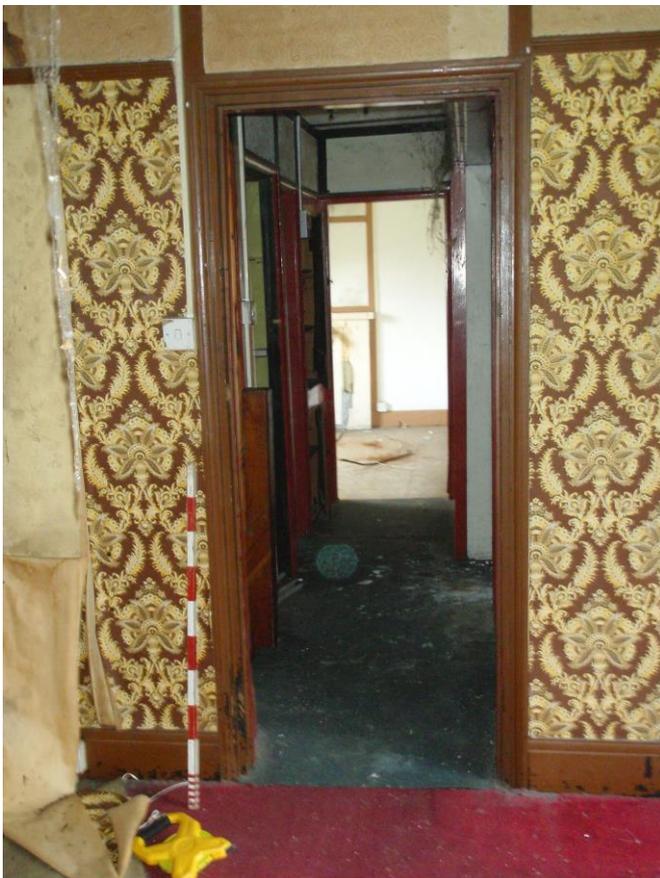
Plate 21: Room Five looking through landing to Room Four

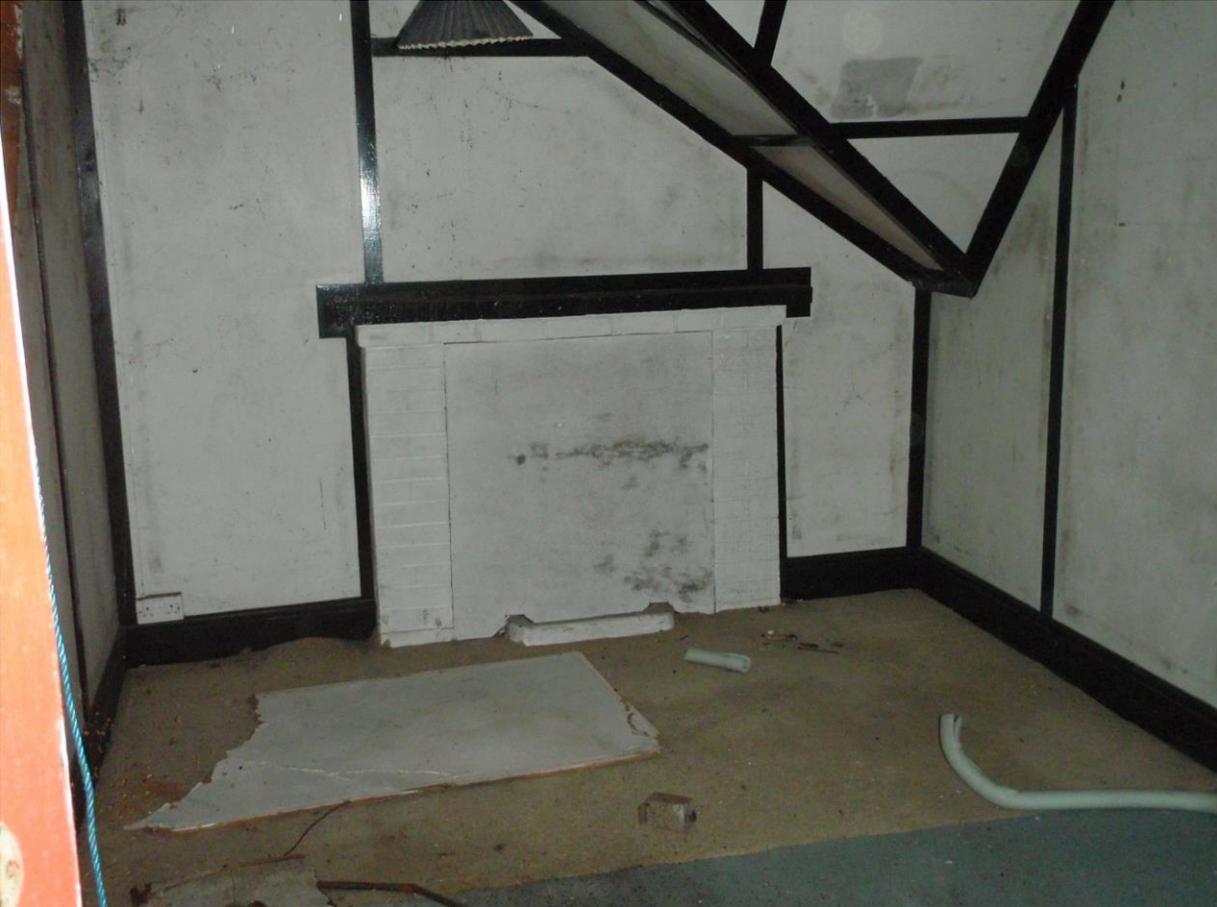
Room 4 is an upstairs bedroom and measures 3.6m X 3m and faces south with a sloping roof and boarded up fireplace with wall and ceiling finished with plasterboard panels painted white (Plate 22).

Plate 22: Room Four (looking west)

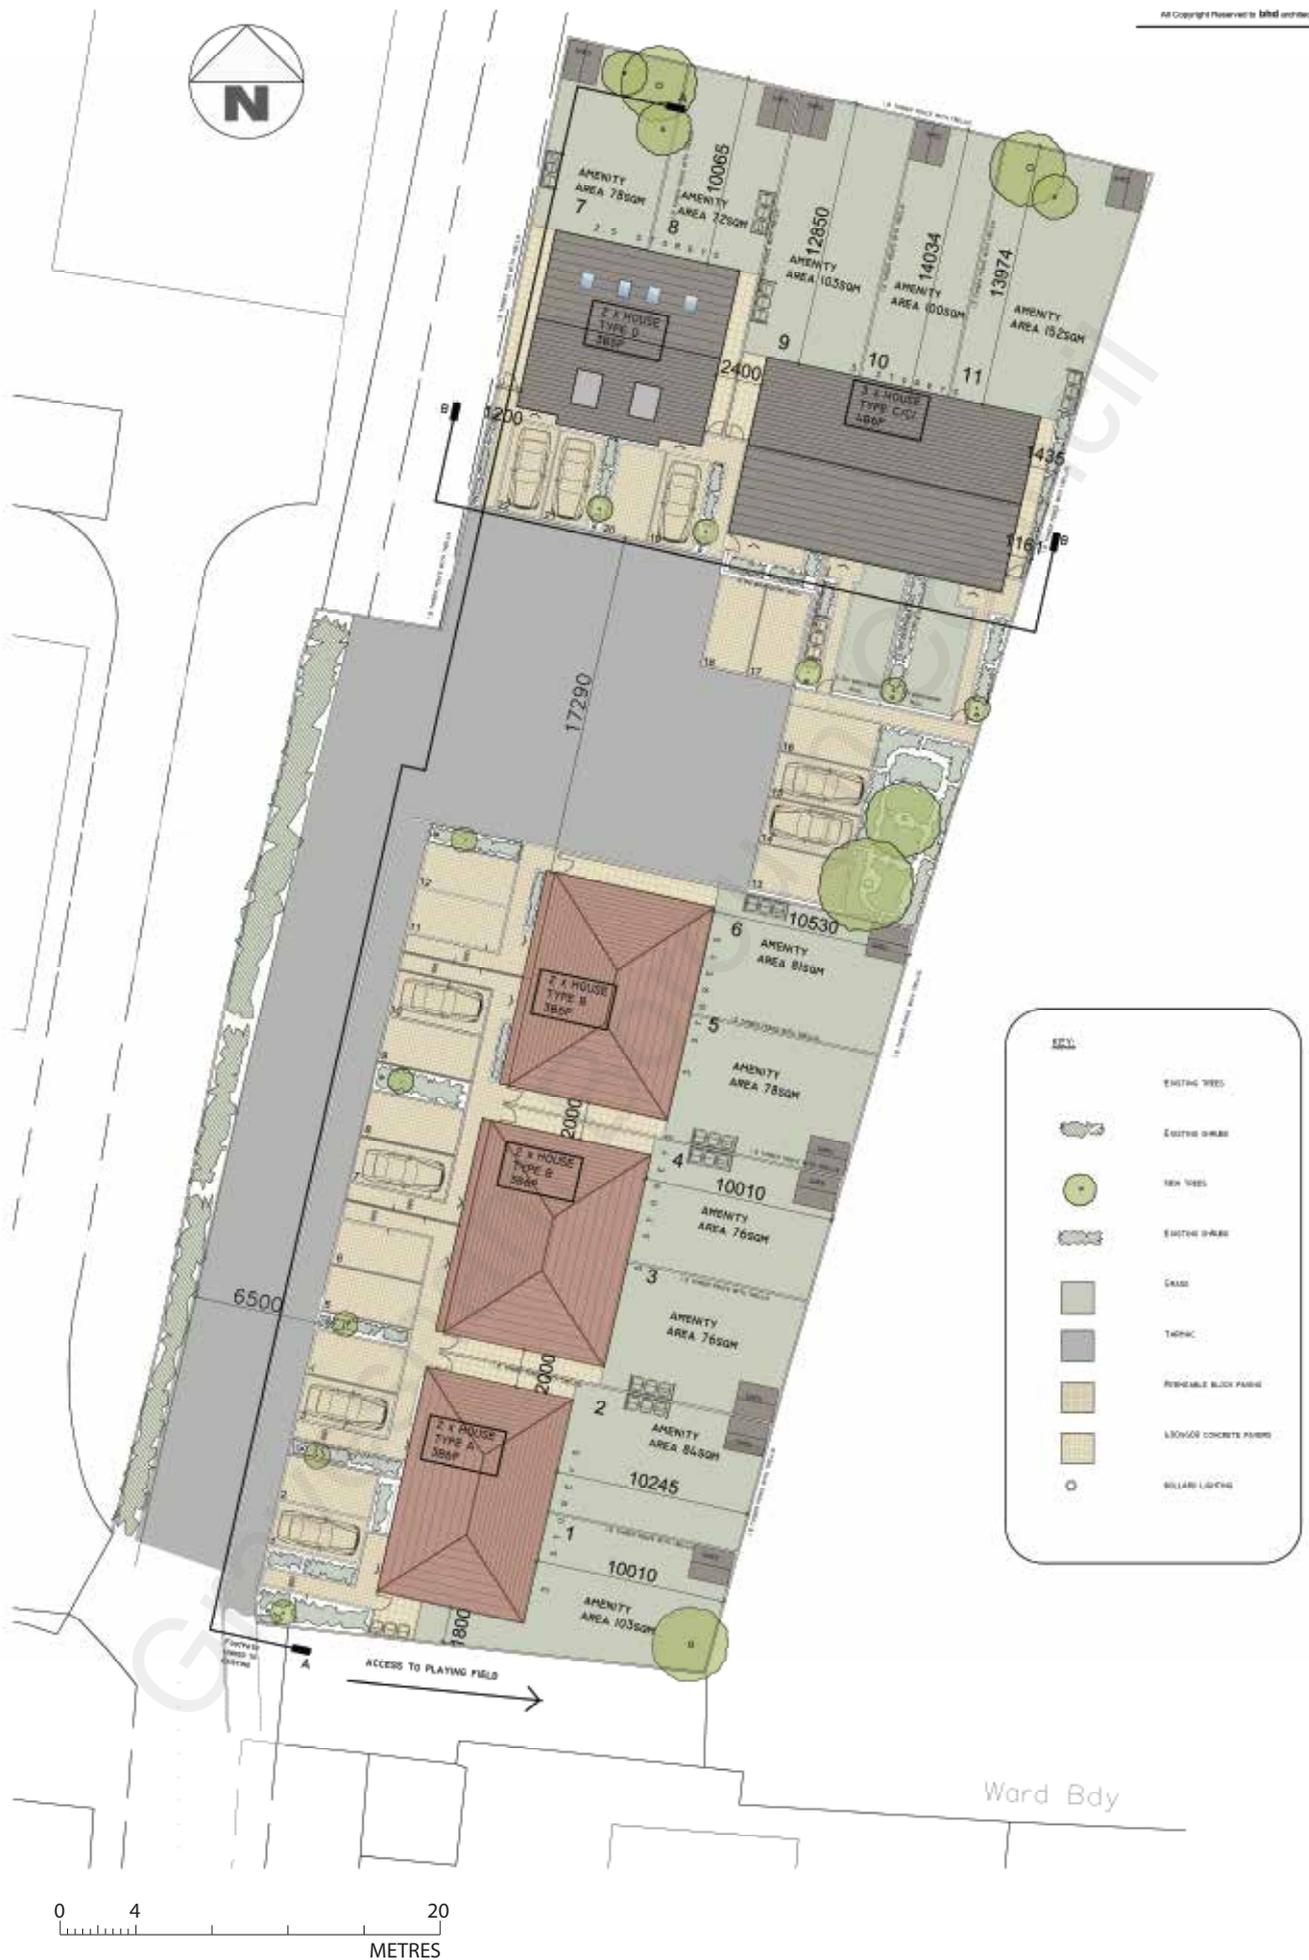
Figure 3: Proposed development

5.1 A review of the proposed development proposals show that Bailiffs Cottage is to be demolished and recording of the building is a planning condition. The survey of the building has shown there is little if any structure or architectural details of merit or in need of special recording.
