HISTORIC BUILDING RECORDING OF THE BEACON CHURCH, LONDON ROAD, DOVER, KENT

1.0 INTRODUCTION

1.1 In February 2019 Dr Paul Wilkinson of SWAT Archaeology carried out a historic building recording of the Beacon Church, London Road, Dover in Kent (Figures 3-8). The building is presently unoccupied and is undergoing development and repair.

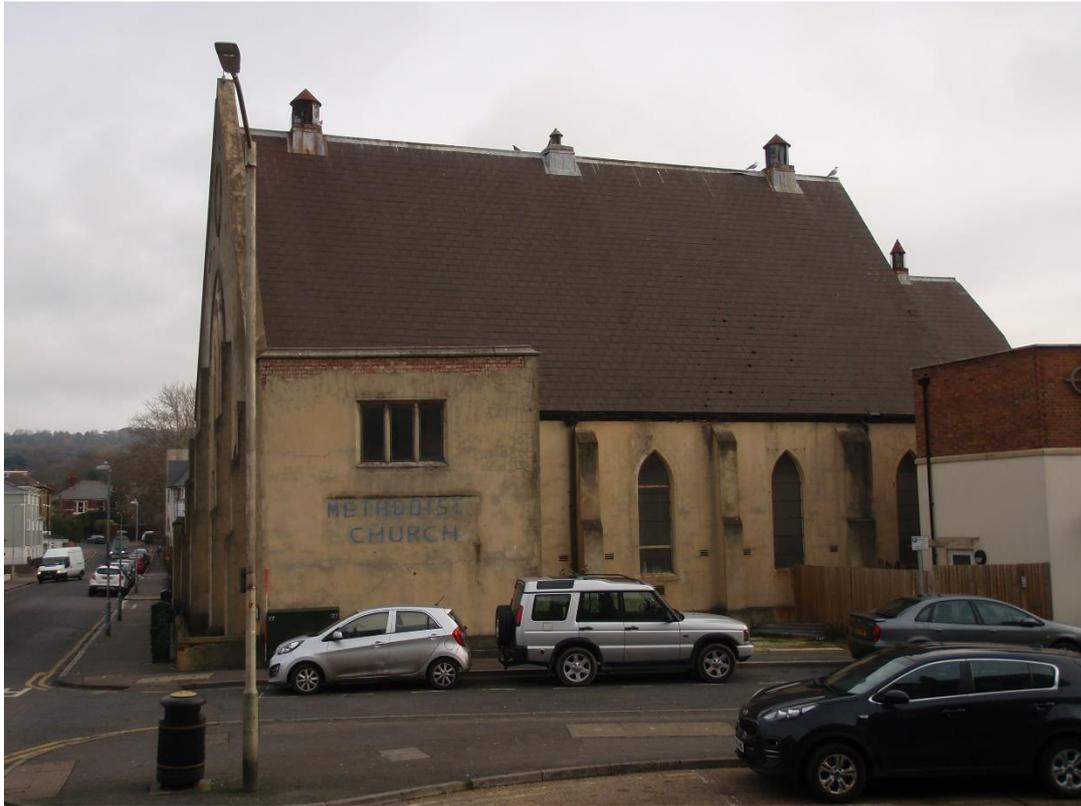
Plate 1. Exterior (looking north-east)

3.3 The north east frontage is faced with unpainted cement render and pierced by one doorway with two side windows all with lancet arches and a large window also with a lancet arch with three trefoil headed lights of which all are framed by four stepped buttress. All windows have had the glass removed and replaced with plastic sheeting (Plate 1. Figure 4).

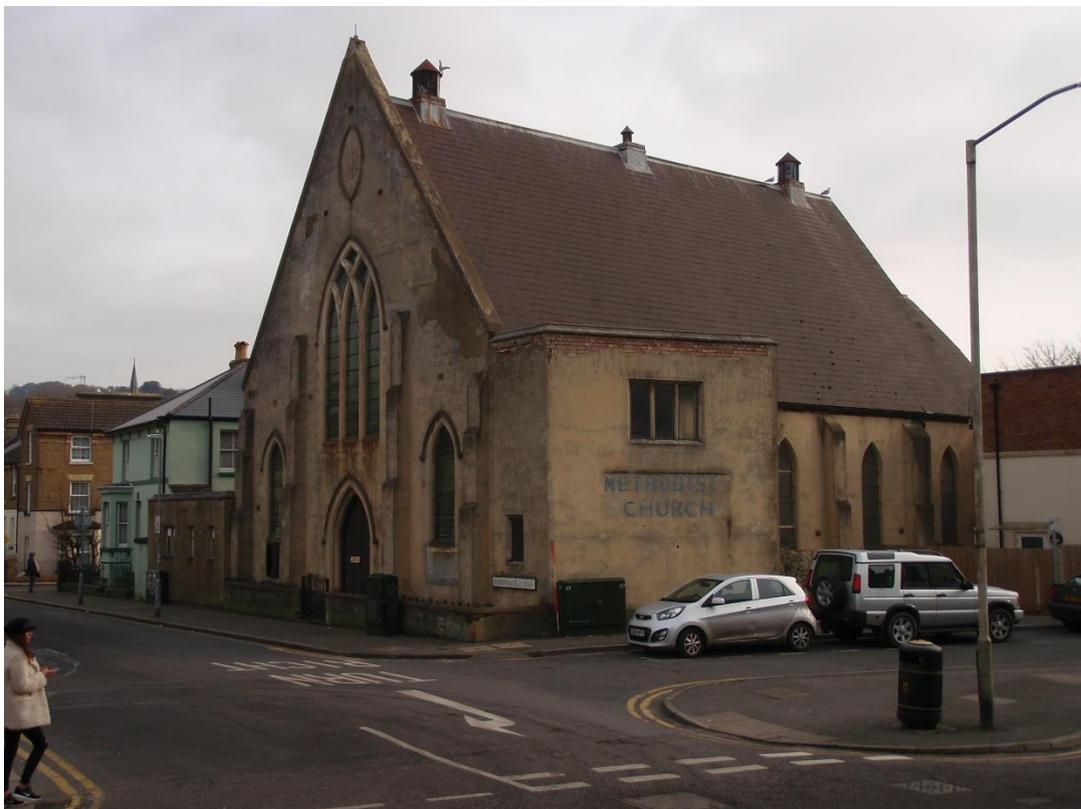
Plate 2. Front and side elevation (looking east)

The east facing side wall is cement render with three stepped buttress and to the north east a flat roofed double storey extension, again finished in a unpainted cement render and pierced by a rectangular mullioned window. For views of the exterior see: <https://www.youtube.com/watch?v=4x6Jw6orTEg>

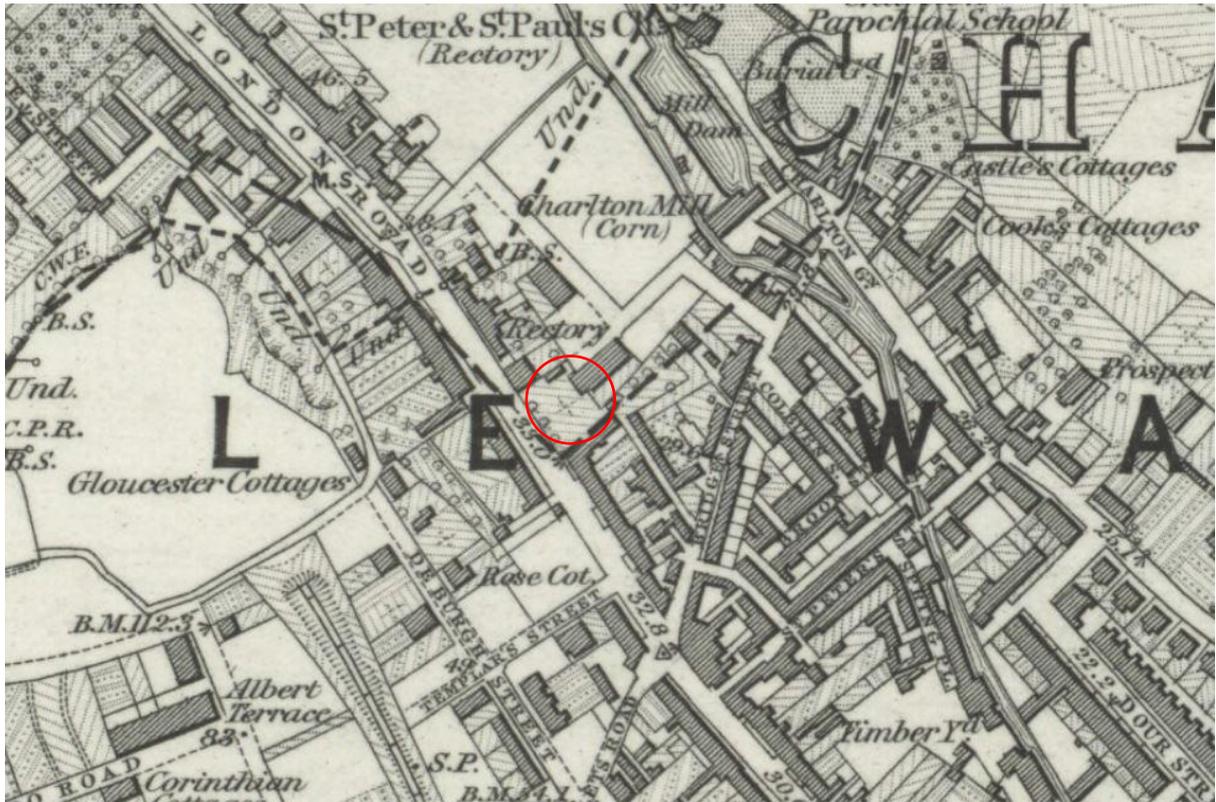
MAP/1 OS plan 1871

1.5 A review of Historic OS mapping has been made (MAP 1-3) and the Pevsner Architectural Guide (*Kent, North East and East 2013*) was consulted as was the National Heritage Register for England.

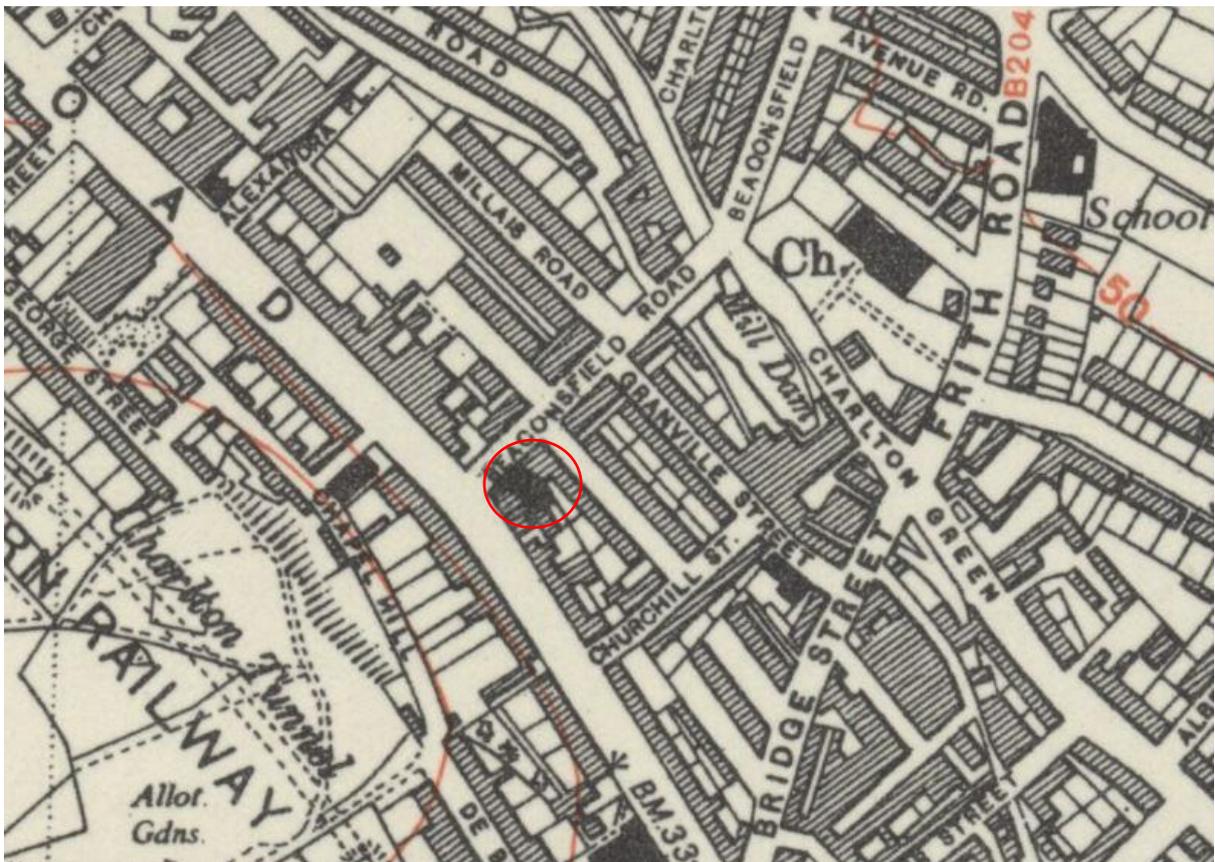
MAP/4 OS plan 1938

The OS map of 1938 shows the site fully developed (MAP 3).

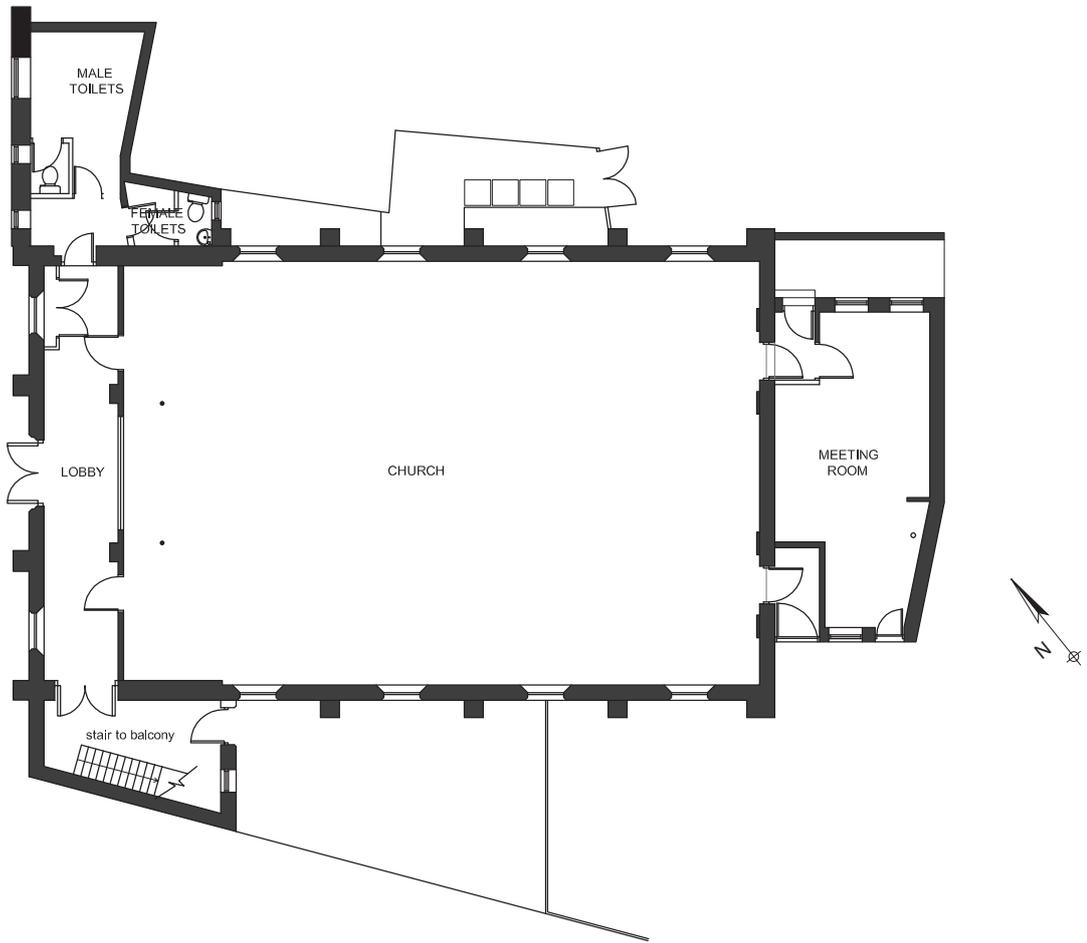
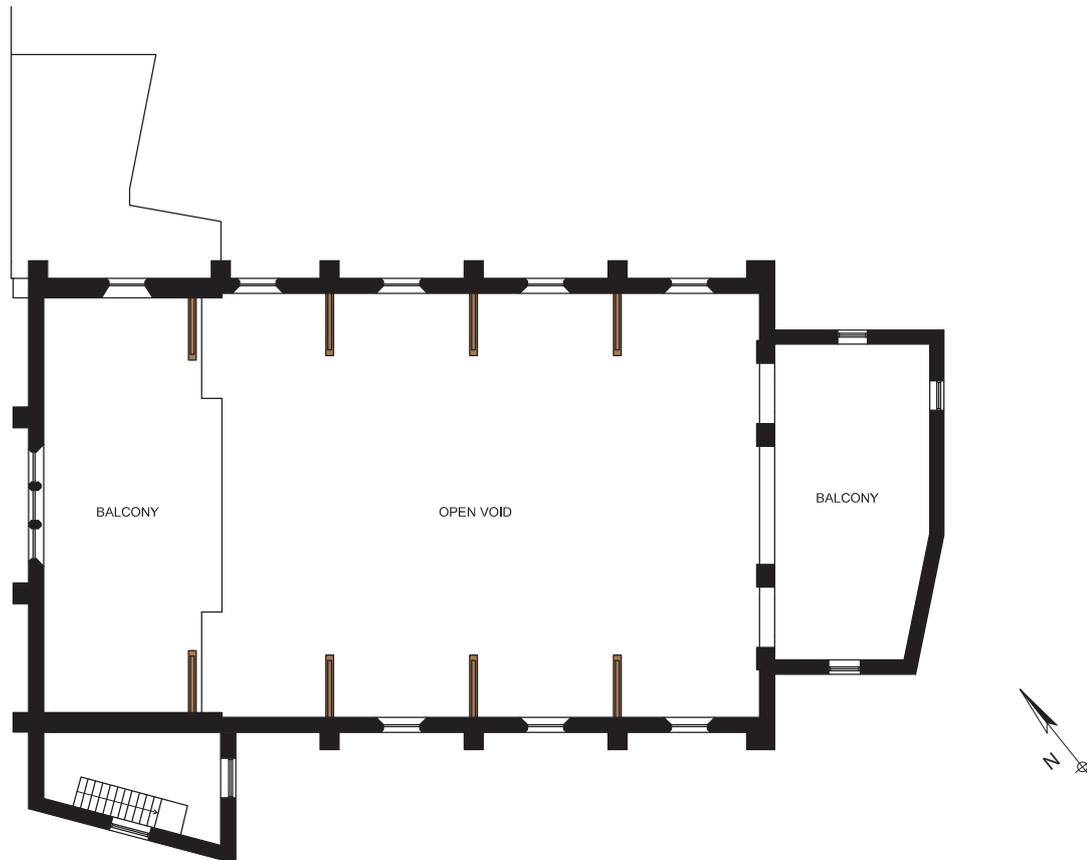
Figure 3: Floor plans.

The building is a seven room double storey building and is entered in the centre from the north-west, where a lobby gives access to the church hall and at the far end two doors lead into the meeting room. To the left of the lobby are the male and female toilets and to the right through double swing doors are stairs to the upper levels and balcony (Figure 3). The overall length of the current building is 19.20m. The width of the building including the rear extension but not including the front porch is 11.65m. The overall height is about 14.00m and to the gutter 6.00m.

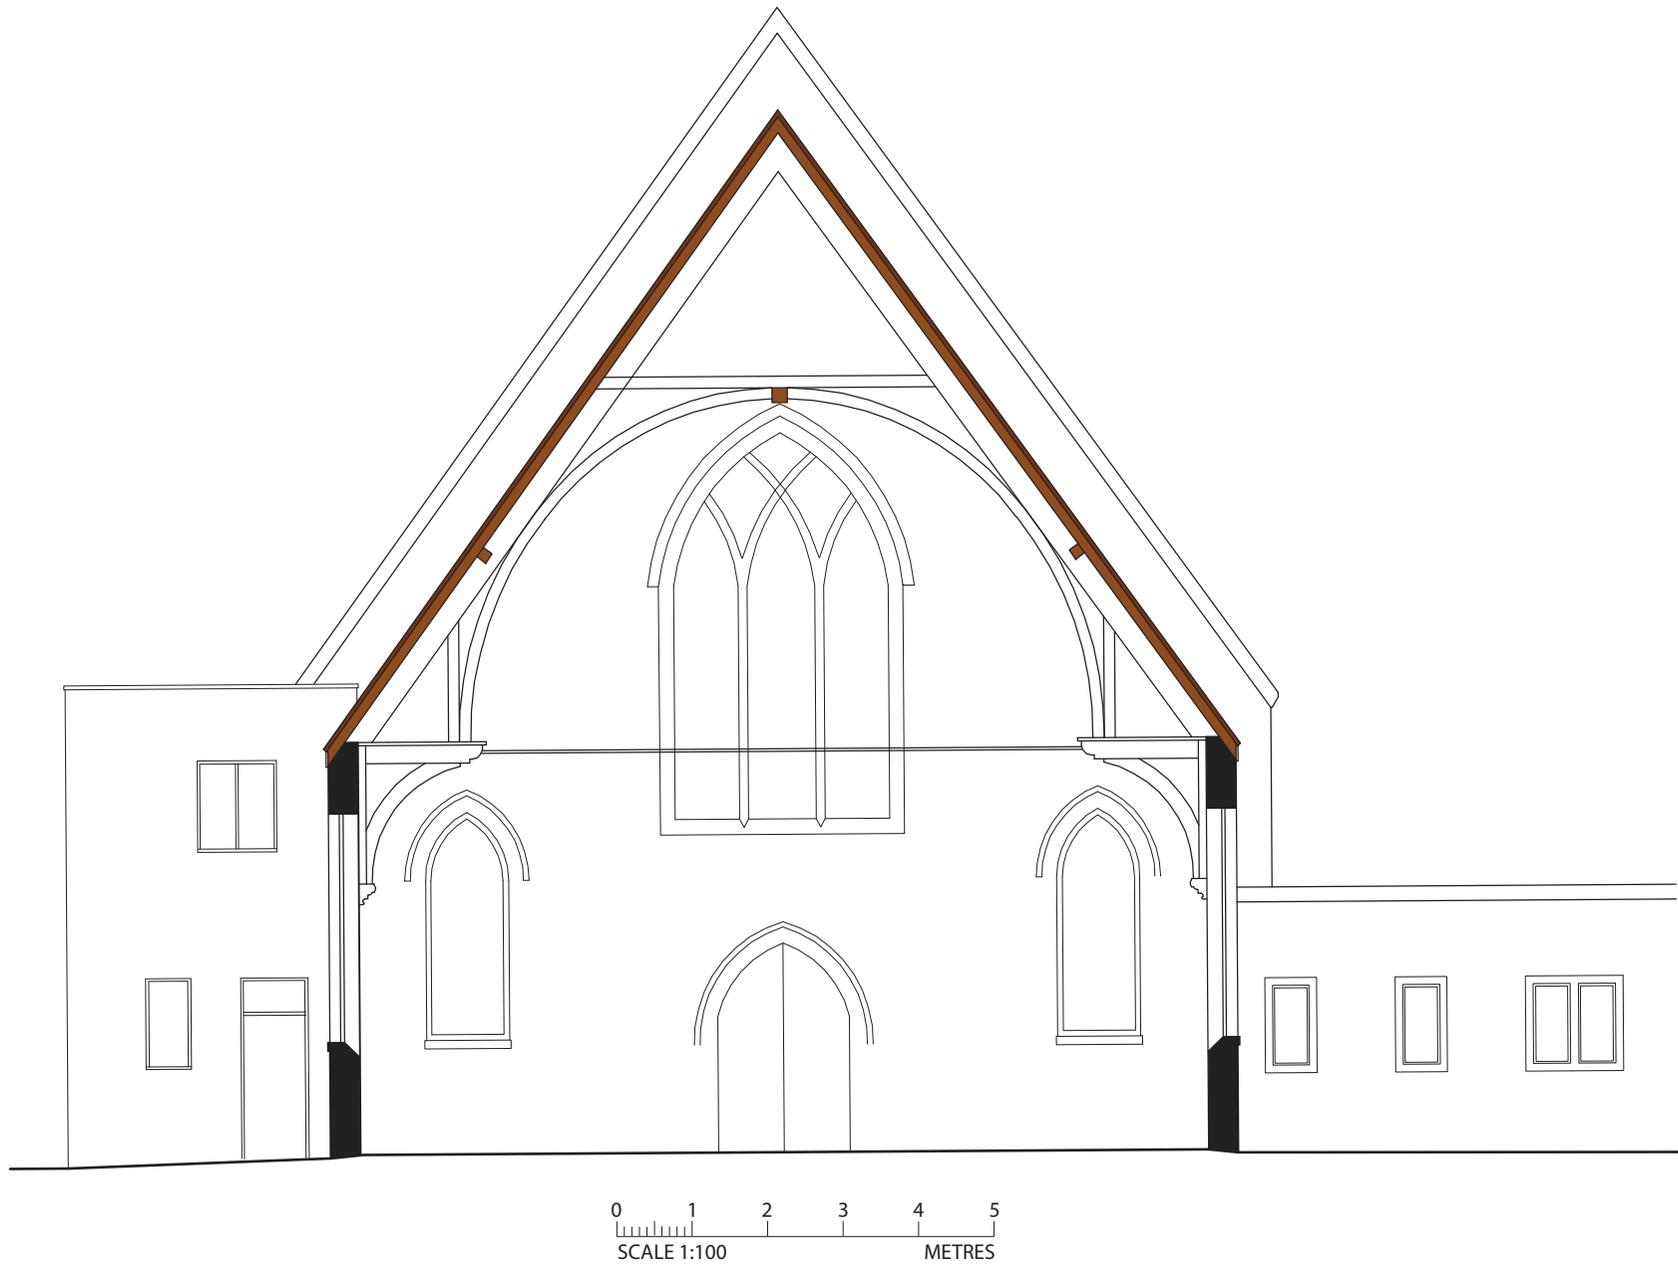
Figure 8: Cross-section

4.1 The interior of the building is of double storey height with a part exposed collar-braced or arch-braced hammer beam roof with ridge piece and collar beams. Most of the ancillary rooms are of 20th century construction and of little architectural merit. For views of the interior see: <https://www.youtube.com/watch?v=4x6Jw6orTEg>
