HISTORIC BUILDING RECORDING AT THE BLACK HOUSE, LOWER RAINHAM ROAD, RAINHAM, GILLINGHAM, KENT

January 2019

1.3 In summary the work consists of an analytic record of the infilled hearth and chimney in the western elevation accompanied by digital photographs and plans.

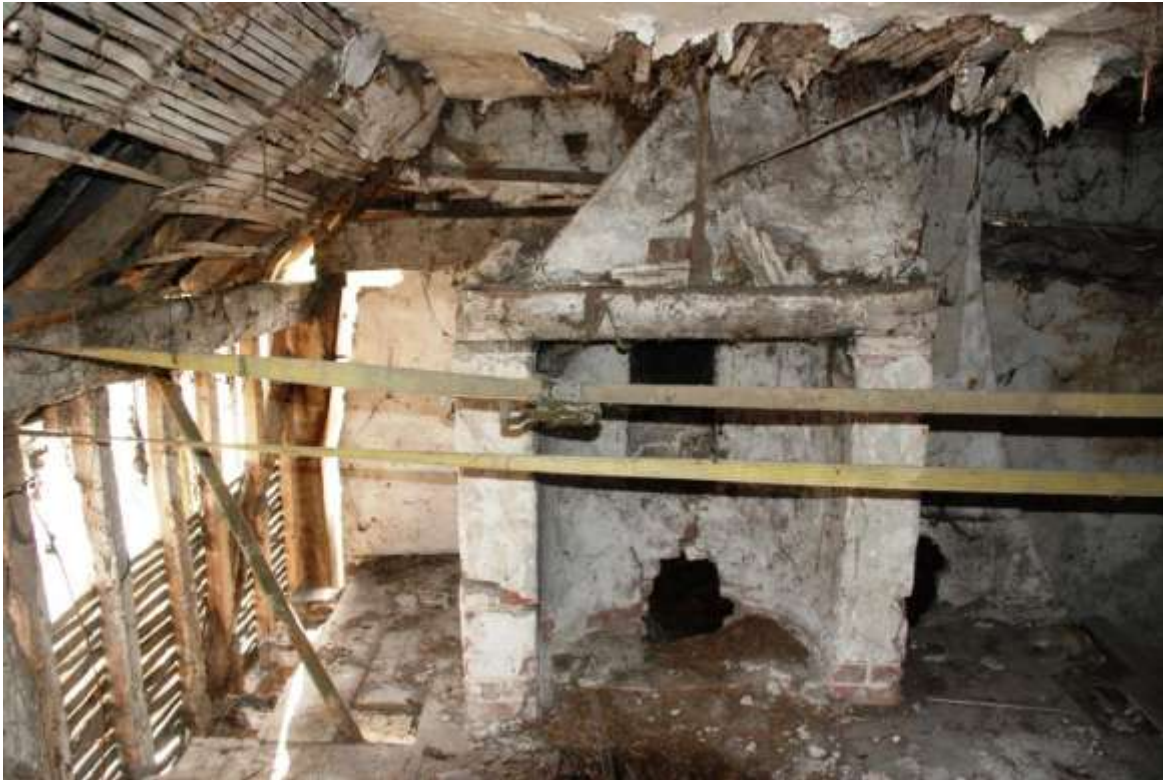
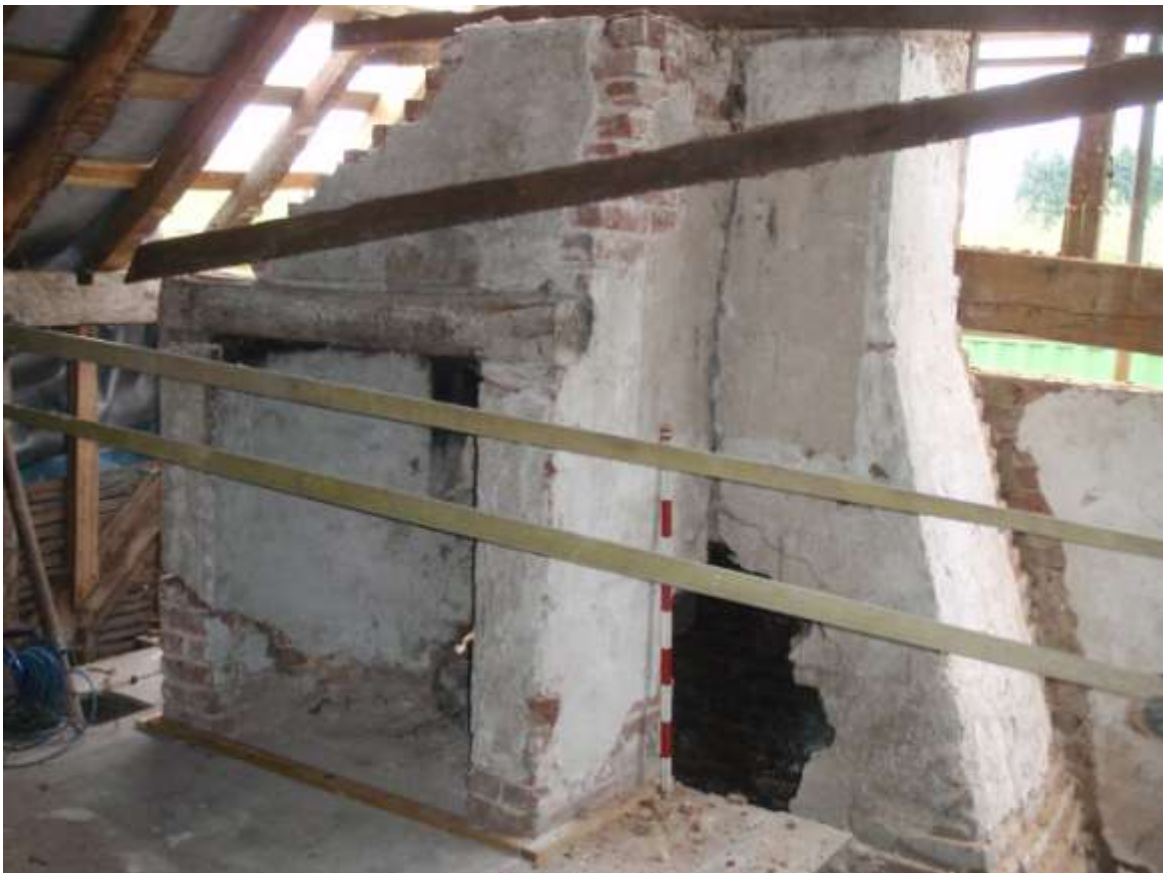
Plate 5. First Floor (looking east)

4.4 First-floor 17th century floorboards and fireplace with wooden bressumer and curved back. Roof has coupled rafters without ridge piece, collar beams with carpenter's marks and lath and plaster partition. Frame has jowled posts and diagonal tension braces (Plates 5-6).

4.7 The Phase 1 build had an arched opening springing from two brick piers with a surviving brick tilt on the upper courses. It is likely at this stage the building did not have an upper floor but the chimney stack was rebuilt as

Phase 2 with an additional fireplace on the upper floor and an additional flue (Drawing 11 and Plates 5-6).

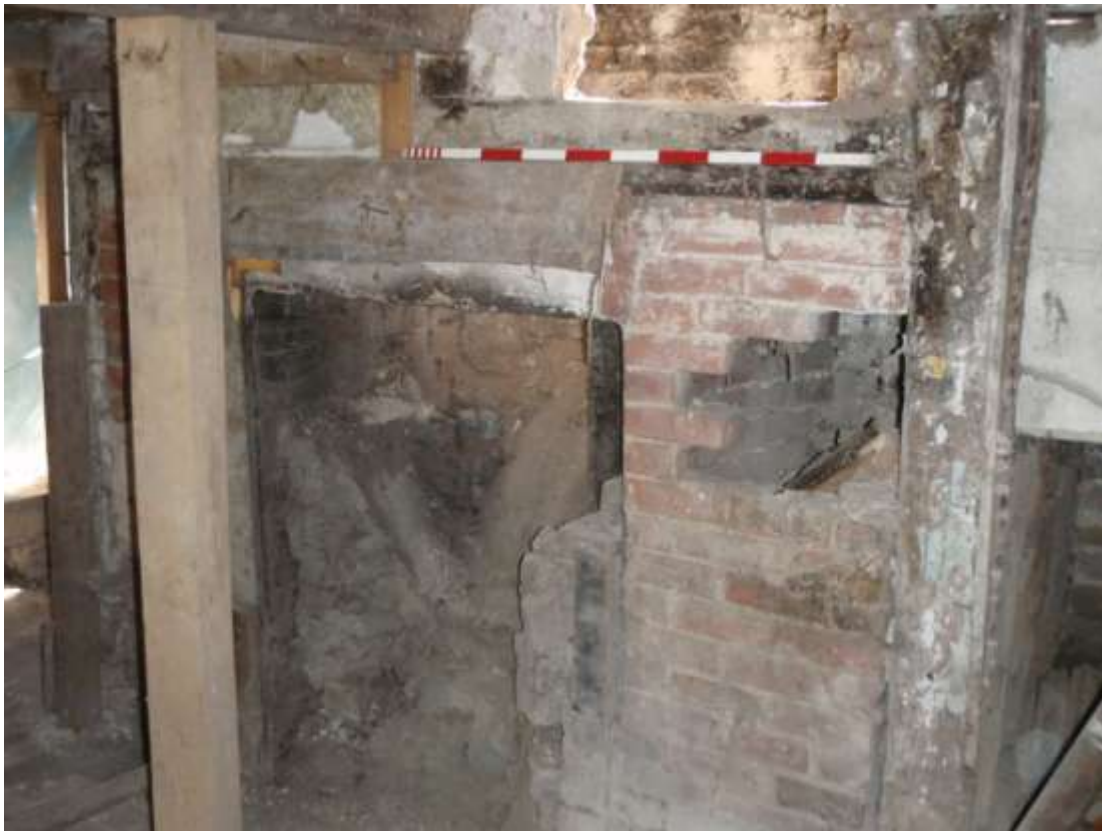
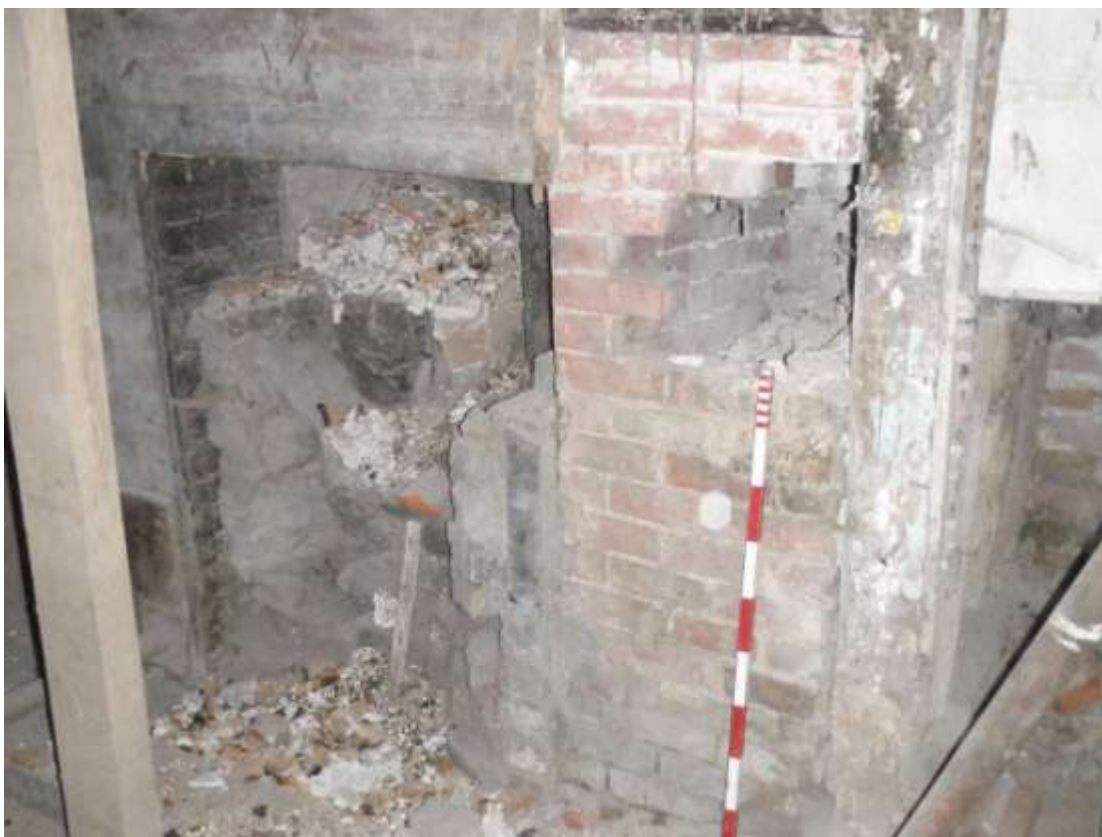
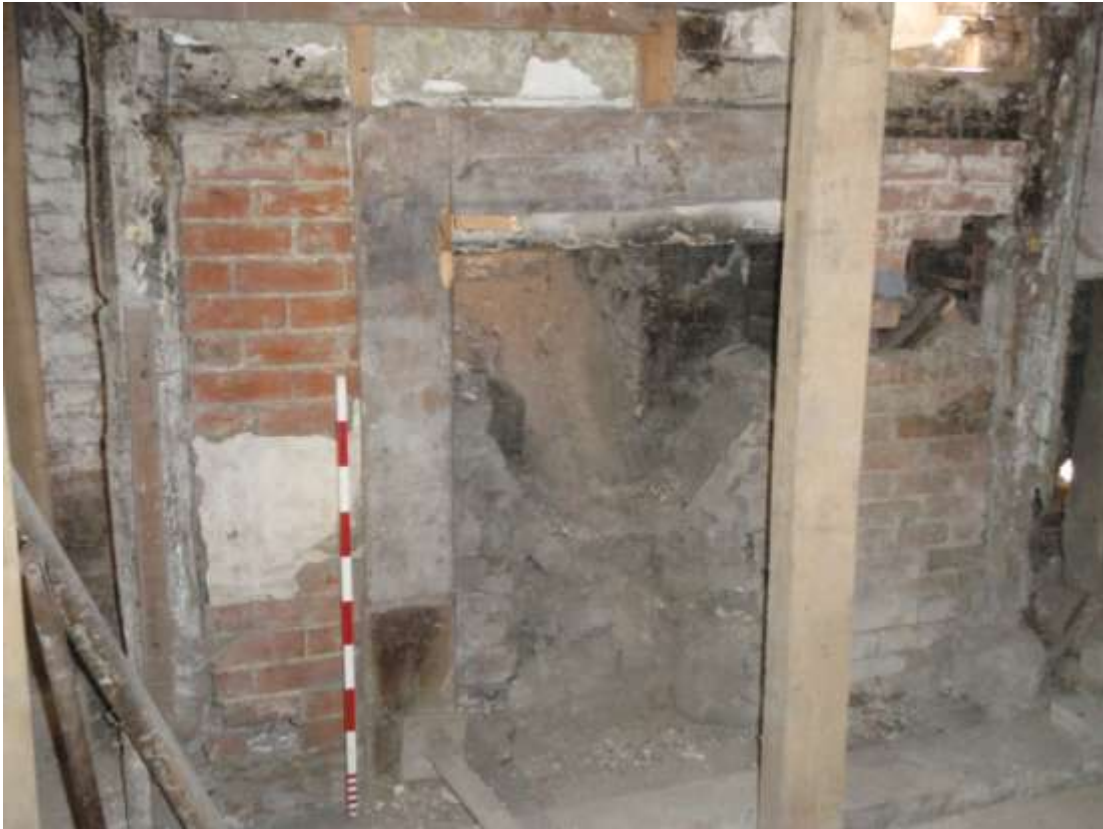
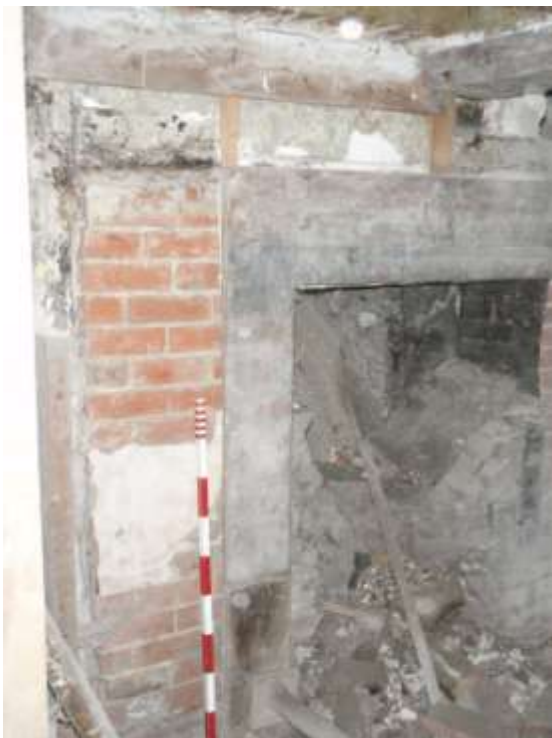
Plate 7. Ground Floor – close up fireplace

4.6 The fireplace is built of red to pink slightly frogged clay bricks measuring 220mm in length and width of 100mm and height of 70mm laid in a Flemish Bond and set in a pale creamy yellow brown fine sandy lime mortar mix of about 18mm thick (Drawing 11 and Plates 7-10).

4.8 As part of the Phase 2 rebuild the arched opening on the ground floor was dismantled and replaced by a 19th century brick soldier course sitting on iron bars. In addition two side walls were added, ground floor levels reduced and a winding staircase added and the access closed with machine cut timber T & G boarding fitted vertically with a later Victorian panelled door (Drawing 11 and Plates 7-10).

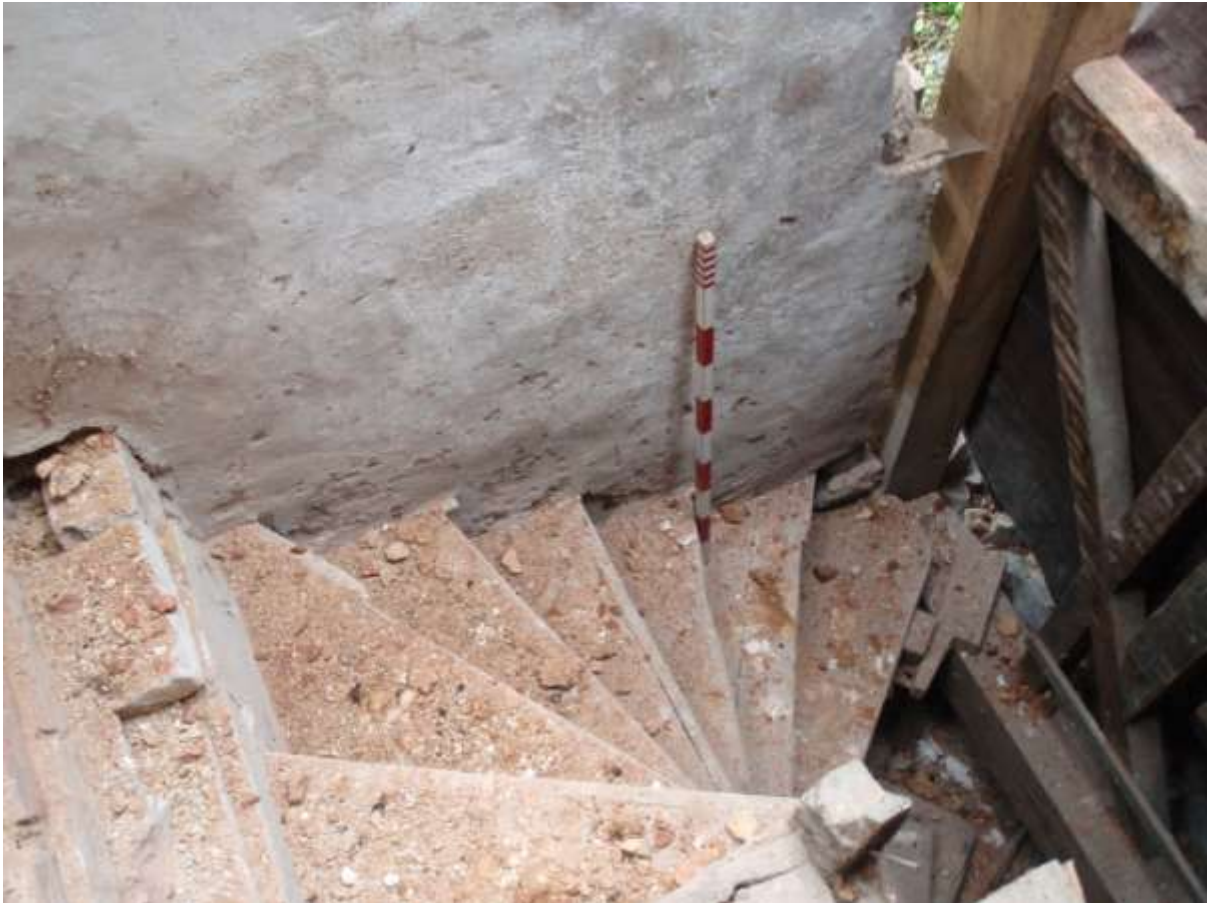
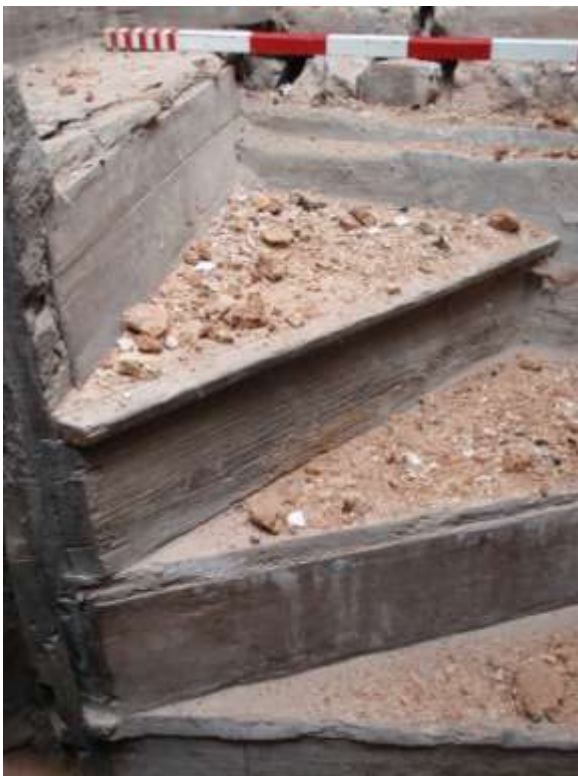
Plate 13. Stairs to the right of chimney

4.3 Eighteenth century wooden winder stair (Plates 13-14).

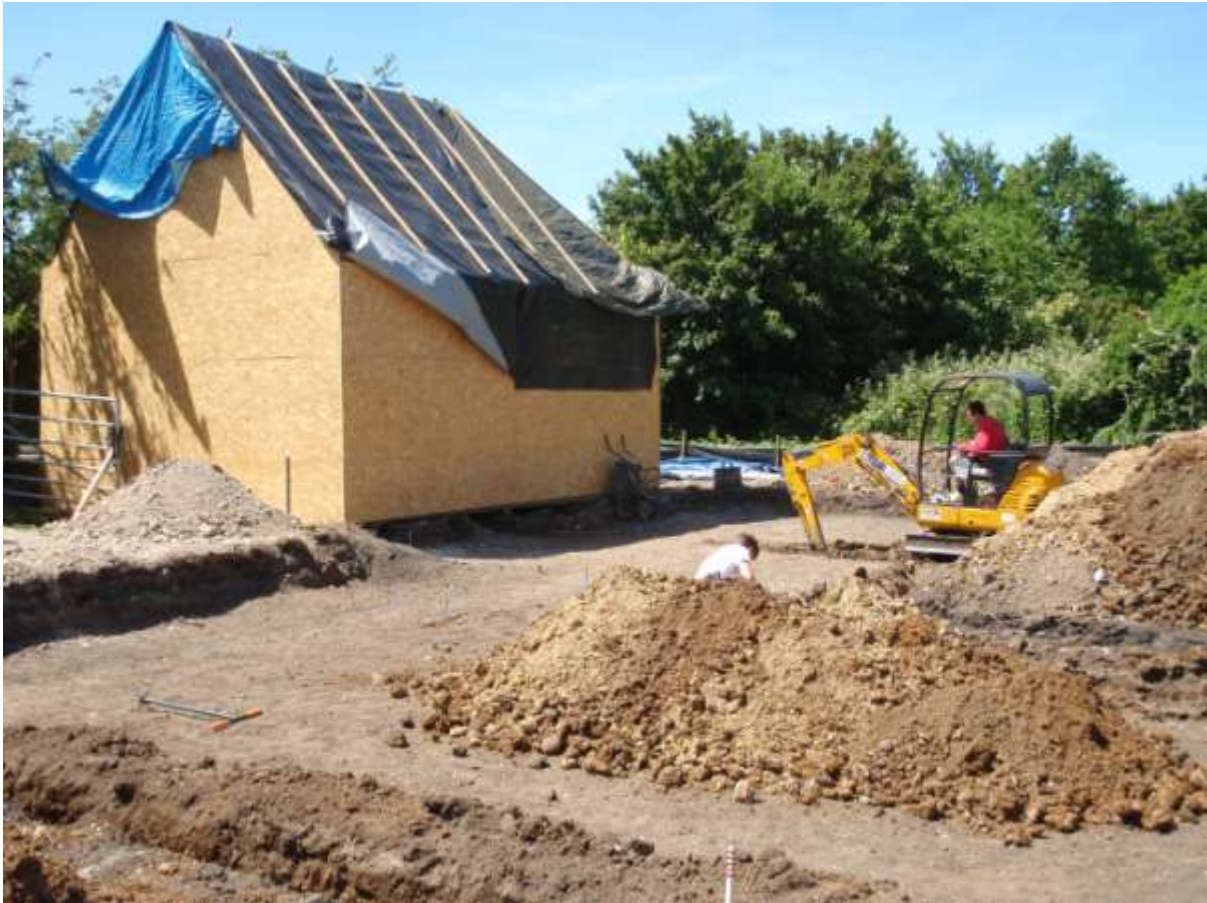
Plate 15. Plate 16 (below) The Black House under preparation for moving and view of trenches being watched

5.1 Behind the weatherboarding is the substantially intact frame of a three-bay 17th century farmhouse which will be moved to a new location. The brick internal fireplace will need to be numbered and de-constructed in a recorded manner to enable reconstruction at the new location site (Figure 1 & Plate 15).
