**HISTORIC BUILDING RECORDING OF
LACTON MANOR FARM BARN,
WESTWELL, ASHFORD, KENT**

1.1 In January 2019 Dr Paul Wilkinson of SWAT Archaeology carried out a historic building recording of Lacton Manor Farm Barn, Westwell, Ashford in Kent (Figure 1). The buildings are presently unoccupied and are about to undergo development and repair.

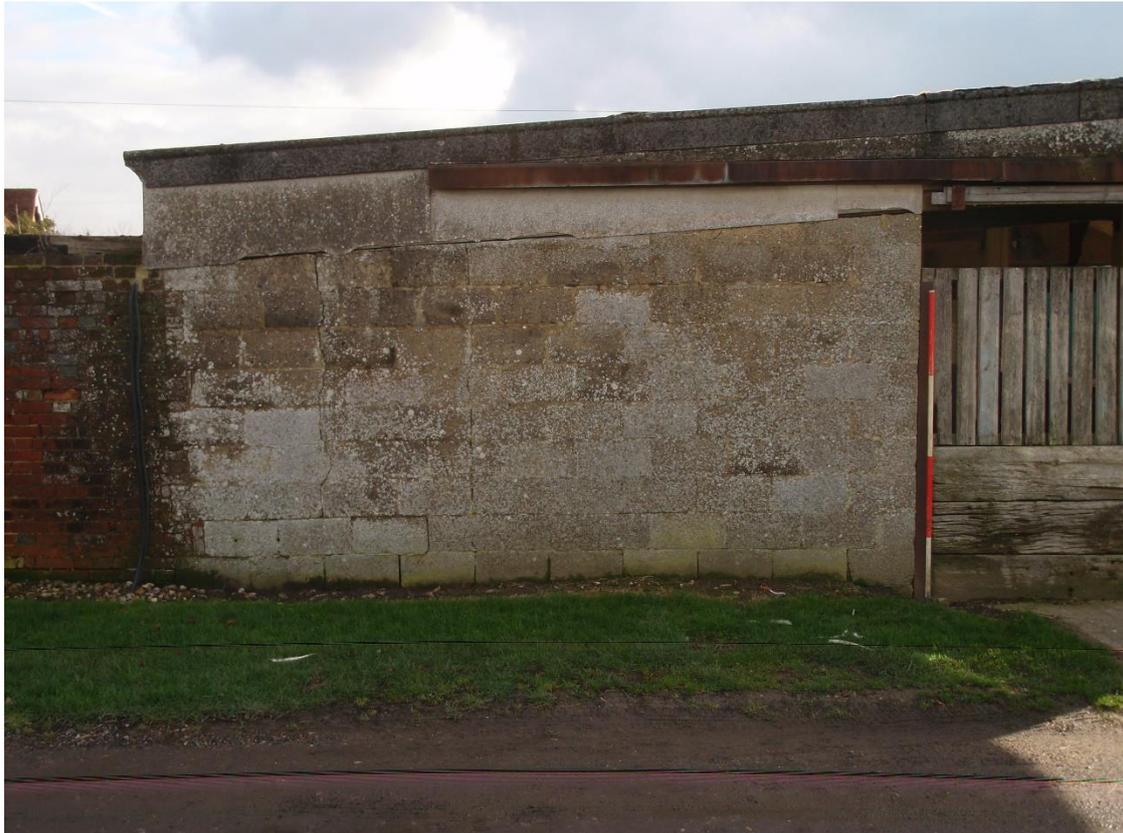
The west facing façade is constructed of un-faced concrete blocks with a width of 4.65m and a height of 2.25m topped by a rendered wall finish 0.30m deep capped by a corrugated asbestos cement roof (Plate 1).

Plate 1. View of external west wall Building 'A' (Elevation A) looking east

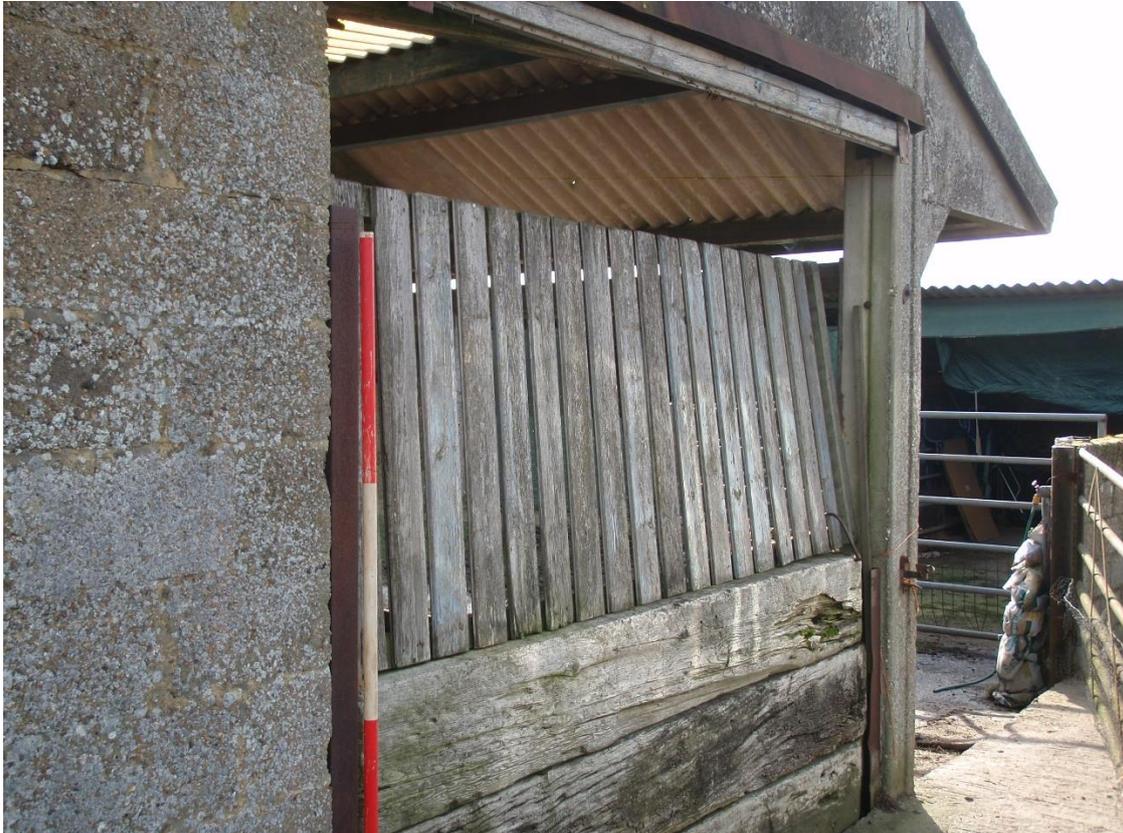
Adjacent and to the south a concrete Atcost frame is exposed with a build date of no earlier than c.1969 infilled with three horizontal timber sleepers topped by wooden vertical fencing (Plate 2).

Plate 2. . View of external west wall Building 'A' (Elevation A) looking south-east

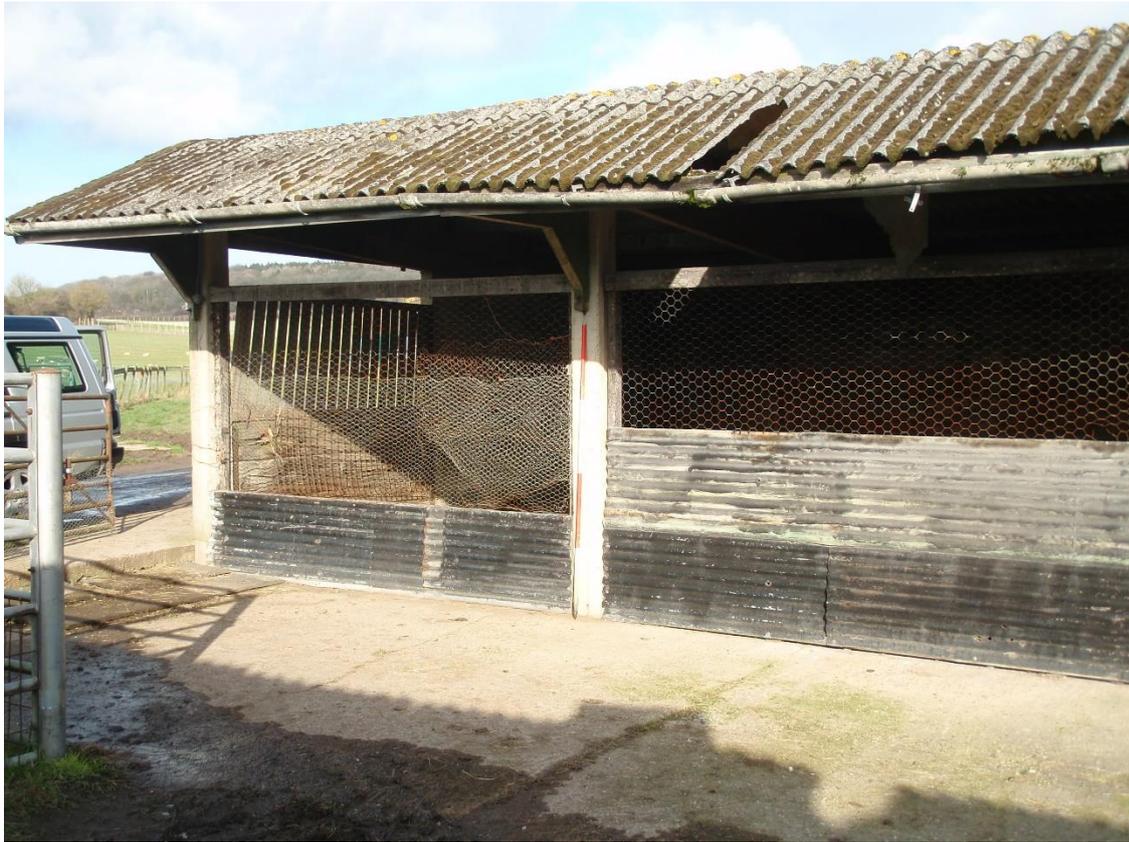
The frontage of Building 'A' which faces south is sub-divided into six bays all about 3.42m wide and 2.75 m high enclosed with horizontal sheets of corrugated iron and topped with galvanised chicken wire (Plates 3,4 Elevation E).

Plate 3. View of Building 'A' (Elevation E) looking north

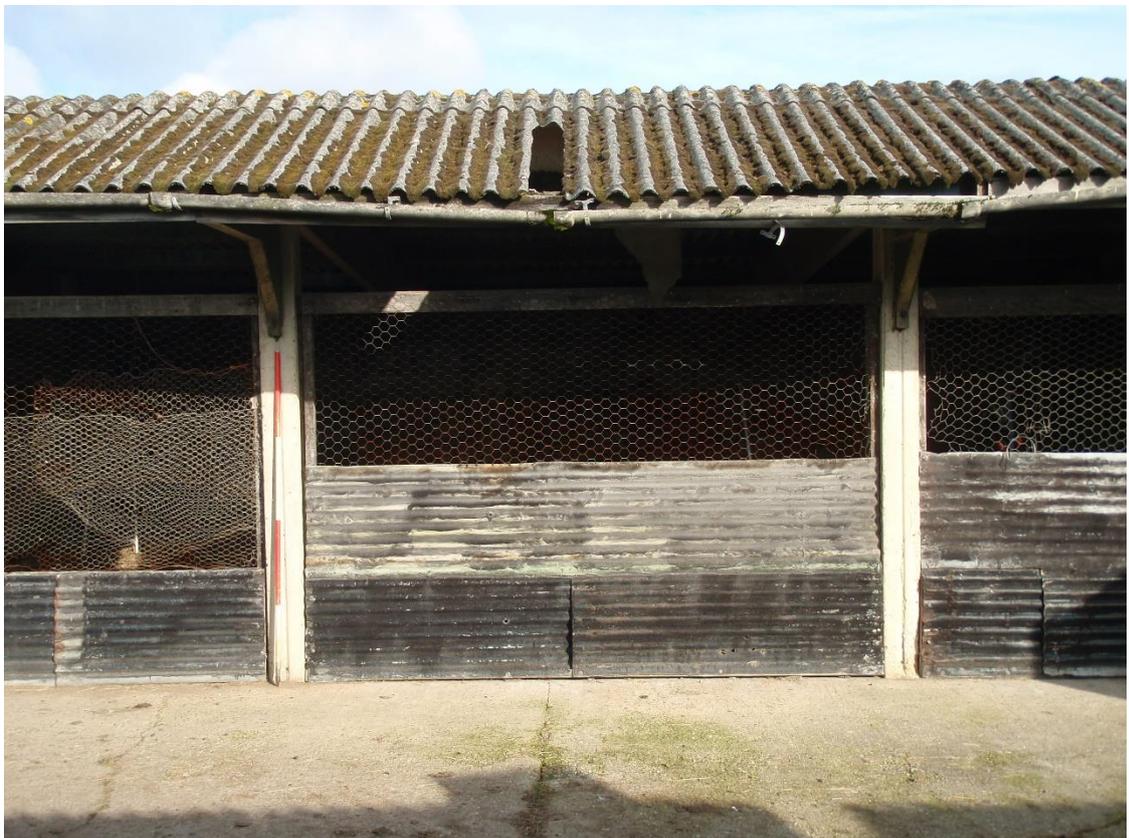
Plate 4. View of Building 'A' (Elevation E) looking NNE

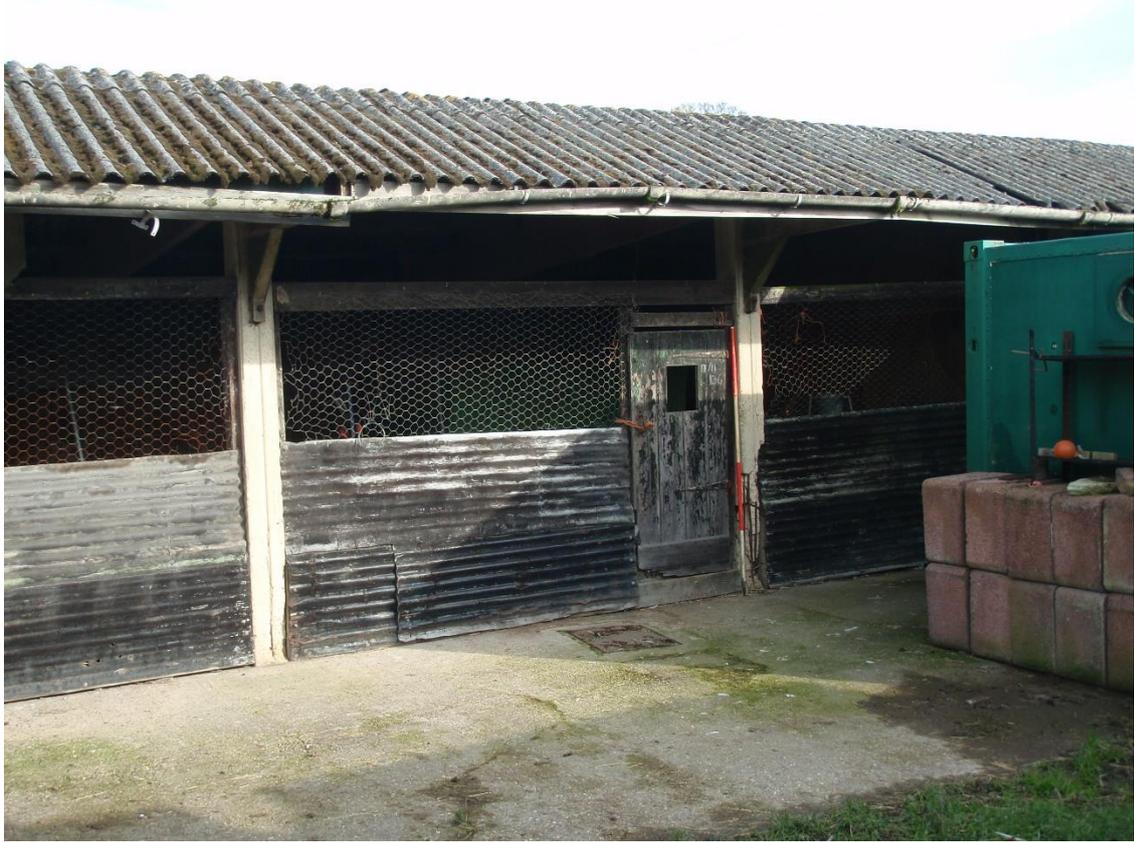
Plate 5. View of Building 'A' (Elevation E) looking north-east

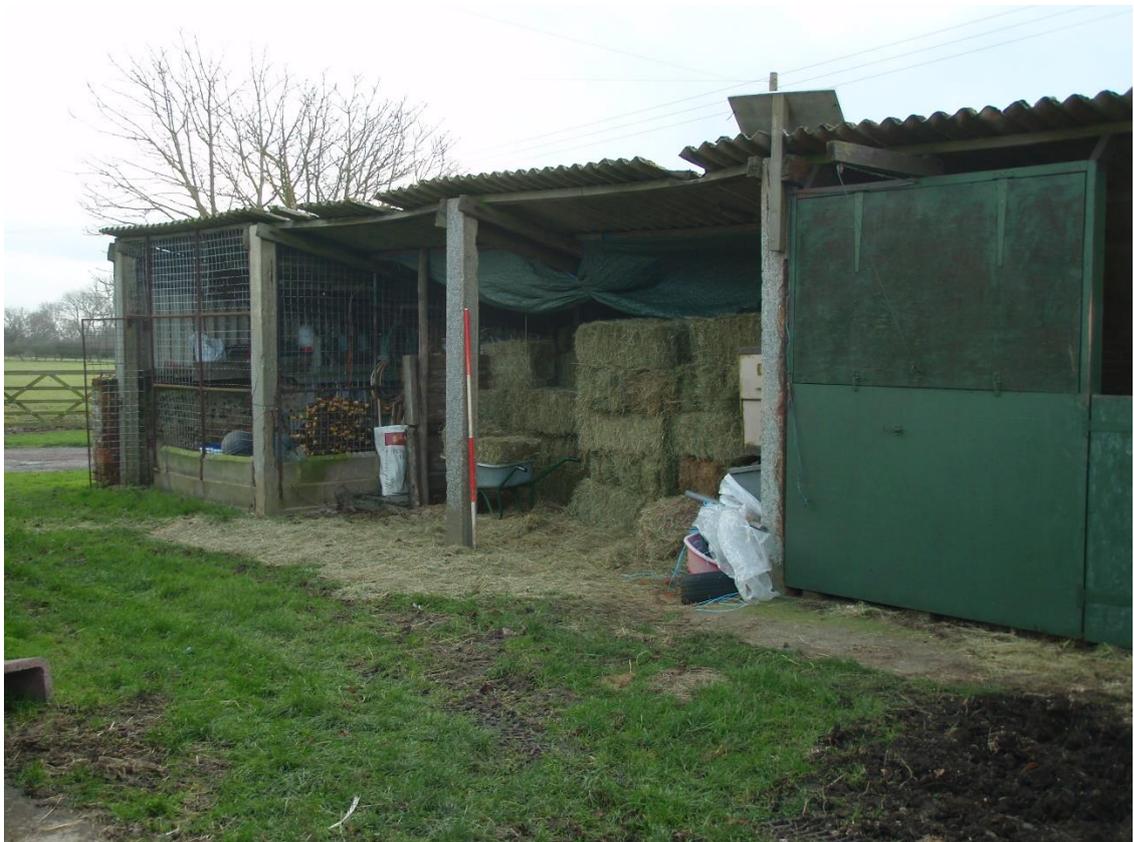
Building 'B' is 18.15m in length and 2.20m in depth with a roof height of 2.75m (Plates 6-8 and Elevation A).

Plate 6. View of Building 'B' (Elevation F) looking south

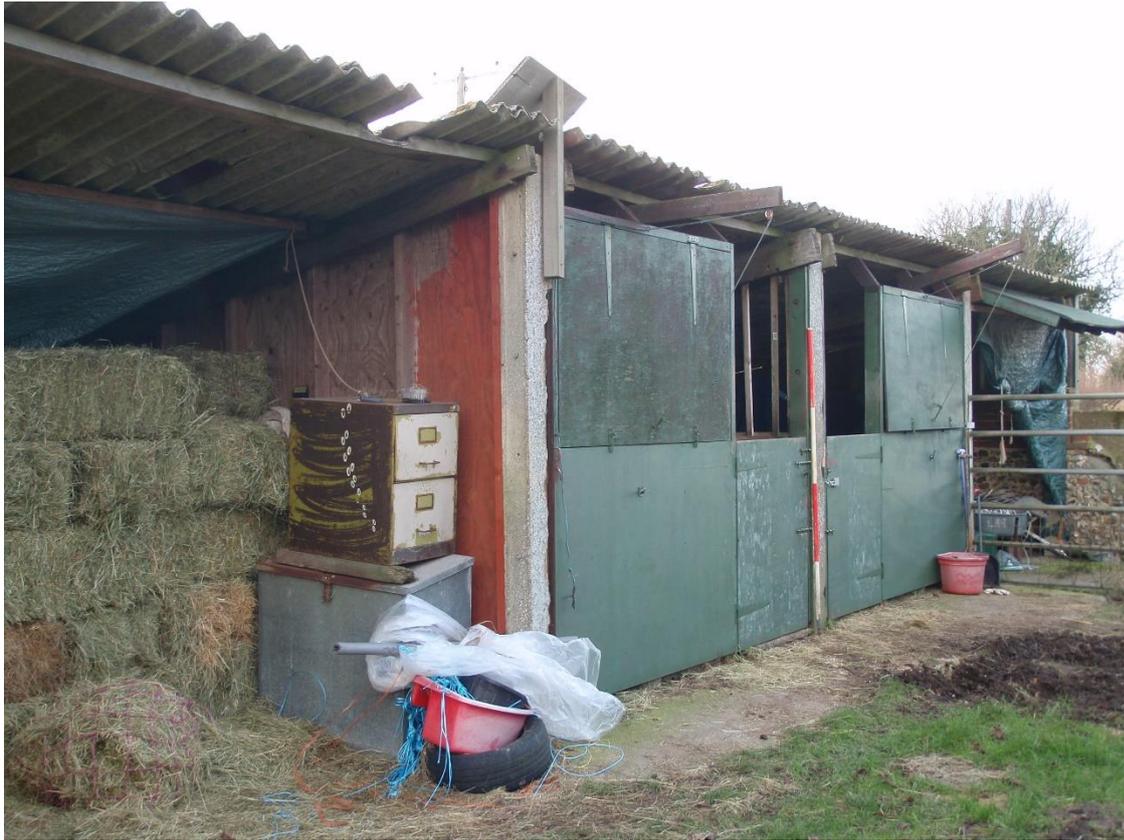
The frontage of Building 'B' is divided into six bays measuring about 2.87m wide and framed by the Atcost concrete structure (Plates 7, 8 and Elevation F).

Plate 7. View of Building 'B' (Elevation F) looking south-west

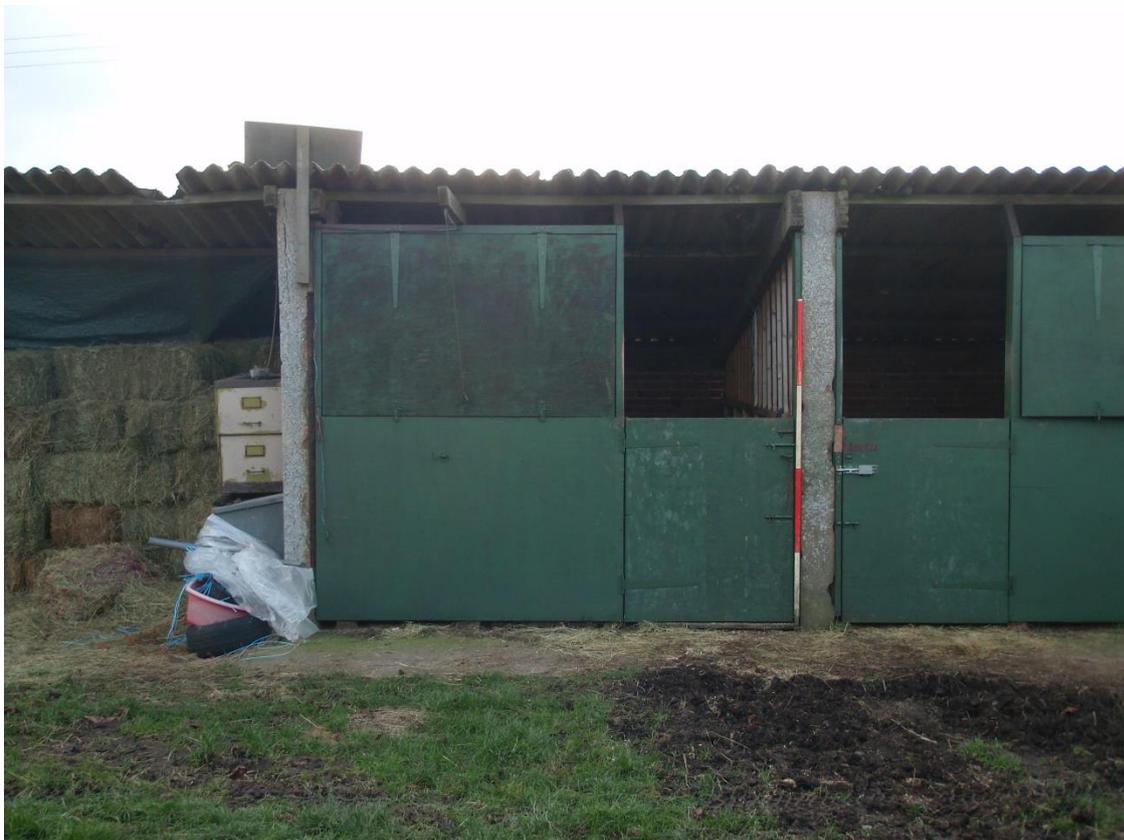
Plate 8. View of Building 'B' (Elevation F) looking SSW

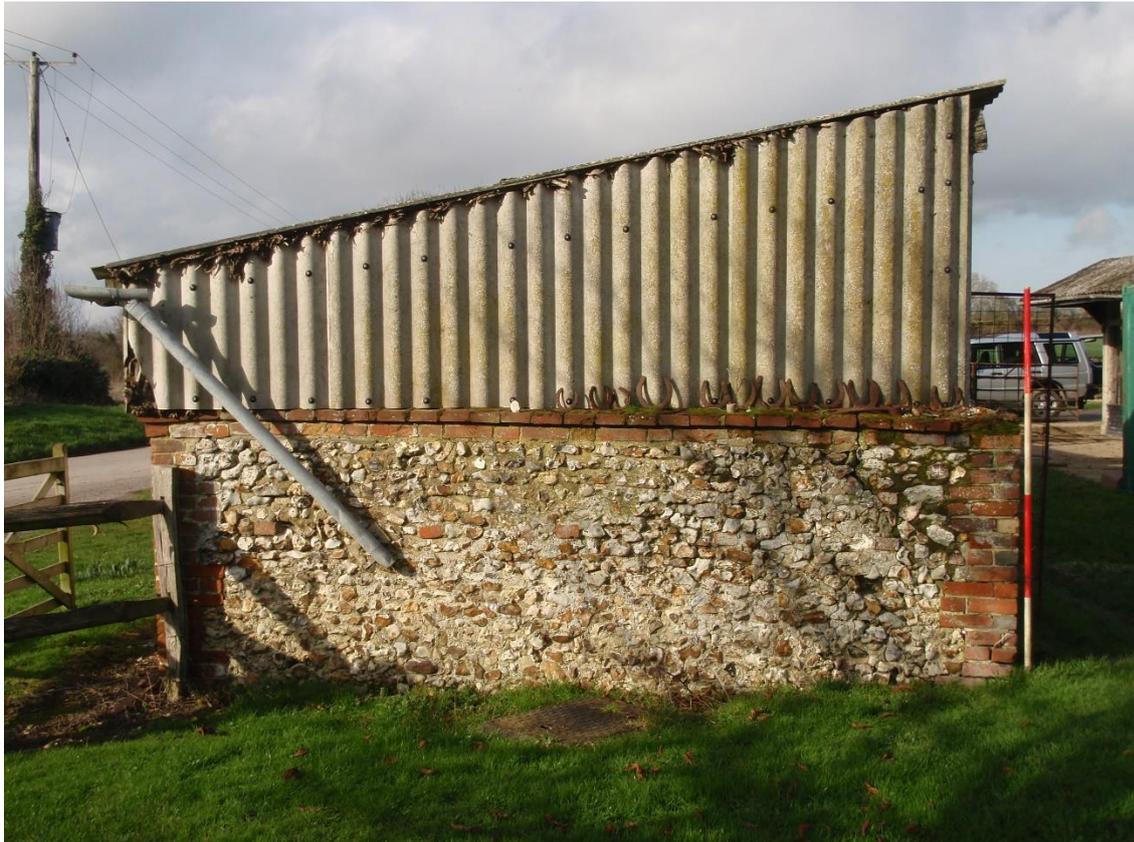
Dwarf walls at the east end of Building 'B' are constructed of flint walling frames by 19th century frogged bricks (Plate 9)

Plate 9. View of Building 'B' (Elevation c) looking NNW

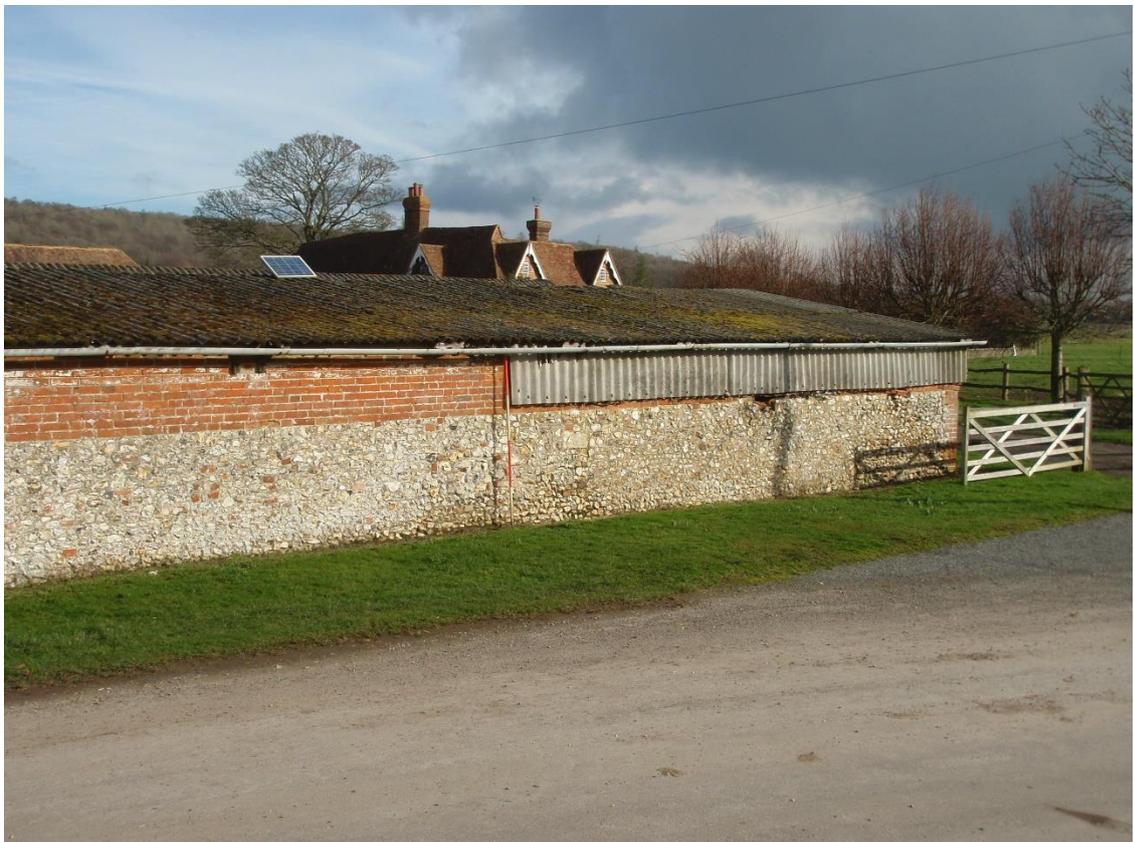
Plate 10. View of Building 'B' (Elevation D) looking north-east

4.3 The proposed works may impact on historic structure and it is recommended that a Watching Brief during the demolition take place to enable recording of exposed historic structures including the historic wall structure still surviving as standing walls in the west area of the Site (Plates 10, 11, 13, 14, 15, 16).

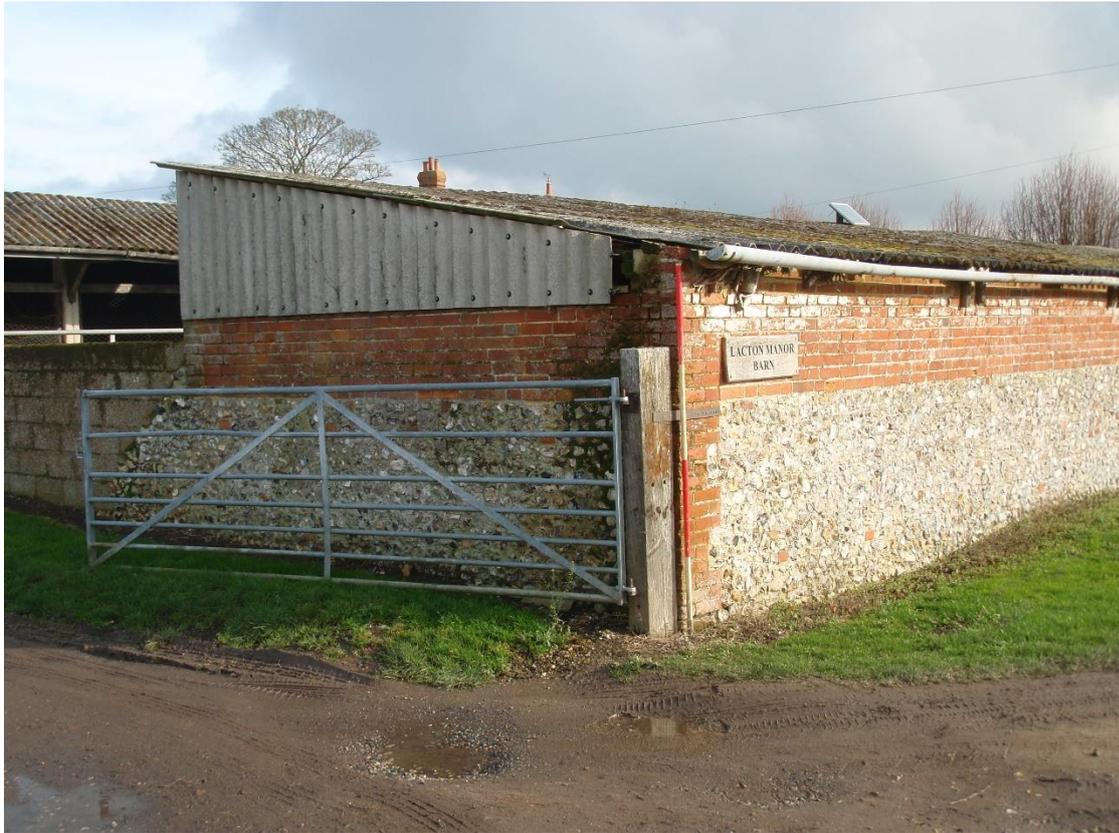
Plate 11. View of Building 'B' (Elevations A & D) looking NNE

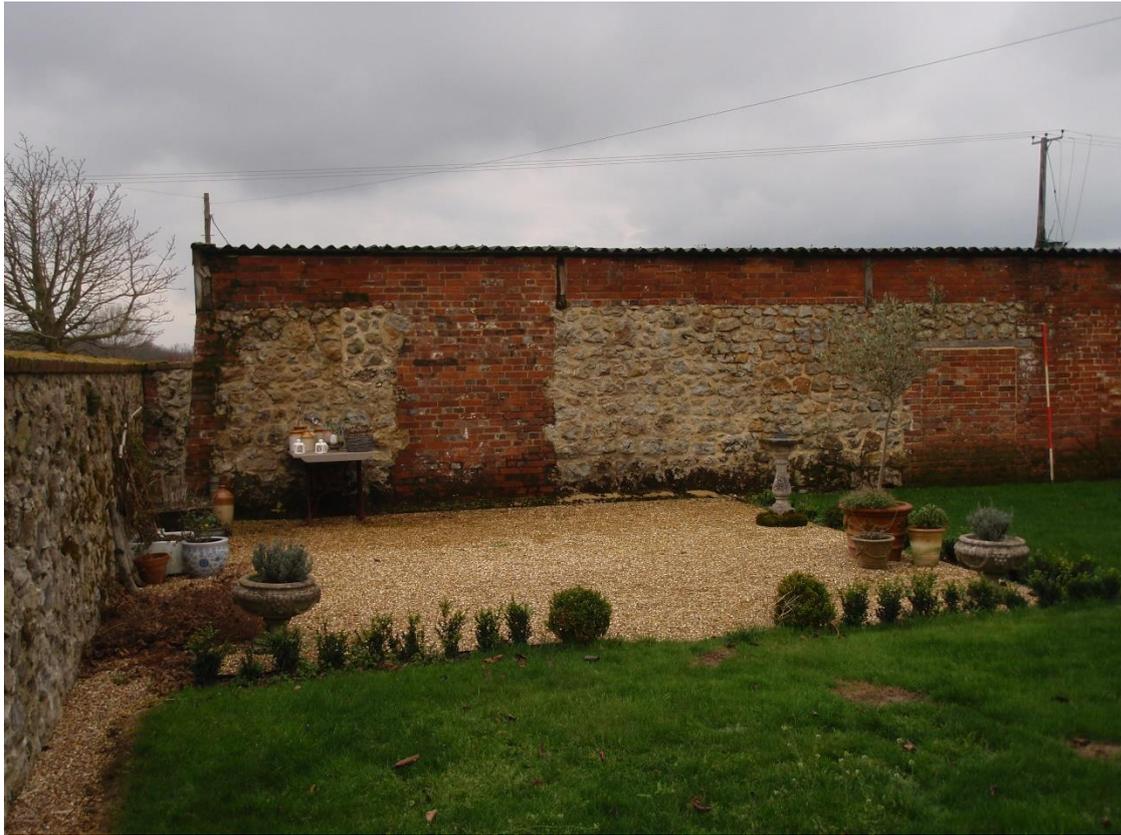
Plate 13. Rear of Building 'A' looking SSW

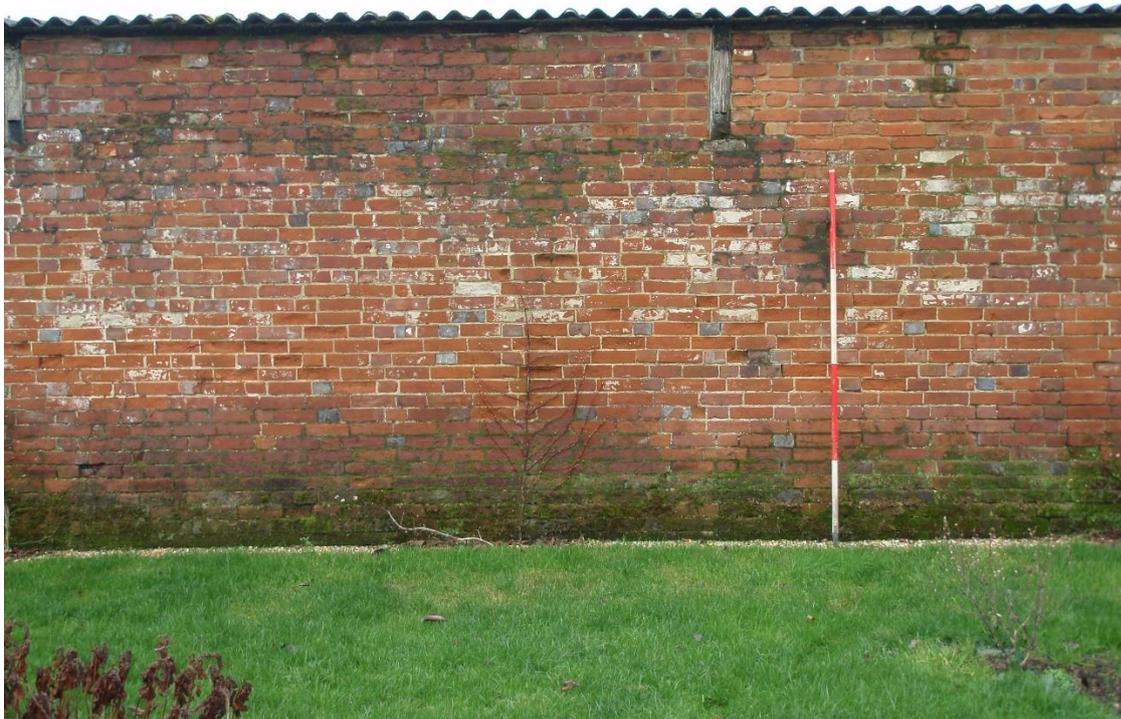
Plate 14. Rear of Building 'A' looking SSW

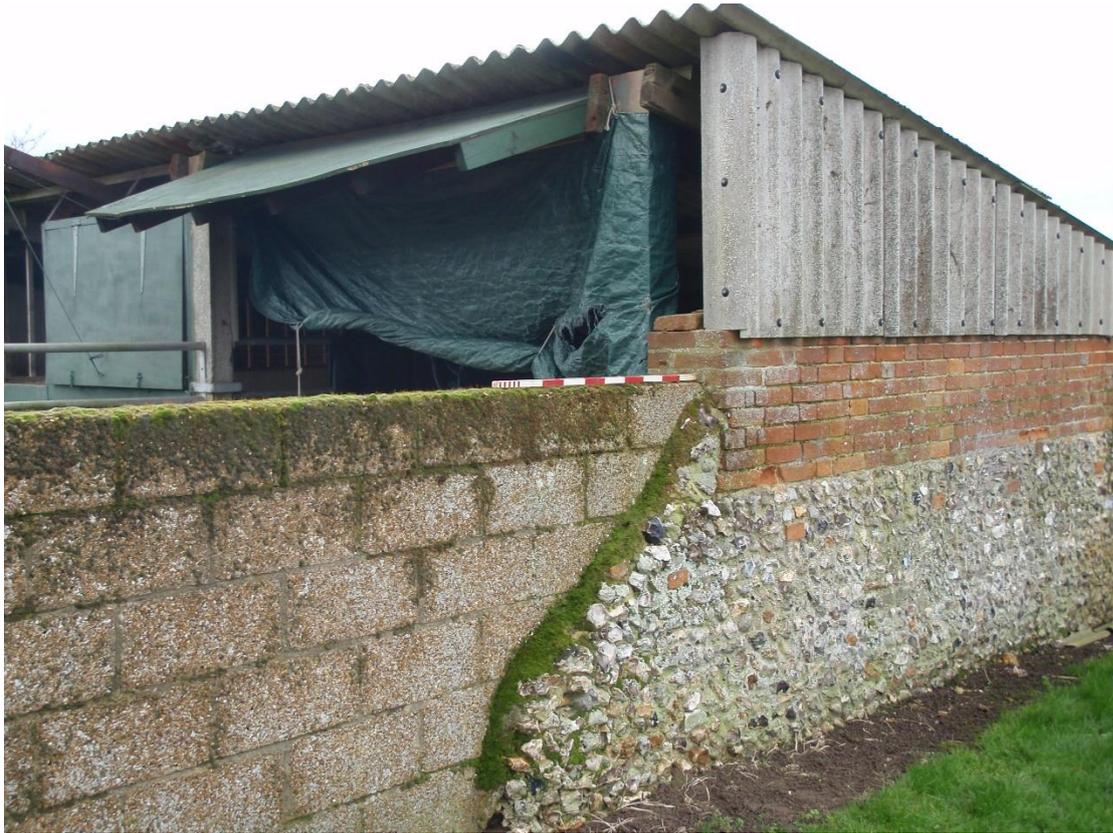
Plate 15. View of Building 'B' (Elevation A) looking south

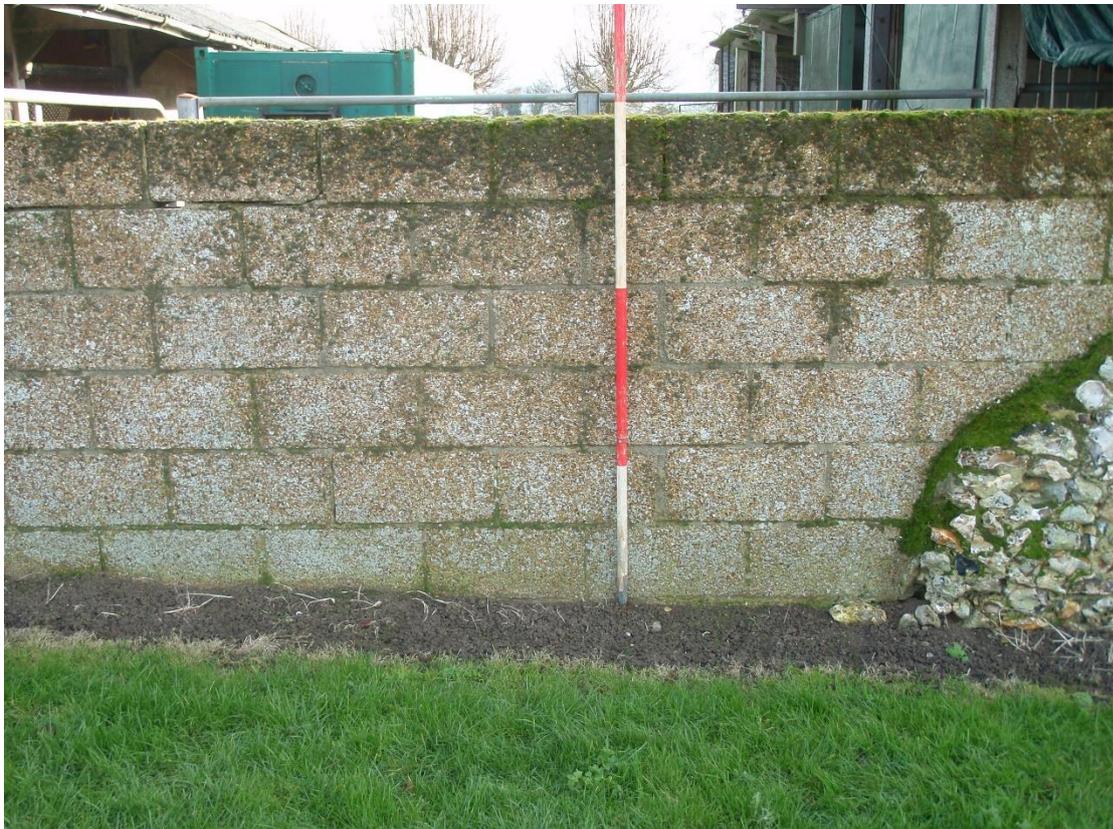
Plate 16. View of Building 'B' perimeter wall (Elevation A) looking SSE

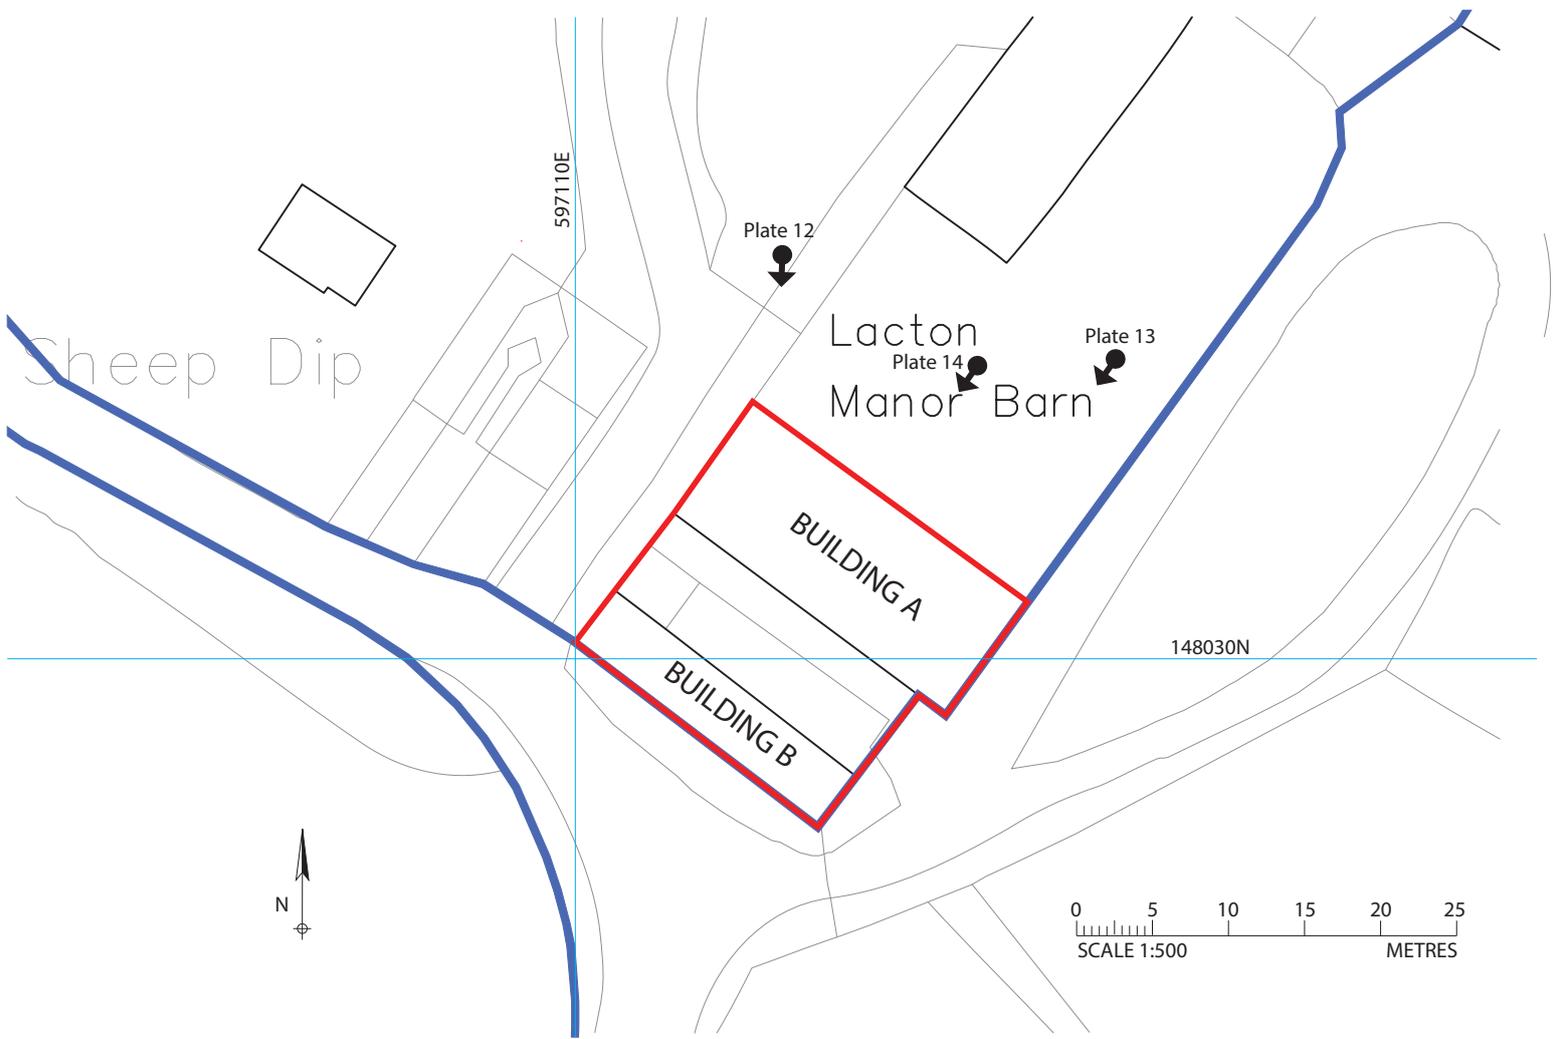
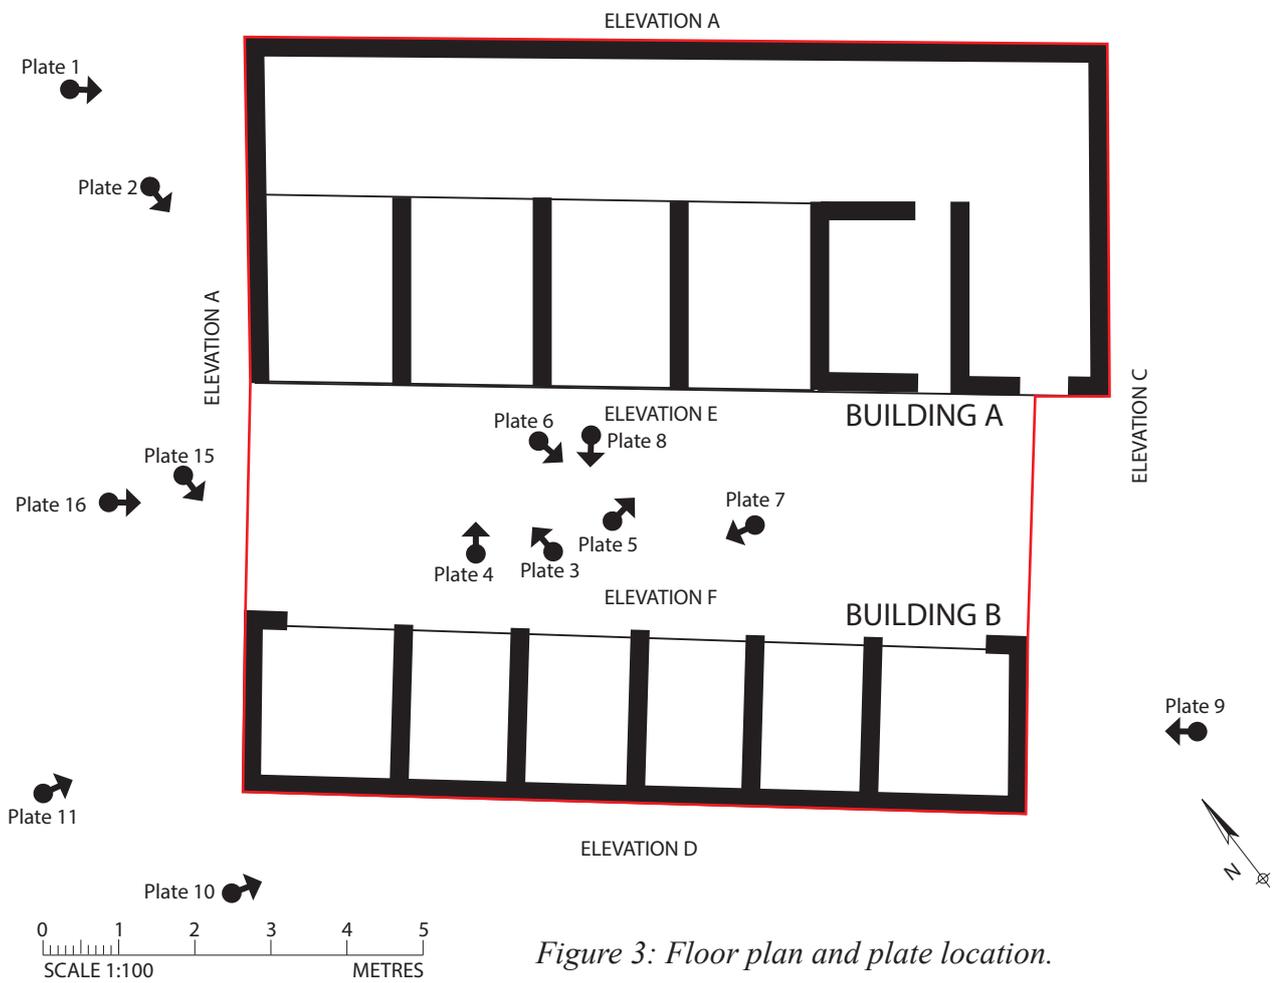
Figure 3: Floor plan and plate location.

The buildings enclose a plot of land measuring 19.20m by 20.15m and comprise two open-fronted concrete framed Atcost sheds facing each other across an open courtyard floored with concrete slabs (Plates 1-14 and Figures 3-6).

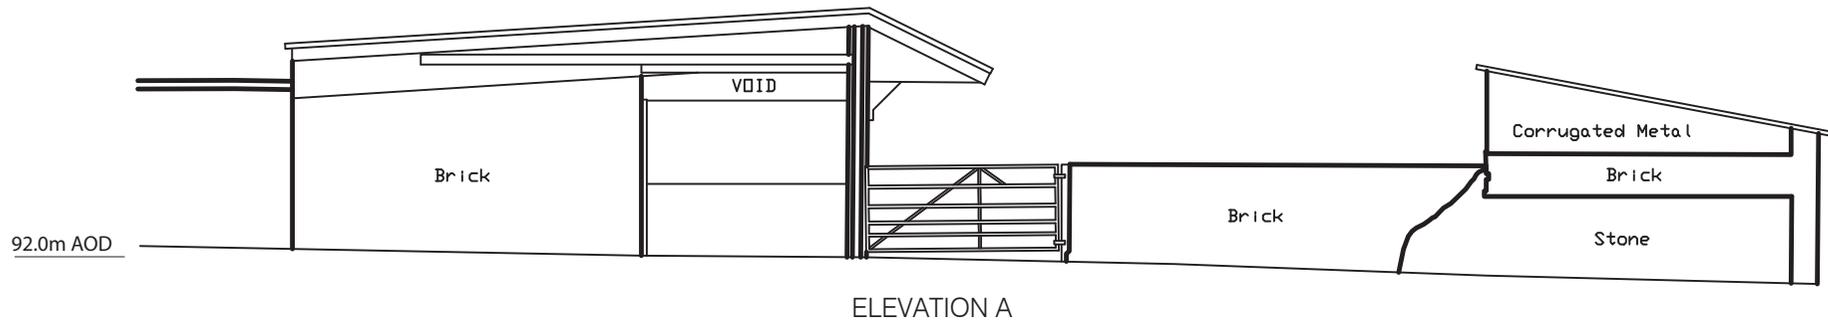
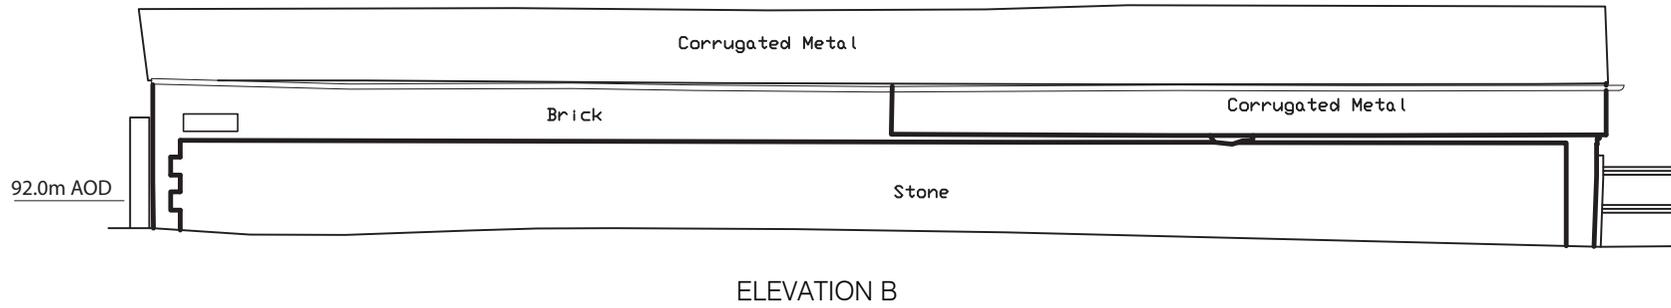
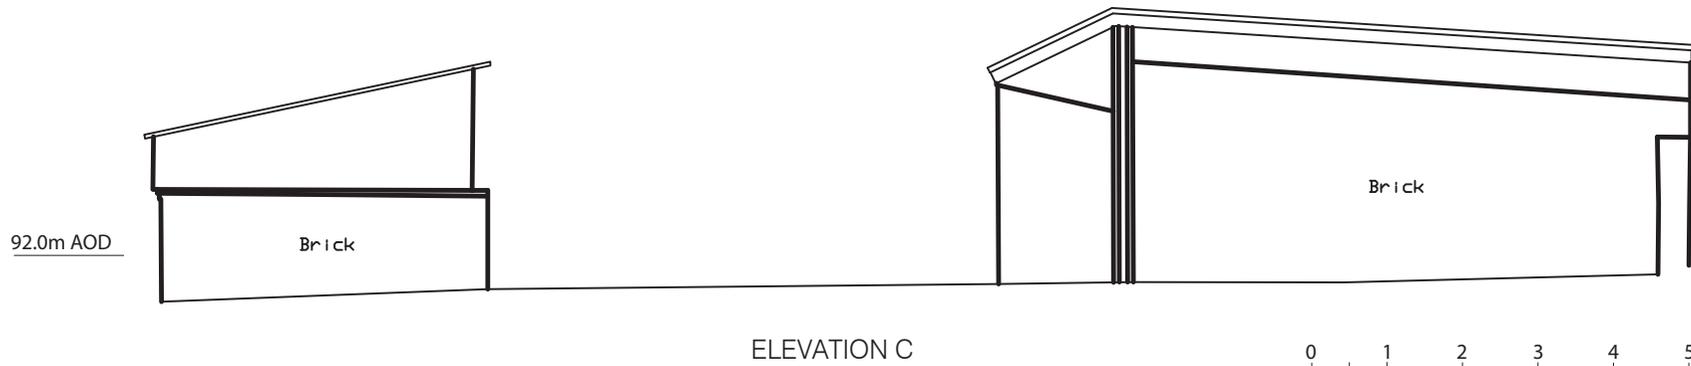
Figure 4: Elevation A, B, and C

To the south the open courtyard is enclosed with a six-barred farm gate and a concrete block wall about 1.36m in height (Elevation A).
