Archaeological Evaluation of Land south of Coleridge Road and Land east of Shaftsbury Lane, Dartford, Kent

December 2016

Site Code: COL/EV/17

Planning Application: DA/15/00084/FUL

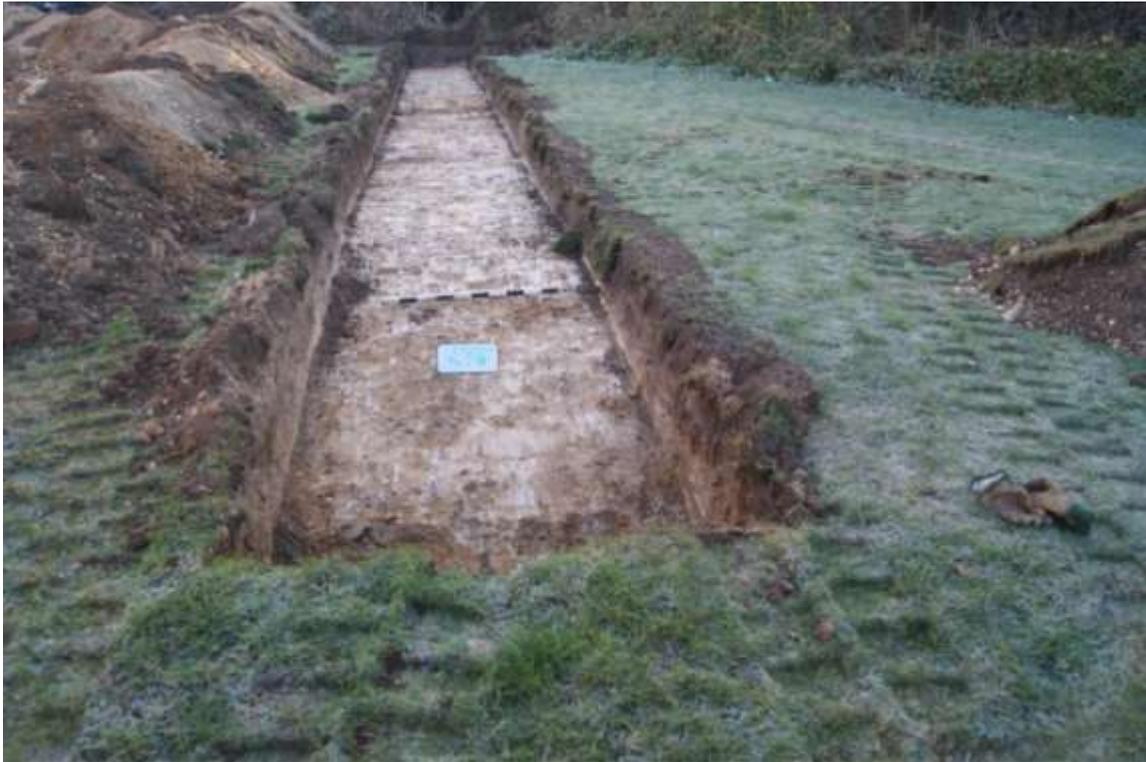
Plate 1. View of Trench 8

The plan is recorded in Figures 1 & 2 (see also Plate 1). The trench lay on an NW alignment and measured approximately 25m by 1.70m.

Undisturbed natural geology **(802)** was identified across the trench as sandy silty clay, at a depth of approximately 0.51m (16.45mOD) below the present ground surface at 16.96m OD at the NW end of the trench.

The natural geology **(802)** was sealed by a layer of mid brown to black silty sandy topsoil **(801)** 0.12m thick.

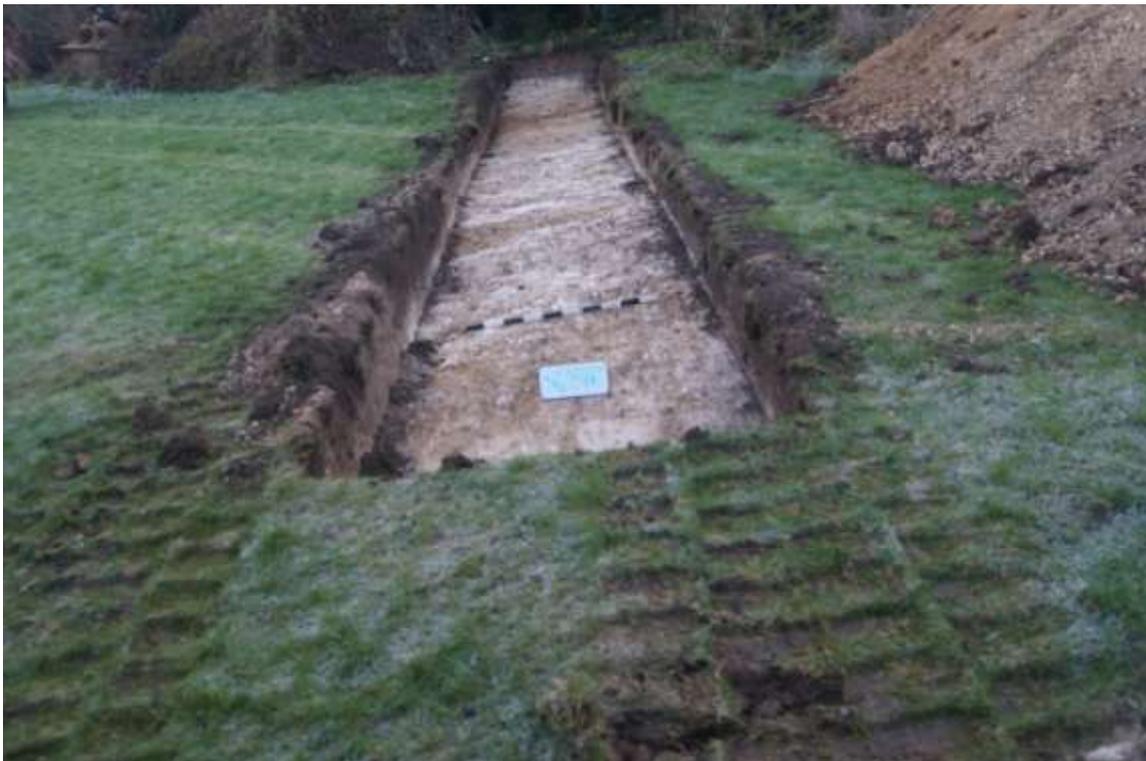
Plate 2. View of Trench 11

The plan is recorded in Figures 1 & 2 (see also Plate 2). The trench lay on an NNW alignment and measured approximately 25m by 1.70m.

Undisturbed natural geology **(1102)** was identified across the trench as sandy silty clay, at a depth of approximately 0.35m (15.96mOD) below the present ground surface at 16.31m OD at the NNW end of the trench.

The natural geology **(1102)** was sealed by a layer of mid brown to black silty sandy topsoil **(1101)** 0.14m thick.

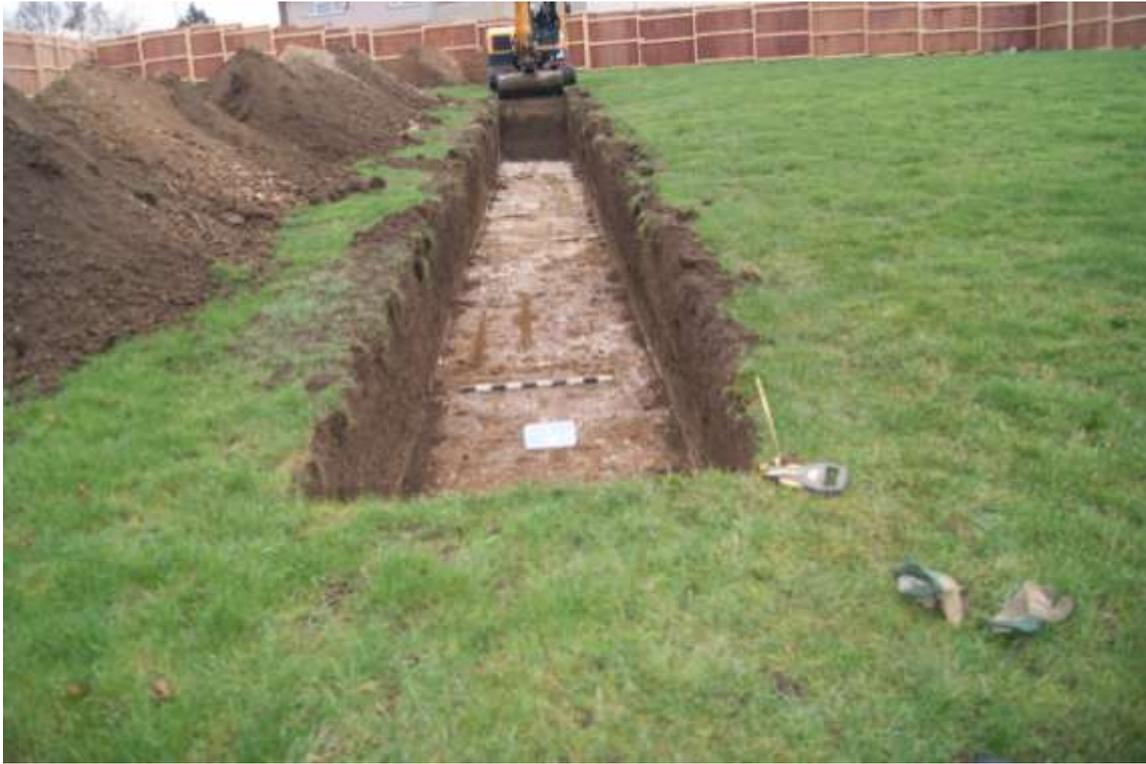
Plate 3. View of Trench 23

The plan is recorded in Figures 1 & 2 (see also Plates). The trench lay on an NNW alignment and measured approximately 25m by 1.70m.

Undisturbed natural geology **(2302)** was identified across the trench as sandy silty clay, at a depth of approximately 0.49m (17.46mOD) below the present ground surface at 17.95m OD at the NNW end of the trench.

The natural geology **(2302)** was sealed by a layer of mid brown to black silty sandy topsoil **(2301)** 0.14m thick.

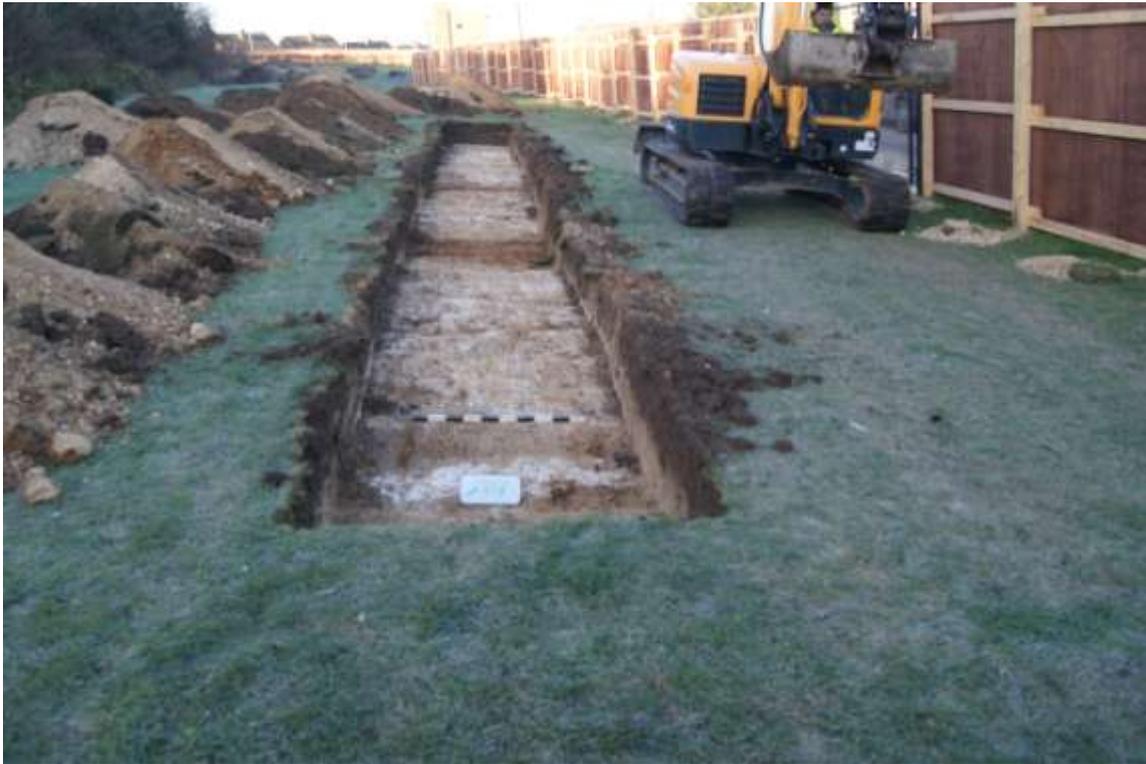
Plate 4. View of Trench 7

The plan is recorded in Figures 1 & 2 (see also Plate 4). The trench lay on an W alignment and measured approximately 25m by 1.70m.

Undisturbed natural geology **(702)** was identified across the trench as sandy silty clay, at a depth of approximately 0.27m (17.65mOD) below the present ground surface at 17.92m OD at the W end of the trench.

The natural geology **(702)** was sealed by a layer of mid brown to black silty sandy topsoil **(701)** 0.11m thick.

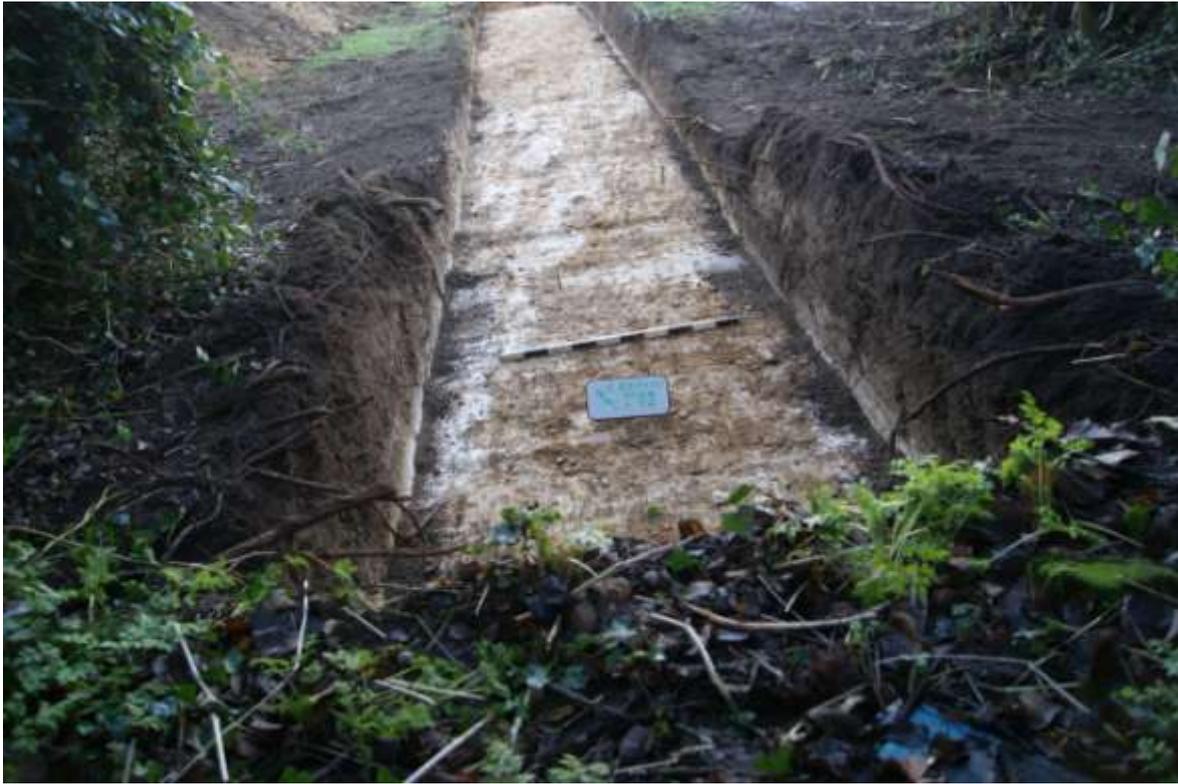
Plate 5. View of Trench 12

The plan is recorded in Figures 1 & 2 (see also Plate 5). The trench lay on an NNE alignment and measured approximately 25m by 1.70m.

Undisturbed natural geology **(1202)** was identified across the trench as sandy silty clay, at a depth of approximately 0.49m (15.62mOD) below the present ground surface at 16.11m OD at the NNE end of the trench.

The natural geology **(1202)** was sealed by a layer of mid brown to black silty sandy topsoil **(1201)** 0.14m thick.

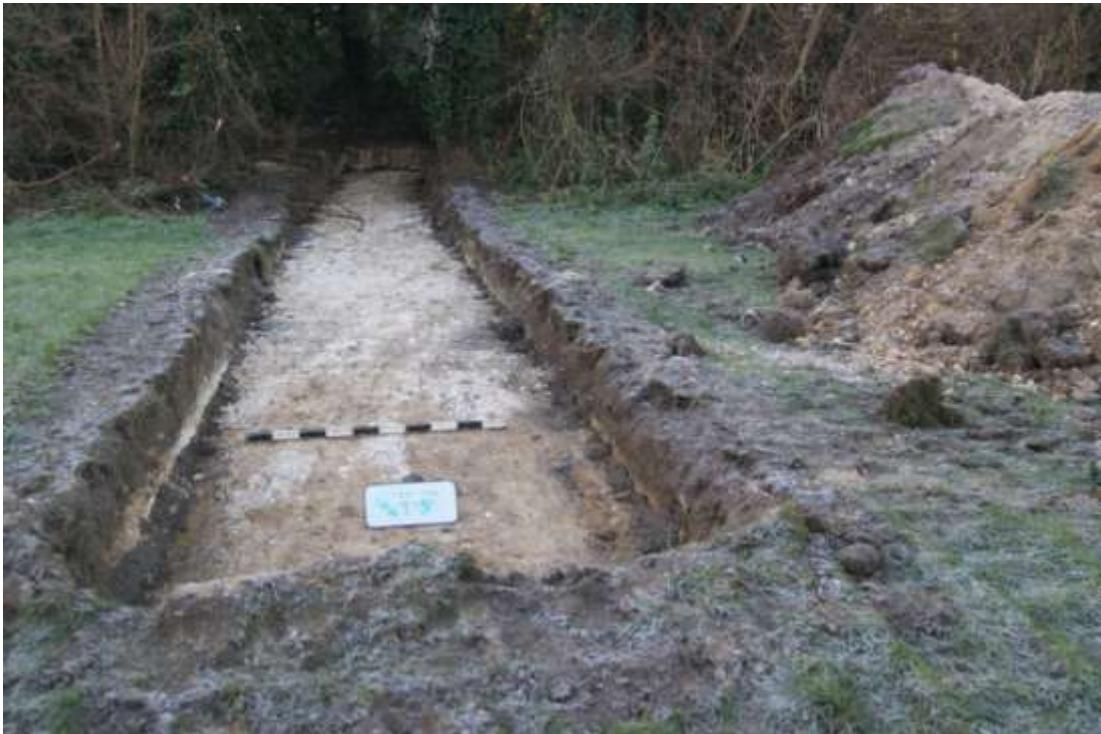
Plate 6. View of Trench 15

The plan is recorded in Figures 1 & 2 (see also Plate 6). The trench lay on an N alignment and measured approximately 25m by 1.70m.

Undisturbed natural geology **(1502)** was identified across the trench as sandy silty clay, at a depth of approximately 0.18m (16.18mOD) below the present ground surface at 16.36m OD at the N end of the trench.

The natural geology **(1502)** was sealed by a layer of mid brown to black silty sandy topsoil **(1501)** 0.10m thick.

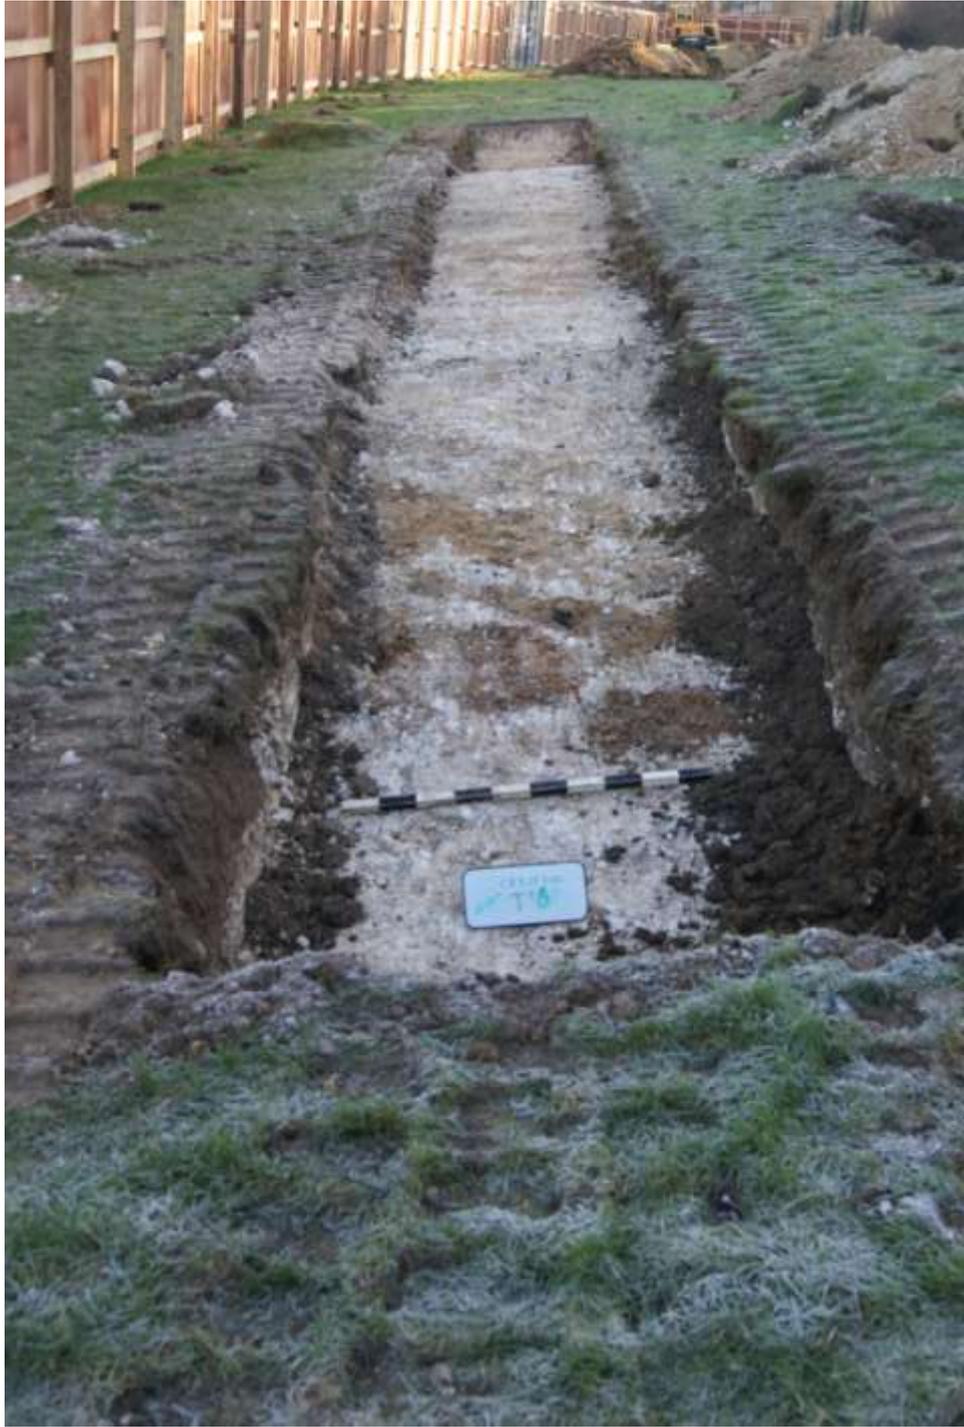
Plate 9. View of Trench 6

The plan is recorded in Figures 1 & 2 (see also Plates). The trench lay on an E alignment and measured approximately 25m by 1.70m.

Undisturbed natural geology **(602)** was identified across the trench as sandy silty clay, at a depth of approximately 0.41m (16.73mOD) below the present ground surface at 17.14m OD at the E end of the trench.

The natural geology **(602)** was sealed by a layer of mid brown to black silty sandy topsoil **(6)** 0.10m thick.

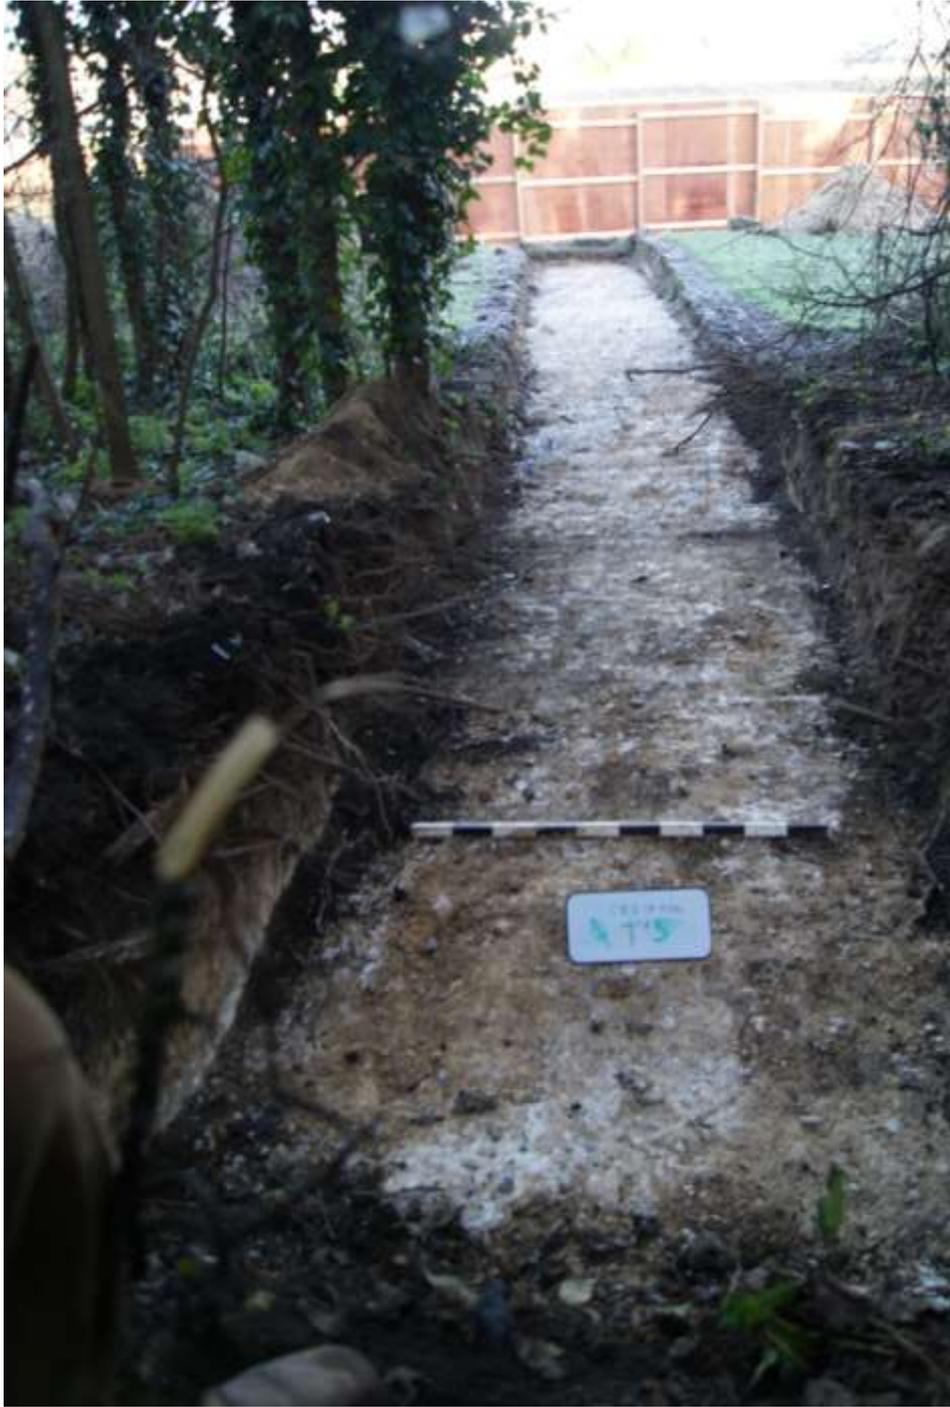
Plate 10. View of Trench 5

The plan is recorded in Figures 1 & 2 (see also Plates). The trench lay on an NNE alignment and measured approximately 25m by 1.70m.

Undisturbed natural geology **(502)** was identified across the trench as sandy silty clay, at a depth of approximately 0.26m (19.78mOD) below the present ground surface at 20.04m OD at the NNE end of the trench.

The natural geology **(502)** was sealed by a layer of mid brown to black silty sandy topsoil **(501)** 0.12m thick.

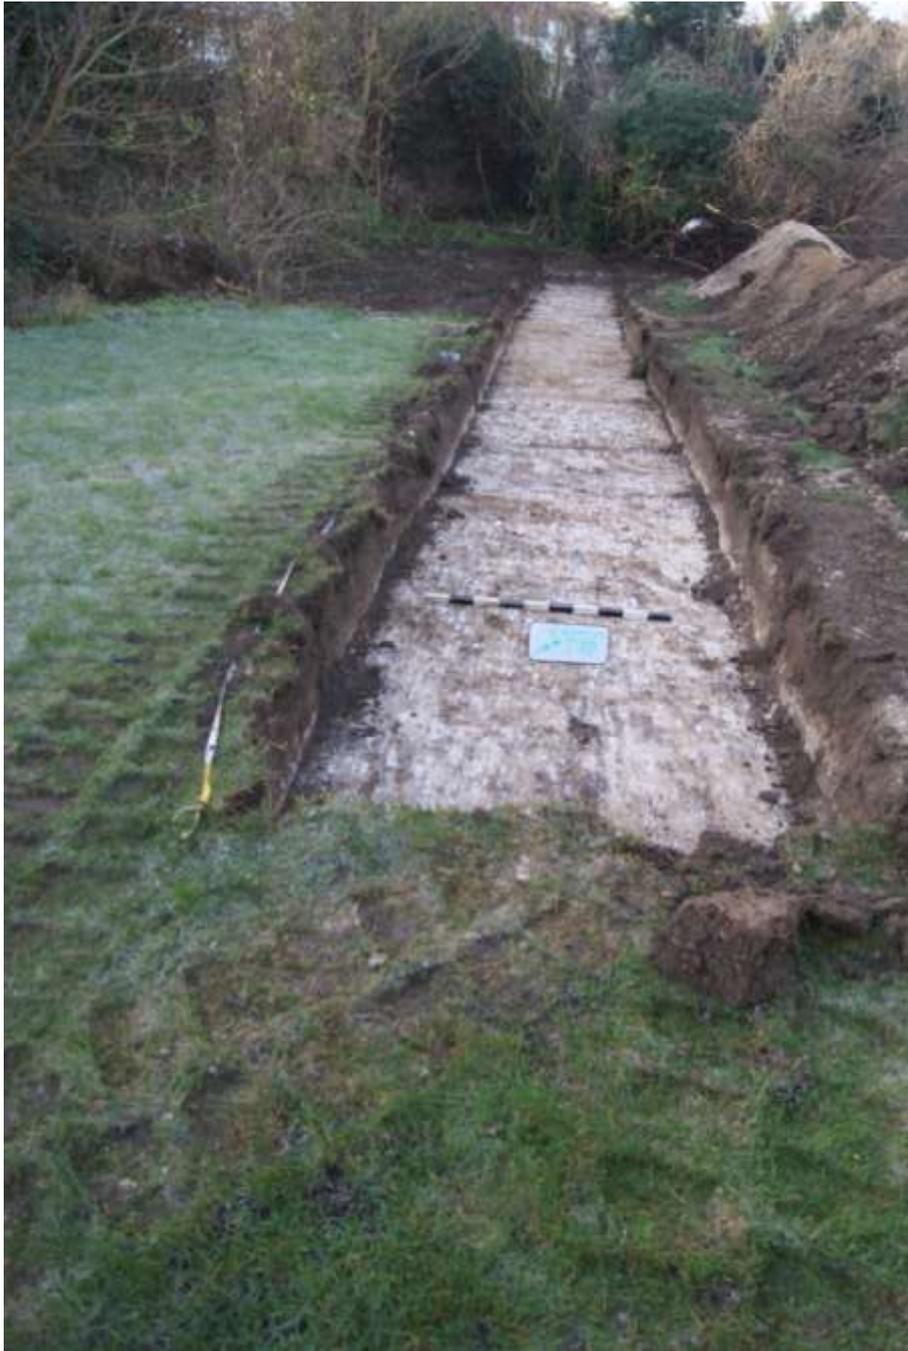
Plate 11. View of Trench 10

The plan is recorded in Figures 1 & 2 (see also Plate 11). The trench lay on an NNE alignment and measured approximately 25m by 1.70m.

Undisturbed natural geology **(1002)** was identified across the trench as sandy silty clay, at a depth of approximately 0.40m (17.31mOD) below the present ground surface at 17.89m OD at the SSW end of the trench.

The natural geology **(1002)** was sealed by a layer of mid brown to black silty sandy topsoil **(1001)** 0.10m thick.

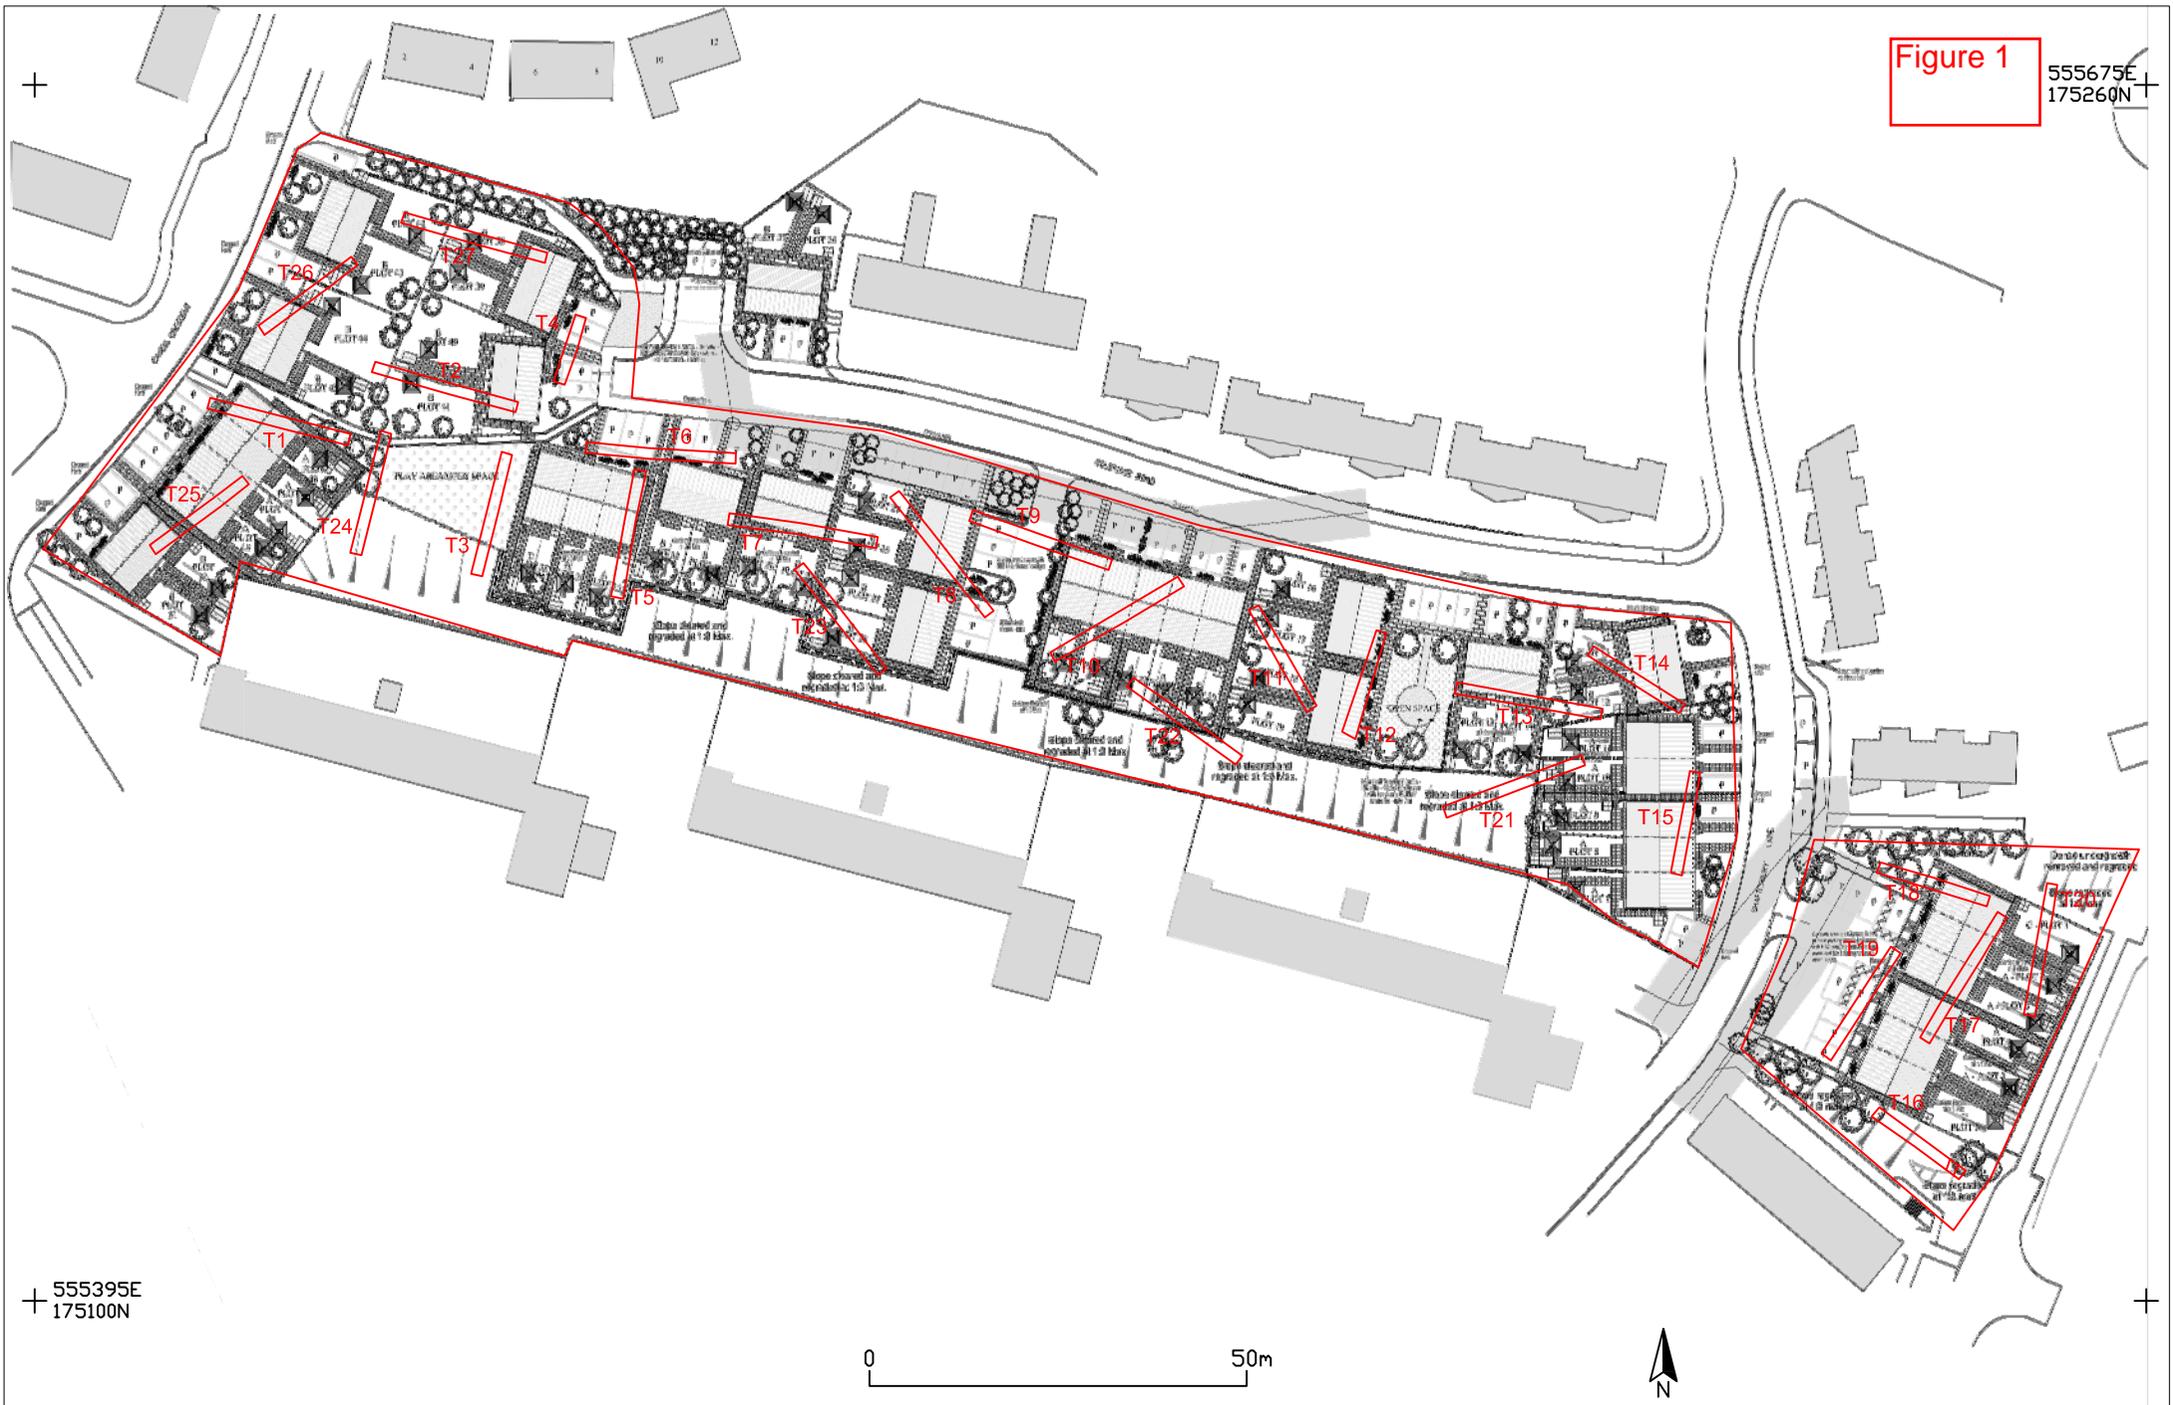
Figure 1

The evaluation has identified no archaeological features within the trenches (Figures 1-3).

Dartford, Coleridge Road: Evaluation trench plan in relation to development plan, scale 1:1000.

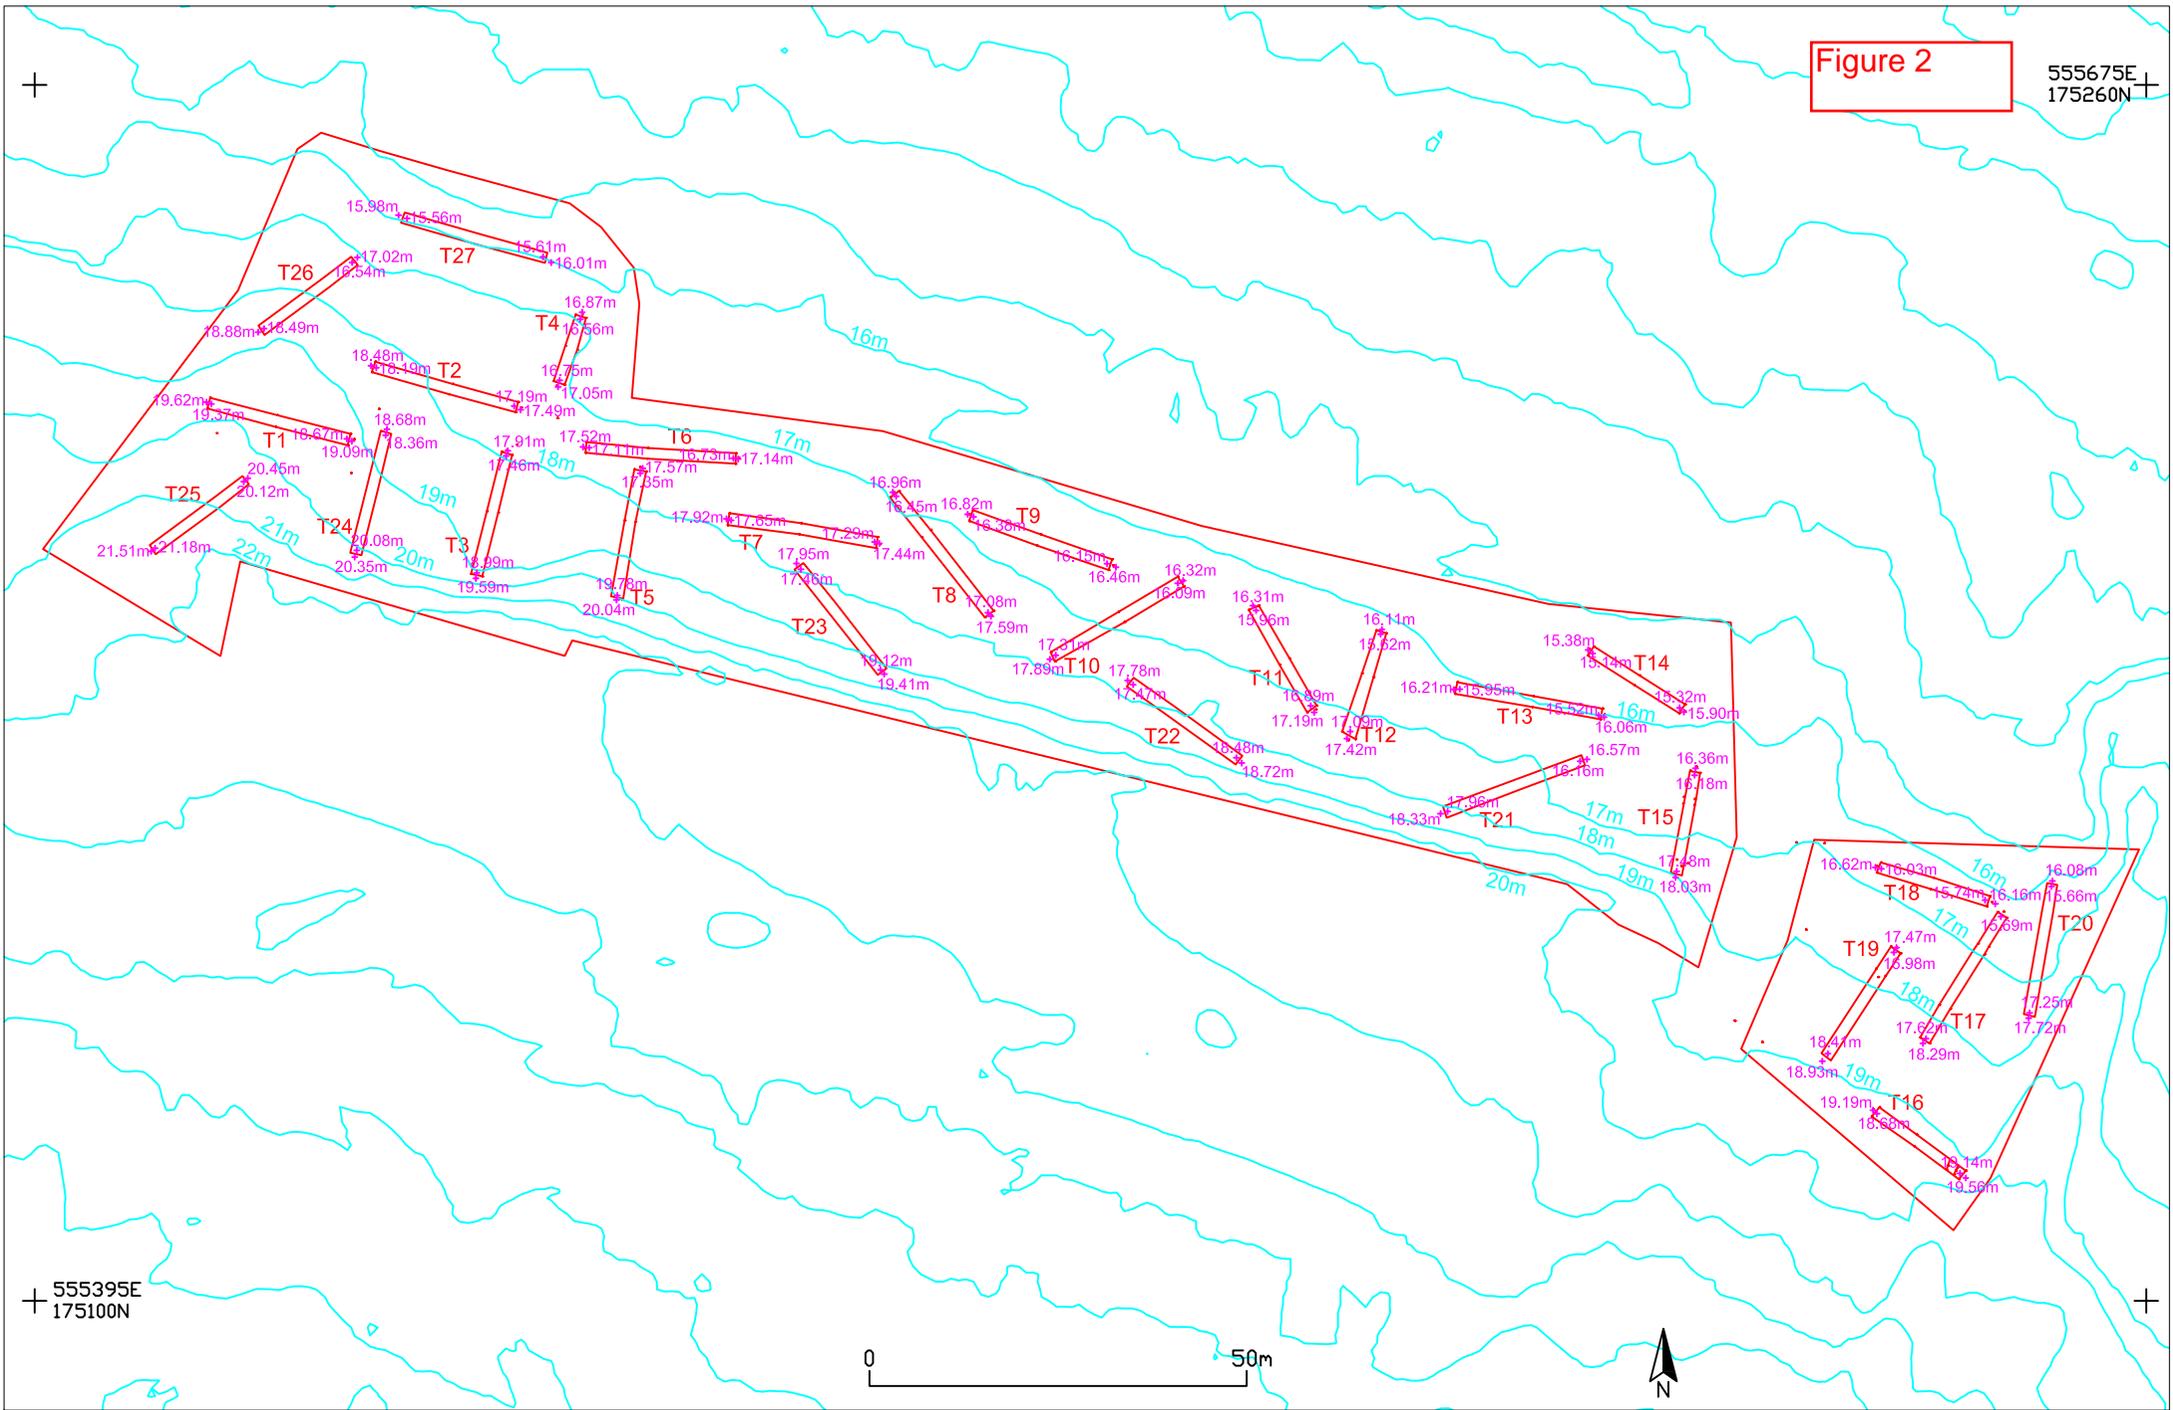
Figure 2

Dartford, Coleridge Road: Evaluation trench plan with spot heights, scale 1:1000.

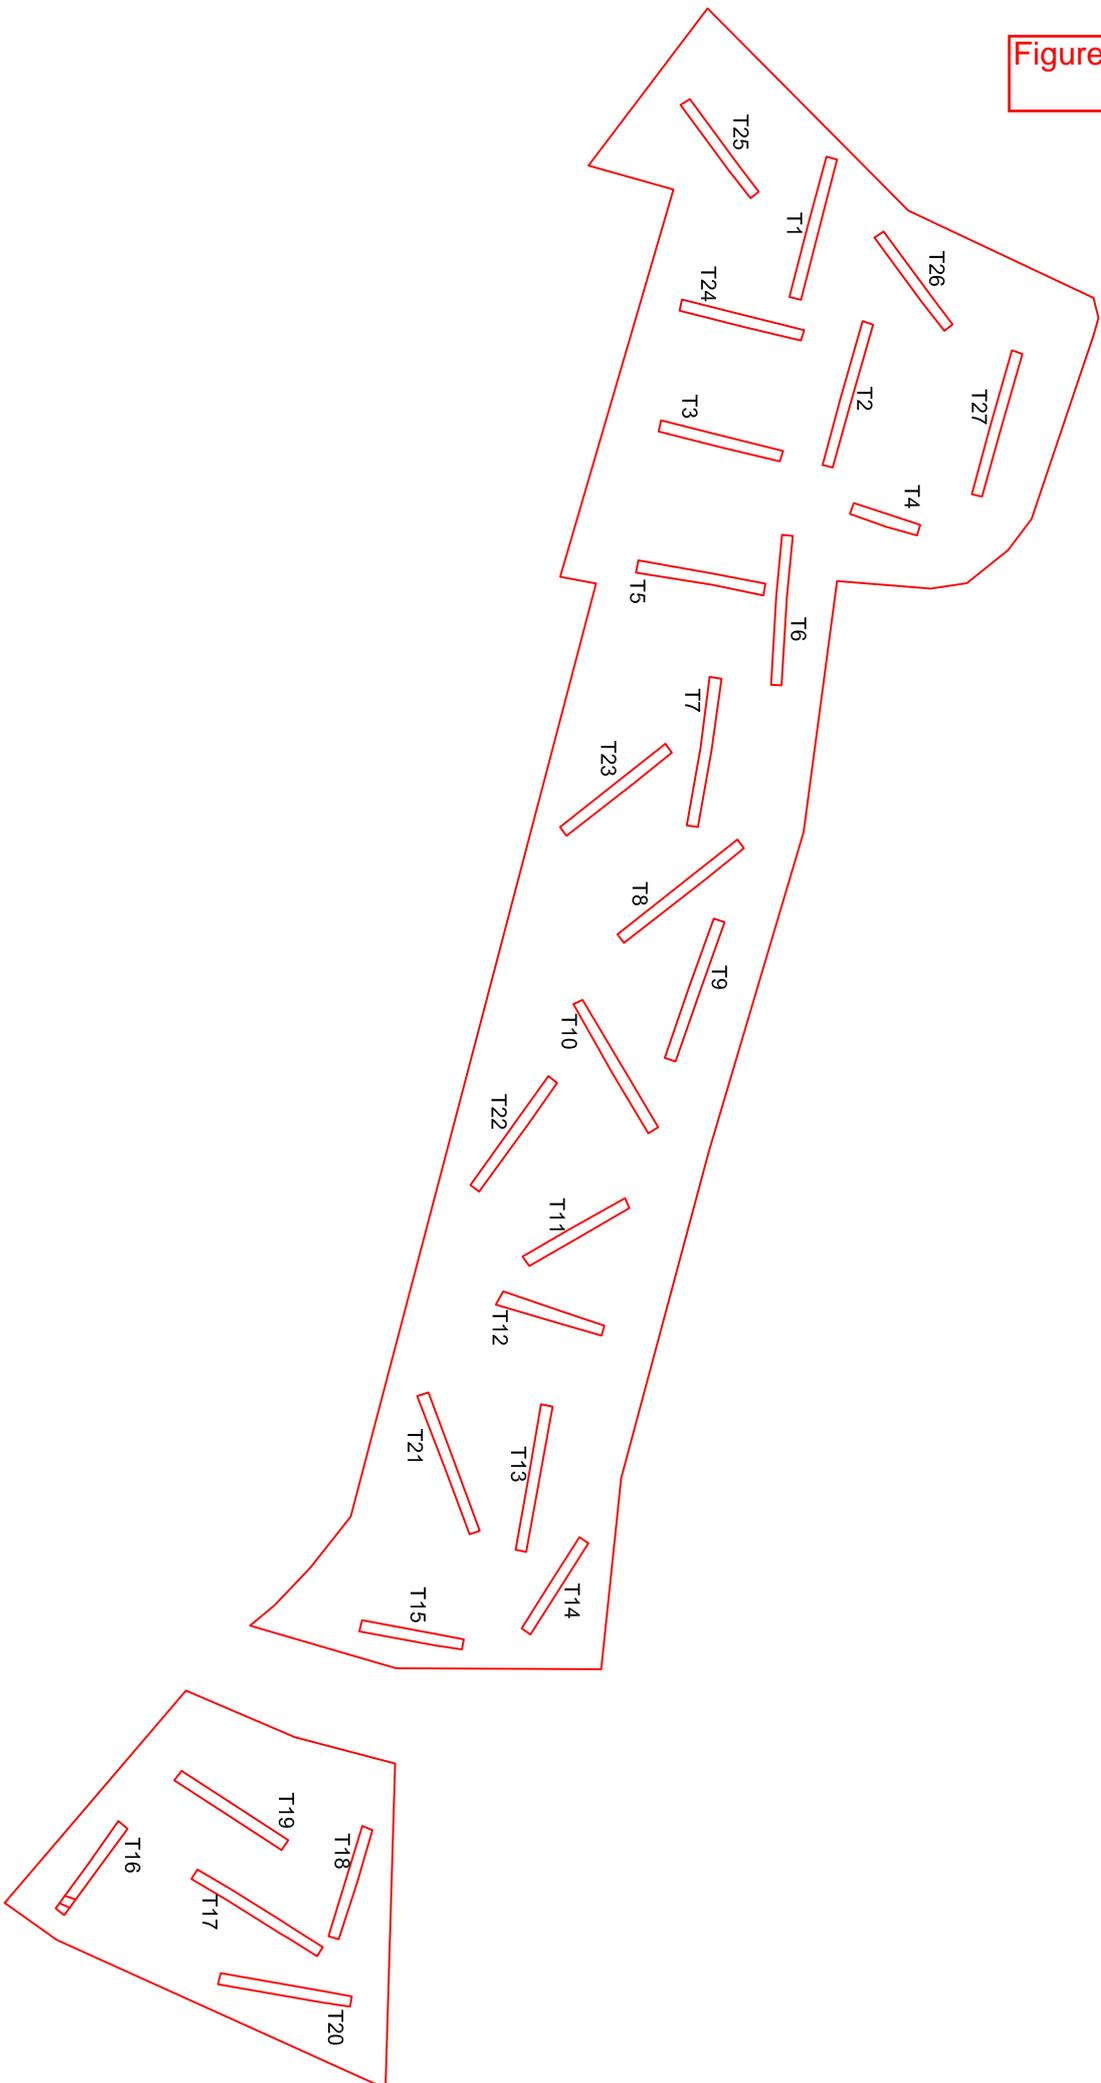
Figure 3

Dartford, Coleridge Road: Evaluation trench plan, scale 1:1000.
