Archaeological Evaluation of Land at the site of the former Klondyke Works, Newtown Road, Ashford, Kent

Planning Application Number: 18/00584/AS

Summary

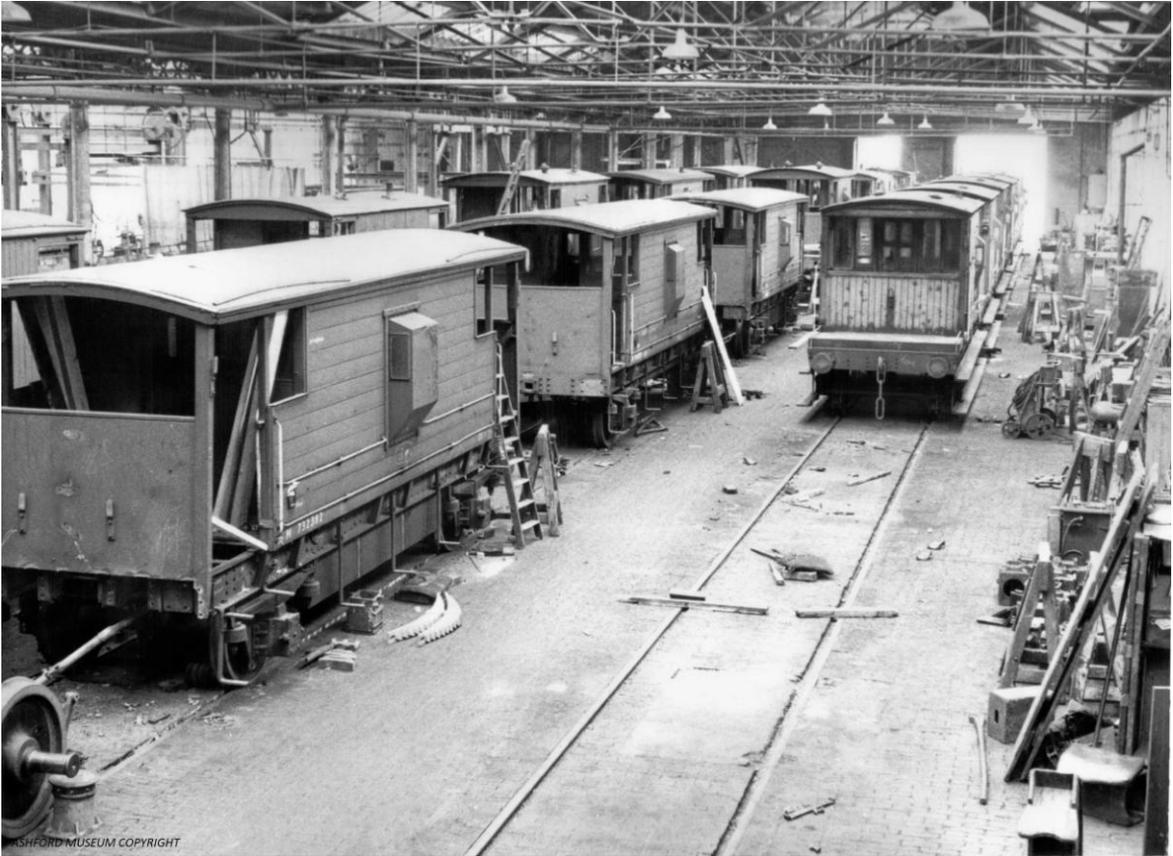
Plate A: Old photograph of Kimberly wagon shop – main building

7.1.3 Evaluation revealed remains of the Railway Works development in 1898 comprising remains of railway tracks, services and massive building (Kimberly Wagon Shop). Prior to development in 1898 extensive levelling work was undertaken involving reducing of the hill slope within south extent of the site and building up ground within northern part.

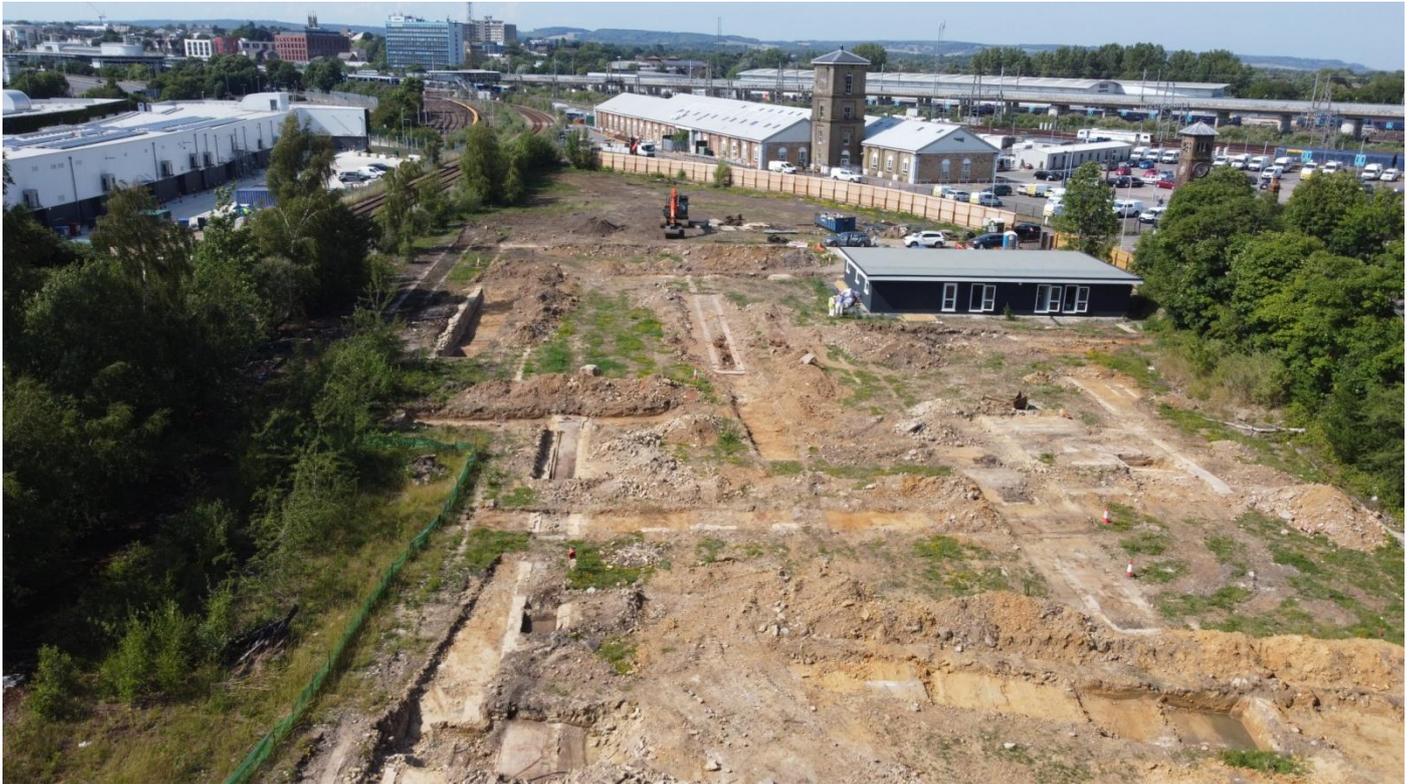
Plate 1: Looking north at the site from its south end.

1.1.1 Swale & Thames Survey Company (SWAT Archaeology) was commissioned to undertake an archaeological evaluation on land at the site of the former Klondyke Works, Newtown Road, Ashford in Kent (*Figures 1-3, Plate 1*).

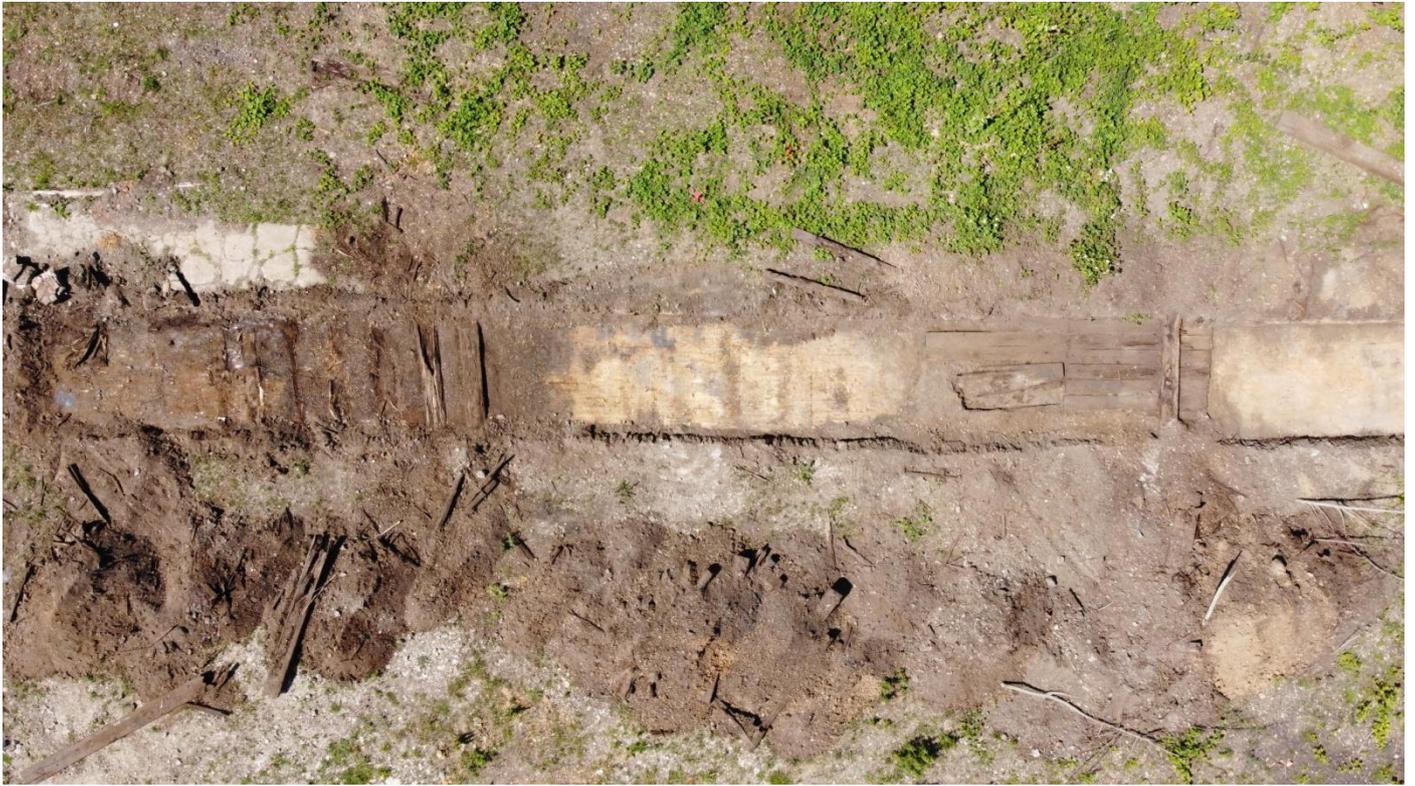
Plate 3: Looking down at Trench 2 with north up. Railway sleepers and underlying bedding gravel remains in situ are visible on the left. Sleepers on the right were stack.

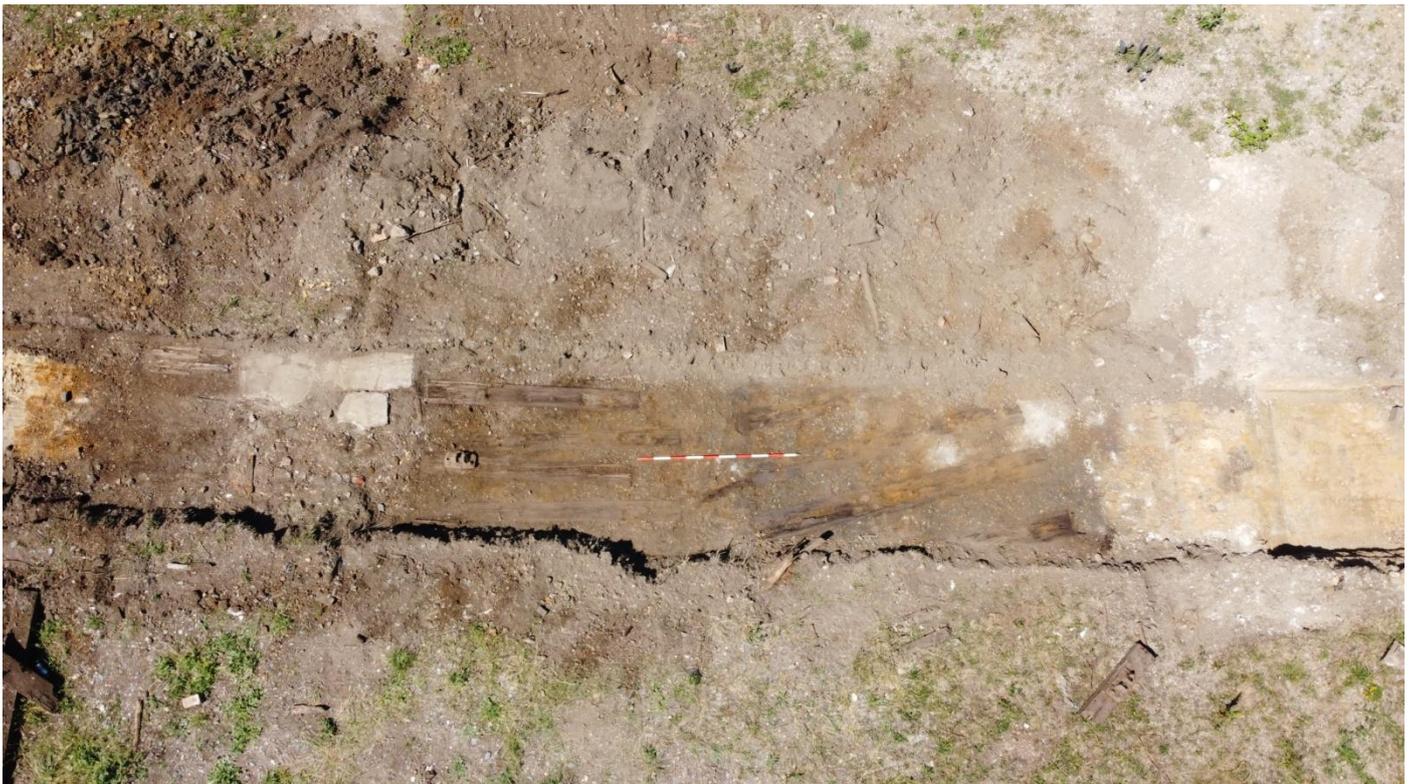
Plate 4: Looking down at Trench 3 with north up and 2 metres scale. Visible sleepers belonged to 4 different railway tracks. Track number 1 is visible on the left side of the concrete slab, track 2 and 3 between the slab and the scale bar and track 4 on the right side of the scale. Buff deposit to the right of track 4 is re deposited natural levelling material.

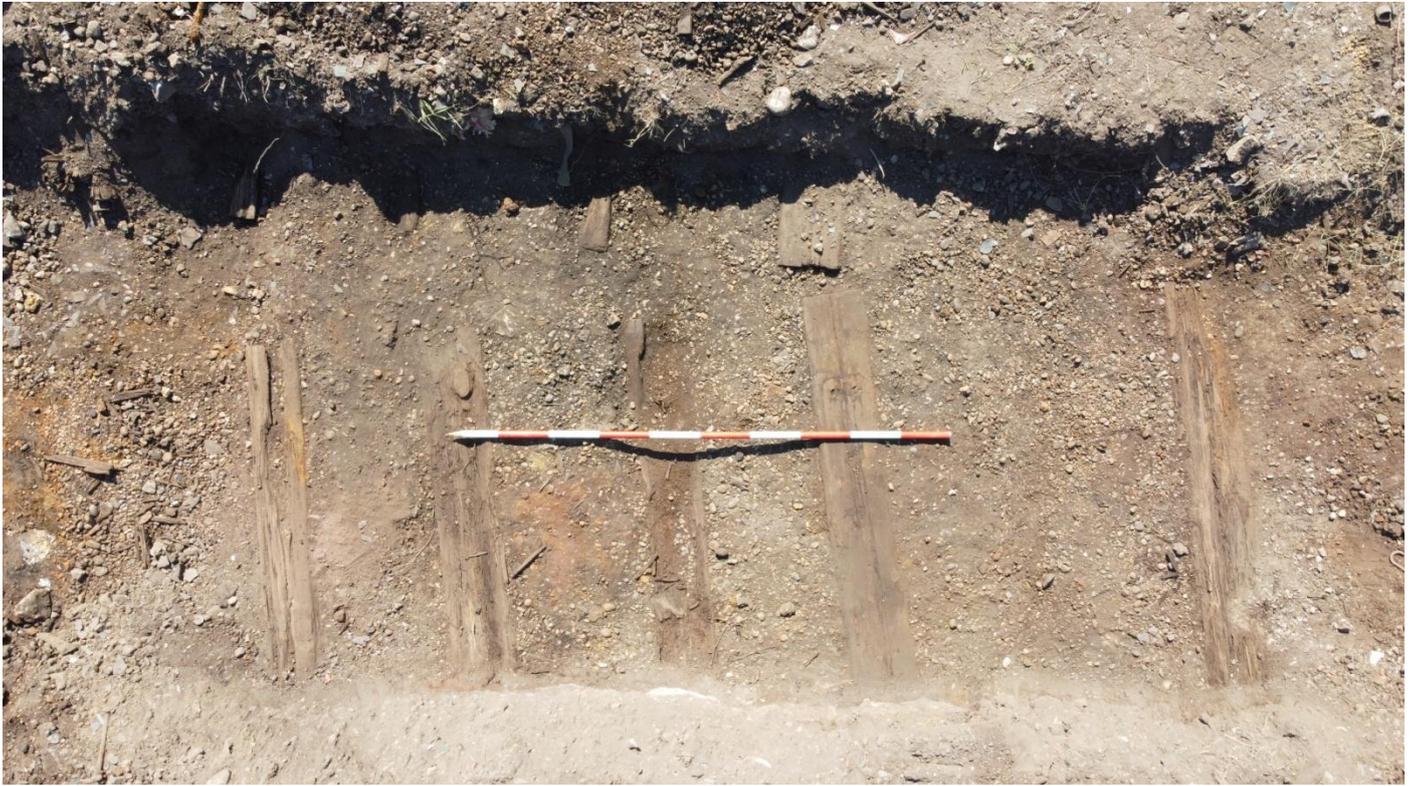
Plate 5: Looking down at Trench 5 with north up and 2 metres scale bar. Visible are railway sleepers of track 2 and 3.

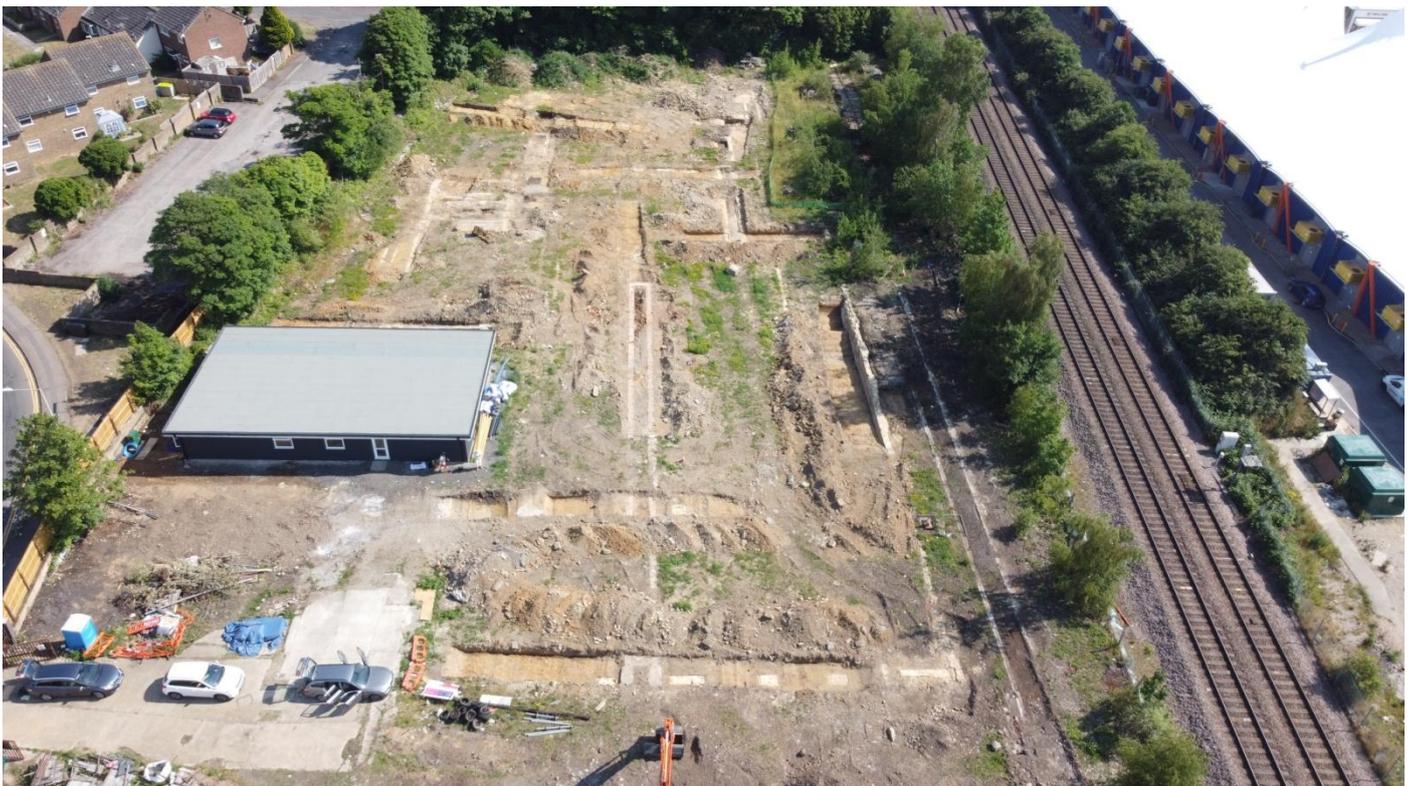
Plate 6: Looking south at building remains. Front wall with gaps indicating the location of the railway tracks are visible in bottom trench. Visible are trenches 7-16 and 1.

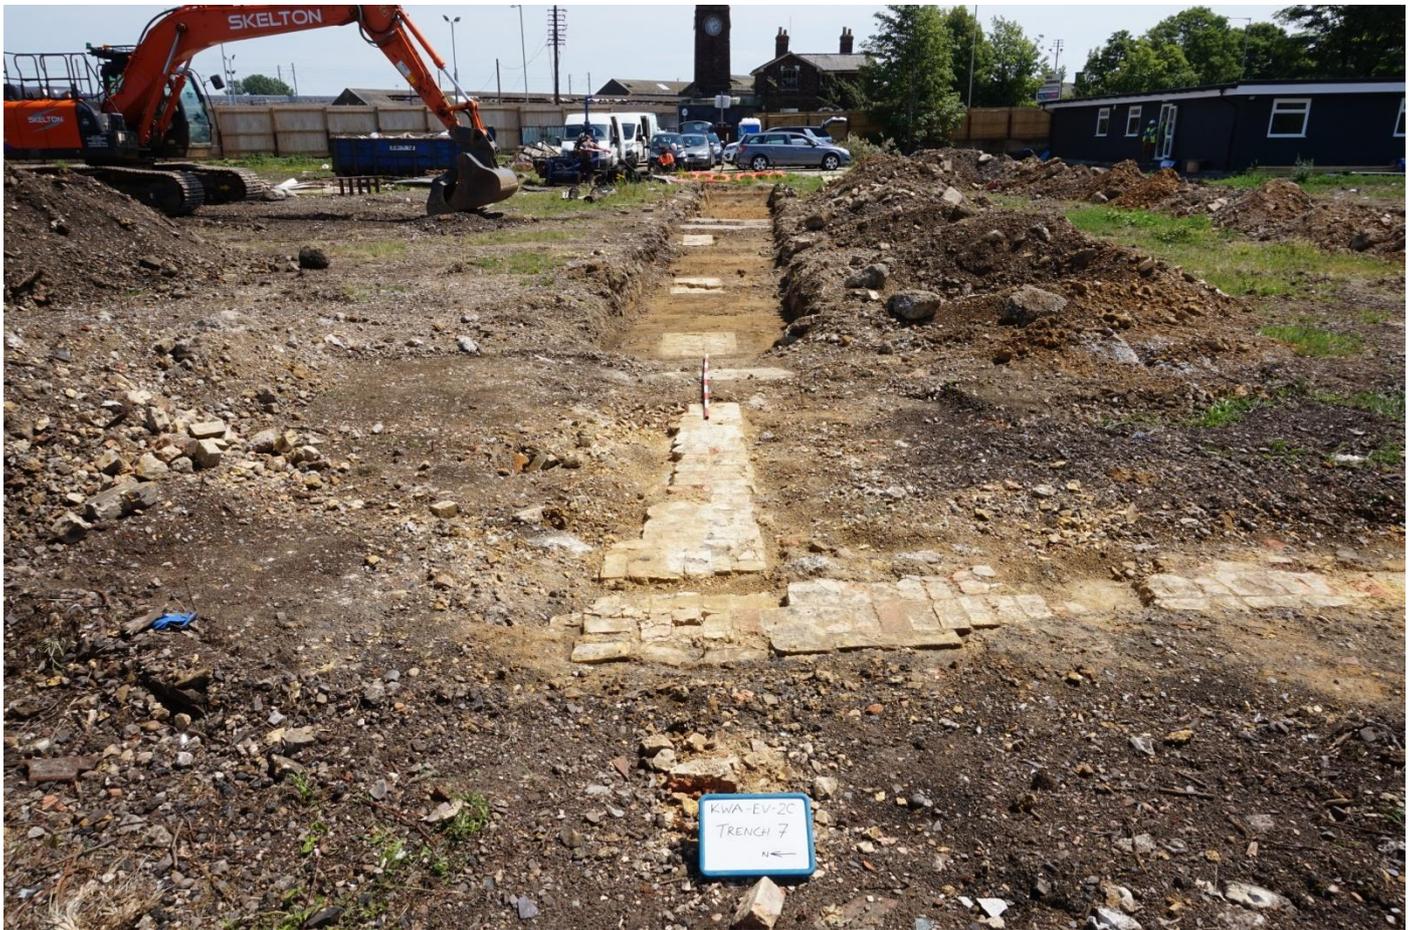
Plate 7: Looking east at north-west corner of the building and its front wall. Photograph is showing walls 724, 723, 717, 714, 713, 710.

723	Structure	Foundation wall	Section of the front, brick foundation north wall of the building located in its NW corner. Feature was 2.92m long and 0.6m wide and exposed depth was 0.1m. Build of yellow stock and occ. red brick (228mm by 108mm by 0.60mm). Context was abutted to the wall 724	0.05+	39.66	7
724	Structure	Foundation wall	Section of the west wall of the building located in its NW corner. Feature was over 20m long and 0.65m wide and exposed depth was 0.1m. Build of yellow stock and occ. red brick (228mm by 108mm by 0.60mm). Context was abutted to the wall 723 and also exposed in trench 9 and 11 and partially visible at top surface of the site.	0.0+	39.66	7
801	Top Layer	Top soil/ Demolition Made ground	Firm compaction, mixed deposit of earth and gravel (concrete, pebbles, aggregate, tarmac bricks) with occ. junk metal. Thin band of patchy top soil with sparse weeds vegetation at the top. Top soil was dark brown sandy loam.	0.0-0.4	39.87	8

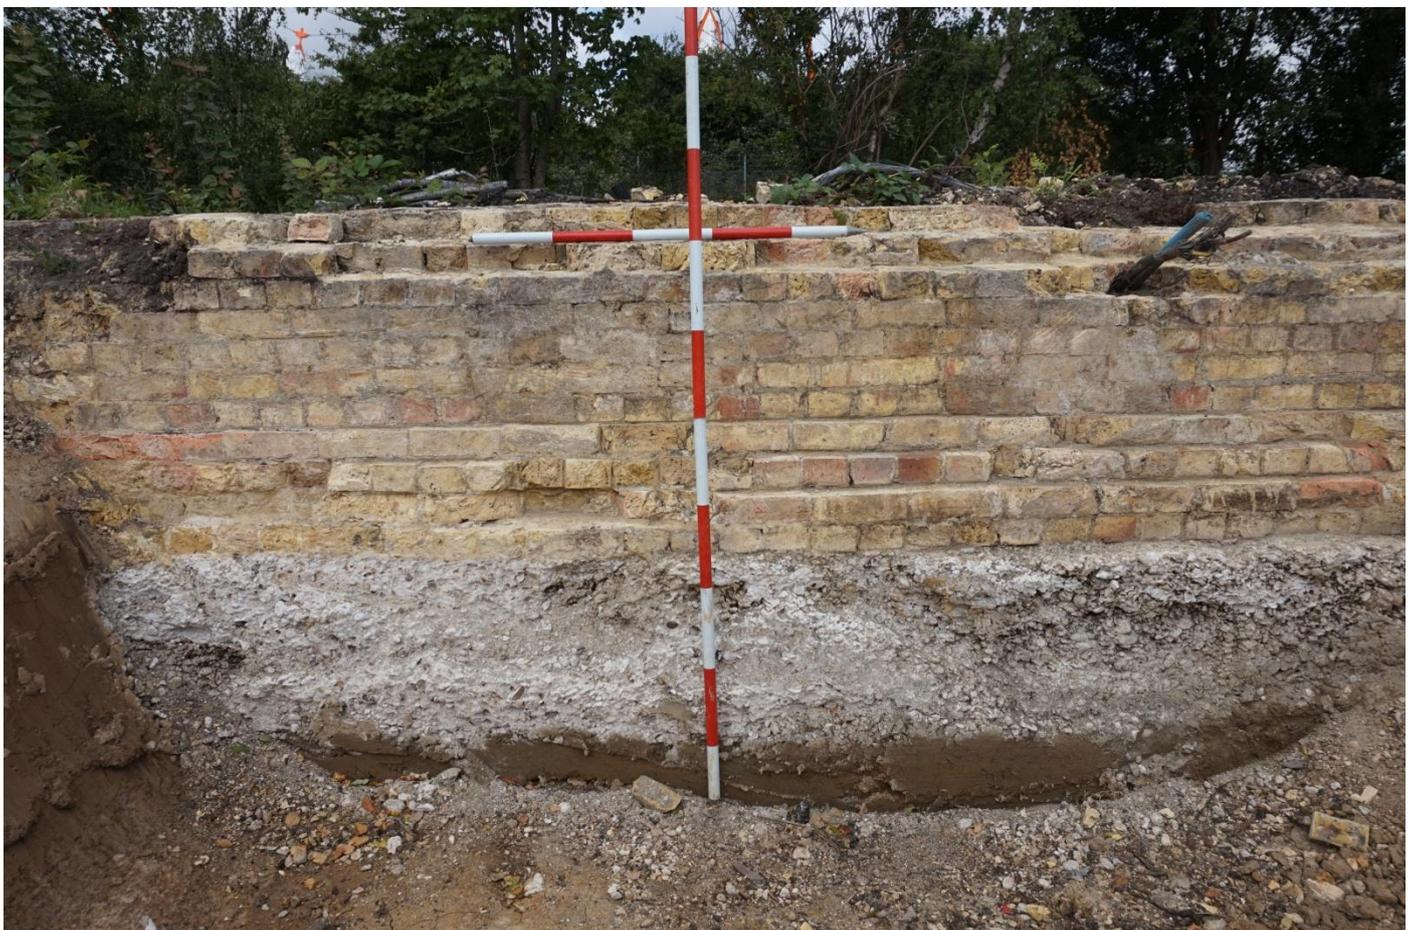
Plate 8: Looking west at exposed elevation of the foundation of the outer wall of the main building. Floor level would be at the top of the wall. Colour section of the scale is 0.2m long.

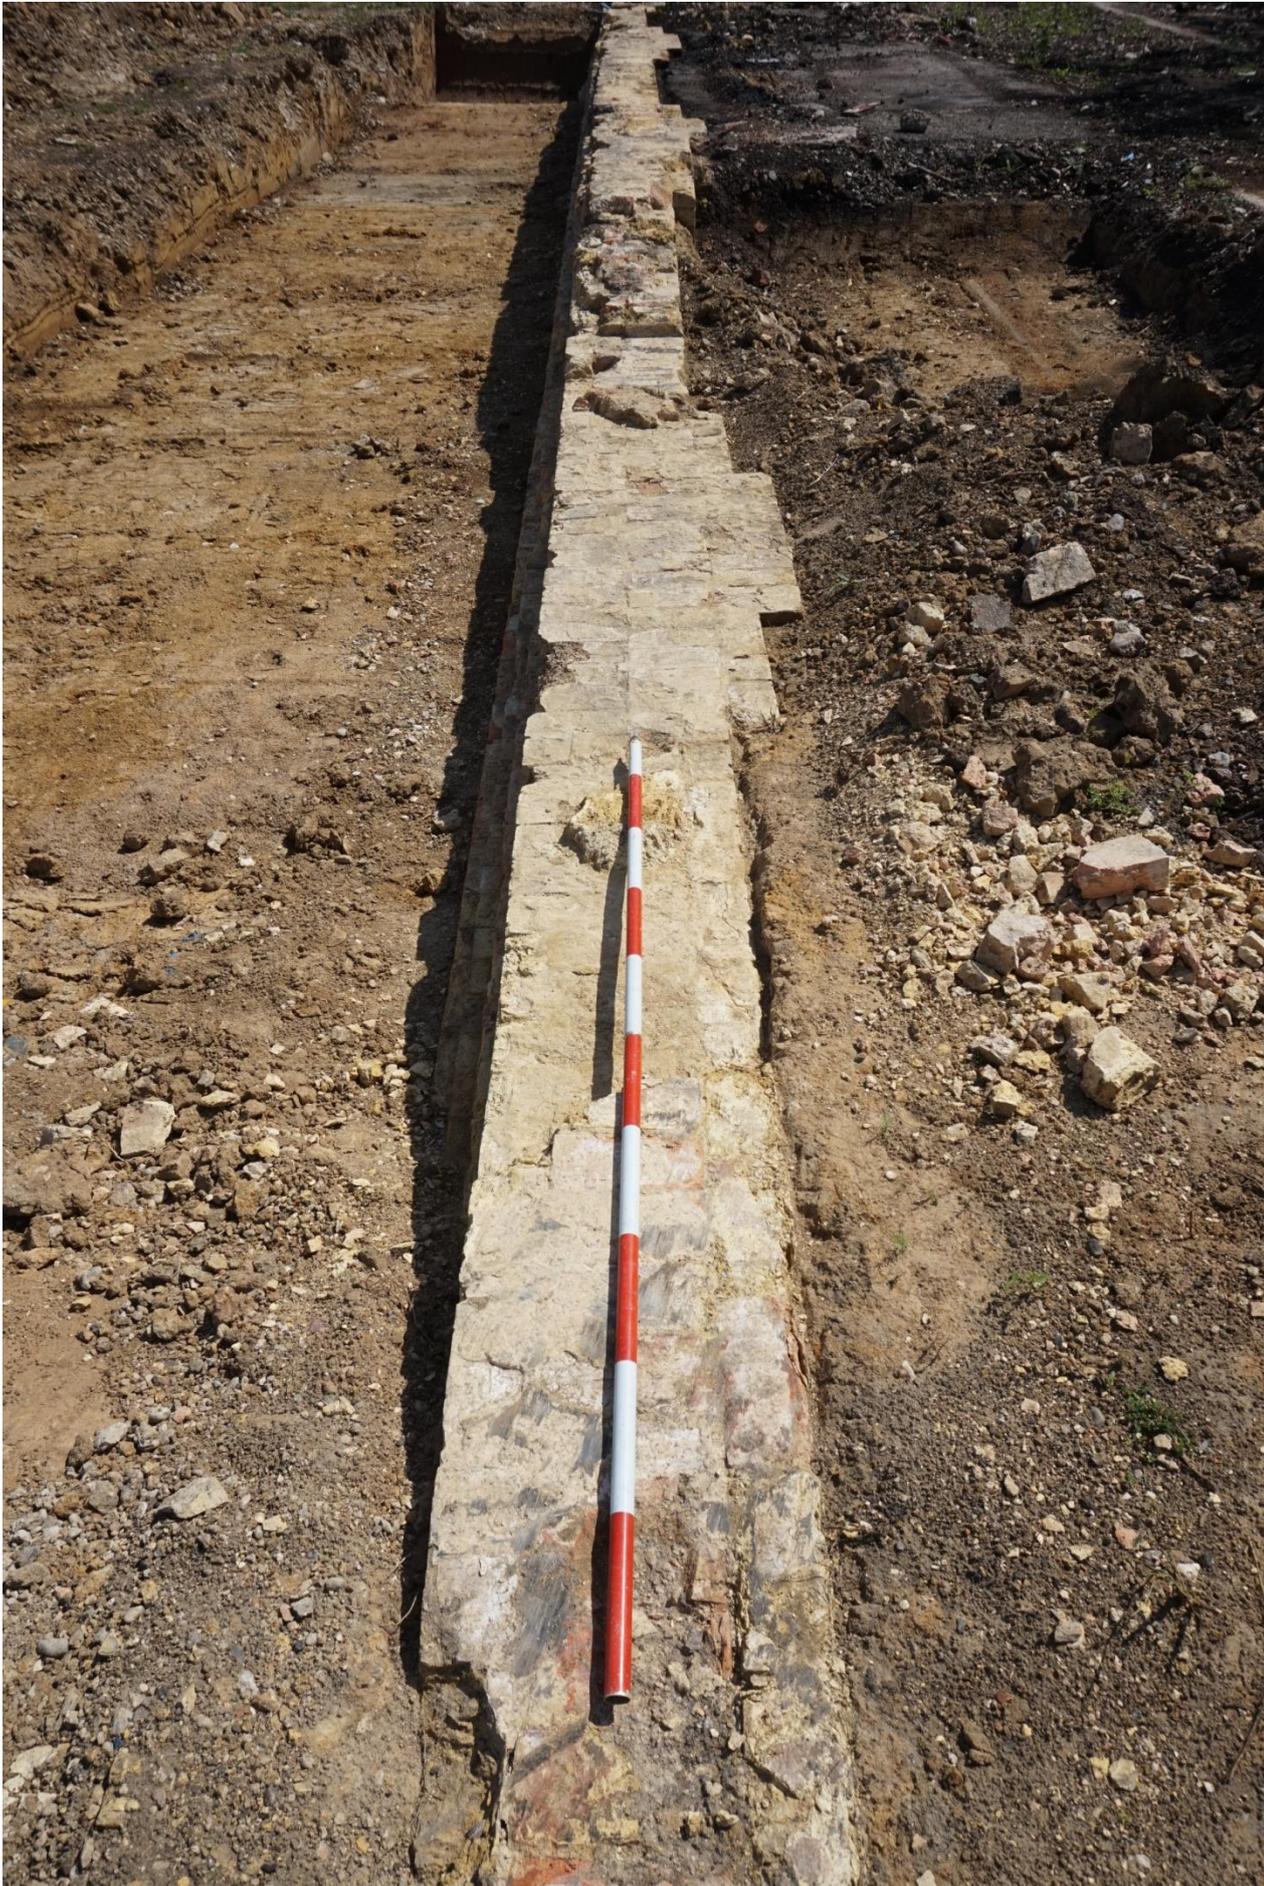
Plate 9: Looking south at west wall of the building and trench 9 and 10 accordingly on the left and right side of the wall. Outside of the building is on the right side of the wall. Wider sections of the wall are piers that were supporting arched lintels spanning over window bays.

907	Structure	Foundation wall	Section of the west wall of the building. Feature was over 20m long and 0.65m wide. It was exposed eleven courses of English bond brickwork. The brick sections of the wall were 1.1m high and build on to of concrete foundation that was 0.7m wide and 0.48m high. Build of yellow stock and occ. red brick (227mm by 110mm by 0.64mm). West face of the wall had piers supporting arched lintels. The window bay was 2.28m long and the wall was 0.47m wide here. Wall pier that was supporting arched lintels was 2.12m long and wall thickness was 0.59m and 0.72m accordingly for 1.16m and 1.04m of the wall length. Wall was also exposed in trench 7 and 11 and partially visible at top surface of the site.	0.0+	39.95	9
1001	Top layer	Made ground	Firm compaction, mix of gravel (tarmac beads, concrete, pebbles and occ. bricks) and re deposited natural sand	0-0.2	39.9	10
1002	Layer	Made ground/ construction	Firm compaction, mid orangey brown sandy clay. Re deposited natural,	0.2-0.5	39.7	10

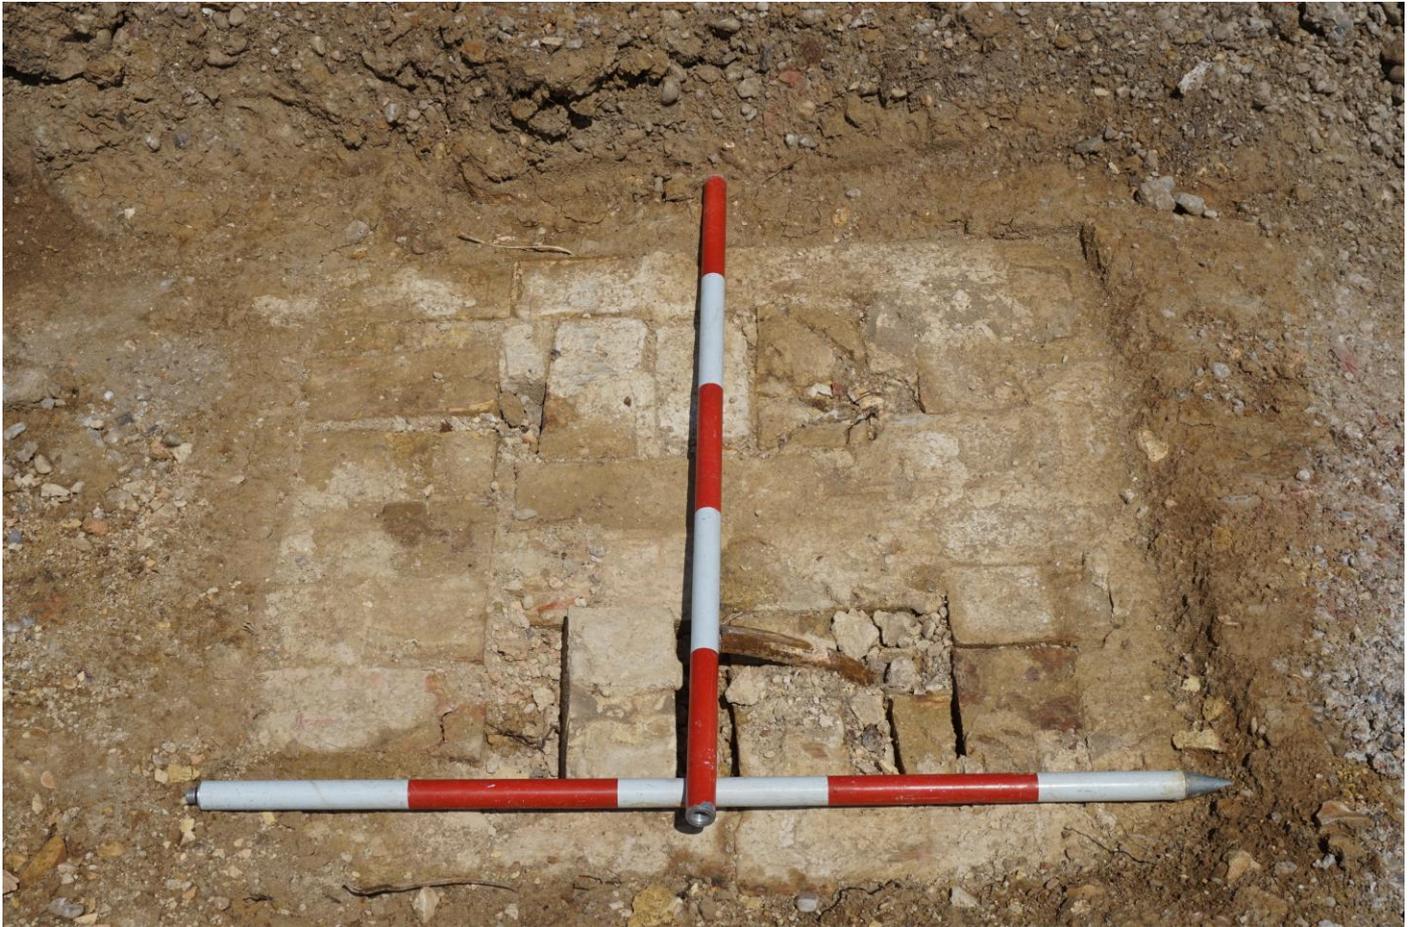
Plate 10: Looking NNW at brick foundation [806] for the column located on central longitudinal axis of the building. Feature was exposed in trench 8.

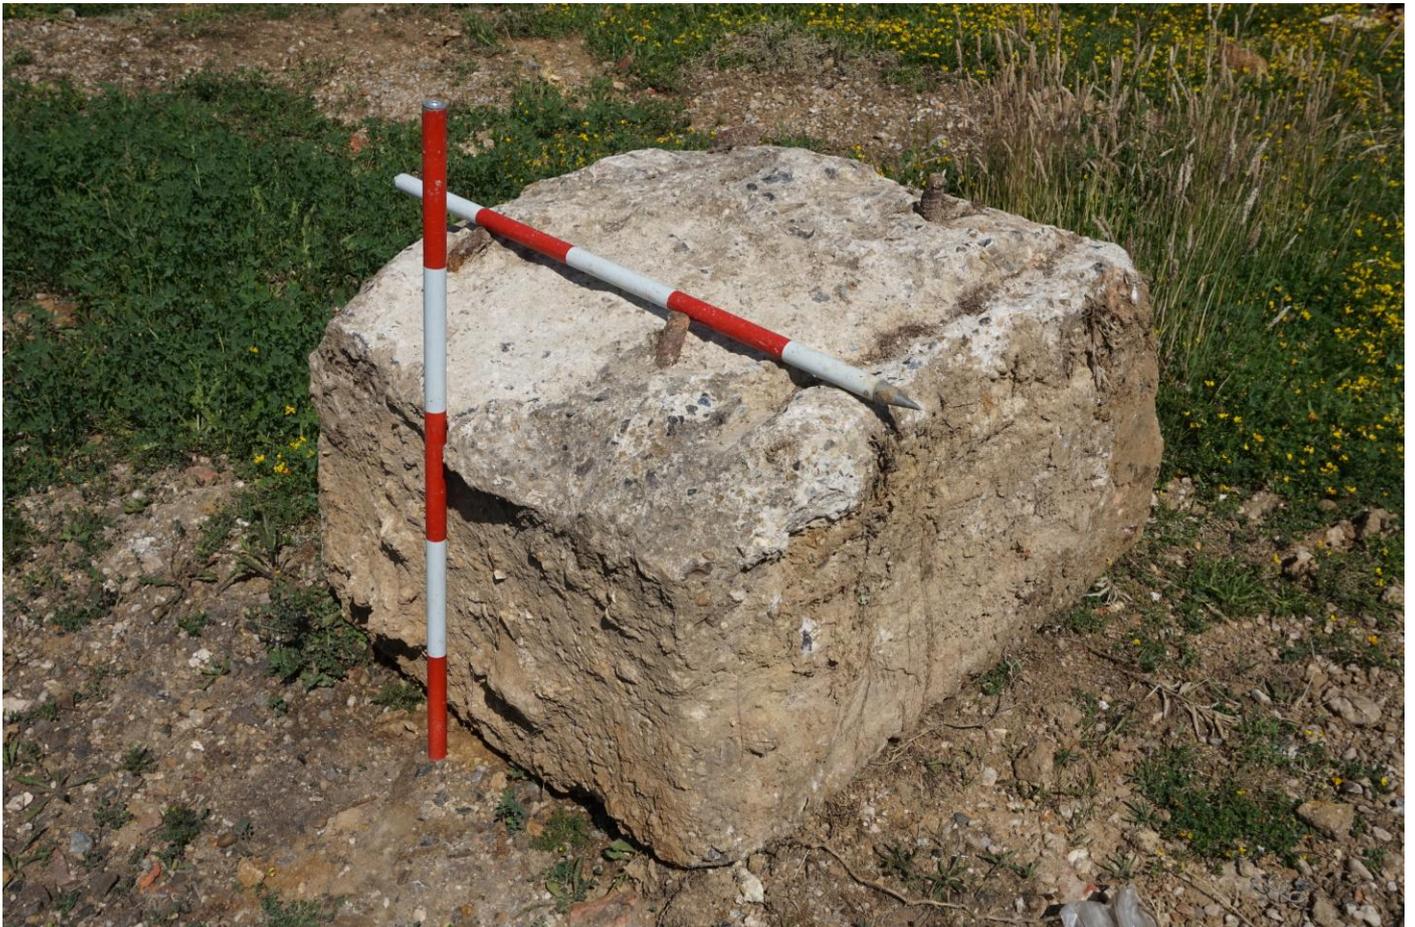
Plate 11: Concrete foundation for the column removed from trench 12. This type of structure was also exposed in trench 8 and 14

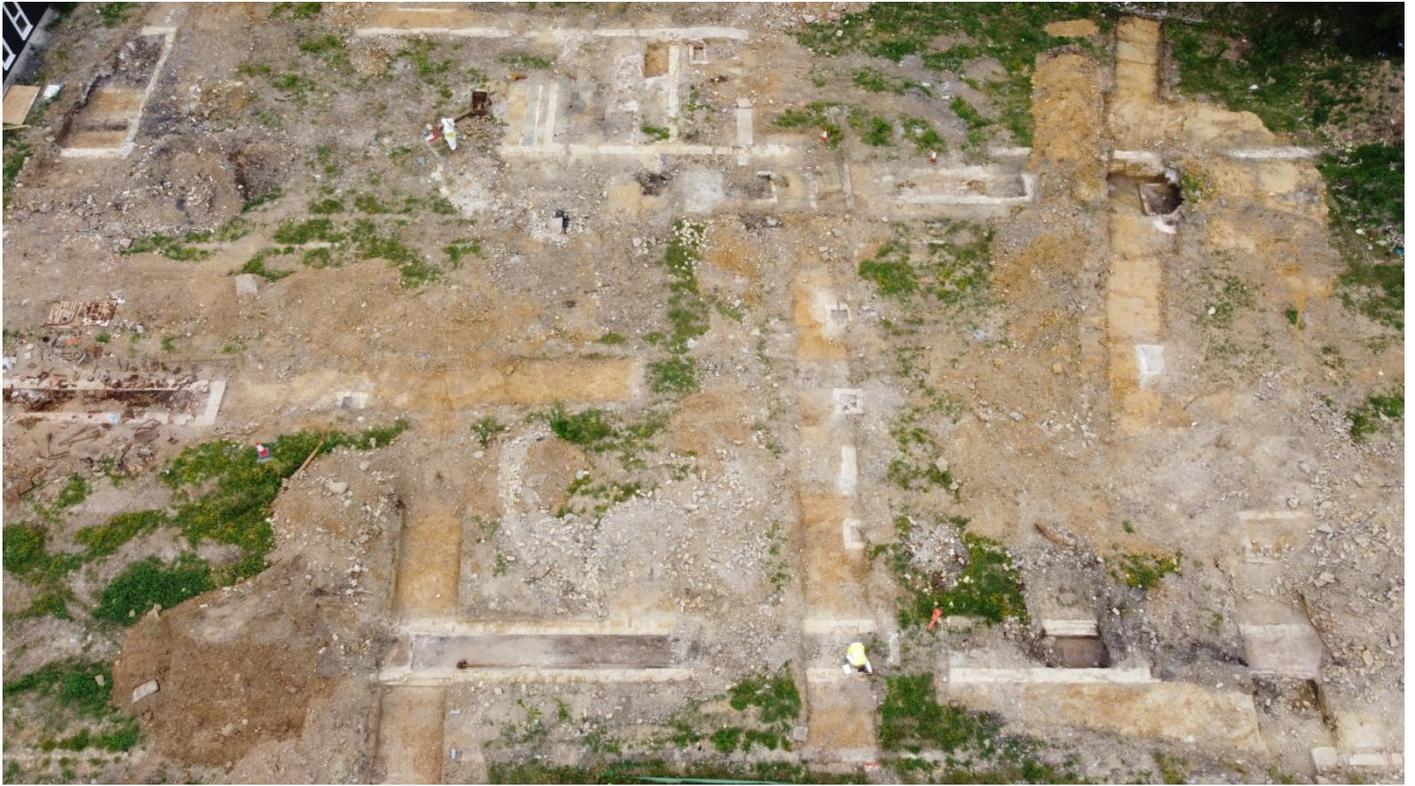
Plate 12: Looking east at south half of the main building. Trenches visible are 1 and 11-16.

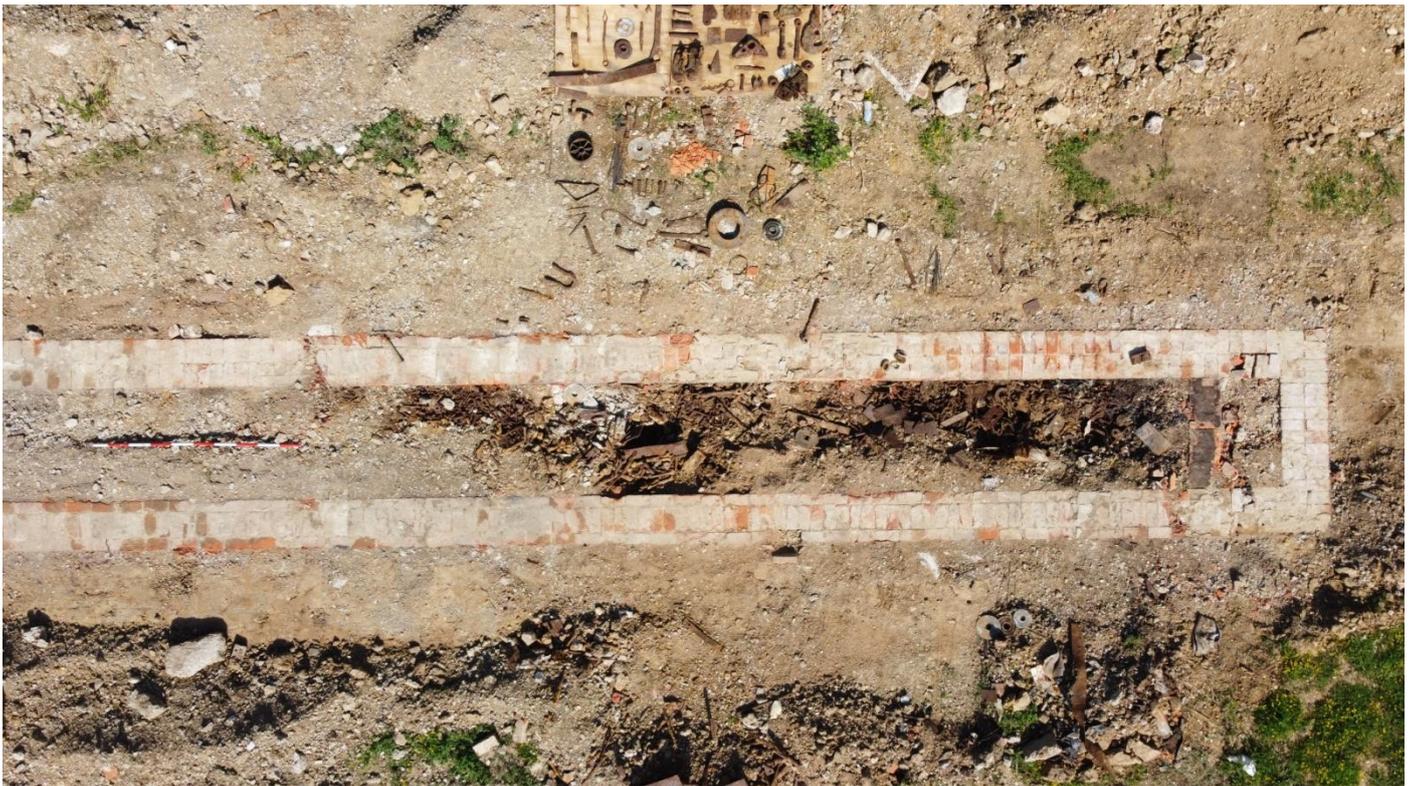
Plate 13: Looking down at trench 1 with exposed south extent of mechanic pit filled up with metal parts; 2 metres scale bar and north up

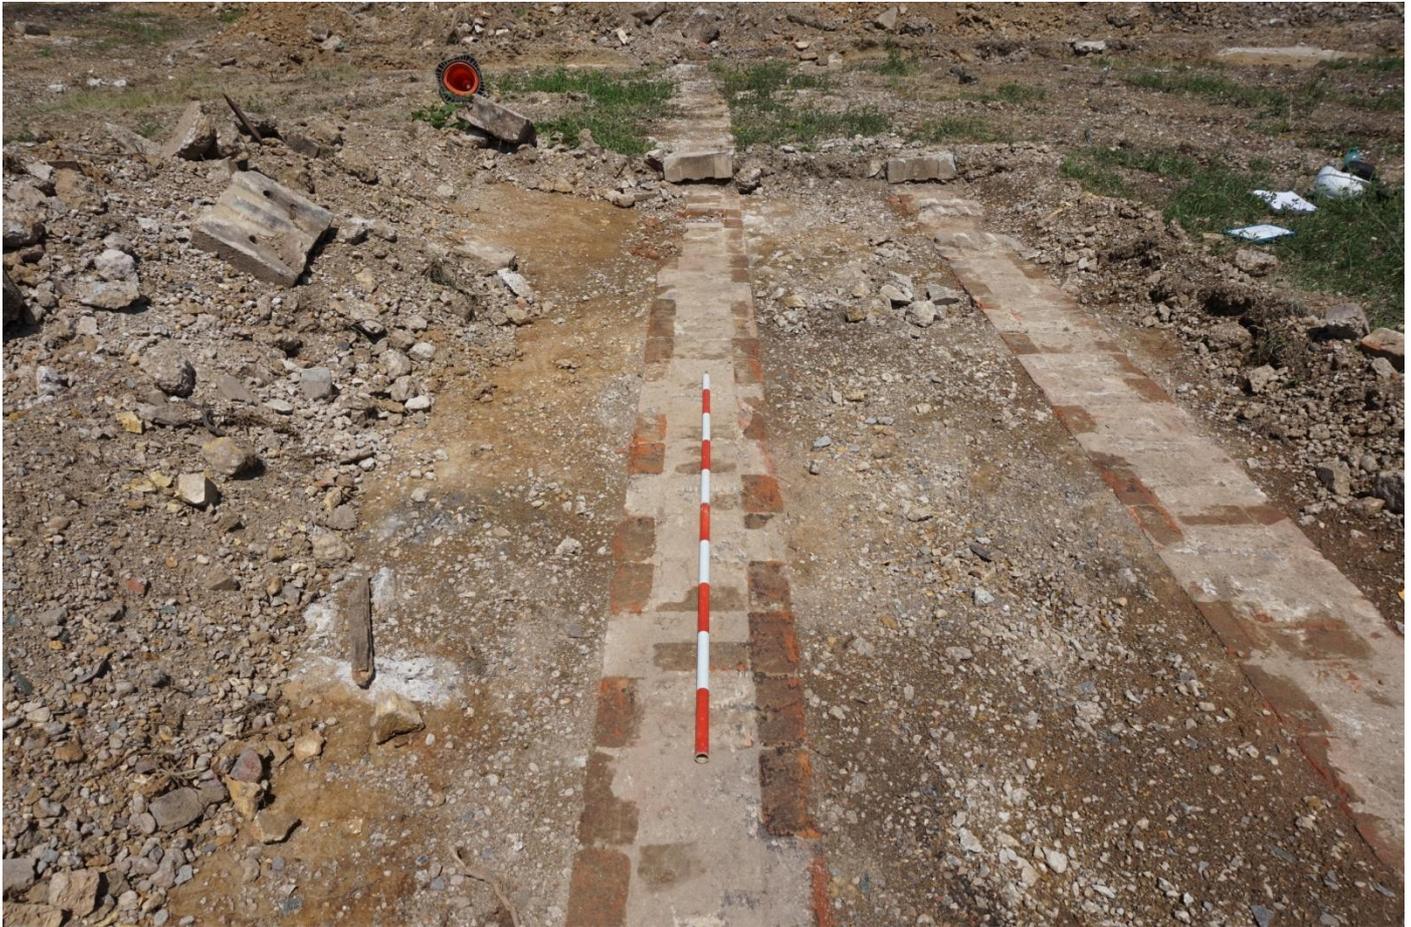
Plate 14: Looking north at top of the brick wall 107 overlaid by wall made of concrete blocks visible here in section in the background. One of the blocks can be seen on the spoil heap on the left.

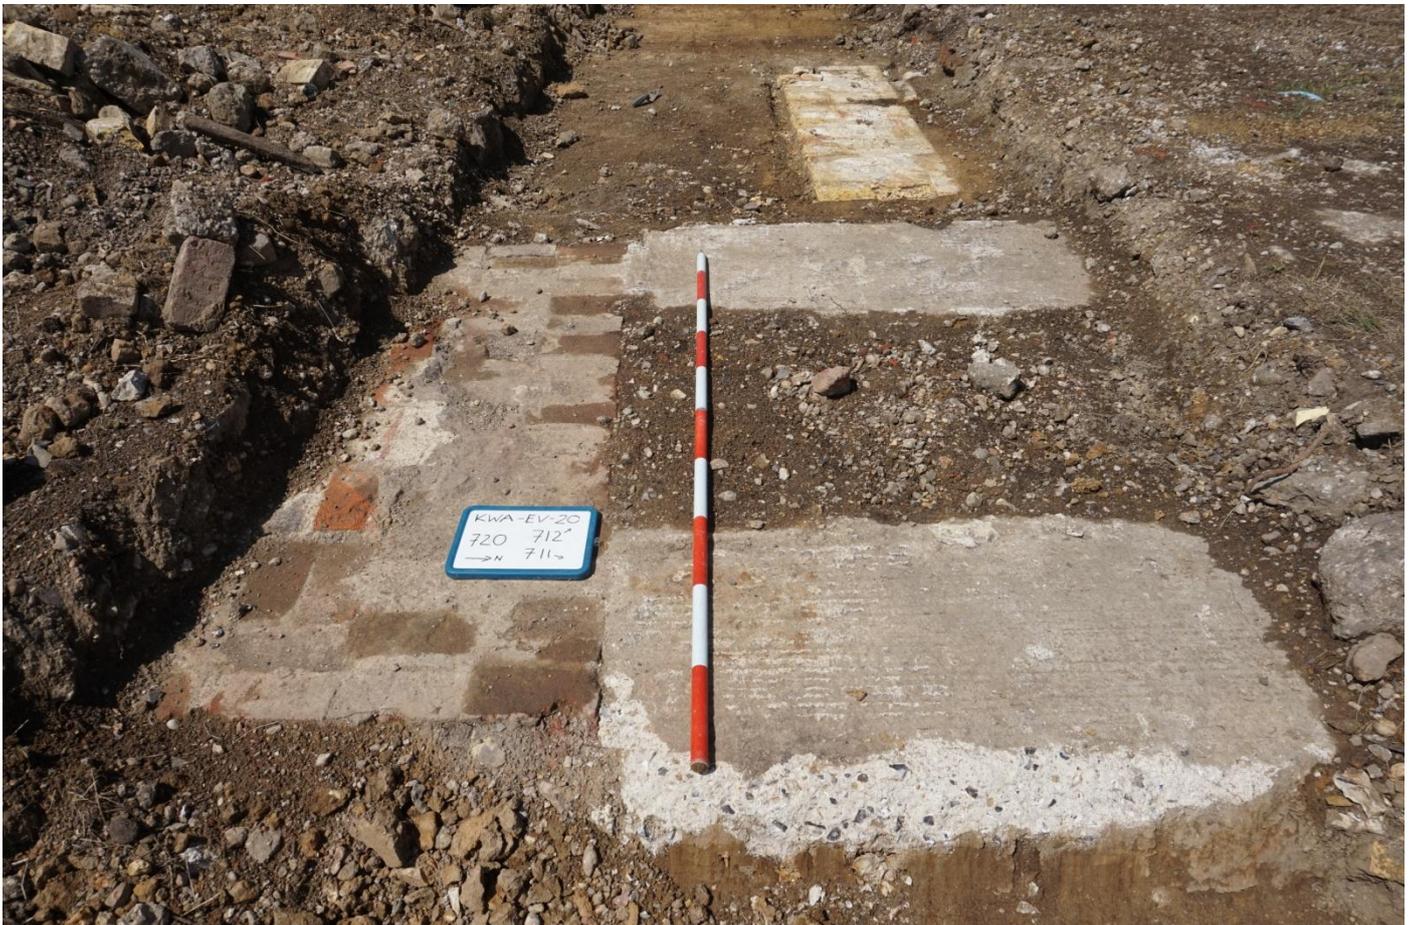
Plate 15: Looking west at north end of the mechanic pit (under board), concrete foundation of railway track (under 2m scale bar) and section of the front wall (top middle margin).

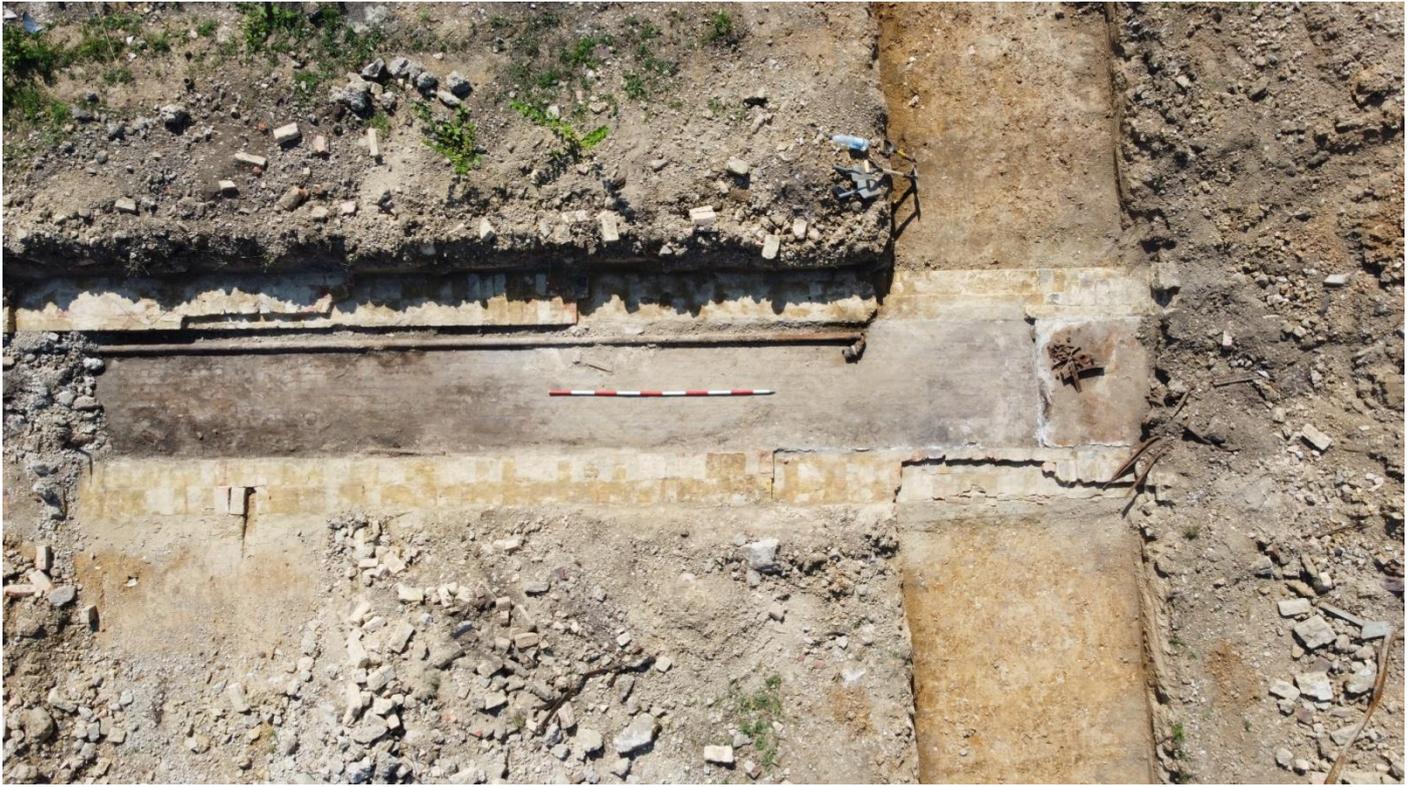
Plate 16: Looking down at brick pit exposed in trench 11; north to the right; 2 metres scale bar.

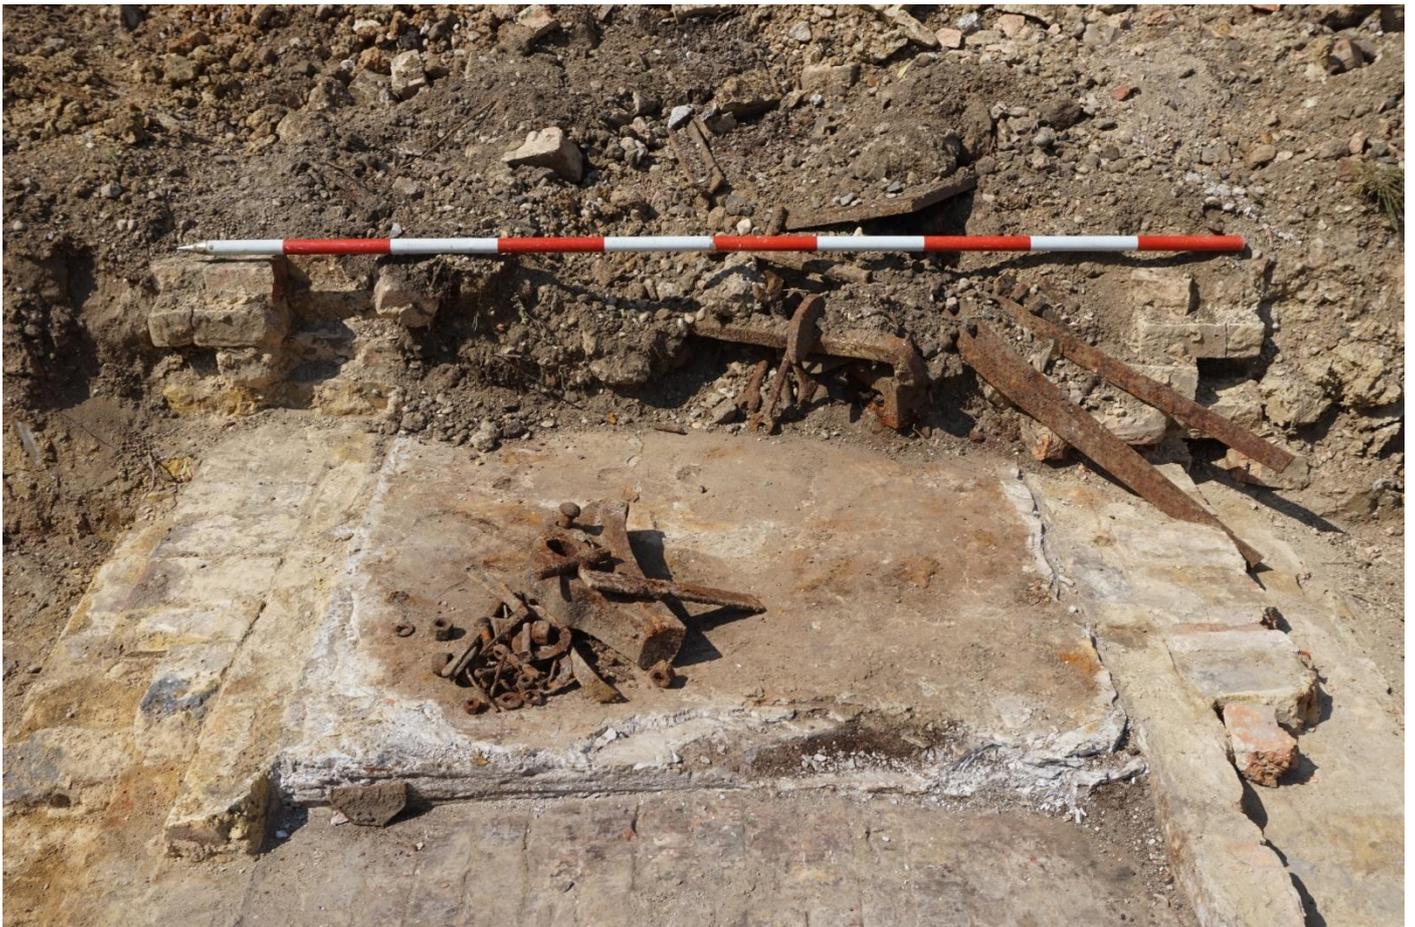
Plate 17: Looking north at section through the pit infill and its walls 1105 and 1106; 2 metres scale bar.
