Archaeological Evaluation of Land at the site of the former Klondyke Works, Newtown Road, Ashford, Kent

Planning Application Number: 18/00584/AS

Summary

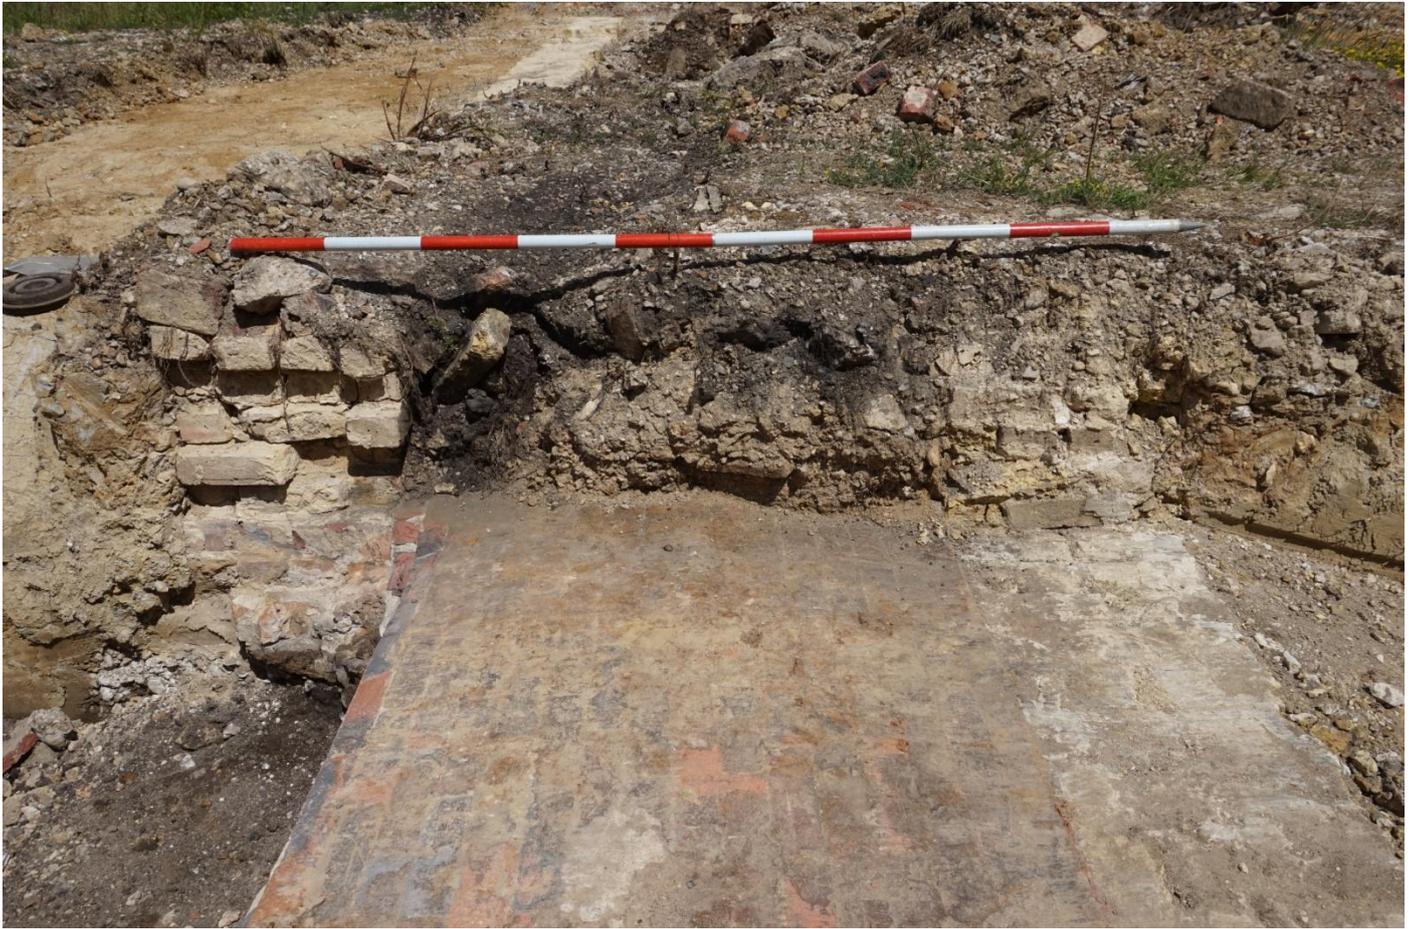
Plate 18: Looking north at section through the pit fill (1310) and its walls (1305 and 1306). Two metres scale bar.

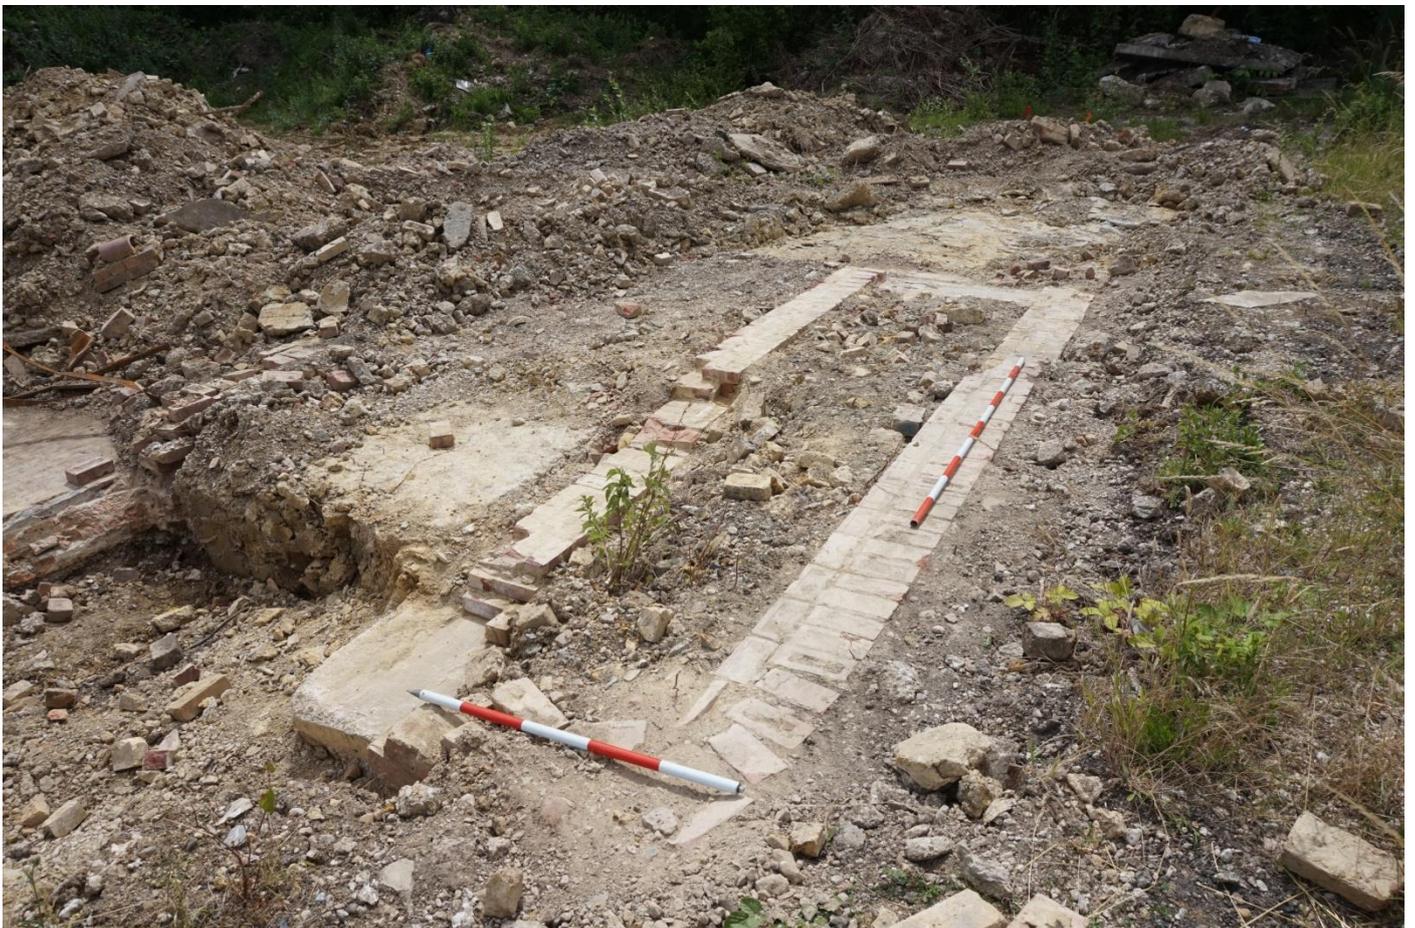
Plate 19: Looking south east at small brick pit [1304] built on concrete slab within a generous size trench.

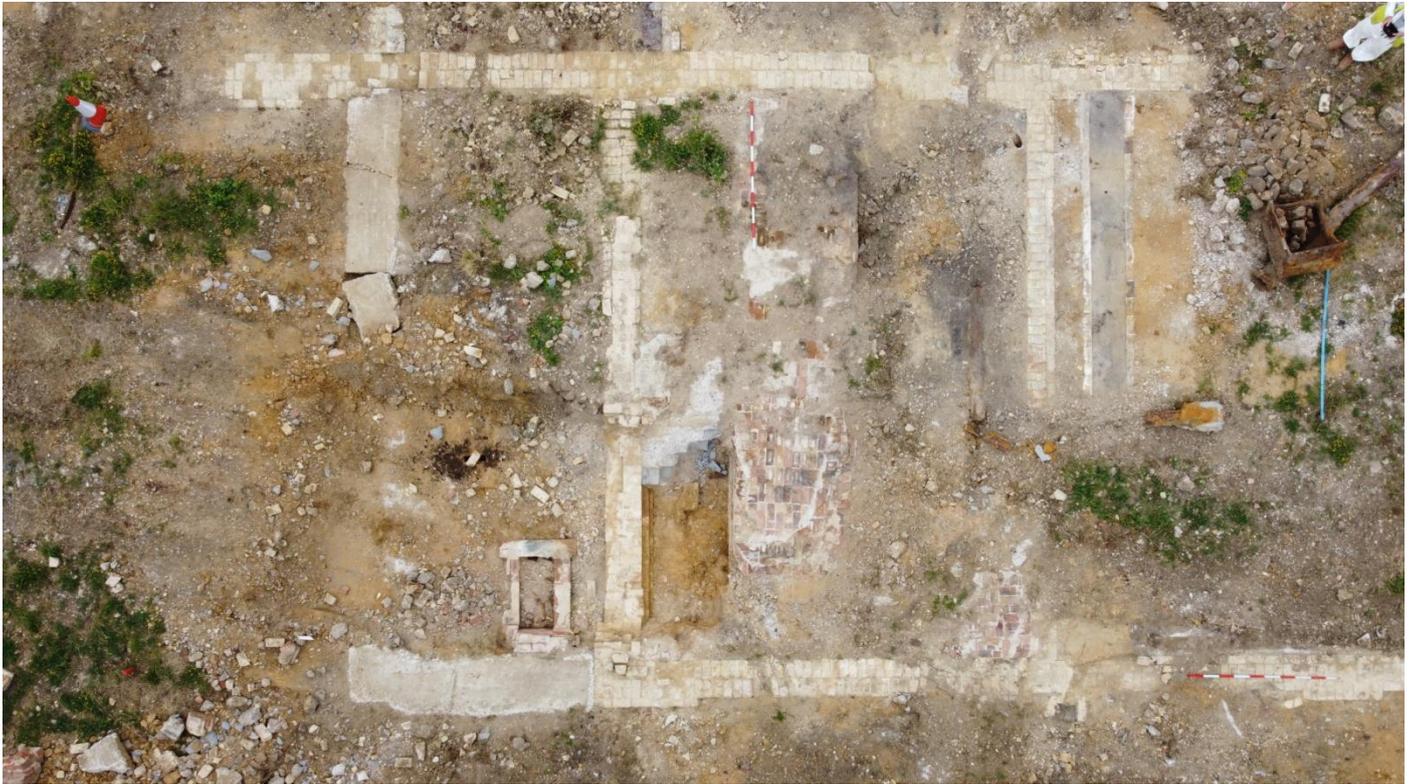
Plate 20: Looking down at south end of East Side Building. Visible scale bar is 2 metres and north is off to the right. Two metres scale bar is placed within the room with robust foundations that were accommodating heavy machinery that was connected to the pipe is visible on the right side of the room near the wall. Further to the right a displaced pipe end embedded in concrete can be seen with a trail directing to its original location.

7.1.6 The east side building comprised of at least 5 rooms that were exposed in trenches 15 and 16. One exposed room was located within east end of the building and comprised footing that were accommodating heavy machinery in the past, most likely water compression pump. The room contained 2 robust brick foundation across the middle of the room and two smaller on sides. Potentially there was a wheel pit to the north of middle foundations and there was a steel pressure pipe placed with end embedded in concrete just before one of the side foundation indicating that next section of the pipe after the 90 degree joint was vertical. There was a lever mechanism in one of the middle foundation block 1509 in its SE corner at the bottom there was an opening with a lever turning vertical axle. The room to the south of machinery room contain one man hole and its function couldn't be estimated. Their walls were concrete that was abutted to other walls which might be later extension on the south end of the east side building but it's uncertain. On the north side of the machinery room exposed fragment of the room had two parallel narrow walls with a concrete floor between them with two square sockets and rusty round plate in the corner. Very likely these walls were supporting narrow rail track for small wagon. Further to the north within trench 16 two or six rooms were exposed. It is unknown if walls exposed there were dividing internal space of the building but it is highly possible. Some of these rooms were filled with boiler slag that is a waste product from coal combustion which indicates nearby extensive burning activity.

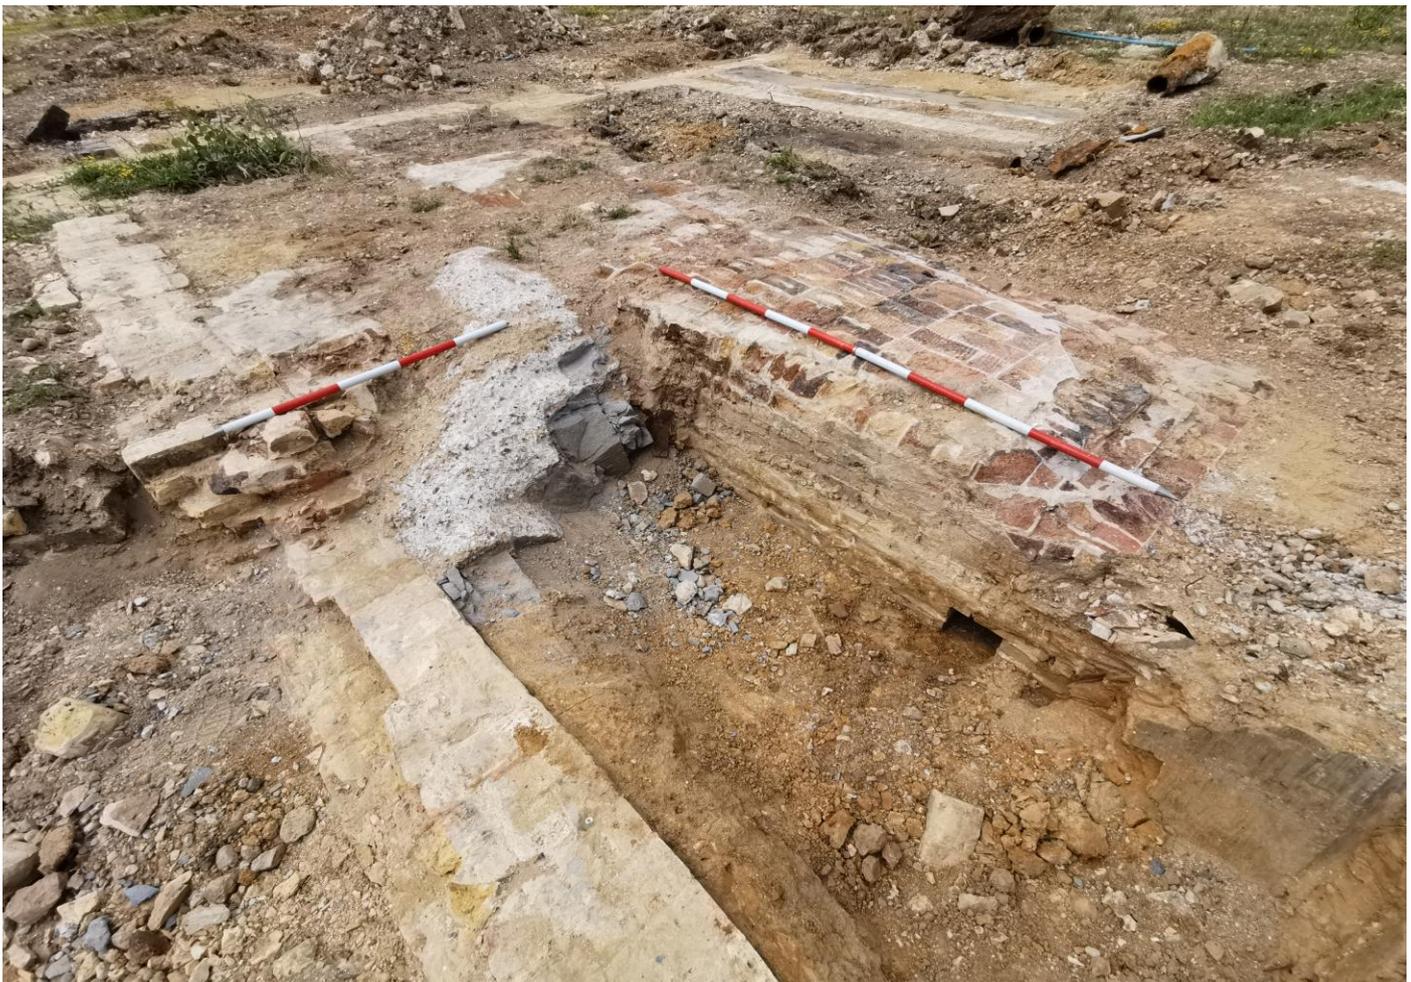
Plate 21: Looking north-west at room located within south end of east side building. Robust brick and concrete foundations were accommodating heavy machinery of some sort, very likely water compression pump. Possibly a wheel pit is located behind the structure [1509] with 2 metres scale bar. There is a lever mechanism in the socket below right end of two metre scale. Grey concrete blocks visible

under right end of one metre scale were used within the structure [1509] where the axle was going through them and they been smaller there measuring 0.1m by 0.1m with a hole in the middle.

1508	Fill	Fill of cellar	Compacted hardcore (mostly crushed concrete and occ. bricks. The depth was not investigated. Possibly it's a infill of the wheel pit or construction cut associated with structure 1505 and 1510	0-0.3+	40.09	15
1509	Structure	Robust brick foundation	Sunken brick structure that was rectangular in plan measuring 2.94m by 1.45m. Structure was built with frogged bricks (red, dark grey and purple). At the top of the structure a threaded bolt vertically positioned was poking out. To the west similar structure 1510 was located with 0.38m gap between the structures. Structure is a footing of some sort of heavy machinery. In the SE corner at the base of the structure there was opening with a lever turning vertical axis. Structure is a footing of some sort for heavy machinery.	0.1-0.6	39.87	15

Context number	Type	Category	Description	Depth (m bgl)	Altitude m OD Top of context	Trench number
1510	Structure	Robust brick foundation	Sunken brick structure that was rectangular in plan measuring 2.94m by 1.45m. Structure was built with frogged bricks (red, dark grey and purple). Structure was abutted on the east side of the wall 1517. At the top of the structure four threaded bolts vertically positioned were poking out. To the east similar structure 1509 was located with 0.38m gap between the structures. Structure is a footing of some sort for heavy machinery.	0.1-0.6	39.87	15
1511	Structure	Concrete foundation	Triangular in plan, concrete uneven surface. Structure measured 0.85m by 0.85m and was abutted on E side of the wall and S side of the structure 1510	0.1+	39.87	15
1512	Structure	Robust brick foundation	WSW-ENE aligned, sunken brick structure that was rectangular in plan measuring 2m by 1.1m. Structure was built with frogged bricks (red, dark grey and purple). Structure was abutted on the south side of the structure 1509 and on the north side of wall 1503. At the top of the structure threaded bolt vertically positioned was poking out. In east part at the bottom a concrete blocks were used and covered by cast coarse concrete. The top surface was uneven and sloping to the south. The concrete used is alike one used in building wall foundation. Brick part of the structure seems to overlay the concrete and very likely built with different material rather than later repair work. Structure is a footing of some sort for heavy machinery.	0.1-0.6	39.87	15

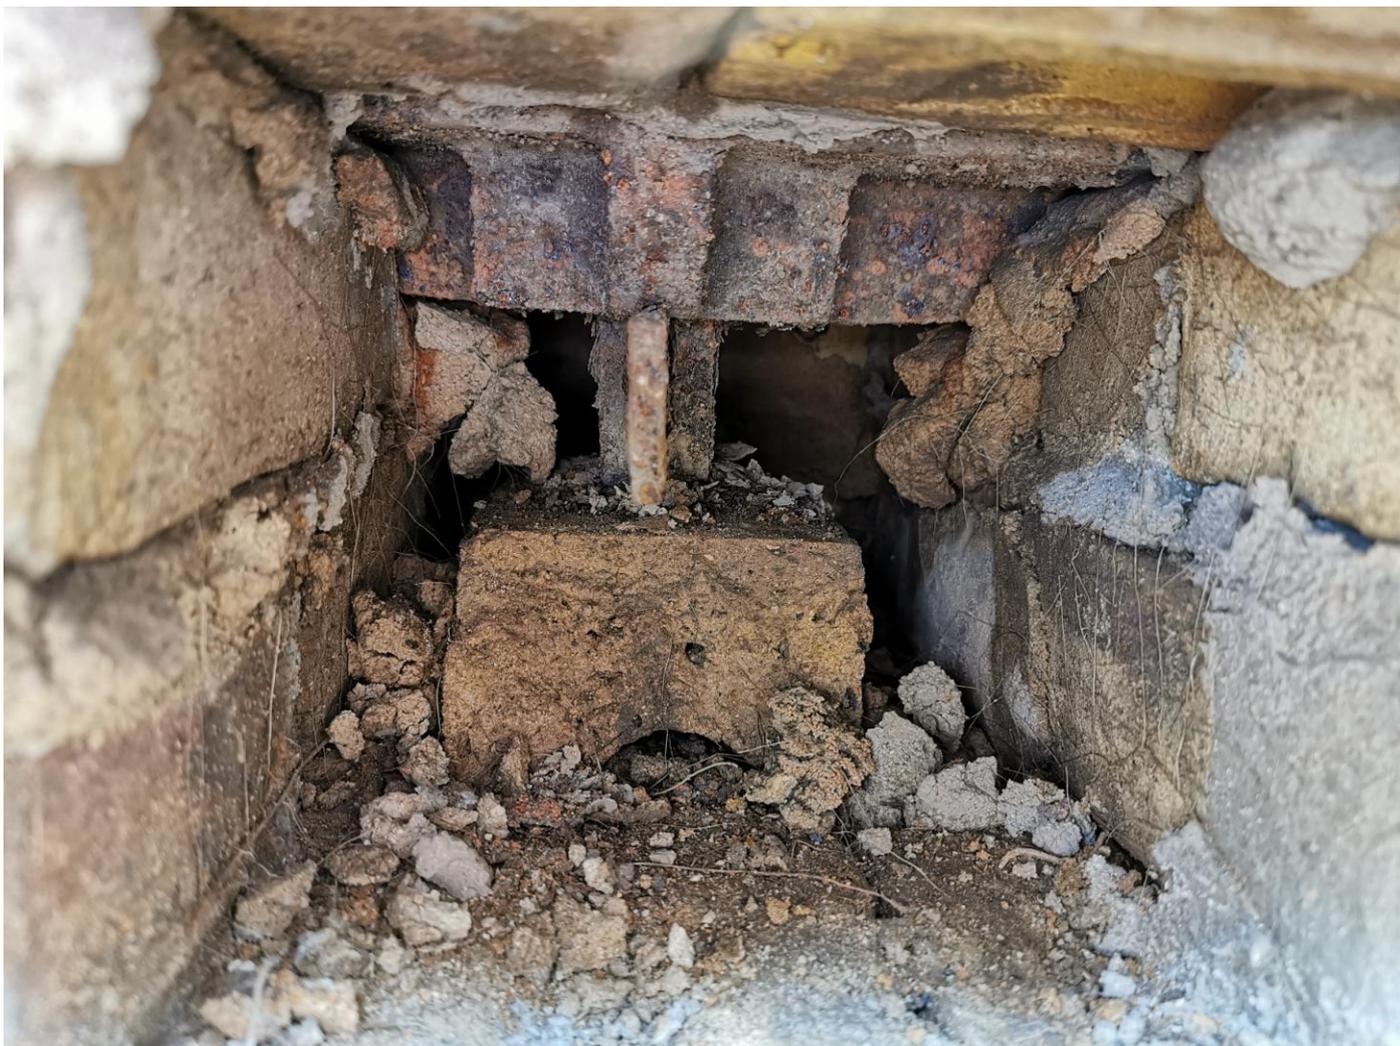
Plate 22: Leaver mechanism in located inside the structure [1509]. It was turning vertical axle visible at the top of the structure.

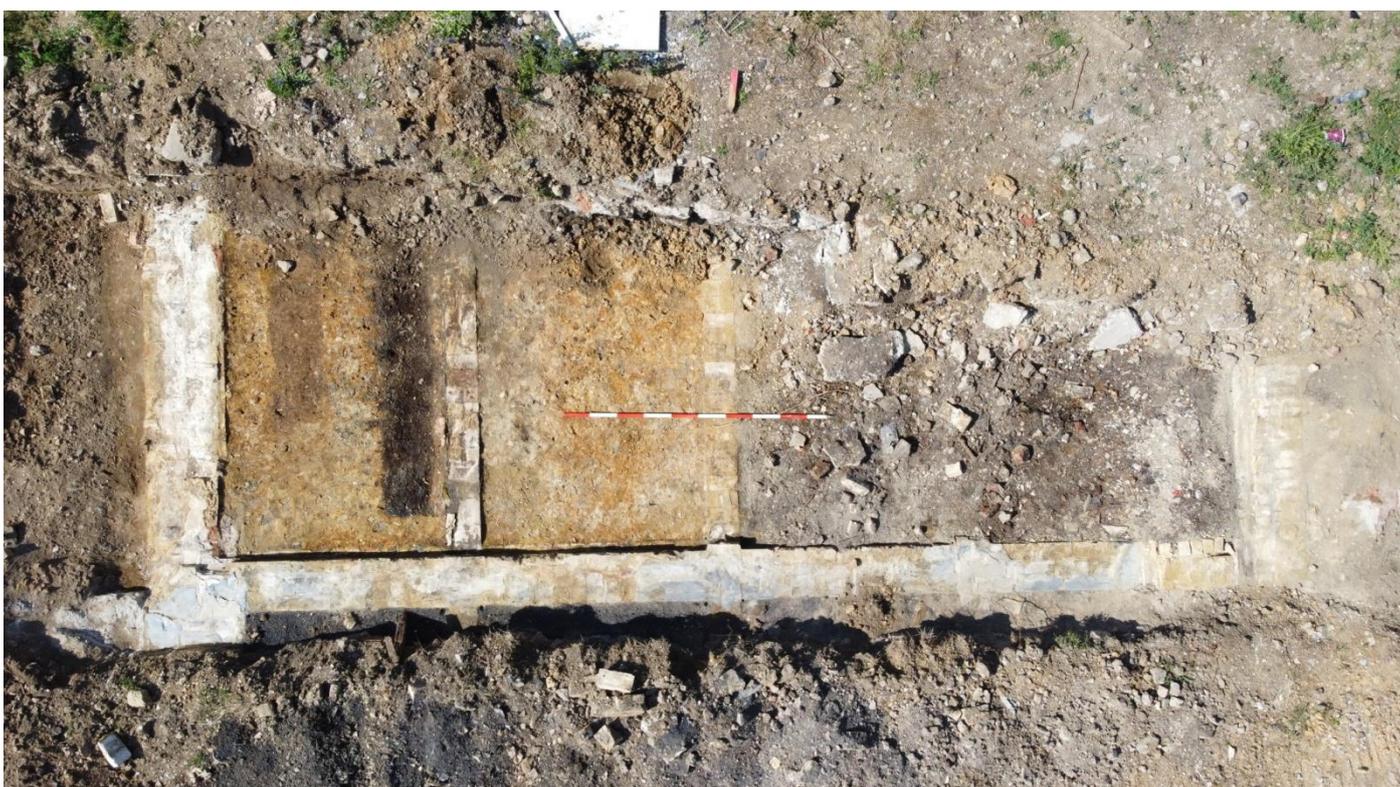
Plate 23: Looking down at walls of East Side Building exposed here in trench 16. Visible scale bar is 2 metres and north is off to the top.

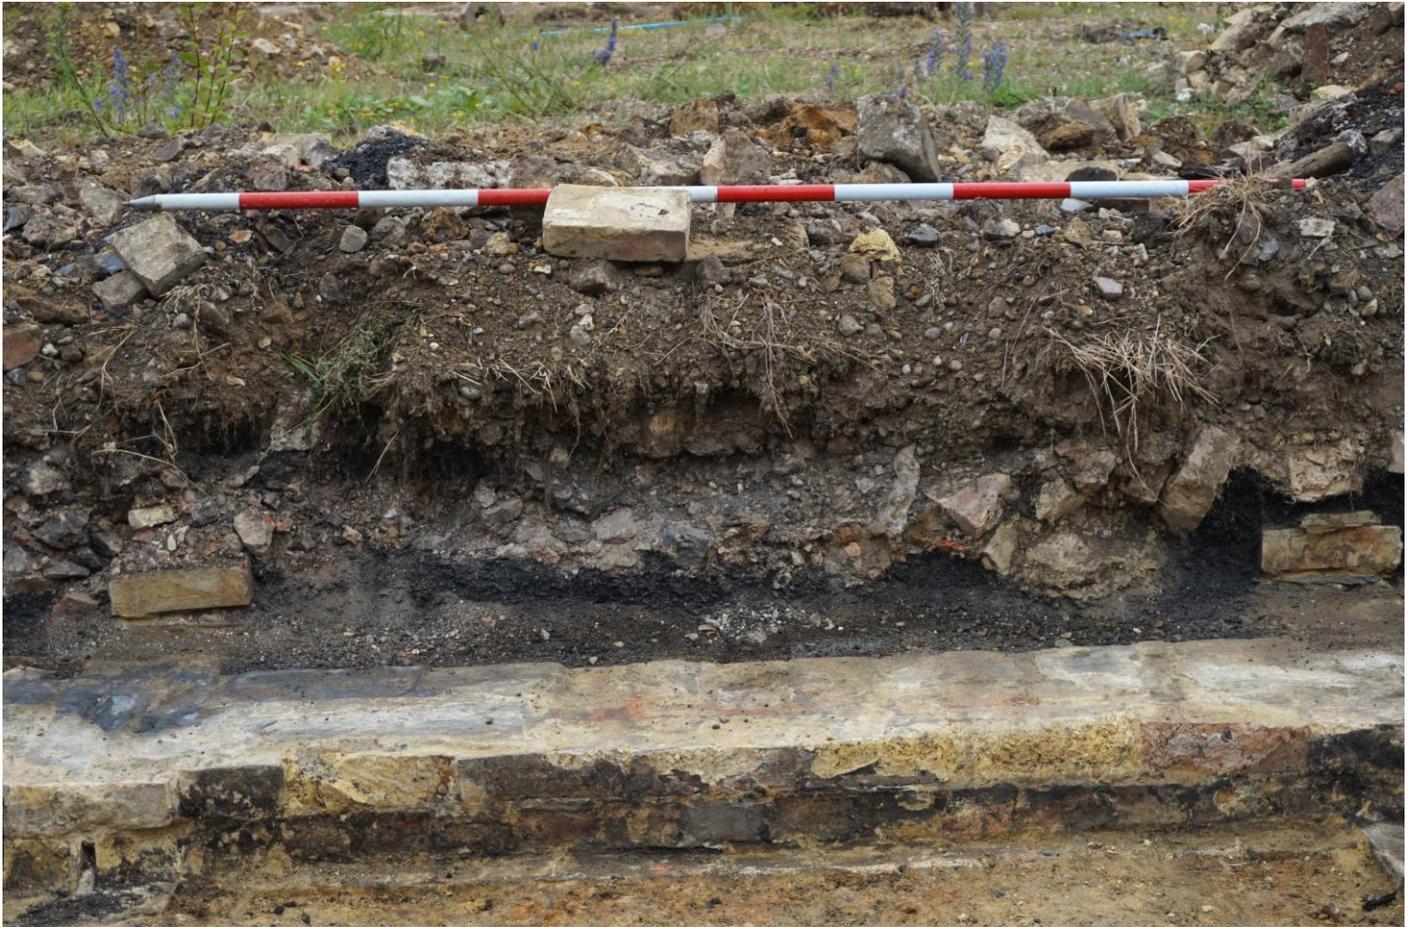
Plate 24: Looking south at section through demolition layer overlying clinker infill of the rooms located on the south side of the wall [1606]. Vast clinker (boiler slag) deposit indicates extensive burning in nearby area. Boiler slag is a waste product of coal combustion and is visible here as a black layer at the bottom of the section.

1606	Structure	Foundation wall	ENE-WSW aligned internal wall of the east side building. The wall was 7.33m long, 0.36m wide. Build of yellow stock and occ. red brick (227mm by 110mm by 0.64mm) in English bond. Structure was adjacent to walls 1607, 1608, 1609 and 1610	0.3+	39.83	16
1607	Structure	Foundation wall	Section of the east outer wall of the east side building. Wall exposed length was 2.2metres, width 0.5. Build of yellow stock and occ. red brick (227mm by 110mm by 0.64mm) in English bond. Wall was also exposed in trench 15.	0.3+	39.83	16
1608	Structure	Foundation wall	NNW-SSE aligned section of the internal wall of the east side building. Exposed part of the wall was 2.28m long, 0.3m wide. Build of yellow stock and occ. red brick (227mm by 110mm by 0.64mm) in English bond. Adjacent to wall 1606 and also on the other side of the wall 1606	0.3+	39.83	16
1609	Structure	Foundation wall	NNW-SSE aligned section of the internal wall of the east side building. Exposed part of the wall was 2.28m long, 0.3m wide. Build of yellow stock and occ. red brick (227mm by 110mm by 0.64mm) in English bond. Adjacent to wall 1606 and also on the other side of the wall 1606	0.3+	39.83	16

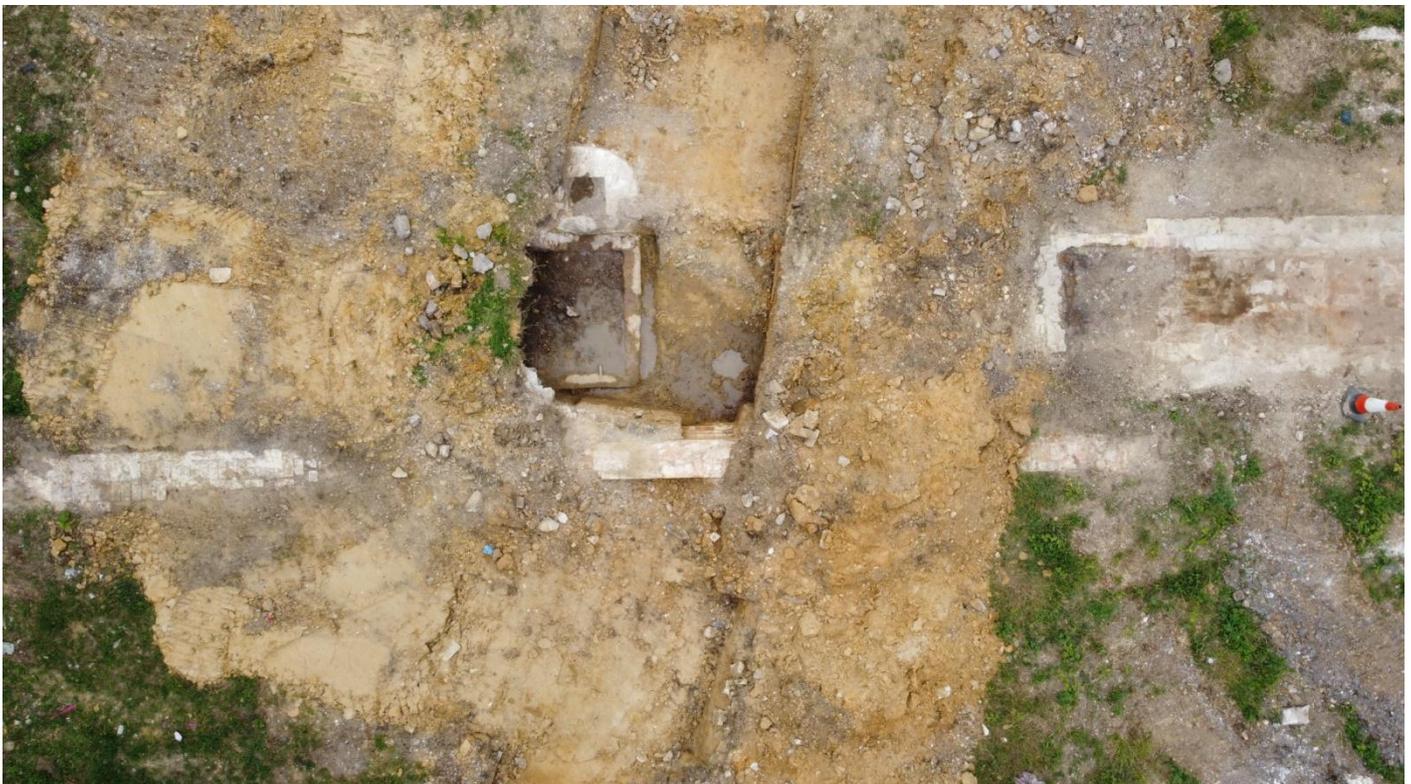
Plate 25: Looking down at east, outer wall of the main building exposed here in trench 14. Area above the wall with cellar and concrete manhole would be placed inside of the building. North is off to the right.

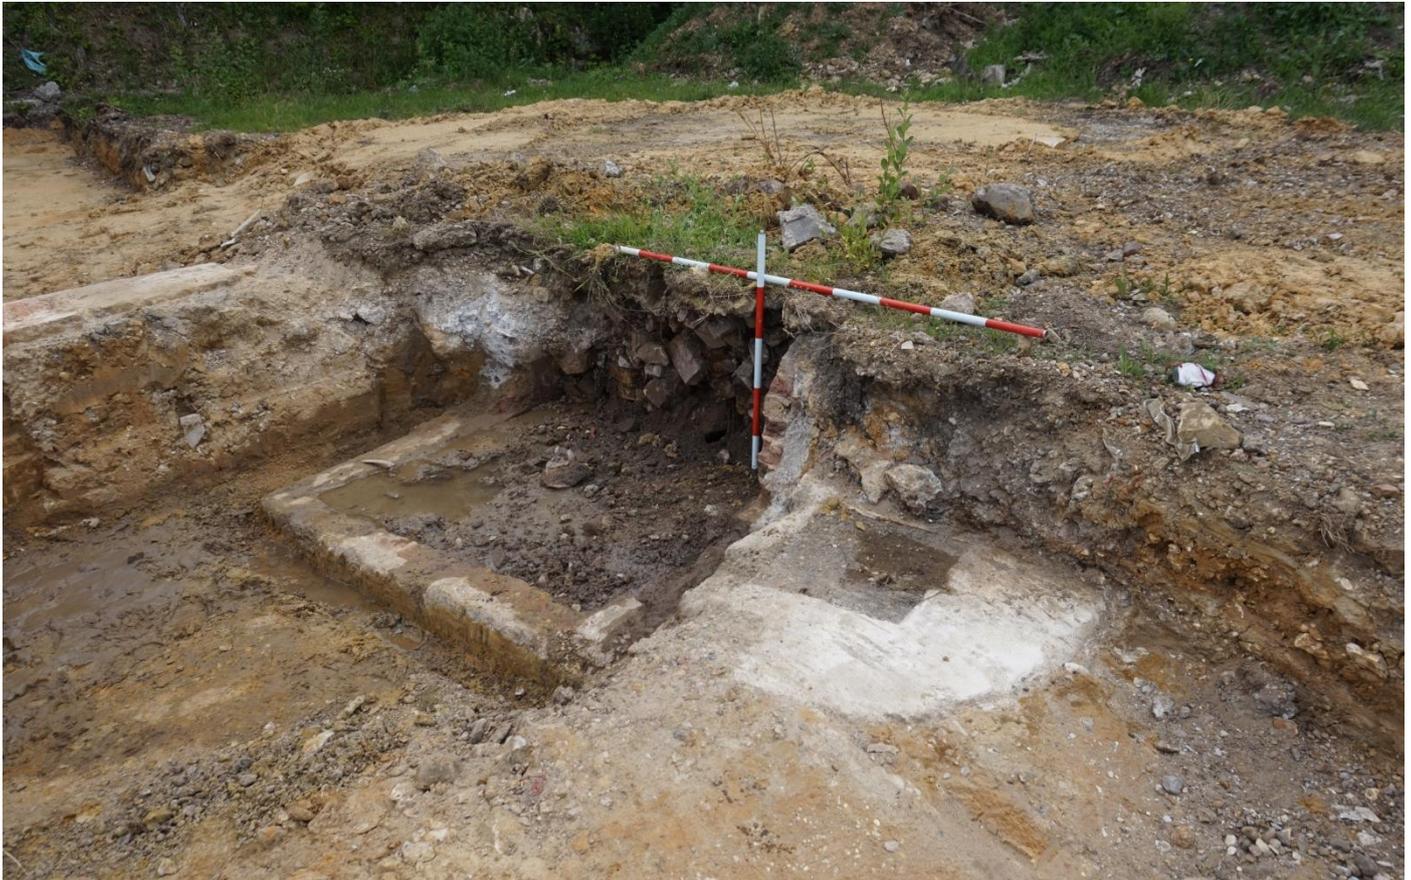
Plate 26: Looking at section through cellar [1409] with infill (1406) and demolition deposit (1401) above the man hole [1404]. The structures were located inside of the building and its outer- east wall is visible on the left side of the cellar.

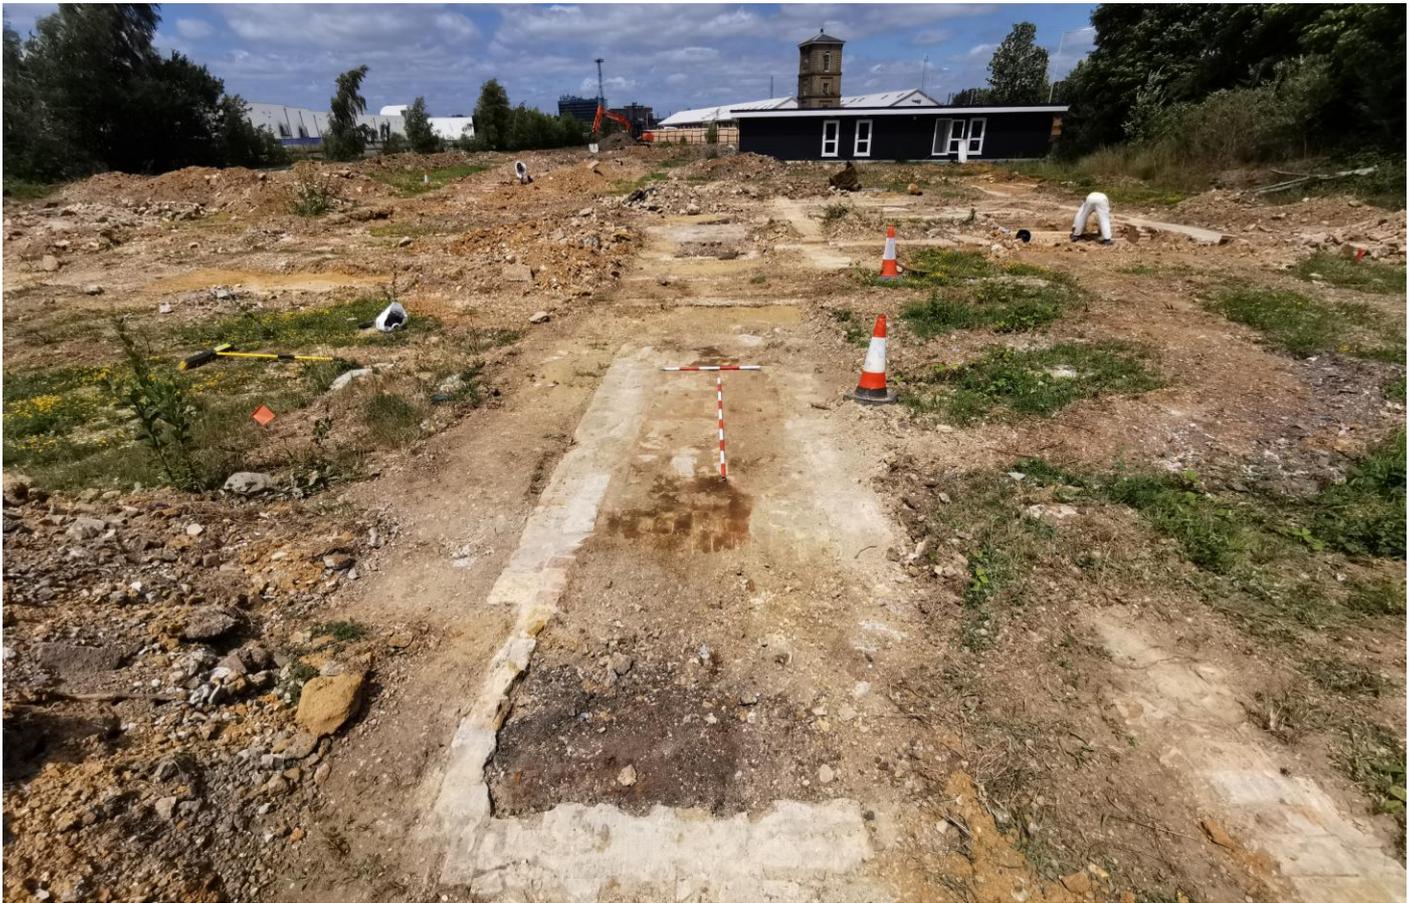
Plate 27: Looking north at the pit defined by walls 1530, 1531 and 1532. Most likely the brick floor (1525) is a later addition and was placed on backfilled pit. Later during the demolition the floor was removed on both ends of the pit. It is the middle pit of three pit/cellar structures located alongside the outer east wall of the main building within its south extent. One of the pits was exposed in trench 14 and two in trench 15. Outer east wall 1533 is visible in bottom right corner.

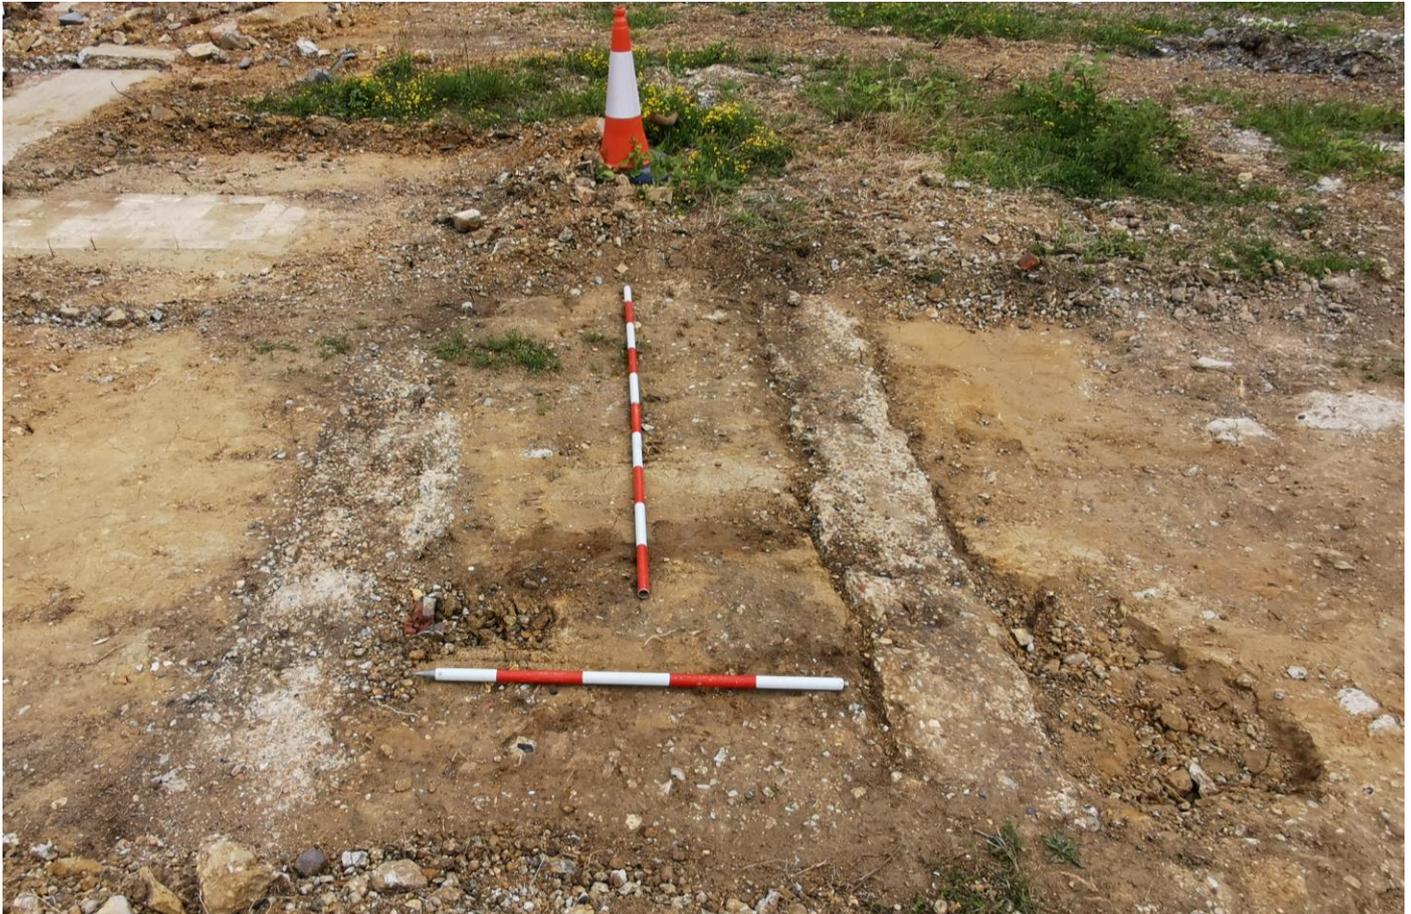
Plate 28: Looking east at concrete track walls [1527] and [1528] that were rails. The track runs through the gate in outer east wall of the main building. The east wall is visible across the photograph between the road cone and two metres scale bar.

1528	Structure	Concrete track	WSW-ENE aligned foundation of the railway rail. The concrete was coarse pebble and cast into trench what was 0.35m wide and 0.3m deep. Together with 1527 forms a base for railway track that runs through the gate in the east wall of the main hall. 4 meters in line to the west a toilet block was located.	0-0.2	40.1	15

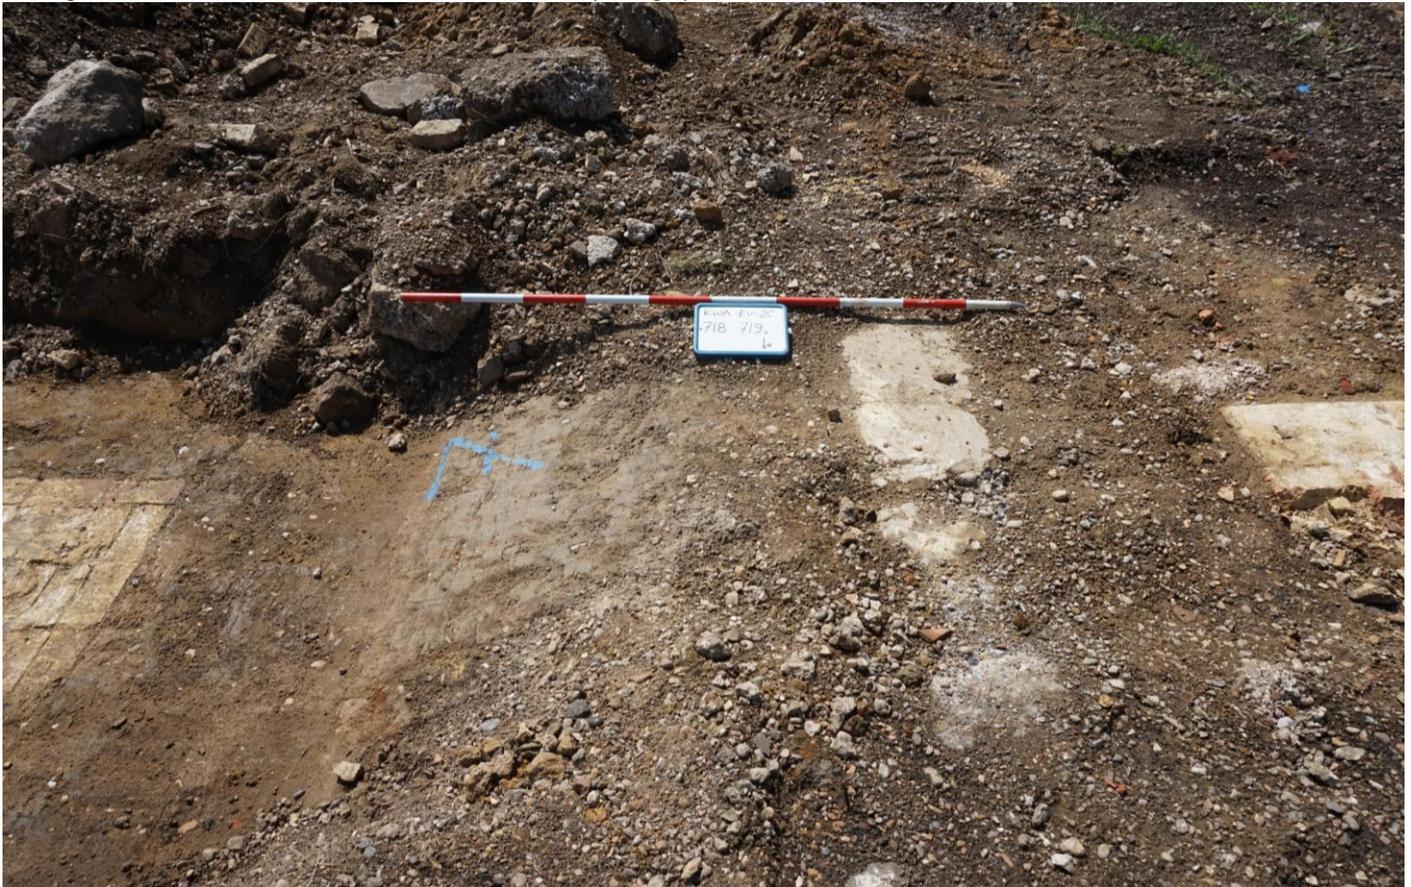
Plate 29: Looking south at one of the concrete track walls exposed in trench 7 was crossing the front wall of the main building. The one of the wall is shown in section under the left side of two metres scale.

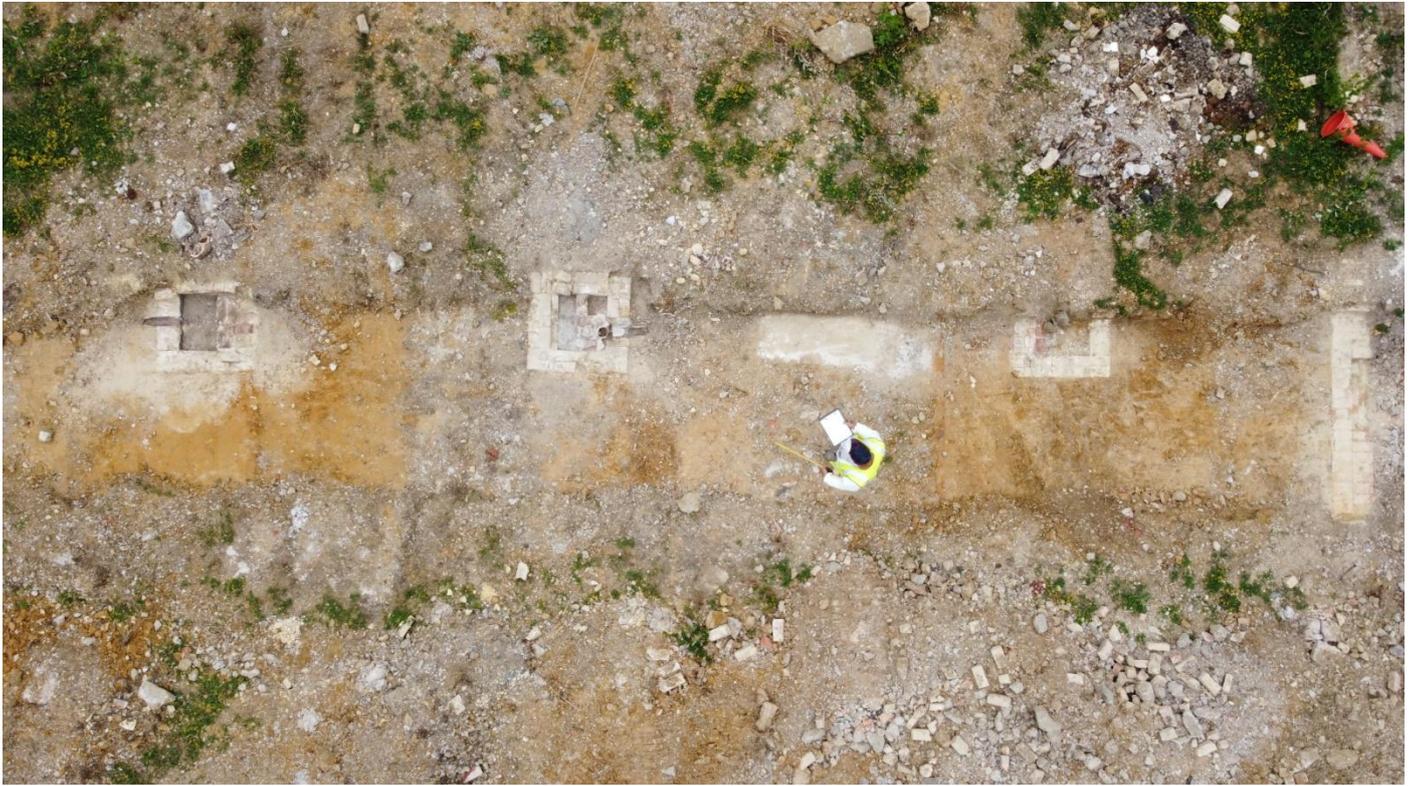
Plate 30: Looking down at trench 12 with north towards down of the photo. Visible square man hole are remains of toilet blocks.

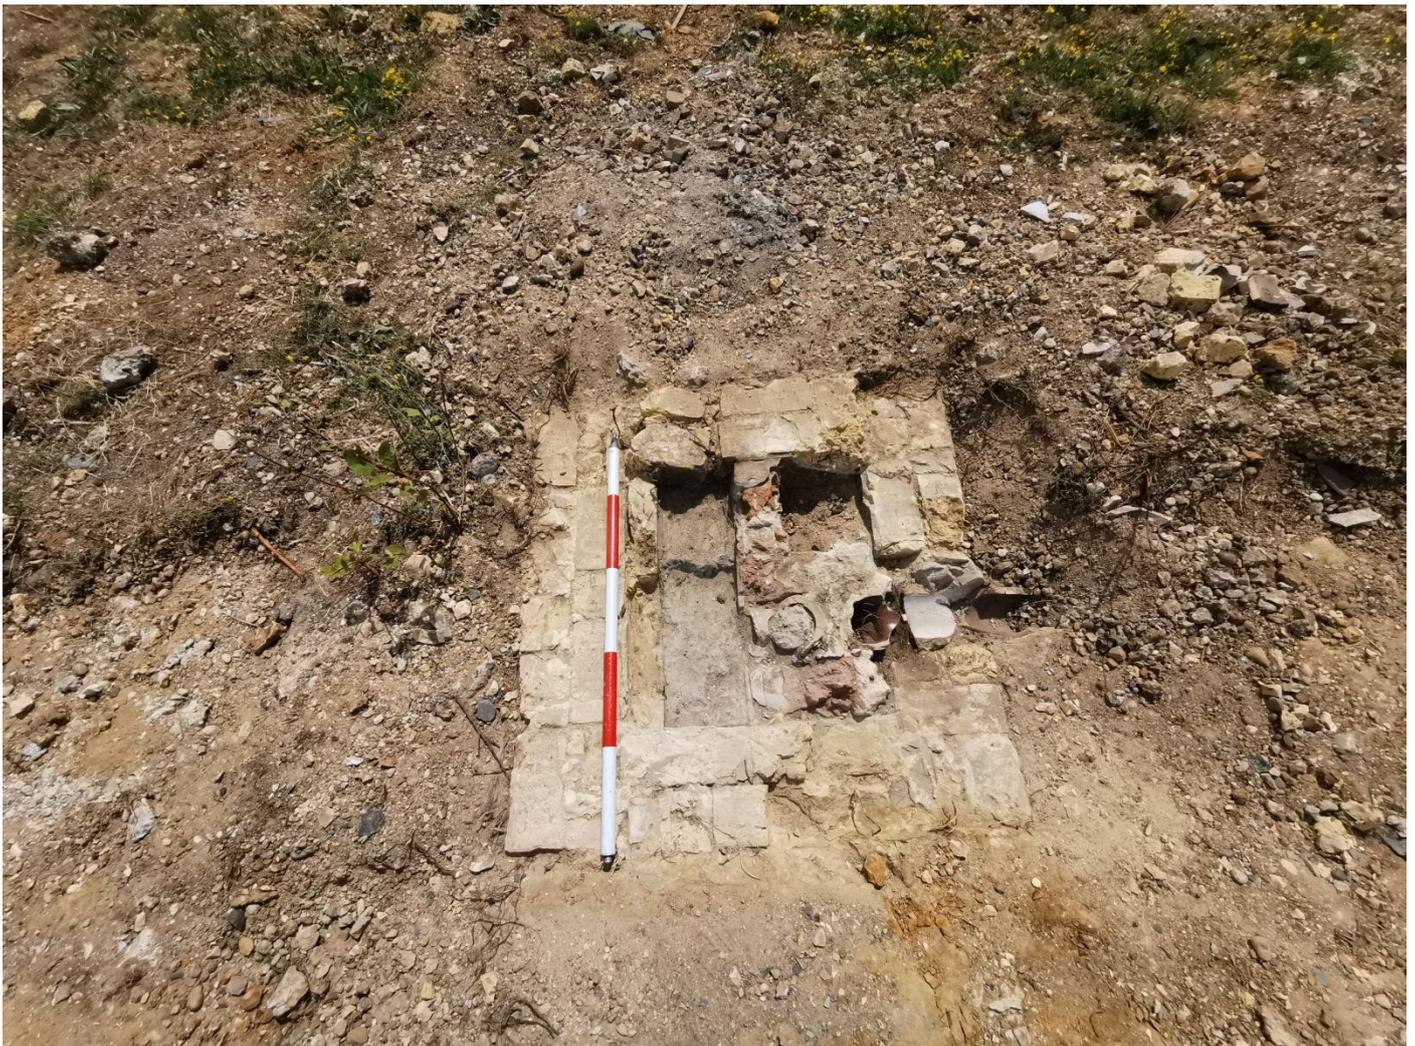
Plate 31: Looking south at toilet block 1210 underneath 1 metre scale.

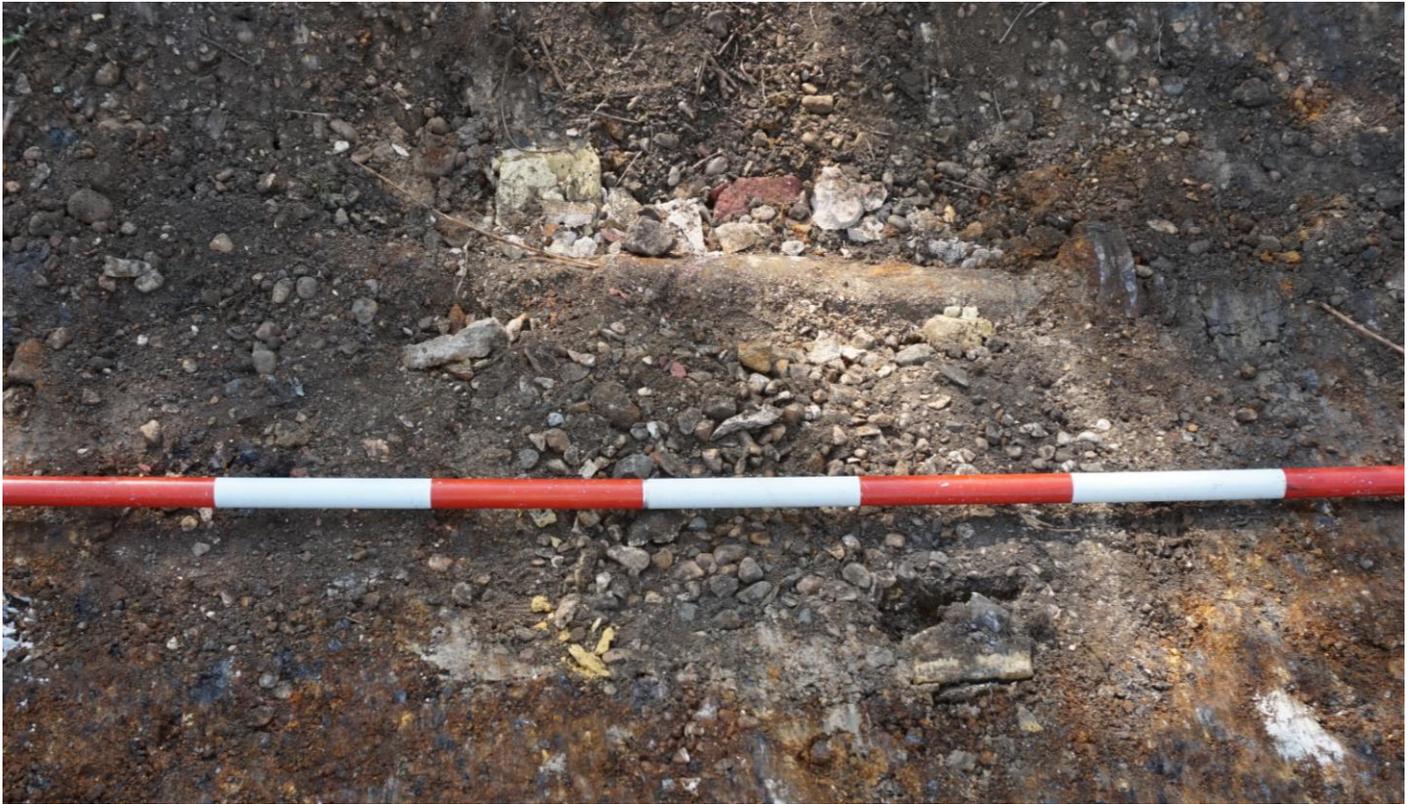
Plate 32: Looking west at steel pipe [312] exposed in trench 3 commonly exposed across the site. For the purposed of this report it's called railway pressure pipe.

312	Services	Railway pressure pipe	NNW-SSE aligned narrow trench with iron pipe measuring 0.1m in diameter with round plate at the end measuring 0.2m in diameter. The pipes were joined using bolt screws and nuts	0.2-0.4	39.46	3
313	Services	Electric cable	High voltage electric cable measuring 70mm in diameter	0.18-0.4	39.5	3
314	Services	21st C drain	Plastic drain pipe laid recently	0.18-0.4	39.5	3
401	Layer	Top soil/made ground	Mid compaction, black gravelly loam	0-0.26	39.75	4
402	Layer	Railway sleepers bedding	Compacted and iron cemented rusty mottled black pebble gravel (<40mm).	0.26-0.36	39.49	4
403	Layer	Made ground/natural re deposit	Firm compaction, mid orangey brown sandy clay with occasional flint (sub angular; < 70mm), Material re deposited prior to construction around 1897, derived from hill slope reduction in south half of the site.	0.36-0.5	39.39	4
