Archaeological Evaluation of Land at the site of the former Klondyke Works, Newtown Road, Ashford, Kent

Planning Application Number: 18/00584/AS

Summary

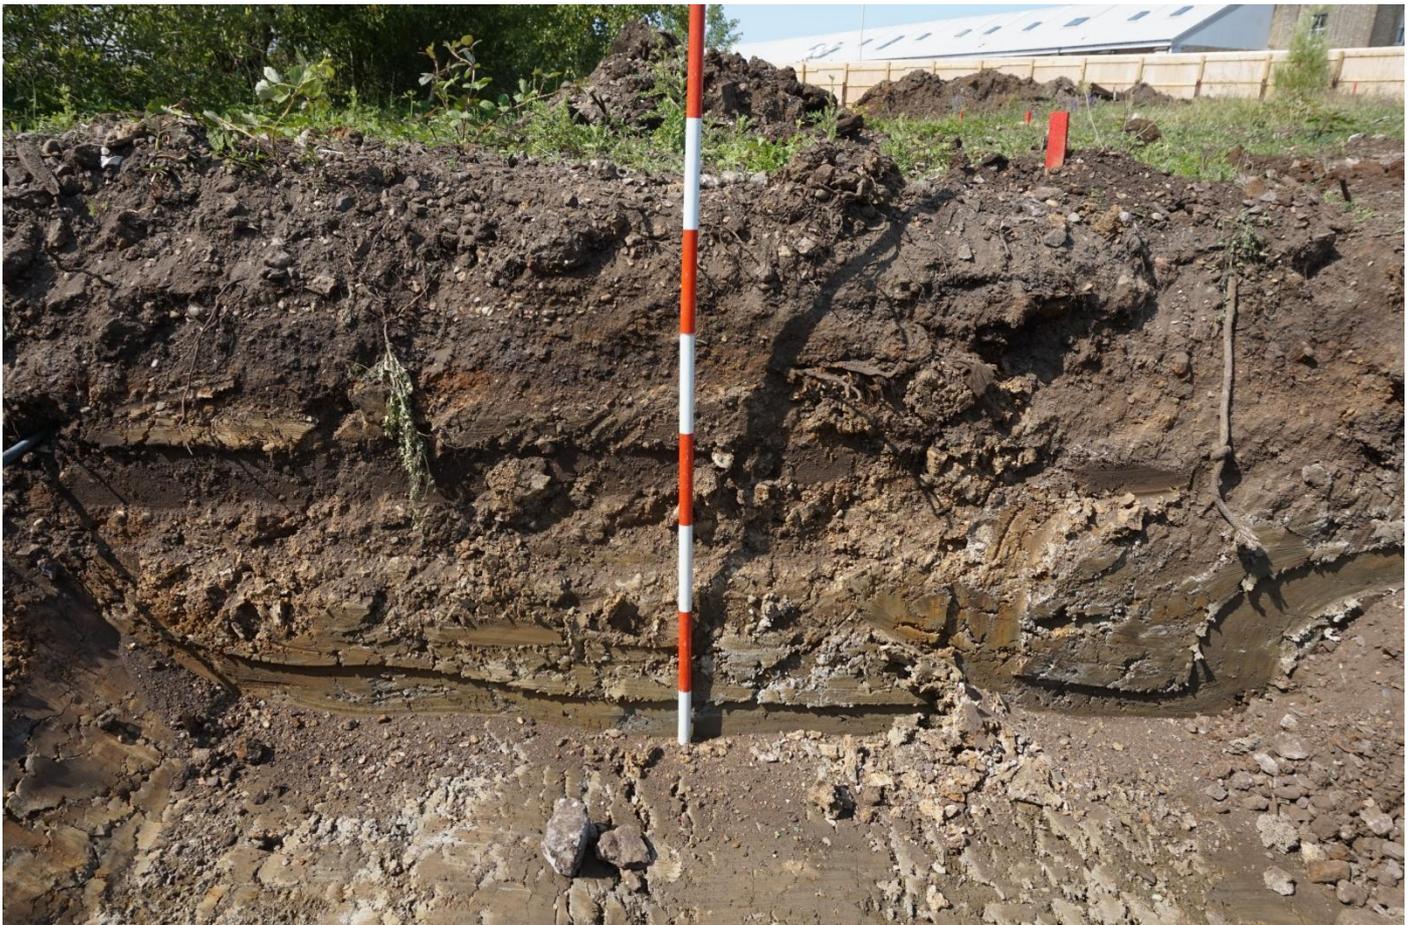
Plate 33: Looking north at section exposed in test pit 4. At the base alluvial clayey loam 405 is overlaid by made ground levelling deposits (404 and 403) followed by railway bedding deposit (402) and sealed with demolition layer 401. The (402) horizon can be seen behind second from the top white section of the scale, Context is rusty brown in colour.

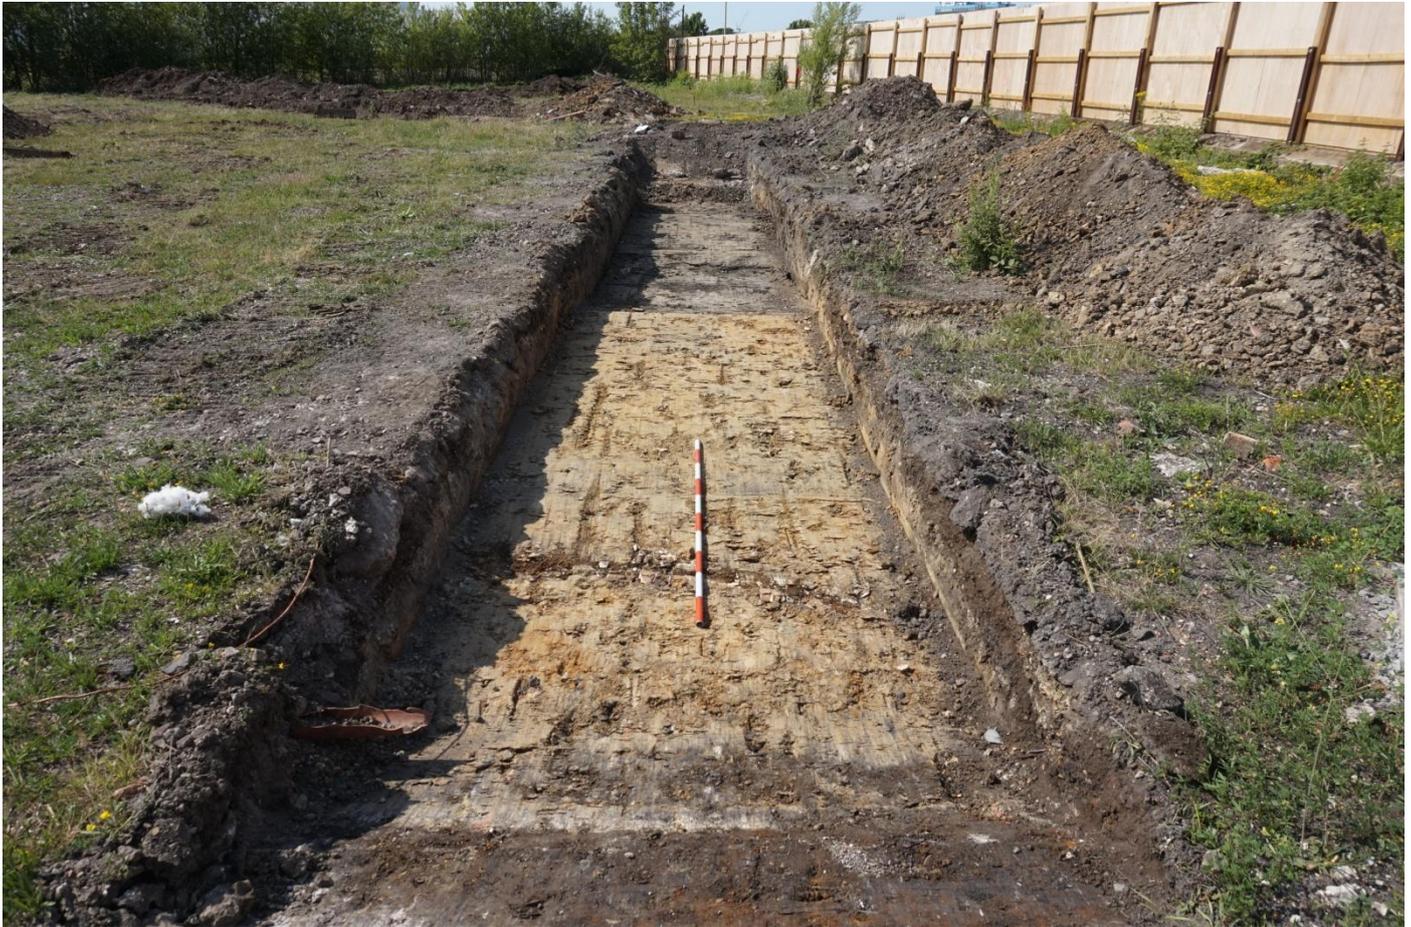
Plate 34: Looking north-west at trench 6. Two metres scale is placed on made ground levelling (603) deposit, further in the back a made ground levelling deposit (604) is visible.

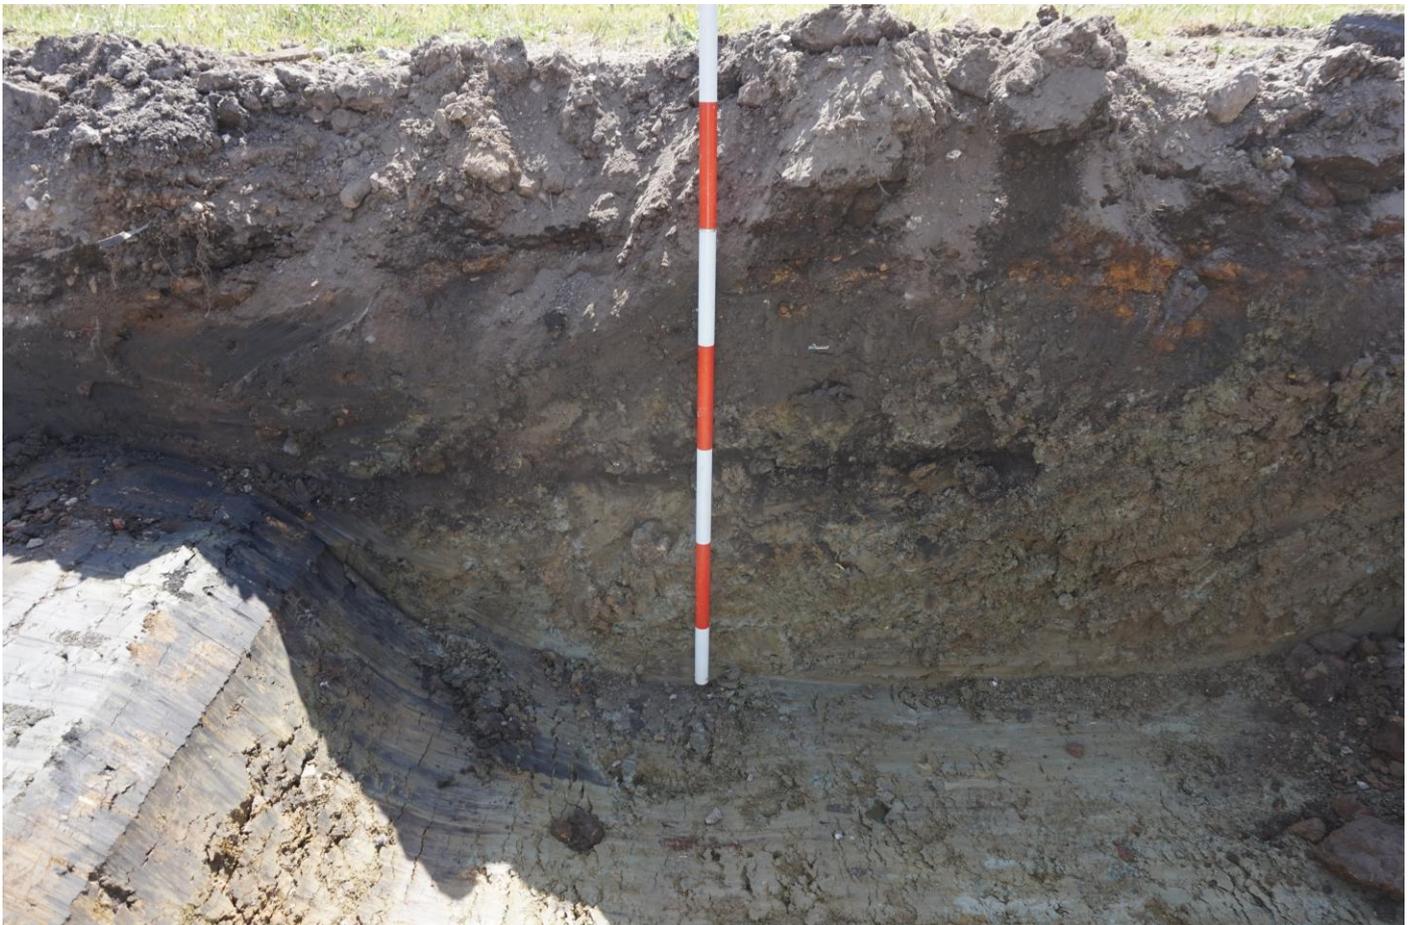
Plate 35: Looking south west at section exposed in test pit 6 located at NW end of the trench 6. Victorian top soil horizon is a thin black band behind second from the base white section of the scale. Context below buried topsoil is alluvium and context above are made ground levelling deposits (603 and 604) followed by railway bedding (602) sealed by demolition deposit (601)

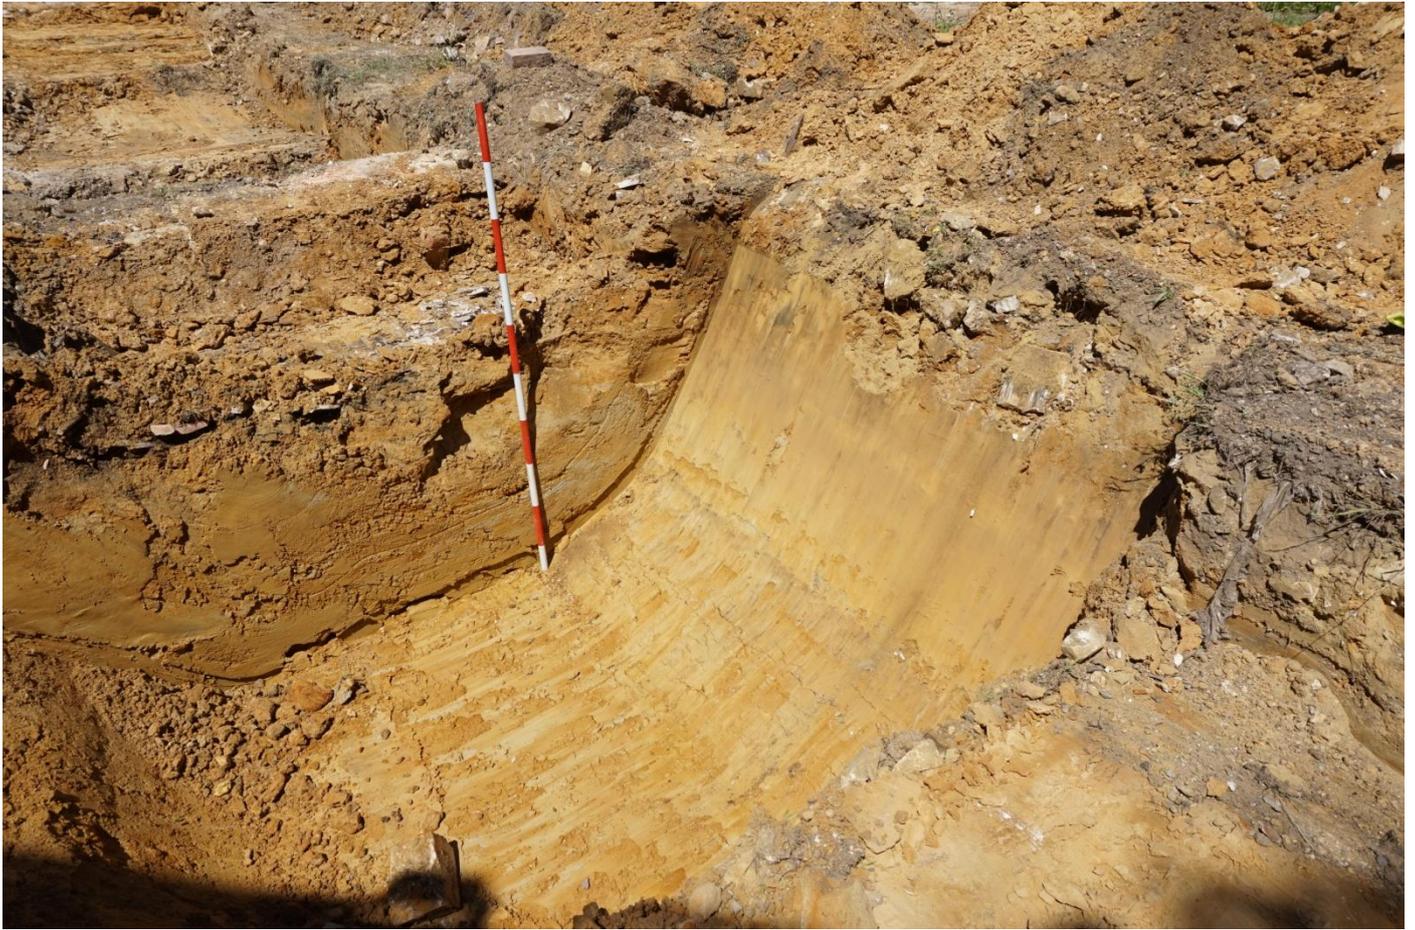
Plate 36: Looking north-west at test pit 14 through natural alluvial sand.
