# Archaeological Watching Brief at The Lime Kiln Farm, Smarden, Ashford TN27 8QN

Site code: LKF-WB-22

Date of report: 4 April 2022

SWAT ARCHAEOLOGY

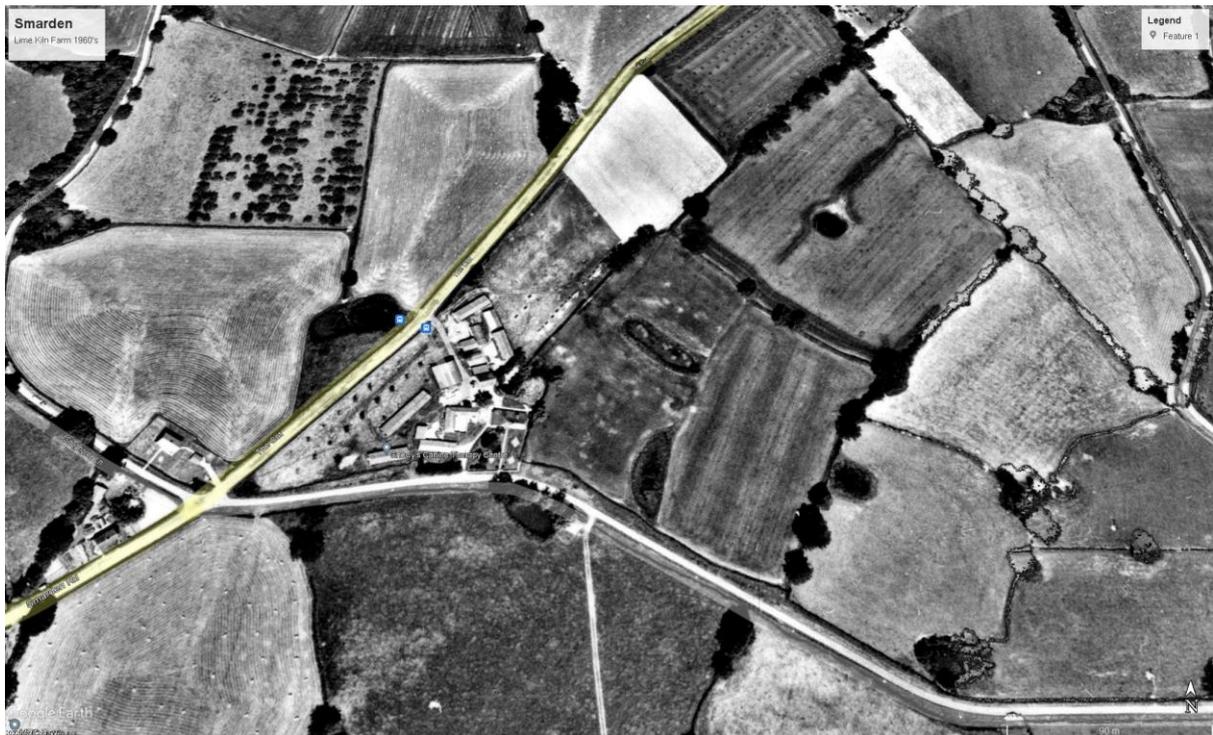
Plate 1: Aerial footage 1960 showing Lime Kiln Farm and adjacent fields.

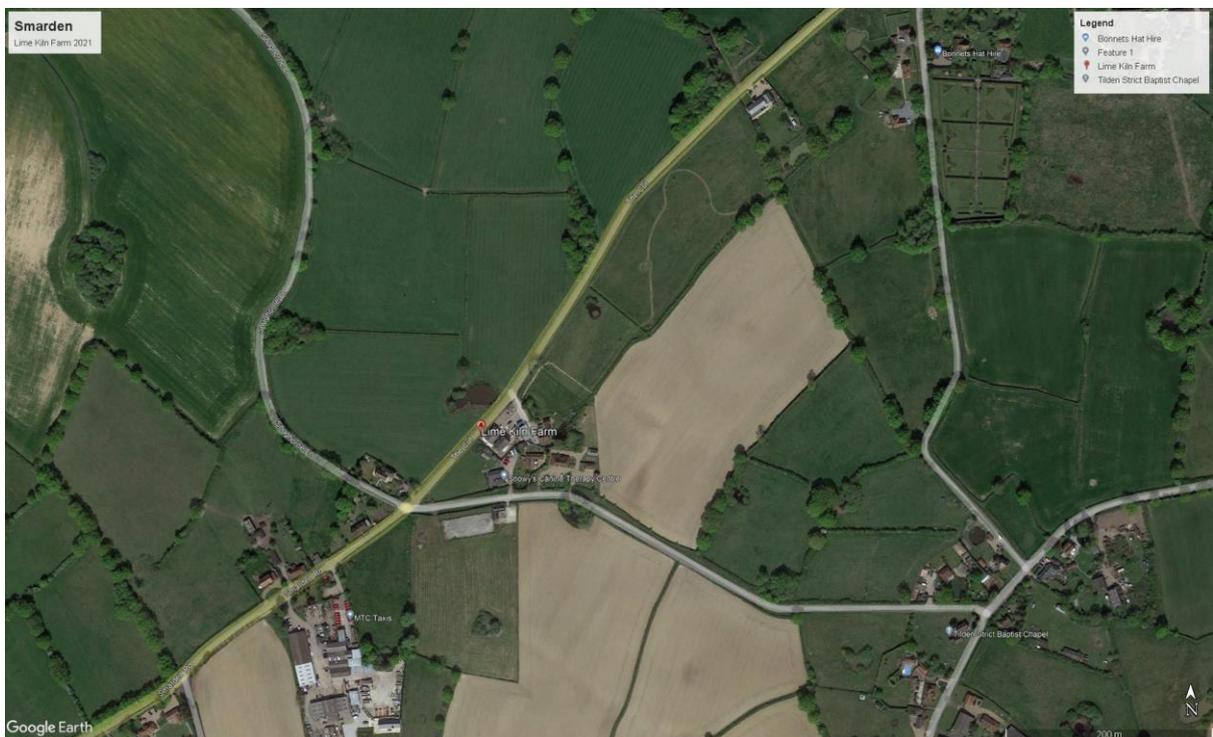
Plate 2: Aerial footage 2021 showing Lime Kiln Farm and adjacent fields.

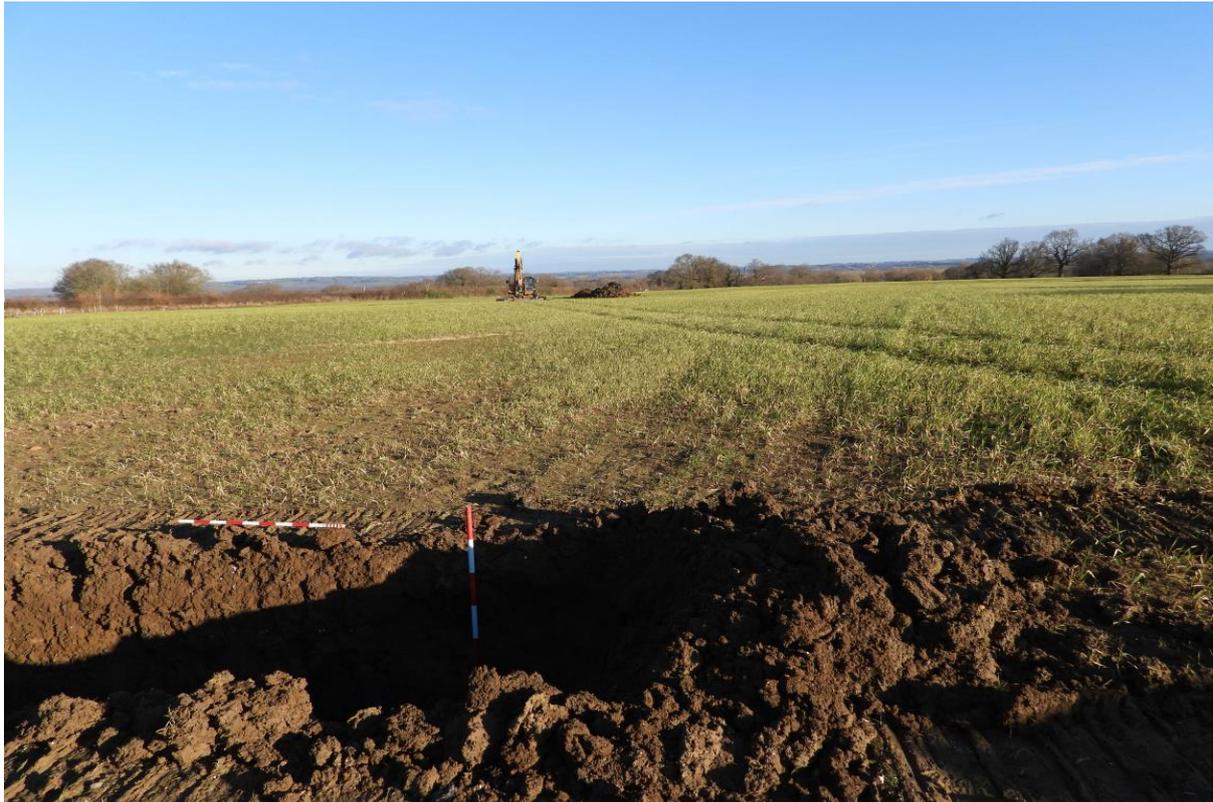
Plate 3: A sondage was excavated first to establish the location of Pond 1. Lime Kiln Farm, eastern field, looking north with one- and two- metres scales.

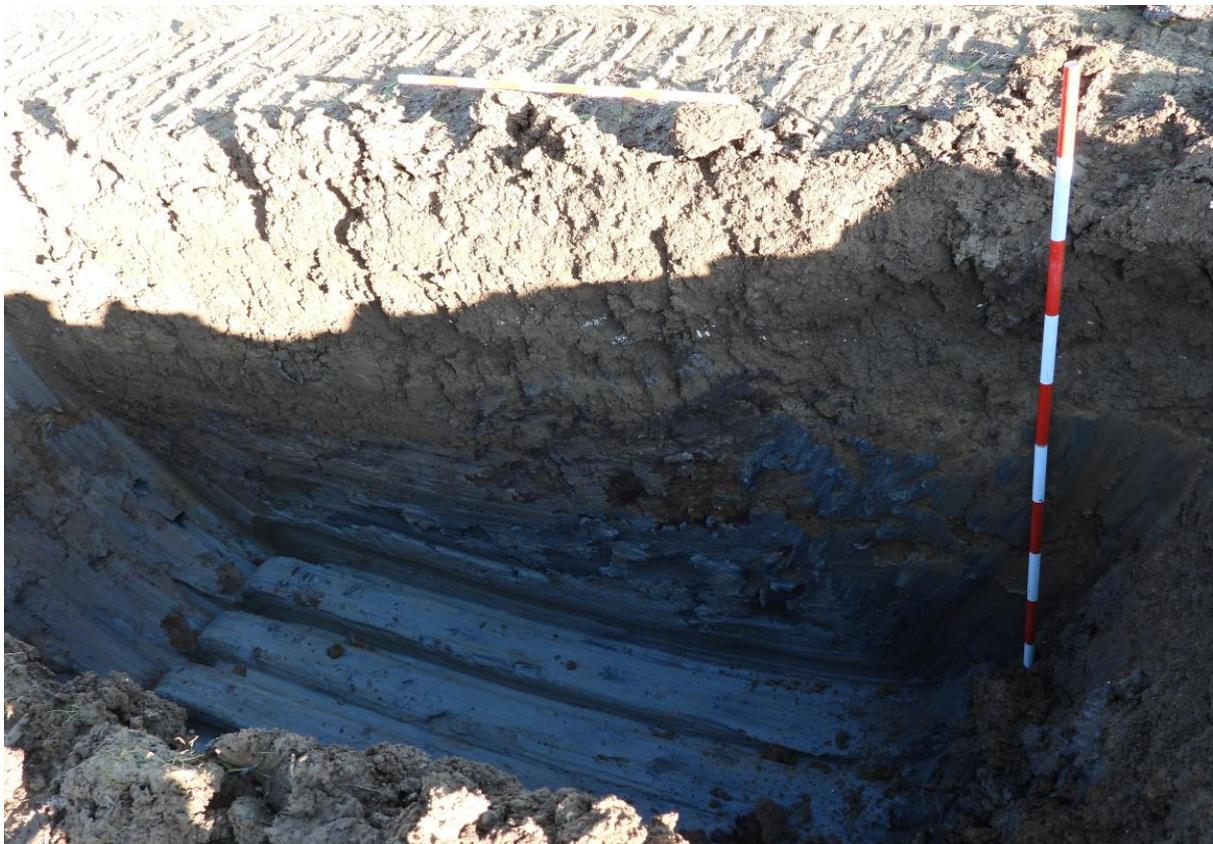
5.2.3 A backfill sequence revealed in Pond 1 comprised primary fill with deliberated backfill. Primary fill (103) comprised firm, blue-grey waterlogged silty-clay with infrequent calcined lime flecks and lumps. Deposit measured 0.33metre in thickness and was concealed by vast modern backfill context (104) comprising dark brown clay-silt with infrequent angular stones. That was capped by sub-soil (102) and top-soil (101) comprising moderately compacted dark brown clay-silt with infrequent angular stones.

Plate 4: Showing revealed primary fill in Pond 1. One and two metres scales.

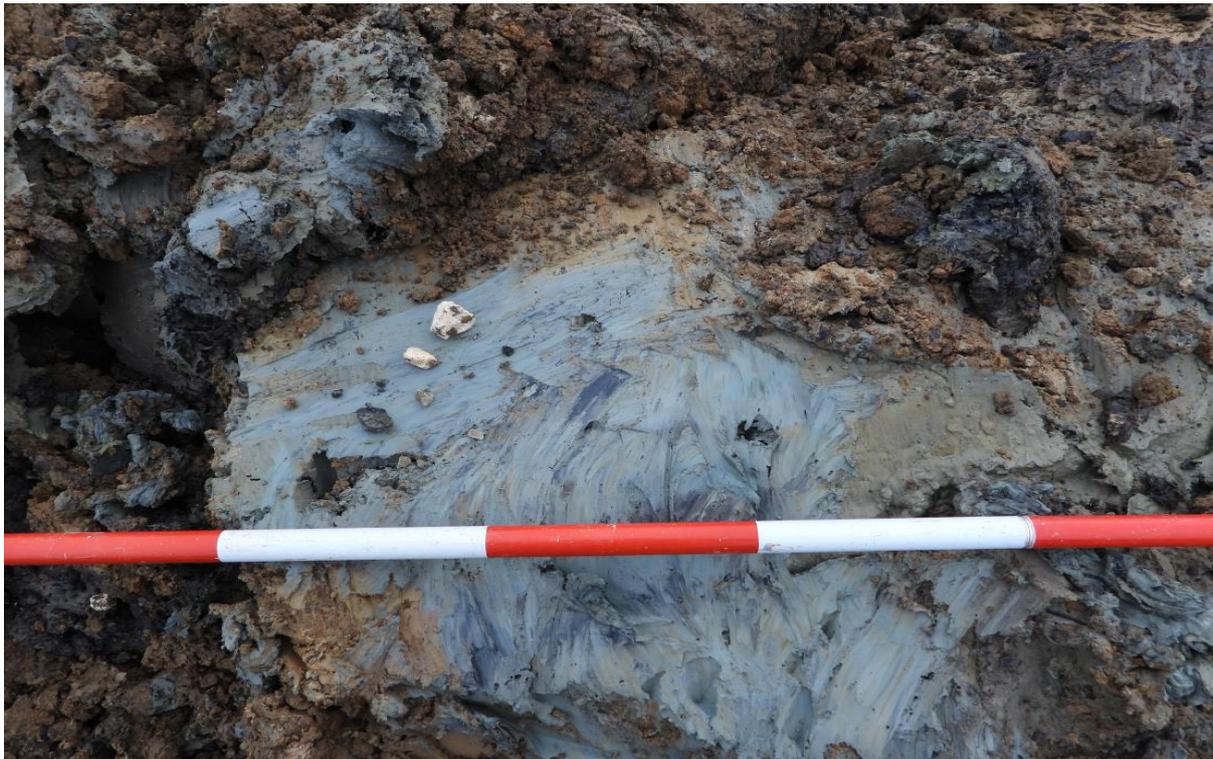
7.1.2 Primary fill exposed in Pond 1 contained infrequent fragments of calcined lime stone what suggests that the pond was still open whilst located nearby lime kiln was still in operation.

Plate 5: Closer examination of excavated primary deposit revealed infrequent calcined lime stone (chalk). Red and white scale segments equal 0.2metres.

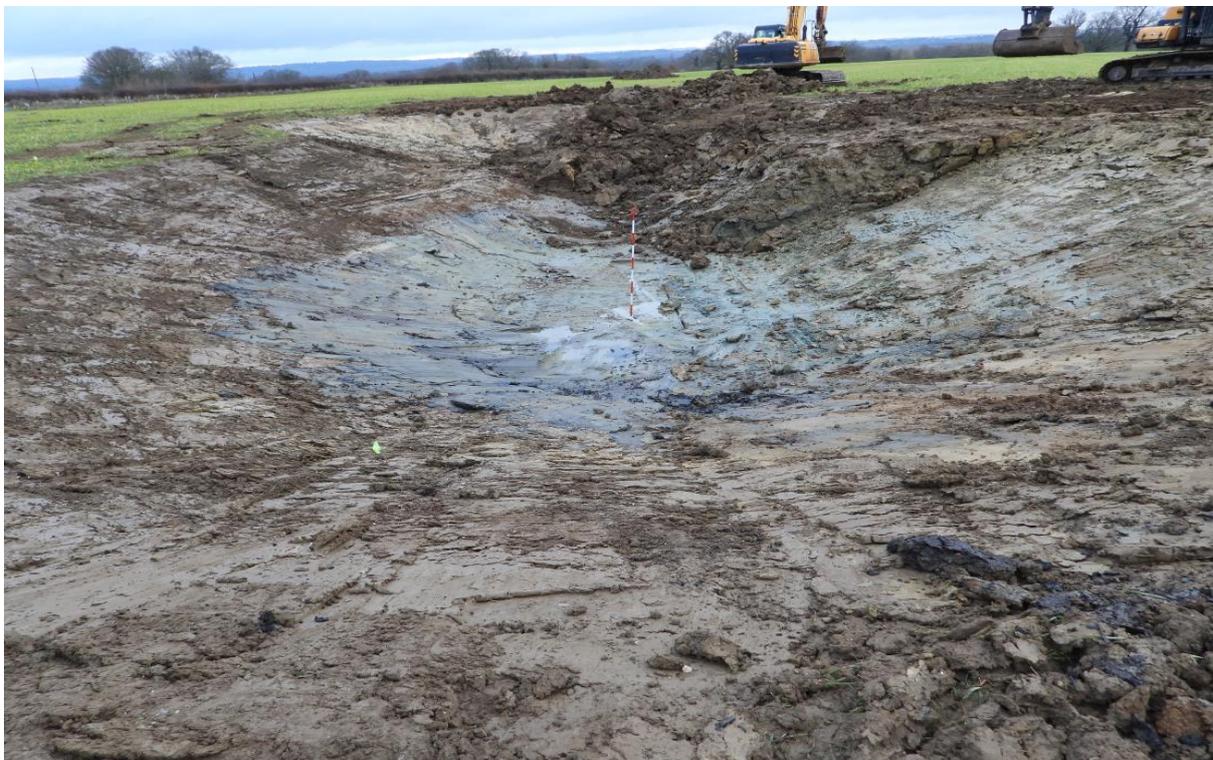
Plate 6: Showing nearly fully excavated Pond 1 in southern extent of the eastern field. Looking north with two-metre scale.

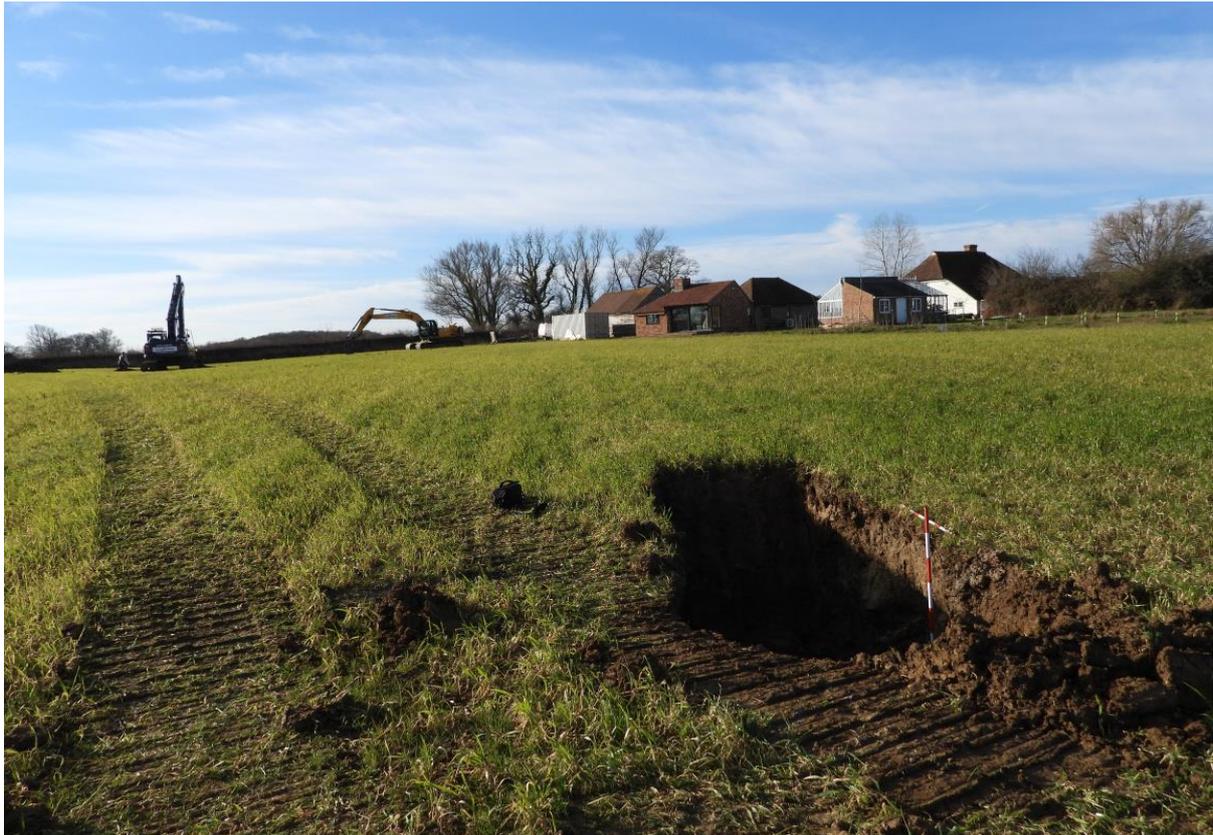
Plate 7: Showing a dug sondage to establish the location of Pond 2. Looking southwest with one- and two-metres scales.

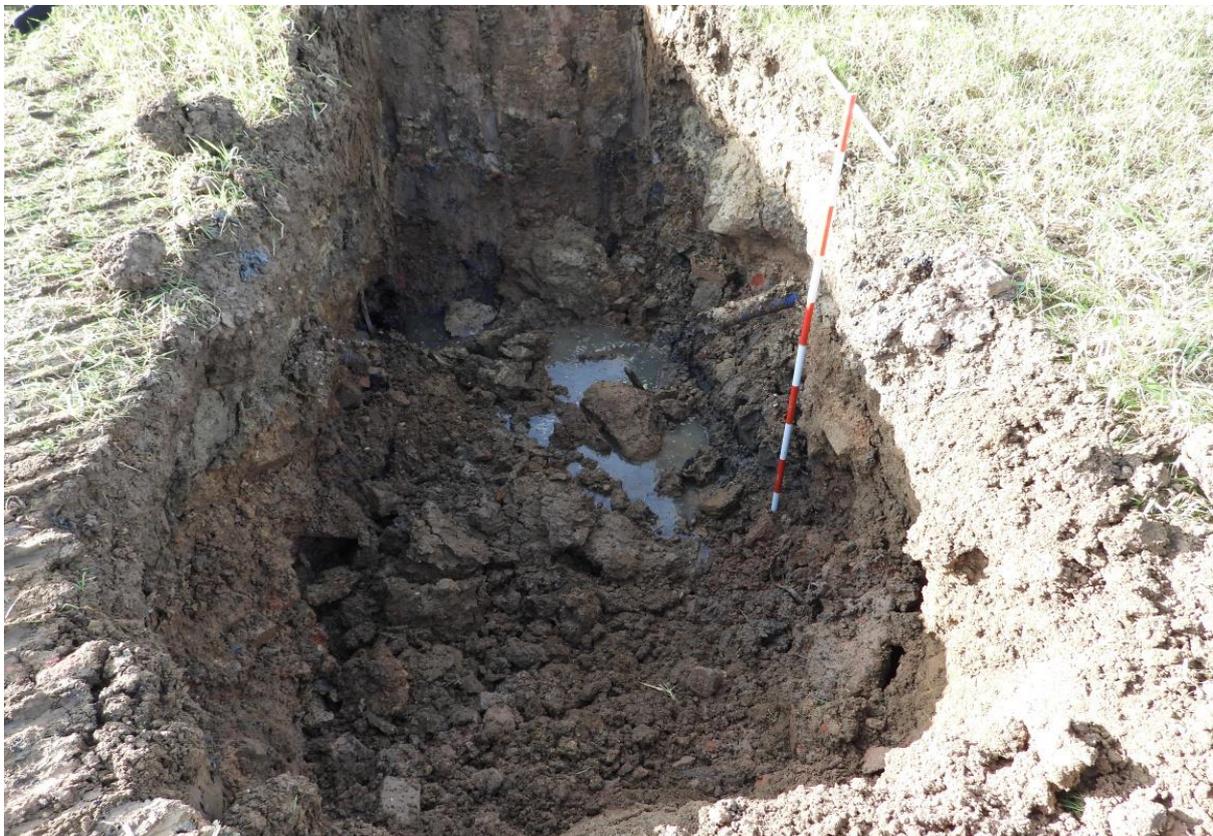
5.2.4 Pond 2. A backfill sequence revealed in Pond 2 comprised primary fill with deliberated backfill. Primary fill (203) comprised firm, blue-grey waterlogged silty clay with infrequent organic remains comprising twigs and leaves. Deposit measured 0.52metres in thickness and was concealed by vast modern backfill context (204) comprising dark brown clay-silt with infrequent angular stones and abundant amount of modern building waste. That was capped by sub-soil (202) and top-soil (201) comprising moderately compacted dark brown clay-silt with infrequent angular stones.

Plate 8: Backfill sequence in Pond 2 consisted of relatively modern construction waste, including plastic pipes, brick fragments and ferrous objects. Two metre scale

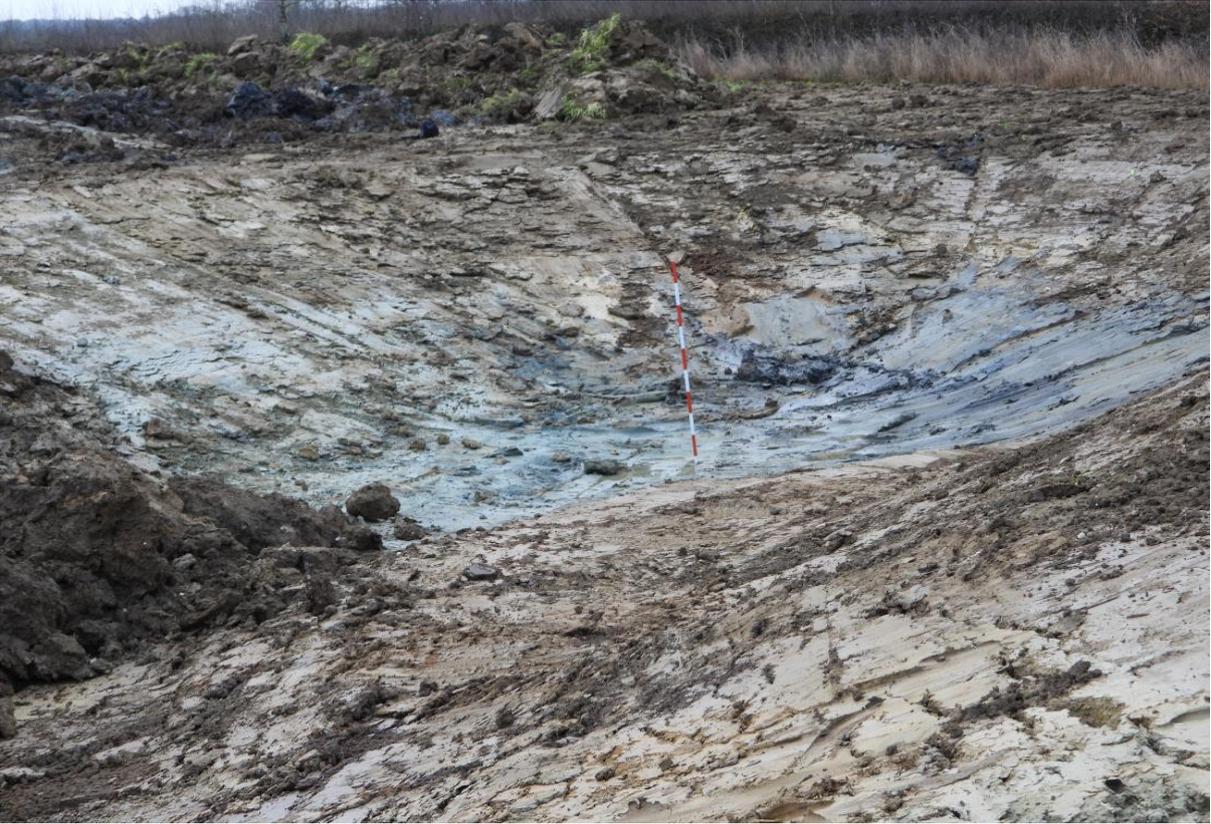
Plate 9: Showing fully excavated Pond 2. Looking west with two-metre scale.

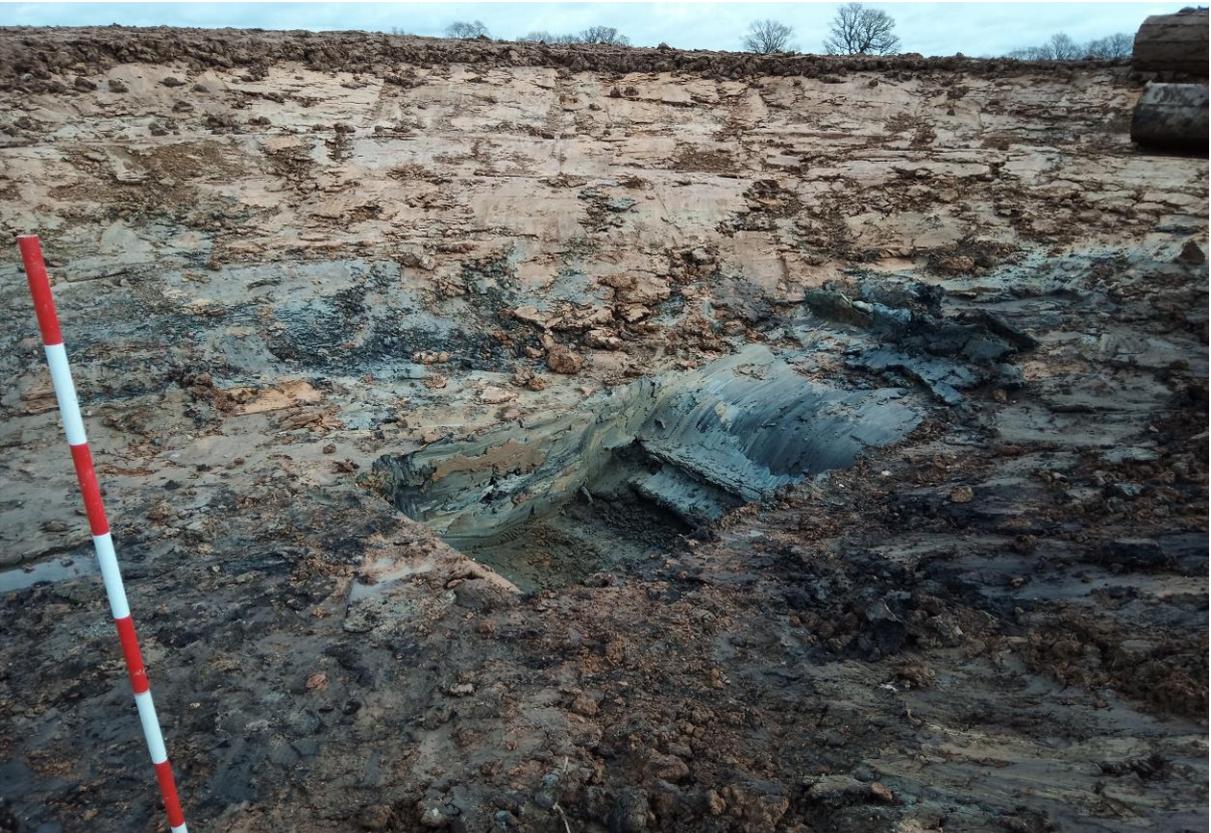
5.2.5 Geoarchaeological test-pit was excavated throughout primary deposits revealed in Pond 2 but neither archaeological remains nor artefacts were revealed.

Plate 10: Geoaarchaeological test-pit was excavated through out waterlogged primary deposit in Pond 2. Two metre scale.

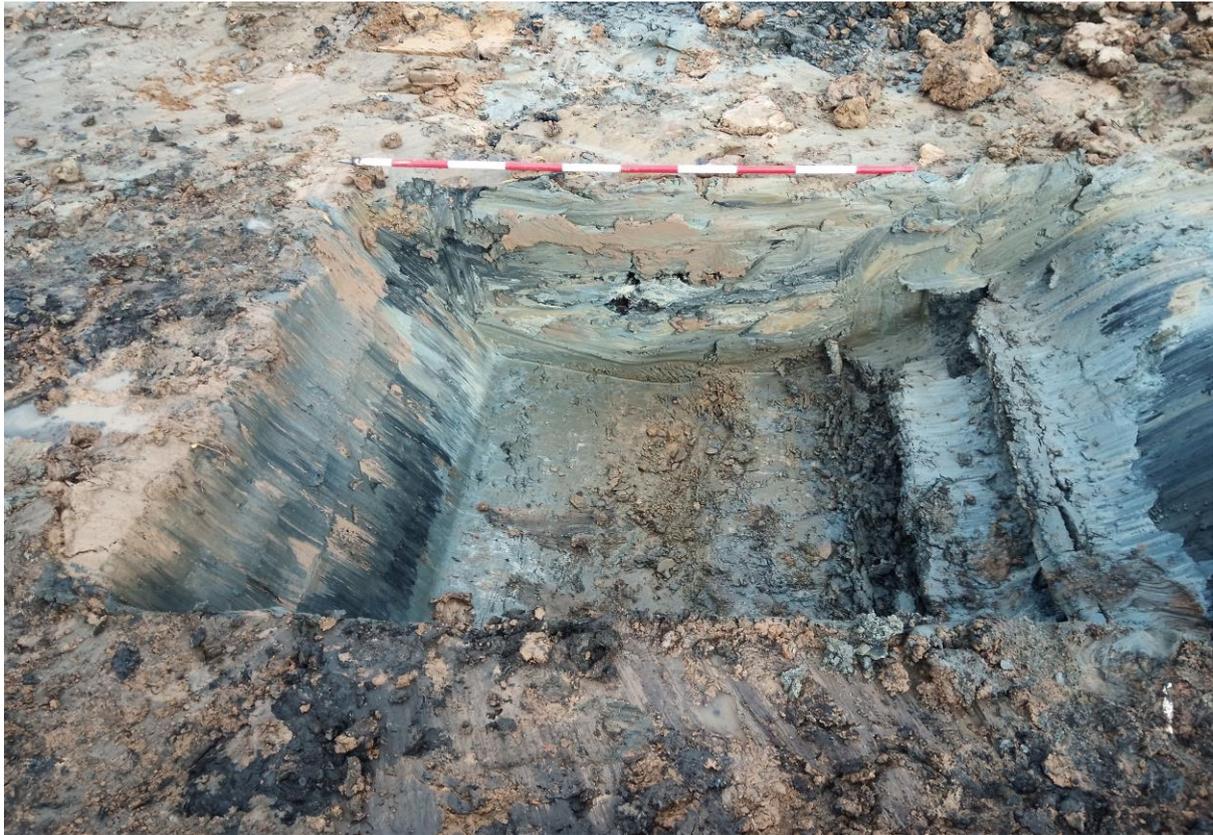
Plate 11: Showing primary infill sequence revealed in Pond 2. Looking north with two-metre scale.

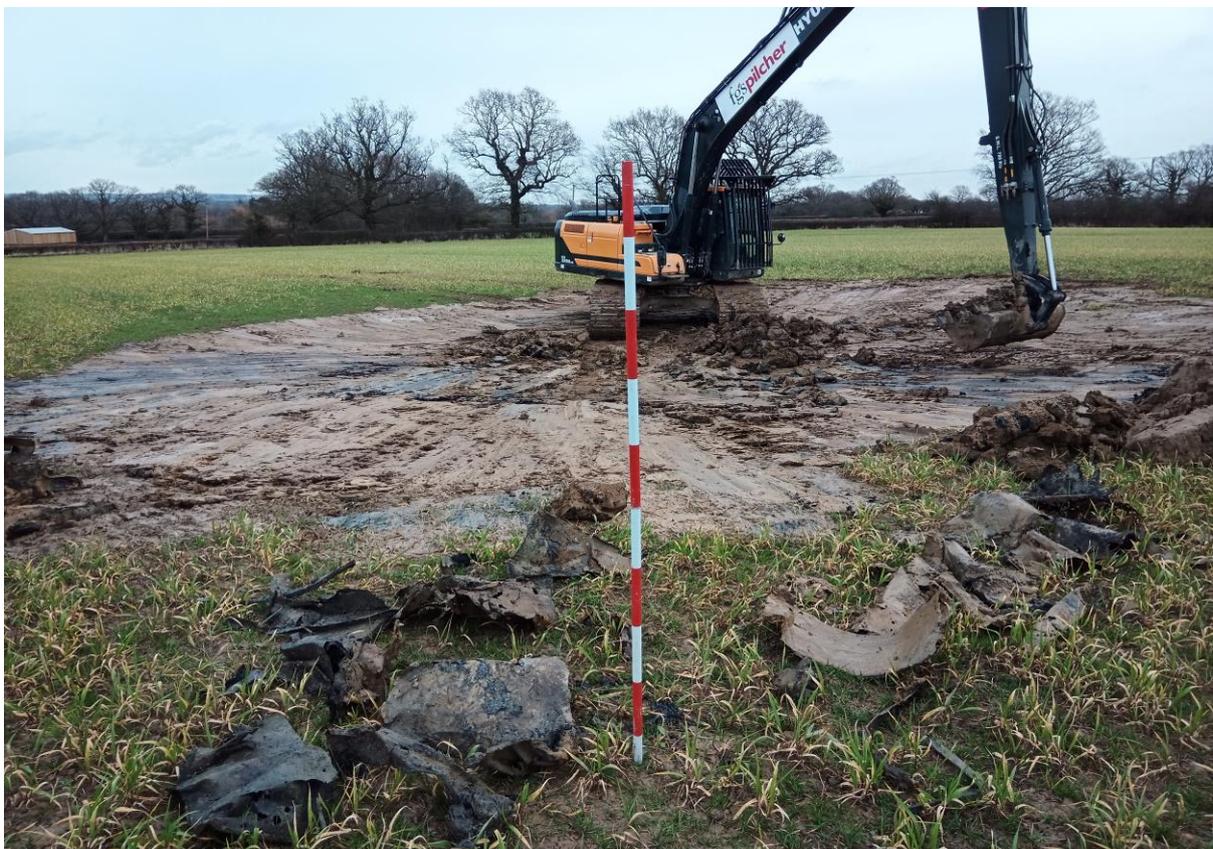
Plate 12: Showing vegetation clearance around Pond 3. Backfill contained moderate amount of various metal debris. Further excavation was not carried out at this stage. Looking northeast with two-metre scale.

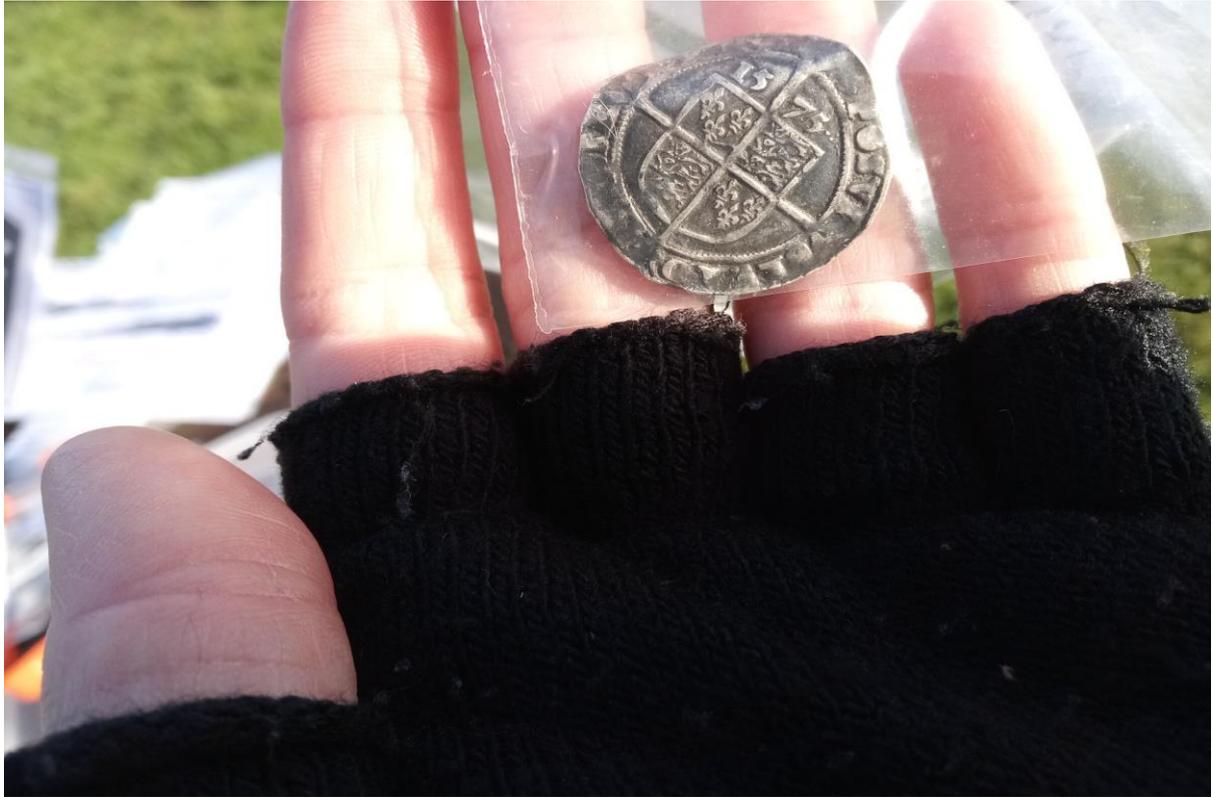
6.1.2 A landowner has carried out metal detecting in the immediate surroundings of the ponds and at their bases following machine excavation. A handful of artefacts were retrieved from top-soil but nothing came out of primary fills inside the ponds. The revealed by metal detecting items including silver coins are representing period from 1500 to 1940 AD. (Plates 13-15)

Plate 13: Revealed during metal detecting. High medieval silver coin dated to 1575.

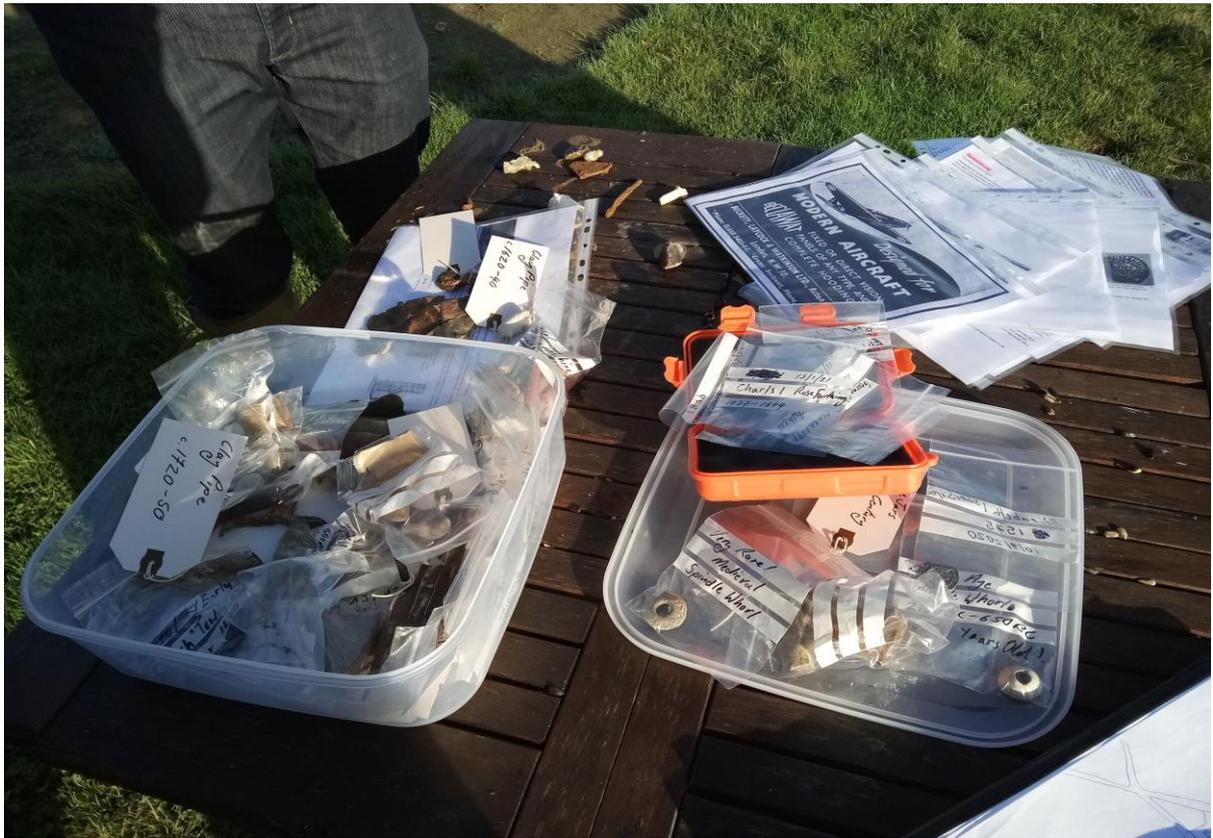
Plate 14: Anassemblage of artefacts yielded during metal detecting of the field.

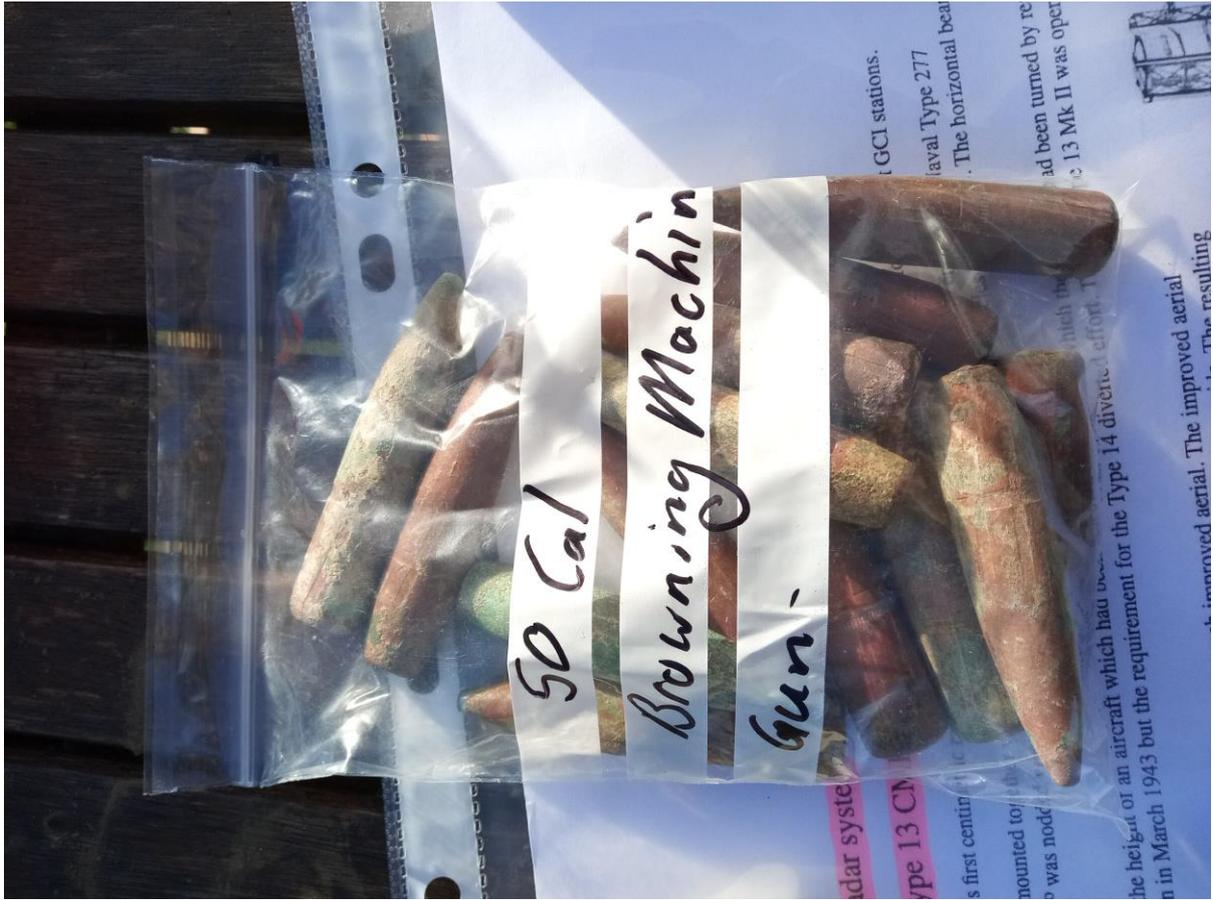
Plate 15: A handful of potential machine gun bullets were revealed during metal detecting

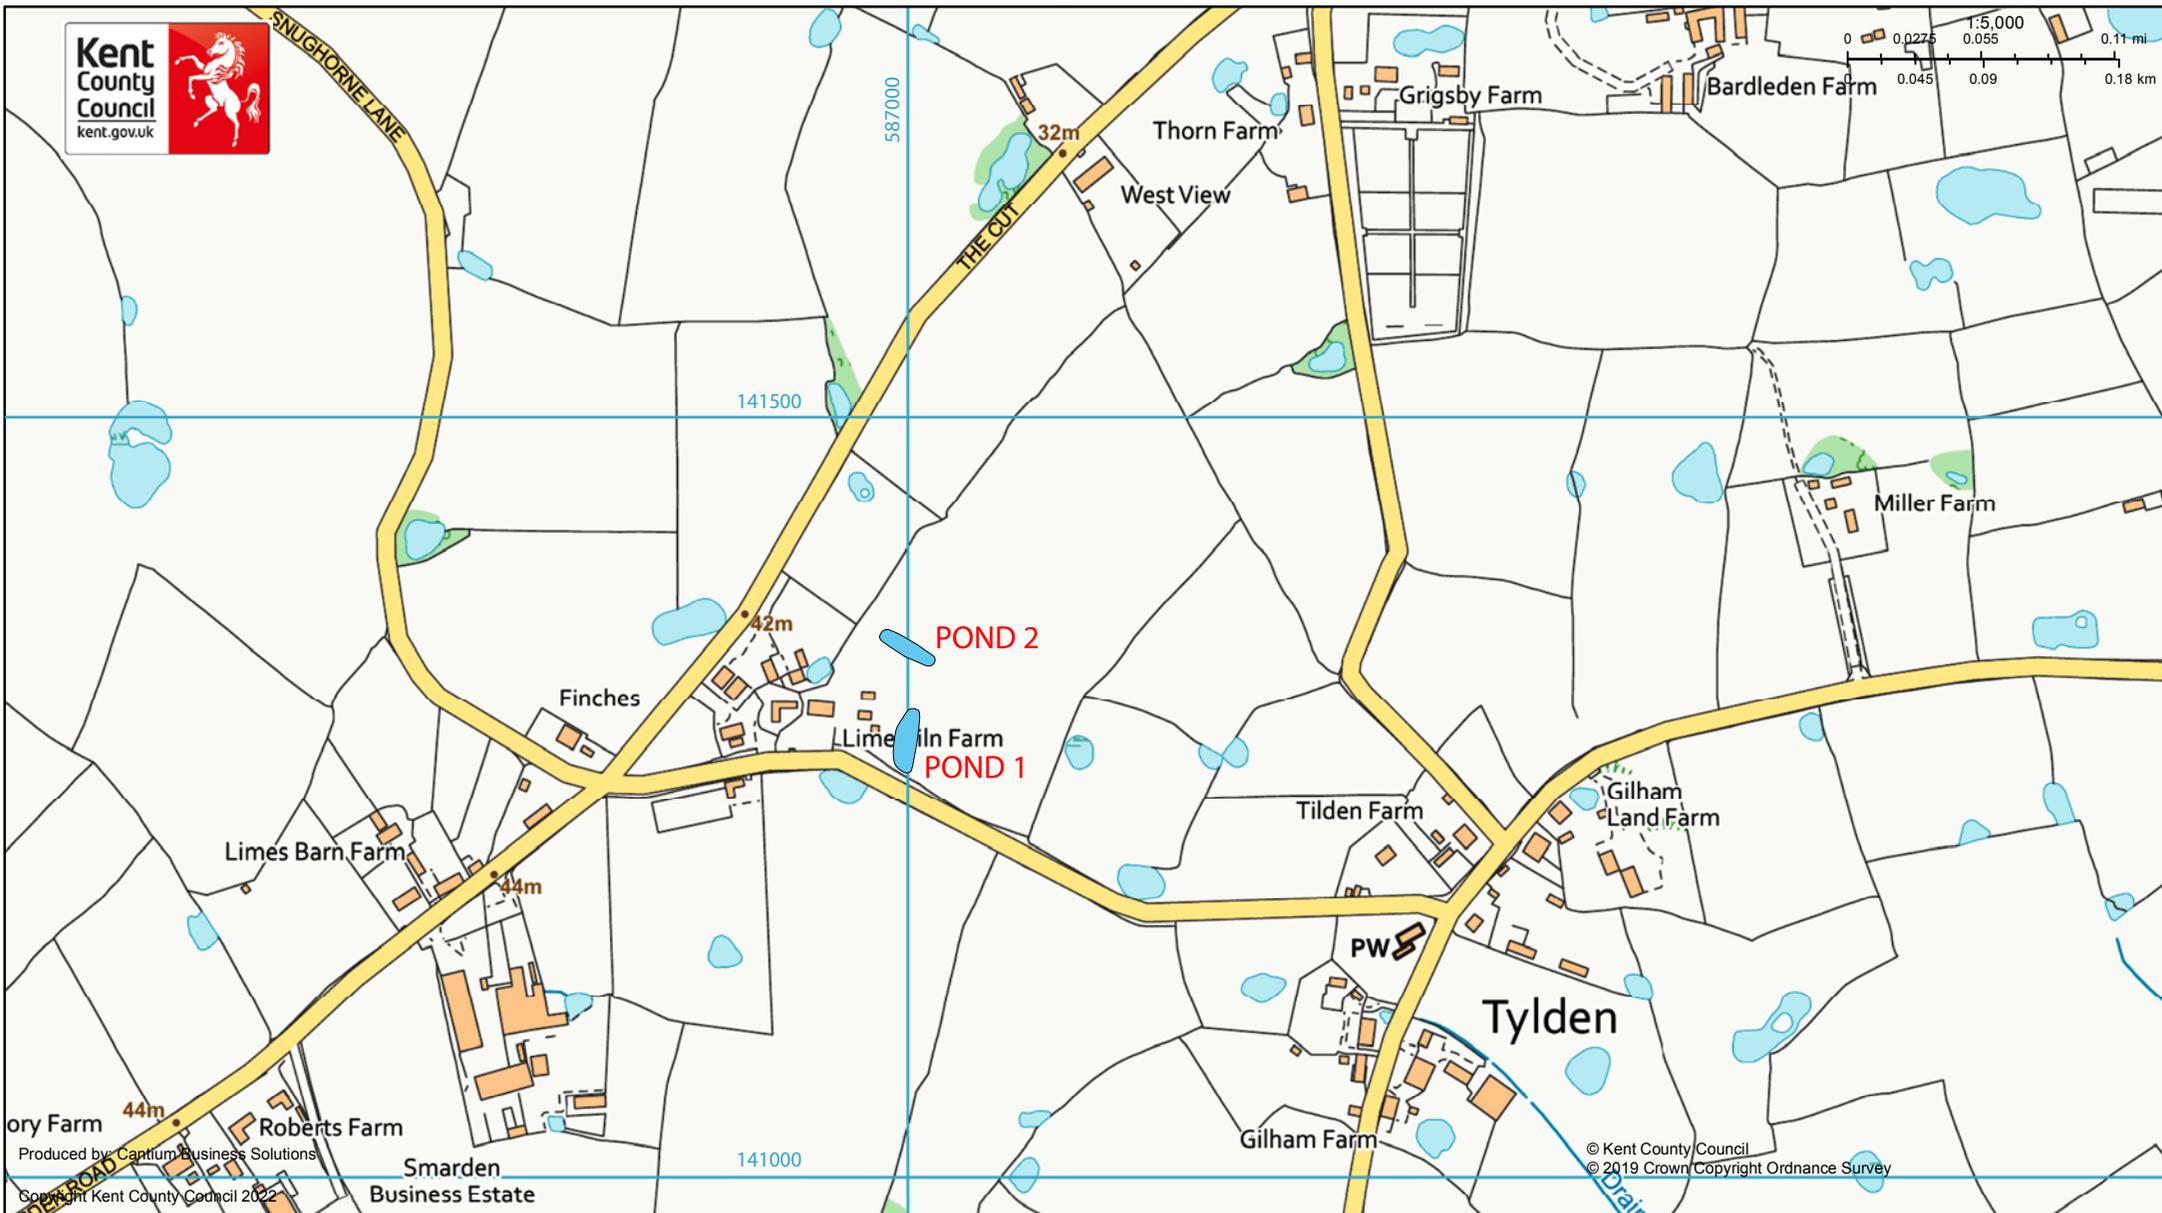
Figure 1: Ponds location

5.2.1 The Ponds restoration works comprised machine-aided re-excavation of two large sub-oval ponds as indicated on Figure 1.
