ARCHAEOLOGICAL DESK-BASED ASSESSMENT OF LAND AT MERE HOUSE, MEREWORTH, KENT, ME18 5NA

1.1 In June 2023 Rebecca Parr carried out a rapid archaeological desk-based assessment for SWAT Archaeology of available data on land at Mere House, Mereworth in Kent.

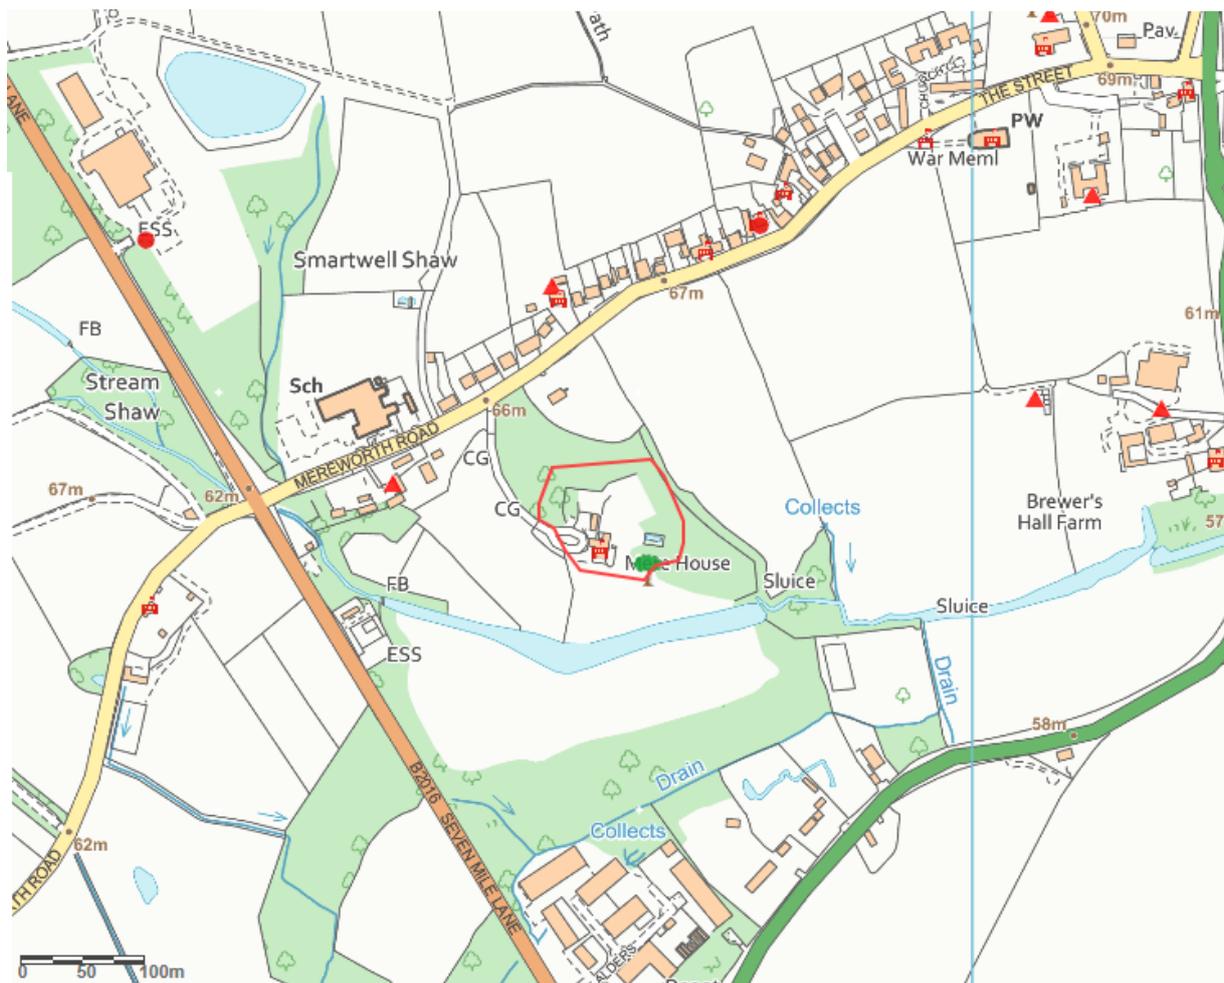
Figure 1. HER mapping (site outlined in red)

The KCC HER map (Figure 1) shows that the majority of HER records are for listed buildings located in and around the village of Mereworth. The PDA, Mere House, being one of those listed buildings (The Rectory - TQ 65 SE 253). In addition, within the PDA is recognition of the landscape at Mere House (TQ 65 SE 275).

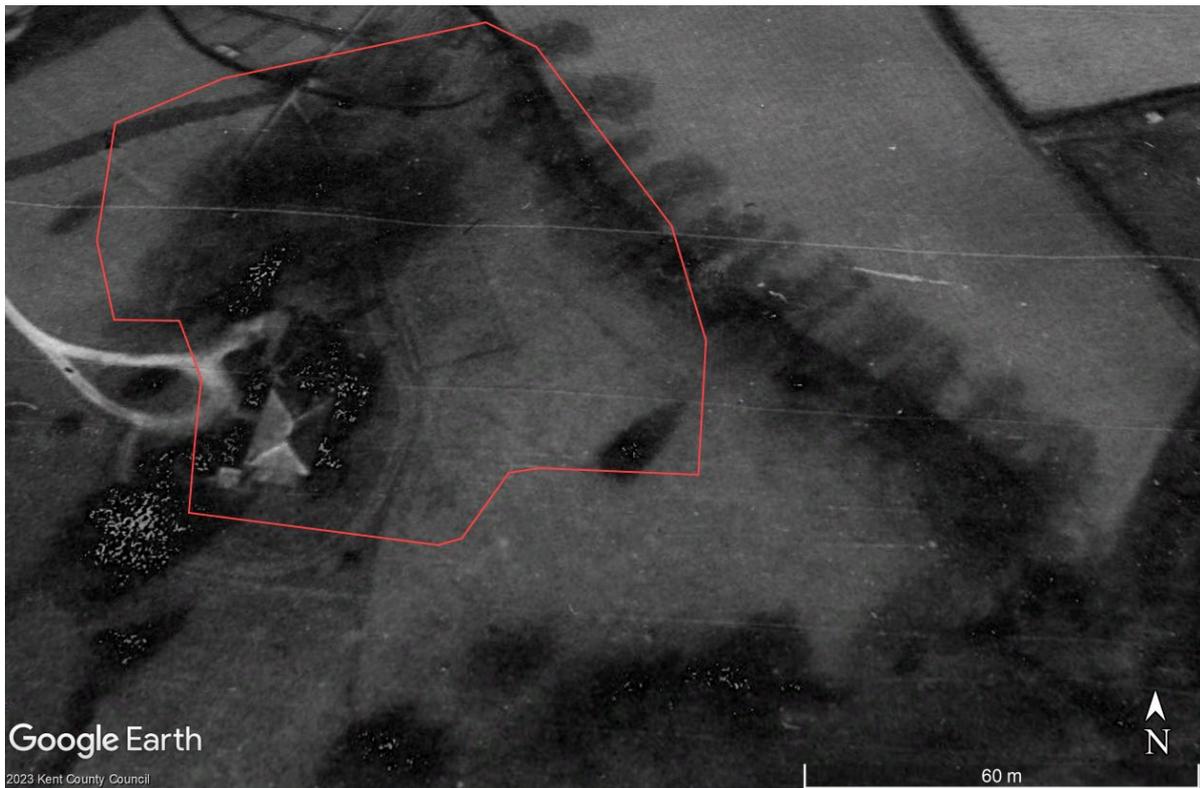
Plate 1. Aerial c.1946 showing extent of site.

The 1946 AP shows this rectangular area which does not appear to be in any different use compared to the area around (Plate 1). The PDA on the eastern side of the house appears grassland with lines possible representing informal paths. The area to the north of the house contains more trees. The 1960s aerial photograph (Plate 2) shows changes in the area north east of the house with what appears to be a nursery, vegetable growing area. This was possibly created following the loss of the area known as the Upper Garden to the north which has been separated from the PDA and now contains a new vicarage. It was probably in this period the Mere House changed its name from that of The Rectory. East of the house at the southern end of the new area mentioned above is the rectangular structure which is located north of that of the present pool. It is unclear what this is. Plate 3 from 1990 shows the nursery area which the structure now covered by trees. South of this area a new pool has been built and the area of the nursery no longer in use and grassed over. Only the extreme northern part of this area has continued in use as a fruit and vegetable growing area as seen in plate 12.

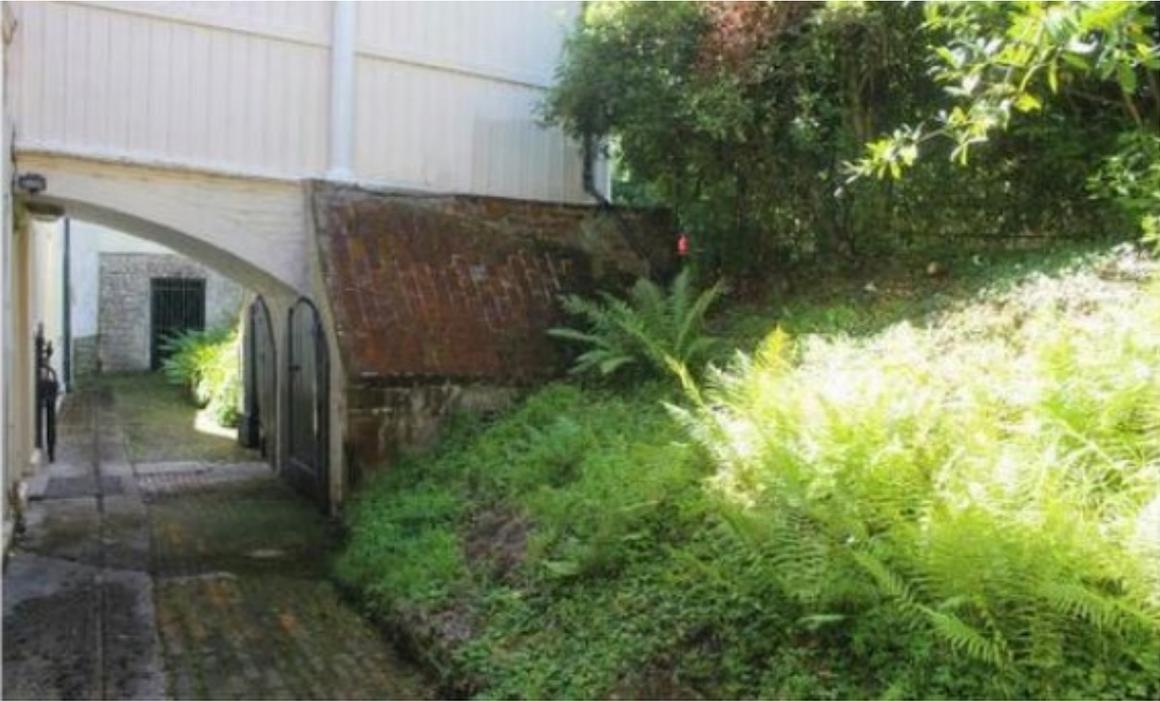
Plate 6: Location of proposed ground floor steps at the front of the house

i) The additional of new proposed steps to the front elevation either side to the main entrance from ground level to the lower ground floor (Plate 6).

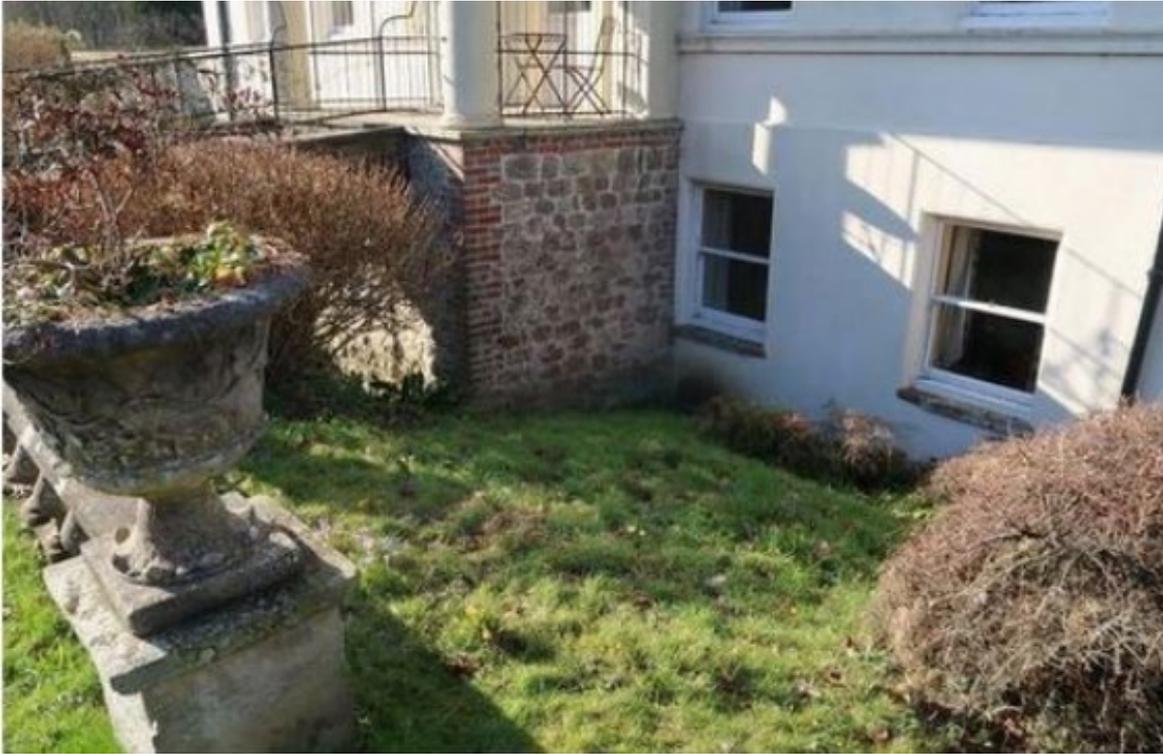
Plate 10: Area of proposed new patio

ii) Proposed patio on the rear of the property reducing the sloping grass banks and the addition of steps on the north east and south east corners and lowering the grass level of the adjacent lawn (Plates 7-10).

iii) Proposed masonry steps and landing platform at the base of the exiting bridge for the lower ground floor access (Plate 10).

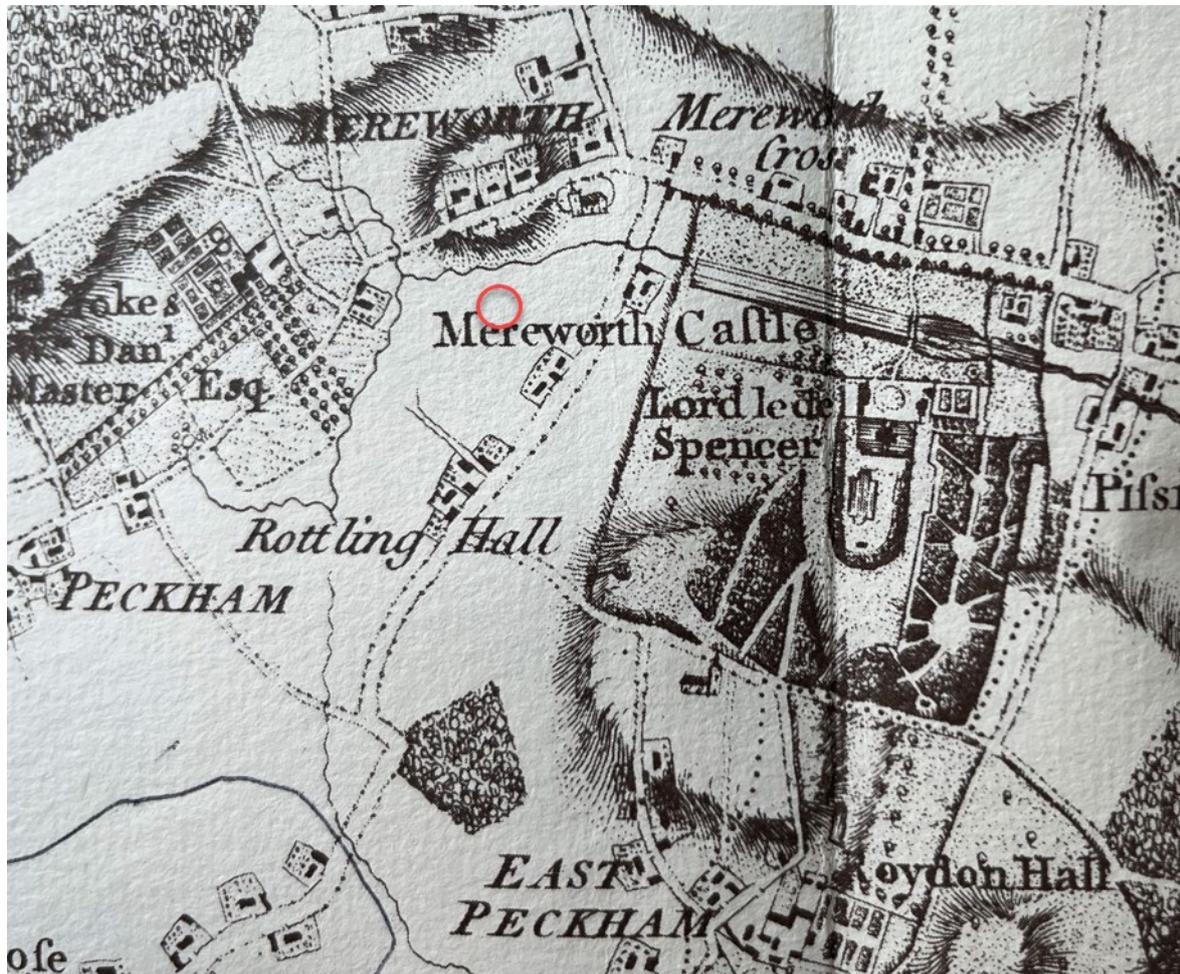
MAP 1. Andrews Dury map of 1769

A rapid map assessment of OS historic mapping shows that in the Andrews Dury map of 1769 (MAP 1) the area of the PDA was open fields being part of the wider agricultural landscape belonging to Mereworth Castle and is prior to the building of the present house around 1780. By 1797, MAP 2 shows the present building in place with the lake to the south. In the wider area to the east is Mereworth Castle and to the west at Yotes Place, both sites show extensive landscaped gardens. There is no indication on this drawing that that is the case at the PDA. To confirm the building as The Rectory (designated 271) the tithe map (MAP 3) from 1840 shows the landowner and occupier is The Honourable and Reverend Sir Francis Stapleton Baronet (Glebe). Around the house, the tithe map shows

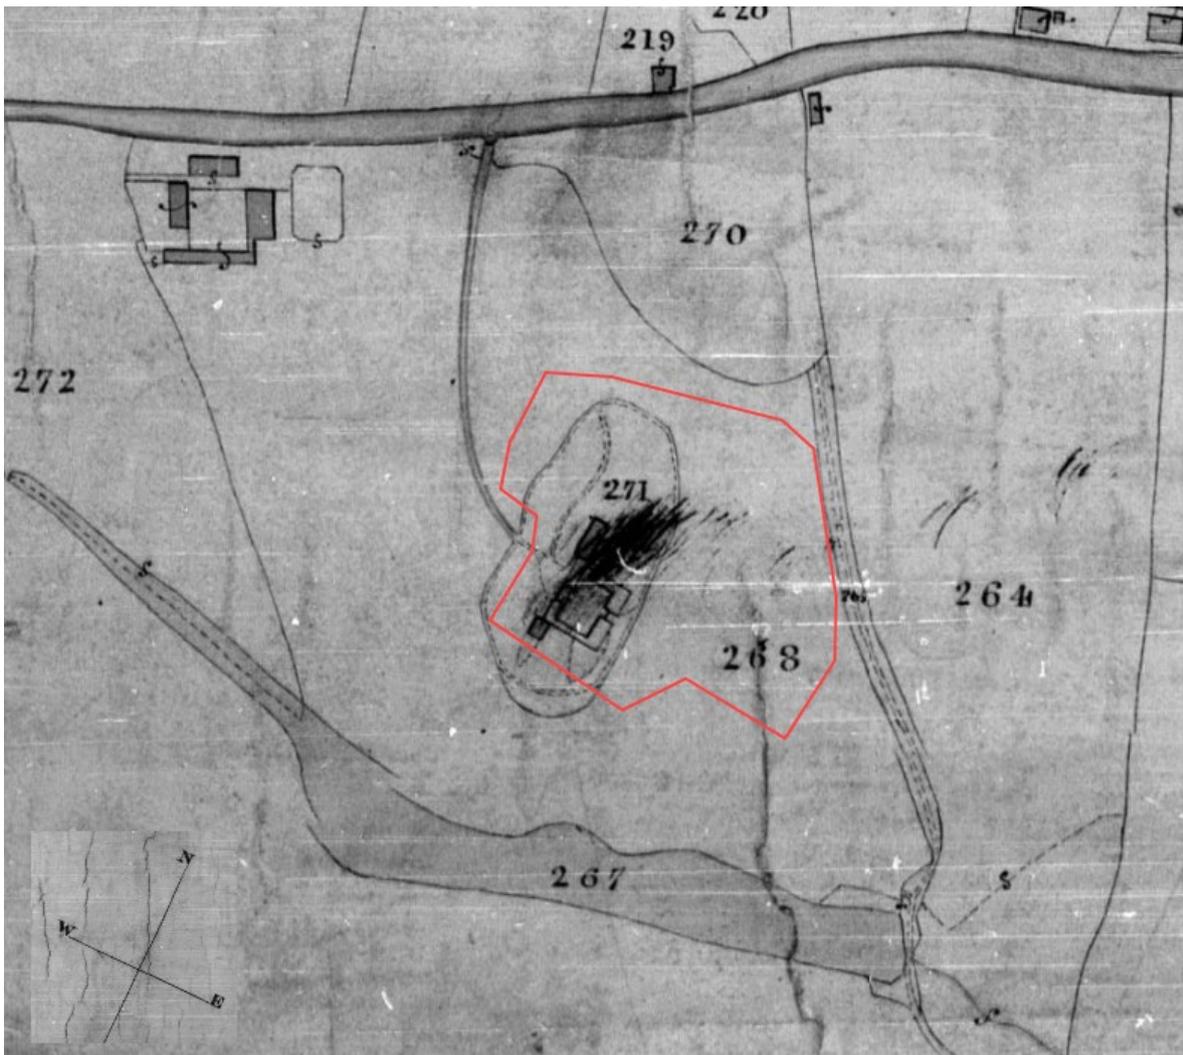
MAP 3: Mereworth tithe map 1840

paths. Land designated 270 north of the house is referred to in the tithe as the Upper Garden and area designated 268 is listed as 'paddock, stables and garden'. With area 267 described as a pond. Area designated 269 is the thin strip on the north-south axis, adjacent to the PDA as is called 'The Walk'. The area beyond this to the east is under separate ownership.

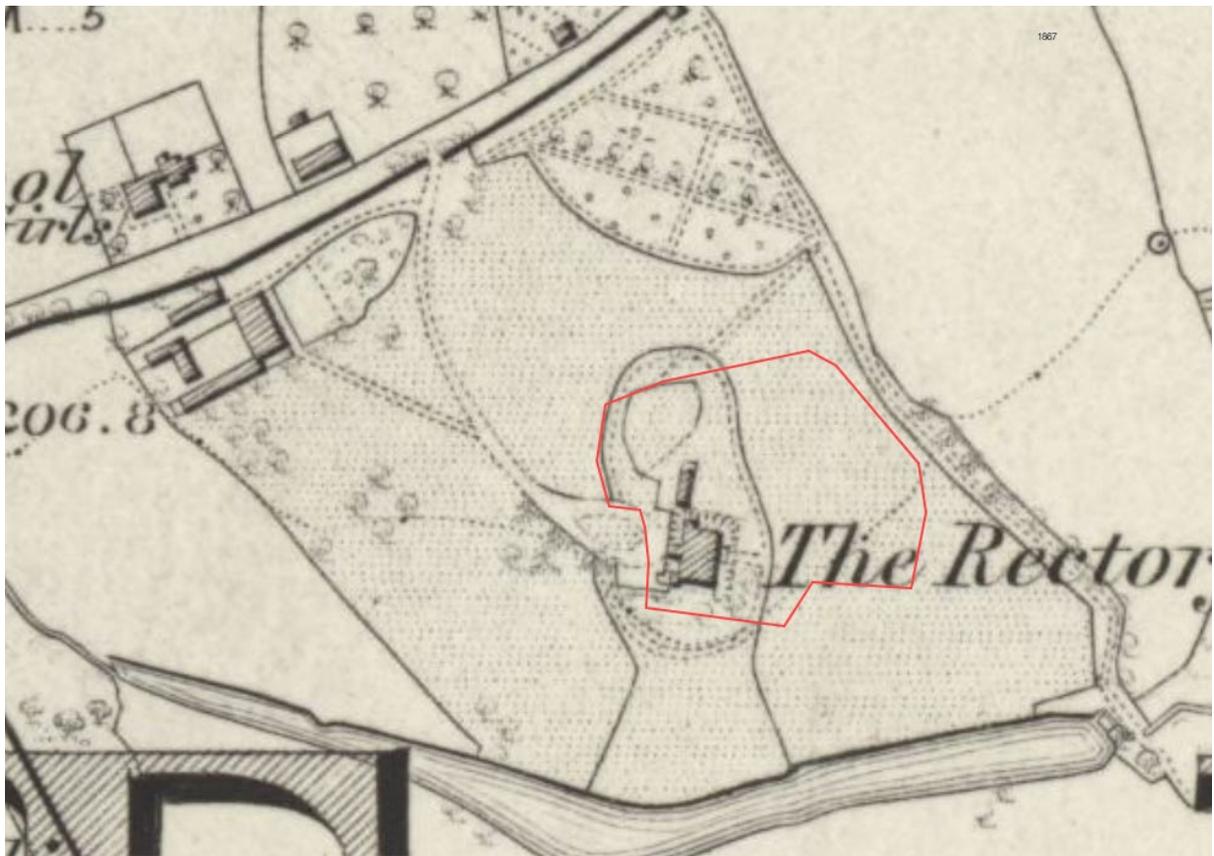
MAP 4. OS map of 1867

The 1867 OS historical mapping (MAP 4) shows little changes with the path around the house remaining and any gardens around the house appearing informal except for the area to the north of the house known as the Upper Garden, which appears more formally laid out. There appears a change in 1895 (MAP 5), whereby the footprint of the house suggests that it was extended on the southern side. By 1938, adjacent to the north west of the house is now a separated rectangular area of unknown use (MAP 6).

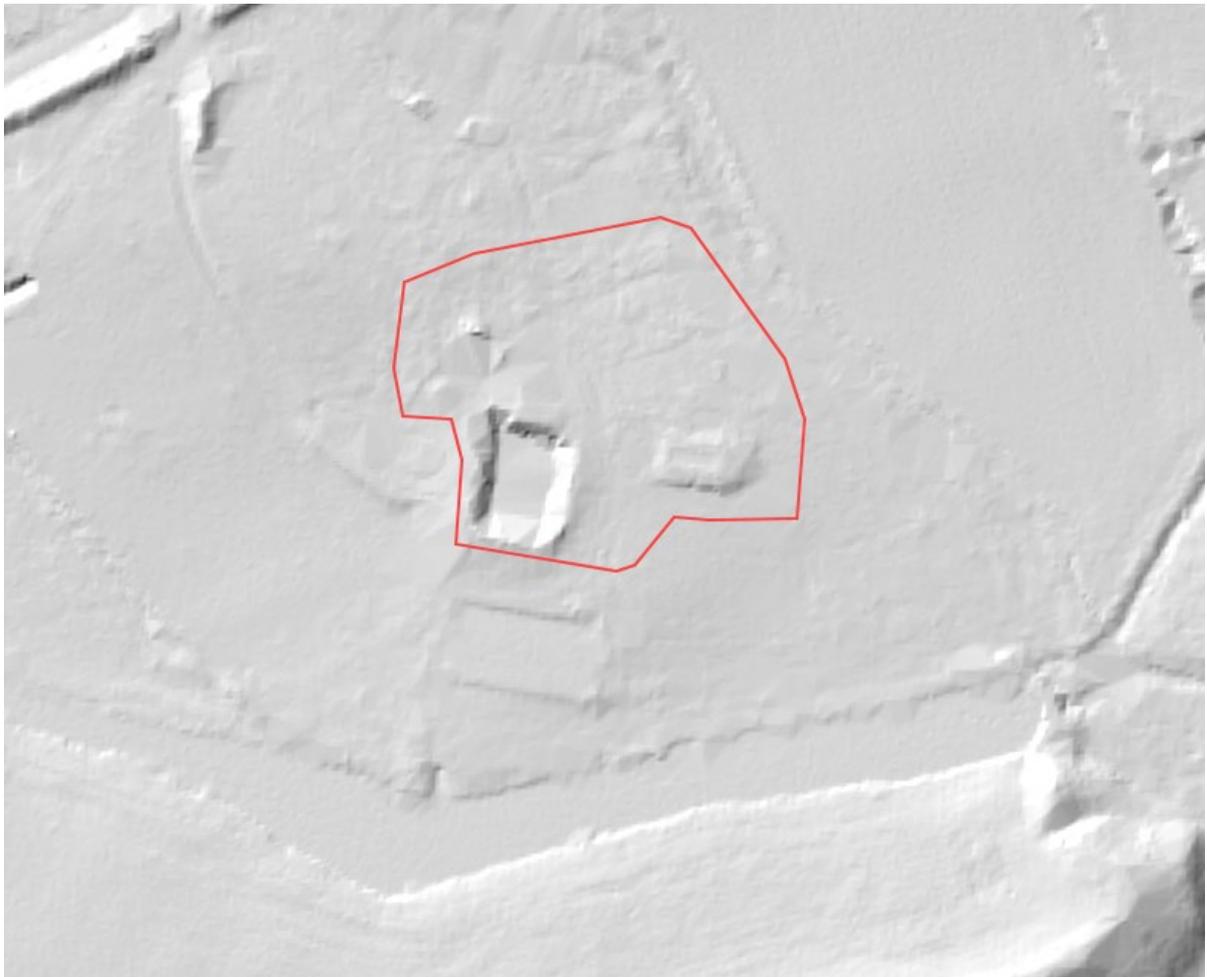
Figure 3: LIDAR 1m DTM (Environment Agency)

3.5 The LIDAR (Figure 3), shows disturbance in the area just to the north of the current pond and identifiable is the existing small rectangular feature of the existing pool equipment. The raised paving around the current swimming pool also shows up. South of the house the rectangular area that is showing as flat with no features and is the location of the croquet lawn. The LIDAR also highlights the banks around the house where the house sits at the lower ground level. The area of LIDAR in the far north of the PDA also shows disturbance from the use of this area for fruit and vegetable growing.
