Archaeological Evaluation of Land at Henwood Car Park, Henwood, Ashford Kent TN24 8YF

Site Code: HRA-EV-23

Planning Application Number: 22/00249/AS

Document Reference: 33610.01

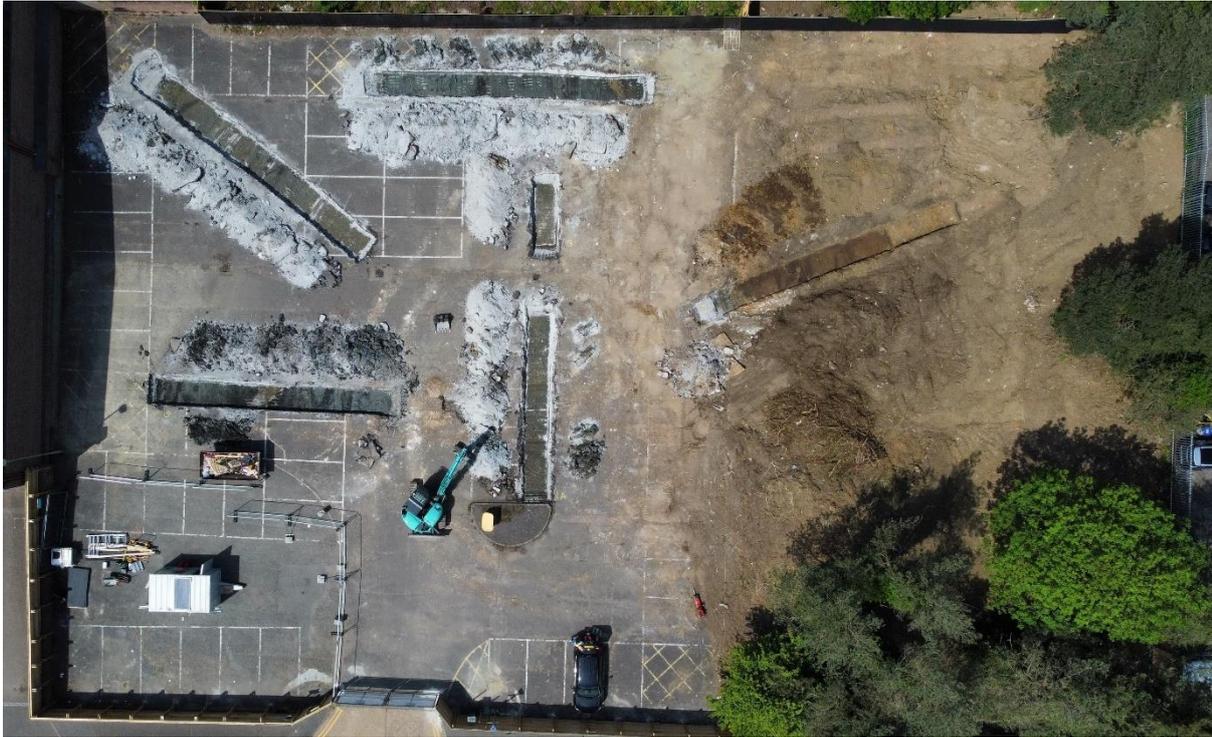
Plate 1 Aerial view of the site following excavation of the five trenches

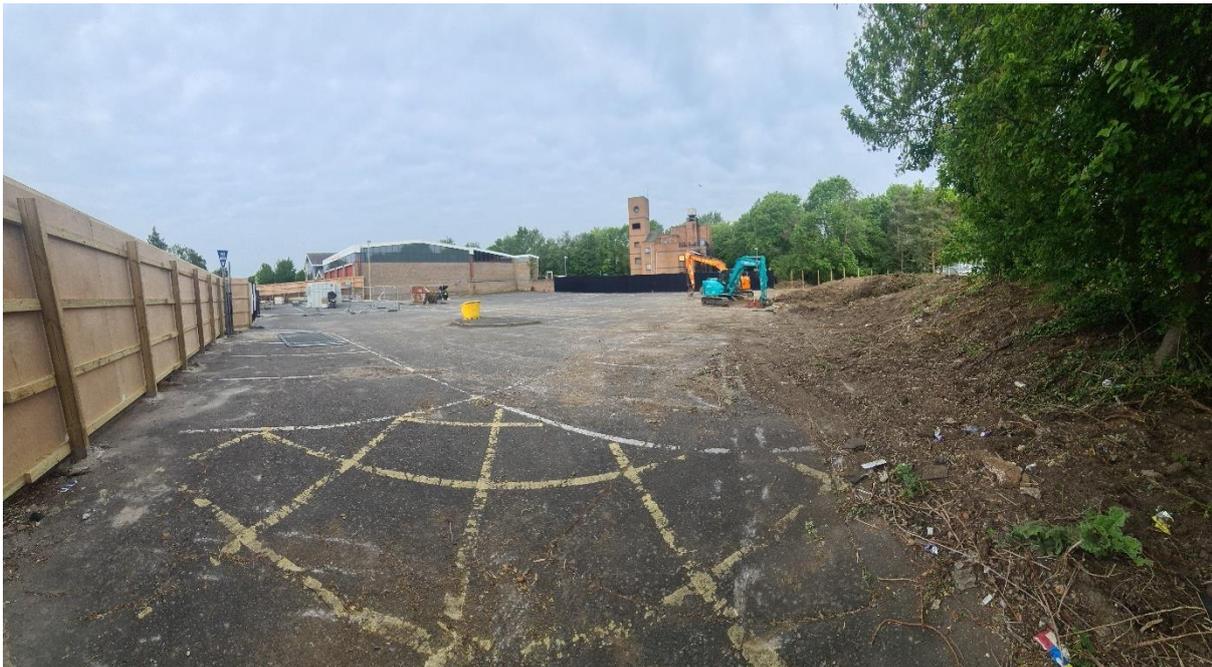
Plate 2 Panoramic view of the site, viewed from the north-eastern corner

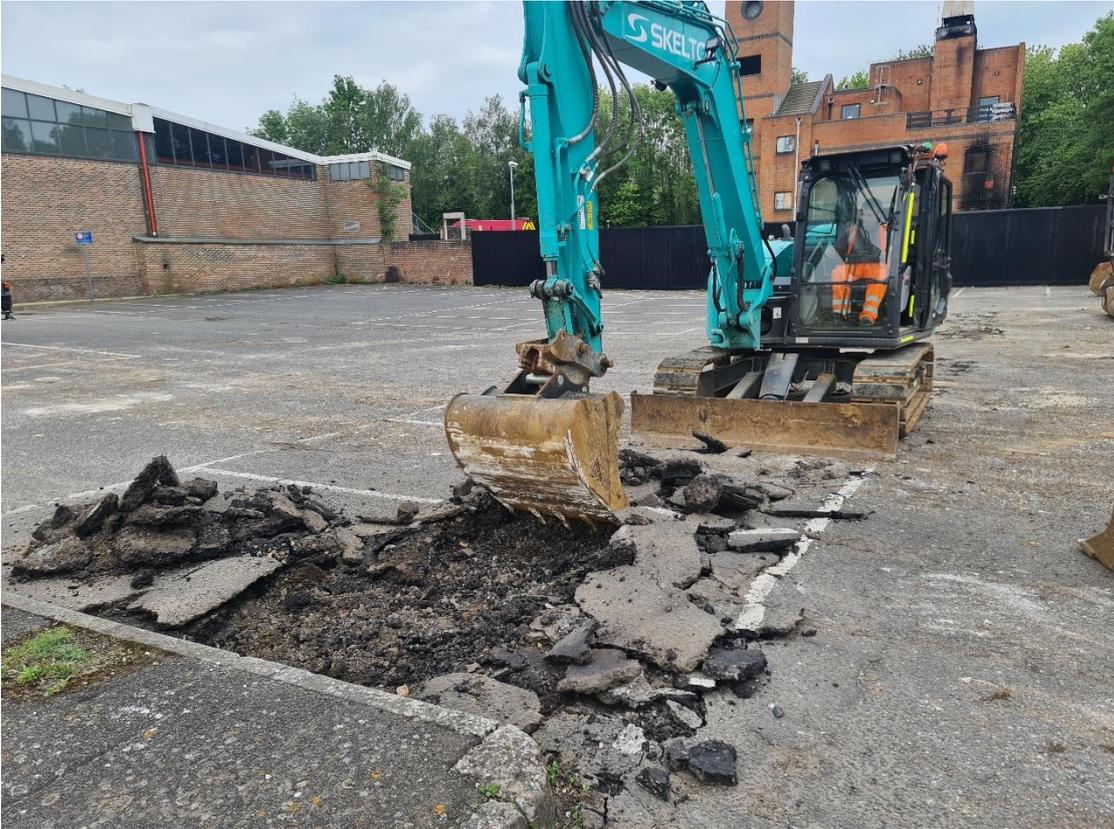
Plate 3 Excavation of the tarmac surface, Trench 1, viewed from the northeast

5.2.2 Removal of the tarmac and compact hardcore was carried out using a concrete breaker and toothed bucket, with a ditching bucket for the final clean and removal of lower stone (Plate 3 and Plate 4).

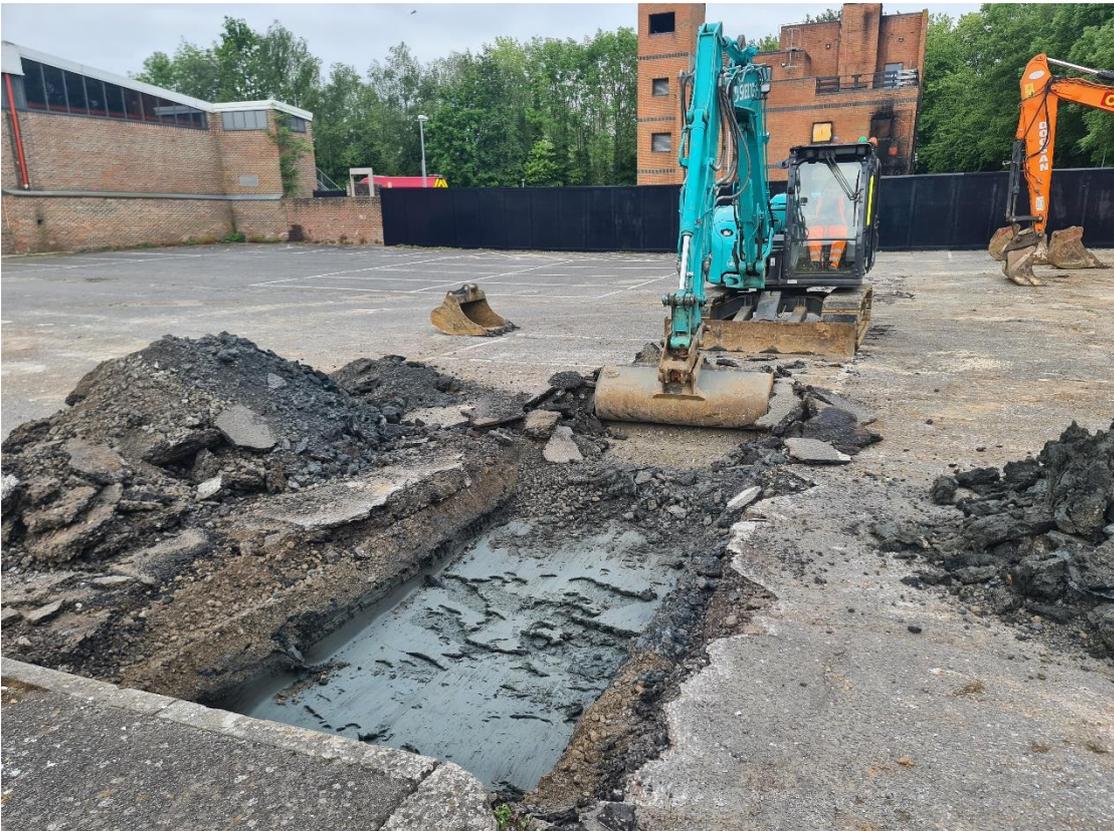
Plate 4 Removal of the overburden exposing natural clay alluvium, Trench 1, viewed from the northeast

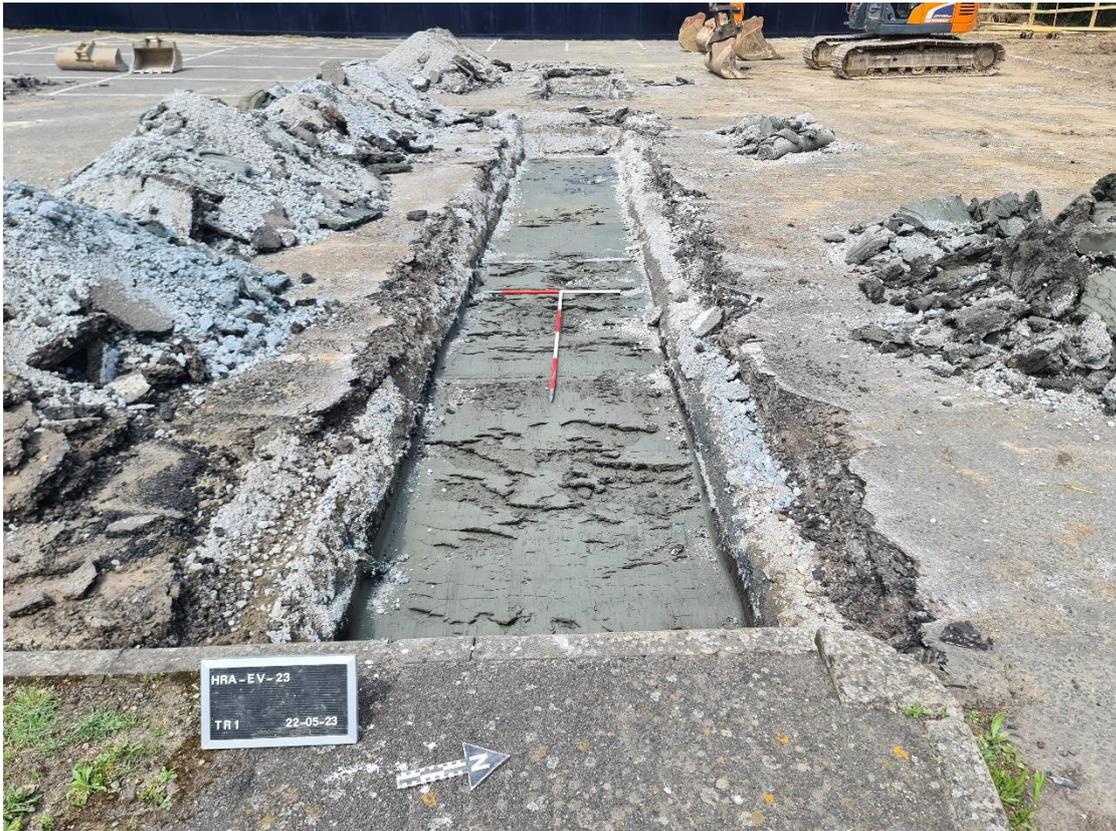
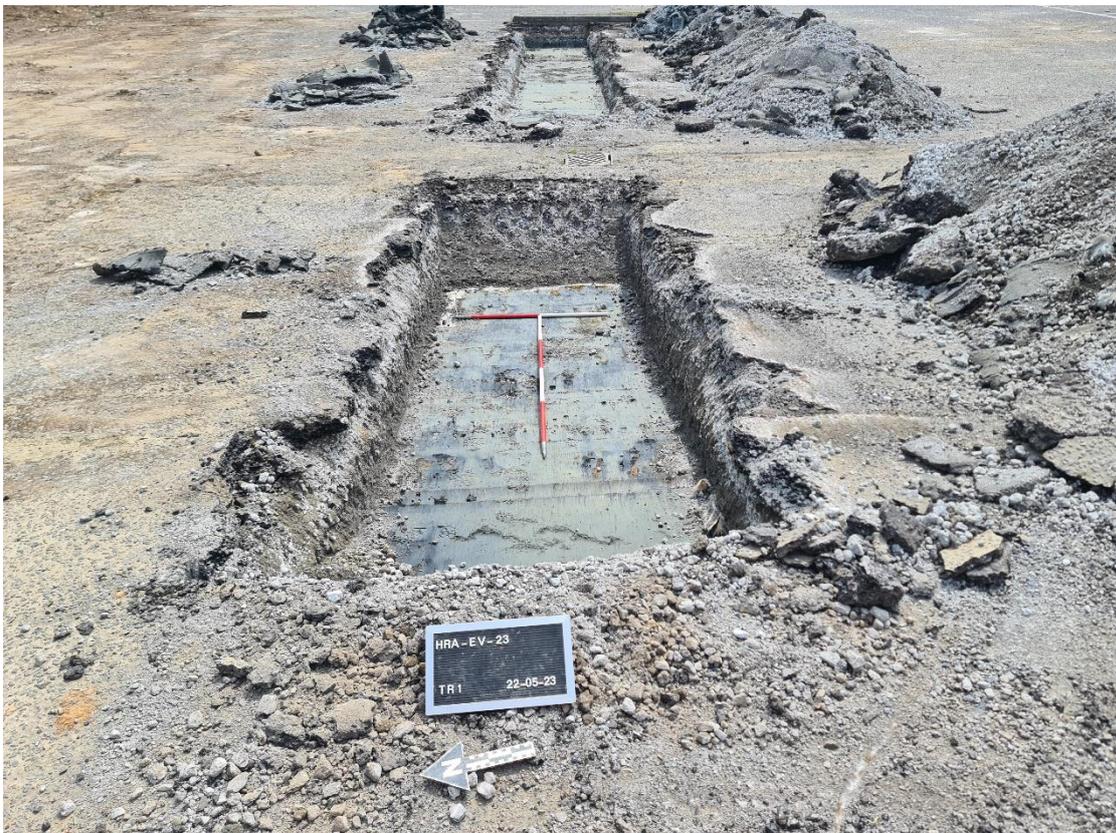
5.3.2 This trench measured 22.36m (17.07m (1A) + 5.29m (1B)) in length, 1.8m in width and a maximum depth of 0.61m (Figure 3). Natural geological deposits were recorded at a level of approximately 34.16m OD.

5.3.3 No archaeological finds or features were present in Trench 1.

Plate 5 Trench 1, viewed from the east

Plate 6 Trench 1, viewed from the west

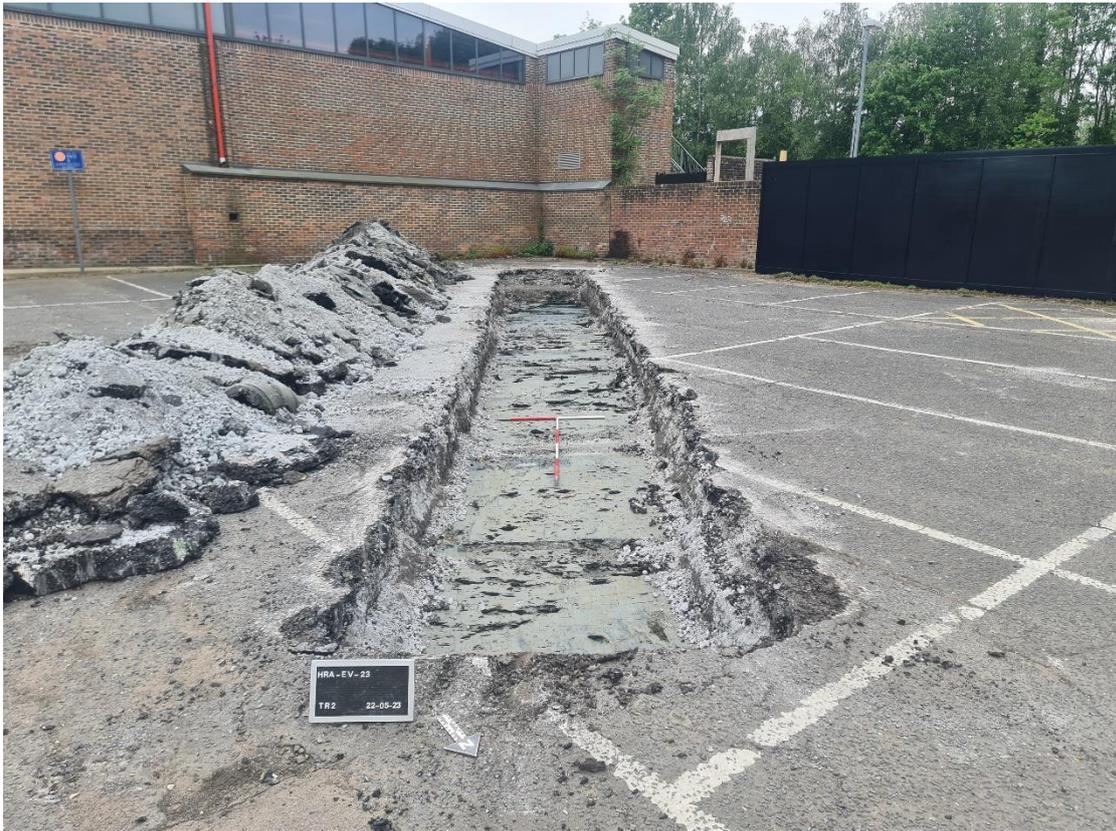
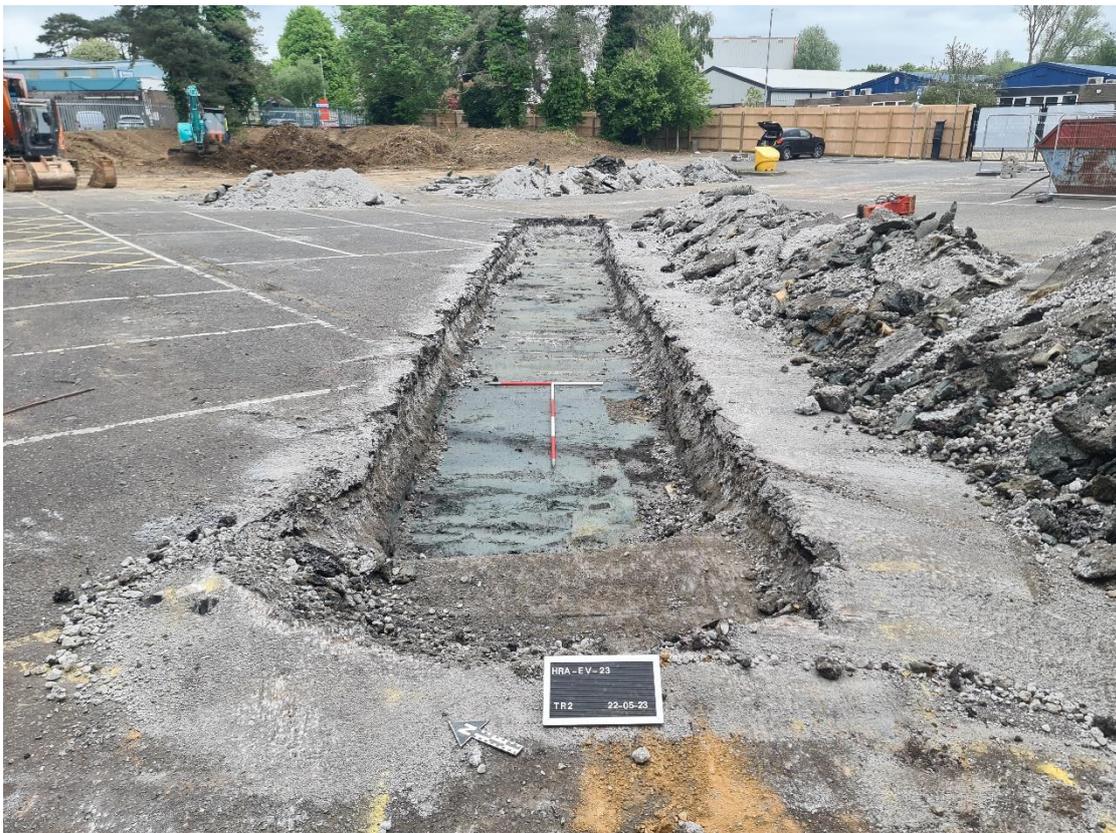
5.3.4 Within the south-western corner of the site (Figure 2), Trench 2 was excavated on a NE-SW alignment and measured approximately 18.4m in length, 1.8m in width with a maximum depth of 0.51m (Figure 3). Natural geological deposits were recorded at a level ranging between 34.00m OD and 34.26m OD.

5.3.5 The upper surface of the natural clay (204) was lightly truncated with modern material pressed in causing regular track-like patterns. No archaeological finds or features were present in Trench 2.

Plate 7 Trench 2, viewed from the northeast

Plate 8 Trench 2, viewed from the southwest

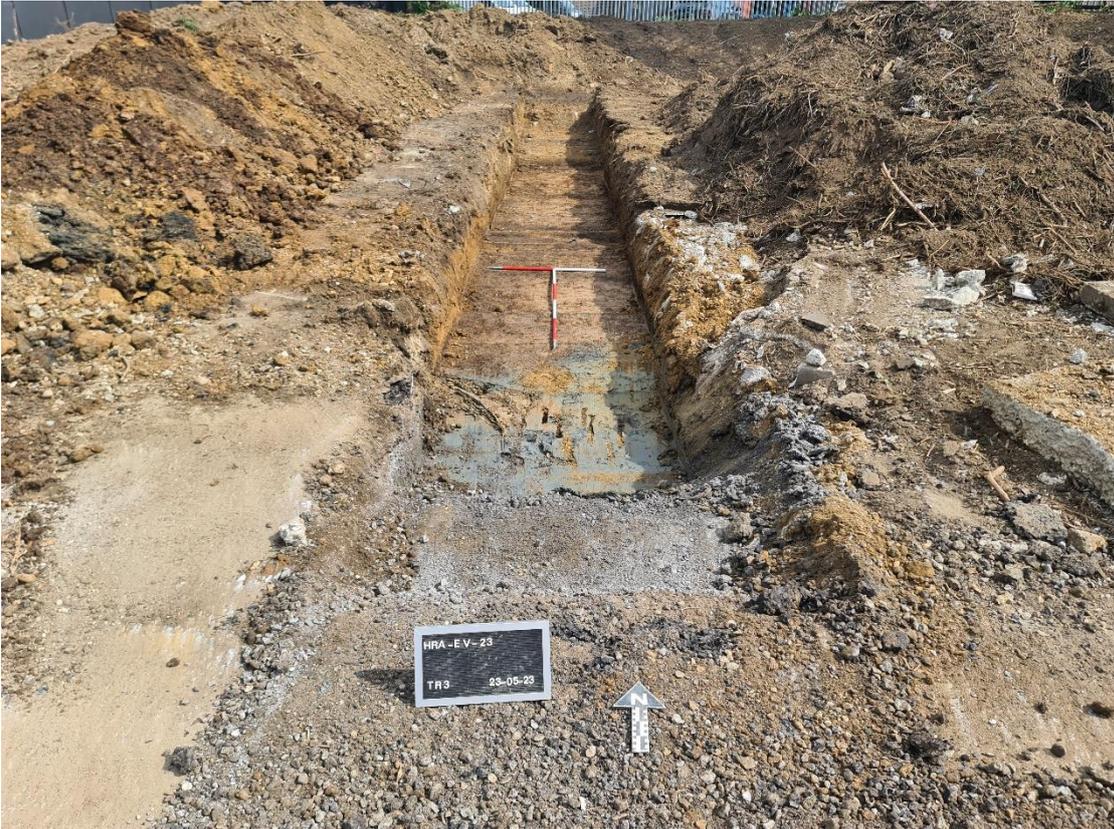
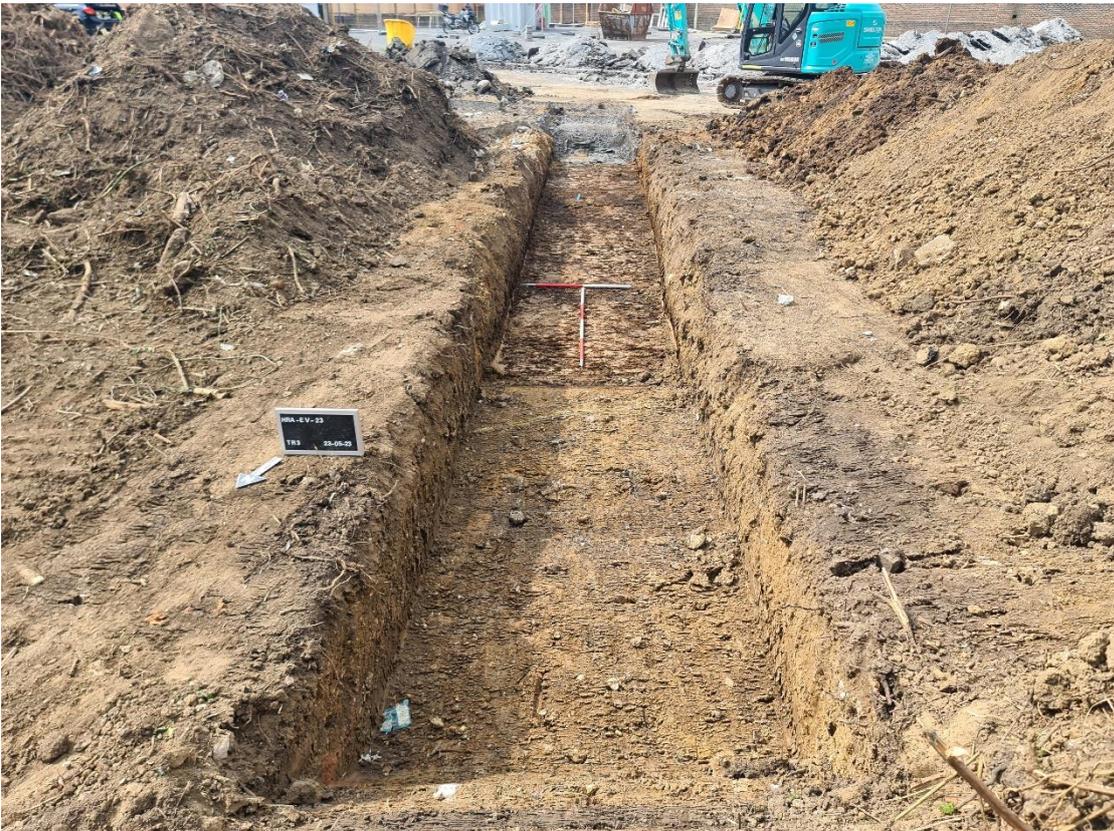
5.3.6 Within the northern extent of the site (Figure 2), Trench 3 was excavated on a N-S alignment and measured approximately 17.07m in length, 1.8m in width with a maximum depth of 1.01m.

5.3.7 The stratigraphic sequence in this trench varied from the other due to the fact that it was located outside of the car park; topsoil (301) sealed modern redeposited made ground (302) which had been placed on a surviving subsoil (303). Natural geological deposits (304) were recorded at a level of approximately 34.19m OD and were more mottled than other areas on site. The natural was sealed by a modern electricity cable and water pipe, both of which were left intact and undisturbed.

5.3.8 No archaeological finds or features were present in Trench 3.

Plate 9 Trench 3, viewed from the south

Plate 10 Trench 3, viewed from the north

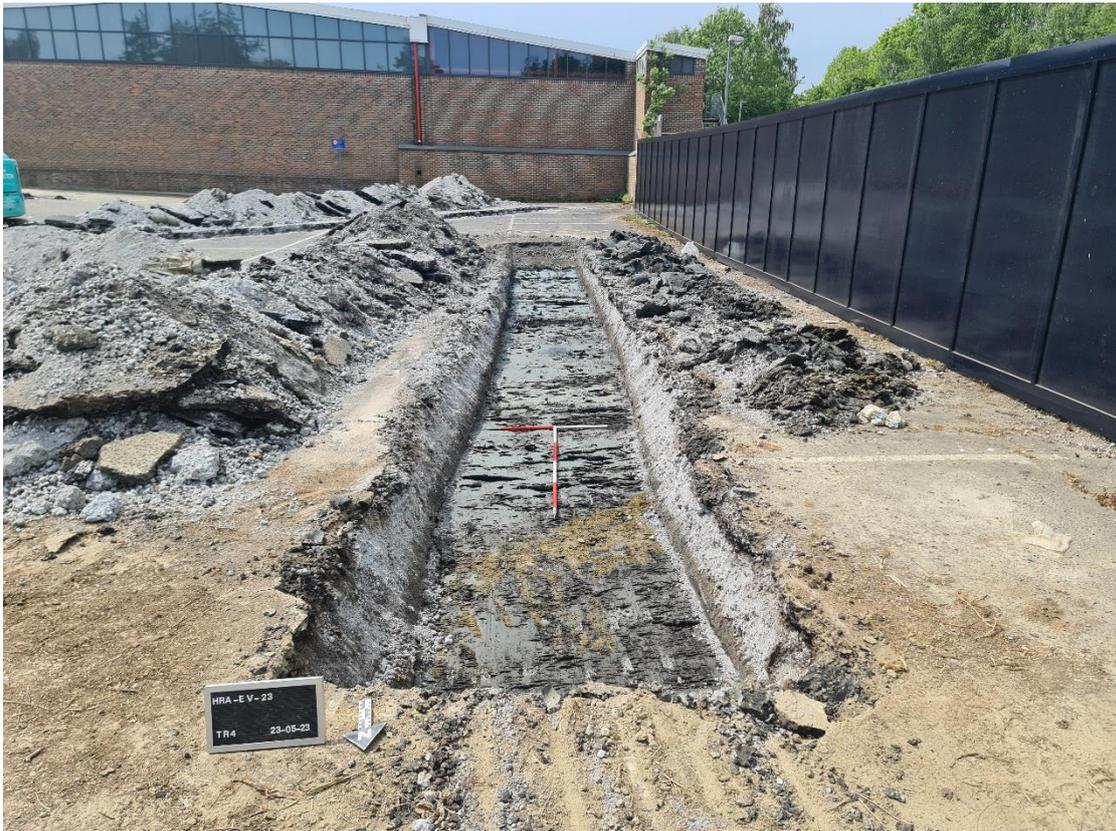
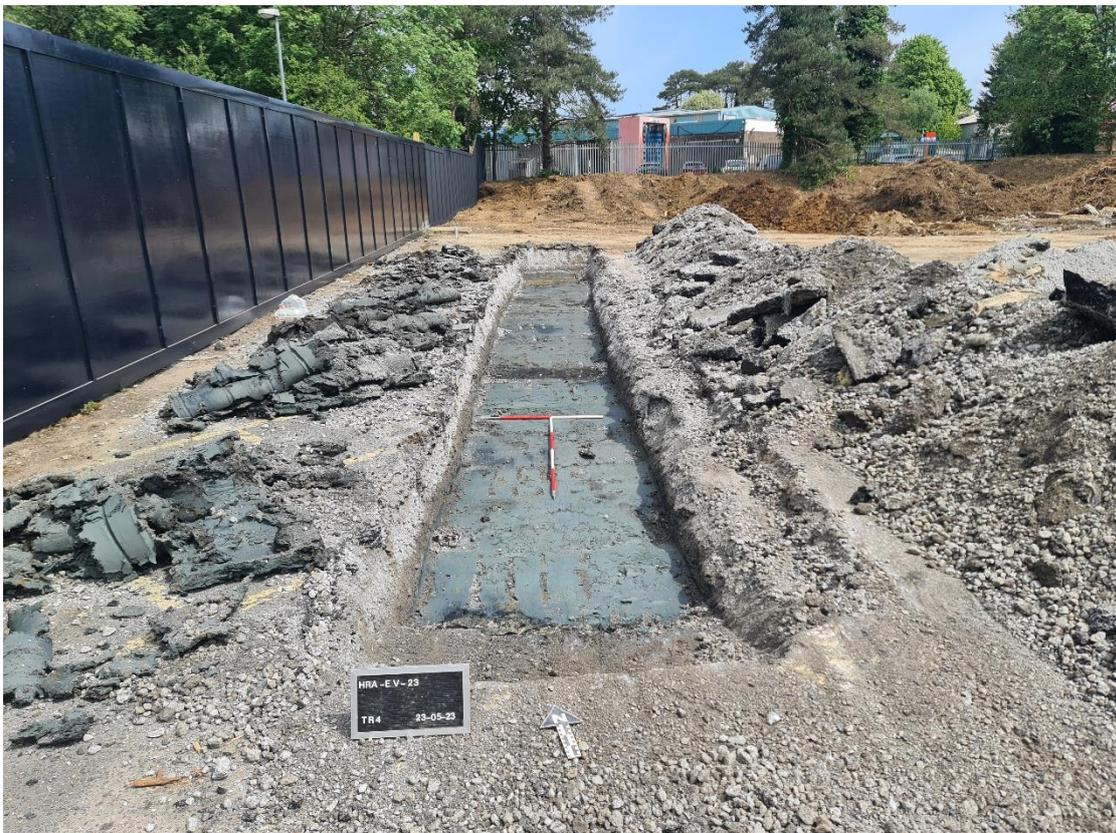
5.3.9 Within the western extent of the site (Figure 2), Trench 4 was excavated on an N-S alignment and measured approximately 18.02m in length, 1.8m in width with a maximum depth of 0.59m. Natural geological deposits were recorded at a level ranging between 34.19m OD and 34.25m OD.

5.3.10 Once again, the upper natural alluvium (403) had been lightly truncated, and no archaeological finds or features were present in Trench 4.

Plate 11 Trench 4, viewed from the north

Plate 12 Trench 4, viewed from the south

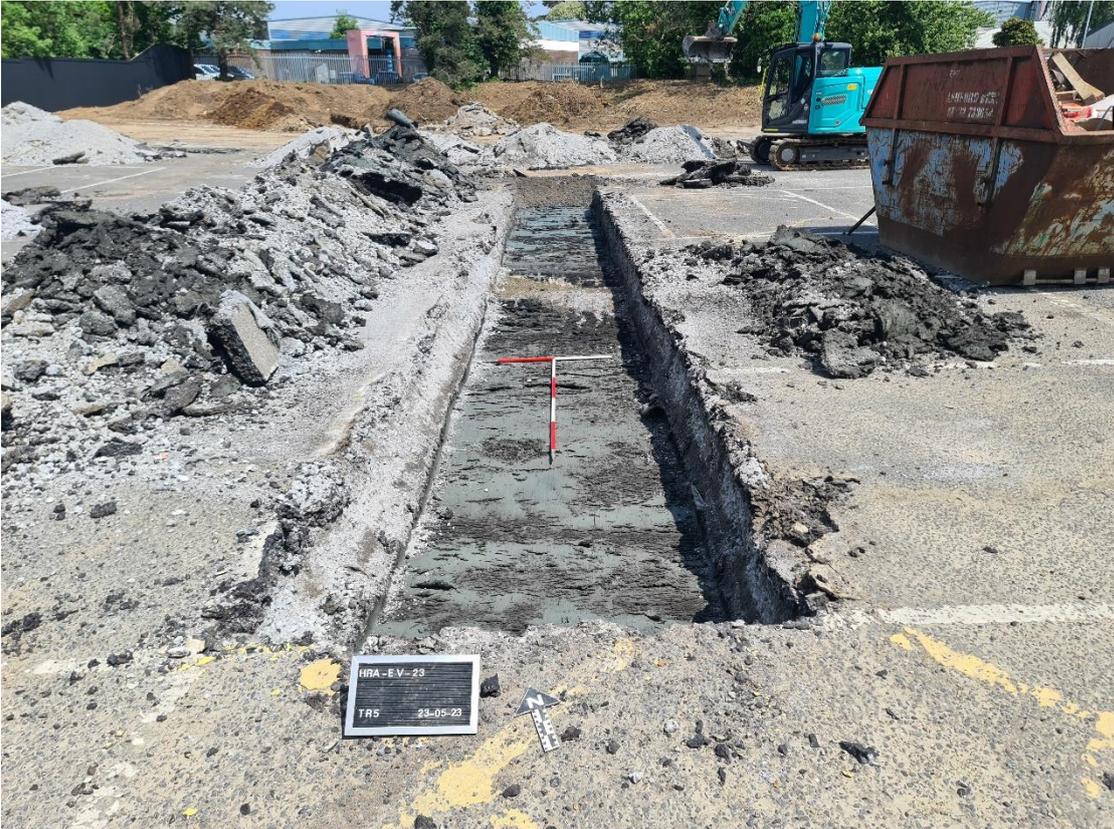
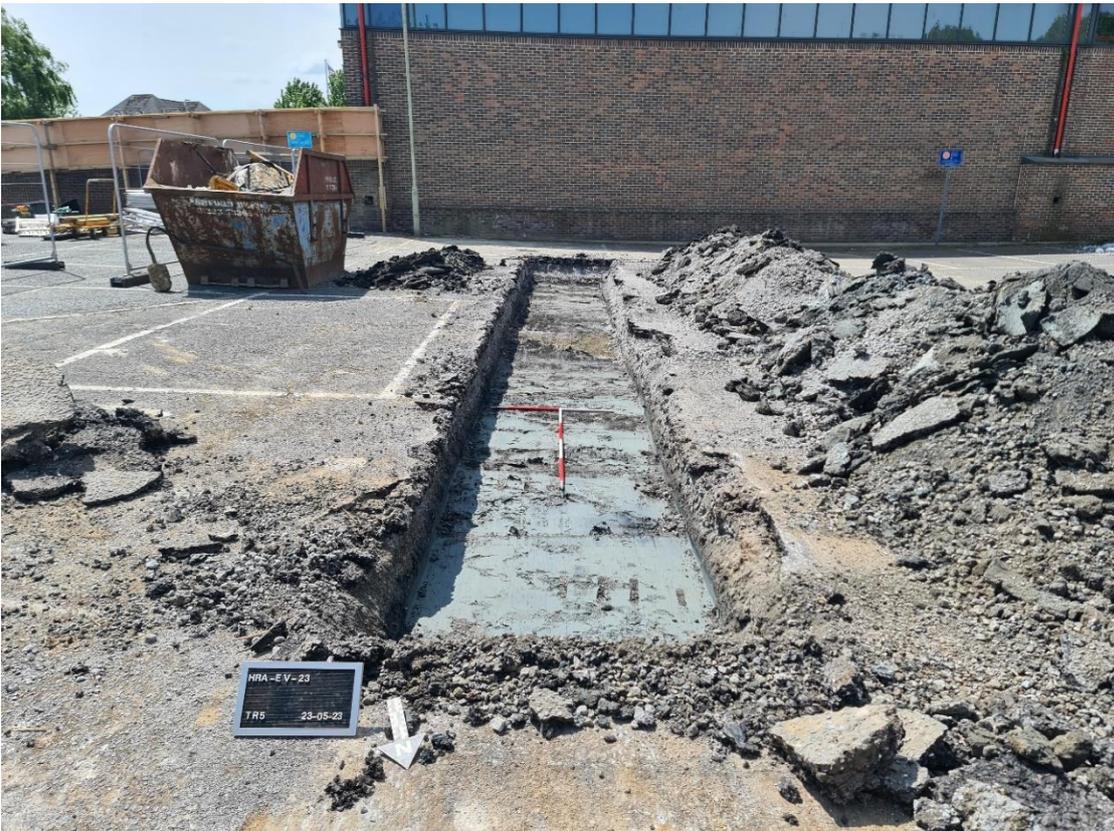
5.3.11 Trench 5 was excavated within the southern extent of the site and measured 16.01m in length with a maximum depth of 0.64m. Natural alluvium was recorded at levels between 34.14m OD

and 34.22m OD. A modern drain capped with concrete was present within the centre of this trench.

5.3.12 No archaeological finds or features were present in Trench 5.

Plate 13 Trench 5, viewed from the south

Plate 14 Trench 5, viewed from the north

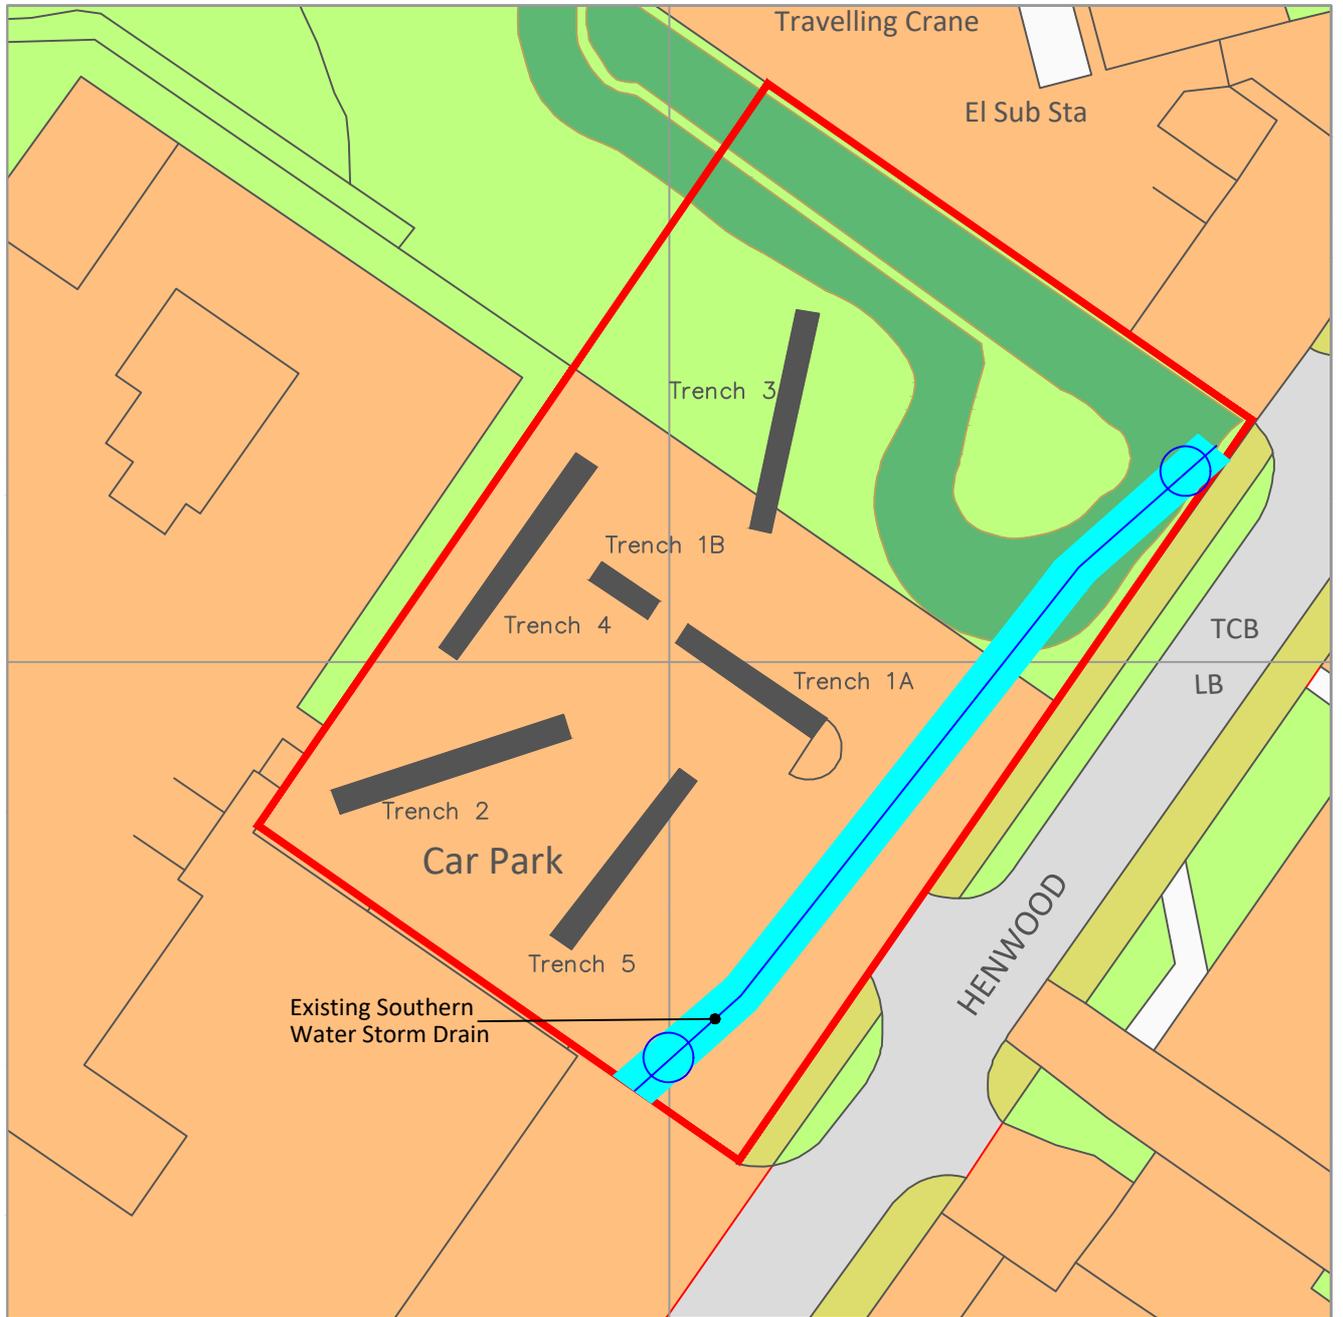
Figure 2 Site Plan

4.2.1 A total of five trenches were excavated (Figure 2). Excavation was carried out using a mechanical excavator fitted with a toothless ditching bucket, removing the overburden to the top of the first recognisable archaeological horizon, under the constant supervision of an experienced archaeologist.

5.1.2 The site, as shown on Figure 2, provides the trench layout with Figures 3 and 4 illustrating the results for each individual archaeological evaluation trench. Plates 1-14 consist of photographs of features and selected trenches that have been provided to supplement the text. Appendix 1 provides the stratigraphic sequence and contextual information for all trenches.
