HISTORIC BUILDING RECORDING OF WELSH TAVERN, 161 LONDON ROAD, STONE, KENT

Date of Report: 12th June 2023

Site Code: WTS-BR-23

SWAT ARCHAEOLOGY

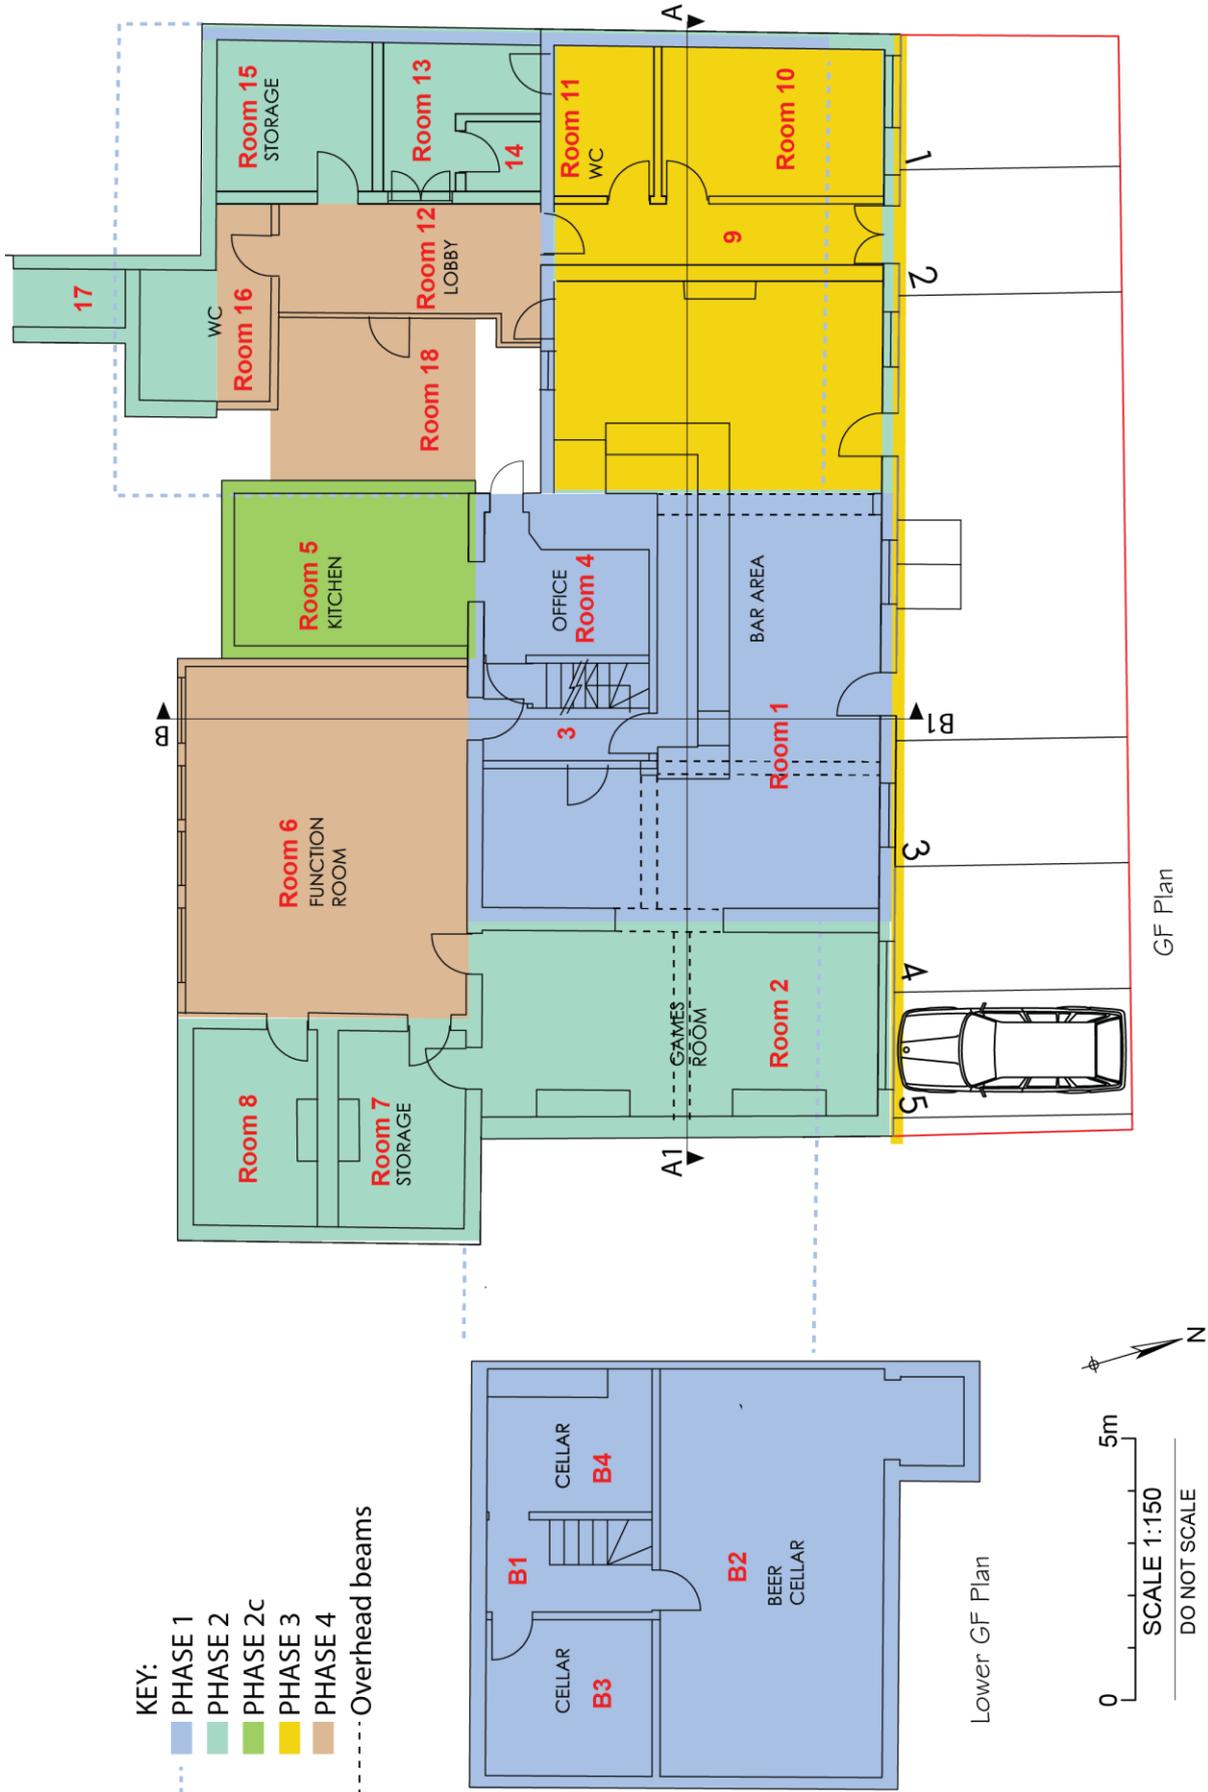
Figure 10: Basement and Ground floor plans

- 6.2.1 The 3 stories detached building has rectangular floor plan and basement based on square plan. Adjacent on the west side extension building B has rectangular layout slightly smaller from the main building.
- 6.2.2 The room 1, bar area covers majority of the floor of the main building and half of the extension building which is a conversion of former stables (Plate 5).

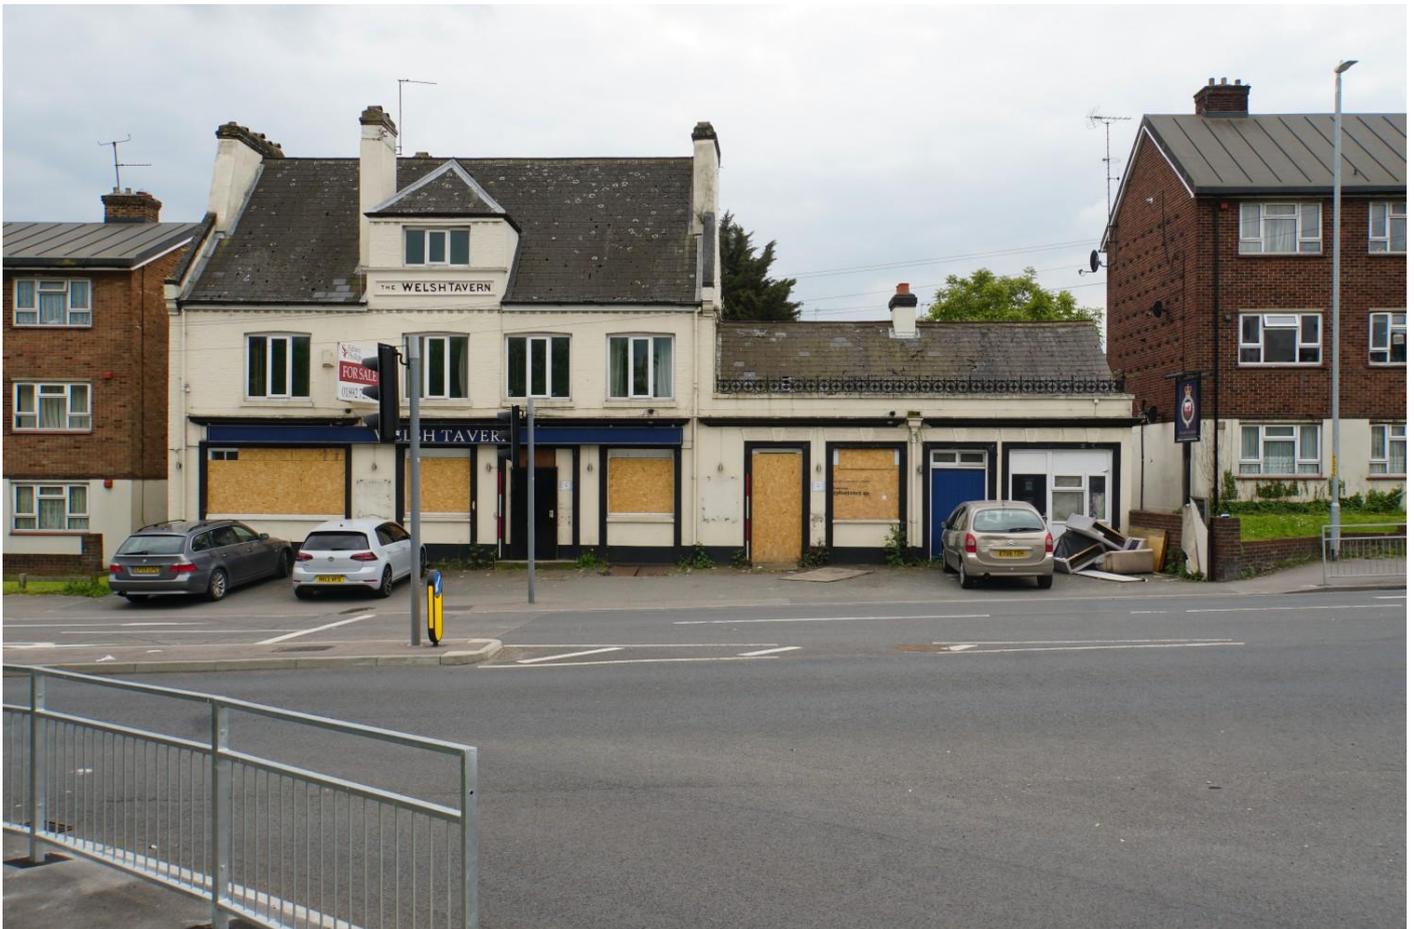
Plate 11

6.3 Northern – Front façade (Plate 11 and 12)

6.3.1 It comprises the northern wall of the building A and B respectively on the left and right. The façade is painted white in yellow hue. The ground floor level part of the façade features black painted sills expanding to the ground, white parapets, concrete rendered walls, black painted bottom part of the wall and cornices. On the upper levels the bricks were painted without concrete render.

6.3.2 Lower part of the façade features from left to right: wide window, 1.3metres gap, square window in the middle of building A, 0.9 metres gap, doorway, 1.1metres gap, square window. All the listed openings belong to building A. Further to the left there is 1.7 metres gap, doorway, 0.7metres gap, square window, 0.7metres gap, wing doorway, 0.45metre gap, and wide square opening filled with door, side windows and

panels. The latter openings belong to building B.

6.3.3 Below the eaves there are four three-pane windows of the first floor placed asymmetrically. One window is placed in the middle of the façade with two windows on the right with uniform intervals. The fourth window is placed in the middle of the left half of the wall. On the right the façade part of building B features side of the eave less gable roof with a central chimney and at the short wall topped with black iron railing with spear, circle and cross pattern.

6.3.4 The left side features side of the gabbled slate tiled roof with three pane dormer window with a chimney located on its left side and row of chimney located on the gabble end walls.

6.3.5 The façade part of the building A retain its original form but experienced alterations as blocking part of the openings on the ground floor, replacing windows, removing two small dormer, triangular eyebrow type windows flanking the central one . The black contour of the sill indicates the size of the openings visible on 1915 photograph.

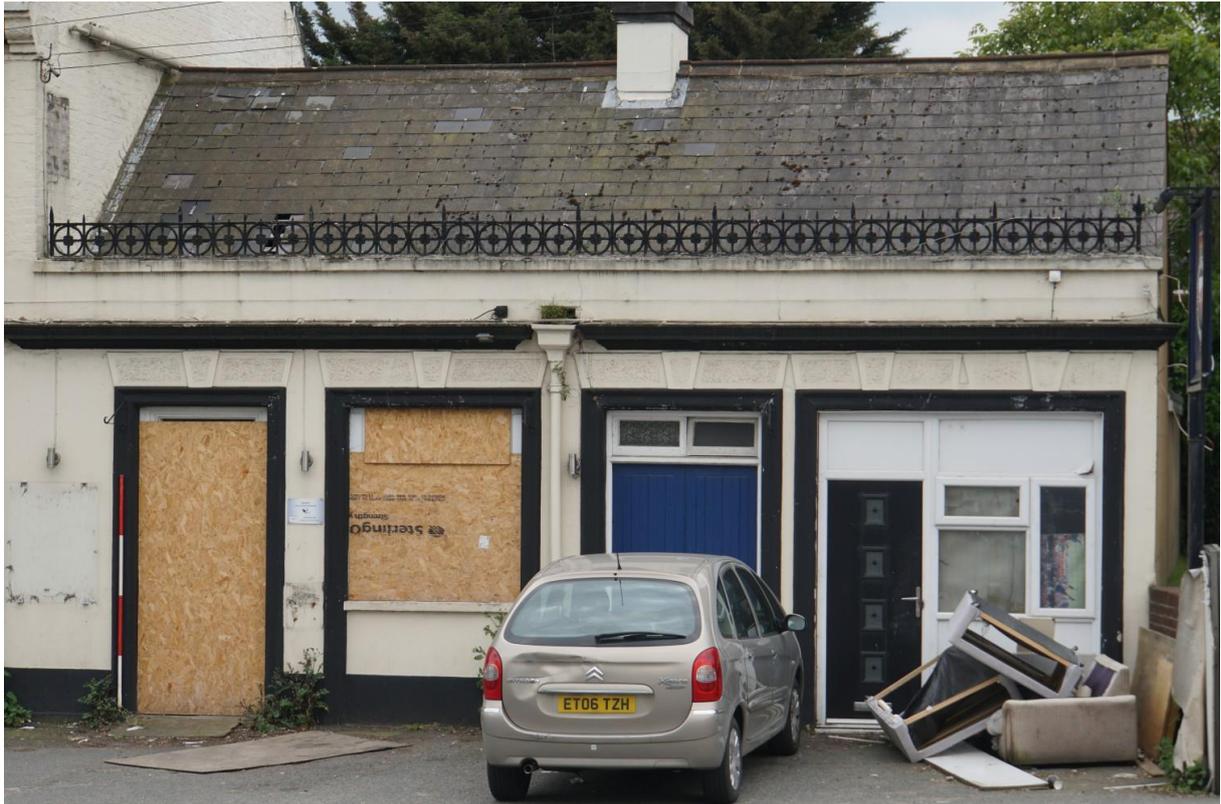
Plate 12

6.3.6 The façade of the building B changed radically. Still in 1920 it was a stable building with central large two wing gate flanked by small square windows placed immediately underneath relatively low eaves located 2 metres above the ground level. Between 1920 and 1950 the building was converted to its current form involving blocking

former openings, raising the wall by 1.7 metres to form a parapet wall and constructing a chimney in the centre.

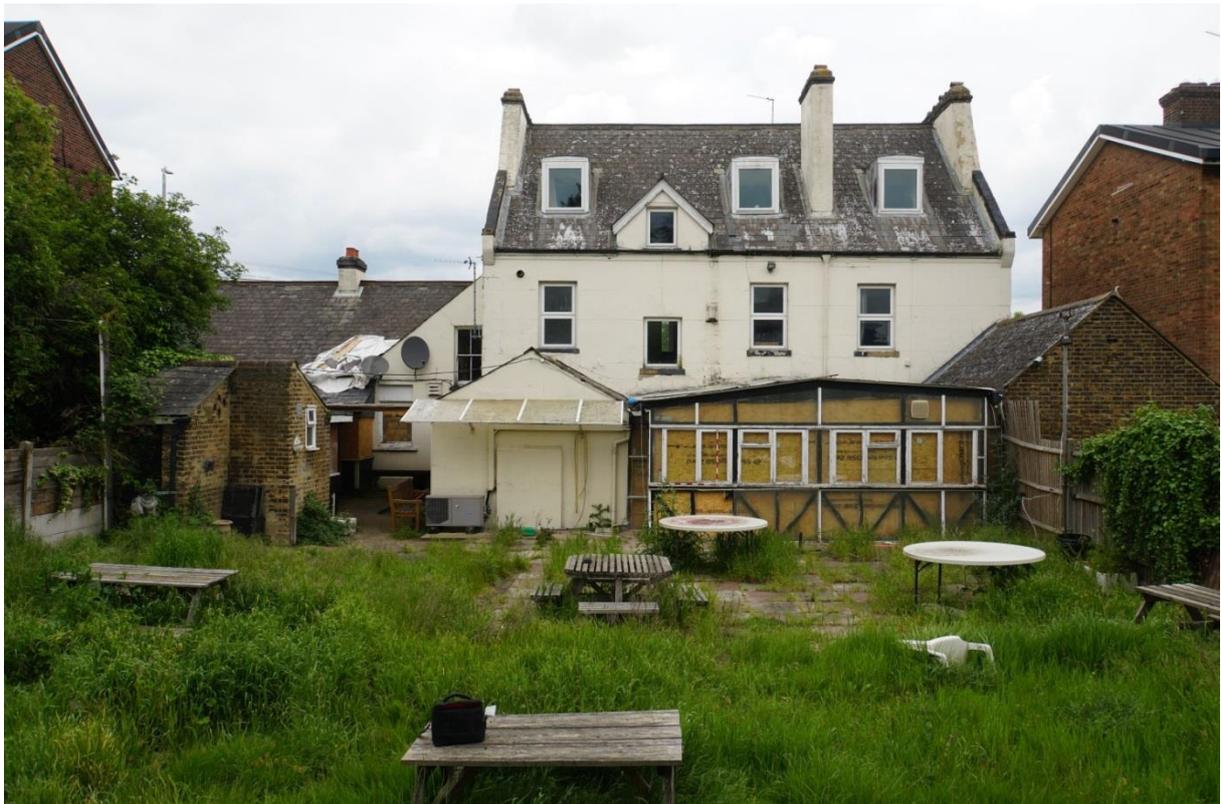
Plate 15

6.5 South façade – rear (Plate 14, 15, 16 and 17)

- 6.5.1 It comprises elevation of the main building and extension buildings C, E, F, G and H.
- 6.5.2 Elevation of extension C is obscured by tree and vegetation. It is very likely build of brick as the building E and features eaves of the flat roof.
- 6.5.3 Elevation of the block E is built of yellow stock bricks in Flemish bond. It features ridge of the pitched roof and porch entrance covering the west half of this elevation. The porch comprises two walls, eave above the porch entrance and the side of a pitched, slate roof.

- 6.5.4 The elevation of the extension building F features flat rendered surface of the wall and gable end of the slate roof which is a gable end of low pitch, almost flat roof covered with corrugated sheet.
- 6.5.5 Wall of building block G is built of wood frame with a row of four large, two pane windows.
- 6.5.6 Elevation of block H is brick built in Flemish bond and features gable end of high pitched slate roof.

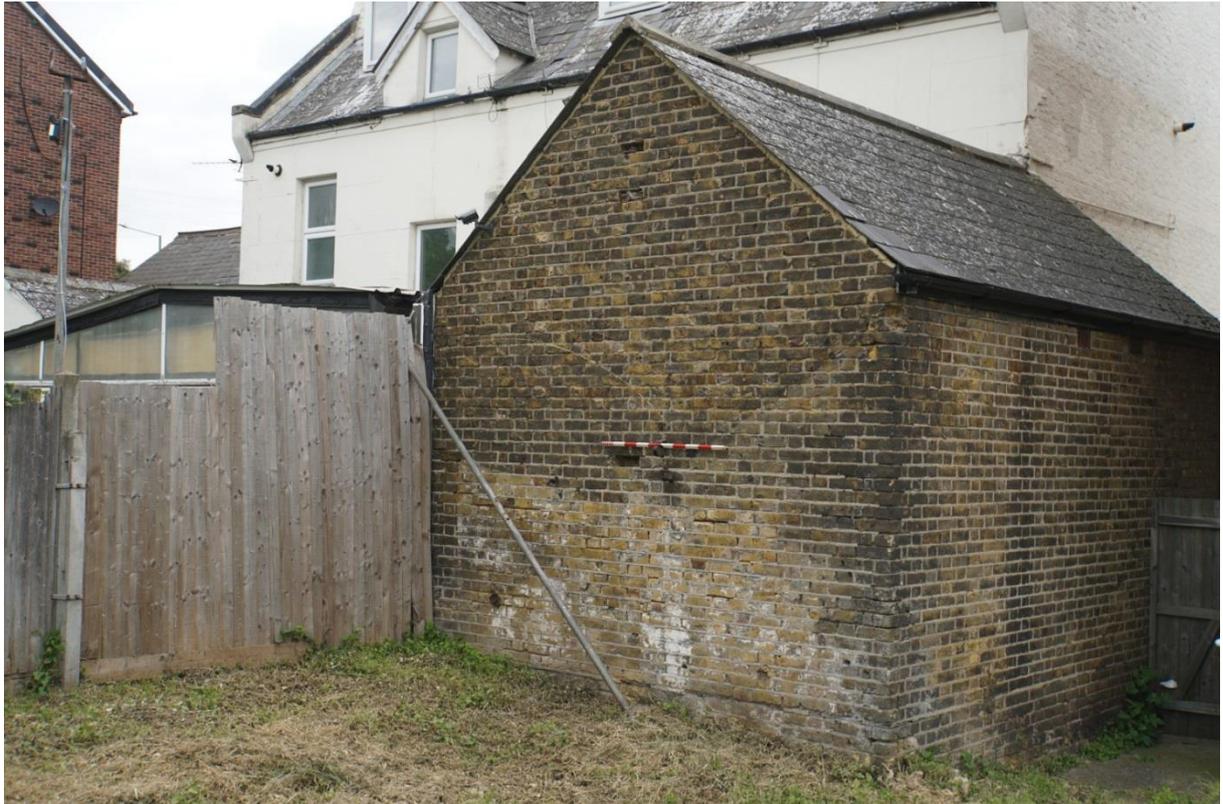
Plate 16

6.4 East façade – left side (Plate 13 and 16)

- 6.4.1 It comprises elevation of the main building A and single story extension block B and E. The elevation of the former is gable end chimney row which is brick built in Flemish bond and painted which is obscuring the brick pattern. The wall features an imprint of the gable end of a former terrace cottages located to the east that had front elevation two metres to the back from the front elevation of the main building.
- 6.4.2 The elevation of the extension building B features unpainted brick wall in Flemish bond and side of a gable roof.

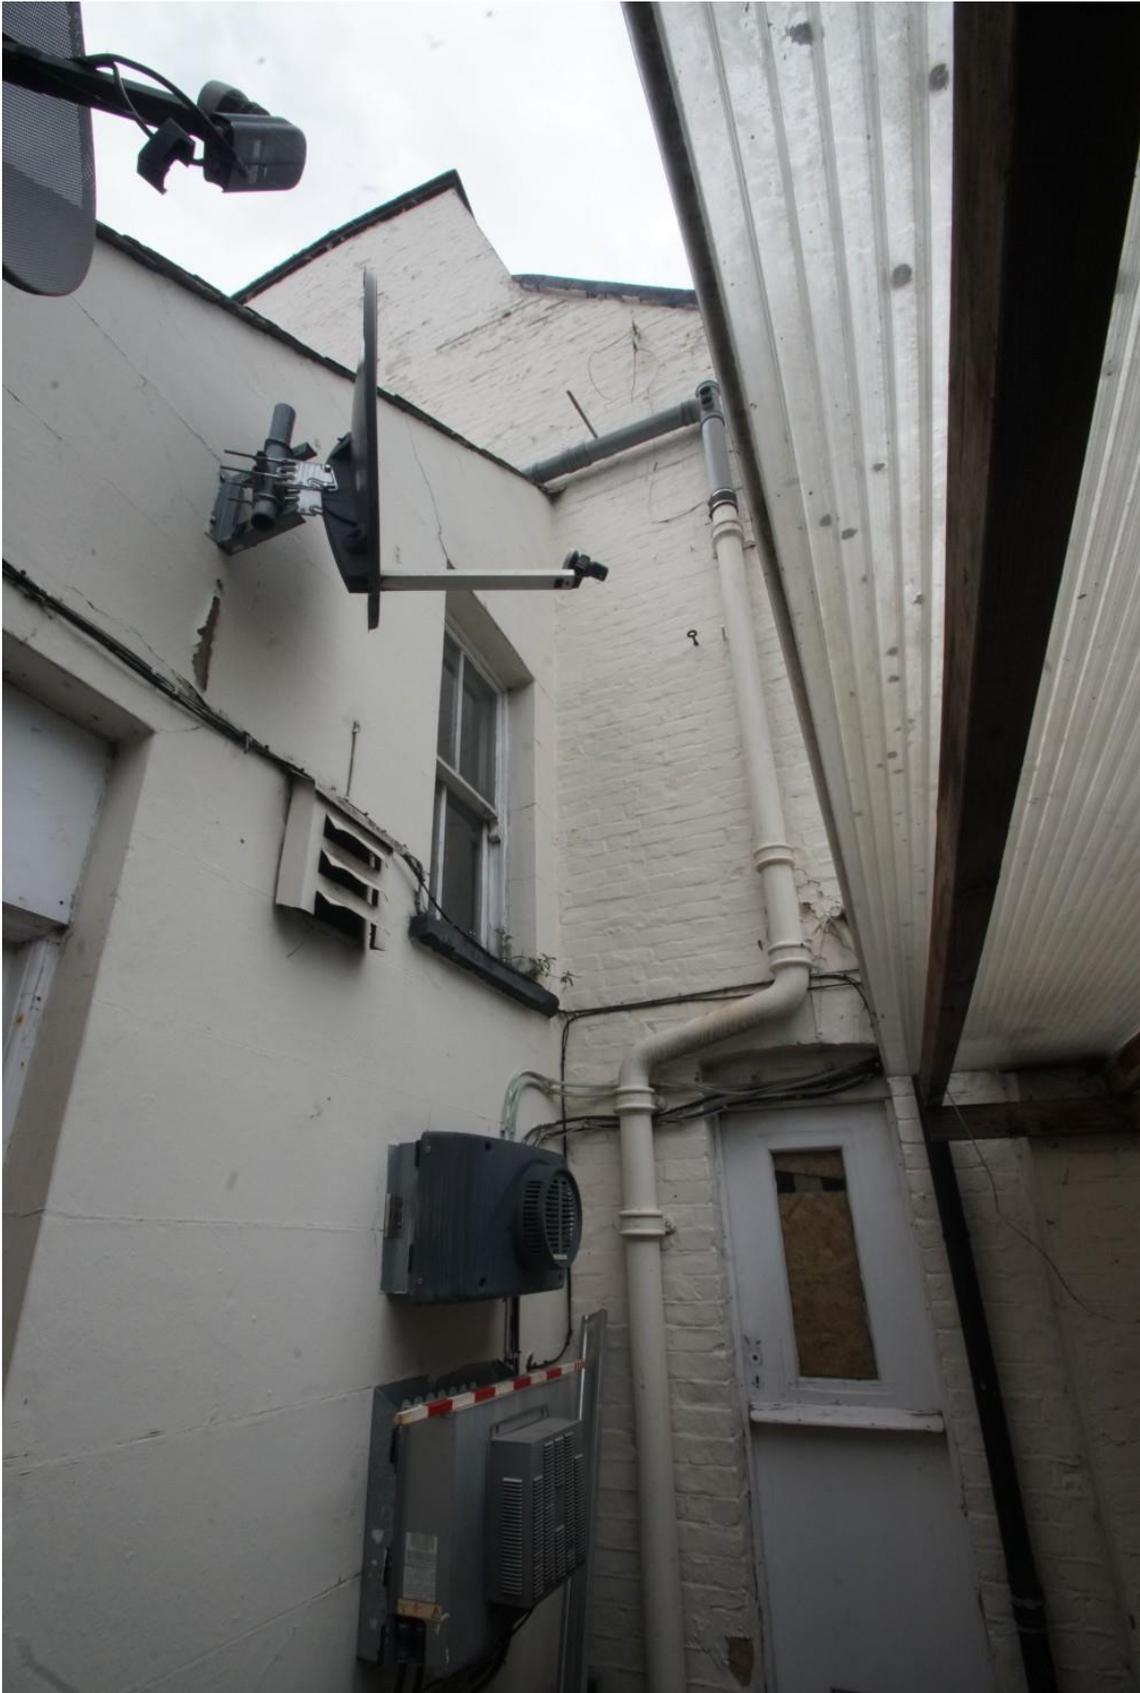
Plate 18

6.6 West façade – right side (*Plate 18, 19, 20, 21, 22, 23 and 24*)

- 6.6.1 It comprises elevation of the main building, extension block B and C. The elevation of the former, at the level of first floor, is obscured by gable roof of the extension B, other way it's the same as the east side elevation. It's built of brick in a Flemish bond and features gable end wall with a row of chimneys. The wall is painted white but one red brick is exposed in the middle of the wall, at the level of the top floor.
- 6.6.2 The elevation of the extension block B feature gable end and concrete render wall with lines imitating dressed stone pattern. The wall is built of brick that is visible in the loft area – room32.
- 6.6.3 The elevation of the block C features the same concrete render as previous extension and an eave of flat bitumen covered roof.

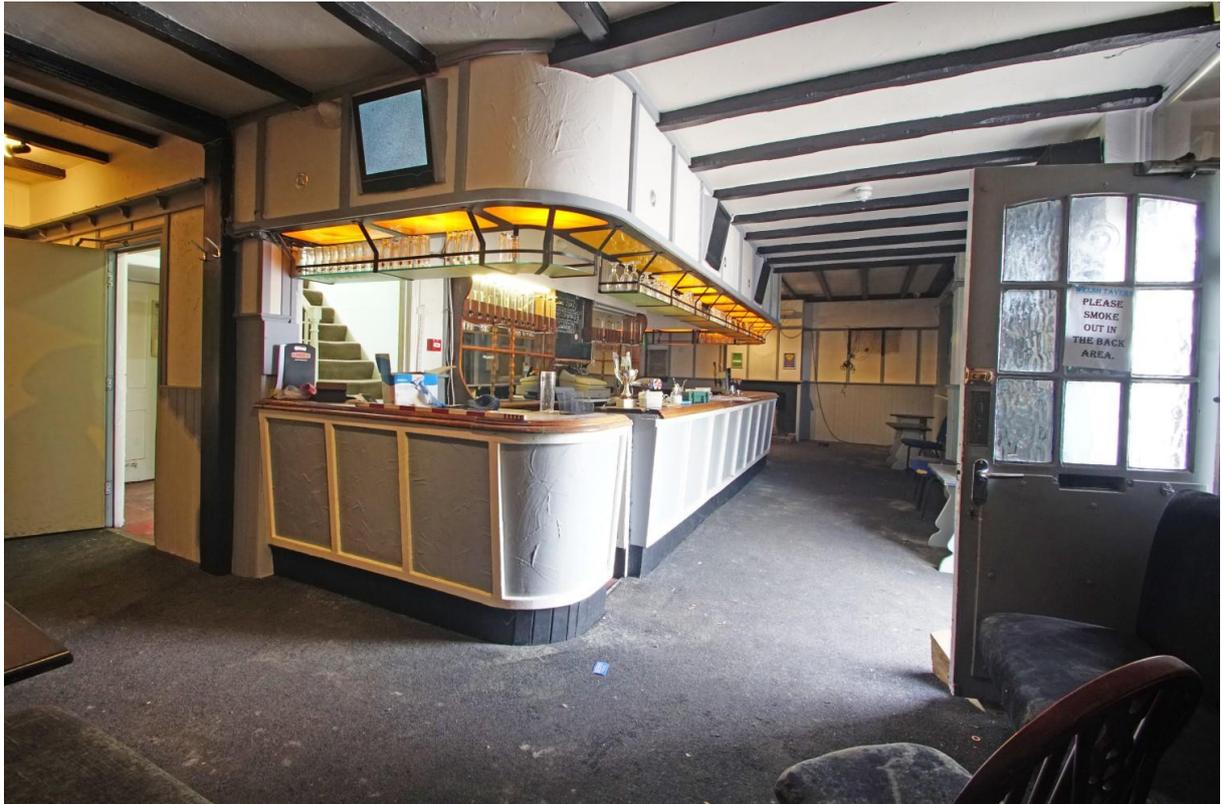
Plate 26

6.7 Room 1 – Bar Area of the main building A (*Plate 26, 27, 28, 30, 31, 32, 33, 34, and 35*)

- 6.7.1 This room is accessible from the London Road via two doorways evenly spaced between three windows. It's about U shape in plan wrapped around the bar and rooms behind it. The room is 12 metres long and 4.25metres wide. East end of the room is 7.53 metres wide and west end is 6.25metres wide. The bar counter is located in a central area with room 3 and 4 in the back separated by the walls concealing bearing structural elements.

- 6.7.2 Floor is covered with dark brown carpet throughout the room. The walls feature vertical plank boards panelling at lower half and plastered upper half comprising single vertical topped with horizontal plank board imitating elements of the frame construction. All the wood elements of the walls and bar counter are painted mid bluish grey. The ceiling features black painted wood beams mostly of decorative function.

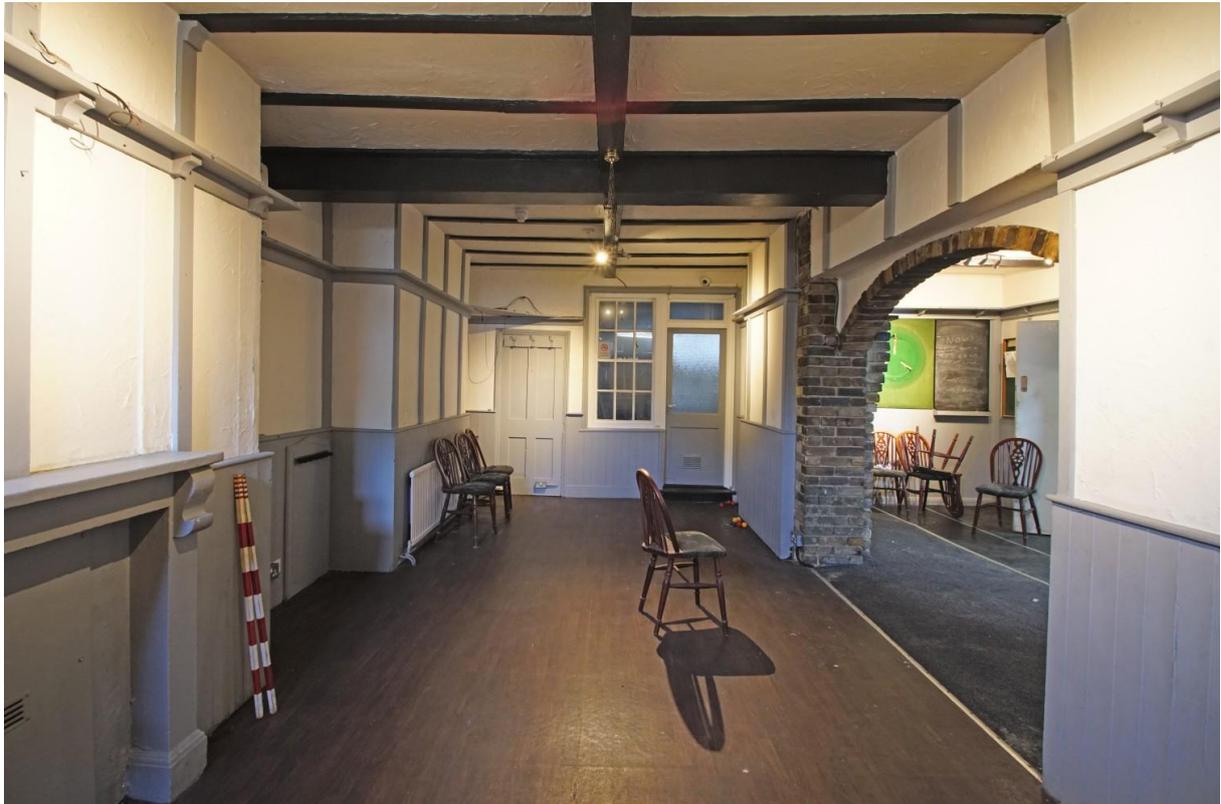
Plate 29

6.8 Room 2 – Games room of the main building A (Plate 29)

- 6.8.1 The room is rectangular in plan measuring 7.46 metres long and 3.53 metres wide.
- 6.8.2 Floor is covered with brown vinyl panels throughout the room imitating wooden floor. The walls similarly as in room 1 feature vertical plank boards panelling at lower half and plastered upper half comprising single vertical topped with horizontal plank board imitating elements of the frame construction. All the wood elements of the walls are painted mid bluish grey. The ceiling features black painted wood beams mostly of decorative function, however one large beam span between the east and west wall of the room is very likely a structural element and it seems to support smaller perpendicularly aligned beam span between northern and southern walls.

- 6.8.3 Western wall features wide arched opening with brick sill in the centre leading to the room 1. The wall is plastered and planked as previously described

- 6.8.4 Northern wall features large window covering all upper half of the wall with three times 9 pane divisions.
- 6.8.5 Eastern wall comprises two blocked fireplaces located in the middle of each of the half of the wall.

- 6.8.6 Southern wall features blocked doorway on the left, 12 pane side window on the middle right with the doors with transom on the right. The blocked doorway on the left leads to the room 7 while the other doorway leads to room 6.

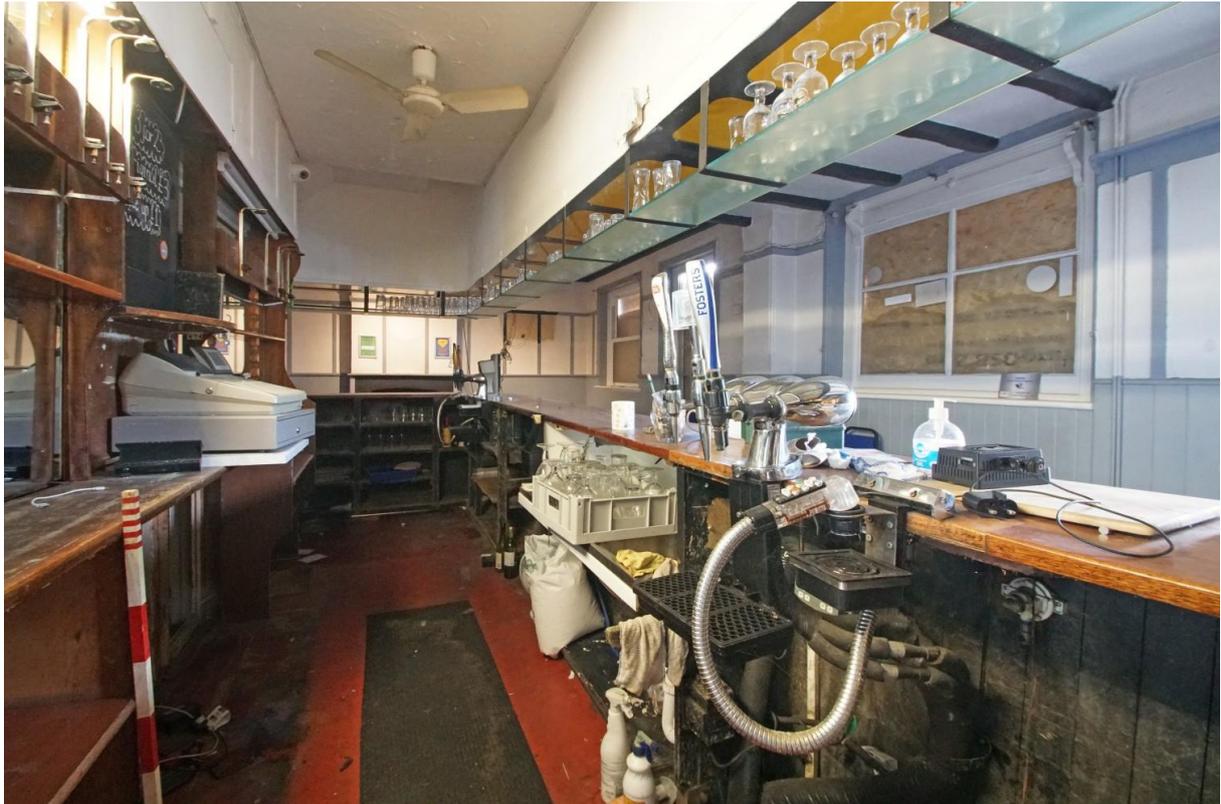
Plate 30

- 6.7.5 The eastern wall is built of brick in stretcher pattern. It comprise wide arched doorway in the middle leading to the room 2, arched fireplace on the left followed by blocked arched door opening, now niche in the north east corner of the room. On the right side there are two niches, one circular and the other rectangular and arched. Overhead a large beam spans between the brick wall and plinth which is wood post included within the wall behind the bar.
- 6.7.6 Southern wall within east part of the room feature no openings while within western part there is a window and doorway in the south west corner of the room leading to the room 12. The western wall behind the bar in eastern part of the room comprise doorway to the room 3.

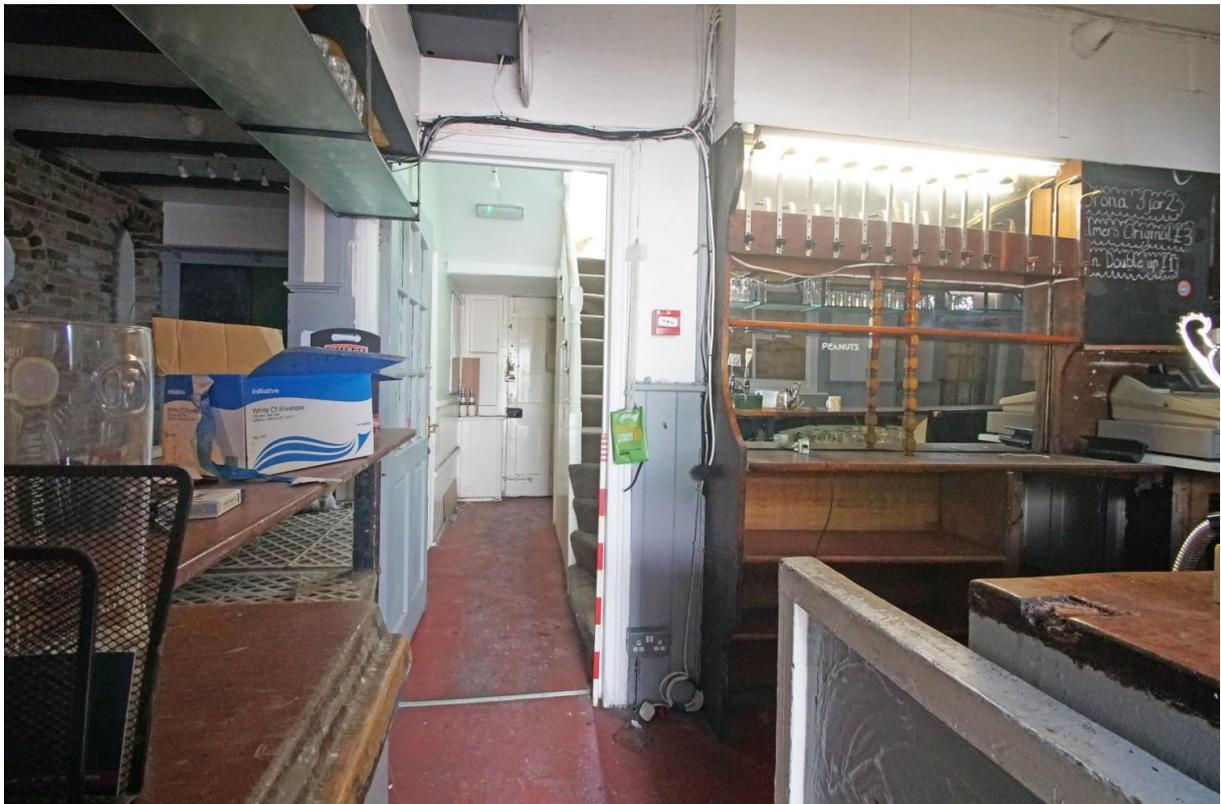
Plate 31

6.9 Room 3 – Staircase of the main building A (Plate 31 and 52)

- 6.9.1 Room comprises a narrow corridor and a half turn layout stairs leading to upper floor. Overall it's rectangular in plan measuring 3.13metres in length and 1.9metres in width.
- 6.9.2 Floor is covered with brown carpet, walls in lower half are rendered with white vertical plank boards panelling and wallpaper elsewhere.
- 6.9.3 The room is accessible from room 1 via doorway located on the eastern wall of the room, opposite the doorway there is a stairs leading to the upper floor, on the north side wall there is a doorway leading behind the bar counter. On the southern wall there is a doorway with side window and transom. This doorway leads to room 6. In the south west corner of the room there is doorway on the western wall leading to the

room 4 and doorway to the basement. Both located underneath the landing of the stairs leading to the upper floors.

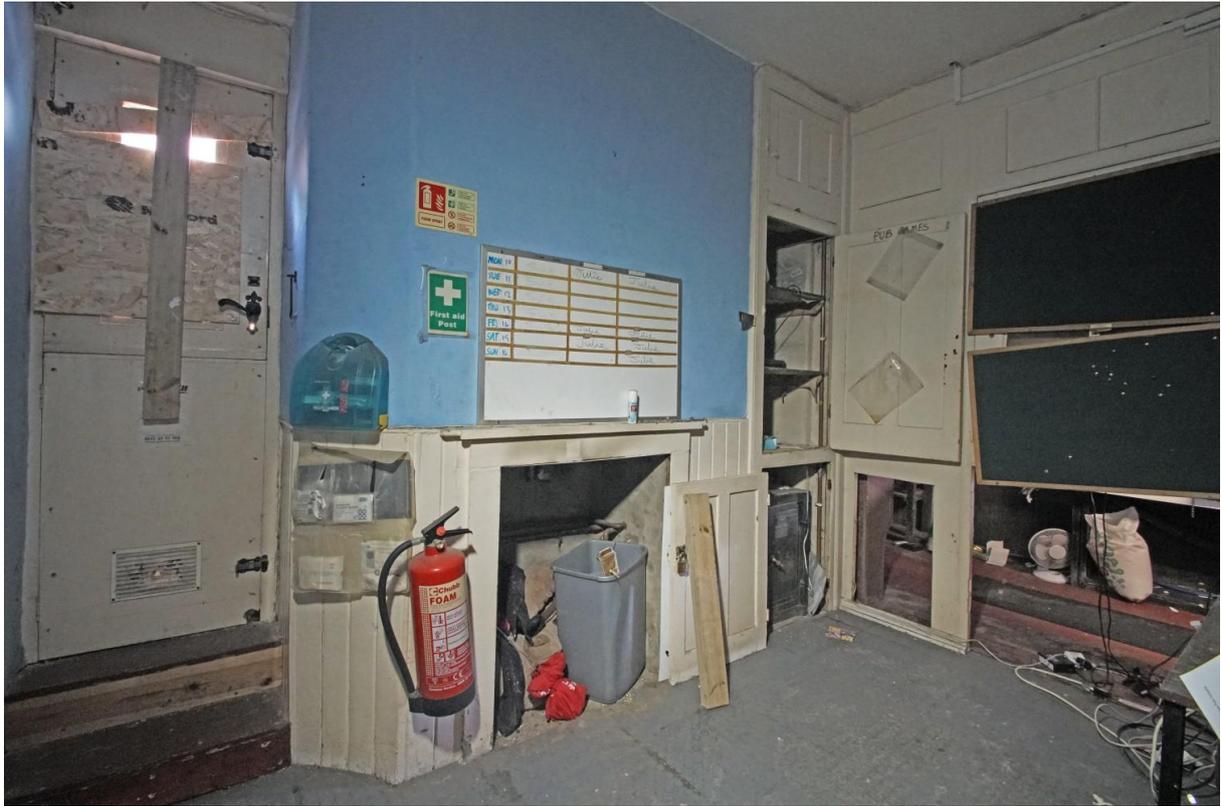
Plate 36

6.10 Room 4 – Office of the main building A (Plate 36 and 37)

- 6.10.1 Rectangular room measures 3.13 metres in length and 2 metres in width. The floor features rubber panels.
- 6.10.2 Western wall features doorway located in the south west corner of the room leading to the room 18. In the middle of the wall there is a fireplace and on its right side there is a storage compartments with service pipes. The lower half of the wall is rendered with cream coloured horizontal planking board panelling whilst upper part features painted blue wallpaper.

- 6.10.3 Northern wall features wooden frame covered with wood panels, some of them were originally openable allowing access to the area behind the bar counter.

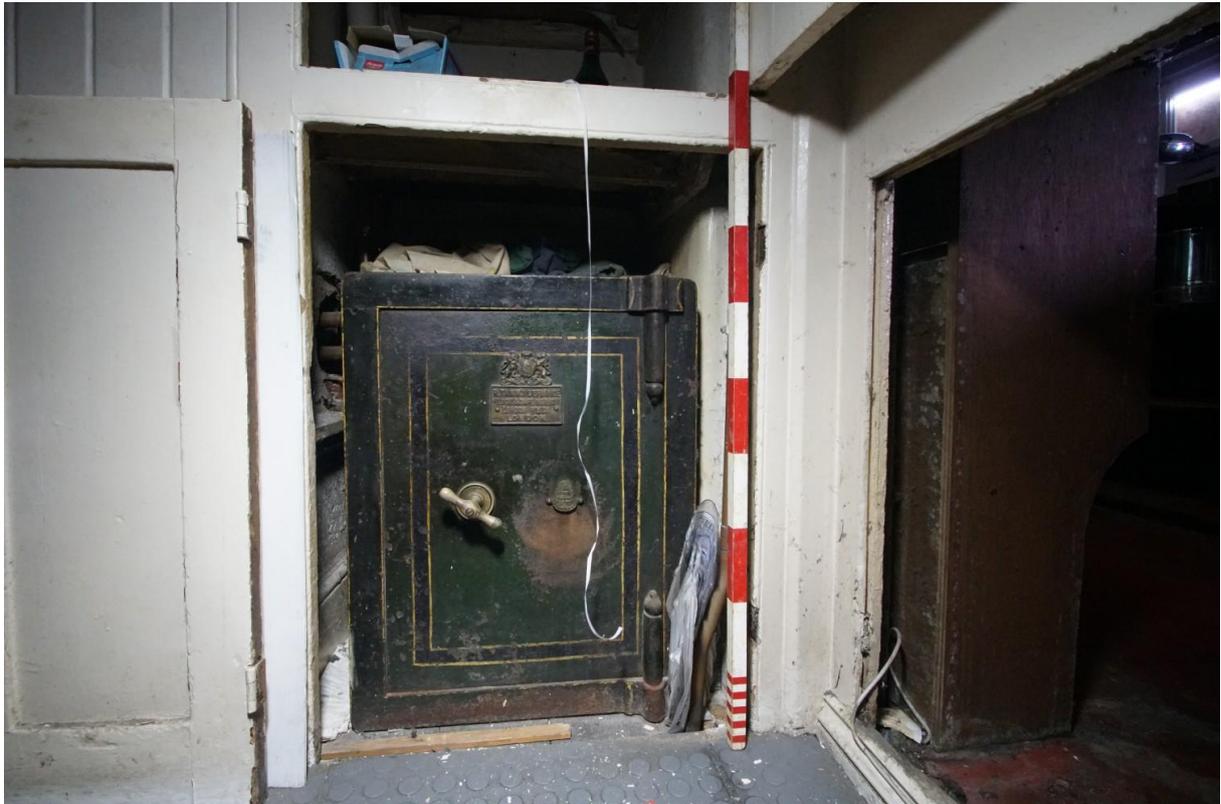
Plate 37

- 6.10.4 Eastern wall features doorway on the right, leading to the room 3. The lower half of the wall is rendered with cream coloured horizontal planking board panelling whilst upper part features painted blue wallpaper.

- 6.10.5 Southern wall features doorway in the middle, leading to the room 5. The wall render is the same as eastern wall.

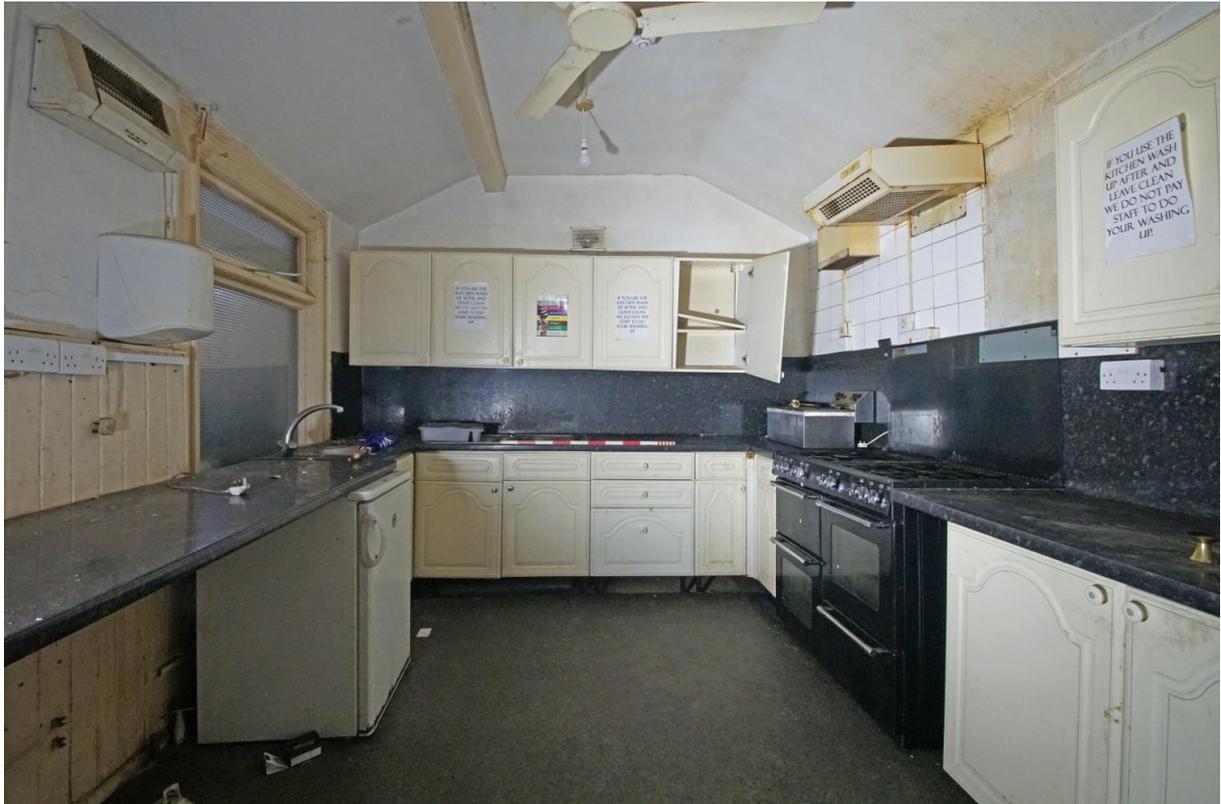
Plate 38

6.11 Room 5 – Kitchen, extension block F (Plate 38 and 39)

- 6.11.1 Rectangular room measures 4.4 metres in length and 2.94 metres in width. The floor is covered with dark vinyl. Walls are obscured by modern kitchen appliances and cupboards. Eastern wall features creamy panelling, the same was present in room 3. The room defines the extent of the extension building abutted to the south west corner of the main building. All structural elements are obscured by render. Outside on the western wall of this building block a painted bricks have Flemish bond. Based on historic maps, this building appears to be built in 20th C.

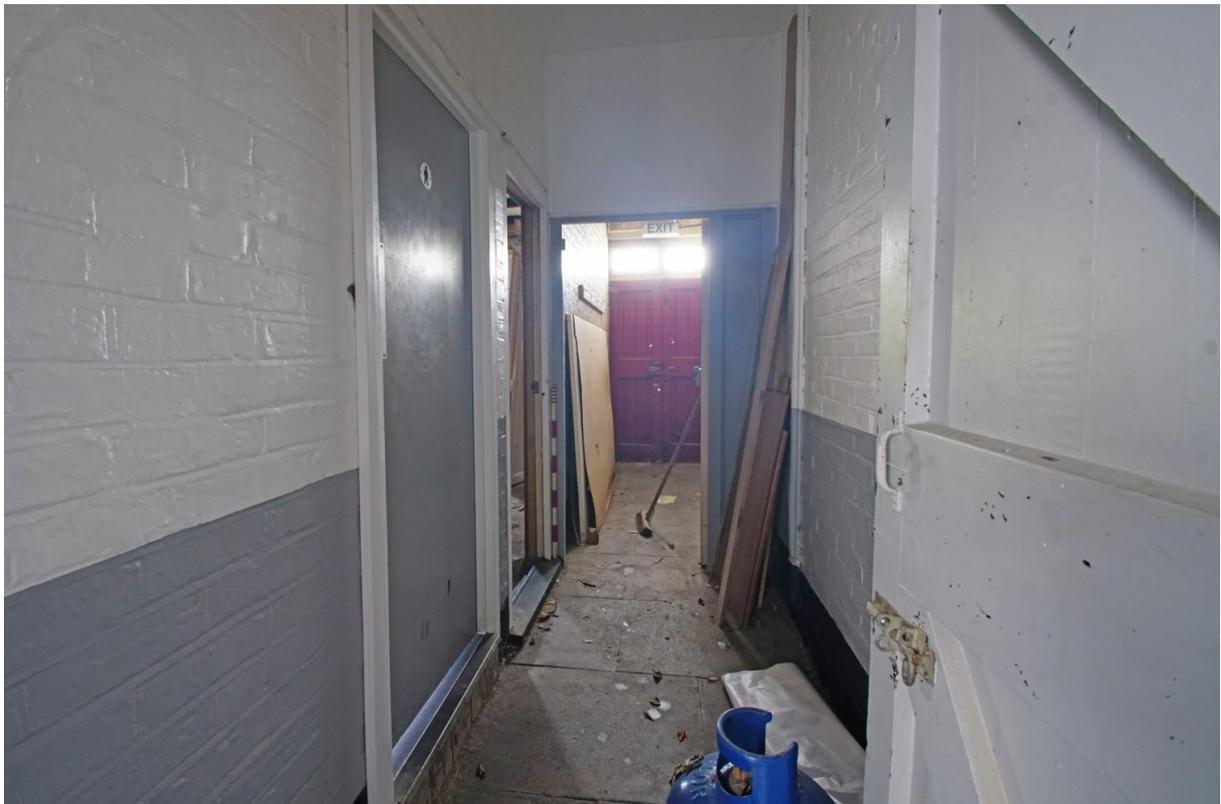
Plate 43

6.14 Room 9 – Corridor of extension block B (Plate 43)

6.14.1 It measures 6.4 metres by 1.18 metres and is divided by a doorway in the middle. The east wall of the room features rear of the brick chimney in the middle and the rest of the wall are plain and most likely built of wood and rendered with concrete. At the north end of the room there is a doorway leading to the street. Western wall is built of brick in stretcher bond and contains two doorways leading to the room 10 and 11. All walls are painted grey at lower 0.9 metres height and white above, whilst the doors are grey with white sill except for a northern door that is of cherry colour.

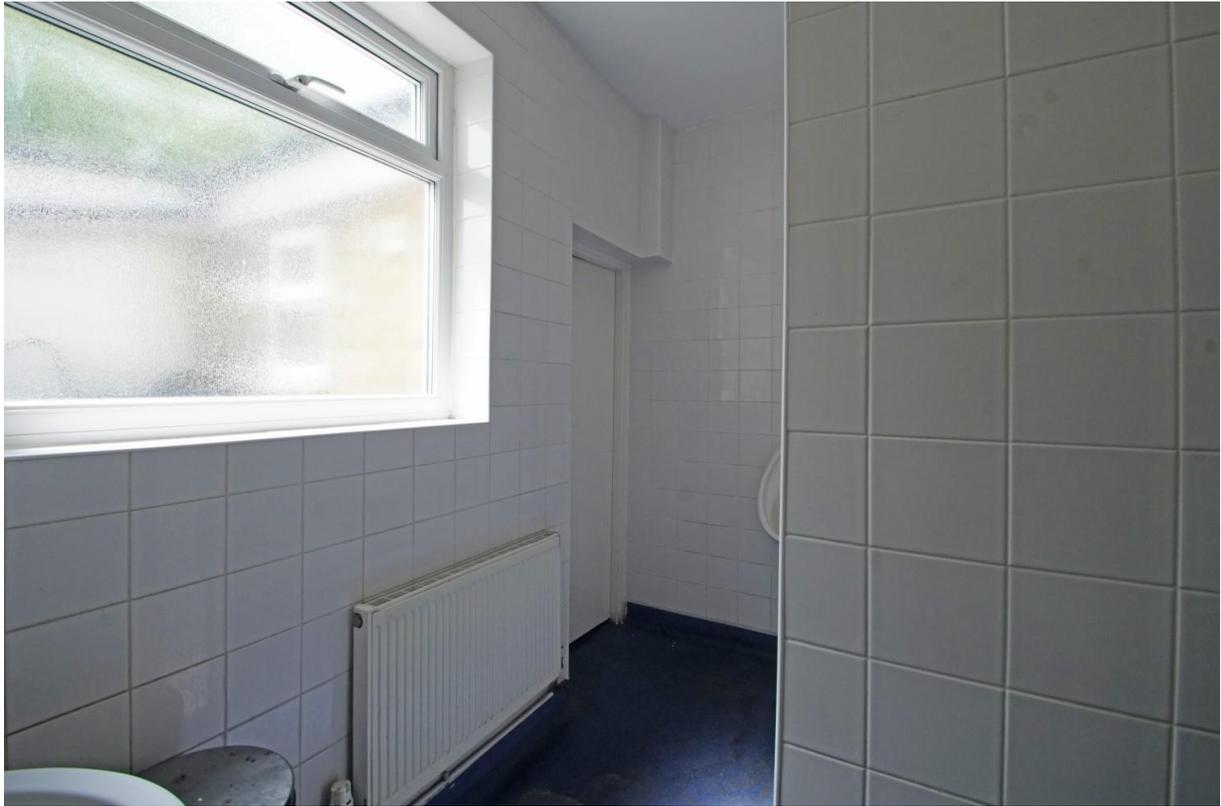
Plate 44

6.16 Room 11 – WC of extension block B (Plate 44)

6.16.1 Rectangular room measures 2.9 metres by 1.86 metres with internal walls dividing it into smaller areas. All walls are covered with white ceramic tiles, floor is features dark vinyl and the ceiling is plain. On the southern wall there is a modern window with view to the small courtyard outside and a doorway on the right.

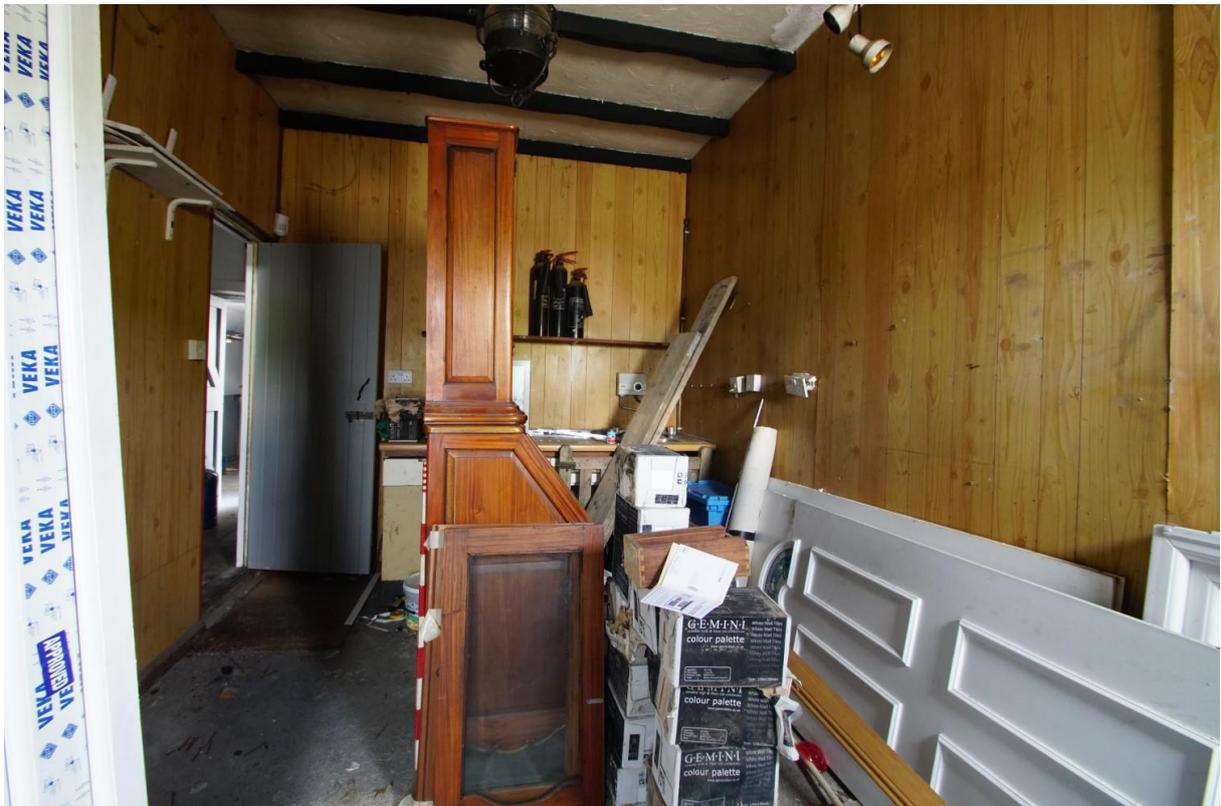
Plate 45

6.15 Room 10 – Storage room of extension block B (Plate 45 and 4 6)

6.15.1 Rectangular room measures 4.2 metres by 2.9 metres. Entrance is located in the south east corner of the room. Walls are rendered with vertical wooden boards, floor is covered with carpet and the ceiling is rendered with plaster and features mock black joists. The structural joists are visible in above room 32. The northern wall features large rectangular opening filled with PCV panel door and windows. There is an old lamp hanging from the ceiling in the middle of the room.

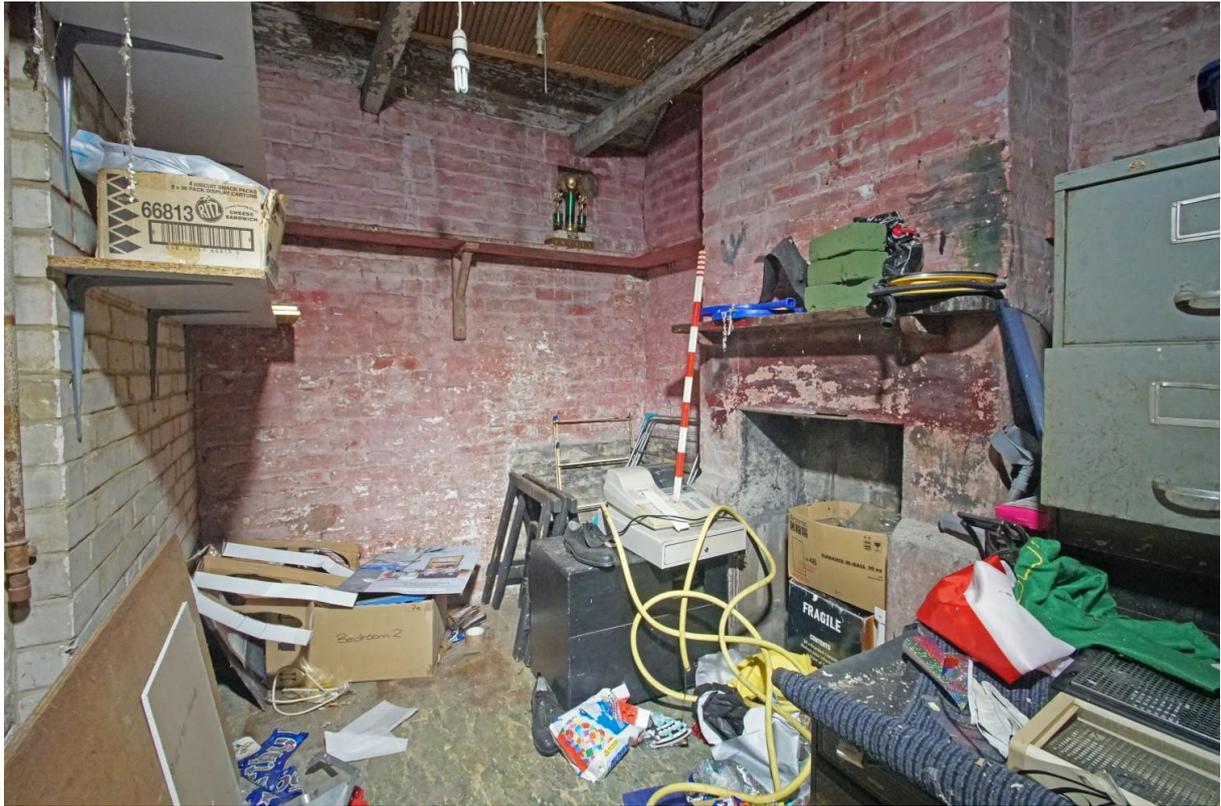
Plate 48

6.13 Room 7 and 8 – Storage rooms of extension block H (Plate 48, 49 and 50)

6.13.1 Both rooms measures 3.75 meters by 2.4 metres and are separated by a wall that divides extension building into two rooms. The wall, built of brick in stretcher bond contains a fireplace for each room and the chimney that doesn't protrude through the roof anymore. The brickwork was red washed masking the real colour of the bricks.

6.13.2 The northern wall of the room seven contain modern brick wall, half brick wide that is abutted to the face of the wall of the main building. The ceiling is made of plank board attached to common rafters of the roof. There is an installation of pipes that were providing a gas for lighting. One of the vertical pipes hangs down overhead in the middle of the room.
