HISTORIC BUILDING RECORDING OF WELSH TAVERN, 161 LONDON ROAD, STONE, KENT

Date of Report: 12th June 2023

Site Code: WTS-BR-23

SWAT ARCHAEOLOGY

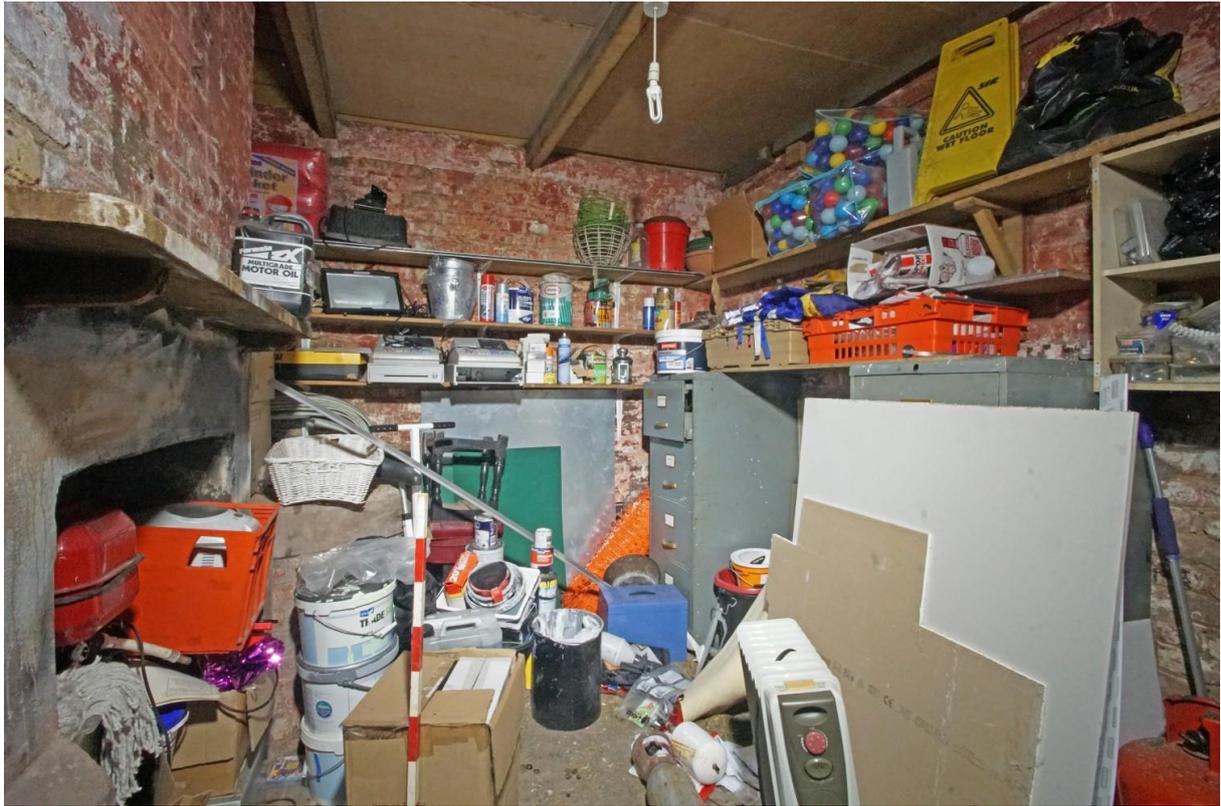
Plate 50

6.13 Room 7 and 8 – Storage rooms of extension block H (Plate 48, 49 and 50)

6.13.3 The room 8 have flat ceiling made of boards attached to the joist beams.
