Archaeological Desk-Based Assessment
in Advance of the Proposed
Development of Land at Rear of
No.62 Burgate, Canterbury, Kent

May 2023

National Grid Reference TR 15165 57711

Report for Clague Architects

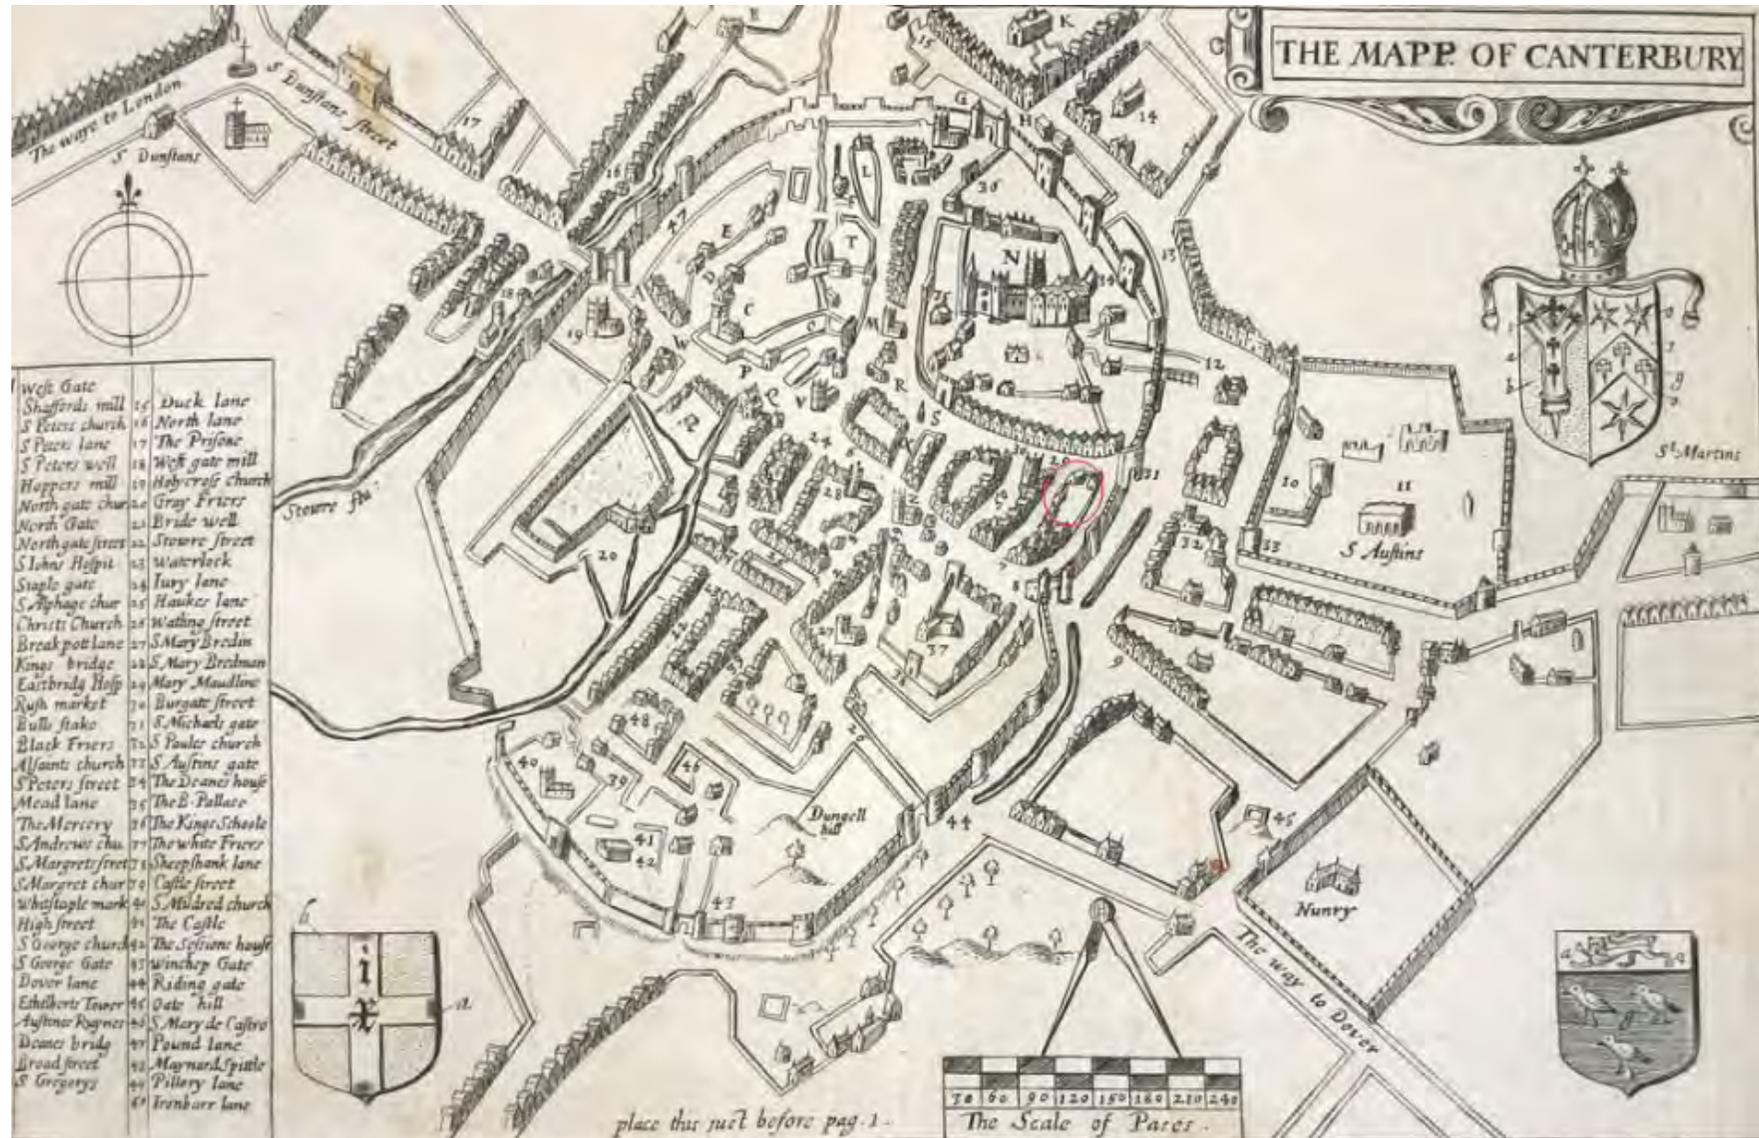
Figure 3: 1640 Reprinted Speed Map of 1611.

- 5.5.1 One of the earliest maps of Canterbury it represents the Medieval layout of the streets which exists today. The broad area of the PDA is depicted with a feature annotated number 7 to the south which is St George's Church. To the west further along Burgate is highlighted feature 29 being Mary Maudline Church. The area of the PDA is located in the central area in between houses suggesting it is not built on (Fig.3).

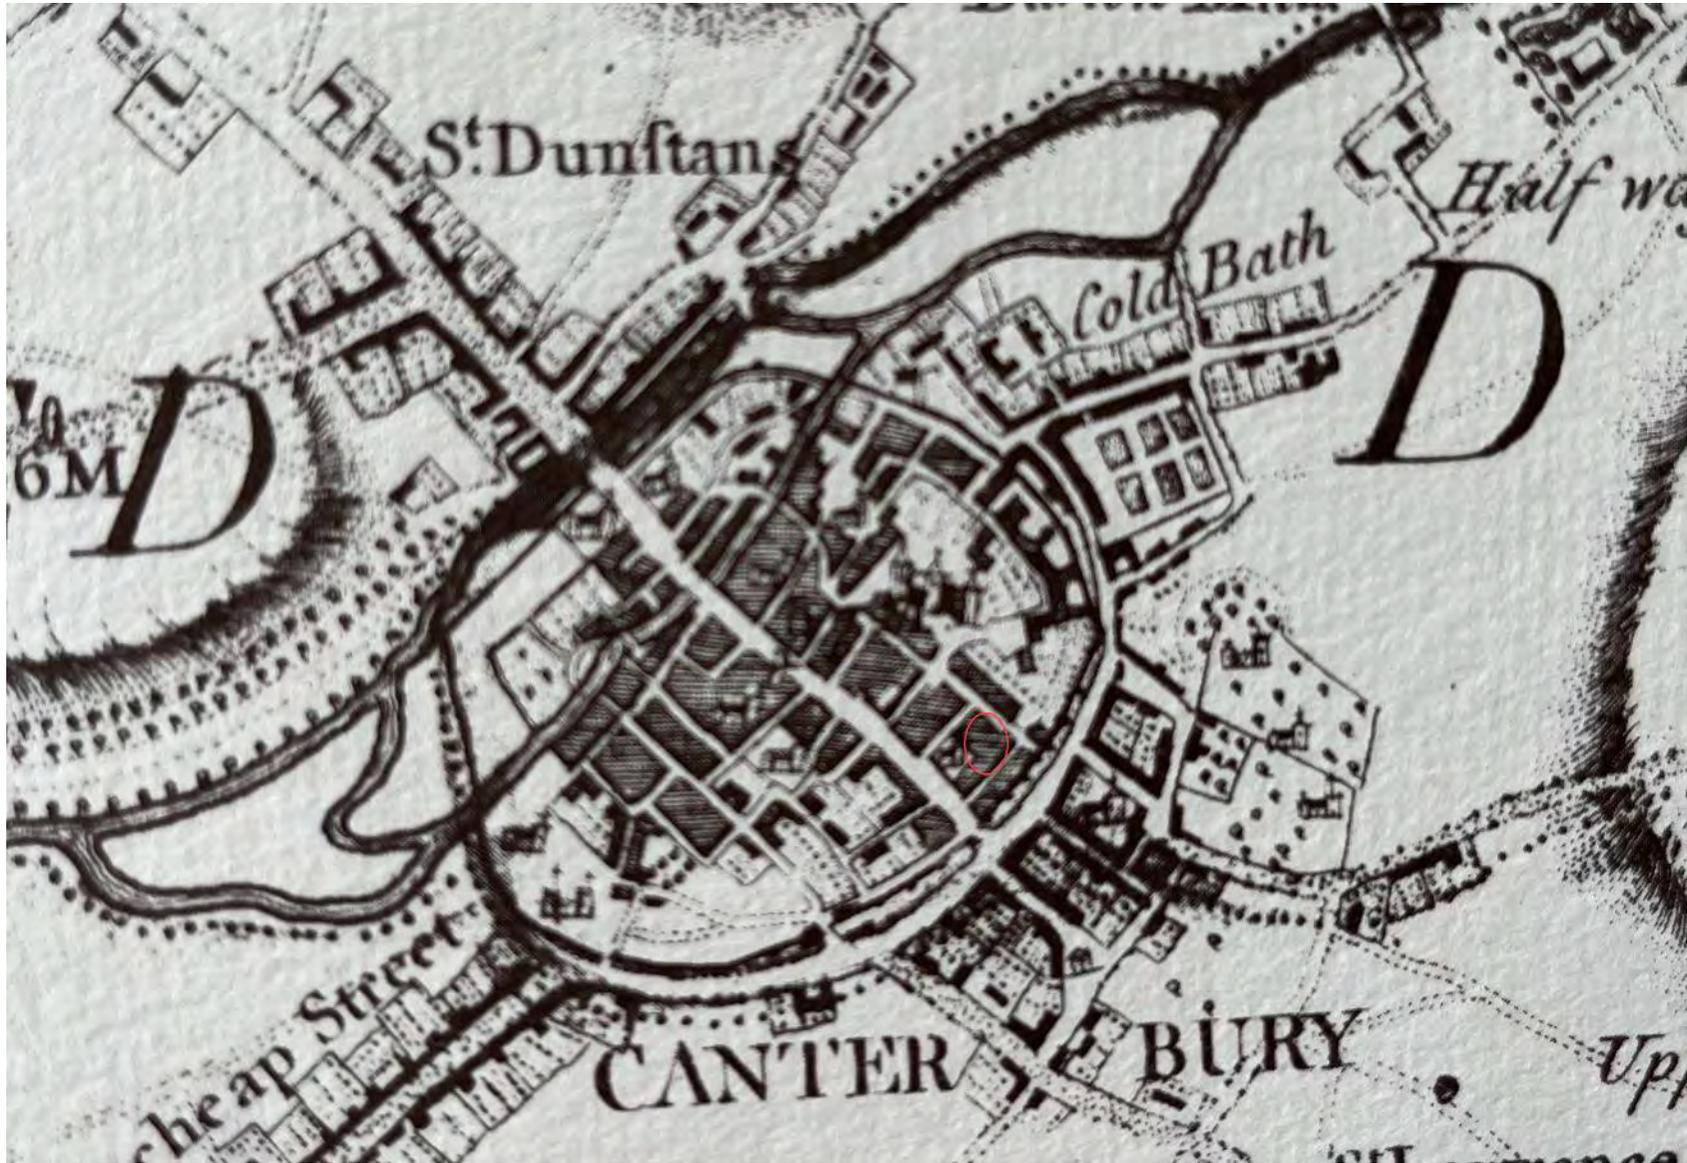
Figure 4: Andrew, Dury and Herbert Map from 1769

- 5.5.2 This is a more generalised map showing less detail than Speed's map. The area of the PDA shows St George's Church to the south and suggests that the block of houses on this part of Burgate is built up (Fig.4).

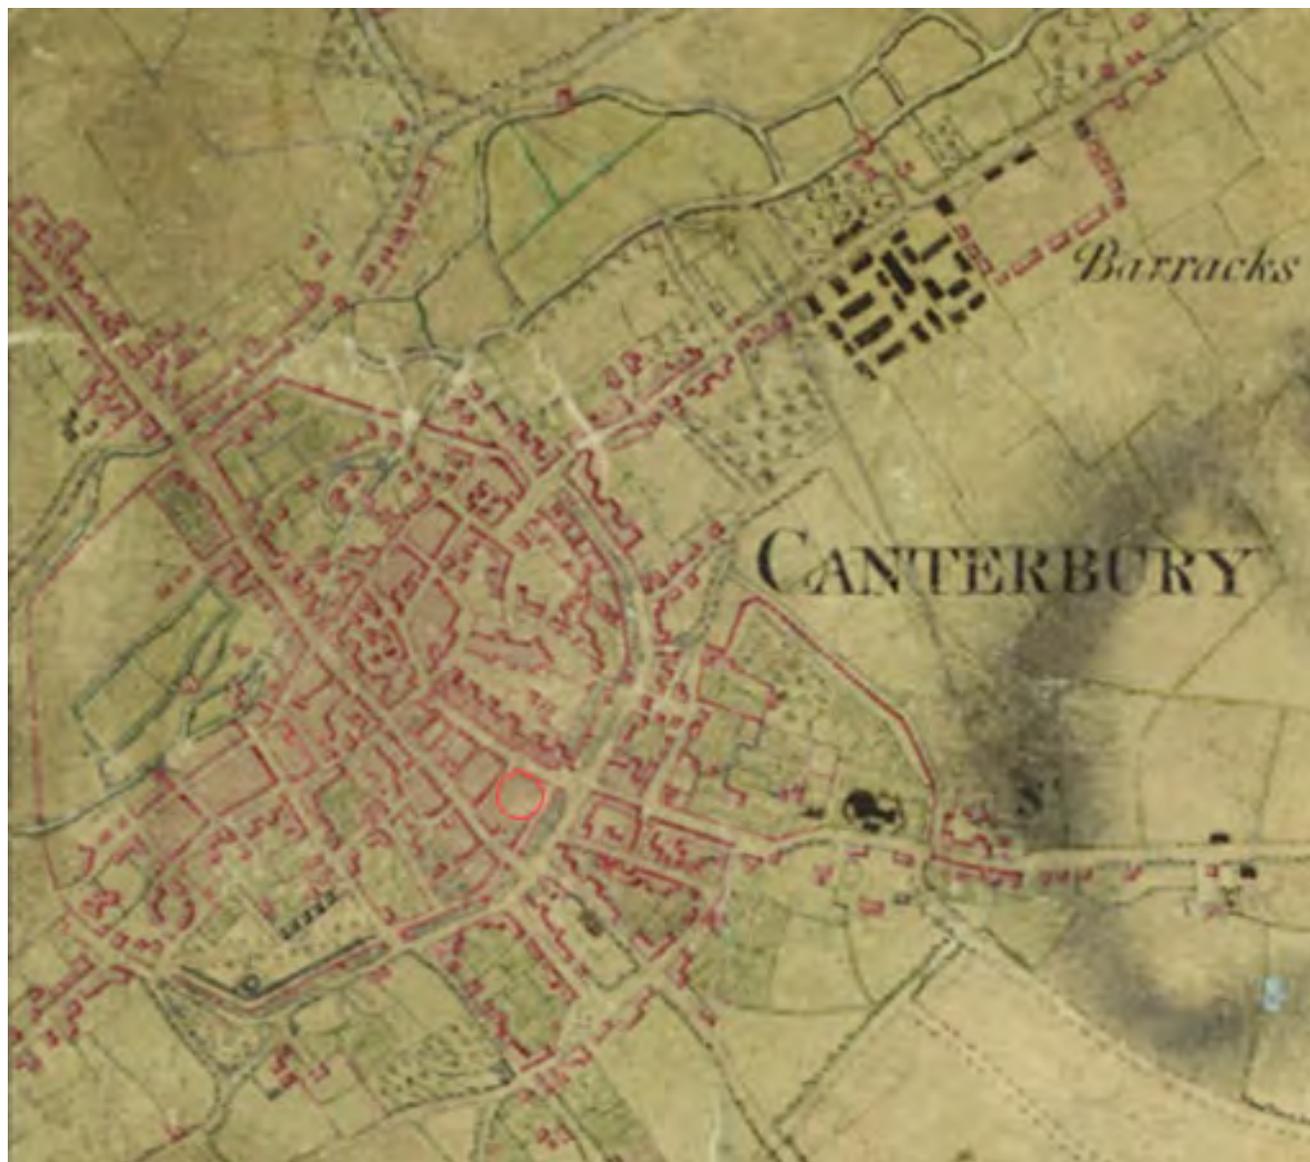
Figure 5: Ordnance Surveyors Drawing, 1797

- 5.5.3 This map again does not show details regarding individual houses nor does it highlight the churches. It suggests that this area of Burgate is urbanised (Fig.5).

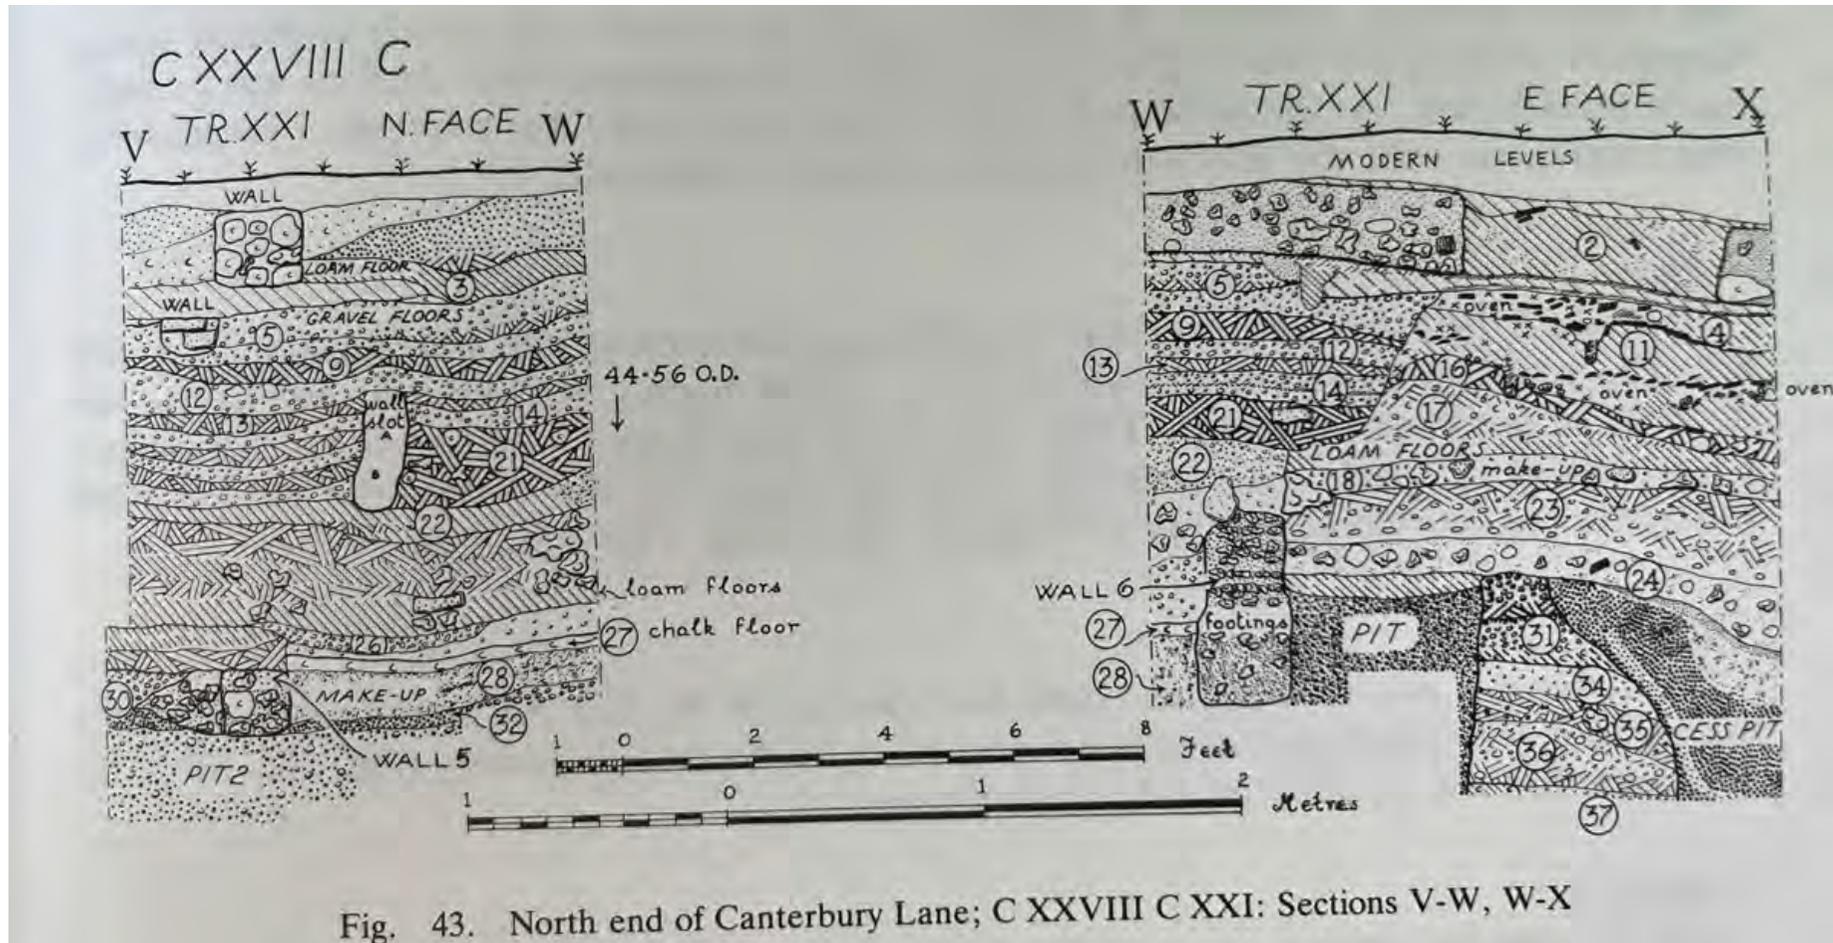
Figure 24: Sections of the area at the north end of Canterbury Lane (Frere)

Fig. 43. North end of Canterbury Lane; C XXVIII C XXI: Sections V-W, W-X

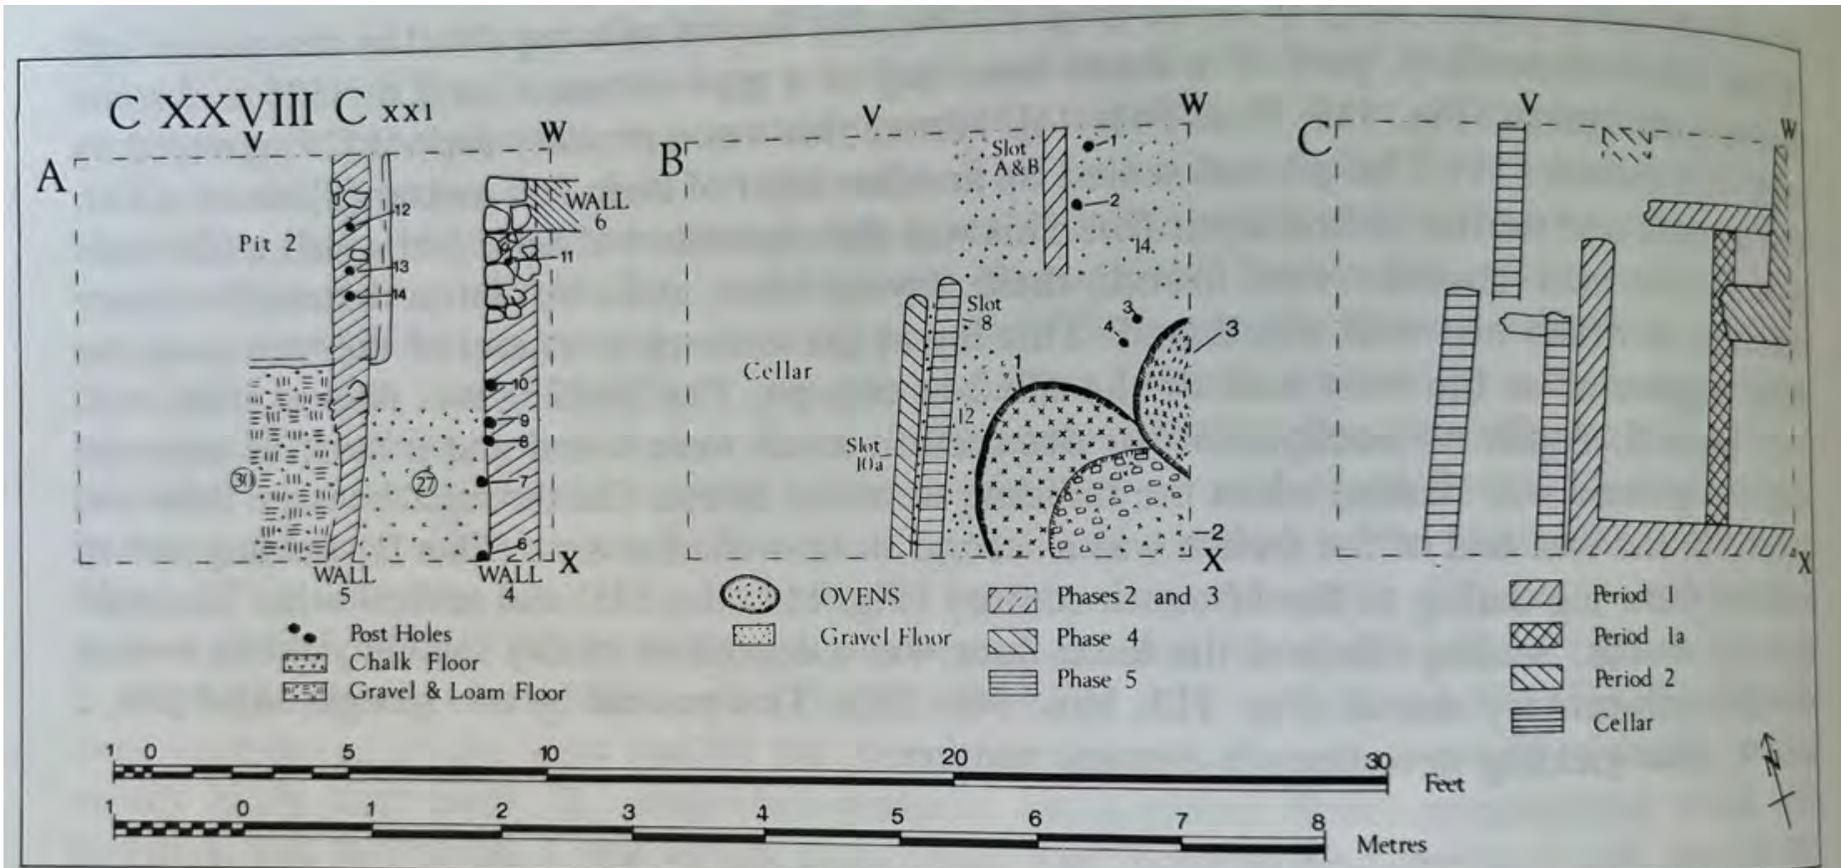
Figure 25: Plans of Post War Trenches at the north end of Canterbury Lane (Frere)

Fig. 42. North end of Canterbury Lane; C XXVIII C XXI: plans. A. Medieval Buildings 1-3. B. Medieval Building 4. C. Late and post-medieval Buildings

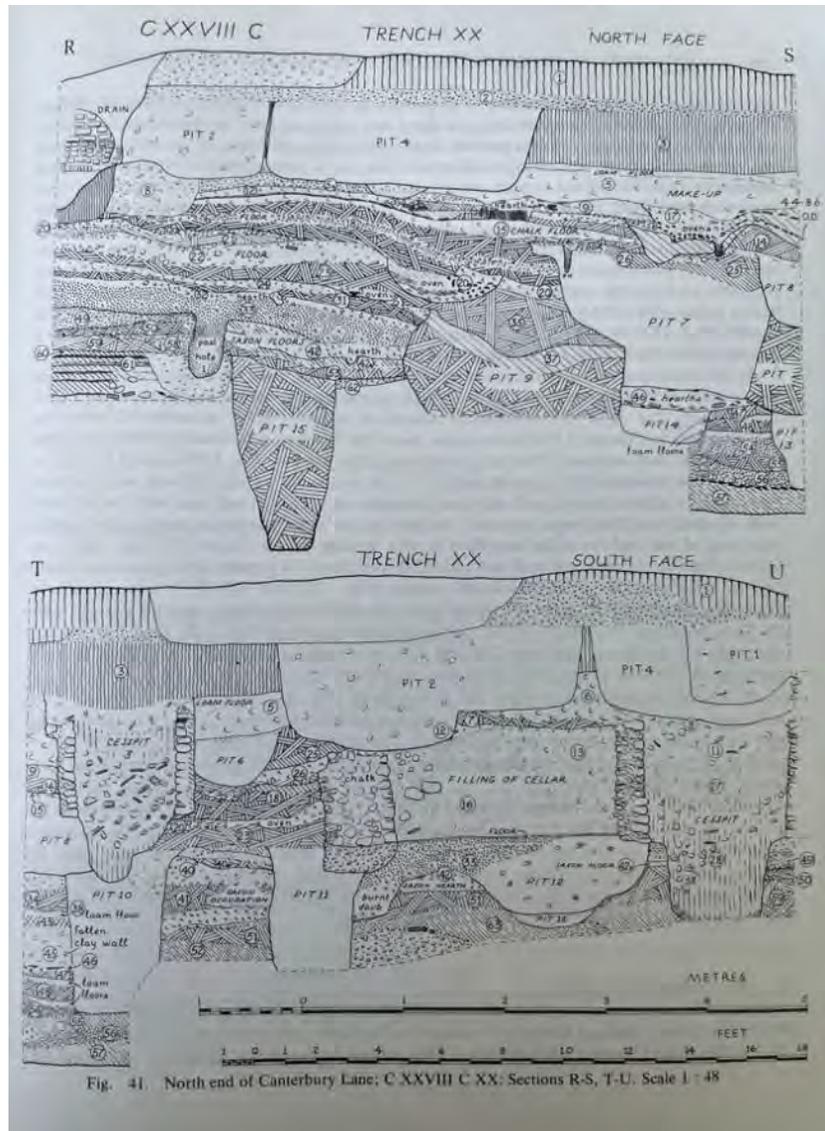
Figure 26: Post War Sections of trenches at the north end of Canterbury Lane (Frere)

Fig. 41. North end of Canterbury Lane: C XXVIII C XX: Sections R-S, T-U. Scale 1 : 48

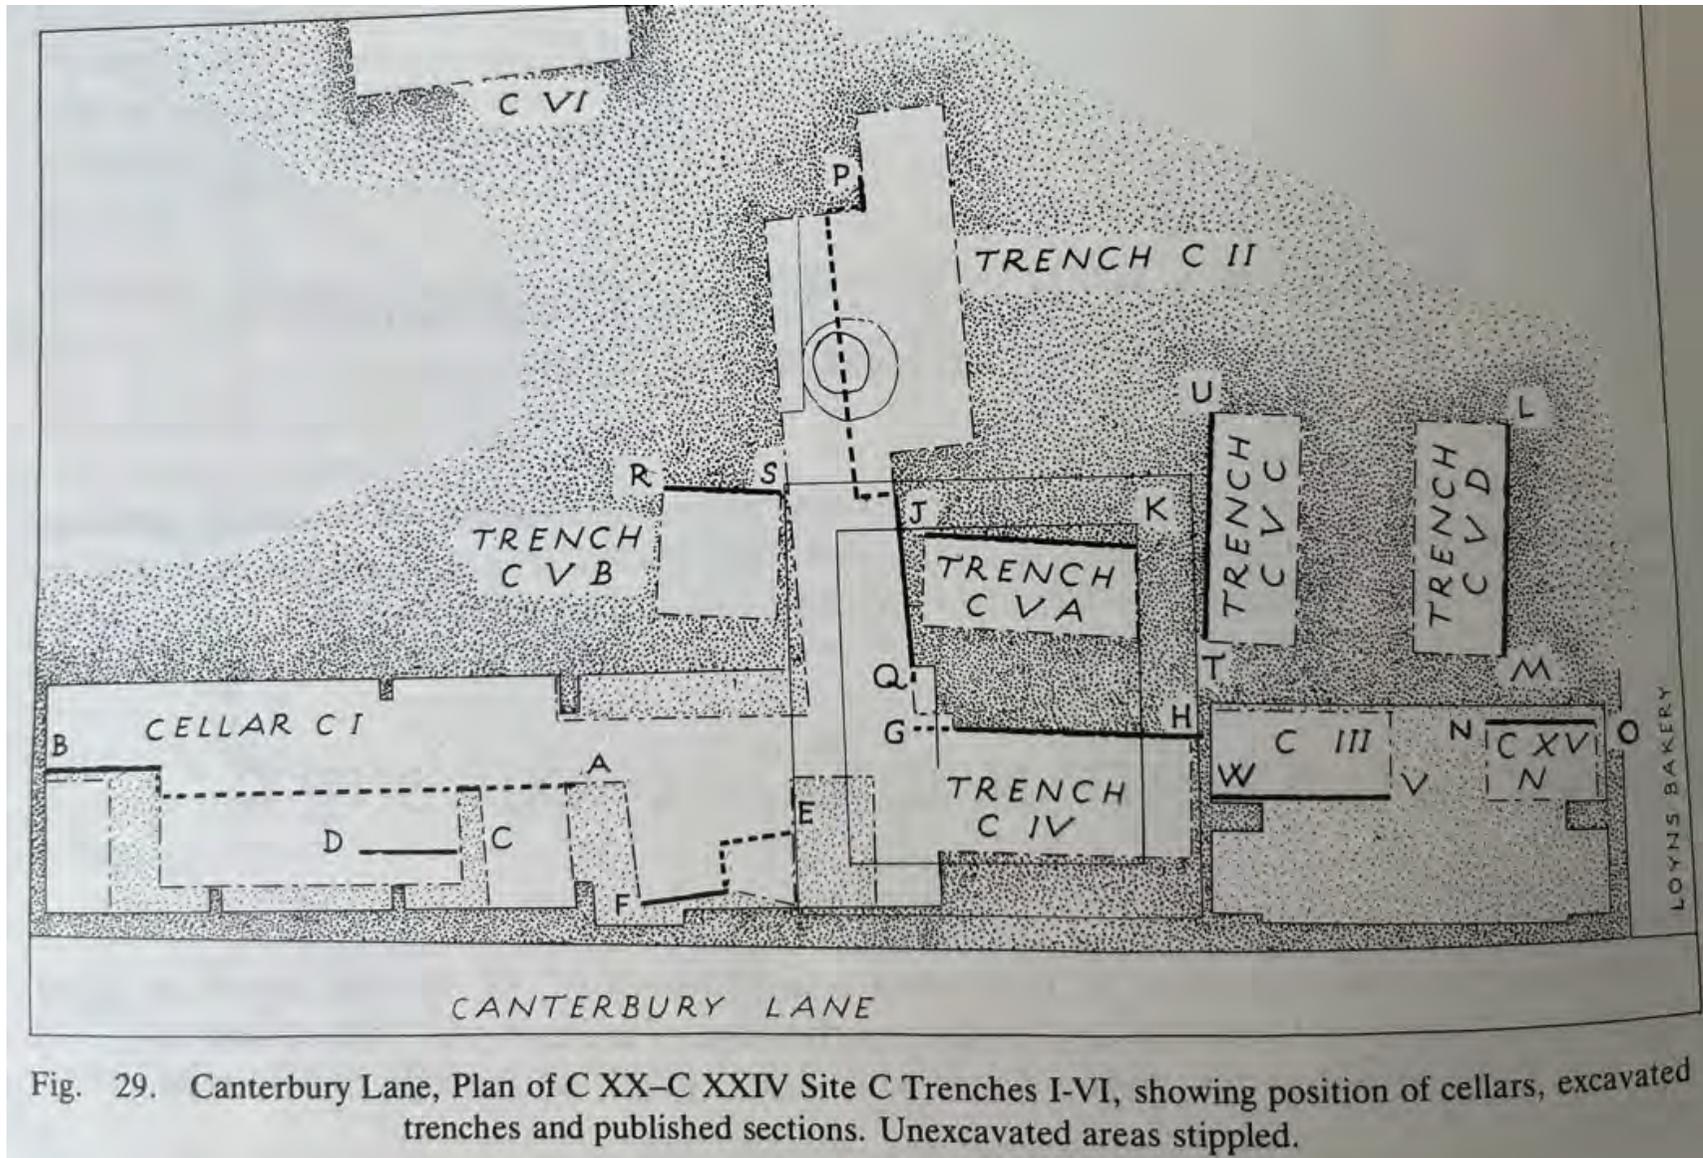
Figure 27: Trenches in Area C of the PDA. (Frere)

Fig. 29. Canterbury Lane, Plan of C XX-C XXIV Site C Trenches I-VI, showing position of cellars, excavated trenches and published sections. Unexcavated areas stippled.

- 5.3.11 In trench CXX, circa 14m north of the PDA, the Roman levels were not fully examined due to lack of time. Belgic pottery, occupation layers and Samian ware was found along with a Roman building probably belonging to the early 3rd century.

- 5.3.14 Trench CXXI, circa 28m north of the PDA was smaller and little detail about individual medieval buildings could be obtained, but it seems that the area was occupied continuously from the 12th century onwards. Roman levels were found in the southern part of the trench including a pit filling and an occupation layer. There was no sign of any Saxon occupation in this trench. However, it was interpreted that due to lower Medieval layers in this trench compared to trench CXX, it was possible that any Saxon evidence had been destroyed by Medieval occupation. Of the Medieval period, at least 4 different buildings were identified, of which building IV was identified as having several phases.

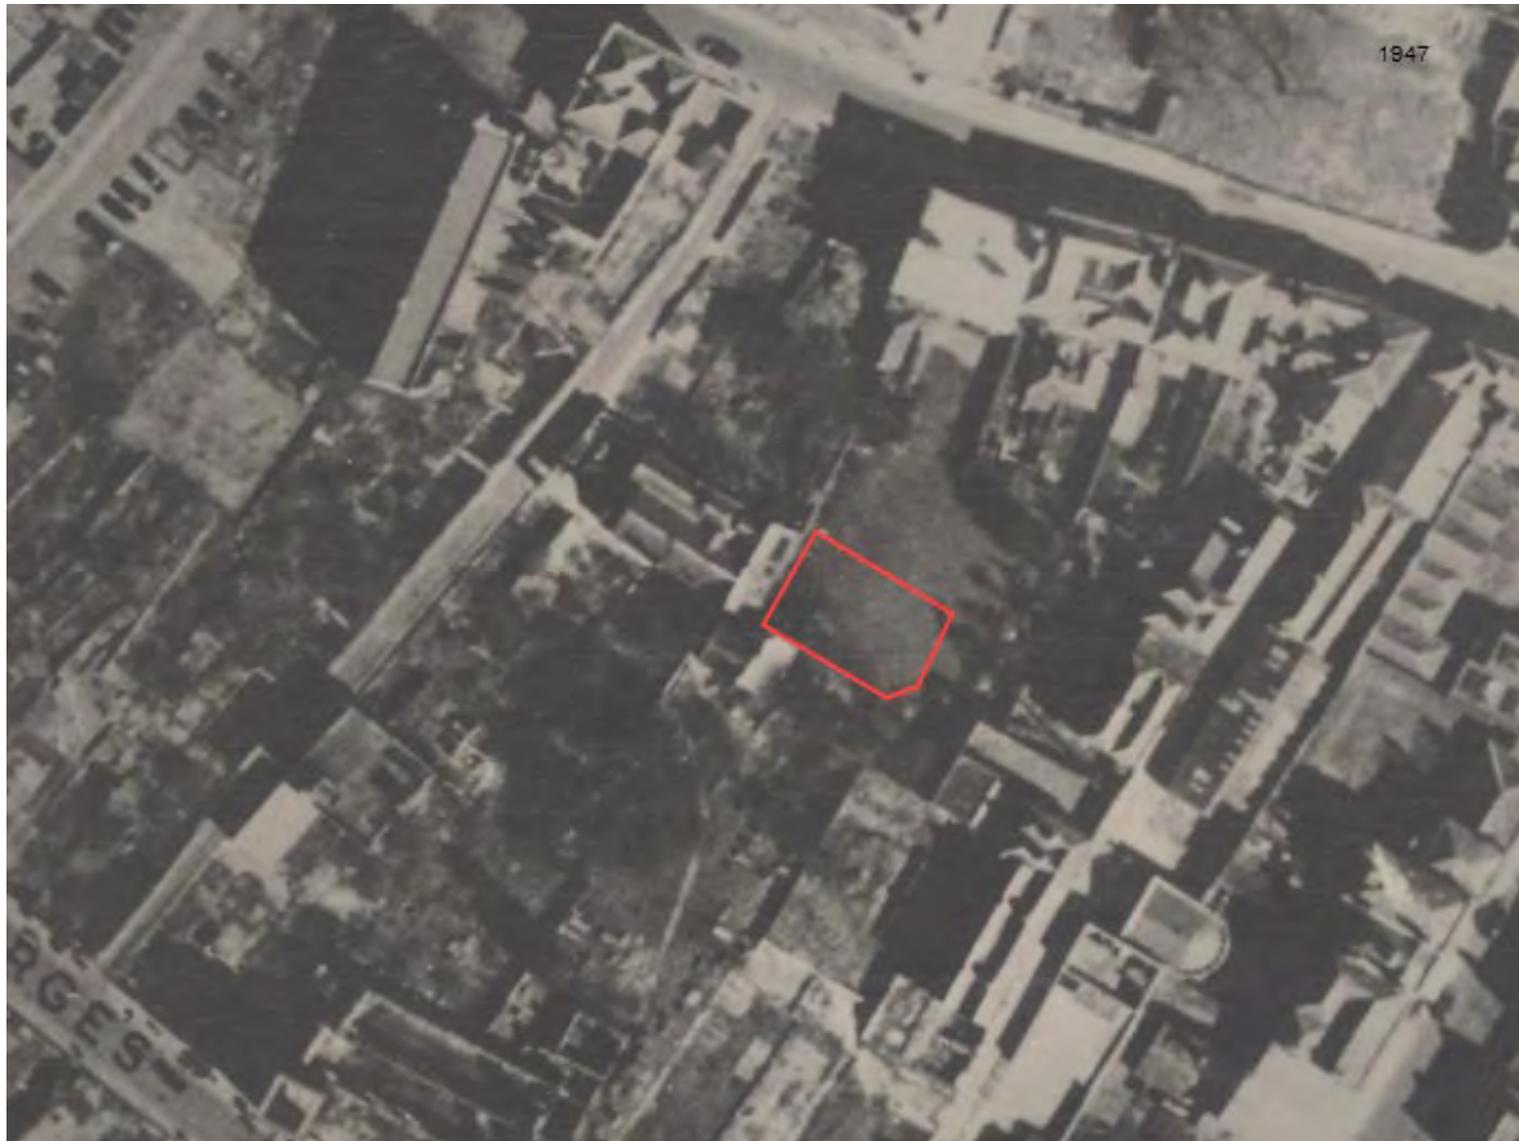
Plate 2: 1947. (Google Earth).

- 5.6.2 This photo shows the garden at 62 Burgate being much more open. 1-3 Canterbury Lane, immediately west of 62 Burgate has been destroyed by a bomb in the Second World War. St George's School adjacent to the PDA to the west remains in situ but south west of the PDA has also been destroyed (Plate 2).

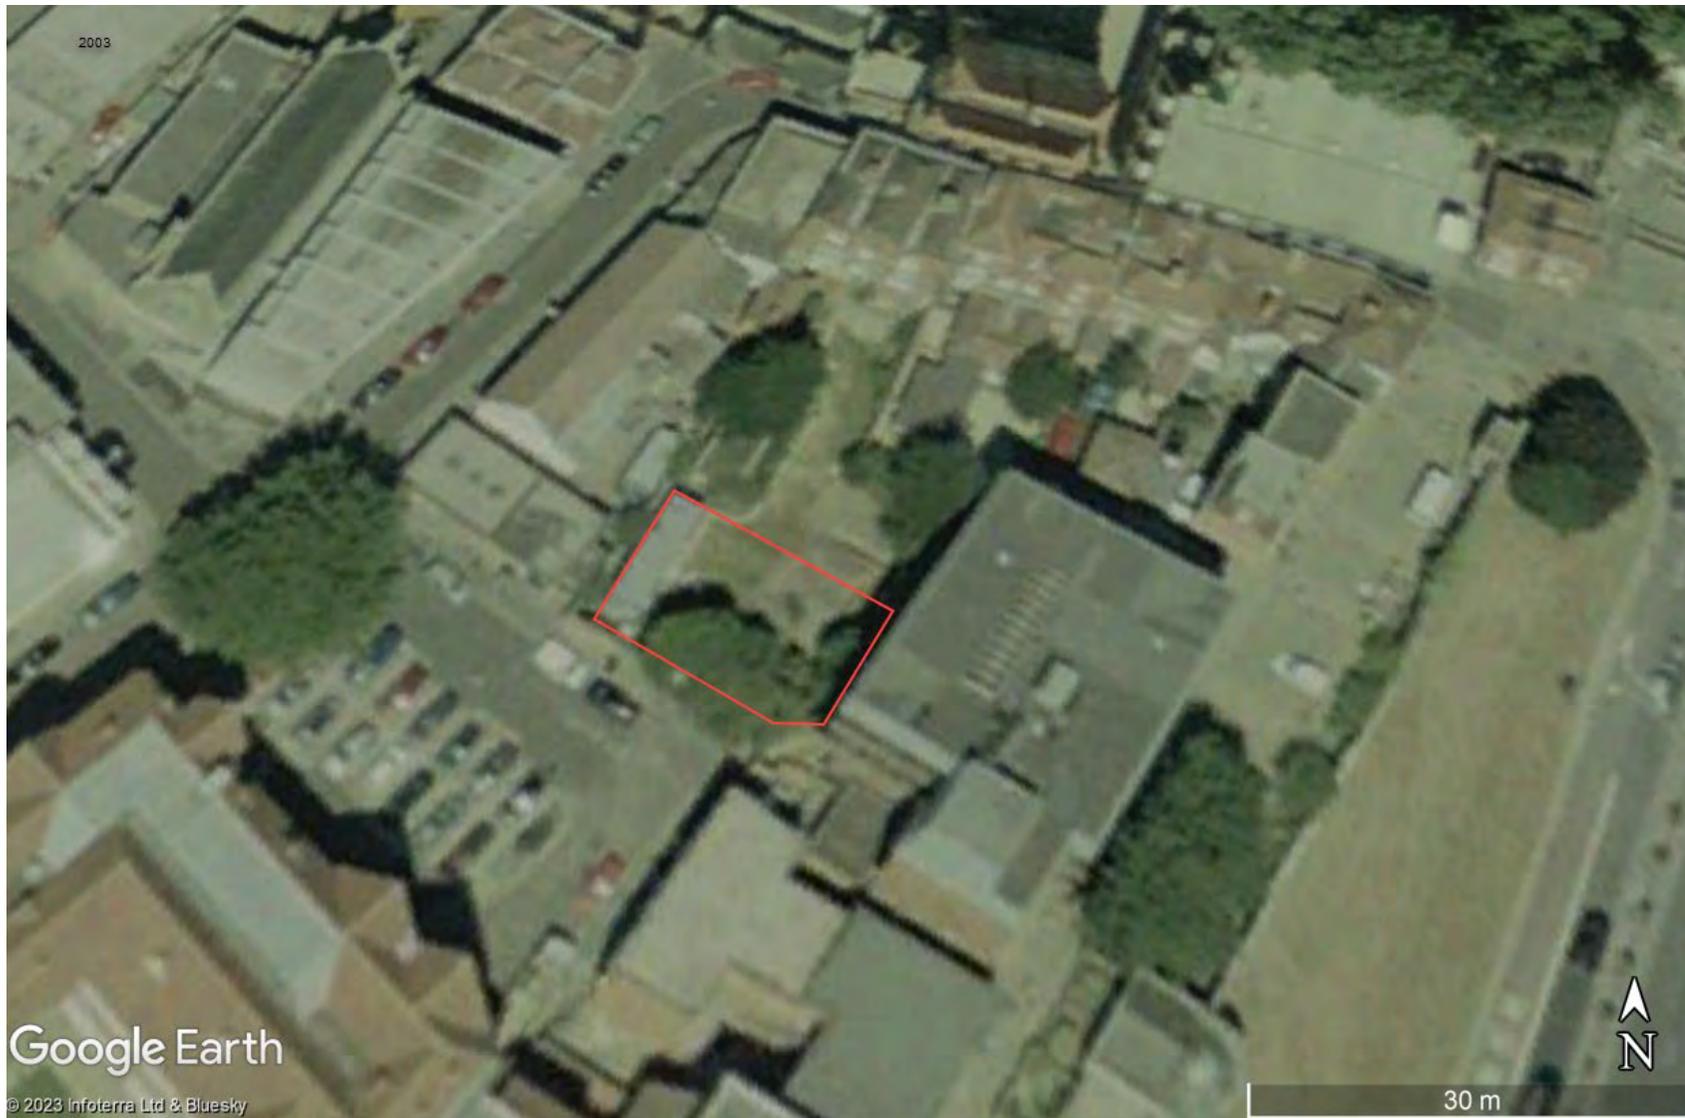
Plate 6: 1990 (Google Earth)

- 5.6.6 Within the PDA at the western end is a new building recognised as the extent Portakabin (Plate 6).

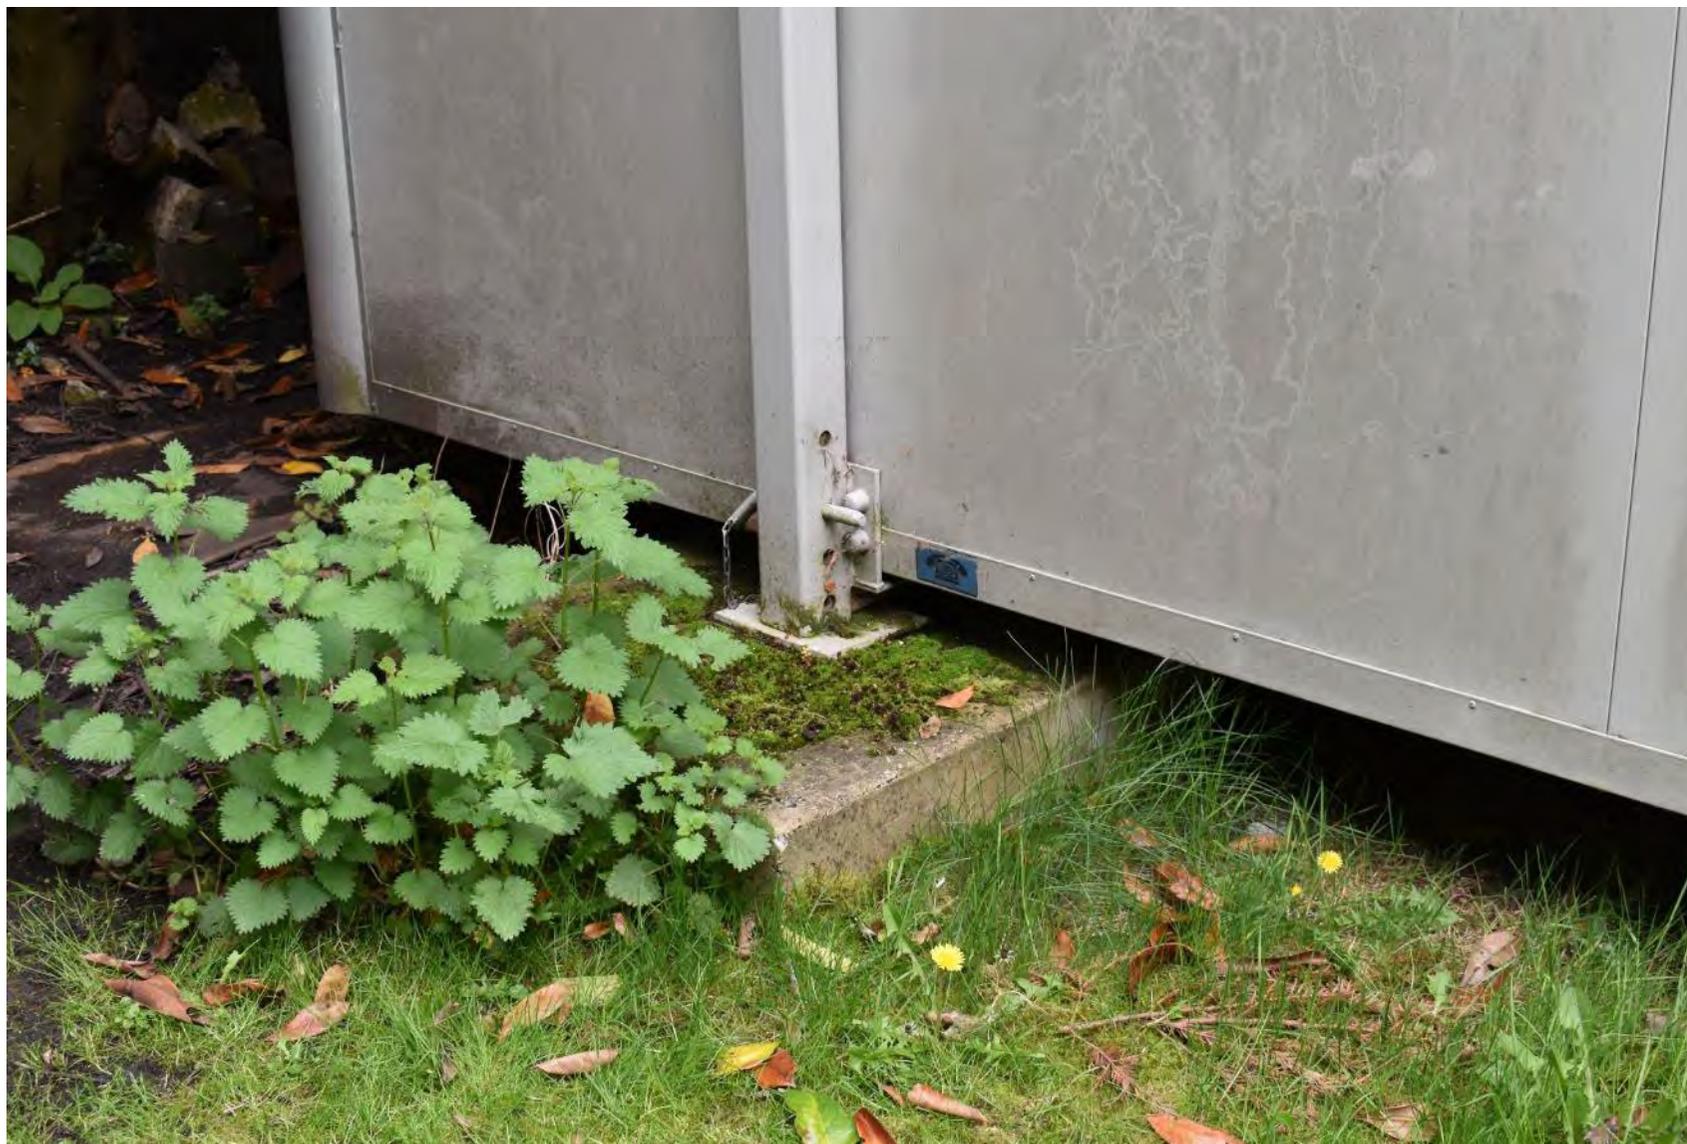
Plate 12: One of the existing Portakabins concrete pads

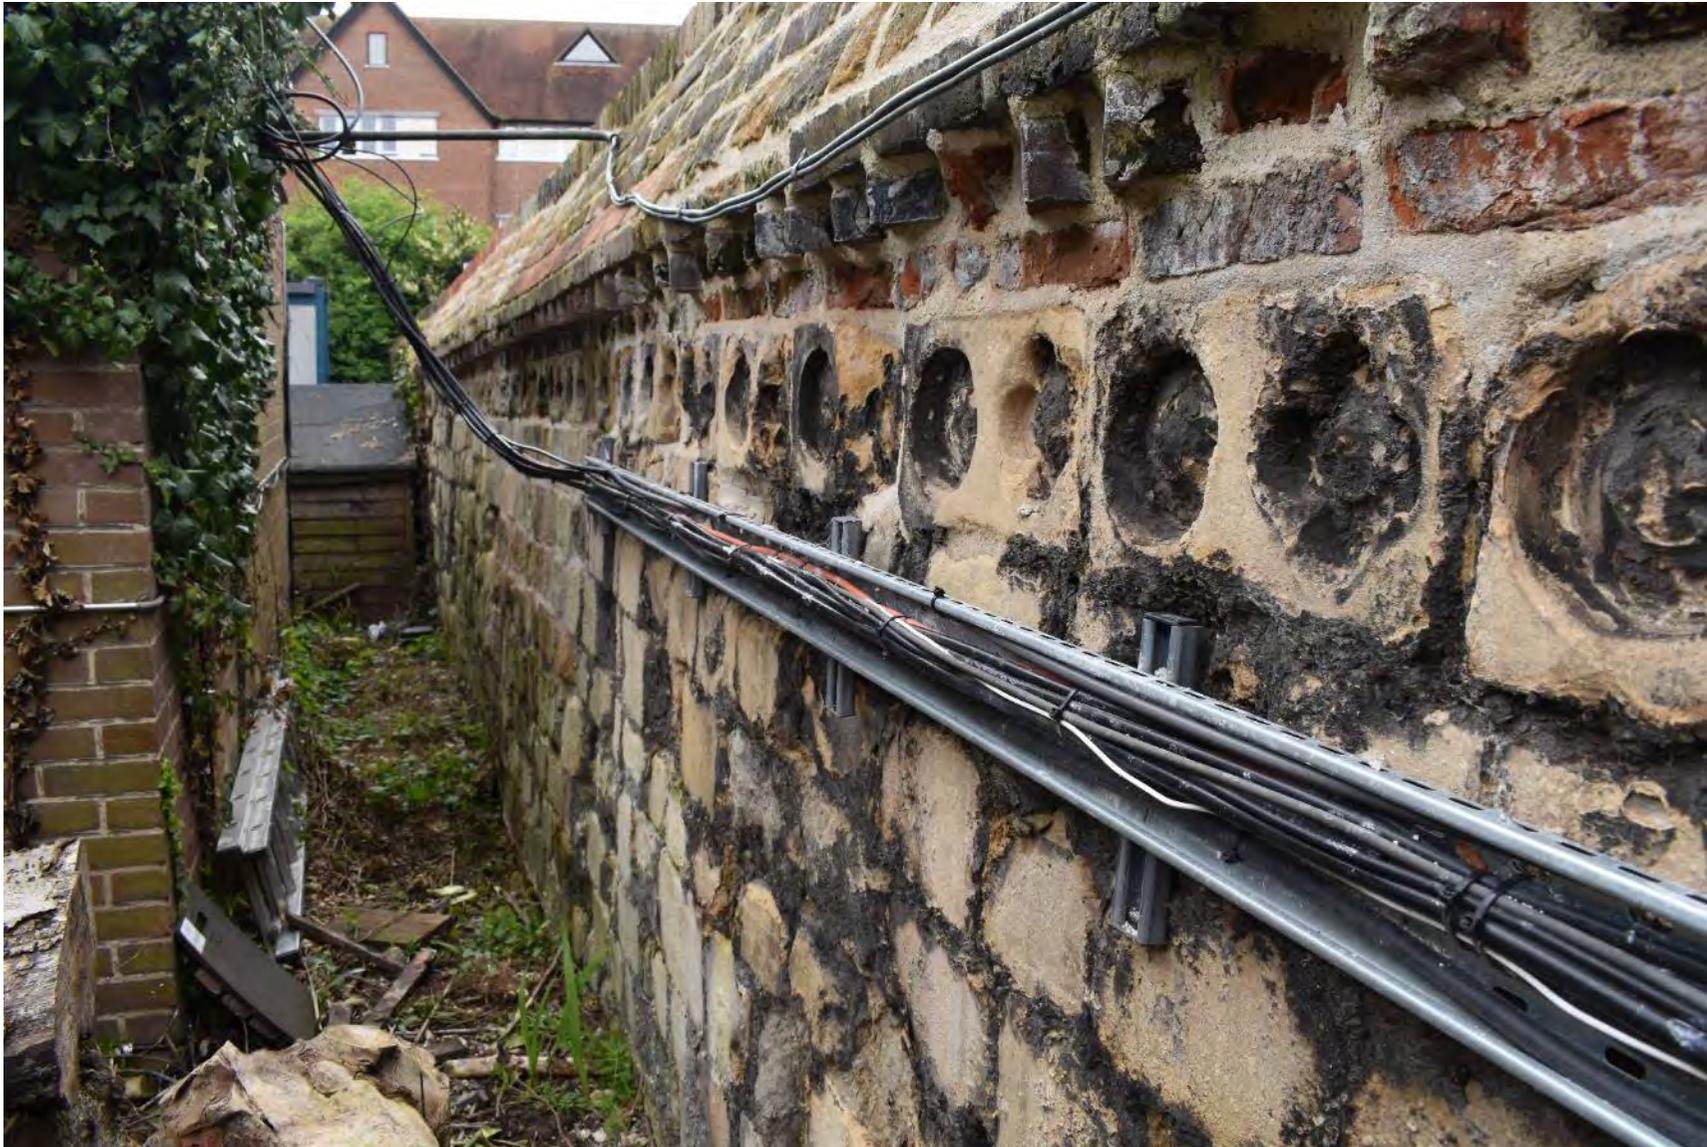
Plate 13: Western boundary wall at the southern end (facing SSW)

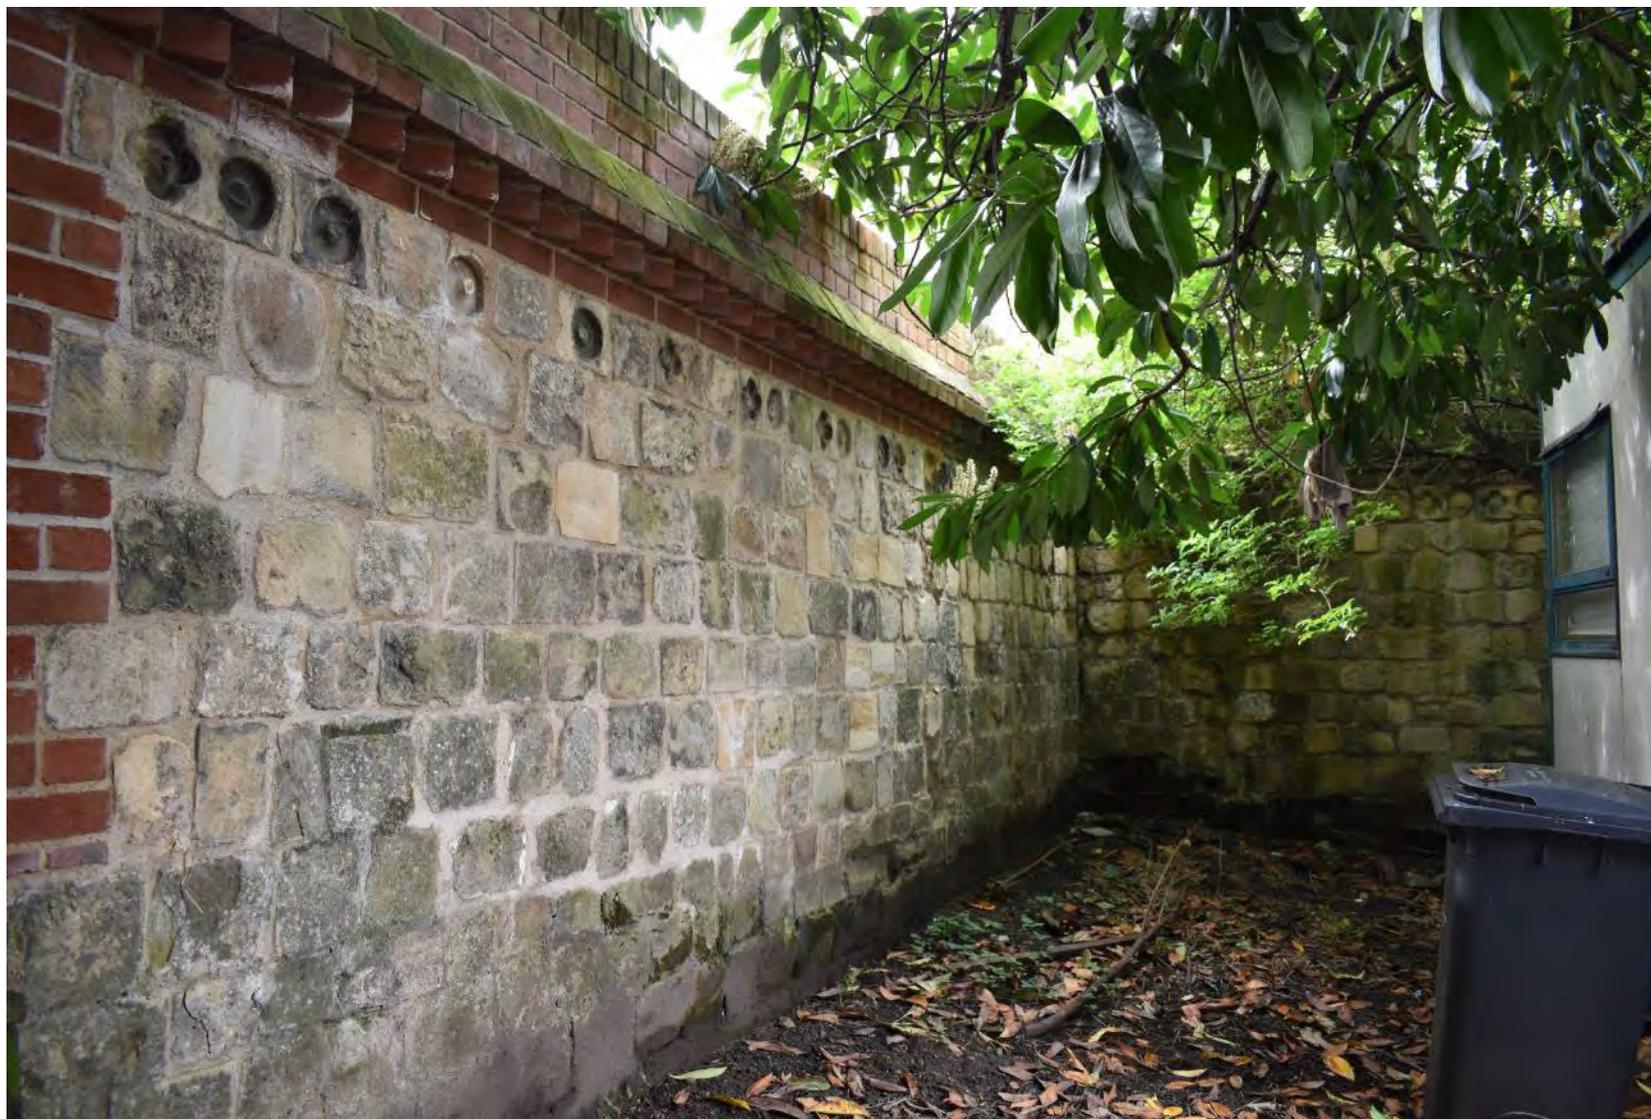
Plate 16: Boundary Wall in the south western corner (facing W)
