Archaeological Desk-Based Assessment
in Advance of the Proposed
Development of Land at Rear of
No.62 Burgate, Canterbury, Kent

May 2023

National Grid Reference TR 15165 57711

Report for Clague Architects

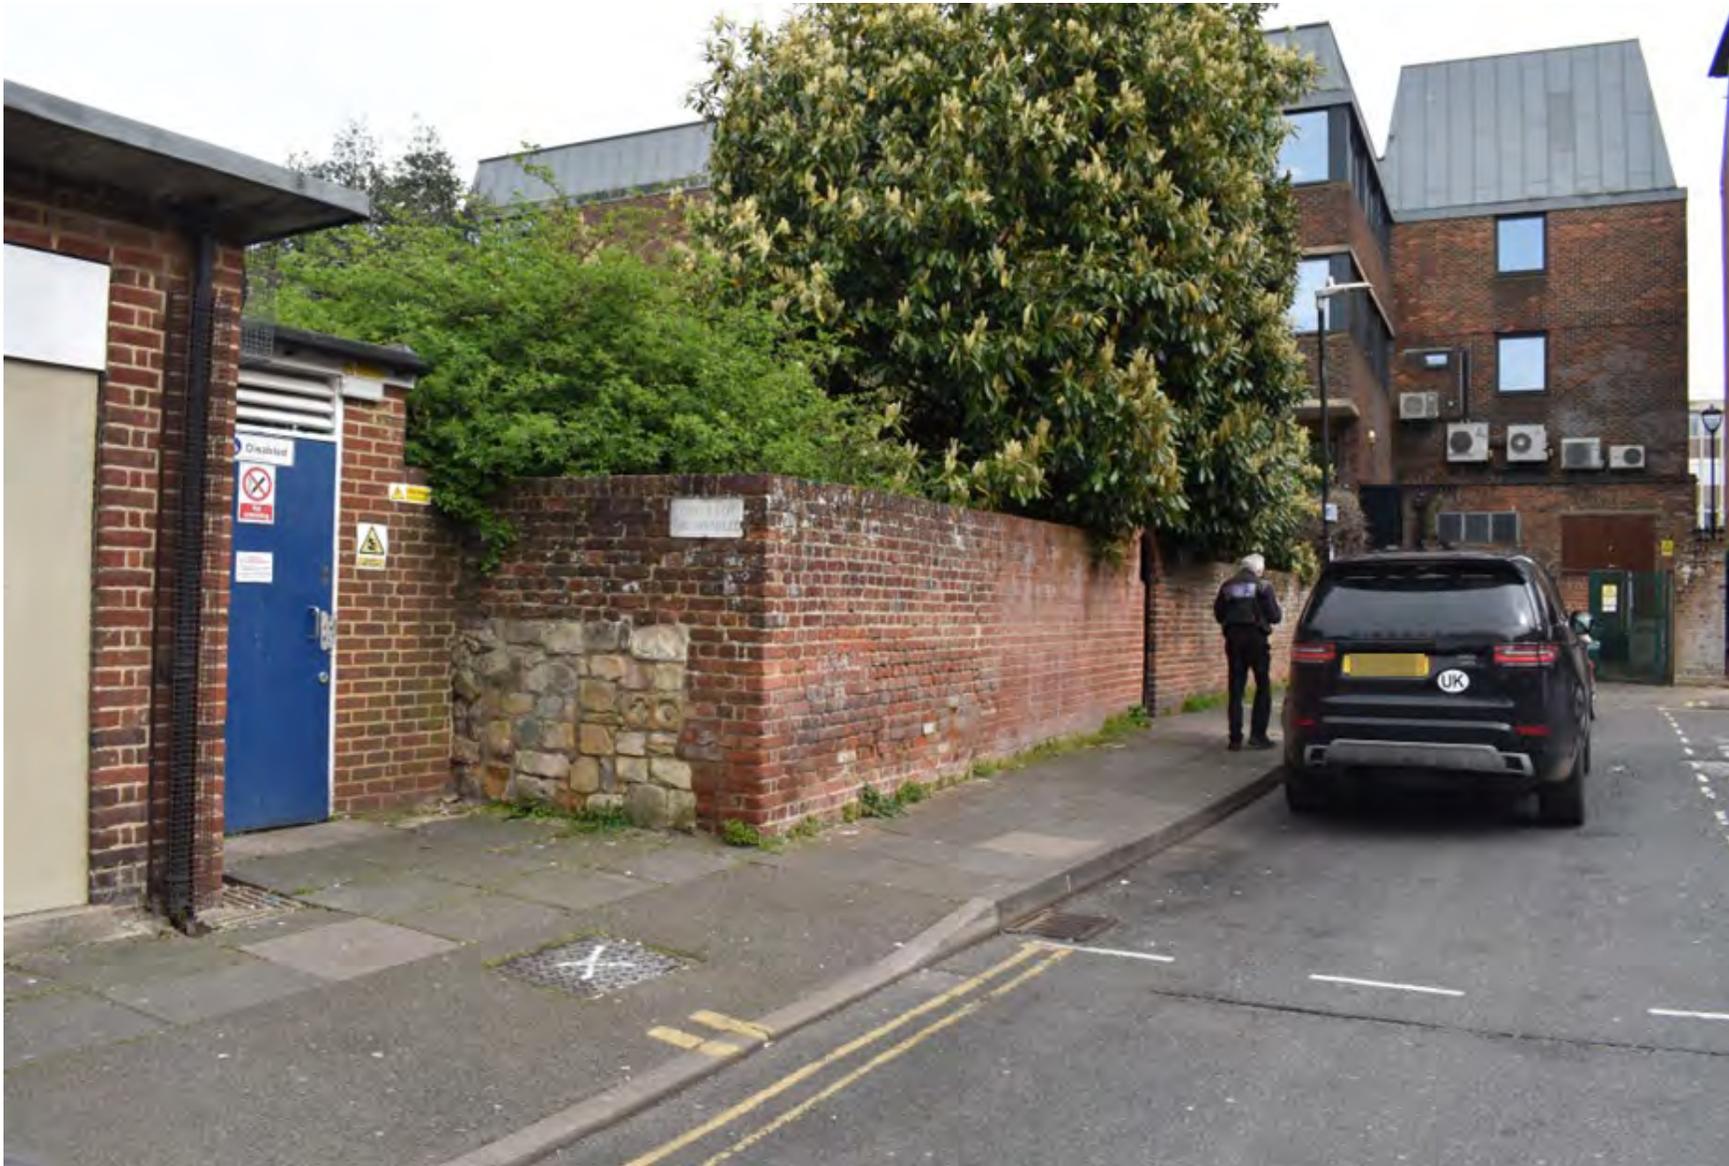
Plate 17: External view of the south western corner boundary wall (facing E)
