Historic Building Recording at Springfield Mill, Sandling Road, Maidstone, Kent

Date of Report: 18/03/2020

SWAT Archaeology has been commissioned by Redrow Homes Ltd to carry out a programme of historic building recording at Springfield Mill, Sandling Road, Maidstone in Kent.

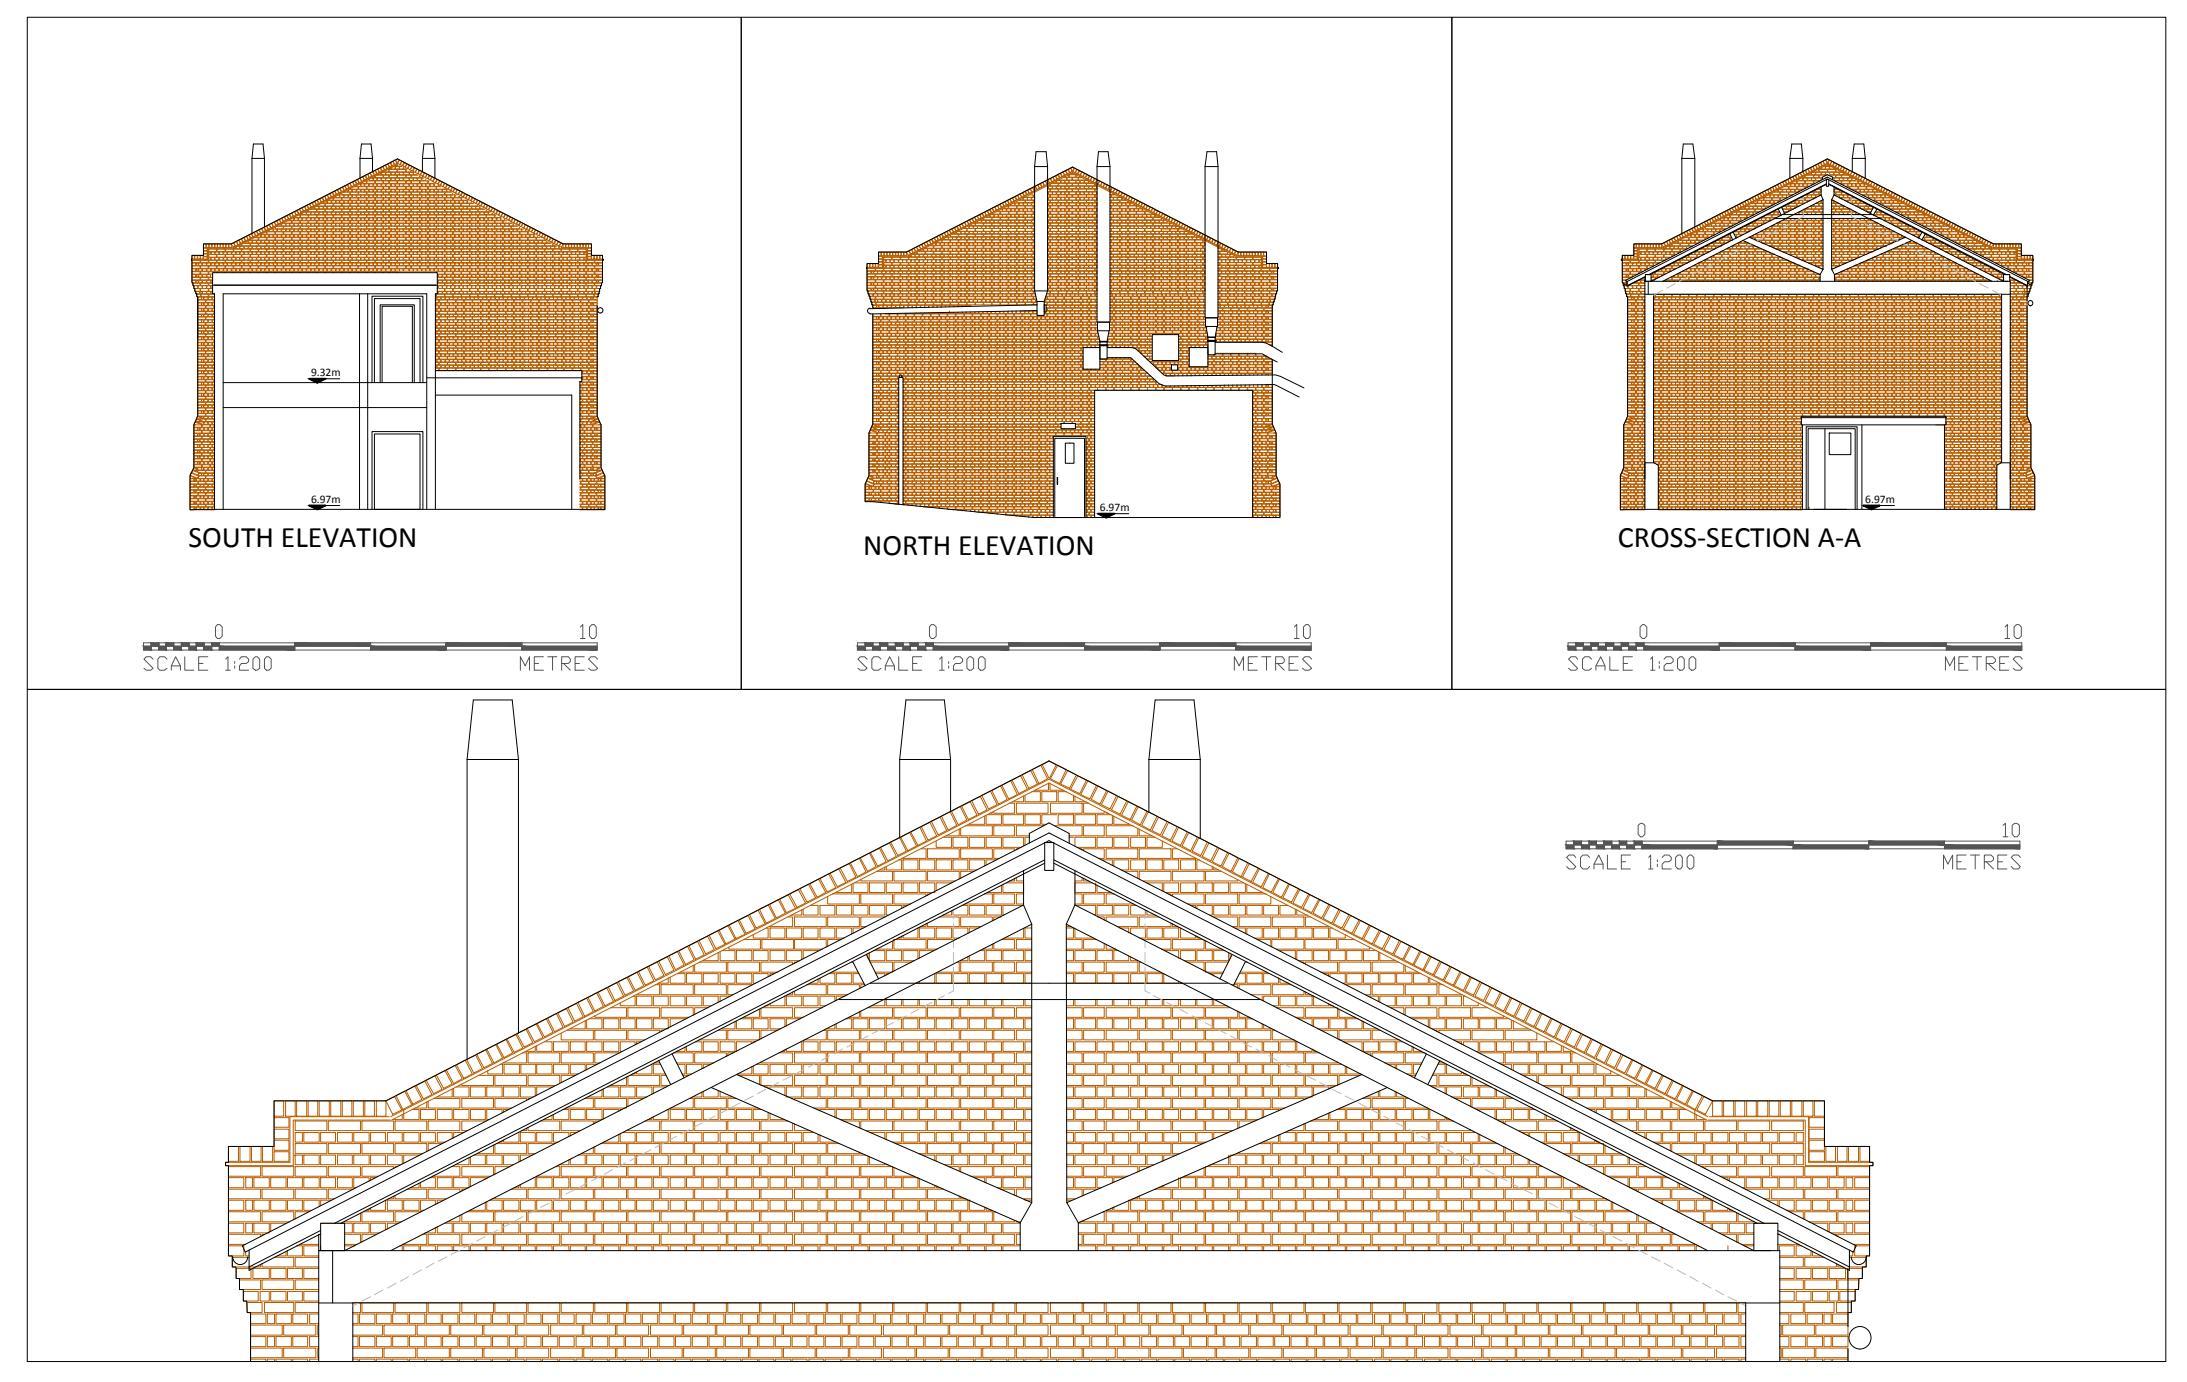
Figure 2.3: Building 2 - South and north elevation; cross-section and roof truss

Internally, the timber king-post roof trusses remain in place, supported in places by a modern steel frame. All the full-height drying racks which lined the walls have been removed, replaced by modern plant (Figure 2.3. Plates 2.14-2.19).

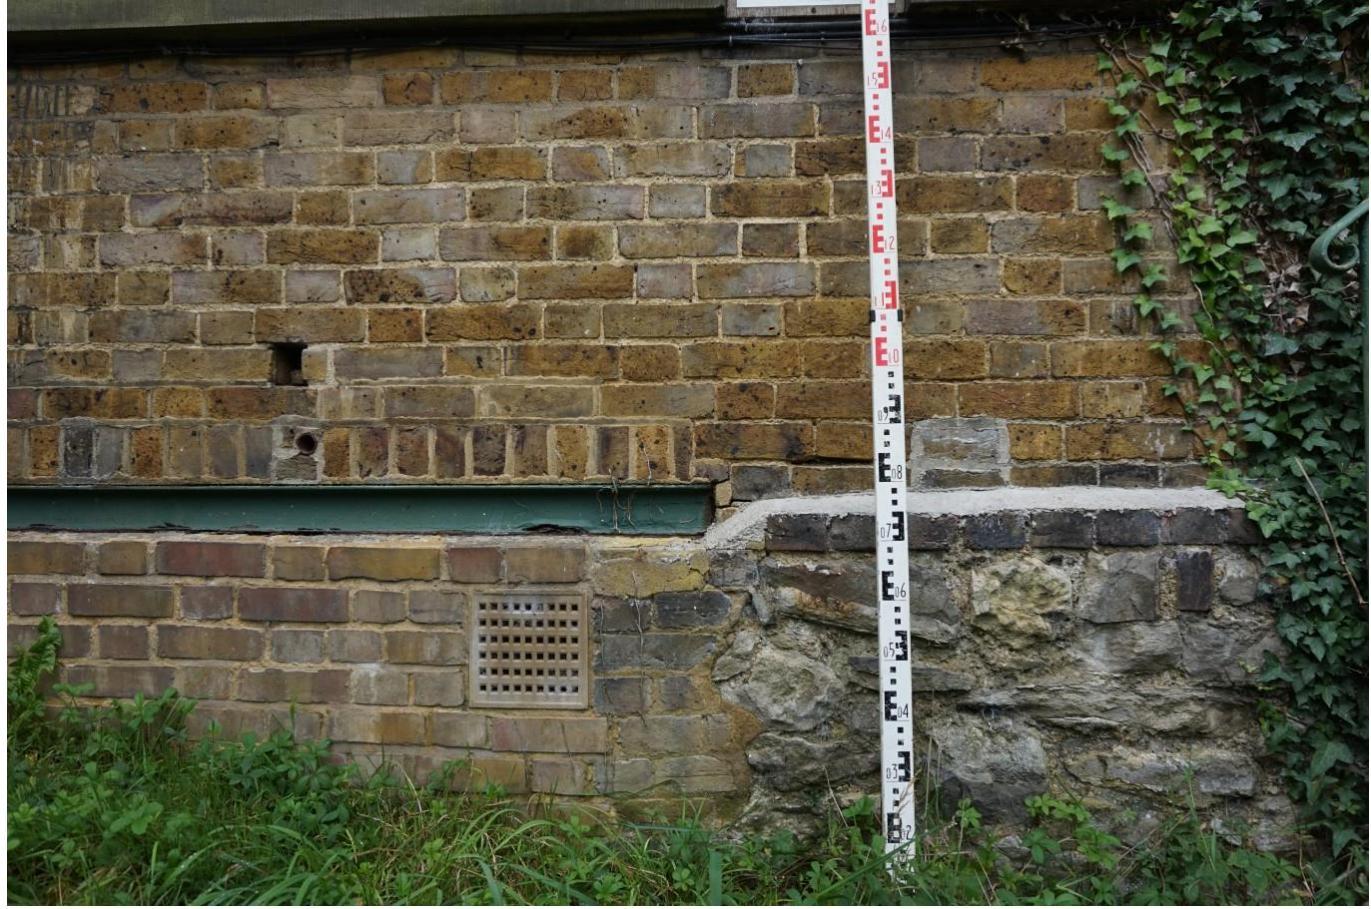
Plate 3. 5: Looking south-south-east at north elevation of building 3. Visible here are Rag-stone foundation wall and part of the wall face rebuilt with bricks.

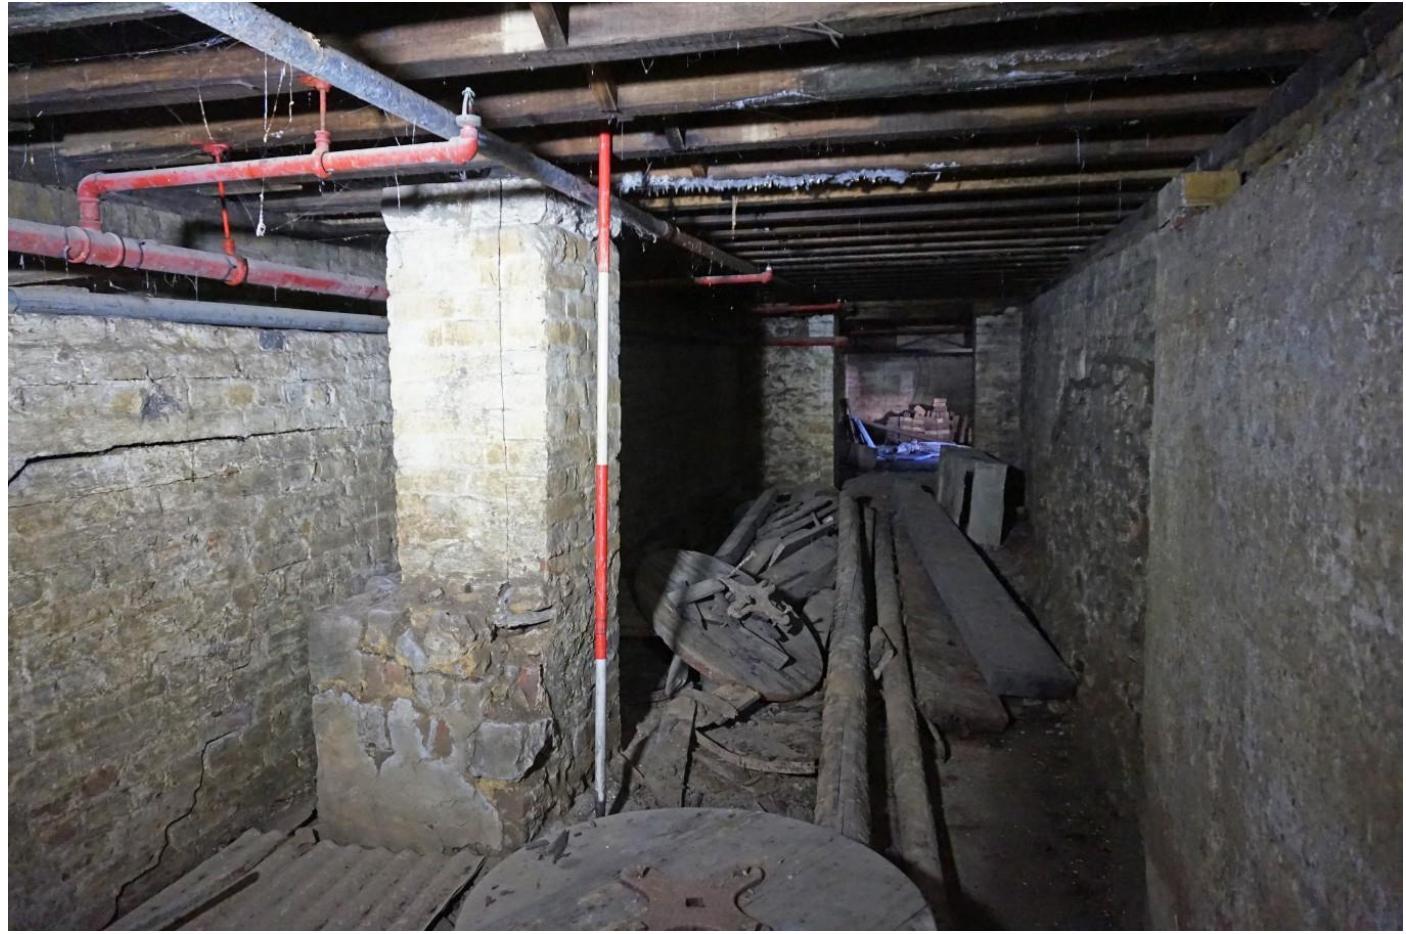
Plate 3. 41: Building 3 - Basement: Looking west-south-west at the remains of original stone pillar replaced by brick one.

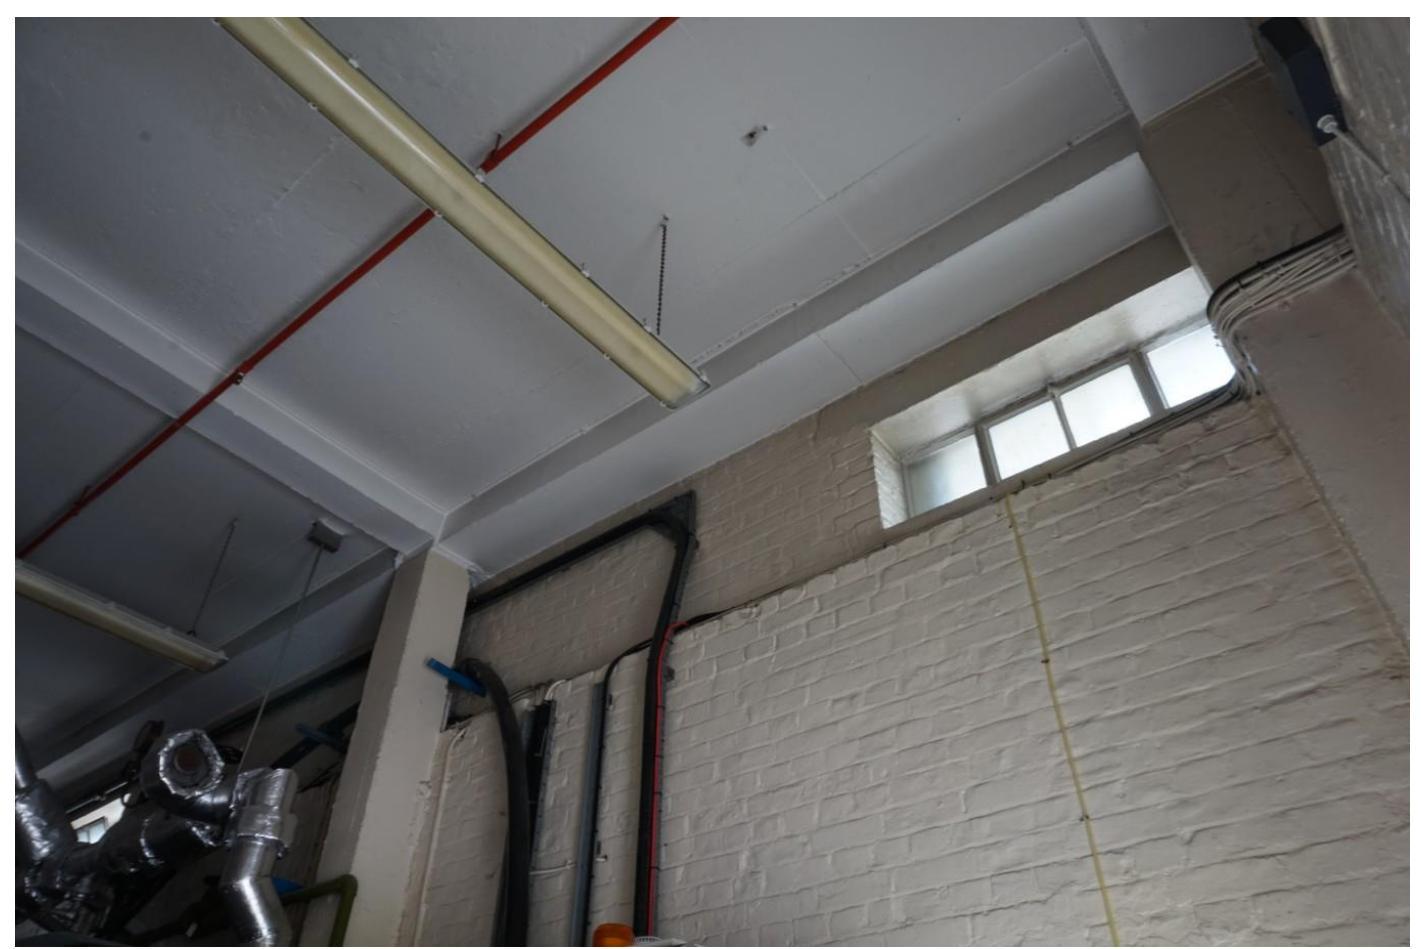
Plate 5.14: Building 5 – Ground Floor, Room 1: Looking north-east at the overbuilt steel columns and beams supporting upper floor

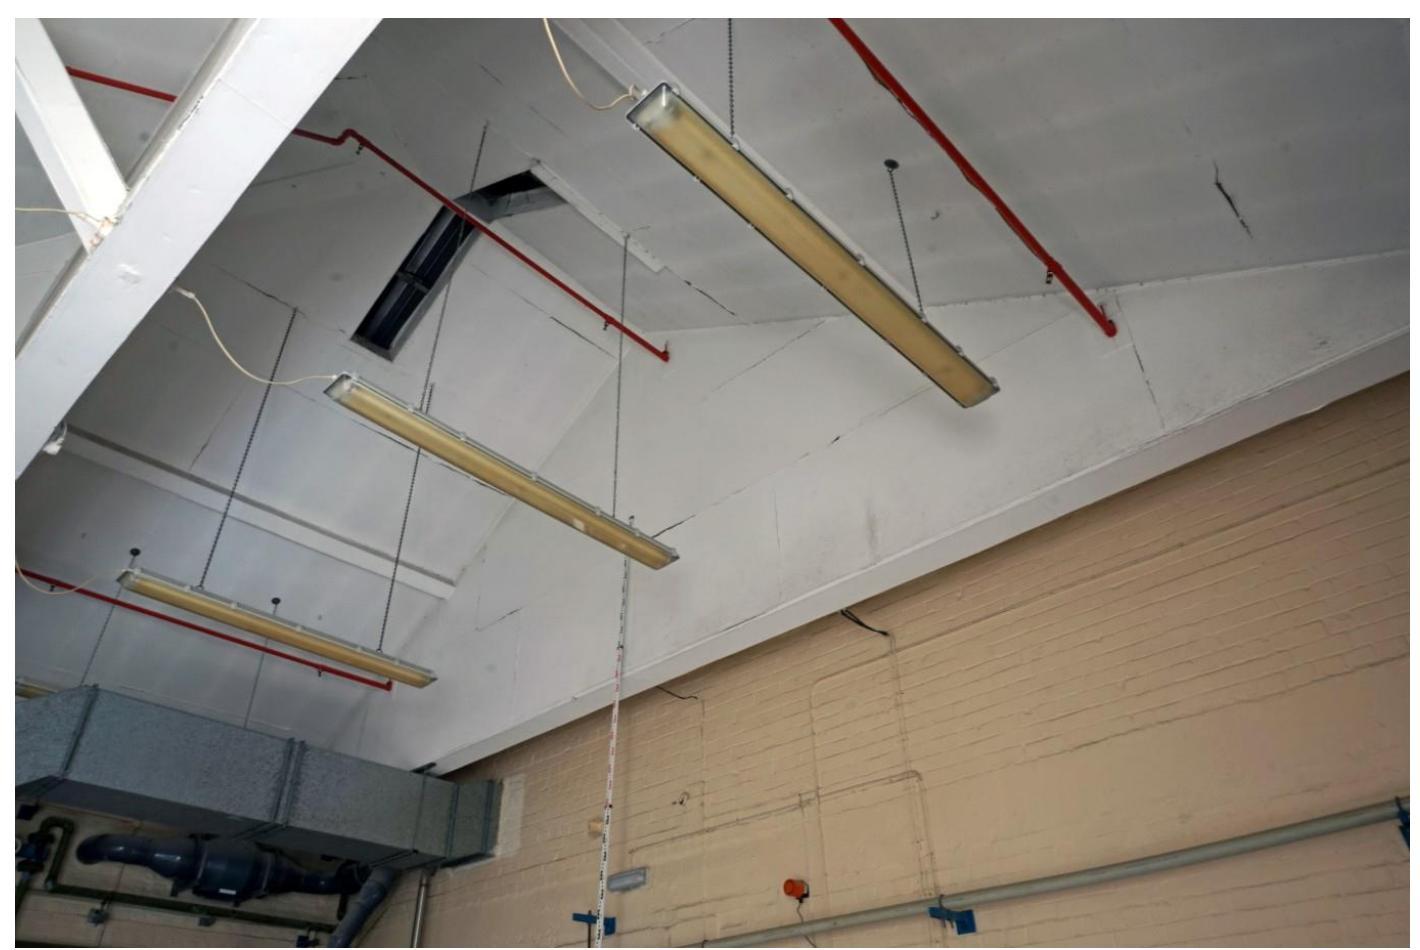
Plate 5.24: Building 5 – First floor, Room 4: Looking north-north-east at the roof truss overbuilt with wood boards

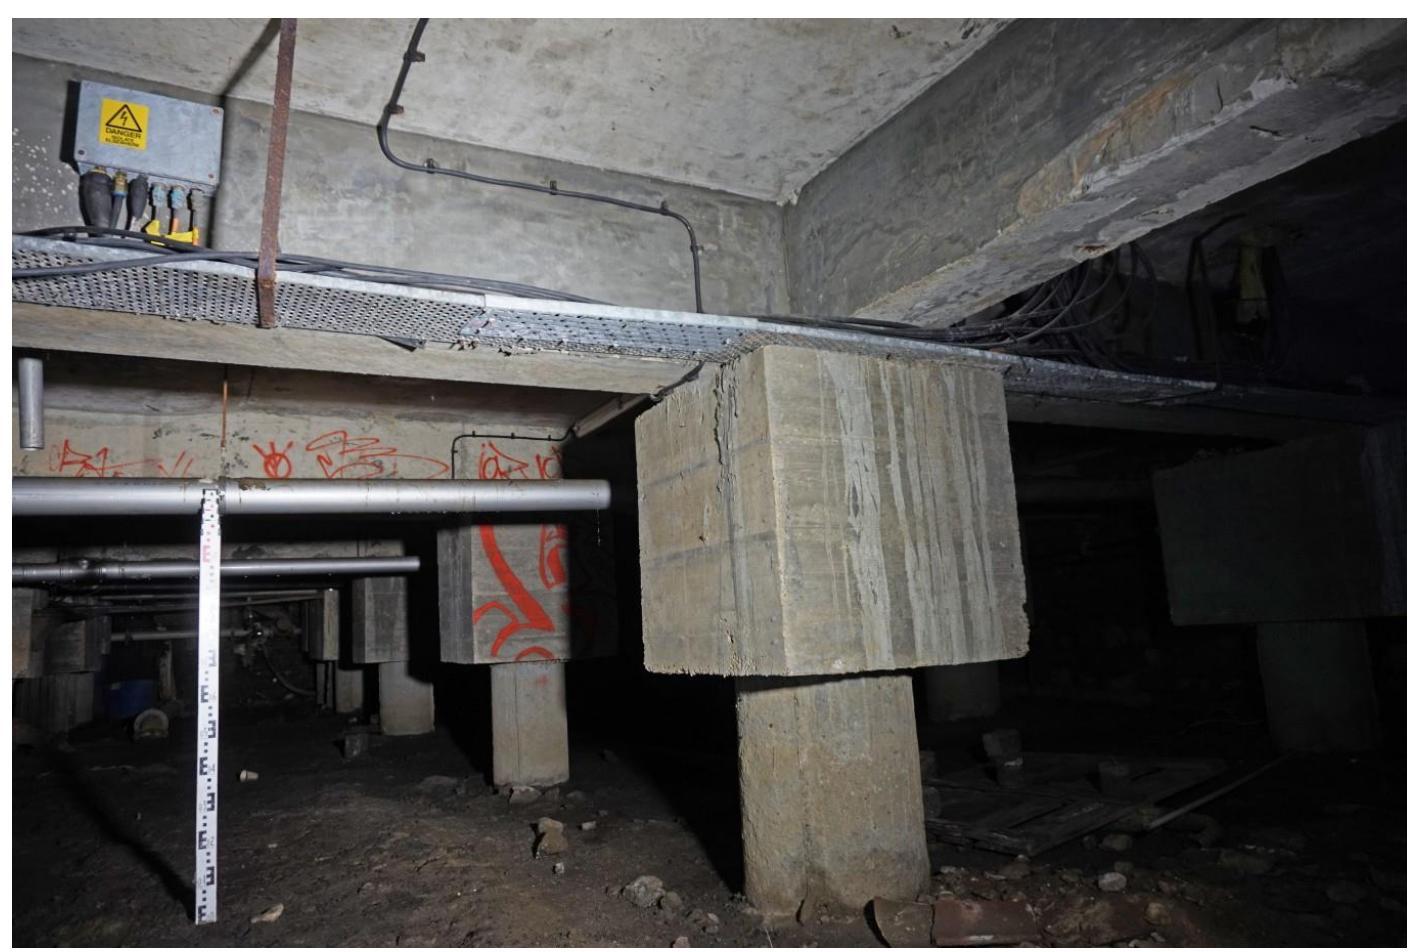
Plate 5.38: Building 5 – Basement: Looking east at the concrete pillars and beams supporting floor

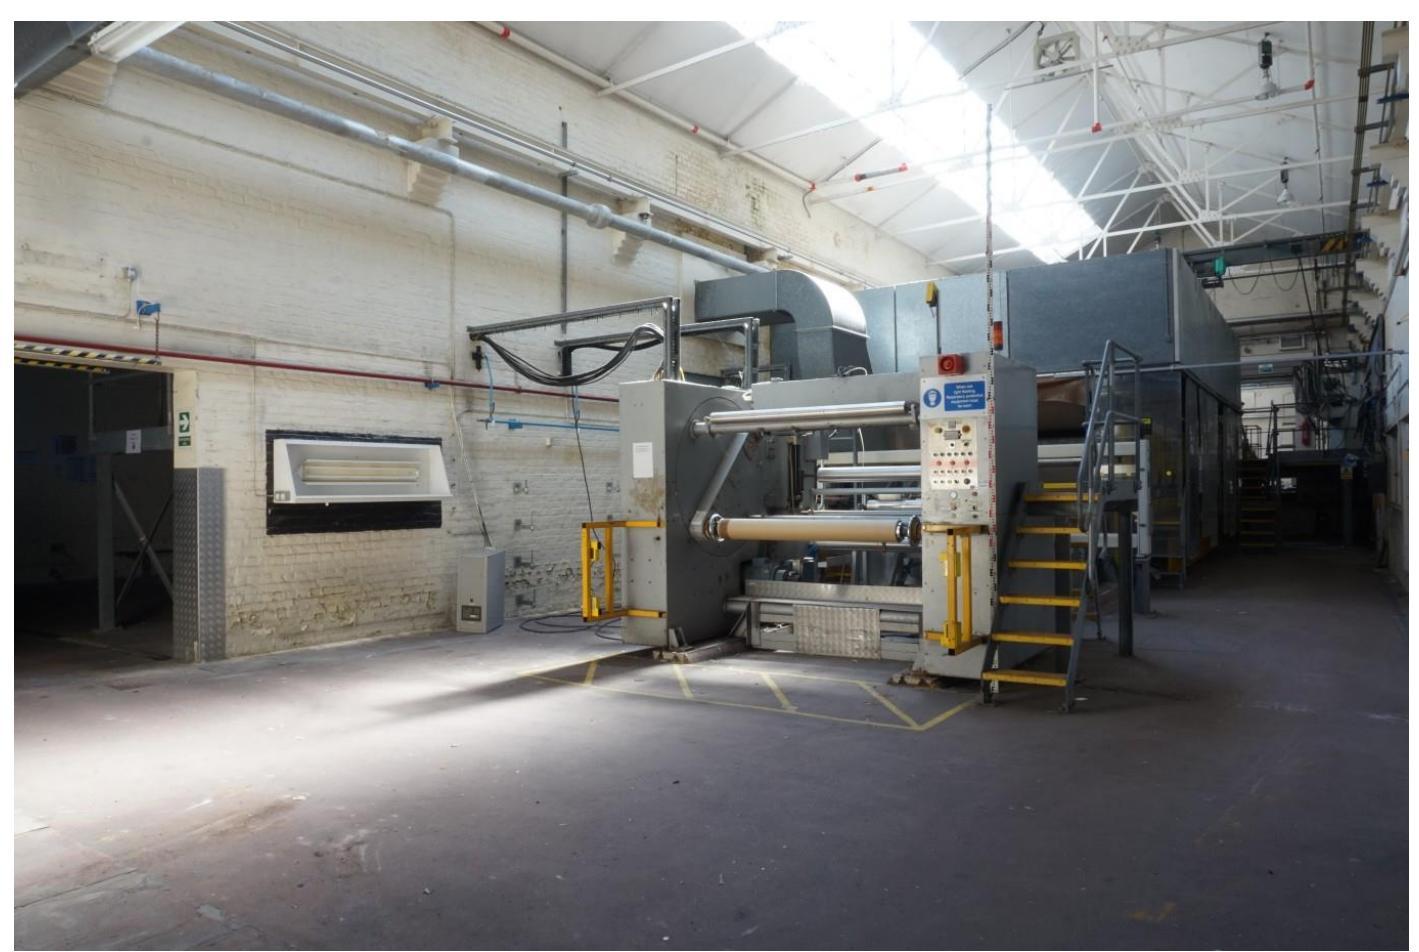
Plate 7. 16: Building 7 – Room 1: Looking south east at the room from its NW end. Kent machine occupies the whole area of the room.

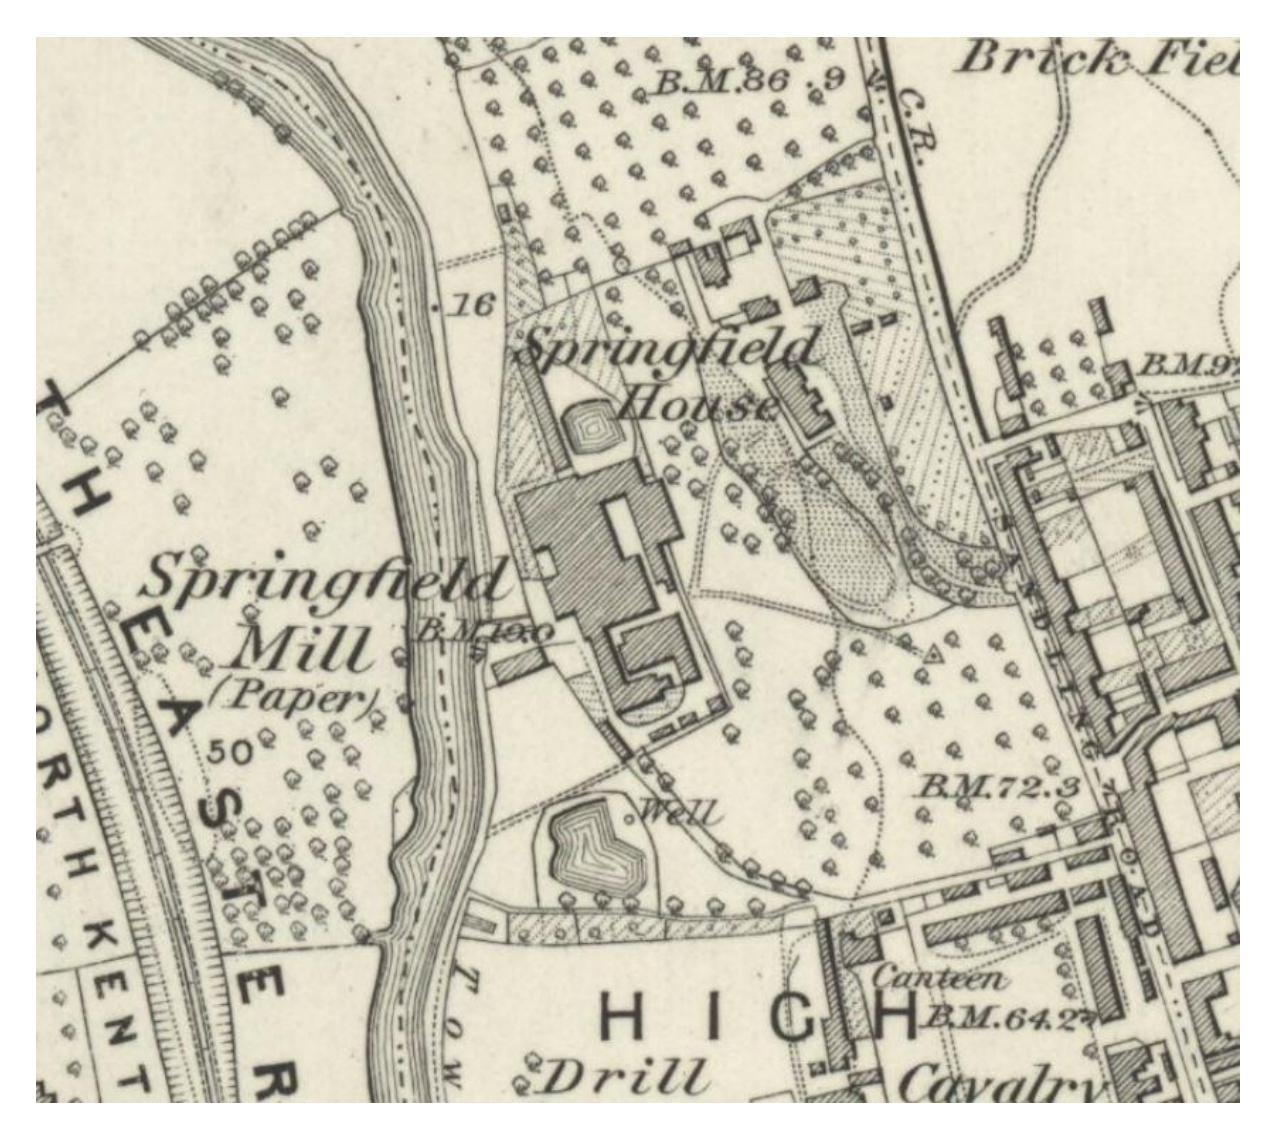
MAP 1. OS map 1865

7.1 The OS map survey in 1865 is of particular interest as it was surveyed just three years after the fire of 1862 and shows that all the buildings destroyed or damaged by fire have been rebuilt. The map also shows that Springfield House just to the north east of the paper mill is still extant with its own entrance off Sandling Road whilst the paper mill had its own entrance further downslope and to the south with its own gate house (MAP 1). 7.2 The OS map of 1868 shows more detail than the previous map with details of the formal gardens of Springfield House and greenhouses to the north but facing south and built against a retaining brick wall, a formal planted orchard to the south within the curtilage of the paper mill. Fountains and wells are annotated and even individual posts. To the west of the main paper mill buildings the 19th century rag store can be identified and adjacent to the north a dock for barges off the River Medway leading to a 'Coal Pen'. The Drying Room the most northerly of the paper mill buildings is shown in such details that the three bays can be identified on the OS map joined to the main building complex by a narrow corridor and to the east a sub-rectangular pond (8a) can be indentified (MAPs 2 & 2A).

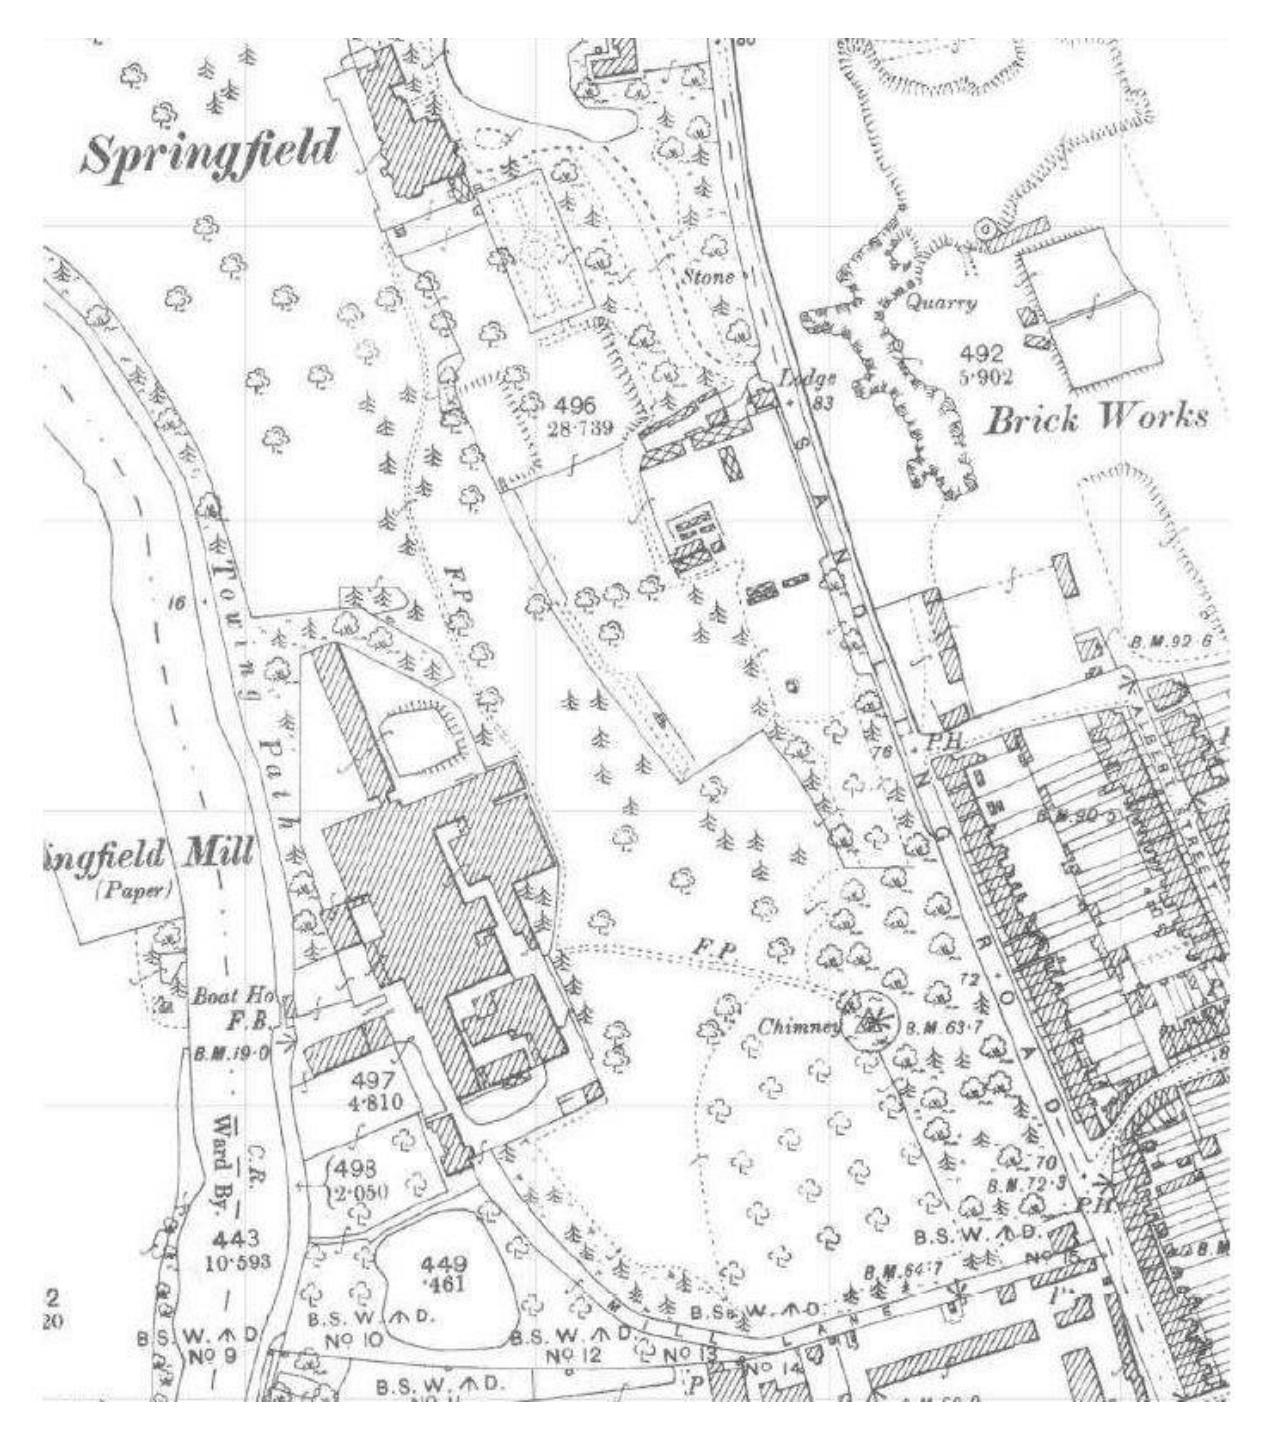
MAP 3. OS map of 1869

7.3 Just a year later the OS map of 1869 shows that Springfield House has been demolished and some paper mill buildings to the south and adjacent to the Smithy have also been demolished (MAP 3).

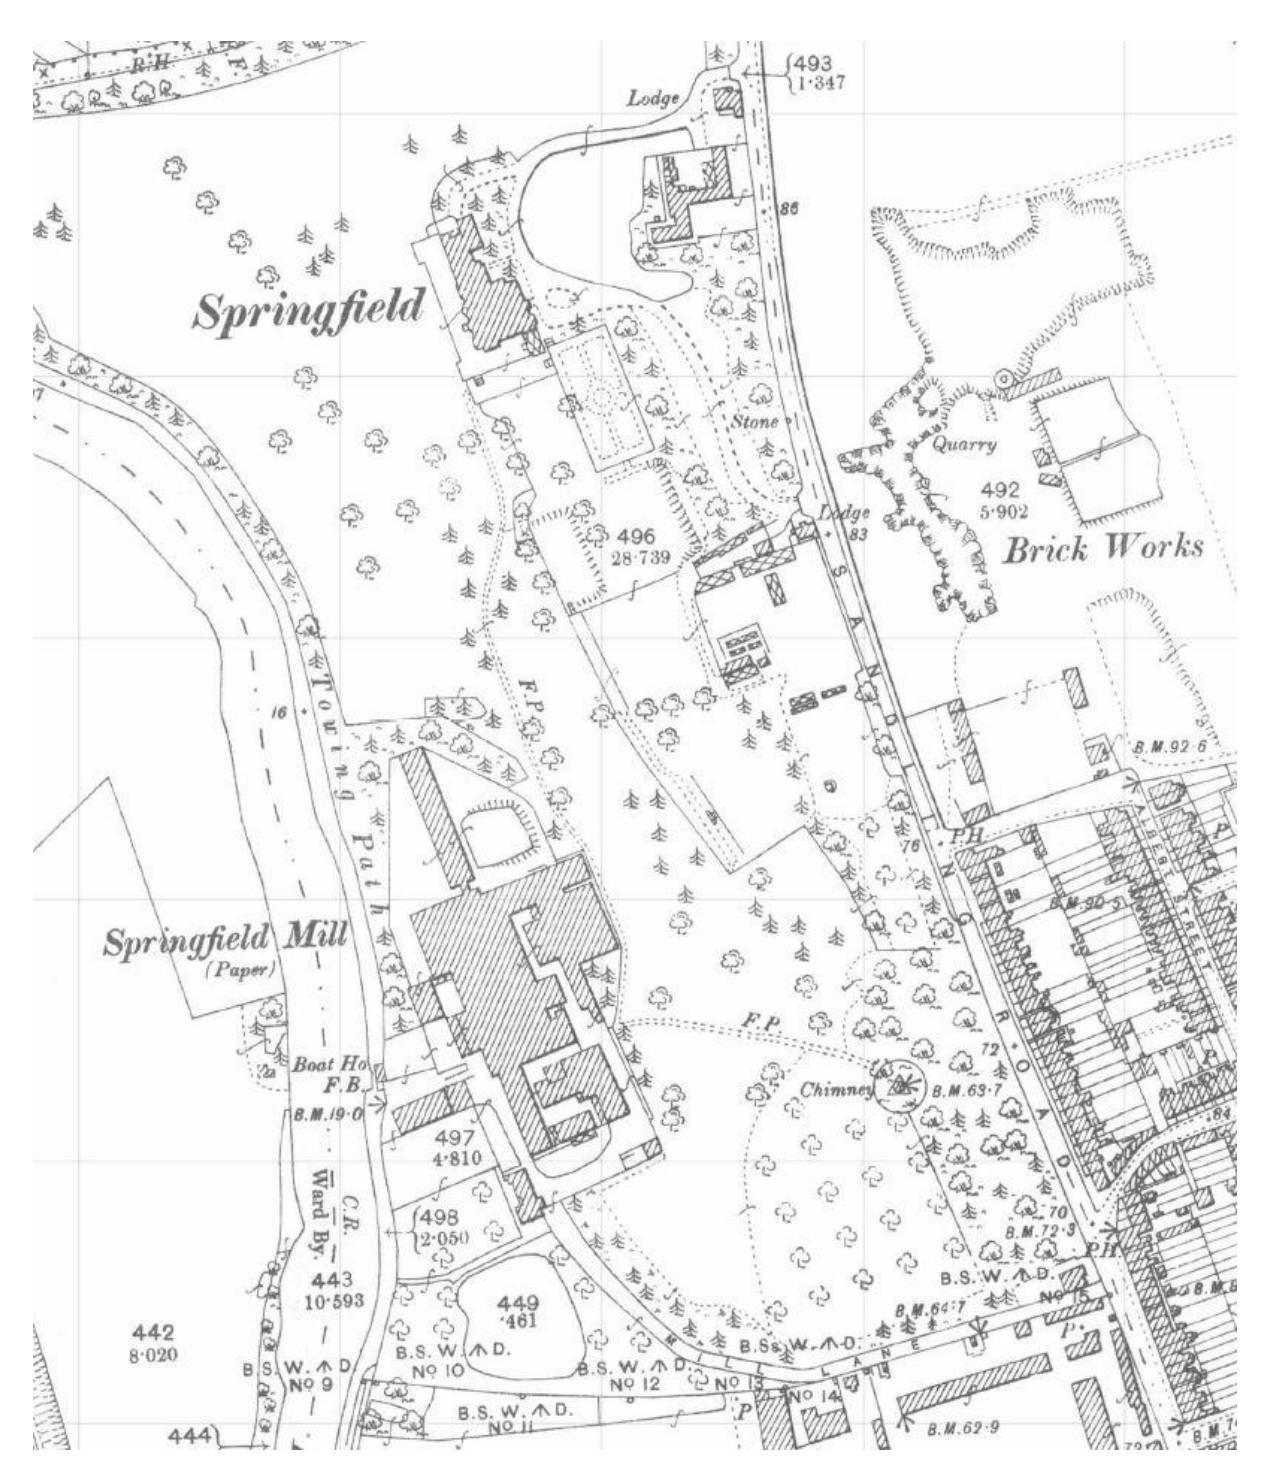
MAP 4. OS map of 1895

7.4 The OS map of 1895 shows that the orchard situated in the south-east area of the Site has been reduced in size (MAP 4).

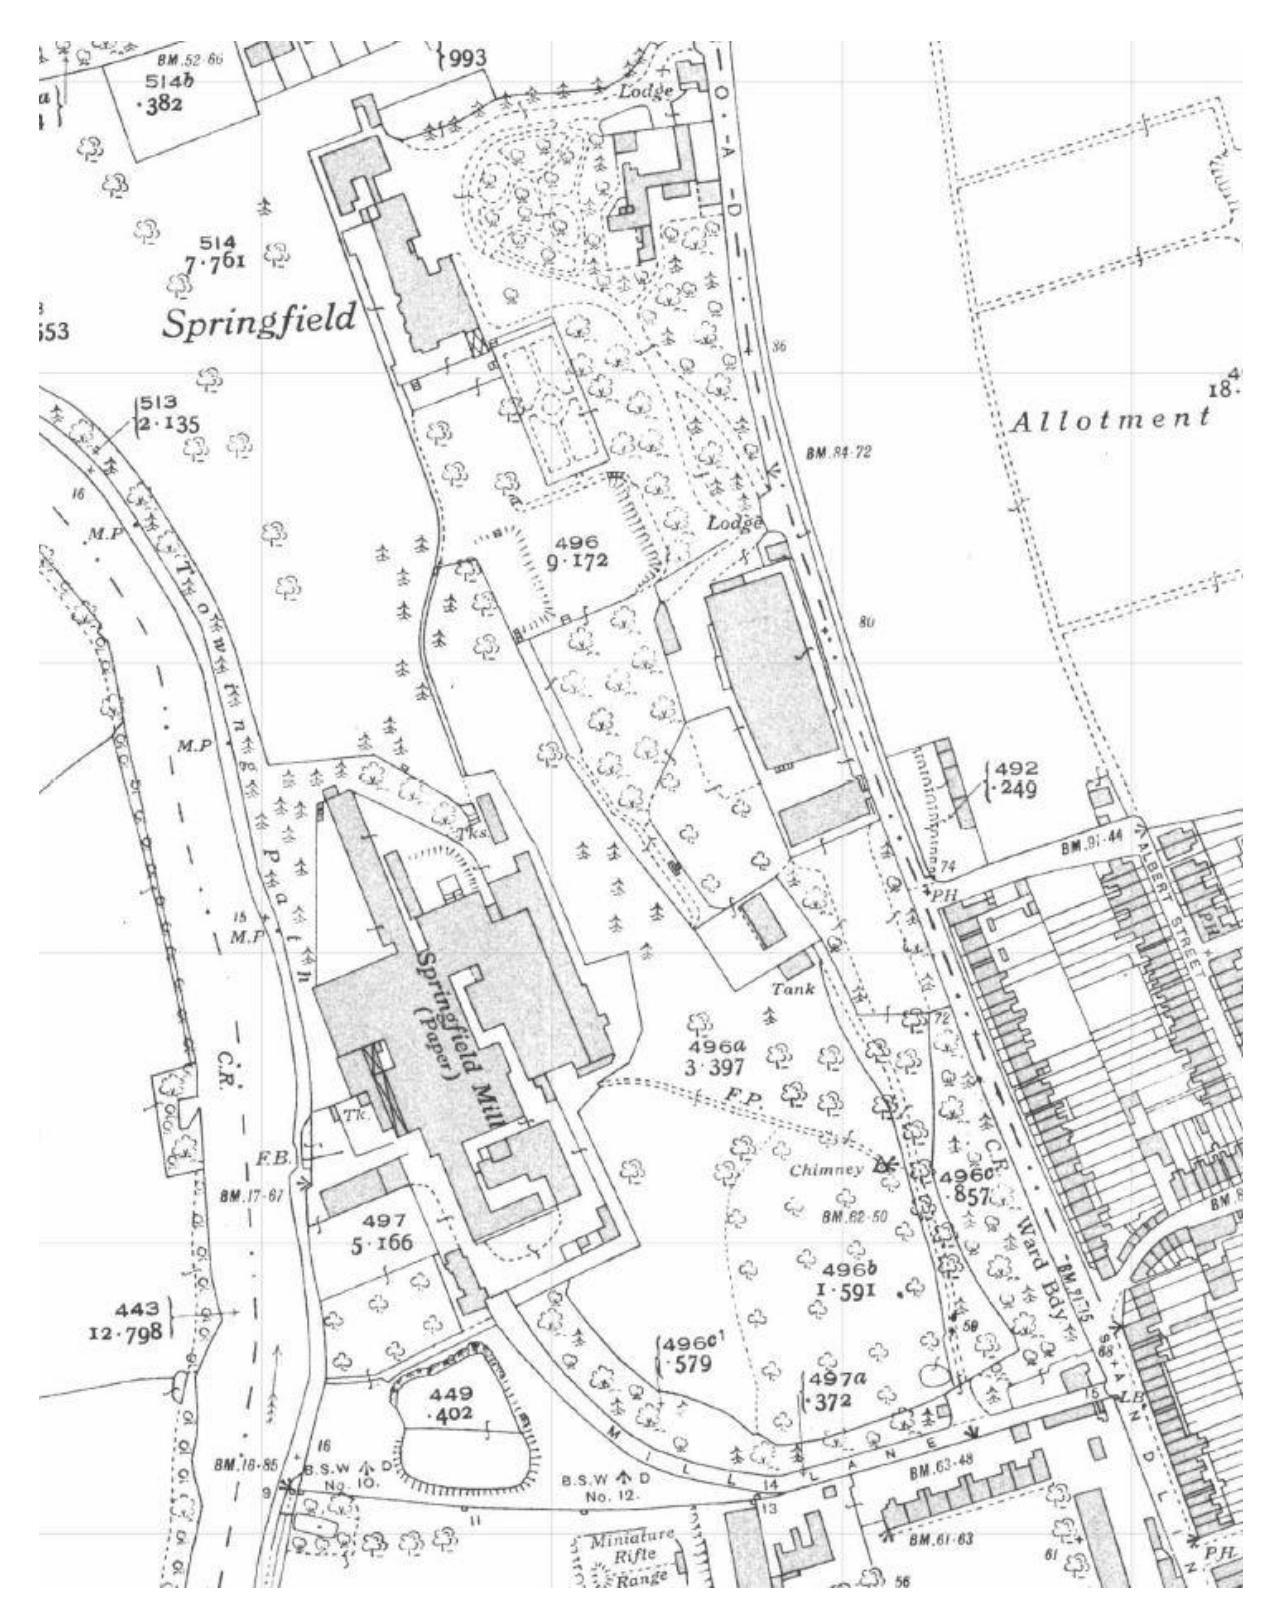
MAP 7. OS map of 1932

7.6 The OS map of 1932 shows additional buildings to the north and east of the original mill and the addition of a miniature Rifle Range to the south of the main complex (MAP 7).

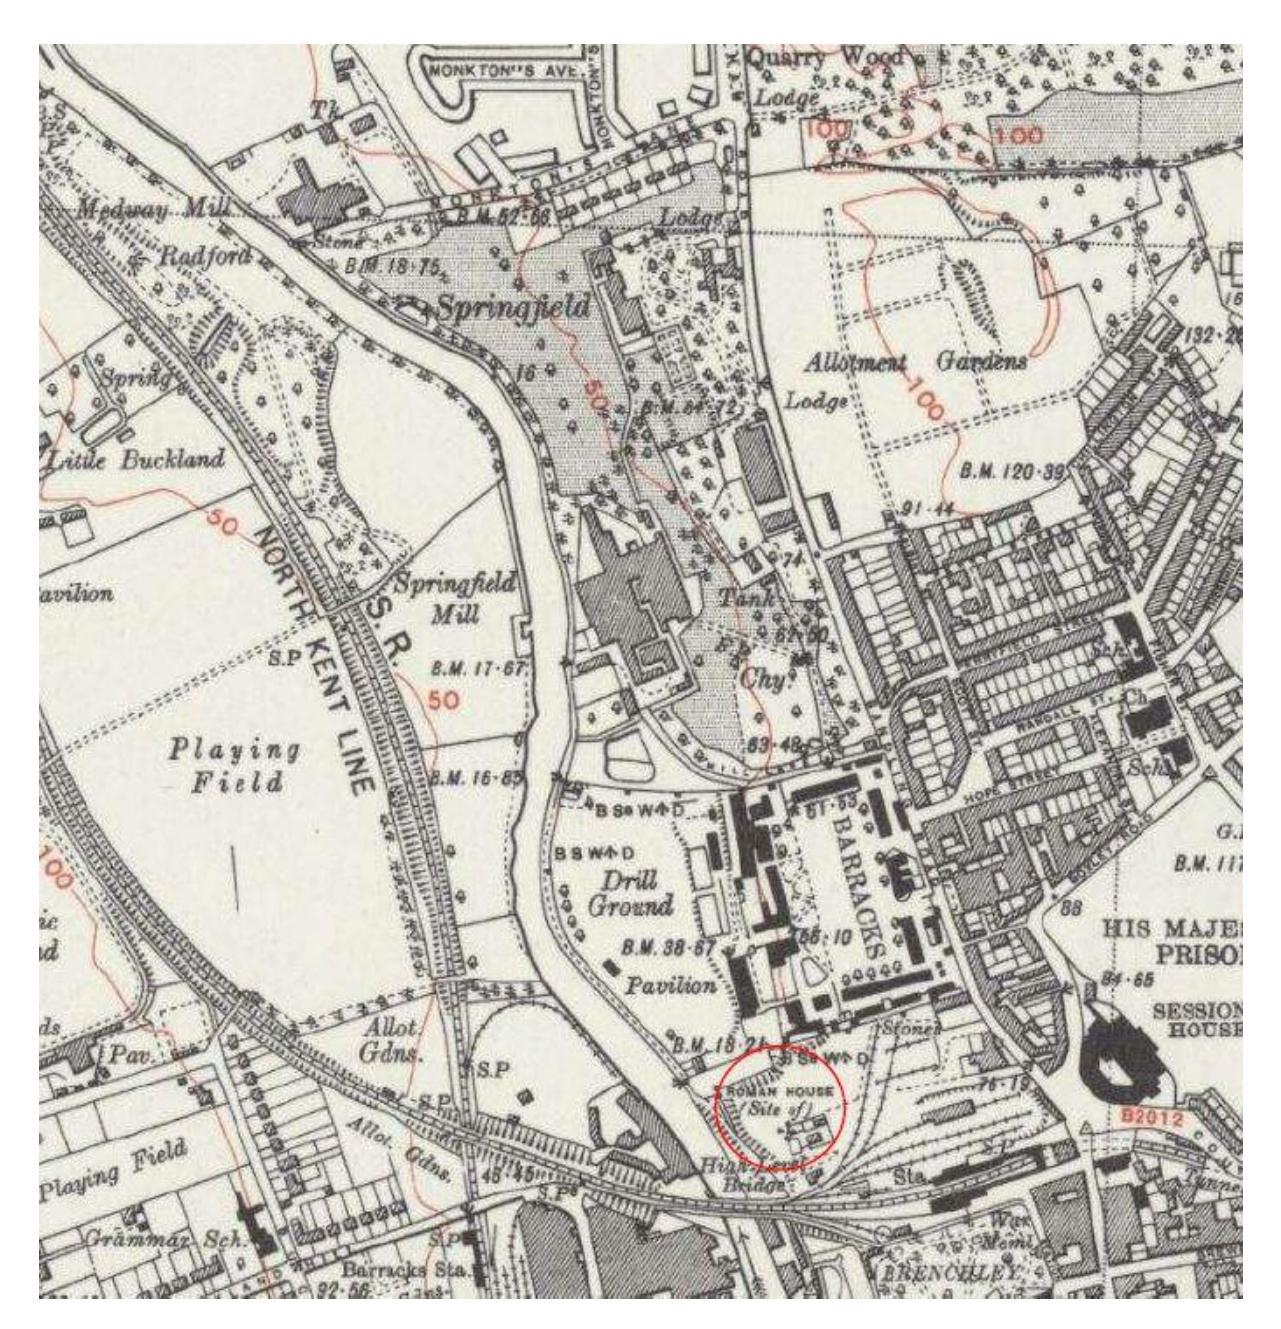
MAP 8. OS map of 1938

7.7 The OS map of 1938 (MAP 8) shows to the south of the paper mill the location of; ROMAN HOUSE (Site of).

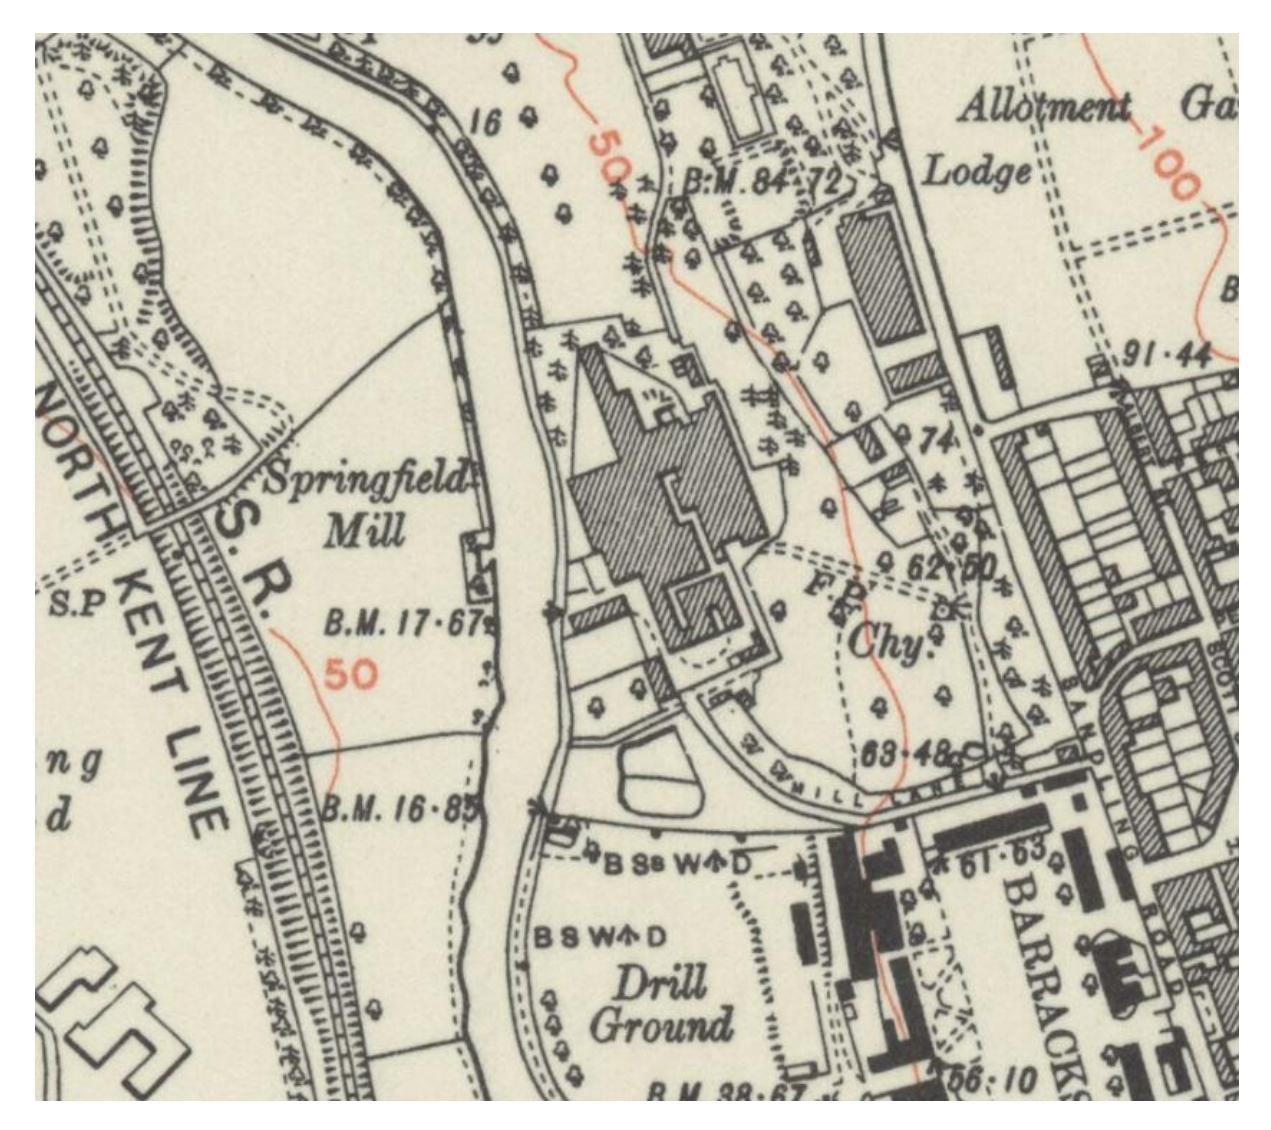
MAP 9. OS map of 1947

7.8 Nine years later the OS map of 1947 shows additional buildings (red circle) attached to the Smithy (MAP 9).
