Historic Building Recording at Springfield Mill, Sandling Road, Maidstone, Kent

Date of Report: 18/03/2020

SWAT Archaeology has been commissioned by Redrow Homes Ltd to carry out a programme of historic building recording at Springfield Mill, Sandling Road, Maidstone in Kent.

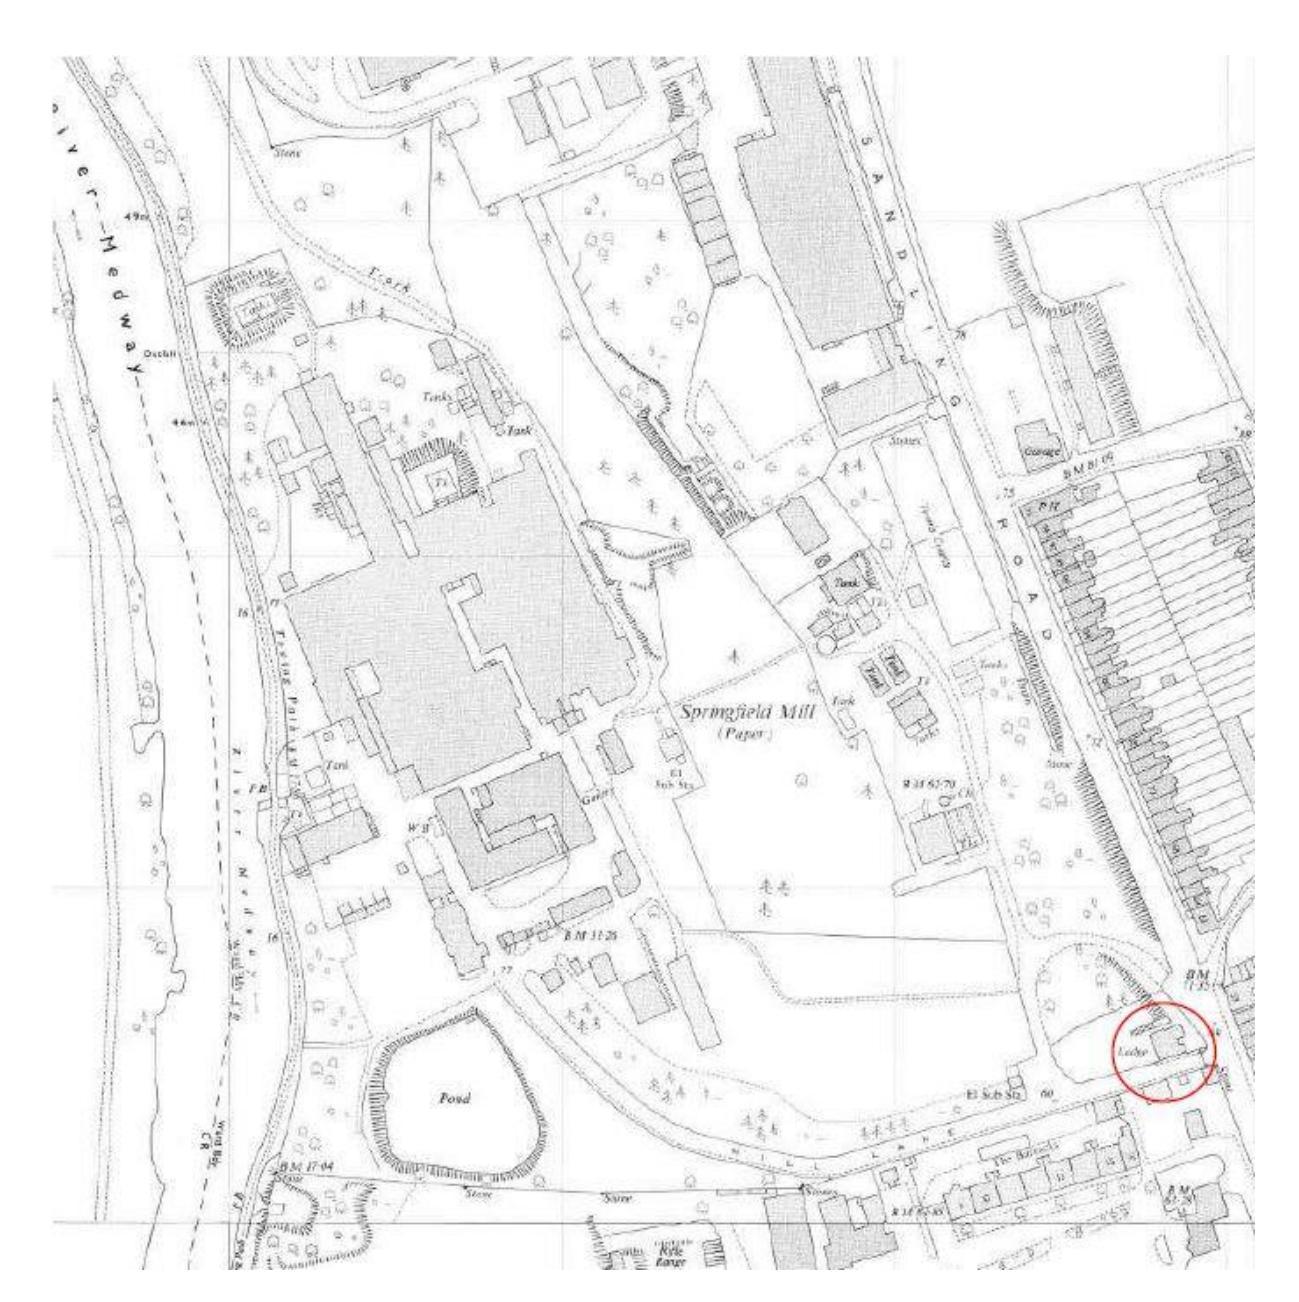
MAP 10. OS map of 1968

7.9 The OS map of 1968 (MAP 10) the Gate House is now labelled 'Lodge' (red circle) and extended with a greenhouse and adjacent shed. To the west 'El Sub Sta' is marked and additional buildings south of the Smithy. To the west of the Smithy additional building have been erected whilst to the east numerous tanks have been installed.

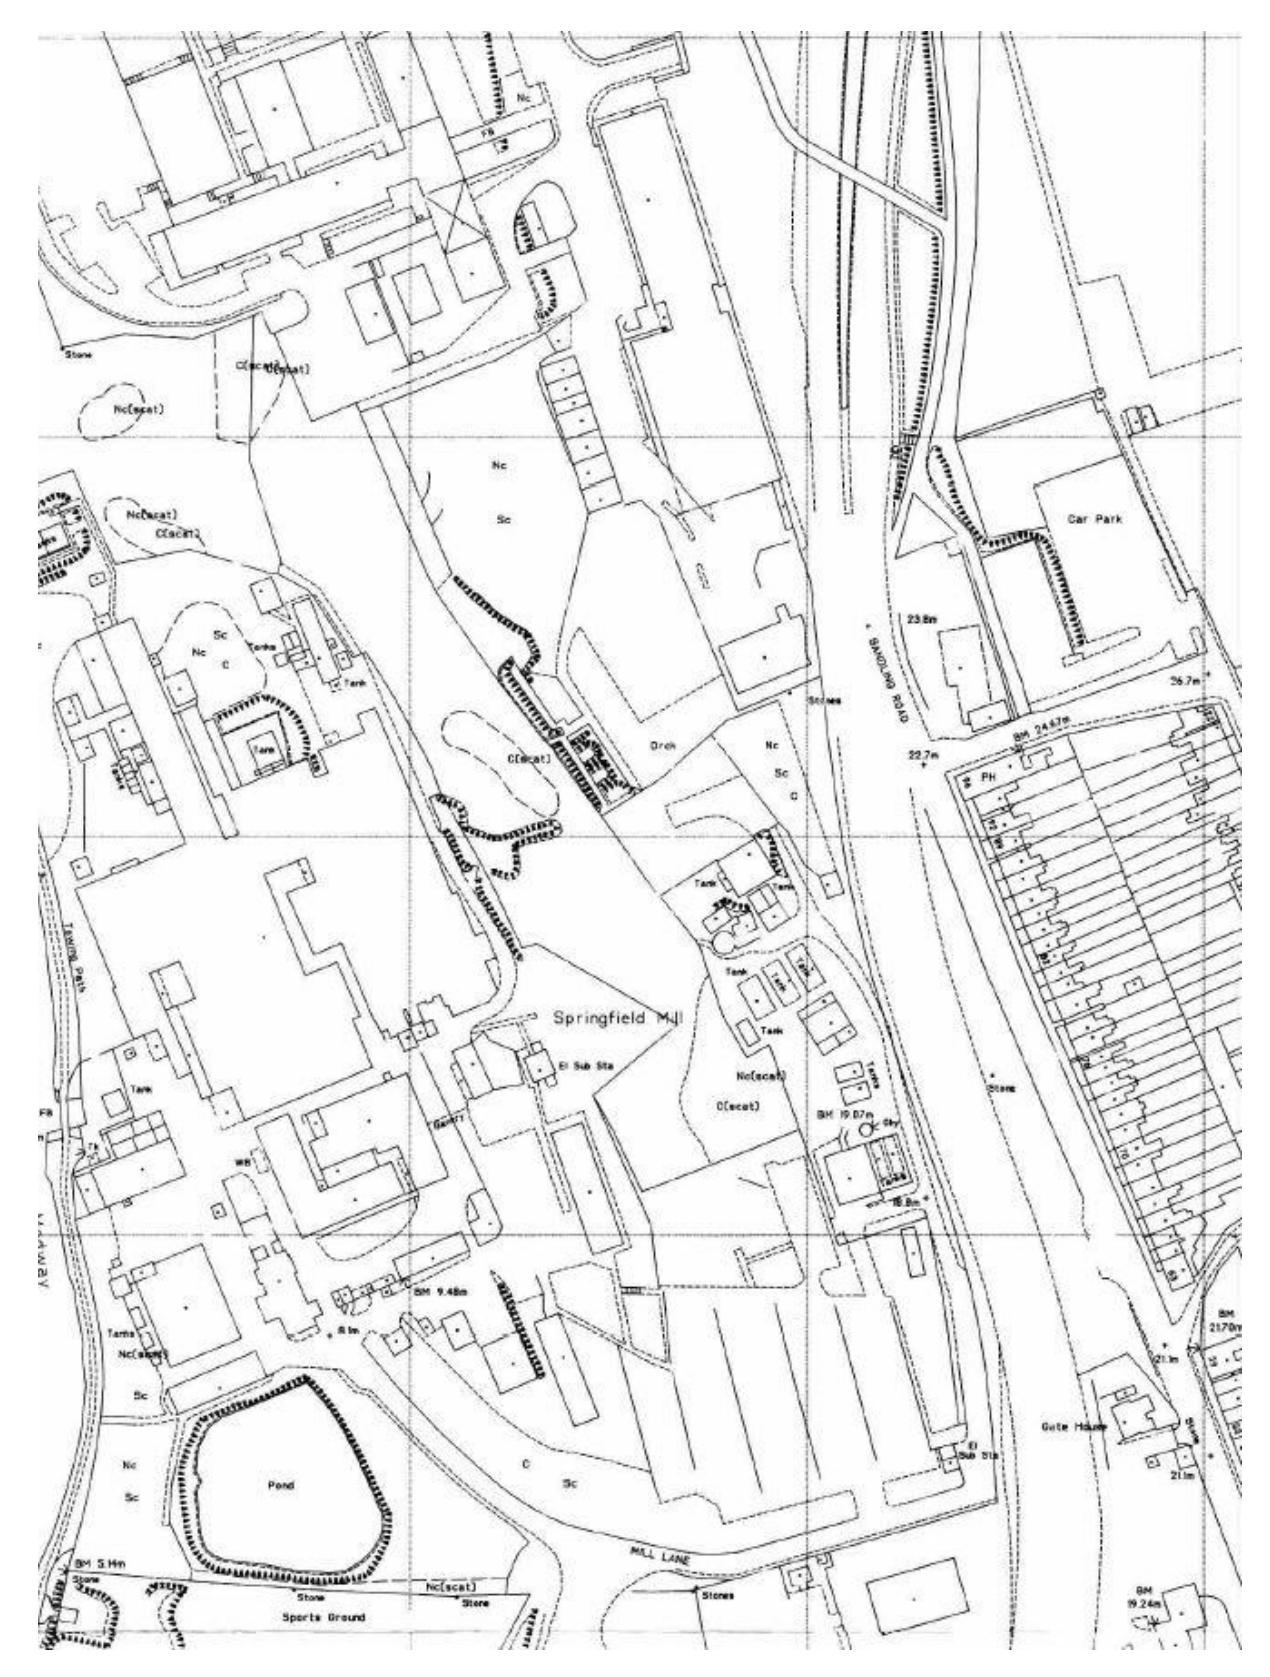
MAP 11. OS map of 1995

7.10 The OS map of 1995 (MAP 11) shows the site almost as it is today with the buildings still surviving. To the east Sandling Road has been rebuilt on a different alignment cutting a swathe through the grounds of Springfield Mill and isolating the 'Lodge' on the wrong side of the road the paper mills Plates 1.2, 1.3).
