# Archaeological Evaluation of Land at 15 Albion Place, Canterbury, Kent

Site Code: ALB/EV/16

(Planning Application: CA/13/01727/FUL)

**SWAT Archaeology**

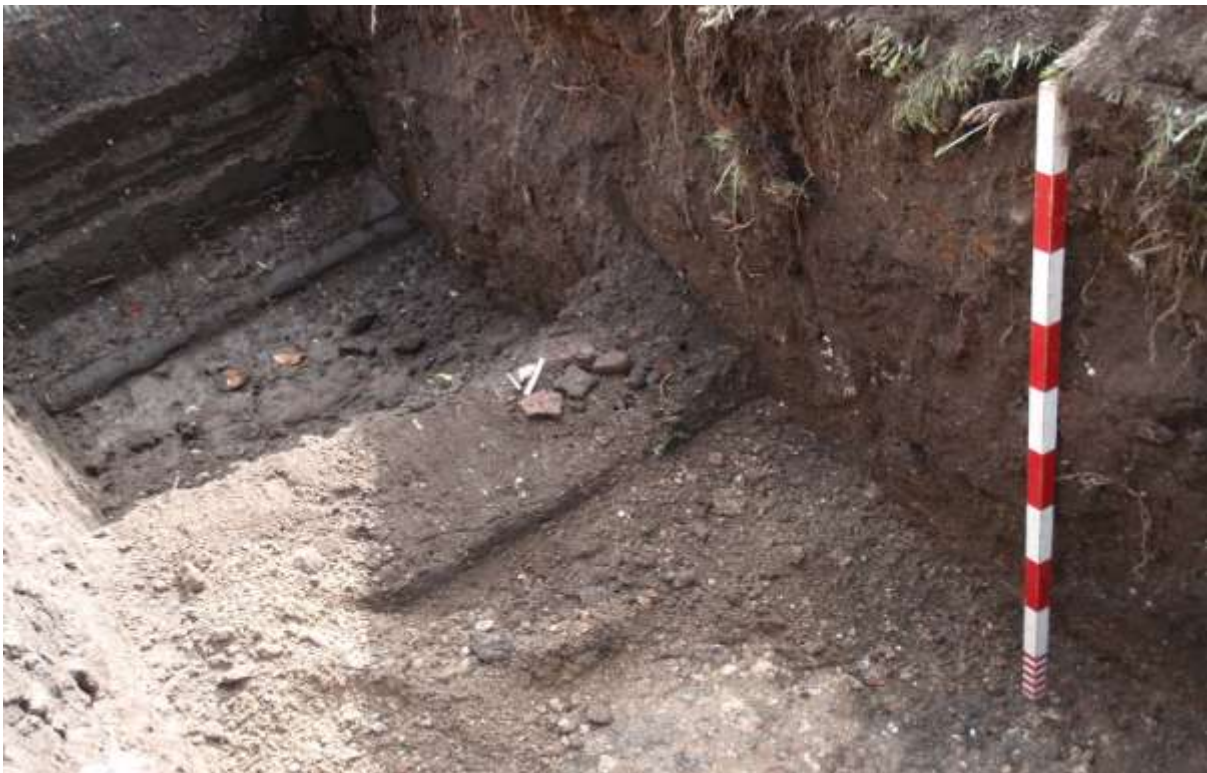
Plate 2 – Trench 1 (looking NE)

**9.1** The plan is recorded in Figure 1 (see also Plates 1-6). The trench lay on a SW to NE alignment and measured approximately 8m by 1.80m.

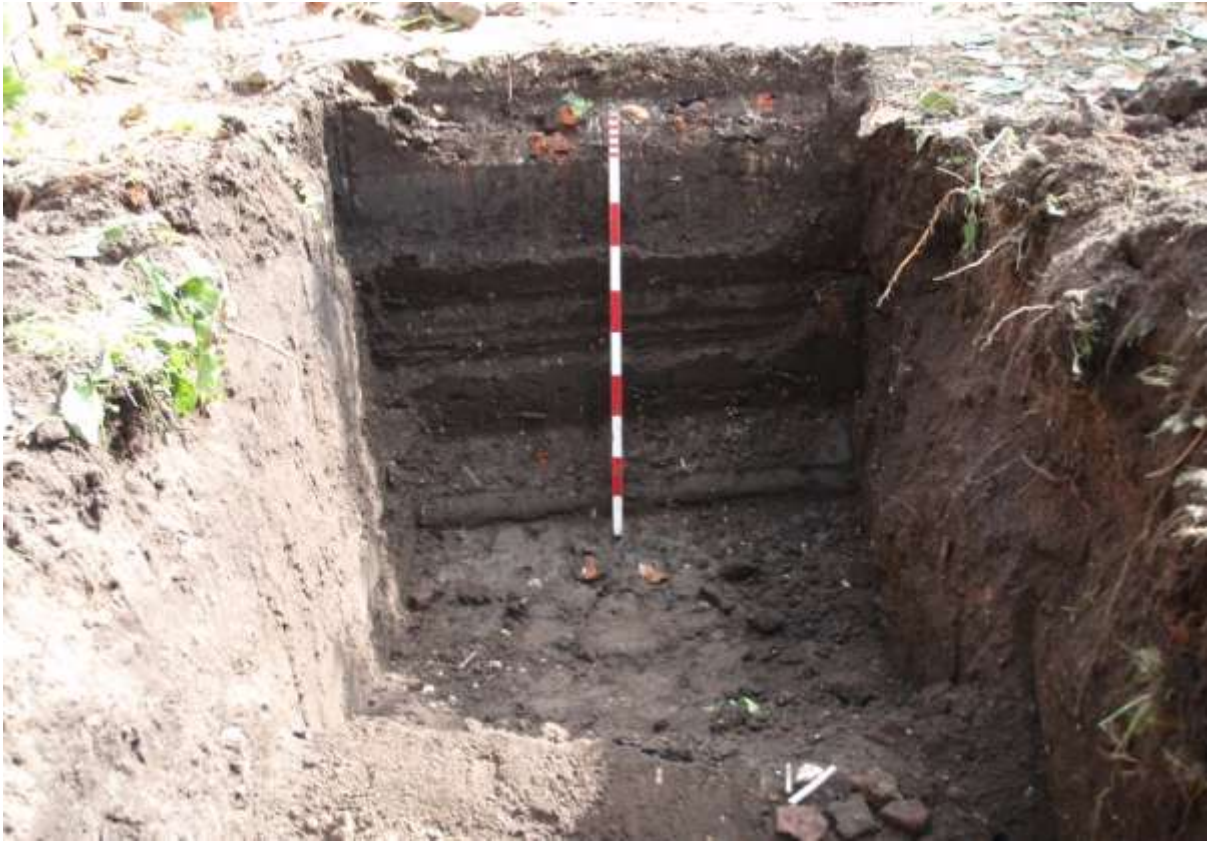
Plate 5- Trench 1 section (lookinh NE)

Made-up ground (**104**) was identified across the trench as a mix of clinker, shells and modern pottery at a depth of approximately 1.05m (10.95m OD) below the present ground surface at 12.00m OD at the NE end of the trench. This depth was the extent of the proposed ring beam foundations. The made-up ground was sealed by a layer of modern rubbish which included motorcycle parts, inner tubes and bottles (**103**) 0.70m thick. Overlaying was a 15cm thick deposit of brown sandy silty soil (**102**) overlaid by topsoil (**101**). This probably represents a modern topsoil layer filled with a high organic content from garden use.

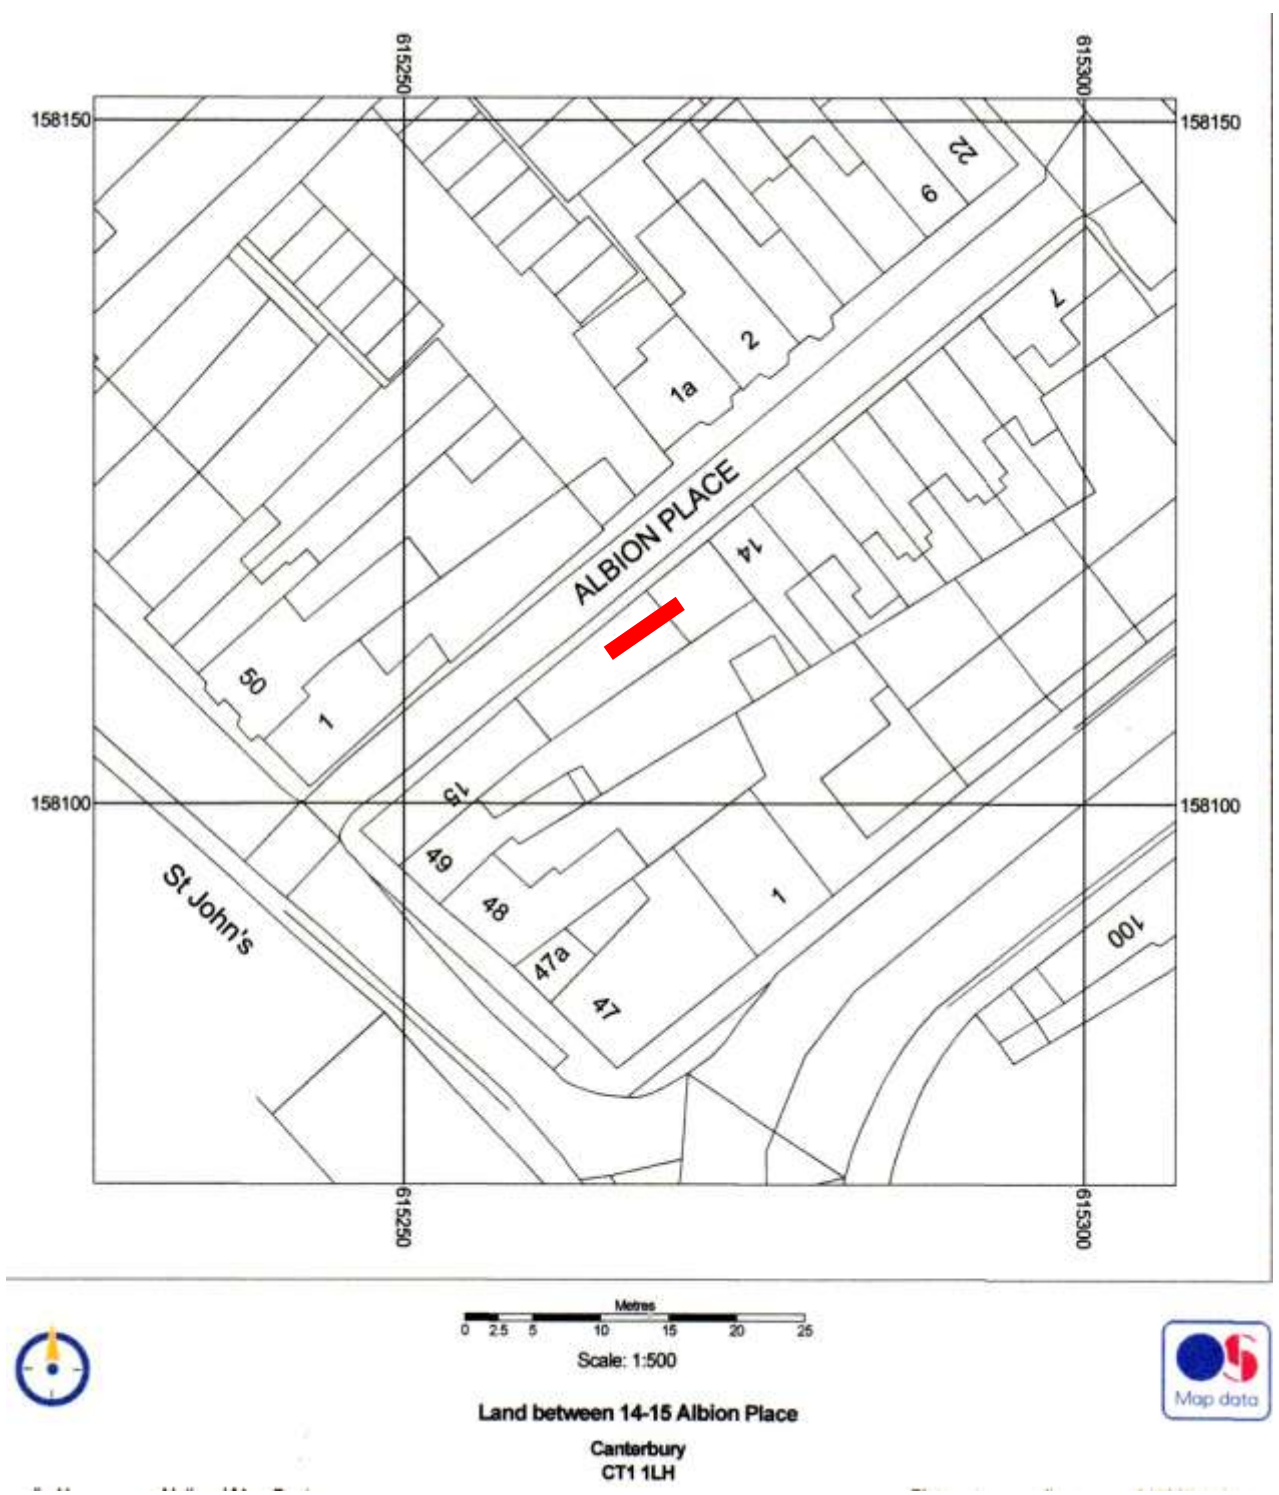
Figure 1. Trench location

The archaeological evaluation was undertaken by the machine excavation with a flat-bladed ditching bucket of one evaluation trench of 8m length. The trench was located across the footprint of the proposed development (Fig. 1).
